Sydney Trains Environmental Management System Site Environmental Management Plan (SEMP)

Project / Program Details		
Project/Program Name	Petersham Terminus Street Building works (Internal)	
Project/Program No	P.0091011.03	
Scope of Works	Heritage maintenance works including; Internal refurbishment works to bring the building to a 'warm shell', as per heritage approvals.	
What is the cost of the scope of works?	<input type="checkbox"/> Routine maintenance - any value <input checked="" type="checkbox"/> Capital investment - less than \$5 million <input type="checkbox"/> Capital investment - more than \$5 million	
Location	Petersham – 5.540 km	
Attach applicable Environmental Work Method Statement (EWMS)	EWMS Number	EWMS Title
	EMS-03-EW-0299	Station Refresh
Is any of the proposed work outside of the EWMS' scope?	<input checked="" type="checkbox"/> No: Continue to next question <input type="checkbox"/> Yes:

SCHEDULE OF WORKS – FORMER PETERSHAM STATION BUILDING INTERIOR CONSERVATION – ISSUE E – 26 May 2025

Hazardous Building Materials Management Plan

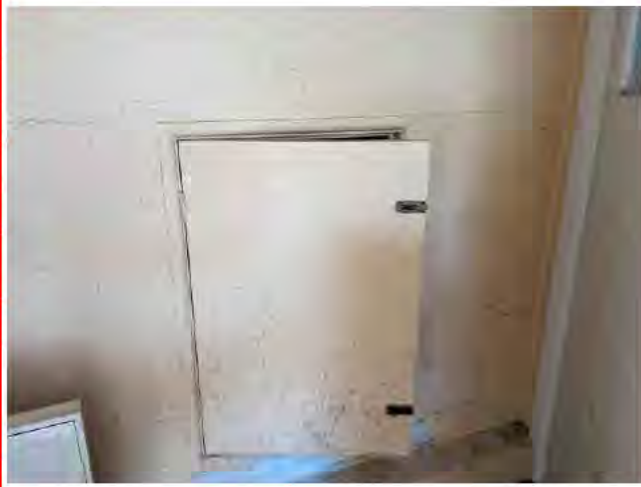
Survey Level	Basement			
Building	Building 1 Old Petersham Station			
Room	Basement			
Item Location and Description	Access door - Fibre cement sheet			
Sample Number	Previously Sampled: OHMS-41907			
Sample Status	Positive			
Hazardous Material / Asbestos Content	Chrysotile			
Risk Assessment	3	Priority Rating	Very Low	
Recommendations	Label and manage in-situ (non-friable).

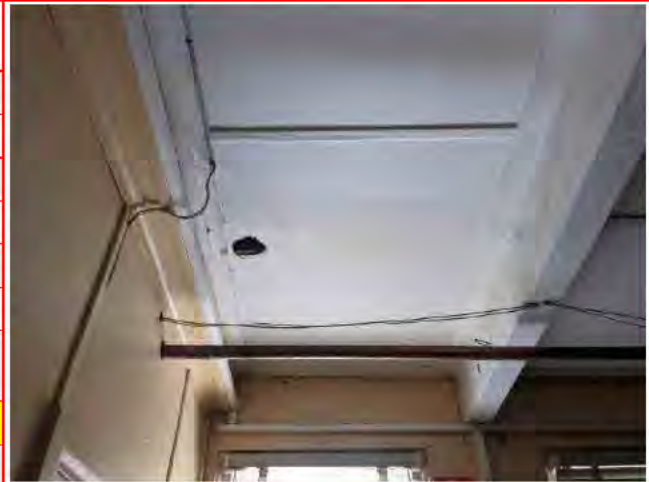
Item Number	4	Reinspection Date	Apr-27
Survey Level	Basement		
Building	Building 1 Old Petersham Station		
Room	Basement, Room under stairs		
Item Location and Description	Ceiling - Fibre cement sheet		
Sample Number	Previously Sampled: 003		
Sample Status	Positive		
Hazardous Material / Asbestos Content	Chrysotile / Amosite		
Risk Assessment	7	Priority Rating	Very Low
Recommendations	Remove under non-friable conditions.

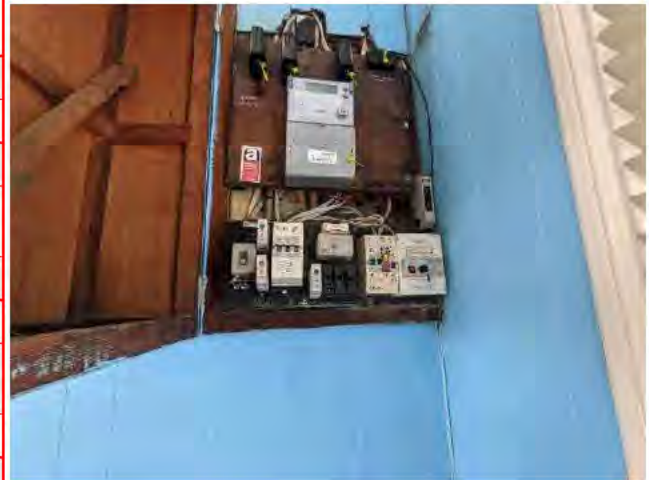
Item Number	10	Reinspection Date	Apr-27
Survey Level	1st Floor		
Building	Building 1 Old Petersham Station		
Room	Entry room		
Item Location and Description	Electrical board - Bituminous backing board		
Sample Number	P2100299-OHMS-41906		
Sample Status	Positive		
Hazardous Material / Asbestos Content	Chrysotile		
Risk Assessment	5	Priority Rating	Very Low
Recommendations	Label and manage in-situ (non-friable).

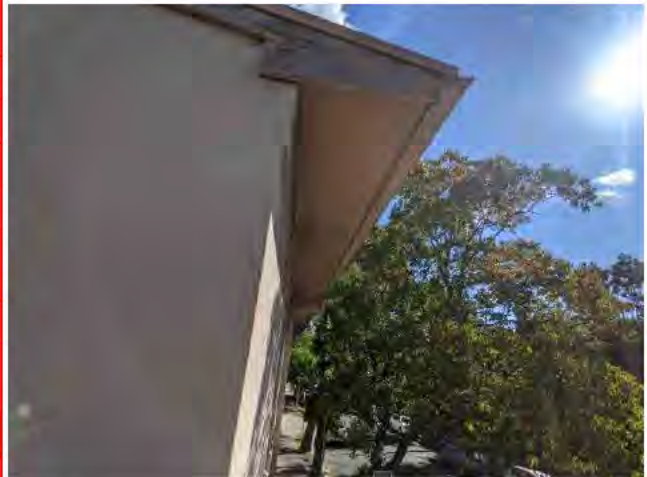
Item Number	13	Reinspection Date	Apr-27
Survey Level	1st Floor		
Building	Building 1 Old Petersham Station		
Room	External, Kitchen		
Item Location and Description	South Wall - Fibre cement sheet		
Sample Number	P2100299-OHMS-41907		
Sample Status	Positive		
Hazardous Material / Asbestos Content	Chrysotile		
Risk Assessment	8	Priority Rating	Very Low
Recommendations	Encapsulate, label and manage in-situ (non-friable).

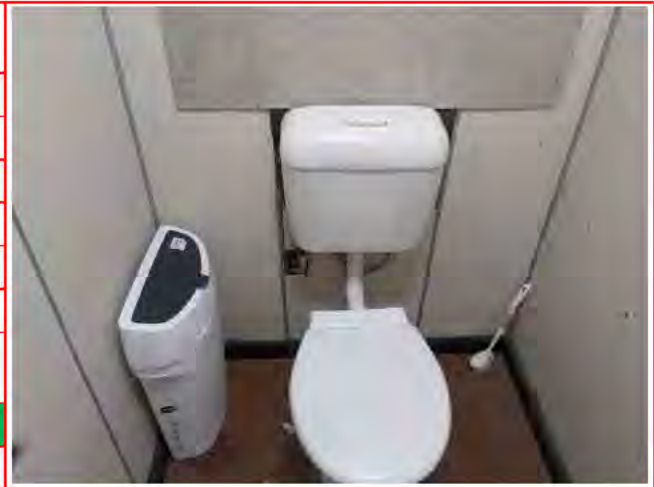
Item Number	17	Reinspection Date	Apr-27
Survey Level	1st Floor		
Building	Building 1 Old Petersham Station		
Room	Male toilet		
Item Location and Description	Ceiling lining - Fibre cement sheet		
Sample Number	Previously Sampled: OHMS-41907		
Sample Status	Positive		
Hazardous Material / Asbestos Content	Chrysotile		
Risk Assessment	4	Priority Rating	Very Low
Recommendations	Label and manage in-situ (non-friable).

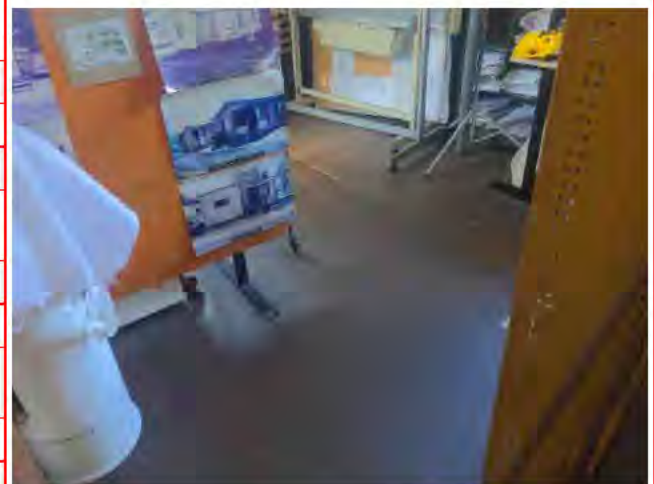
Item Number	20	Reinspection Date	Apr-27
Survey Level	Basement		
Building	Original Petersham Station		
Room	Basement, Undercroft		
Item Location and Description	Shelves - Fibre cement sheet		
Sample Number	Previously Sampled: 011		
Sample Status	Positive		
Hazardous Material / Asbestos Content	Chrysotile		
Risk Assessment	8	Priority Rating	Very Low
Recommendations	Remove under non-friable conditions.

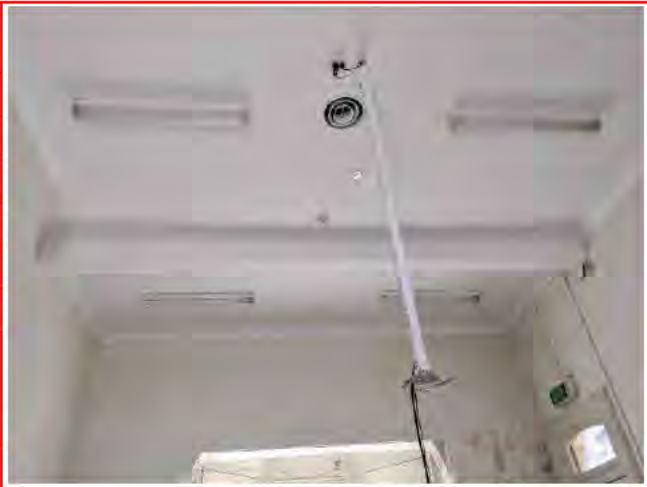
Item Number	26	Reinspection Date	Apr-27
Survey Level	1st Floor		
Building	Original Petersham Station		
Room	Rooms No.2 East, No.4 East, No.2 West & No.5 West		
Item Location and Description	Ceiling linings - Fibre cement sheet		
Sample Number	P2100299-OHMS-41917		
Sample Status	Positive		
Hazardous Material / Asbestos Content	Chrysotile		
Risk Assessment	12	Priority Rating	Low
Recommendations	Encapsulate, label and manage in-situ (non-friable).

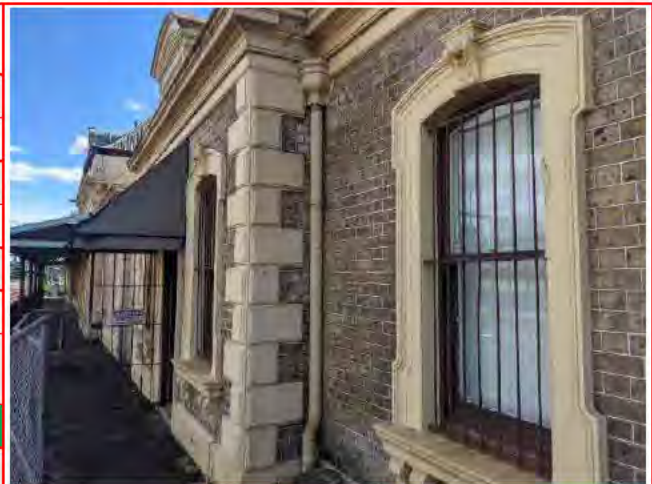
Item Number	38	Reinspection Date	-
Survey Level	1st Floor		
Building	Building 1 Old Petersham Station		
Room	External		
Item Location and Description	Window frames & Bars (Peach Brown paint)		
Sample Number	OHMS-41914		
Sample Status	Sampled		
Hazardous Material / Asbestos Content	Lead Containing Paint		
Risk Assessment	9	Priority Rating	Medium
Recommendations	Remove in accordance with legislation (industrial applications).

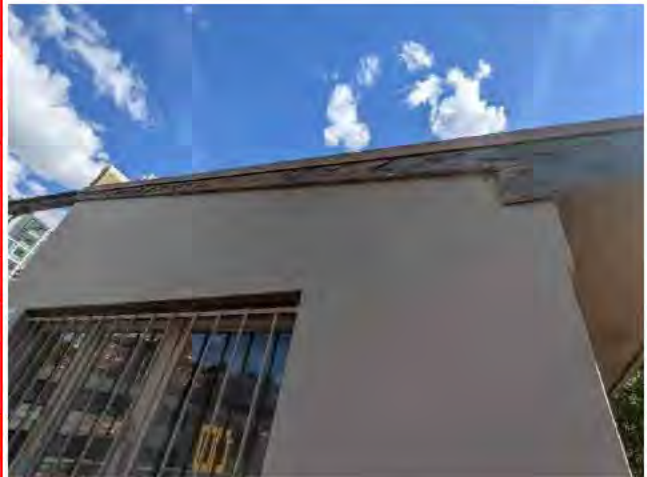
Item Number	42	Reinspection Date	-
Survey Level	1st Floor		
Building	Building 1 Old Petersham Station		
Room	External q		
Item Location and Description	Window frames and Bars (Brown paint)		
Sample Number	OHMS-41910		
Sample Status	Previously Sampled		
Hazardous Material / Asbestos Content	Lead Containing Paint		
Risk Assessment	8	Priority Rating	Low
Recommendations	Manage in-situ.

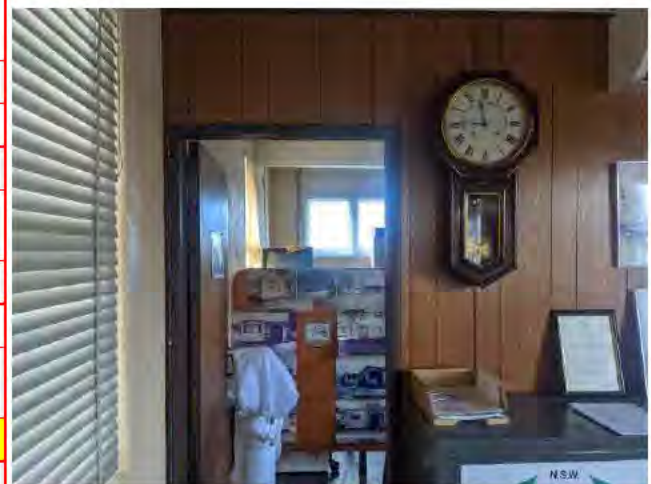
Item Number	46	Reinspection Date	-
Survey Level	1st Floor		
Building	Building 1 Old Petersham Station		
Room	Storage room		
Item Location and Description	Windows (Cream paint)		
Sample Number	OHMS-41902		
Sample Status	Sampled		
Hazardous Material / Asbestos Content	Lead Containing Paint		
Risk Assessment	7	Priority Rating	Low
Recommendations	Manage in-situ.

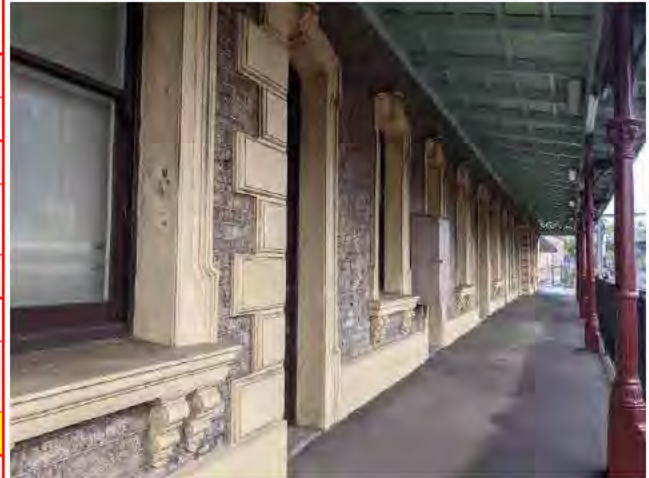
Item Number	57	Reinspection Date	-
Survey Level	1st Floor		
Building	Original Petersham Station		
Room	External, Awning		
Item Location and Description	Timber work (Green paint)		
Sample Number	OHMS-41923		
Sample Status	Sampled		
Hazardous Material / Asbestos Content	Lead Containing Paint		
Risk Assessment	4	Priority Rating	Very Low
Recommendations	Manage in-situ.
