# Tarago Action Plan Routine Inspection Checklist

| Date: | 10-Dec-24 | Ramboll and UGL RL Environmental |

| Title: | Tarago Rail Yard Inspection | Approved:<br>JA | Project-Nr.:<br>318001704 | Date:<br>10 December 2024 |
| Site: | Tarago, NSW | | | |

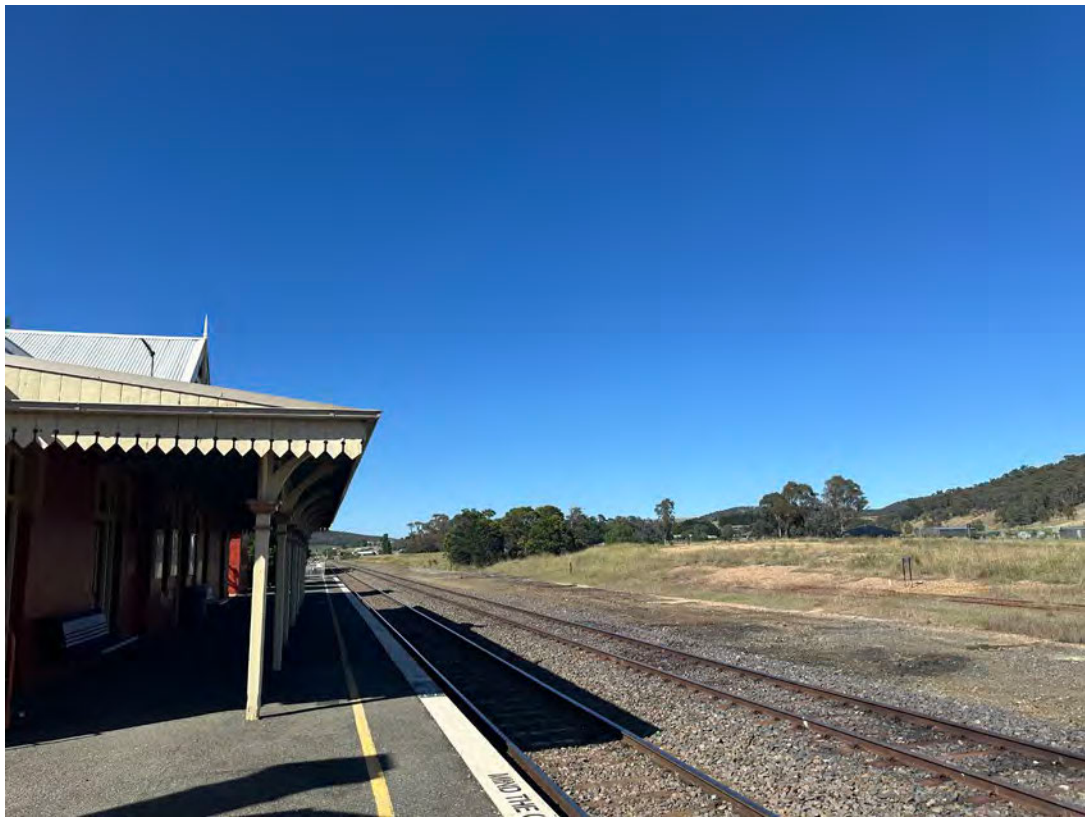
| No airborne dust was visible ( <b>Photos 1 - 2</b> ). | | |

Photo 1: Picture at northern end of Tarago railway station platform facing south, no airborne dust visible.

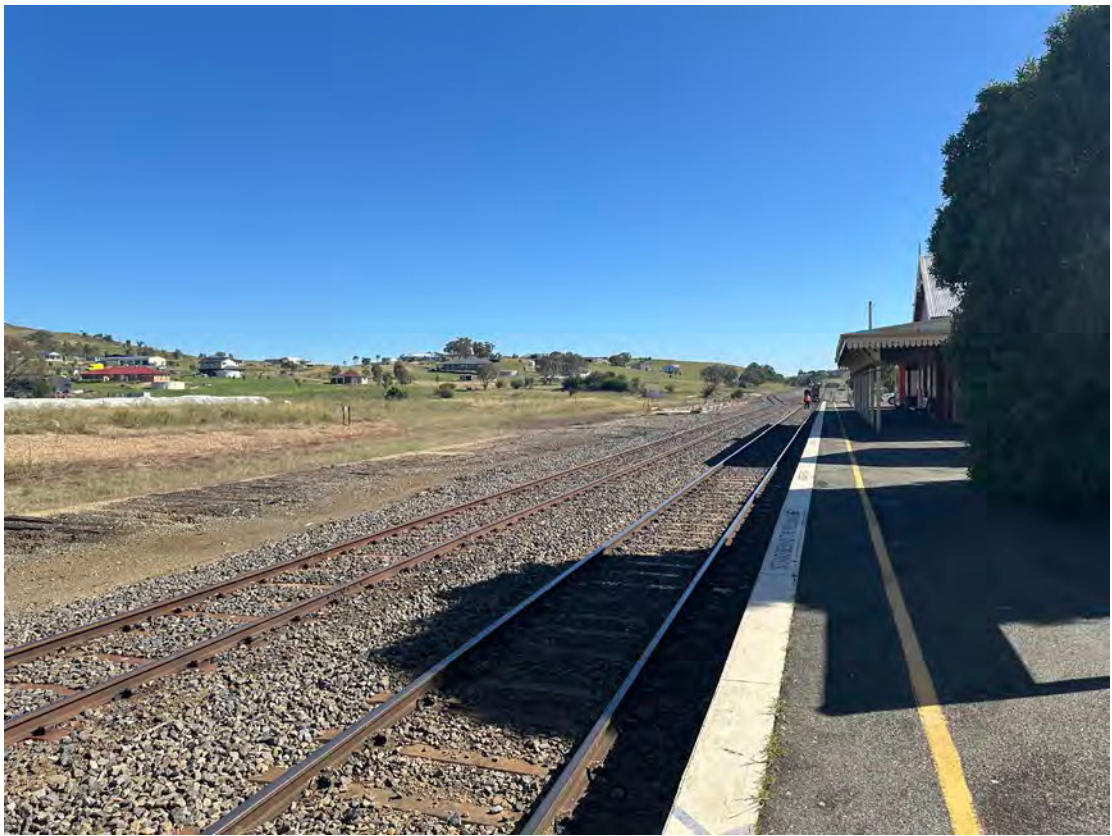
Photo 2: Picture facing north towards Tarago railway station, no airborne dust visible.

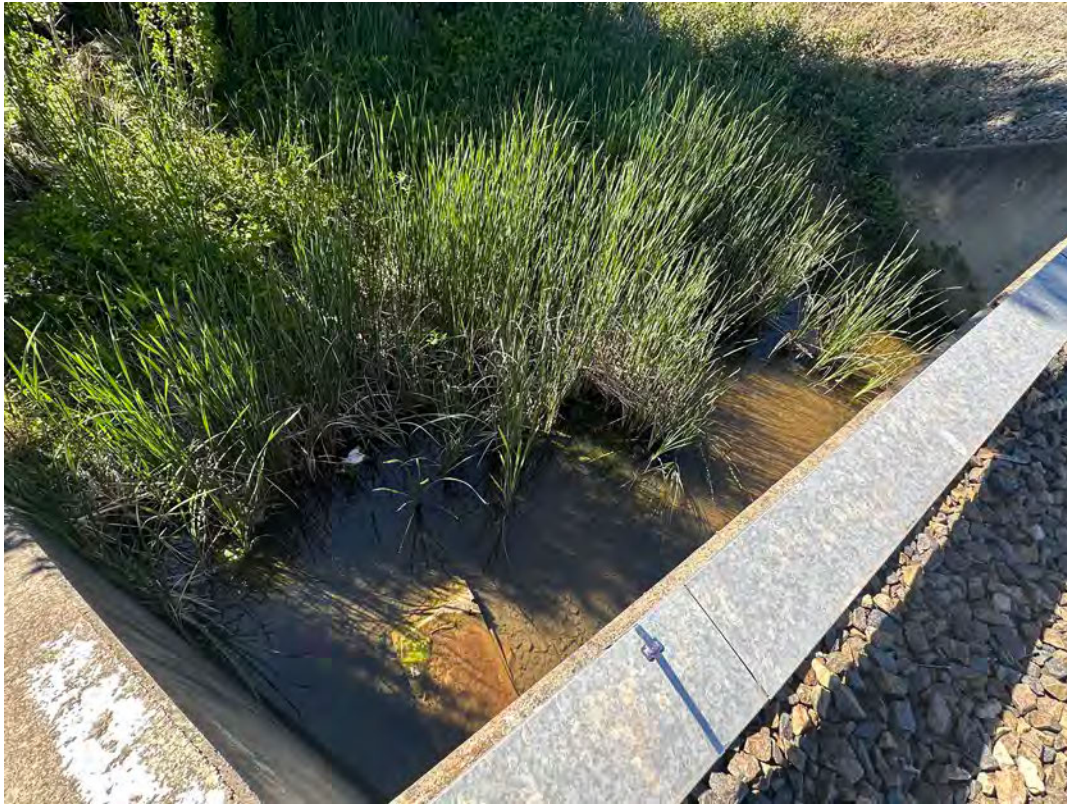
| No sign of sediment run-off seen in surface water flowing off-site at southern or middle culverts ( <b>Photos 3 - 6</b> ). No evidence of sediment run-off from northern culverts observed ( <b>Photos 7 - 8</b> ). | | |

**Photo 3: Southern culvert downgradient of railway line with slow moving surface water flowing offsite. Surface water was clear with no visible turbidity or suspended solids.**

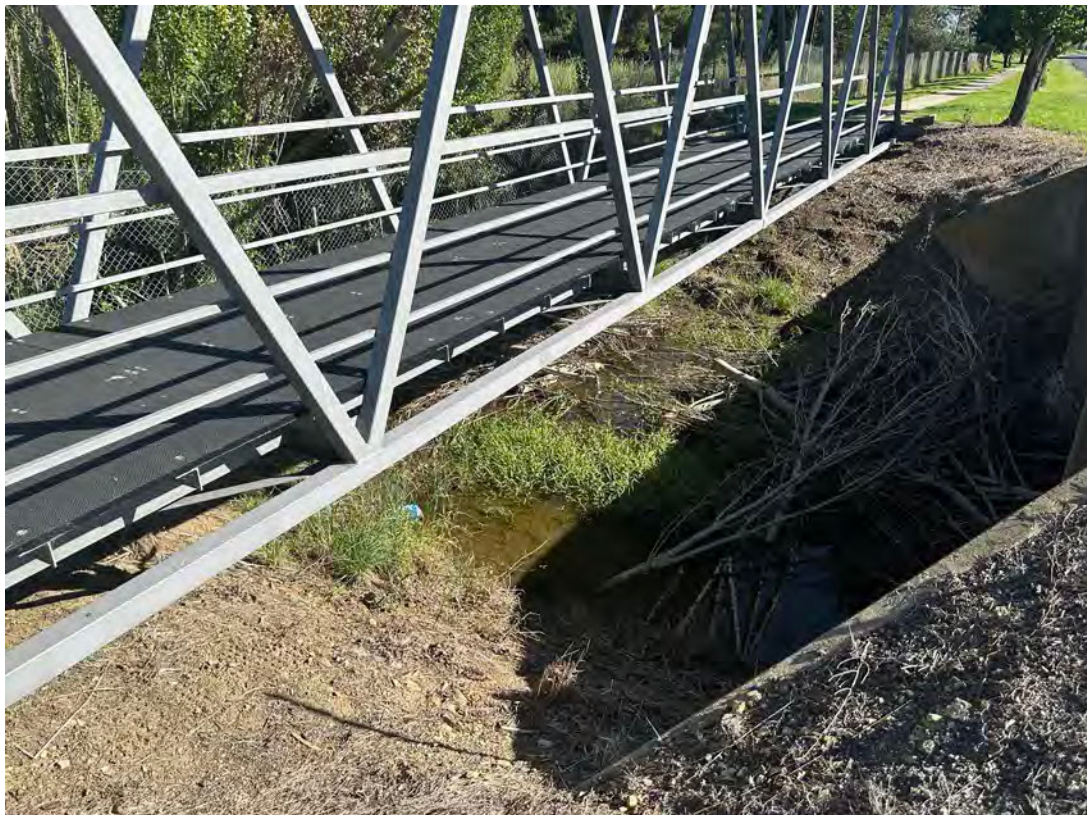
**Photo 4: Downgradient of southern culvert off site. Slow water flowing (left to right) off site underneath roadway.**

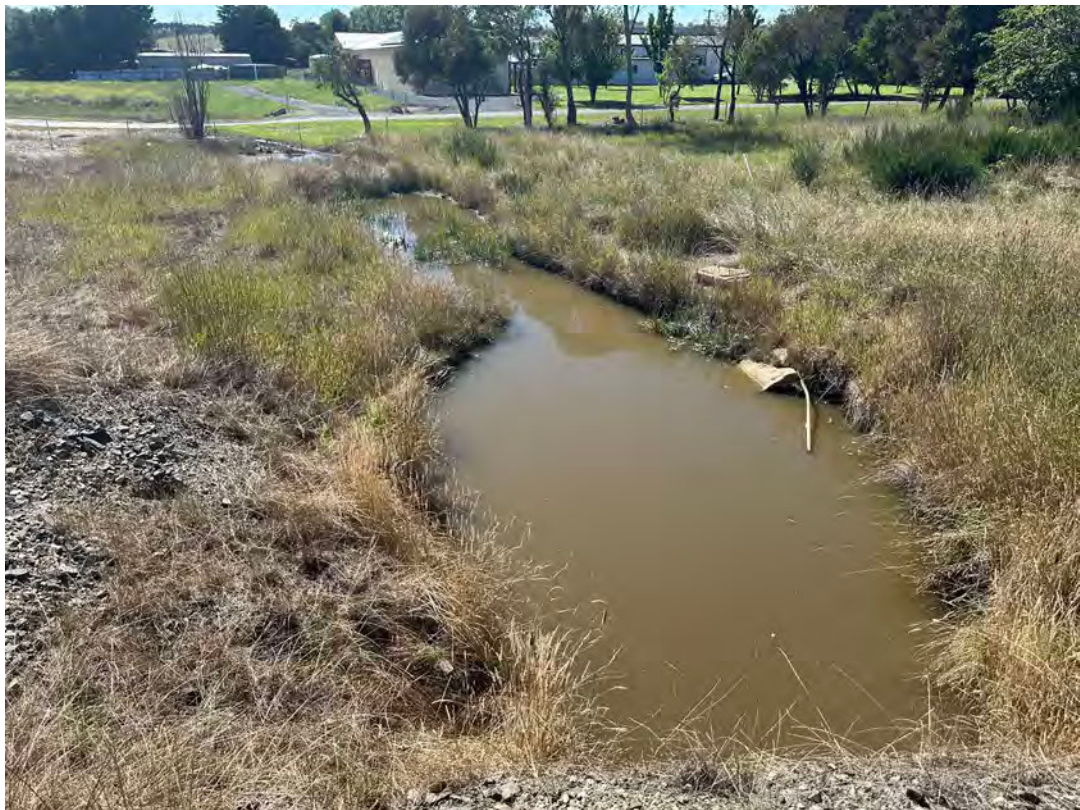
**Photo 5: Downgradient of middle culvert with slow moving surface water flowing off site. Surface water near culvert was brown.**

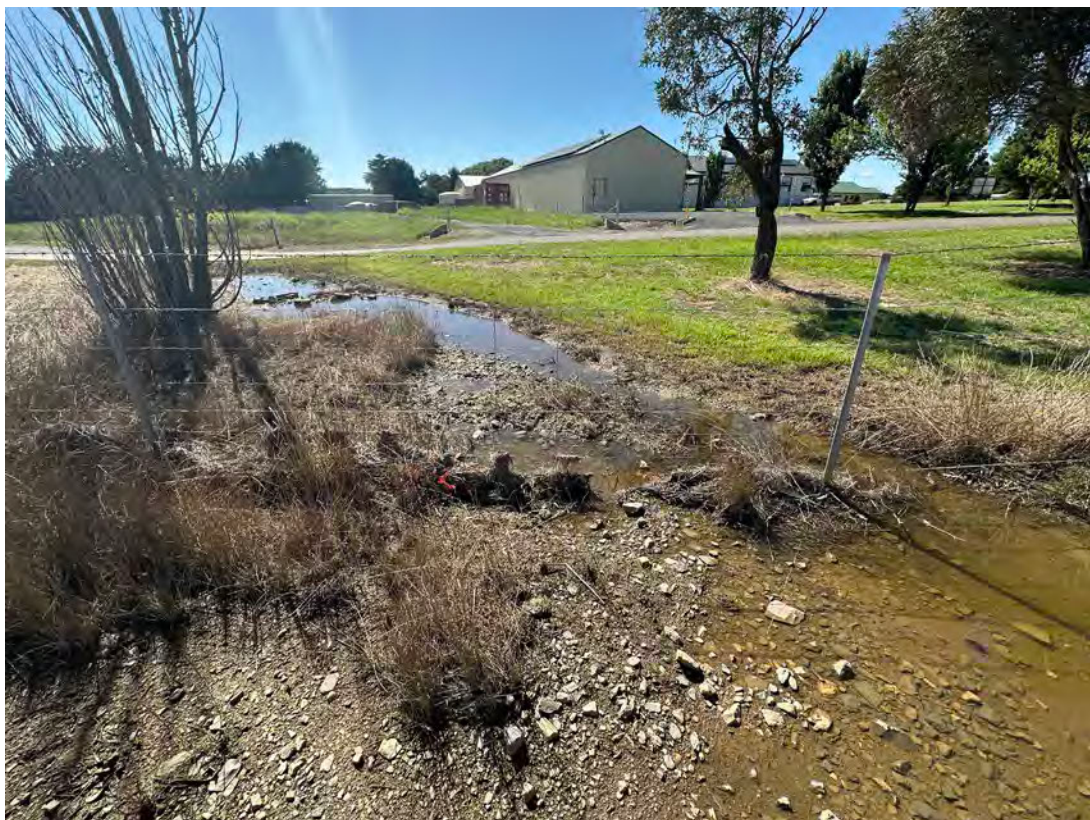
**Photo 6: Downgradient of middle culvert facing south with slow moving surface water flowing off site at fence line. Surface water was clear with a brown tint and no visible turbidity.**

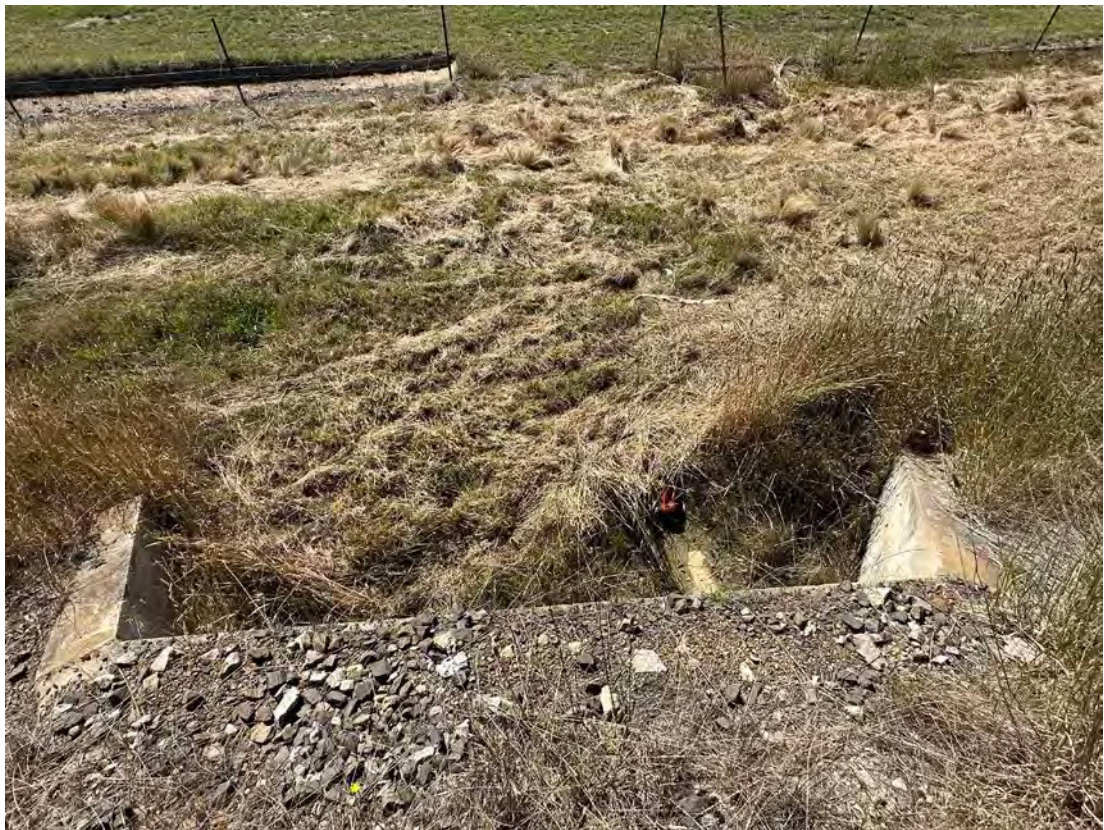
Photo 7: Downgradient of northernmost culvert with no observed surface water. Trench line had been dug on adjacent property.

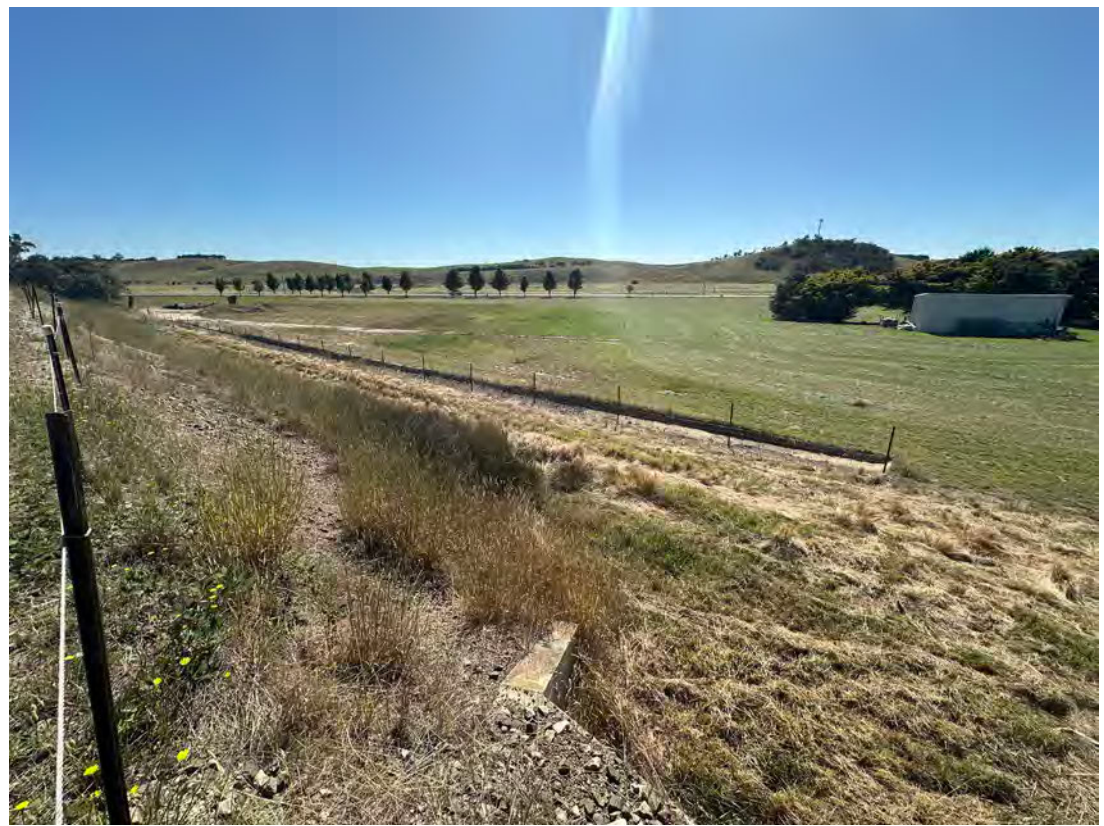
Photo 8: Property downgradient of northernmost culvert with no observed surface water.

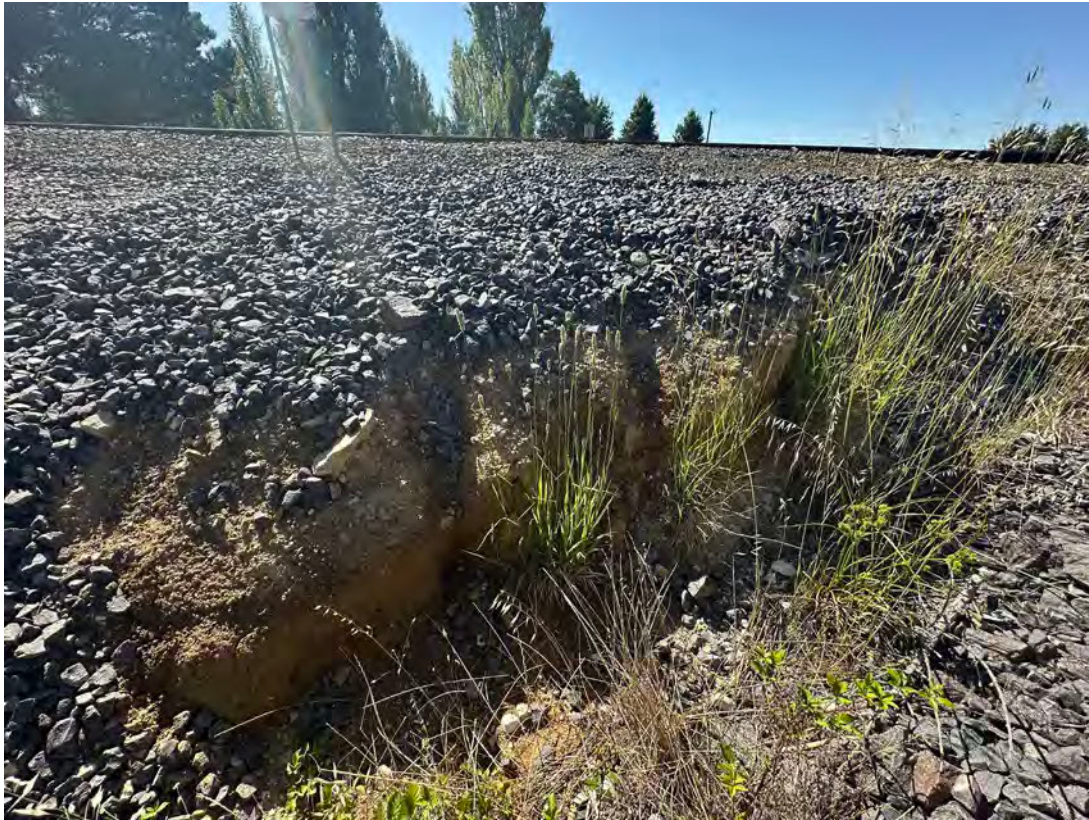
**Photo 9: Southernmost culvert upgradient of the railway line. The erosion due to lack of ground cover observed during multiple previous inspections is still present.**

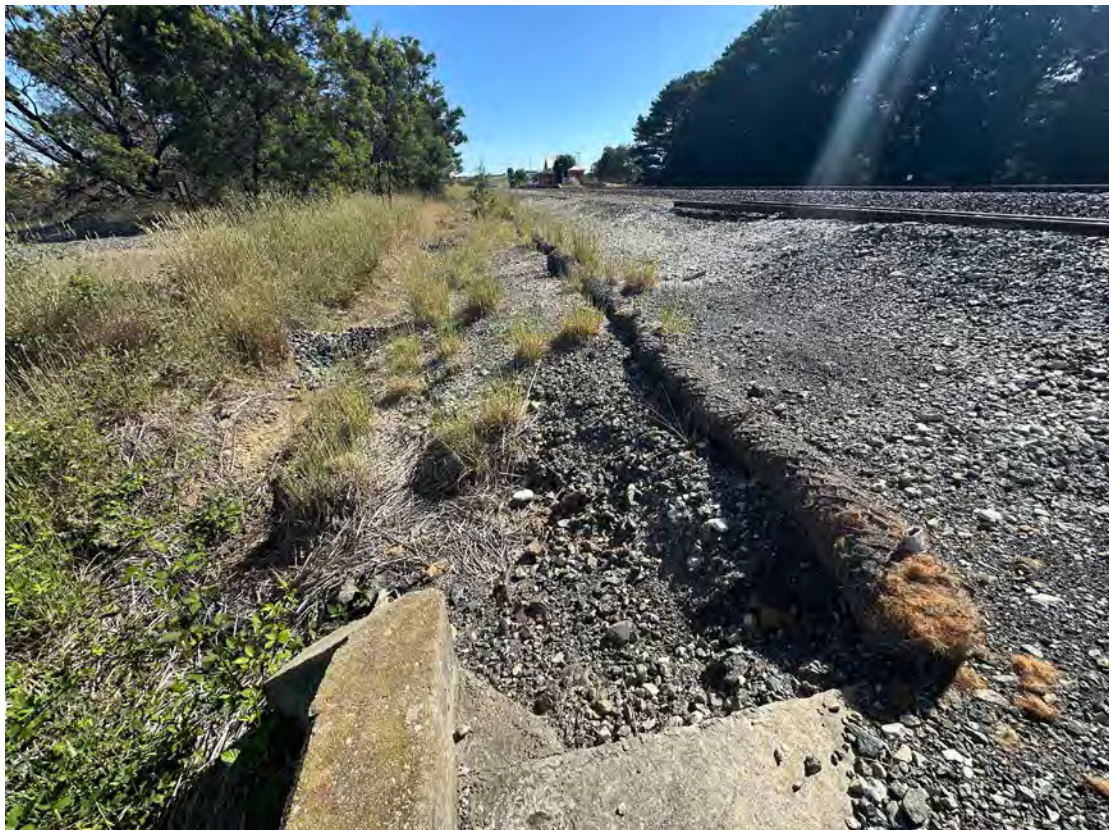
**Photo 10: Sediment controls at southernmost culvert upgradient of the railway line.**

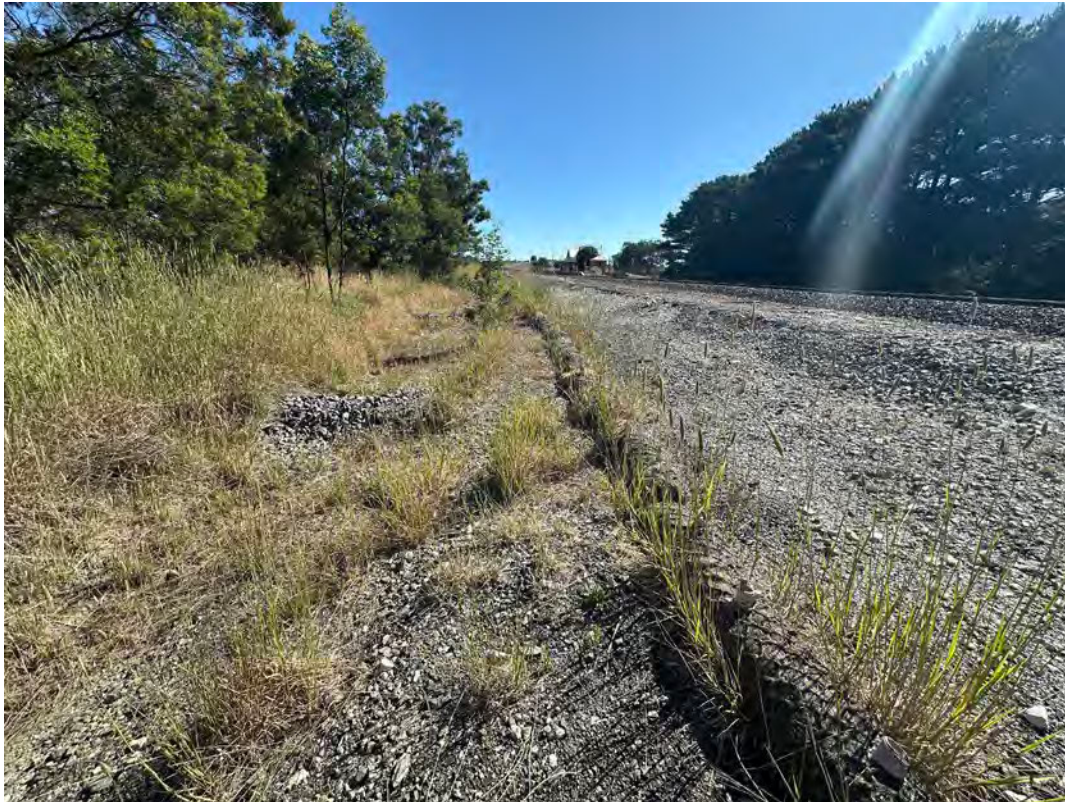
**Photo 11: Rock armoury in drainage channel between southern and middle culverts replenished and less sediment and vegetation build up observed.**

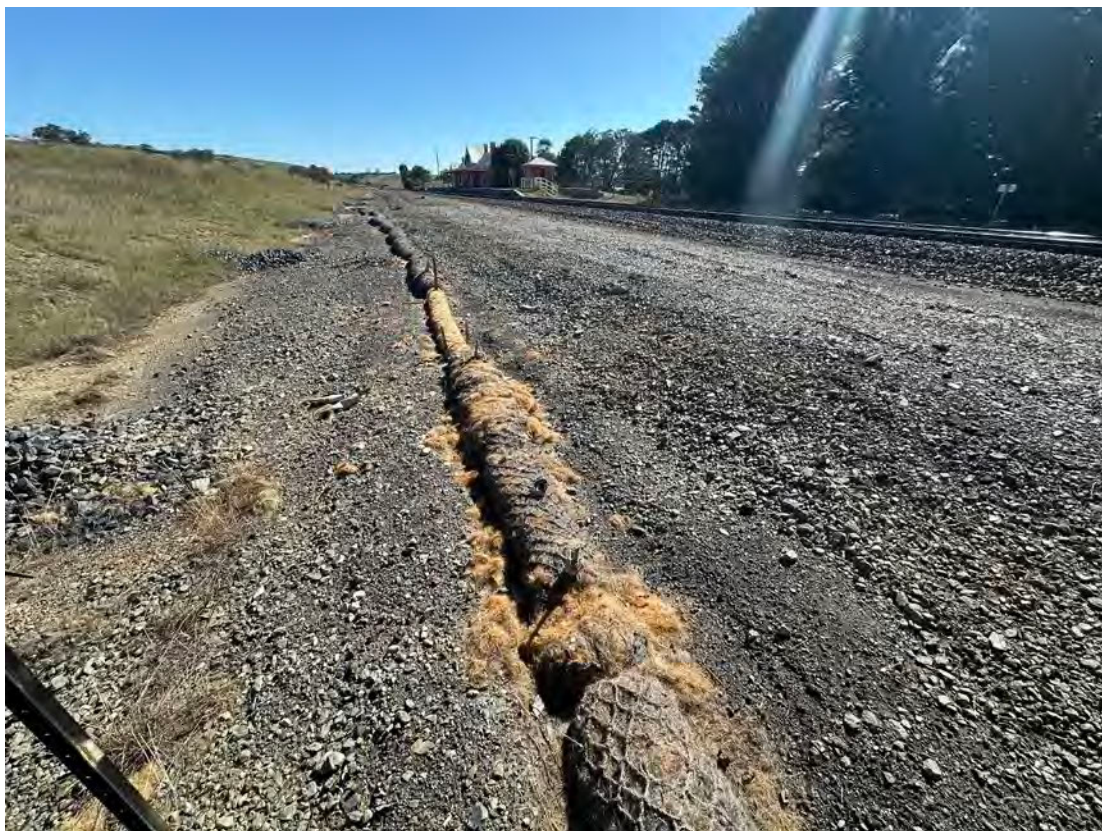
| <p>1. Damages to sediment control coir logs located between middle and southern culverts were observed in previous and current inspections. It is suspected the damage has been caused by birds. This was observed to be appropriately maintained (<b>Photo 12</b>). New coir logs are available on-site, and Ramboll recommends replacing any damaged coir logs that are no longer effective in controlling sediment.</p> <p>2. Evidence of erosion noted upgradient of the southern most culvert in previous site inspections remains on site but in a stable condition (<b>Photo 9</b>). No evidence of sediment was observed in water pooled downgradient onsite at southern culvert during this site inspection. In addition, some minor erosion due to inadequate ground cover was also observed upgradient of the railway line, to the north of the middle culvert (<b>Photo 15</b>). Ramboll recommends replacing ground cover material (ballast) if further erosion occurs or sediment is visible in the downstream surface water.</p> | | |

**Photo 12: Damage to sediment control coir logs between southern and middle culverts maintained appropriately. Suspected damage caused by birds.**

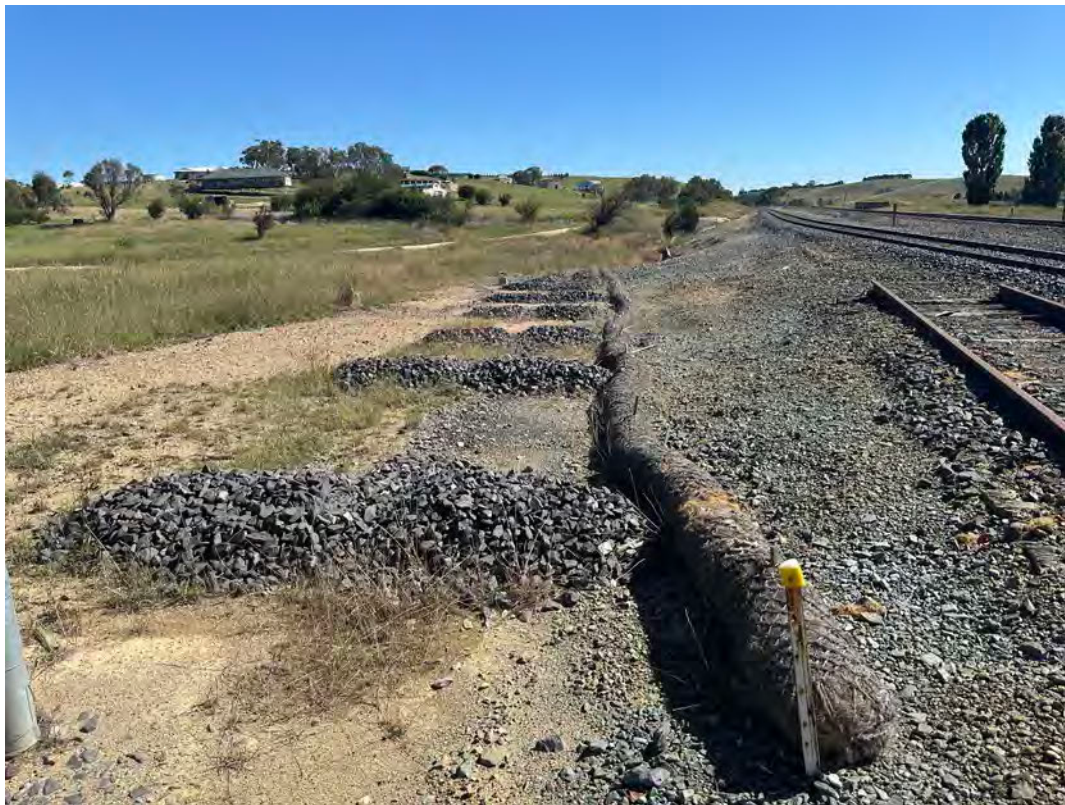
**Photo 13: Rock armoury in drainage channel between southern and middle culverts appears to be in good condition.**

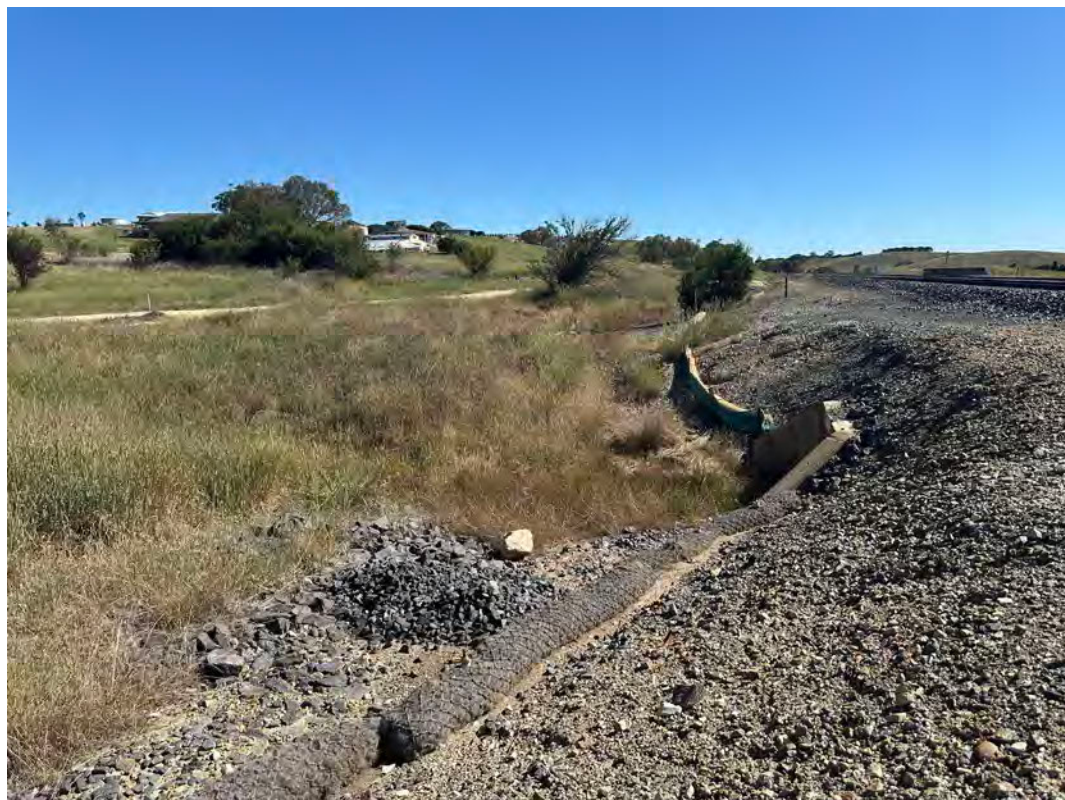
**Photo 14: Sediment controls at the middle culvert upgradient of the railway line in good condition.**

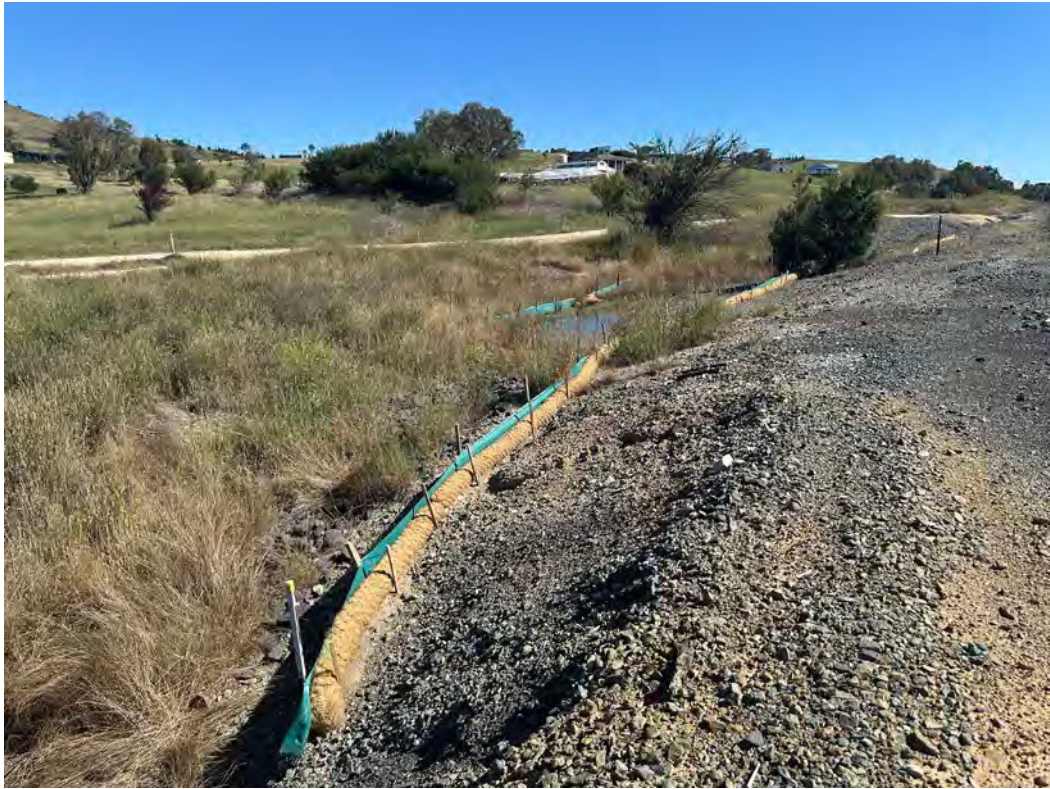
**Photo 15: Sediment controls north of middle culvert, upgradient of railway line in good condition. Minor inadequate ground cover observed during the previous inspections remained in a stable condition.**

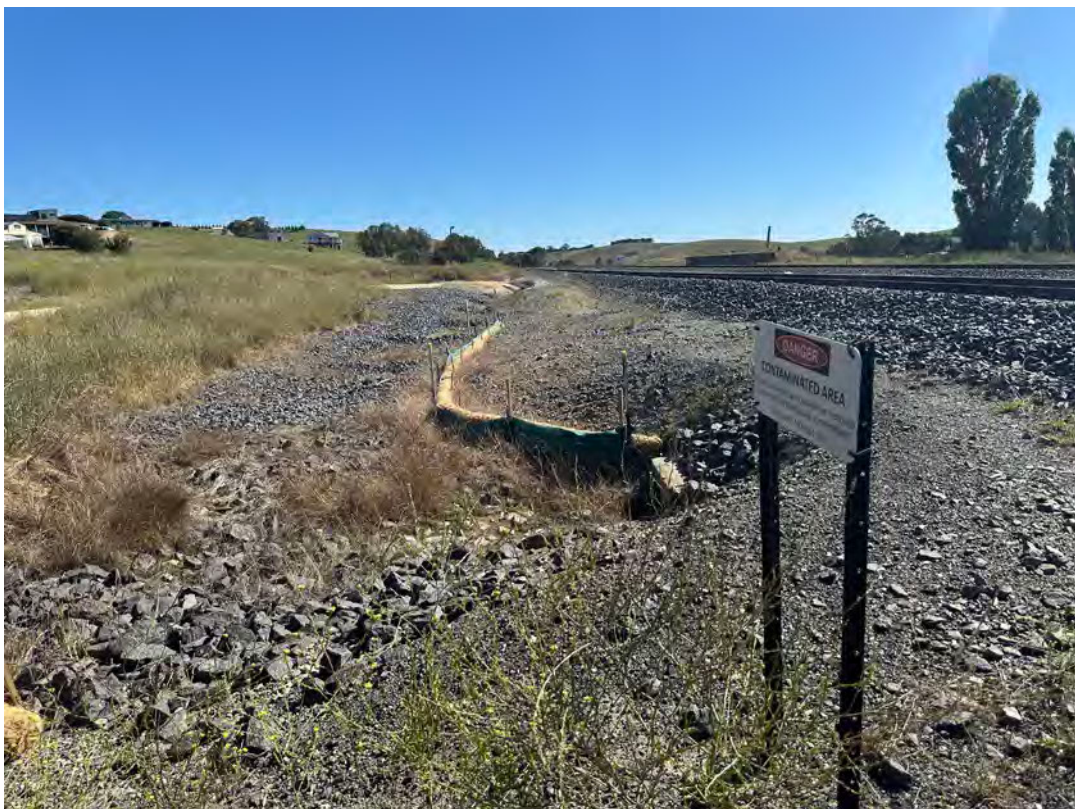
**Photo 16: Sediment controls in drainage channel between middle and northern culverts appears to be in good condition.**

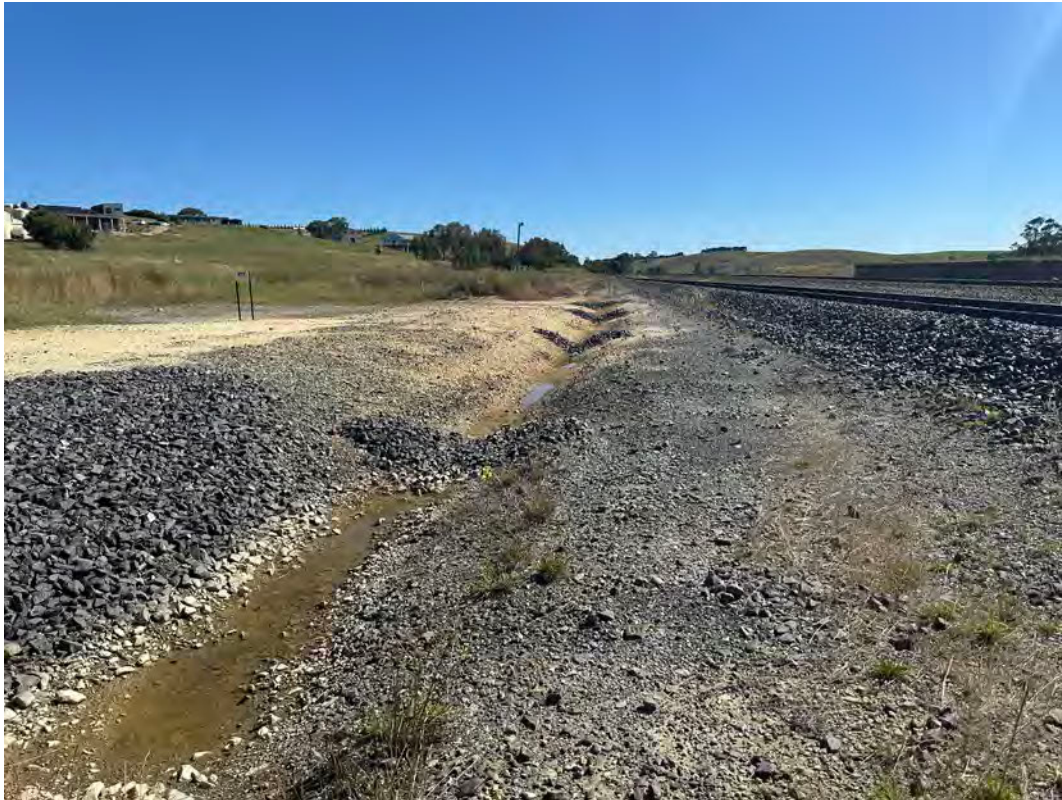
**Photo 17: Rock armoury in drainage channel between middle and northern culverts appears to be in good condition.**

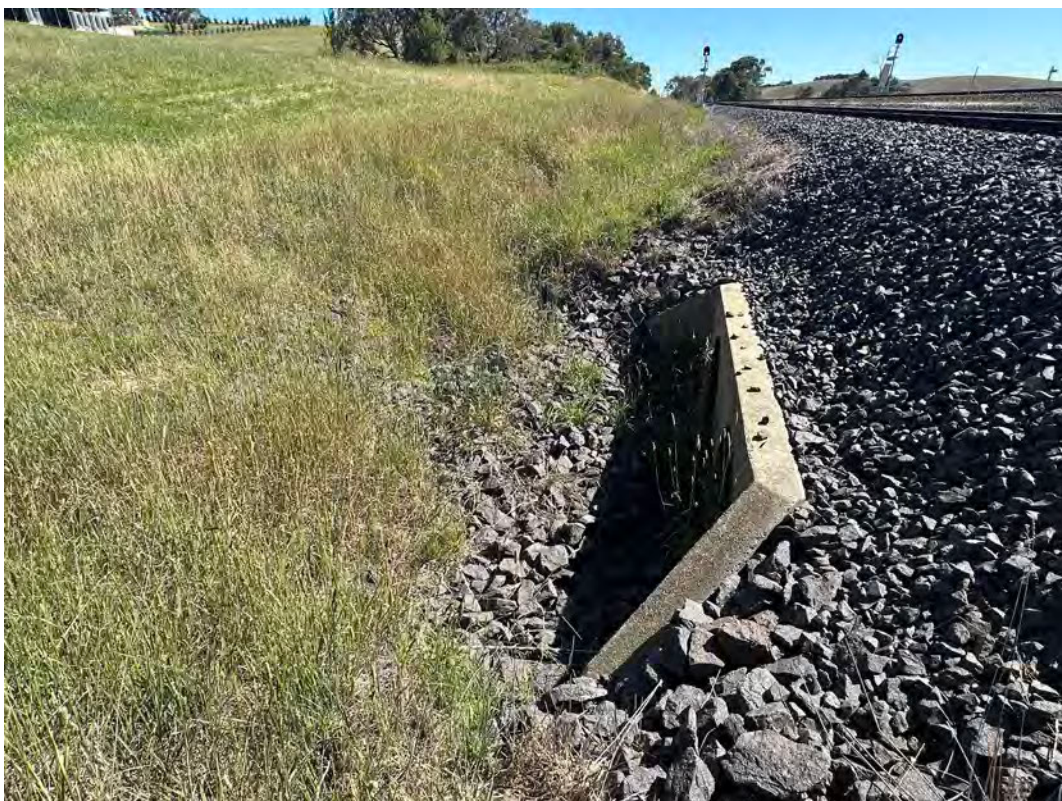
**Photo 18: Upgradient of northernmost culvert with no surface water. No sediment build up was noted on rock armoury.**

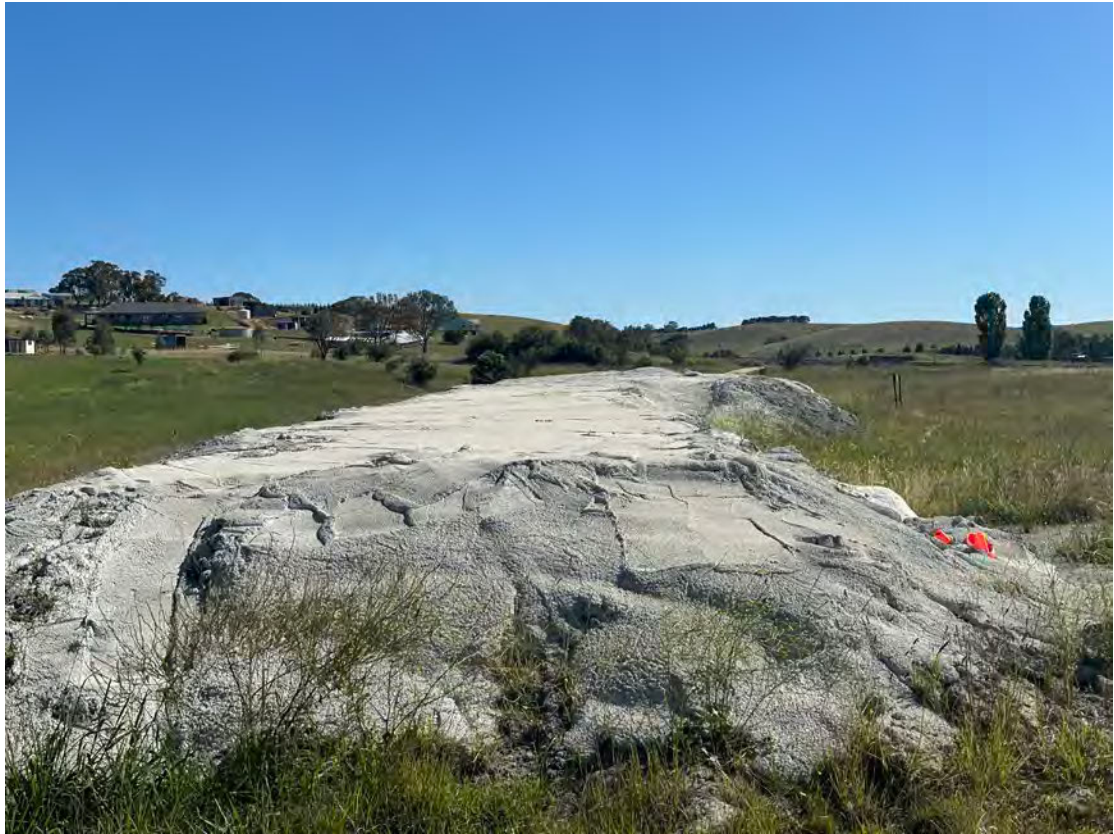
| Section | Control | Inspection | | Corrective Action |
|---|---|---|---|---|
| | Are cracks present in the capping of the existing stockpile? If so record the width and length of cracks in written form and through photographs and consolidate with this checklist. | Yes, minor hairline cracking is present on the stockpile, these remain stable and are not expected to adversely affect cap competency in current condition. | | |

**Photo 19: The concrete-capped stockpile is generally in good condition with no new erosion observed.**

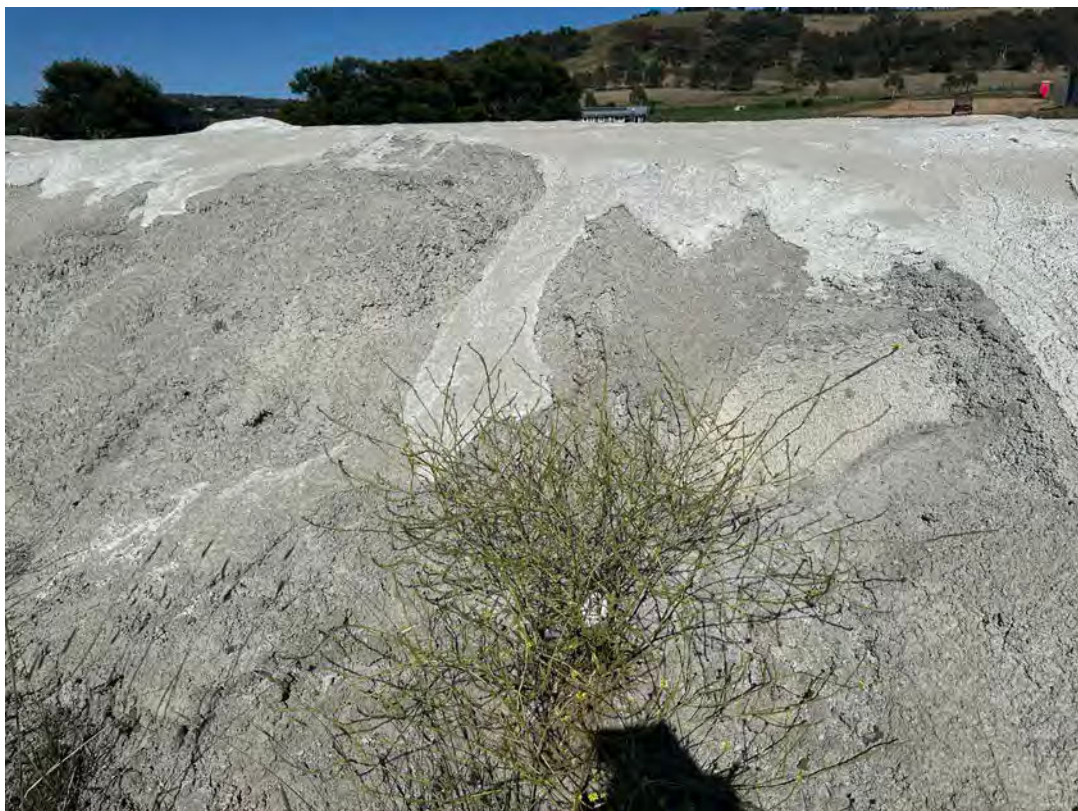
| Section | Control | Inspection | | Corrective Action |
|---|---|---|---|---|
| | Are there signs of vegetation on the existing stockpile? If so record in written form and through photographs and consolidate with this checklist. | Yes, several small-medium sized weeds ( <b>Photo 20</b> ) were identified growing out from the stockpile from previous inspections. These are not expected to affect stockpile capping effectiveness. | | |

**Photo 20: Minor vegetation and weeds growing out of stockpile capping.**

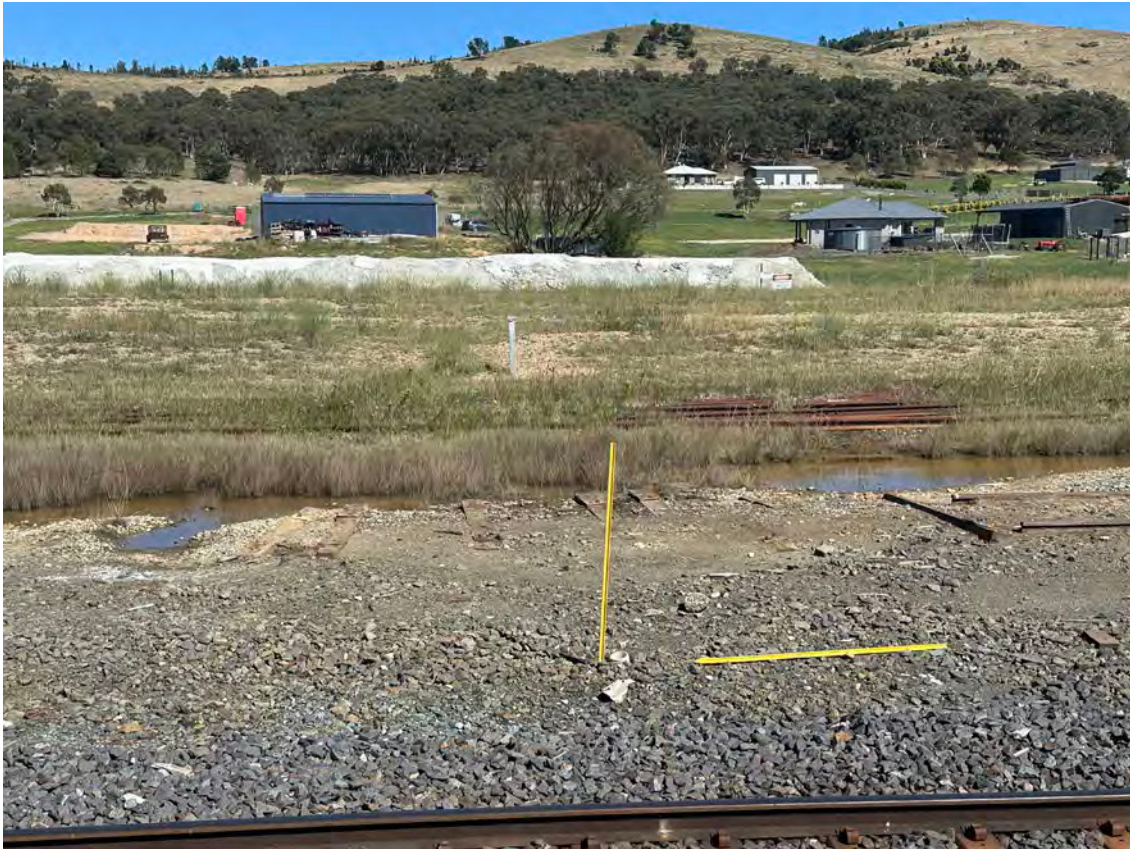
Photo 21: Surface water pooled on site appeared to be clear.
