# Tarago Action Plan Routine Inspection Checklist

| Date: | 20-Jan-25 | Ramboll and UGL RL Environmental |

| <b>Title:</b> Tarago Rail Yard Inspection | <b>Approved:</b><br>JA | <b>Project-Nr.:</b><br>318001704 | <b>Date:</b><br>20 January 2025 |
| <b>Site:</b> Tarago, NSW | | | |

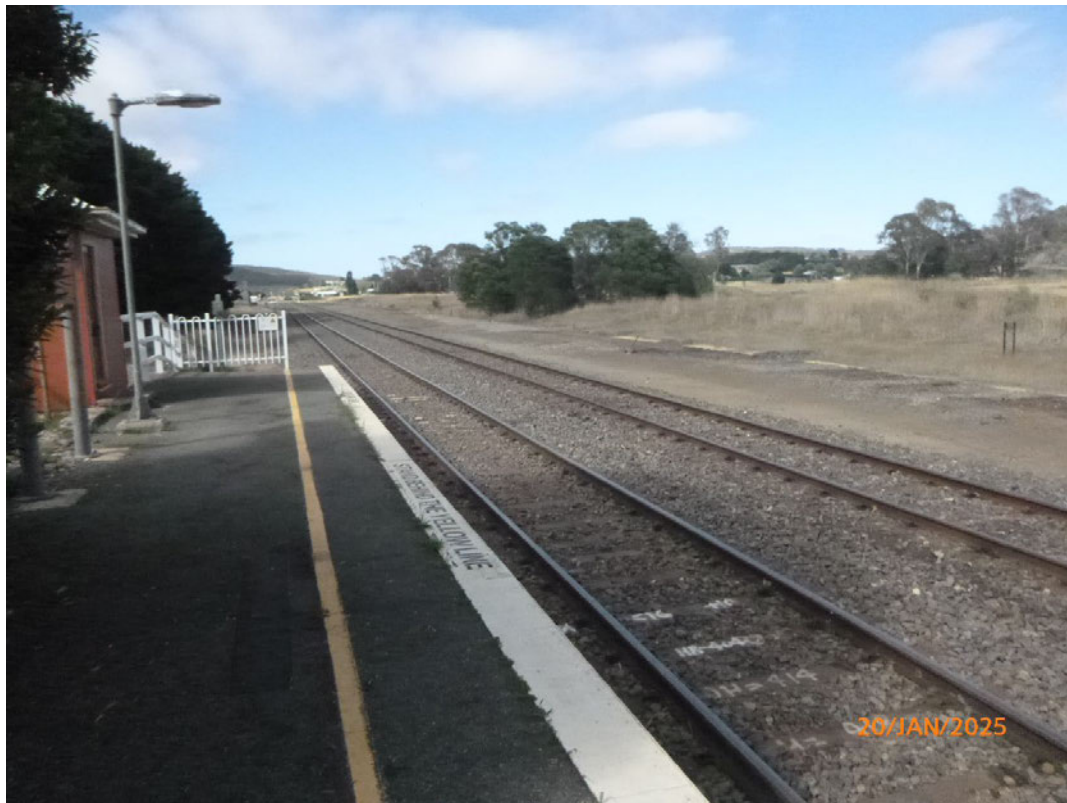
| No airborne dust was visible ( <b>Photos 1 - 2</b> ). | | |

**Photo 1: Picture at northern end of Tarago railway station platform facing south, no airborne dust visible.**

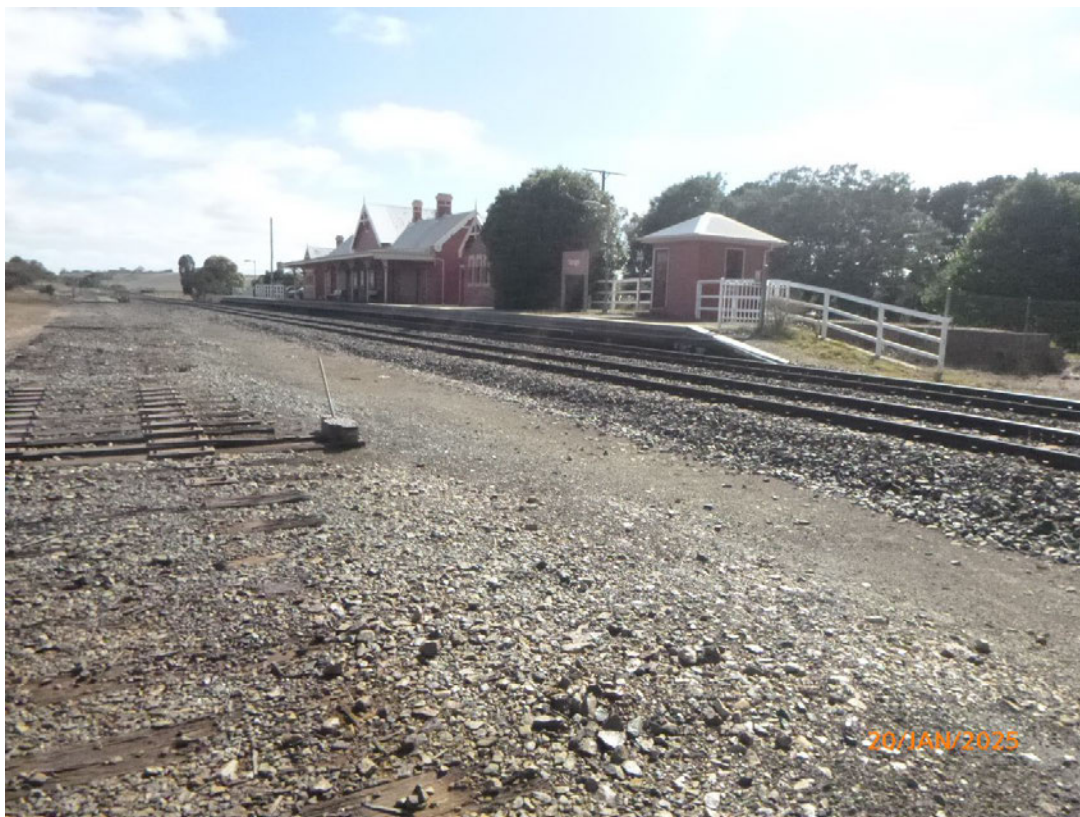
**Photo 2: Picture facing northeast towards Tarago railway station, no airborne dust visible.**

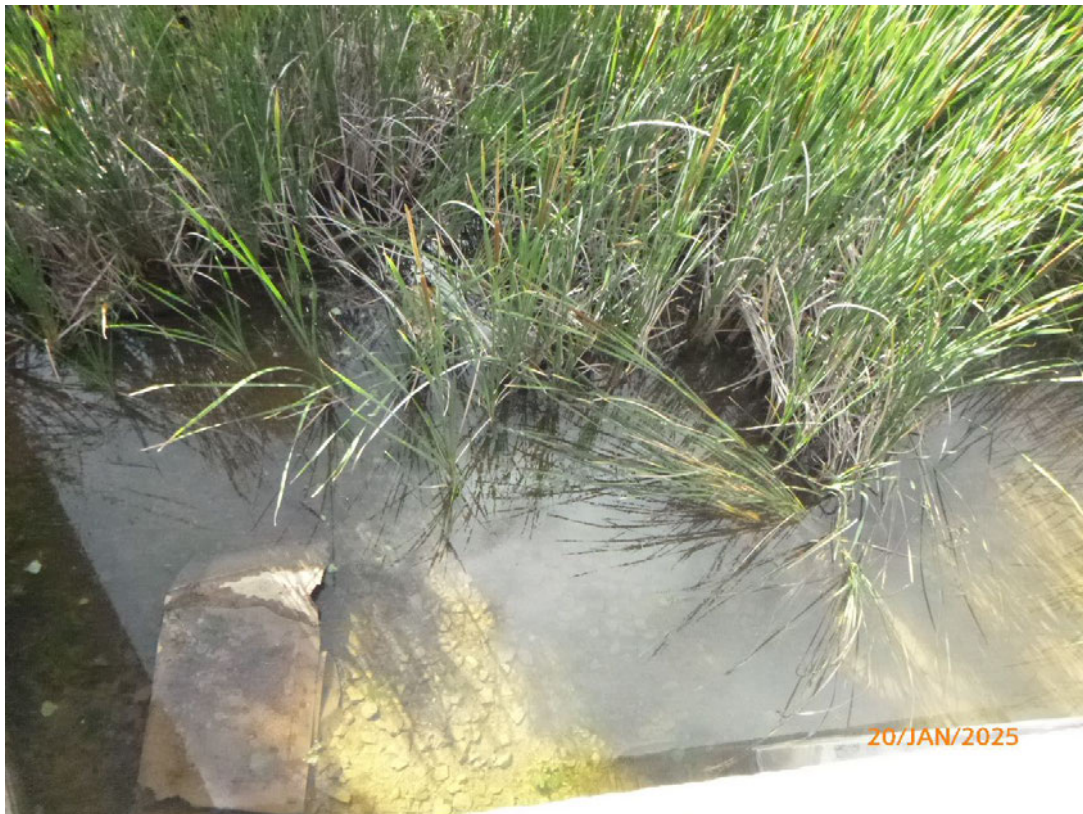
| No sign of sediment run-off seen in surface water flowing off-site at southern and middle culverts ( <b>Photos 3 and 4</b> ). No evidence of sediment run-off from northern culvert ( <b>Photos 5 and 6</b> ). | | |
| Surface water was observed discharging from the site at the southern and middle culverts ( <b>Photos 3 and 4</b> ). Pooled water was observed in a few locations on site ( <b>Photo 13</b> ). No other flowing surface water was observed onsite during the inspection. | | |

**Photo 3: Southern culvert downgradient of railway line with slow moving surface water flowing offsite. Surface water was clear with no visible turbidity or suspended solids.**

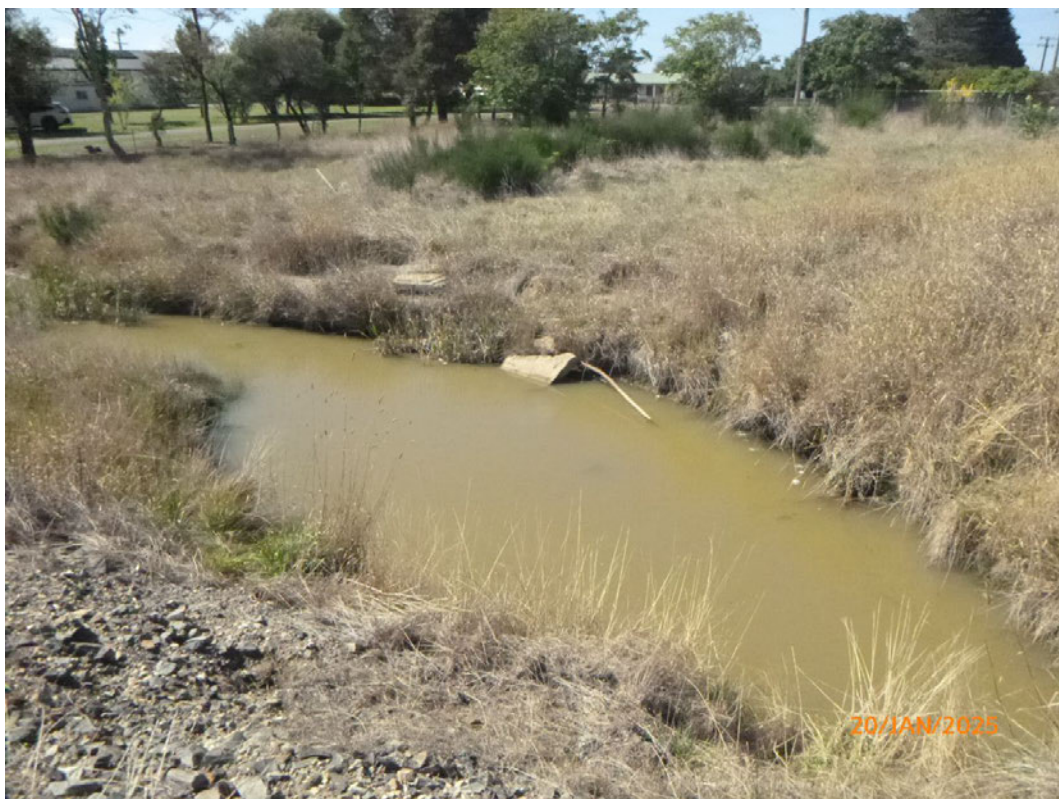
**Photo 4: Downgradient of middle culvert with slow moving surface water flowing off site. Surface water near culvert was brown.**

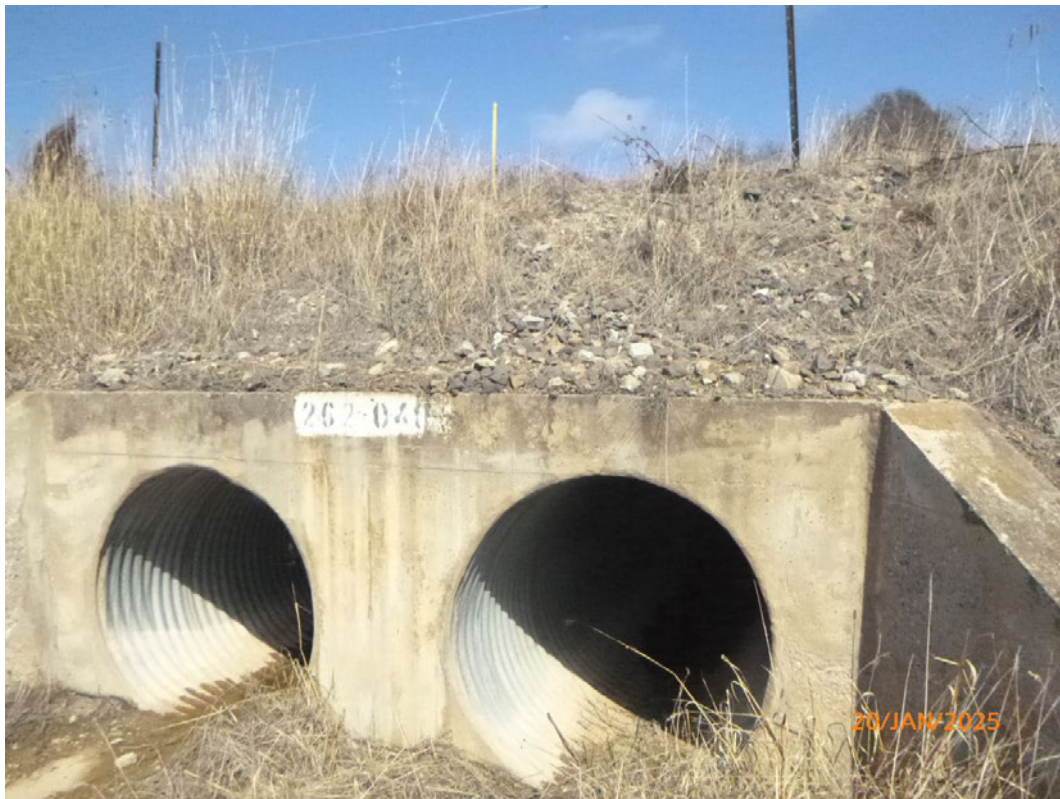
**Photo 5: Downgradient of northernmost culvert, minimal pooled surface water observed within culvert. Not flowing offsite.**

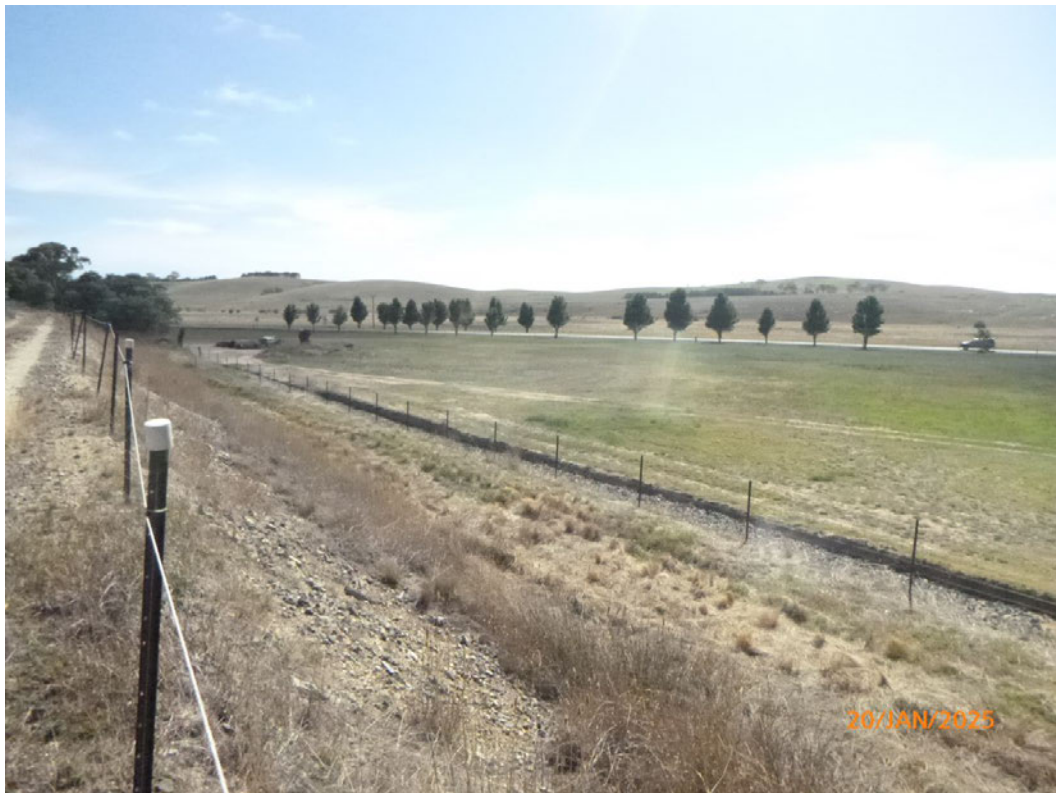
**Photo 6: Property downgradient of northernmost culvert with no observed surface water. Trench line had been dug on adjacent property.**

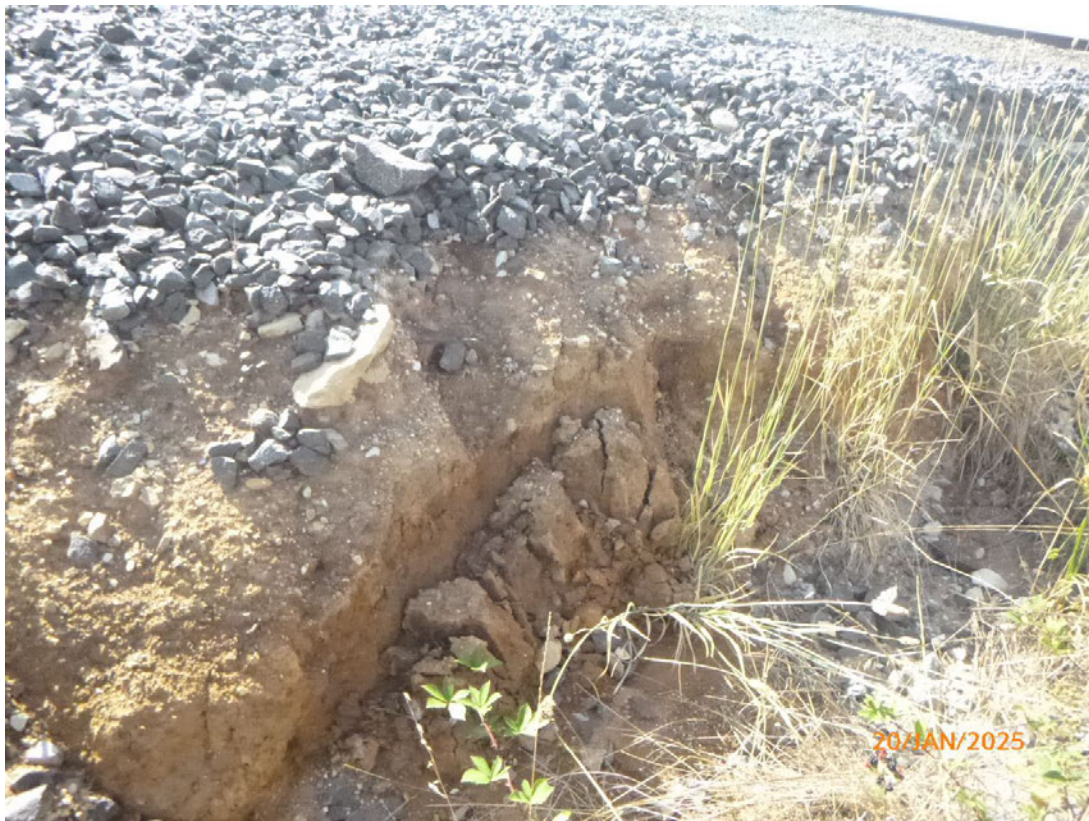
**Photo 7: Southernmost culvert upgradient of the railway line. The erosion due to lack of ground cover observed during multiple previous inspections is still present.**

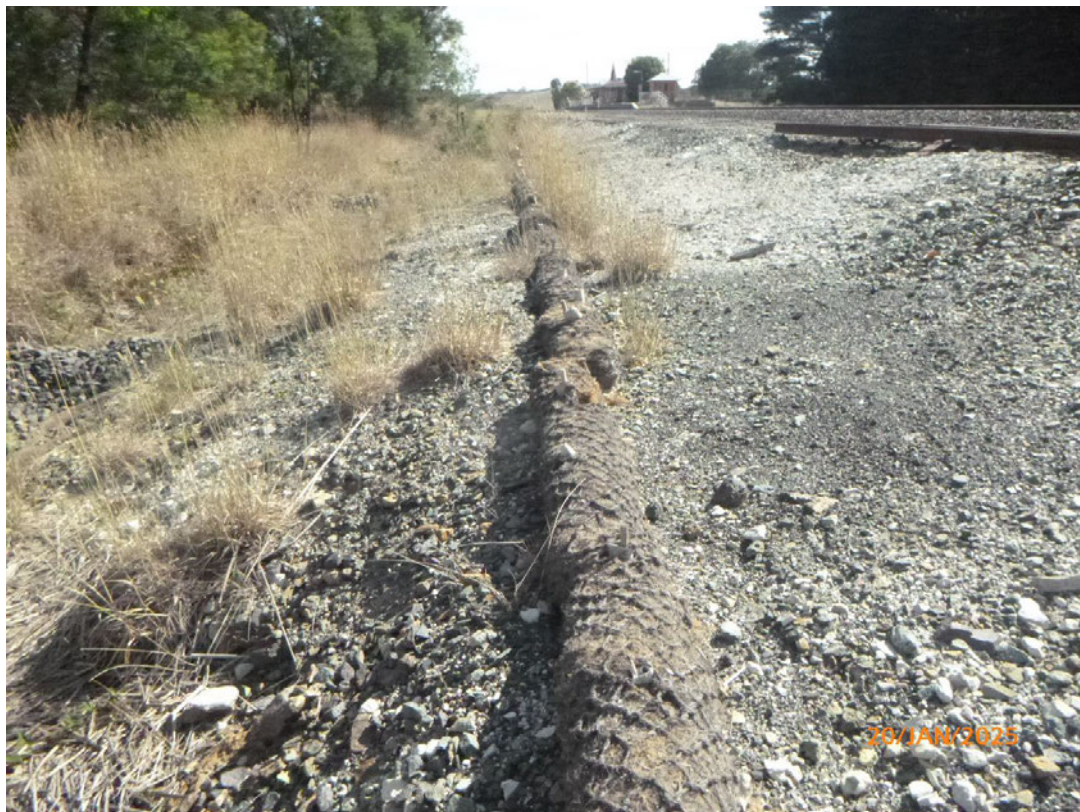
**Photo 8: Sediment controls at southernmost culvert upgradient of the railway line.**

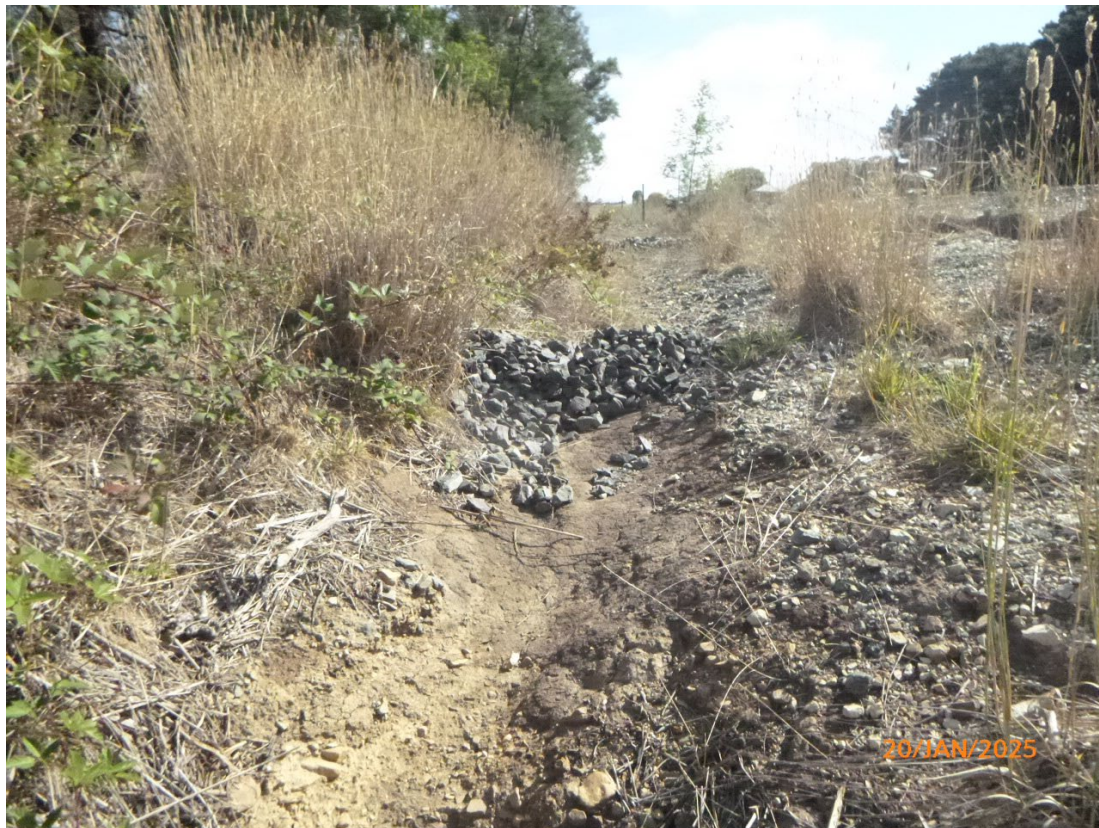
**Photo 9: Rock armoury in drainage channel between southern and middle culverts. Sediment and vegetation buildup minimal within drainage line.**

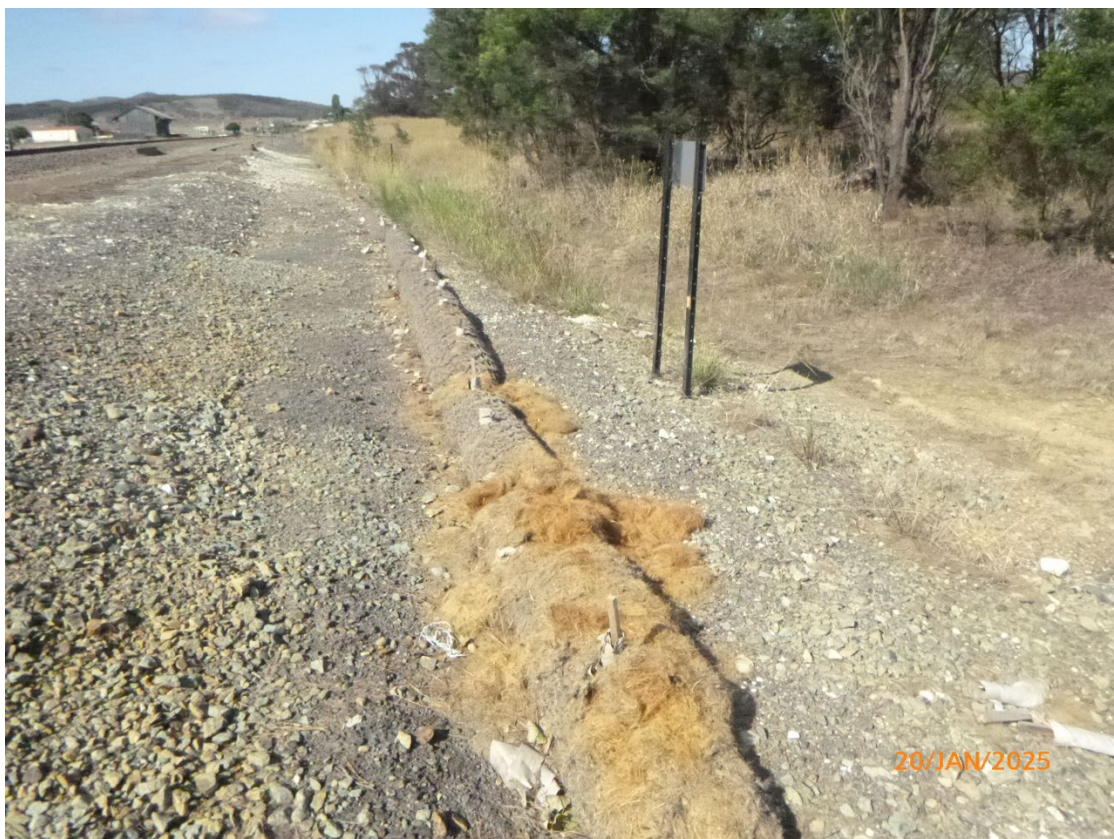
| <p>1. Damage to the sediment control coir logs located between the middle and southern culverts was observed (<b>Photo 10</b>). However, the coir logs remain functional, and replacement is not currently recommended.</p> <p>2. Evidence of erosion noted upgradient of the southern most culvert in previous site inspections remains on site but in a stable condition (<b>Photo 7</b>). No evidence of sediment was observed in water flowing offsite at southern culvert during this site inspection.</p> <p>3. One exclusion sign postage was noted to be missing (<b>Photo 20</b>). Signage is located approximately 100 north on eastern side of rail. Ramboll recommends replacing the signage to comply with the 100 lineal meter increments required by the Tarago Lead Management Plan.</p> | | |

**Photo 10: Damage to sediment control coir logs between southern and middle culverts.**

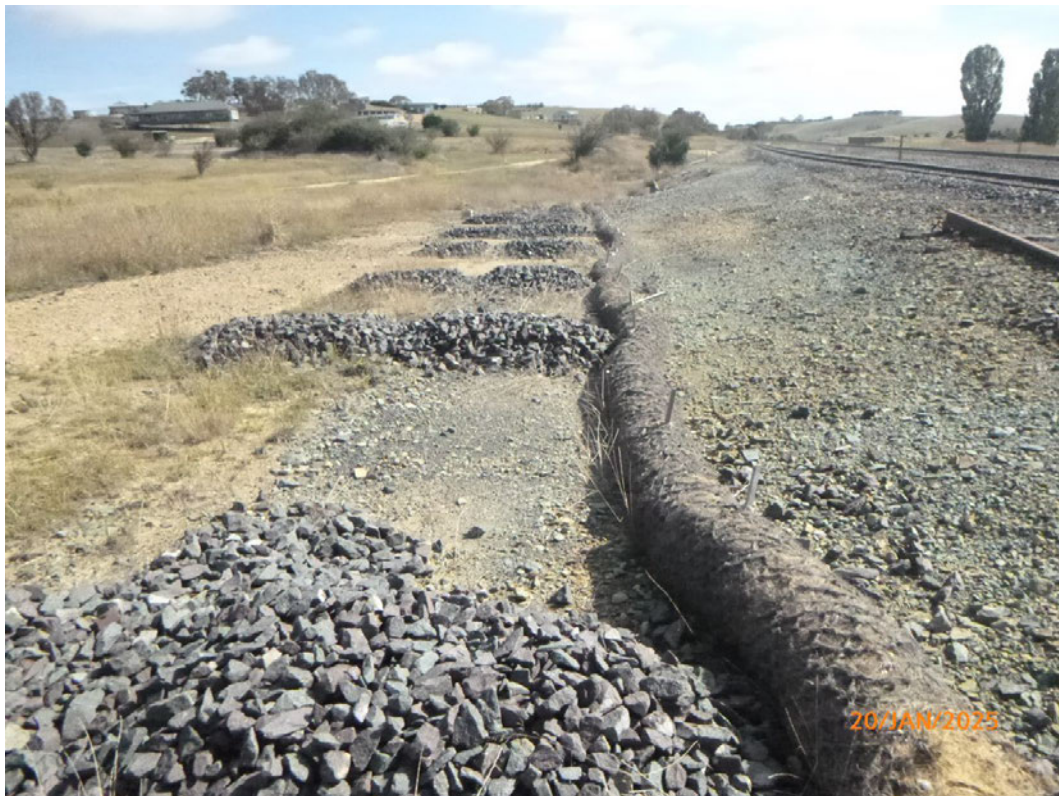
**Photo 11: Rock armoury in drainage channel between southern and middle culverts appears to be in good condition.**

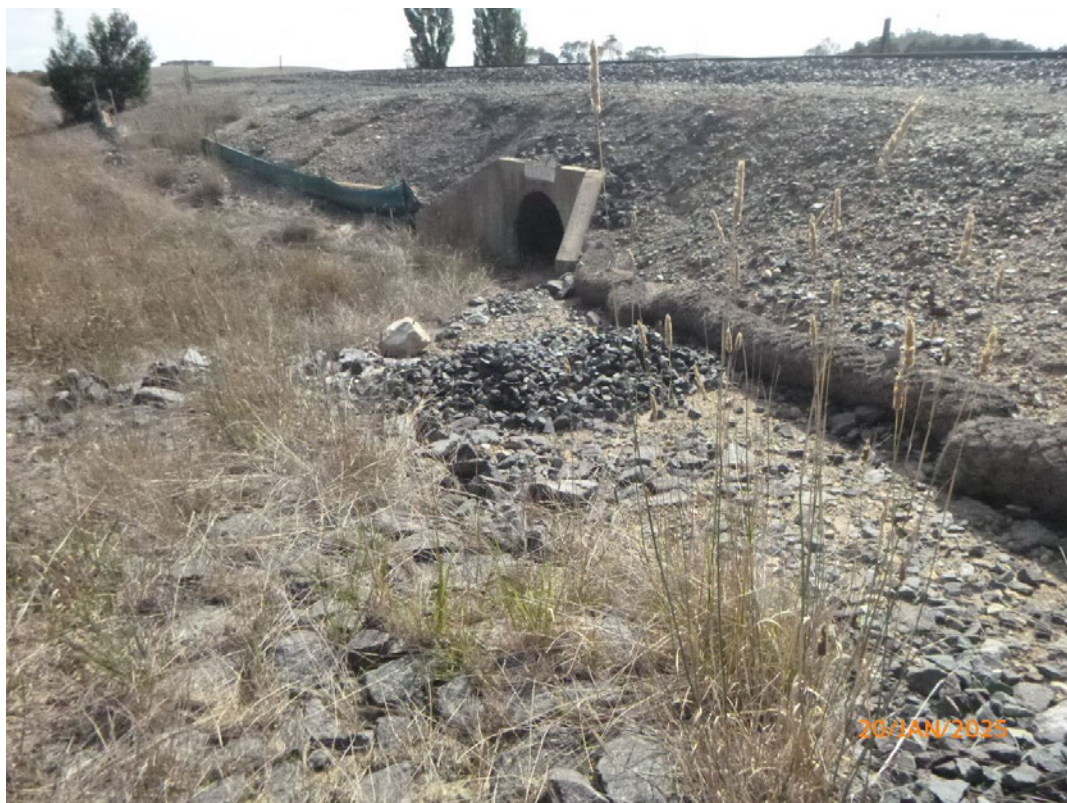
**Photo 12: Sediment controls at the middle culvert upgradient of the railway line in good condition.**

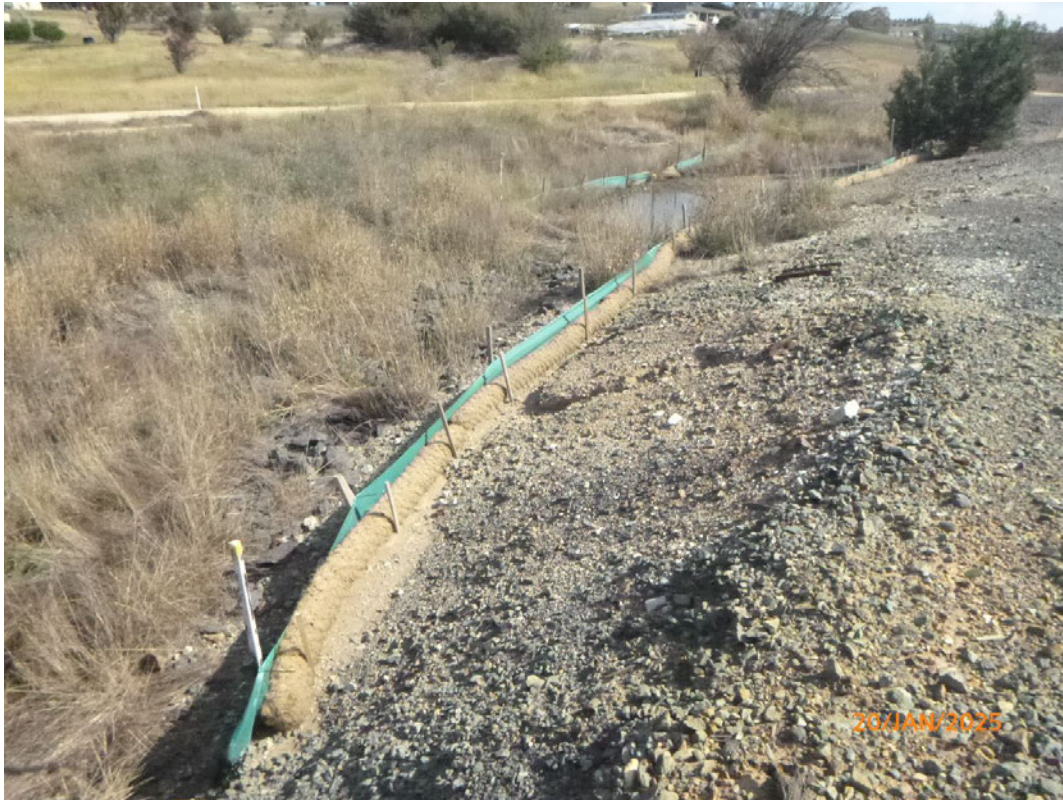
**Photo 13: Sediment controls north of middle culvert, upgradient of railway line in good condition. Sediment buildup in front of coir logs increased since last inspection.**

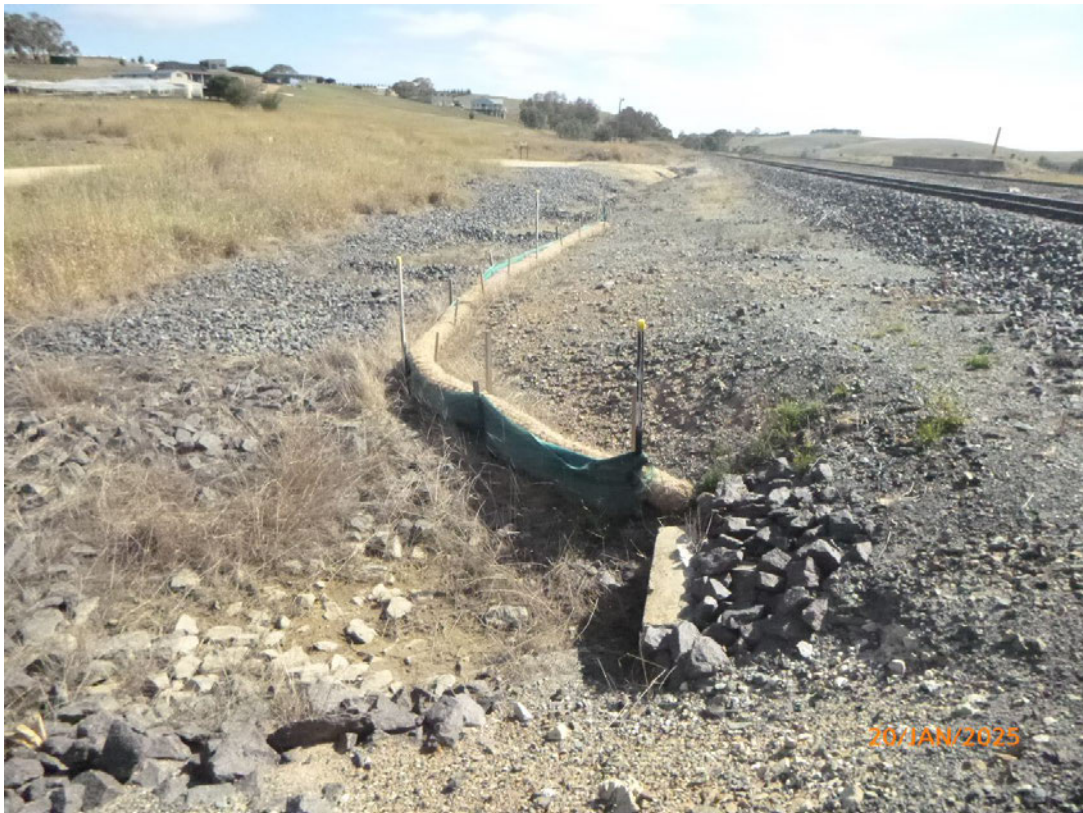
**Photo 14: Sediment controls in drainage channel between middle and northern culverts appears to be in good condition.**

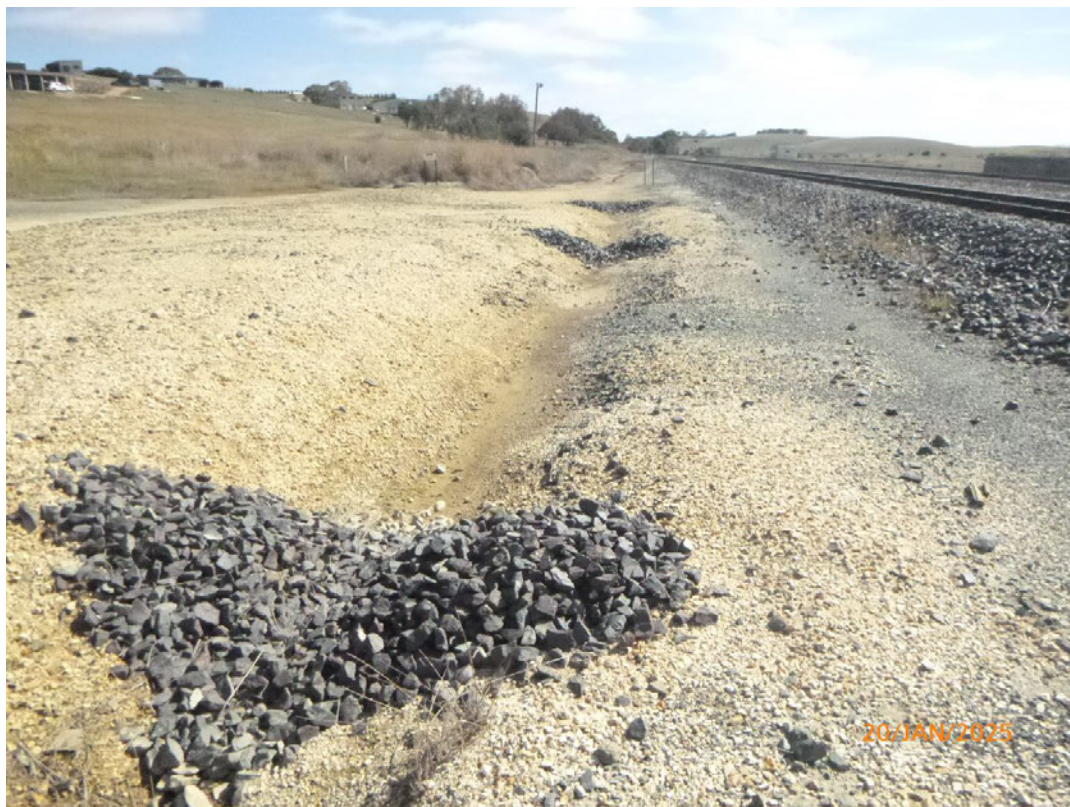
**Photo 15: Rock armoury in drainage channel between middle and northern culverts appears to be in good condition.**

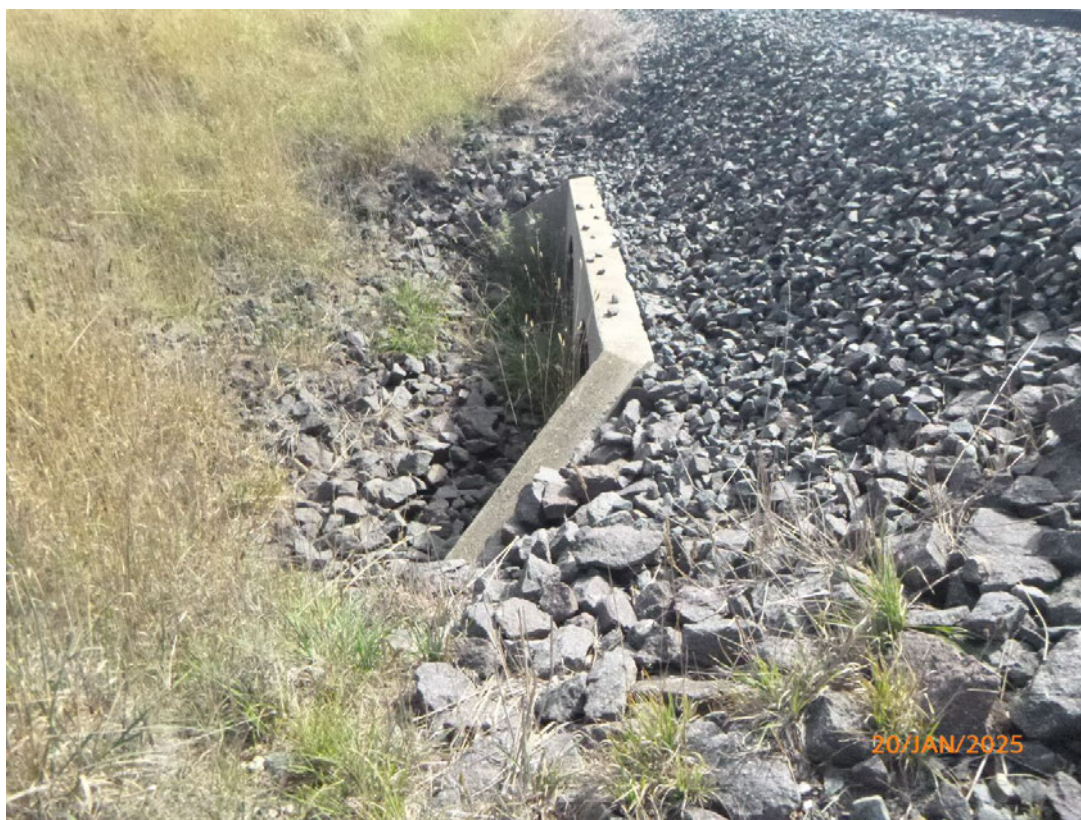
**Photo 16: Upgradient of northernmost culvert with no surface water. No sediment build up was noted on rock armoury.**

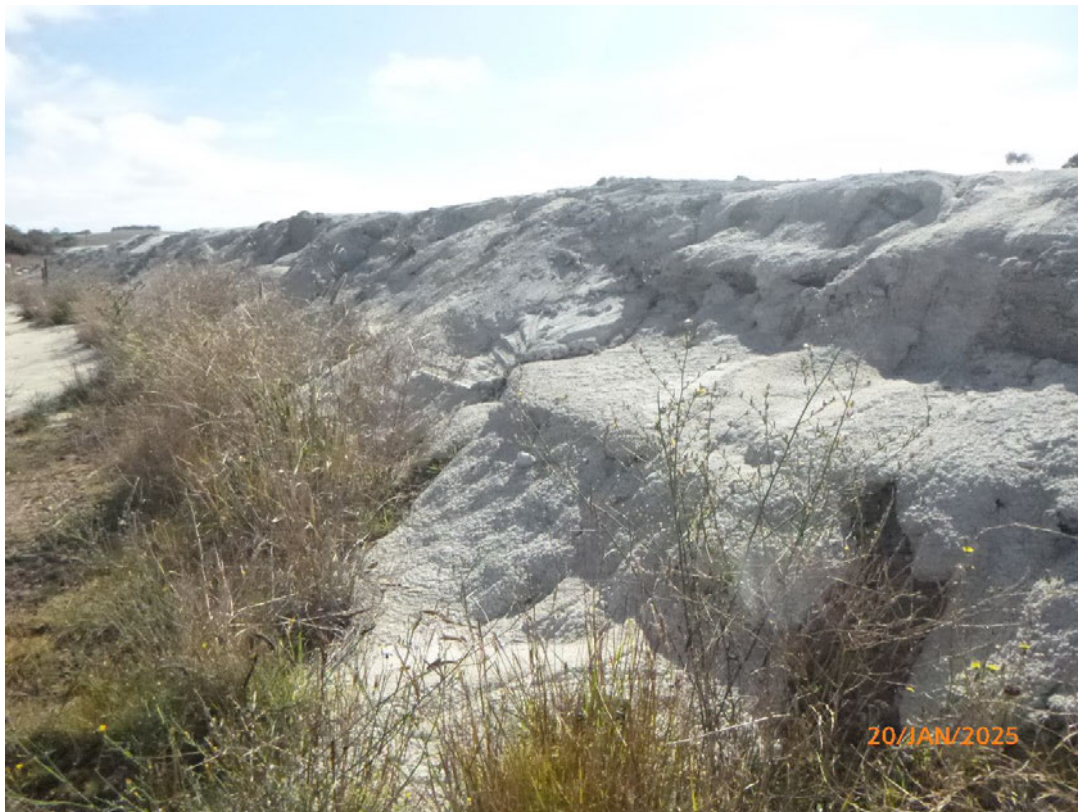
| Section | Control | Inspection | | Corrective Action |
|---|---|---|---|---|
| | Are there signs of vegetation on the existing stockpile? If so record in written form and through photographs and consolidate with this checklist. | Yes, several small-medium sized weeds were identified growing out from the stockpile from previous inspections ( <b>Photo 17</b> ). These are not expected to affect stockpile capping effectiveness. | | |

**Photo 17: The concrete-capped stockpile is generally in good condition with no new exposure locations observed.**

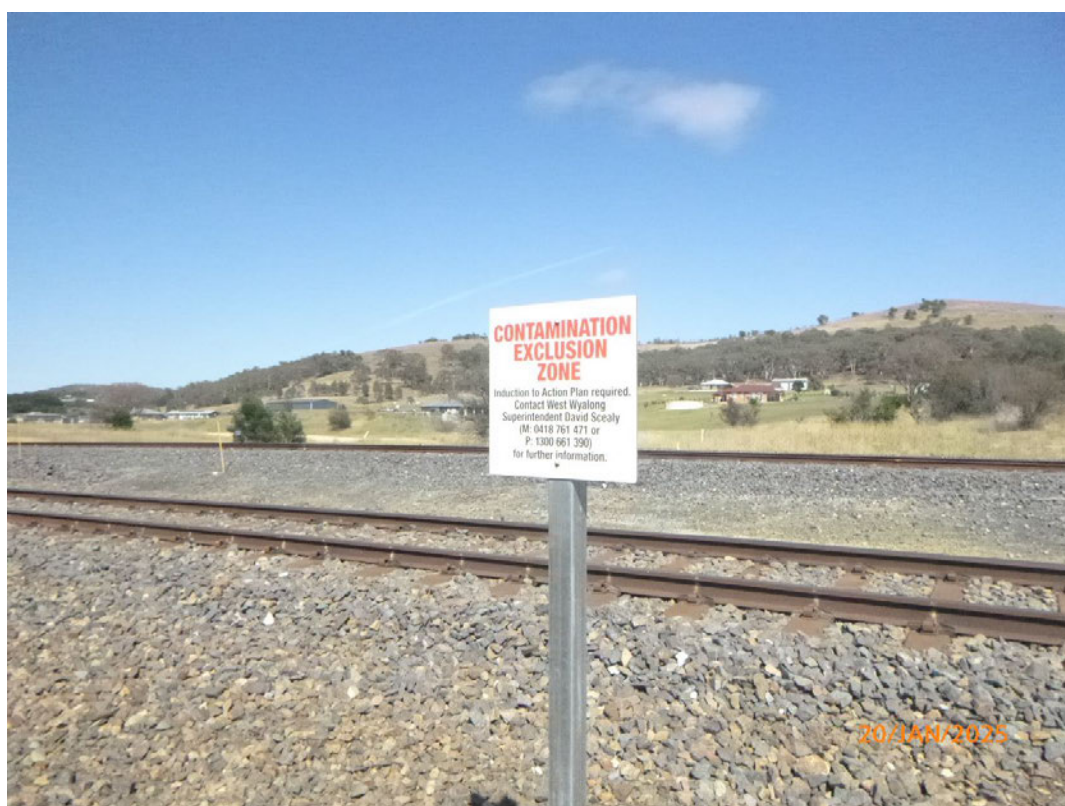
| Section | Control | Inspection | | Corrective Action |
|---|---|---|---|---|
| 5.1 | Is Exclusion Zone signage present as recommended on Figures 2a - 2e Appendix 1 to demarcate contamination in the rail formation and adjacent soils? | Yes ( <b>Photos 18 - 20</b> ). | | |

**Photo 18: Exclusion zone signage posted and in good condition.**

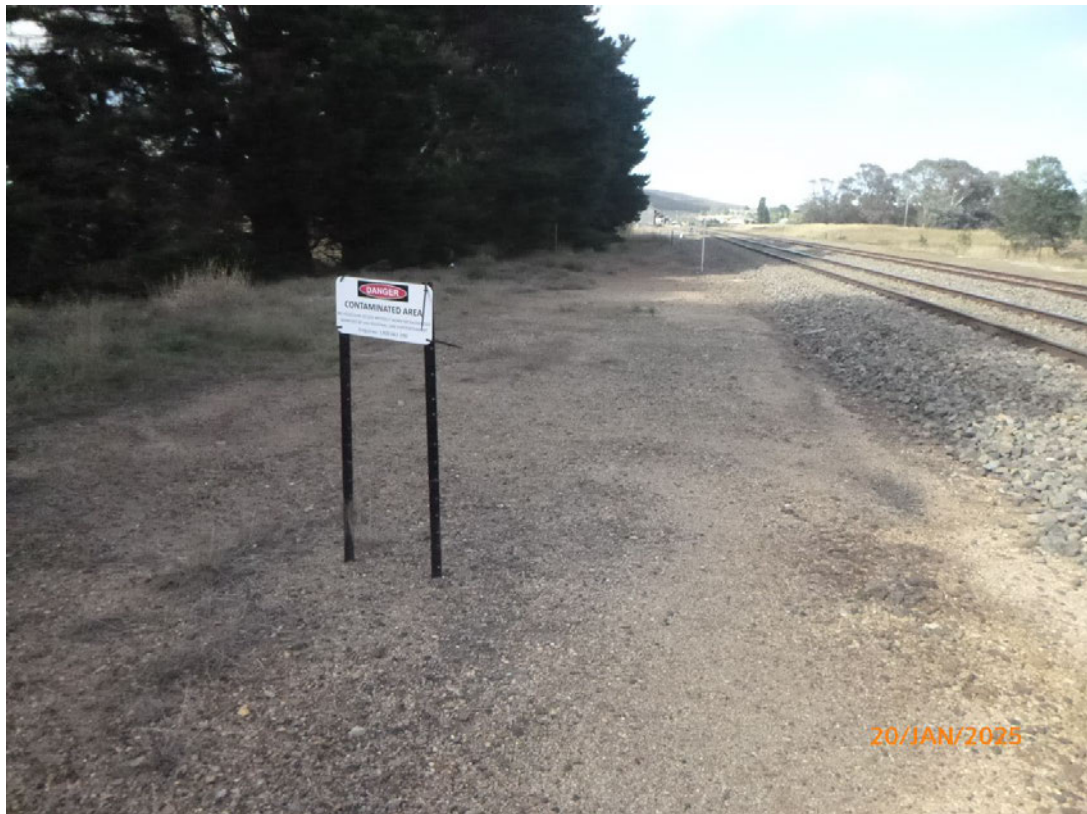
**Photo 19: Exclusion zone signage posted and in good condition.**

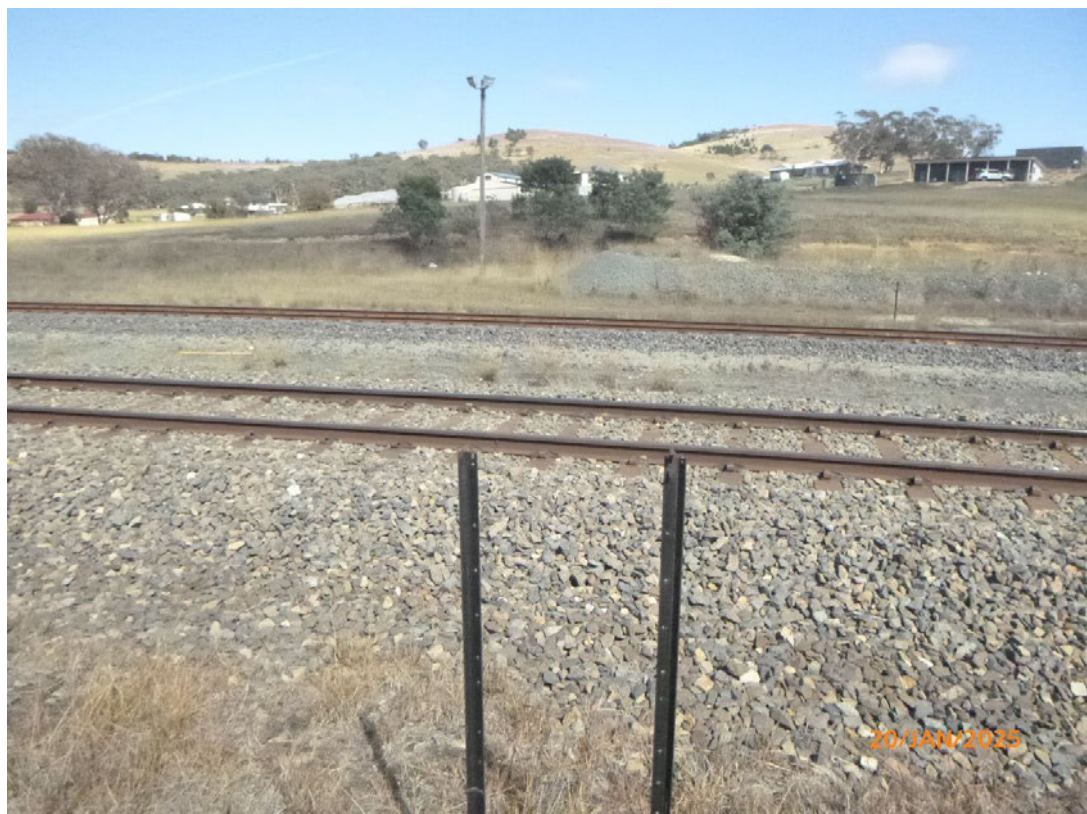
| Section | Control | Inspection | | Corrective Action |
|---|---|---|---|---|
| | Is Exclusion Zone signage undamaged? | Yes, exclusion zone signage appeared in good condition except for one missing sign on the eastern side of the track approx. 100m north of the station ( <b>Photo 20</b> ). | | |

**Photo 20: One exclusion zone sign missing. Signage approximately 100 north on eastern side of rail.**
