Captains Flat EMP Inspection Checklist					
Date:	18 October 2024	UGL Representative completing inspection:			
Start time:	12:43 PM				
Finish time:	1:43 PM				
Weather:	17.2°C, 9°C lowest temp, 18°C highest temp, 0.8mm of rain since 9am, N 4 km/h wind speed, 92% humidity.				
					BoM
Date and volume of maximum rainfall in a 24hr period since last inspection?					
Date:		26-Sep-24			
Max volume (mm) in 24hr period:		25.8			
Plan Ref	Control	Inspection		Corrective Action	Implemented?
		Yes	No		
General Observations					
NA	Is airborne dust from site evident?		No	No airborne dust was visible (Photos 1 - 4)	
	Is sediment run-off evident?		No	Evidence of erosion and sediment run-off adjacent the former loader (Photos 4 - 5). Erosion and sediment controls should be reviewed in this area.	
	Is surface water discharging from site?	Yes		Coppers Creek flowing through site, no surface water was running off site into Coppers Creek (Photo 6). Small unnamed creek flowing through south-east corner of site fed by upstream mine site (Photo 7).

Title: Captain's Flat Rail Corridor Inspection	Approved: JA	Project-Nr.: 318001704	Date: 18 October 2024
Site: Captains Flat, NSW			
Client: UGL Regional

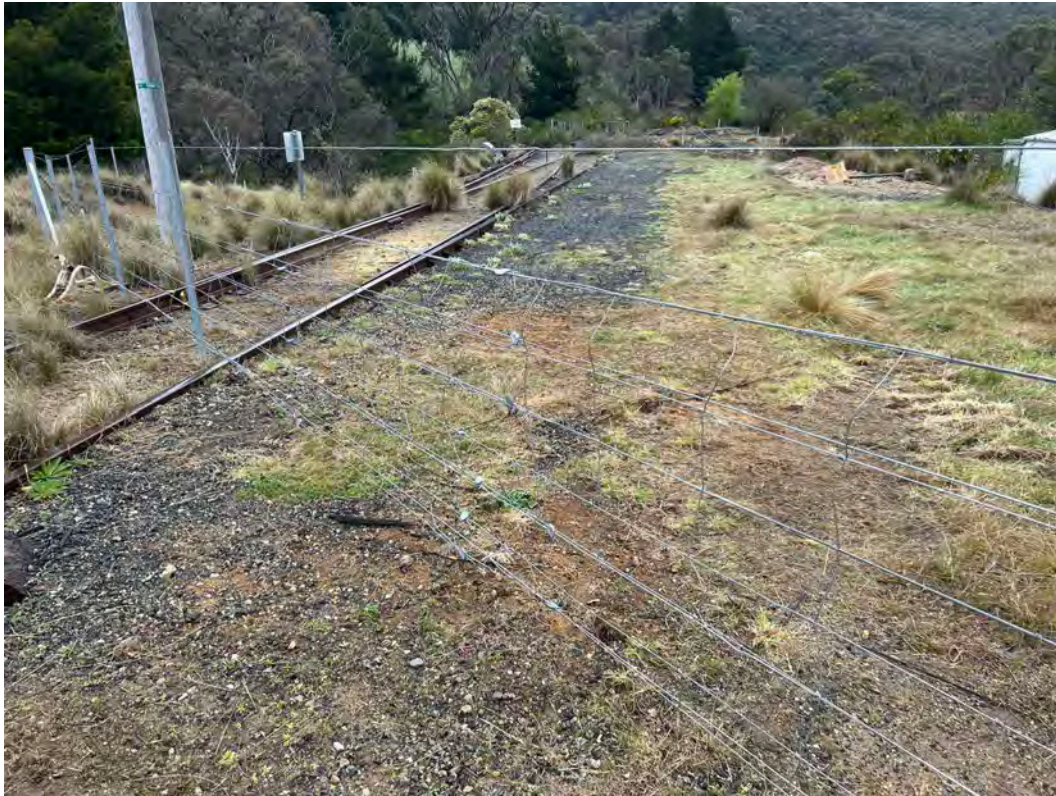
Photo 1: Trainlines behind fence facing north-west. Station Master Cottage to the right of photo. No airborne dust was visible on site.

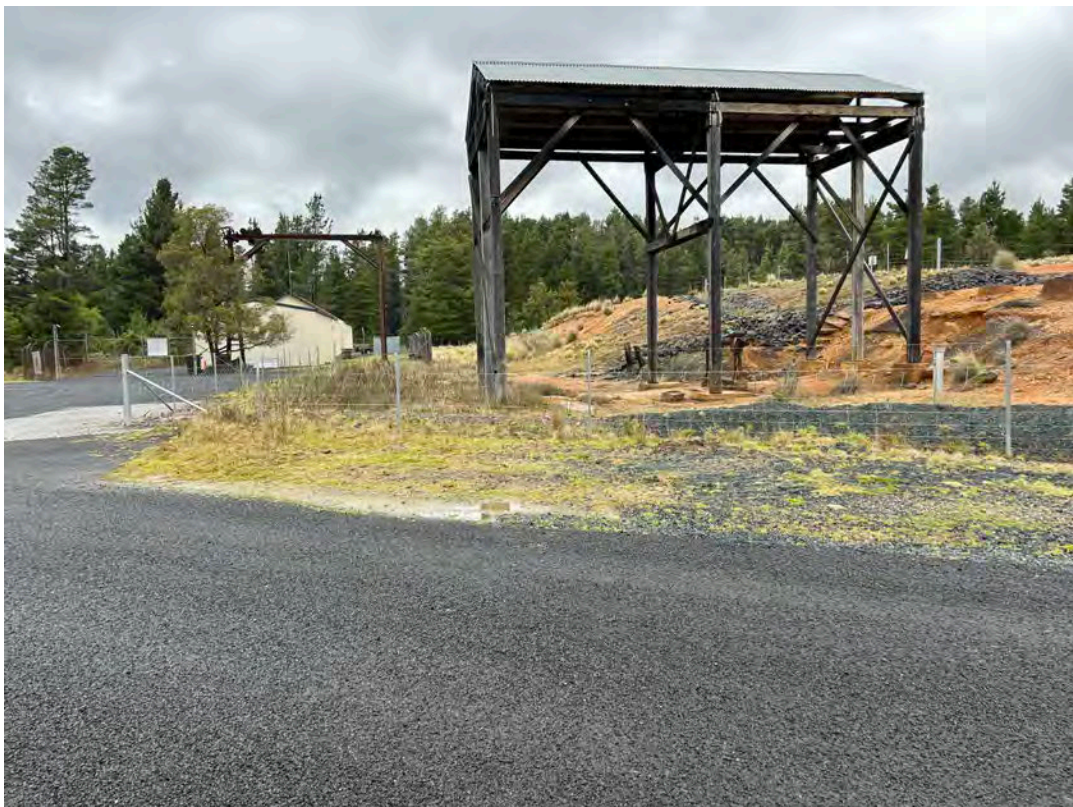
Photo 2: Former Loadout Facility and Weigh Bridge. No airborne dust was visible on site. Facing south-west.

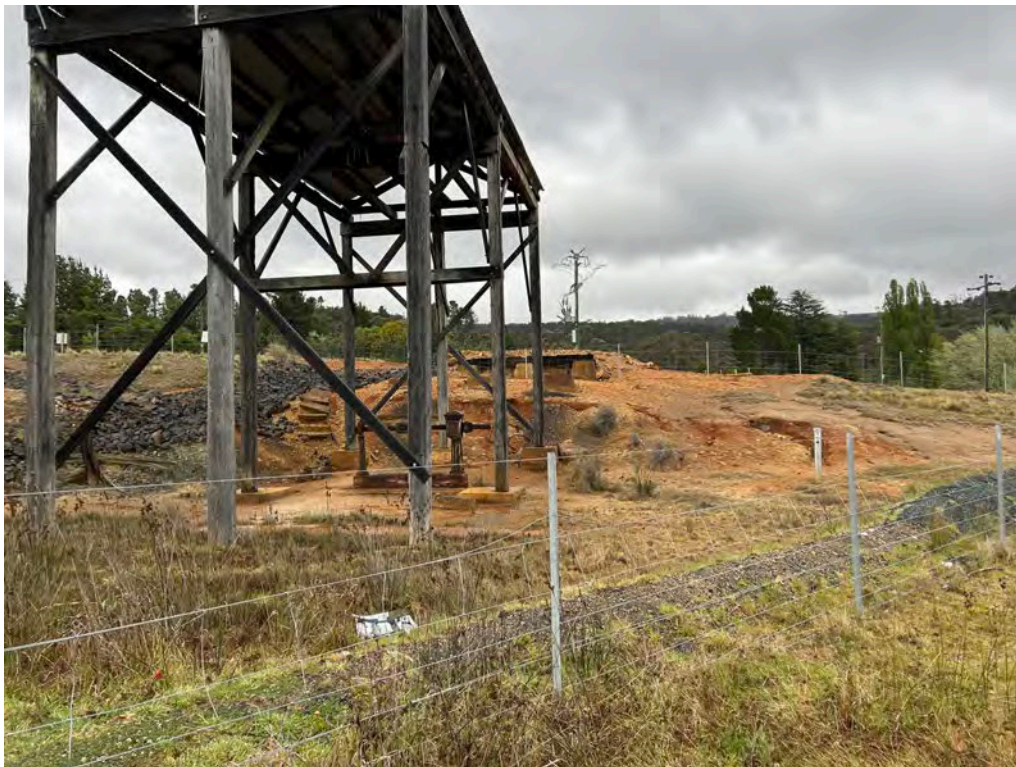
Photo 3: Minor evidence of erosion of soils on site. The condition has been observed during multiple previous inspections and has remained stable. Located adjacent to Former Loadout Facility and Weigh Bridge. Facing south.

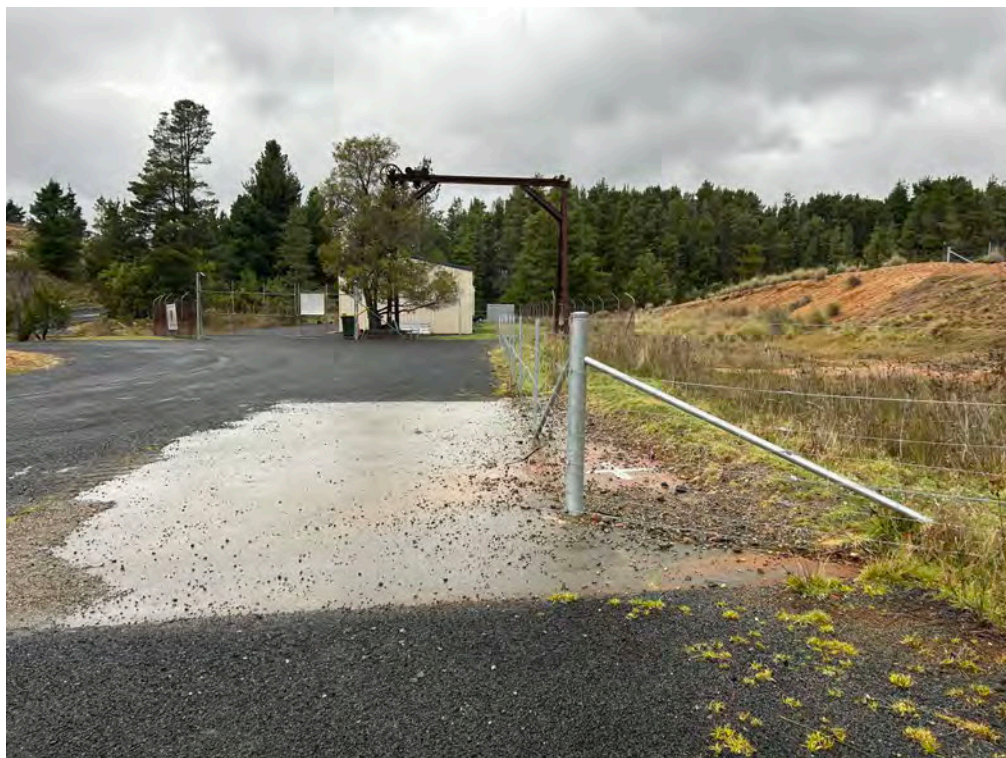
Is there evidence of excavation or other works non-compliant with the EMP?		No	n/a no excavation occurring on site	
Table 3-1					
3.3	Is signage in place adjacent the Copper Creek Road crossing and at other readily accessible areas?	Yes		Multiple signposts on fences along where site is accessible from the roadside.	
	Is fencing in place to prevent access via the Coppers Creek Road crossing?	Yes		Fencing is placed to restrict access to site from Coppers Creek Road crossing (Photo 4).	
	Exclusion Zone fencing and signage undamaged?	Yes		All fencing and signage was in good condition.	
	Is evidence of unauthorised site access visible?		No	No evidence of unauthorised site access visible.	
	Has durable erosion resistant capping been applied over the Coppers Creek Road crossing?	Yes		Coppers Creek Road Crossing was covered with a sealed road. Some evidence of sediment was observed on the road (Photo 4).

Orange/brown staining on asphalt adjacent the replica ore loading ramp consistent with evidence of mine drainage (**Photo 4**).

Photo 4: Some minor sediment visible on asphalt surface on site upgradient of Coppers Creek.

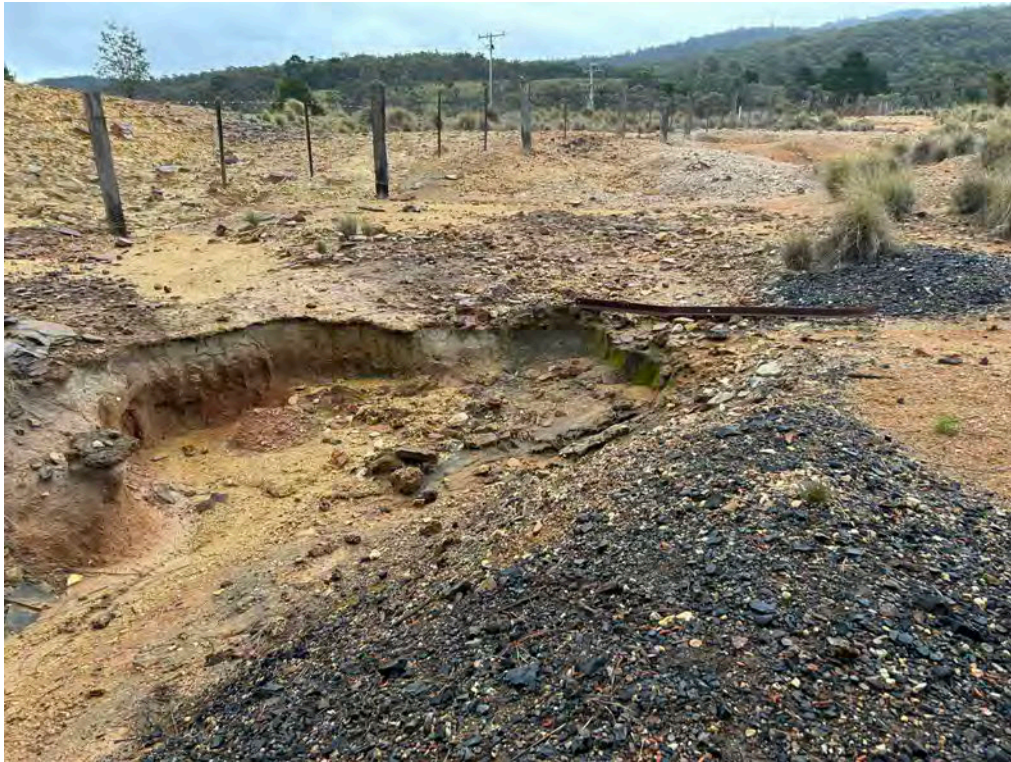
Photo 5: Evidence of erosion of soils on site observed during the previous inspections. Larger erosion has been observed during this inspection. No evidence of current surface water runoff into Coppers Creek was observed. Located south of the State Emergency Service (SES) facility.

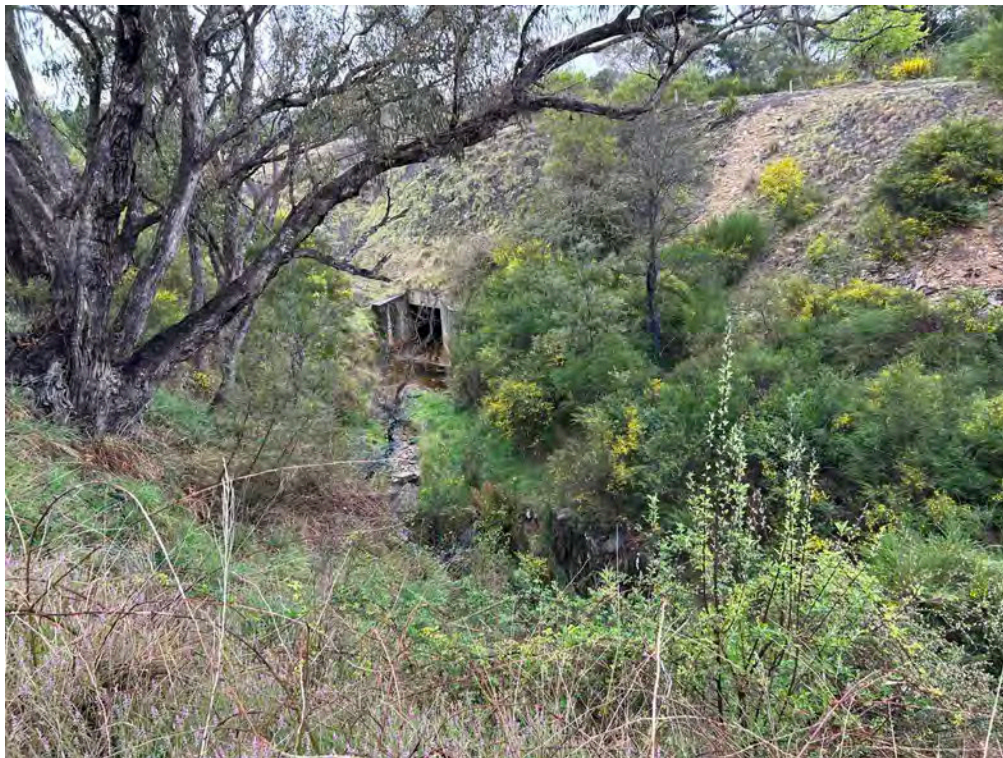
Photo 6: Copper Creek visible. No evidence of current onsite surface water runoff into Coppers Creek. Facing south.

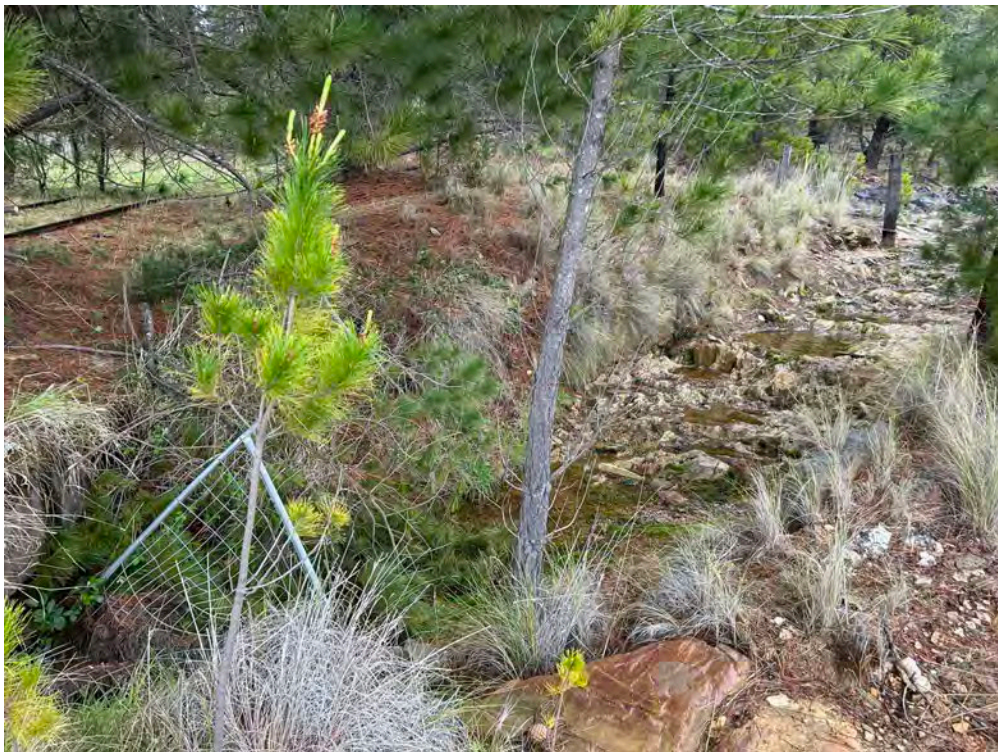
An unnamed creek off-site and down gradient from Captains Flat State Emergency Service shows slightly cloudy surface water with sediment present. This creek is fed from the mine site upstream and is not expected to contain sediment from site (**Photo 7 and 9**).

Photo 7: A small unnamed Creek slowly flowing through the south-eastern half of the site. No sign of additional surface water from on-site sources contributing to the Creek and no evidence of sediment run off from site was observed.

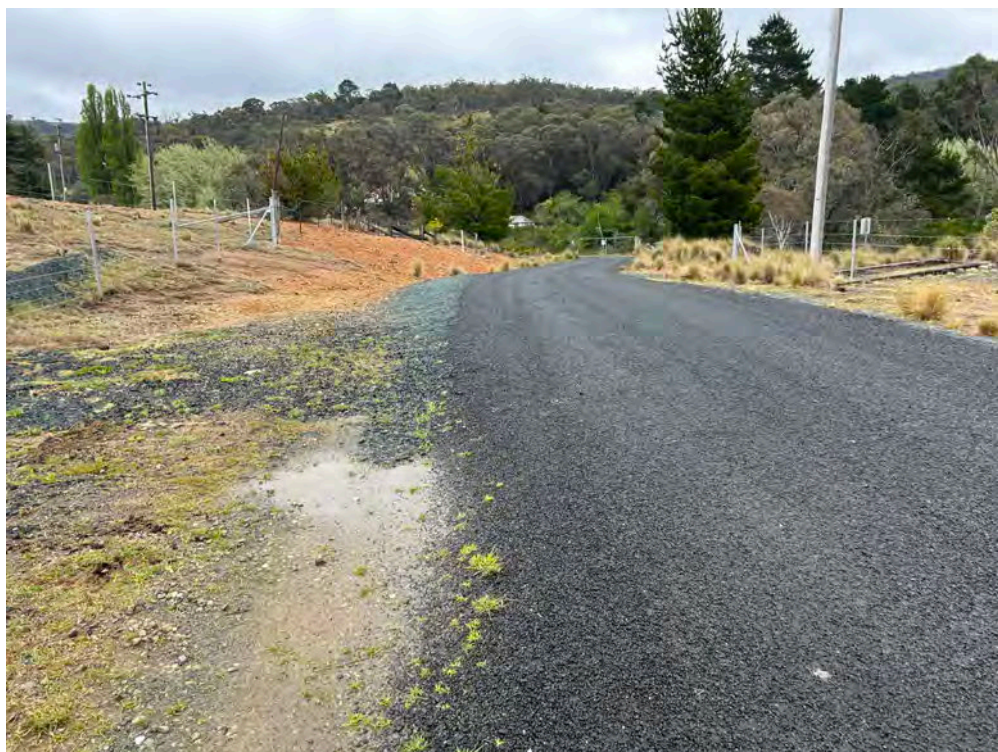
Is capping over Coppers Creek Road preventing inadvertent access to site materials?	Yes		Copper Creek Road Crossing is a sealed road preventing access to soil underneath (Photo 8).	
	Is excavation occurring onsite?		No	n/a no excavation occurring on site	
Plan Ref	Control	Inspection		Corrective Action	Implemented?
		Yes	No

Photo 8: Sealed road over Copper Creek Road crossing, preventing inadvertent access to site materials underneath.

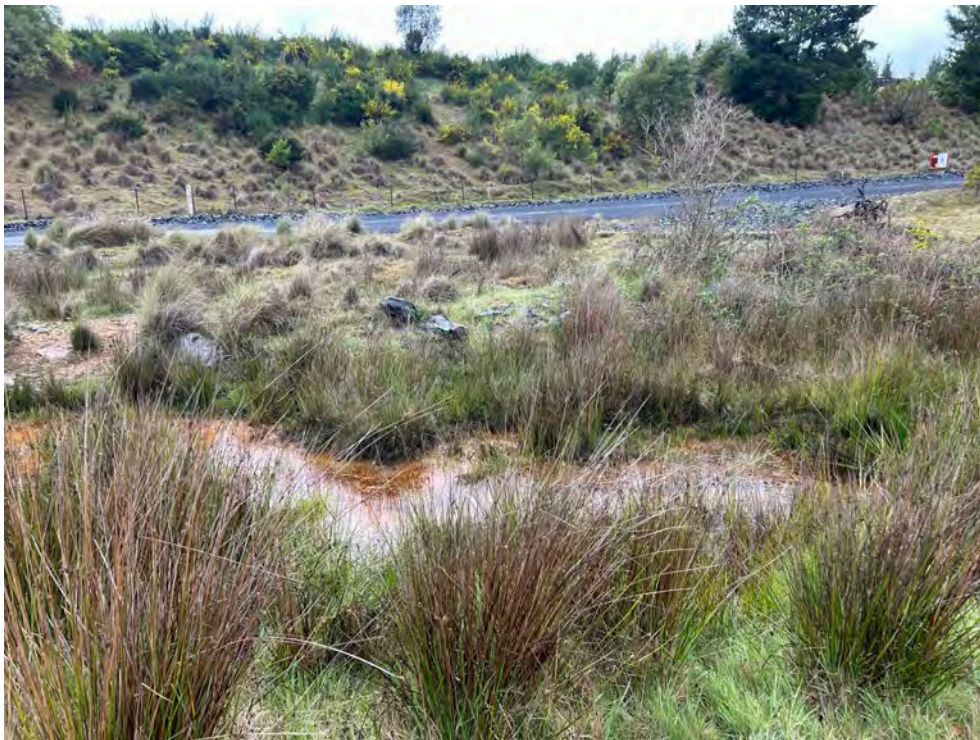
Photo 9: Unnamed stream off site and down gradient from Captains Flat State Emergency Service (SES), showing cloudy surface water with low sediment.

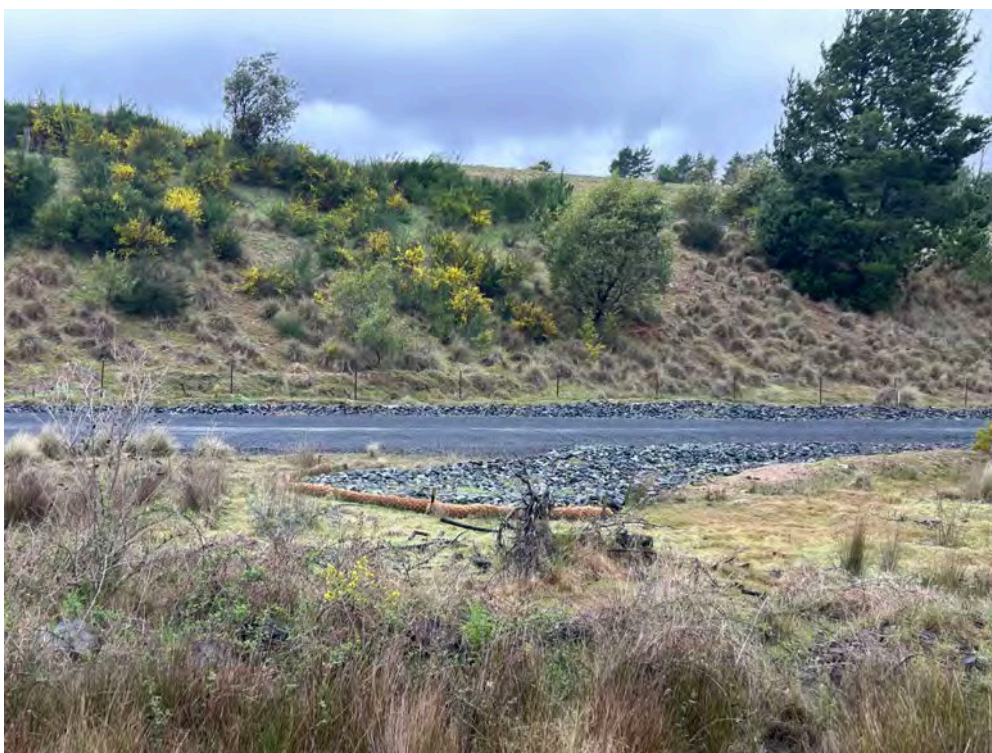
Rock armoury and sediment coir logs adjacent to the north of the site were observed in the previous inspection and again observed during the inspection (**Photo 10**). This is suspected to be related to the mine site remediation program occurring upgradient of the site.

Photo 10: Rock armoury and sediment coir logs adjacent to the north of the site observed in the previous site inspection installed due to mine site remediation works are in good condition.
