# Tarago Action Plan Routine Inspection Checklist

| Date: | 11-Jun-25 | Ramboll and UGL RL Environmental |

| <b>Title:</b> | <b>Tarago Rail Yard Inspection</b> | <b>Approved:</b><br>JA | <b>Project-Nr.:</b><br>318001704 | <b>Date:</b><br>11 June 2025 |

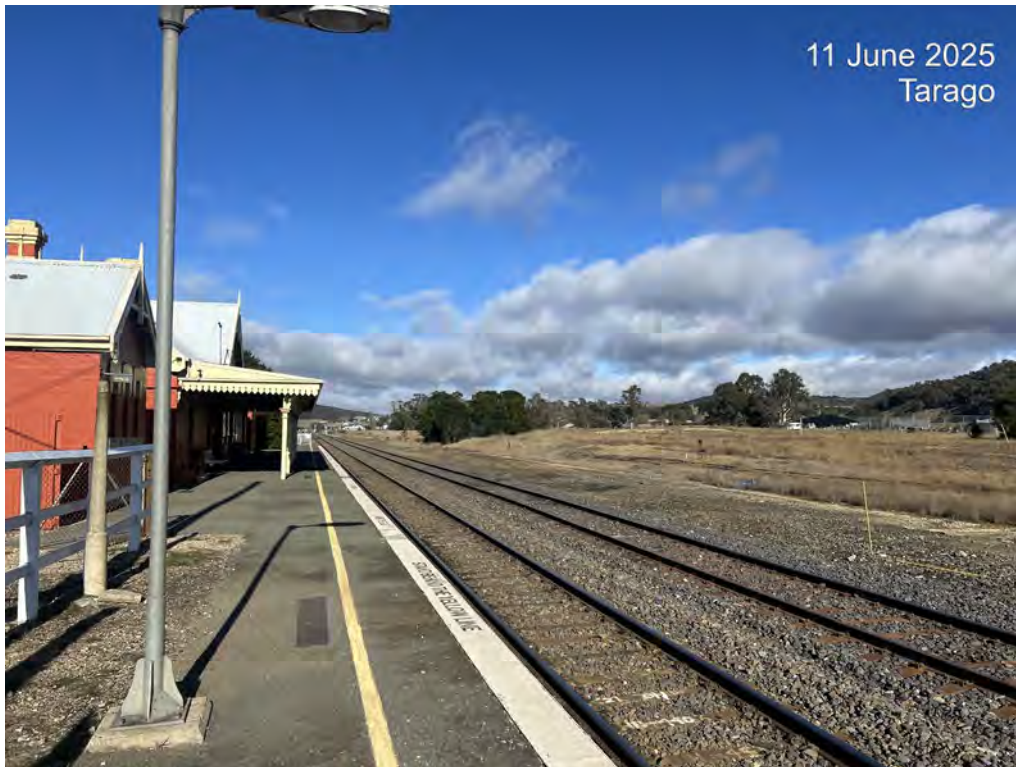
No airborne dust was visible (**Photos 1 - 2**).

**Photo 1: Picture at northern end of Tarago railway station platform facing south, no airborne dust visible.**

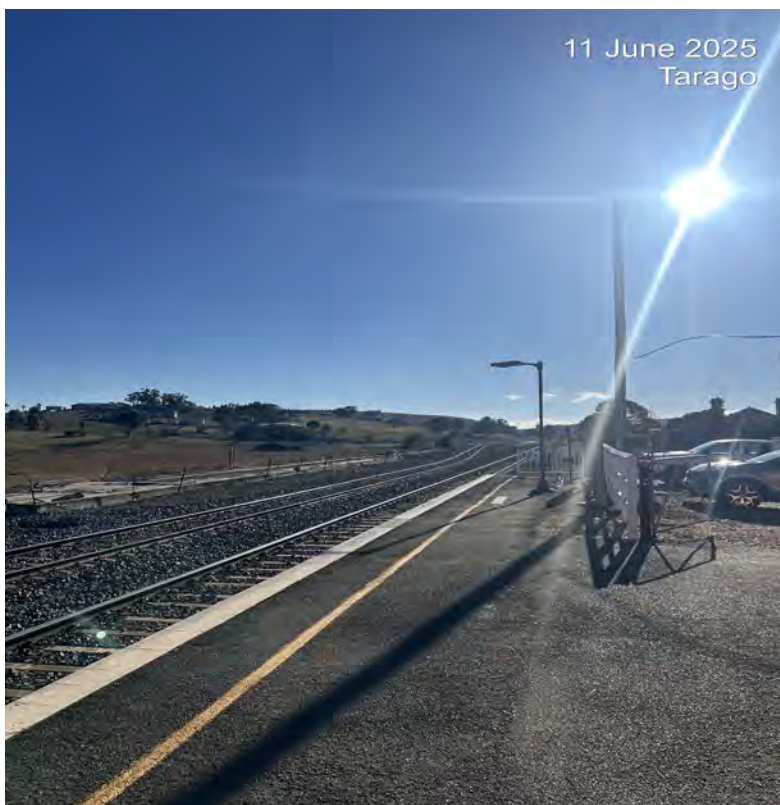
**Photo 2: Picture facing north from station platform, no airborne dust visible.**

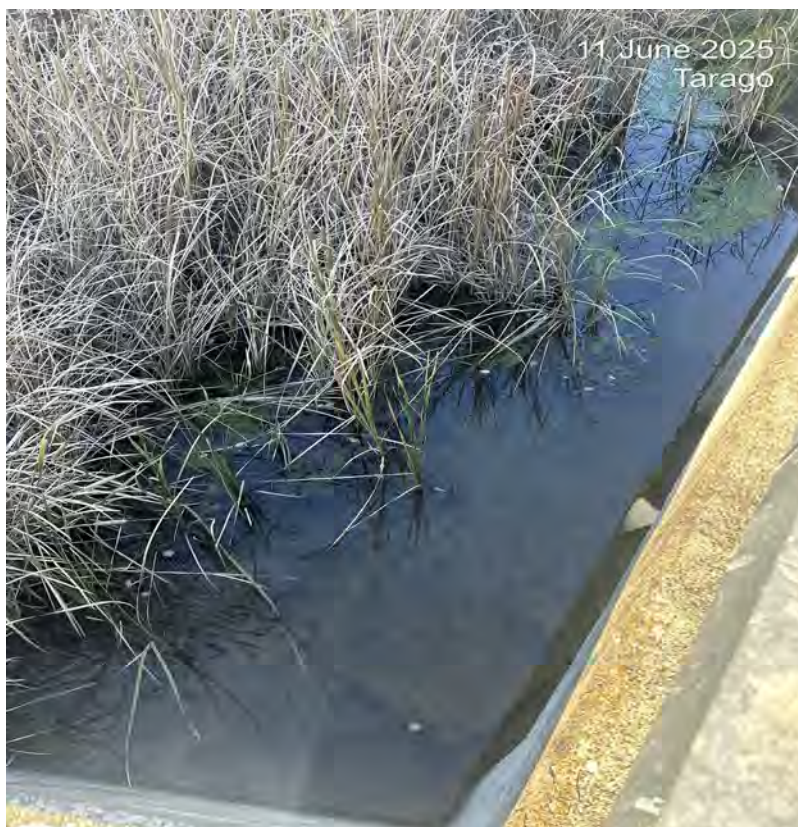
No sign of sediment run-off seen in surface water at southern and middle culverts (**Photos 3 - 7**). No evidence of sediment run-off from northern culvert (**Photo 8**).

Surface water was not observed to be flowing from the site at the northern, middle or southern culverts (**Photos 4, 7 and 8**). Pooled water was observed in a few locations on site (**Photos 3, 5 and 17**). No other flowing surface water was observed onsite during the inspection.

**Photo 3: Southern culvert downgradient of railway line with pooled surface water. Surface water was clear with no visible turbidity or suspended solids. Algae growth present.**

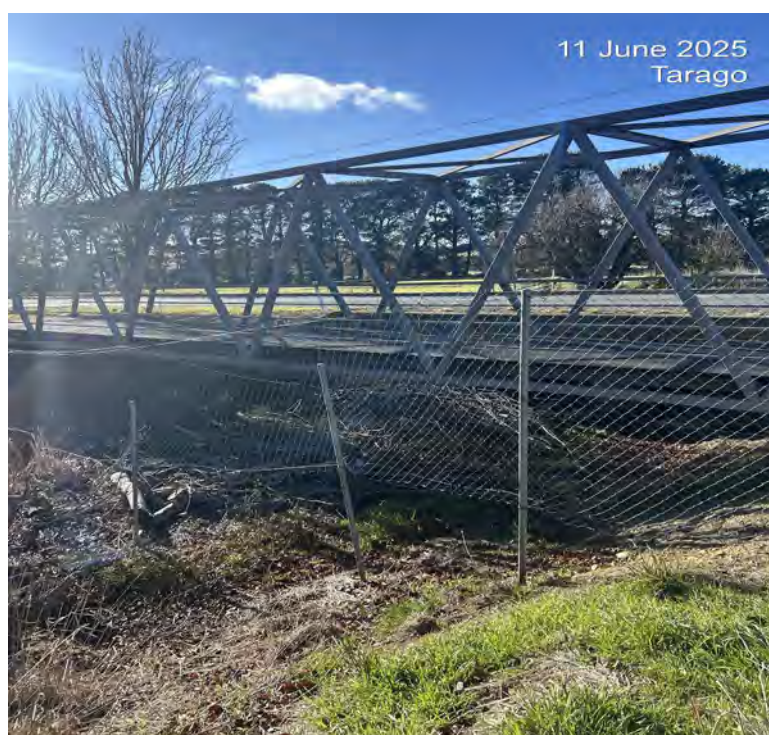
**Photo 4: Southern culvert downgradient of railway line at site boundary. No surface water flowing off site.**

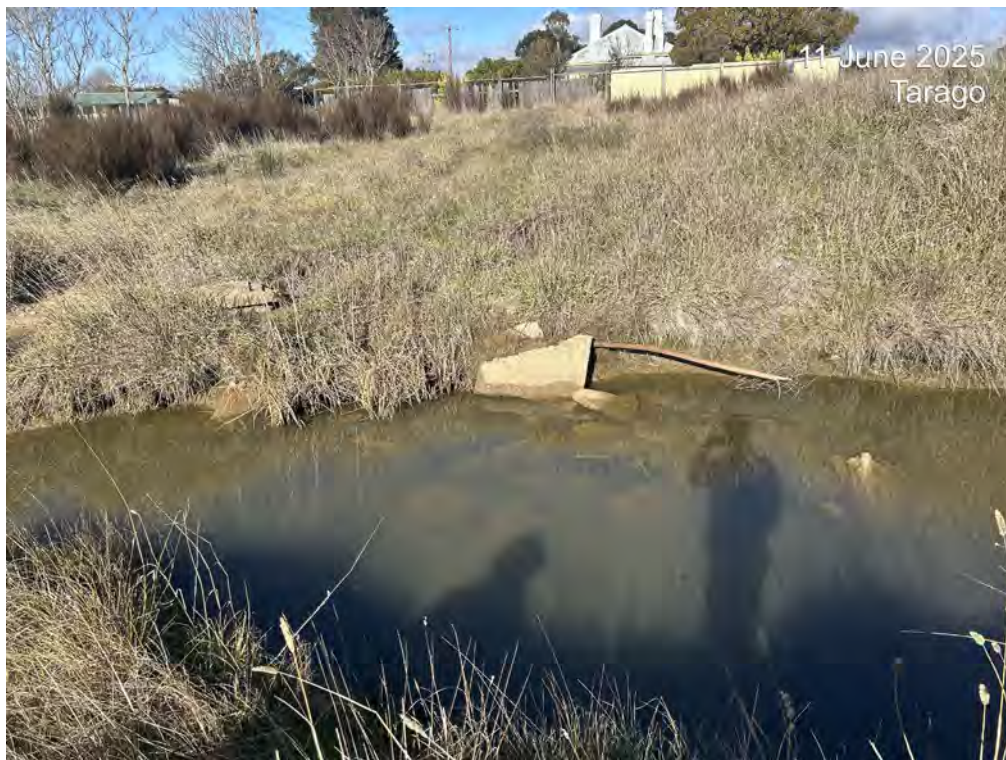
**Photo 5: Downgradient of middle culvert with pooled surface water. Surface water near culvert was clear with a brown tint and algae growth on the bottom.**

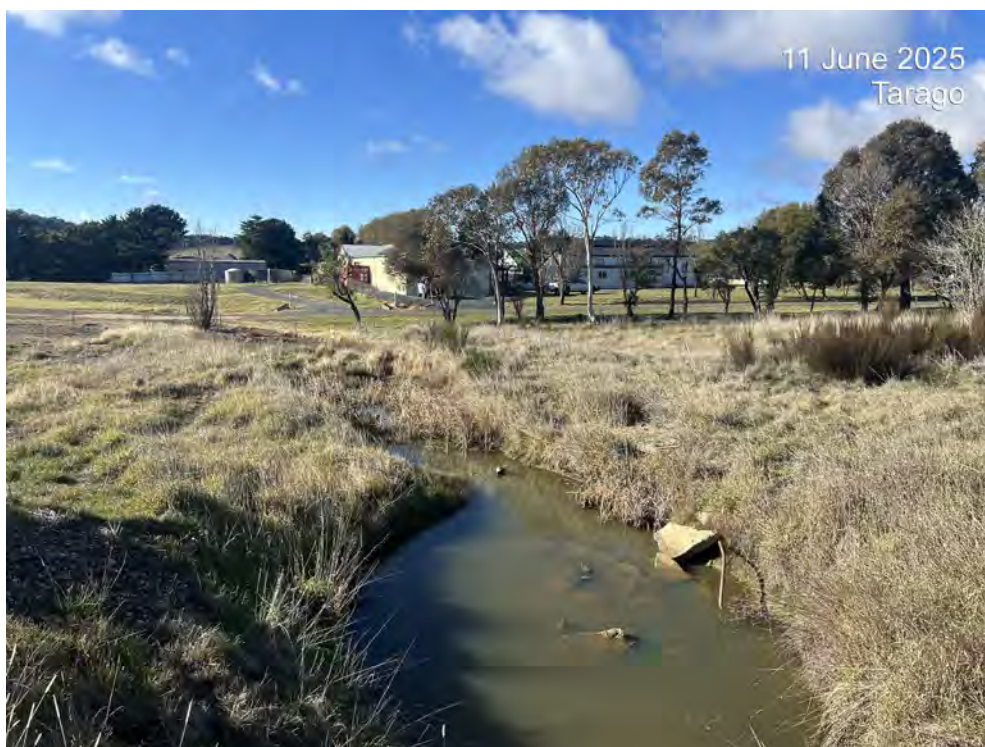
**Photo 6: Downgradient of middle culvert. Drainage line becoming drier leading towards the site boundary. Minor algae growth in moist soil.**

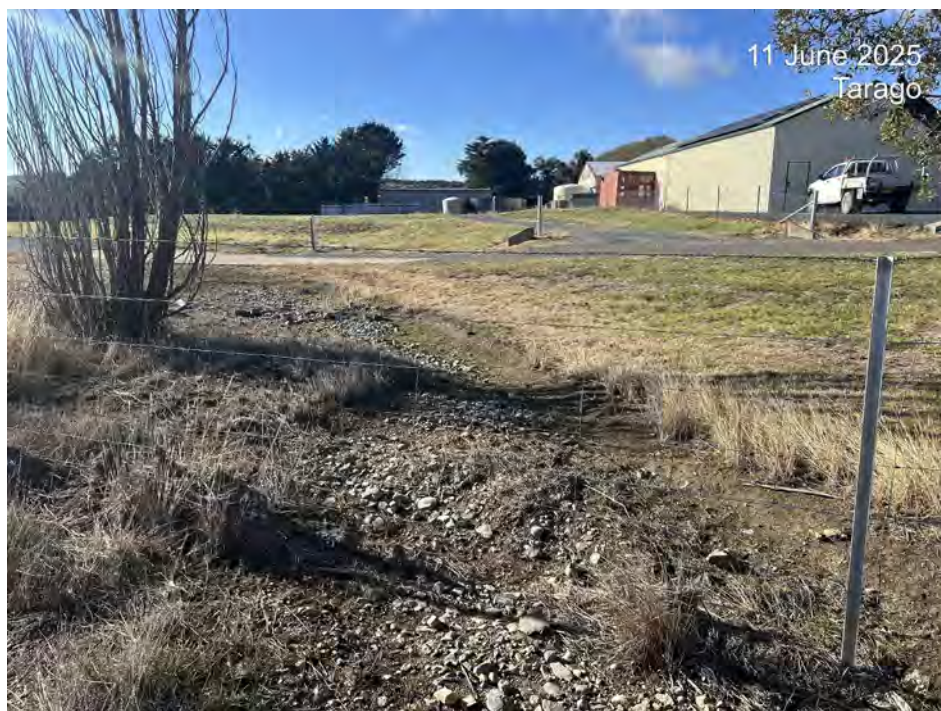
**Photo 7: Downgradient of middle culvert. No water observed flowing offsite. No sediment observed on gravels.**

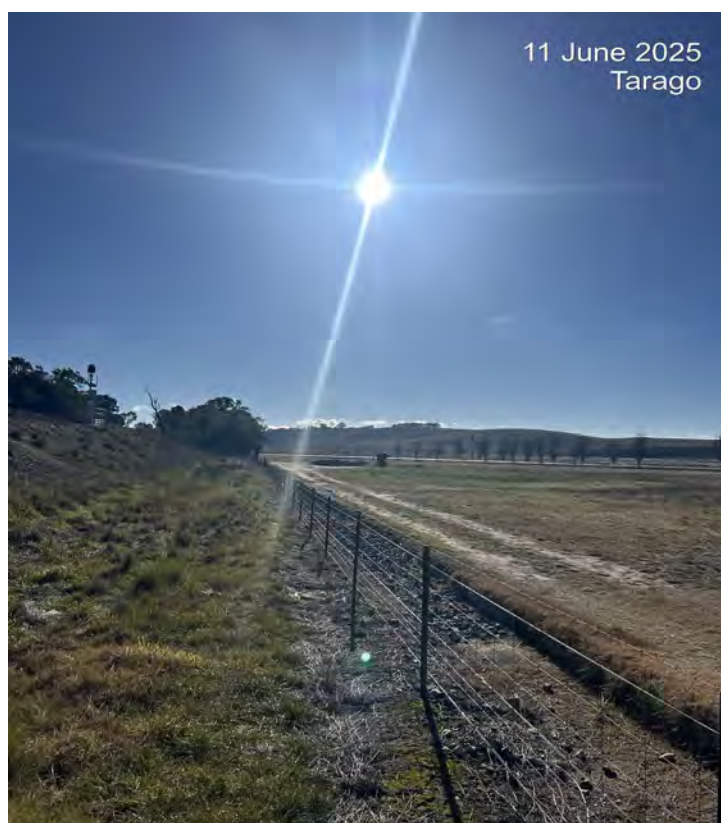
**Photo 8: Downgradient of northernmost culvert, no surface water observed.**

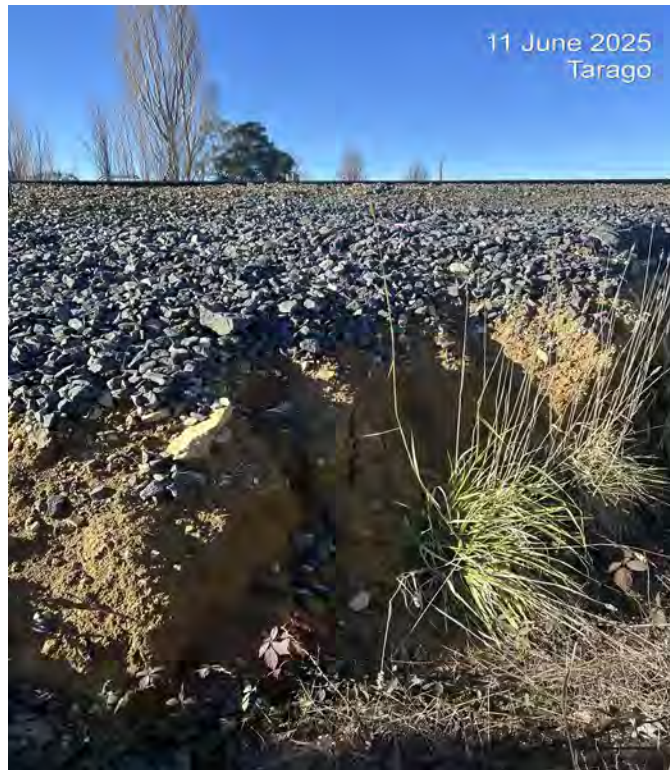
**Photo 9: Southernmost culvert upgradient of the railway line. The erosion due to lack of ground cover observed during multiple previous inspections is still present.**

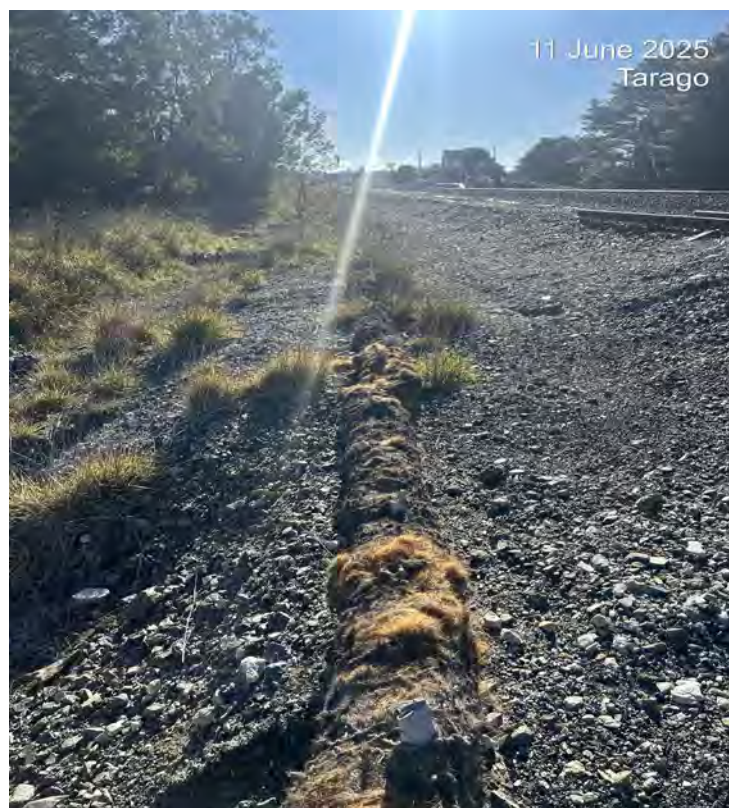
1. Damage to the sediment control coir logs located between the middle and southern culverts was observed (**Photo 10 and 12**) and appears similar to previous inspection. However, the coir logs remain functional, and replacement is not currently recommended.
2. Evidence of erosion noted upgradient of the southern most culvert in previous site inspections remains on site but in a stable condition (**Photo 9**). No evidence of sediment was observed in water flowing offsite at southern culvert during this site inspection.
3. Evidence of erosion noted upgradient of the sediment controls nearby the middle culvert (**Photos 15 and 16**). No evidence of sediment was observed in water flowing offsite at the middle culvert during this site inspection. Sediment controls appear to be working appropriately.

**Photo 10: Sediment controls at southernmost culvert upgradient of the railway line.**

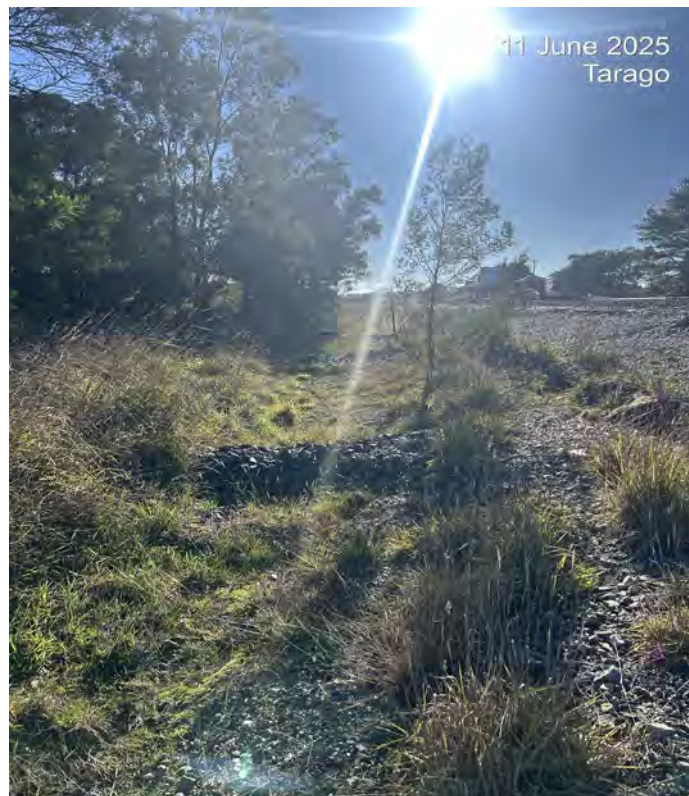
**Photo 11: Rock armoury in drainage channel between southern and middle culverts. Minor sediment and vegetation buildup within drainage line.**

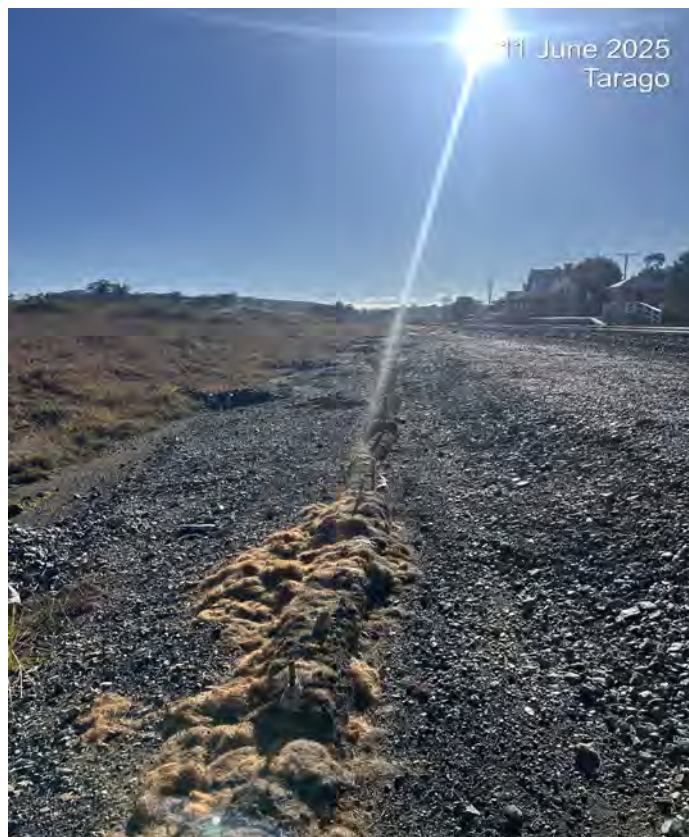
**Photo 12: Damage to sediment control coir logs between southern and middle culverts.**

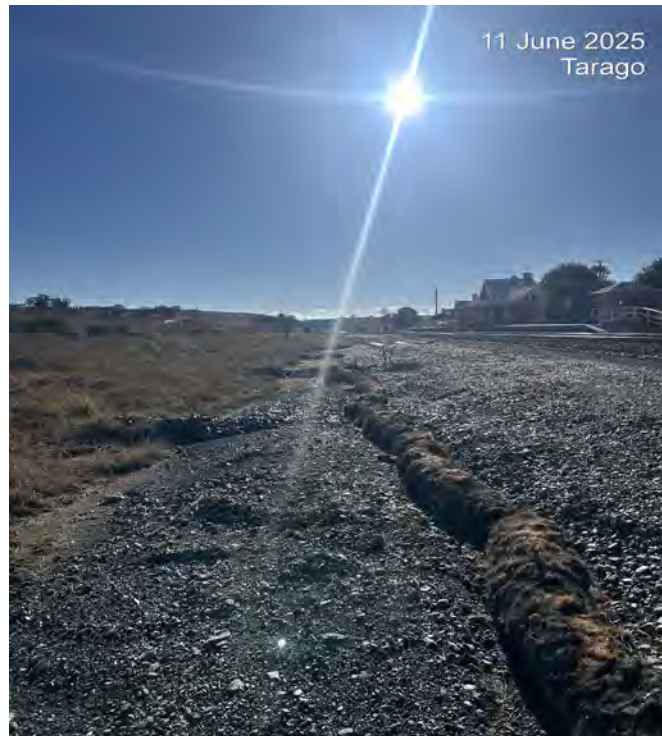
**Photo 13: Rock armoury and sediment coir logs in drainage channel between southern and middle culverts appears to be in good condition.**

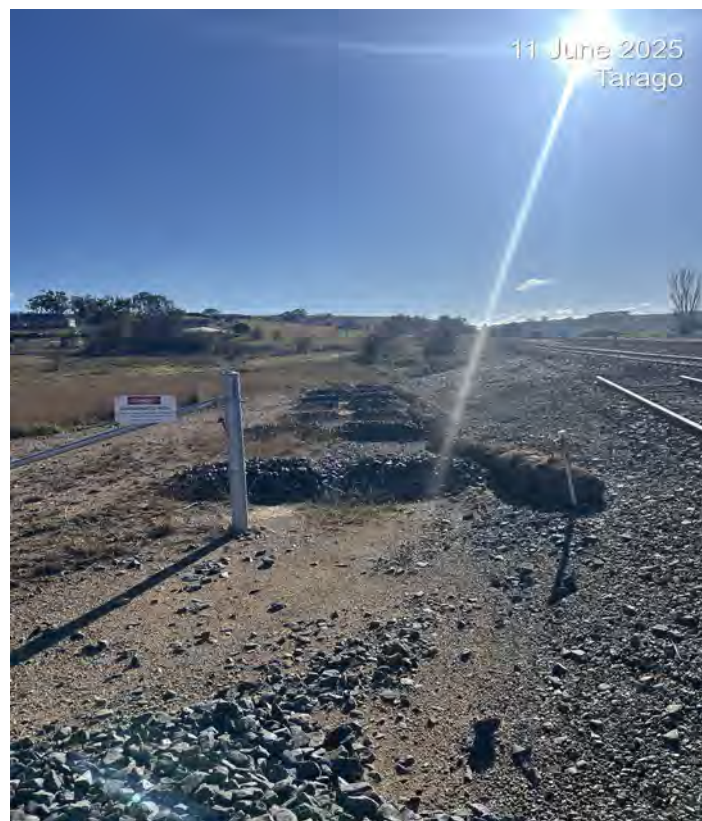
**Photo 14: Rock armoury and sediment coir logs in drainage channel between southern and middle culverts appears to be in good condition.**

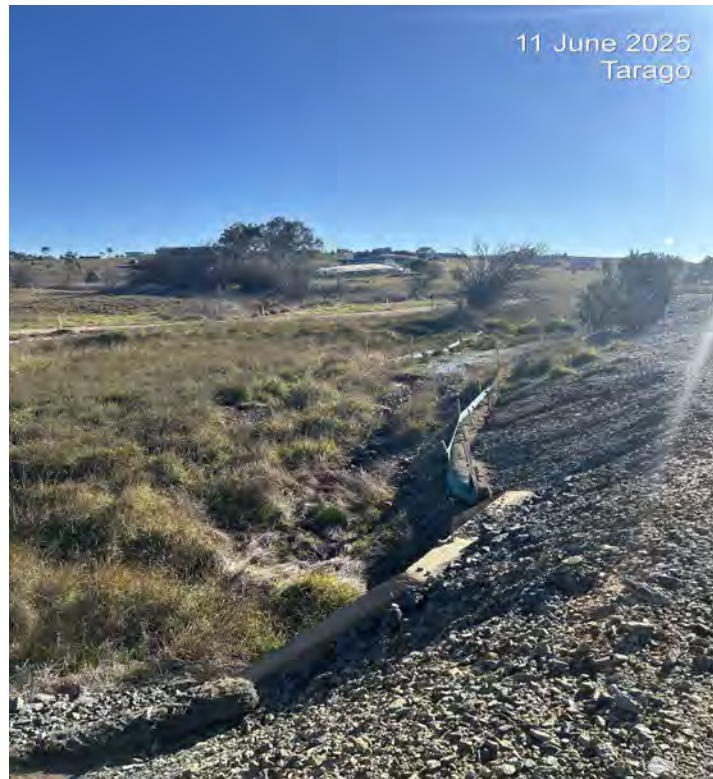
**Photo 15: Sediment controls at the middle culvert upgradient of the railway line in good condition. Sediment buildup in front of coir logs remains similar to previous inspection.**

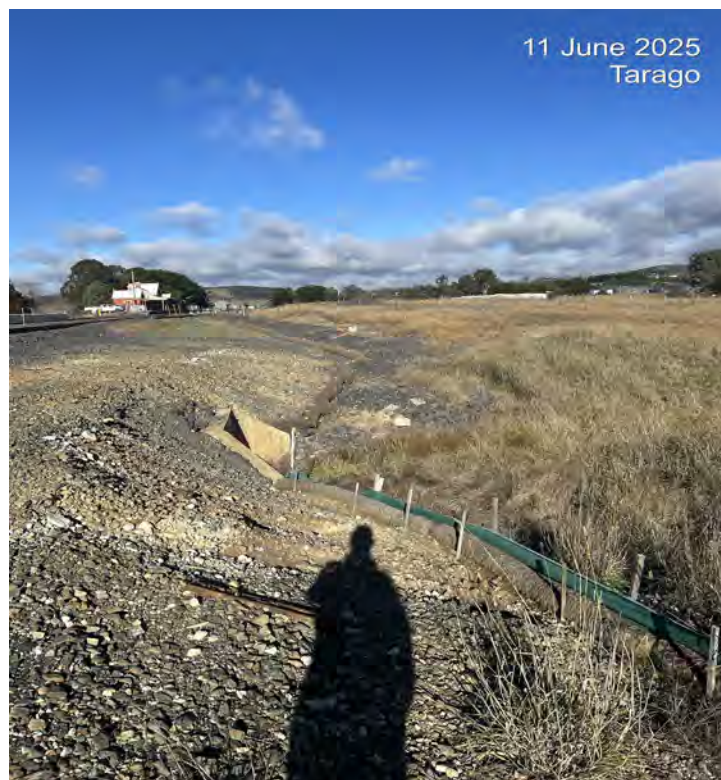
**Photo 16: Sediment controls north of middle culvert, upgradient of railway line in good condition. Sediment buildup in front of coir logs remains similar to previous inspection.**

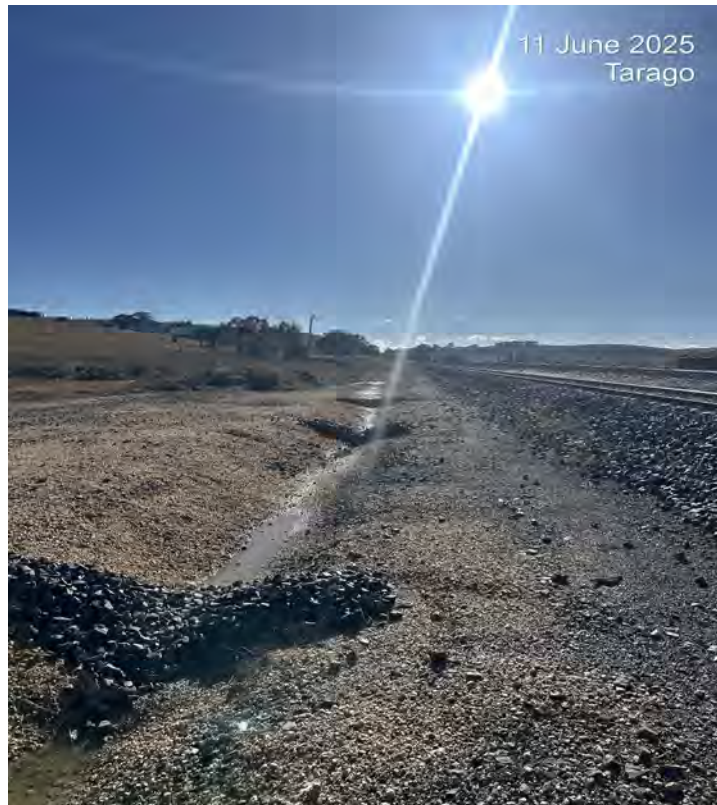
**Photo 17: Sediment controls in drainage channel between middle and northern culverts appear to be in good condition. Minor surface water pooled on site.**

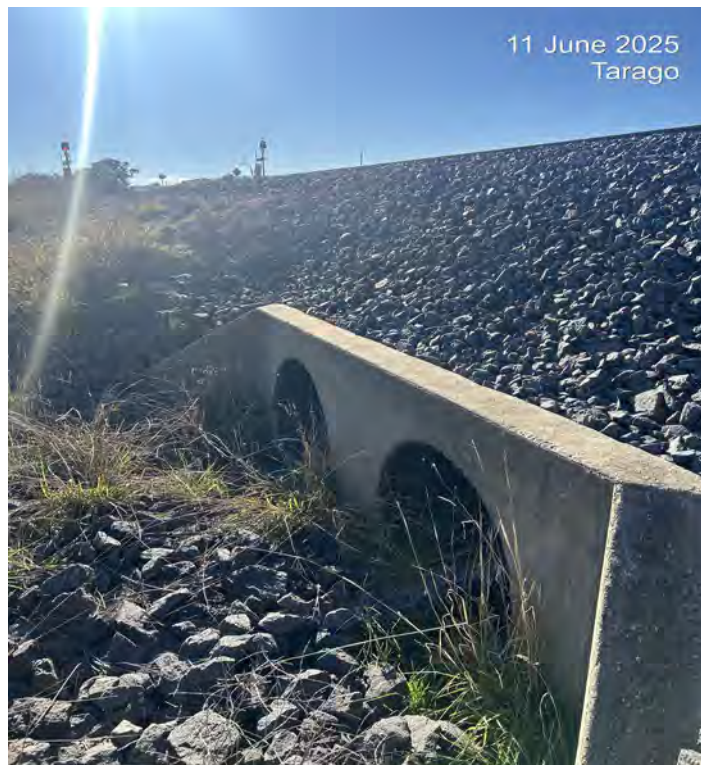
**Photo 18: Upgradient of northernmost culvert with no surface water. No sediment build up was noted on rock armoury.**

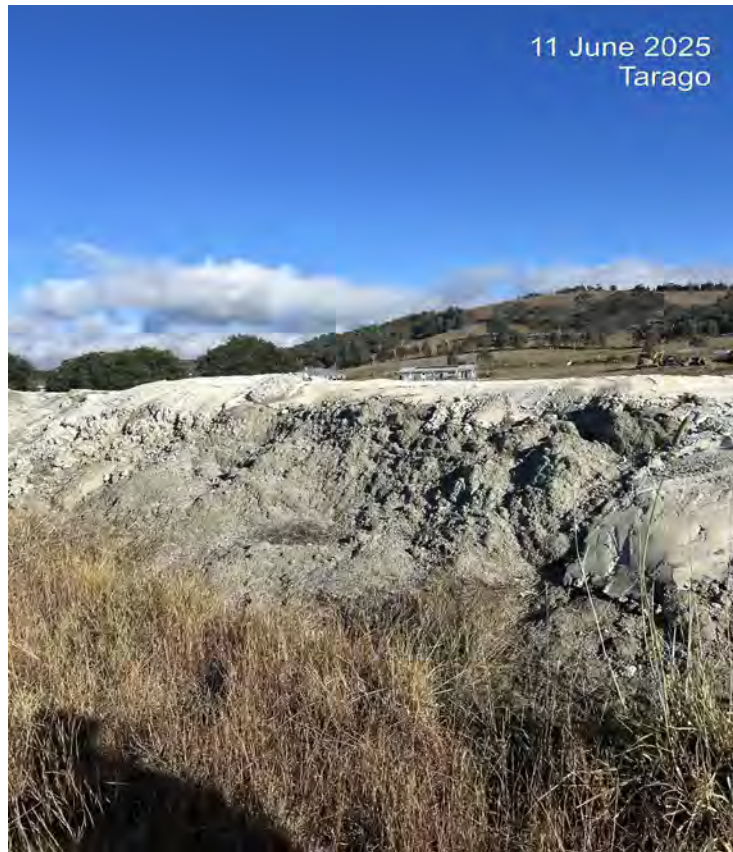
**Photo 19: The concrete-capped stockpile is generally in good condition with no new exposure locations observed.**

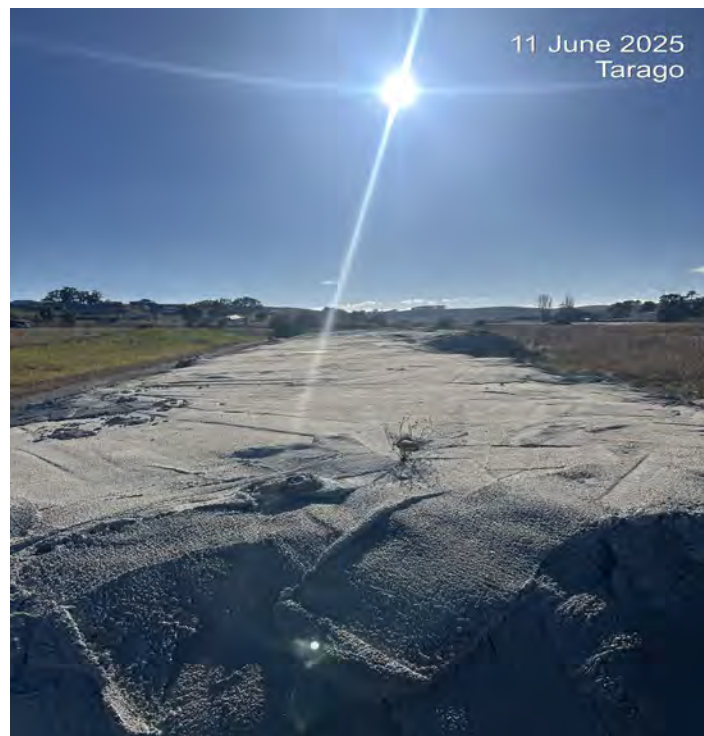
**Photo 20: The concrete-capped stockpile is generally in good condition with no new exposure locations observed.**

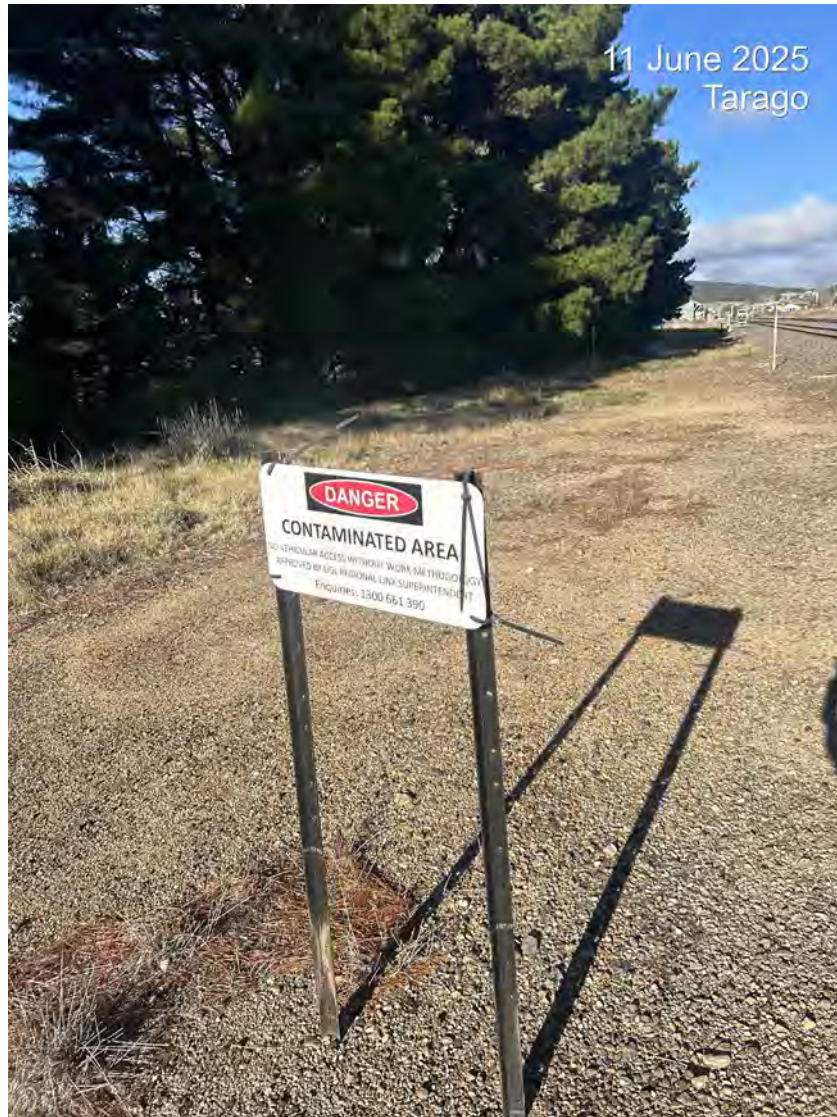
| Section | Control | Inspection | | Corrective Action |
|---|---|---|---|---|
| 5.1 | Is Exclusion Zone signage present as recommended on Figures 2a - 2e Appendix 1 to demarcate contamination in the rail formation and adjacent soils? | Yes ( <b>Photo 21</b> ). | | |

**Photo 21: Exclusion signage posted at regular intervals along the corridor appearing to be in good condition.**
