# Tarago Action Plan Routine Inspection Checklist

| Date: | 13-Mar-25 | Ramboll and UGL RL Environmental |

| Title: | Tarago Rail Yard Inspection | Approved: | Project-Nr.: | Date: |
| Site: | Tarago, NSW | JA | 318001704 | 13 March 2025 |

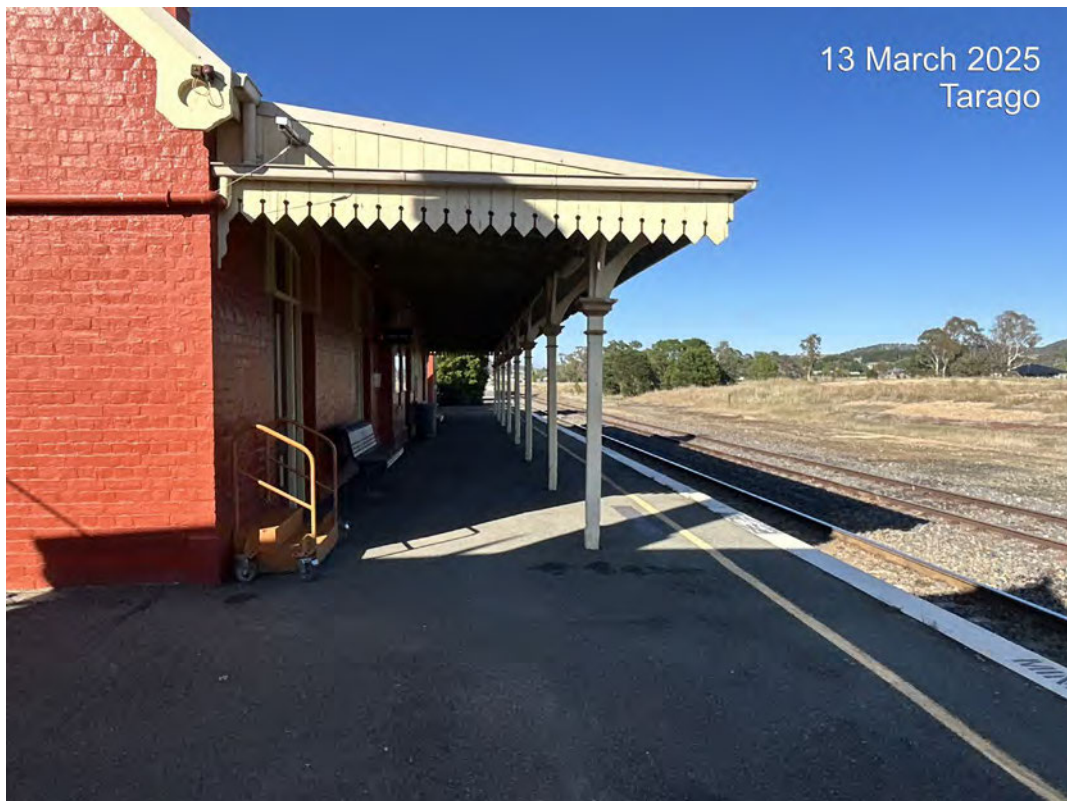
No airborne dust was visible (**Photos 1 - 2**).

Photo 1: Picture at northern end of Tarago railway station platform facing south, no airborne dust visible.

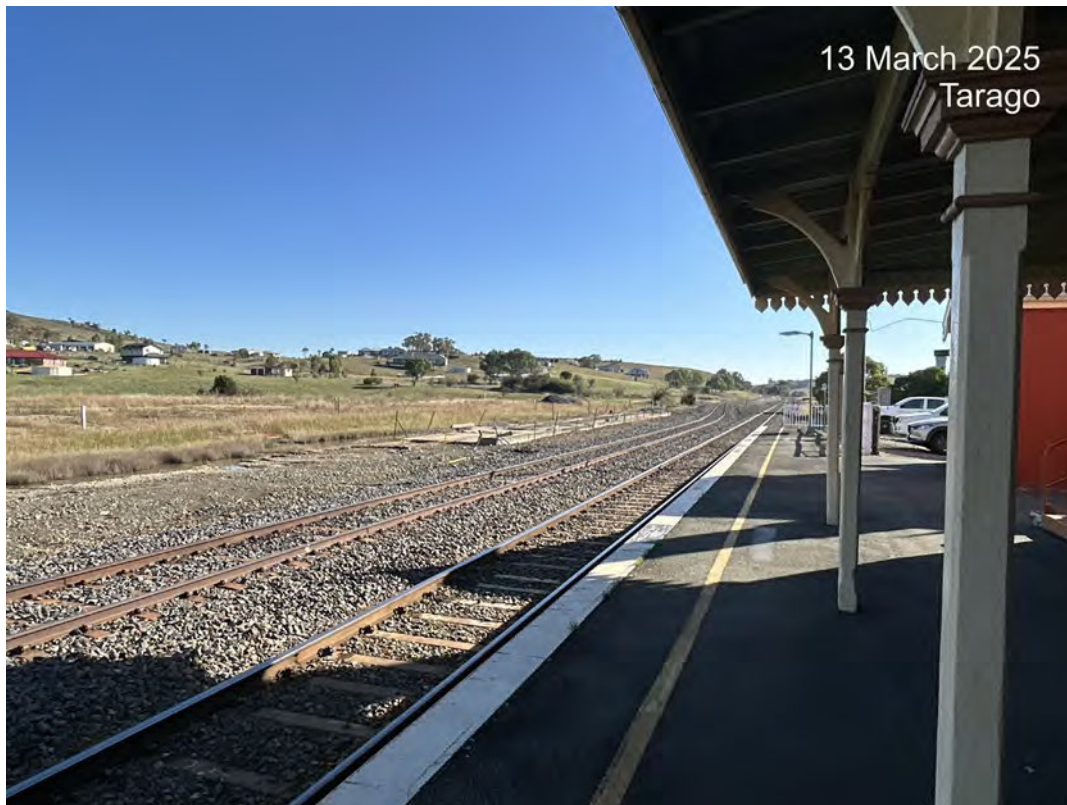
Photo 2: Picture facing northeast towards Tarago railway station, no airborne dust visible.

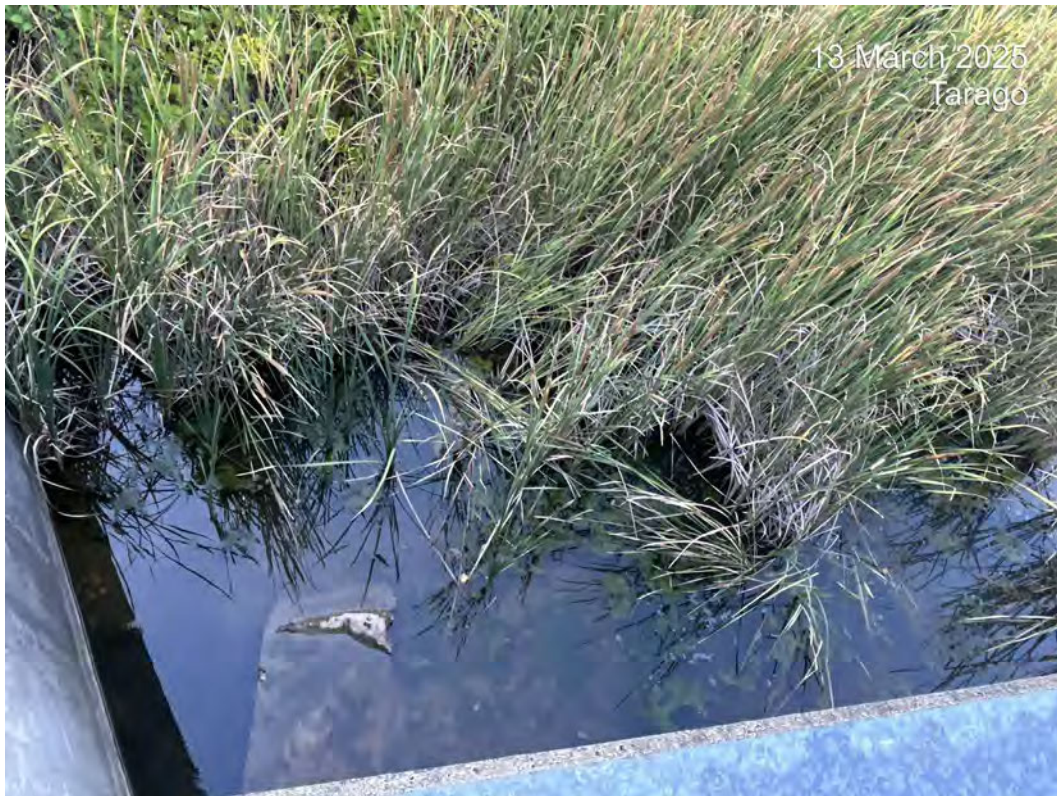
No sign of sediment run-off seen in surface water at southern and middle culverts (**Photos 3 - 6**). No evidence of sediment run-off from northern culvert (**Photo 7 - 8**).

Surface water was observed discharging from the site at the middle and southern culverts (**Photos 3, 5 and 6**). Pooled water was observed in a few locations on site (**Photos 15 and 16**). No other flowing surface water was observed onsite during the inspection.

**Photo 3: Southern culvert downgradient of railway line with pooled surface water. Surface water was clear with no visible turbidity or suspended solids.**

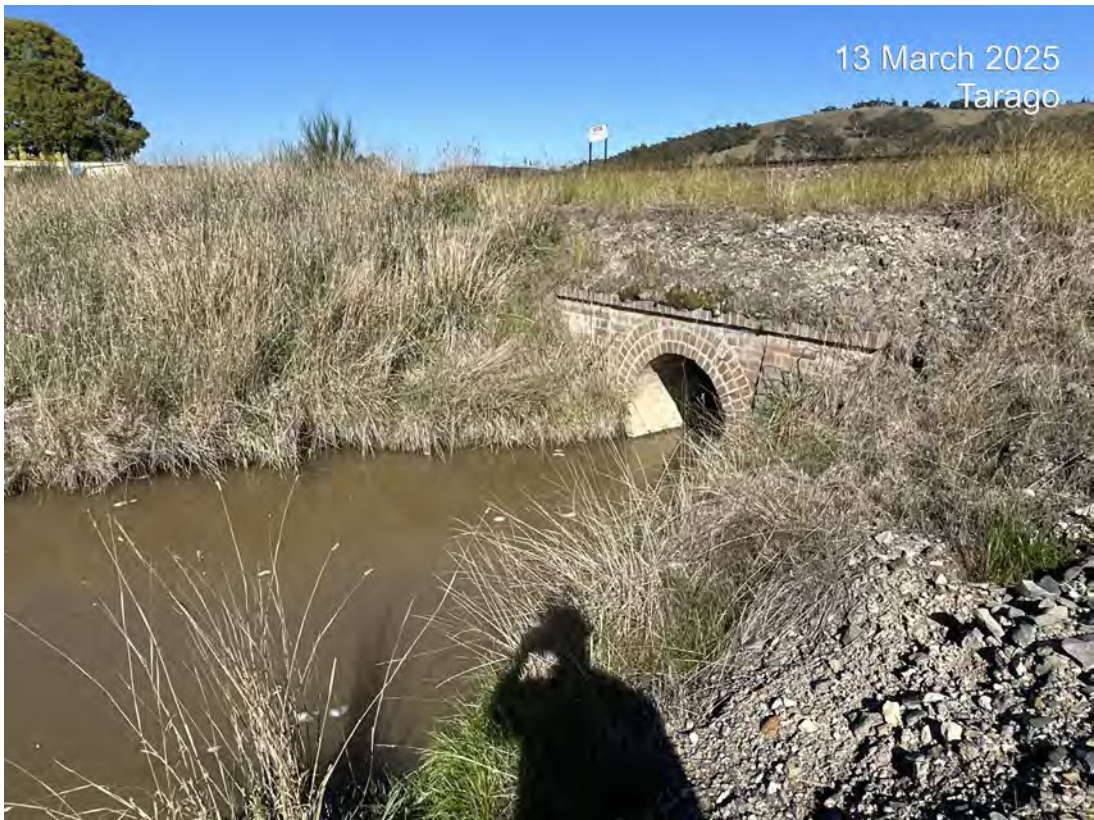
| Section | Control | Inspection | | Corrective Action |
|---|---|---|---|---|
| 5.1 | Is Exclusion Zone signage present as recommended on Figures 2a - 2e Appendix 1 to demarcate contamination in the rail formation and adjacent soils? | Yes ( <b>Photos 4 and 16</b> ). | | |

**Photo 4: Downgradient of middle culvert with pooled surface water. Surface water near culvert was brown.**

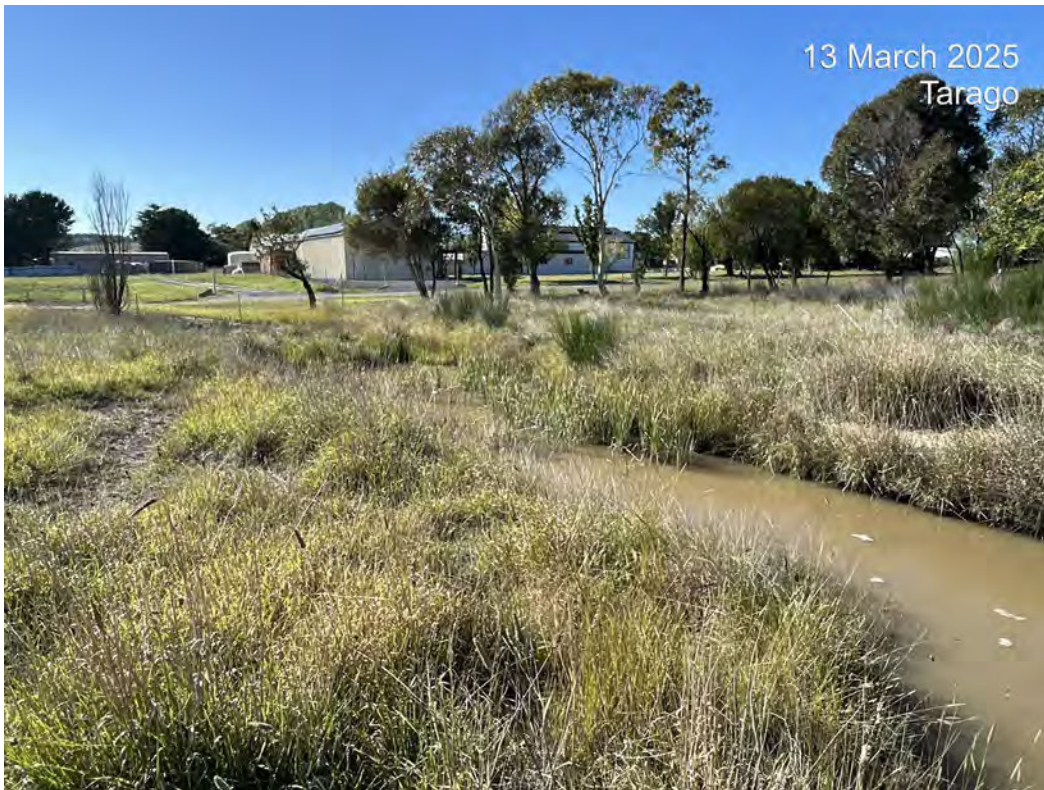
**Photo 5: Downgradient of middle culvert with pooled surface water. Surface water further away from culvert is clear with some algae growth on bottom.**

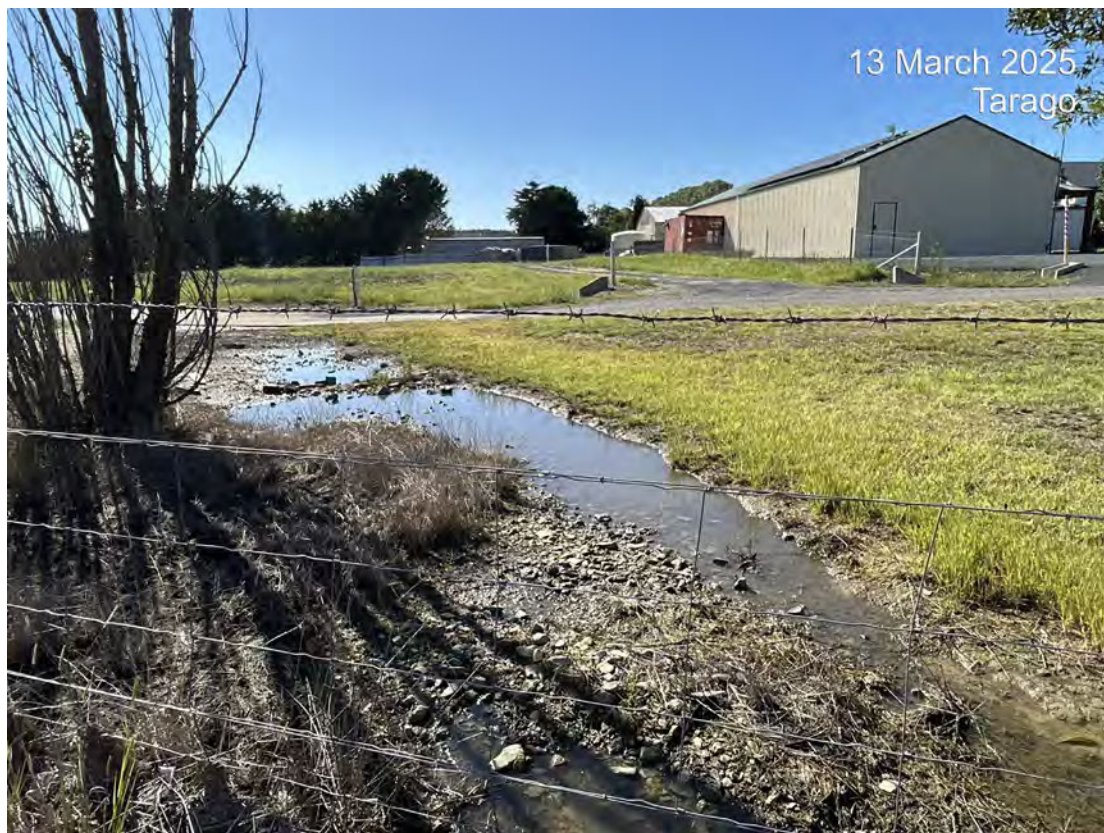
**Photo 6: Downgradient of middle culvert with surface water flowing offsite. Offsite water was clear.**

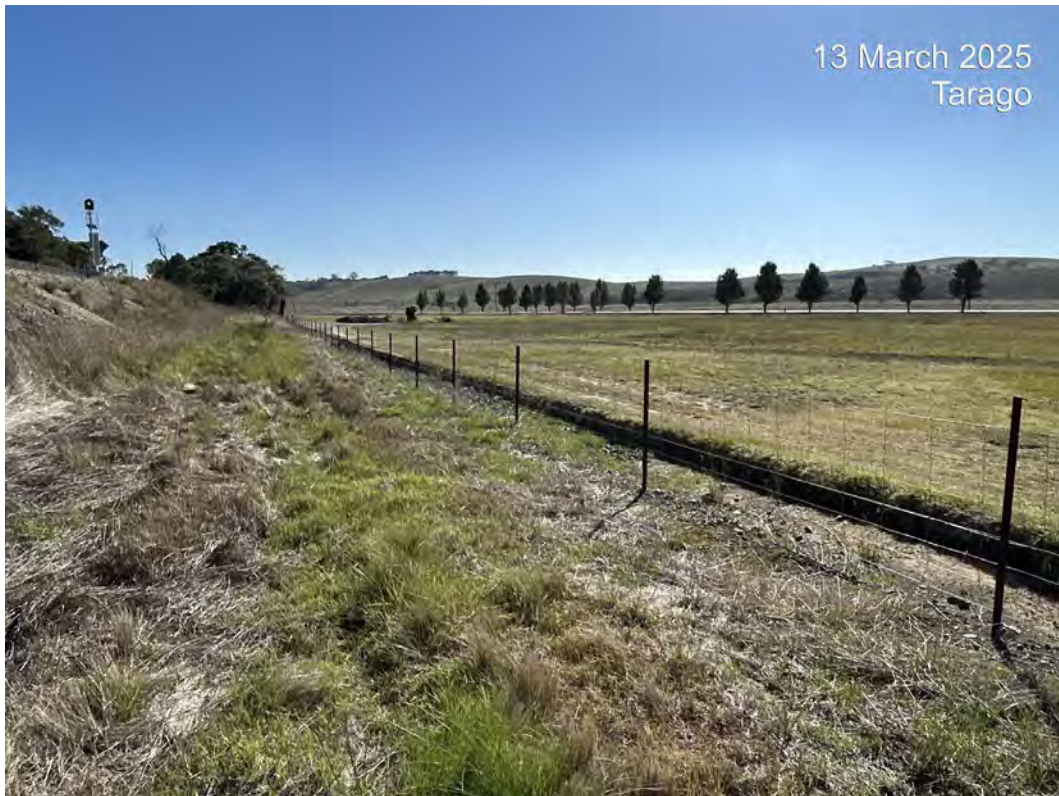
**Photo 7: Downgradient of northernmost culvert, no surface water observed.**

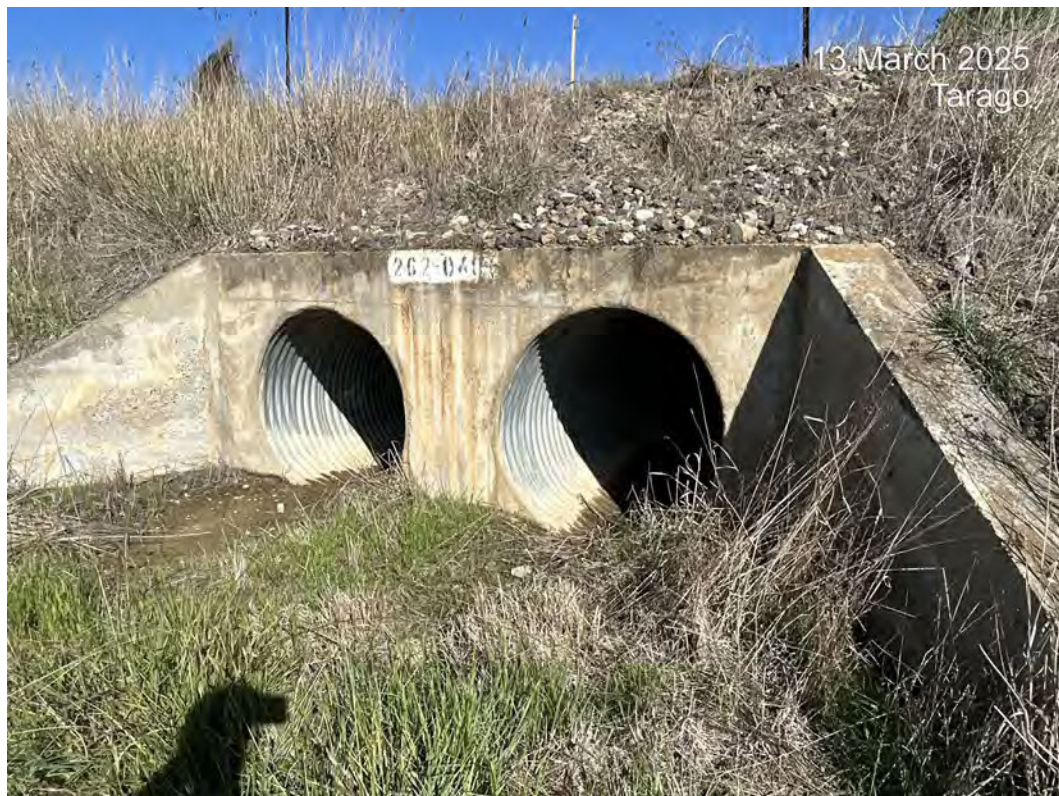
**Photo 8: Downgradient of northernmost culvert, no surface water observed.**

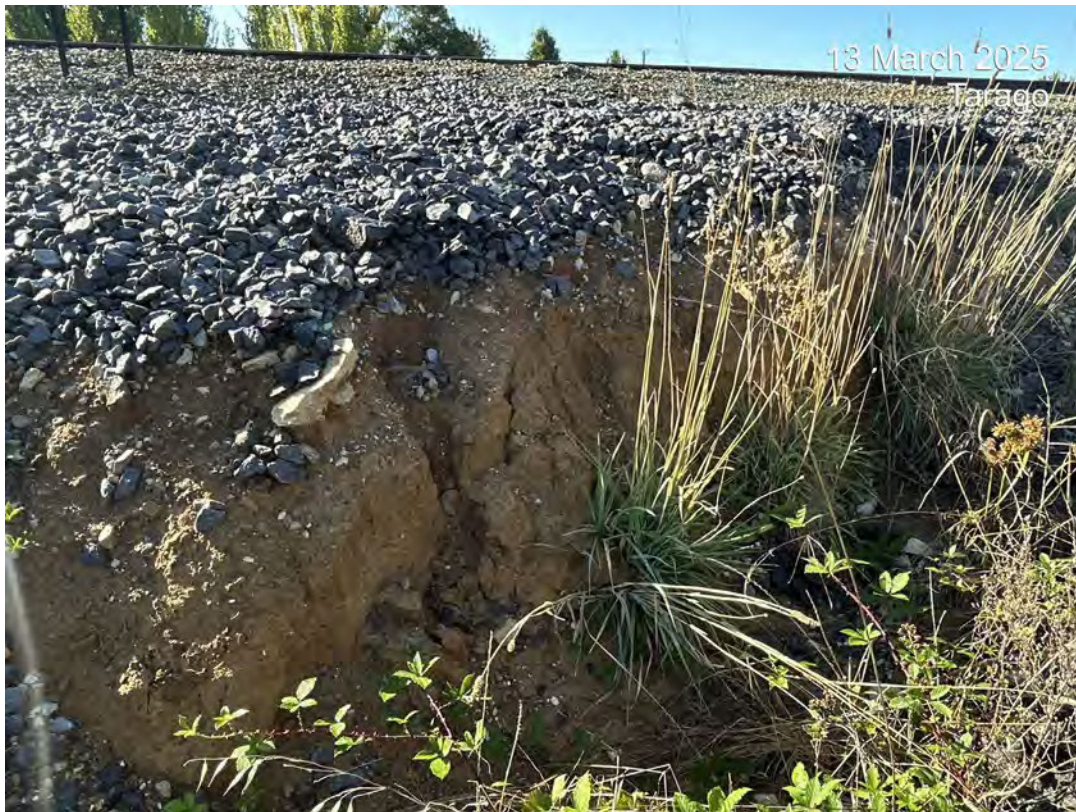
**Photo 9: Southernmost culvert upgradient of the railway line. The erosion due to lack of ground cover observed during multiple previous inspections is still present.**

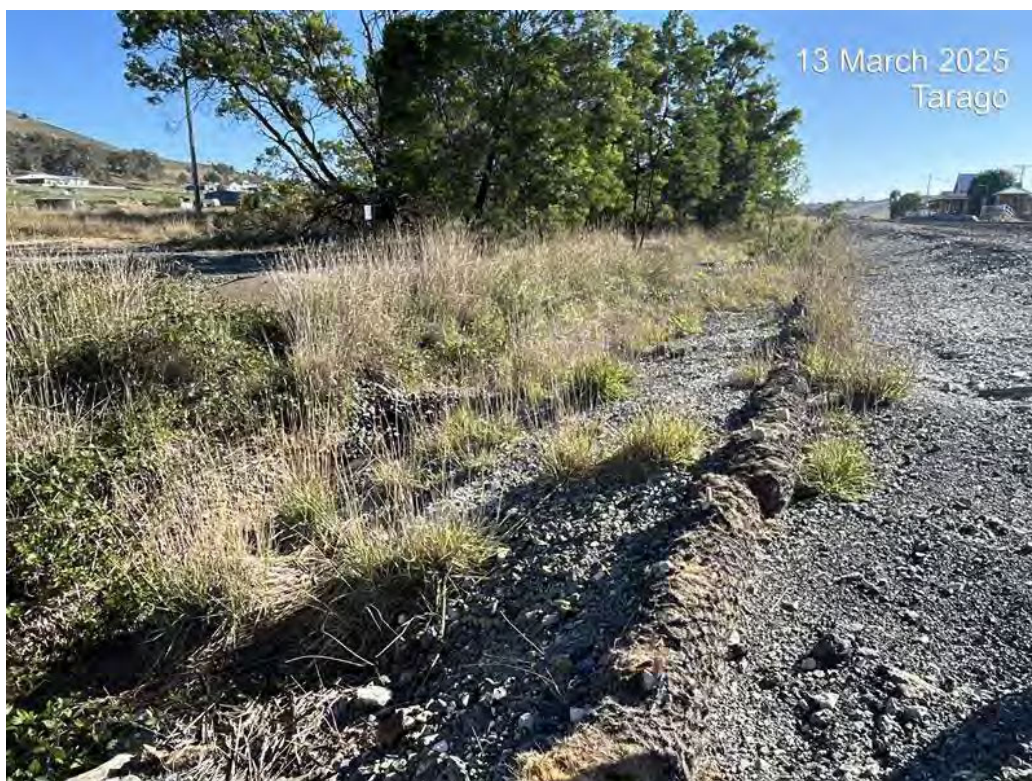
**Photo 10: Sediment controls at southernmost culvert upgradient of the railway line.**

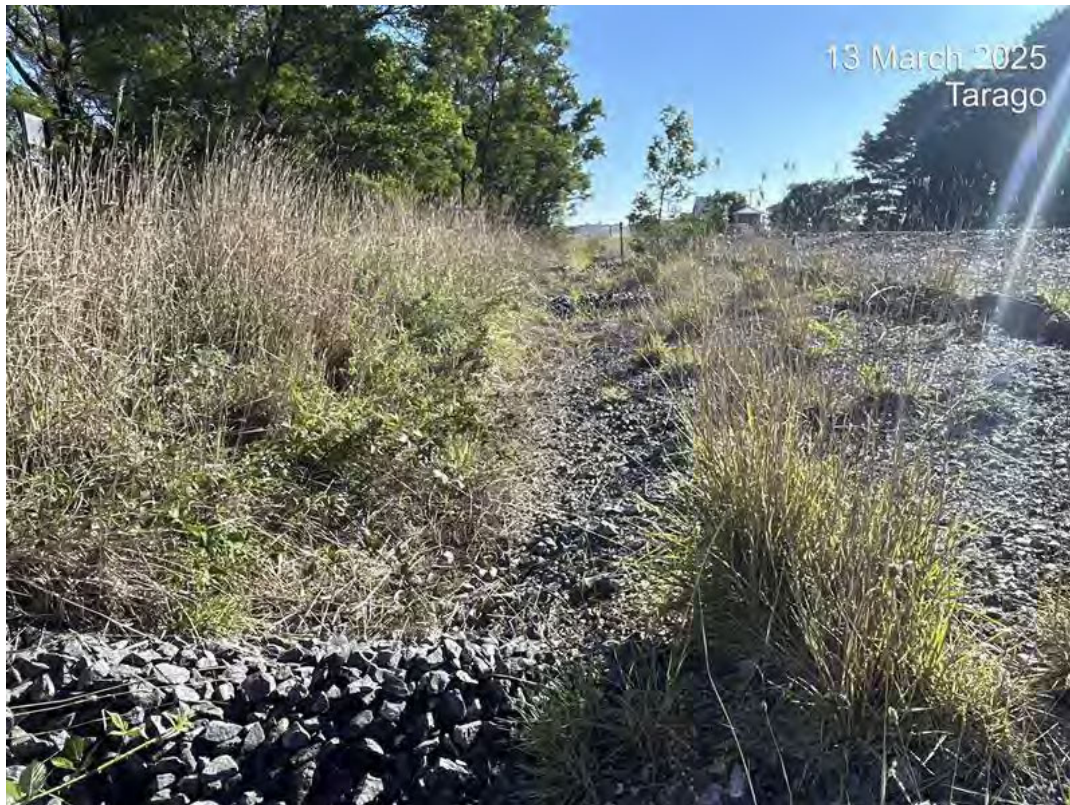
**Photo 11: Rock armoury in drainage channel between southern and middle culverts. Minor sediment and vegetation buildup within drainage line.**

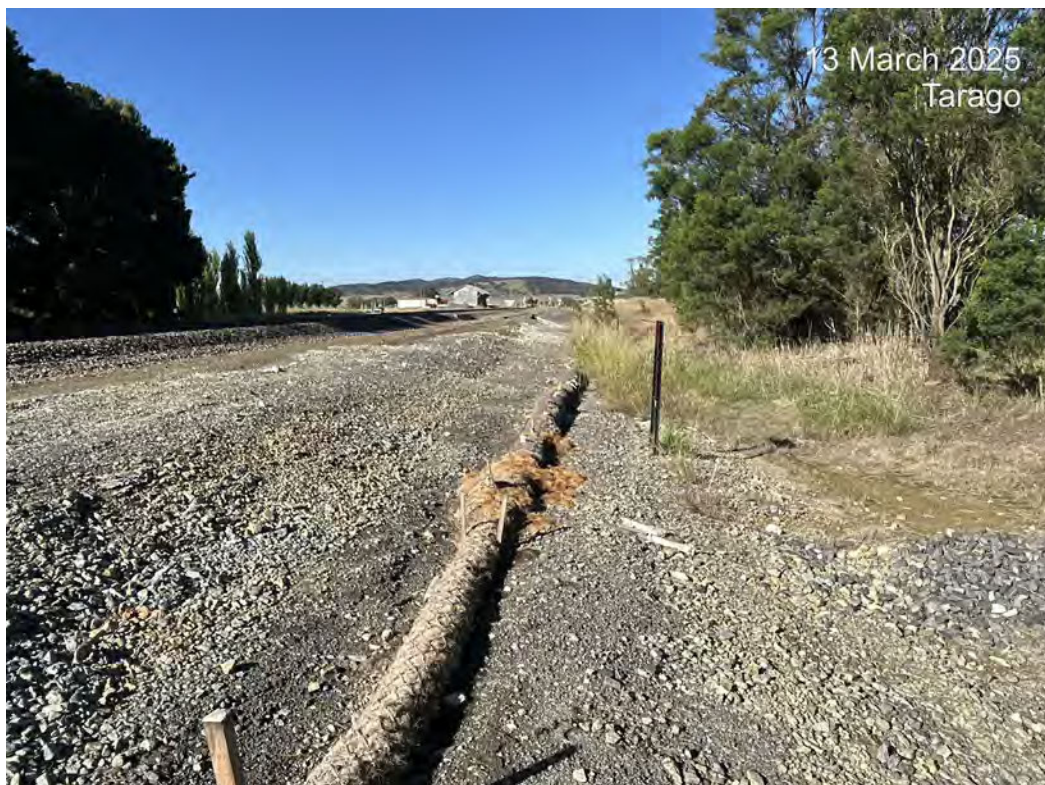
1. Damage to the sediment control coir logs located between the middle and southern culverts was observed (**Photo 12**) and appears similar to previous inspection. However, the coir logs remain functional, and replacement is not currently recommended.
2. Evidence of erosion noted upgradient of the southern most culvert in previous site inspections remains on site but in a stable condition (**Photo 9**). No evidence of sediment was observed in water flowing offsite at southern culvert during this site inspection.
3. Evidence of erosion noted upgradient of the sediment controls nearby the middle culvert. No evidence of sediment was observed in water flowing offsite at the middle culvert during this site inspection. Sediment controls appear to be working appropriately.

**Photo 12: Damage to sediment control coir logs between southern and middle culverts.**

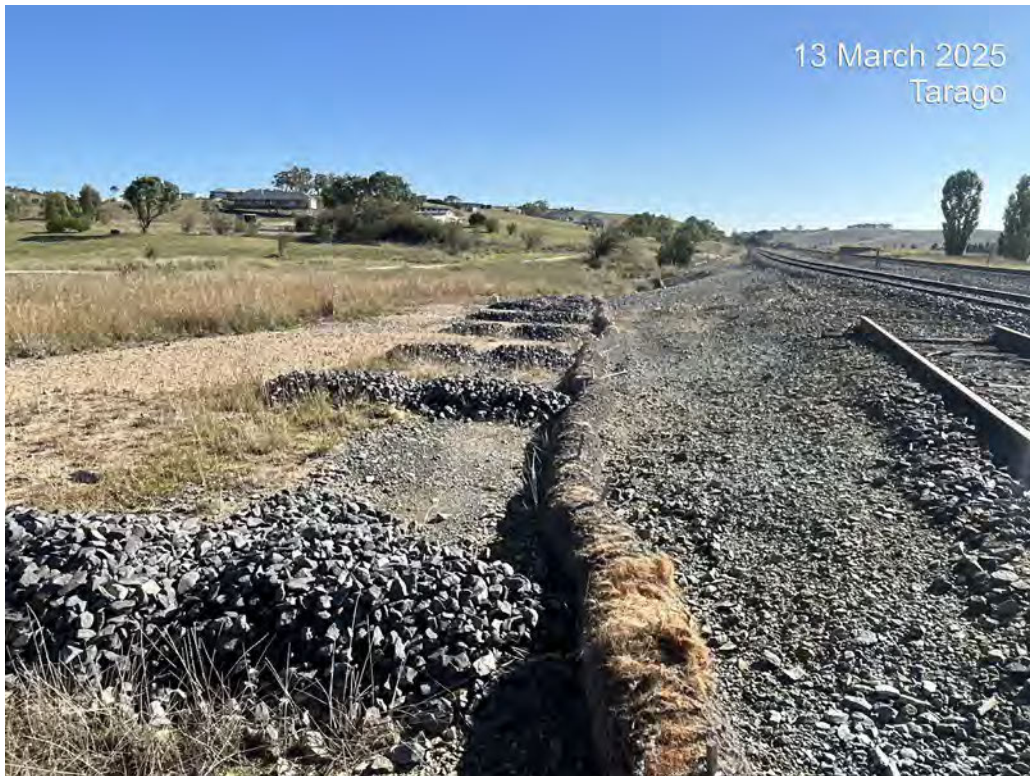
**Photo 13: Rock armour and sediment coir logs in drainage channel between southern and middle culverts appears to be in good condition.**

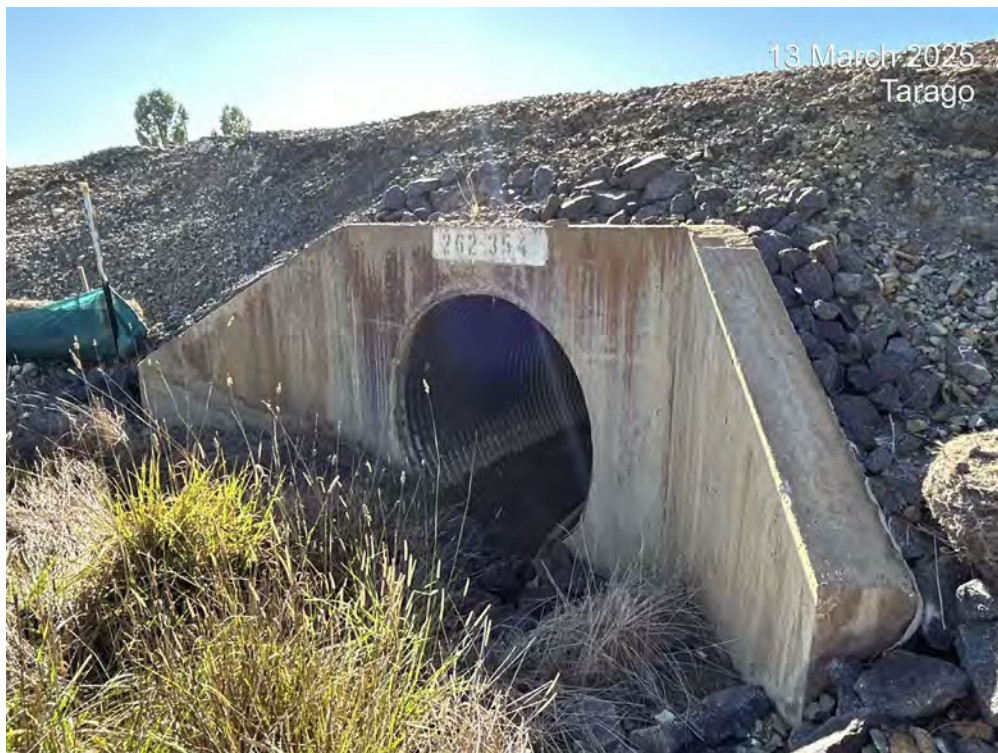
**Photo 14: Sediment controls at the middle culvert upgradient of the railway line in good condition. Sediment buildup in front of coir logs remains similar to previous inspection.**

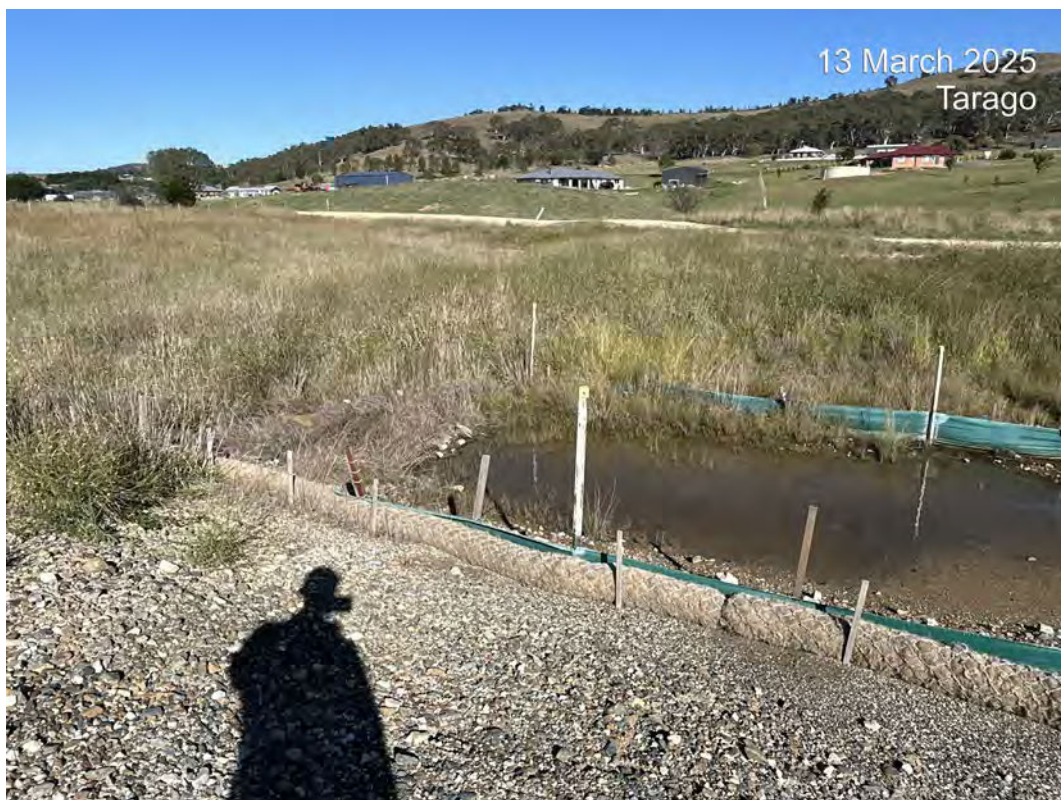
**Photo 15: Sediment controls north of middle culvert, upgradient of railway line in good condition. Sediment buildup in front of coir logs remains similar to previous inspection.**

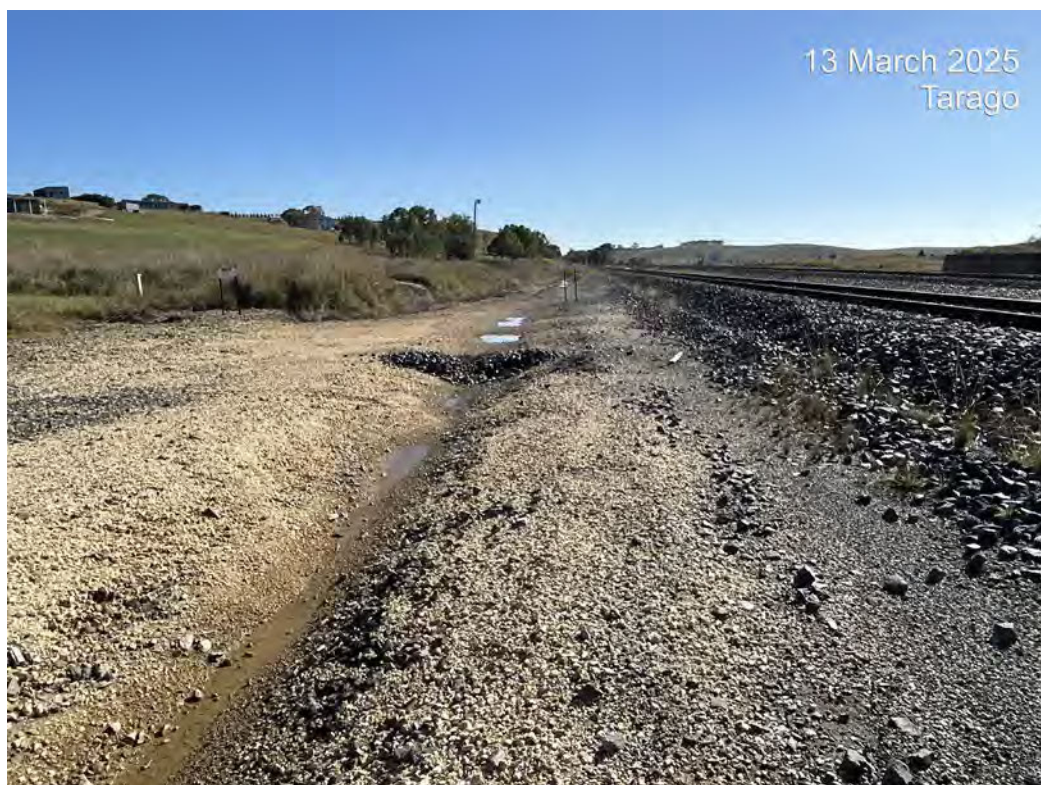
**Photo 16: Sediment controls in drainage channel between middle and northern culverts appear to be in good condition.**

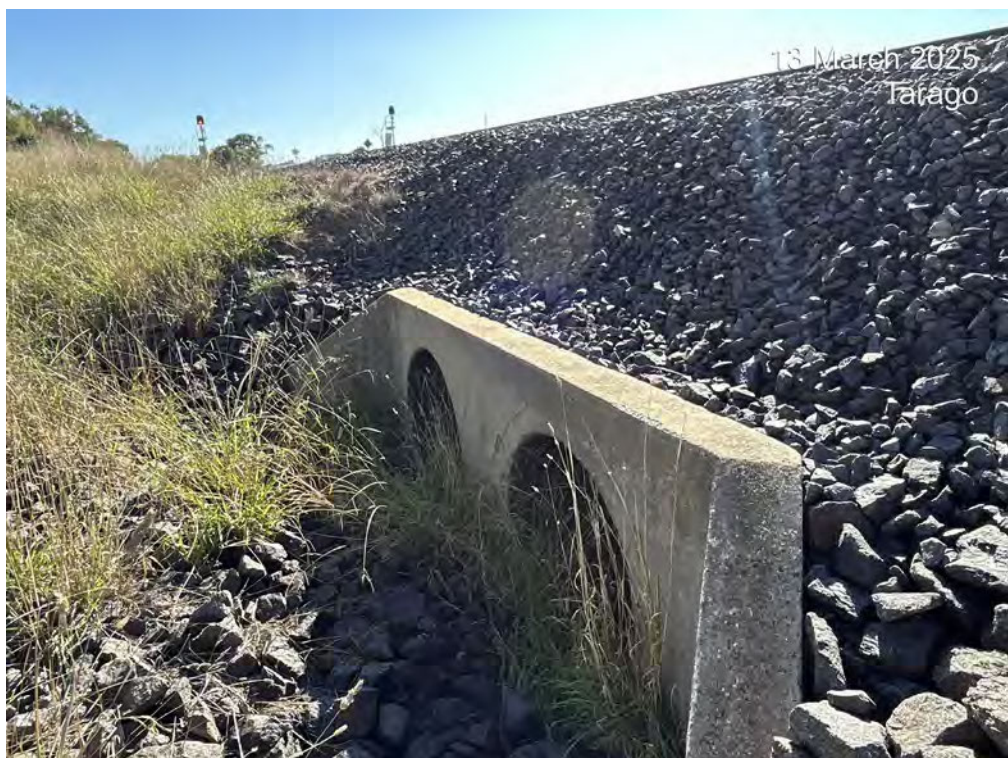
**Photo 17: Upgradient of northernmost culvert with no surface water. No sediment build up was noted on rock armoury.**

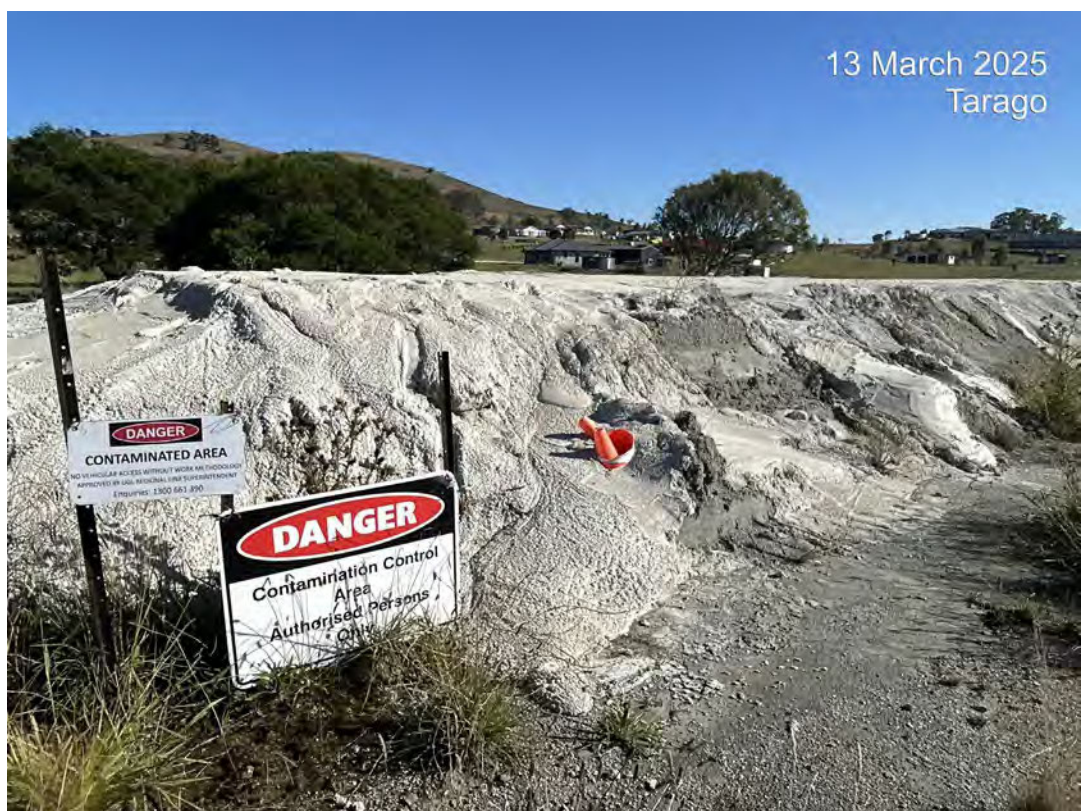
| Section | Control | Inspection | | Corrective Action |
|---|---|---|---|---|
| | Are cracks present in the capping of the existing stockpile? If so record the width and length of cracks in written form and through photographs and consolidate with this checklist. | Yes, minor hairline cracking is present on the stockpile, these remain stable and are not expected to adversely affect cap competency in current condition. | | |

**Photo 18: The concrete-capped stockpile is generally in good condition with no new exposure locations observed.**

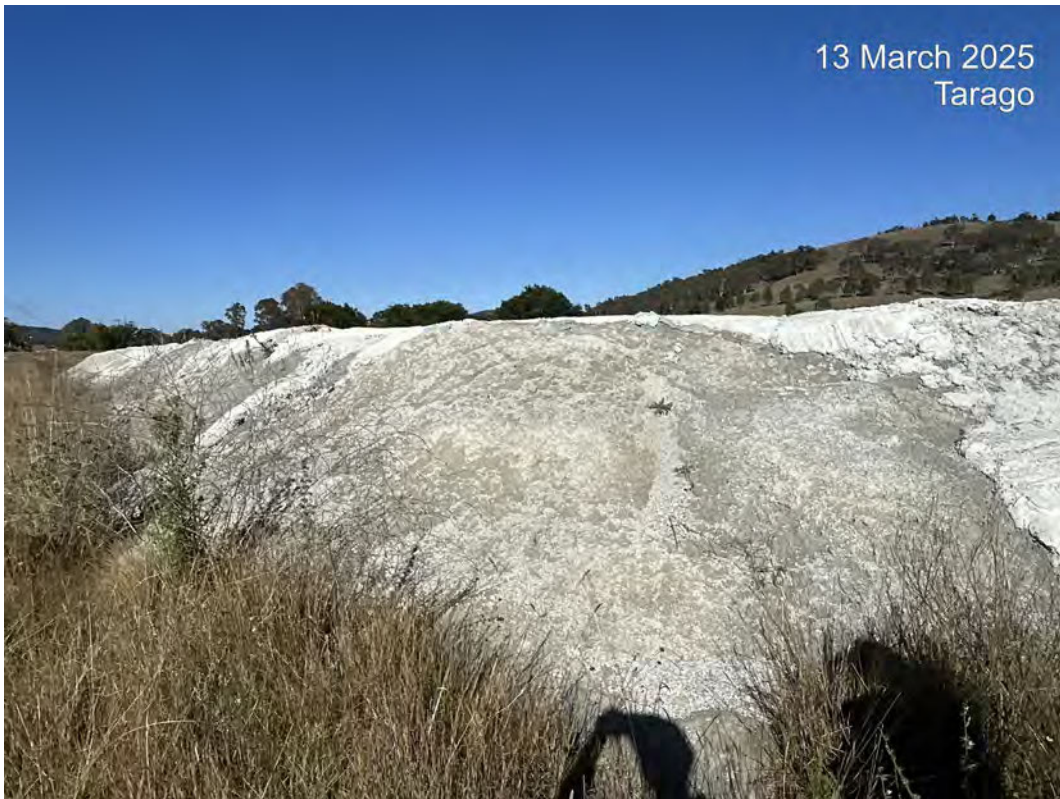
**Photo 19: The concrete-capped stockpile is generally in good condition with no new exposure locations observed.**
