Appendix J – Arboricultural Development Impact Assessment

ARBORICULTURAL DEVELOPMENT IMPACT ASSESSMENT REPORT

Wyong Palms - Pacific Highway Wyong NSW

16th of September 2023

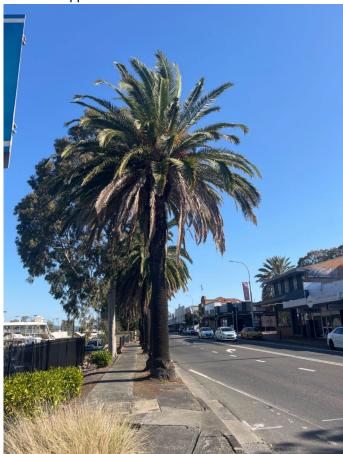
Figure 1 - Tree 3

This mature tree is approximately 12m tall with a canopy spread of 7m. It has a single trunk. This tree is in fair health and condition with a thinning canopy and significant deadwood. There is evidence of Fusarium spp. infestation.

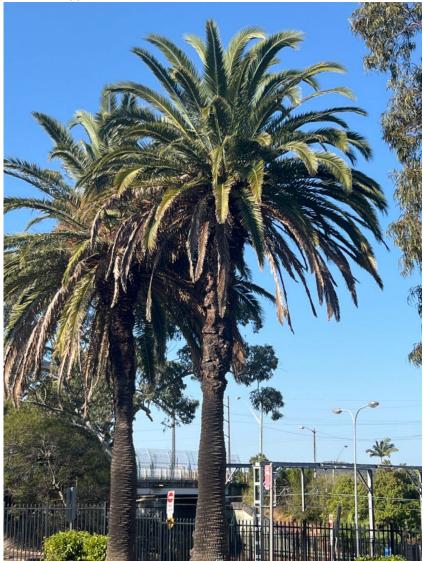
Figure 2 - Tree 4

This mature tree is approximately 12m tall with a canopy spread of 7m. It has a single trunk. This tree is in fair health and condition with a thinning canopy and significant deadwood. There is evidence of Fusarium spp. infestation.

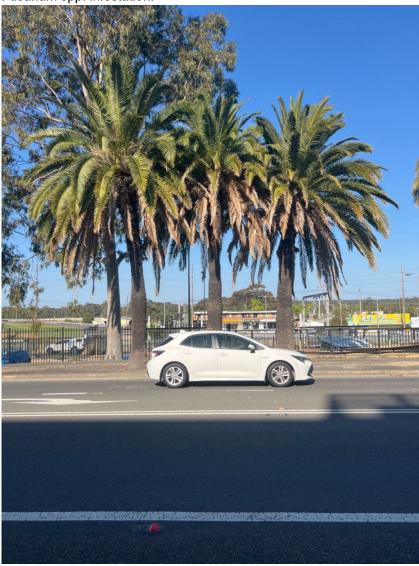
Figure 3 - Trees 5, 6, 7.

This mature tree is approximately 10m tall with a canopy spread of 6m. It has a single trunk. This tree is in fair health and condition with a thinning canopy and significant deadwood. There is evidence of Fusarium spp. infestation.

This mature tree is approximately 9m tall with a canopy spread of 6m. It has a single trunk. This tree is in fair health and condition with a thinning canopy and significant deadwood. There is evidence of Fusarium spp. infestation.

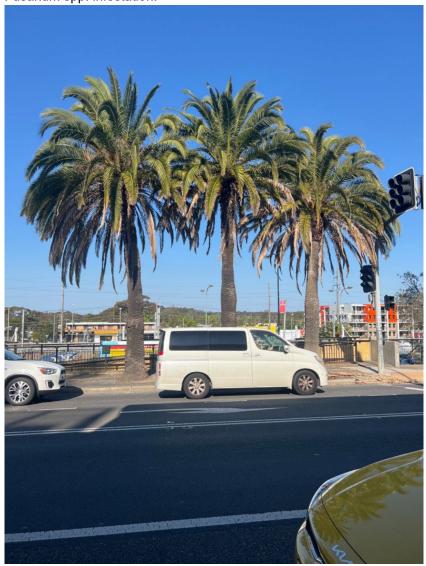
Figure 4 - Trees 8, 9, 10.

This mature tree is approximately 11m tall with a canopy spread of 6m. It has a single trunk. This tree is in fair health and condition with a thinning canopy and significant deadwood. There is evidence of Fusarium spp. infestation.

This mature tree is approximately 11m tall with a canopy spread of 6m. It has a single trunk. This tree is in poor health and condition with a thinning canopy and significant deadwood. There is evidence of Fusarium spp. infestation.

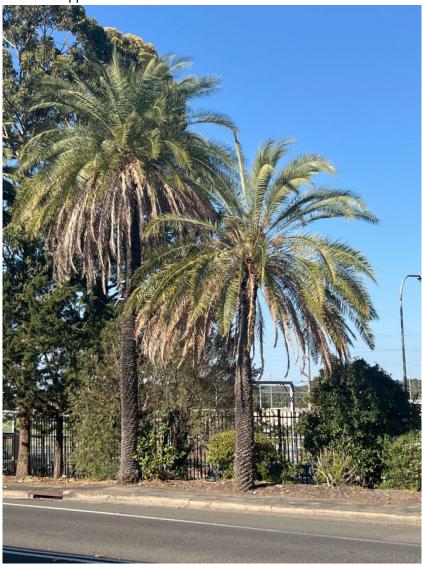
Figure 5 - Trees 14 and 15.

This mature tree is approximately 12m tall with a canopy spread of 6m. It has a single trunk. This tree is in poor health and condition with a thinning canopy and significant deadwood. There is evidence of Fusarium spp. infestation.

This mature tree is approximately 7m tall with a canopy spread of 6m. It has a single trunk. This tree is in poor health and condition with a thinning canopy and significant deadwood. There is evidence of Fusarium spp. infestation.

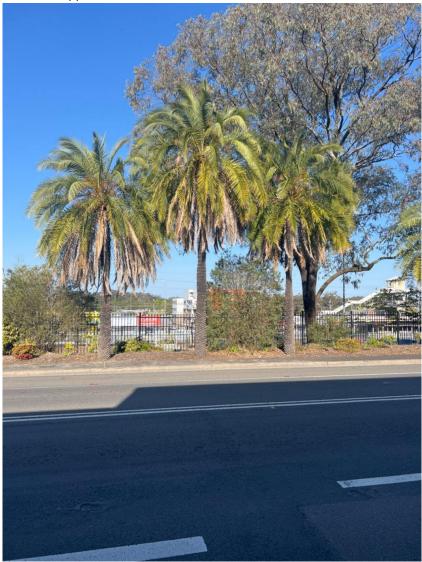
Figure 6 - Trees 16, 17, 18.

This mature tree is approximately 8m tall with a canopy spread of 5m. It has a single trunk. This tree is in poor health and condition with a thinning canopy and significant deadwood. There is evidence of Fusarium spp. infestation.

This mature tree is approximately 10m tall with a canopy spread of 6m. It has a single trunk. This tree is in poor health and condition with a thinning canopy and significant deadwood. There is evidence of Fusarium spp. infestation.

This mature tree is approximately 9m tall with a canopy spread of 6m. It has a single trunk. This tree is in poor health and condition with a thinning canopy and significant deadwood. There is evidence of Fusarium spp. infestation.

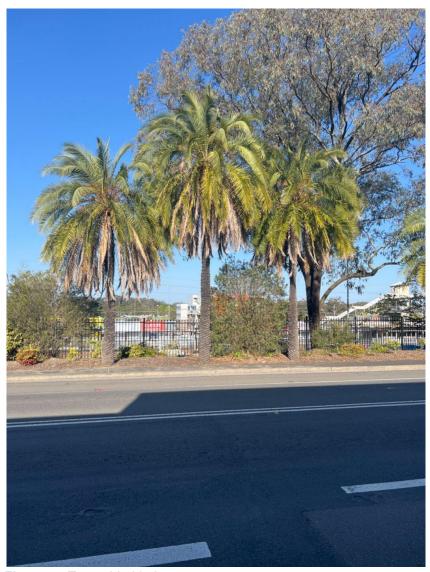
Figure 7 - Trees 22, 23, 24.

This mature tree is approximately 11m tall with a canopy spread of 6m. It has a single trunk. This tree is in poor health and condition with a thinning canopy and significant deadwood. There is evidence of Fusarium spp. infestation.

This mature tree is approximately 7m tall with a canopy spread of 4m. It has a single trunk. This tree is in poor health and condition with a thinning canopy and significant deadwood. There is evidence of Fusarium spp. infestation.

This mature tree is approximately 9m tall with a canopy spread of 5m. It has a single trunk. This tree is in fair health and condition with a thinning canopy and significant deadwood. There is evidence of Fusarium spp. infestation.

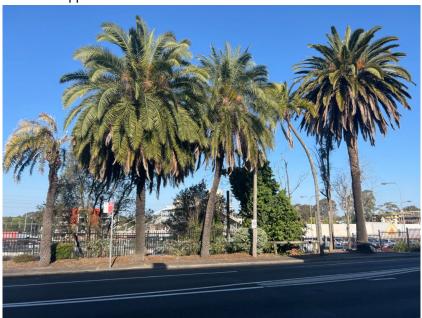
Figure 8 - Trees 25, 26, 27, 28, 29.

This mature tree is approximately 6m tall with a canopy spread of 2m. It has a single trunk. This tree is in poor health and condition with a thinning canopy and significant deadwood. There is evidence of Fusarium spp. infestation.

This mature tree is approximately 6m tall with a canopy spread of 2m. It has a single trunk. This tree is in good health and condition with a thinning canopy and significant deadwood. There is evidence of Fusarium spp. infestation.

This mature tree is approximately 11m tall with a canopy spread of 8m. It has a single trunk. This tree is in fair health and condition with a thinning canopy and significant deadwood. There is evidence of Fusarium spp. infestation.

This mature tree is approximately 11m tall with a canopy spread of 8m. It has a single trunk. This tree is in poor health and condition with a thinning canopy and significant deadwood. There is evidence of Fusarium spp. infestation.

This mature tree is approximately 14m tall with a canopy spread of 8m. It has a single trunk. This tree is in poor health and condition with a thinning canopy and significant deadwood. There is evidence of Fusarium spp. infestation.

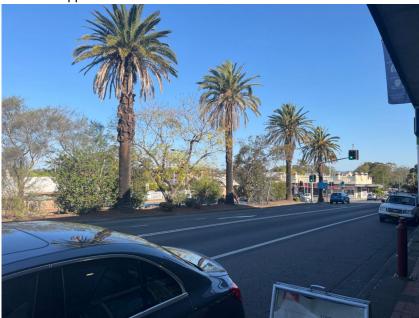
Figure 9 - Trees 30, 31, 32, 33.

This mature tree is approximately 13m tall with a canopy spread of 8m. It has a single trunk. This tree is in fair health and condition with a thinning canopy and significant deadwood. There is evidence of Fusarium spp. infestation.

This mature tree is approximately 13m tall with a canopy spread of 7m. It has a single trunk. This tree is in fair health and condition with a thinning canopy and significant deadwood. There is evidence of Fusarium spp. infestation.

This mature tree is approximately 12m tall with a canopy spread of 7m. It has a single trunk. This tree is in fair health and condition with a thinning canopy and significant deadwood. There is evidence of Fusarium spp. infestation.

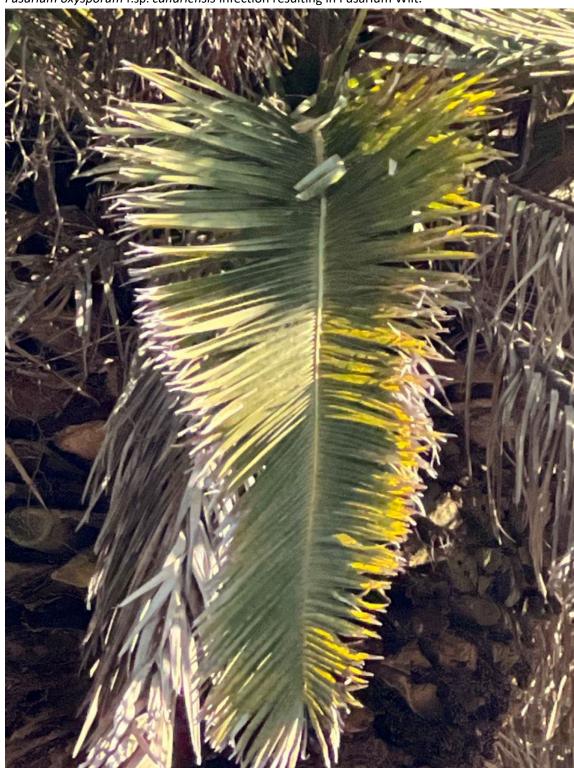
The subject trees present crown dieback that is presenting in a very specific pattern with the crown dying back from the centre down and each frond initially dying on one side of the midrib before the other. This specific pattern of dieback is indicative of Fusarium oxysporum f.sp. canariensis infection resulting in Fusarium Wilt.

Figure 10 - Unilateral dieback of palm fronds.

Fusarium oxysporum f.sp. canariensis is an Ascomycota fungal pathogen that impacts Phoenix spp. and some Washingtonia spp.. Fusarium spp. is a serious pathogen which

will eventually kill the palm. There is no known treatment for this pathogen. Fusarium is easily spread and therefore complete removal of the tree is recommended as soon as possible in order to prevent the spread of the pathogen.

We recommend that this initial diagnosis of *Fusarium spp* infestation be corroborated by pathology testing of frond base samples at the Plantclinic, Royal Botanic Gardens. Based on confirmation of diagnosis, we recommend the safe removal of all of the *Phoenix canariensis* trees and replacement planting within the landscape design of the final development. *Fusarium spp*. Chlamydospores can survive in the soil for up to two years and therefore we recommend that no *Phoenix spp* or *Washingtonia spp*. are planted in the soil in this area.
