Project No: SHBC/NORTH/22 Report No: SHBC/NORTH/PAR/B

PRELIMINARY ARBORICULTURAL REPORT

Sydney Harbour Bridge Cycleway Northern Access Milsons Point

23rd May 2022
Revision B

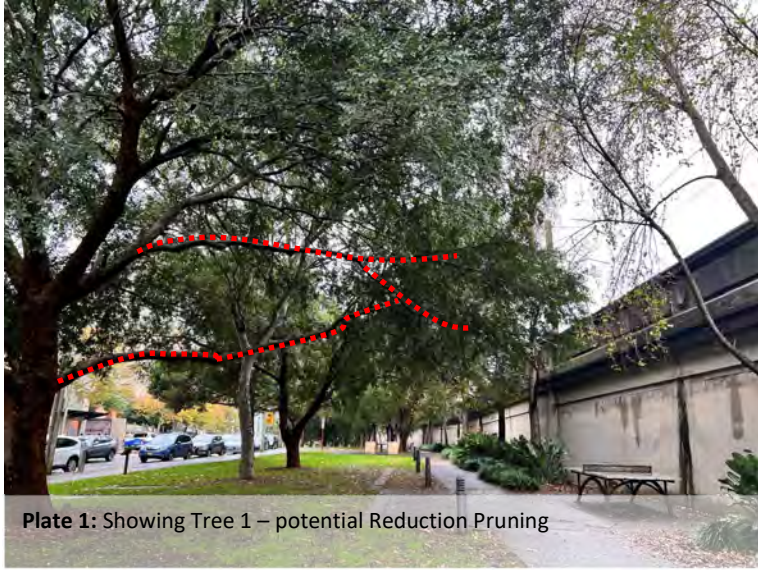
2.3.5 Trees 1 and 23 are in good health and structural condition with no significant defects identified at the time of inspection. A major inclusion has developed at the junction of co-dominant stems on Tree 26. This defect is not considered a significant hazard at the current time however it may become more serious as the tree's crown grows in size, weight and sail area.

Plate 1: Showing Tree 1 – potential Reduction Pruning

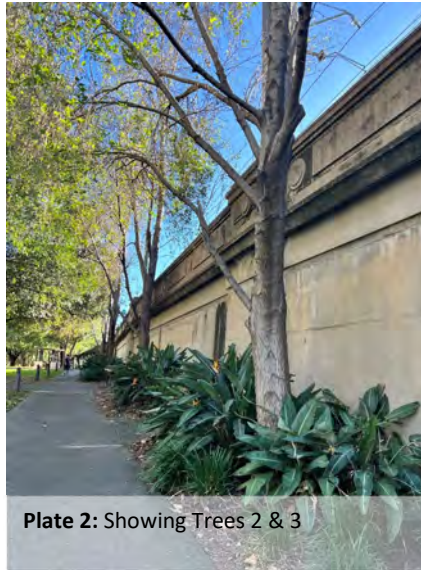
- 2.3.7 Trees 2, 3 and 28-30 are in good health. Trees 2, 3 and 30 are in fair structural condition as a result of the pruning works undertaken for viaduct clearance. The branching structure of a tree is mechanically optimized to dissipate wind loading forces, providing a dampening effect in windy conditions which helps to protect against failure. Where excessive lateral branches are removed, the dampening effect is reduced increasing the likelihood of branch failure.

Plate 2: Showing Trees 2 & 3

Trees 2, 3 and 28-30 *Populus simonii* (Simons Poplar) are proposed for removal in the Concept Design to allow for the ramp footprint and new footpath below. Archival images of the site show these trees were planted in the 1990s to replace the original 1960s Poplars. The trees have short (5-15 years) and transient (<5 years) ULEs and should not be considered a design constraint.

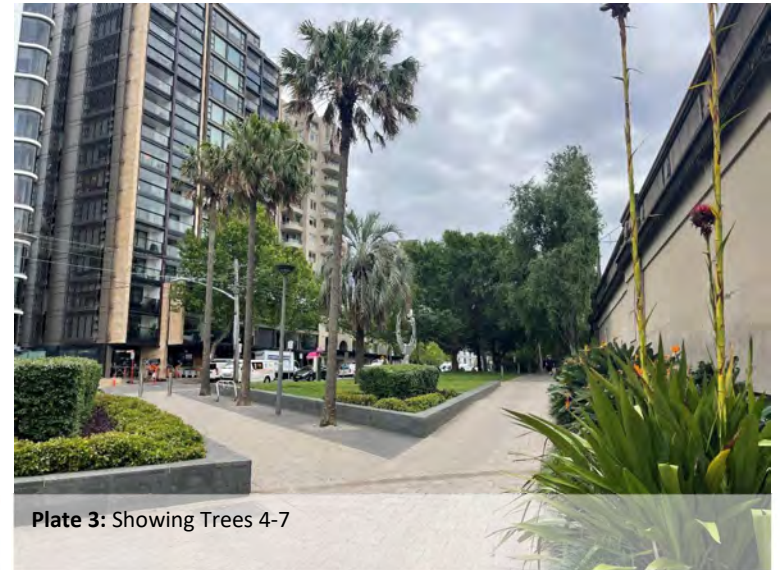
- 2.3.10 Trees 8 and 20 are in good health and structural condition with no significant defects identified at the time of inspection. Tree 4 is in fair health as indicated by foliar damage (widespread yellow/orange necrotic spotting of older fronds) consistent with either a leaf blight and/or nutritional deficiency. Potassium is the most likely nutritional deficiency to be affecting the palm which may eventually result in palm death. Pathology testing of damaged foliage and nutritional analysis of soils in the vicinity of the tree is recommended. Recommendations for ameliorative action should be determined on the testing results.

Plate 3: Showing Trees 4-7

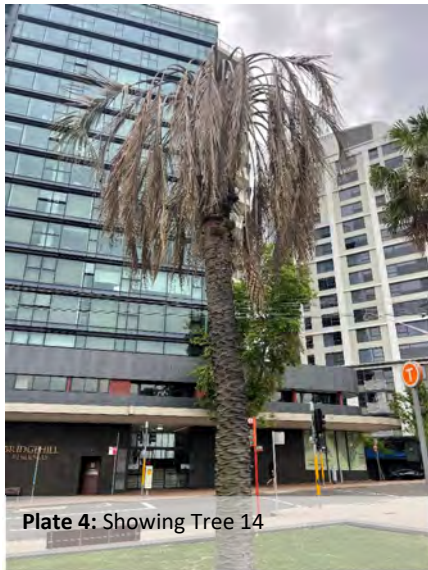
- 2.3.11 Tree 14 is dead and appears to have died relatively recently as indicated by the uniform appearance of the desiccated crown which has not yet begun to shed dead fronds. The cause of death is not known however the potential biotic and/or abiotic factors affecting Tree 4 are likely to have also contributed to or caused the death of Tree 14. To minimise the potential for spreading pathogens between trees, tools used for the removal of Tree 14 should be thoroughly sterilized using an 80% methylated spirits/20% water spray on completion of the works. This also applies to the removal of dead/dying fronds on all other palms at the site.

Plate 4: Showing Tree 14

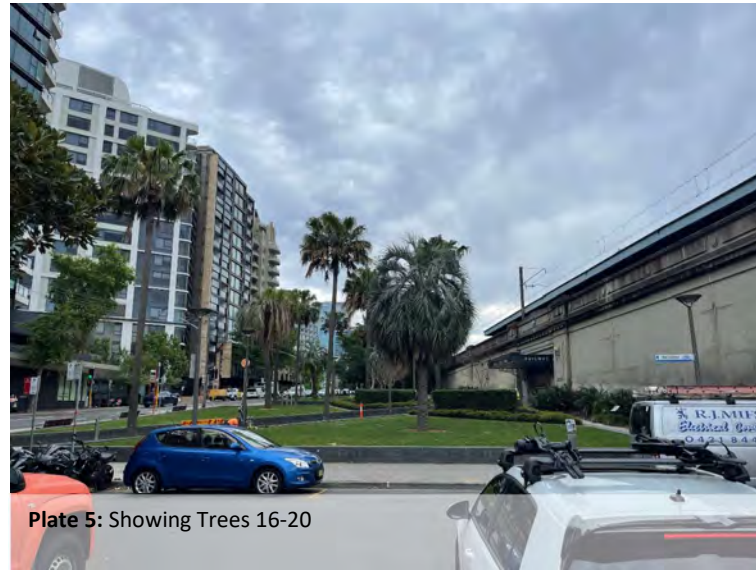
- 2.3.13 Trees 5-7, 10-13 and 16-18 are in good health and structural condition with no significant defects identified at the time of inspection. Tree 18 has a cable tie affixed to the trunk which is starting to become occluded as the trunk expands. The cable tie should be removed to prevent restriction of the tree's vascular function.

Plate 5: Showing Trees 16-20

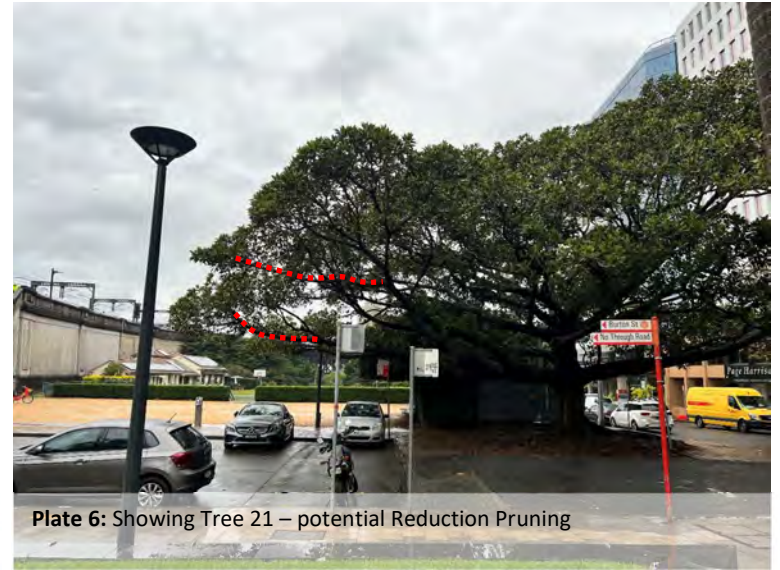
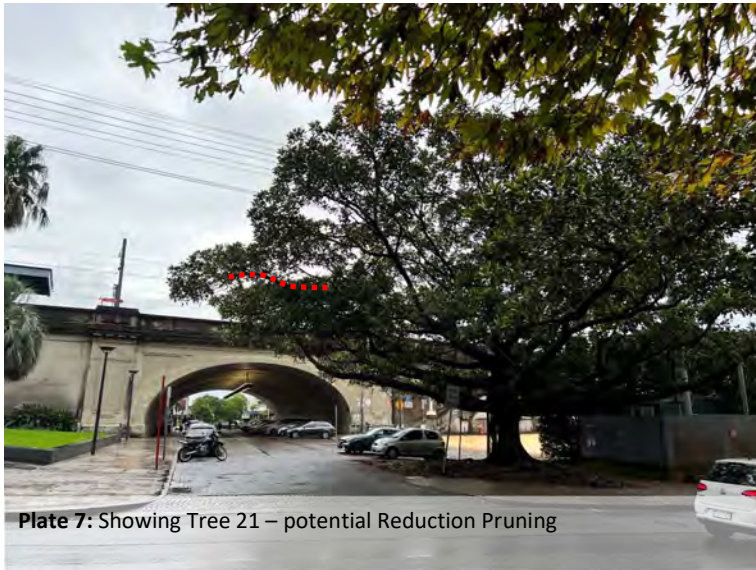
2.3.17 Tree 21 is in good health and structural condition with no significant defects identified at the time of inspection. Fungal fruiting bodies consistent in appearance with the genus *Auricularia* are present at the wound face of a pruned dead branch. This fungus is predominantly a saprobe which is feeding on the dead tissue at the wound face and should not impact the health of the tree.

Plate 6: Showing Tree 21 – potential Reduction Pruning

Plate 7: Showing Tree 21 – potential Reduction Pruning

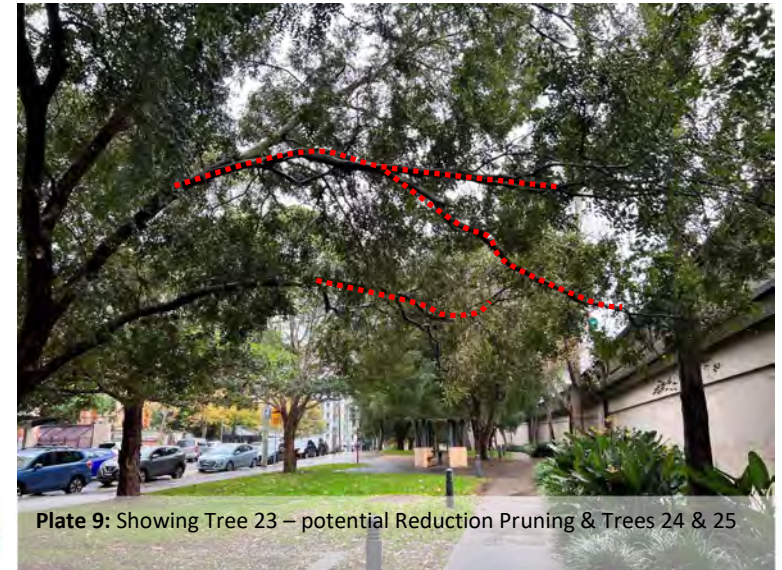
Plate 9: Showing Tree 23 – potential Reduction Pruning & Trees 24 & 25

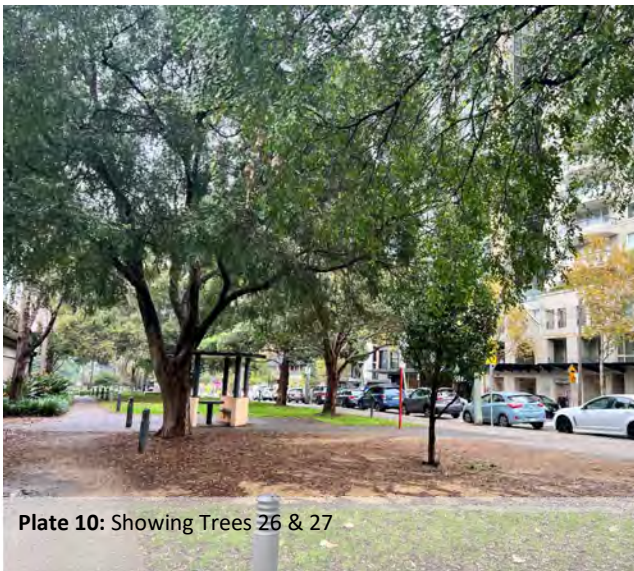
2.3.23 Tree 27 is in good health and structural condition with no significant defects identified at the time of inspection. The tree is starting to develop a phototropic lean due to suppression from the adjacent Tree 26. It is expected the form of the tree will continue to be impacted as it grows.

Plate 10: Showing Trees 26 & 27

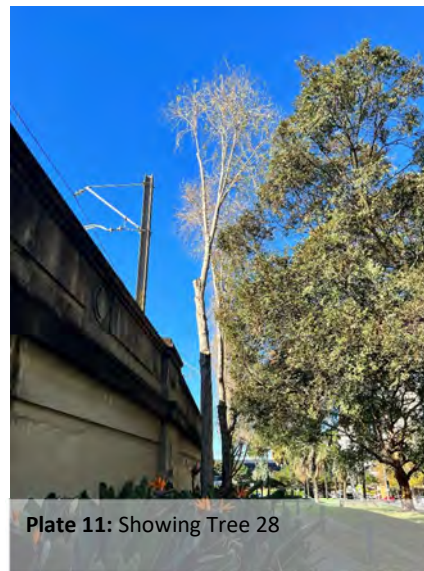
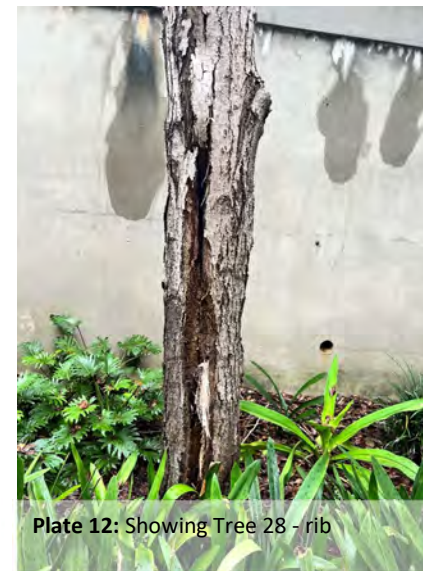
- 2.3.8 Trees 28 and 29 are in poor structural condition and have also been impacted by the pruning works. In addition, a major basal wound and rib of adaptive growth is present on the trunk of Tree 28 and a seam of depressed tissue which runs from the base of the trunk to 1.5m was noted on Tree 29.

Plate 11: Showing Tree 28

Plate 12: Showing Tree 28 - rib

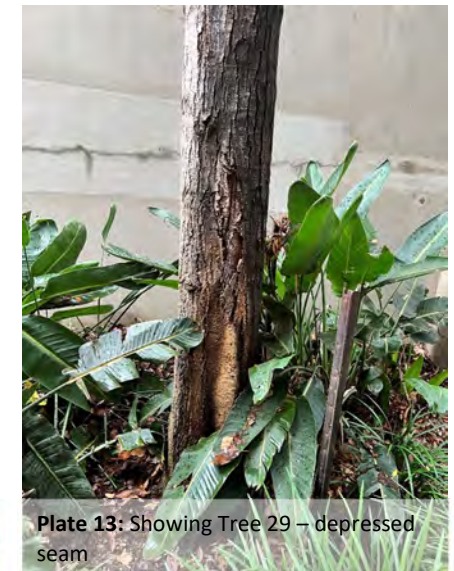
Plate 13: Showing Tree 29 – depressed seam

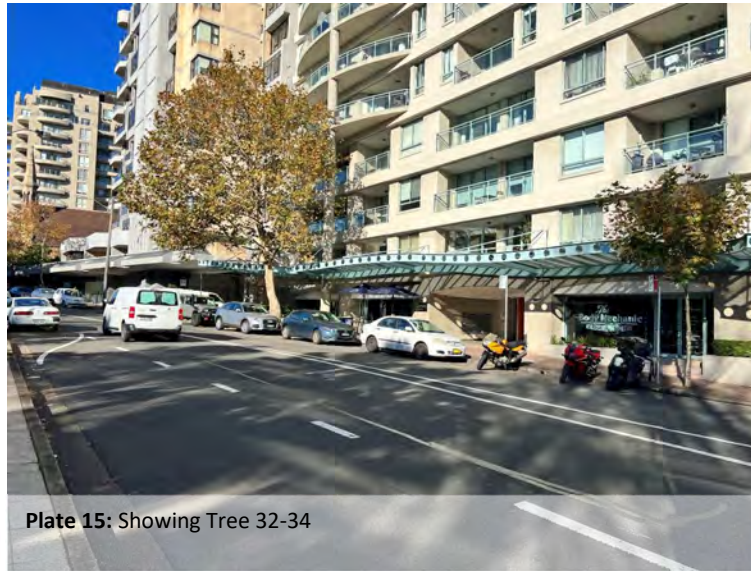
Plate 15: Showing Tree 32-34

Trees 32 and 34 *Planantus x acerifolius* (London Plane Tree) are proposed for retention in the Concept Design. Trunk protection should be installed to protect the trees against impact damage.

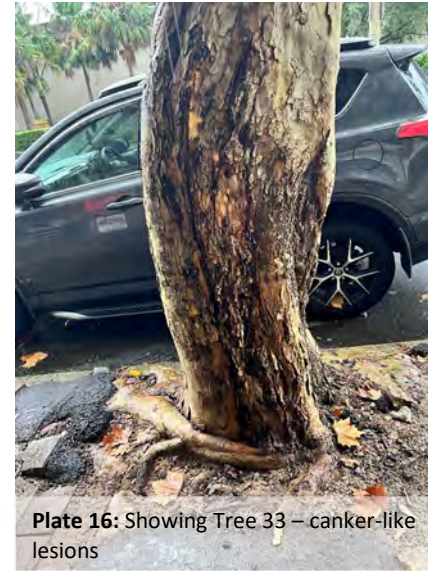
2.3.29 Tree 33 is in good health. It is in poor structural condition with significant canker-like wounds located on the lower trunk. This wounding is consistent with infection by *Phytophthora* sp. *Phytophthora* sp. is relatively common, fungus-like (oomycete) plant pathogen responsible for *Phytophthora* Dieback or *Phytophthora* Root Rot and can also cause trunk and stem lesions.

3.2.17 It should be noted that Tree 33 is in poor structural condition with significant canker-like wounds located on the lower trunk. If Tree 33 is to be retained, pathology testing and internal diagnostic testing should be undertaken to more accurately determine the significance of this defect.

Plate 16: Showing Tree 33 – canker-like lesions

Tree 33 *Planantus x acerifolius* (London Plane Tree) is proposed for retention in the Concept Design. Trunk protection should be installed to protect the trees against impact damage. In addition, the basal flare of the tree has overgrown the adjacent section of kerb. This section of kerb should be retained in-situ as part of the works. The front face of the kerb may be cut back if required however demolition saw cuts should avoid damaging any part of the tree.
