ARBORICULTURAL IMPACT ASSESSMENT & TREE PROTECTION PLAN

East Hills Station Upgrade
Transport Access Program (TAP)
Version 4

Prepared for: Cardno

14 October 2020

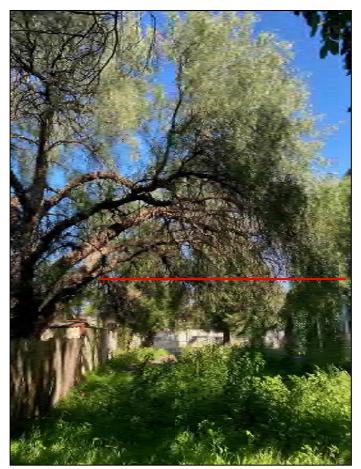
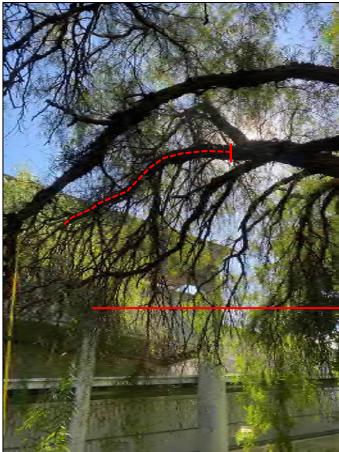
Image 1: Pruning locations (Tree 13)

Image 2: Pruning location (Tree 13)

• Canopy pruning: Tree 13, 16, 17, and 18 will require pruning for construction clearances. The pruning is unlikely to impact the overall health and condition of the trees and is considered the preferred option when compared to tree removal. Images showing the suggested pruning locations can be found in Appendix I. No habitat was observed within limbs that are required to be pruned.

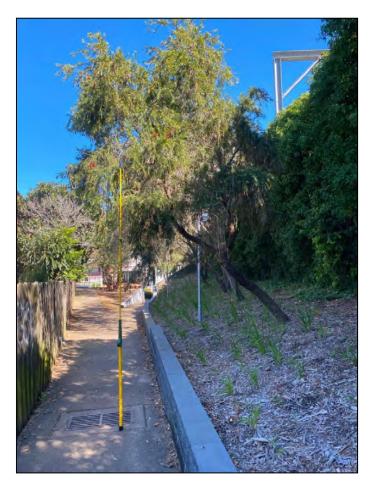
Image 3: The subject tree (Tree 16)

Image 4: Pruning location (Tree 16)

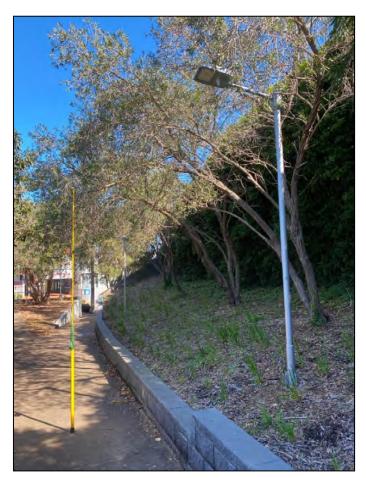
Image 5: The subject tree (Tree 17)

Image 6: Pruning location (Tree 17)

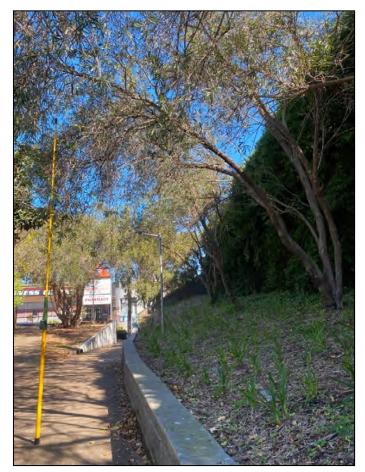
Image 7: The subject tree (Tree 18)

Image 8: Pruning location (Tree 18)
