# **Pymble Station Upgrade**

## **Arboricultural Impact Assessment Report**

For the site address  
Pymble Station, PYMBLE, NSW

**REFERENCE**            D4273

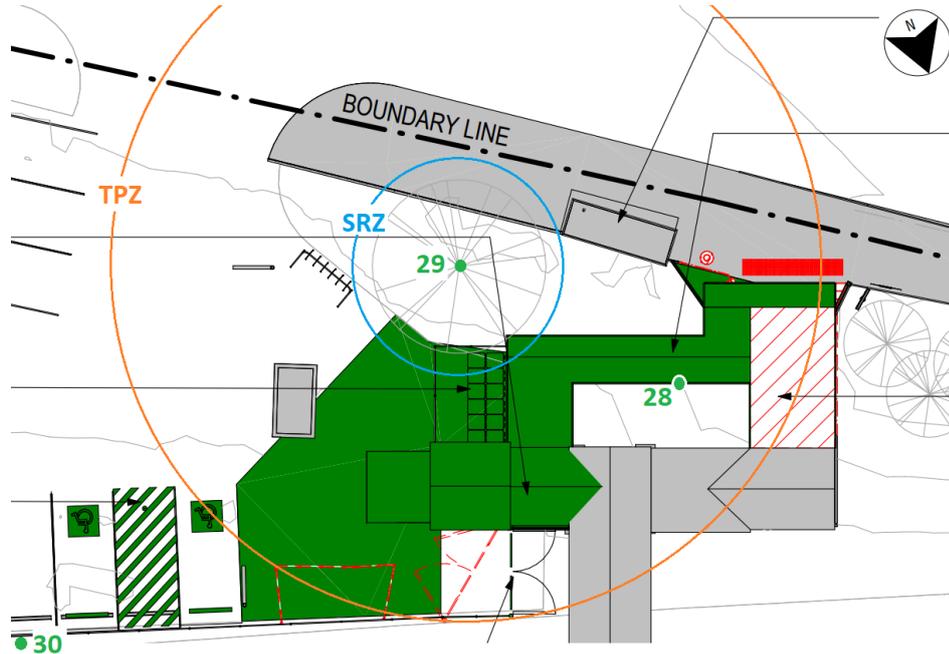
**Figure 2; Location of trees No. 28-30 in relation to the proposed work, including the zones of protection for tree No. 29.**

This tree is not directly located in the footprint of the proposed design, however subject to a major encroachment. The extent for these work illustrated on the drawings will include the lift (being the foundation), excavation (i.e. retaining wall realignment) for the relocated bin enclosure, resurfacing of the car park (and this may require grade changes) and new path connecting the bus stop to the lift. These are illustrated in Figure 2 in relation to the zones of protection.

All these work occur within both the TPZ and some within the SRZ. Both the lift foundation and pathway will require excavation. The type of footing (strip or pier) used for the pathway will determine the extent of encroachment, that is, impact on the root zone, where a strip type excavation will offer the greatest impact. The realignment of the dry stack retaining wall will likely require excavation into the root zone (SRZ) that exists behind this wall. This area is likely to contain a greater root density than typical for this distance from the tree because roots have accumulated against the back of the wall. Pending the structural integrity of this wall, it may also require replacement. Based on the height of this wall, it will likely require an engineered design, therefore incorporating a foundation that is certain to require excavation within the SRZ where an impact to the root system will occur. This will be an impact to the tree.

Tree No. 29, although posing high amenity value based on the size, this tree is an introduced species. It is indigenous to a small area in northern New South Wales and is not local. The tree has been subject to failure of large branches/leaders and contains active decay, and the life expectancy is dubious. Although the existing risk is unknown without further specialist assessment, the symptoms and signs contained in the structure will limit the useful life expectancy. The primary issue at the time of assessment is that a risk for failure exists, although no time can be assigned to this without further assessment. The likelihood of impacting a target is 'very likely', and these target zones range from moderate to high use. The consequence for failure is 'Significant' and therefore assigns a risk rating between MODERATE to EXTREME<sup>7</sup>. The introduction of the design components increases these variables and rating.
