## STATEMENT of HERITAGE IMPACT

**Proposal:** Adaptive re-use of the former Tank Annex building 22 to provide a storage facility with building and site conservation works to suit Transport Heritage NSW

**Client: Transport Heritage NSW**

David Scobie Architects Pty Ltd  
Architects & Heritage Consultants

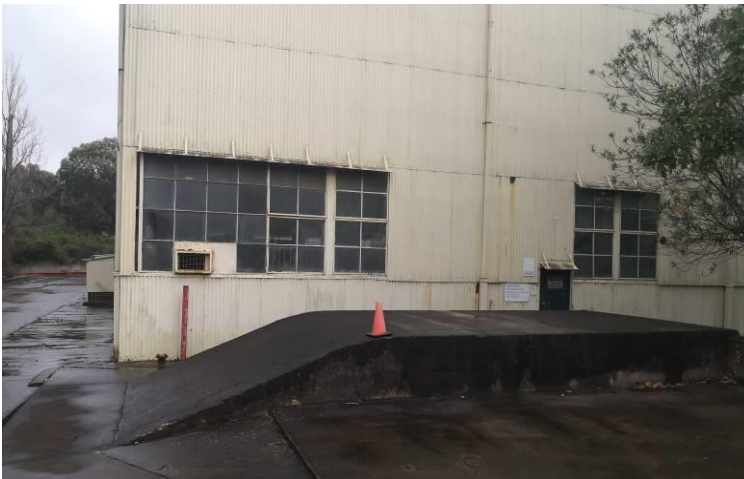
**Figure 6** The significant tank ramp at the South west corner. Areas of the window band have sustained various alterations including removal for doors and air-conditioners. Some areas have simply been sheeted over.

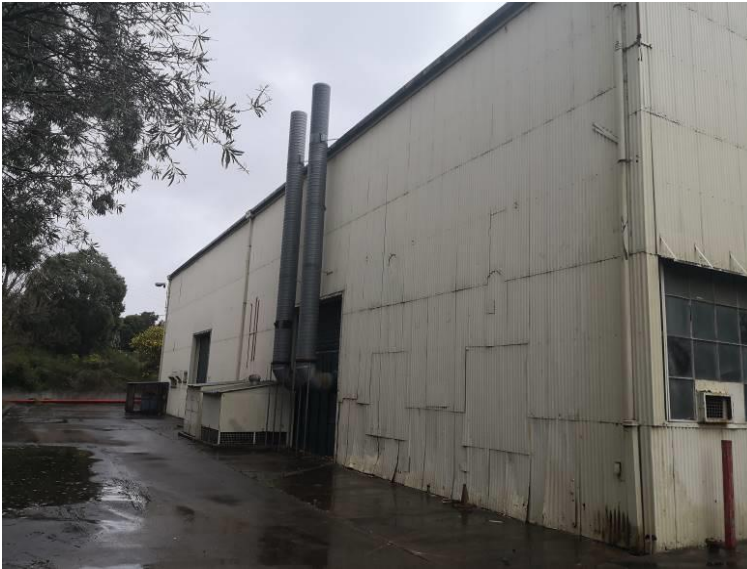
**Figure 7** View of the West Elevation. The elevation is a patchwork of alterations and minor additions completed from the 1950s with the introduction of diesel electric maintenance tasks. The bottom level of the sheeting has suffered from collision damage and rust in contact with the slab surrounds.

Repair timber windows to West Elevation	Conservation and restoration works to enhance original fabric	Conservation work and like for like works, materials and colour
Reinstate missing structural elements to main structure	Conservation and restoration works to enhance original fabric	Conservation work and like for like works, materials and colour
Prepare structure to east end for new door openings	Loss of original fabric required to adapt for new use	Sympathetic structure, materials and details
Remove internal and external lighting and redundant services	Loss of fabric and services with low level of significance. No loss of original service and fabric such as bus-bars to be retained	Works required to install contemporary services to current standards for new storage use
Repair and replace doors and roller shutters	Loss of fabric with low level of significance from late 1970s	Works required to install contemporary services to current standards for new storage use and egress Code

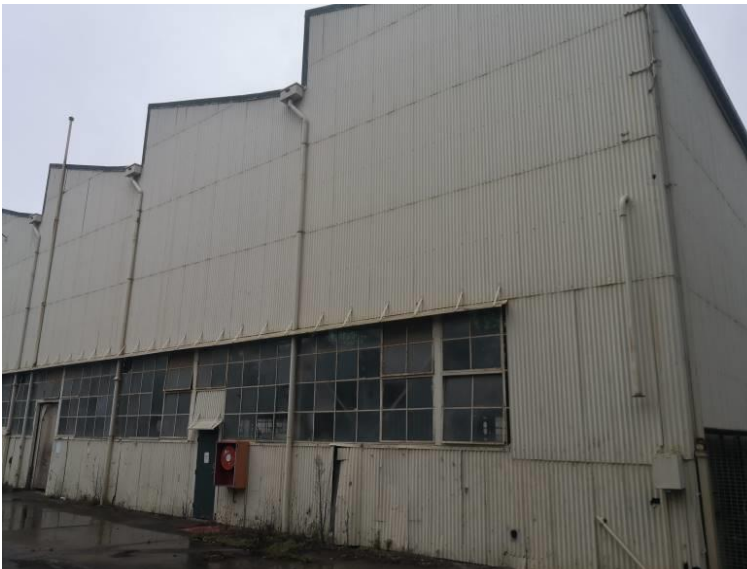
**Figure 8** View of the western end of the North elevation. The original galvanised iron sheet cladding and steel framed windows are generally intact and retain their significance. The rain heads have been replaced. The bottom level of the sheeting has suffered from collision damage and rust in contact with the slab surrounds. The steel framed windows are affected to various degrees by rust and have sustained damaged glass panes and many replacement panes.

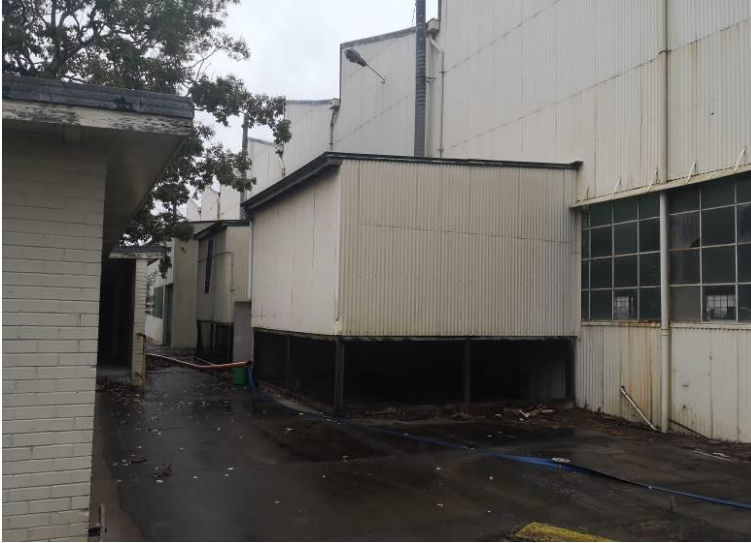
**Figure 9** View of the skillion roofed extensions to the Tank Annex. These timber framed structures were built with wire screened open bases to accommodate diesel electric maintenance works introduced in the late 1950s. The timber frames have rotted and the structures are not capable of certification. It is proposed that these be removed to accommodate the access.

- Retention of the skillion roofed northern extensions would require their reconstruction due to the decayed condition of their timber frames which have been exposed by the open nature of the structures.

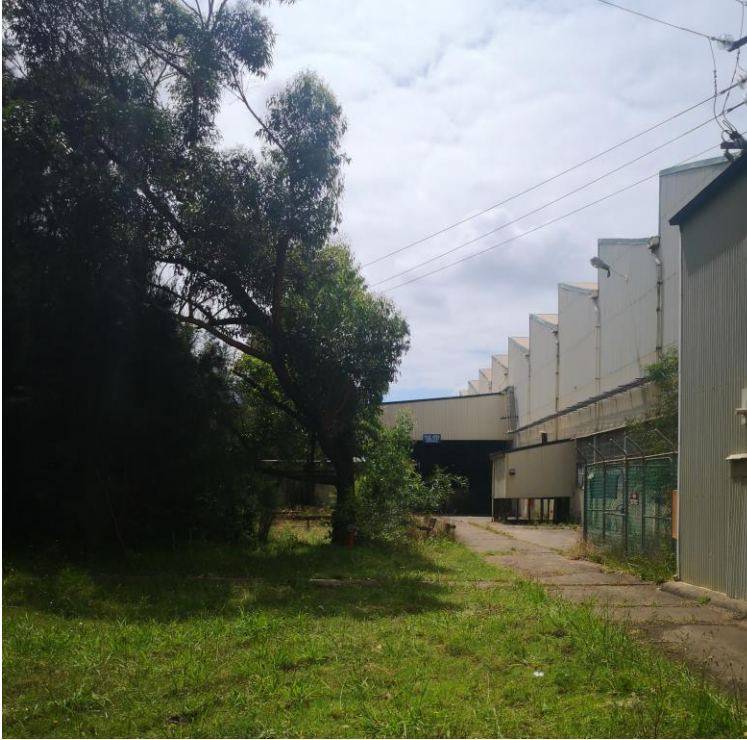
**Figure 11** View of the second tree in the vicinity of the shed. This tree is in poor condition and is to be removed for the required access road and for improved clearance to the main Electricity supply cabling overhead. The tree has been severely and unevenly pruned on several occasions to provide clearance for the main electrical overhead line entry to the building.

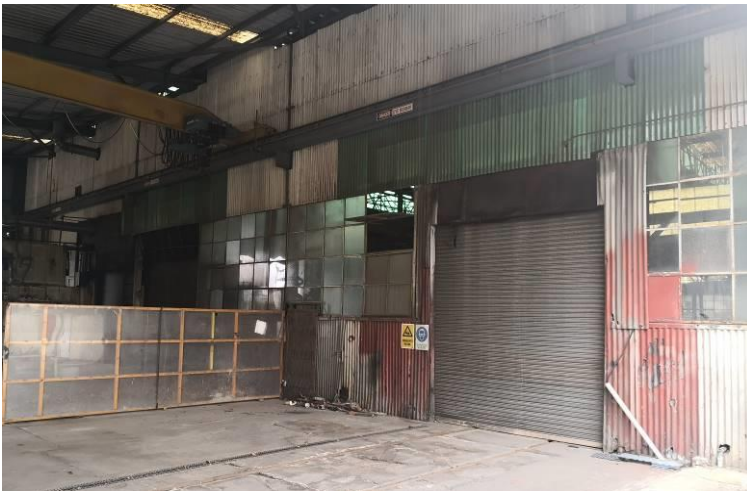
**Figure 12** View of the eastern end of the North elevation within the open skillion extension. The alterations and addition of the large skillion extension were part of changes in the 1980s to accommodate the Electrical Maintenance Centre. The damaged walls and windows are to be restored to conserve and secure the building envelope.

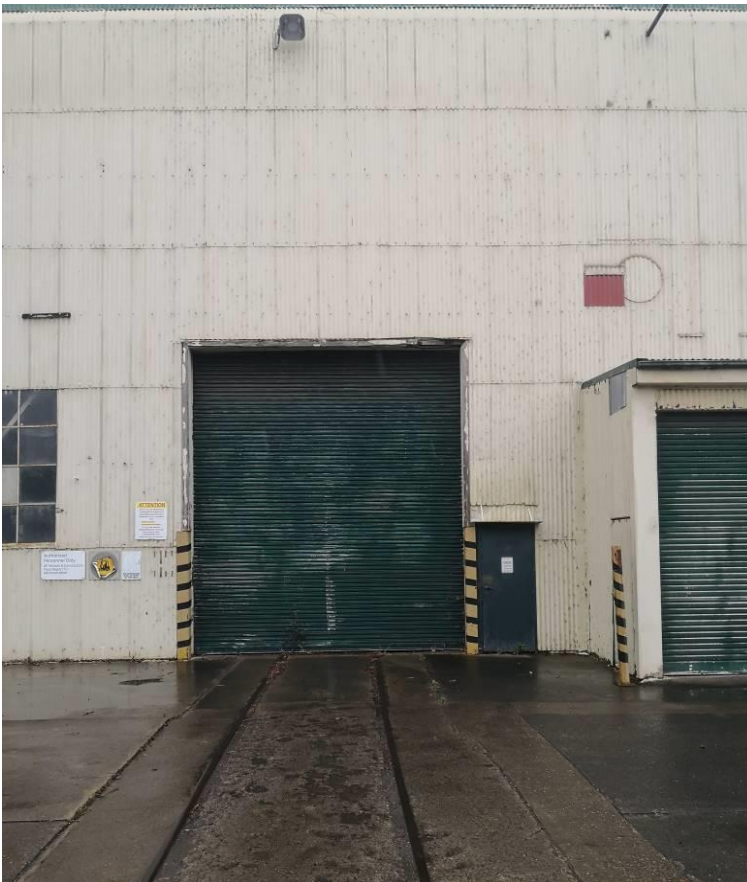
**Figure 14** Part of the East elevation with significant embedded track. Tracks to be retained and doors to be replaced for rolling stock access. The extension from the late 1980s over the northern door is to be removed to return the elevation to the original alignment.

- *The cladding and doors to the East elevation are to be removed to provide access for the heritage rolling stock. The replacement steel cladding and doors are sympathetic to the original materials and the design. The colour proposed for the replacement roller shutters has been selected from the standard colour range used by the Australian Army for tank camouflage on the Cruiser tanks assembled in the building. This provides an appropriate interpretation for this use.*
