Project No: SHBC/NORTH/22 Report No: SHBC/NORTH/AIA/A

ARBORICULTURAL IMPACT ASSESSMENT

Sydney Harbour Bridge Cycleway Northern Access Milsons Point

5th June 2023
Revision A

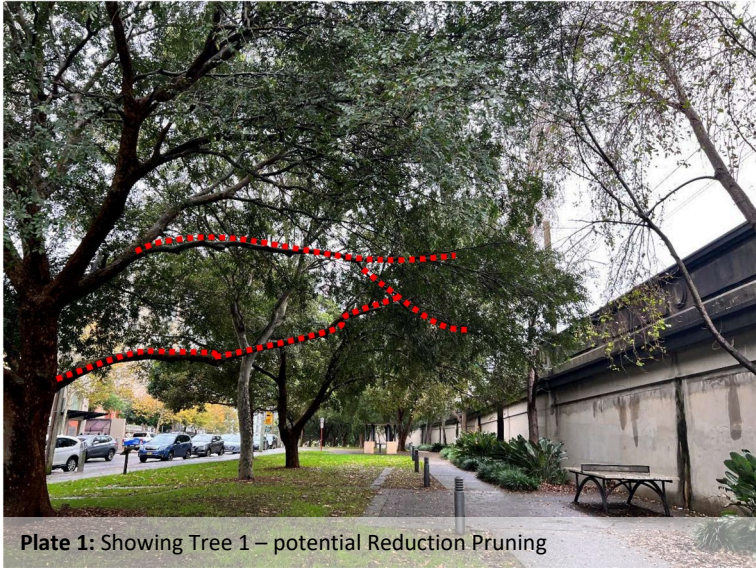
Trees 1, 23, 26 and 34 were identified as *Ulmus parvifolia* (Chinese Elm) and are mature specimens located in the southern section of Bradfield Park North. Trees 1 and 23 are in good health and good structural condition with no significant defects identified at the time of inspection. Major bark inclusions have developed at the junction of co-dominant stems on Trees 26 and 34. These defects are not considered a significant hazard at the current time however they may become more serious as the crowns of the trees increase in size, weight and sail area. The trees are of moderate Landscape Significance and have been allocated a Retention Value of *Consider for Retention*.

Plate 1: Showing Tree 1 – potential Reduction Pruning

3.2.3 The supplied plans show Trees 1, 23, 26 and 34 are to be retained with new pavement areas proposed within their Tree Protection Zone (TPZ) areas. The extent of works represent *Major Encroachments* as defined by AS-4970. Clause 3.3.4 of AS-4970 outlines that design factors and tree sensitive construction methods should be considered when determining the potential impact of the encroachment.

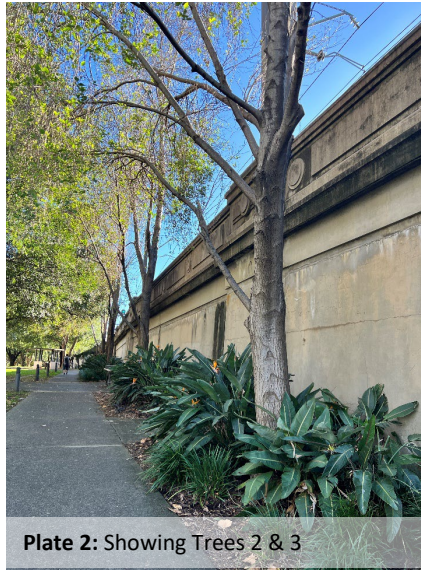
Trees 2, 3, 28-30 and 35 were identified as *Populus simonii* (Simons Poplar) and are mature specimens located in the southern section of Bradfield Park North, adjacent to the SHB viaduct wall. In general the trees are in good health and fair to poor structural condition due to wounds with advanced stages of decay. The trees are of moderate Landscape Significance however their form has been significantly impacted by Reduction Pruning to provide clearance for the SHB viaduct wall. Trees 2, 3, 29, 30 and 35 have been allocated a Retention Value of *Consider for Retention* with Tree 28 being in sufficiently poor structural condition to be allocated a Retention Value of *Priority for Removal*.

Plate 2: Showing Trees 2 & 3

3.1.3 The supplied plans show Trees 2, 3, 28 and 29 are to be removed to accommodate the footprint of the proposed elevated cycleway and Trees 30 is to be removed due to accommodate new areas of pavement. Tree 35 is recommended for removal due to its poor structural condition.

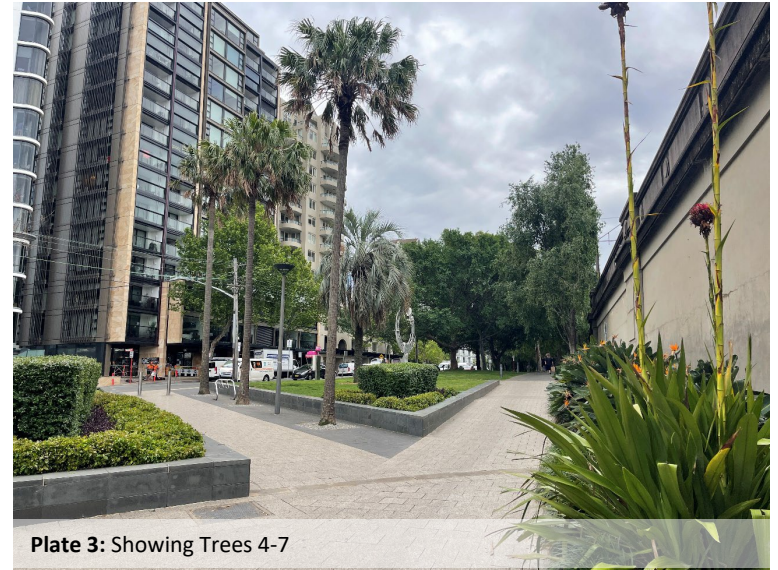
Trees 4, 8, 14 and 20 were identified as *Butia capitata* (Jelly Palm) and are late-mature specimens located within the raised lawn areas fronting the station entrance. Trees 8, 14 and 20 are in good health and structural condition with no significant defects identified at the time of inspection. Tree 4 is in fair health as indicated by foliar damage (widespread yellow/orange necrotic spotting of older fronds) consistent with either a leaf blight and/or nutritional deficiency. Potassium is the most likely nutritional deficiency to be affecting the palm which may eventually result in palm death. The trees are of very high Landscape Significance and have been allocated a Retention Value of *Priority for Retention*.

Trees 5-7, 10-13 and 16-18 were identified as *Livistona australis* (Cabbage Tree Palm) and are mature specimens located in pavements intersecting the raised lawn areas to the front of the station. The trees are in good health and structural condition with no significant defects identified at the time of inspection. Tree 18 has a cable tie affixed to the trunk which is becoming occluded as the trunk expands. The trees are of high Landscape Significance and have been allocated a Retention Value of *Priority for Retention*.

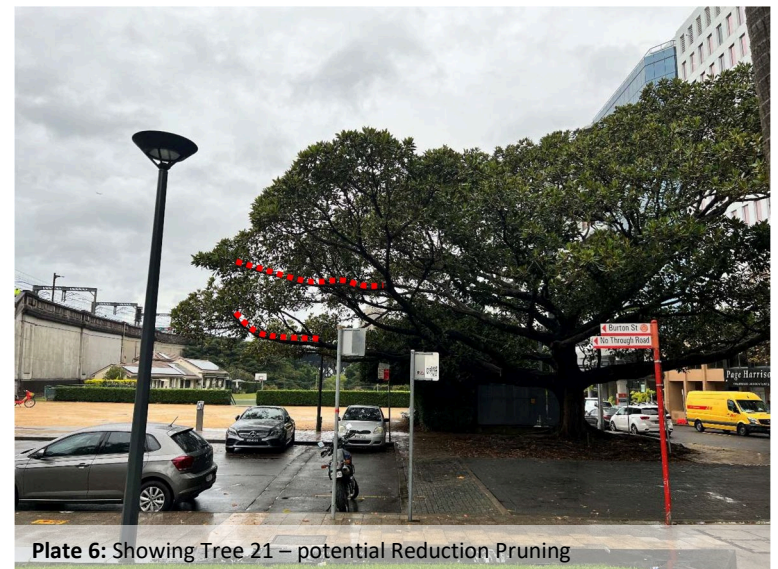
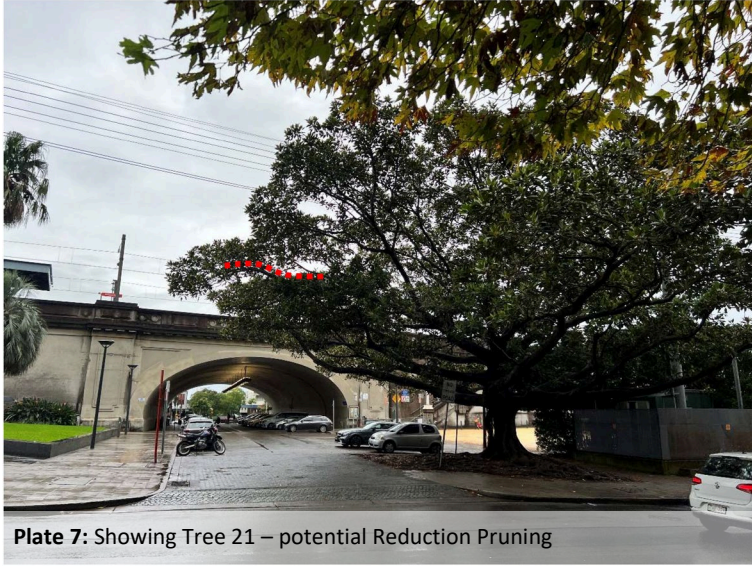
Tree 21 was identified as *Ficus macrophylla* (Moreton Bay Fig) and is a mature specimen located in the south-western corner of the site. Tree 21 is in good health and good structural condition with no significant defects identified at the time of inspection. Fungal fruiting bodies consistent in appearance with the genus *Auricularia* are present at the wound face of a pruned dead branch. This fungus is predominantly a saprobe which is feeding on the dead tissue at the wound face and should not impact the health of the tree. The tree is of high Landscape Significance and has been allocated a Retention Value of *Priority for Retention*.

Plate 6: Showing Tree 21 – potential Reduction Pruning

Plate 7: Showing Tree 21 – potential Reduction Pruning

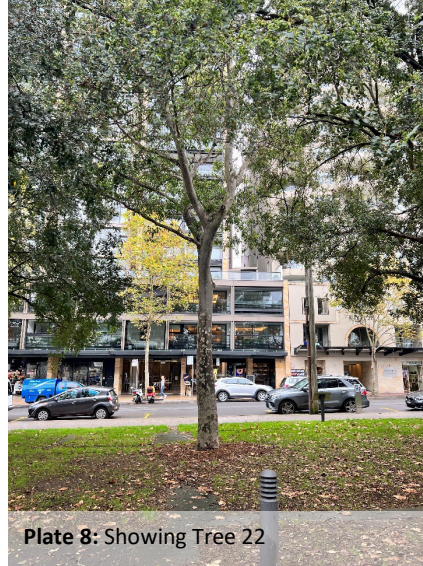
Plate 8: Showing Tree 22

Tree 22 was identified as *Corymbia maculata* (Spotted Gum), Trees 25 and 38 were identified as *Lophostemon confertus* (Brush Box) and Tree 37 was identified as *Agonis flexuosa* (Willow Myrtle). They are mature specimens located in the southern section of Bradfield Park North. Trees 22, 25 and 38 are in good health and good structural condition with no significant defects identified at the time of inspection. Tree 37 is in fair health with a reduced crown density of 50-75% and in poor structural condition due to the presence of a major inclusion at the junction of co-dominant stems. Trees 22, 25, 37 and 38 are of moderate Landscape Significance and have been allocated a Retention Value of *Consider for Retention*.

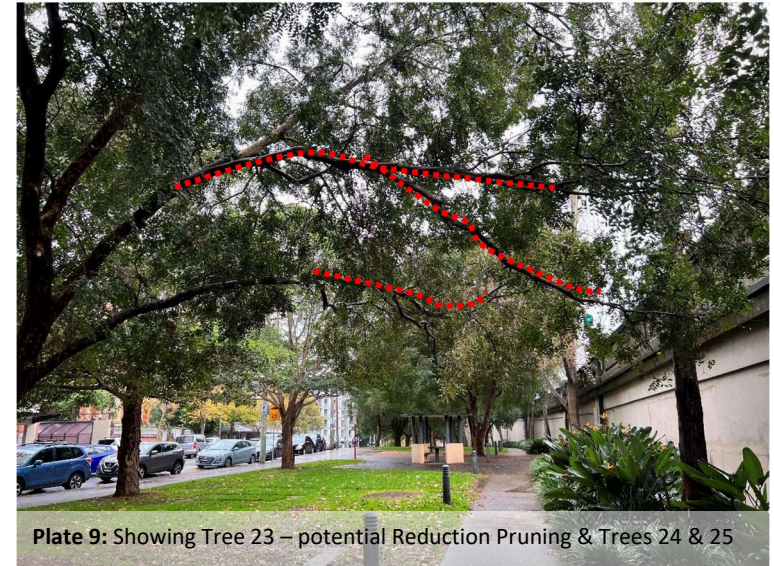
Plate 9: Showing Tree 23 – potential Reduction Pruning & Trees 24 & 25

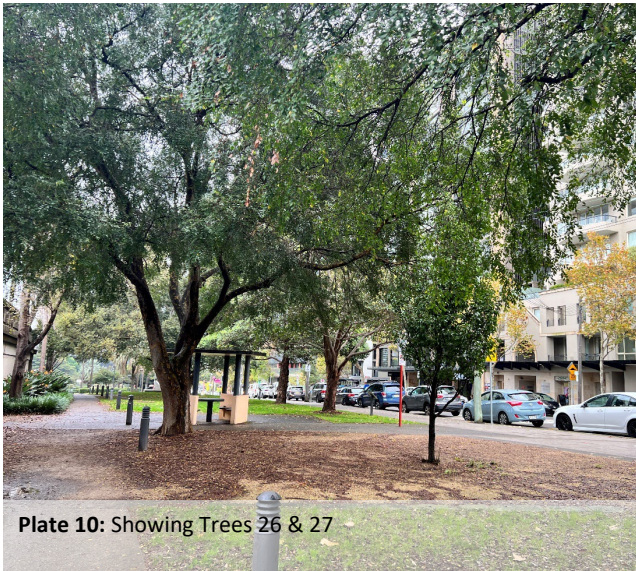
Plate 10: Showing Trees 26 & 27

Tree 27 was identified as *Pyrus cvs* (Ornamental Pear cultivar) and is a young specimen located in the southern section of Bradfield Park North. Tree 27 is in good health and good structural condition with no significant defects identified at the time of inspection. The tree is starting to develop a phototropic lean due to suppression from the adjacent Tree 26. It is expected the form of the tree will continue to be impacted as it grows. The tree is of low Landscape Significance and has been allocated a Retention Value of *Consider for Removal*.

3.1.5 The supplied plans show Tree 27 is to be removed due to accommodate new areas of pavement.

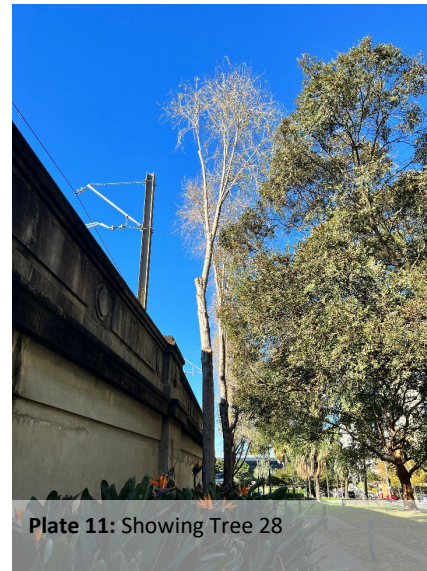
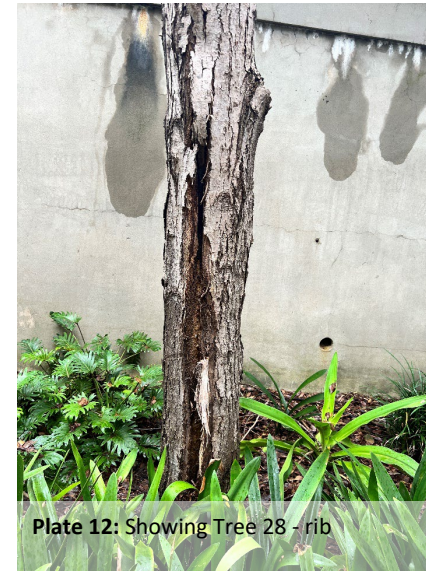
Plate 11: Showing Tree 28

Plate 12: Showing Tree 28 - rib

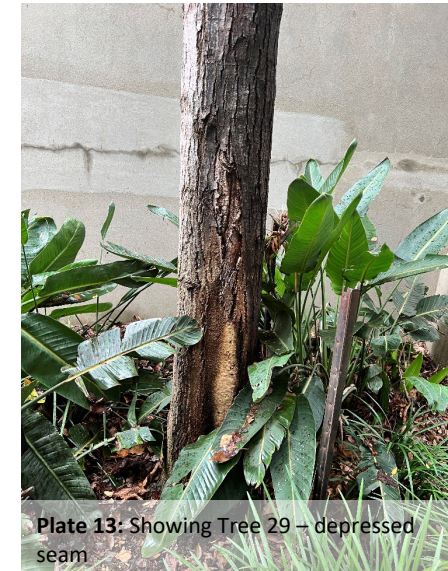
Plate 13: Showing Tree 29 – depressed seam

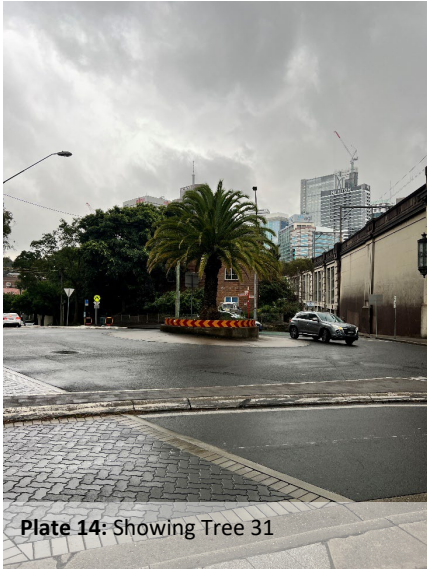
Plate 14: Showing Tree 31

Tree 31 was identified as *Phoenix canariensis* (Canary Island Date Palm) and is located in a roundabout at the junction of Alfred Street and Fitzroy Street. Tree 31 is in good health and good structural condition with no significant defects identified at the time of inspection. The tree is of moderate Landscape Significance and has been allocated a Retention Value of *Consider for Retention*. *Phoenix canariensis* (Canary Island Date Palm) is an exotic palm species which was introduced to Australia in the late 1800's. It is historically associated with commemorative plantations and civic landscapes established during the late nineteenth and early twentieth centuries (including the Inter-war Period). Tree 31 is not visible in aerial imagery from 1943 and is unlikely to be a culturally significant specimen.

3.1.7 The supplied plans show Tree 31 is to be removed as part of the road reconfiguration works. It may be possible to transplant this tree to a new location. However, new plantings of this species are now uncommon due to its propensity to self-seed and become weedy and its susceptibility to the fungal disease *Fusarium oxysporum* f. sp. *Canariensis*.

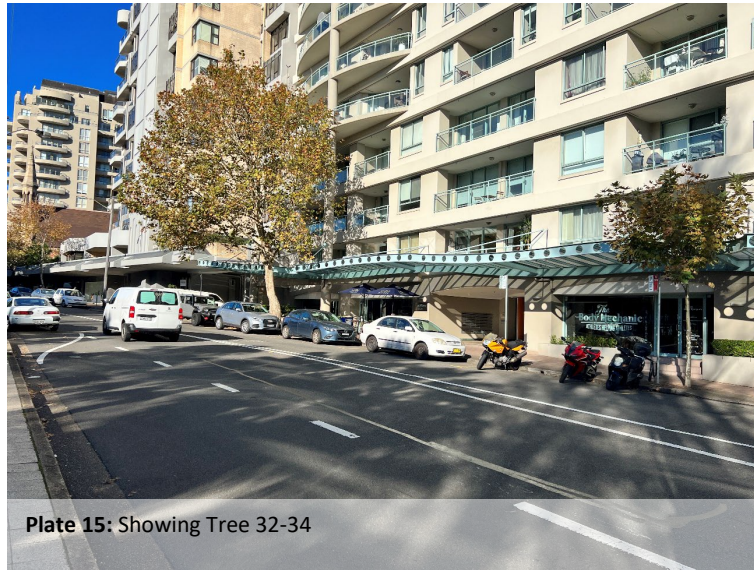
Plate 15: Showing Tree 32-34

Trees 32 and 33 were identified as *Platanus x acerifolius* (London Plane Tree) and are located within the western Alfred Street road reserve. Tree 32 is in good health and good structural condition with no significant defects identified at the time of inspection. Tree 32 is of low Landscape Significance and has been allocated a Retention Value of *Consider for Removal*. Tree 33 is in good health and poor structural condition due to significant canker-like wounds located on the lower trunk. This wounding is consistent with infection by *Phytophthora* sp. *Phytophthora* sp. is relatively common, fungus-like (oomycete) plant pathogen responsible for *Phytophthora* Dieback or *Phytophthora* Root Rot and can also cause trunk and stem lesions. Pathology testing and internal diagnostic testing should be undertaken to more accurately determine the significance of this defect. Tree 33 is of moderate Landscape Significance and has been allocated a Retention Value of *Consider for Retention*.

3.2.22 The supplied plans show Trees 32 and 33 are to be retained with new pavement areas proposed within their TPZ areas. The extent of works represents *Major Encroachments* as defined by AS-4970. Tree sensitive methods as per Section 3.2.4 should be used to minimise adverse impacts. The design should ensure there is adequate clearance from the cycleway to the trees, particularly Tree 33 which is located parallel to the proposed road crossing. In addition, consideration should be given to the installation of bollards to prevent accidental bike impact damage. Bollards/posts should be installed to avoid roots (>25mm ϕ).

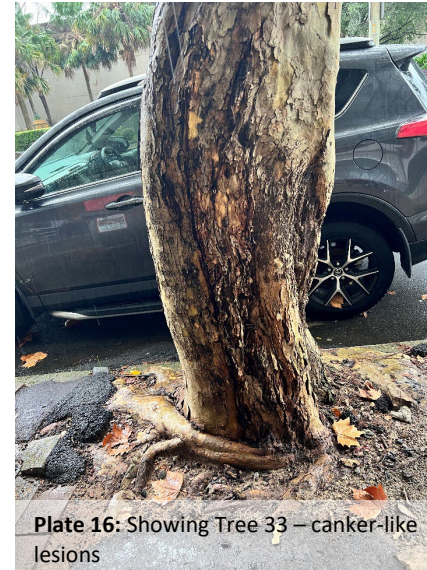
Plate 16: Showing Tree 33 – canker-like lesions

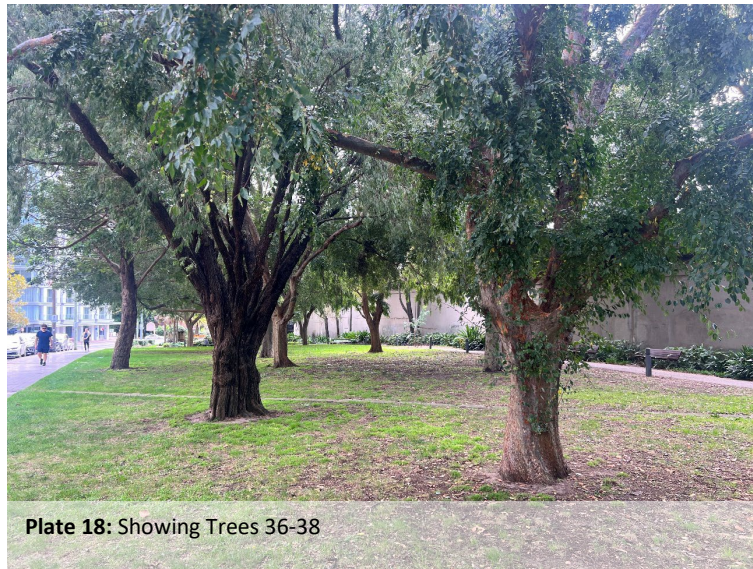
Plate 18: Showing Trees 36-38

Tree 24 was identified as *Lophostemon confertus* (Brush Box) and Trees 36, 39 and 40 were identified as *Ulmus parvifolia* (Chinese Elm). They are mature specimens located in the southern section of Bradfield Park North. The trees are in good health and good structural condition with no significant defects identified at the time of inspection. Trees 24, 36, 39 and 40 are of moderate Landscape Significance and have been allocated a Retention Value of *Consider for Retention*.

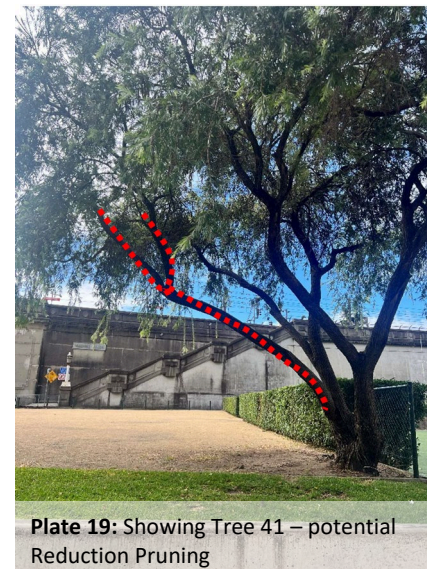
Tree 41 was identified as *Callistemon viminalis* (Weeping Bottlebrush) located in the south-western corner of the site. The tree is in good health and fair structural condition due to the presence of minor bark inclusions. Tree 41 is of low Landscape Significance and has been allocated a Retention Value of *Consider for Removal*.

Plate 19: Showing Tree 41 – potential Reduction Pruning
