The NSW Government is delivering major improvements to maritime infrastructure and facilities statewide, to help the boating and wider community safely access, use, and navigate our inland and coastal waters. As part of that work, we are undertaking essential repair work to the Port Macquarie Southern Breakwall.

The last maintenance work on the Port Macquarie Southern Breakwall was completed nine years ago. Early investigations in 2022 for this project (including underwater assessments and scans) revealed that the effectiveness and structure of the wall have been compromised over that time and are now in need of repair work.

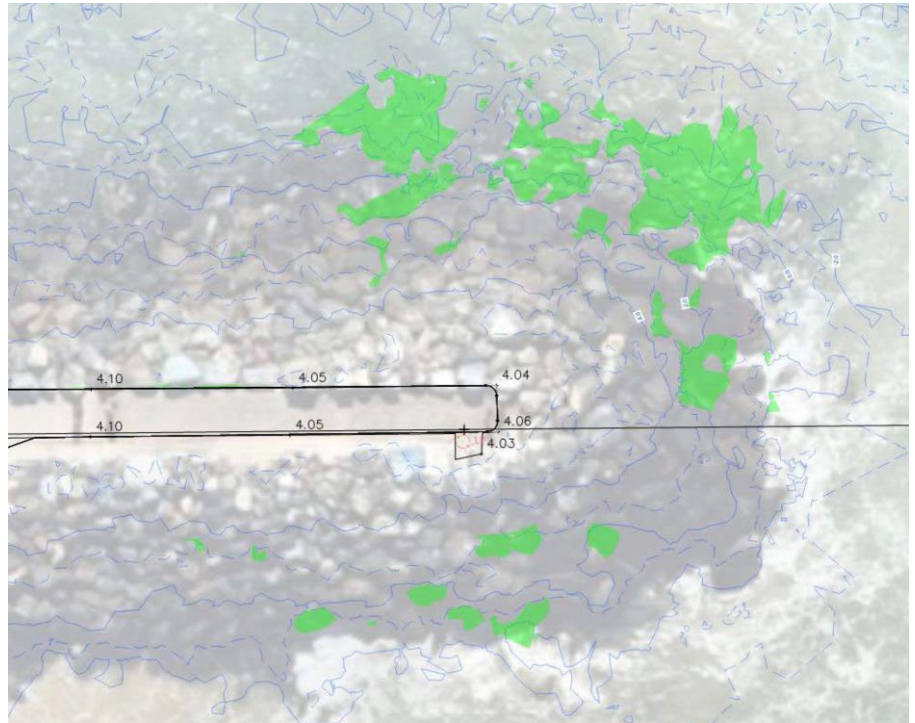
Voids have opened and oversteepening has occurred since the previous remediation works (see Figure 1). As part of this project, placement of the rocks is required to restore the breakwall profile and rock armour thickness to the previously installed extents which satisfy the overall design intent of the structure. Failure to remediate this damage will leave the breakwall head vulnerable to progressive damage over time and potential failure.

Figure 1: Extent of the Breakwall head indicating areas of damage requiring remediation in green. (Source: Design Report, October 2022)

It is not intended to increase the southern breakwall extent beyond that of the original design intent of the 2014 remediation work. The placement of rocks will be within the current footprint and design slope.
