Preliminary assessment results for Appin Road Safety Improvements Project based on the Procedure for Aboriginal cultural heritage consultation and investigation (the procedure).

ARBORICULTURAL REPORT

Appin Road Heritage Tree

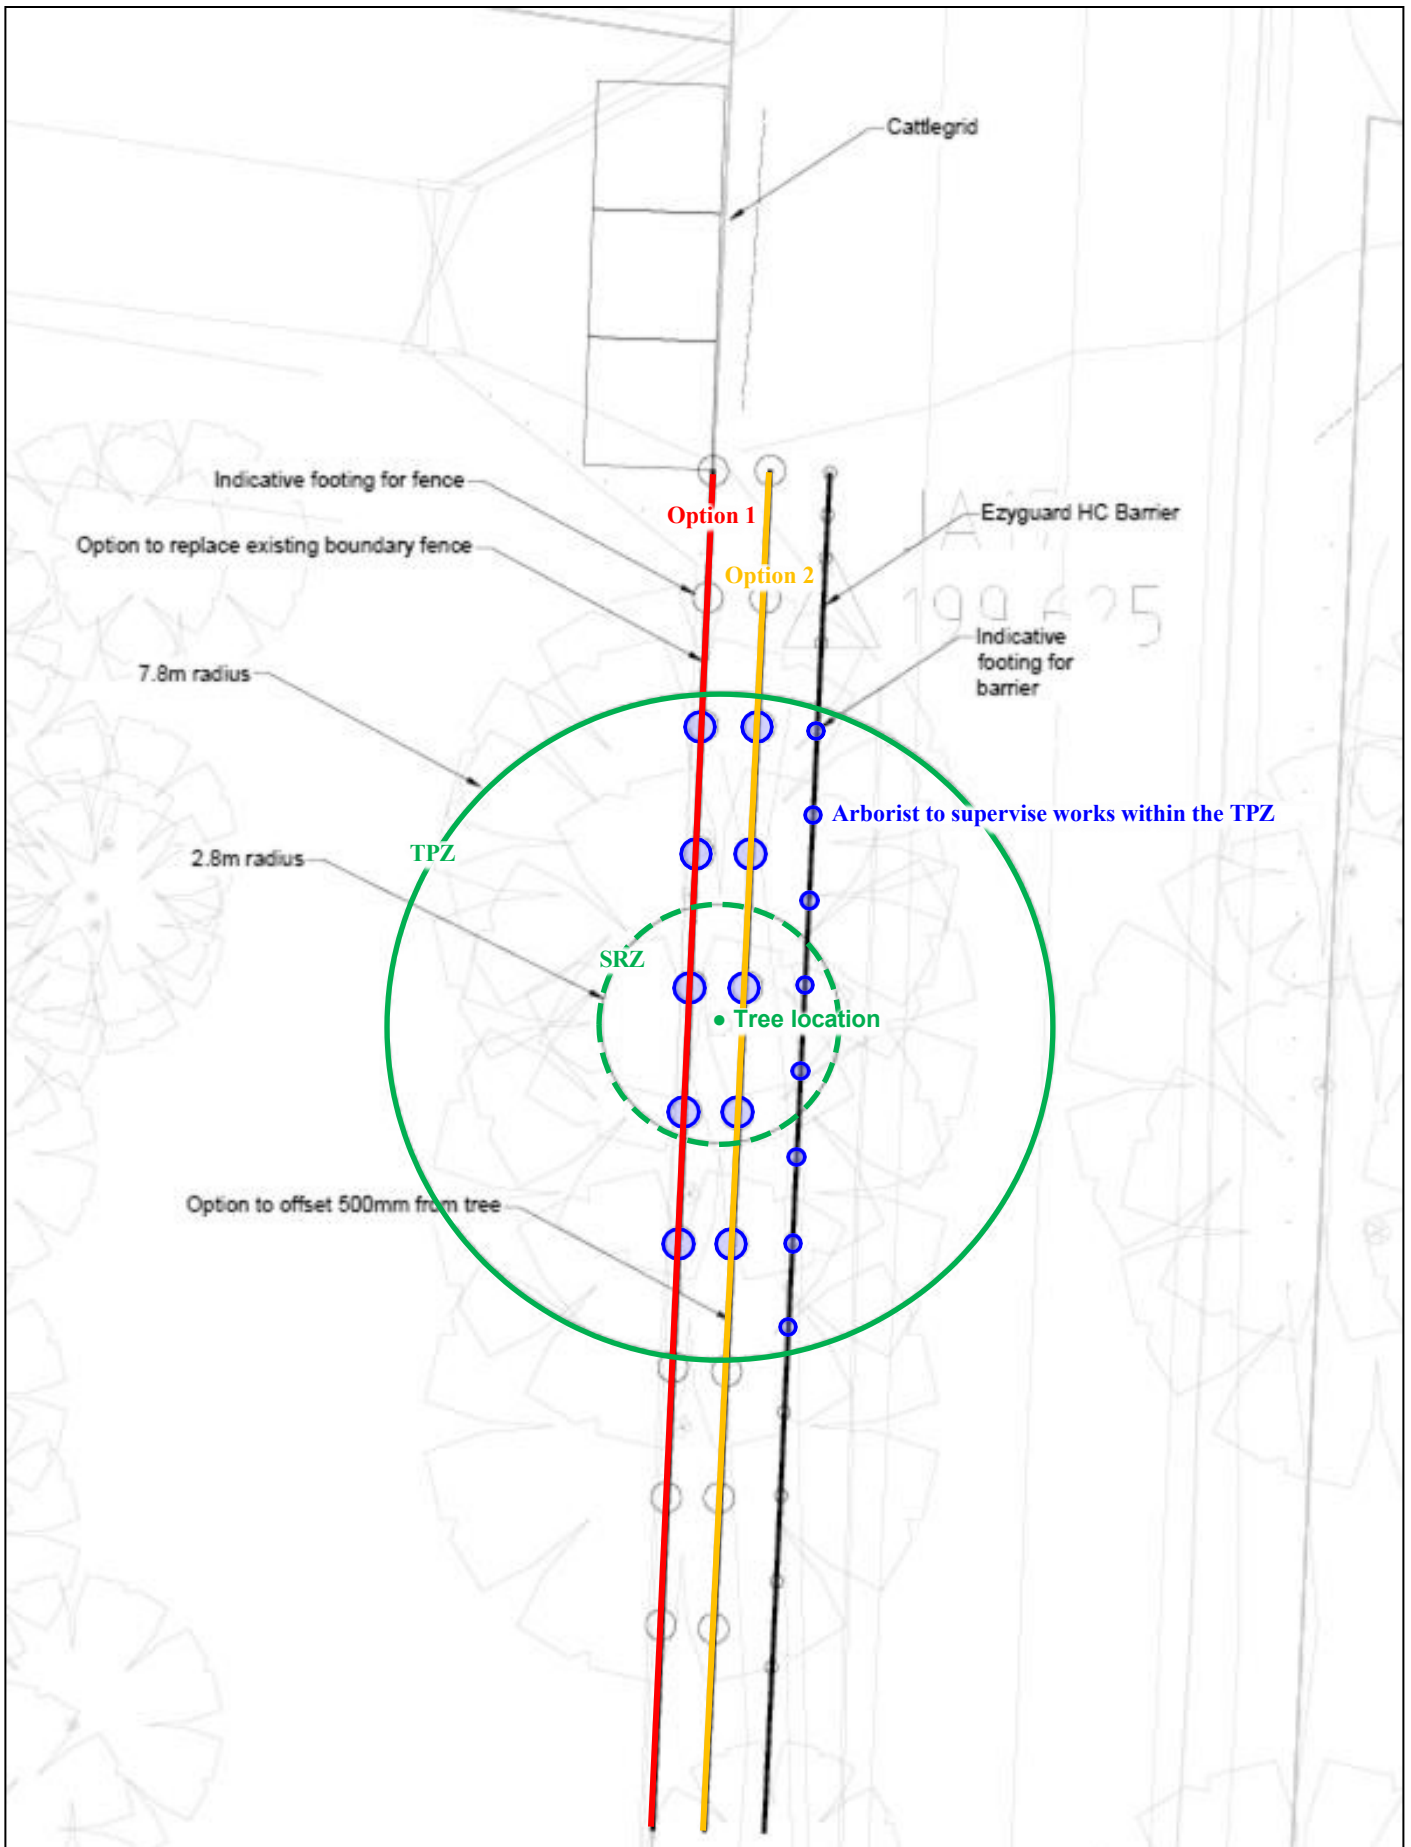
Appendix I – Site Plan

- The tree protection zone (TPZ) for this tree has been calculated at 7.8m radius from the centre of the trunk. The structural root zone (SRZ) has been calculated at 2.8m radius from the centre of the trunk.

- A road safety barrier and fauna fence are proposed to be installed within the TPZ of the subject tree.
- There are two (2) options for the location of the fauna fence, in front (roadside) or behind the tree. Both options comprise the same number of footings and will have the same construction impact

- The road safety barrier will require eight (8) footings (150mm in diameter) within the TPZ.
- The fauna fence will require five (5) post footings (350mm in diameter) within the TPZ.

- Encroachment within the TPZ has been calculated at less than 3%.

- **Trunk protection:** Trunk protection should be installed for the duration of the build. Trunk protection should comprise a thick layer of geotextile fabric beneath 1.8m lengths of softwood timbers aligned vertically and spaced evenly around the trunk (with a small gap of approximately 50mm between the timbers). The timbers should be secured using galvanised aluminium strapping (but not fixed to the tree).
- **Root pruning:** Any conflicting roots greater than 50mm in diameter identified during the supervised excavations shall be pruned using clean, sharp secateurs or a pruning saw to ensure a clean cut, free from tears. All root pruning (>50mm) must be documented and carried out by the project arborist.

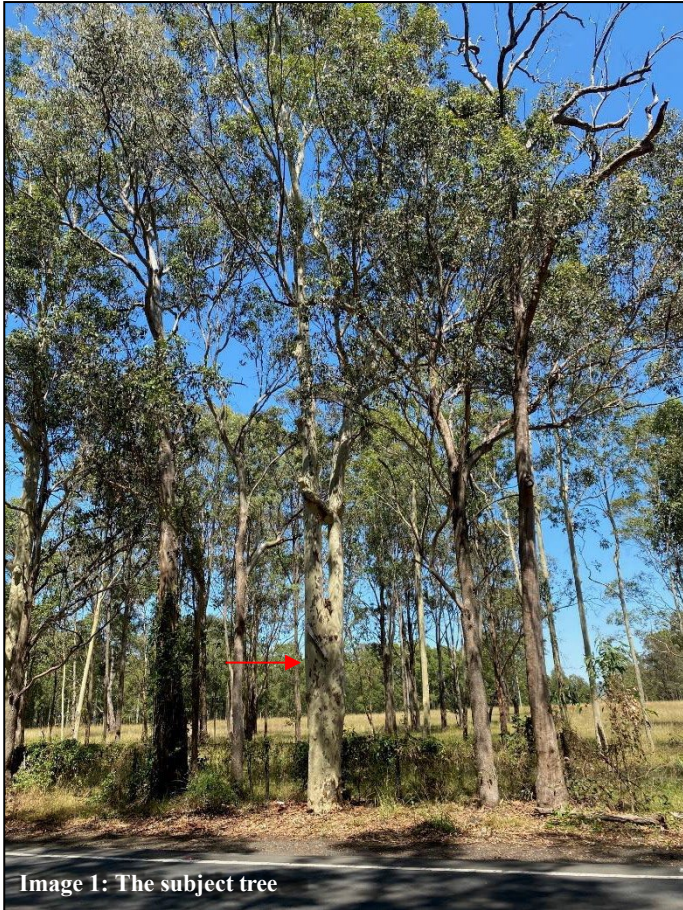
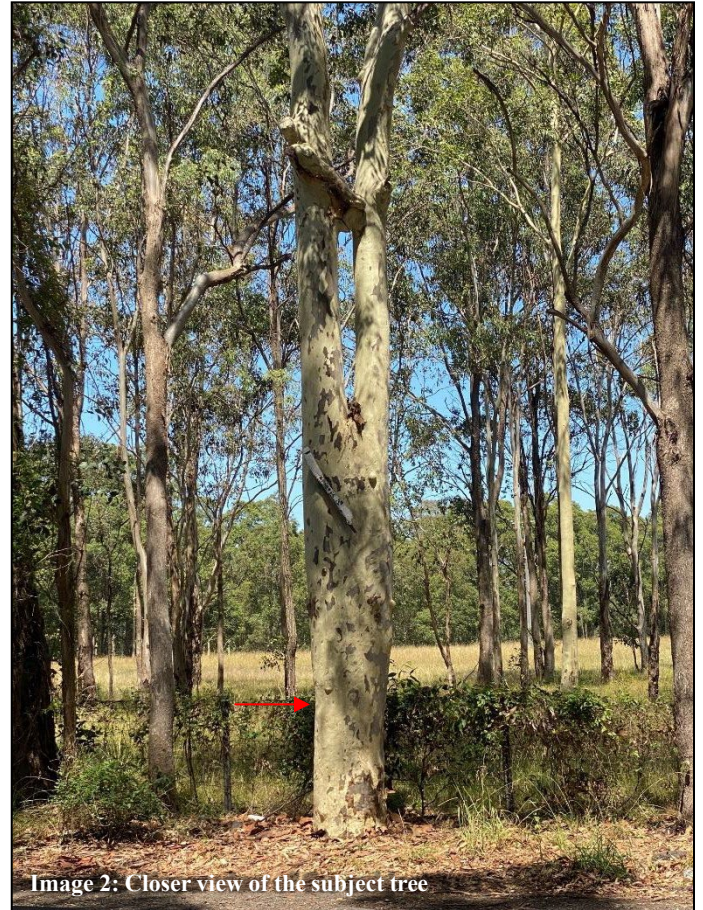
Appendix II – Site Photos

- The subject tree (*Corymbia maculata*) is approximately 24m in height, with a canopy spread of 14m and a trunk diameter at breast height (DBH) of 650mm.

- The overall health and condition of the tree are good.
- The tree has been assessed as a high priority for retention due to its listing as Aboriginal Heritage.
