Sydney Trains Environmental Management System Site Environmental Management Plan (SEMP)

Project / Program Details	
Project/Program Name	Bld Refurb RRR Bldg Mittagong
Project/Program No	P.0078604
Scope of Works	<p>Railway Refreshment Room (RRR) Building at Mittagong Railway Station is a two storey building with brick external wall and a slate hipped roof and is Heritage listed (SHR#01195).</p> <p>The building is old and require repair works.</p> <p>This scope of work is to:</p> <ul style="list-style-type: none"> - Repair/reconstruction works on chimney stacks as per Heritage Architect documentation and TTW Engineering design. - Replacement of windows on the 1st floor as per Heritage Architect documentation and TTW Engineering design. - Repair of crack on external wall on the end of corridor on the 1st floor as per Heritage Architect documentation and TTW Engineering design. - Replacement of roof gutters with larger capacity OG gutters as per Heritage Architect documentation. - Minor repair works on roof structure including replacing cracked or damaged roof slates as per Heritage Architect documentation. - Additional 2 downpipes to the platform side of RRR building and relocation of

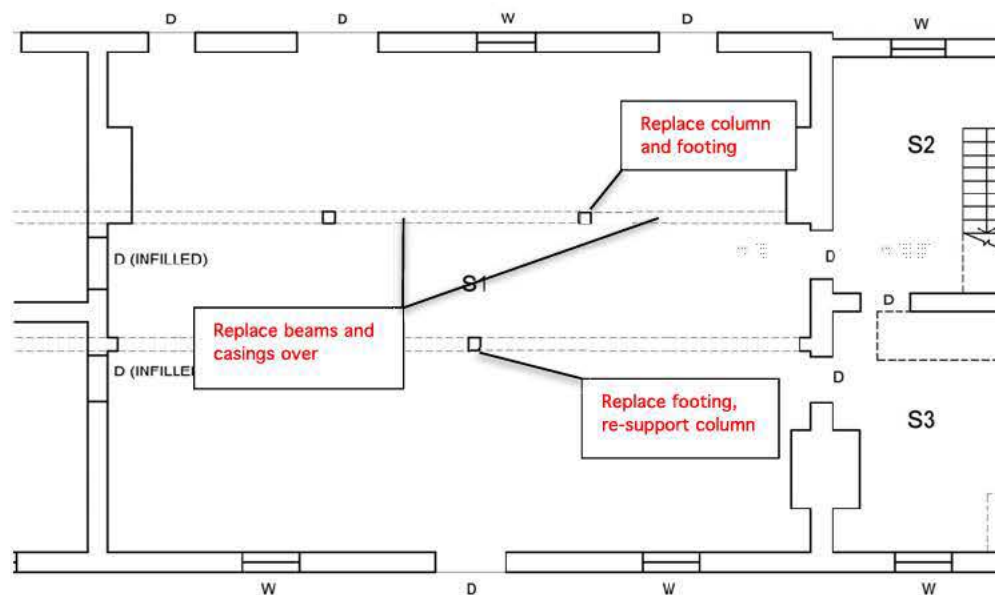
Figure 5: Location of structural works in Space 1

Replacement of 2 termite affected beams (and timber beam casing) on the southern side extending from the west wall to the SE post. Replacement of the south west column. Provision of new footings and concrete pad stone (replacing the damaged sandstone pad stone) as shown on TTW drawing SK01_001&4.

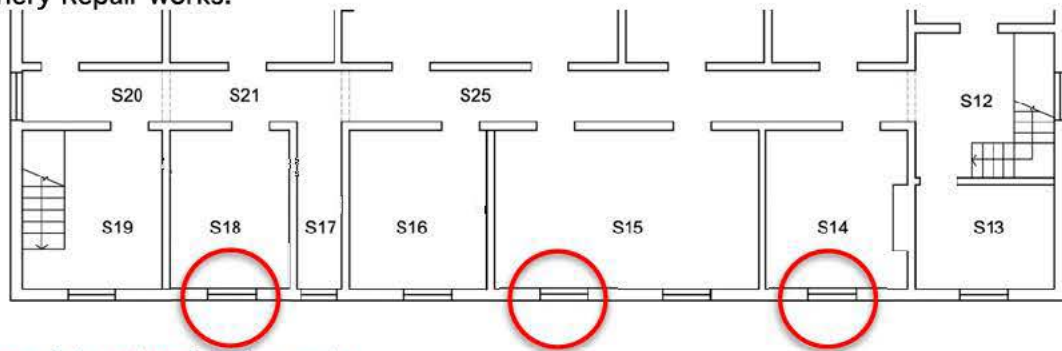
Figure 6: Location of window repairs

Reconstruction of the double hung sash window in Space 14 and resealing double hung windows in spaces S15 and 18.

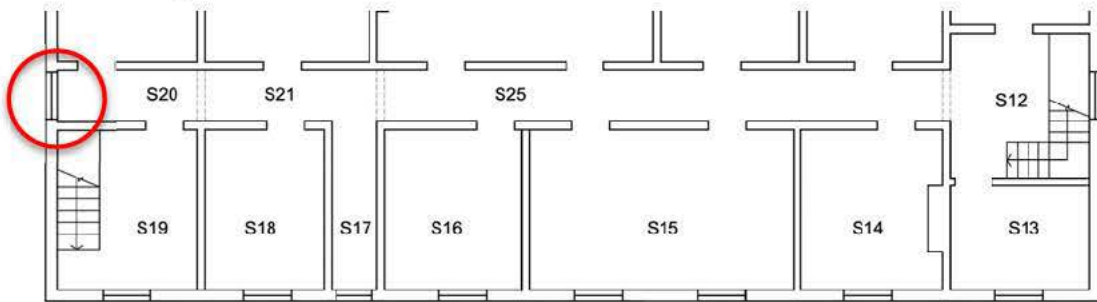
Figure 7: Location of crack stitching

Stitching of the external crack in the brickwork of the north elevation see drawing 104 and TTW drawing 03_002.

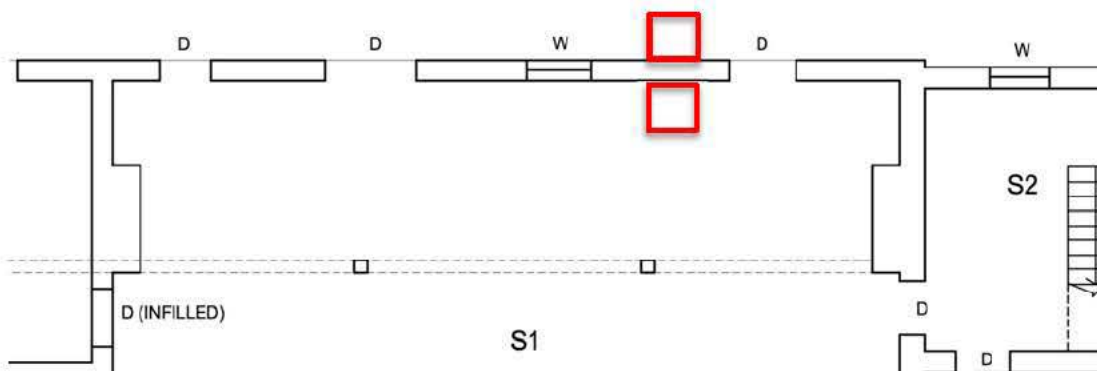
Figure 8: Location of trial holes

Two trial holes to expose the configuration of the platform wall of the RRR Building

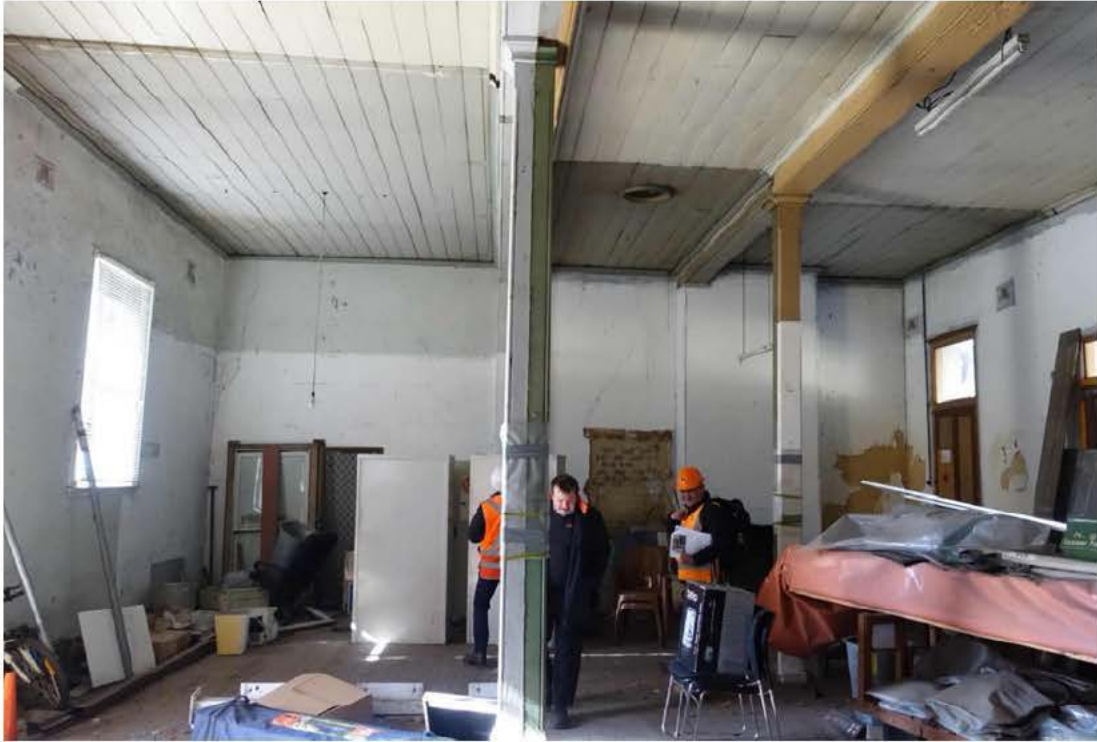
Figure 9 Space 1 the former Buffet

The Oregon SW post and its supported beams are badly termite affected and require replacement. The proposed replacement is like for like using a more termite resistant timber species. The central north column is supported on a failed blocking timber which will be replaced with concrete, the robust ironbark column will be retained. Both columns will have new concrete footings. The footings have been designed to avoid damage to the stone footings of the 1867 station building.

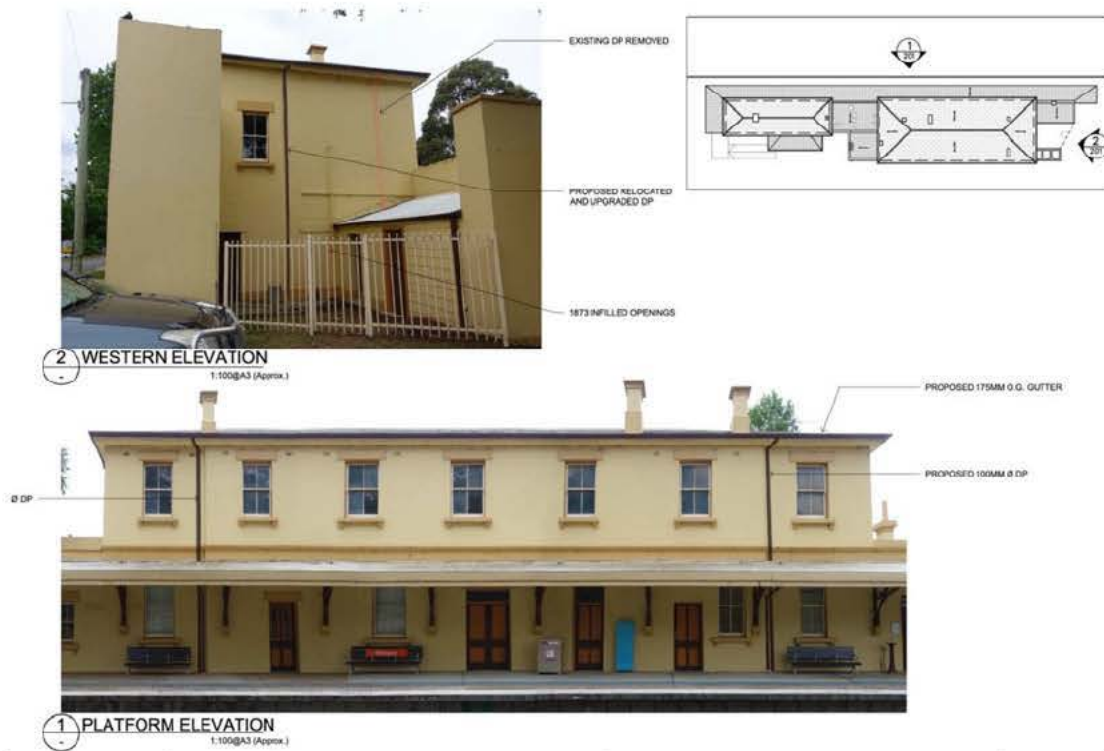
Figure 10 Photomontage showing proposed new downpipes to the platform and west elevations

The present drainage of the 2-storey roof of the RRR has inadequate capacity, it proposed to add 2 downpipes adjacent to the break front of the building and relocate the west downpipe to drain directly to the new in ground system. In addition, guttering will be replaced with larger capacity OG guttering in place of the relatively recent 125mm D guttering. The downpipes will become operation when the new stormwater system is installed.

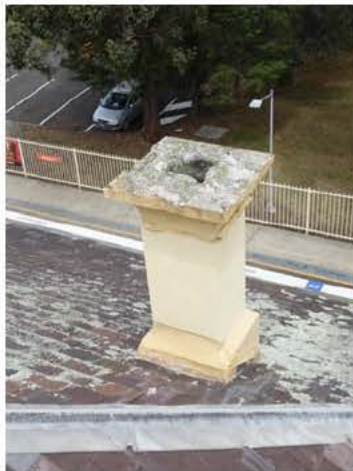
Figure 13 Stack M2

All stacks are open and letting water in. 3 stacks are degraded to the point of requiring reconstruction. The condition of the stone plinths of stacks M4 and 5 is such that replacement of the stone plinth is necessary. The reconstruction will include the faithful reconstruction of the rendered moulded capping. All flues will be terminated with terracotta pots and cowls.

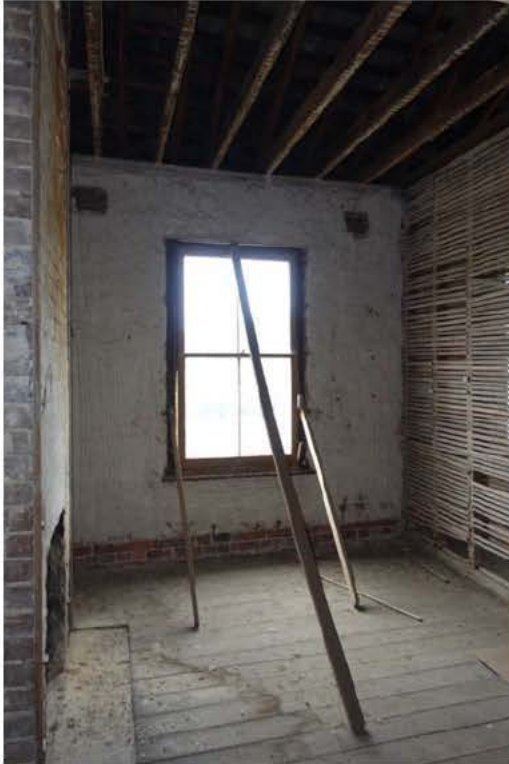
Figure 11 Window in S14

The three windows are at risk of falling in and require urgent fixing. The frame of the S14 window is damaged beyond repair and requires replacement (the sashes can be salvaged). The windows will be secured into their rebates by new matching architraving.

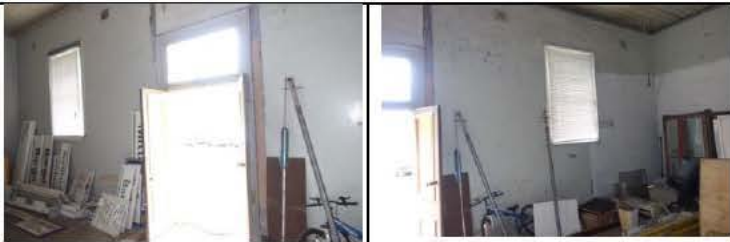
Consideration should also be given to strengthening the overall lateral stability system of the building				
S1 Former Refreshment Room				
Wall, North	Plaster on brick, rising damp to base

Following damp remediation works/actions repair damaged plaster	C+ Timing based on reuse
Wall, East

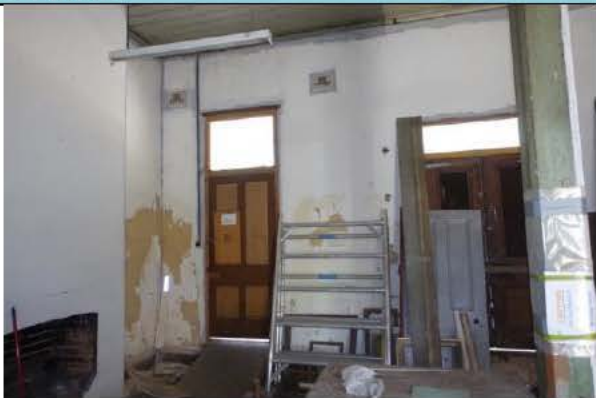
Door South	Original 1867 double door leaves in recent timber frame with fixed overhead. Reset to higher platform level. Masonite ? upper panels	Worn. Damage to west hinge stile, stile to rail joints opening up, damage to sunk moulds	<div>Piece in repair upper section of west hinge stile 500 x 50mm</div> <div>Overhaul door leaves. Replace straps hinges with butt hinges</div> <div>Replace upper panels</div> <div>Repair sunk moulding</div>	C
Door South west	Non-original 4 panelled door in recent timber frame. Doorway raised about 400mm with new galvanised steel lintel. Glazed upper panels. Missing architraves	Fair and incomplete.	Complete framing and trim and associated plaster repair.	C
