Appendix H – Nowra Bridge adaptive reuse strategic options report

Nowra Bridge (BN713) over the Shoalhaven River

Adaptive Reuse Strategic Options

November 2023

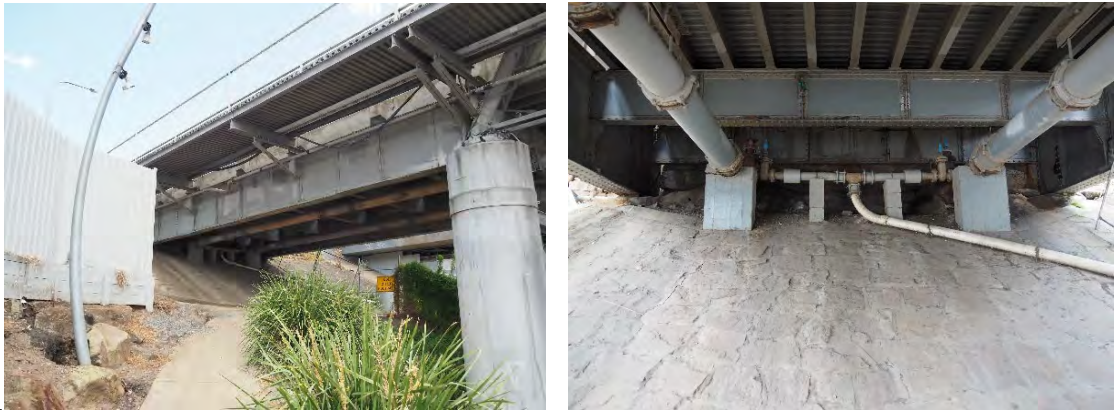
Figure 3-1 Approach span 9 (Source: FBE)

From the review of level 2 information, essential maintenance items include corrosion, section loss, and a section of damaged concrete kerbing where the steel traffic barrier connects.

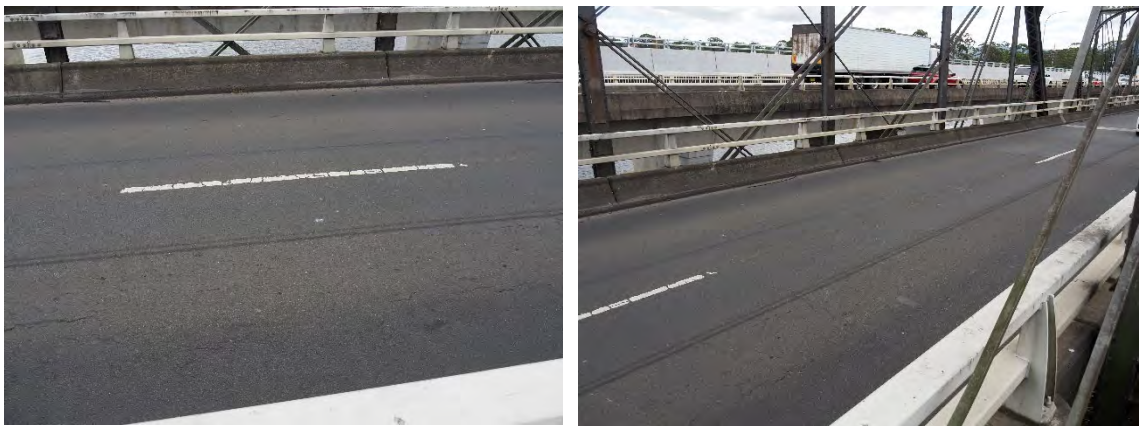
Figure 3-3 Road deck (Source: FBE)

There may be localised areas of concrete spalling and cracking present in the deck, as reported in the most recent level 2 inspection (TfNSW, February 2014).

Additionally, several areas of asphalt have been noted as failing and require minor to moderate pavement patching and crack sealing repairs.

The overall rating of the concrete deck has been assessed as **“Fair”** by TfNSW.

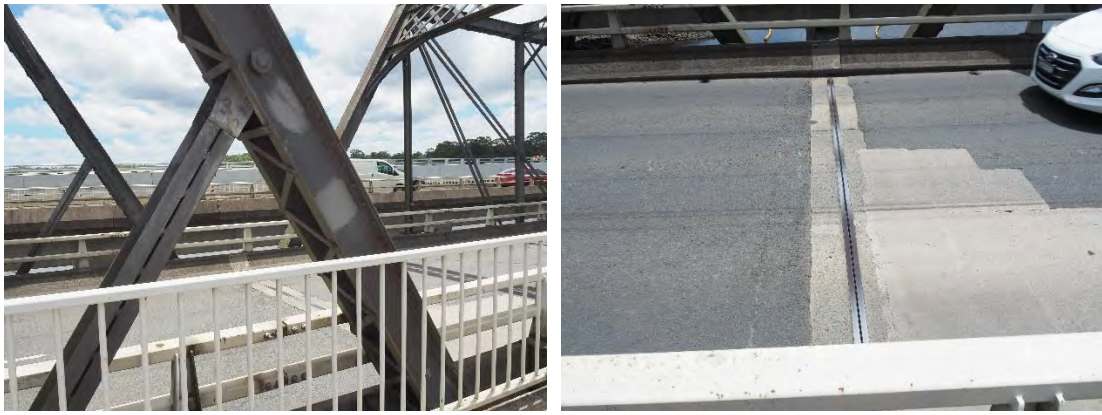
Figure 3-4 Bridge joint with steel nosing (Source: FBE)

The overall rating of the bridge joints has been assessed as **“Good”** by TfNSW.

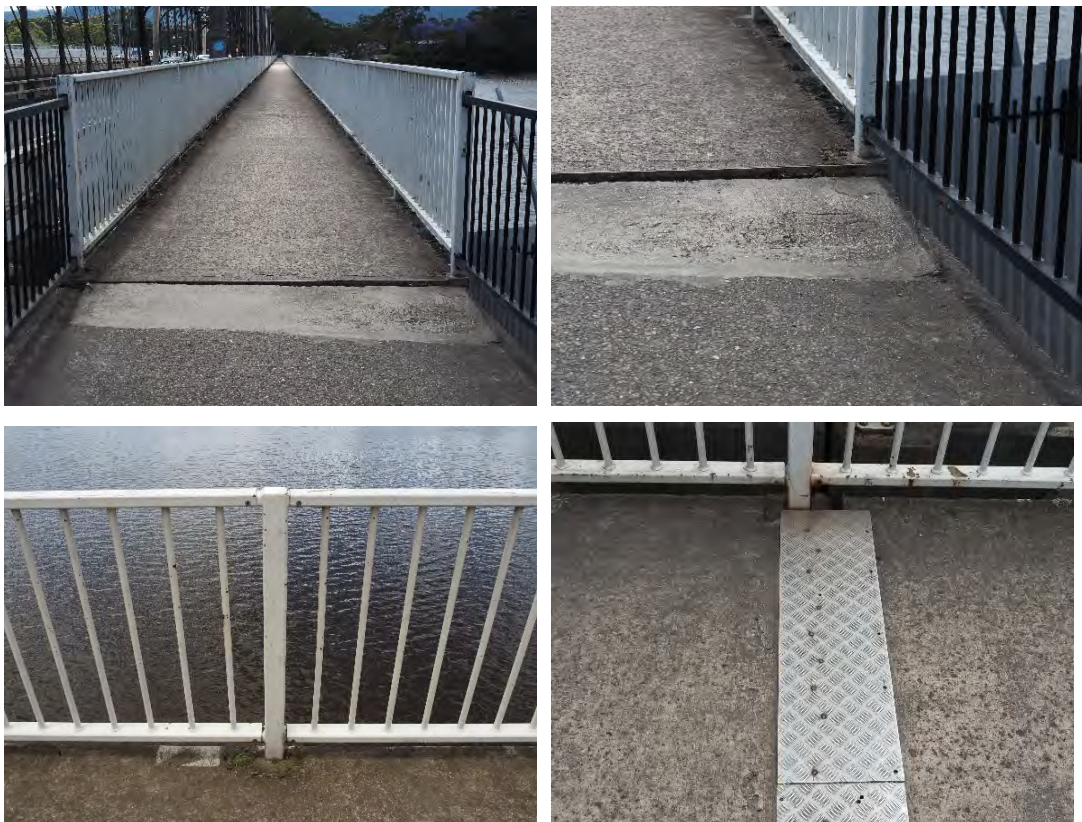
Figure 3-5 Pedestrian Walkway (Source: FBE)

Its main issues appear to be uneven surfaces and/ or protruding compression seals. Some minor spalls and cracking are also present.

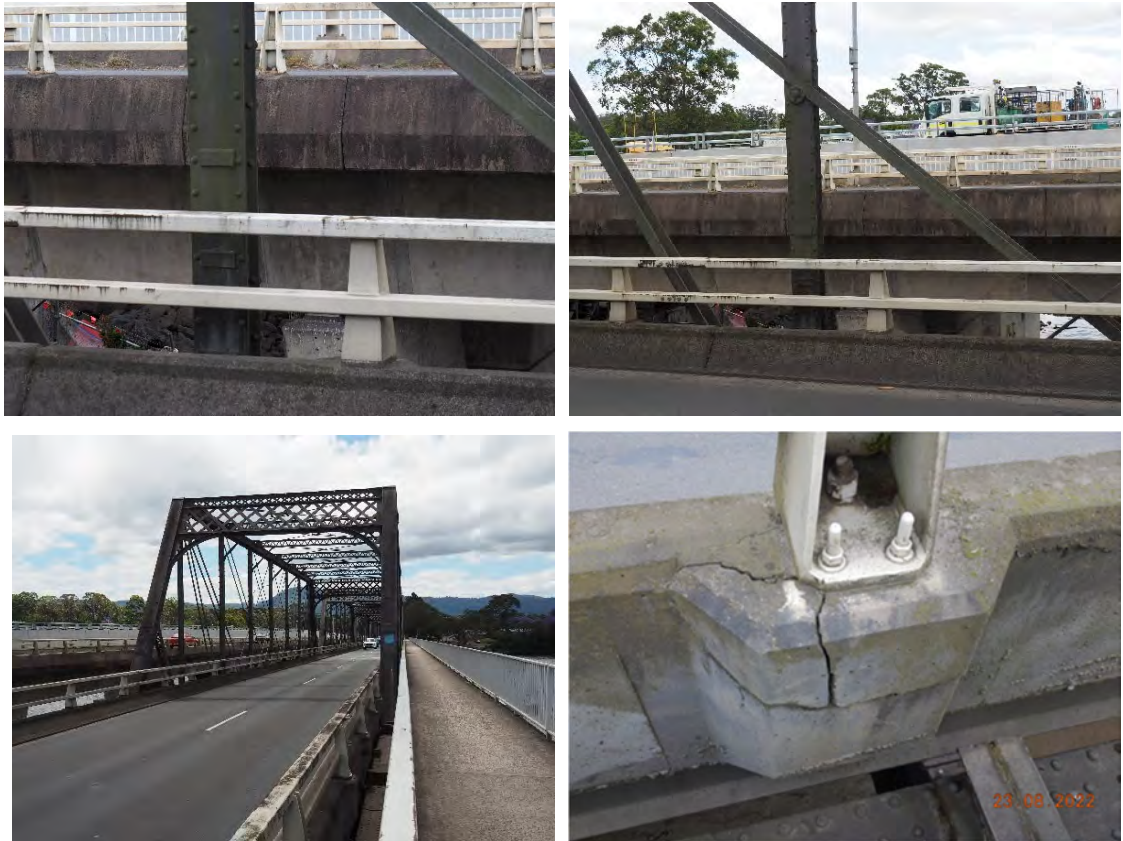
Figure 3-6 Traffic barrier (Source: TfNSW)

As highlighted in the Level 2 inspection report, corrosion and section loss are noted on the steel twin rail at various locations. Additionally, the modified concrete jersey kerb has cracking and spalling. Span 1 (4th post on the bridge's eastern side from Abutment A) and Span 9 (3rd post from Abutment B) have the worst reported damage. TfNSW conducted a concrete condition survey in 2023 that found no current penetration of chlorides and carbonation to the reinforcing steel. A discussion of the results from the survey and options for remediation are provided in Section 5.2.2.

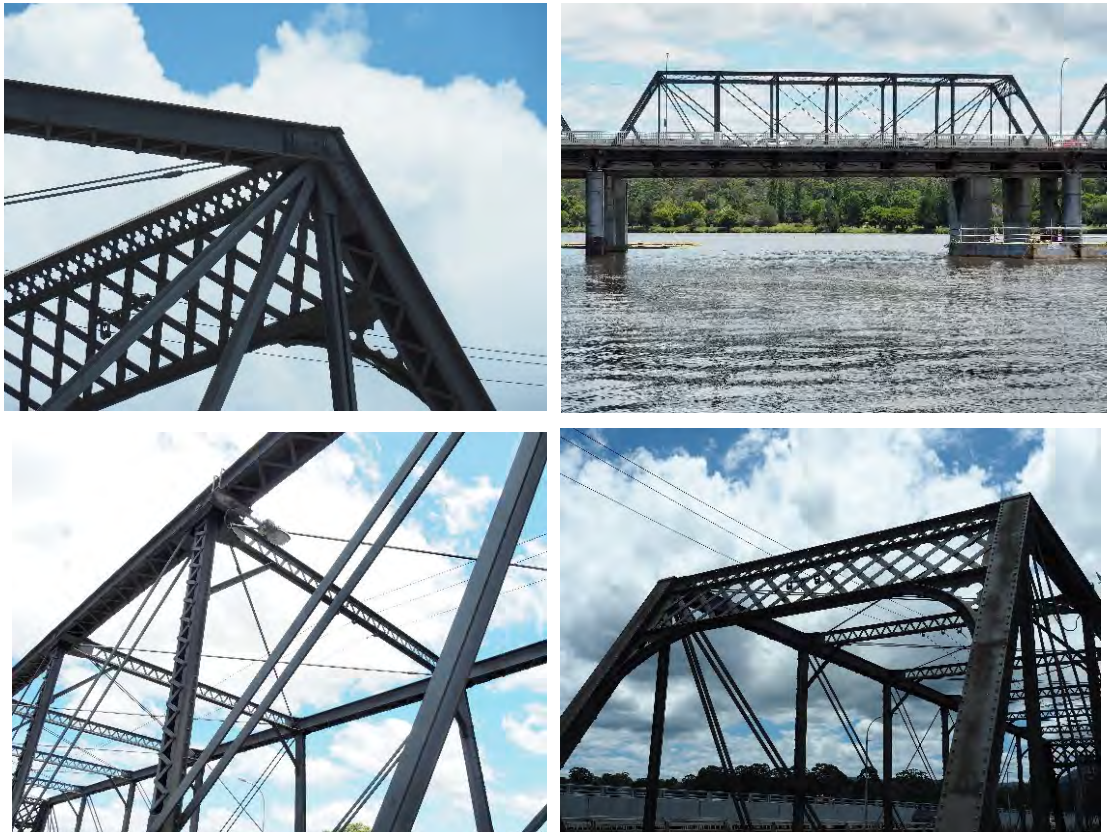
Figure 3-7 Various Views of the Nowra Bridge Whipple Truss (Source: FBE)

The condition of the Trusses (bottom bracings, bottom chord, cross girders, diagonal, gusset plates, principals, stringers, top bracings, top chords and verticals) was rated as **“poor”** by TfNSW. However, the protective coating had a rating of **“Good”**. Additionally, the Level 2 Inspection notes the following:

“Strengthening of the top chord and verticals at areas around the pin connections, most areas have been rehabilitated but there are some that will need monitoring. Some of the square and plate bracing on the truss are either deformed, loose and have come away from the vertical strut connection. The span 7 and 8 spans seems to have a lot of movement occurring in the deck, with a lot of broken vertical strut washers”.

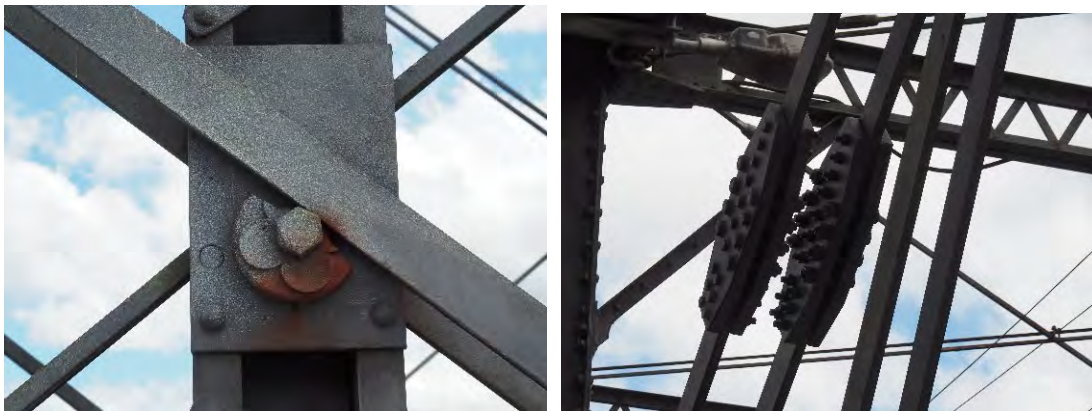
Several of these washers are broken and need replacement. Additionally, certain diagonals have turnbuckles for tension adjustment that require re-tensioning.

Figure 3-8 LHS: Damaged rosette-shaped washers RHS: New Strengthening tension member span 1 (Source: FBE)

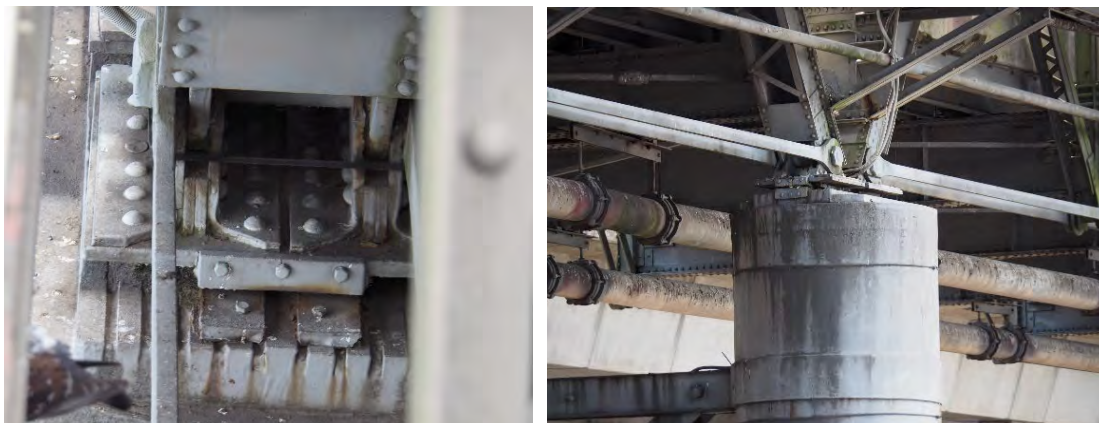
Figure 3-9 Bridge Bearings (Source: FBE)

The most recent level 2 inspection (TfNSW, August 2022) found significant damage to spans 3 and 4 locations for bridge bearings, and all five end cross girders require remedial action.

The overall rating of the bridge bearings has been assessed as “Fair” by TfNSW.

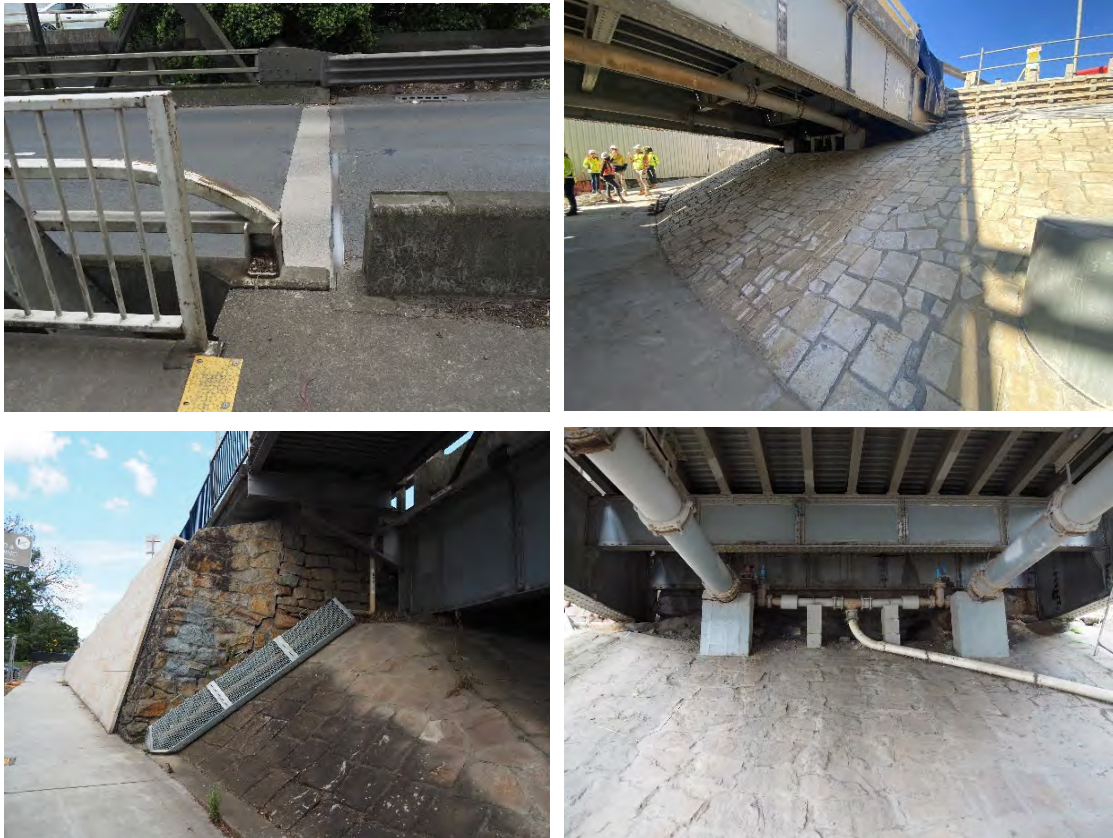
Figure 3-15 Abutment B - Nowra end (Source: FBE)

The stone pitching at Abutment B, situated at the northern Sydney end, has not been rated by TfNSW and exhibits severe cracking. There is also evident spalling and damage to sections of the wing wall at this abutment, particularly between the adjacent concrete bridge. On the other hand, the southern Abutment Nowra End A has seen enhancements, with new stone pitching introduced as part of the recent new bridge works.

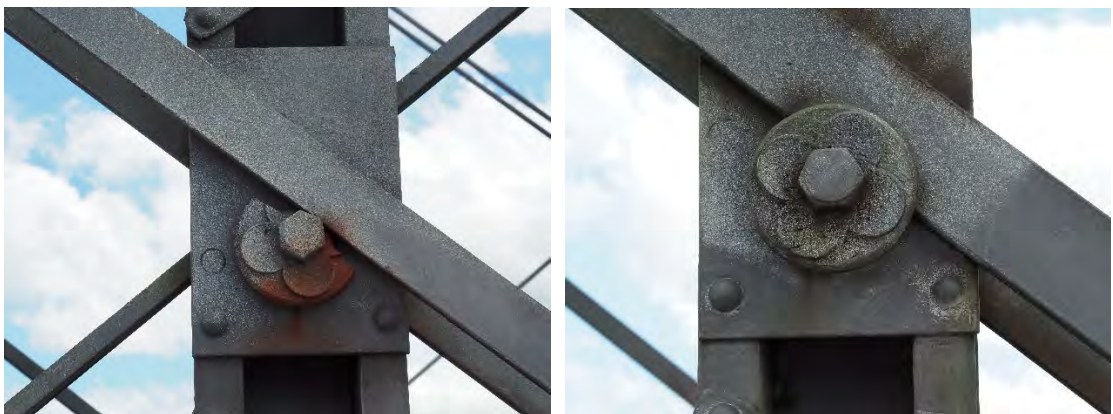
The circular cast iron rosettes are captivating details of the trusses, especially when viewed up close from the walkway. However, their choice of material, being brittle, proved unfortunate as many of them failed, and some were removed from the entry portals. Despite this, their significance remains high due to their aesthetic value.

Figure 4-13 Tension member rosettes, LHS: broken, RHS: as-built condition (Source: FBE)
