New Intercity Fleet Springwood to Lithgow Rail Corridor Modifications - Eskbank Station

Statement of Heritage Impact

Report to Transport for NSW

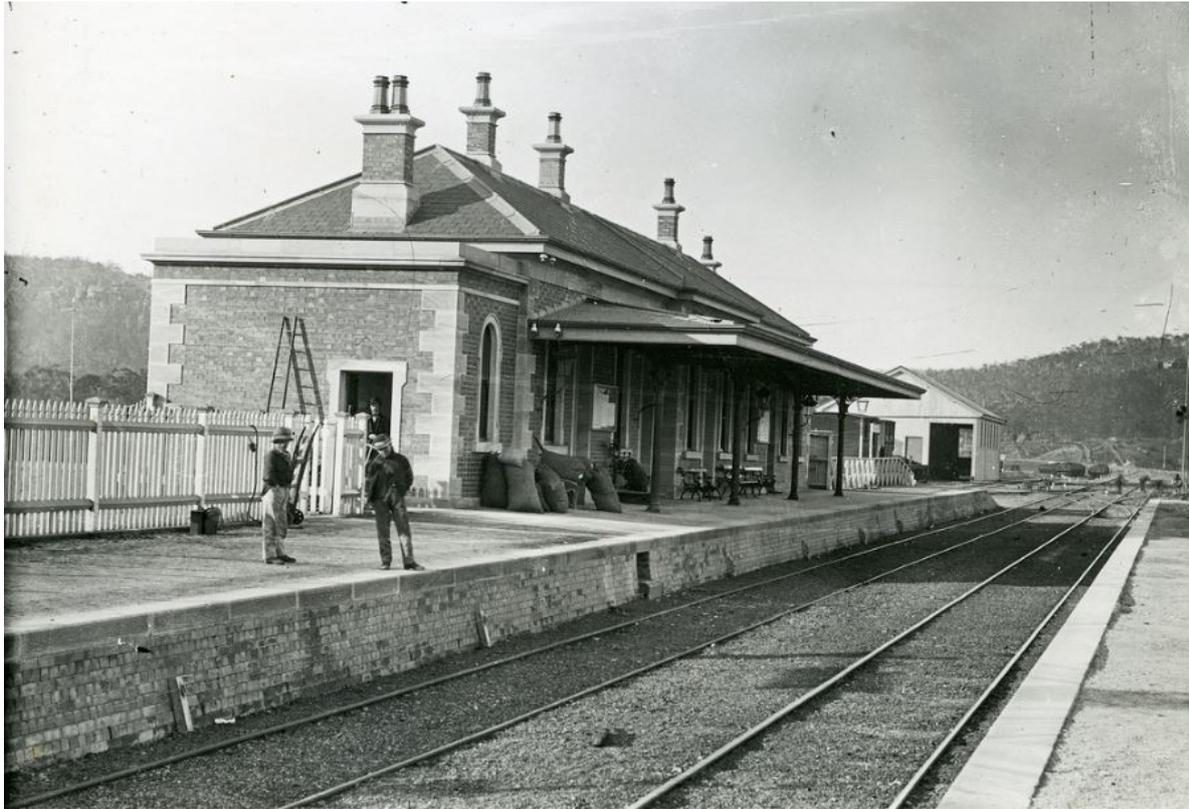
Figure 3: Eskbank Station, c1880
(Source: Blue Mountains Local Studies Collection - LS Images SHS 256)

On 1 March 1882, the new Eskbank Station (Figure 3) was opened following duplication of the Main Western Railway Line through Lithgow in October 1880. Two side platforms were erected in a battered masonry style (Figure 4). The main station building was erected on the city-bound platform. Constructed with locally resourced sandstone brick, the station building was designed in the Victorian Italianate style developed by John Whitton for important railway buildings at significant locations during the first decades of railway construction. In 1882, a simple gabled 'through' design goods shed with an open loading platform and goods loading crane on the west end was built to the east of the station, along with a timber frame horse dock (Figure 5).³

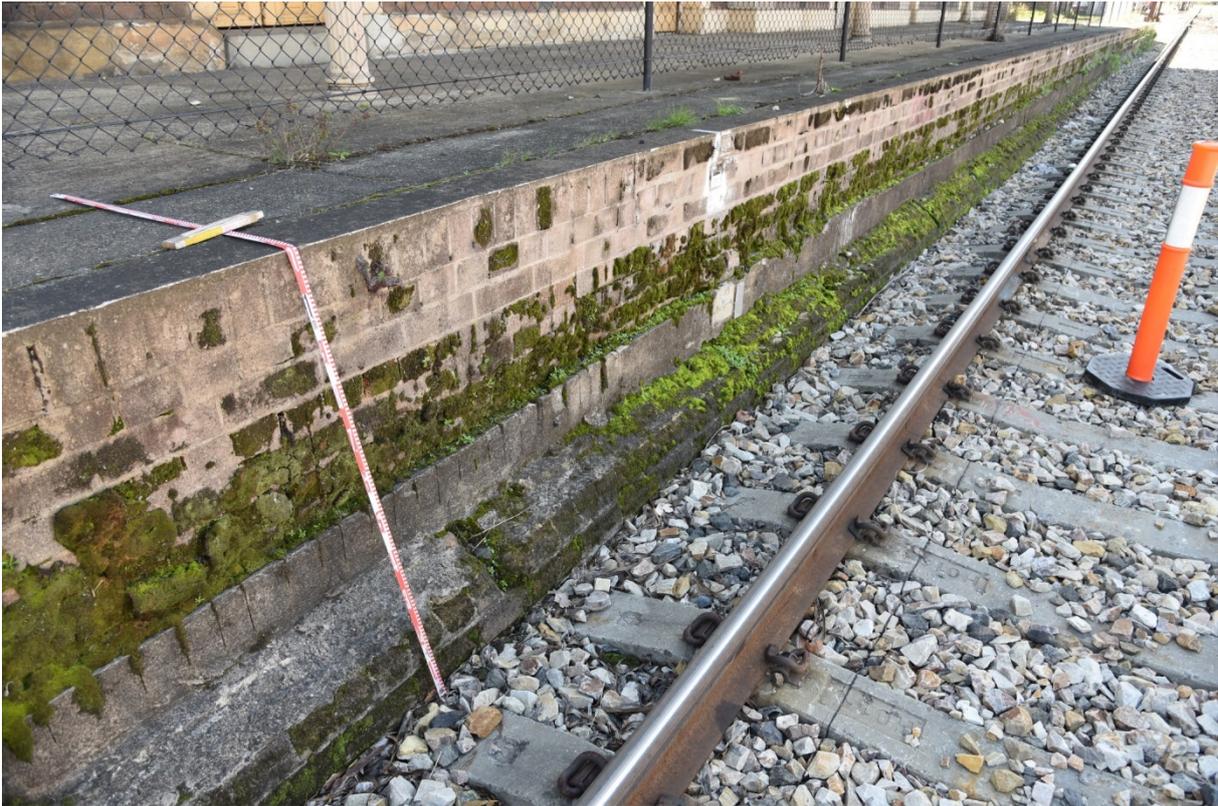
Figure 6: View of platform 1 coping, north-east aspect

The existing platform 1 at Eskbank Station is a side platform 50 metres long. The platform commences from a ramp around seven metres east of the Bridge Street overbridge and terminates 10 metres to the east of the Eskbank Station building. The current platform surface consists of a thin (10 millimetre) layer of concrete capping overlying the brick masonry retaining wall. Upper brick courses consist of grey-brown brick in an English bond with the top course in rowlock orientation. Below these vertically aligned courses, the platform retaining wall steps out towards the rail corridor 70 millimetres with a course of rowlock bricks in poor condition. These overlie concrete capping which steps out a further 180 millimetres. Below the concrete capping, original outer facing brick courses are evident in two exposed courses of English bond, which are stepped out towards the rail corridor a further 15 millimetres (refer to Figure 6).

Overall the platform edge is in poor condition. At the western and eastern ends of the platforms thick of concrete capping (up to 250 millimetres) has been laid on the top course of platform bricks. Former weepholes are evident along the outer surface of the platform retaining wall. Brick courses located at the country-end of the platform have been rough cut from earlier trimming of the platform edge. Moss has grown over large portions of the brick retaining wall (refer to Figure 6).

The cutting would result in reducing the stepping out of the base of the platform retaining wall, which although in poor condition is the only remaining visual remnant of the original battered platform retaining wall profile. While the stepped out lower profile of the wall would remain, it would be highly reduced (more than half of its present width for much of the platform width).

The platform 1 retaining wall, particularly the lower courses of brick and concrete which are to be trimmed, are obscured by moss, partially damaged by former trimming and also show surface damage from track and ballast wear. Due to these factors, the stepped-out profile of the lower courses of the wall are not easily discernible as remnant portions of the original profile of the retaining wall. Because of the existing damage to the wall, alterations to the wall's profile would result in a minor visual impact to the Eskbank Railway Station Group.

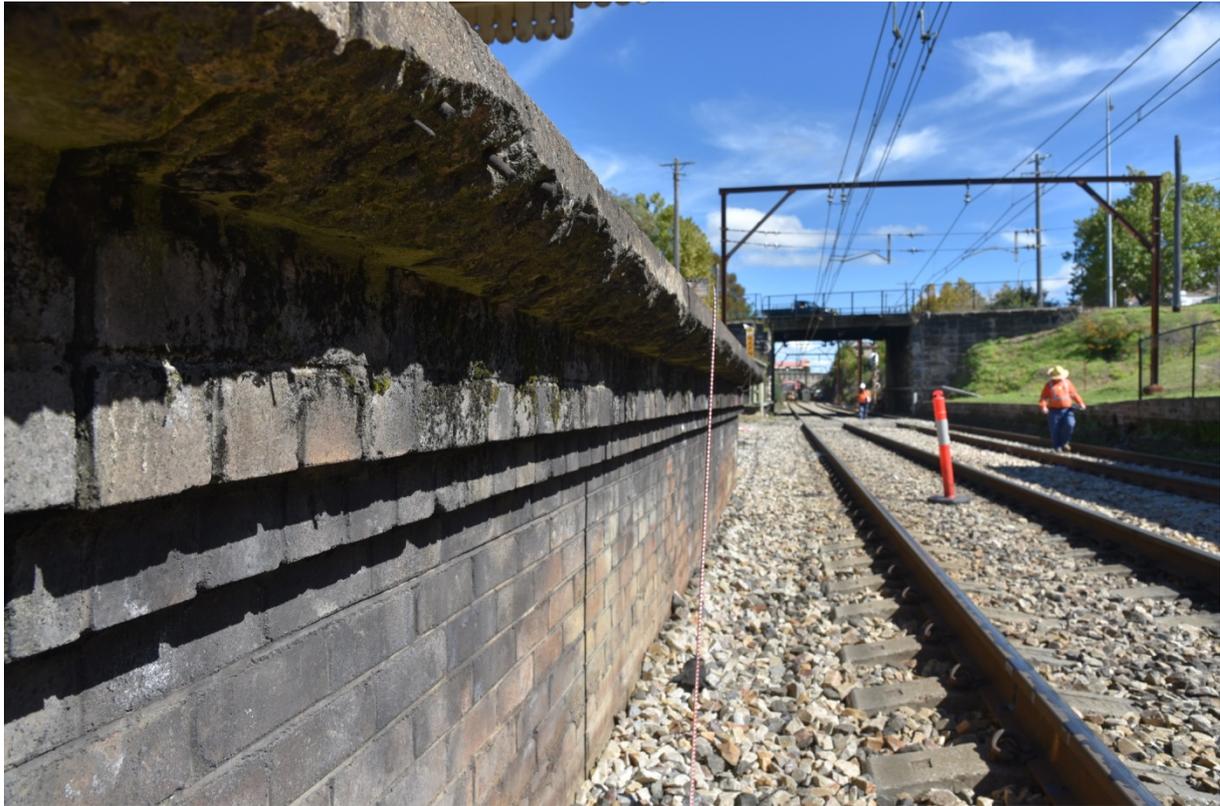
Figure 7: View of platform 2 coping, west aspect

The current main platform consists of a thick (130 millimetre) aggregate concrete capping surface overlying two courses of red-brown machine brick. The concrete capping projects 170 millimetres towards the rail corridor compared to the underlying brick courses, and has a roughly damaged lower edge. The underlying two brick courses project a further 55 millimetres above a further underlying brick course, which also projects 55 millimetres towards the rail corridor. Below these projected brick courses, the remainder of the platform wall consists of ten courses of red-brown brick laid in a stretcher bond in a vertical profile (Figure 7).

Platform 2 is in a poor state of intactness. The original extent of the platform on both the Central and Lithgow ends has been removed. The exposed side course of the platform shows that only two courses of brick are present within the platform 2 retaining wall, behind which aggregate concrete has been poured to create the one-sided island platform.

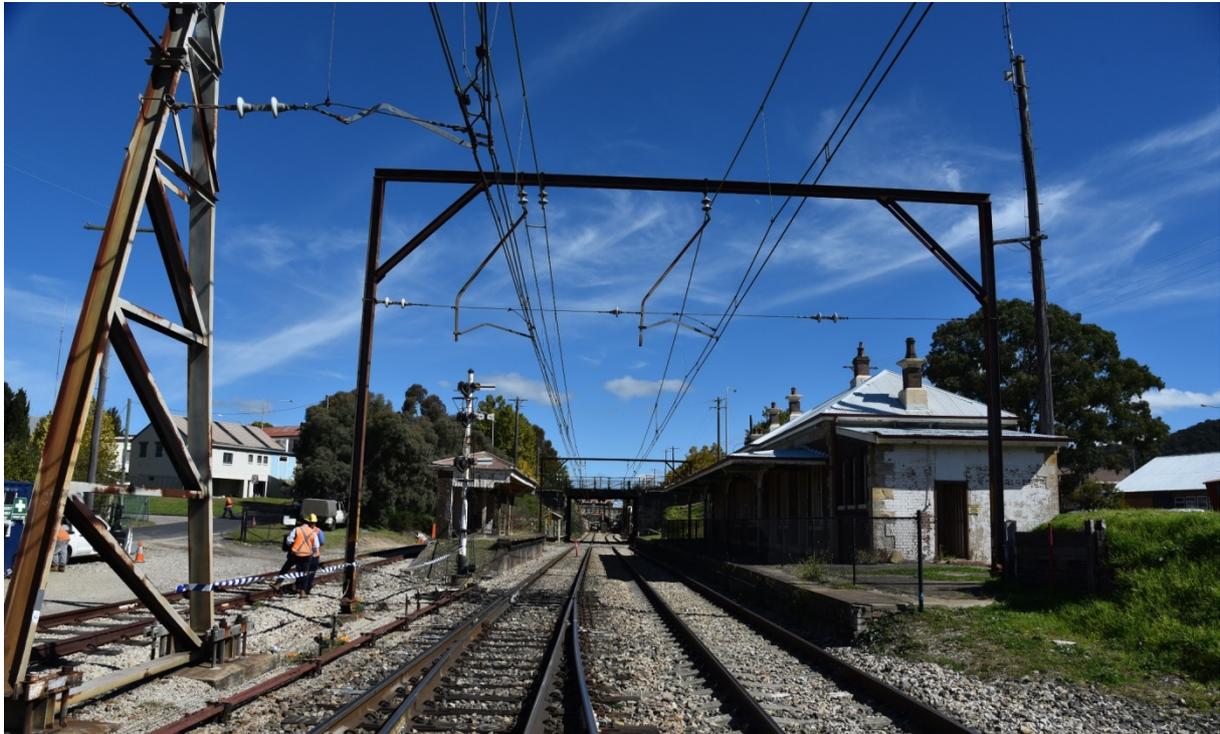
Figure 8: Western main lines near station platforms, showing portal overhead wiring structure and signalling lights. West aspect

Overhead wiring stanchions in the rail corridor are largely older models, with cantilevered arched stanchions dating from the original electrification of the railway line in the 1950s as well as later portal overhead wiring structures (Figure 8). Stanchion supports are located lineside on both the northern and southern main tracks and are in a variable condition of physical intactness.

Line side equipment along the Main Western Line include signalling lights, structures and conduits as well as point controls, switch levers, point rods and locking mechanisms. The majority of this infrastructure is late twentieth-century to modern equipment, with some earlier mid-twentieth century switch rods and point rodding remaining in the corridor.

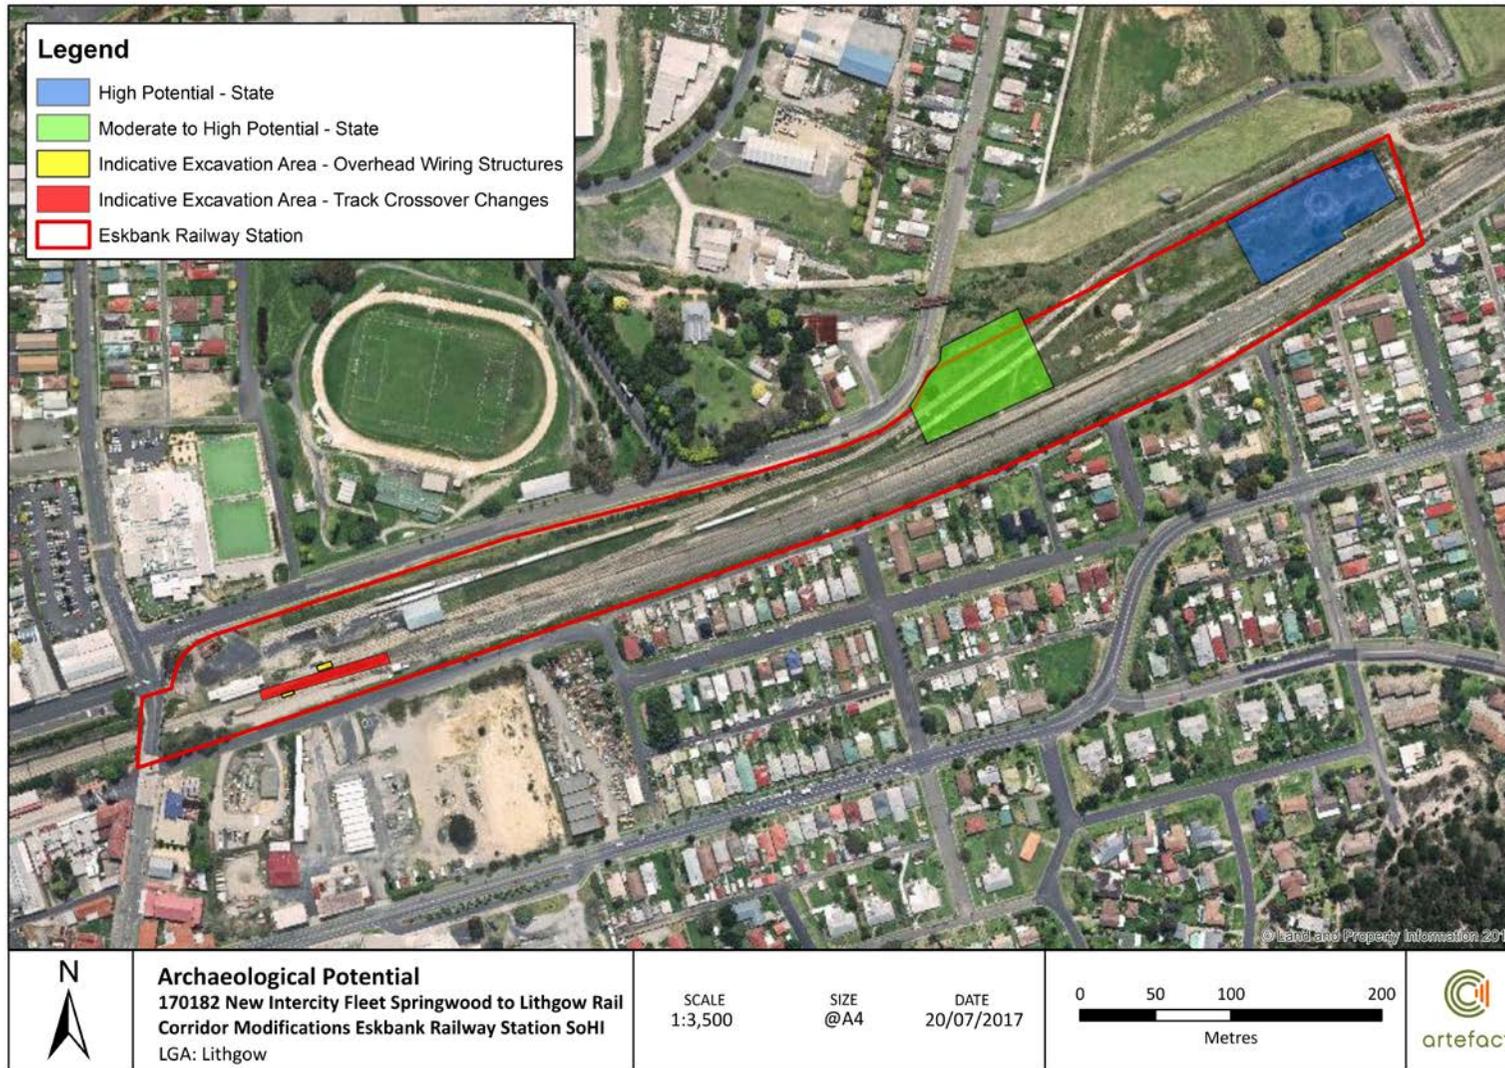
Figure 14: Areas of archaeological potential at Eskbank Station

Archaeological remains relating to the former Eskbank Locomotive Depot and former rail workers' accommodation and amenities buildings would be State heritage significant.
