Rooty Hill Station Precinct – Accessibility and Commuter Carpark Upgrade

Statement of Heritage Impact

Prepared for Transport for NSW

November 2017

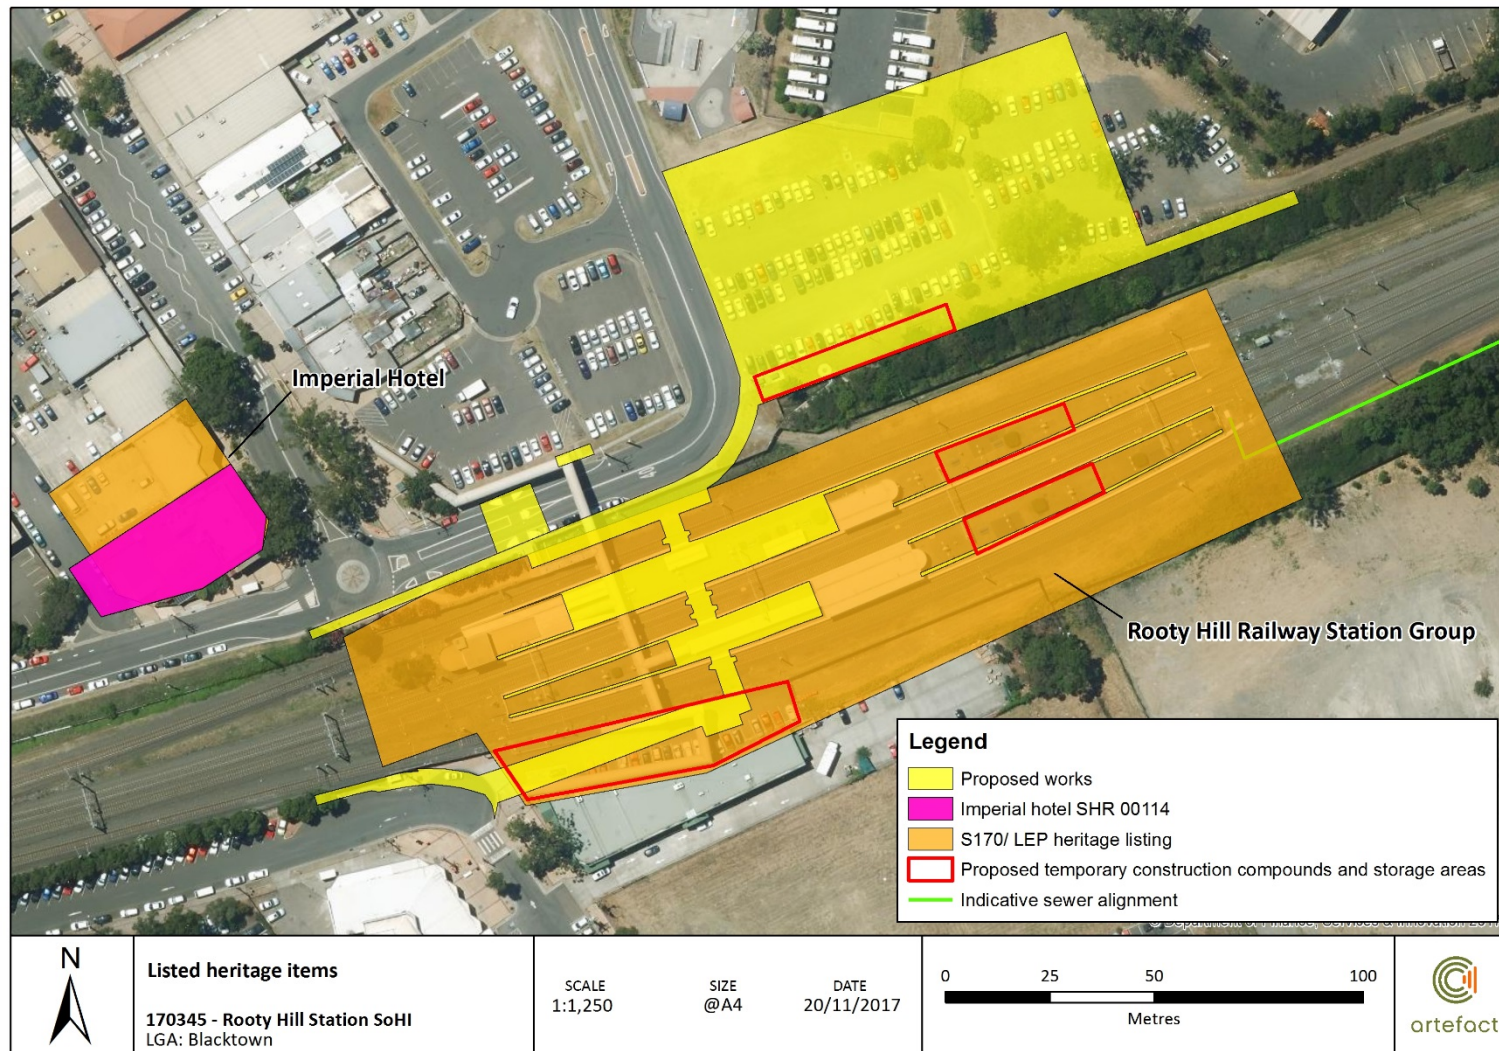
Figure 3: Location of heritage listing curtilages within study area

There is **one** heritage item located within the study area (50 metre visual buffer zone). This item is not located inside the project area. This item is shown in Table 4. The curtilages of this item are illustrated in Figure 3.

Rooty Hill Station is listed on several heritage registers, summarised in Table 3 below. The curtilages of these items are illustrated in Figure 3.

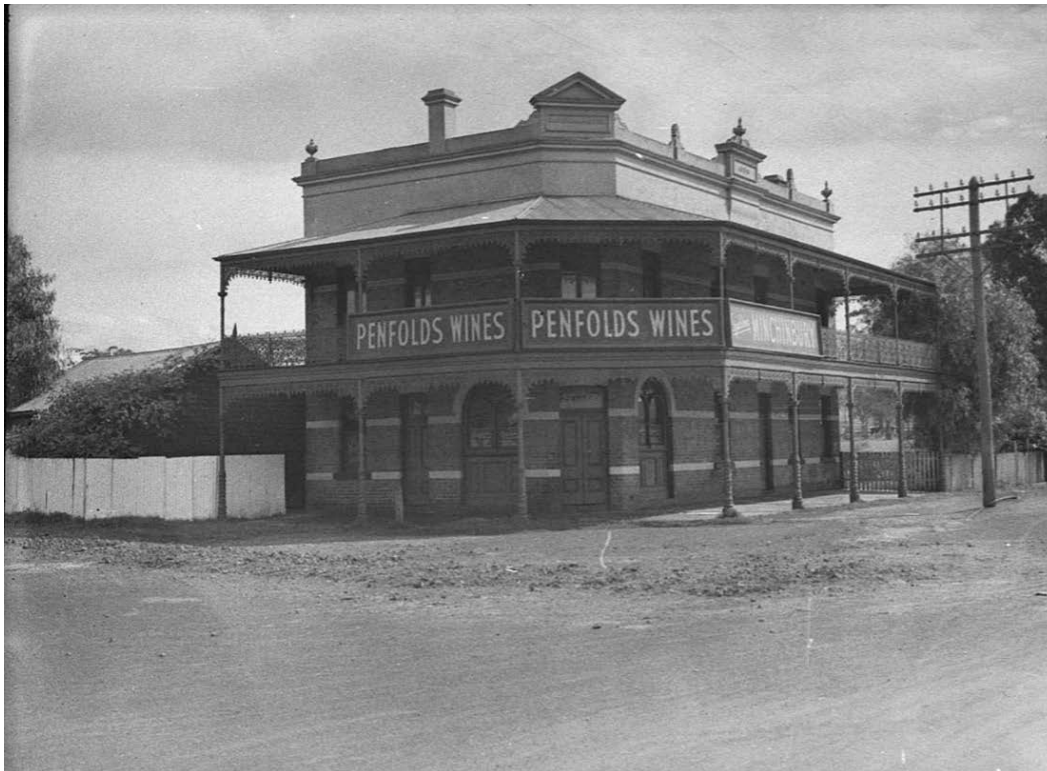
Figure 4: The Imperial Hotel on what is now Rooty Hill Road (North), 1939.
(Source: State Library NSW)

Arrival and expansion of the railway prompted consolidated development of the township of Rooty Hill at the turn of the 20th century, which centred around the station. In 1890, the Imperial Hotel was built to the north of Rooty Hill Station by a F.J. Weston. Located in close proximity to the railway, the hotel was intended to cater for the crowds associated with greyhound racing events at Plumpton. In 1891, the Pioneer Memorial Church located on Rooty Hill Road South was established. During the early decades of the 20th century, Rooty Hill was characterised by increasing subdivisions and residential development.

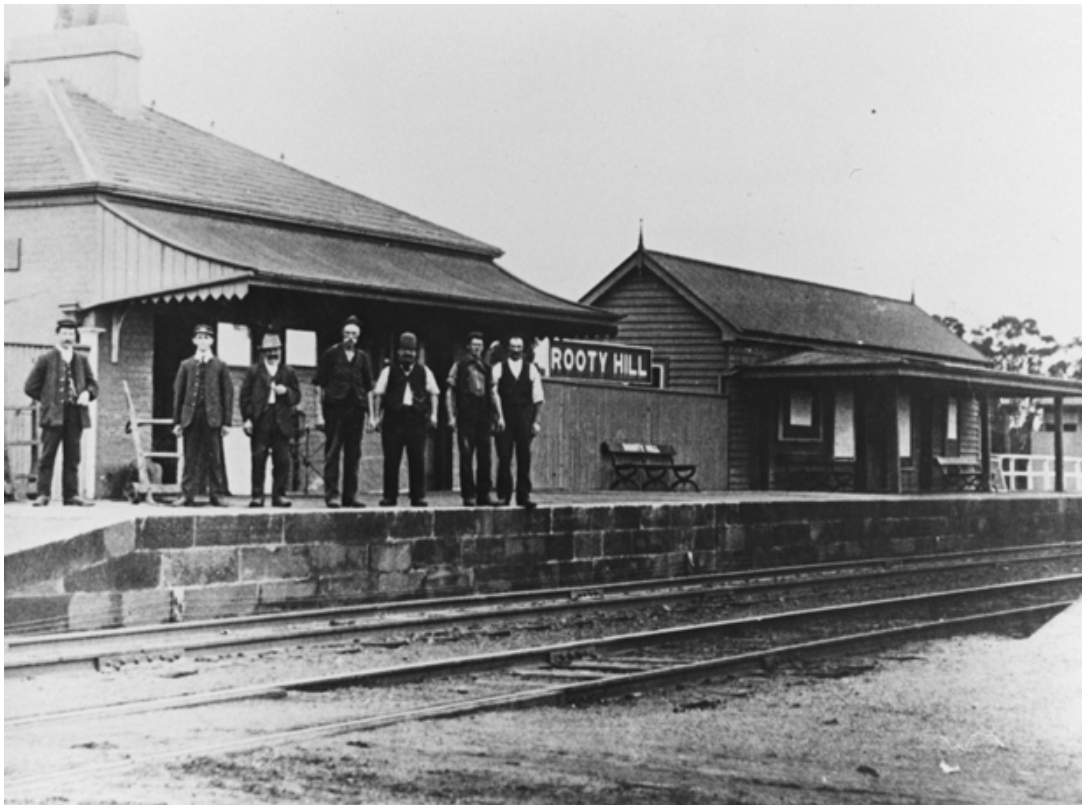
Figure 5: Historical photograph of Rooty Hill Station shortly after the station's completion, circa early 1860s. Station Master's Office seen to left and station building seen to right. (Source: State Archives & Records)

The first Rooty Hill Station was established during the early 1860s, with a station platform completed in 1862 and the first station opened in 1863. An historical photograph dating from around this time shows the original station platform as having featured a small single storey booking of masonry construction with a hipped roof and awning over platform, and a small single storey station building with weatherboard cladding and a simple gable roof that featured timber finials and a hipped awning over platform. The photograph (refer to Figure 5). indicates the original platform coping was of stone construction.

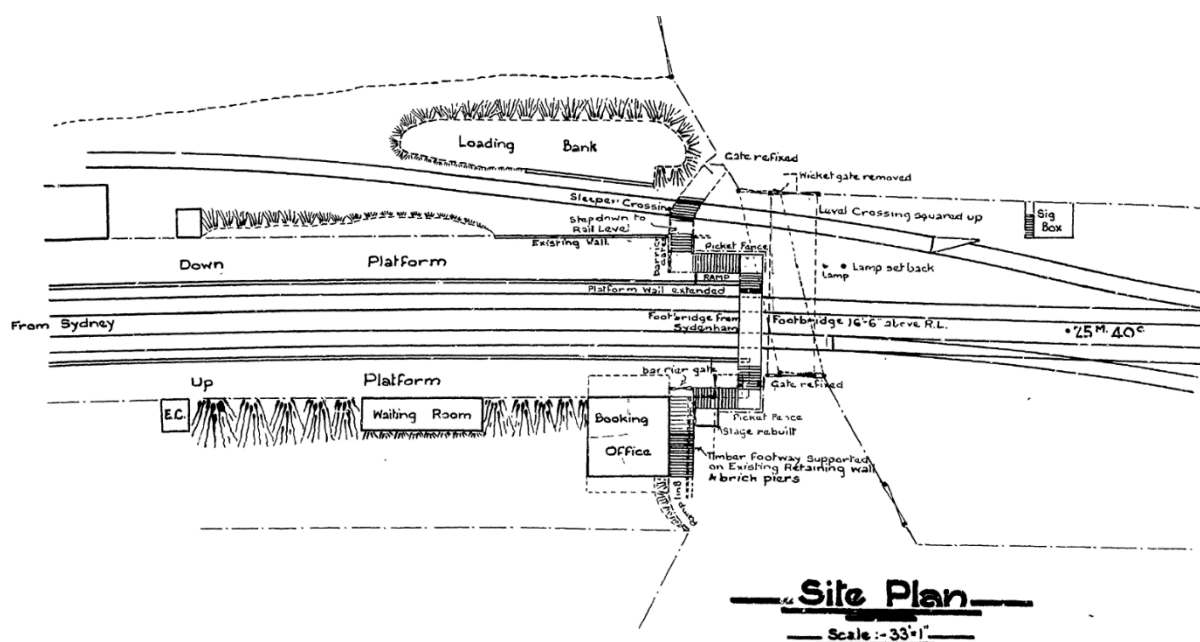
**Figure 6: Detail of first Rooty Hill Station in 1919 showing configuration of first footbridge established in 1919. Plan orientated south.
(Source: State Rail Archives)**

A plan prepared for the installation of a new pedestrian footbridge at Rooty Hill Station in 1919 demonstrates that by this time the Main Western Line had been duplicated and a second platform established at the station, with the partial outline of a platform building visible (refer to Figure 6). The drawing shows the proposed location of the footbridge over the railway lines to join the two platforms. The first footbridge is noted as having been the old Sydenham footbridge. The riveted steel structure, which comprised four flights of stairs, was located adjacent to the booking office.

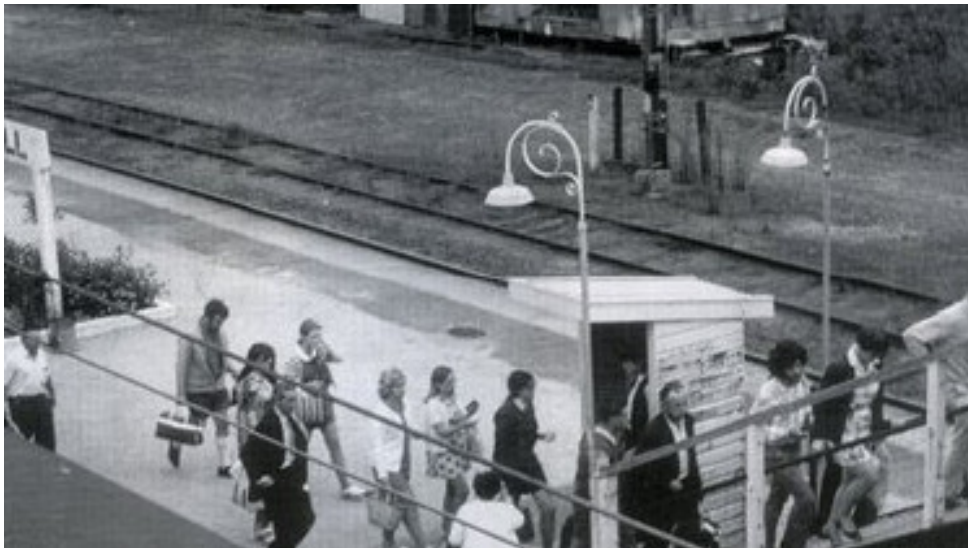
Figure 7: Rooty Hill Station c1970s showing footbridge stairs prior to later alterations.
(Source: National Library of Australia)

In 1995, the signal box was closed, although signal equipment remains in situ. In 2000, refurbishments were undertaken to strengthen the steel footbridge, which involved installation of steel parallel flange channel cross members beneath the footbridge deck. In circa 2001, awnings were placed on all platforms, and two platform canopies were constructed on Platform 1/2.¹³ The platform buildings have undergone substantial internal alterations in recent years, which have removed most of the original interior furnishings and finishings of these buildings, although their overall configuration and layout has been retained.

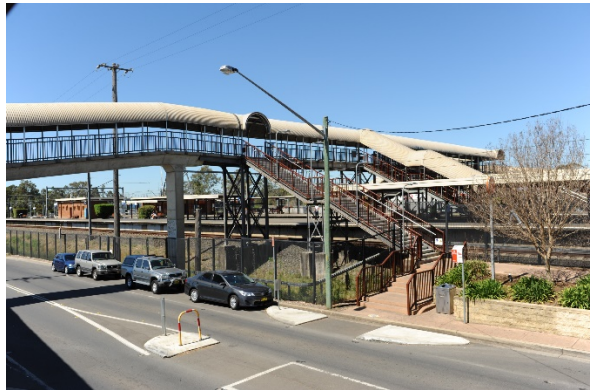
Figure 9: View south east from the northern pedestrian ramp showing the footbridge and concrete ramps.

The current footbridge over Rooty Hill Station consists of steel framing that supports concrete deck panels, treads and landings, and is supported on raised plinths. The steel footbridge has been refurbished over time, with a small extension having been carried out to the north and a number of minor repairs.

While the main structural elements of the steel footbridges appear to be original, the girders have been strengthened via the installation of additional steel parallel flange channels (PFC) cross members beneath the concrete deck of the footbridge. The steelwork appears to be in good condition, with relatively small localised areas of corrosion, paint discolouration and rusting.

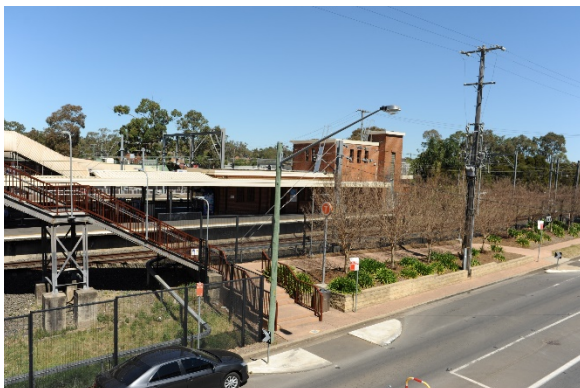
Figure 10: View south west from the northern ramp showing the former signal box building and footbridge stair to North Parade.

The former signal box building, which incorporates the parcels and booking offices, is located at the western end of Platform 1/2. Designed in the Inter-War Railway Functionalist style, the building is of face brick construction and features shallow pitched metal roofs of varying heights, the ground floor roof extending to a narrow awning on all four sides of the building and abutting the second section of the building. This comprises a two-storey square structure, elongated tower and single storey elongated semi-circular bay. The curved bay is defined by a series of curved glass windows in steel frames. The first floor of the building is accessed via a spiral stairway that features panels of glass bricks. A gated curved walkway provides access between the platforms, and was formerly the entry point to the station from the north. The curved brick walls of the walkway feature several artistic murals.

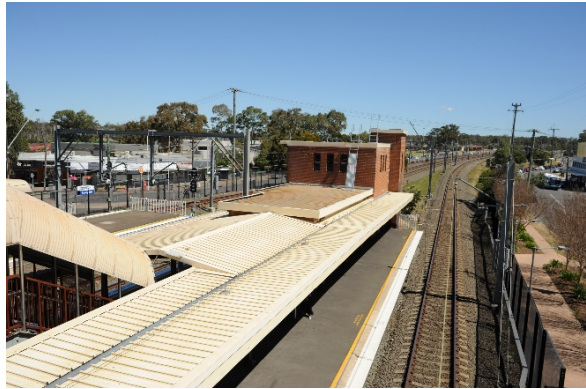
Figure 13: View west from footbridge over modern canopy extending from footbridge to the former signal box building on Platform 1/2.

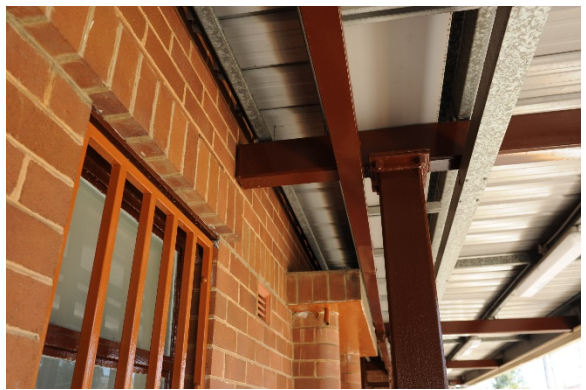
Figure 15: Detail shot showing 'floating' joint between the steel structure of the modern canopy and the former signal box building on Platform 1/2.

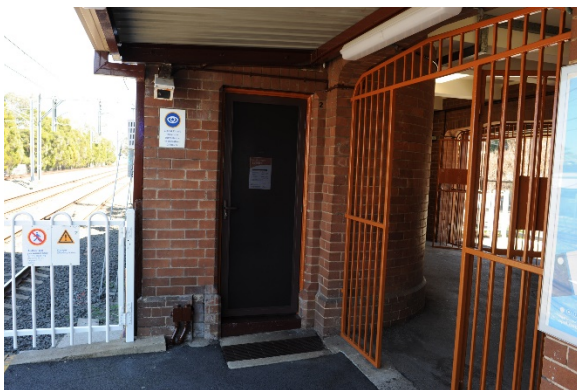
Figure 16: View west on Platform 2 to former signal box building, showing gate to walkway and steel grate boot scraper at entry step.

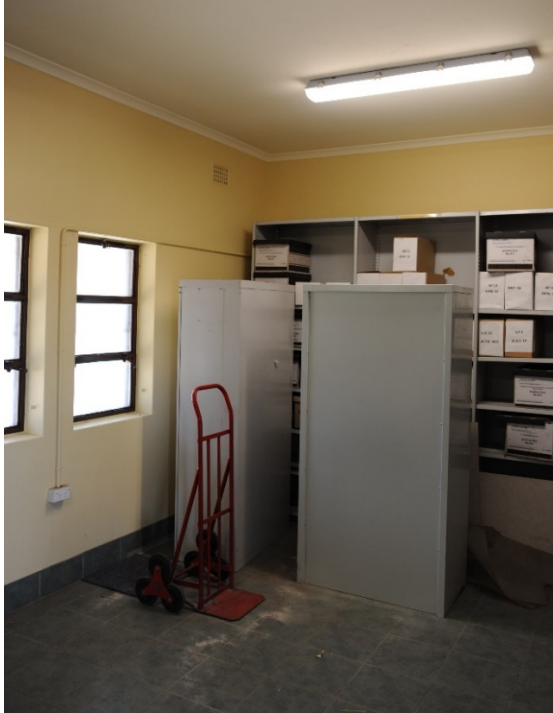
Figure 19: Interior shot of storage space within former signal box building, showing modern tile floor covering and two windows.

Several of the interior spaces of the former signal box building were accessed during the inspection, which indicated a range of intactness within the building's rooms. While some rooms retained original finishings and fittings, others have been adapted for new use. The former signal relay room, although now decommissioned, retains its original fitout including conduiting and equipment. All ground floor openings have been fitted with security grills.

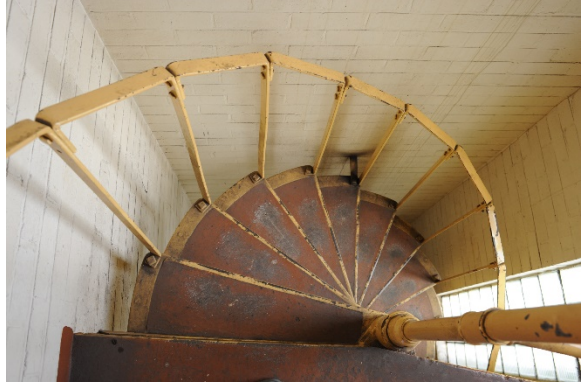
Figure 18: Spiral staircase within former signal box building, leading to second level signal area.

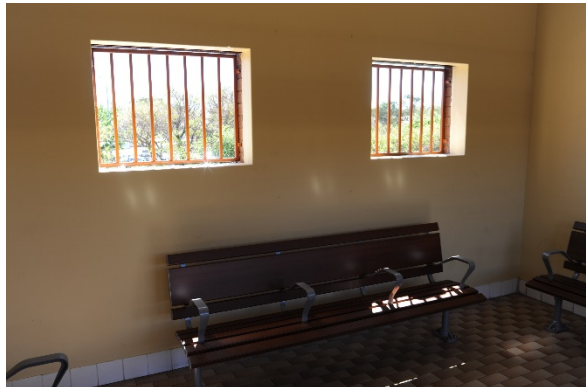
Figure 27: Interior shot of waiting room within passenger building on Platform 1/2 showing grated window openings, timber bench seating and tiled flooring.

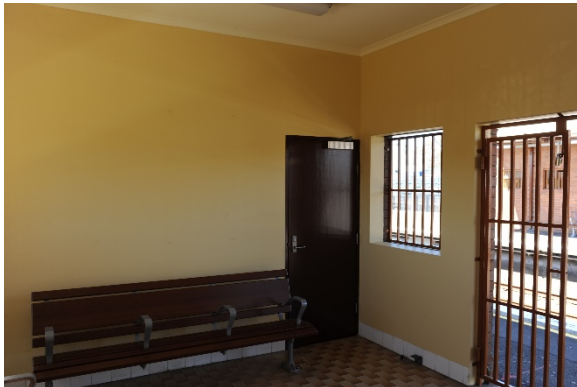
Figure 28: Interior shot of waiting room within passenger building on Platform 1/2 showing grated window and door openings, timber bench seating and tiled flooring.

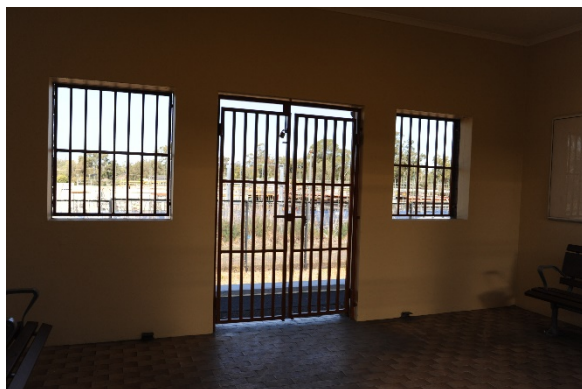
Figure 35: Interior shot of waiting room within passenger building on Platform 3/4 showing grated window and door openings, timber bench seating and tiled flooring.

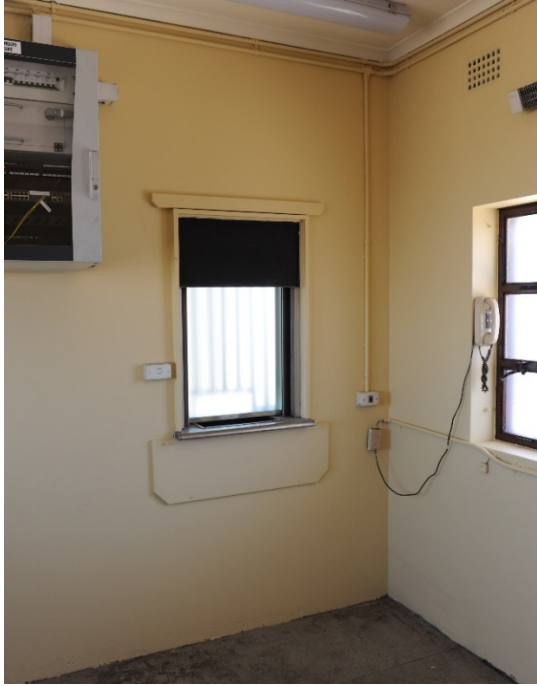
Figure 37: Interior shot within passenger building on Platform 3/4 showing window openings and original flooring.

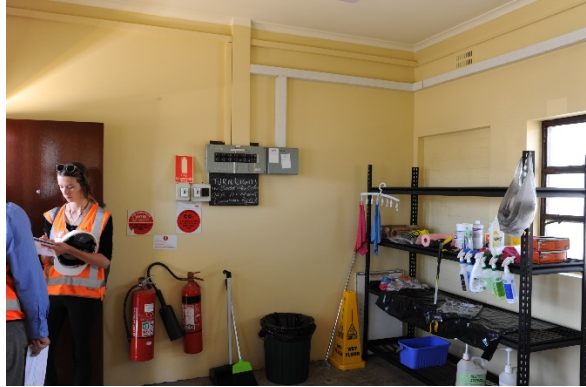
Figure 36: Interior shot within passenger building on Platform 3/4 showing window openings and original flooring.

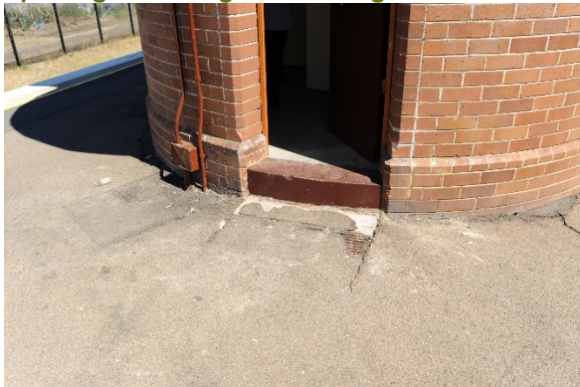
Figure 38: Detail shot of metal grate boot scraper located at entry step to the passenger building on Platform 3/4, note asphalt covering.

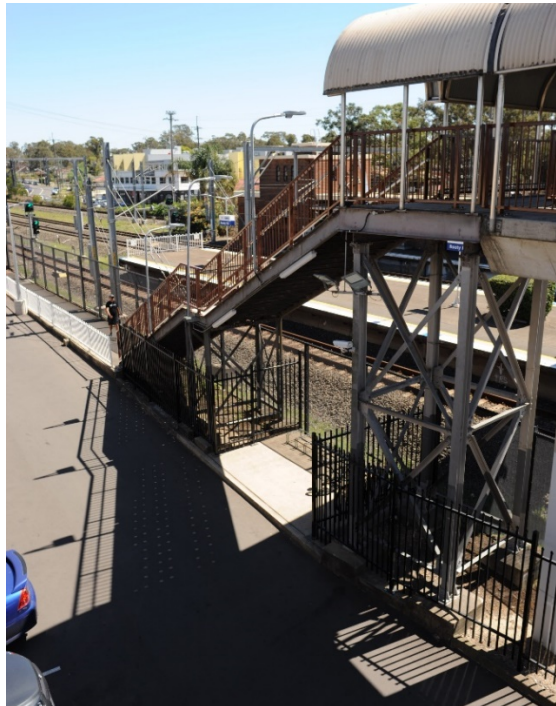
Figure 39: View north west from footbridge ramp over Beames Avenue showing steel construction of 1940s footbridge and commuter carpark to left of image.

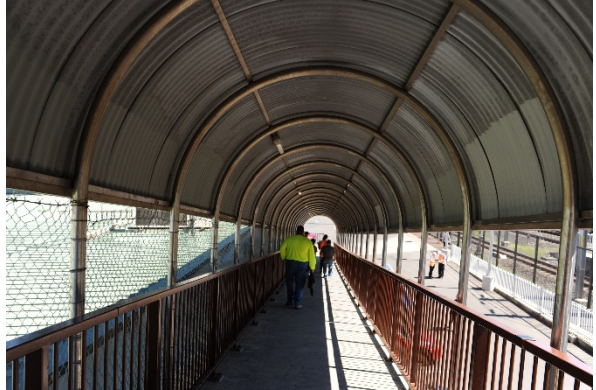
Figure 41: View west down footbridge ramp showing modern curved roof canopy, Beames Avenue commuter carpark seen to right.

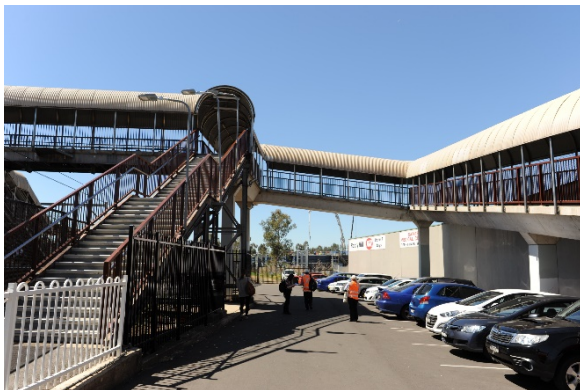
Figure 42: View east across Beames Avenue commuter carpark showing modern concrete ramp to right and footbridge stairs to left.

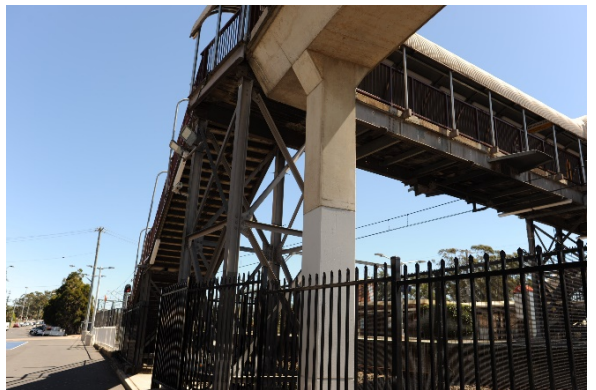
Figure 43: Detail shot to junction of 1940s steel footbridge with modern concrete ramp.

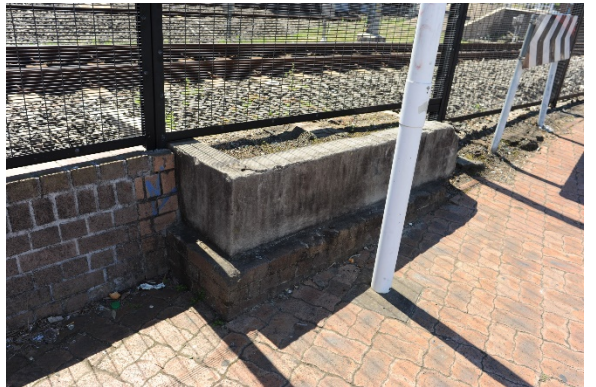
Figure 45: Detail shot of concrete pit associated with the former level crossing boom gate that connected Rooty Hill Road (North) with Rooty Hill Road (South).

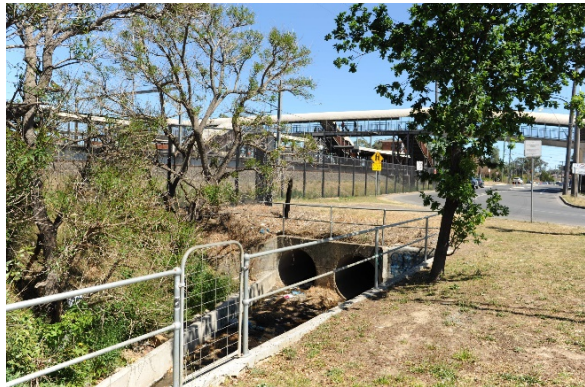
Figure 49: Shot of open water drain to the north of Rooty Hill Station that runs parallel to the railway line.

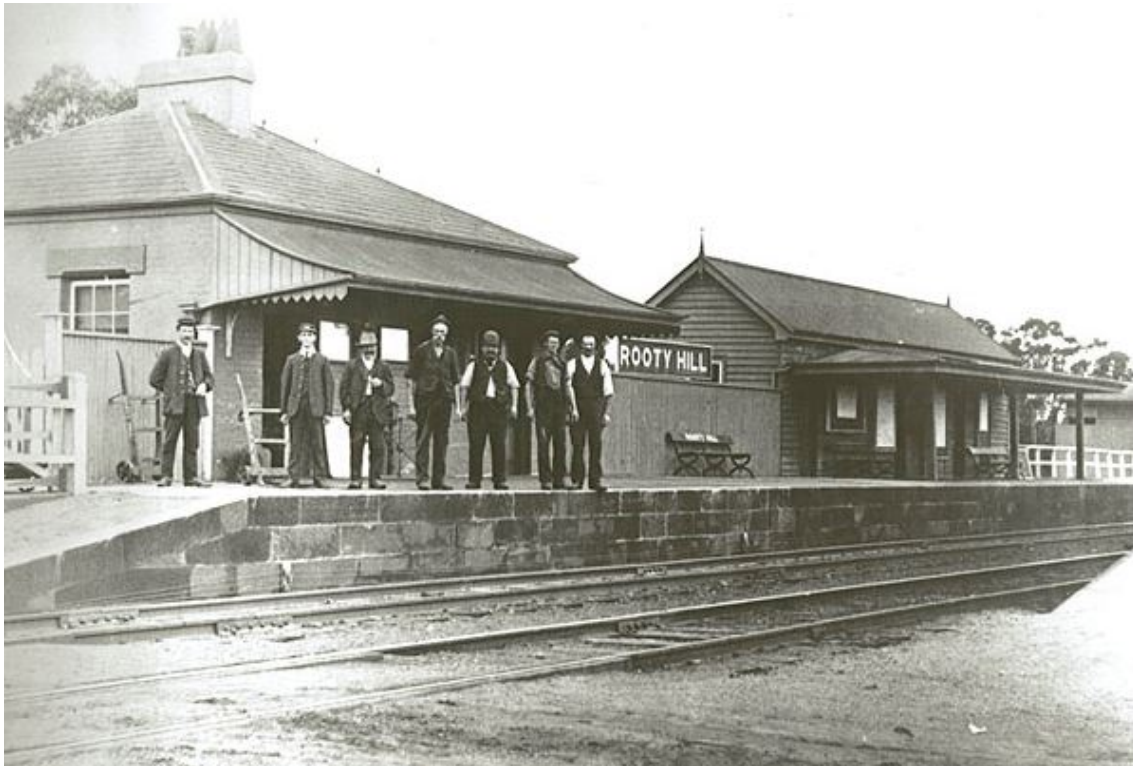
Figure 52: First Rooty Hill Station in 1862 looking north east to Station Master's Office (left) and Station building (right). (NSW State Records & Archives)

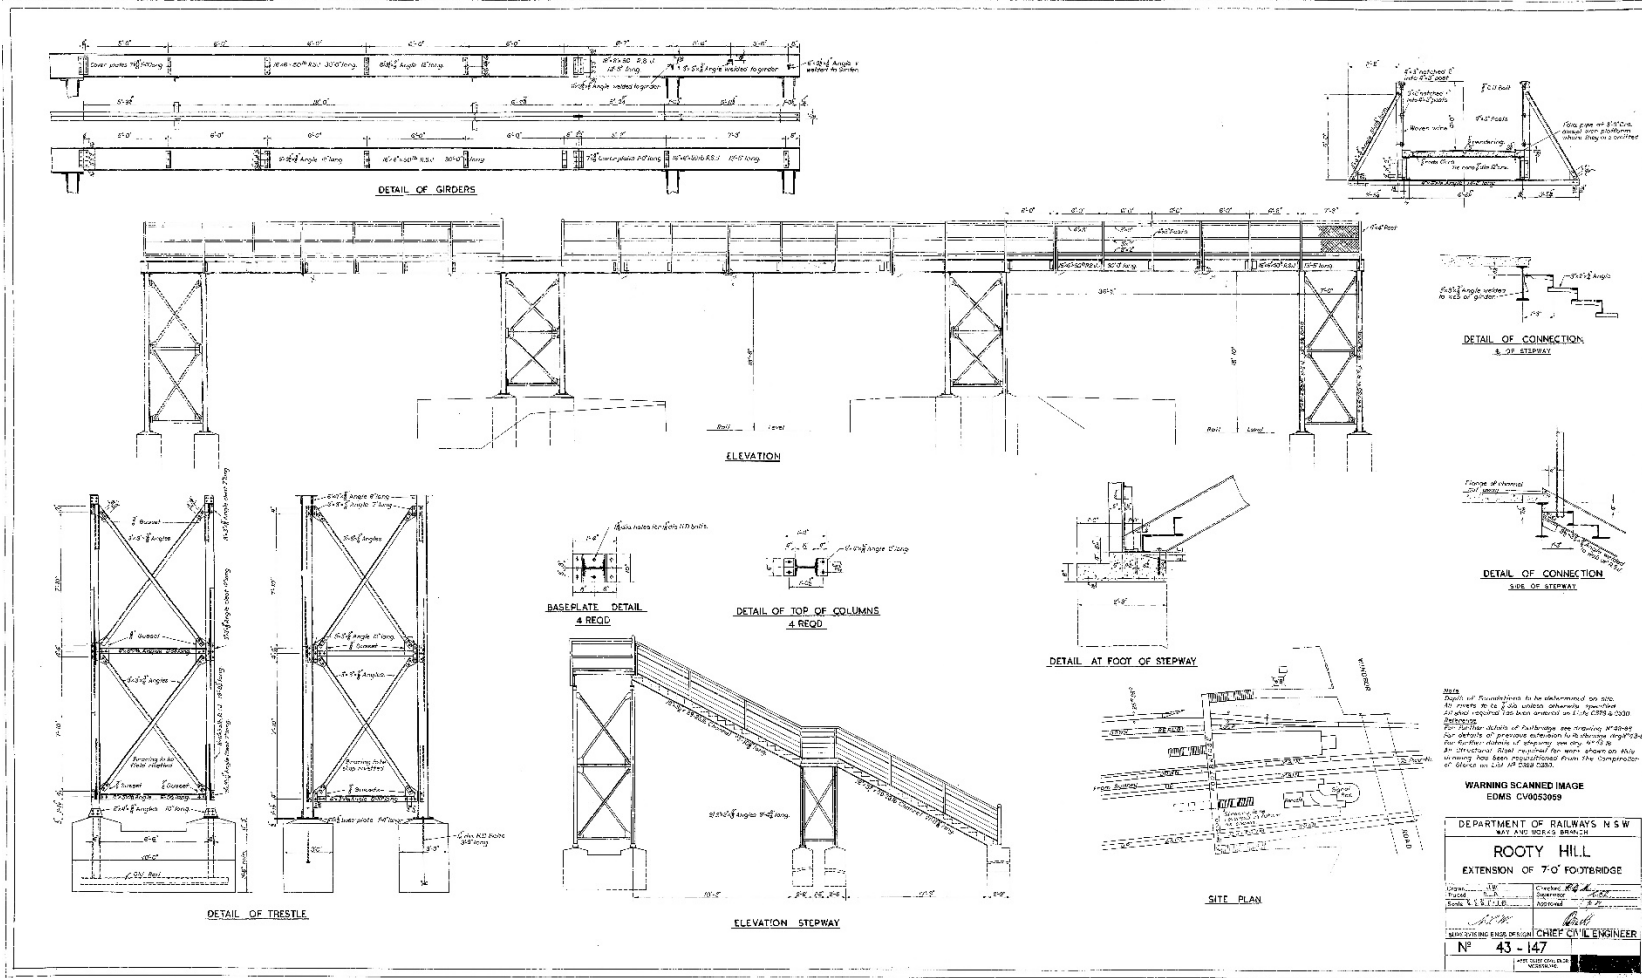
Figure 61: Rooty Hill Station in 1951 showing proposed extension of footbridge to North Parade. (Source: State Rail Archives)

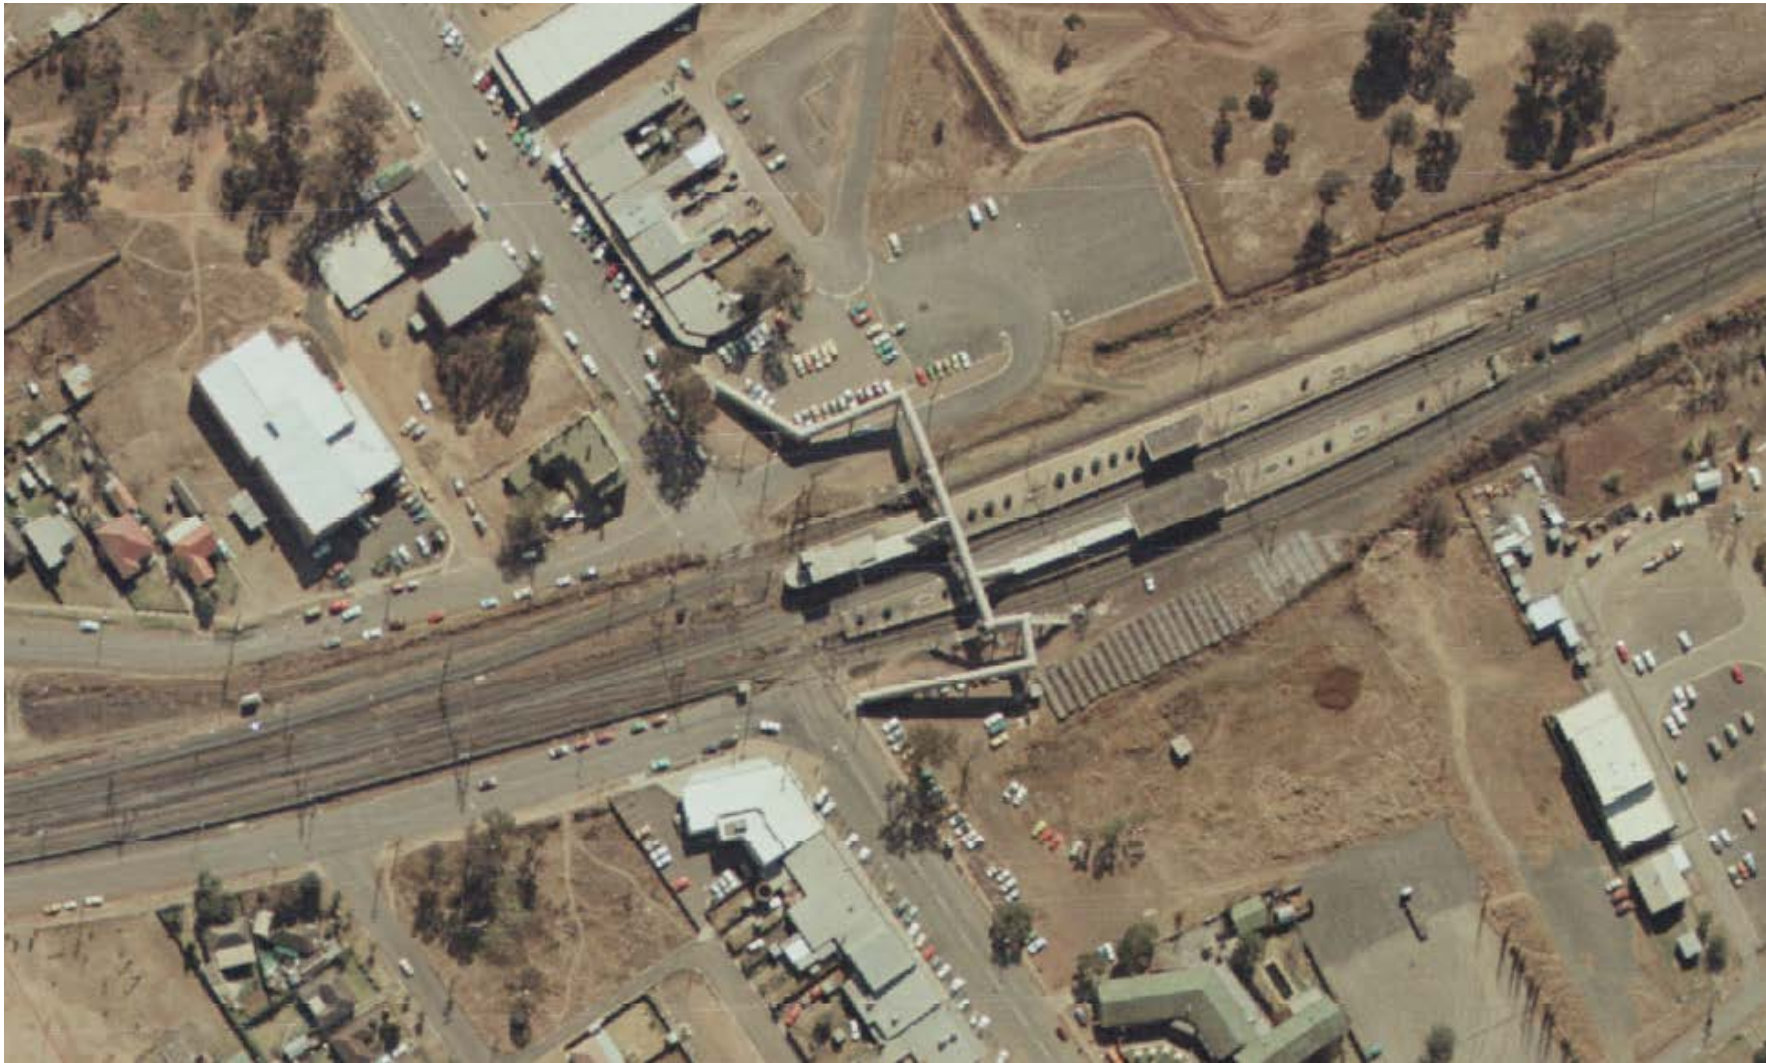
Figure 65: Aerial photograph of Rooty Hill Station in 1982 (Source: Lotsearch Pty Ltd)

Plans of the station and historical aerial photography indicate that by the 1960s, the north-most overbridge associated with the drainage channel alongside what is now Rooty Hill Road (North) had been replaced by culverts, and the drainage channel removed. The south-most overbridge associated with the former drainage channel appears to have been removed between 1970 and 1982.

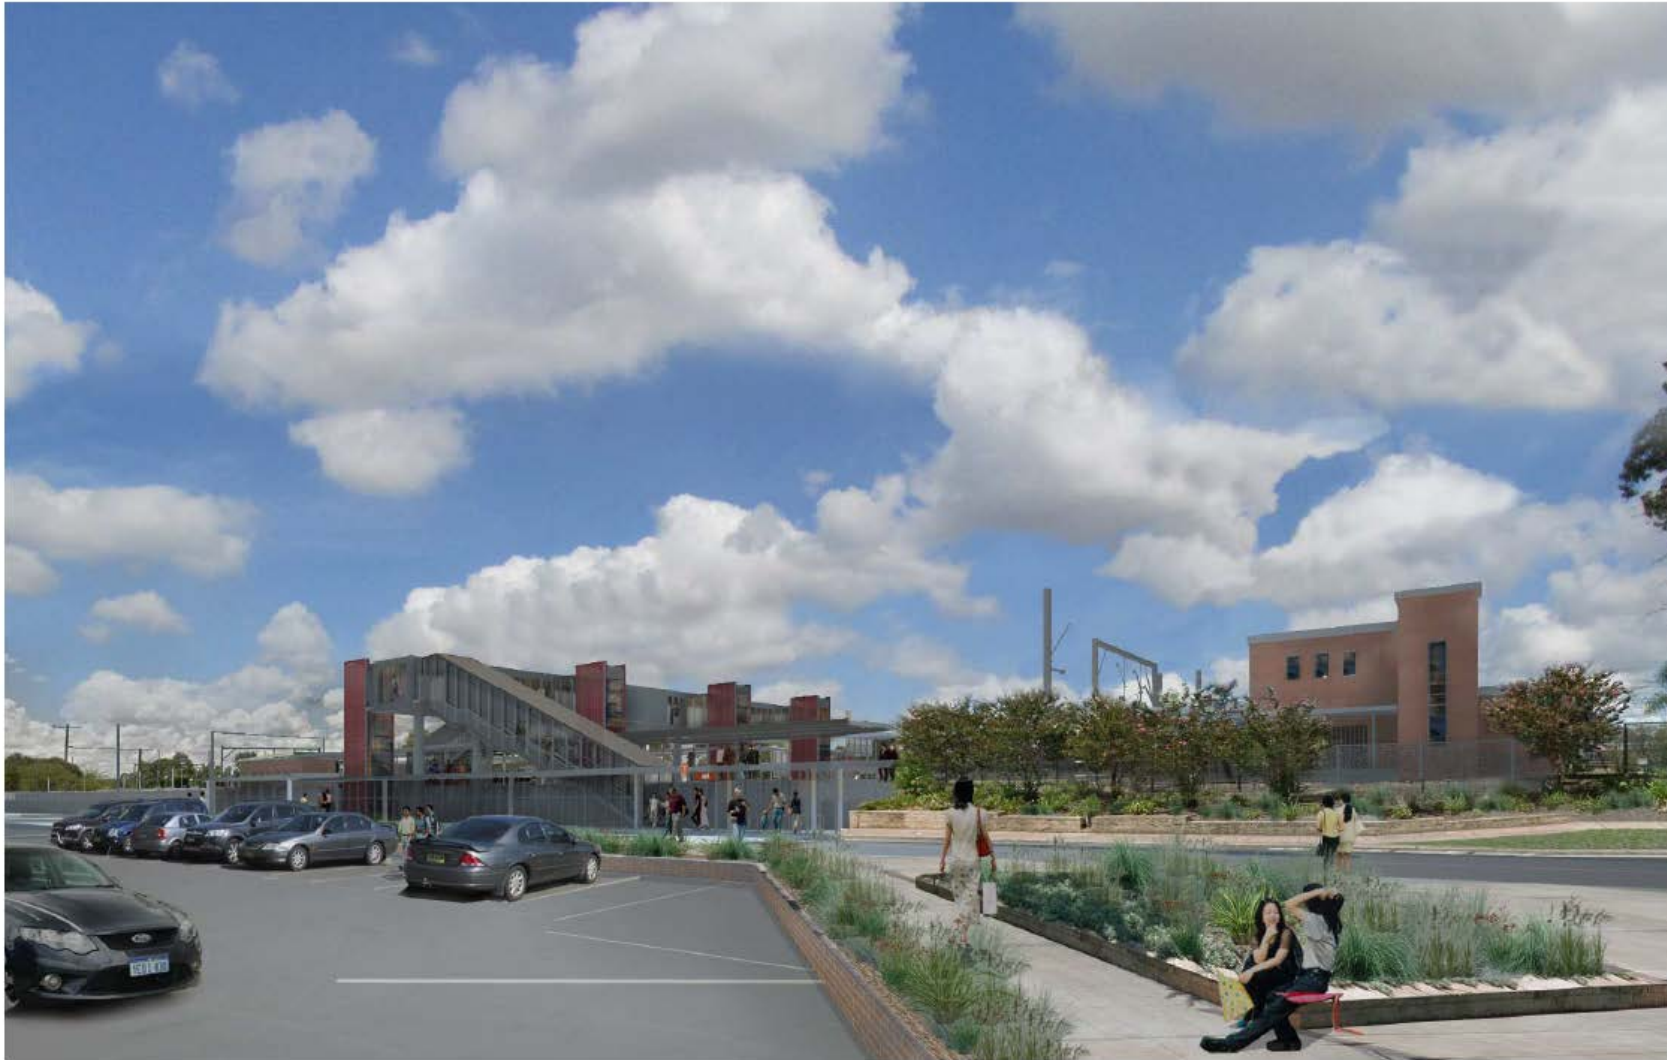
Figure 81: Render view of the proposed Rooty Hill Station Accessibility Upgrade, looking south east from corner of North Parade/Rooty Hill Road North.

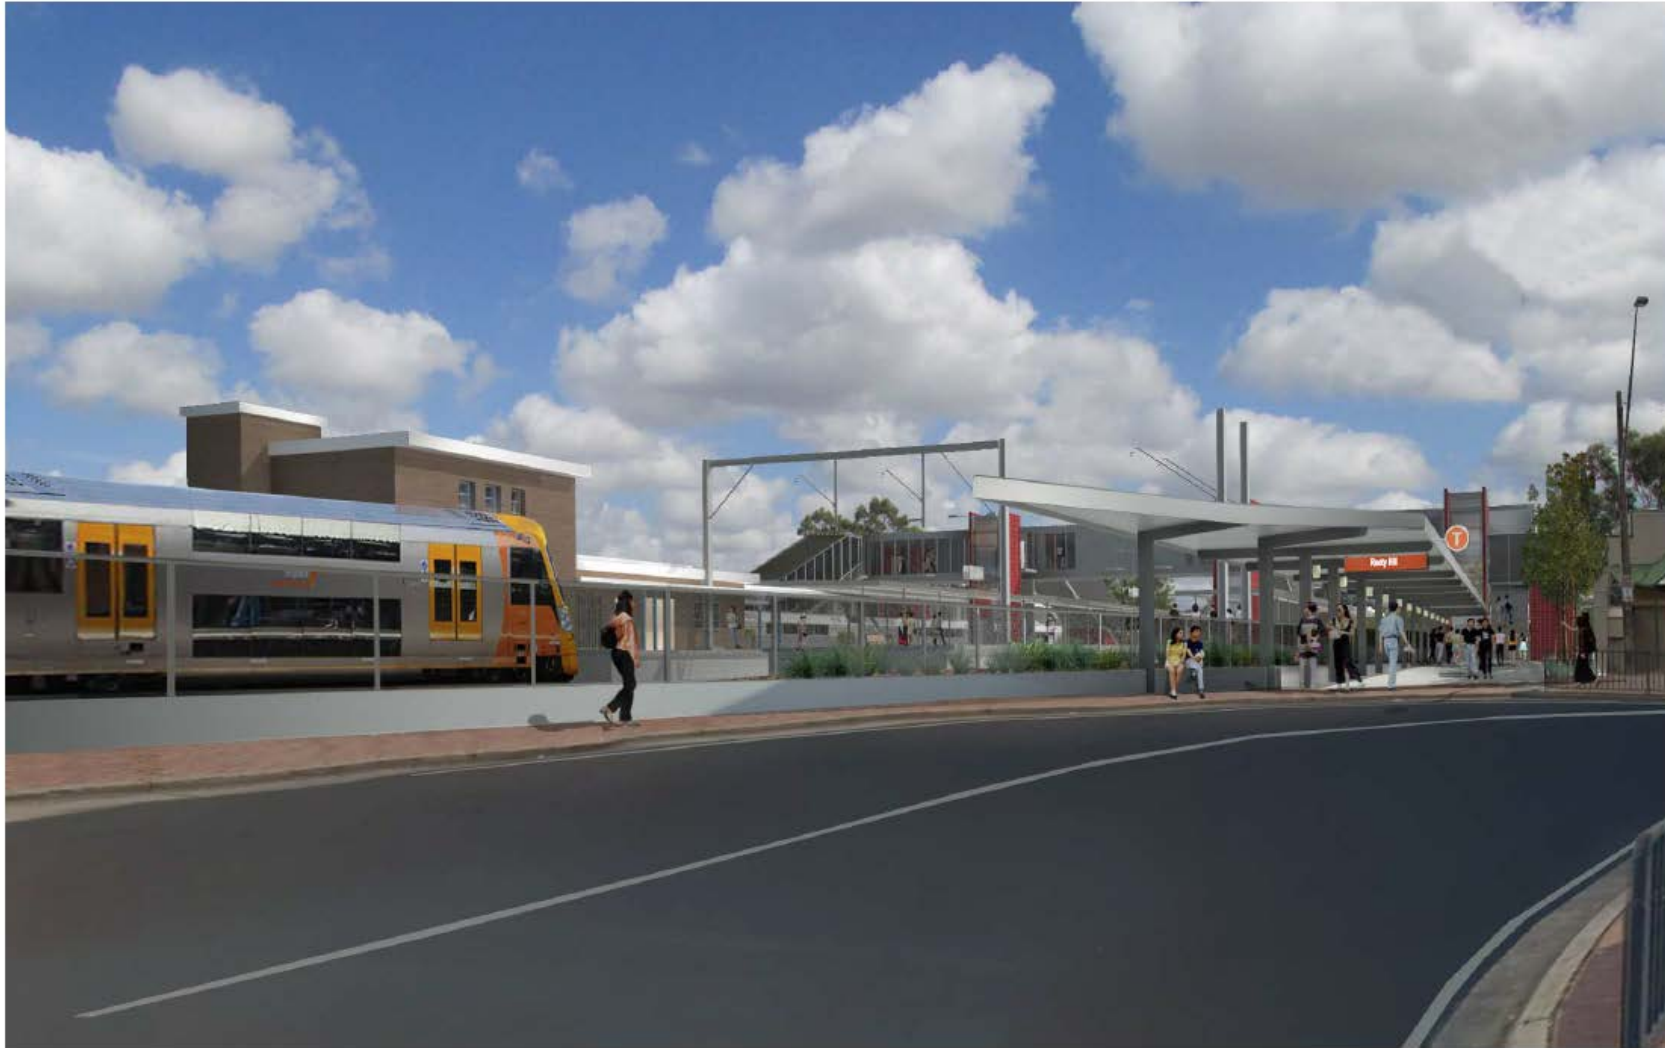
Figure 82: Render view of the proposed Rooty Hill Station Accessibility Upgrade, looking north east from Beames Avenue.

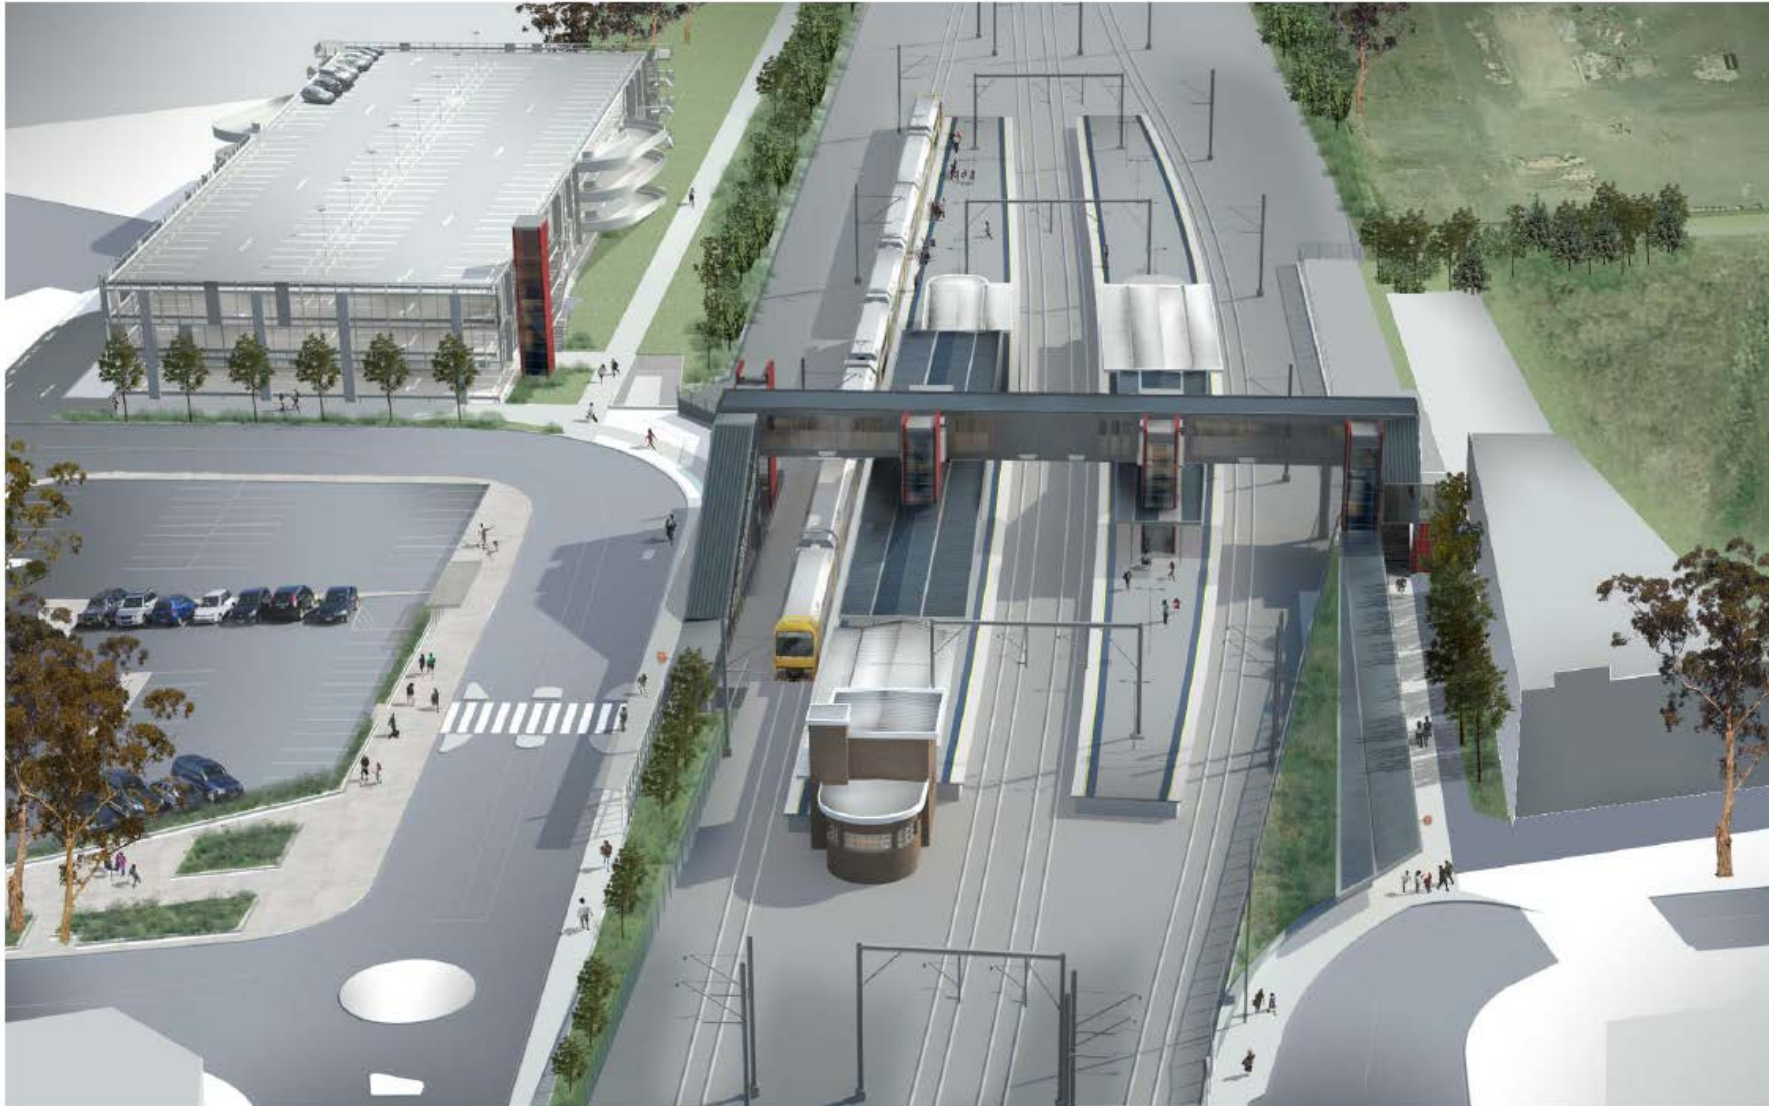
Figure 86: Render aerial view of the Proposal.
