OCTOBER 2018

Transport for NSW Transport Access Program 3

Glenbrook Station Upgrade - Statement of Heritage Impact

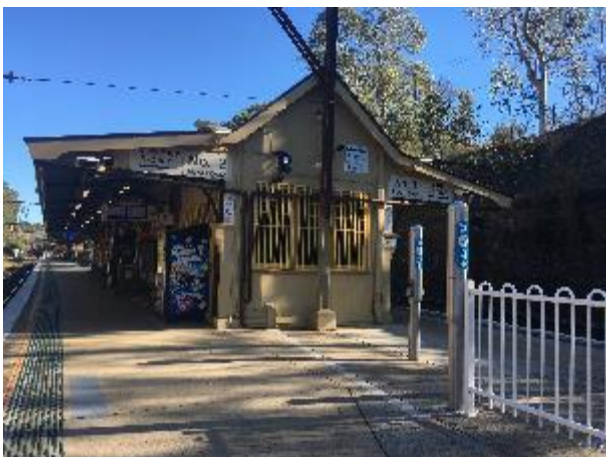
Plate 3.5: Station Building, eastern elevation showing fretted work to ends of awnings and weatherboard signal room (RPS, 2018)

The Sydney end of the Station Building is a weatherboard enclosure accommodating the decommissioned signal box levers and features large three to four panelled windows with security grills to its three elevations (Plate 3.5). The western end of the building is a simply detailed gabled façade with rectangular gable vent and a brick privacy wall to hide the men's toilet entrance (Plate 3.8).

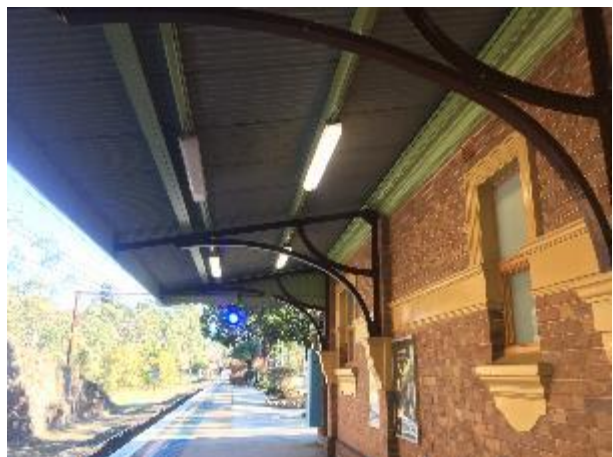
Plate 3.6: View west, platform 2 showing distinctive brick work and iron brackets over corbels (RPS, 2018)

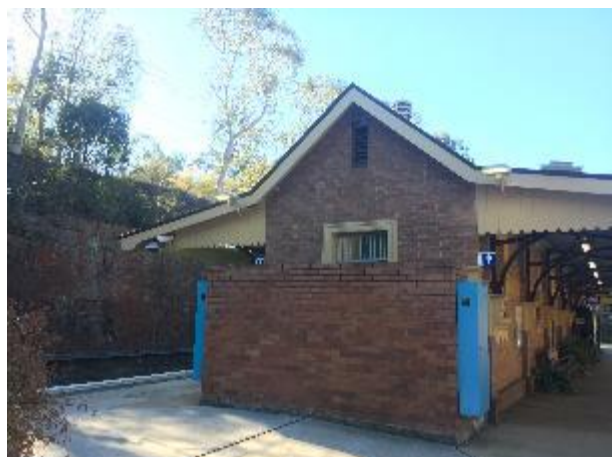
Plate 3.8: Station Building, western elevation showing privacy wall (RPS, 2018)

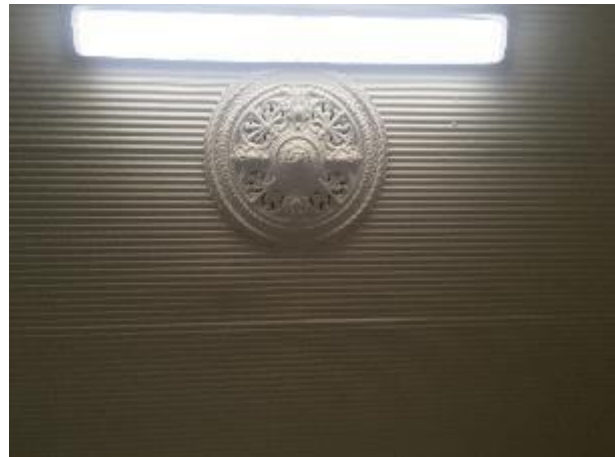
Plate 3.16: Custom orb ceiling with ceiling roses (RPS 2018)

The interiors generally feature custom orb ceilings with ceiling roses, enclosed or adapted fireplaces, later floor tiling or carpet finish, timber flooring to signal room and concrete flooring to the storeroom and timber bead style cornices to ceiling and wall junctions (Plate 3.16 to Plate 3.18).

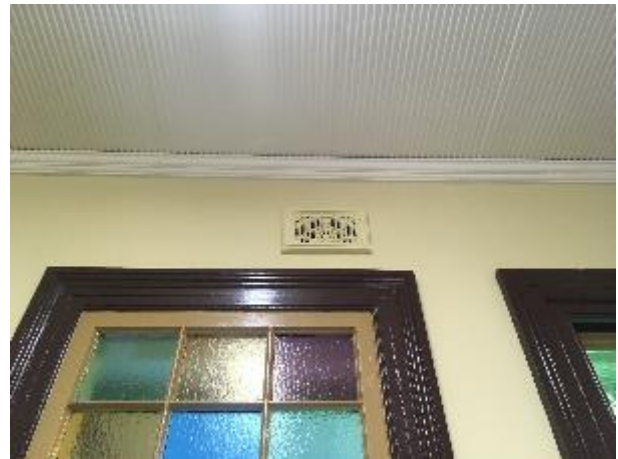
Plate 3.18: Timber bead style cornices to ceiling and wall junction (RPS 2018)

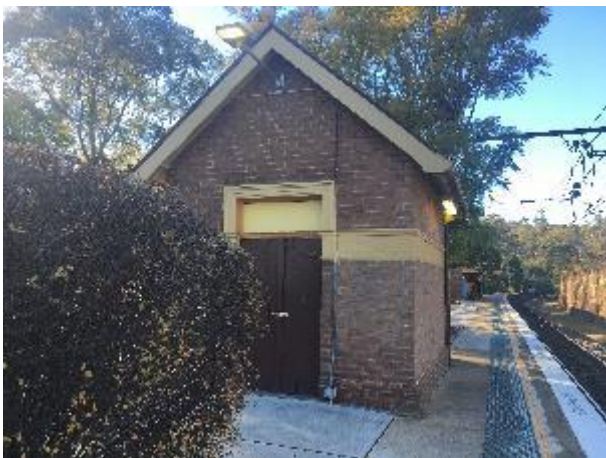
Plate 3.19: Western elevation of Out of Shed (RPS 2018)

The Out of Shed building consists of a small square shaped brick shed featuring moulding and rendered string course detailing similar to the Station Building (Plate 3.19 and Plate 3.20). It is located west of the Station Building towards the end of the platform. The shed features a gabled corrugated metal roof with timber bargeboard and narrow eaves, contrasting rendered moulded trim above a single door on the west side elevation and a string course throughout all elevations. There are no other openings on the building.

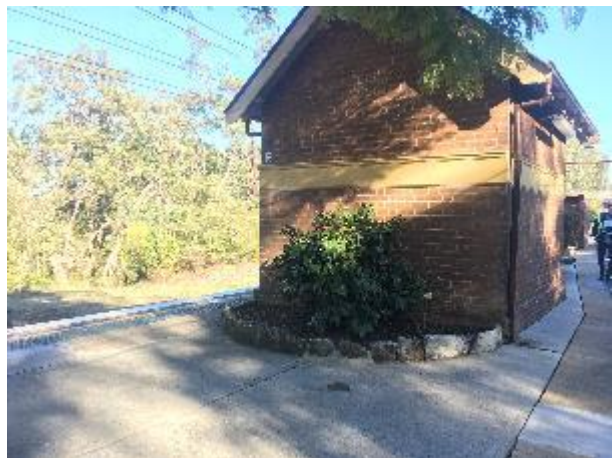
Plate 3.20: Eastern elevation of Out of Shed (RPS 2018)

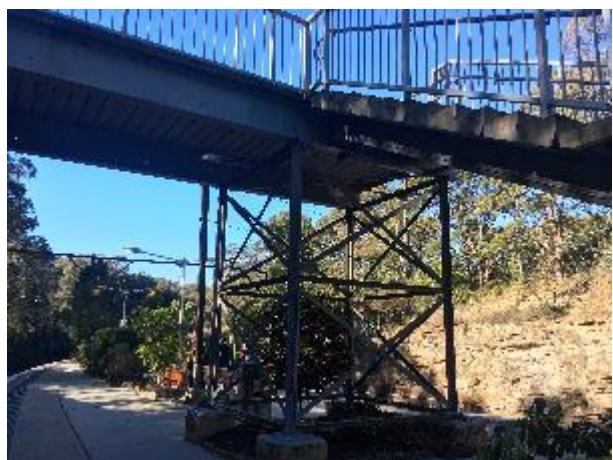
Plate 3.32: View east showing original steel structure of footbridge (RPS 2018)

The footbridge comprises a standard steel beam bridge supported on steel trestle with bracing extending from the street ramp over the Up main tracks with stairs to the island platform (Plate 3.31). With exception of the original steel structure, all components of the bridge have been replaced since the 1990s (Plate 3.32). The SHI sheet for the station group describes the footbridge as having a concrete deck over the top of timber. However, the under deck of the bridge also appears to be concrete with a concrete upper deck (Plate 3.33 and Plate 3.34). The Glenbrook Footbridge is included in the *Railway Footbridges Heritage Conservation Strategy* prepared for Sydney Trains by the NSW Government Architect's Office (GAO) Heritage Group (2016). This Conservation Strategy graded the Glenbrook Footbridge to be of moderate heritage significance and recommended retention of the structure as a first preference in all station works (GAO Heritage Group 2016: 83).

The condition of the footbridge is considered to be good. The original 1913 footbridge was replaced in 1916. Modifications in the 1990s include addition of a concrete deck, stairs and new balustrades.

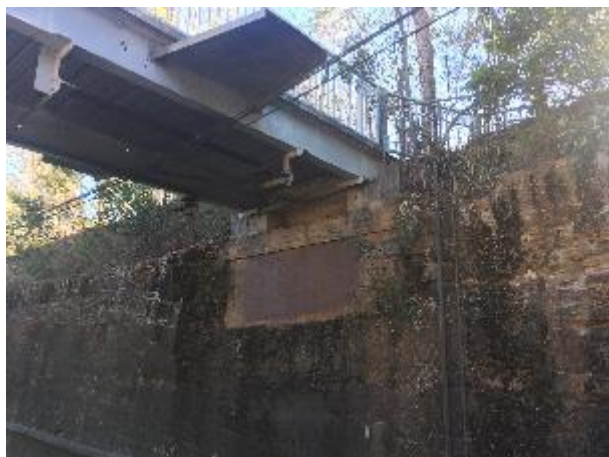
Plate 3.33: View north west showing under deck of footbridge (RPS 2018)

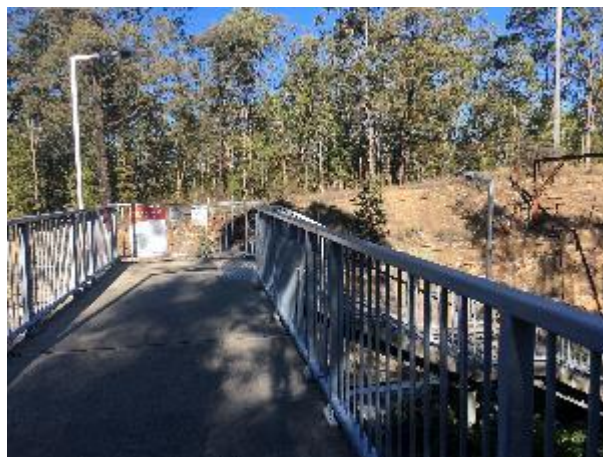
Plate 3.34: View south showing deck leading from Burfitt Parade to stairs (RPS 2018)

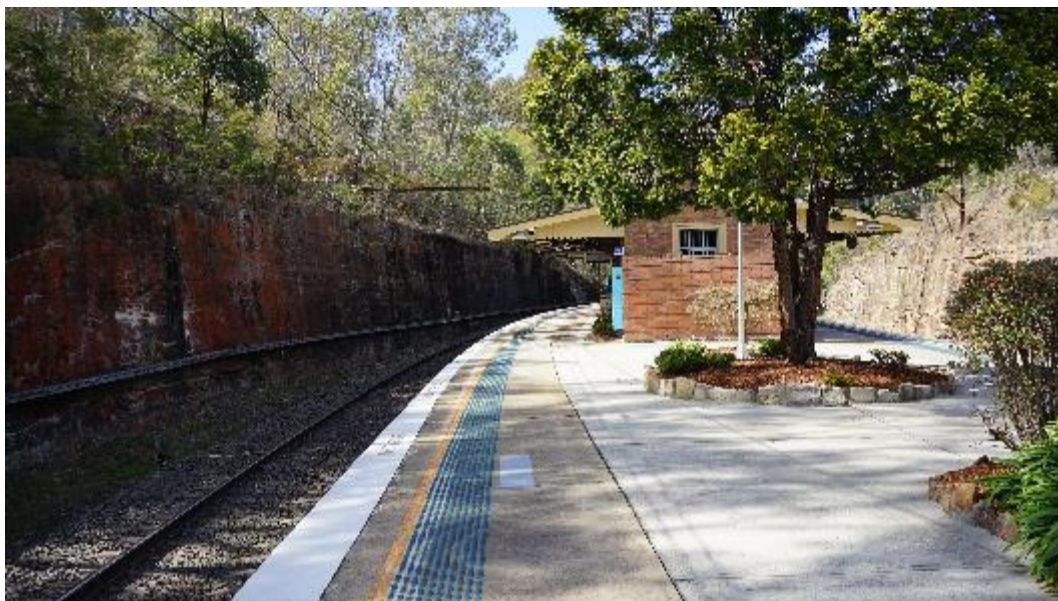
Plate 6.3 View towards the Station Building and proposed lift structure from western end of Station Building (RPS 2018)

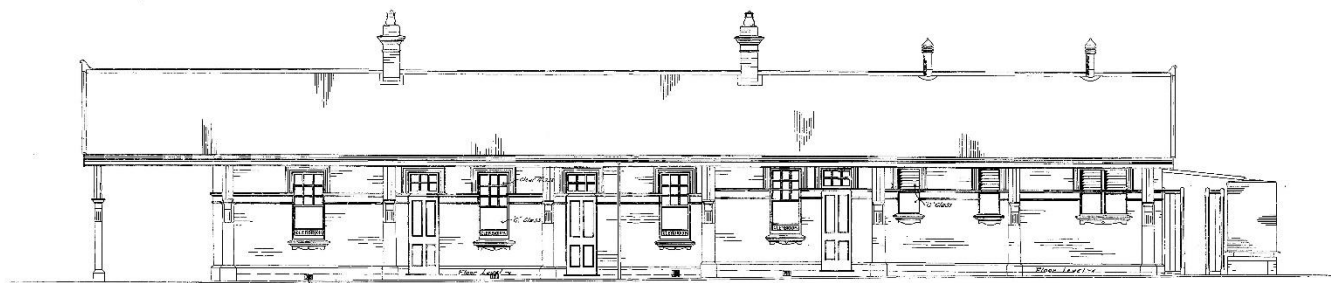
Drawing No. 1

Elevation to Rail

Paint all woodwork, & counter, & coats
Drainage & footings to be indicated on site
