TAP 3 Warrawee Station

Statement of Heritage Impact

Report to WSP on behalf of Transport
for NSW

March 2019

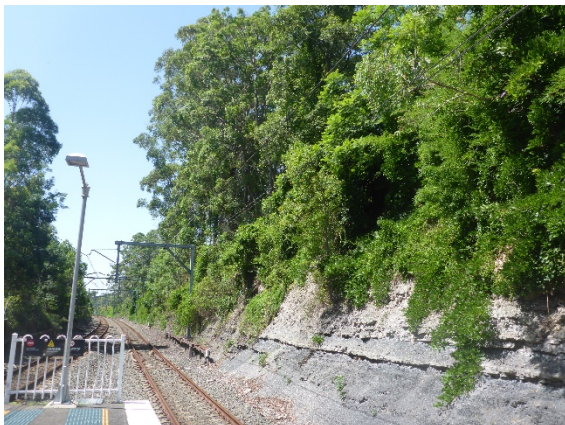
Figure 5-7. View southwest showing the extent of the rail cutting along the southern end of the Warrawee Station platform.

The station itself is located within a deep rail cutting, which varies in depth along the corridor, its highest point being near the pedestrian footbridge and southern end of the platform (Figure 5-7 and Figure 5-8). Some sections of the cutting have been stabilised using shotcrete (Figure 5-9). Dense vegetation, primarily ferns and eucalyptus trees, are present above the cutting on either side of the corridor (Figure 5-7 - Figure 5-10).

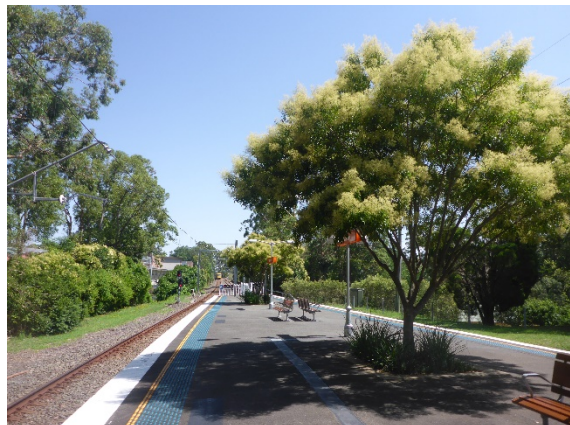
Figure 5-8. View northwest showing the relatively flat nature of the topography along the northern end of the Warrawee Station platform.

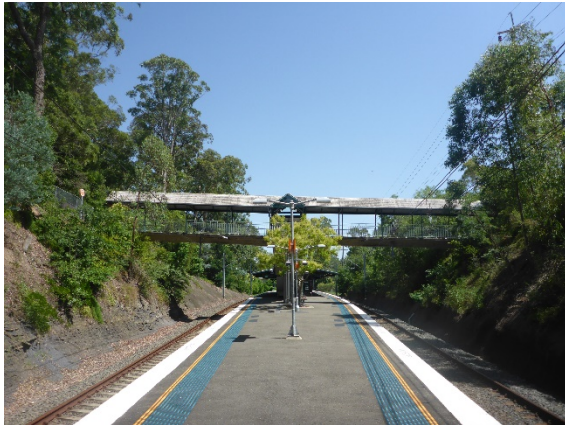
Figure 5-11. View northwest from the south end of the Warrawee Station platform looking towards the pedestrian footbridge. Note the variable grade, with the western extend of the bridge sloping up towards Heydon Avenue.

Modern lighting, vending machines, Opal card facilities, benches and water fountains are present along the platform (Figure 5-11, Figure 5-18, Figure 5-21, Figure 5-23 and Figure 5-24). The platform surface is asphalted and bordered with TGSIs (Figure 5-19 and Figure 5-22). The platform face is brick.

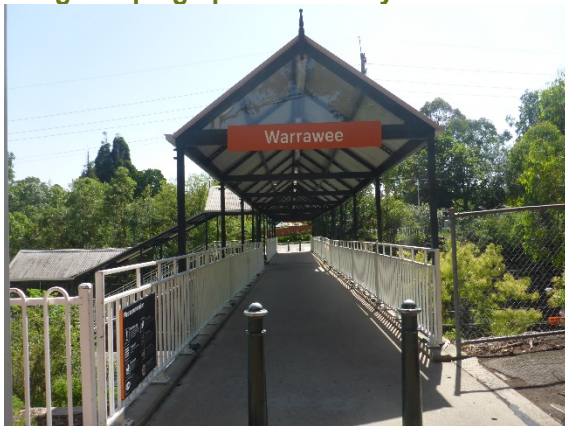
Figure 5-13. View east of the pedestrian footbridge from the Heydon Avenue entrance. Note the corrugated iron canopy.

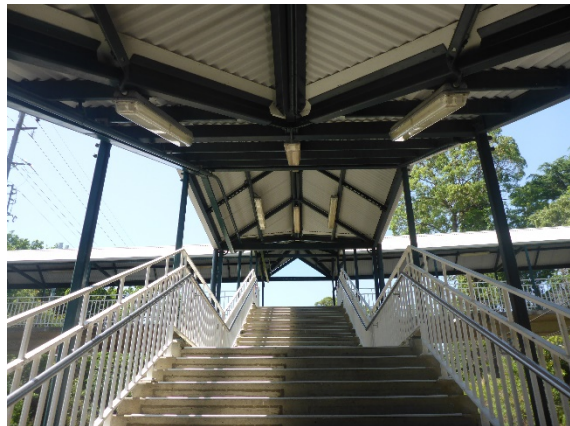
Figure 5-14. View northeast showing stairs leading up the pedestrian footbridge from the Warrawee Station platform. Note the corrugated iron canopy.

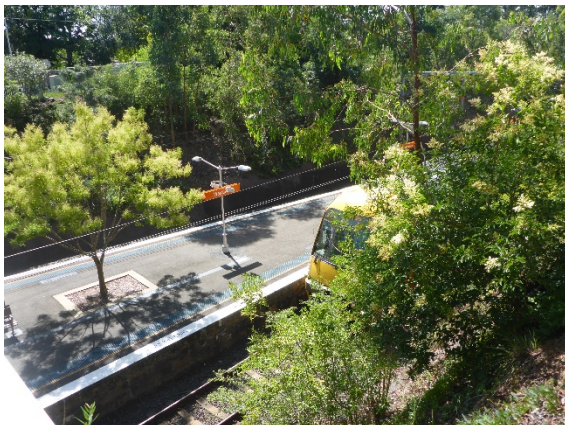
Figure 5-15. View towards the southern end of the Warrawee Station platform showing the Evergreen Ash (*Fraxinus griffithii*) tree which is proposed to be relocated/removed.

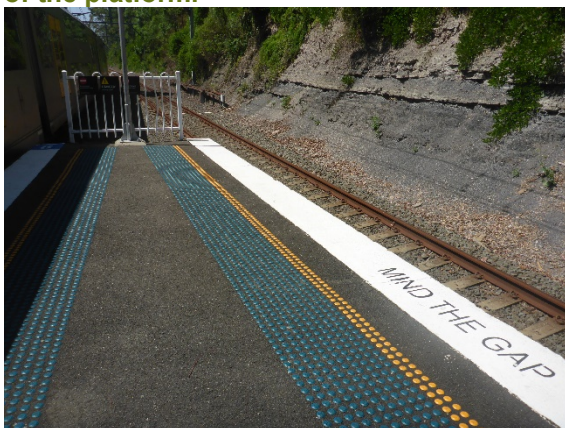
Figure 5-19. Detail of existing TGSIs along the station platform.

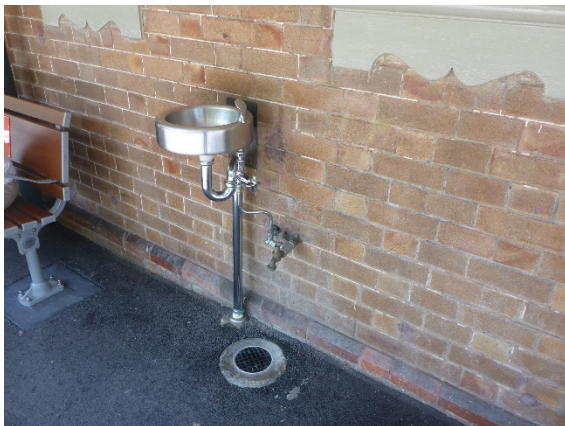
Figure 5-21. Existing water fountain along eastern elevation of the Warrawee Station building.

- The relocation or replacement of existing customer facilities (drinking fountain, vending machine, seating and telephone booth) should endeavour to use existing penetrations and entry points where possible. Customer facilities should not cover significant fabric or areas of detailing wherever possible.

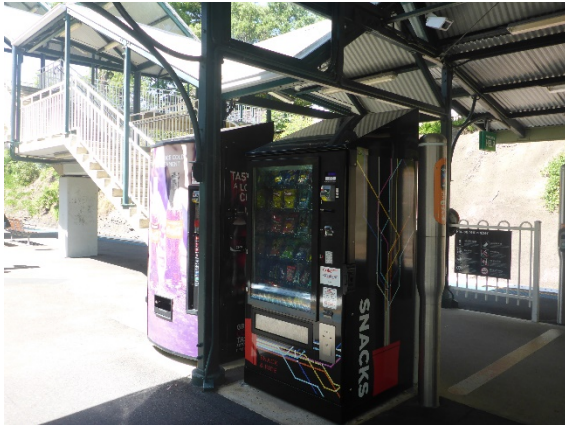
Figure 5-23. Modern vending machines along the eastern side of the island platform.

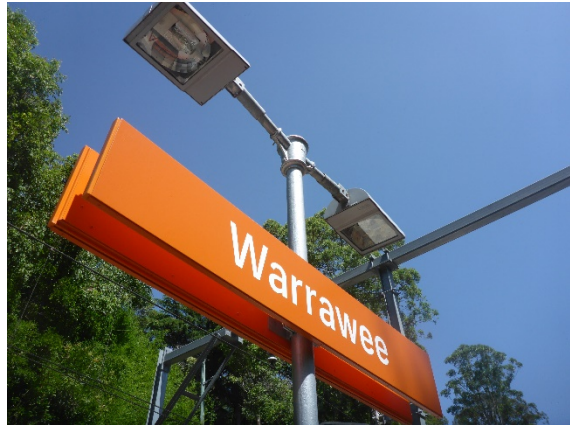
Figure 5-24. Detail of modern lighting located along the platform.

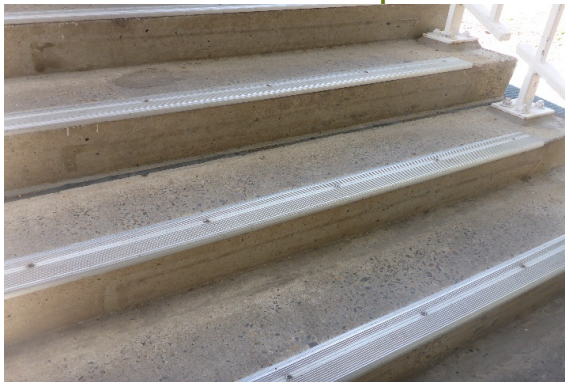
Figure 5-25. Detail of nosing on stairs.

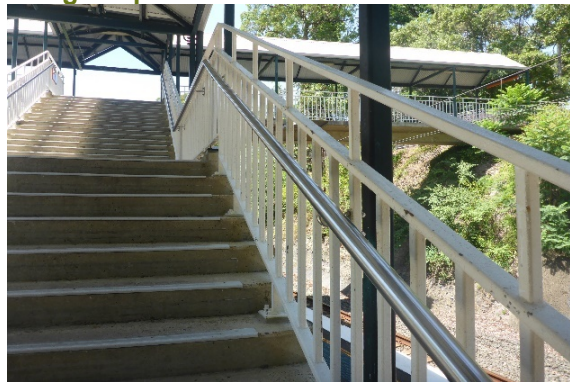
Figure 5-26. Detail of hand rails on stairs

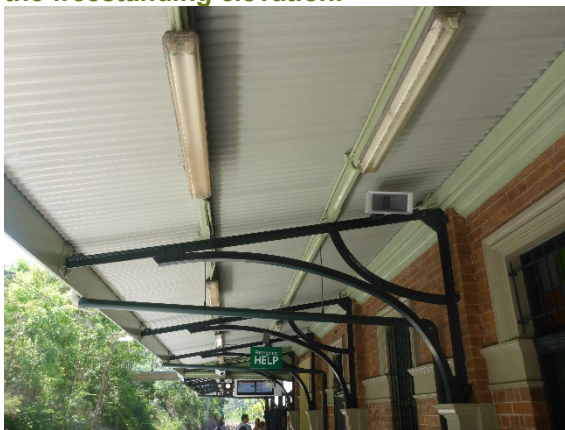
Figure 5-29. Detail of gabled roof and cantilevered curved cast iron brackets.

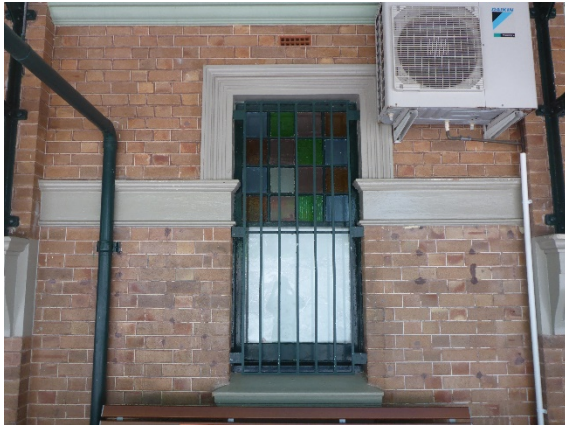
Figure 5-31. Detail of original 'cathedral glass' window panes, moulded render architraves, string course and window sills.

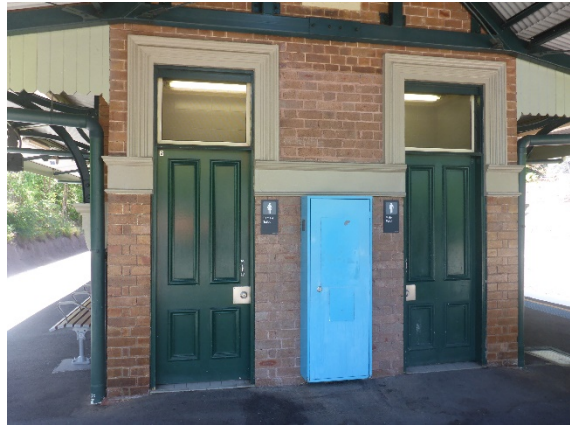
Figure 5-32. The northern elevation of the station building showing the entrance to the male and female bathrooms. Note the modified brick between each door where the wall was modified to accommodate each two entrance during upgrades to the station in 1995 and intrusive blue box secured to the wall.

- Widening of existing doorways to the bathrooms would be carried out in such a way that intact brickwork is avoided, and openings are returned to their existing appearance upon the completion of works. For example, doors should be widened in the centre of the northern elevation where bricks were replaced or reinstated during the 1995 refurbishment works. All modified rendered architraves and string courses should be reinstated to match the design and dimensions of the remainder of the station building.

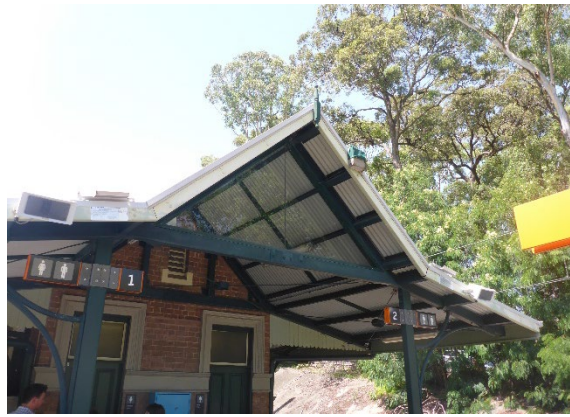
Figure 5-34. Detail of awning at northern of the station building. This was extended during upgrades to the station in 1995.

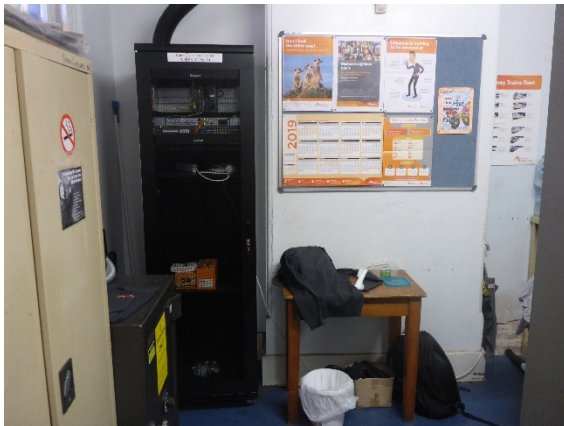
Figure 5-35. Interior of the station master's office (former booking office) showing the main switch board which is located at the northern end of the room.

The station master's office is located at the northern end of the building and contains modern furnishings, shelves and electrical equipment, including a switchboard (Figure 5-35). The installation of conduits, lighting and other modern services has resulted in localised damage to the ceiling at the northern end of the room (Figure 5-35 - Figure 5-39). Ceiling fans have also been removed, although their decorative mini orb fixtures have been retained (Figure 5-38). Other details that have been retained within the station master's office include corrugated iron ceiling panels and decorative cast-plaster air vents (Figure 5-37 - Figure 5-39).

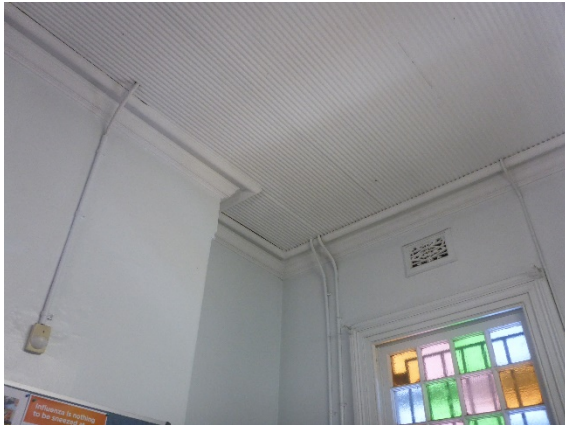
Figure 5-37. Detail of original corrugated iron ceiling panels and decorative cast-plaster air vents in the station masters office.

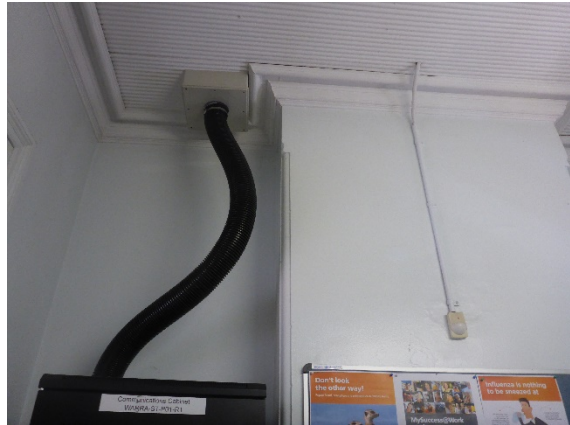
Figure 5-38. Detail of existing conduit leading from the main switchboard to the corrugated iron ceiling.

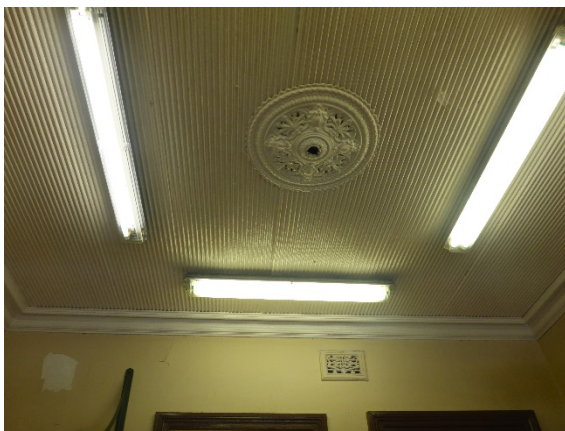
Figure 5-39: Detail of decorative mini orb ceiling fixtures which once accommodated a ceiling fan (now removed). Note unsympathetic addition of LED light fixtures.

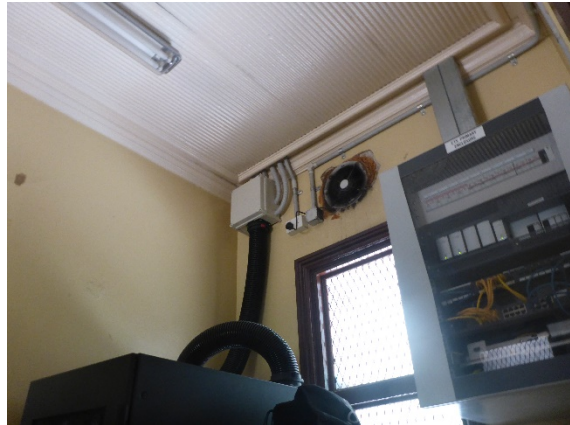
Figure 5-44. Interior of the store room (former booking office) showing an ETS primary enclosure for equipment and conduits leading into original corrugated iron ceiling.

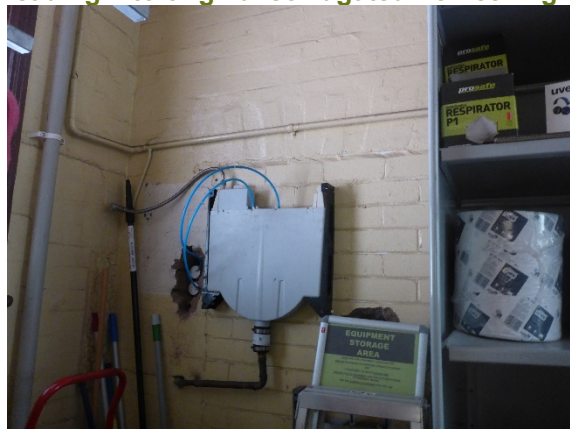
Figure 5-46. Detail of bricked-in door in partition wall at northern end of the store room (former booking office). This may have led into the bathrooms prior to their upgrade in 1995.

The bricks of a semi-circular arch – which may represent a doorway between the storage area and current bathrooms – is visible underneath the rendering of the northernmost wall in the third room (Figure 5-46). This has been filled in with brick and painted over. The ceiling in the first two storage rooms has retained its original corrugated iron panels (Figure 5-44 and Figure 5-45). Corrugated iron panels are missing in the room where a water heater has been installed (Figure 4 45). The ceiling is instead covered by a mesh sheet, leaving the insulation of the roof visible. Like the station office, the installation of conduits, lighting and other modern services has resulted in localised impacts to the ceiling at the end of the room (Figure 5-44 - Figure 5-47).

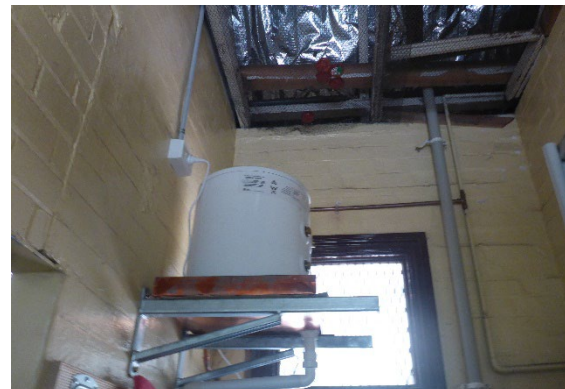
Figure 5-47. Detail of missing corrugated iron ceiling panels in the northern end of the storeroom (former waiting room).

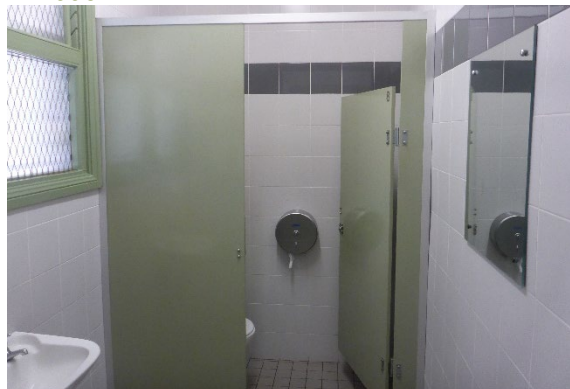
Figure 5-48. Interior of the women's bathrooms upgraded in 1995.

- New tiling to be installed on original fabric should also be affixed and grouted with care to prevent long-term damage to underlying brickwork. Original decorative features (such as skirting boards and cornices) that may be overlayed with tiling should be physically protected prior to the installation of tiling.

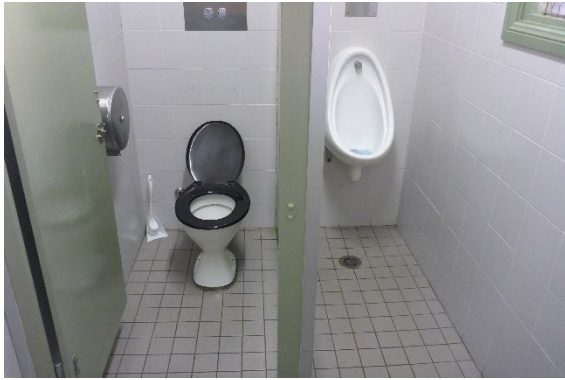
Figure 5-49. Interior of the male bathrooms upgraded in 1995.

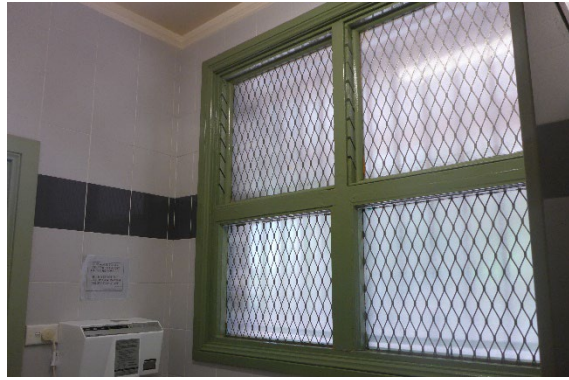
Figure 5-50. Window in male bathrooms.

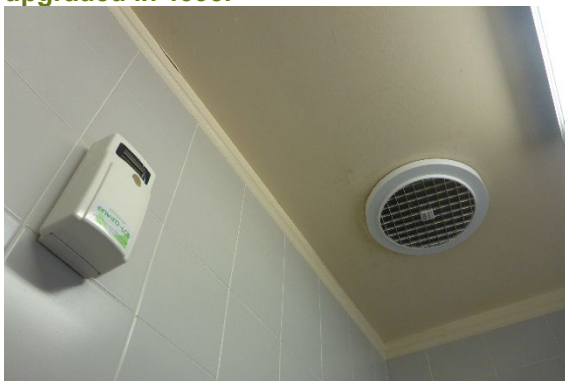
Figure 5-51. Detail of ceiling in women's bathrooms. Note that no original details are visible.

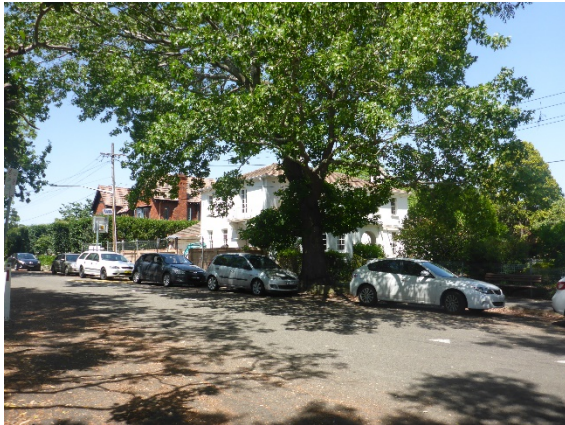
Figure 5-53. Proposed location of two new disabled parking bays on Heydon Avenue, view southwest from the station entrance.

The current Warrawee Station does not possess any dedicated car parks, with commuters instead relying on street parking along Warrawee Avenue or Heydon Avenue (Figure 5-53 and Figure 5-56). Both streets are sloped on moderately steep gradients, with the slope descending to the north of the pedestrian footbridge. The kerb on Heydon Avenue does not currently have any ramps that would be appropriate for wheelchairs or prams, the footpath is an uneven surface and does not have TGSi surfaces (Figure 5-55). On Warrawee Avenue there is a sloped kerb point for entry to the station however the surface is still irregular and not DDA compliant (Figure 5-54). The current streets would require kerb works and possible widening of the road to provide a safe kiss and ride zone and accessible parking (Figure 5-53 and Figure 5-56). Bollards, which are currently located at each entrance would be replaced with a single bollard under the Proposal to allow for DDA-compliant access (Figure 5-57 and Figure 5-58).

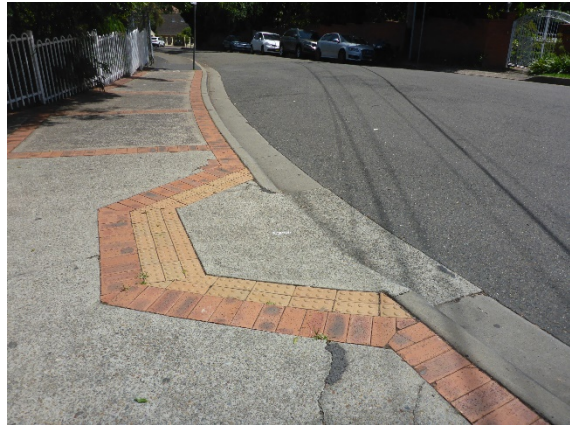
Figure 5-54. Existing ground surface and pedestrian footpath outside Warrawee Station along Warrawee Avenue, view northwest.

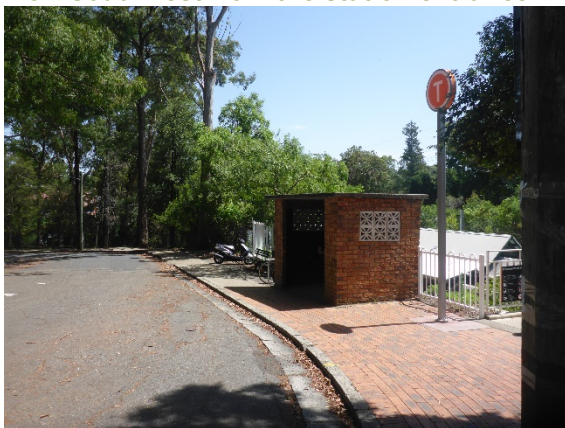
Figure 5-55. Entrance to Warrawee Station. Note absence of ramp and TGSi surface, View north.

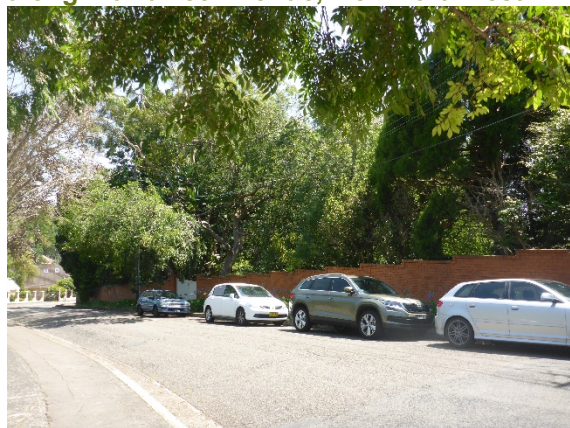
Figure 5-56. General location of proposed kiss and ride bays along Warrawee Avenue. View north.

- Two new accessible car parking spaces are proposed on Heydon Avenue (Figure 5-53)
- Three new kiss and ride bays are proposed on Warrawee Avenue (Figure 5-56)

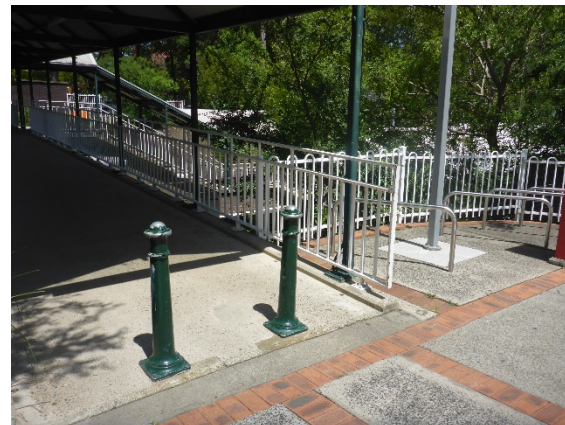
Figure 5-57. Existing bollards outside Warrawee Station's Warrawee Avenue entrance which would be removed under the Proposal.

- Footpath widening and associated kerb works including the addition of a ramp at Heydon Avenue and TGSIs
- Removal of existing bollards at Heydon Avenue and Warrawee Avenue entrance to footbridge (Figure 5-57 and Figure 5-58) and replacement with one bollard in the centre of the path to achieve minimum 1200 millimetre clearance

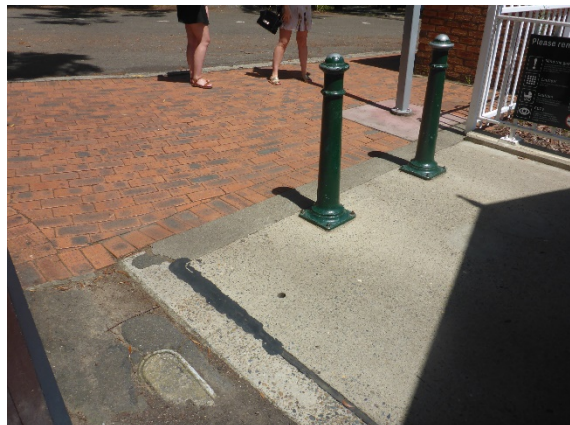
Figure 5-58. Existing bollards outside Warrawee Station's Heydon Avenue entrance which would be removed under the Proposal.

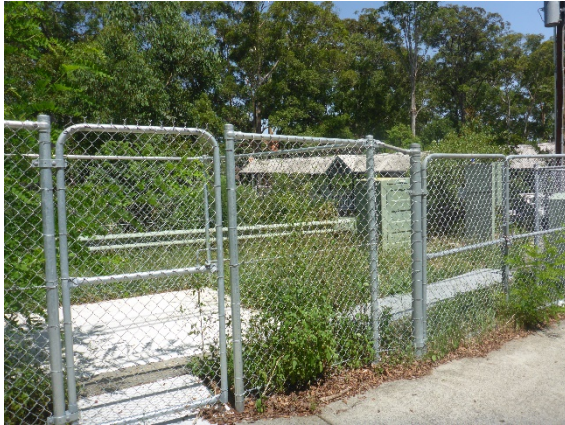
Figure 5-59. View northwest towards proposed temporary site compound access gate at Warrawee Avenue.

The proposed temporary compound area is located within an existing vehicle access road which runs east of the rail corridor and west of Warrawee Avenue and a pedestrian footpath (Figure 5-61) and is bounded by the Warrawee Avenue entrance to the station to the north (Figure 5-59) and substation to the south (Figure 5-62). Access to the compound area is via Warrawee Avenue to the north and Brentwood Avenue to the south.

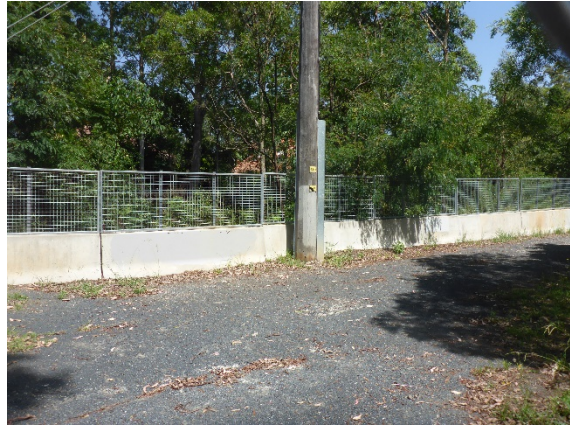
Figure 5-60. View northwest towards proposed temporary site compound showing nature of ground surface and fencing.

The road comprises of a loose dirt track surrounded by trees and aluminium fence (Figure 5-60). Views to and from the compound area are generally obstructed by trees and fence lines, however some gaps in vegetation are present (Figure 5-62).

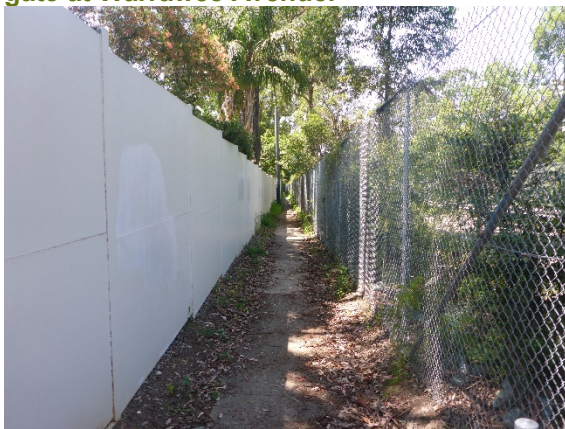
Figure 5-61. View southeast along pedestrian footpath between proposed temporary site compound (to the right) and residential boundary wall (left).

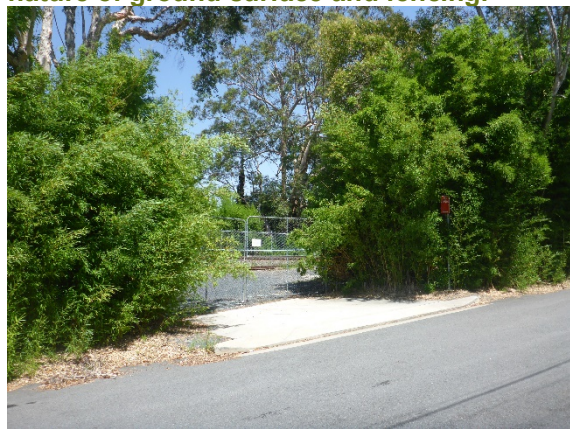
Figure 5-62. View northwest towards Brentwood Avenue entrance to proposed temporary site compound showing thick vegetation on either side of the gate.

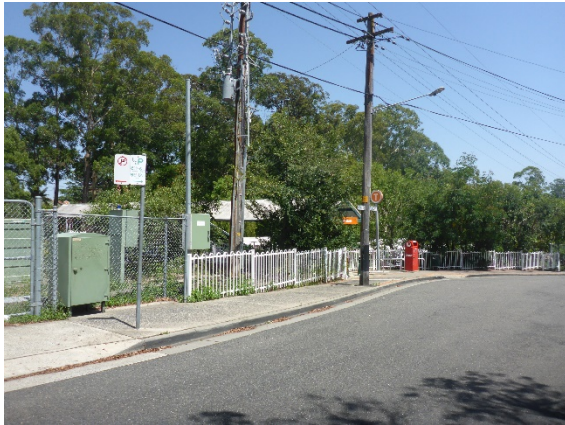
Figure 5-67. View south towards Warrawee Station from northern end of Warrawee Avenue. Footbridge is visible to the left.

The footbridge and platform is visible from some sections of Warrawee Avenue where the topography is slightly raised or trees have been removed to provide access for vehicles into the rail corridor and surrounding parklands (Figure 5-67 and Figure 5-69) and partially visible from heritage items I1050, I1072 and I1074, although they are obstructed by trees and fence lines (Figure 5-67, Figure 5-70, Figure 5-70 and Figure 5-72).

In certain areas at the northern end and slightly south of the pedestrian footbridge the proposed location of the elevator would be visible from the street and would therefore alter the existing view lines towards the station from the street (Figure 5-67 and Figure 5-68). However, the majority of the train station and the proposed work locations are blocked by vegetation (Figure 5-72 and Figure 5-73).

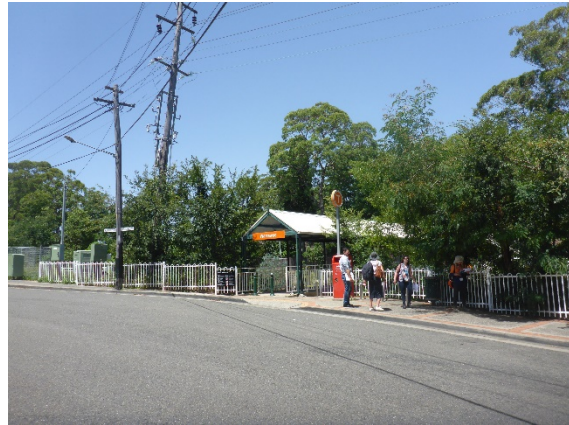
Figure 5-68. View northwest towards Warrawee Station from Warrawee Avenue showing extent of views towards station and existing footbridge.

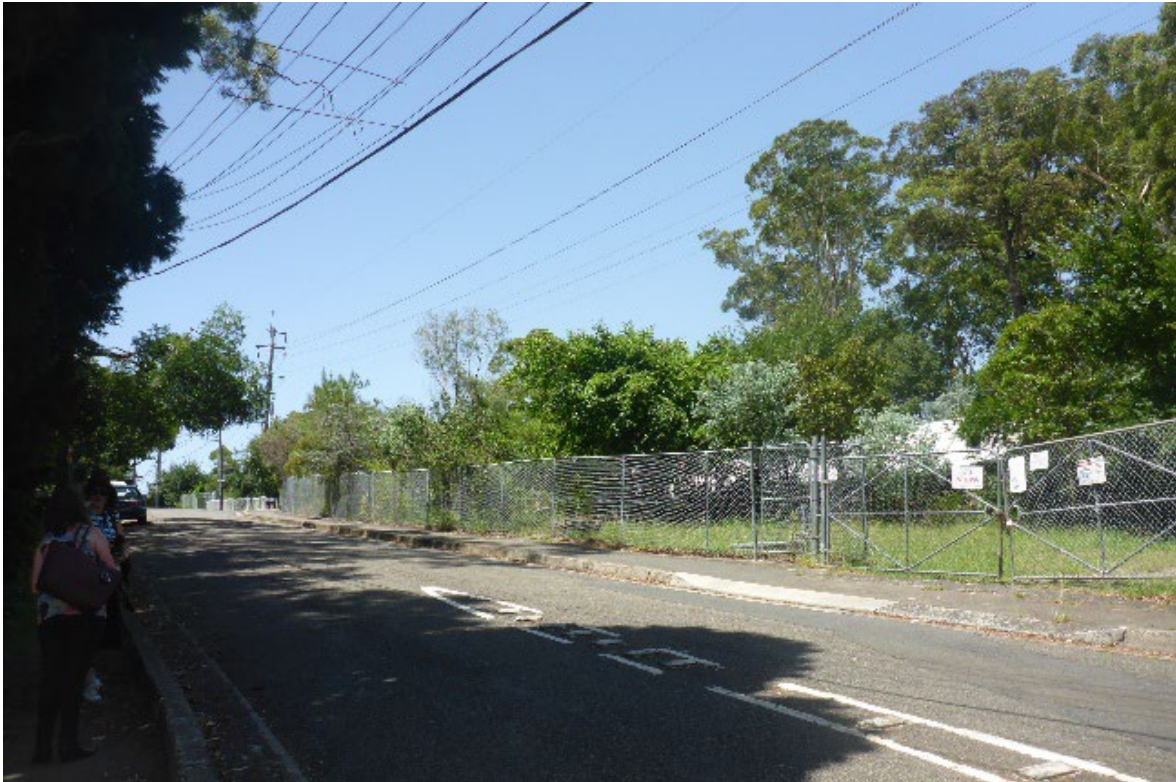
Figure 5-73. Example of views towards the Warrawee station platform and building partially obstructed by trees, view northwest towards station from Warrawee Avenue.

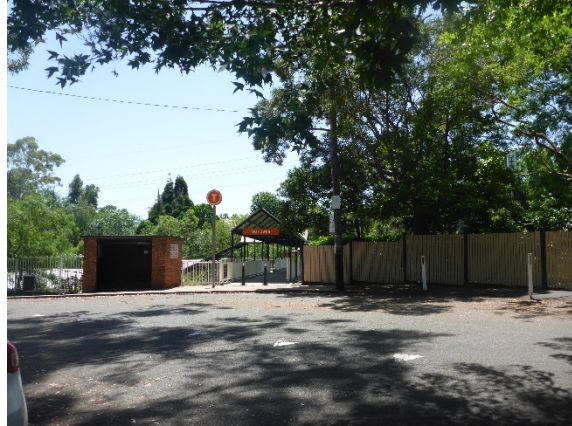
Figure 5-81. View east towards Warrawee Station entrance from corner of Borambil Street and Heydon Avenue. The footbridge and canopy are clearly visible although trees obstruct views towards the proposed lift structure.

Vegetation between the street and the train station is much denser and the rail cutting is slightly steeper than on Warrawee Avenue, which provides a visual barrier between the residential properties and Warrawee Station (Figure 5-78 - Figure 5-81). The road runs north-west to south-east, parallel to the rail corridor. The station building, platform and existing footbridge is partially visible from Heydon Avenue although trees and fence lines obstruct these site lines (Figure 5-78 and Figure 5-81). The station is not visible from I1055, I1056 or I1028. View lines from I1054 could not be assessed as the property was not accessible during the inspection. However, due to the property's location, which backs onto the rail corridor, there is potential for the dwelling to have unobstructed views to the station.

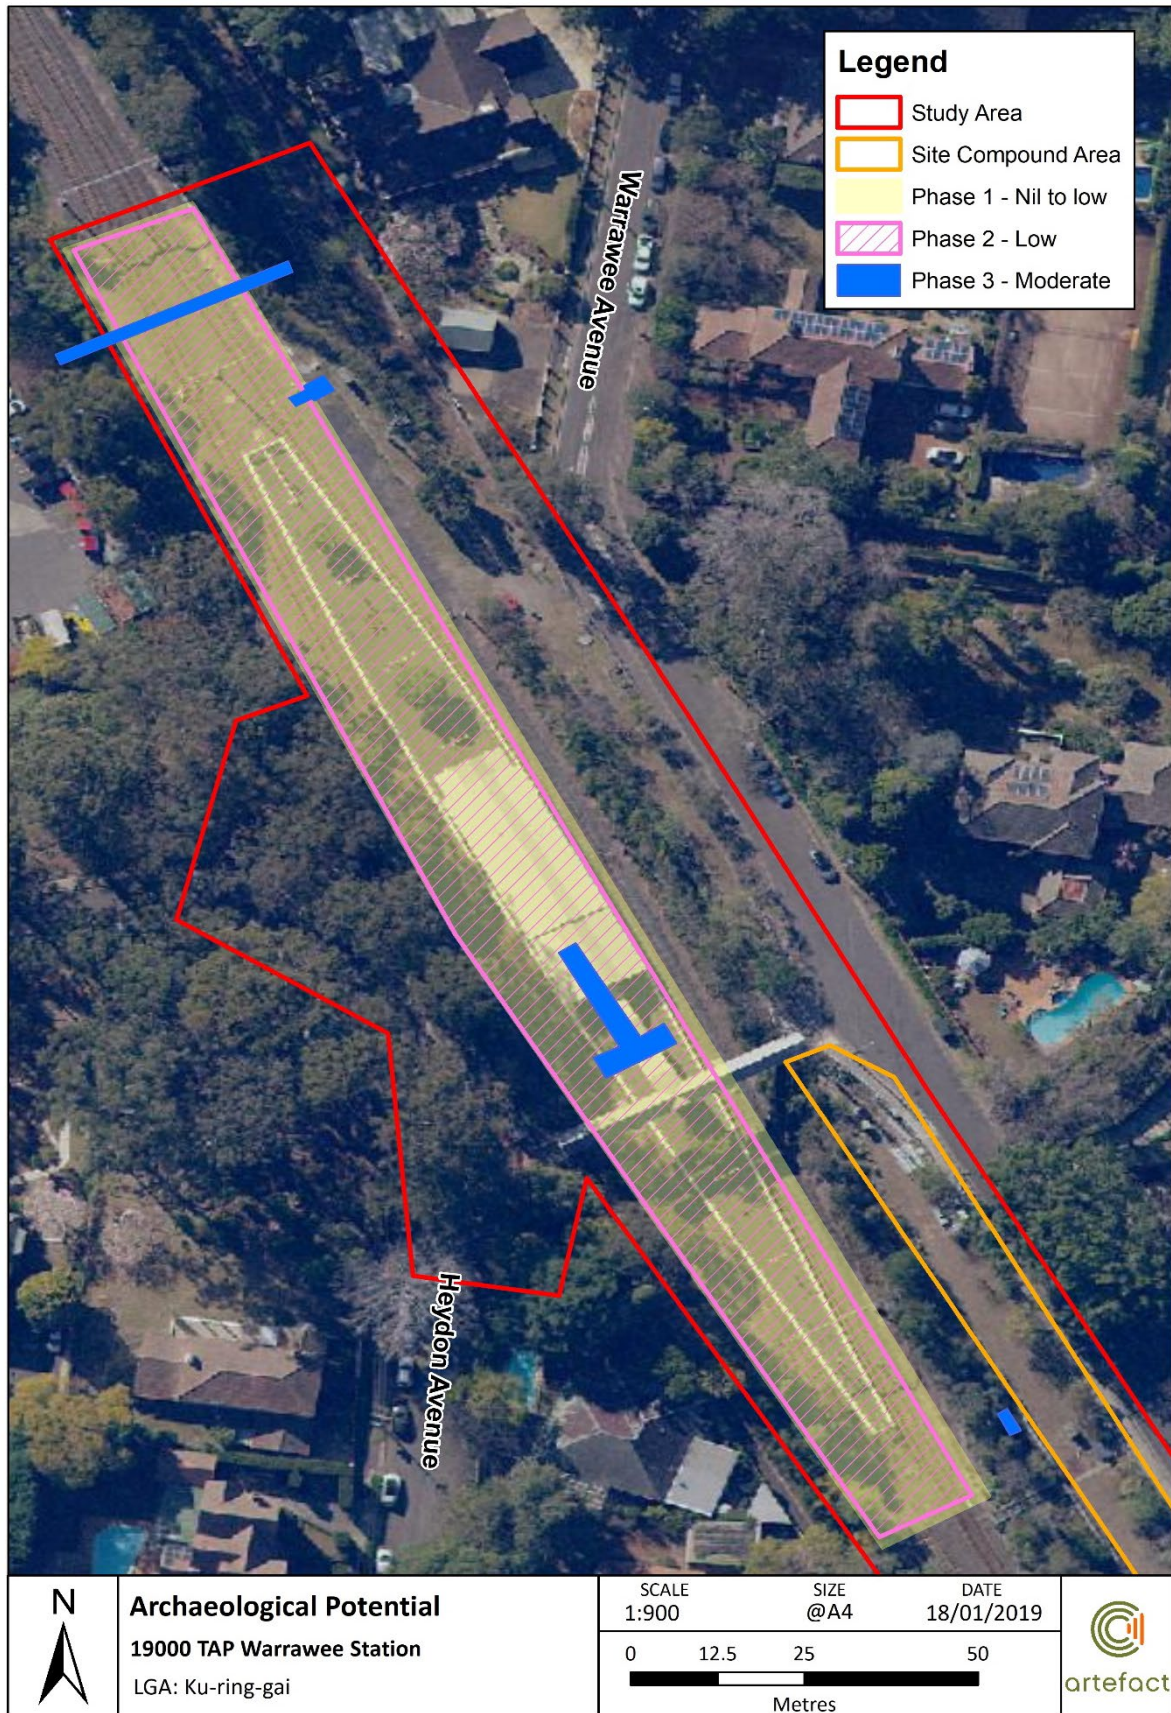
Figure 7-1 Location of areas containing archaeological potential. Note that potential Phase 1 and 2 remains are located below the existing platform.

The second Warrawee Station continues to exist and has retained its original layout along the platform and within the railway corridor, although the original timber footbridge was replaced in 1977. A plan of the station prepared in 1925 shows the location of the original footbridge, unidentified structure along the top of the eastern side of the cutting, septic tank and a culvert (Figure 4-5). The septic tank and culvert are located to the north of the platform and the septic tank is still visible in contemporary aerials. The footbridge appears to have been located approximately 3.5 metres north of the current footbridge, although this may reflect an inaccuracy in the 1925 plan. The footbridge can be seen in Figure 4-4 and Figure 4-7.
