## **Re: Hornsby Junction remodelling and commuter car park Aboriginal heritage Due Diligence assessment**

This letter report has been prepared by Artefact Heritage at your request to form part of the Review of Environmental Factors (REF) for the proposed Hornsby Junction remodelling and commuter car park (Figure 1). It outlines the results of a preliminary due diligence Aboriginal heritage assessment which meets the requirements of the Office of Environment and Heritage (OEH) 2010 *Due Diligence Code of Practice for the Protection of Aboriginal Objects in New South Wales*, and includes recommendations as to whether further archaeological investigation may be required in relation to the current proposal.

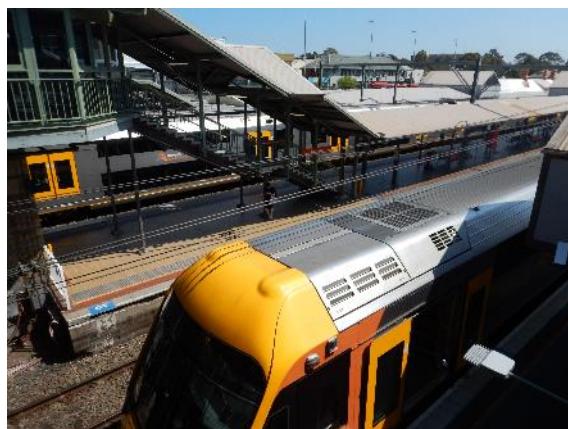
**Plate 1: Hornsby Station**

The study area encompasses the rail corridor, Hornsby Station and adjacent carpark (Plate 1 and Plate 2). The area has been highly modified by the construction of the railway, station and carpark. Visibility was generally low across the study area, impeded by structures, sealed bitumen surfaces and the rail itself. Where ground exposures were observed they appeared to be within artificial disturbed contexts such as gardens within the carpark areas (Plate 3).

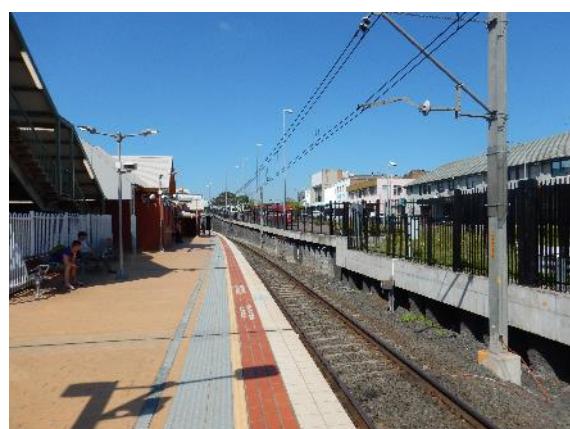
**Plate 4: Station cut into landform below Jersey Street**

The station and rail corridor has severely impacted the natural landform. The original landform appears to have been a slope, sloping down to the east. The Station and rail corridor has been cut into the slope below Jersey Street and built up above the slope above George Street (see Plate 4 and Plate 5). There were no Aboriginal objects or areas of archaeological potential located within the study area during the site visit.
