**Barham-Koondrook Bridge Restoration
Work**

**LIMITED ENVIRONMENTAL ASSESSMENT AND
WASTE CLASSIFICATION REPORT –
BARHAM-KOONDROOK BRIDGE
(VICTORIAN APPROACH)**

Roads and Maritime Services

Report No: AL14-218-1C

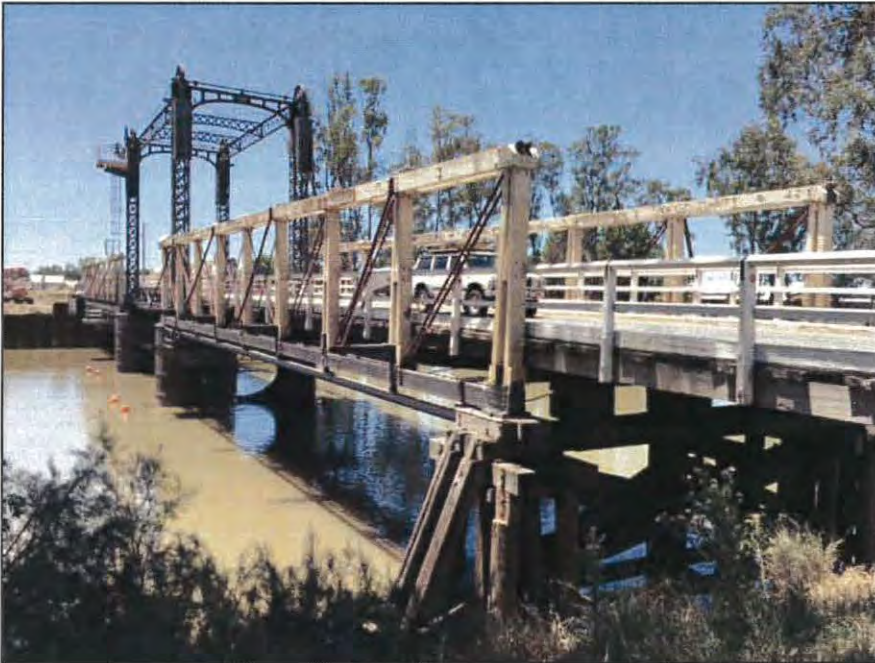
Plate 1: View of the subject site looking toward the north from the Victorian approach of the bridge structure. The steel lift span structure is visible as well as associated above-deck timber bridge support elements. Timber piers are also visible in the lower central portion of this photo.

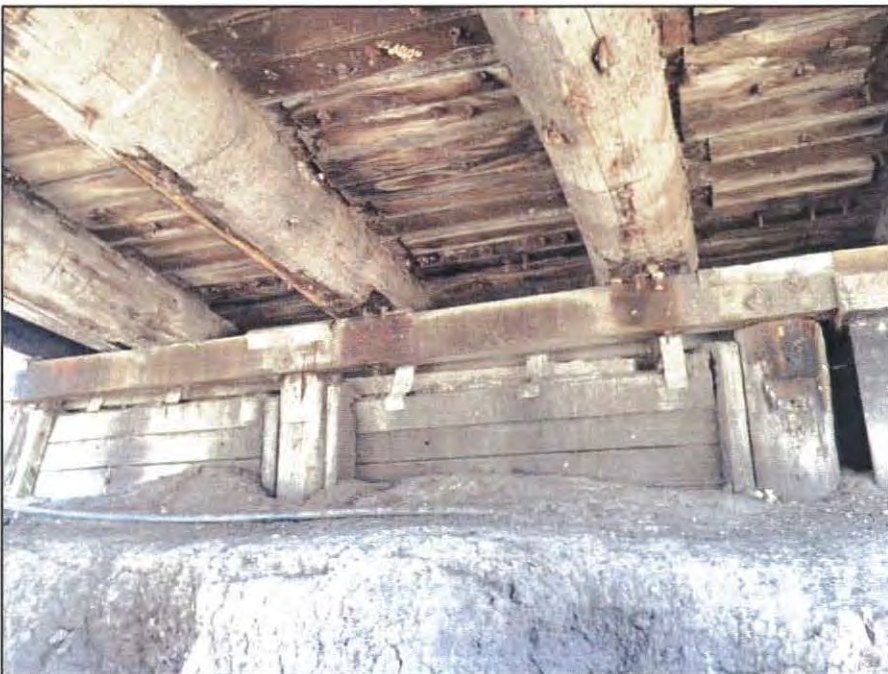
Plate 2: View of the Victorian abutment and associated embankment soils. The abutment sheeting timber was noted to be in fair to poor condition and some evidence of the application of treatment chemicals was noted. Transverse bridge beams (stringers) and decking are also visible.

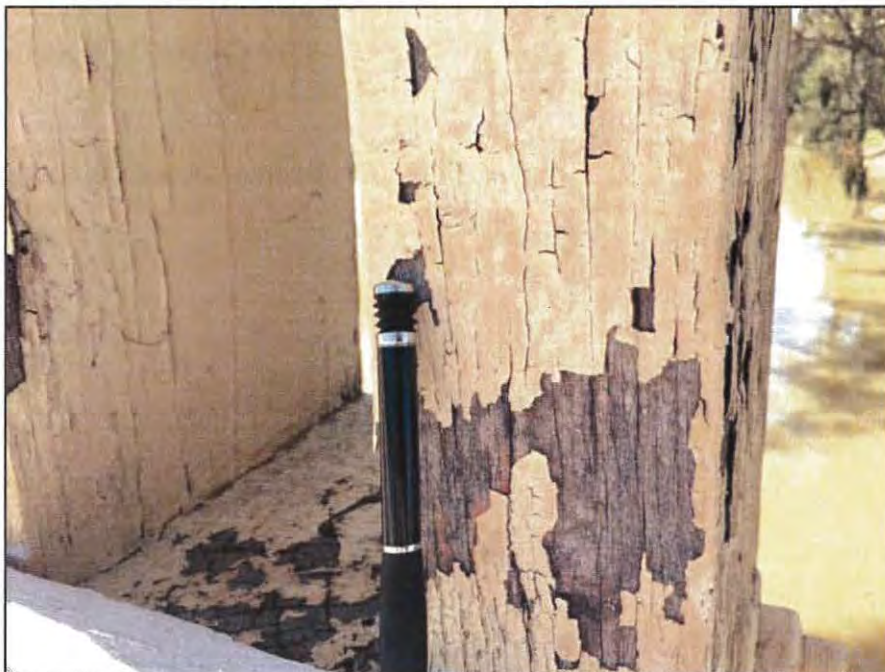
Plate 3: Detailed view of bridge timber exhibiting white and cream coloured paint where sample PS-6 was collected. A pinkish-red undercoat was also observed at several locations. Paint was noted to be in poor condition and laboratory analysis indicated lead was present.

Based on the sampling and analysis completed as part of this current assessment the painted elements at the site would be pre-classified as NSW *General Solid Waste*. Based on review of Victorian EPA waste classification guidelines painted bridge elements would be classified as Victorian *Industrial Waste*. It is noted that where paint is stripped from elements the lead paint waste would be pre-classified as NSW *Hazardous Waste* or Victorian *Prescribed Industrial Waste (PIW)*.

It is further noted that lead paint waste is pre-classified as **Hazardous Waste** in NSW and **Prescribed Industrial Waste** in Victoria.

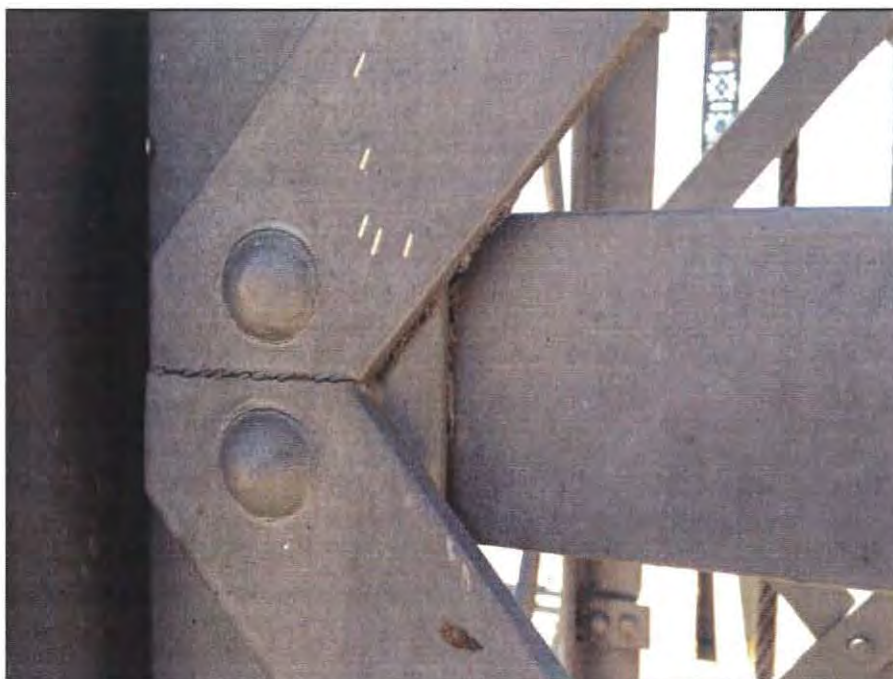
Plate 4: Detailed view of silver-grey paint on metal lift-span bridge elements where sample PS-7 was collected. Paint was noted to be in fair to poor condition and laboratory analysis indicated that lead was present.
