BARHAM-KOONDROOK BRIDGE

Capacity Upgrade

Statement of Heritage Impact

November 2014

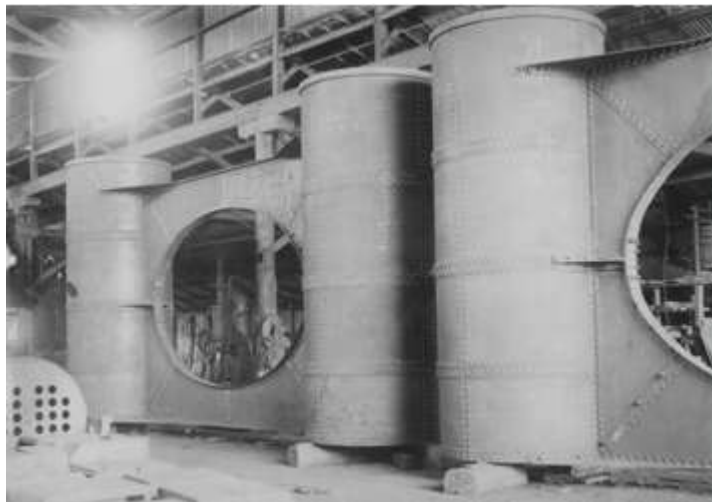
Figure 5: Paired iron cylinders for Barham Bridge prior to shipment from Eureka Ironworks at Ballarat (Reinforced Concrete & Monier Pipe Construction Co Collection, University of Melbourne Archives, BWP/23839).

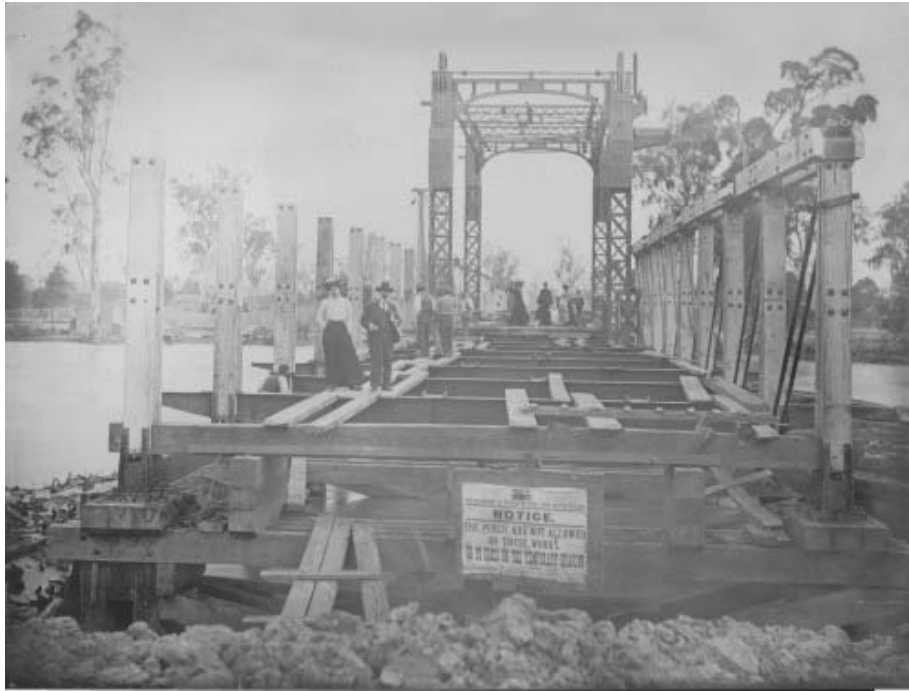
Figure 6: View of the Bridge during construction in mid 1904 with lift span in place. The near side span has the right hand truss complete, but left hand truss is still under construction. The deck cross-members of the near side span are in place, but not decking (University of Melbourne Archives, UMA/I/6290).

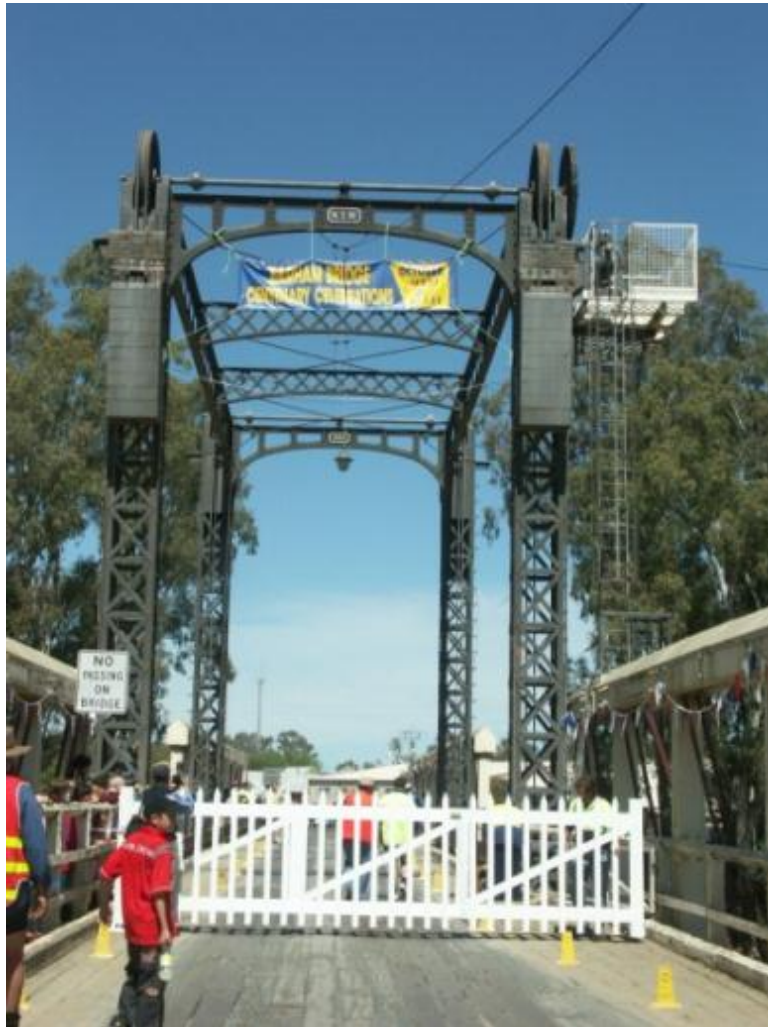
Figure 8: Decorative gate set up on bridge for Centenary celebrations, October 9th and 10th, 2004, note access ladder right side of lift span first attached to bridge in 1923 and replaced at regular intervals.

The Barham Koondrook community turned out to acknowledge the centenary of the bridge's opening in 2004 by organising festivities with the bridge as a focus and commemorative a banner was hung from the lift tower. A decorative picket gate was put in place on the deck; this was the original form later replaced with the existing tubular steel gates.

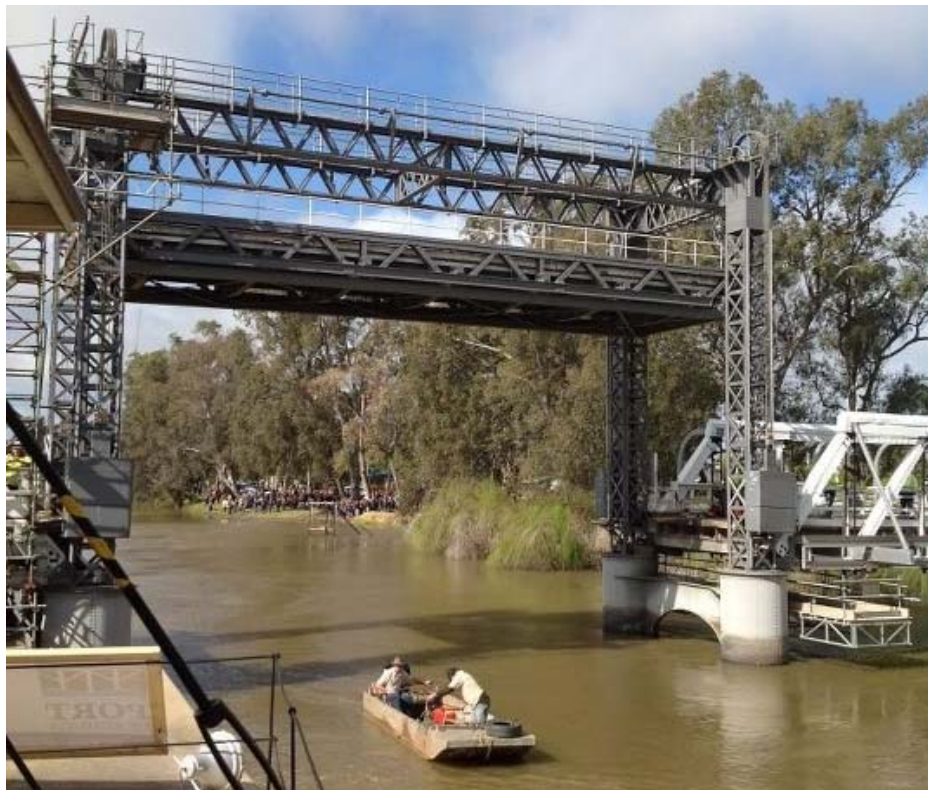
Figure 10: A test left undertaken in 2012 after repair works (RMS Bridge File).

From the 1990s after more than ten years of drought and a low Murray River, river traffic was at a minimum and the high clearance under the bridge resulted in very few lift requests from river boats or paddle steamers. The lift span remains in regular but infrequent use (see **figures 9** and **10**).

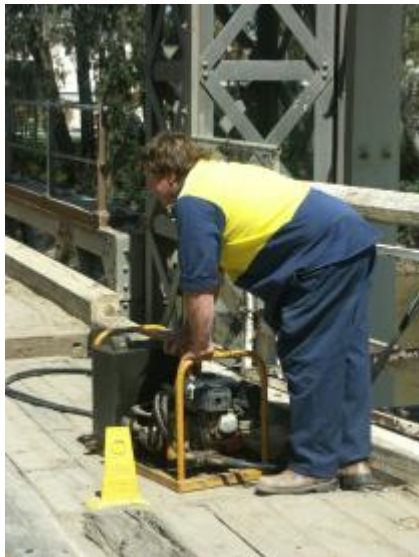
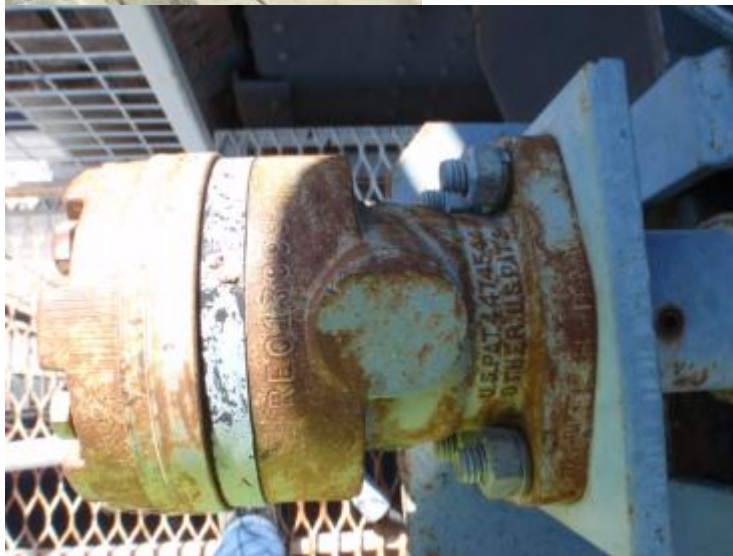
Figure 11: Wakool Council officer with removable power pack to facilitate opening (RMS).

Motors and electrical components were not originally installed on Barham Bridge. It remained manually operated throughout the initial period of its operation. Since 1997 the opening function of the bridge has been undertaken by Wakool Shire Council and a hydraulic motor has been used to drive the opening mechanism of the bridge. The motor is driven by a portable power pack (fError! Reference source not found.11).

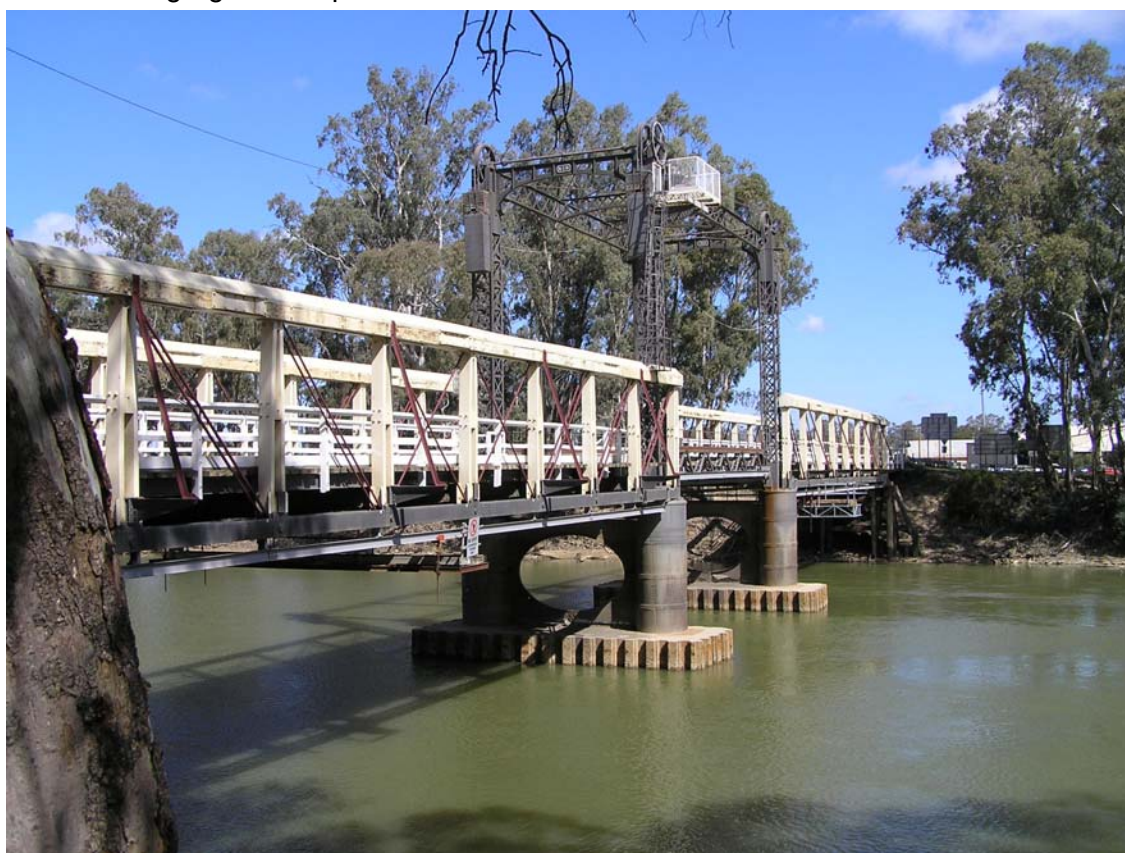
Figure 11: General View of Barham Bridge looking south (RMS).

Barham Bridge comprises three main spans including one lift span, supported on wrought iron piers. There is a single timber approach span at each end, supported on timber trestle piers. The lift span, which measures 17.8 metres, is of lattice steel construction, similar to the design developed by Percy Allan and first used at Swan Hill nine years previously. Barham Bridge shows some variation from that format and those designs used later for the bridges at Tooleybuc and Abbotsford. Barham Bridge has the counterweights on the main axis side of the supporting columns, while the others have the weights on the cross axis. In addition the cross girders on the top of the structure are unusually curved and decorated. These changes may be due to the fact that the design was undertaken by Ernest de Burgh, who also changed timber trusses from Allan's design to the de Burgh style.

The two other main spans are 31.7 metres in length and are timber trusses of the "de Burgh" type. Ernest de Burgh developed the De Burgh truss as an improvement on the Allan Truss. The truss uses a steel bottom chord and supports steel cross girders and steel longitudinal stringers. The main bridge piers are twin wrought iron columns protected within concrete cofferdams. Except for the centre lift span, the timber deck has been segregated for pedestrian use with a kerb and handrail.

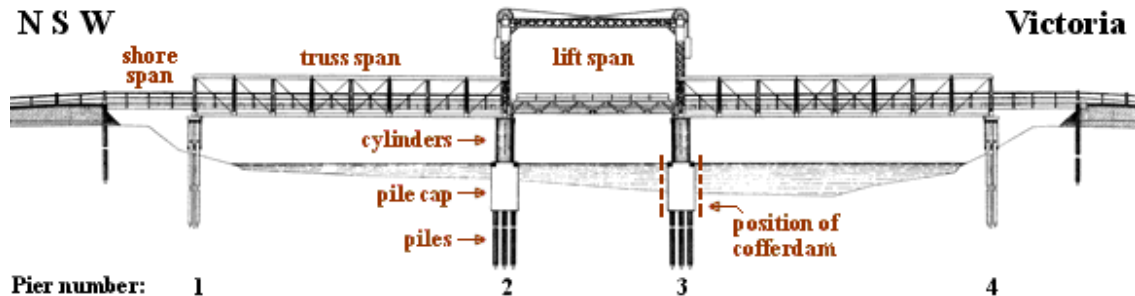
Figure 14: Profile view looking east.

The separate components that make up the Bridge are shown in a general plan of the western elevation in 1902 reproduced below.

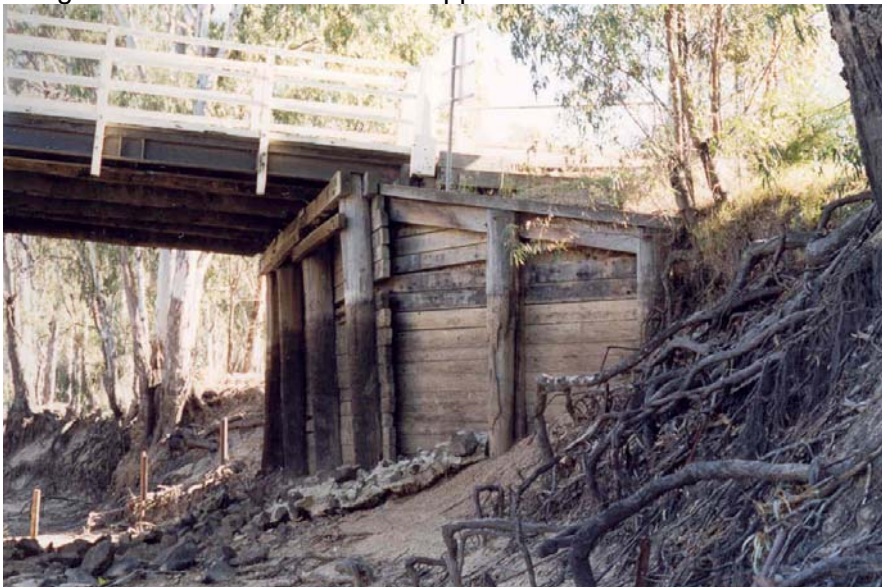
Figure 15: View of Abutment A looking west in 2004 prior to replacement in 2013. Stones from the original spill through abutment can be seen at the base.

The existing NSW abutment was built in 2013 and replaced successive timber abutments built from 1958 onwards. The original design for the abutments is of the spill through type. The reduced waterline evident in **figures 15** and **16** has exposed rocks from the former spill through abutment.

The existing NSW abutment consists of timber capwales supported on circular timber piles. The piles extend approximately 5m above existing riverbed level. Wing walls, supported by wing piles extend back approximately 5m at 45 degrees from each side of the abutment. Timber back sheeting installed behind the piles is designed to retain the soil of the approach embankment.

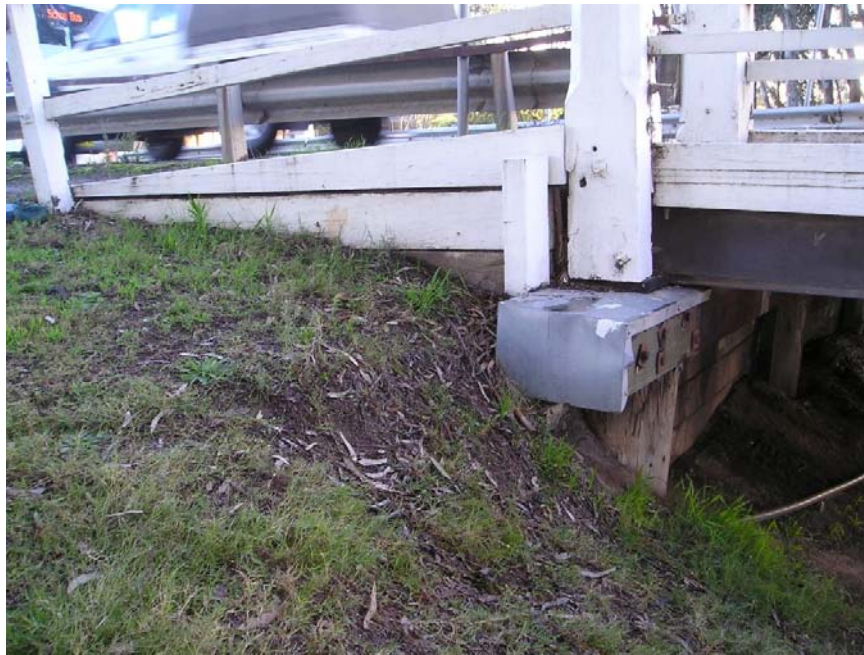
Figure 16: View of Abutment B detailing its low clearance above the river bank.

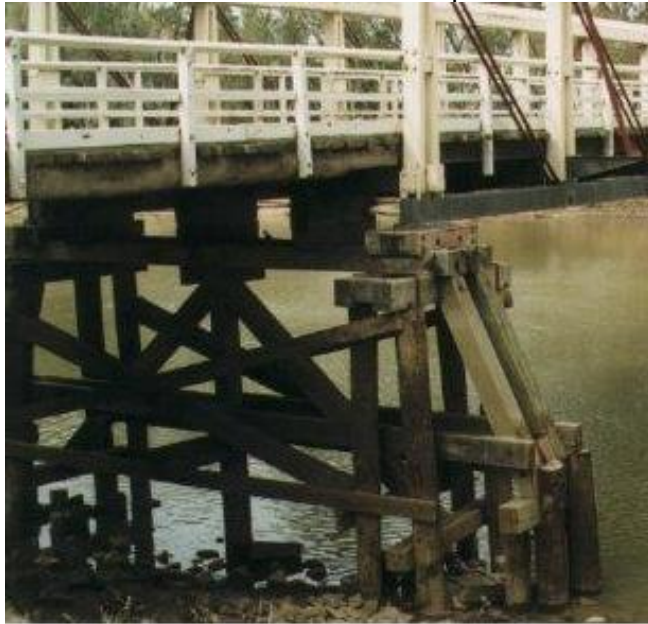
Figure 17: View of the timber trestle Pier 4.

Piers 1 and 4 support the truss spans (**figure 17**). These piers are relatively typical of piers supporting a truss on one side and a timber girder span on the other. They are also typical of timber trestles that have undergone upgrading and strengthening over time. Pier 1 was replaced in 2013 with a timber pier of similar configuration. Pier 4 consists of four, round section, vertical piles in a group, with crossheads under each truss support. These vertical piles are located on upstream and downstream sides of each timber trestle and represent replacement elements of the timber square-section piles. The piers are laterally braced by square section, twin raking columns on the downstream side. Each truss end rests on three square section corbels supported on four timber capwales. Horizontal timber members (walers) are located near water

level, on either side of the pier trestle. The piers are well braced, with diagonal timber members (braces) running across the trestle. The timber bracing is arranged to brace against the force on the upstream side during flooding. The original trestle is braced as well as the additional piles on both sides of the trestle.

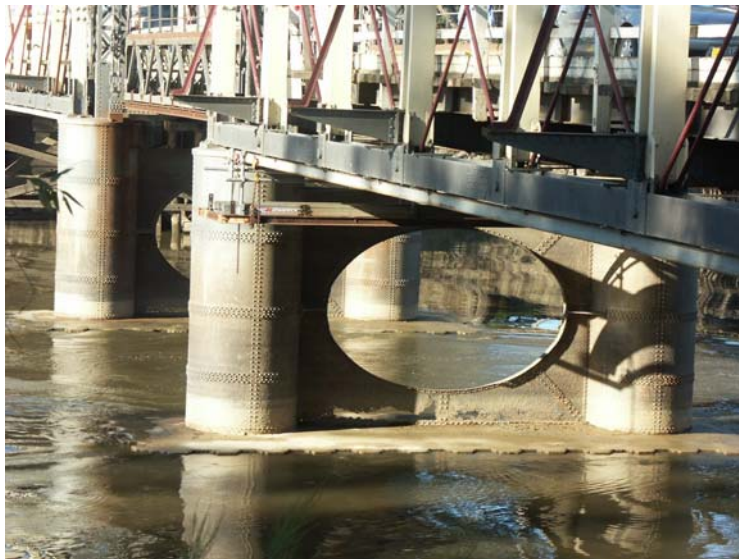
Figure 18: View of the iron Piers 2 and 3.

The piers that support the lift span comprise twin wrought iron cylinders, connected by wrought iron plate diaphragms with an elliptical opening (**figure 18**). This pier system is common for river crossings of this period of construction. The upper portions of the wrought iron caissons were filled with concrete to provide support for the lift towers lift span and timber truss spans. The cylinders were supported on a concrete pile cap, excavated in the riverbed, in turn founded on timber piles driven deep into the riverbed.

Steel sheet piling encloses each pier and this extends approximately one metre above normal water level. Sheet piling encasement was installed in the 1970s as a cofferdam to protect the concrete pile caps from undermining due to scour. The bottom edge of the steel plate bracing between cylinders at Pier 3 has some corrosion loss.

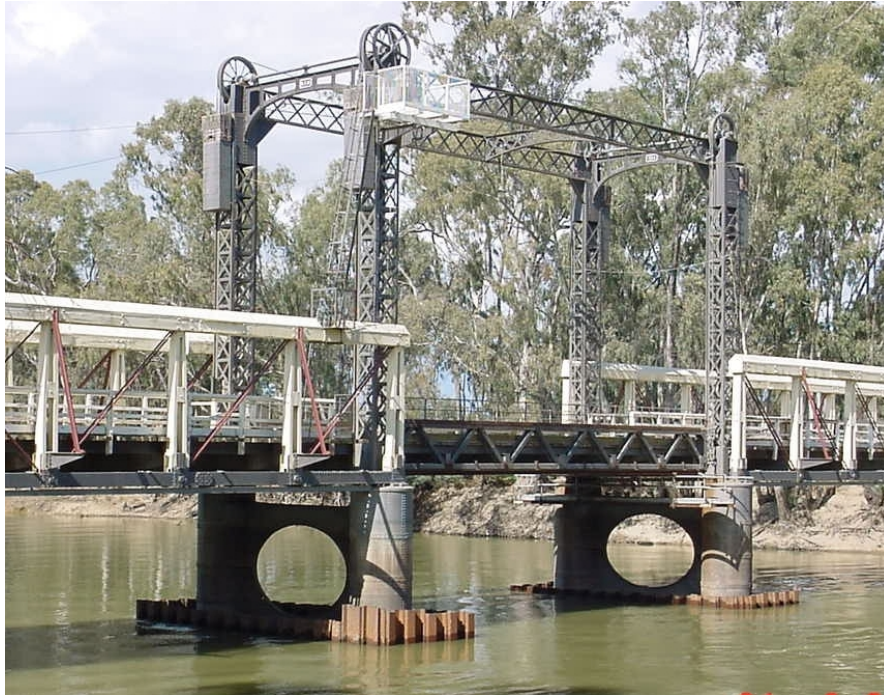
Figure 19: View of the Warren truss of the lift span on the upstream side.

The lift span is a vertical type and consists of a steel Warren type truss on each side, joined by cross girders (**figure 19**). The riveted built-up steel cross girders are supported on saddle plates riveted to the bottom chord of the truss at the bottom chord panel points. All cross girders except the end ones have a convex soffit. These cross girders support steel stringers topped with timber decking and sheeting. The four towers consist of a wrought iron lattice column system. Steel lattice truss girders brace the tops of the four towers both longitudinally and transversely. The underside of the upper lattice girder transverse bracing is curved. The counterweights are located on the main Bridge axis side of the lifting towers.

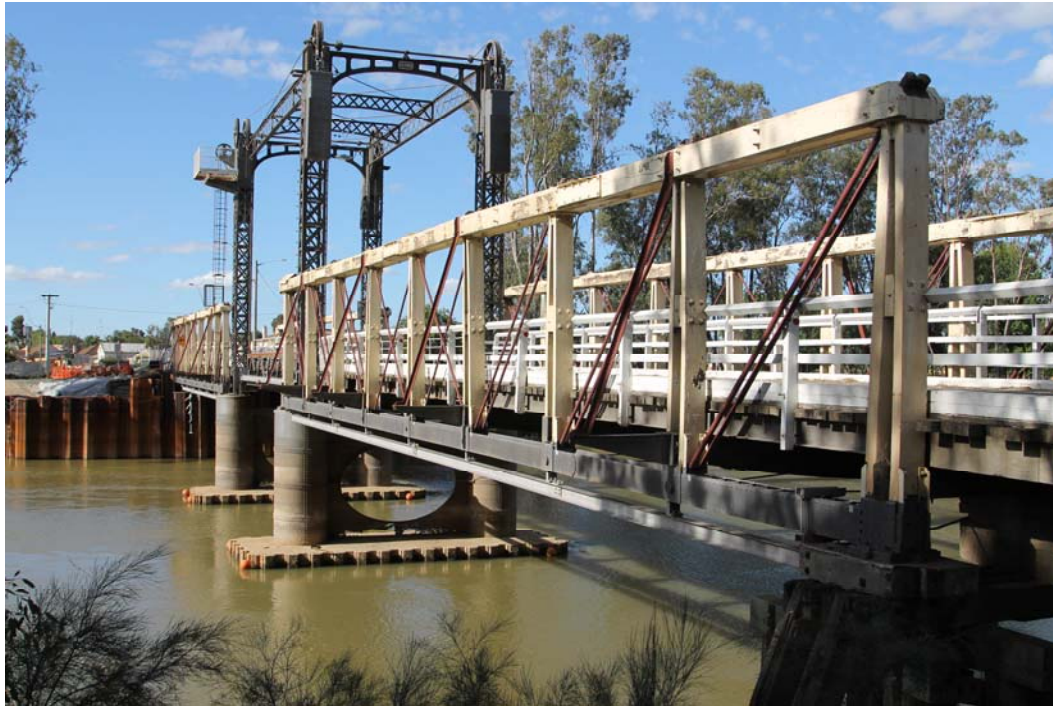
Figure 20: View of southern truss span (Span 4).

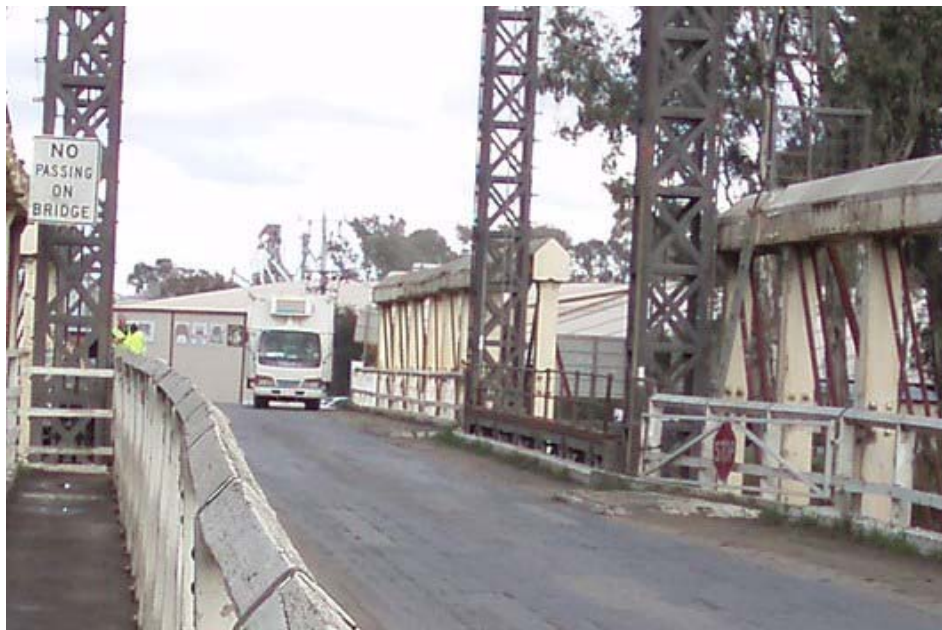
Figure 21: View of deck on lift and truss spans.

Behind the timber kerbs on both edges of the deck, at the truss spans and approach spans, is traditional timber ordinance railing, approximately 1 metre high. The existing timber railing has no structural capacity and represents no real barrier, except to pedestrians or travelling stock. The ordinance railing terminates with timber end posts at each end of the Bridge structure. At the lift span the railing comprises a steel tubular system, fixed to the top flange of the top chord of the main trusses.

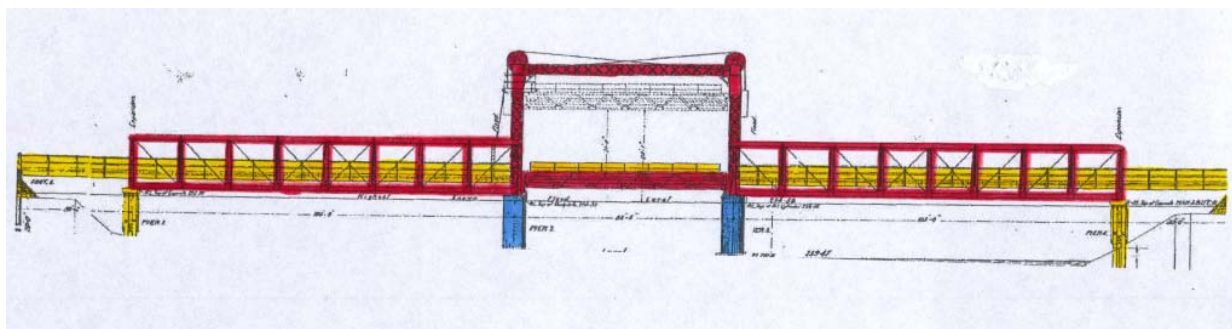
Figure 22: Profile of Barham Bridge illustrating the elements described in the text. The NSW approach span and Abutment A are on the left hand side.

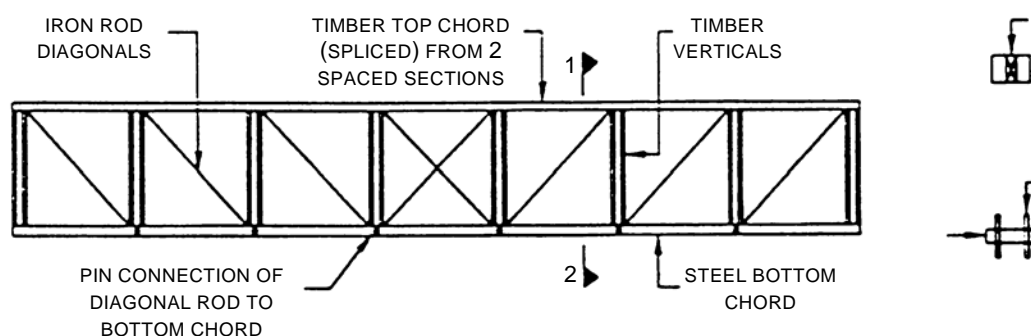
Figure 23: Profile view of a De Burgh truss span.

As previously described the De Burgh truss spans are of composite construction featuring large size timber in the top chord and verticals and wrought iron in the bottom chord. The different components of the truss are detailed in **figure 6**.

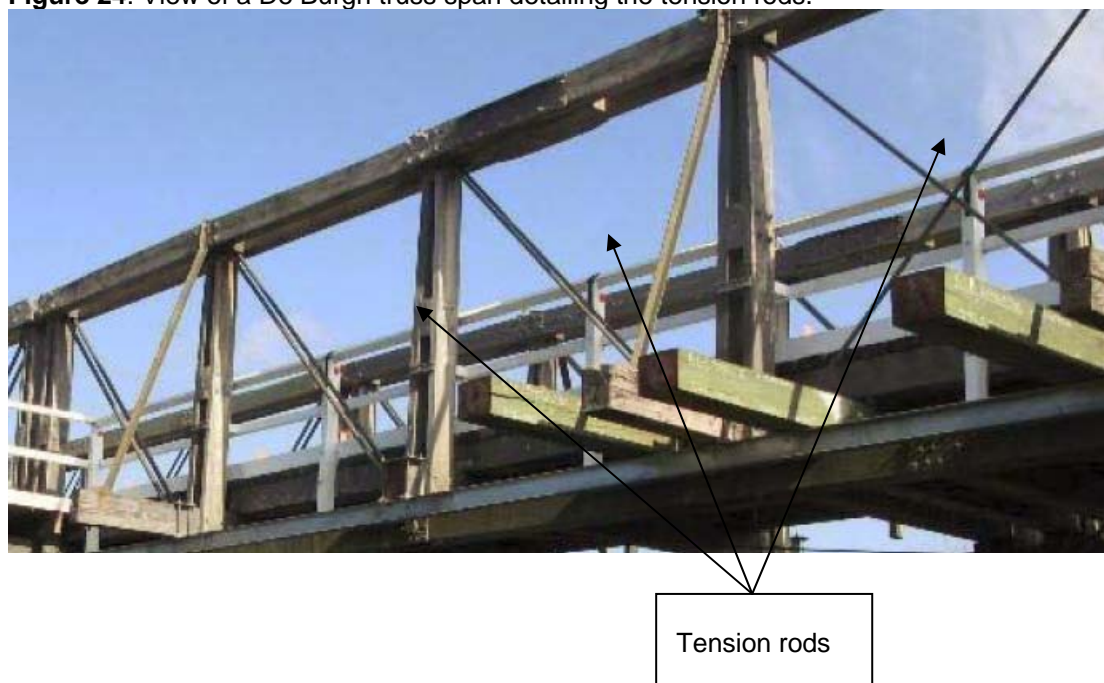
Figure 24: View of a De Burgh truss span detailing the tension rods.

There is widespread evidence of corrosion on the existing wrought iron tension rods in the form of “waisting” or loss of cross section in the area of the bottom chords. While like for like replacement of these components would be a preferred heritage option the inability to obtain wrought iron requires the RMS to substitute similar material instead.

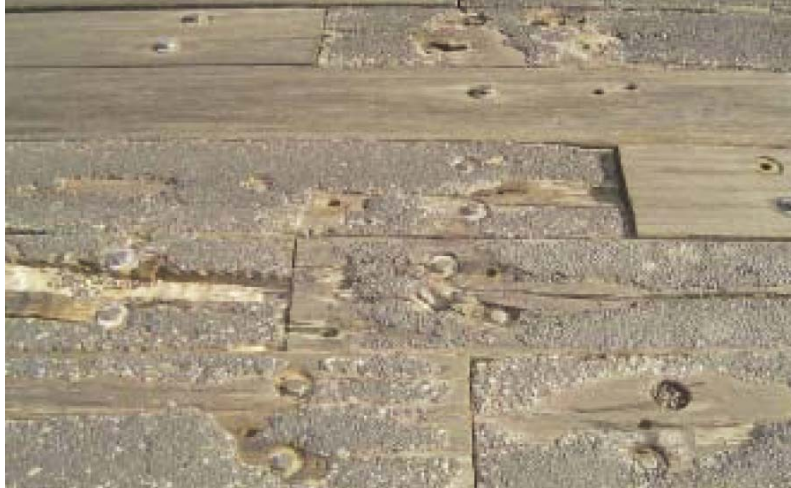
Figure 25: Detailed view of deck detailing its poor condition with splits and decayed timber.

The refurbishment of the timber deck in a “like for like” manner such that the form and fabric of the approaches would remain unchanged has been considered but rejected. While this would appear to be the best option from a heritage perspective it is not considered adequate as it does not address the issue that the Bridge does not meet current load requirements.

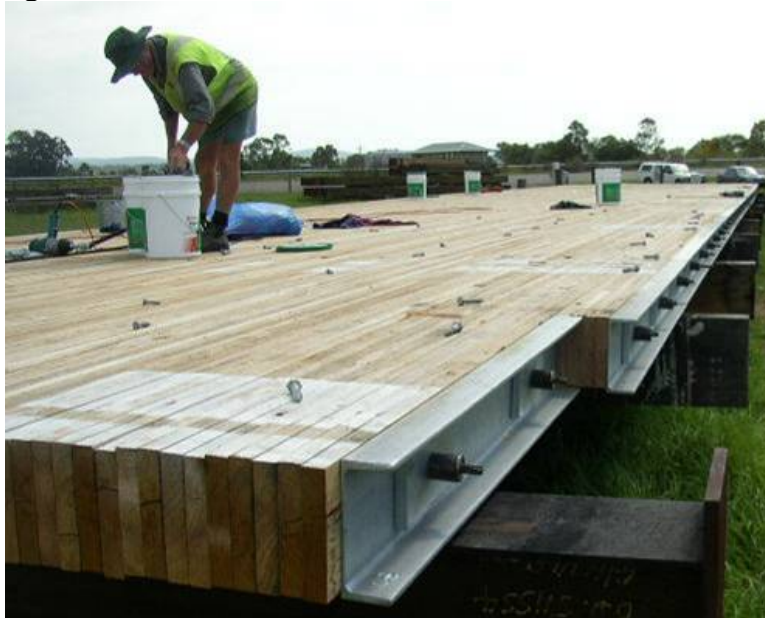
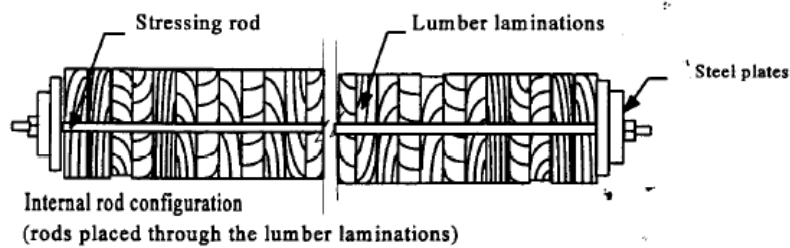
Figure 26: Cross sectional view of SLT decking system detailing timber laminates and stressing rod.

Deck strengthening on the truss spans involves the replacement of the existing timber deck with a transversely stressed Stress Laminated Timber (SLT) decking system. It consists of a series of timber laminates that are held rigid by the regular tightening of a stressing rod that runs transversely through the deck as shown in **figure 26**.

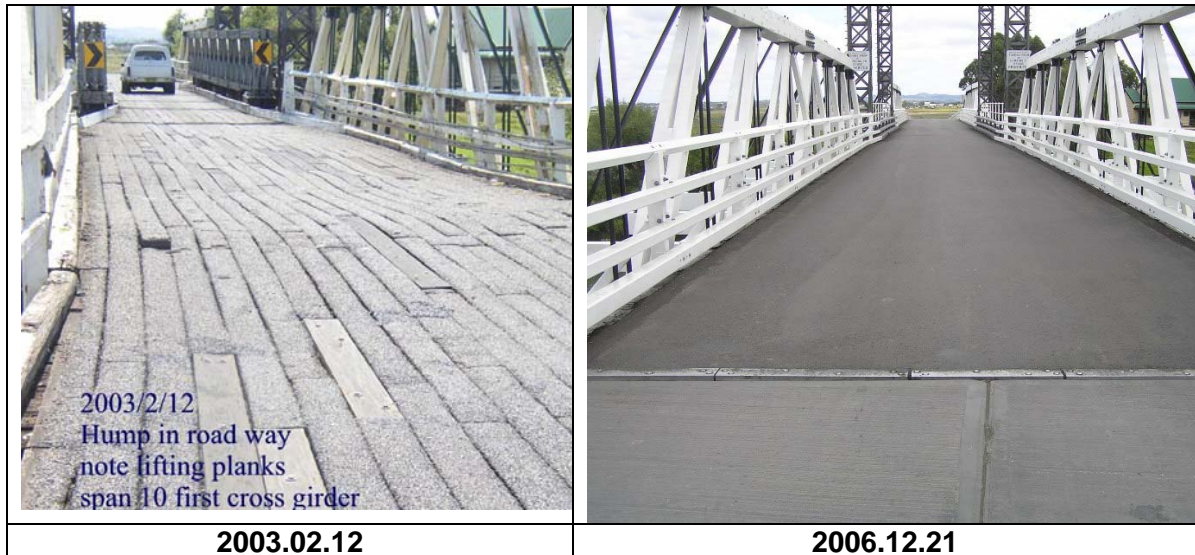
Figure 27: Two views of capacity upgrade of Hinton Bridge, detailing the change from timber planks to an SLT decking system topped with a rubberised bitumen seal.

SLT has a number of advantages over the current timber plank decking. It provides a more rigid surface for holding a sprayed bitumen and stone chip seal, providing a stronger and smoother running surface for traffic and lessens its dynamic effects. In addition, it has the advantage of being waterproof, so that rainwater would run off the edges of the deck preventing rapid deterioration of not only the deck but also the elements of the span below. This is an inherent flaw of the more traditional decking system, as there is no way to effectively waterproof it so that water does not run through and pool in the channels and crevices of the timberwork and steelwork below. The deck surface would be topped with a rubberised bitumen seal.

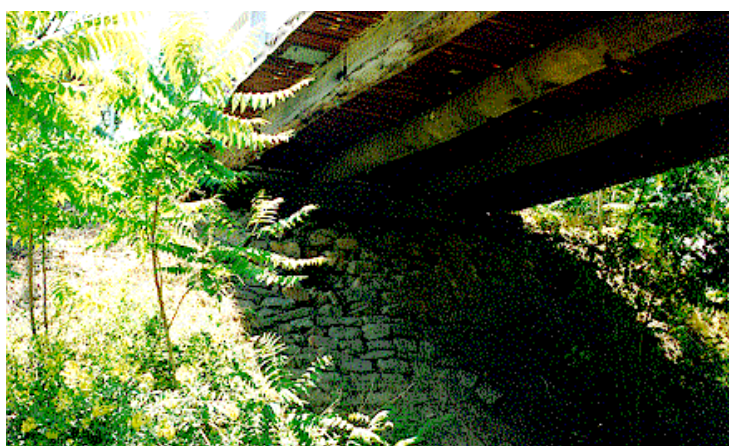
Figure 28: Abutment A at St Albans Bridge.

It is considered that **Option B** best meets the objective of the project of providing a long-term solution to the erosion at the NSW abutment to ensure that this critical bridge component is not undermined by scour. In addition to an improved engineering performance this option could mark a return of this component to a profile closer to its original design. An image of a similar original spill through abutment on a timber truss bridge is shown in **figure 28**.

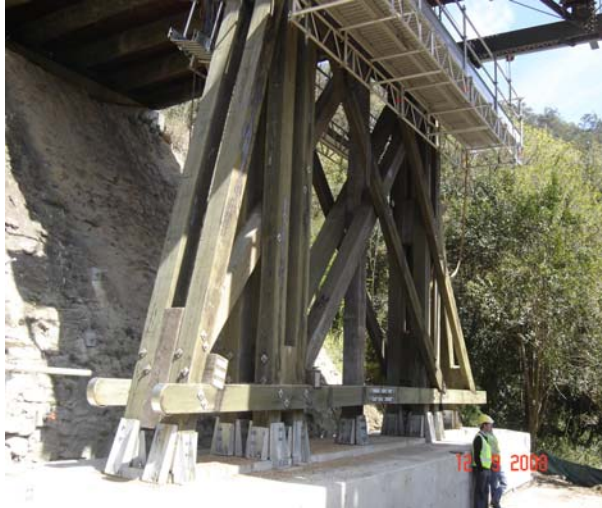
Figure 29: View of Pier 4 of St Albans Bridge detailing pilecap and steel shoes at base of timber trestle. A tall spill through abutment is visible at left.

Removal of central single column and replacement with two double columns. This option further involves the installation of steel shoes at the base of the columns to provide full fixity in line with the existing structural system. The proposed steel shoes provided are in line with those previously approved and since constructed on the SHR listed timber truss bridge at St Albans Bridge (**figure 14**).

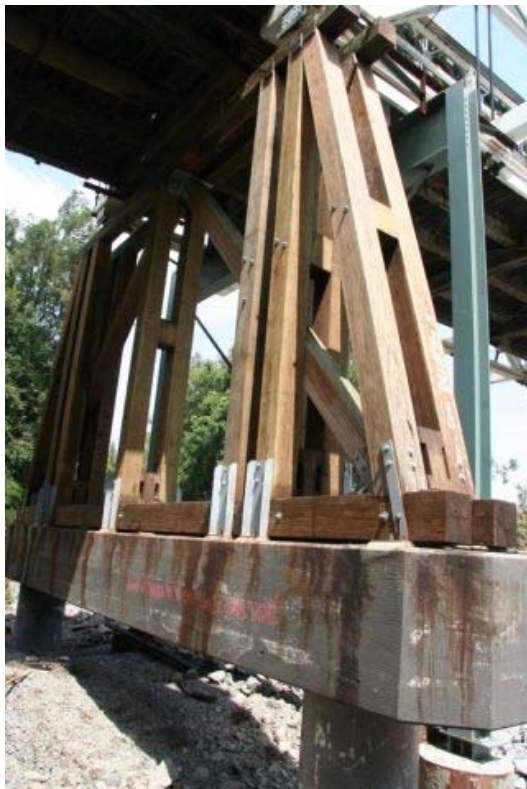
Figure 30: View of Pier 3 of Coorei Bridge detailing pilecap and steel shoes at base of timber trestle. The capwale is just visible at the top of the pier.

Removal of central single column and replacement with a single double column (see **Appendix E Sheet 3**). As a variation on the steel shoes of Option 1 consideration has been given to the installation of hinge connections. Hinge connections have previously been approved and since constructed on the SHR listed timber truss Coorei Bridge near Dungog (**figure 30**).

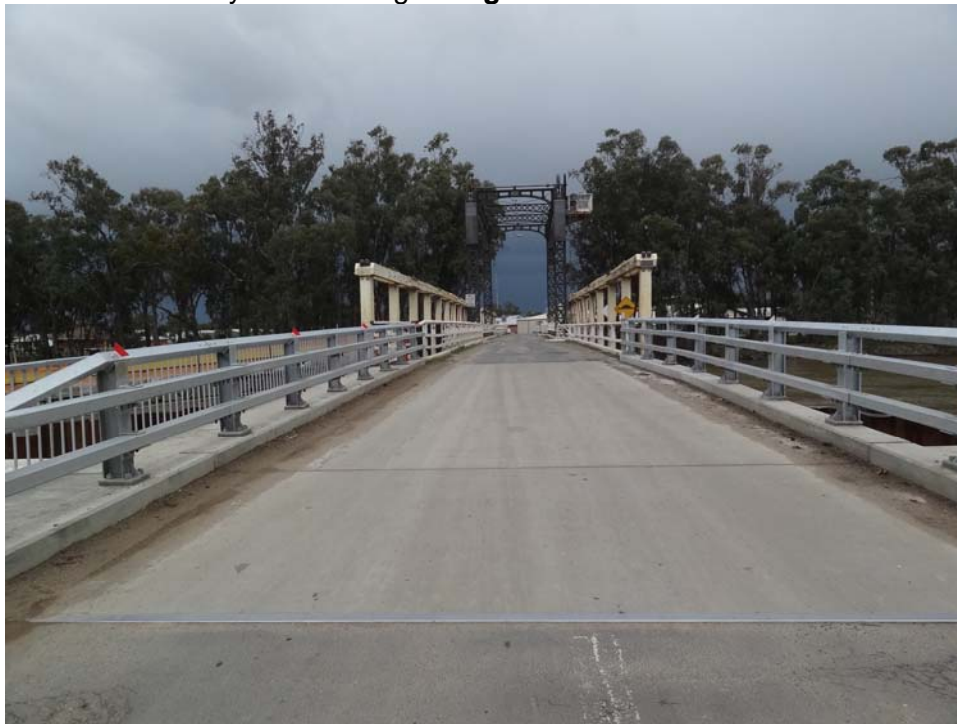
Figure 30: View completed NSW approach span (span 1) of Barham Bridge in March 2014 prior to painting of barrier railing white.

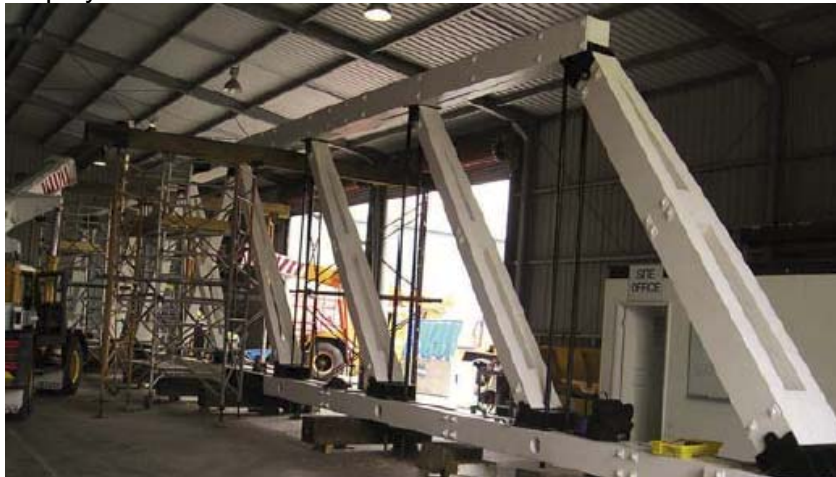
Figure 32: Replacement truss span of Hinton Bridge under construction in 2006.

In order to ensure least disruption to the community and driving public the trusses would be built under cover in sheds near the bridge site. This would ensure that all components are structurally sound before being fitted onto the bridge (**figure 32**). This method of fabrication also removes the risk of working at heights to RMS employees.

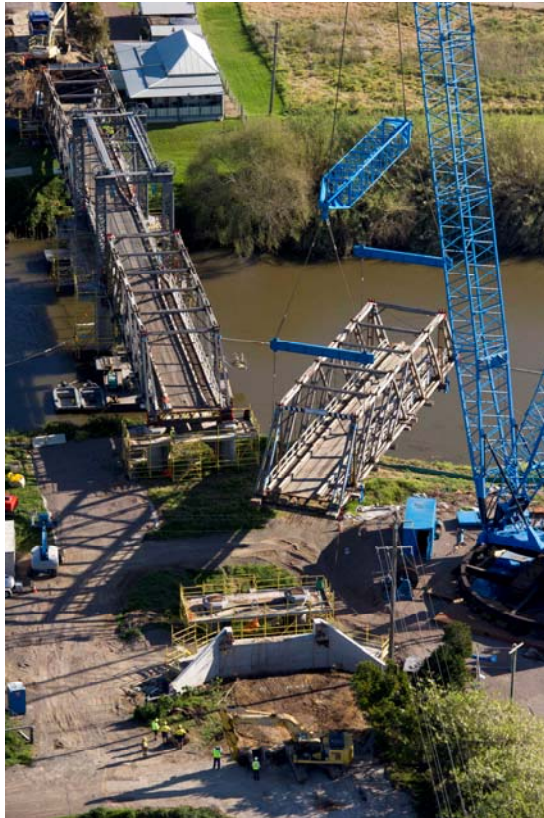
Figure 33: Truss being removed from Dunmore Bridge in 2013 prior to a replacement truss being manoeuvred into position.

Once completed the trusses are trucked to site, the existing trusses removed and the replacement trusses craned into position. **Figure 33** illustrates this process underway as part of the Dunmore Bridge upgrade which received the Colin Crisp award from Engineers Australia for Heritage Conservation.
