# **Batemans Bay Bridge replacement**

Soils and Geology Assessment

**Roads and Maritime Services**

Reference: 256009-005-01

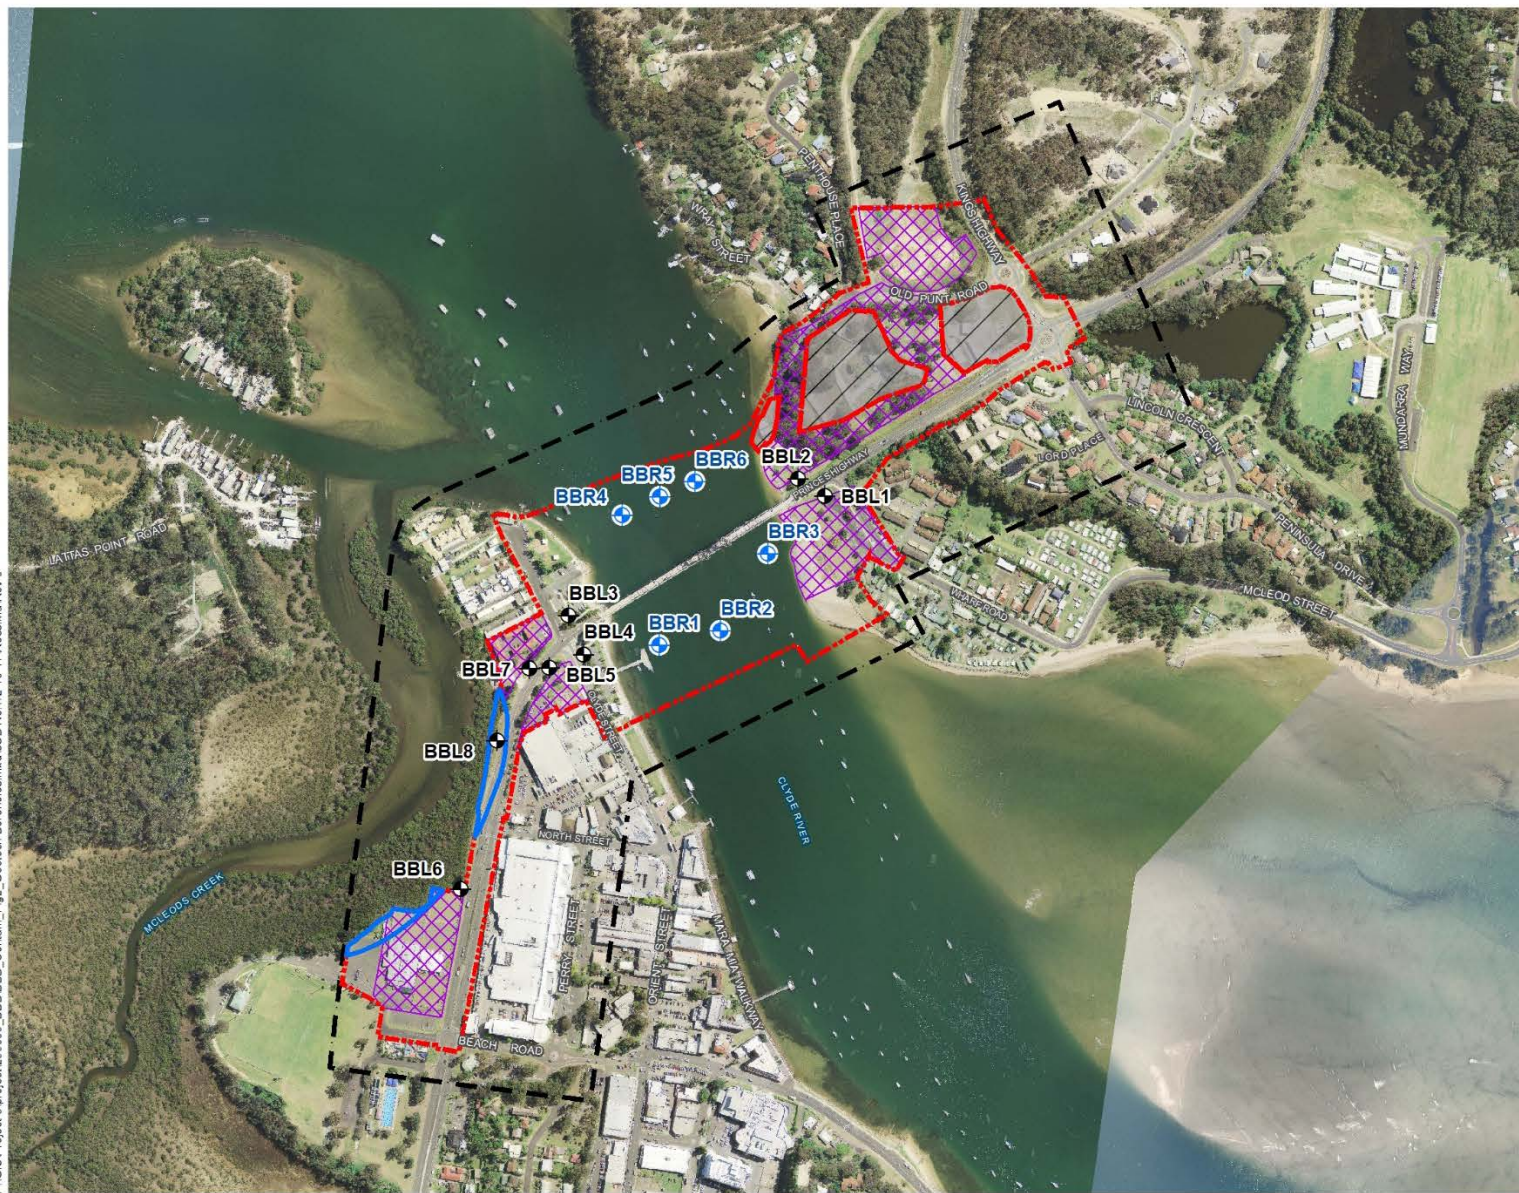
**Batemans Bay Bridge replacement**  
**FIGURE 2-1: Geotech Boreholes**

Results from geotechnical drilling indicate topsoil is present in only one location (BBL2). Fill materials comprising sand, silty sand, gravelly silty sand and gravelly sandy clay were observed at variable depths, up to a maximum thickness of 1.6m. The base of fill material ranged from 2.02mAHD to 0.37mAHD.

Recent investigation in 2017 by Newcastle Geotech has identified variable thickness of alluvial sediments to be present within the proposal area and surrounds at both land-based and over-water locations, where exploratory holes have been drilled (BBL1 to BBL8 and BBR1 to BBR6).
