Bolivia Hill Upgrade - Assessment of
Route Options

APPENDIX E
AQUATIC ECOLOGY REPORT

Aquatic Flora and Fauna Biodiversity Investigation

Prepared for
Roads and Maritime Services

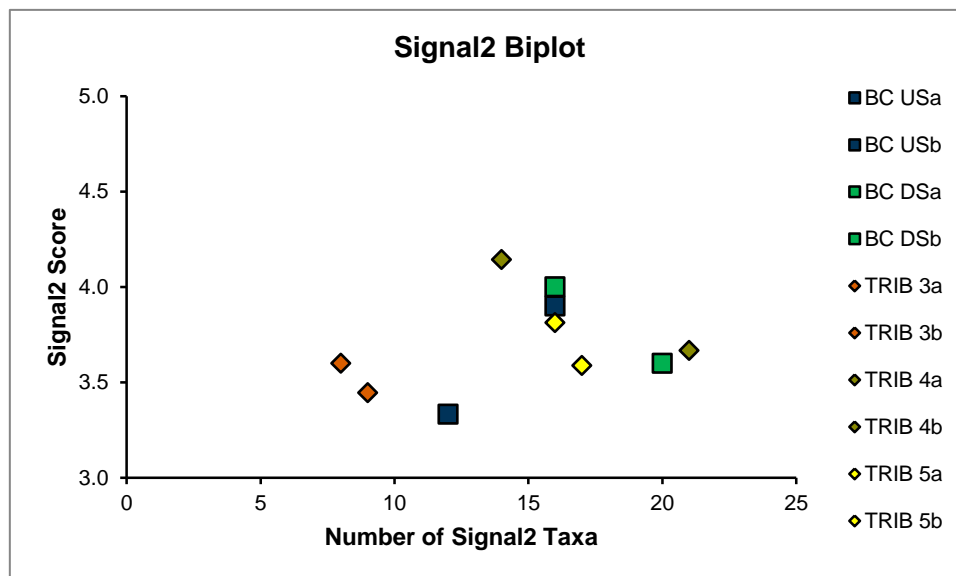
Figure 4-2 SIGNAL2 bi-plot for samples collected from Brickyard Creek and the Tributary

A graphical representation of the SIGNAL2 outputs is provided in **Figure 4-2**. Most samples had a SIGNAL2 score below 4, indicating potential pollution issues, while only one sample, from Site TRIB 4, had a score above 4 (4.1). SIGNAL2 outputs from most replicates taken from each site fell close to each other (**Figure 4-2**). Brickyard Creek had the highest difference among replicates with a variation in SIGNAL2 Score of 0.3. As can be seen in the plot, there was wide range in the number of SIGNAL2 taxa present in samples, however this had little influence on the scores.
