Preliminary Site Investigation

Bungendore Station

03 May 2022

Project No.: 0608750

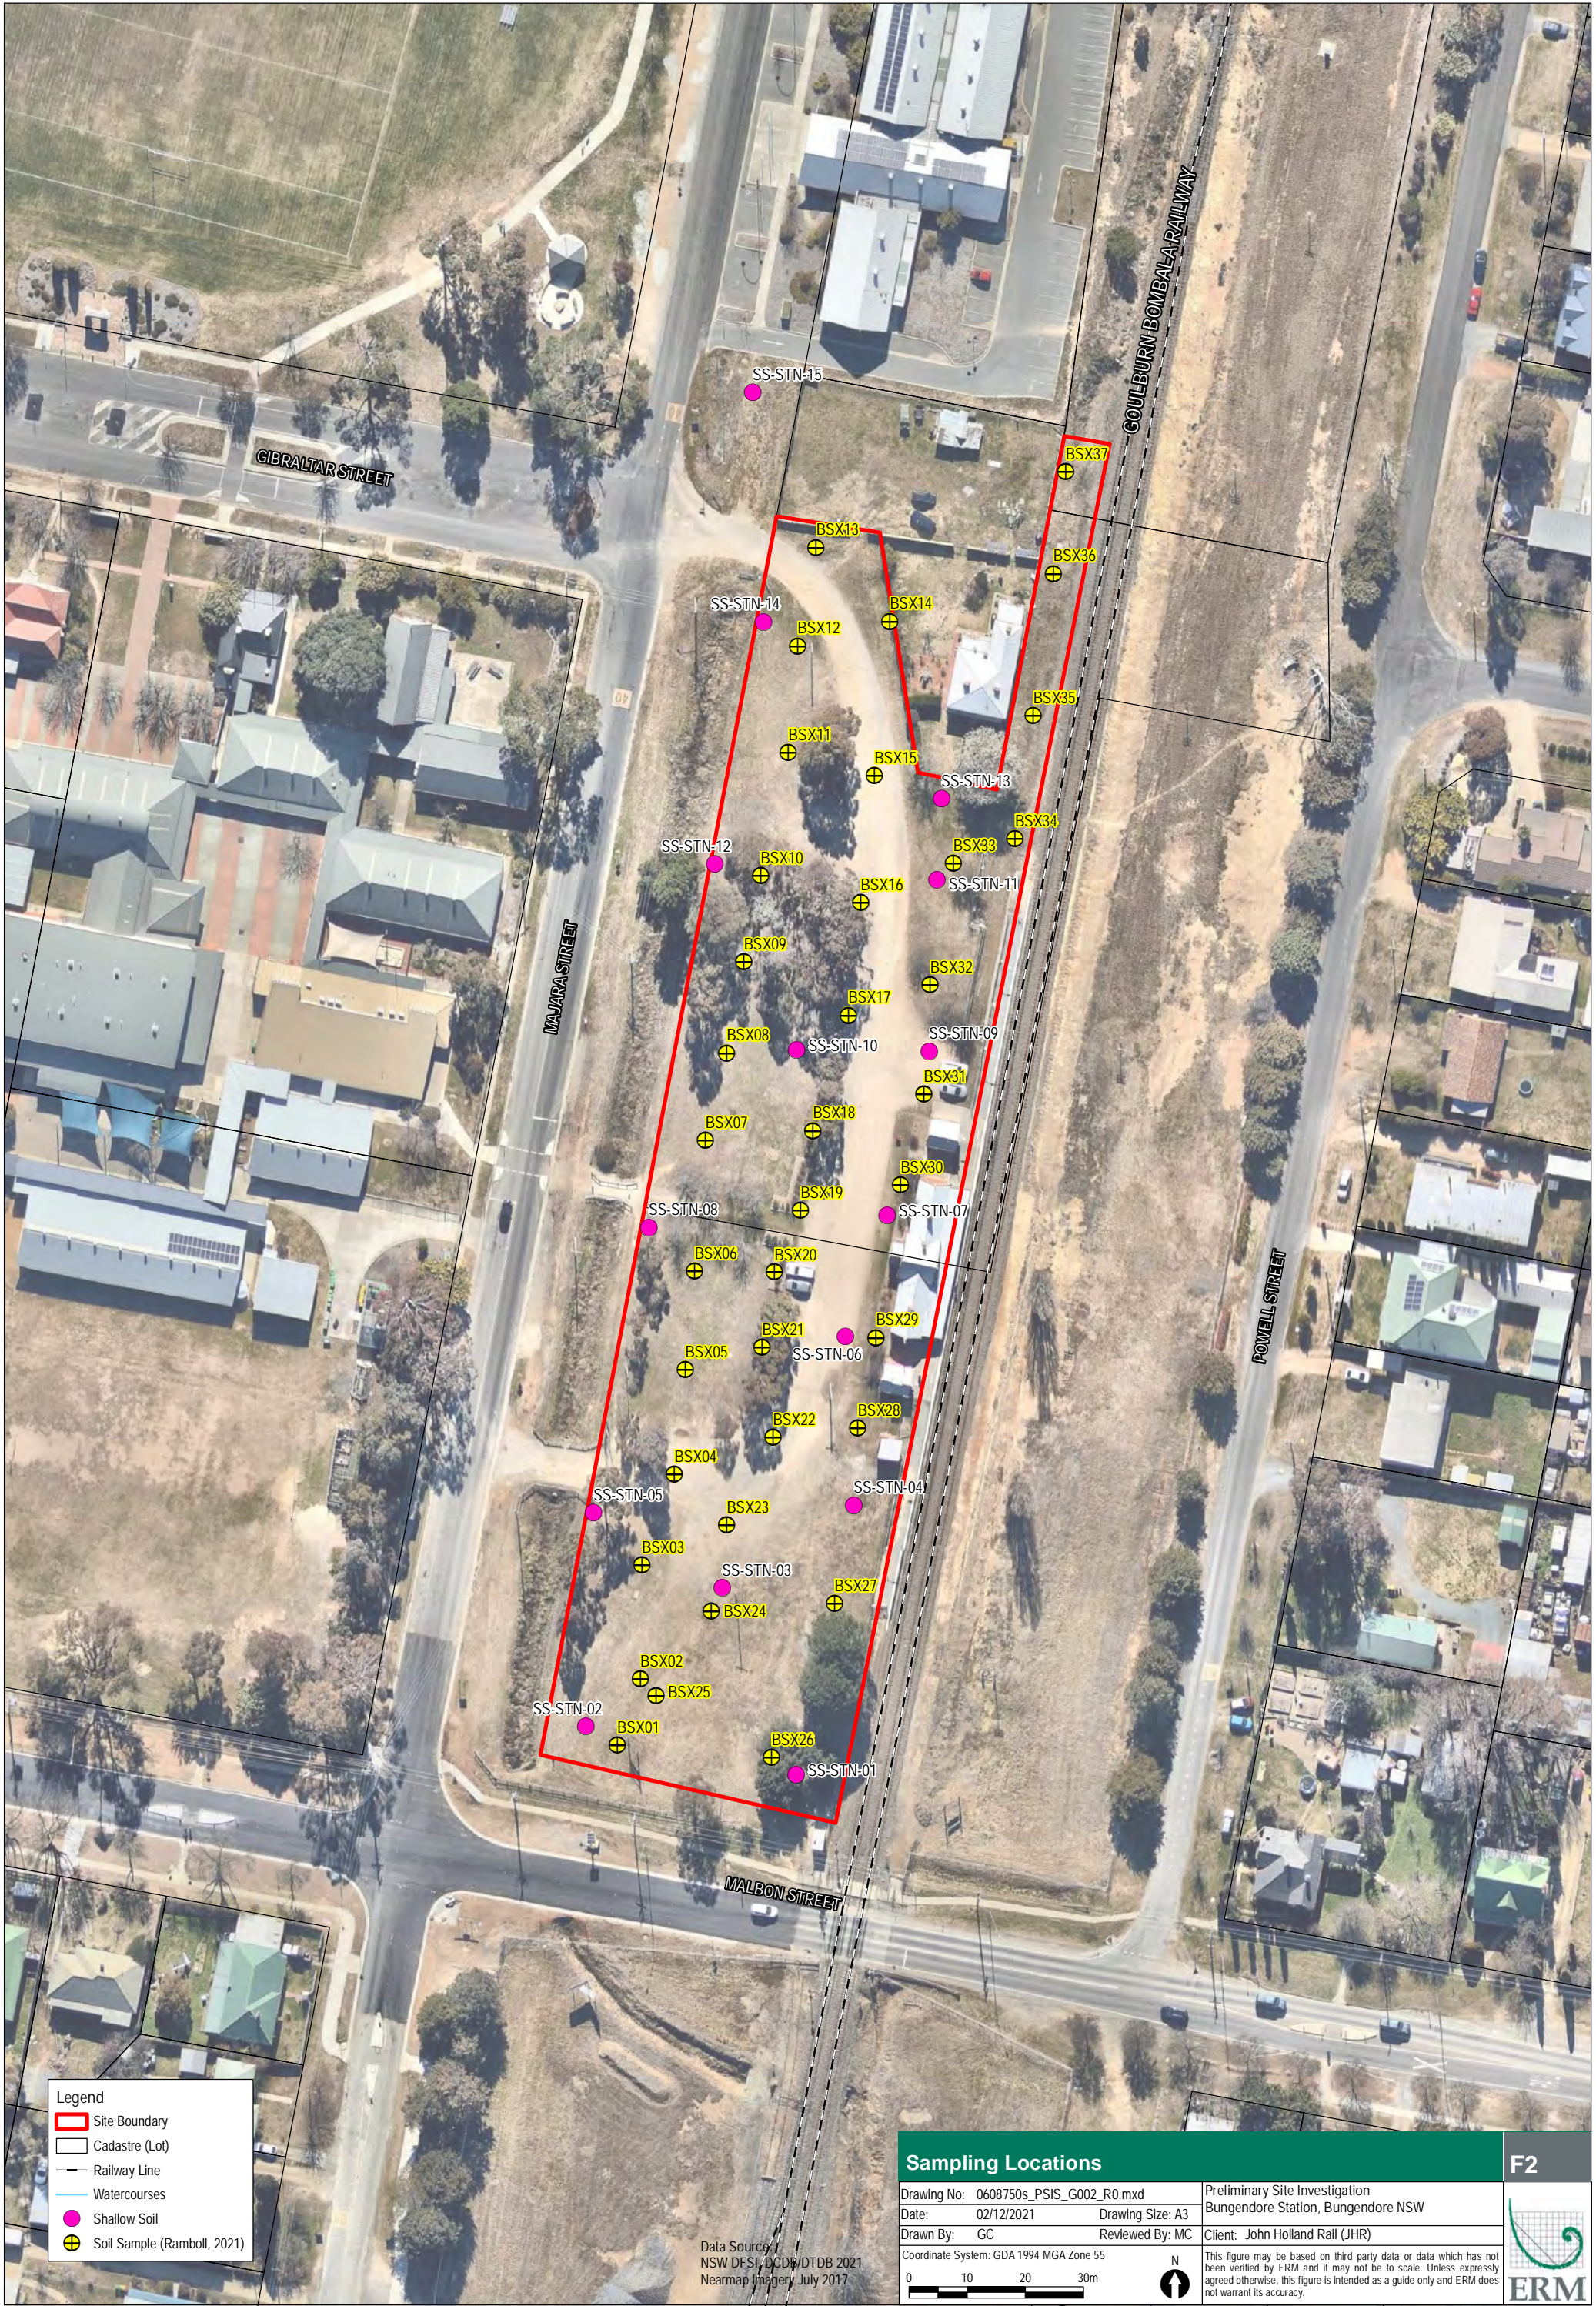
Given the preliminary nature of the investigation, soil sampling design and spread were focused upon gaining a comprehensive and representative understanding of the condition of surface soils. Surface soil samples at the Site were sampled on a ~25m herringbone grid pattern. Sampling locations are illustrated in *Figure 1, Appendix A*.

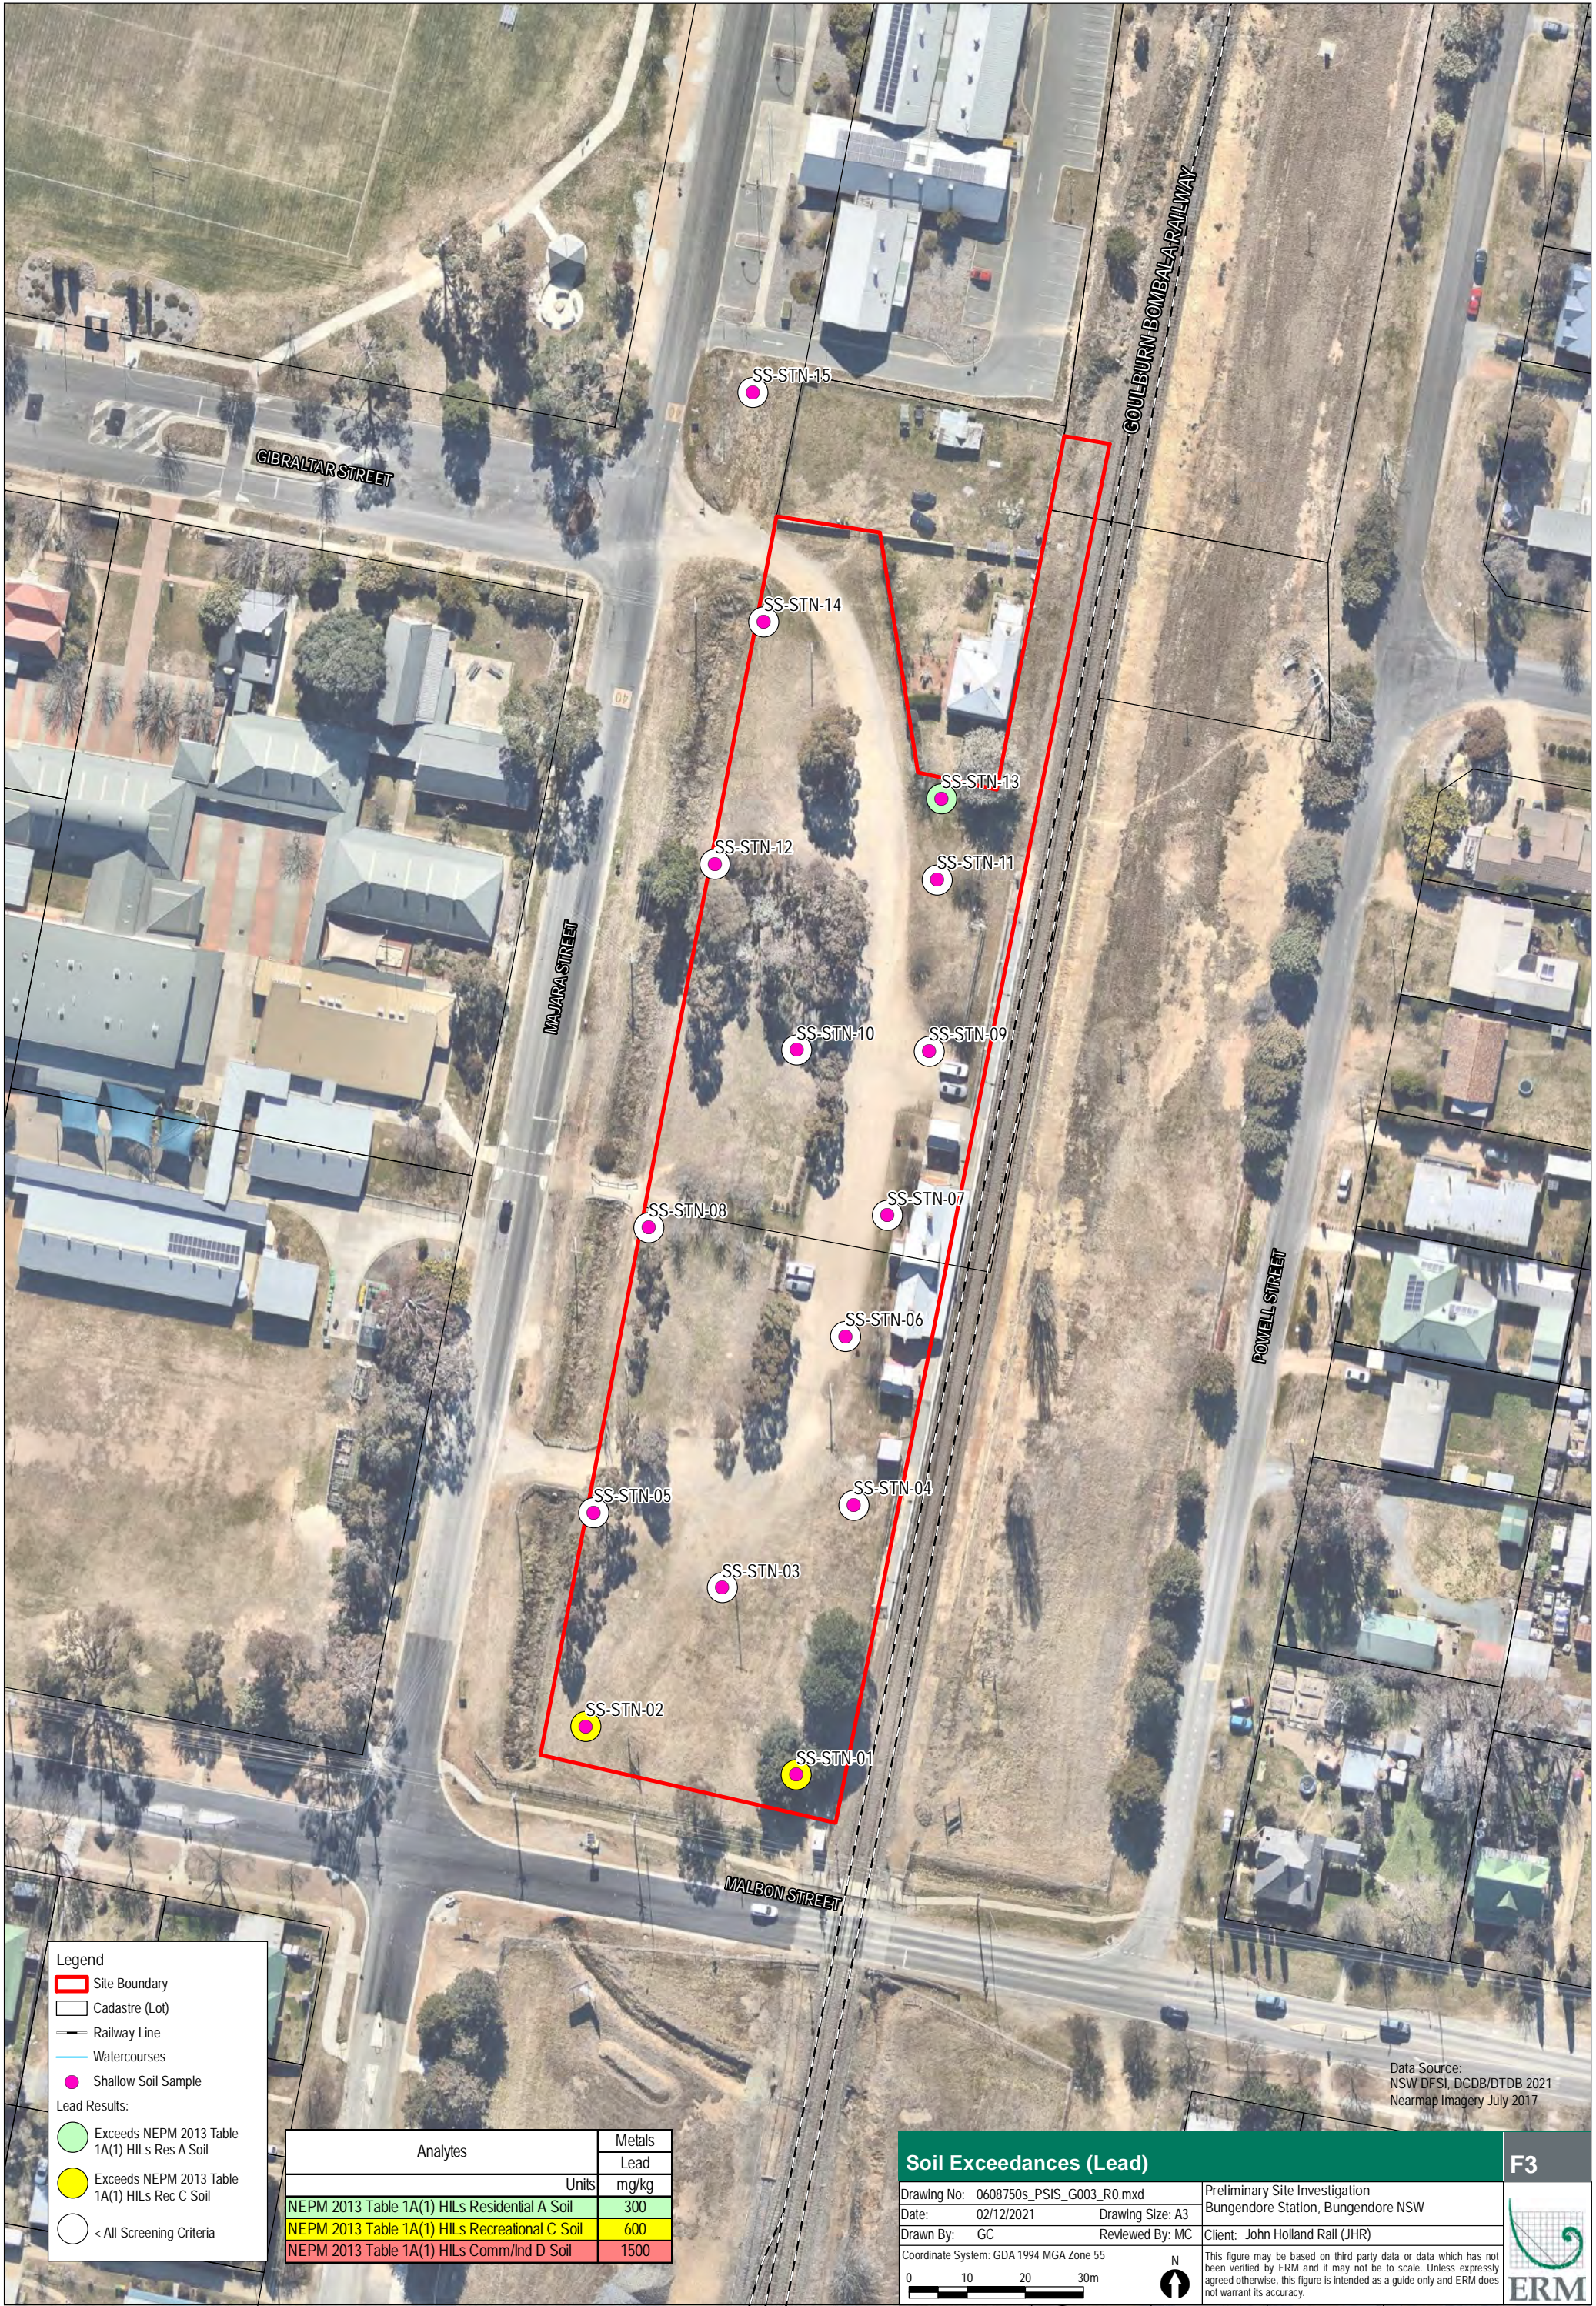
Based on the data collected, concentrations of lead in shallow soils (<0.1 m bgl) are present above applicable screening criteria at a number of locations with the most elevated concentrations observed in the southern portion of the Site and in proximity to the rail line. Concentrations observed during this PSI exceeded recreational HILs at depths of 0.05 - 0.1 m bgl, however historical data (Rambol 2021) indicates concentrations in surface soils exceed commercial/industrial criteria. Concentrations immediately to the east of the former Stationmasters residence (in proximity to the rail line) exceed both residential and commercial/industrial criteria. However, concentrations appear to decrease rapidly with distance from the rail line.

- Concentrations observed during this PSI exceeded recreational HILs at depths of 0.05-0.1 m bgl, however historical data (Rambol 2021) indicates concentrations in surface soils exceed commercial/industrial criteria and concentrations decrease rapidly with depth;

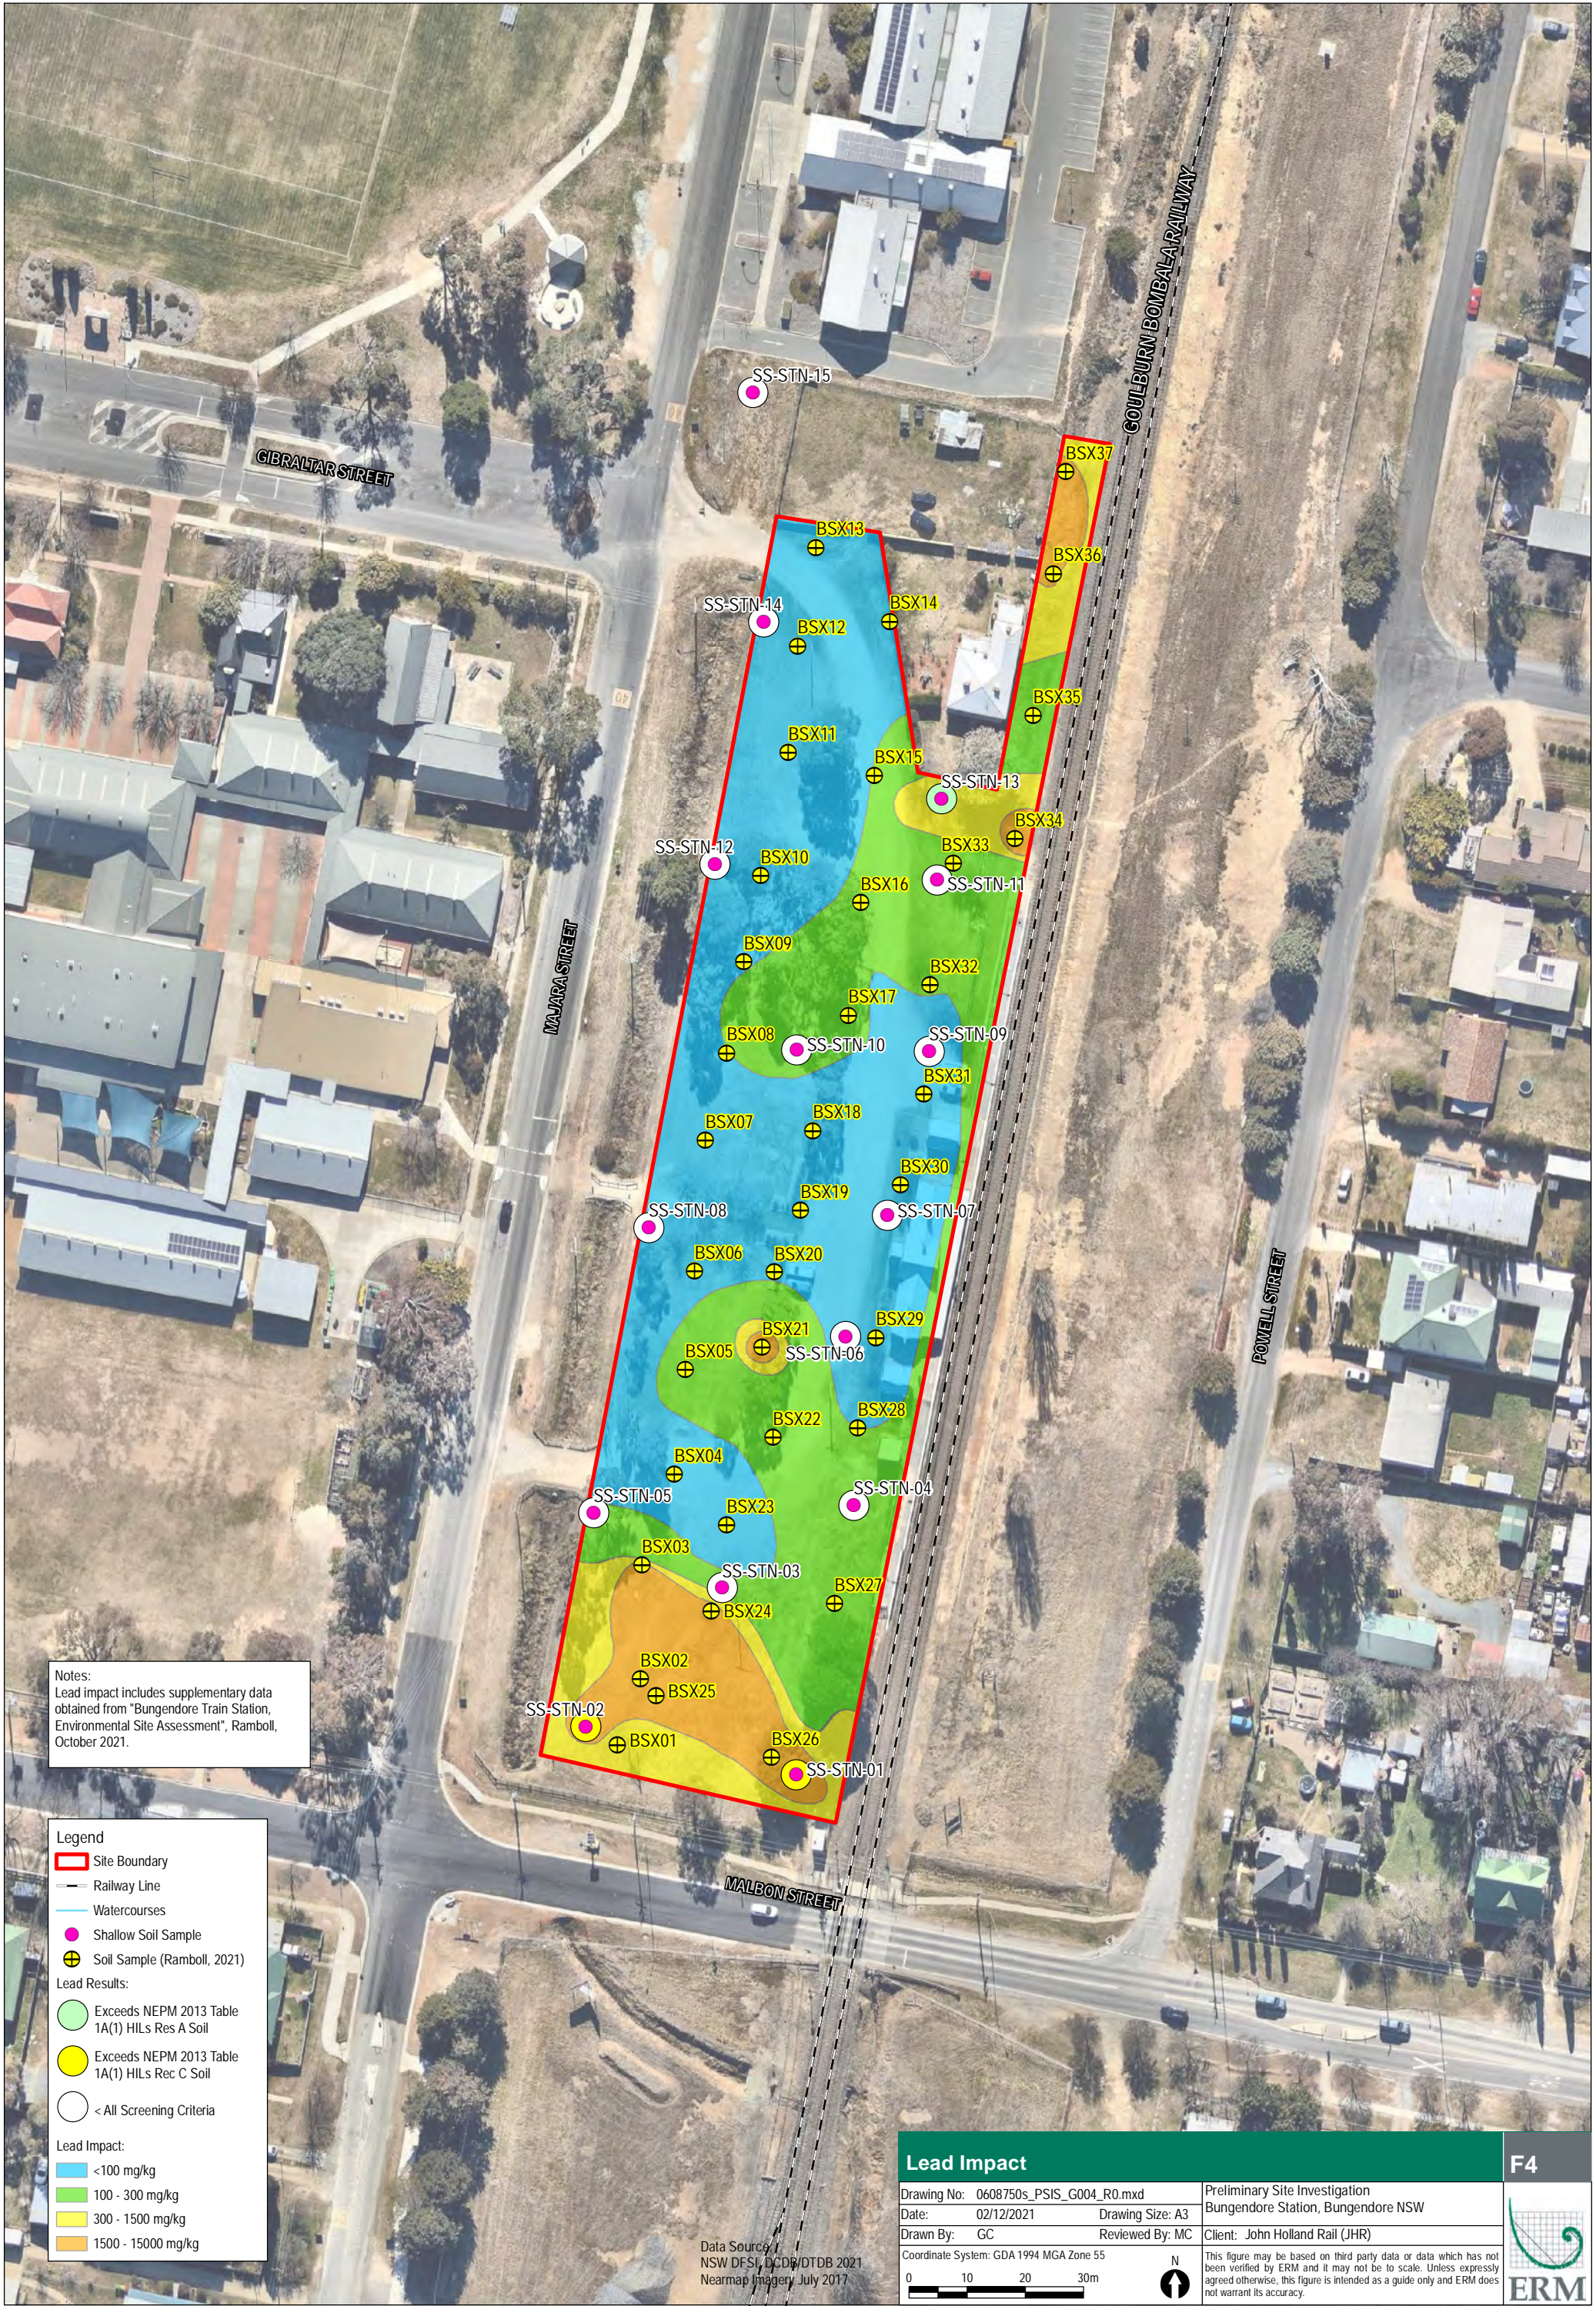
Given that lead is the primary COPC for the Site on the basis of the primary contaminating activities involving movements of lead ore, a concentration map which uses the observed concentrations of lead to estimate potential concentrations across the Site has been included as *Figure 4, Appendix A*.

However, concentrations appear to decrease rapidly with distance from the rail corridor and concentrations observed to the south and west of the residence were below residential criteria. Lead concentrations along the western Site boundary were also below all screening criteria, indicating that the lead concentrations in surface soils observed onsite may not extend offsite to the west.

Results obtained both as part of this investigation and the Rambol investigation demonstrated that the concentrations in the surface soils (0-0.05m bgl) were up to an order of magnitude higher than soils at 0.1m bgl. Samples collected during this investigation were collected from 0.05-0.1m bgl and were therefore lower than the concentrations observed by Rambol.

The observed distribution of the lead concentrations observed has been mapped in *Figure 4, Appendix A*.

Based on the identified lead impact in surface soils at the Site, and the potentially complete SPR Linkages present, a duty to notify the NSW EPA under S.60 of the CLM Act (1997) is considered to have been triggered. As part of the notification process, it is recommended that the NSW EPA should be engaged to discuss whether additional data collection and further assessment of potentially complete SPR Linkages may be beneficial in the NSW EPA's assessment of the Site. This Site should be managed as part of the broader Bungendore Rail Precinct.

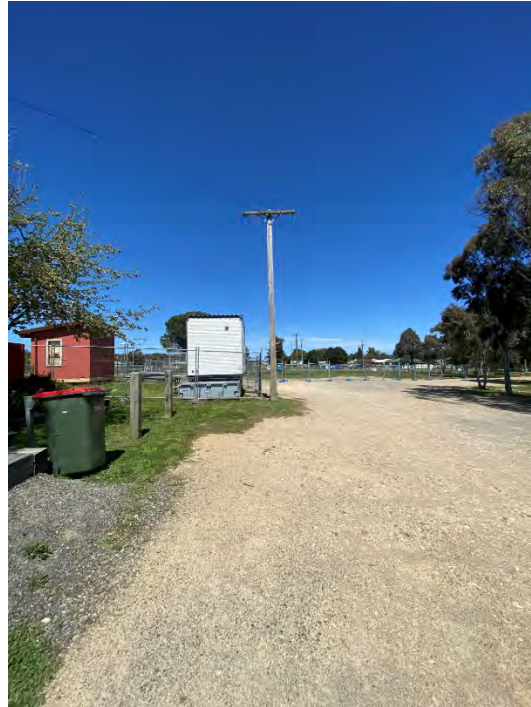
Temporary fencing erected to prevent parking and access to the southern portion of the Site.

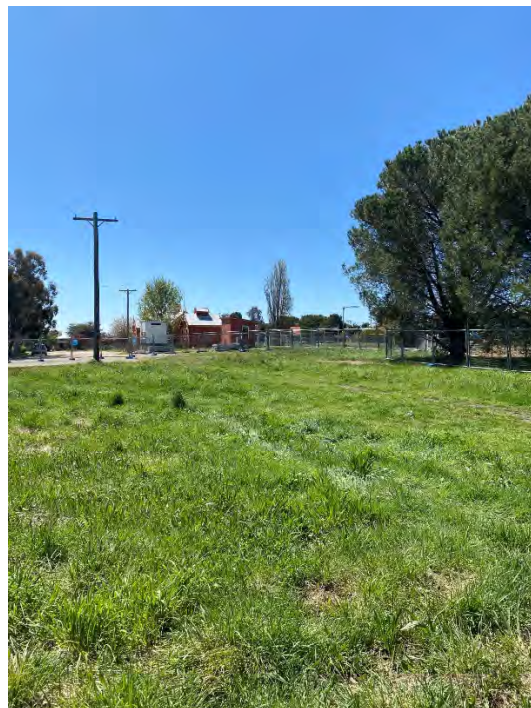
Patchy long grass looking towards the station building.

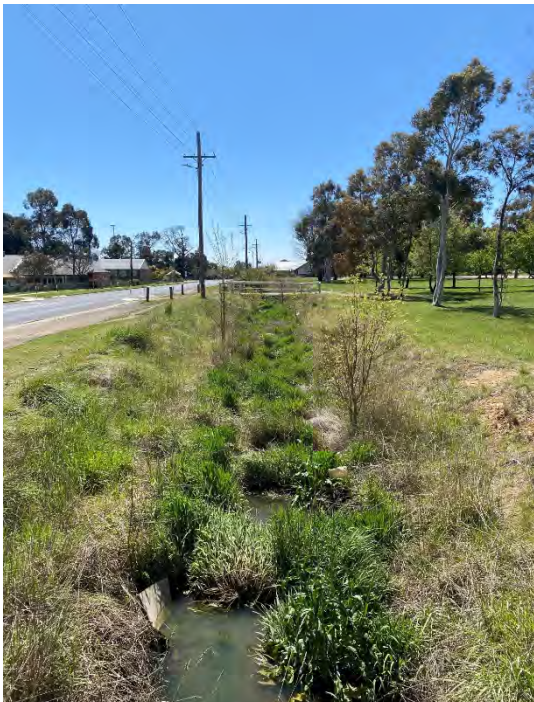
Photo No. 9	Date:

Stormwater and associated runoff is directed offsite through open drainage channels along the western site boundary towards Turallo Creek, to the north surface water is generally expected to either infiltrate directly through the soil profile or in sheet flow in a north-westerly direction.

Direction Photo Taken: North		
Description: The drainage channel running the length of the western Site boundary.

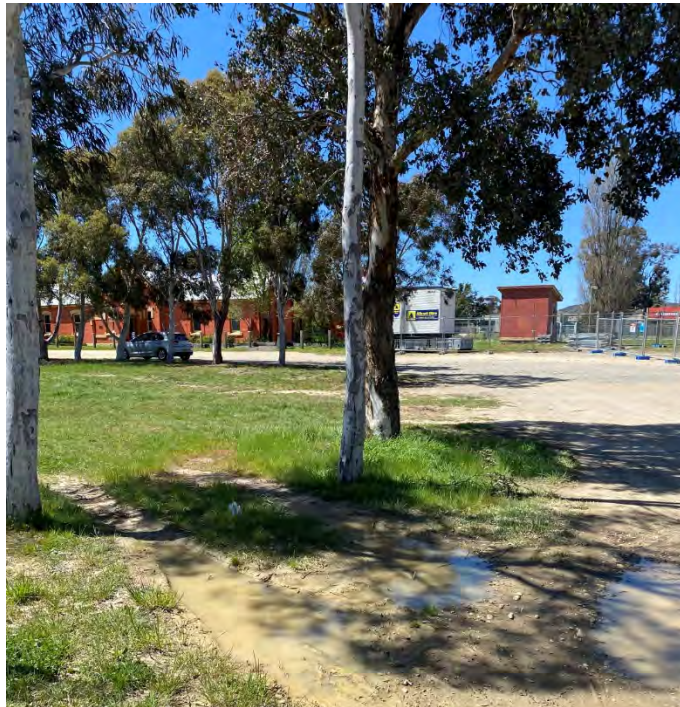
Photo No. 10	Date:

Direction Photo Taken: East		
Description: Pooling water in an area with low groundcover north of the southern access on Majara St.

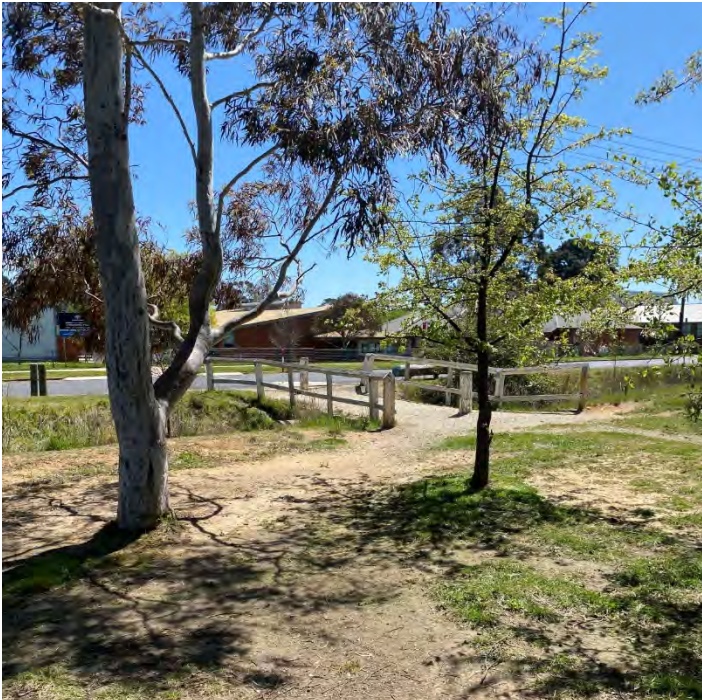
- Bare patches were noted amongst grassed areas across the site, particularly towards the car parking area, and towards the northeast of the site. Grass was also longer, although patchy towards the southern extent of the site;

Direction Photo Taken: North-west		
Description: Bare patches amongst gumtrees east of the walking bridge in the mid-west of Site.

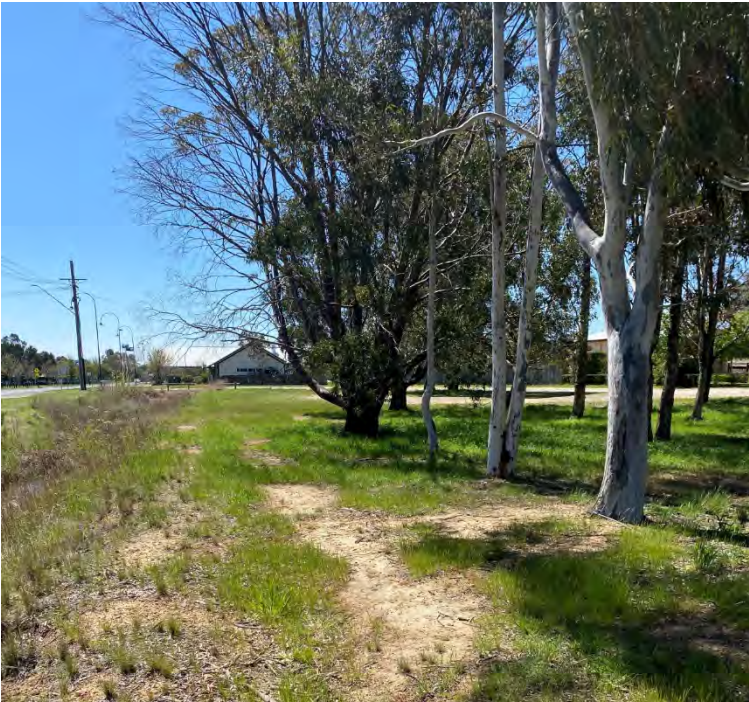
Direction Photo Taken: North		
Description: Bare patches amongst large gum trees in east of the drainage channel in the northwest of Site.

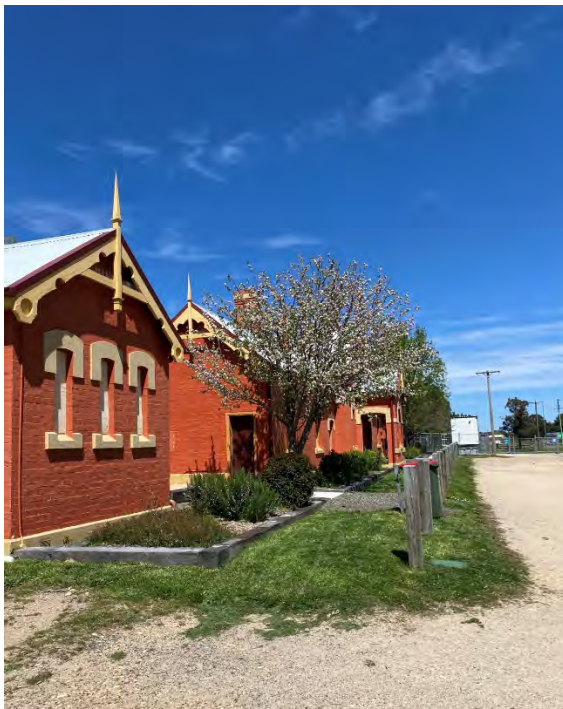
Direction Photo Taken: South-east		
Description: The station building, near to SS-STN-07.
