Epping Road widening between Essex Street and Blaxland Road, Epping

Appendix C
Traffic and transport impact assessment
Part D

Epping Road Widening between Essex Street and Blaxland Road at Epping Pedestrian Access Study

8th October 2015

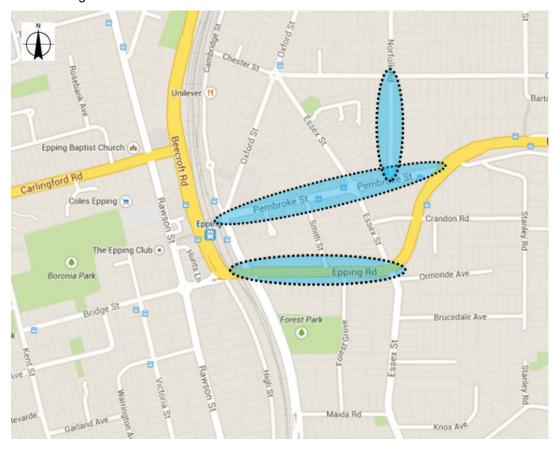
Figure 1 Study area

The study area is surrounded mostly by residential properties to the north and south and is shown in Figure 1.

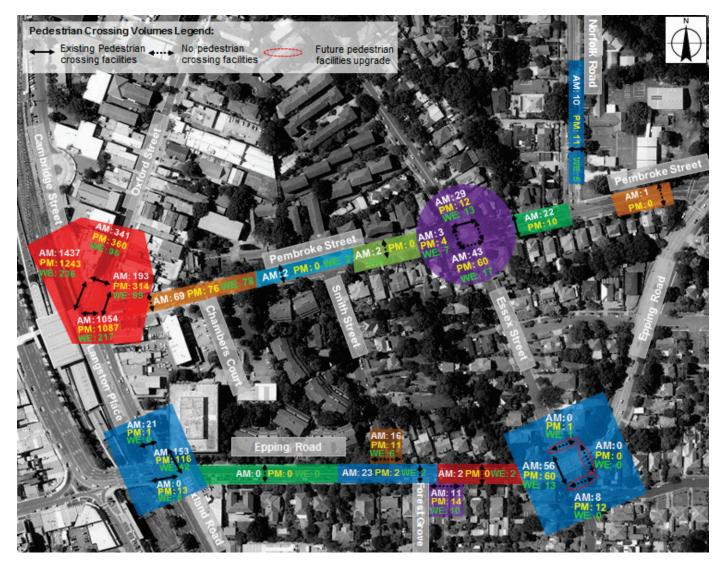
Figure 2 Hourly pedestrian crossing volumes during peak vehicular hours

Diagrammatic representations of the pedestrian survey data is shown in Figure 2 with detailed reports found in Appendix B.

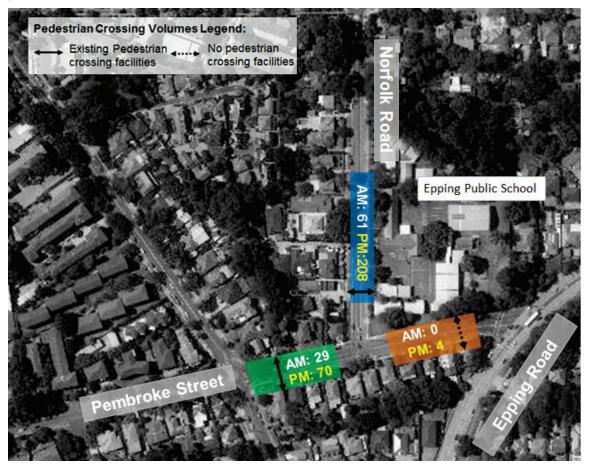
Figure 3 Peak pedestrian crossing volumes in the vicinity of Epping Public School

The pedestrian peak correlates with the road network peak around the train station. However on Pembroke Street in the vicinity of Epping Public School and on Norfolk Road the pedestrian peak relates to the School start and finish times.

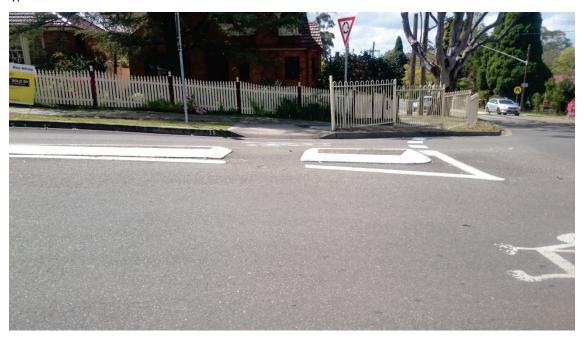
Photo 1 North approach pedestrian refuge island and fencing

A pedestrian refuge island with minimal dimensions can be found on the northern approach of the roundabout, providing access across Essex Street. Pedestrian fencing can also be found in the vicinity of the roundabout which prevents crossing through the roundabout as seen in Photo 1.

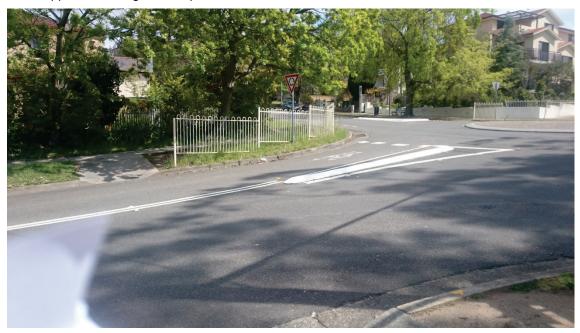
Photo 2 South approach of Pembroke Street and Essex Street roundabout

The southern approach of the roundabout does not have any pedestrian crossing facilities, however does have pedestrian ramps shown in Photo 2. This encourages pedestrians to use the ramps and not cross the carriageway too close to the roundabout which could pose as a hazard. Pedestrian surveys show that 60 pedestrians per hour crossed Essex Street from the south approach during the PM peak.

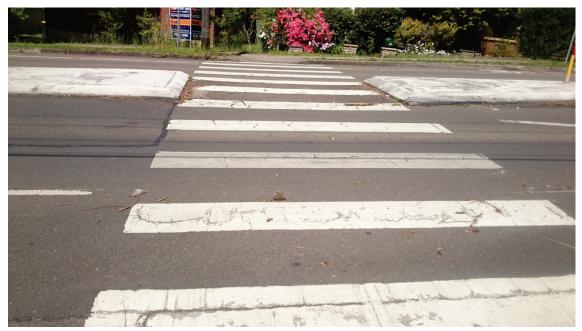
Photo 3 Pedestrian crossing, east of Pembroke Street and Essex Street roundabout

A pedestrian crossing is located on Pembroke Street east of the Essex Street roundabout, providing access across Pembroke Street (Photo 3). As seen from the pedestrian survey data, no pedestrians were recorded crossing the eastern approach at the roundabout. Pedestrians crossing Pembroke Street from the east approach are most likely using the pedestrian crossing.

This pedestrian crossing has a pedestrian refuge in the centre of the road; the refuge island should ideally have keep left signs on the ends in accordance with AS 1742.10 (2009).

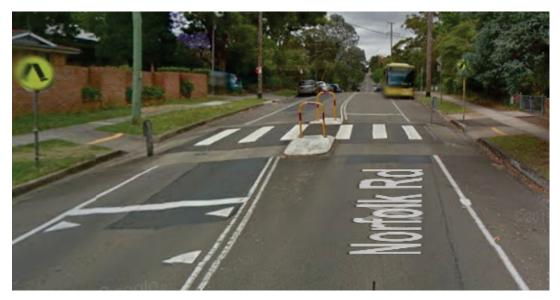
Photo 4 Norfolk Road – pedestrian crossing adjacent to Epping Public School

There is a pedestrian crossing currently located on Norfolk Road around 60 metres north of Pembroke Street adjacent to Epping Public School.

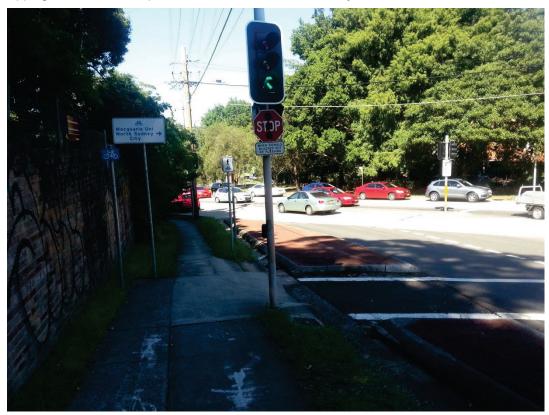
Photo 5 Pembroke Street, approach to Epping Road

The designated shared path facilities provided at the intersection of Pembroke Street and Epping Road are inadequate in terms of width and visibility.

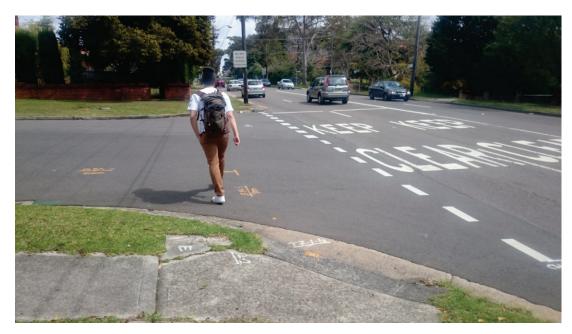
Photo 6 Epping Road, east of Forest Grove

During the AM peak, 23 pedestrians were recorded to be crossing the four lanes of traffic on Epping Road between Smith Street and Forest Grove. This area can be seen in Photo 6. The nearest signalised pedestrian crossing facilities are located to the east and west of the segment at around 150 metres away.

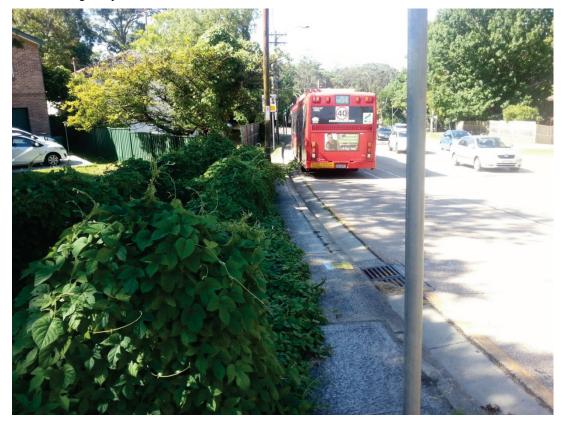
Photo 7 Epping Road, south of Pembroke Street

There is a significant amount of overhanging vegetation obstructing the existing footpaths on the section of Epping Road between Pembroke Street and Essex Street. There are locations where the footpath is totally blocked through vegetation and power poles located within the footpath and also other areas where overhanging vegetation forces pedestrians to walk right on the kerb edge adjacent to the traffic lane as shown in Photo 7.

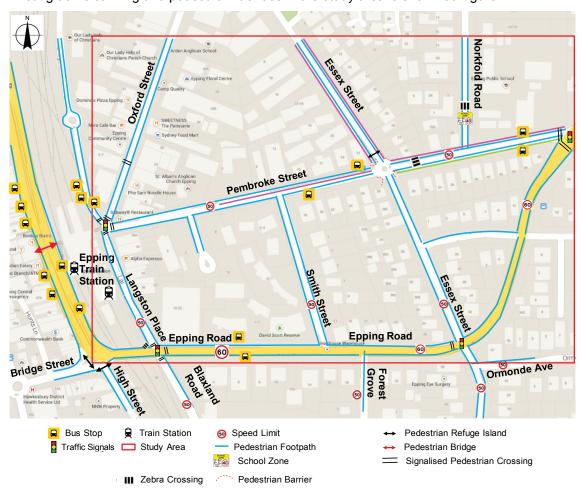
Figure 4 Existing pedestrian infrastructure map

Existing traffic calming and pedestrian facilities in the study area is shown at Figure 4.

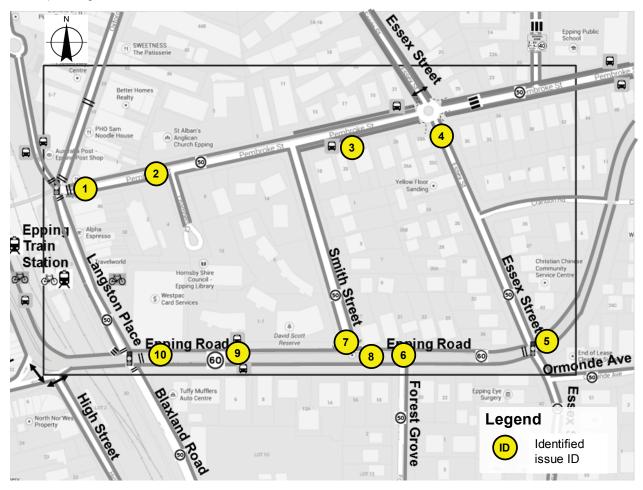
Figure 5 Locations of existing issues and constraints for pedestrians

The issues and constraints for pedestrian access and mobility were determined in a field survey. A summary of the constraint locations are shown in Figure 5 and a description and photos of the corresponding identified issue ID in the tables below.

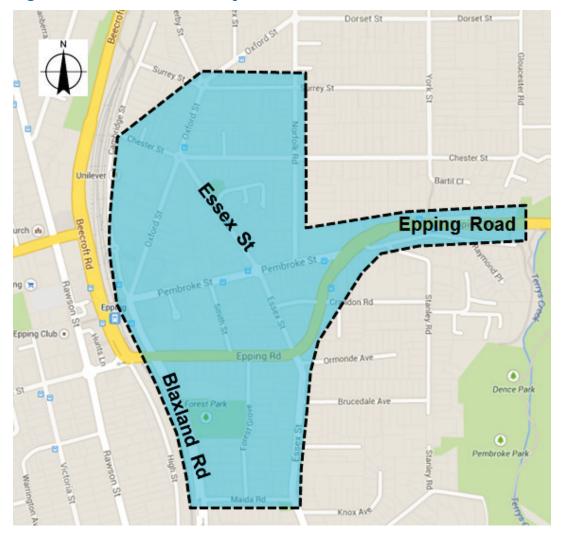
Figure 6 Crash statistic study area

A total of 125 crashes were recorded within the study area. These crashes involved 134 light vehicles and five heavy vehicles. Five pedestrian crashes were recorded, of these all involved pedestrians crossing the carriageway.

A high level assessment was undertaken of vehicle crash data for the study area for the years 2009 to 2014, based on the Roads and Maritime crash data. Within the five-year period, 125 crashes were recorded in the study area, which is illustrated in Figure 6. The following key points were noted from the assessment of this data:

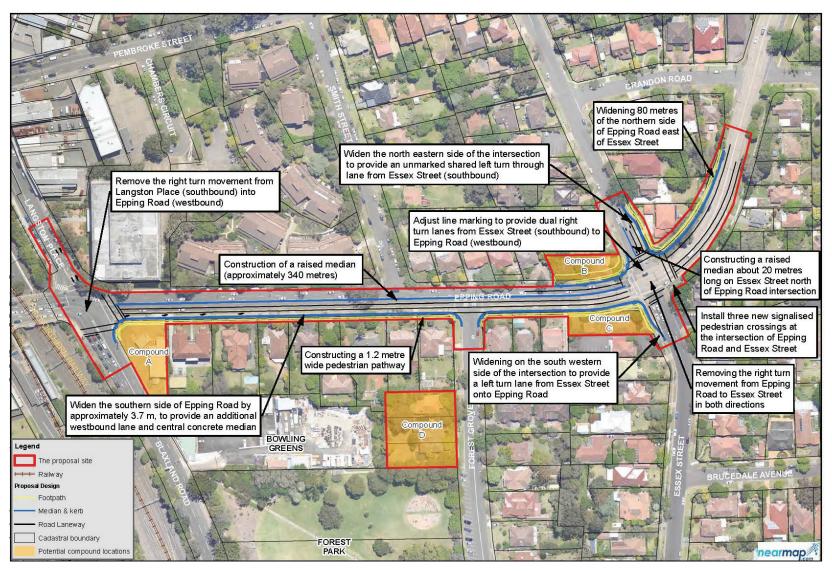
Figure 8 The proposal

- To widen 80 metres of the northern side of Epping Road east of Essex Street.
- Construction of a raised median (about 340 metres long) along Epping Road, between Langston Place/Blaxland Road and just west of Essex Street. This would restrict access from Epping Road to Forest Grove and Smith Street, and to residential properties along this section of Epping Road, to left-in and left-out only.

- Constructing a raised median about 20 metres long on Essex Street north of the Epping Road intersection.
- Constructing a 1.2 metre wide pedestrian pathway on Epping Road.

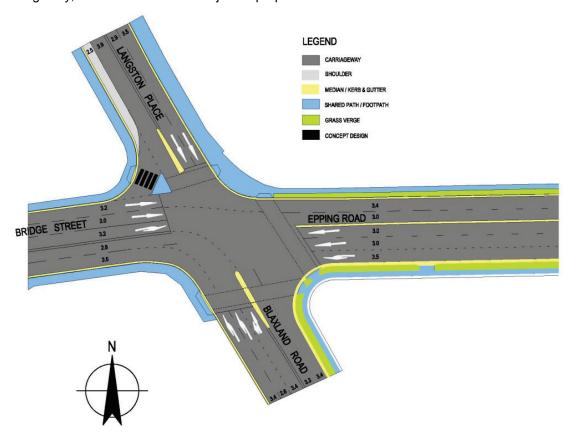
Figure 9 Langston Place/Blaxland Road Intersection

Part of the proposed upgrades involves banning the right turn from Langston Place (southbound) into Epping Road (westbound). These works would only be carried out along the carriageway, and would not affect adjacent properties.

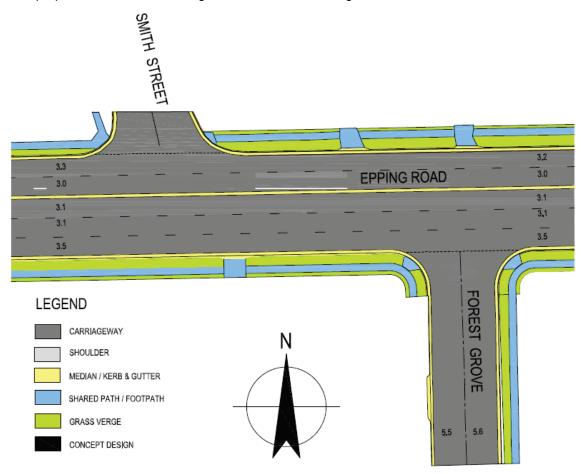
Figure 10 Smith Street and Forest Grove intersections

The existing T-intersections would be restricted to a left-in and left-out only intersection by introducing a 0.5 metre wide concrete median along Epping Road to separate the east and westbound traffic.

The proposed intersection arrangement is illustrated in Figure 10.

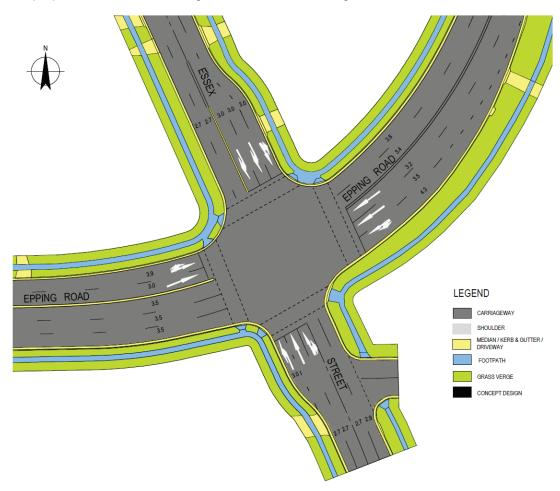
Figure 11 Essex Street intersection

- Banning of the right turn movements from the Epping Road eastern and western approaches;
- Dual right turn from Essex Street (north) to Epping Road in the westbound direction;
- Widening on the south-western side of the intersection to provide an additional left turn lane from Essex Street onto Epping Road (westbound).
- Constructing a raised median about 20 metres long on Essex Street north of Epping Road intersection
- New signal controlled pedestrian crossings at both the Essex Street northern and southern approaches;
- Additional Epping Road westbound through lane; and

The proposed intersection arrangement is illustrated in Figure 11.

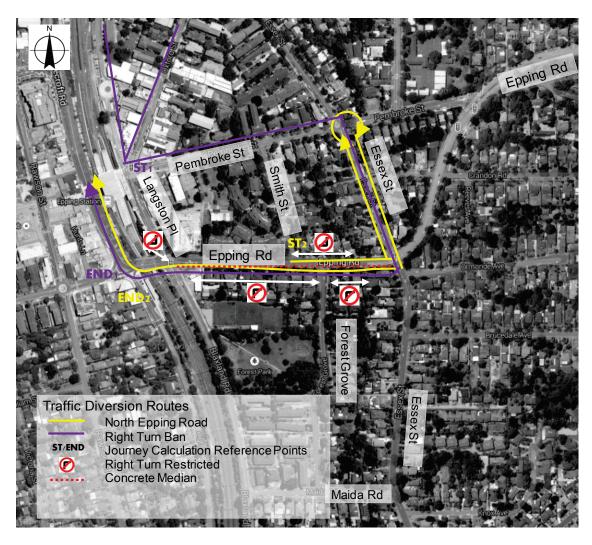
Figure 12 Alternative route A to west of Epping Road

With the installation of the proposed 0.5 metre wide concrete median, indicated by the dotted red line Figure 12, house owners along the northern side of Epping Road would no longer be able to make a right turn onto Epping Road to access the western end of Epping Road. This is a similar situation for vehicles exiting Smith Street.

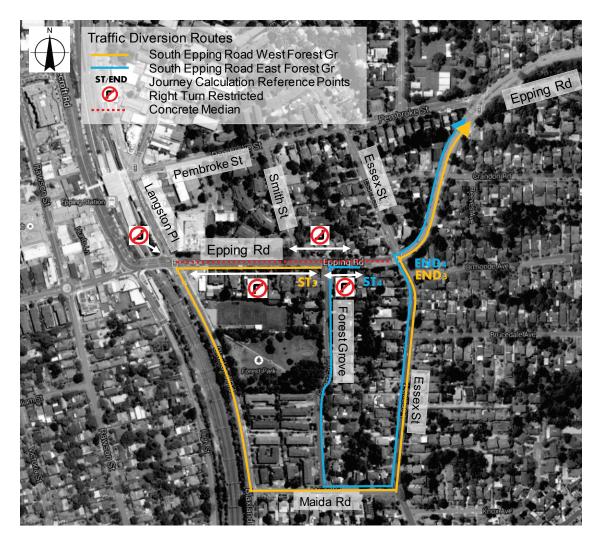
Figure 14 Alternate routes to east of Epping Road - Orange and Blue Route

With the installation of the proposed concrete median, house owners on the southern side of Epping Road would no longer be able to turn right onto Epping Road to travel eastbound. Residents on the east of Forest Grove are likely to use the route shown in Figure 14, indicated by the blue arrows.

Residents on the west of Forest Grove are likely to use the route indicated by the orange arrows.

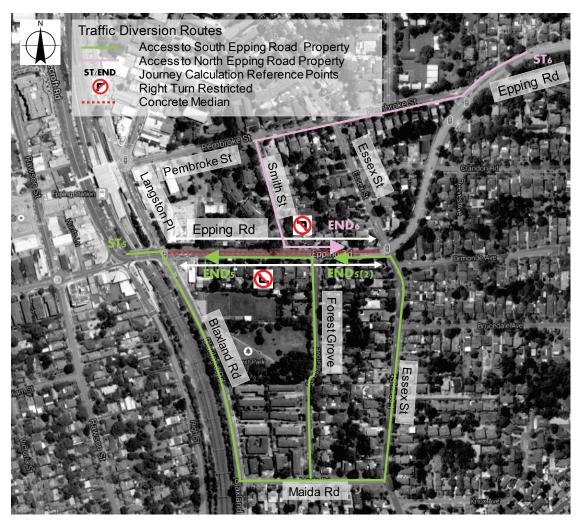
Figure 15 Alternative routes to properties along Epping Road – Green and Pink Route

Vehicles would no longer be able to access properties by making a right turn on Epping Road with the proposed concrete median upgrade. Alternative routes are shown in Figure 15.

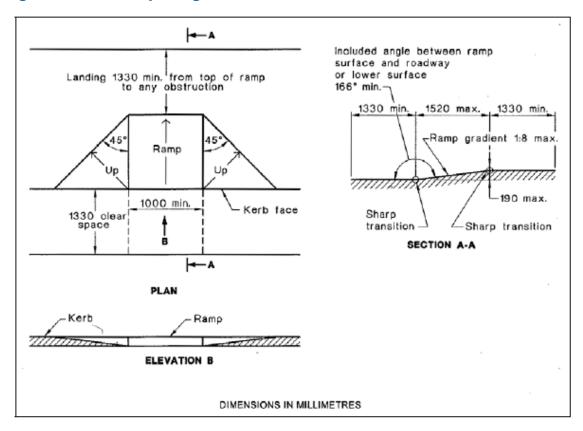
Figure 18 Kerb ramp design

The general dimensions of a drop kerb are illustrated in Figure 18. The Austroads Guide to Road Design Part 4 – Intersections and Crossings states that: "A minimum footway width of 1330 mm should be provided beyond the top of the ramp, to ensure that users of the footway along the street are not inconvenienced by the ramp."

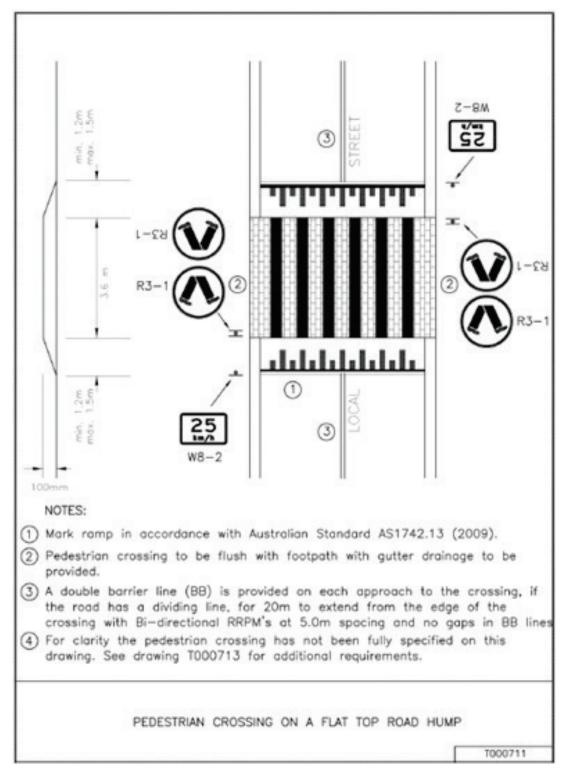
Figure 20 Typical details of a wombat crossing

Wombat crossings are generally the same dimensions as flat top road humps (with pedestrian priority provided with the use of 'zebra' style line markings) as shown in Figure 20. It provides priority to pedestrians as well as acting as a traffic calming measure. The minimum length of the device including ramps is six metres and the desirable minimum height of the platform is 100 mm. Wombat crossings generally have ramp gradients of 1:15 to 1:20 to be bicycle and/or bus friendly. Wombat crossings can be used when the warrant for such a traffic control is met as required in AS 1742.10
