Appendix A

Consideration of clause 228(2) factors and matters of national environmental significance

Concept design

Statement of Heritage Impact for the Proposed Bridge
Replacement

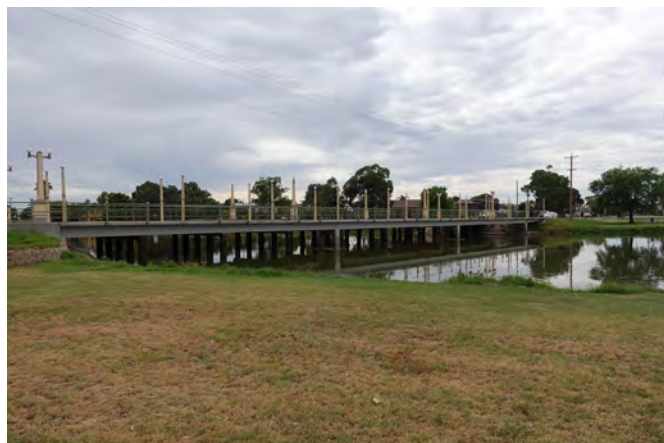
Figure 2.8 The bridge was constructed in the 1927 and its light fixtures are key components that add character to the structure.

Although the bridge was originally built in 1927, it is considered of moderate aesthetic value, despite it being a locally listed heritage item. The light poles are the most important elements that give the bridge its character. The rest of the structure is of limited visual appeal.

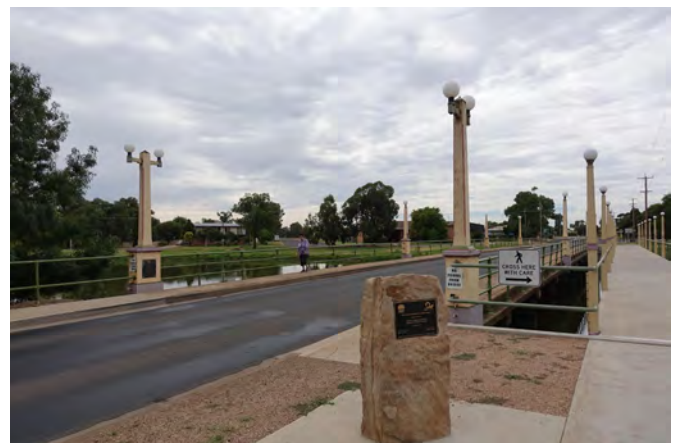
Figure 2.9 The original bridge to the left. The walkway to the right was recently added to provide better pedestrian amenity.

The bridge is about nine metres wide with a single vehicular traffic lane in each direction. There are two narrow footpaths to either side of the carriageway and adjacent to the existing bridge is a recently completed pedestrian bridge south of the historic structure. This pedestrian bridge acts as a shared use path that runs alongside the historic bridge, partially screening it when viewed from the south.

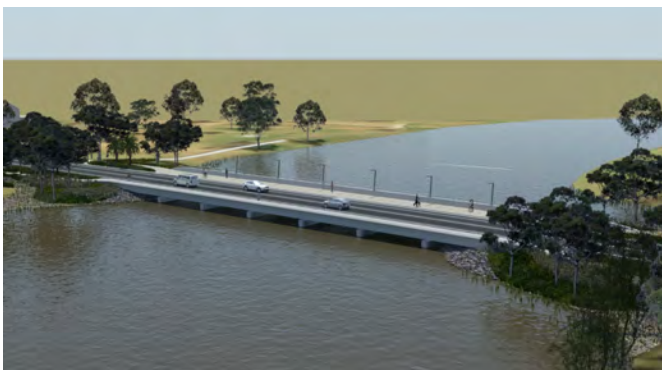
Figure 4.1 Abstract aerial overview of the proposed bridge.

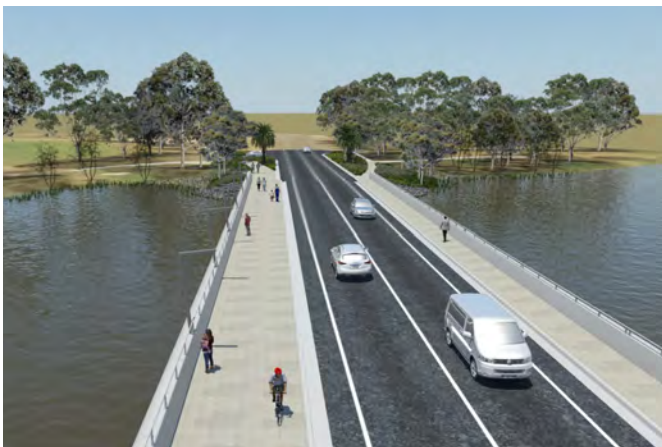
Figure 4.2 The bridge would include a wide promenade to promote a safe crossing.

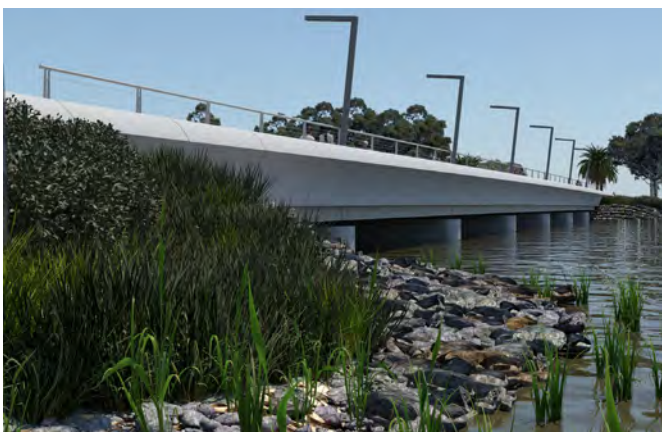
Figure 4.3 The distinct shape of the parapet contributes to the identity of the bridge and reflects the 'art nouveau' theme.

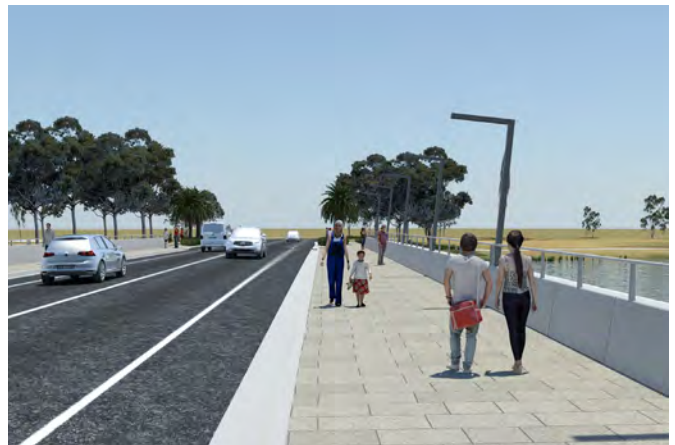
Figure 4.4 The balustrade has been kept as transparent as possible.

A balustrade would be integrated on top of the barrier which would also include a rub rail for cyclists. The balustrade is based on stainless steel cables with steel supports. This would allow an open character with the unobtrusive resolution of this element.

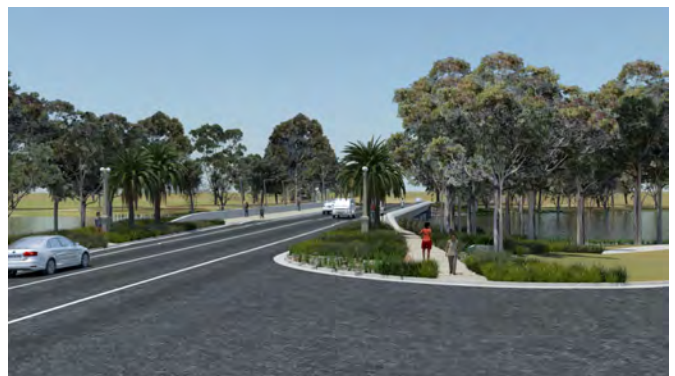
Figure 4.5 The bridge would include a wide promenade to promote a safe crossing.

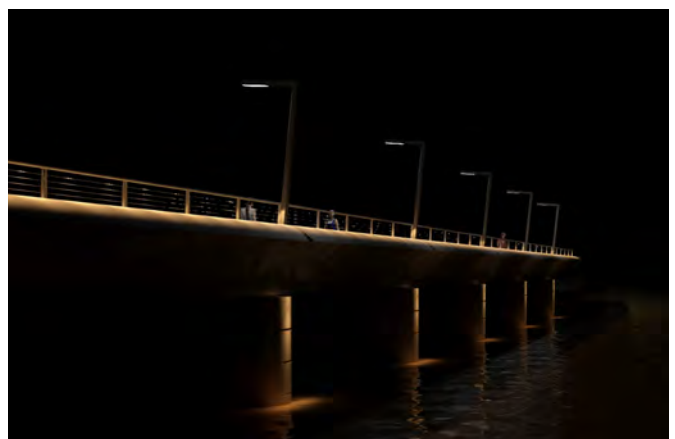
Figure 4.6 Feature lighting to accentuate the parapet would be incorporated within the handrail.

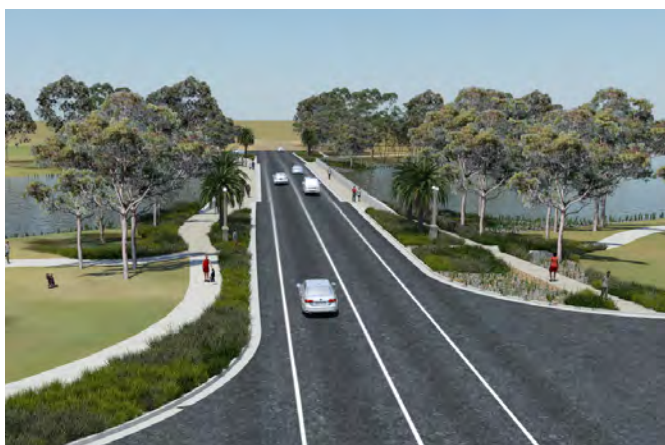
Figure 4.7 Feature pavers would be used for the shared use path and landscaped areas introduced at the approaches to the bridge.

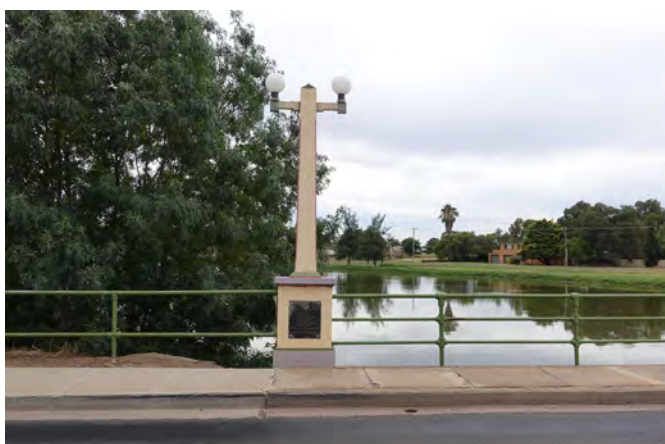
Figure 4.8 The existing light poles would be recycled as part of the approaches to the new bridge.

These landscaped areas incorporate the historic lamp posts of the existing bridge, thereby acting as legible markers and celebrating the historic crossing, whilst reinforcing the arrival sequence into Forbes. The landscaped areas would also soften the streetscape appearance and promote drivers to slow down.

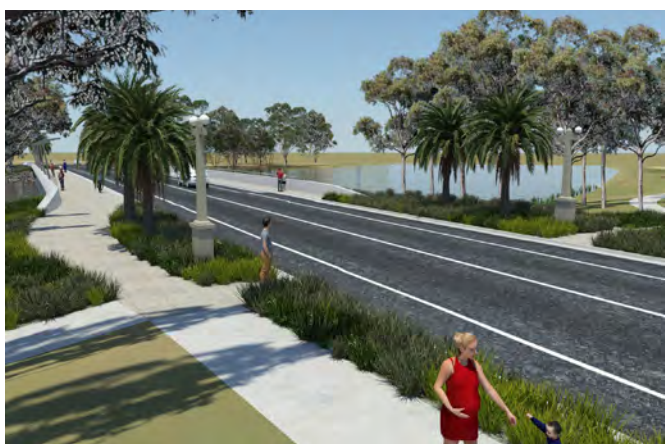
Figure 4.9 The historic light poles would complement the streetscape and announce the entry into the town centre.

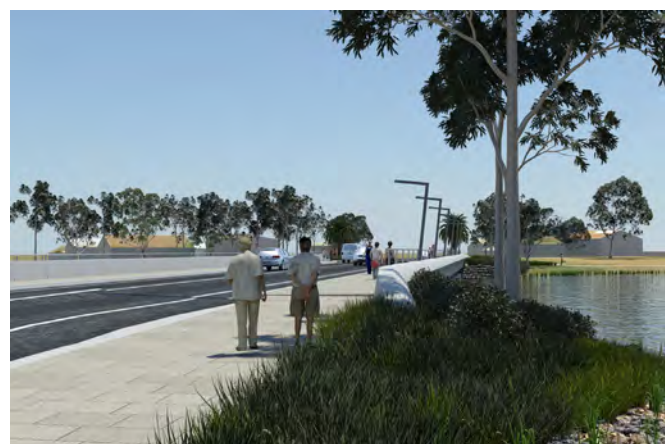
Figure 4.10 The parapet is terminated through a gentle transition back into the ground, creating a fluid end to the bridge.

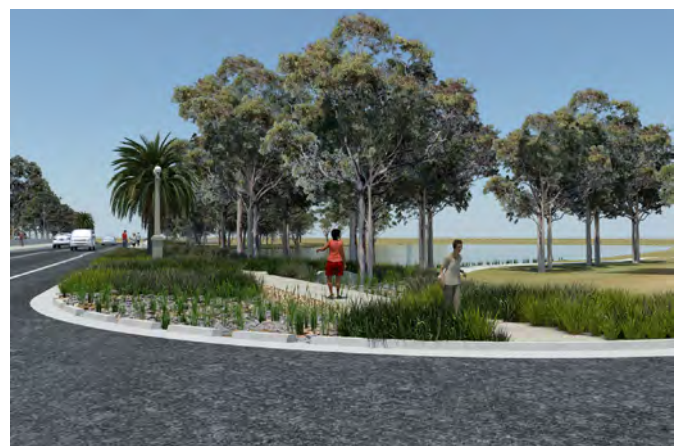
Figure 4.12 The boardwalk would express the interface with water sensitive design initiatives.

A boardwalk is proposed on the town side to integrate with and express the water sensitive design initiatives and add interest to the streetscape. The boardwalk consists of a steel structure painted in grey and to retain an open character, it is devoid of any railing or balustrade.

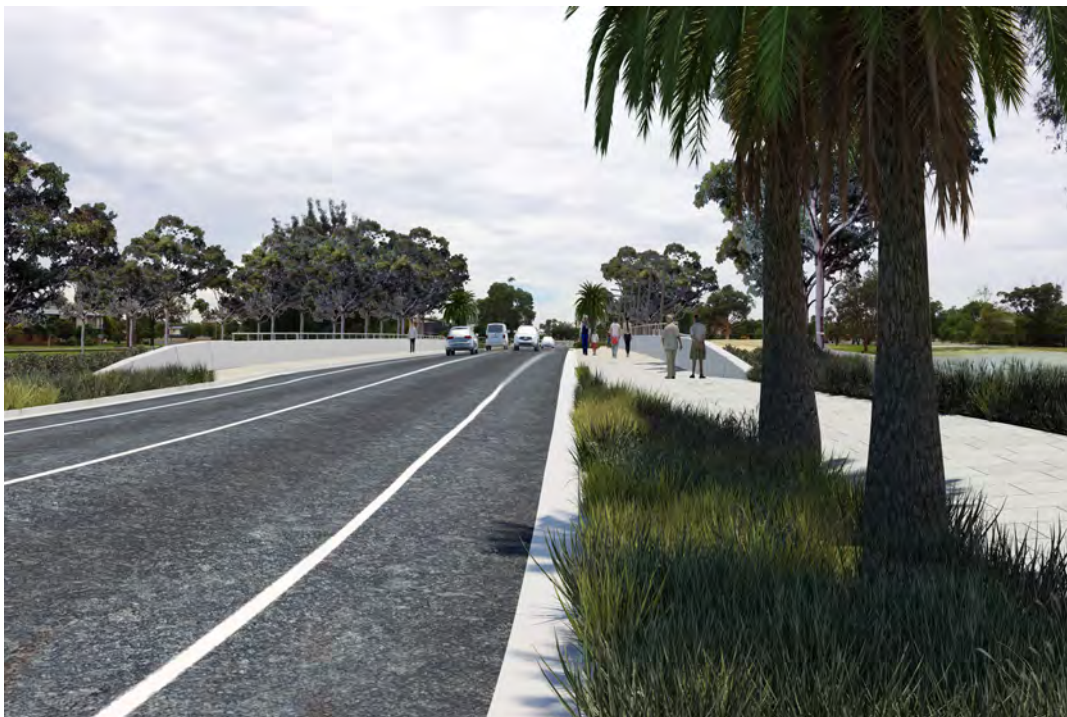
Figure 4.14 Indicative proposed design, including accent planting of Canary Island Date Palms with tussock understorey

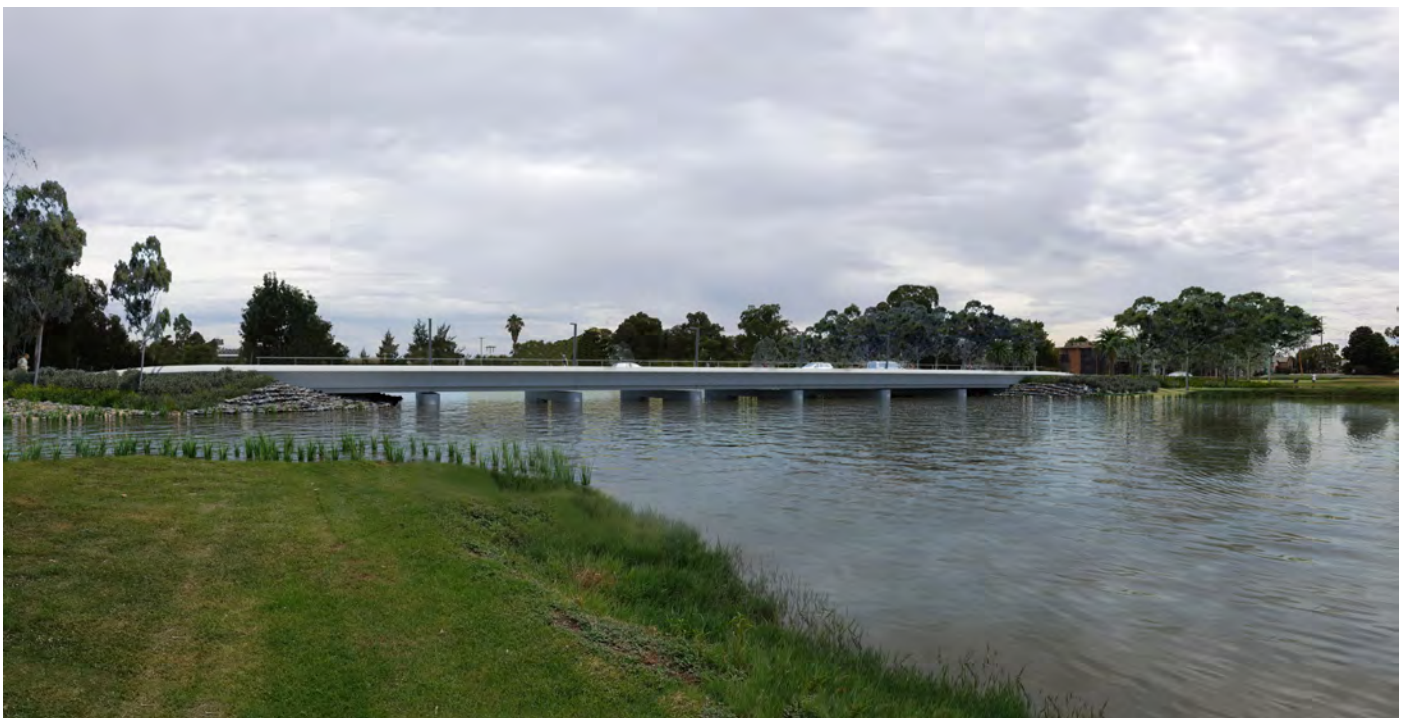
Figure 4.16 Indicative view of the new bridge. The structure reinforces the horizontality of the setting with the form of the parapet catching light and expressing the slender proportion. Water sensitive design initiatives soften and improve the Lake Forbes shoreline

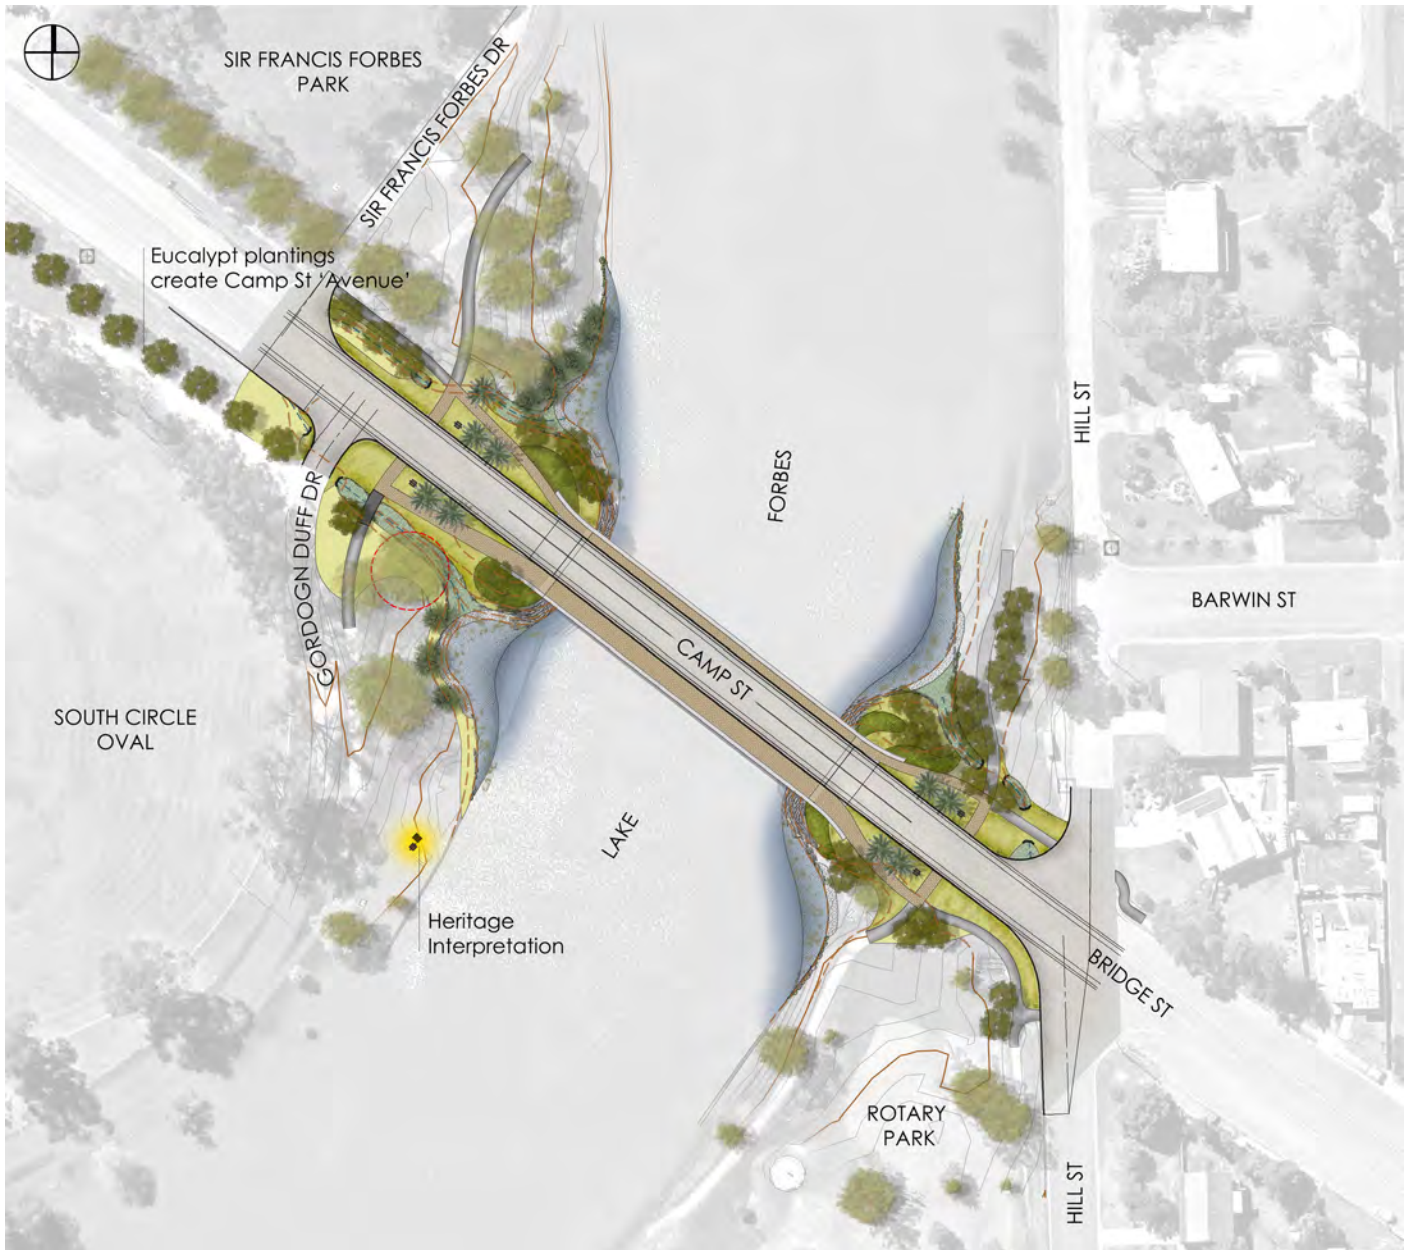
Figure 4.17 The proposed landscape design incorporates water sensitive design elements that soften the lake edge by curving the lake/land interface more to create more natural, organic shapes as well as improving water quality.

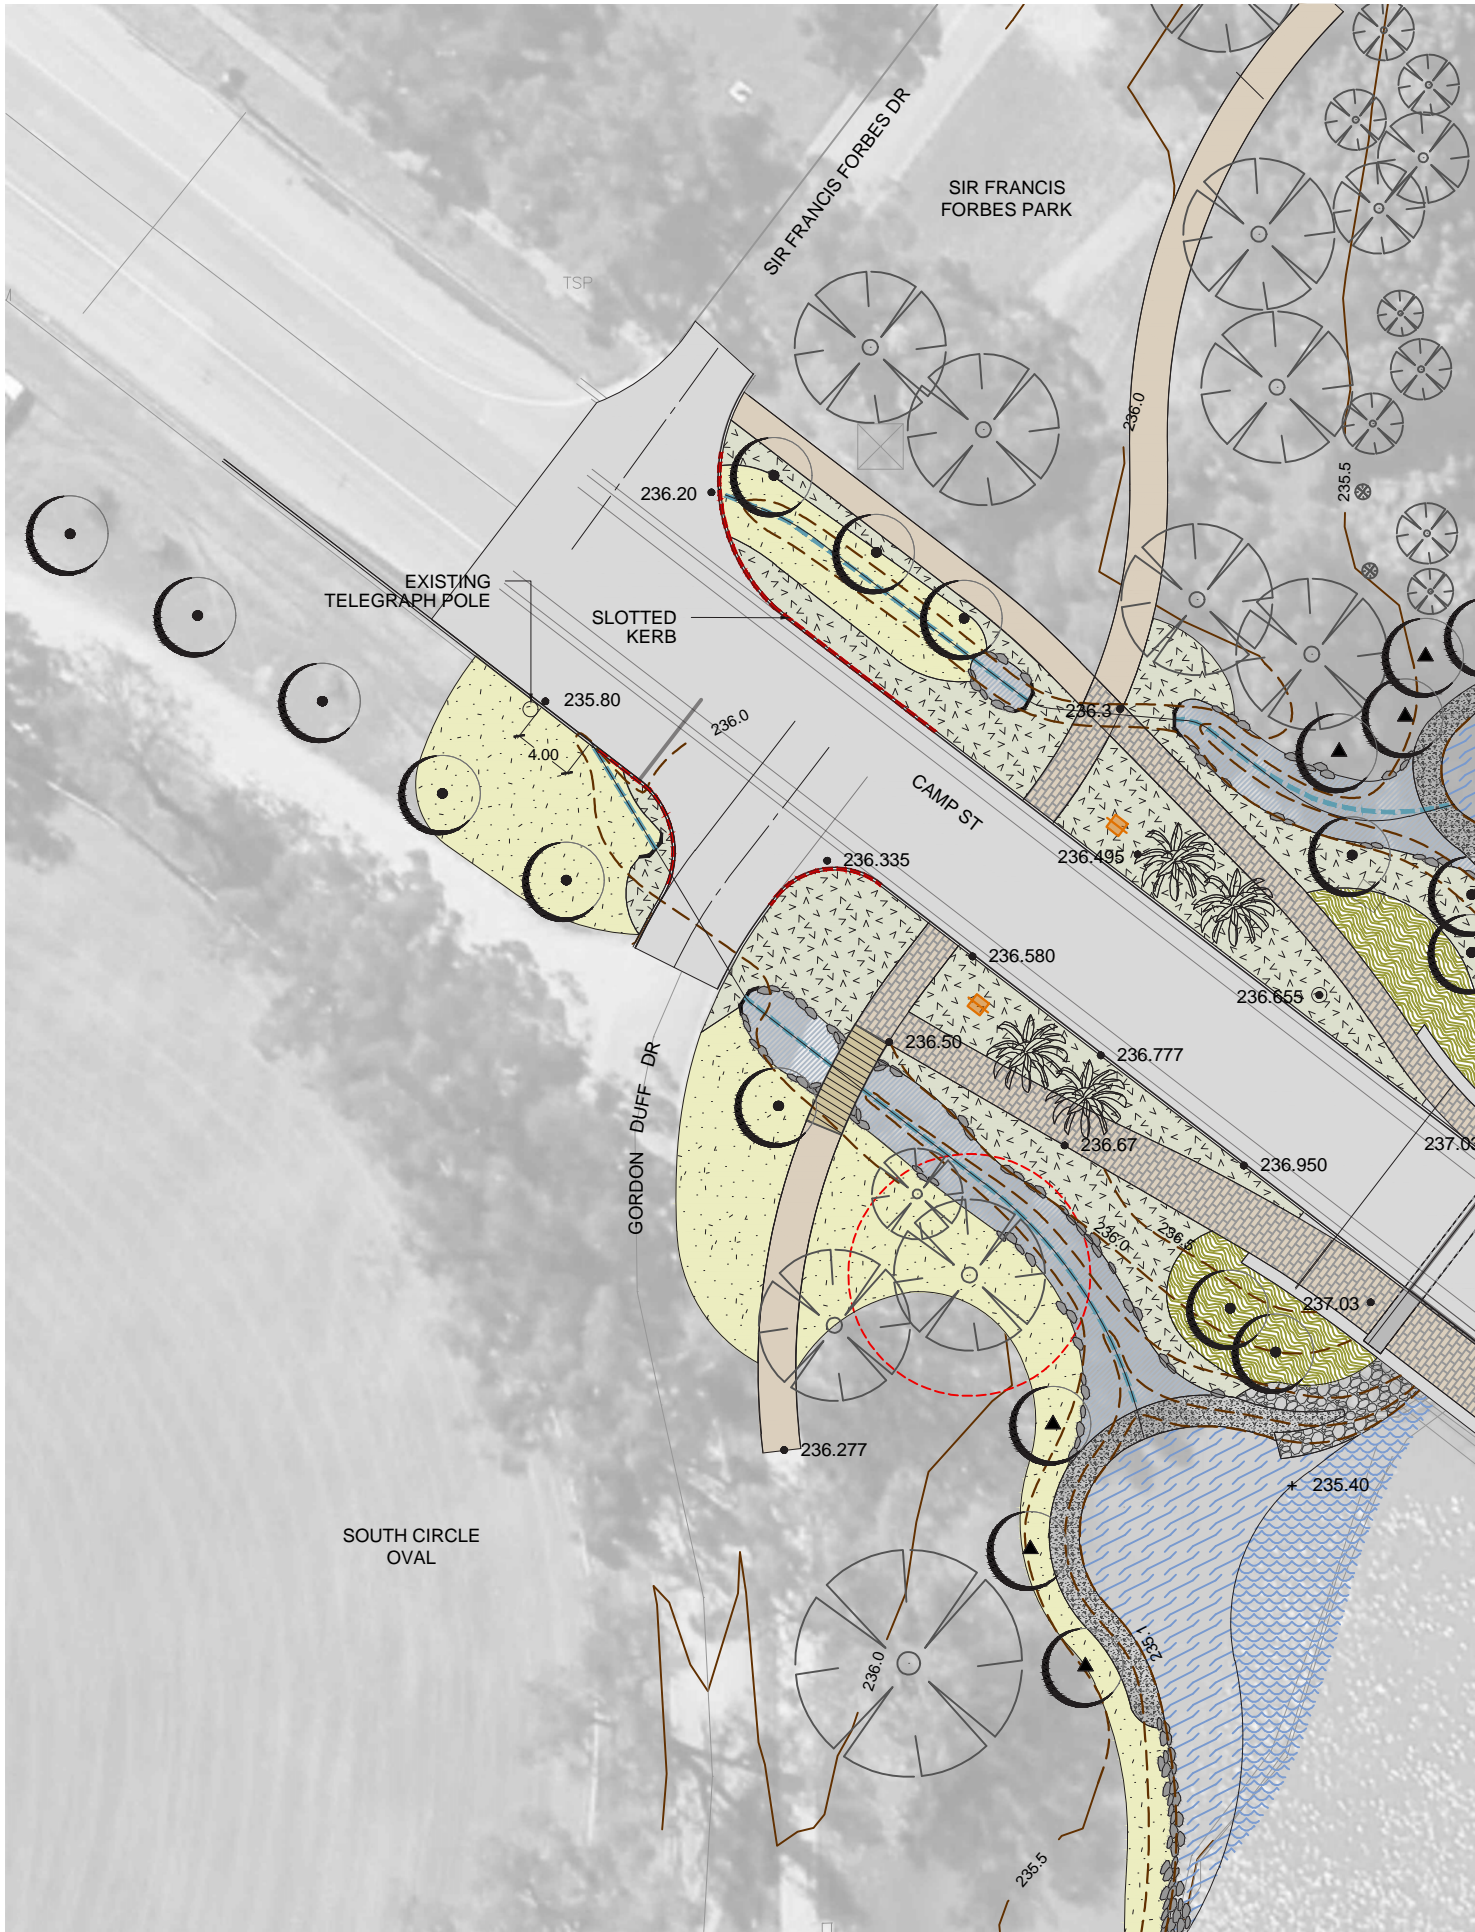
Figure 4.18 The proposed landscape design for the western abutment and adjacent public parks, incorporating water sensitive design elements that also soften the lake interface.

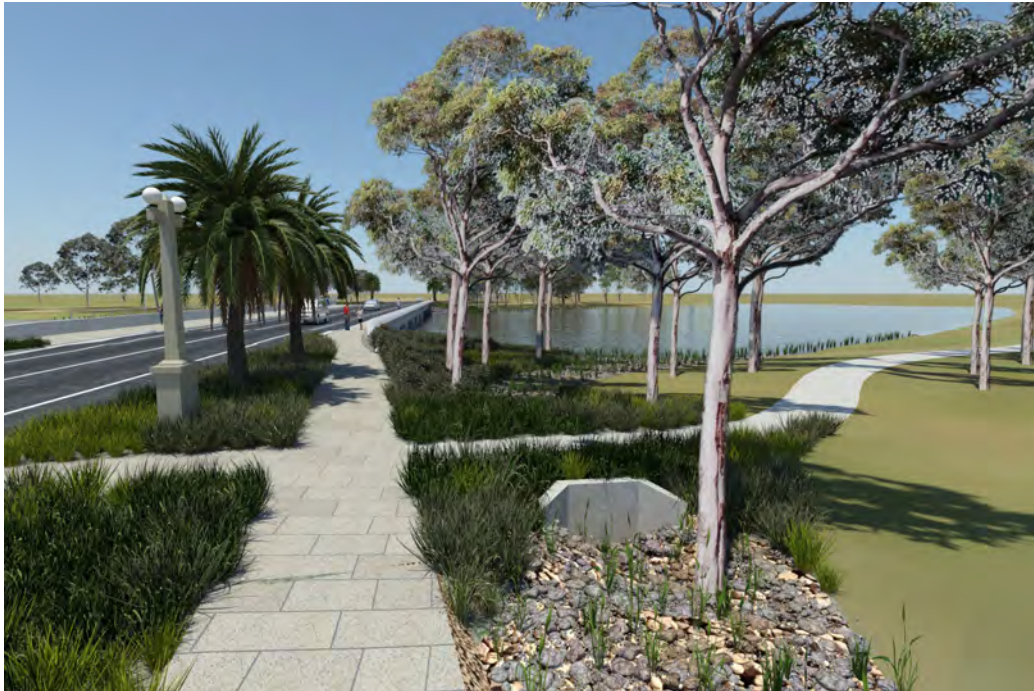
Figure 4.29 Water sensitive design concepts integrated as part of the landscape design works.

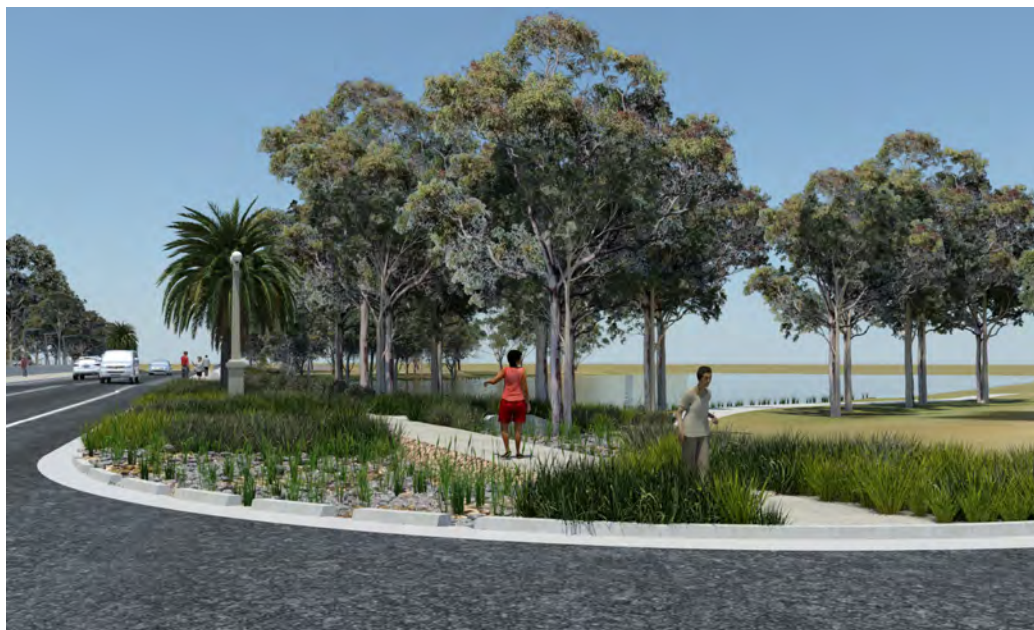
Figure 4.30 This view captures the area where a slotted kerb is used to capture rainwater run off and feeding it into a rock mulched area /infiltration area where the water is cleaned and slowed down, prior to it discharging into the lake

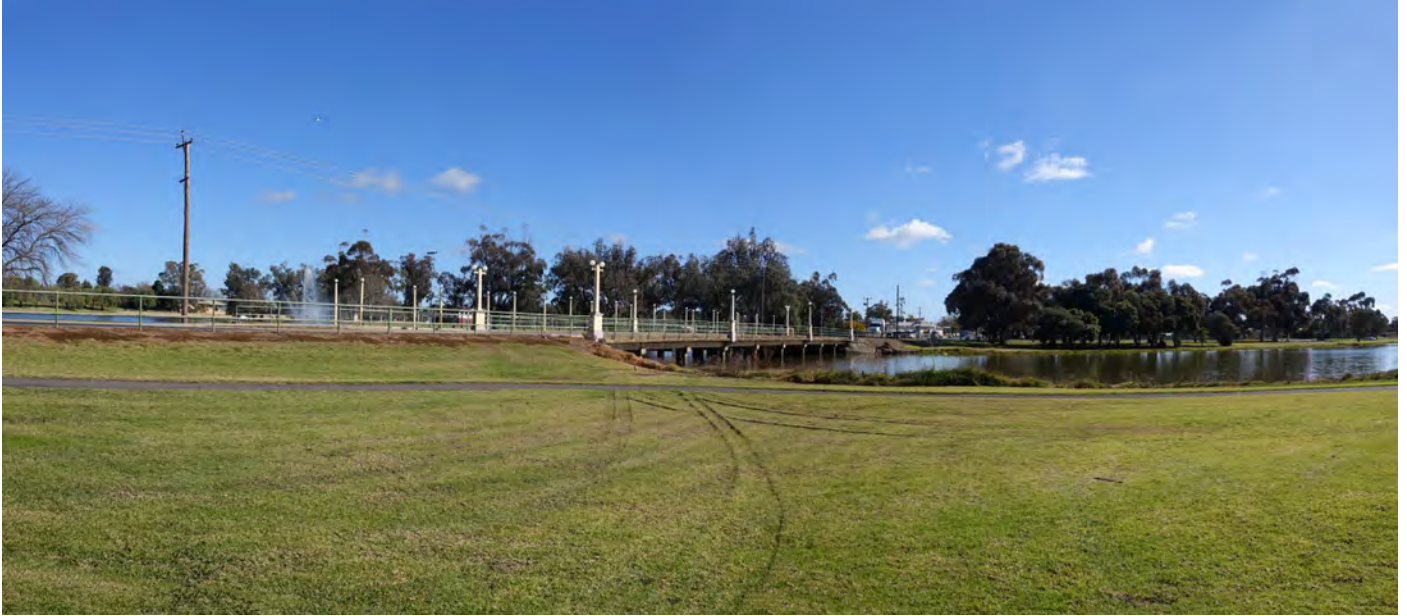
Figure 4.33 Existing situation looking from the vicinity of Hills Street.

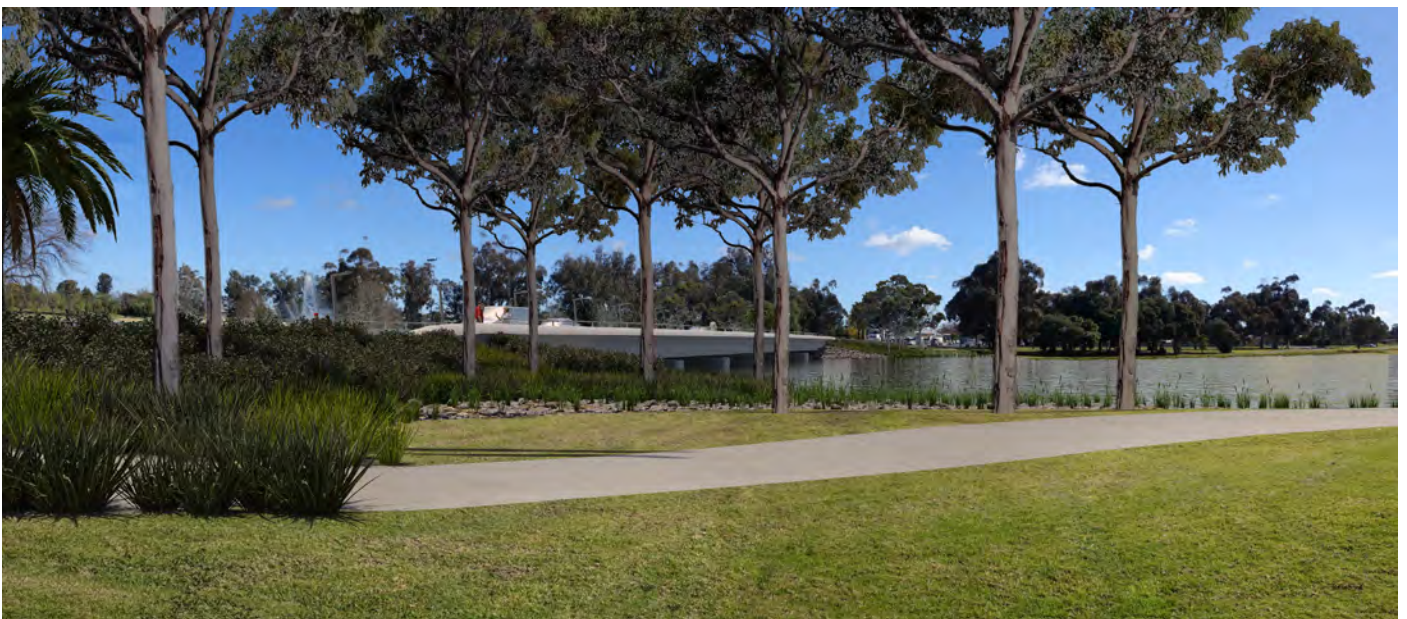
Figure 4.34 Proposed treatment at the north eastern abutment.

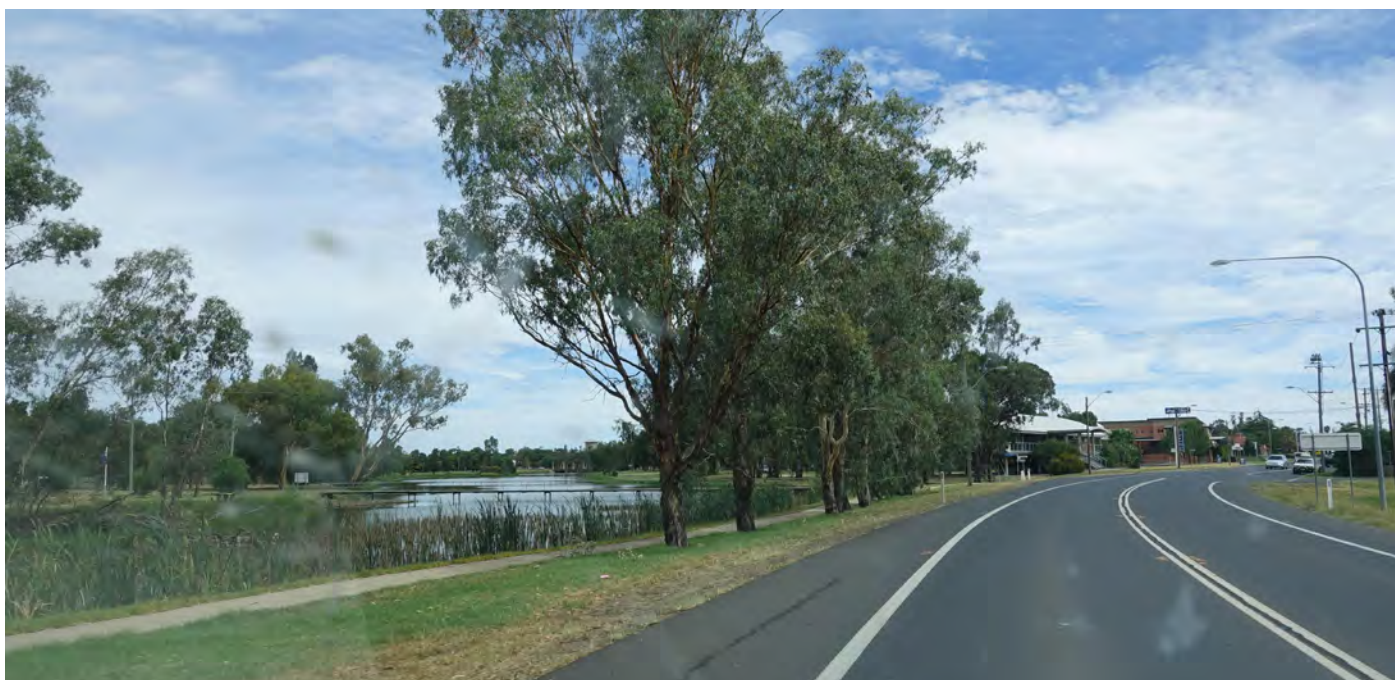
VIEWPOINT 1

Description of the setting	View from the Newell Highway/Sherriff Street looking towards Lake Forbes
Element visible of the project	Camp Street Bridge in the far distance
Category of viewer	Road user
Nature of impact	Adverse
Visual sensitivity	Low due to the transient nature of the viewer. This viewpoint is visually less ceremonial coming into town compared to the Camp Street sequence
Magnitude of impact	Negligible
Overall rating of visual impact	Negligible
Comment / mitigation measures	No mitigation measures identified. The distance to the proposal limits any noteworthy visual effects from the proposal

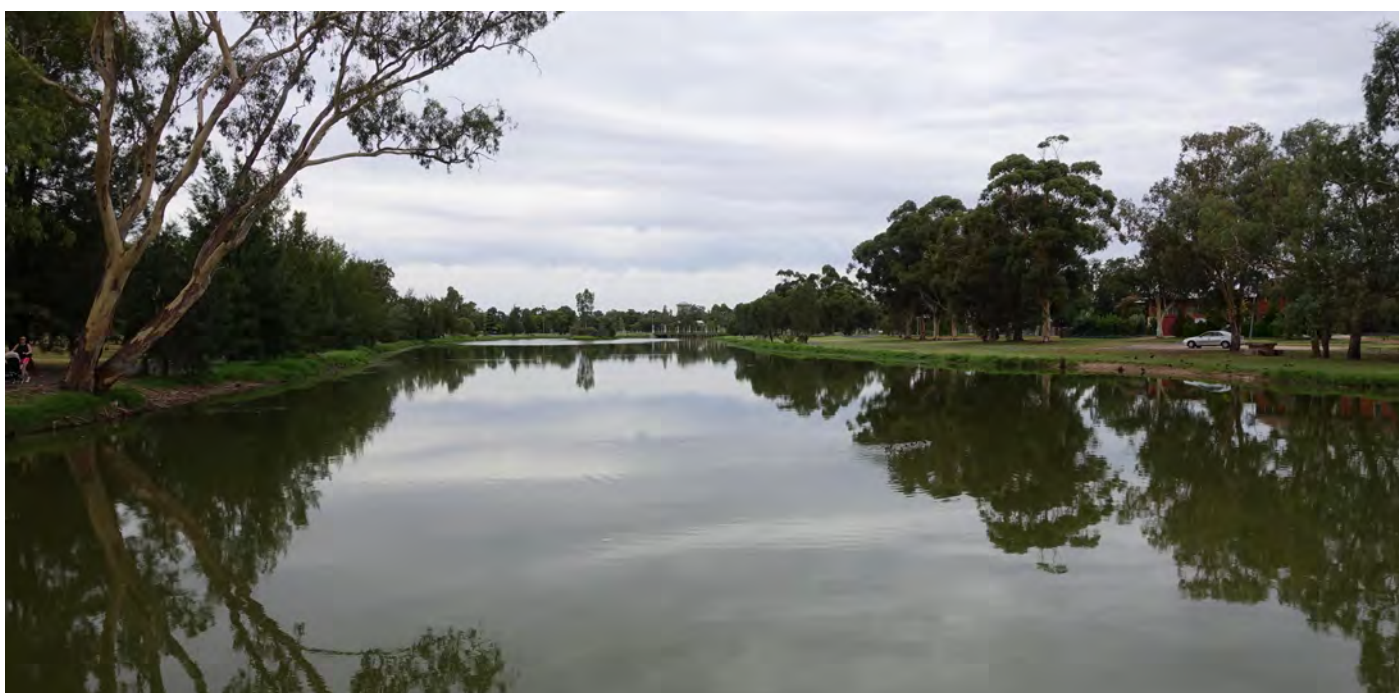
VIEWPOINT 2

Description of the setting	Lake view with established vegetation framing the existing bridge
Element visible of the project	Distant view of the bridge
Category of viewer	Pedestrians and park users
Nature of impact	Adverse
Visual sensitivity	High due to the visual quality and panoramic views
Magnitude of impact	Negligible. The distant views towards the bridge limit its visual effect on the overall composition and scenic value of the setting. It is likely that at night time the magnitude of impact is higher due to the feature lighting which would also be reflected on the water
Overall rating of visual impact	Negligible during day time and moderate during night time
Comment / mitigation measures	During night time, views towards the structure would be more present than during the day

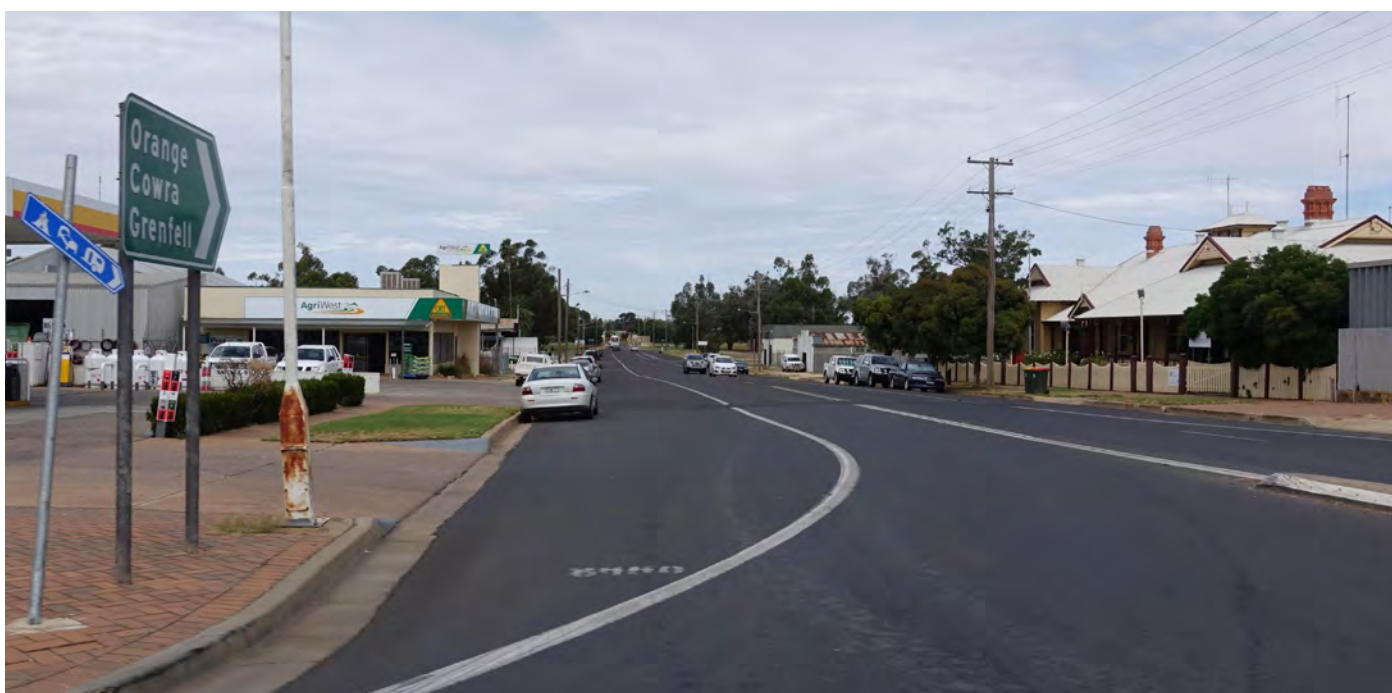
VIEWPOINT 3

Description of the setting	Camp Street, looking from the intersection with the Newell Highway/Sheriff Street looking towards Lake Forbes
Element visible of the project	Glimpses of the bridge in the distance
Category of viewer	Road users
Nature of impact	Beneficial
Visual sensitivity	Low due to the transient nature of the viewer
Magnitude of impact	Negligible. The distance to the proposal limits any visual effects
Overall rating of visual impact	Negligible
Comment / mitigation measures	Although the proposal would have a positive impact to the streetscape, its visual effect is negligible from this location

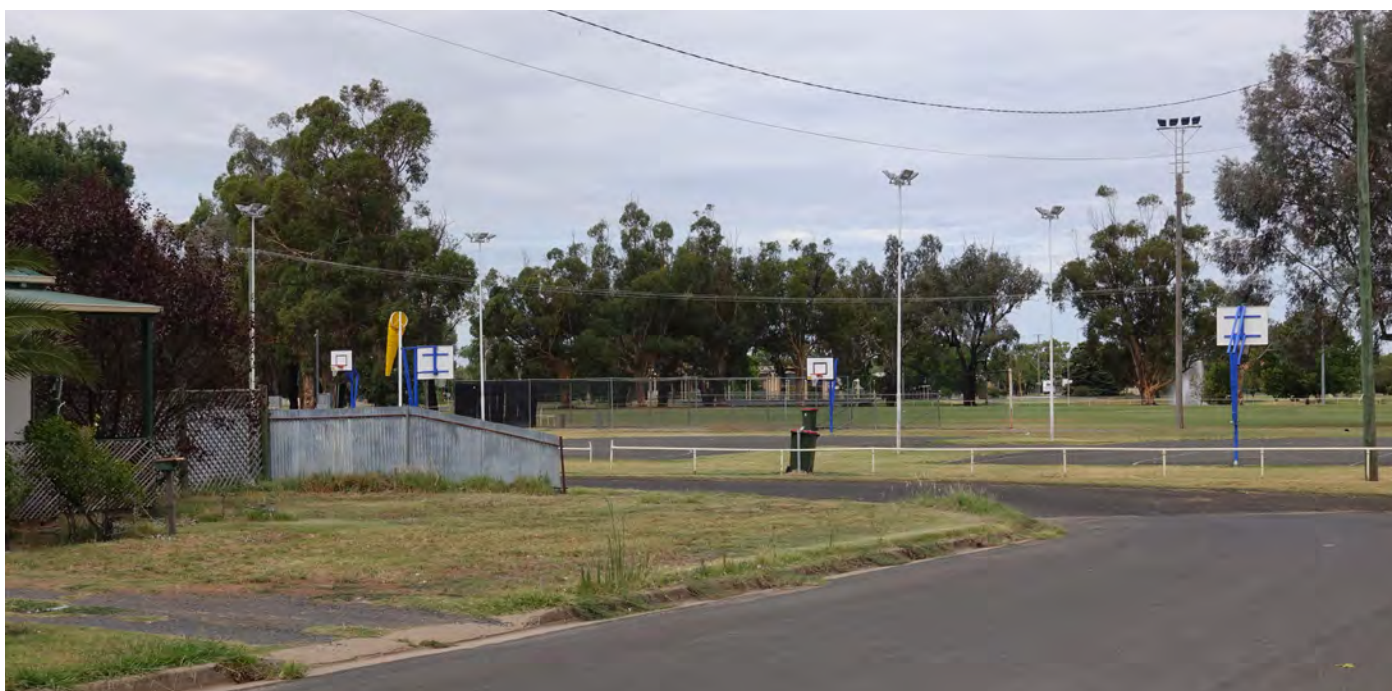
VIEWPOINT 4

Description of the setting	View from the end of Browne Street looking towards Forbes Oval. The Camp Street Bridge is situated behind the oval
Element visible of the project	Partial views of the structure through stands of trees
Category of viewer	Oval visitors
Nature of impact	Adverse
Visual sensitivity	Moderate due to the introverted character of the viewer's activity
Magnitude of impact	Low. Filtered views through greenery limit the overall visual effect of the proposal
Overall rating of visual impact	Low to moderate
Comment / mitigation measures	Limited impact of the proposal to oval visitors. No mitigation measures identified

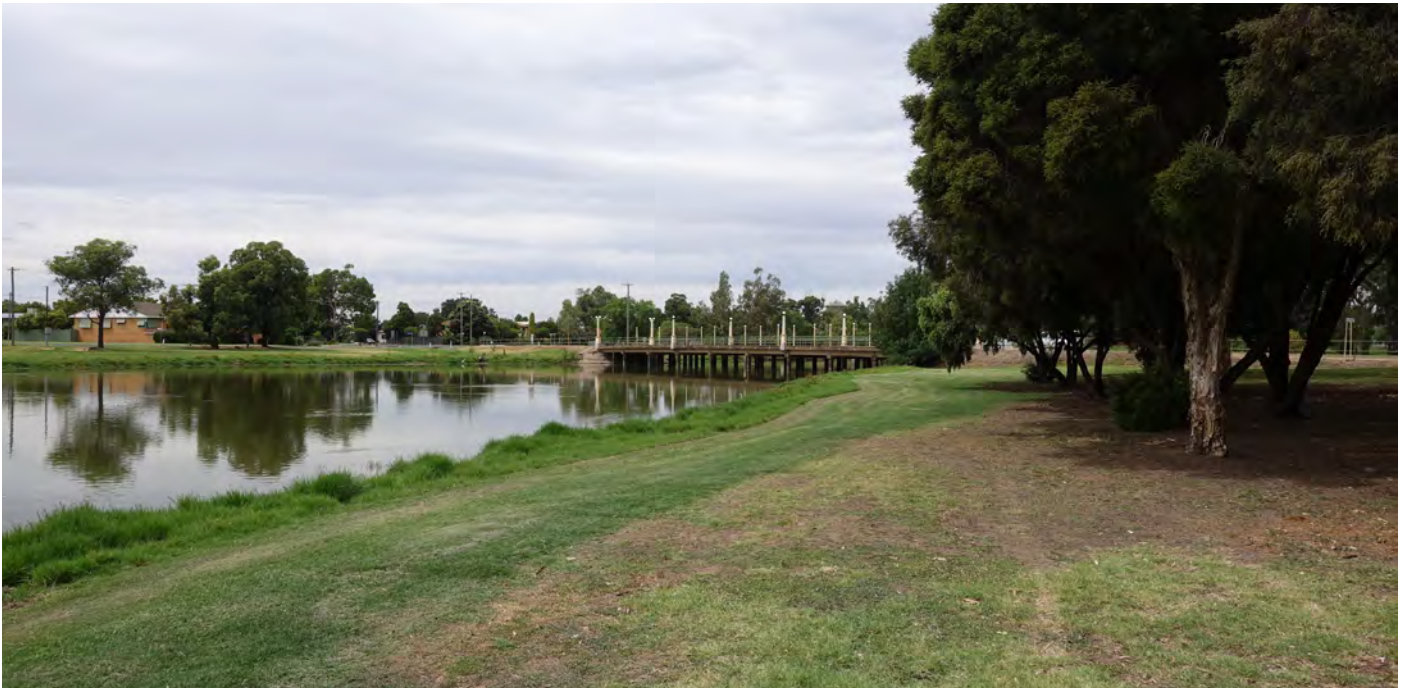
VIEWPOINT 5

Description of the setting	Parkland setting adjacent to Lake Forbes
Element visible of the project	Bridge and eastern approach in the mid-distance
Category of viewer	Park users
Nature of impact	Adverse
Visual sensitivity	High due to the visual quality of the setting
Magnitude of impact	Low. The overall character of the park lands would remain. The proposed bridge would have a similar scale to the existing structure.
Overall rating of visual impact	Moderate: the proposal would introduce a contemporary structure to the setting. Yet this change can also be viewed as positive. The proposed landscape works would help settle the bridge in its setting.

Comment / mitigation measures	Pedestrians would enjoy the riverside the same way. During night time, the structure may appear different due to the lighting scheme. Care has been taken to limit the scale of light poles to retain a similar character.

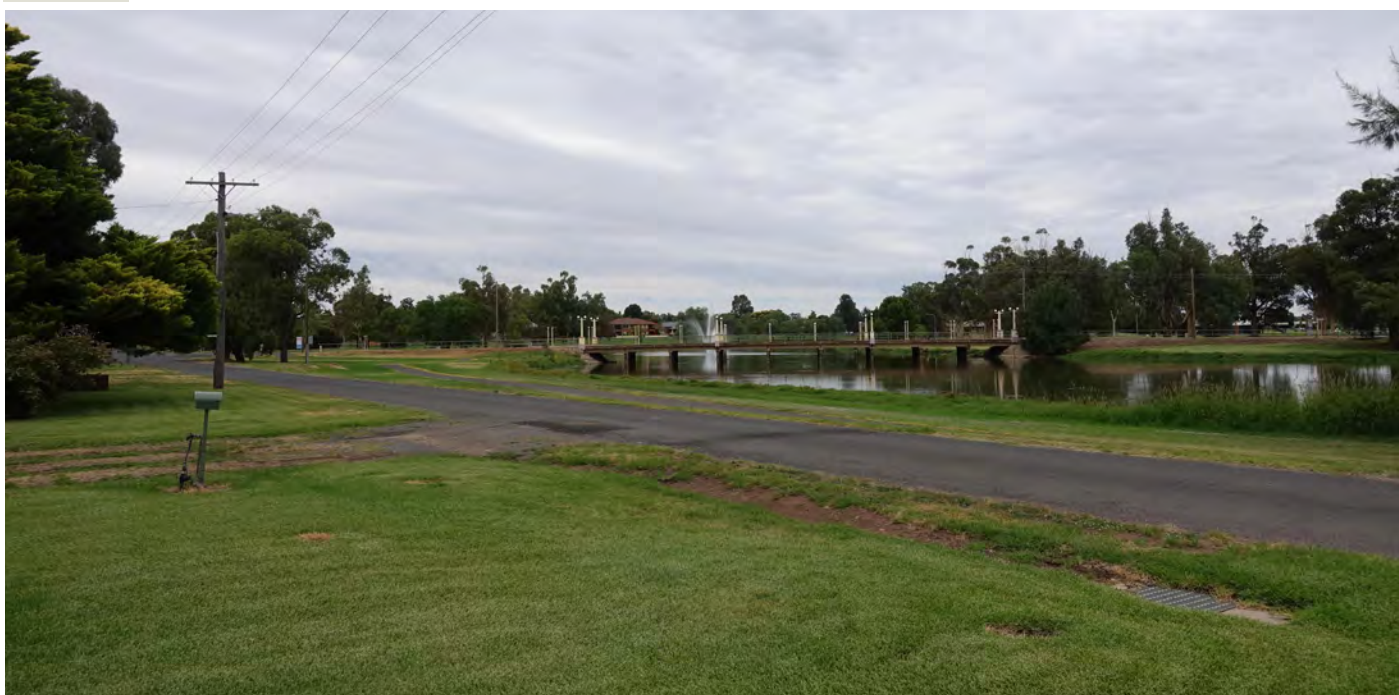
VIEWPOINT 6

Description of the setting	Front yard of one of the residential properties fronting Lake Forbes along Hill Street. The parkland and waterways provide a high quality setting.
Element visible of the project	Mid-distant views of the bridge in its setting
Category of viewer	Residents, pedestrians and park users
Nature of impact	Adverse
Visual sensitivity	High due to the visual quality of the setting
Magnitude of impact	Low. The current vistas would predominantly remain with the proposed bridge structure having a limited visual effect on the setting. The landscape design would contribute to visually settling the structure into the landscape.
Overall rating of visual impact	Moderate
Comment / mitigation measures	Night time impacts may be more noticeable due to a different lighting arrangement, including feature lighting. Some of these aspects may be considered positive.

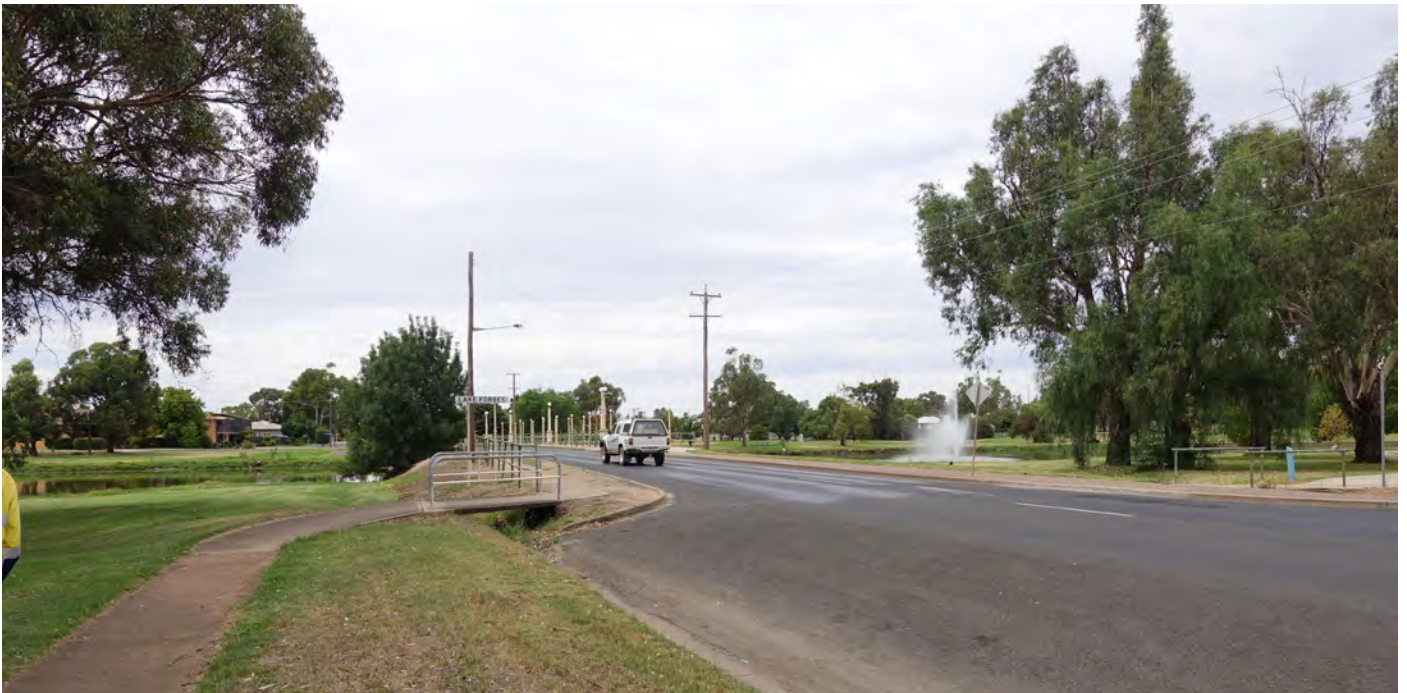
VIEWPOINT 7

Description of the setting	Streetscape setting adjacent to parkland
Element visible of the project	Approach to the bridge, water sensitive design measures and new vegetation visible, including accent planting
Category of viewer	Pedestrians
Nature of impact	Beneficial
Visual sensitivity	Moderate due to the transient nature of the viewer adjacent to the road
Magnitude of impact	High. The proposed landscape would create a strong streetscape feature and additional planting would enhance the streetscape setting
Overall rating of visual impact	Moderate to high. The streetscape would be improved
Comment / mitigation measures	The landscape design is a key mitigation measure incorporated into the design. This results in a higher visual impact, yet with a positive outcome
