Appendix A

Consideration of clause 228(2) factors and matters of national environmental significance

Concept design

Statement of Heritage Impact for the Proposed Bridge
Replacement

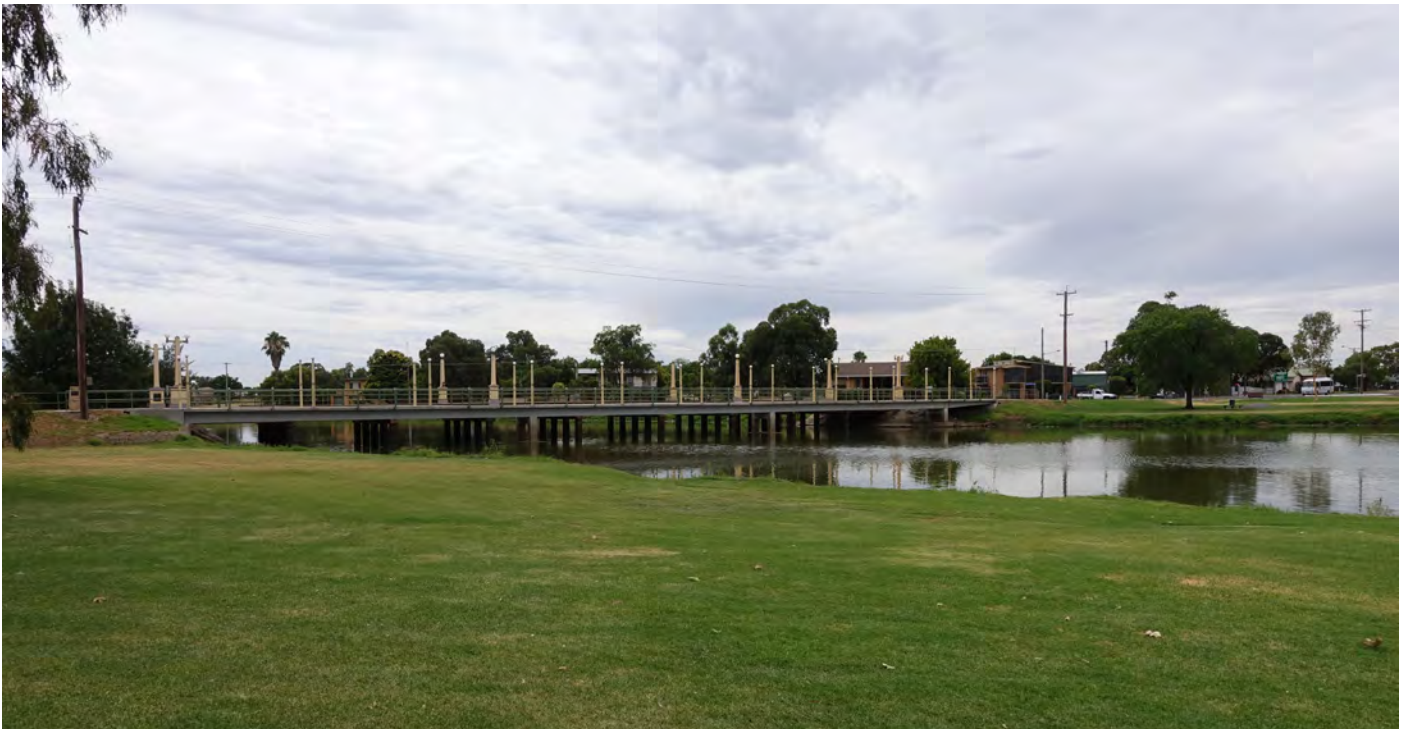
VIEWPOINT 8

Description of the setting	Parkland along the shores of Lake Forbes
Element visible of the project	New bridge and modified approaches
Category of viewer	Pedestrians and park users
Nature of impact	Adverse on bridge / beneficial on park setting
Visual sensitivity	High due to the visual quality and significance of the setting
Magnitude of impact	Moderate. Although a new bridge would be constructed, its mass and general arrangement would be of a similar nature, limiting the magnitude of impact. The landscape design would positively contribute to the setting
Overall rating of visual impact	Moderate to high. The new bridge would have a different appearance both during the day and at night. The additional planting would visually enhance the park

Comment / mitigation measures	Pedestrians and park users would enjoy the parkland in the same way. The new bridge would celebrate the setting and feature lighting at night time would create a visual accent, complementing its gateway function. The proposed planting would define the abutments and improve the foreshore parkland.

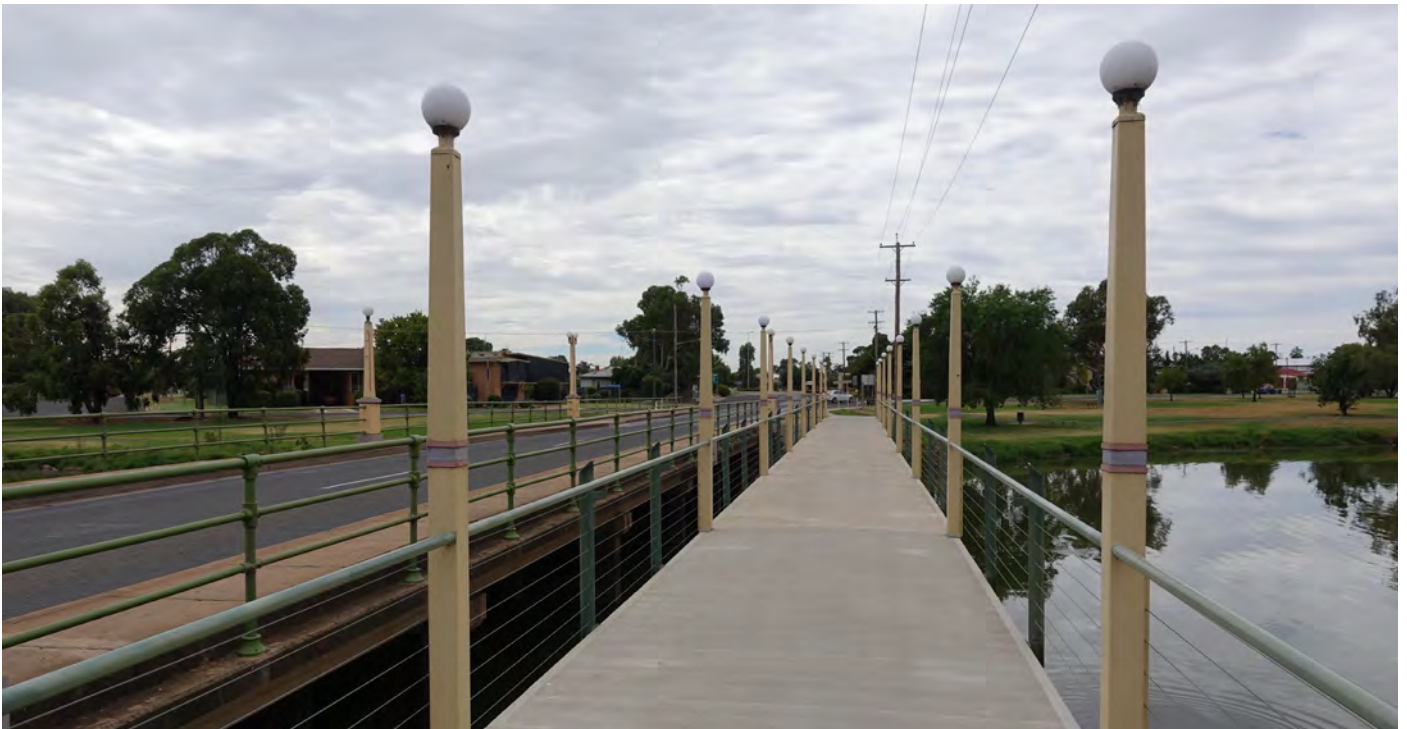
VIEWPOINT 9

Description of the setting	Pedestrian path on recently constructed bridge. Open vistas of Lake Forbes and surrounds.
Element visible of the project	Shared use path adjacent to carriageway
Category of viewer	Pedestrians and park users
Nature of impact	Adverse
Visual sensitivity	Moderate as a result of the combination of low sensitivity due to the transient nature of the viewer and high sensitivity due to the visual quality of the setting
Magnitude of impact	High. The proposal would provide a new crossing with a contemporary character
Overall rating of visual impact	Moderate to high as the proposal would have a different character to the existing crossing

Comment / mitigation measures	The new bridge would provide a different visual experience, still allowing a strong interaction between viewers and the setting. The existing bridge is considered safer due to the complete separation between pedestrians and vehicular traffic. This effect has been mitigated by incorporating a wider shared use path

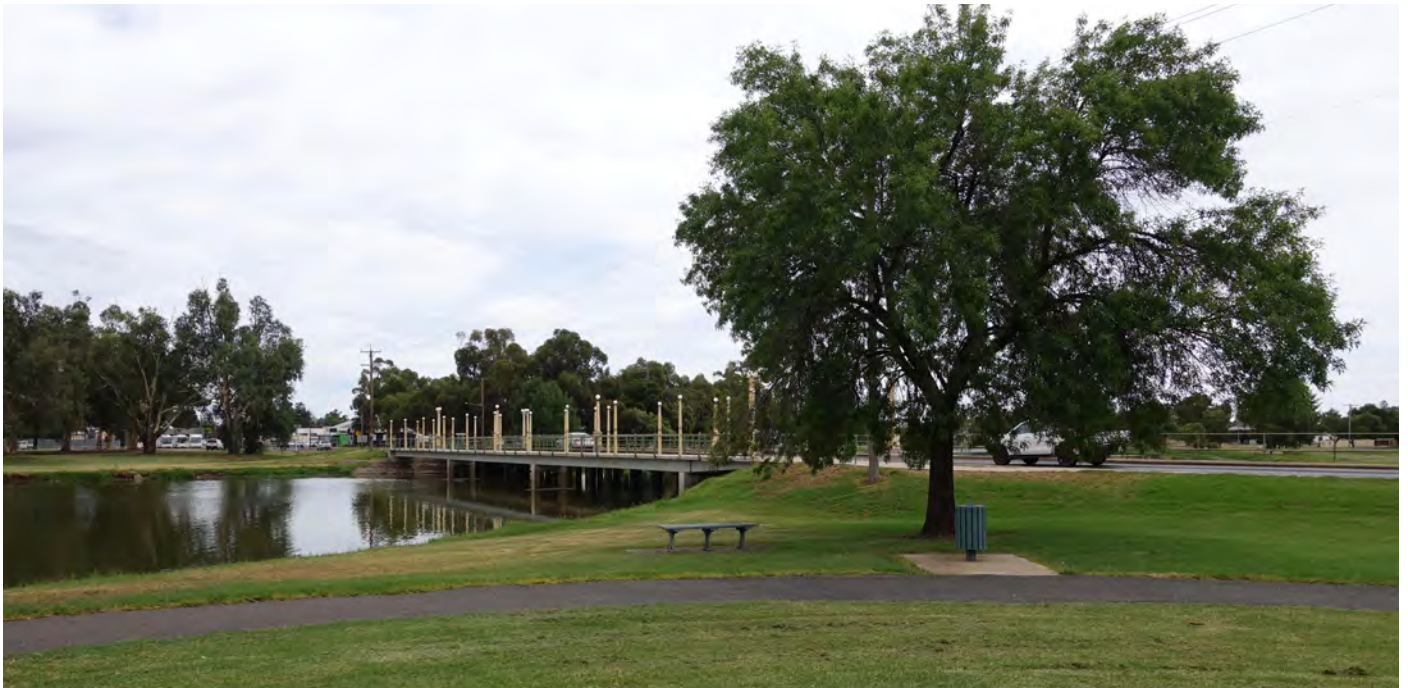
VIEWPOINT 10

Description of the setting	Lake Forbes foreshore near Camp Street looking towards the existing bridge
Element visible of the project	Camp Street Bridge and south eastern approach including new planting
Category of viewer	Park users and cyclists
Nature of impact	Adverse
Visual sensitivity	High due to the importance of this open space for the community
Magnitude of impact	Moderate. A new bridge would replace the existing structure somewhat changing the visual character of the structure
Overall rating of visual impact	Moderate to high. A more contemporary structure that is less cluttered would allow the landscape setting to dominate. Night time lighting is likely to have a different effect with the proposal considered more subtle.

Comment / mitigation measures	Although the new bridge would have a different character, the proposal would de-emphasise the bridge with less vertical elements. The grey finish of light poles would allow these items to recede in the background. Proposed landscape works would settle the bridge in its setting.

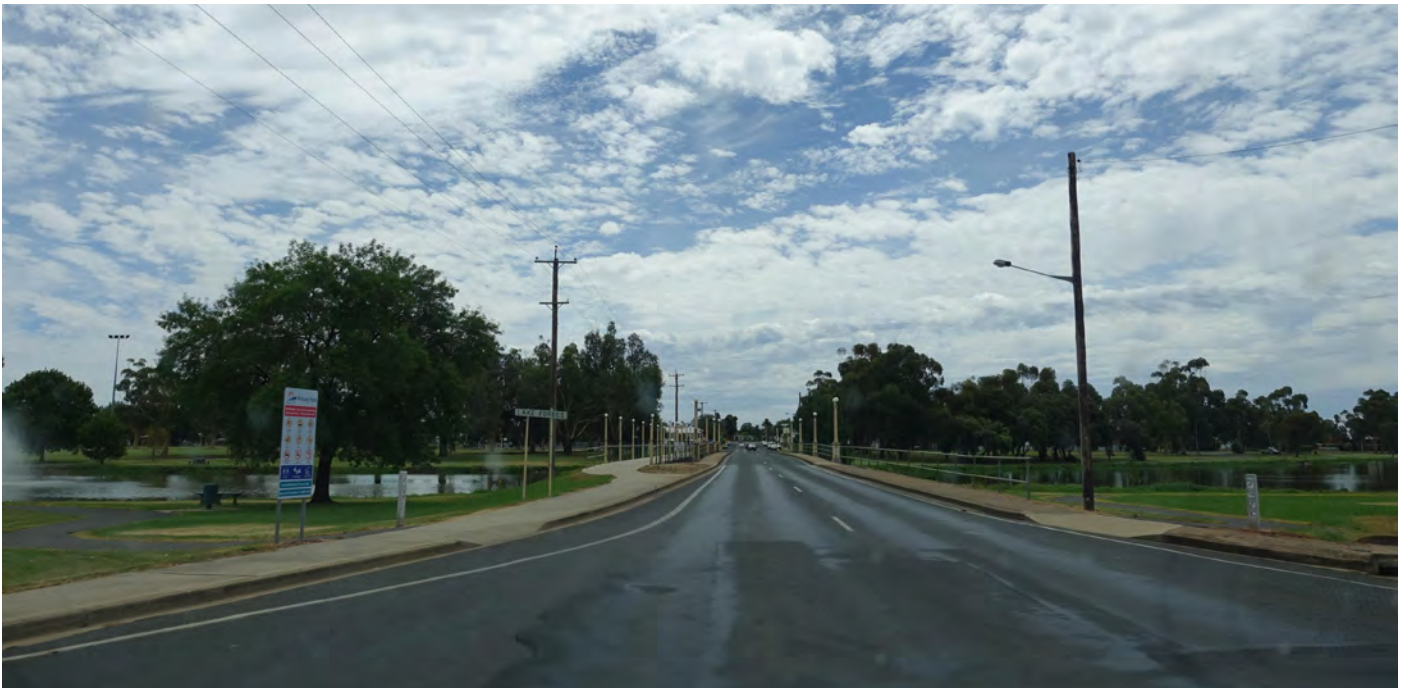
VIEWPOINT 11

Description of the setting	Road users approaching Camp Street Bridge from the south east. Open vistas to lake Forbes and surrounding parklands
Element visible of the project	View of Camp Street Bridge from the road
Category of viewer	Road user
Nature of impact	Beneficial
Visual sensitivity	Moderate. Although transient in nature, this entry into town is an important visual sequence for road users as part of the travel experience
Magnitude of impact	High. The new bridge would have a different appearance, with a promenade to one side and landscape design measures that would visually reinforce the arrival sequence into Forbes
Overall rating of visual impact	Moderate to high. The proposal is considered to provide a contribution to the visual quality of the setting

Comment / mitigation measures	The design has integrated mitigation measures, such as the landscape design and water sensitive urban design to achieve an improve outcome to the existing situation.

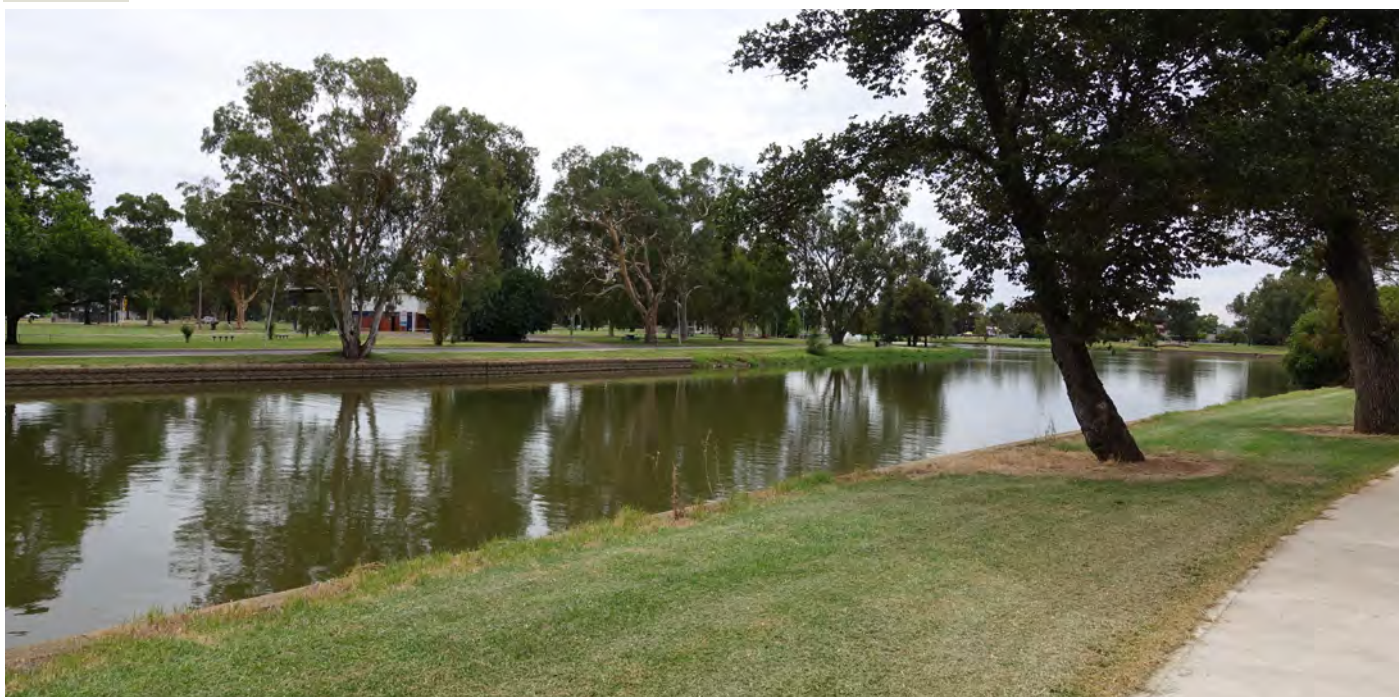
VIEWPOINT 12

Description of the setting	Parkland setting adjacent to Lake Forbes. Residences interface with the parkland
Element visible of the project	Minor filtered views towards the bridge
Category of viewer	Park users and some residents overlooking the lake
Nature of impact	Adverse
Visual sensitivity	High due to the visual quality and panoramic views of the setting
Magnitude of impact	Negligible. Filtered views through greenery limit the overall visual effect of the proposal
Overall rating of visual impact	Negligible
Comment / mitigation measures	No noticeable impact from this vantage point

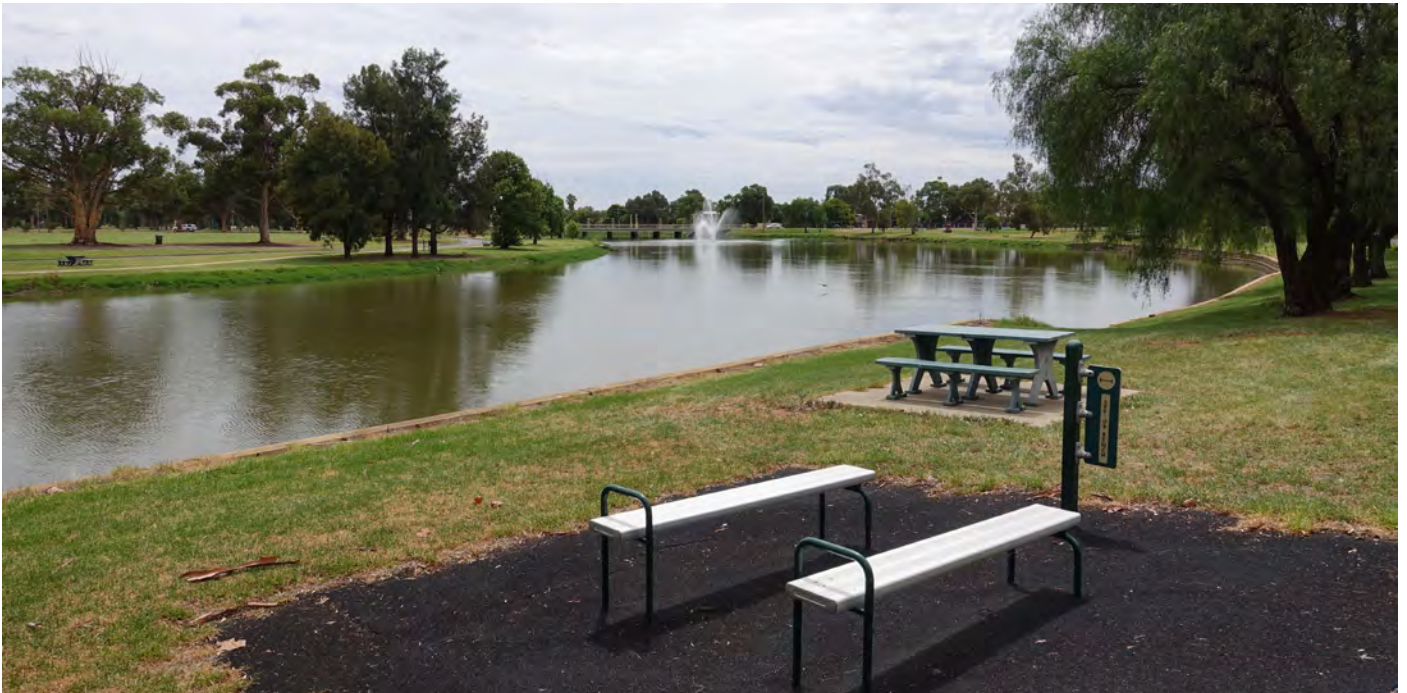
VIEWPOINT 13

Description of the setting	Lakes Forbes foreshore looking towards Camp Street Bridge
Element visible of the project	Camp Street Bridge in the distance including landscape measures
Category of viewer	Park users and cyclists
Nature of impact	Adverse
Visual sensitivity	High due to the importance of this open space for the community
Magnitude of impact	Low. The overall effect of the proposal would be limited as the proposal emulates the existing structure. The landscape design complements the parkland character.
Overall rating of visual impact	Moderate. The proposal would have a limited effect on the views from this vantage point
Comment / mitigation measures	Pedestrians would enjoy the riverside the same way. The general character of the structure would be retained with limited change.

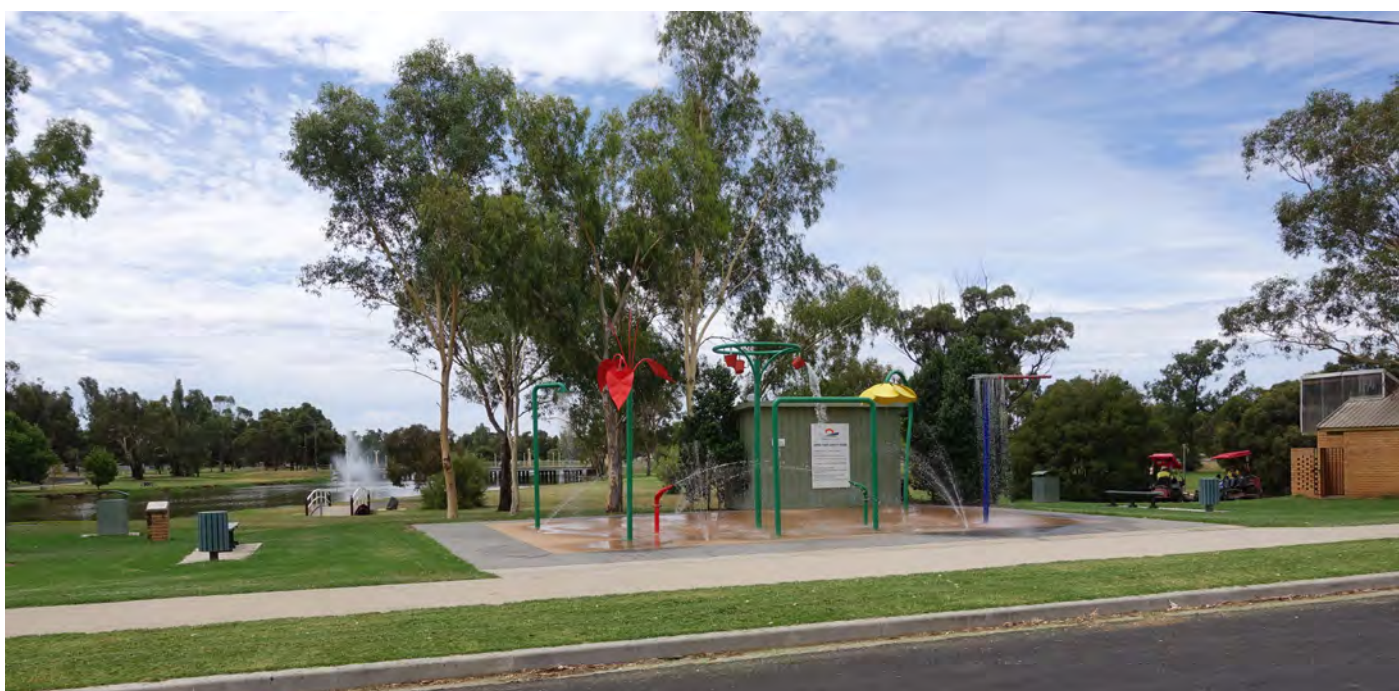
VIEWPOINT 14

Description of the setting	View looking from Bandon Street near the recently completed Waterplay park with Lake Forbes in the background
Element visible of the project	Filtered views to Camp Street Bridge in the background
Category of viewer	Pedestrians, road users, waterplay park visitors
Nature of impact	Adverse
Visual sensitivity	Low either due to the transient nature of the viewer or the introverted character of interaction at the water play park
Magnitude of impact	Negligible. No important visual effect from this vantage point
Overall rating of visual impact	Negligible
Comment / mitigation measures	No mitigation measures identified, the structure would recede in the background

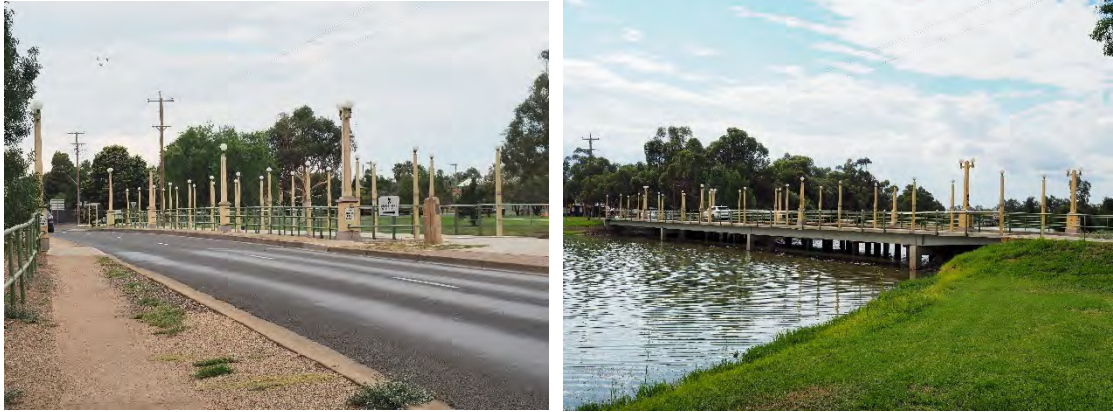
Figure 2-1 Camp Street Bridge (Source: FBE)

The Bridge over Lake Forbes on MR56 Lachlan Valley Way at Forbes, NSW is also known as Camp Street Bridge and was built in 1927 (see Figure 2-1 and Figure 2-2).

The reinforced concrete beam bridge has nine spans with a total length of around 58.826 m. The reinforced concrete deck and five integral girders are supported by reinforced concrete headstock and piers founded on driven timber piles.

The approach spans are constructed of simply supported reinforced concrete girders with a composite concrete deck. The girders sit on tar paper and there are end diaphragms between the girders. The integration of the small cantilevered deck, kerbing and pedestrian balustrade is aesthetically pleasing providing a shadow line for the superstructure profile (see Figure 2-2 and Figure 7-2). The concrete deck is cast integrally with the girders (see Figure 7-3).

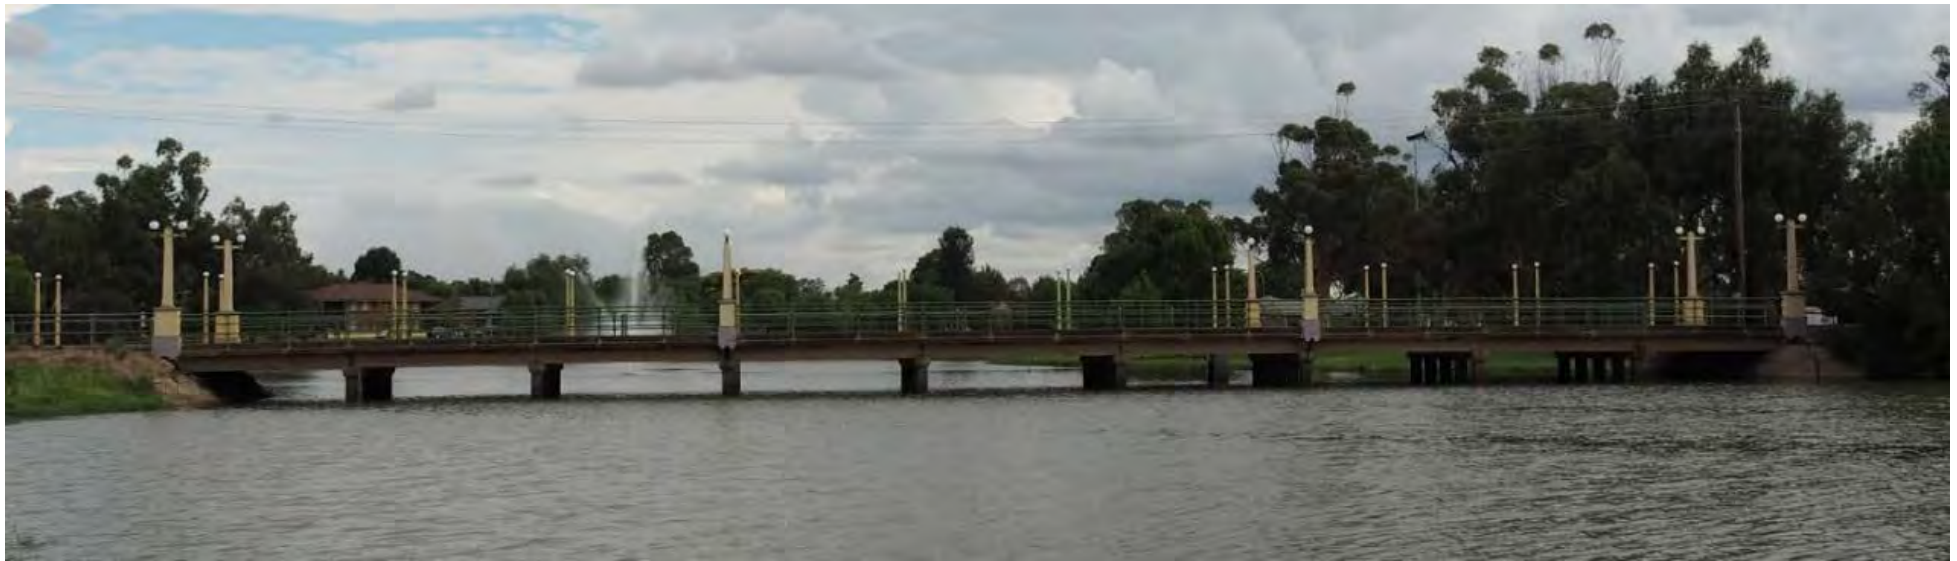
Figure 2-2 Camp Street Bridge elevation (Source: DMR WAE drawings and FBE)

The bridge appears to be in fair to poor condition.

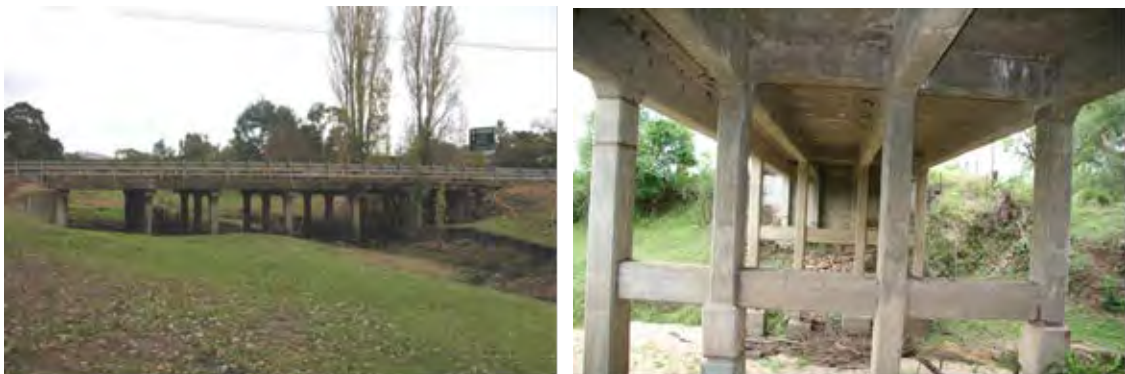
Figure 4-1 Muttama Creek Bridge and Mummulgum Bridge (Source: BRW)

The oldest extant reinforced concrete slab bridge is over Muttama Creek at Cootamundra (RTA Bridge No 6438), built in 1914 (see Figure 4-1). Another crossing, over American Creek near Figtree, also built in 1914, has been replaced.

The oldest surviving beam bridge in NSW is thus the bridge over Mummulgum Creek (RTA Bridge No. 2258), built in 1915 (see Figure 4-1). Although it has been strengthened and widened, it remains in service. Other beam bridges, all now gone, were built in 1916 at Mullet Creek, Dapto Throsby Creek, Wickham and Shark Creek, Maclean. Extant also from 1916 is the slab bridge over Surveyors Creek at Walcha (RTA Bridge No. 3485).

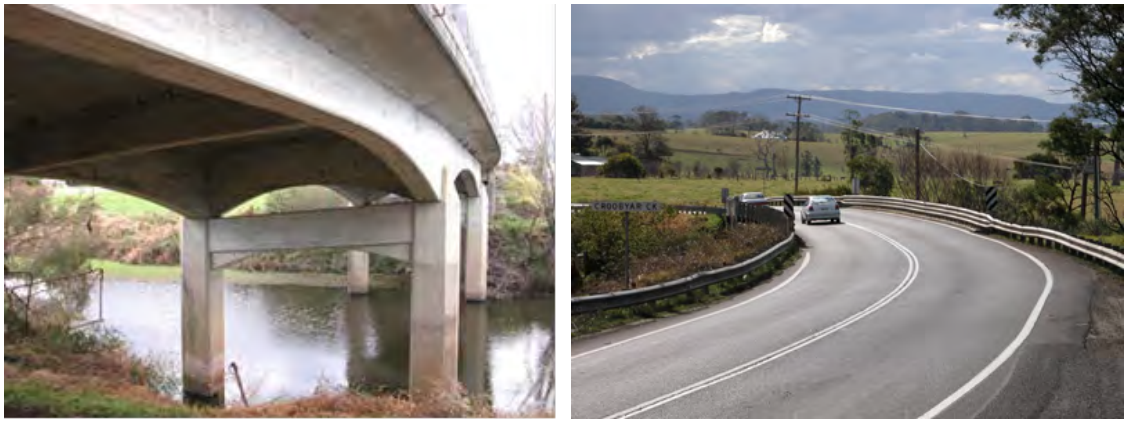
Figure 4-3 Croobyar Creek Bridge curved deck (Source: BRW)

The style of roads and bridges which had sufficed during the nineteenth century, wherein the road alignment and surface was subservient to the surroundings, was no longer acceptable for the higher vehicle speeds now emerging. Road design became a science in which the design speed dictated the minimum radius of vertical curves as well as the horizontal ones (see Figure 4-3). These were predicated on principles of safe stopping sight distances, and on limiting the lateral forces on vehicles. Previous rules, such as that mandated by the railways, that all overbridges must be at right angles to the rail line (to minimise soot effects from steam trains) began to be overturned, as were rules of thumb such as minimising the cost of bridges by making them straight and of minimum length (for example over rivers).

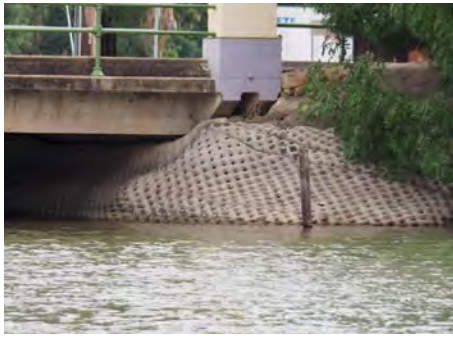
Figure 7-1 Abutment section (Source: FBE)

The abutments are protected from scour in the original drawings by 8" x 6" x15" stone pitching which appears to have been removed and replaced by conventional concrete filled revetment scour protection mattresses (see Figure 7-1).

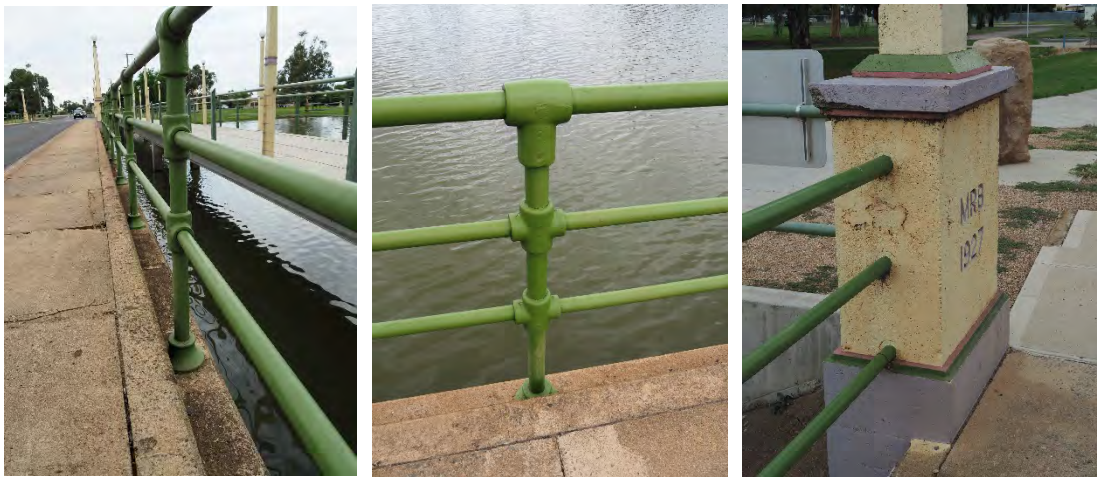
Figure 7-4 Pedestrian balustrade railing (Source: FBE)

The pedestrian balustrade is made up of a 2" diameter top rail and 1" diameter mid and bottom rails, with 1½" diameter vertical posts spaced at varying distances depending on the changing span lengths. The posts are anchored into the cantilevered section of the deck and the railing terminates in the lamp post bases (see Figure 7-4).

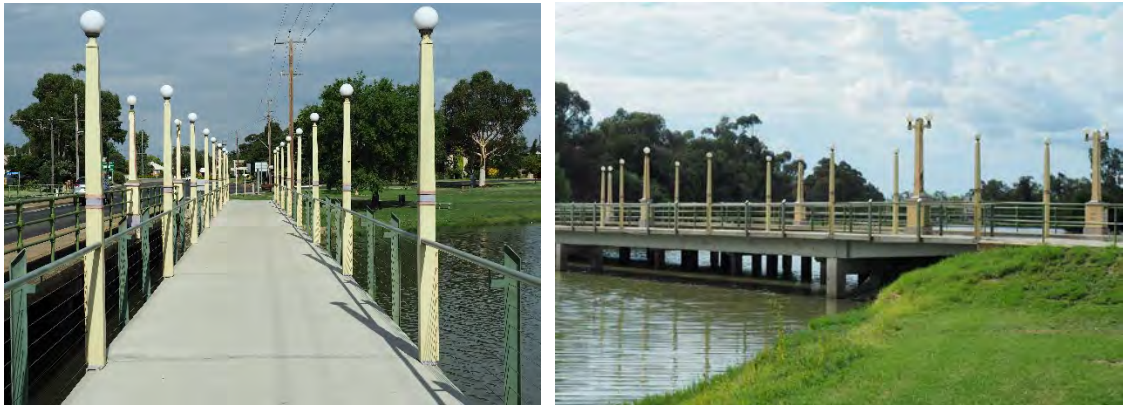
Figure 7-8 New pedestrian bridge (Source: FBE)

The new pedestrian bridge intrudes significantly upon the overall aesthetic of the original bridge. Unfortunately, the twenty-two new bridge lamp posts obstruct and hide the eight existing 1927 lamp posts which are of interest. The new lamp posts appear to replicate the existing single luminaire lamp posts in terms of colour, taper and luminaire globe shape and orientation.

The original bridge aesthetics would have been served much better by the new pedestrian bridge providing a similar or shallower deck profile, with street lighting at balustrade level and not trying to replicate the existing bridge lamp posts and luminaires.

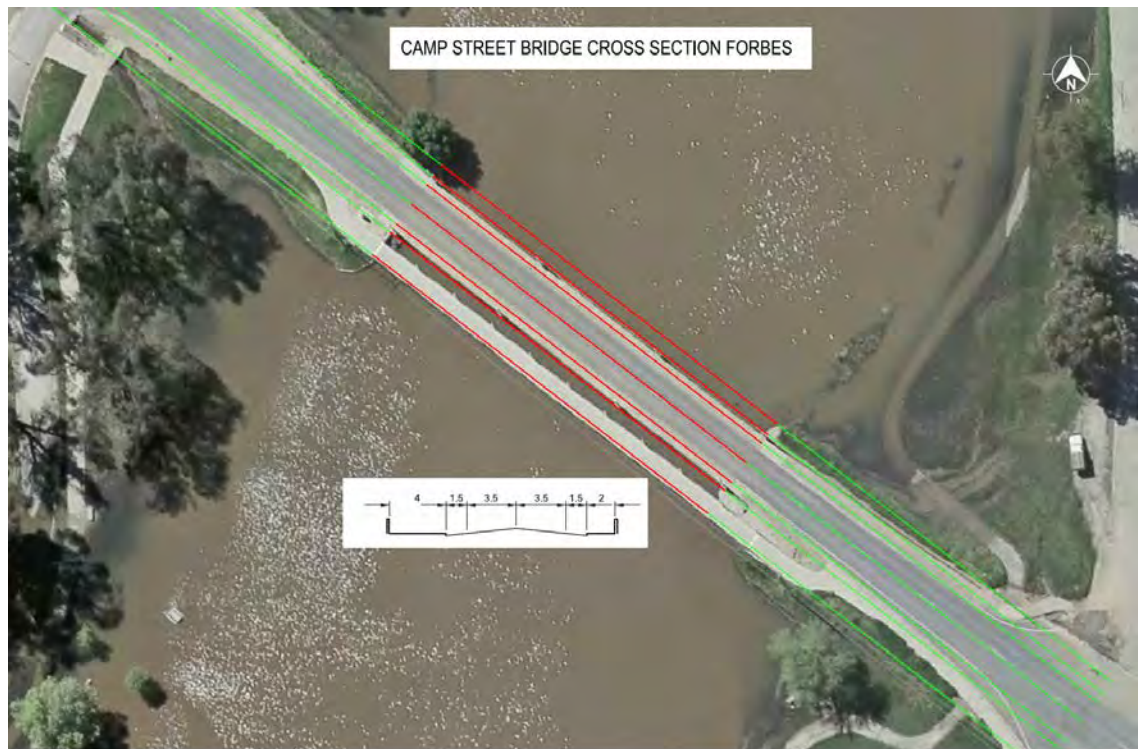
Figure 10-1 Strategic concept bridge layout (Source: RMS)

At this preliminary strategic options stage Roads and Maritime Services has advised it is considering an on-line bridge replacement (see Figure 10-1).

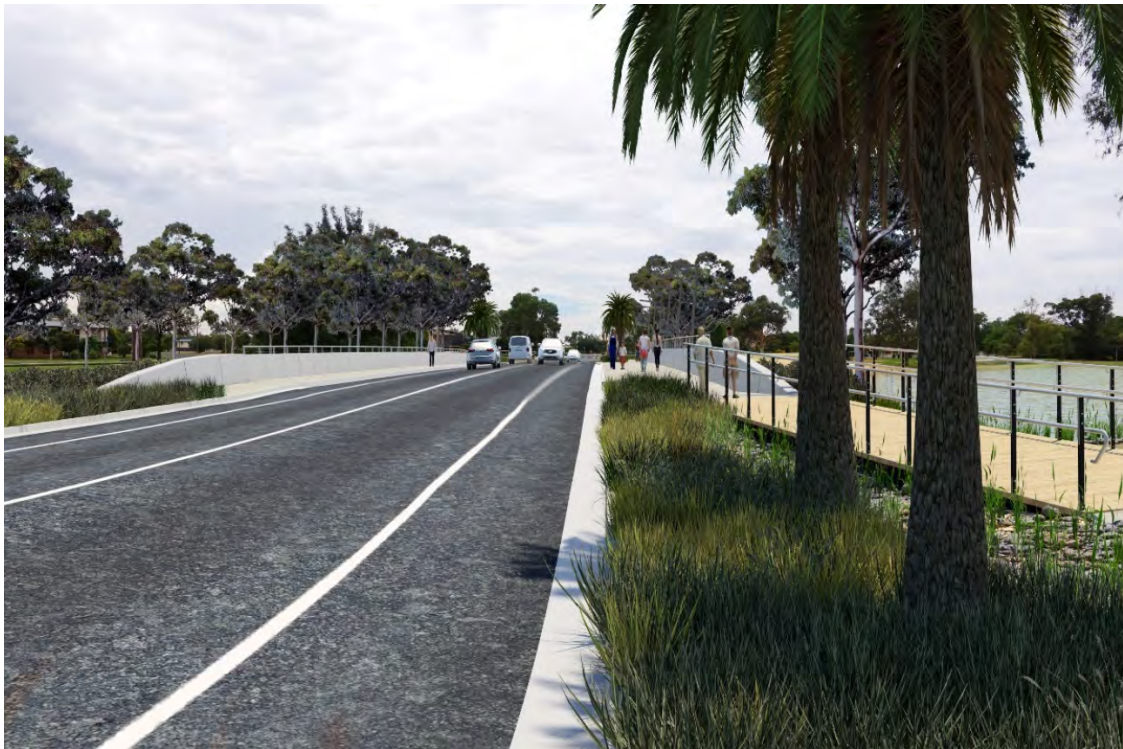
Figure 10-3 New bridge photomontage (Source: RMS)

Roads and Maritime Services has set a number of urban design objectives during the early consideration of bridge replacement options as shown in Figure 10-2 and 10-3.

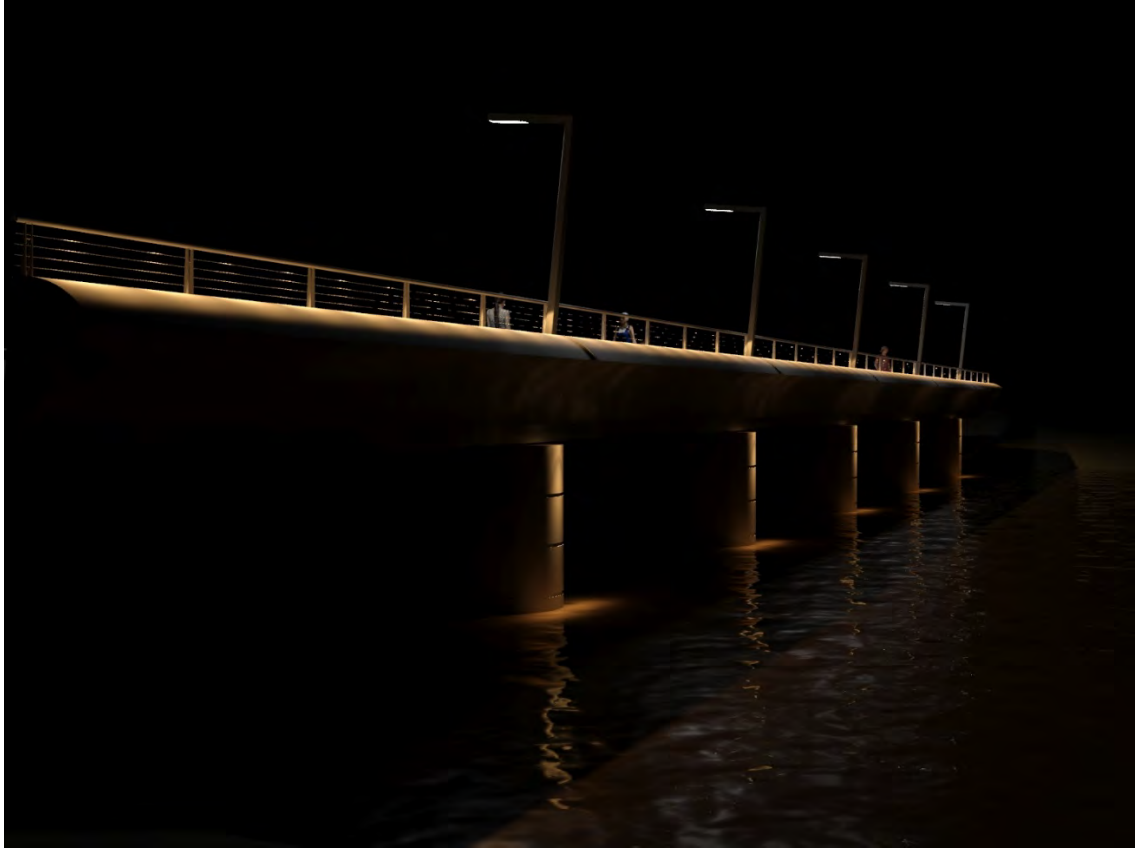
Figure 10-4 Proposed bridge lighting (Source: RMS)

At this early stage Roads and Maritime have allowed for street lighting on the upstream shared footpath side of the new bridge (see Figure 10-4).

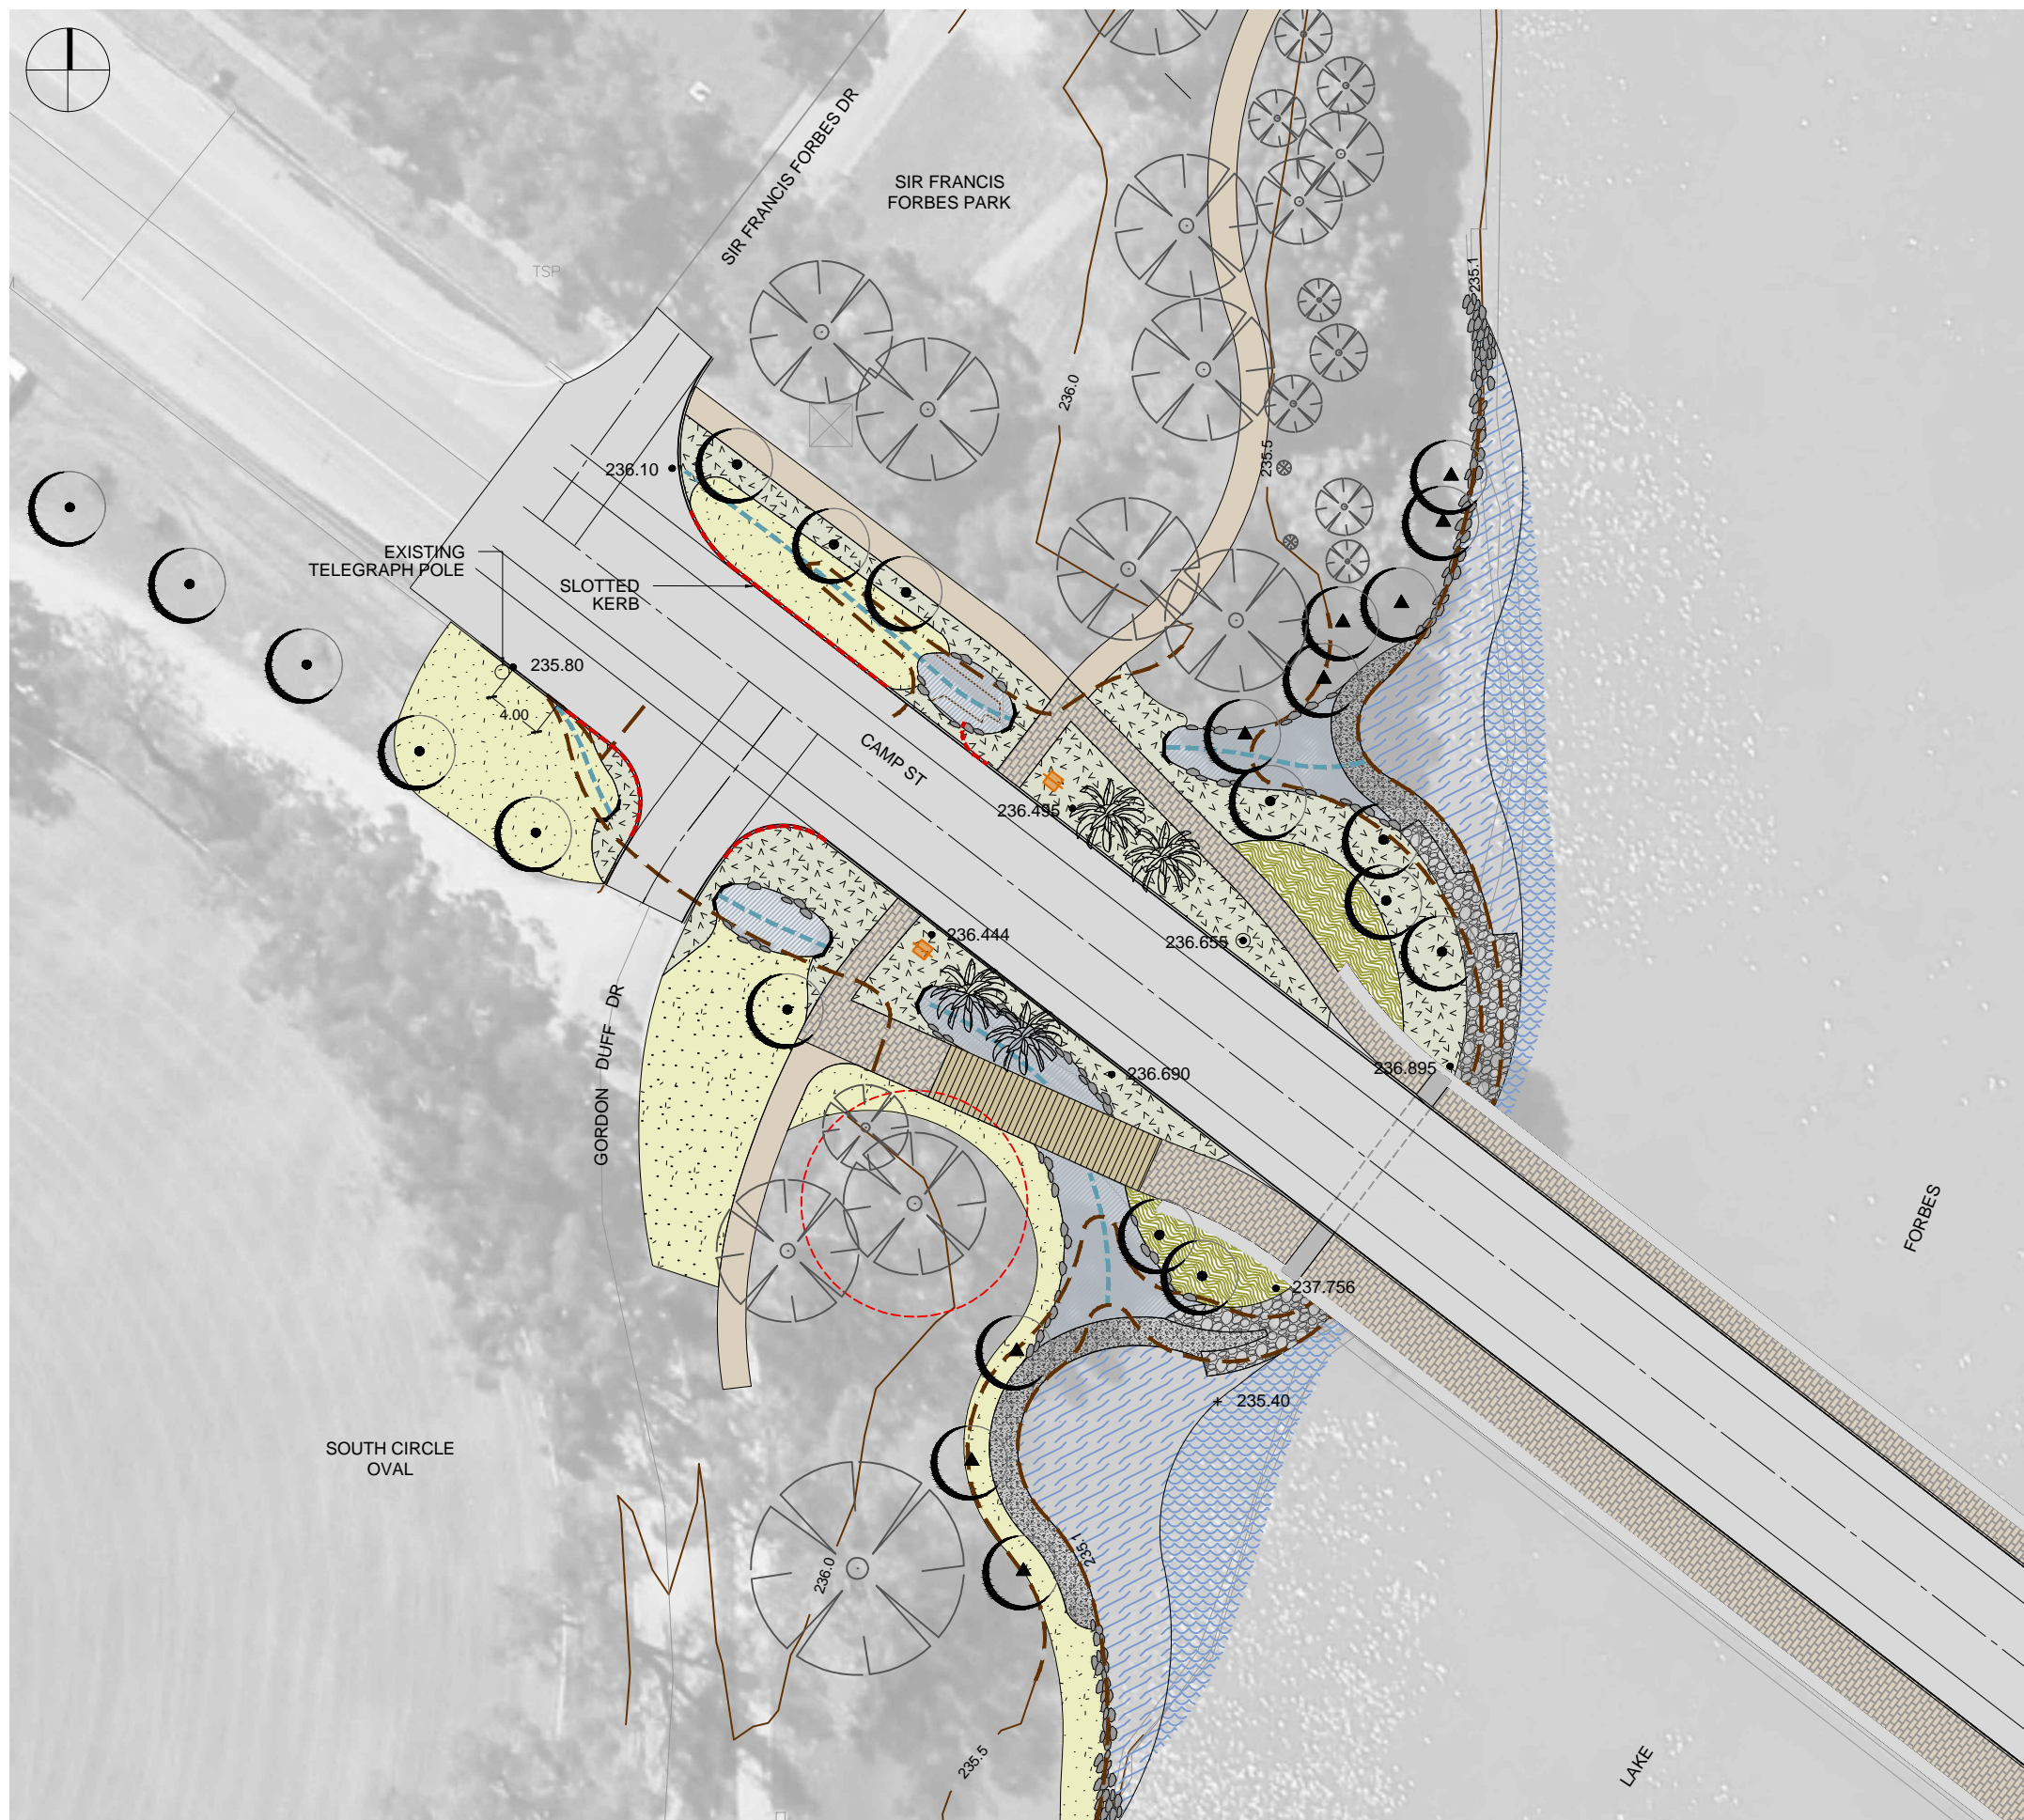
FILE No. 16_32	DRAWING DWG_LD_103	PRINTED DATE 20/07/2017	SHEET No. 02
REGISTRATION NUMBER KIS-1632-DWG-LD

Landscape Design - West Foreshore
Surfaces, Incidental Works & Planting
