Appendix A

Consideration of clause 228(2) factors and matters of national environmental significance

Concept design

Statement of Heritage Impact for the Proposed Bridge
Replacement

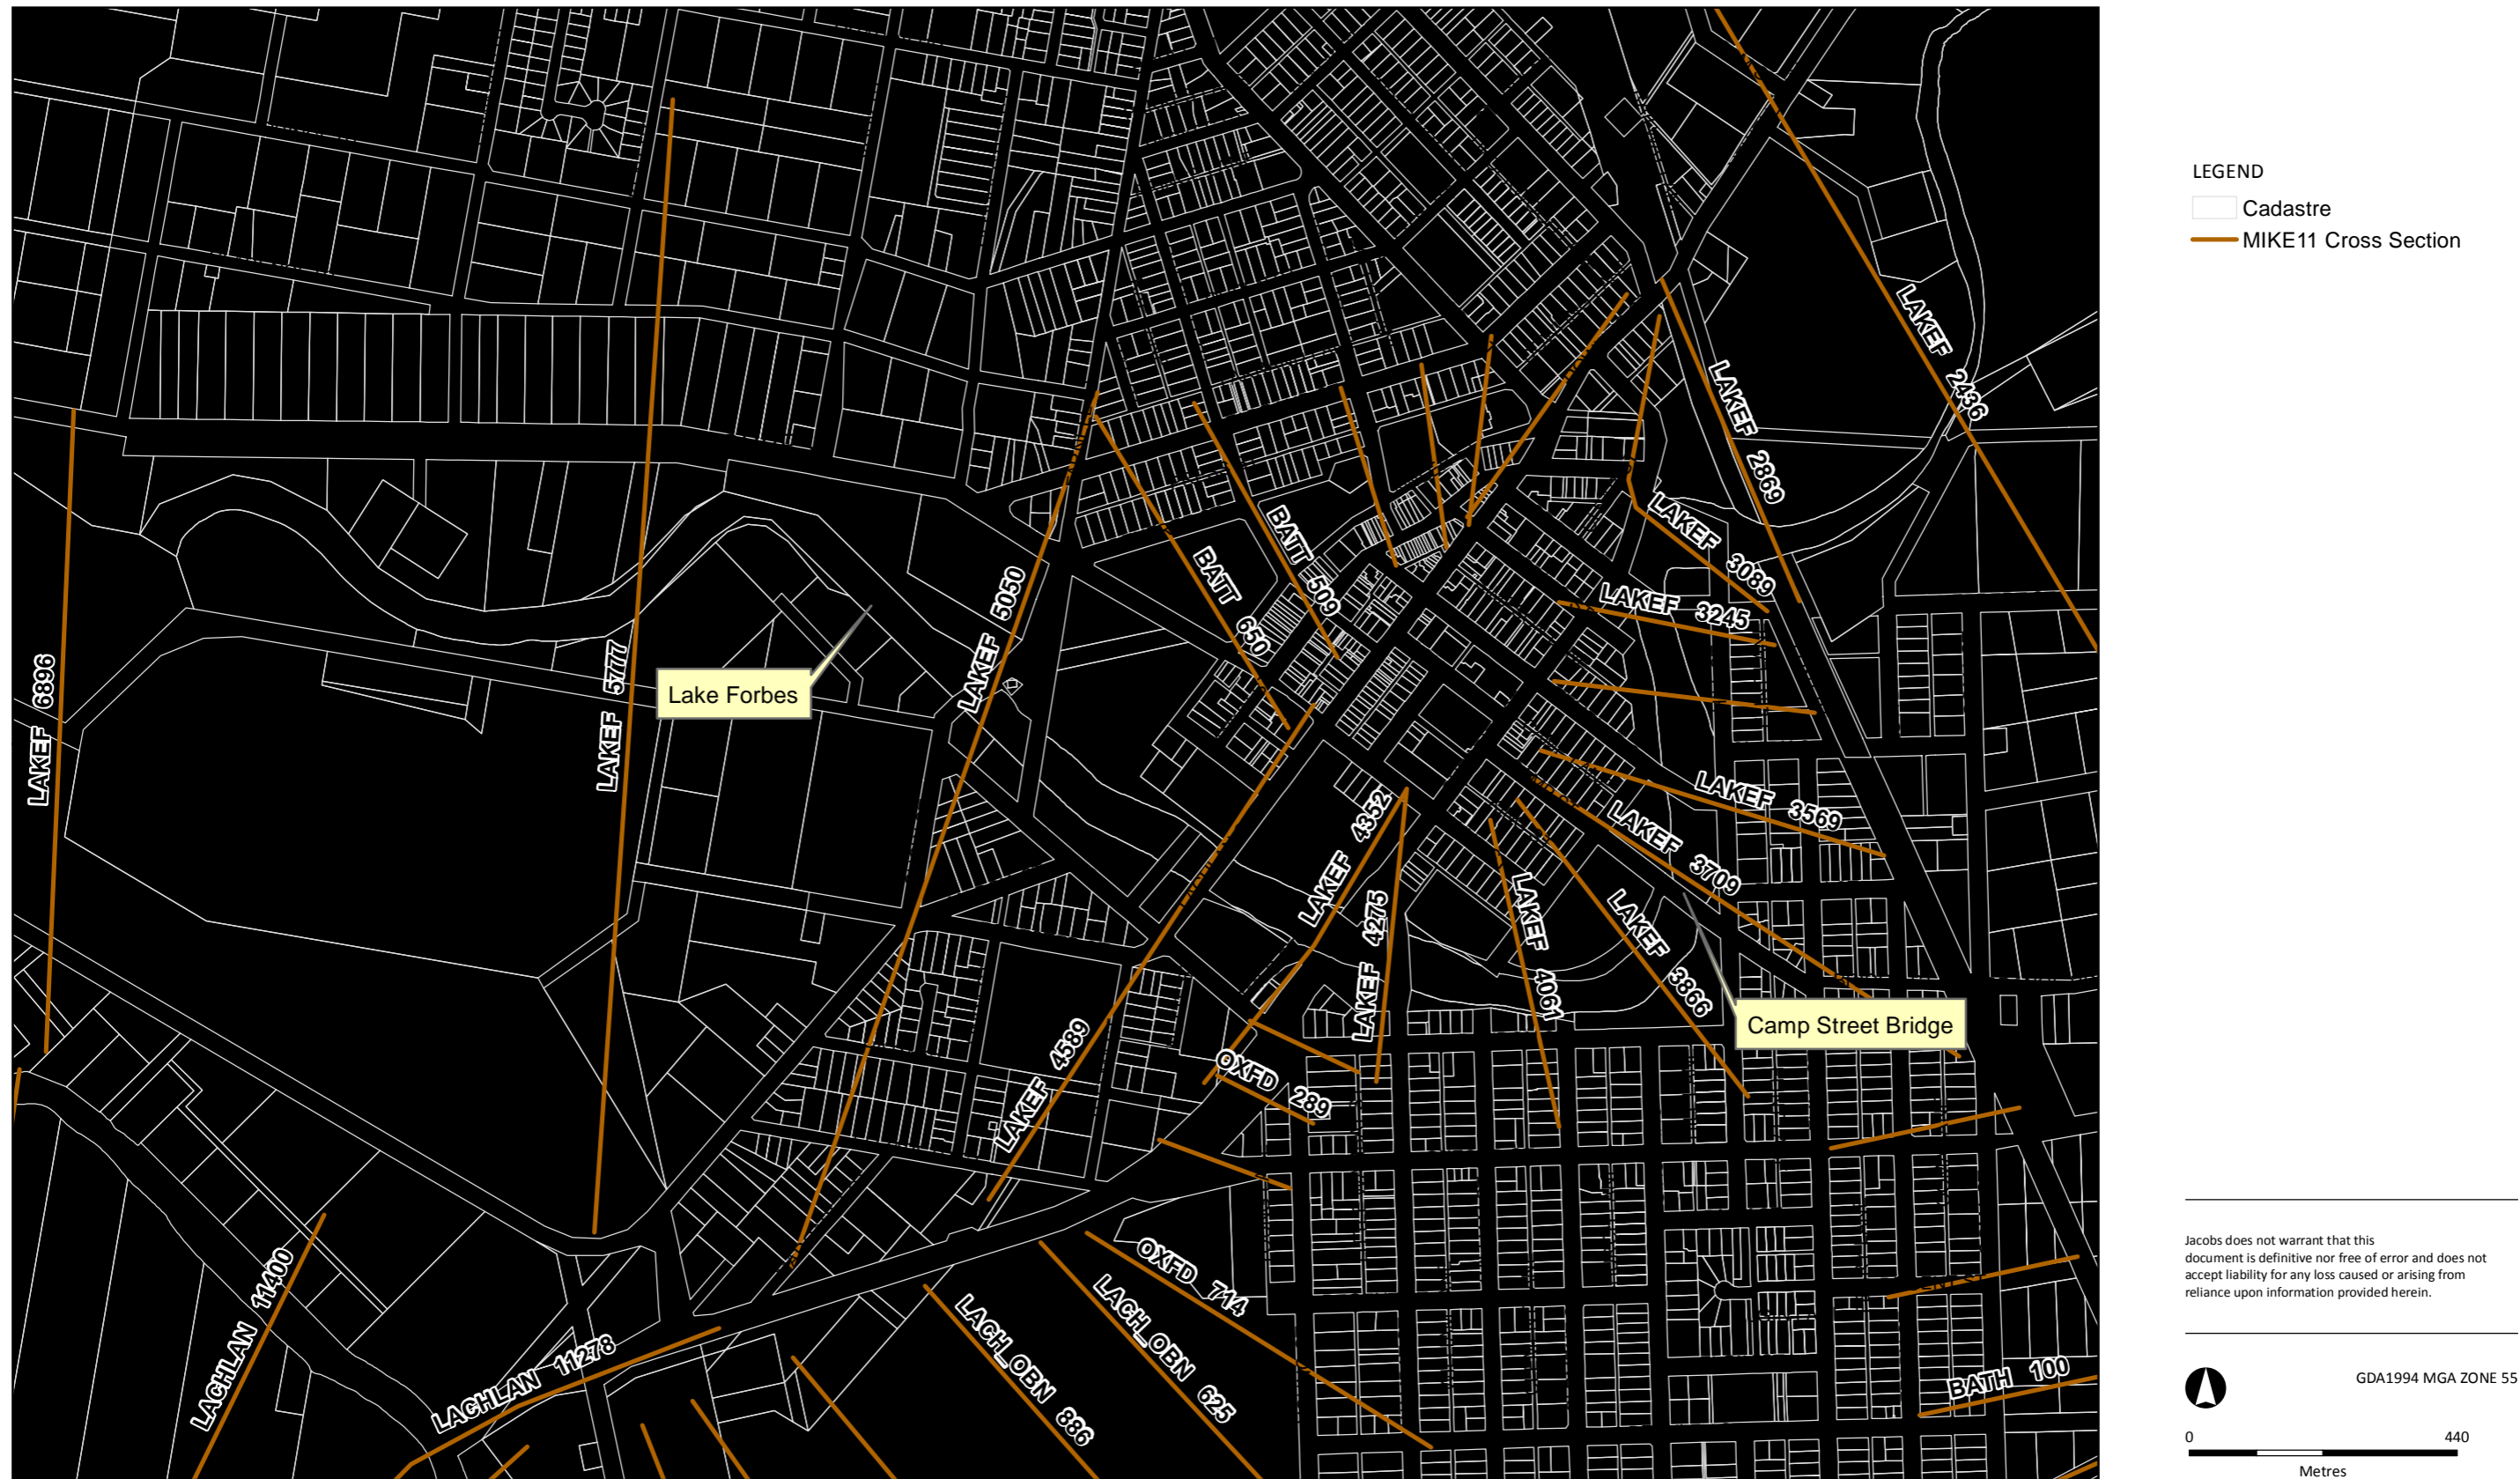
Figure A-1 Location of MIKE11 Cross Sections

SPOT5 Image Captured on 7 March 2012 shows the extent of flooding close to the peak of the flood in Forbes. The Image was provided by NSW Office of Environment & Heritage

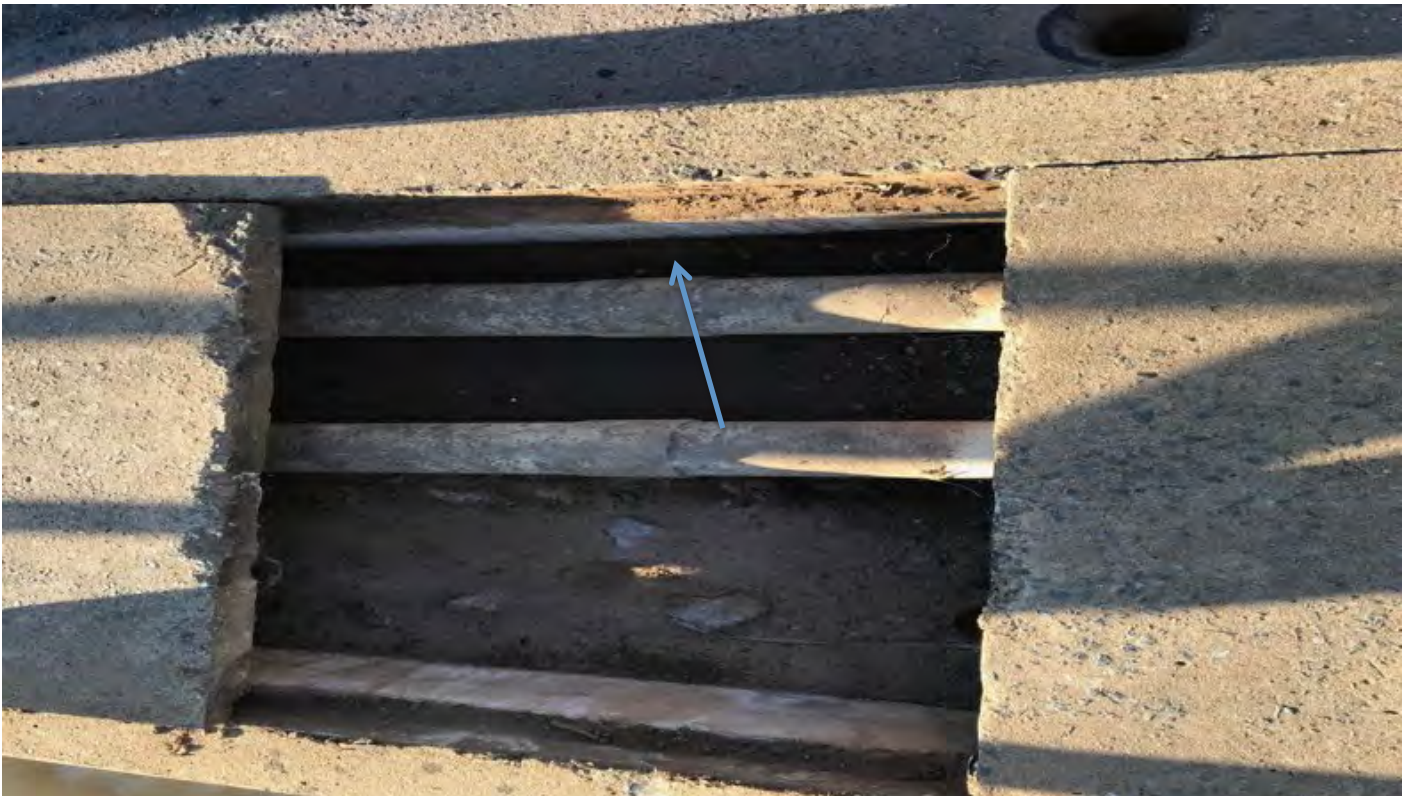
Photo: 1 Friable asbestos detected within a loose fibre bundle within the underside of the concrete slab.

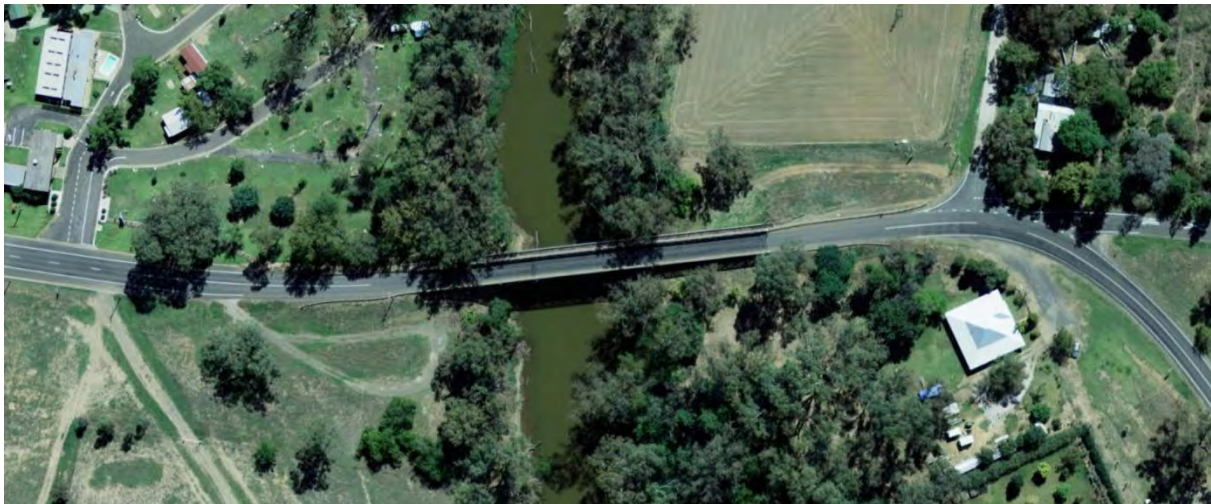
Figure 7 Iron Bridge

Iron Bridge is located on Reymond Street, west of Reising Street. As seen in **Figure 7**, the bridge is narrow in nature and only one heavy vehicle is permitted on the bridge at any one time. Access to the holiday park is located approximately 90 metres east of Iron Bridge.

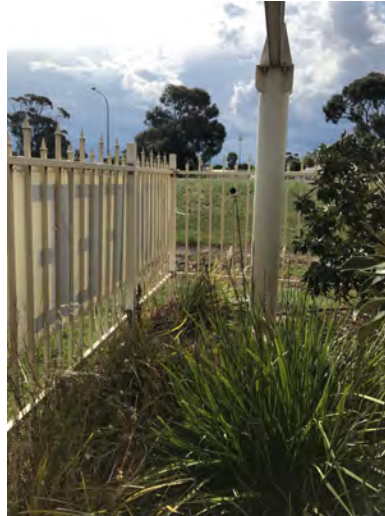
Logger Setup Photo

Logger Type: Rion NL52
 Serial No : 553966
 Address: 7 Oxford Street , Forbes
 Location: Underneath Museum Sign
 Facade / Free Field: Free Field
 Environment: Noise environment dominated by road traffic from Newell Highway. Some light traffic noise from Oxford Street. Slight wind noise in nearby bushes. Cicadas barely audible.

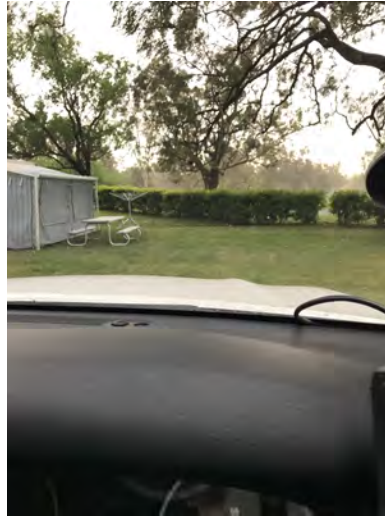
Logger Setup Photo

Logger Type: Rion NL52
 Serial No : 1043455
 Address: 88 Reymond St , Forbes
 Location: On Fence
 Facade / Free Field: Free Field
 Environment: Moderate wind noise. Light road traffic noise from Reymond Street.
