Transport
Roads & Maritime
Services

Construction Heritage Management Sub-plan

Foxground and Berry bypass

September 2017

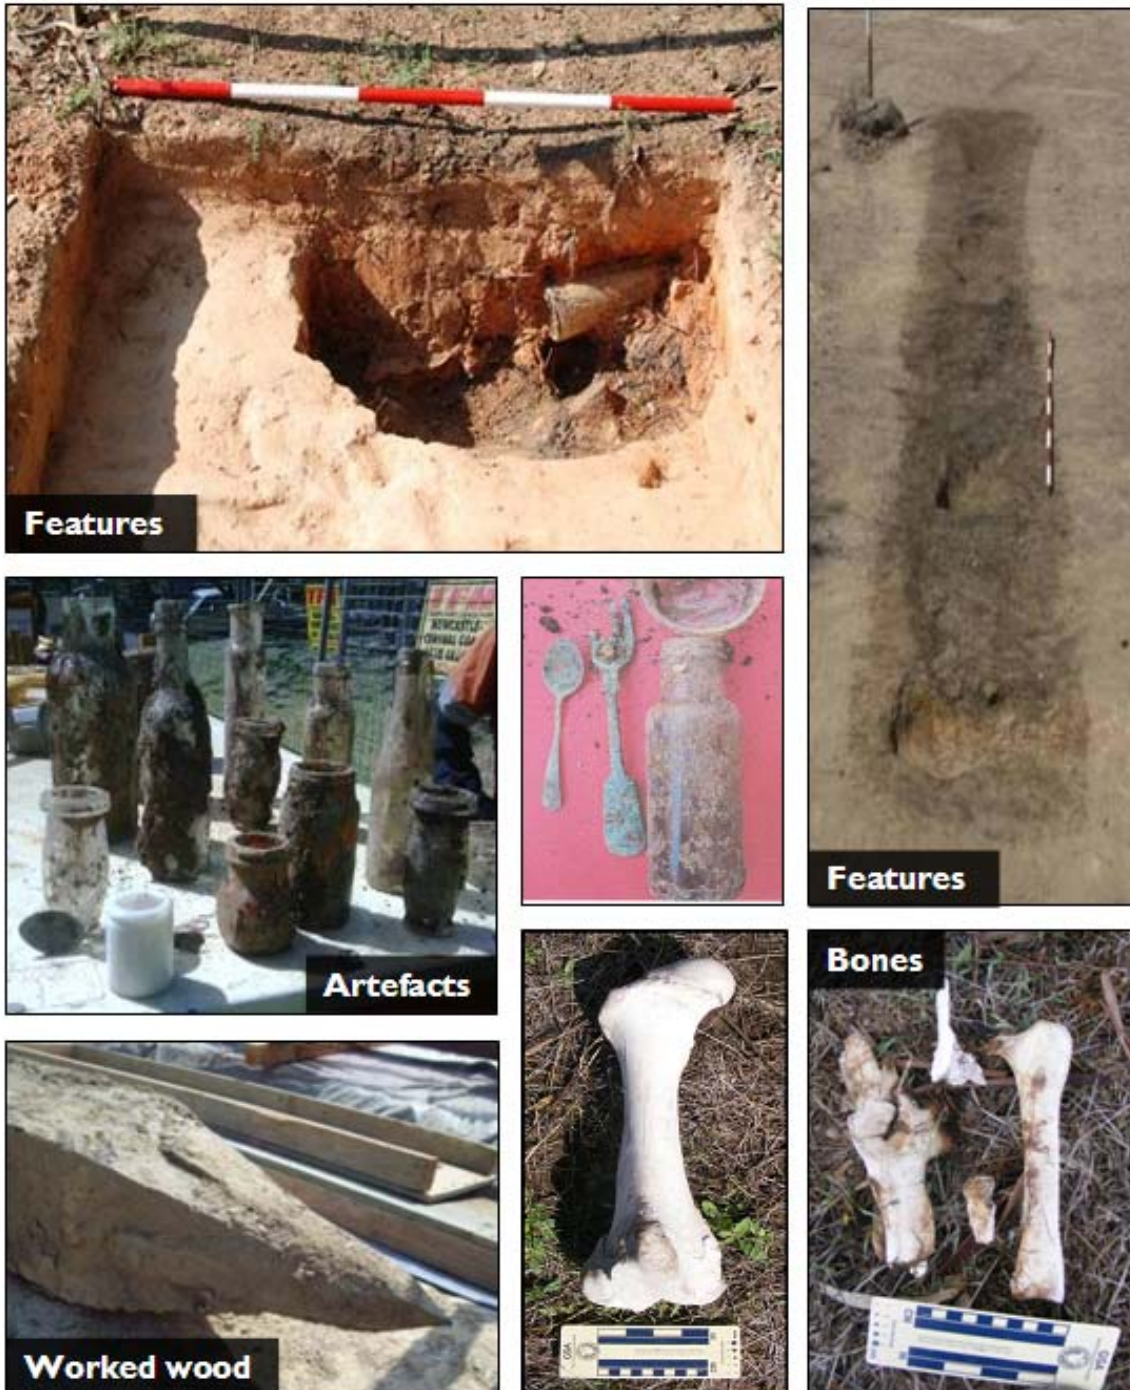
The following images can be used to assist in the preliminary identification of a potential unexpected items (both Aboriginal and non-Aboriginal) during construction and maintenance works. Please note this is not a comprehensive typology.

Top left hand picture continuing clockwise: Stock camp remnants (Hume Highway Bypass at Tarcutta); Linear archaeological feature with post holes (Hume Highway Duplication), Animal bones (Hume Highway Bypass at Woomargama); Cut wooden stake; Glass jars, bottles, spoon and fork recovered from refuse pit associated with a Newcastle Hotel (Pacific Highway, Adamstown Heights, Newcastle area).

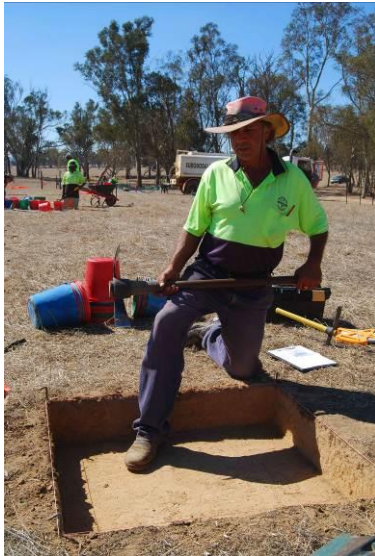
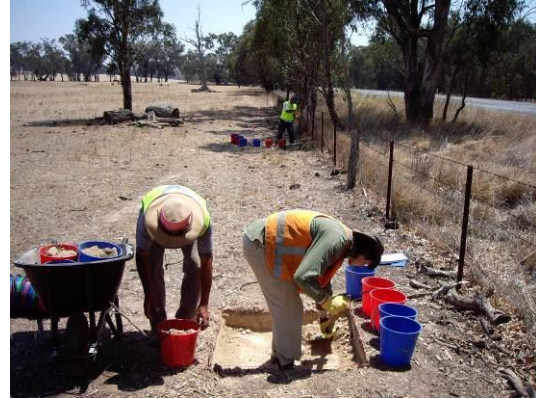
Plate 1. Manual excavation of 1m² archaeological squares

KNC estimate approximately 3-5m² will be excavated at each site location as part of the Phase 1 assessment to supplement existing EA test data. Where no test data exists, Phase 1 testing will require approximately 15-25m² of excavation per landform. The MGA coordinates will be recorded for each square to enable three dimensional modelling. Statistical salvage following this method is highly beneficial because it creates a robust inter-site sample, sufficiently random, critical for regional comparative analysis. No other method is as efficient or effective.

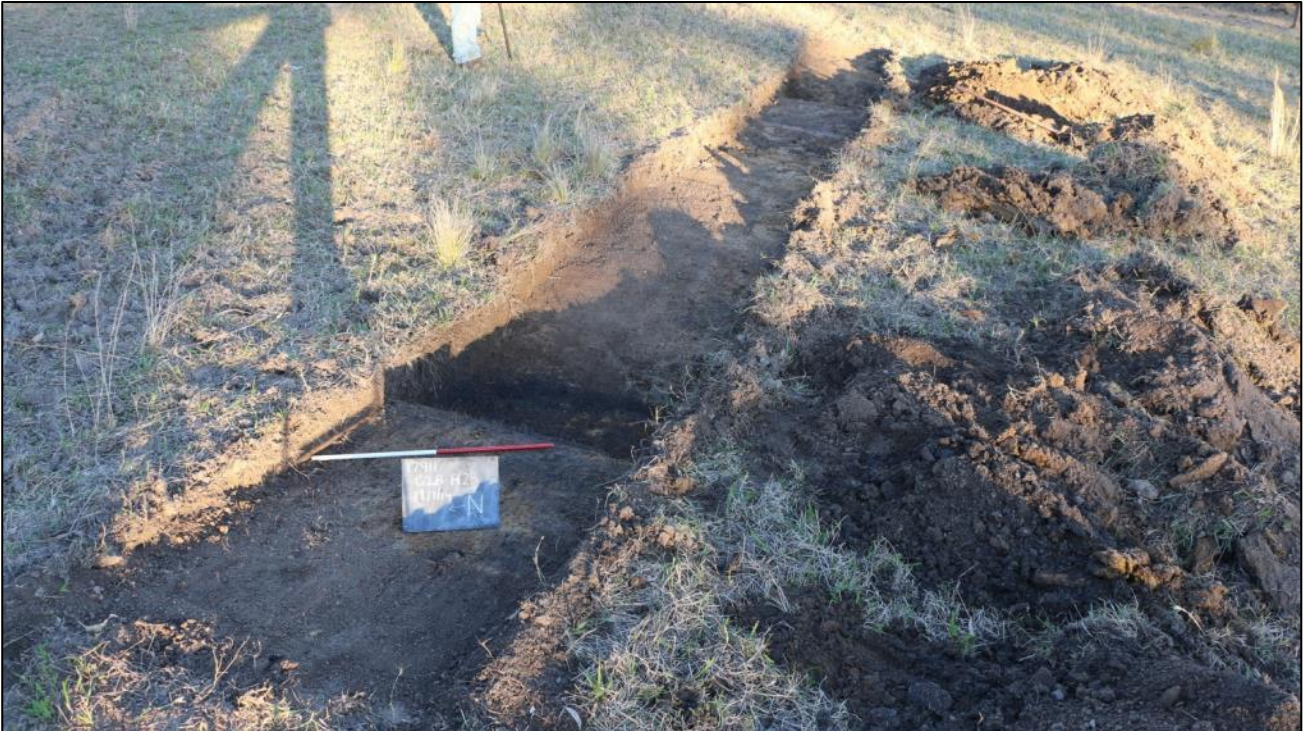
Plate 5: Oblique post excavation photograph facing east with 1 m scale showing cuts 003 and 005 for G2B H23 (Source: Biosis, 2014).

An oblique post-excavation photograph of G2B H23 can be seen in Plate 5. A scale section of cut 003 and plan photograph of cut 005 can be seen in Plate 6 and Plate 7 respectively.

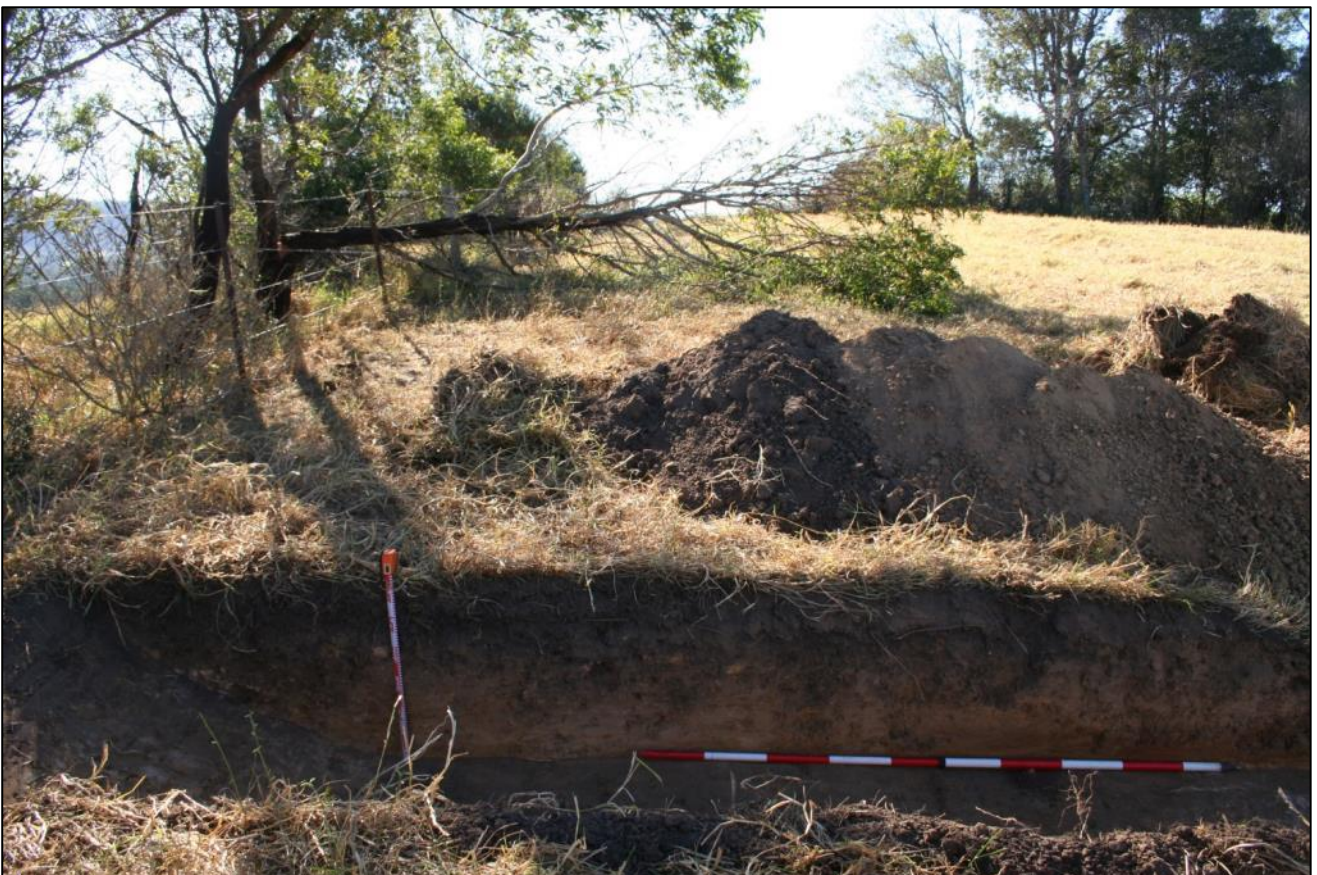
Plate 12: West facing section of trench, 2 m scale (Biosis, 2014).

The road alignment and landform prior to excavation can be seen in Plate 10, along with a post-excavation photograph and section in Plate 11 and Plate 12 respectively.

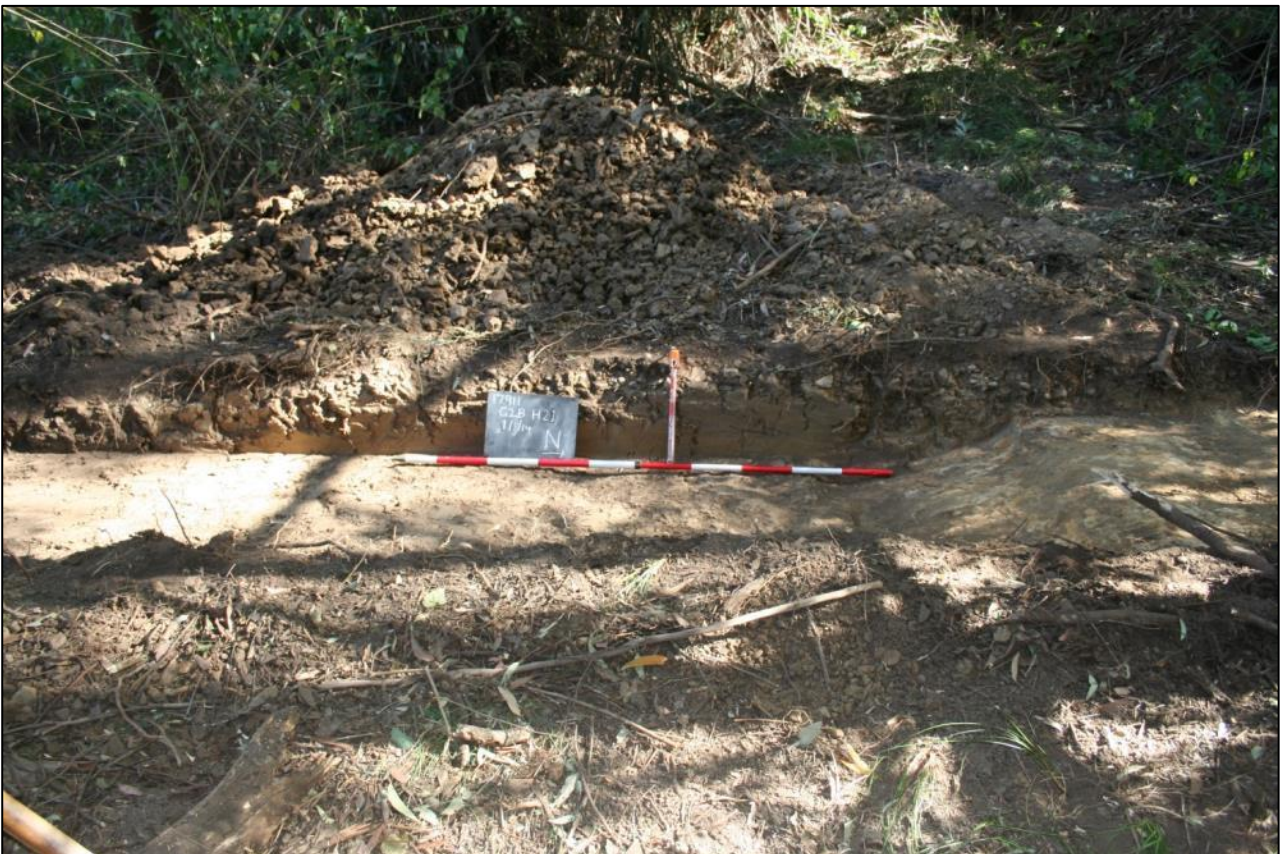
Plate 16: West facing section of G2B H21 with 2 m scale (Source: Biosis, 2014).

See Plate 15 for a post excavation photograph of G2B H21 and Plate 16 for an excavated section of the road profile.

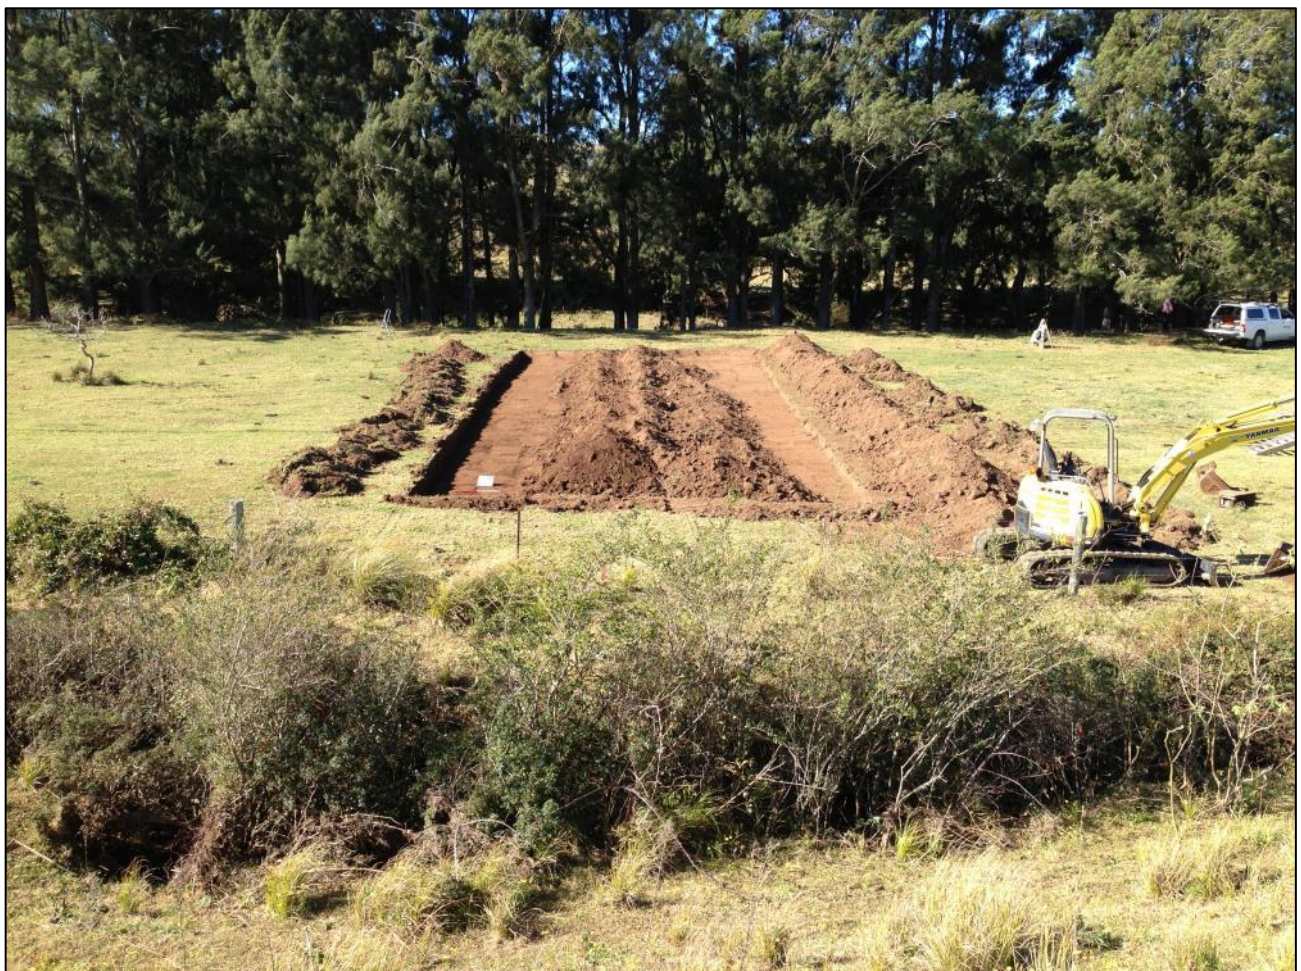
Plate 22: East facing photograph of G2B H28 showing entire stripped area (Source: Biosis, 2014)

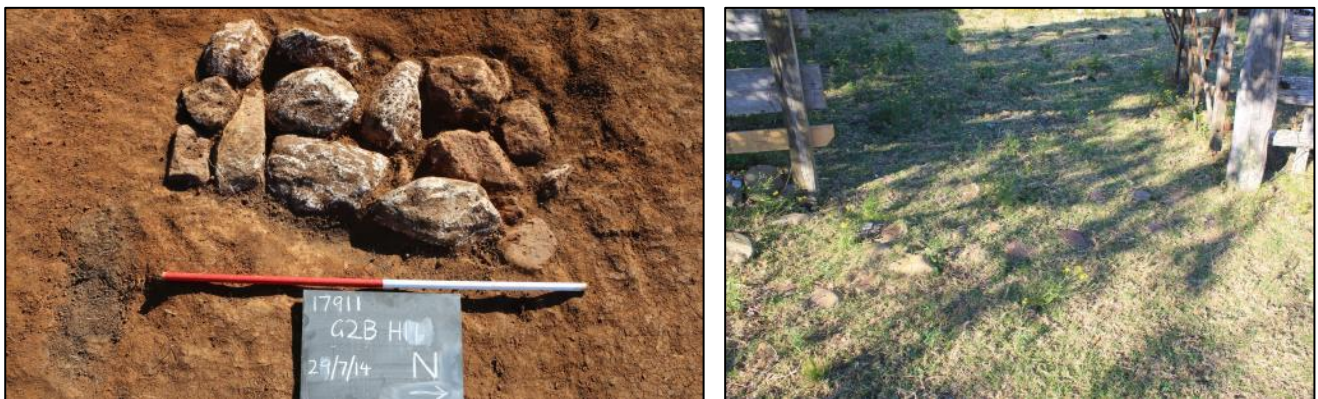
Plate 33: Comparison between feature 006 at G2B H11 – East and example of stone surface within cattle run observed locally during excavations (Source: Biosis 2014).

Excavations at G2B H11 (East and West) and G2B H49 did identify substantial archaeological remains; however whether these are associated with tenant farms is debatable. None of the excavations identified any underfloor deposits or structural evidence of hearths. The excavations at G2B H49 identified a large number of diffuse post holes and features which have been heavily truncated through modern land use activities. Although limited evidence of wall cuts were present the size of the post holes indicates that the trench identified the site was most likely the location of several permutations of small agricultural structures. The excavations at G2B H11 – East identified post holes and stone feature, however the post holes had been disturbed through rabbit burrowing. The stone feature (006) at G2B H11 – East, whilst substantial may represent a small surface used to reinforce the ground surface against cattle movement. Examples seen at local properties display similar characteristics in terms of the size, shape and composition of the stone used (see Plate 33). If correct, this may indicate that the post holes and features within G2B H14- East represent a cattle run rather than a structure.
