# Aquatic Monitoring Annual Report 2018

FOXGROUND AND BERRY BYPASS

Project Number: 17-647 FBB Monitoring

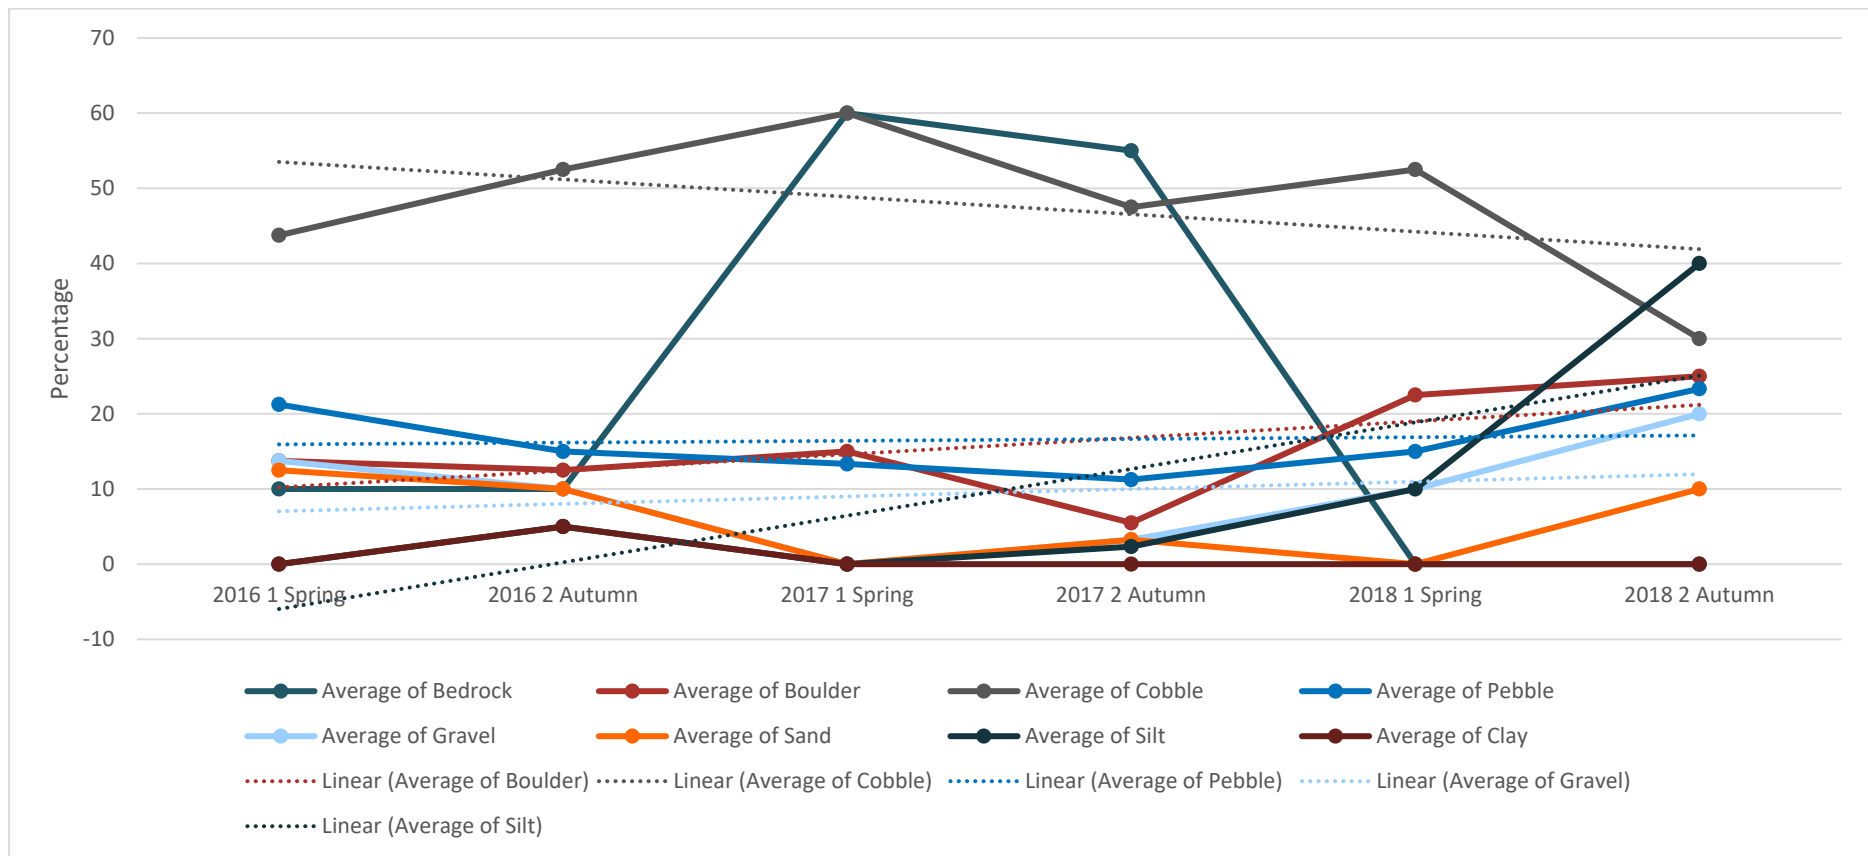
Substrate levels in the two upstream control sites (1 and 2) can be seen below in Figure 3-2. A trendline has been added to the substrate's "boulder", "cobble", "pebble", "gravel", and "silt". Similarly to the subject sites, cobble largely decreased in proportion over the survey periods. Important to note, data was only recorded for these sites between 2016 and 2018, where the subject sites also included 2014 and 2015 data. Boulder, gravel and silt slightly increased in proportion over time. Whereas pebble remained consistent over time.

Figure 3-2 Substrate data of Control Sites 1 and 2 over survey period

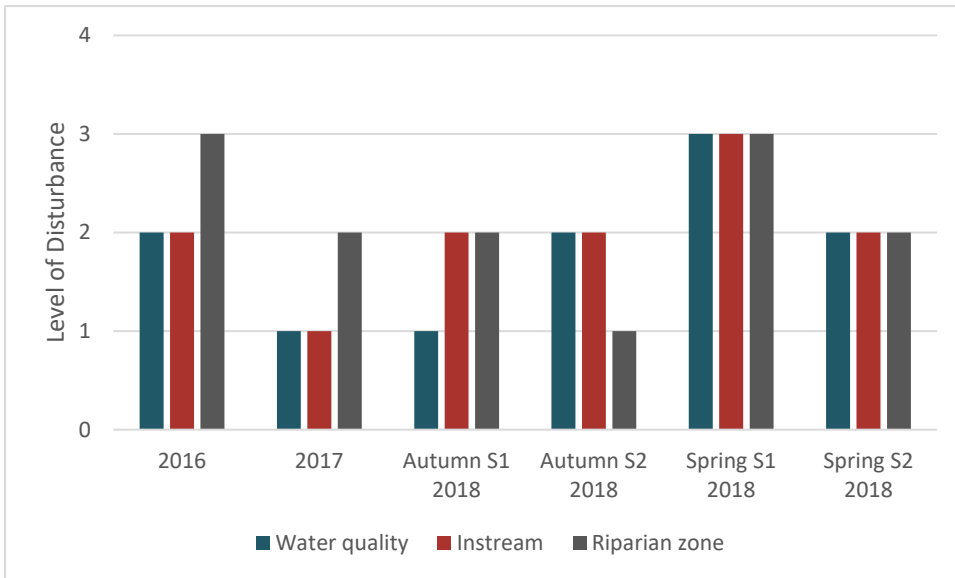
Figure 3-13 Site 27 Level of Disturbance (Water Quality, Instream, Riparian zone).

Level of disturbance 0 = no evidence of disturbance, 1= little disturbance, 2 = moderate disturbance, 3 = high disturbance, 4 = extreme disturbance

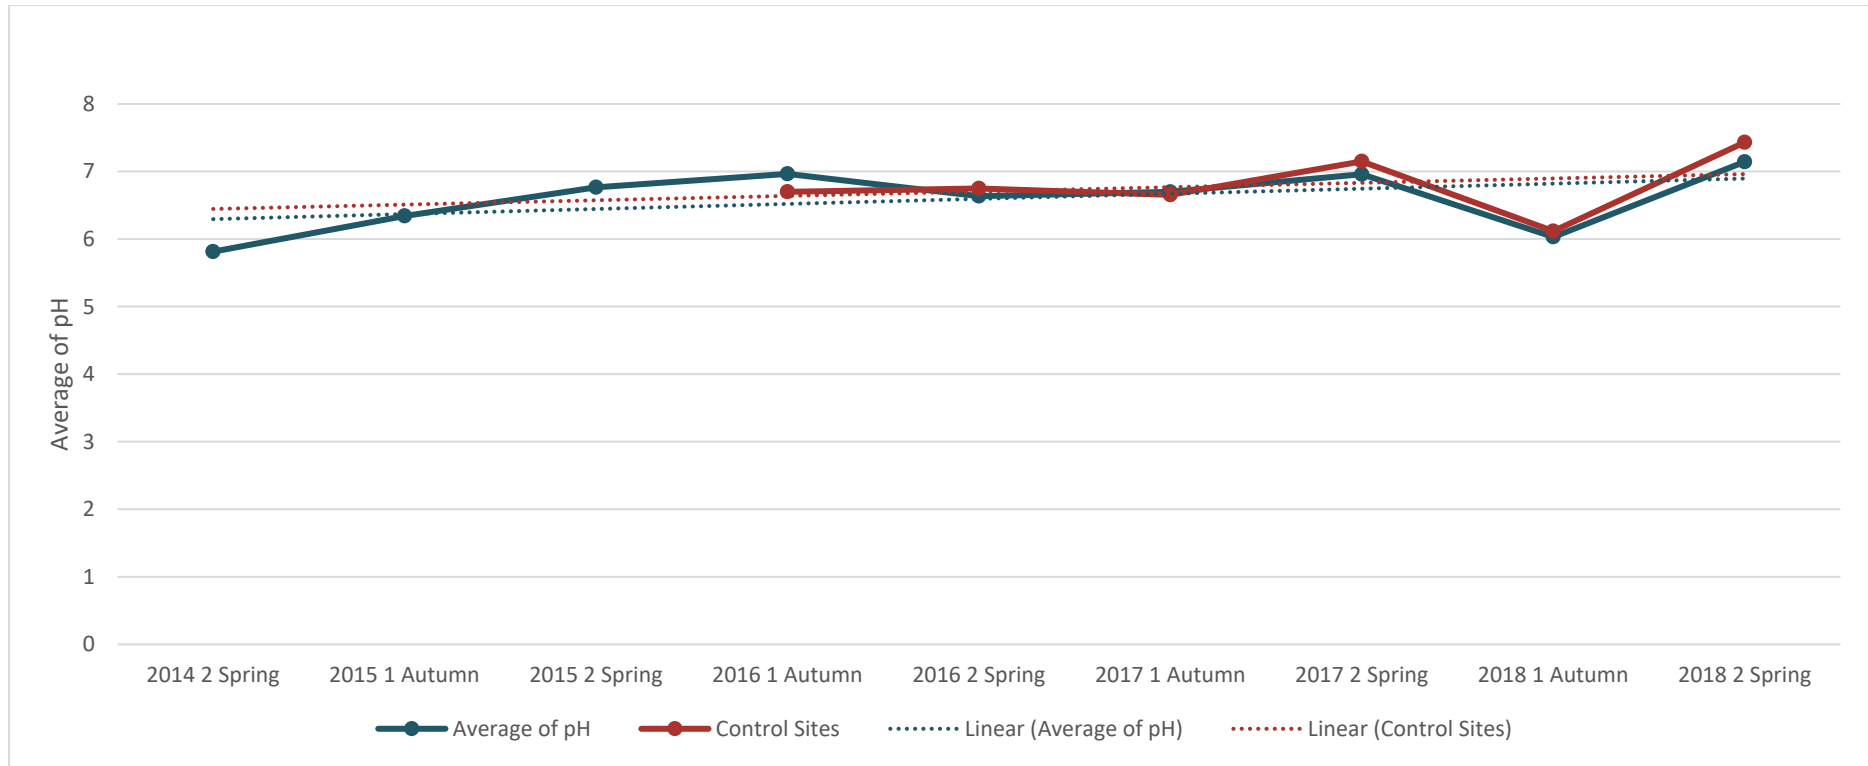
- pH readings in 2018 were variable ranging between 5.25 and 7.84 across all sites and survey sessions. Soil and animal health will not generally be affected by water with pH in the range of 4-9, however values between 4 and 6 should be regarded with caution due to the potential for corrosion and fouling (ANZECC/ARMCANZ 2000). Levels below 6 were seen at all sites excluding site 17 (pH 6.09), all of which occurred during Autumn 2018 Session 2. As mentioned in the limitations, sampling during this time occurred immediately after heavy rainfall which most likely skewed the results. pH values fell within the ANZECC/ARMCANZ 2000 guidelines trigger value range 50% of the time during the 2018 surveys.

Figure 3-20 pH across sites 13, 16, 17, 22, 25, 27, and control sites 1 and 2 over 2016, 2017, and 2018 sampling season

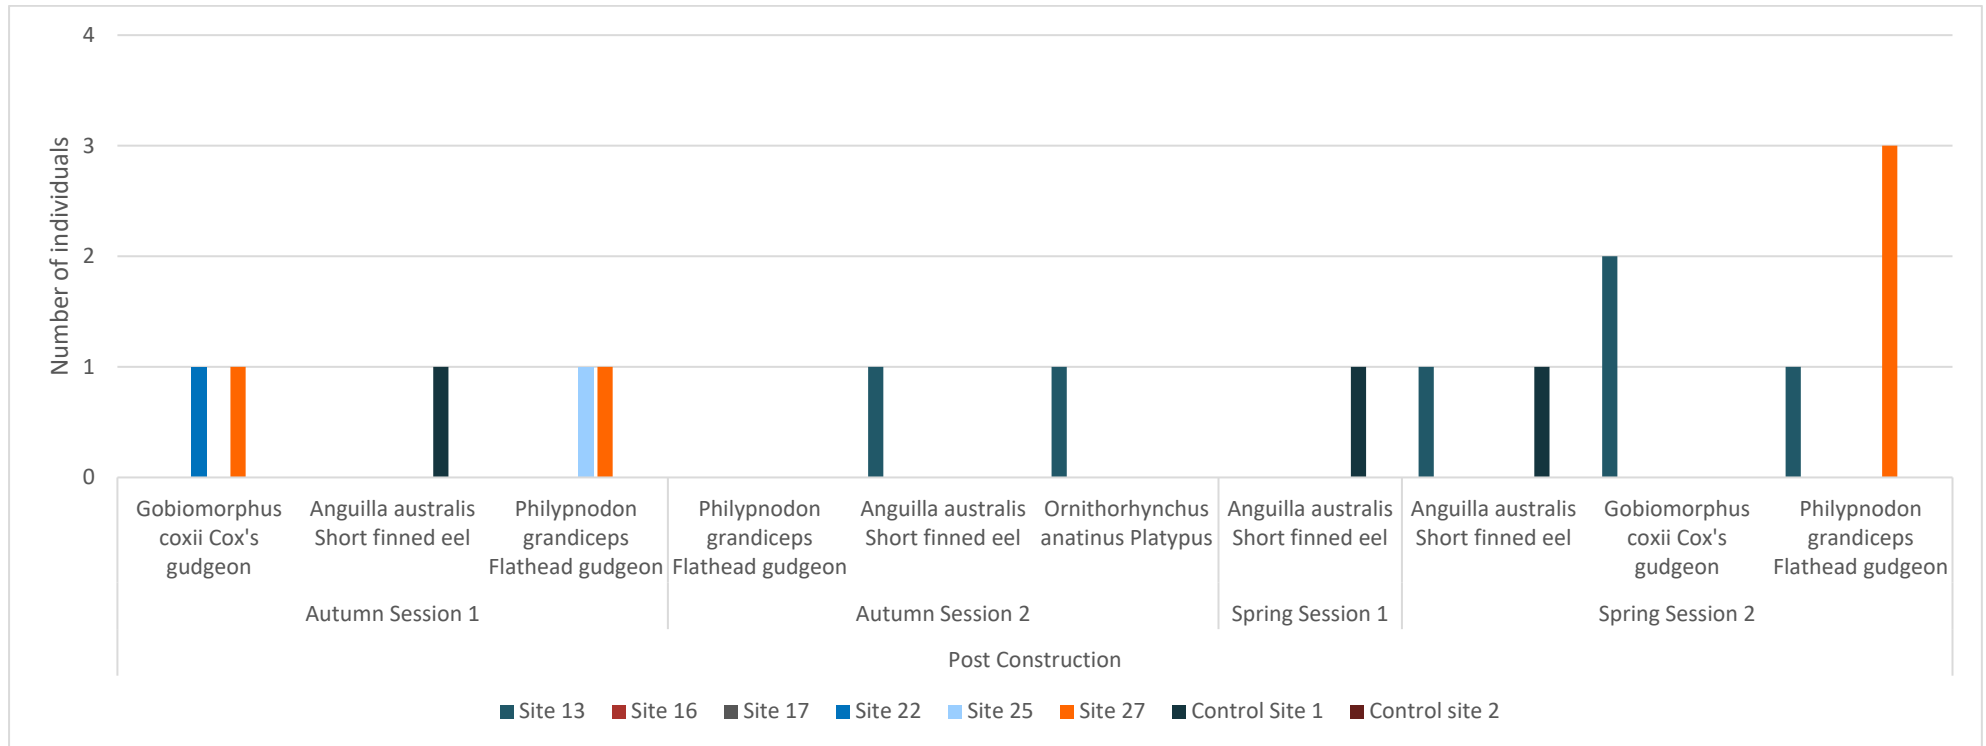
Figure 3-24 Fauna species observed across all sites and seasons in 2018

A small number of fish (10) were collected/observed from two common fish species throughout 2018. The only other fish species observed in 2018 were five Short-finned Eels observed at Control site 1 (Autumn Session 1, Spring Session 1, and Spring Session 2) and Site 13 (Autumn Session 2, and Spring Session 1).

There was a reduction in species diversity and abundance recorded in 2018 compared to previous years. This trend was also observed in control site surveys between 2017 (abundance 6, diversity 3) and 2018 (abundance 3, diversity 1). This therefore may indicate that factors that may be affecting species diversity and abundance are not a result of construction activities, but may be attributed to conditions of this generally disturbed aquatic ecosystem. Factors that typically influence aquatic ecosystems include water supply, water quality, turbidity, pollution and alien species.
