Foxground and Berry Bypass Construction Compliance Report

Report 2
1 May 2015 – 31 October 2015

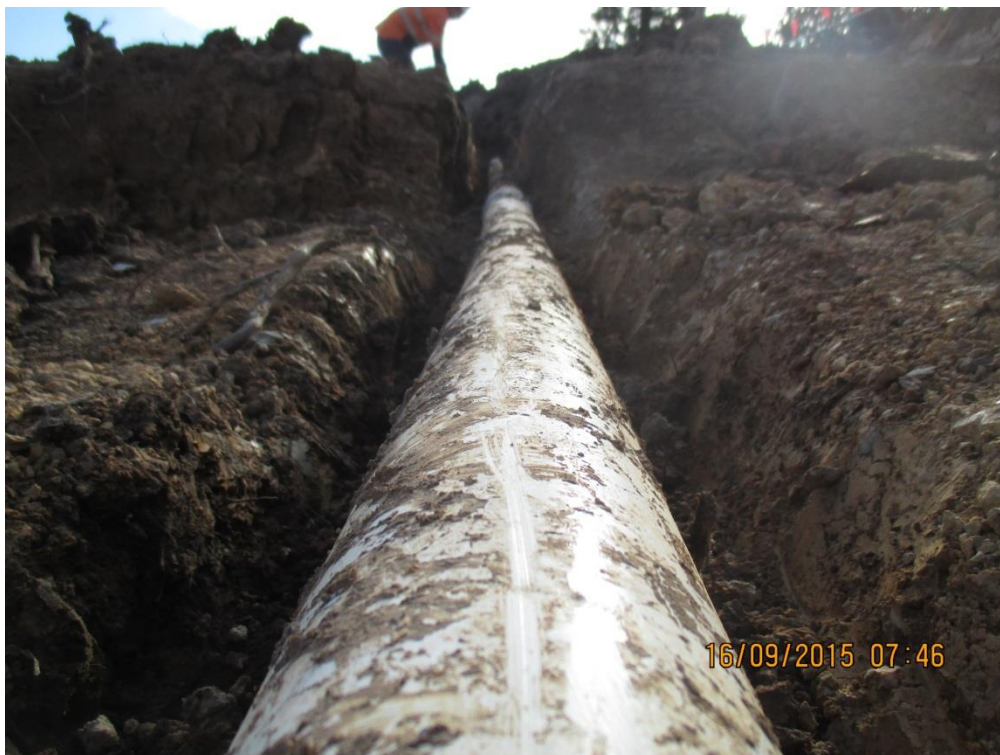
Figure 2-1: Services installed underground across the project

Figure 2-1 below shows the installation of telecommunication services conduits. Southern extension service relocations account for a large percentage of the remaining works and many will be completed in the next reporting period.

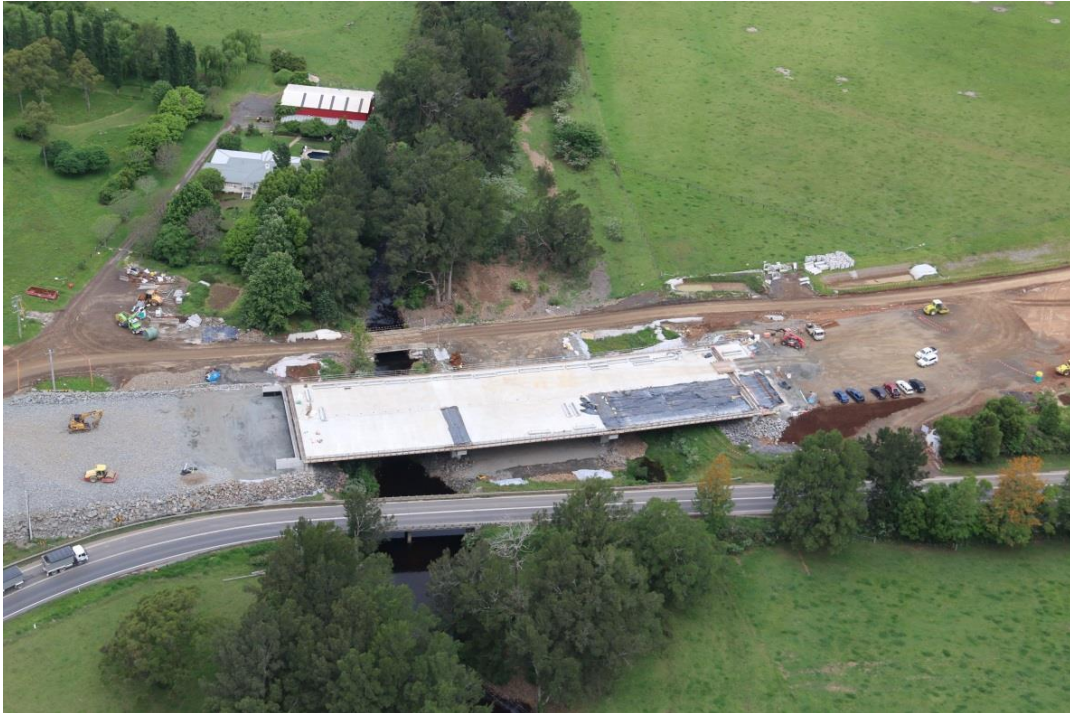
Figure 2-5: Temporary Bridge, new bridge and the existing Princes Highway across Broughton Creek

roads, temporary services diversions, driveway accesses, light vehicle tracks and temporary bridges across Broughton creek.

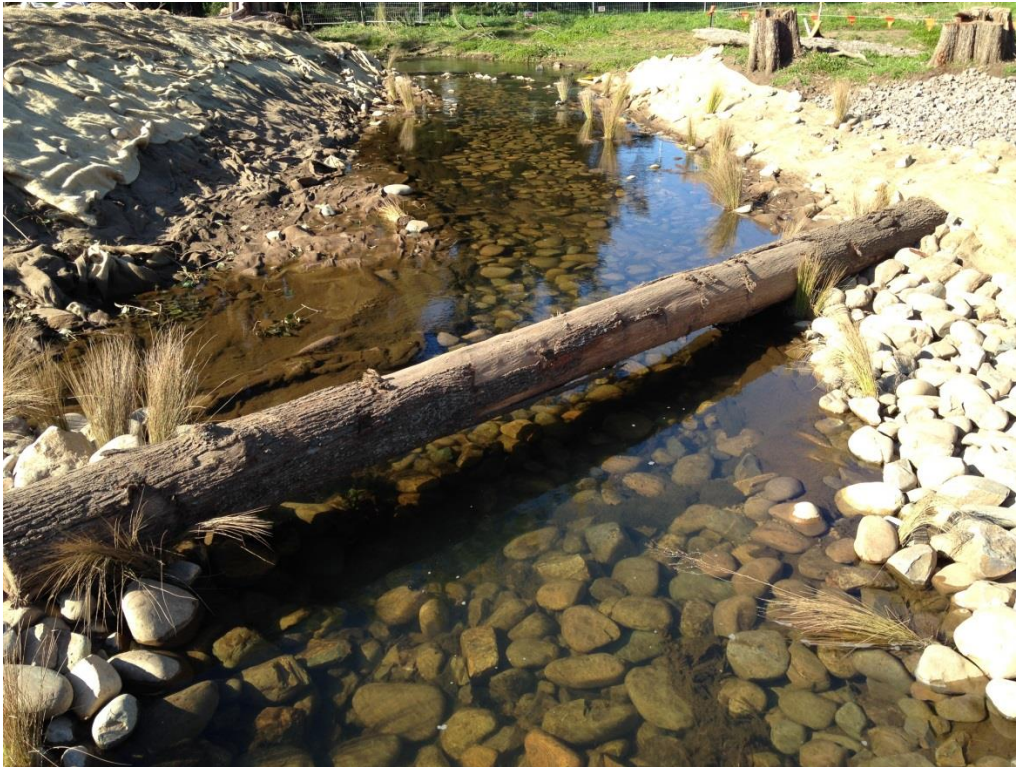
Figure 4-2: Bundewallah creek diversion downstream connection photo

- Use of bio degradable products
- Pools and riffles matching the natural system in preference of a evenly graded engineered channel
- Salvage and replanting of local native plants from other areas of the project required to be cleared
- Weed and waste removal from the existing channel

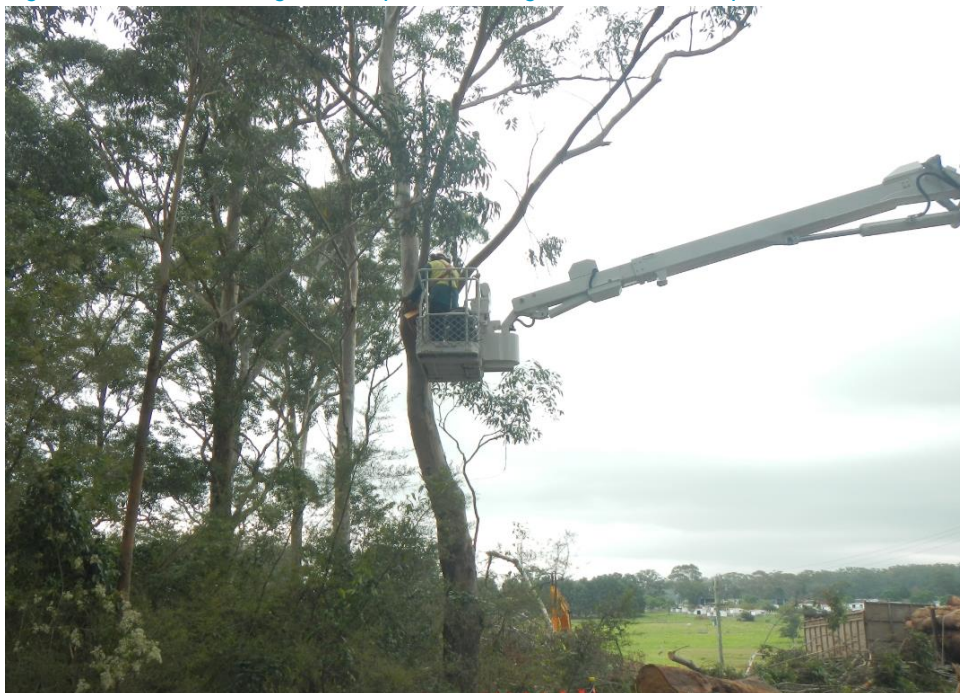
Figure 5-1: Hollow bearing trees inspections using an elevated work platform

A number of fauna relocations were undertaken during clearing. The first stage of nest box monitoring was performed in the reporting period. Approximately twenty percent of nest boxes installed were found to have evidence of fauna use. Aquatic monitoring at Bundewallah, Broughton Mill and Broughton creeks confirmed the presence of Australian Bass and Platypus.

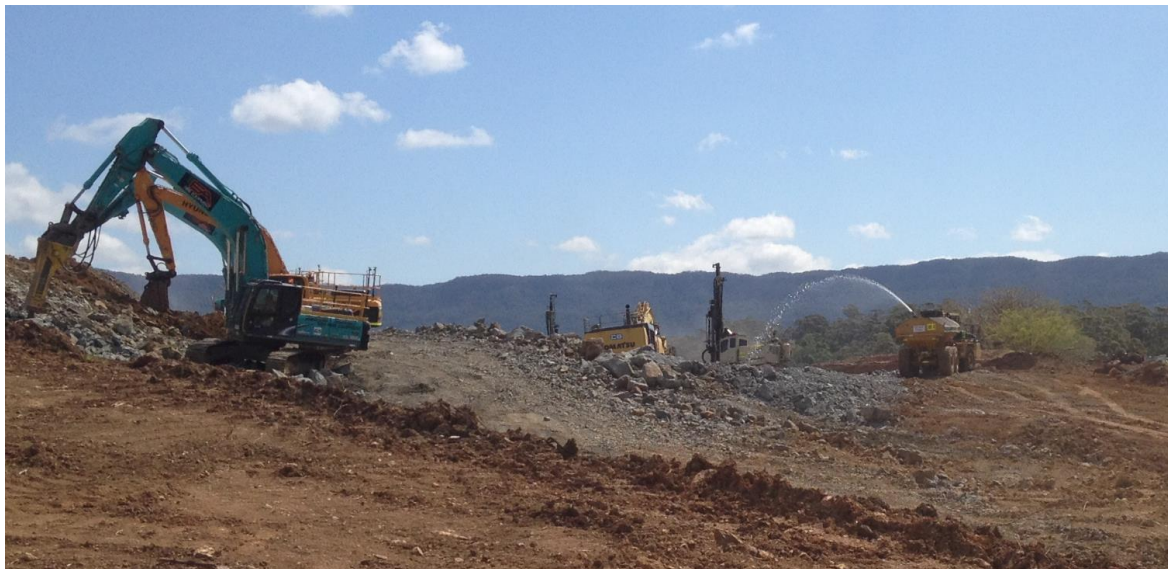
Figure 5-: Dust control in cut 2 with pre-soaking of rock prior to loading into trucks to prevent dust generation

A variety of dust suppression techniques were used across the project these included but were not limited too; water carts, pre-wetting of materials prior to cartage, soil stabilisation polymers, and dust bloc haul road polymers. Progressive rehabilitation is a project focus with continual reduction of the risk footprint throughout construction.

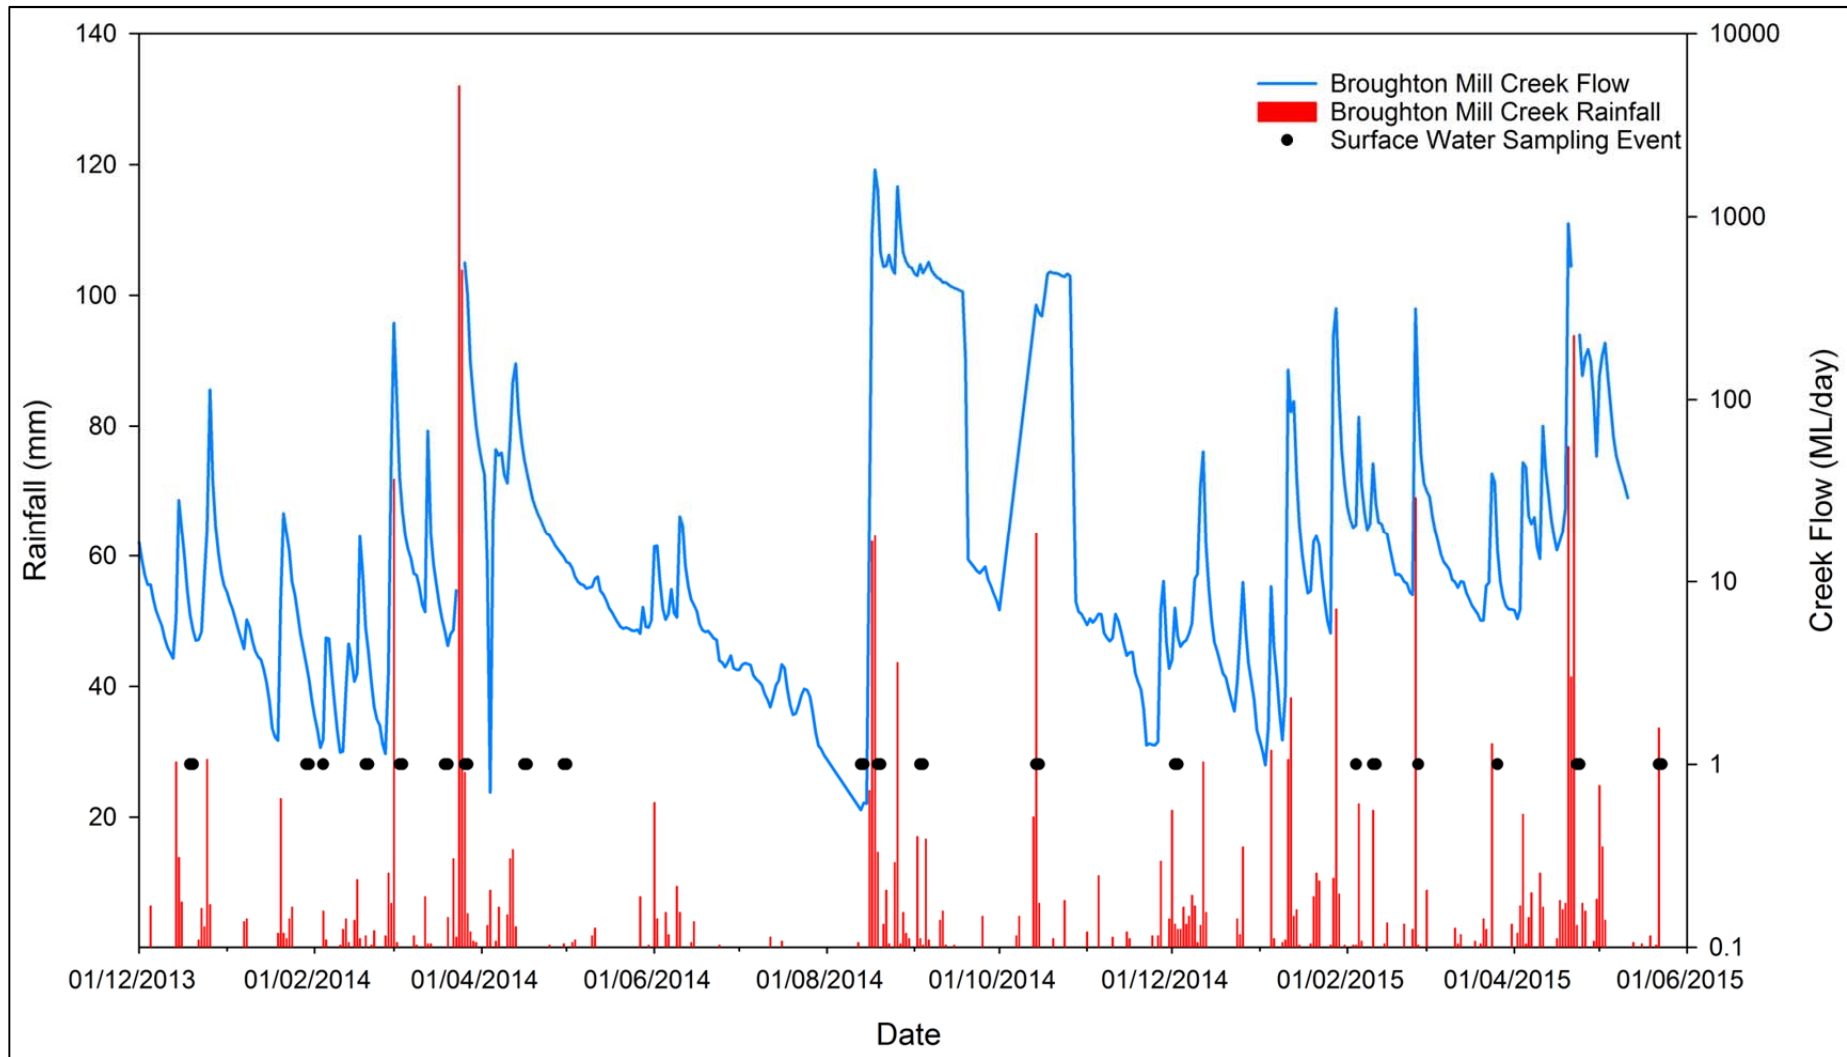
Figure 2 Rainfall vs Flow within Broughton Mill Creek

Note: No data was available for Broughton Mill Creek flow from 12 May 2015 from the NOW website at the time this report was prepared.

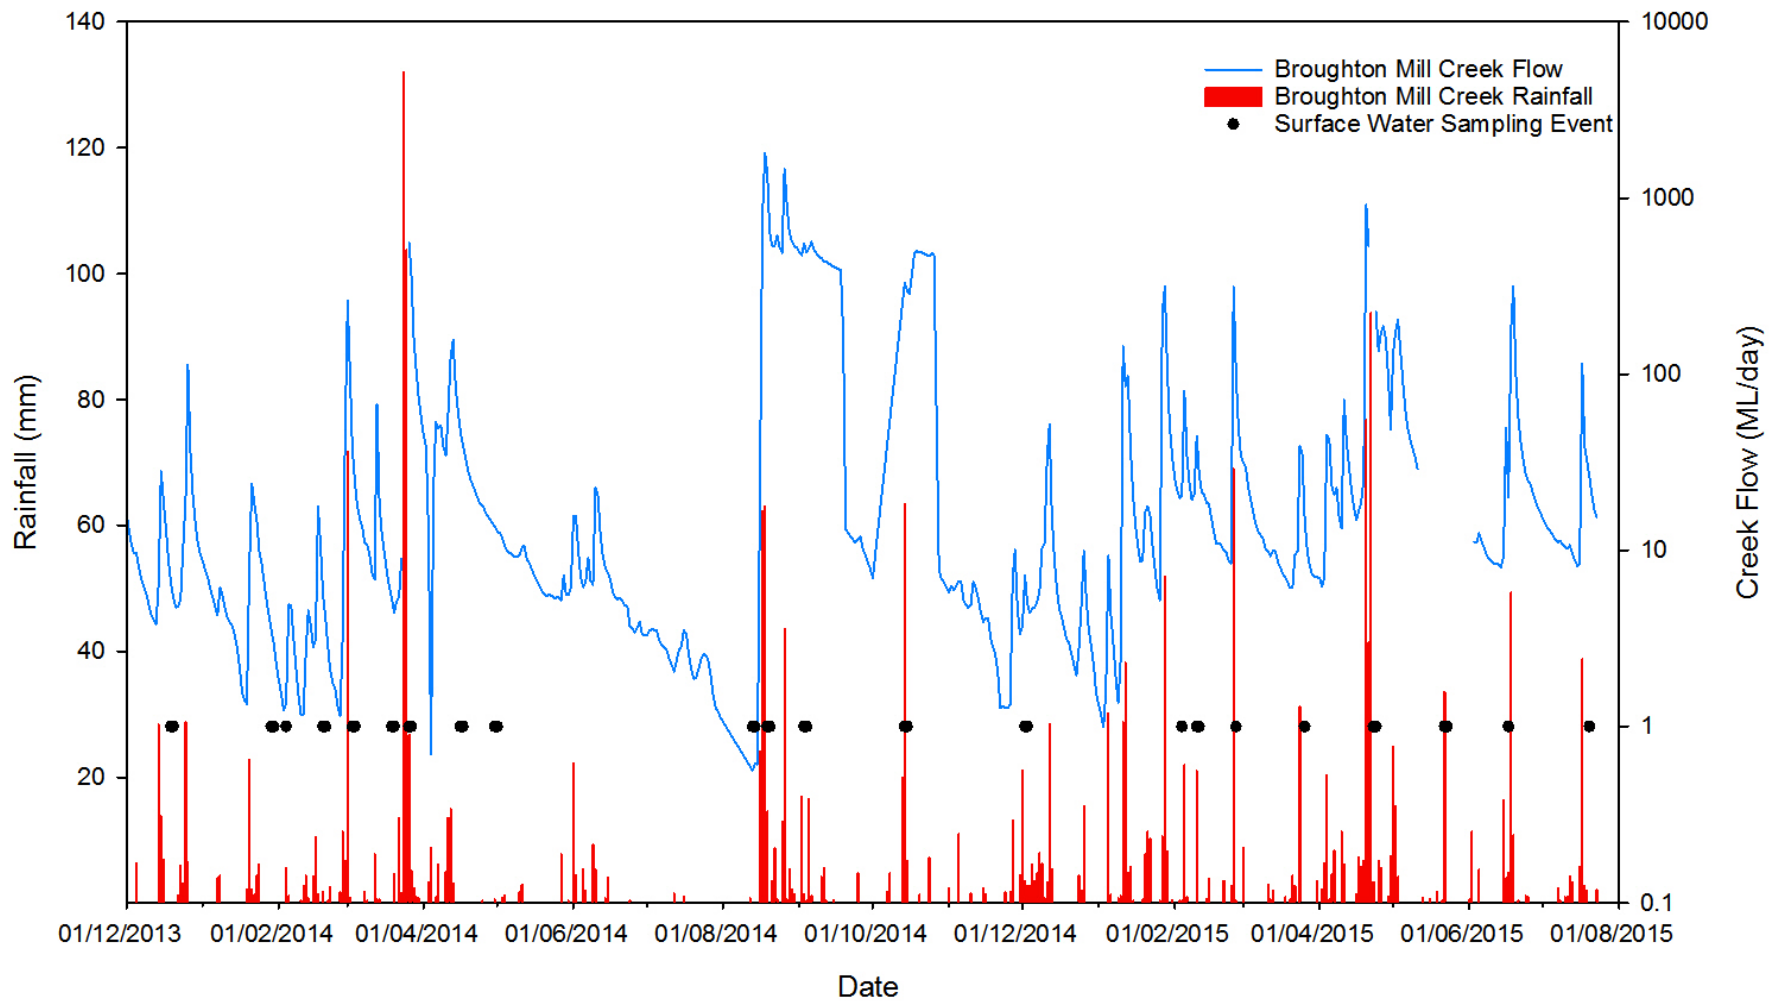
Figure 2 Rainfall vs Flow within Broughton Mill Creek

Note: No data was available for Broughton Mill Creek flow from 12 May to 2 June 2015 from the NOW website at the time this report was prepared.
