# **Foxground and Berry Bypass** Periodic and Pre-Operational Construction Compliance Status Report

Report 7  
1 October 2017 – 31 March 2018

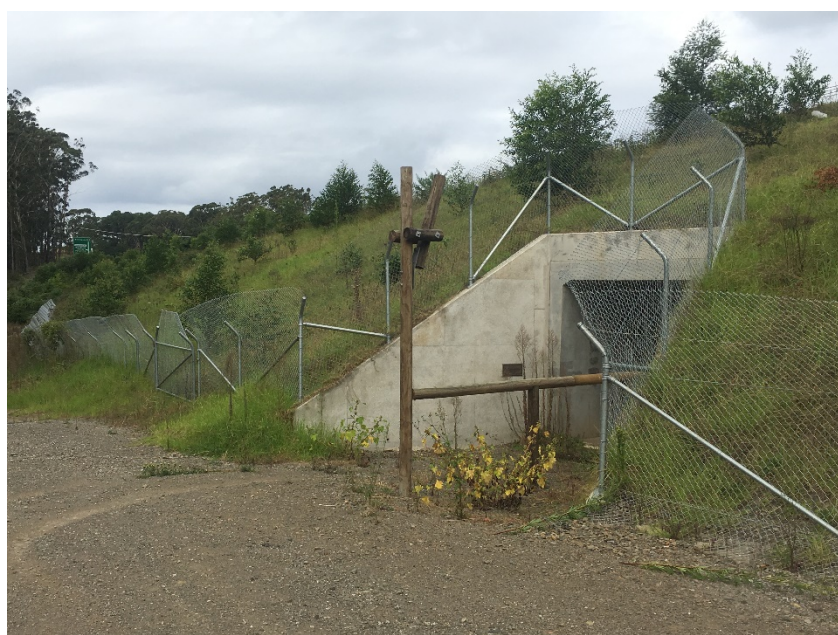
**Figure 2-1: Fauna underpass complete with fauna furniture**

There are six structural culverts on the project which provide connectivity for vehicles and wildlife under the new highway. All culverts have been completed.

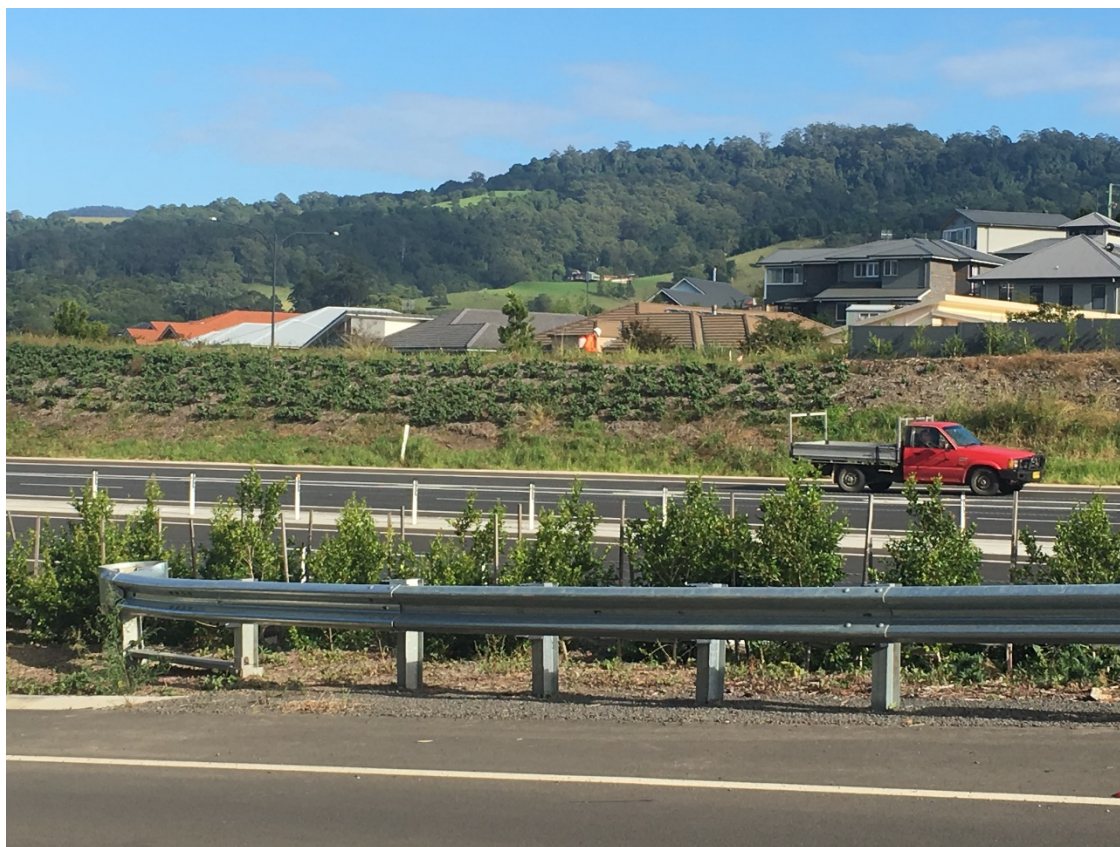
**Figure 2-4: Landscape maintenance of the garden beds south of the southern Berry interchange**

The key focus now that all landscaping works are complete is the maintain the the permanent landscaping via weed removal and general maintenance along the project.

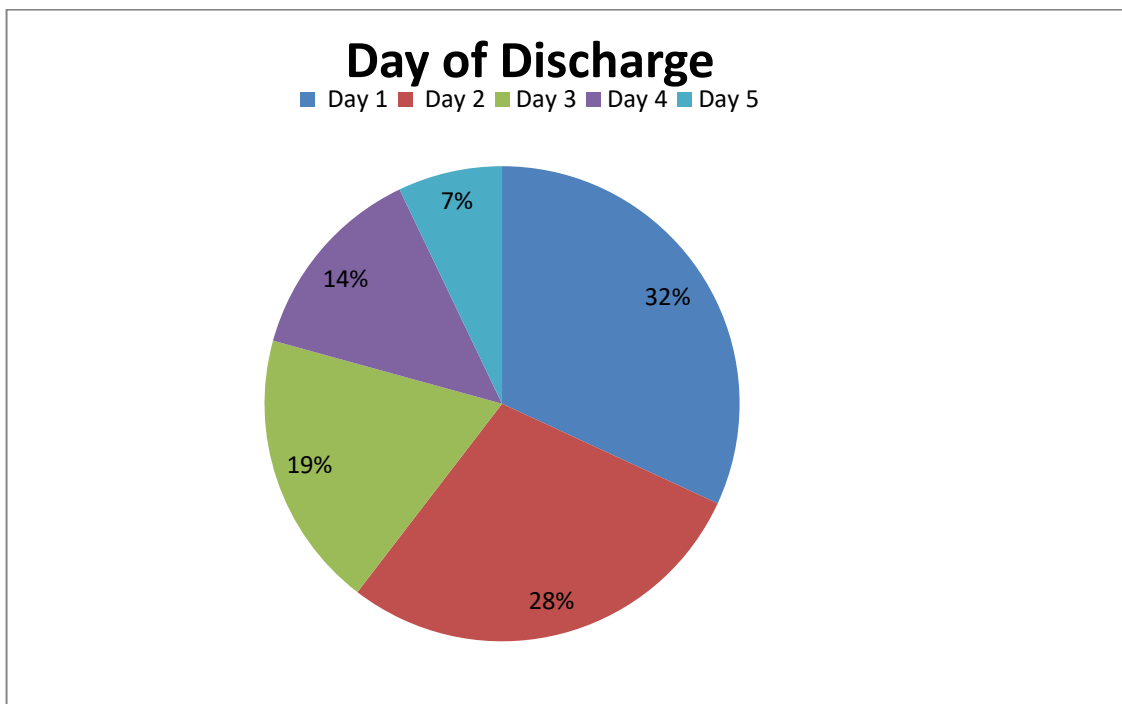
**Figure 2-5: Sediment basin discharges in the five day period after rainfall**

With regard to sediment basin management, the project continues to work diligently at treating and discharging stored site water back into the environment as efficiently as possible. The table below illustrates the timeframe that sediment basins have been discharged.

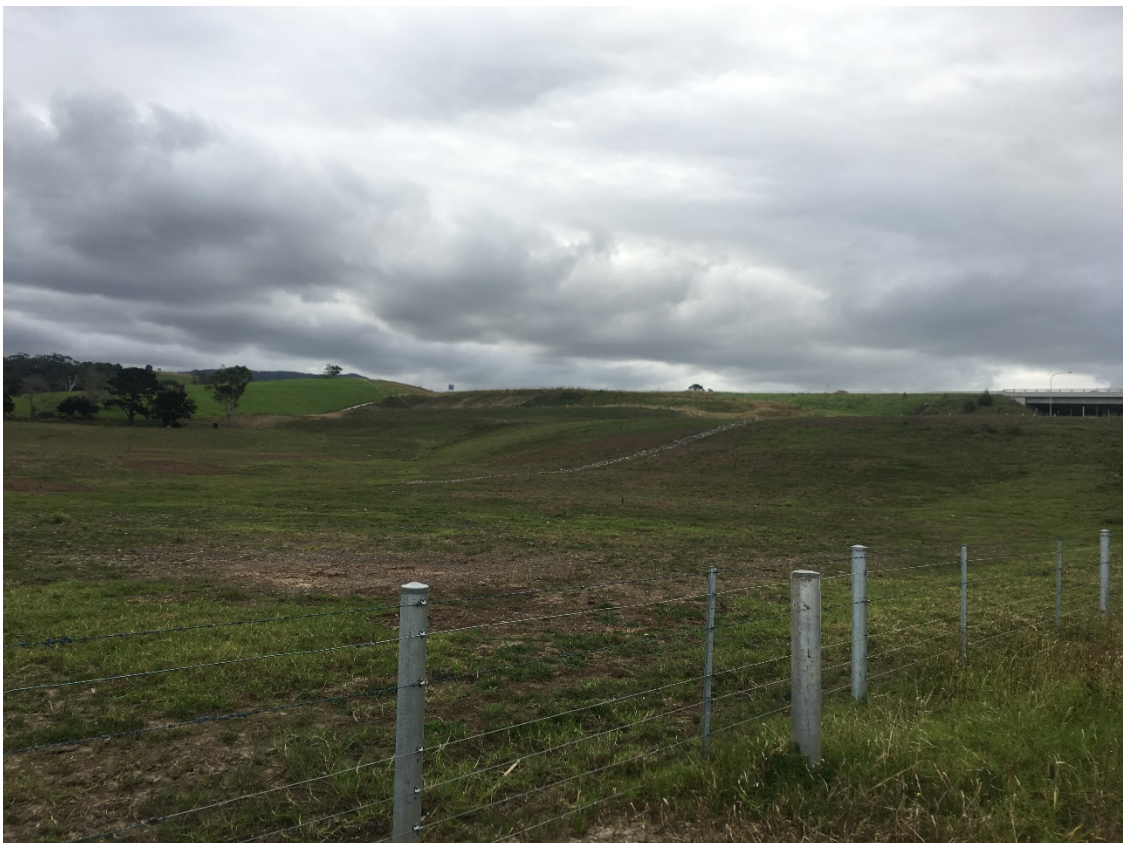
**Figure 2-6: Rehabilitation of Toolijooa ancillary facility complete**

The project is continuing the rehabilitation of all ancillary sites left on the project.

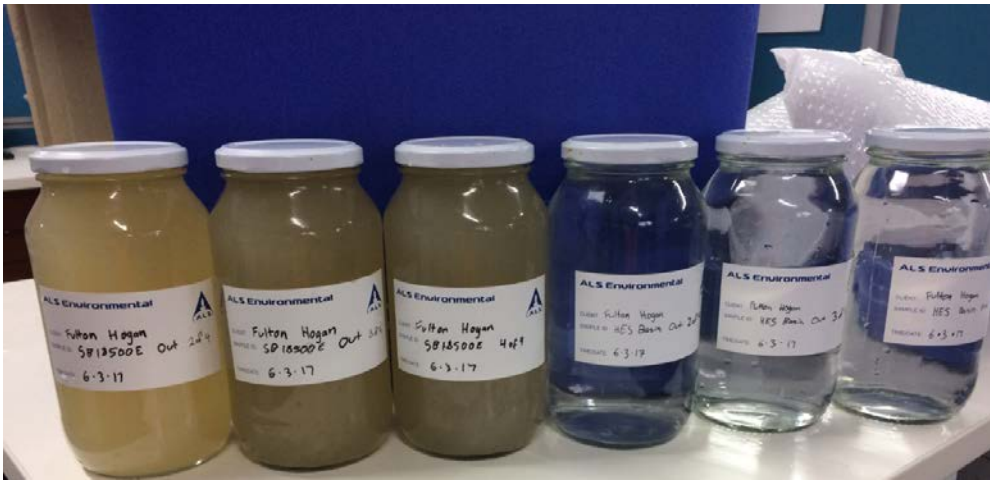
**Figure 4-1: From left to right: Samples taken from batch basin vs HES Basin after rain event**

- Assess the effectiveness of the flocculent in a passive treatment system

This trial is complete with finalisation of the data and the report has been sent to EPA.

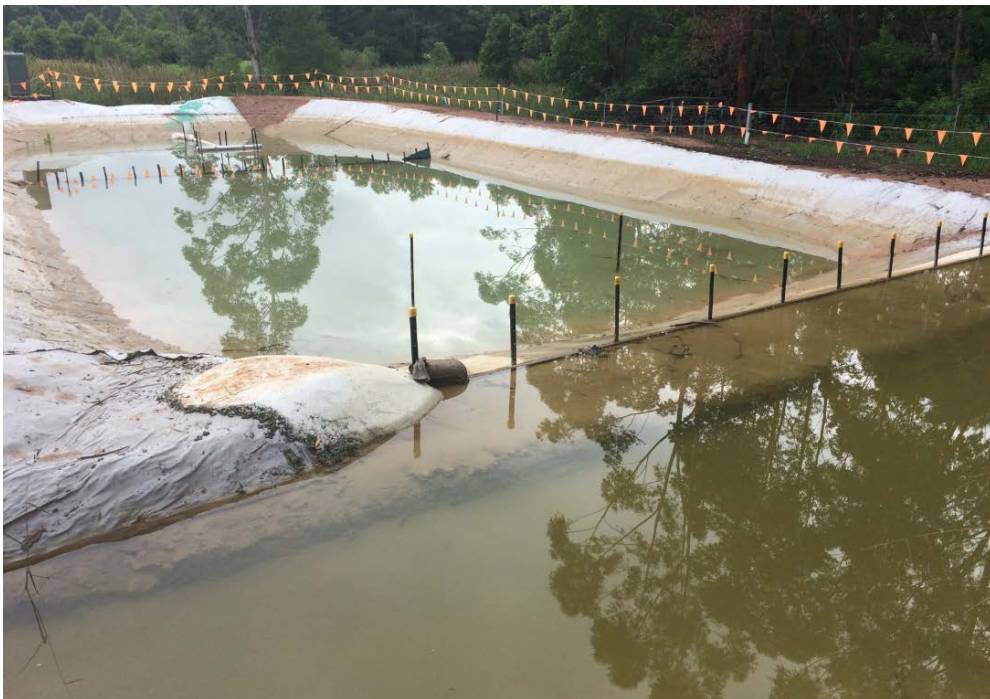
**Figure 4-2: HES Basin looking from the fore-bay across the spreader bar and down to the decanting system after rain event**

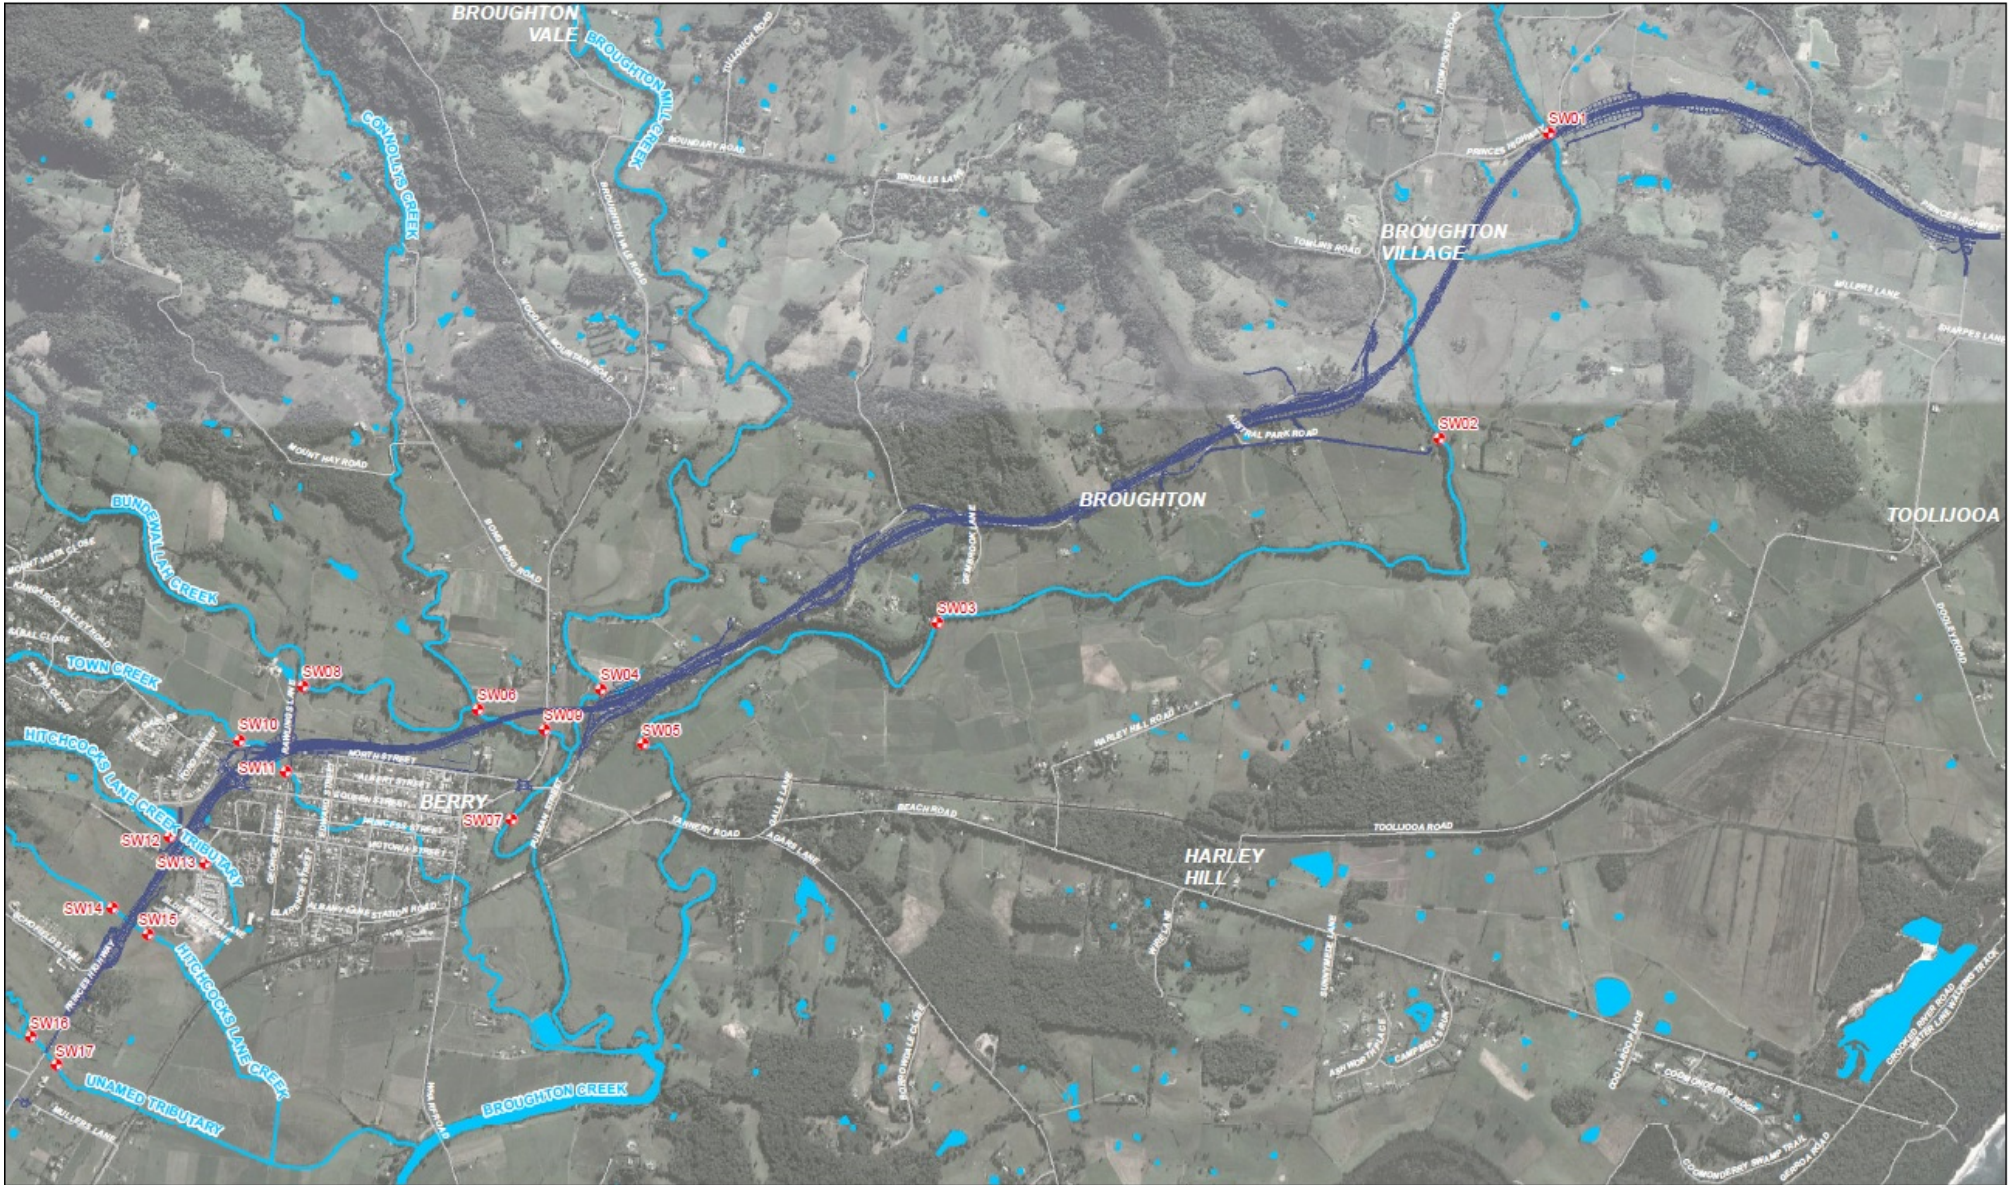
**Surface water sampling locations** **Figure 1**

Unnamed Tributary: Catchment is stabilised and operational resulting in no impacts from construction. Upstream location SW16 unable to be sampled due to shallow depths in waterway caused by low flow conditions.

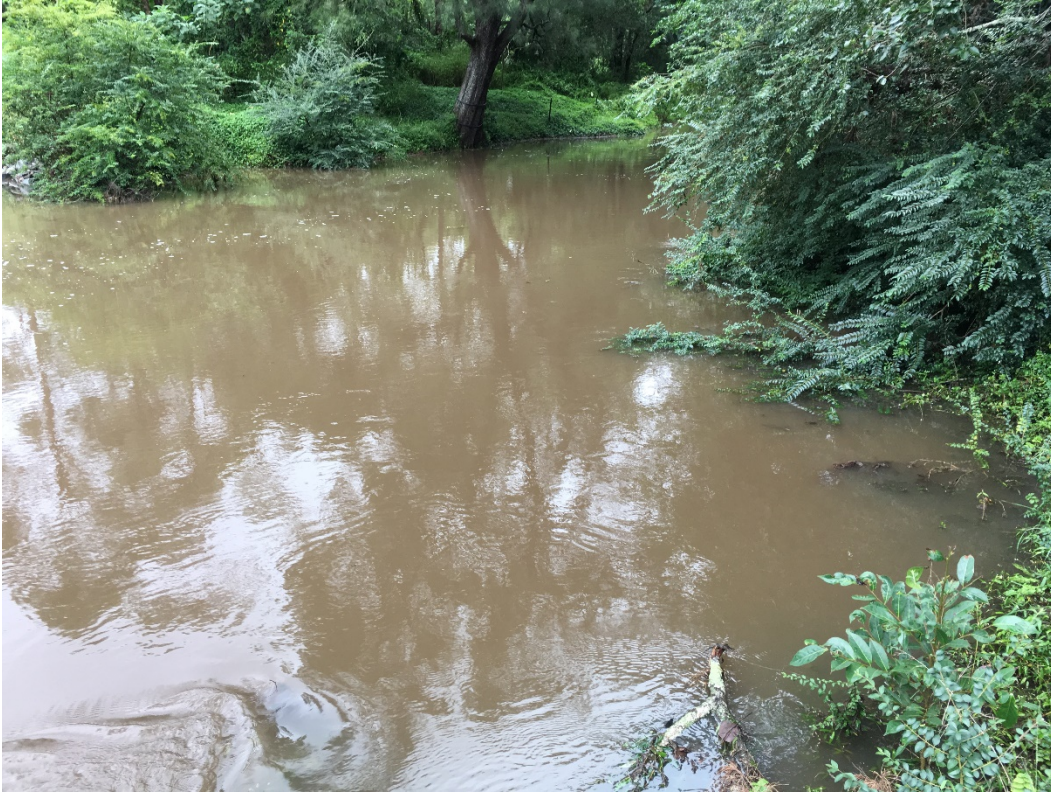
*SW06 – Bundewallah Creek, upstream of works*

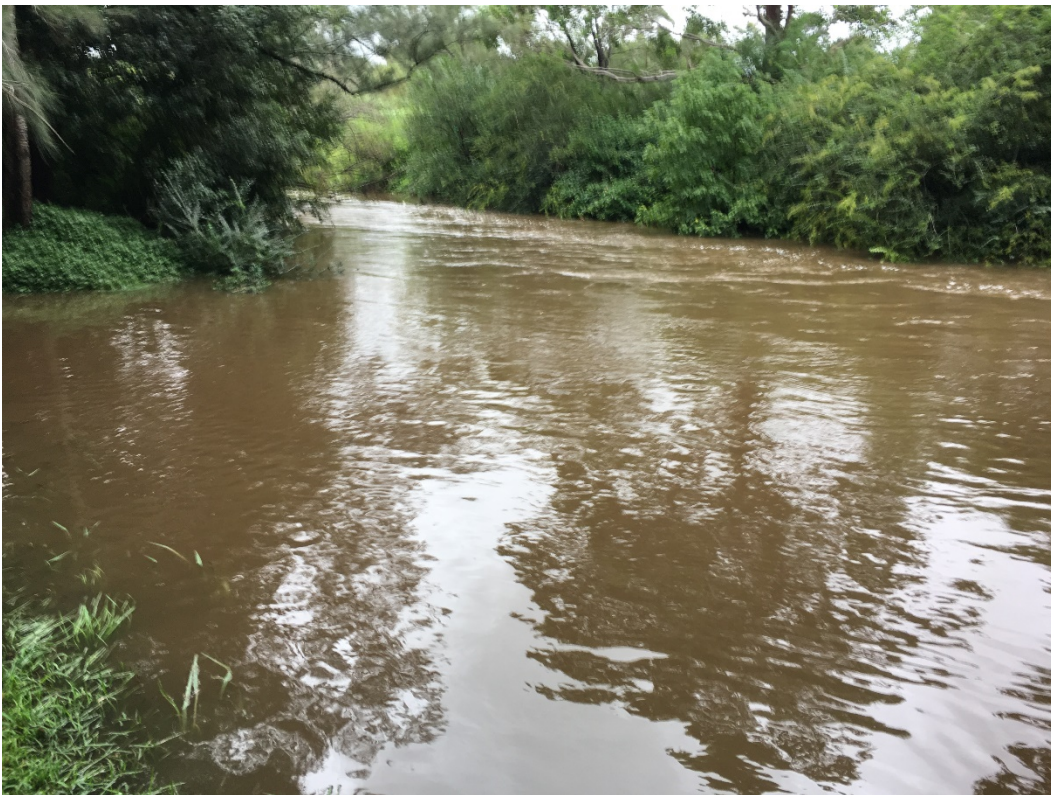
*SW07 – Broughton Mill Creek, downstream of works*

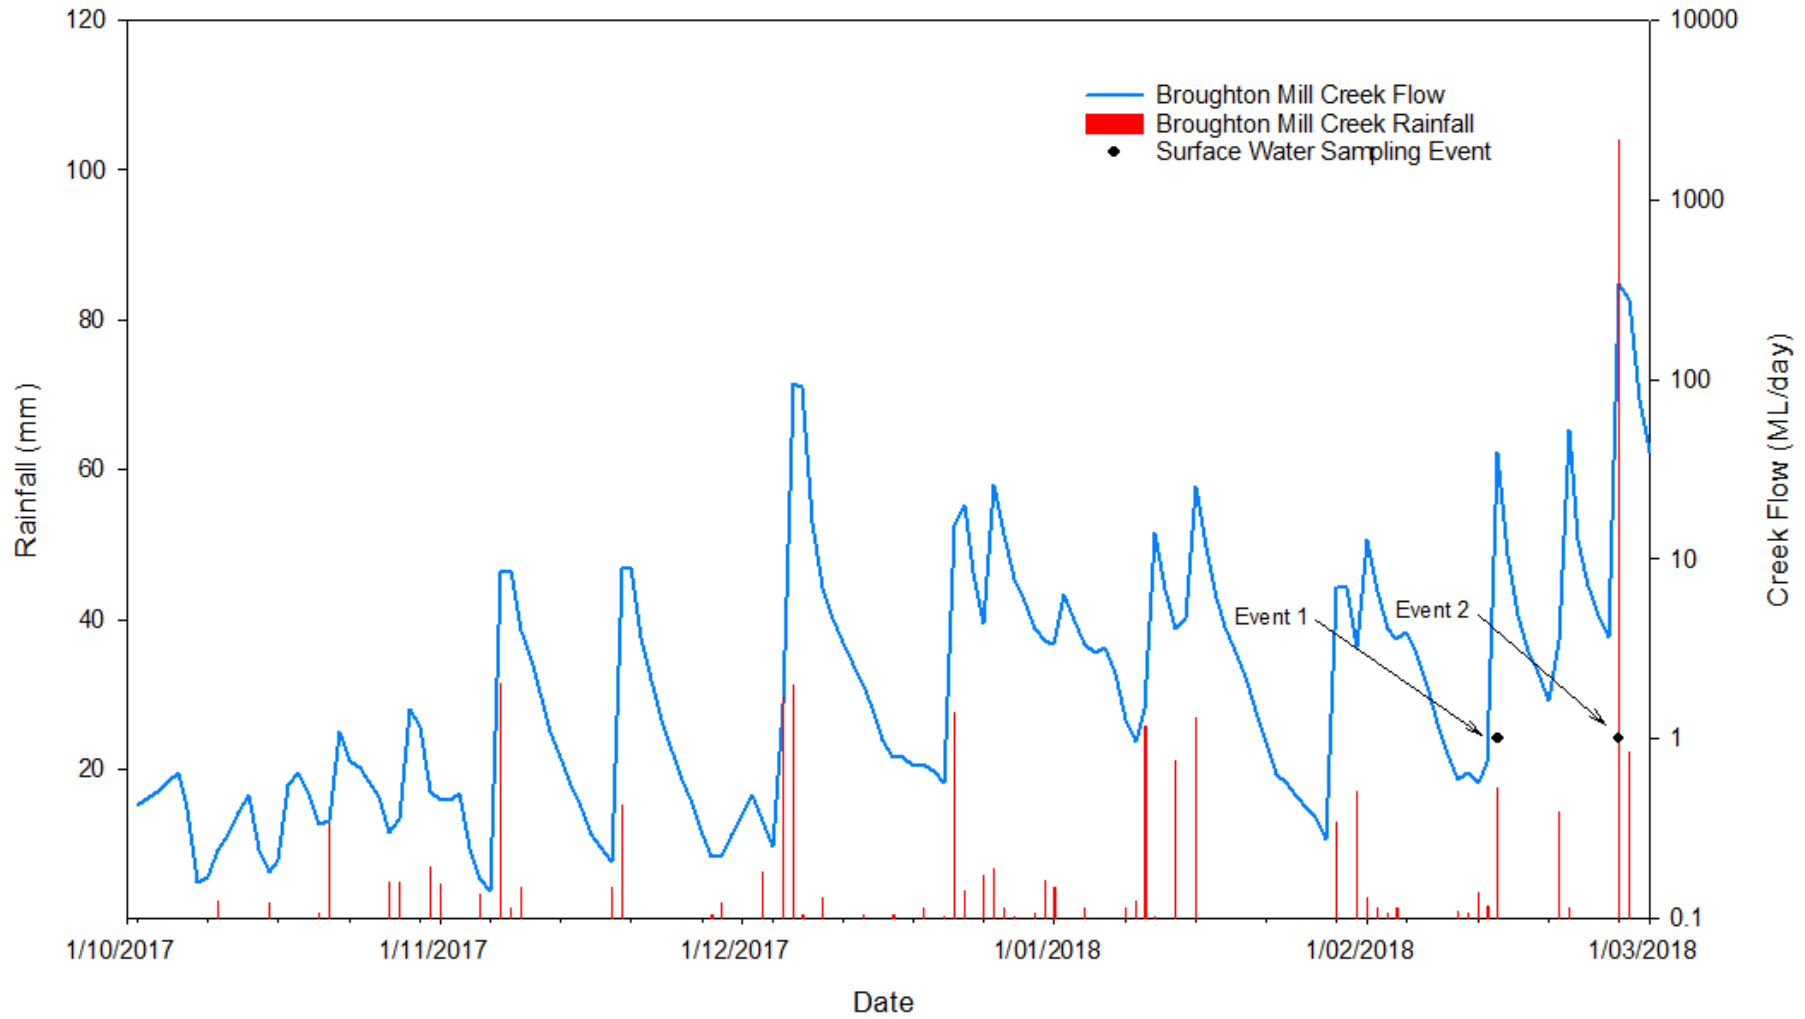
Figure 2 Rainfall vs Flow within Broughton Mill Creek

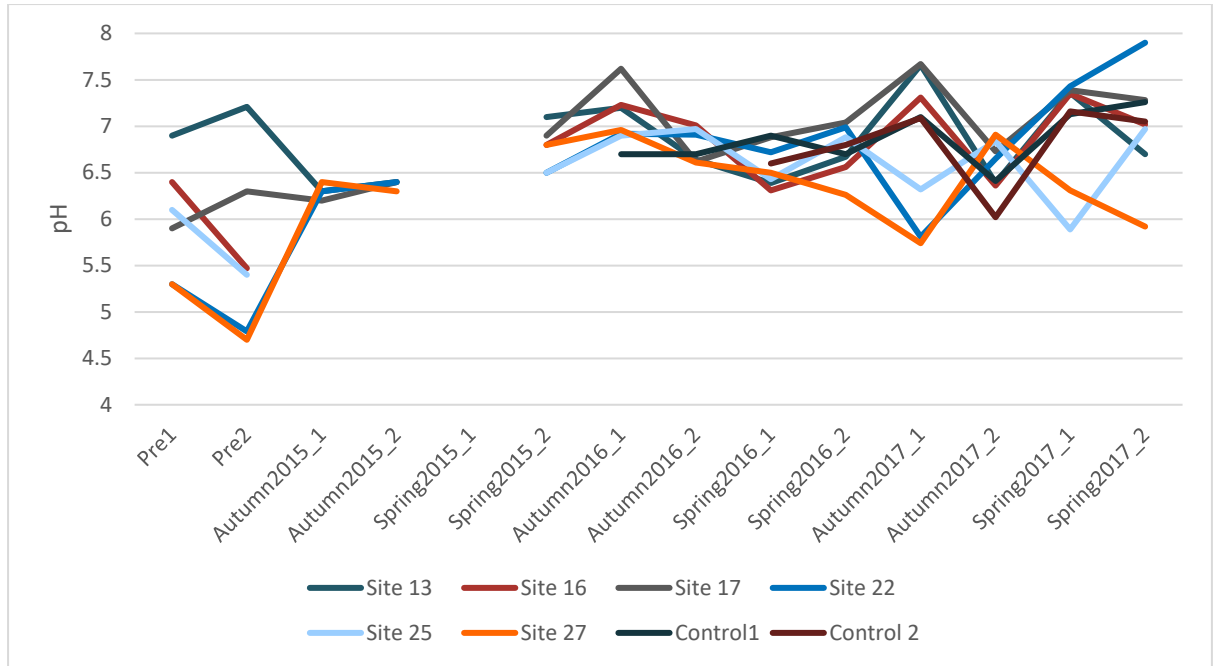
Figure 3-1 pH levels recorded through pre-construction (2014) and construction periods (2015-2017)

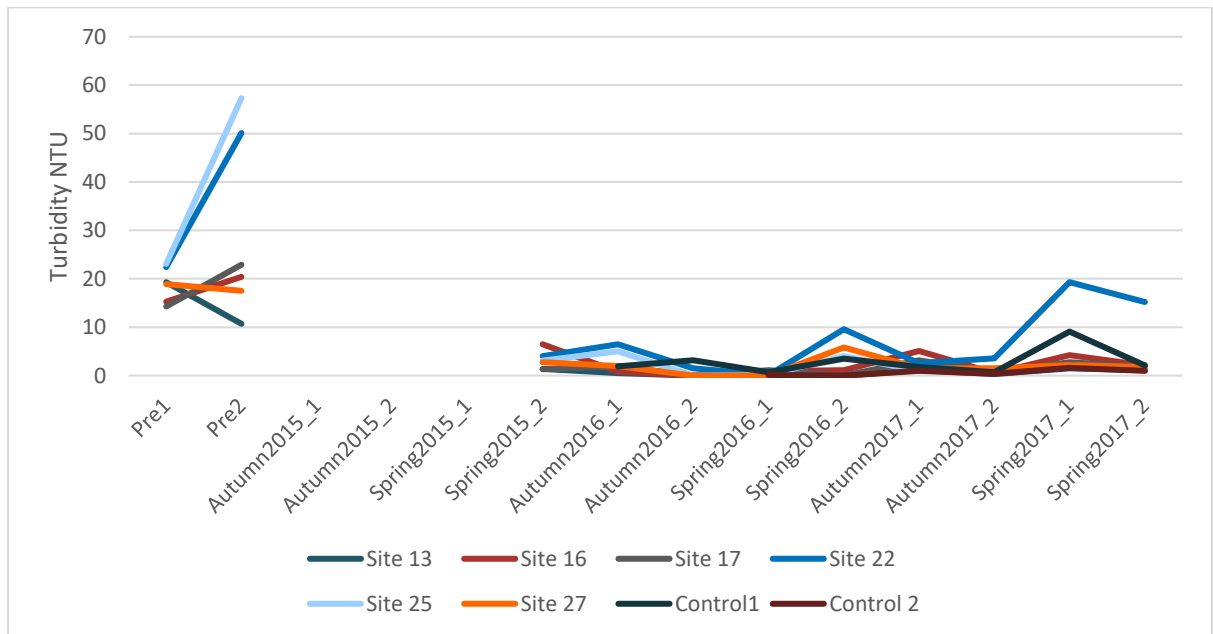
Figure 3-2 Turbidity levels recorded through pre-construction (2014) and construction periods (Spring 2015-2017)

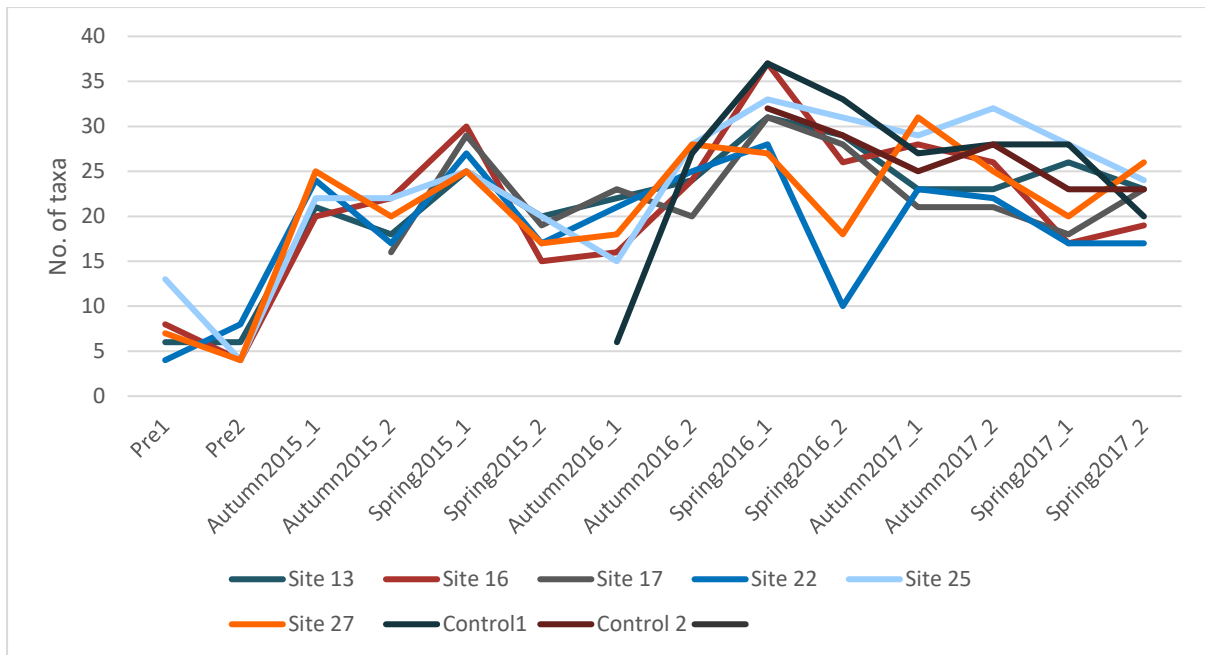
A total of 68 and 61 different taxa were sampled during Autumn and Spring 2017 respectively; this is higher than all previous surveys (31 taxa collected in Spring preconstruction surveys, 46 in Autumn 2015 and 56 in Spring 2015, and 49 in Autumn 2016 and 59 during Spring 2016). However, the number of taxa collected per site and session varied. In previous years there has often been an increase in taxa diversity during Spring, however in 2017 there was a general decline, similar to abundances in 2015 (Figure 3-3). This decline was also evident at the control sites, which indicates that the reasons behind this reduction in the diversity of taxa is unlikely to be related to construction activities. The full list of taxa collected is provided in Appendix D.

Figure 3-3 Taxa diversity throughout pre-construction and construction periods

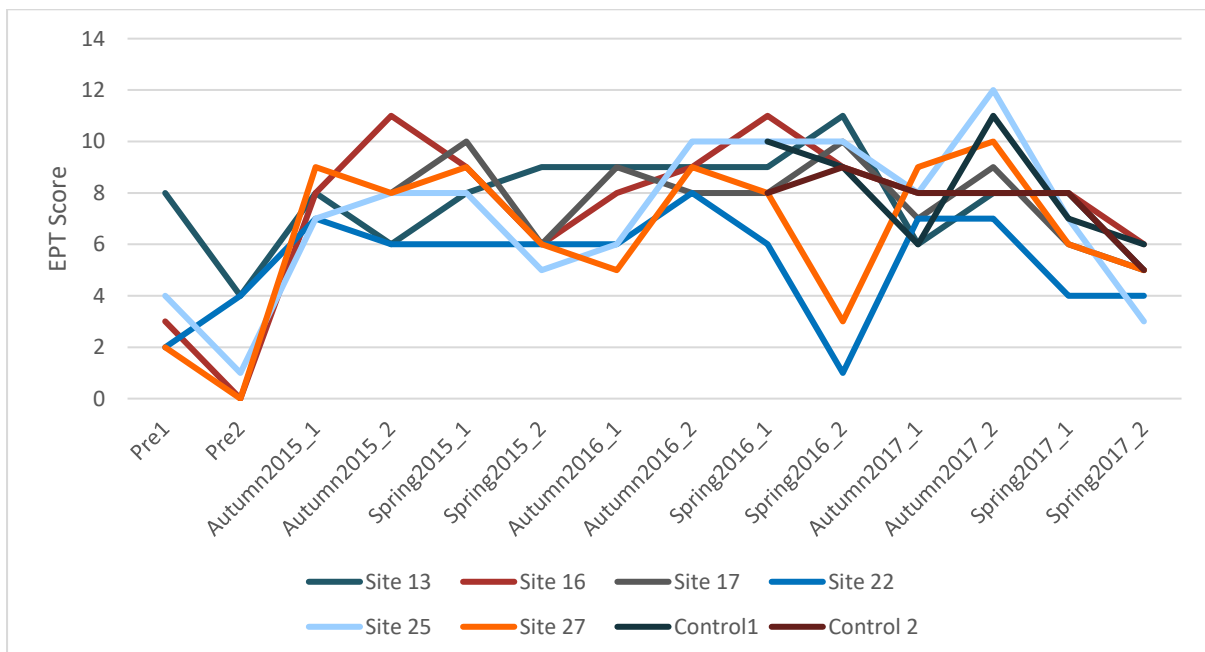
The EPT scores indicate that in 2017 the majority of sites were in fair to poor condition and were similar to the 2015 and 2016 results. There was a decline in the EPT scores during Spring 2016 (Session 2) at Site 27 and Site 22, and across all sites in Spring 2017 (Session 2) (Figure 3-4). These reductions in EPT scores occurred when water levels were either low or when there was no flow. Site 22 and Site 27 continue to have low EPT scores, indicative of poor condition sites. The control sites were mostly in fair condition throughout 2017, except for Autumn 2017 where all sites had a reduced EPT score.

Figure 3-4 EPT Scores through construction and pre-construction periods

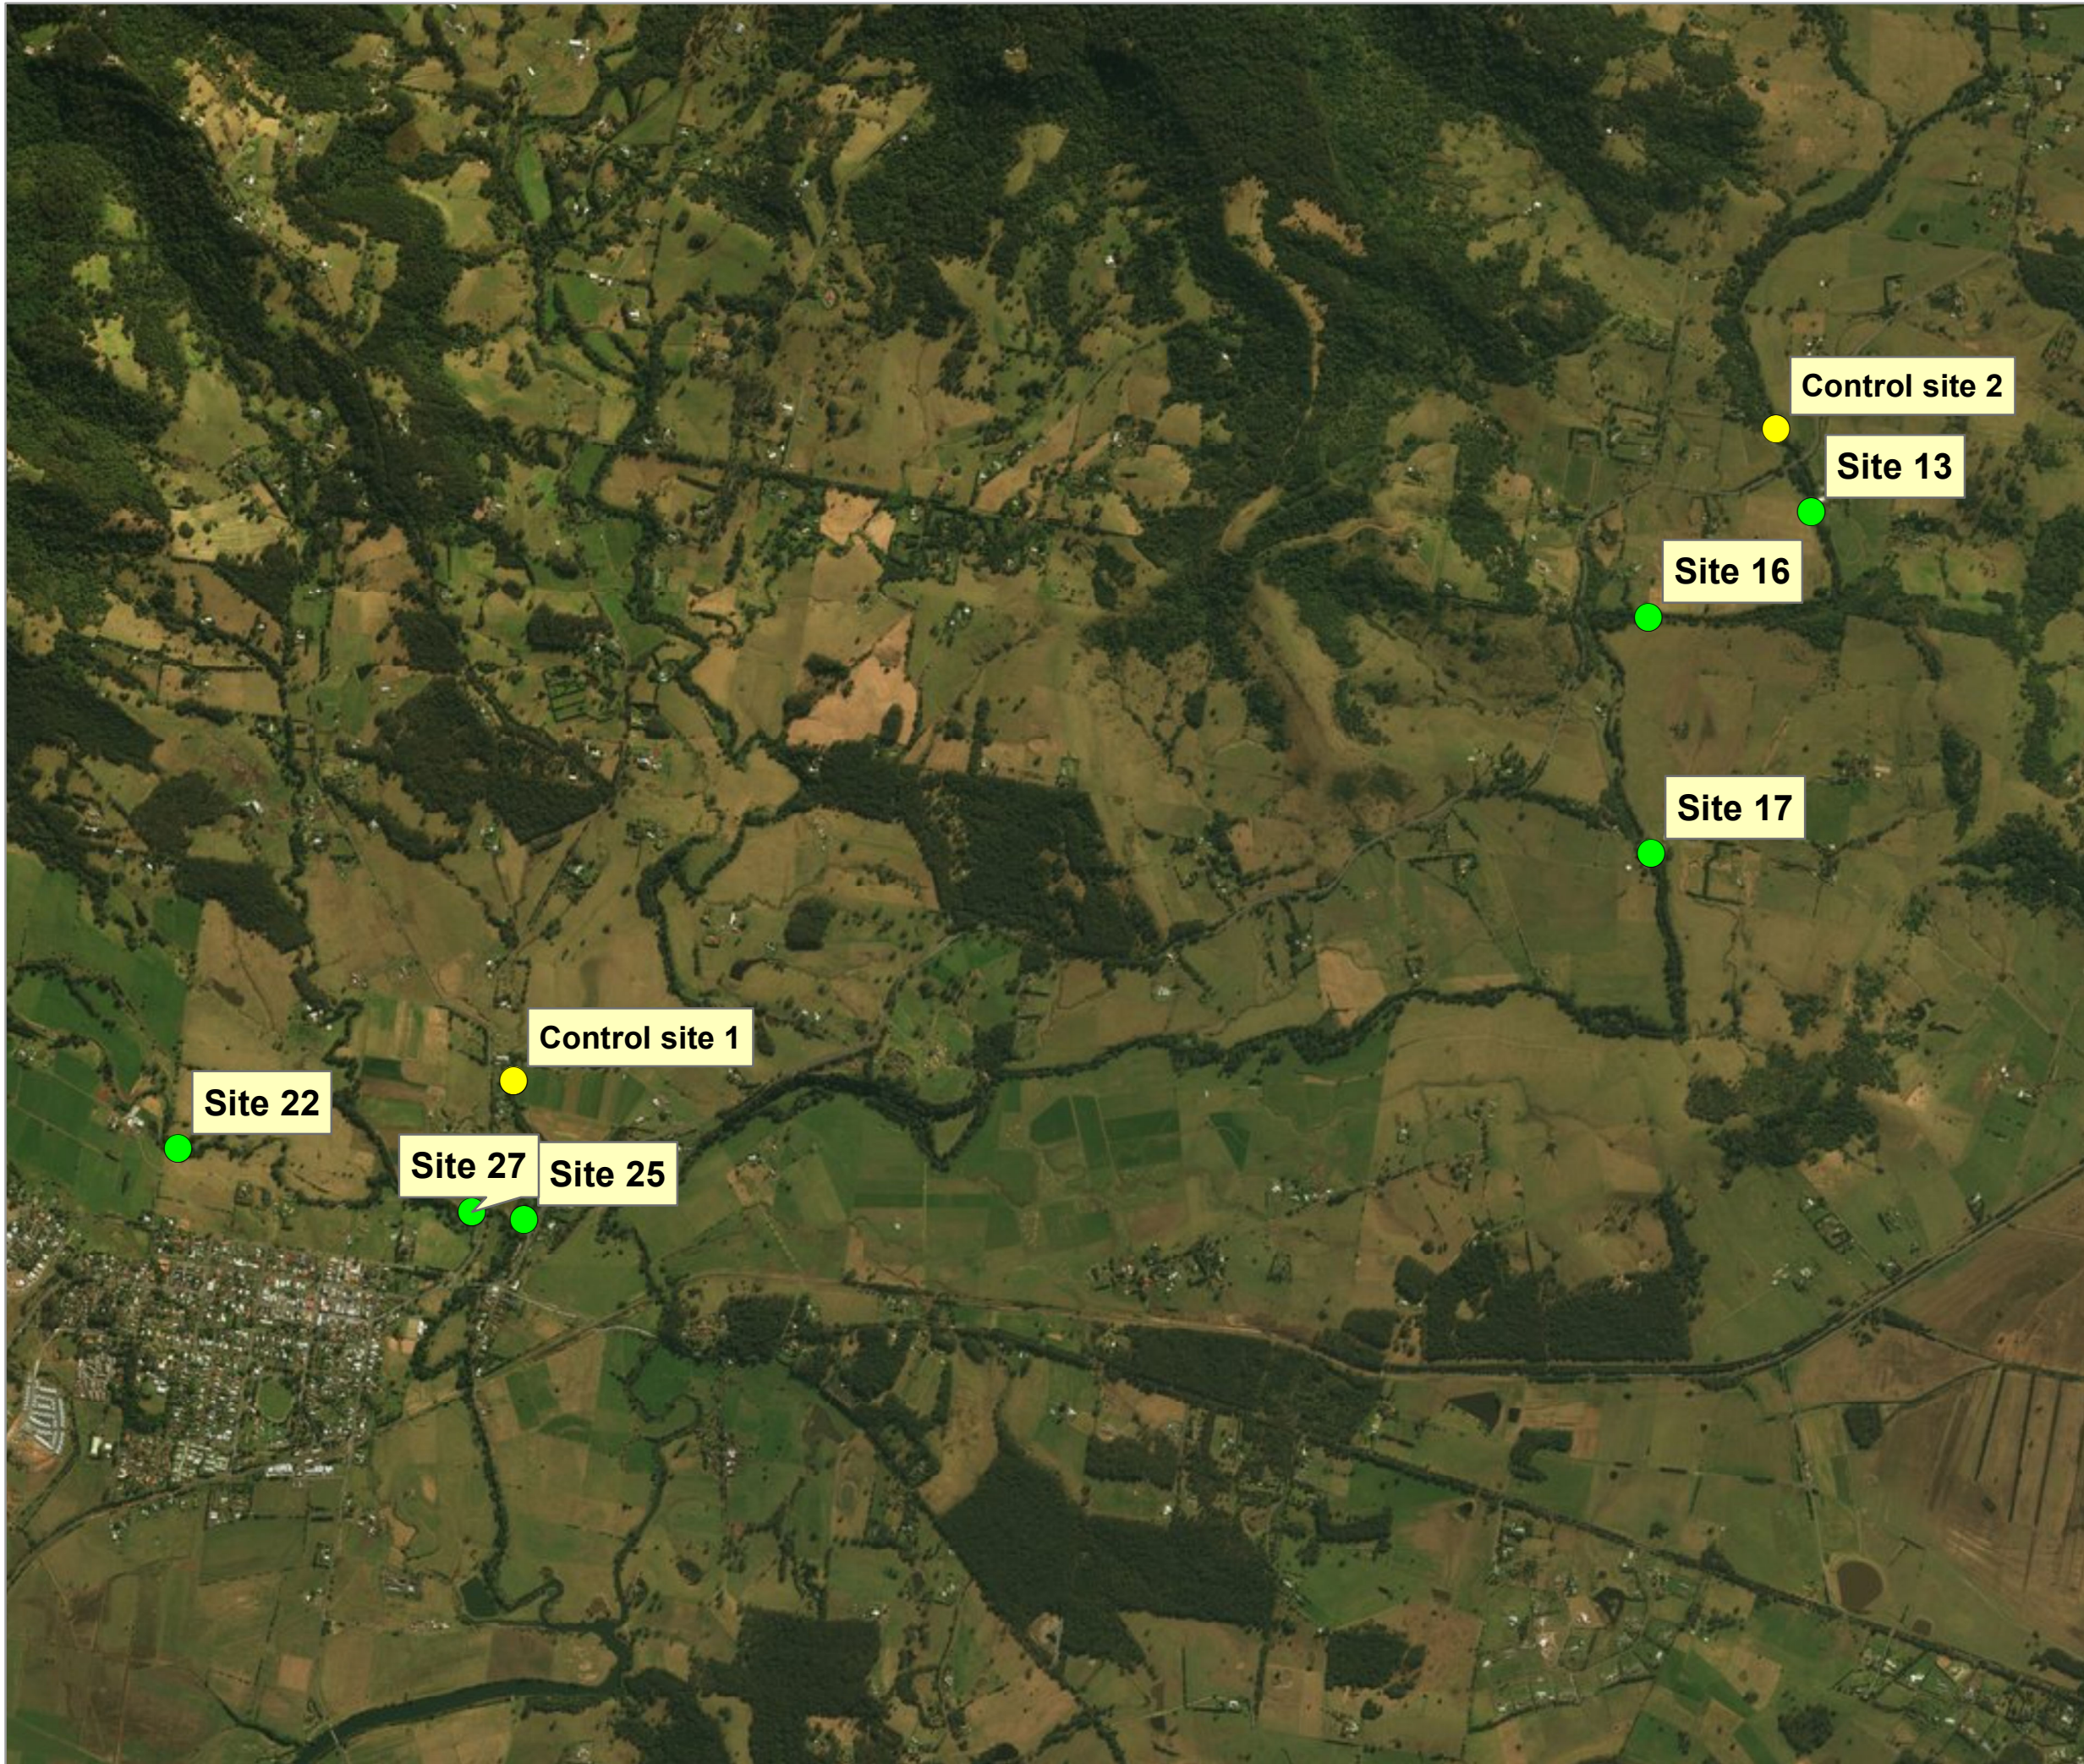
## APPENDIX A MONITORING SITES

**Study sites**

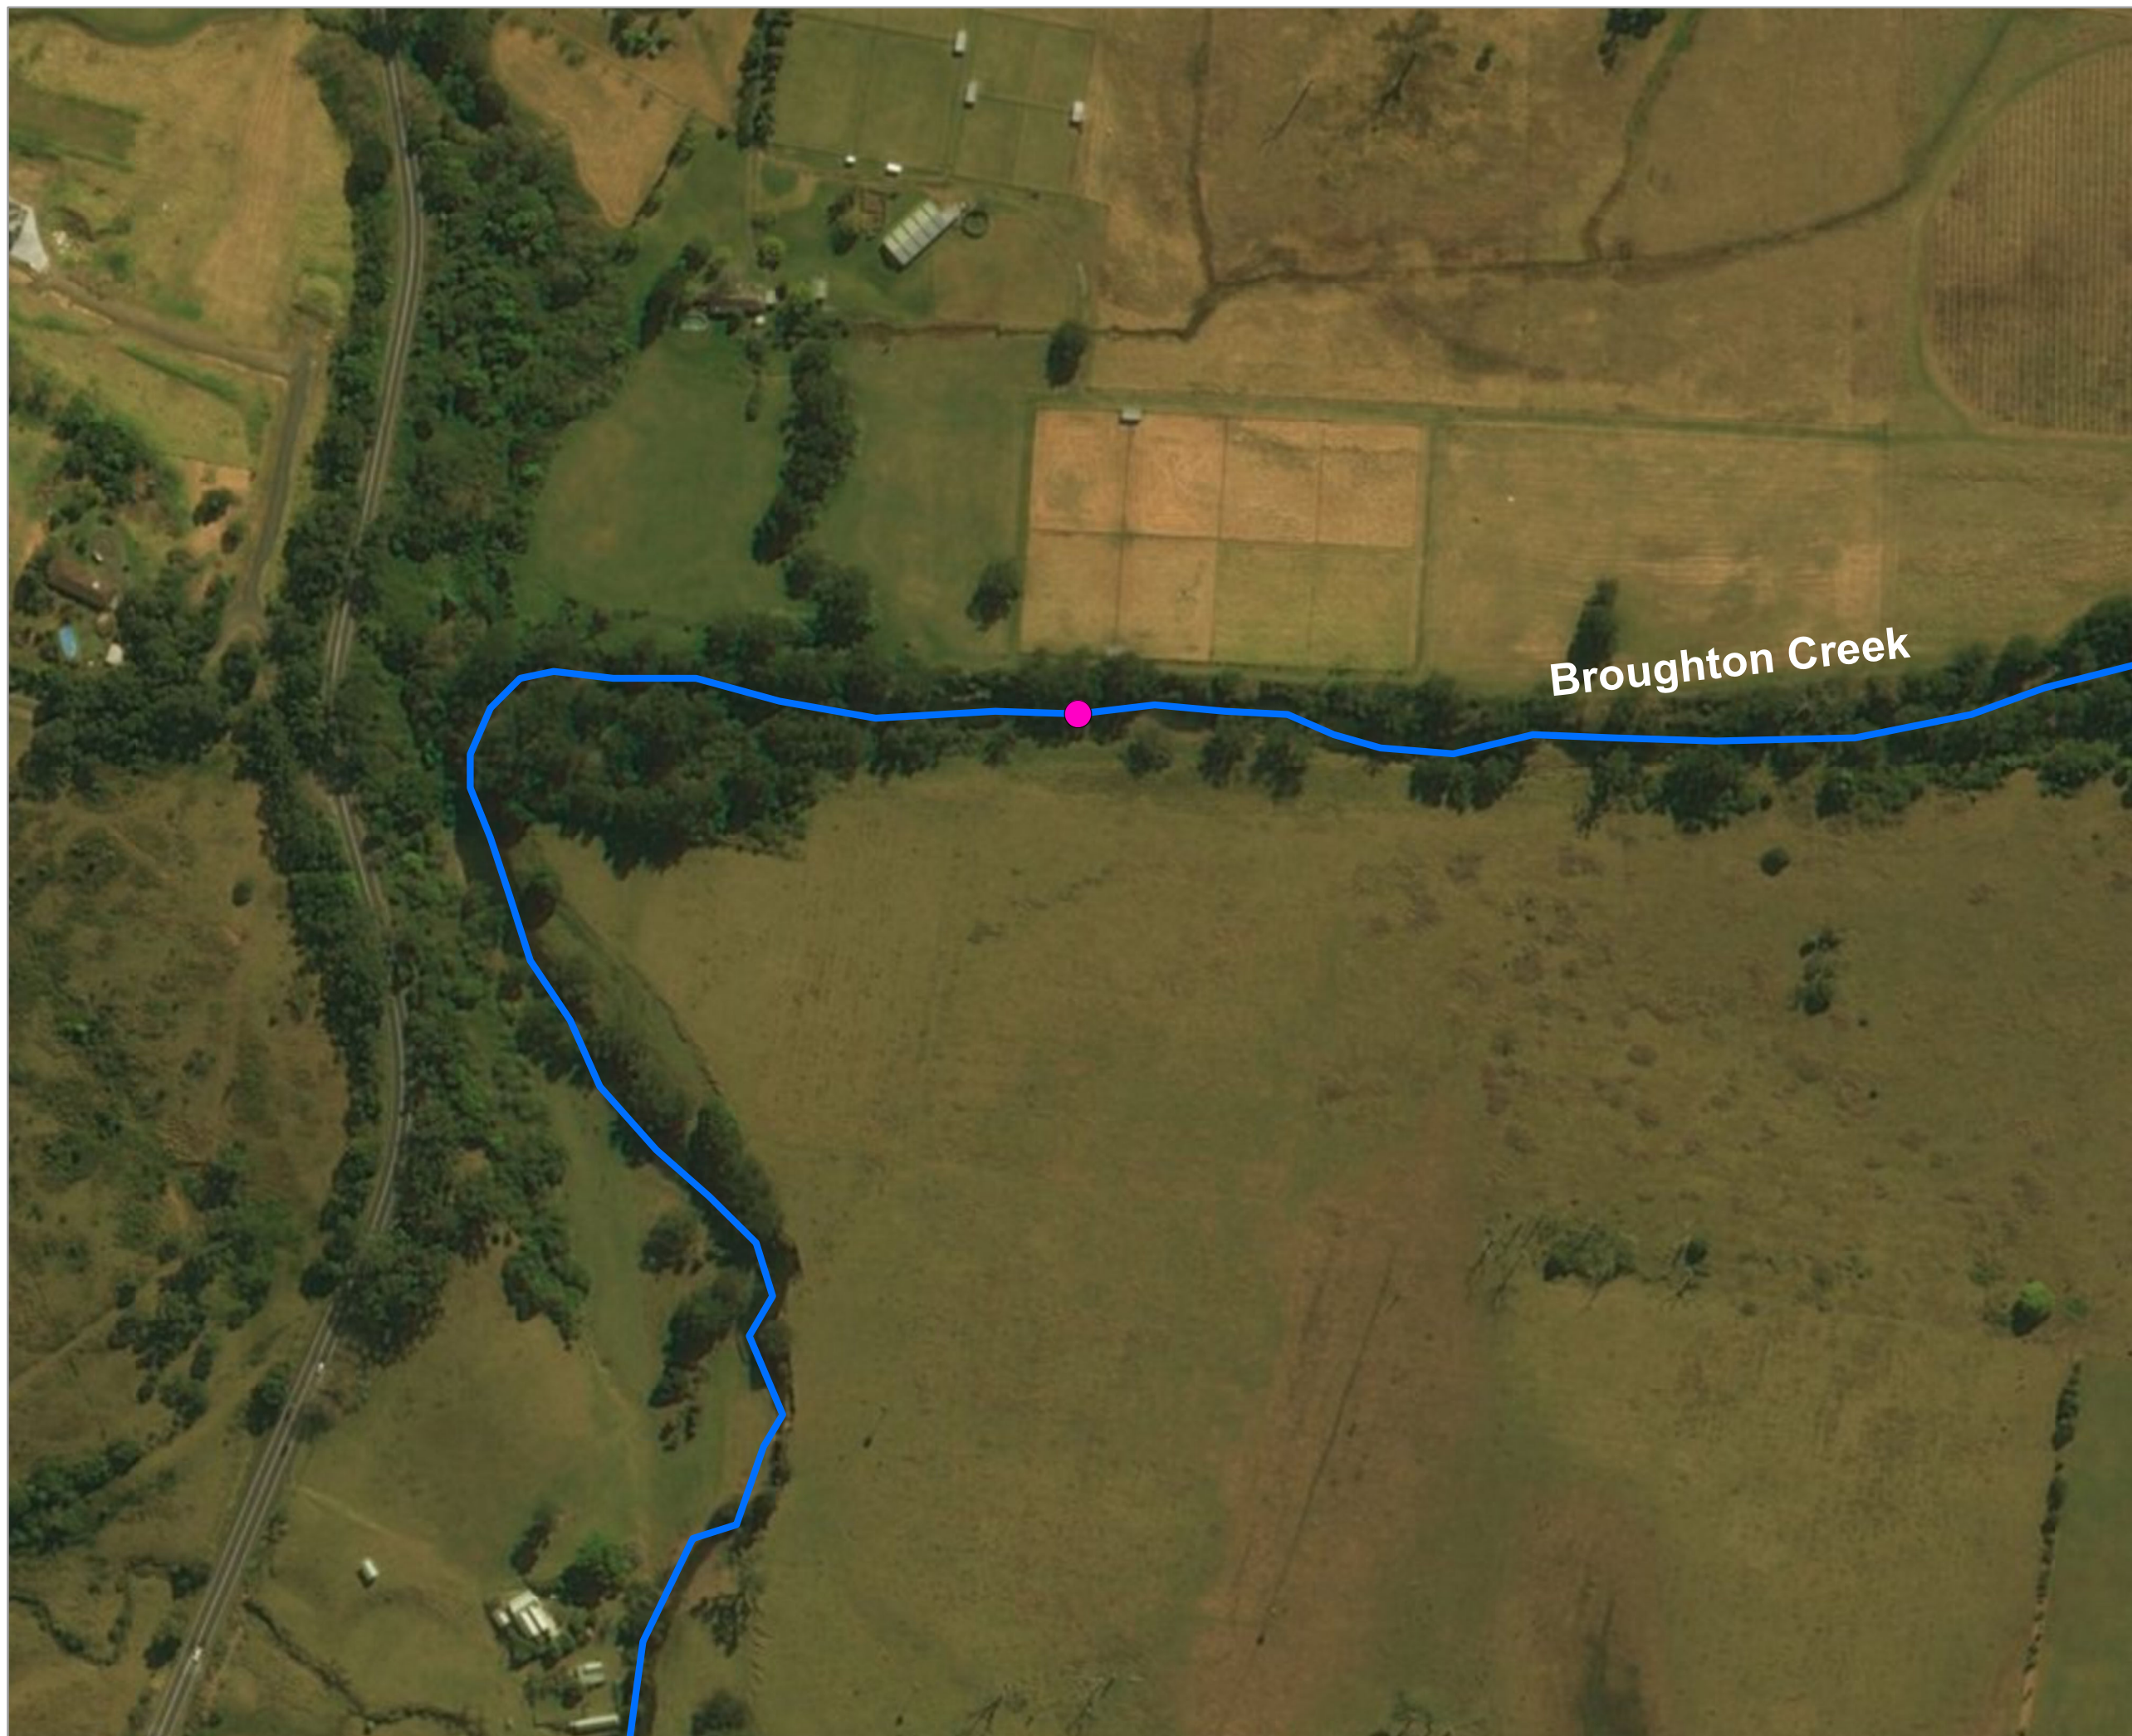
A3 @ 1:3000  
Ref: Site 16 2016  
Author: MH

- Vegetation transect locations
- Project\_boundary
- Water course
