# **Foxground and Berry Bypass** Periodic and Pre-Operational Construction Compliance Status Report

Report 7  
1 October 2017 – 31 March 2018

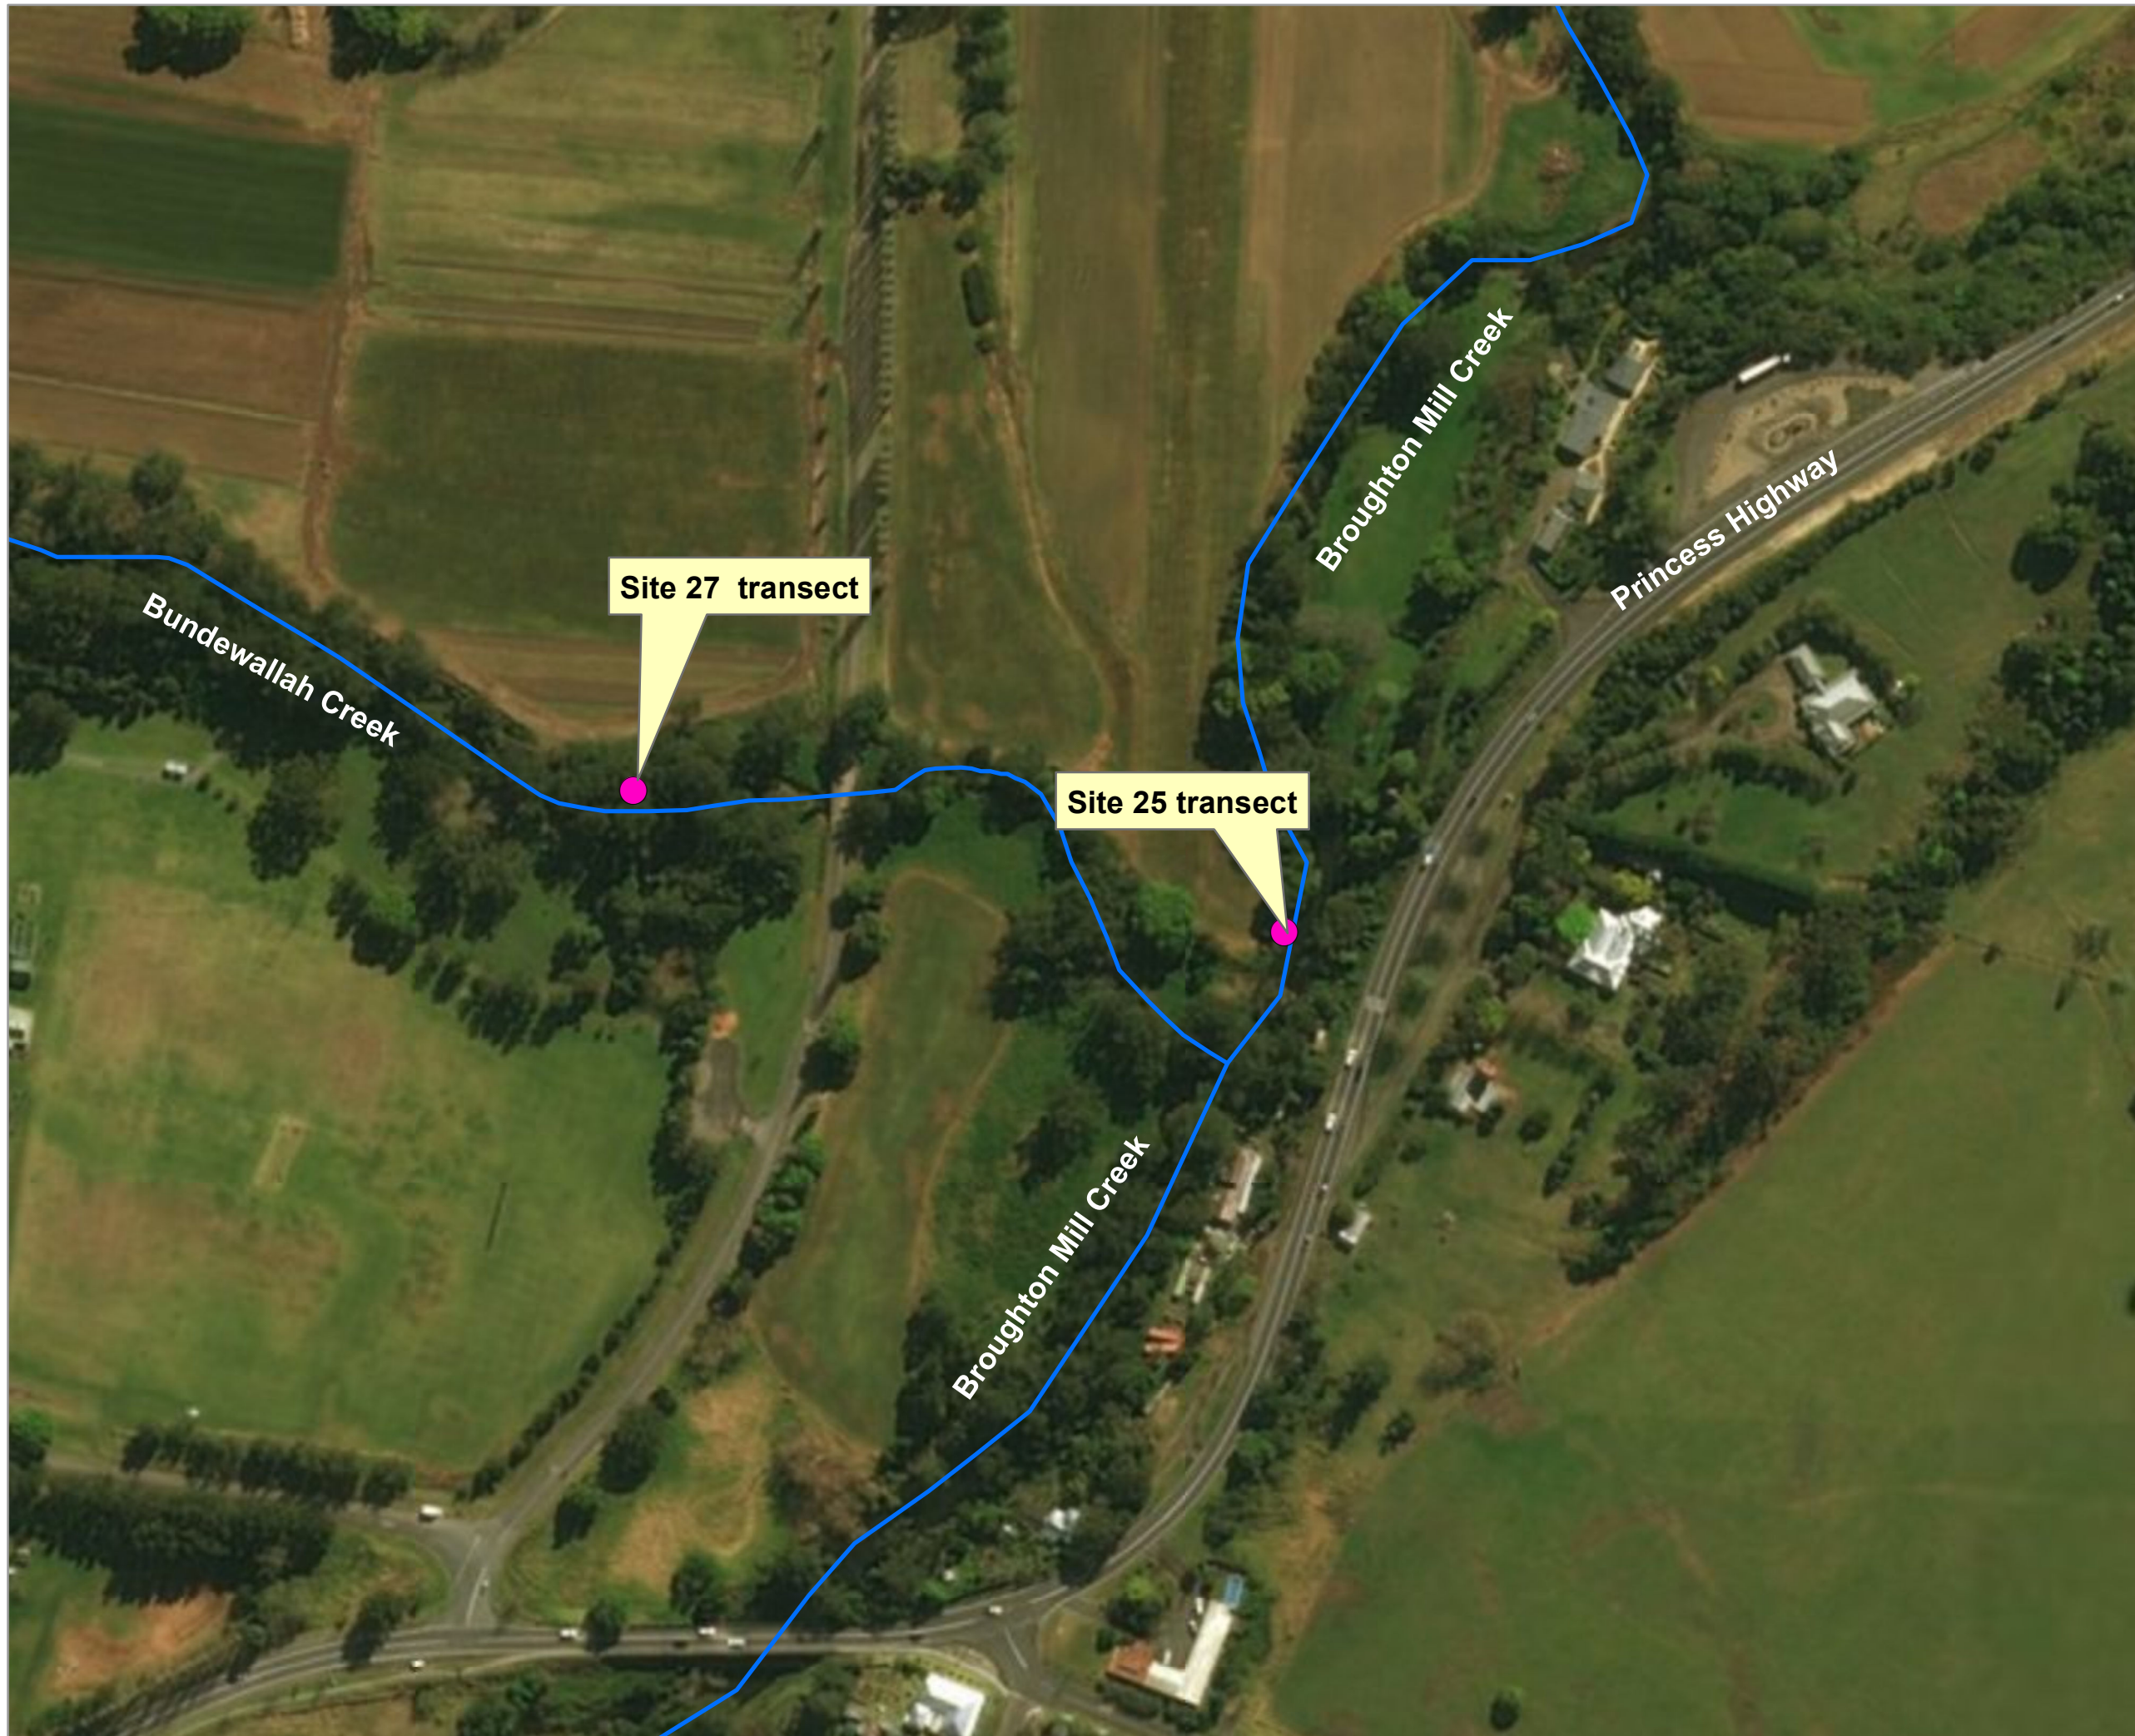
- Vegetation\_transect\_locations
- Project\_boundary
- Water course

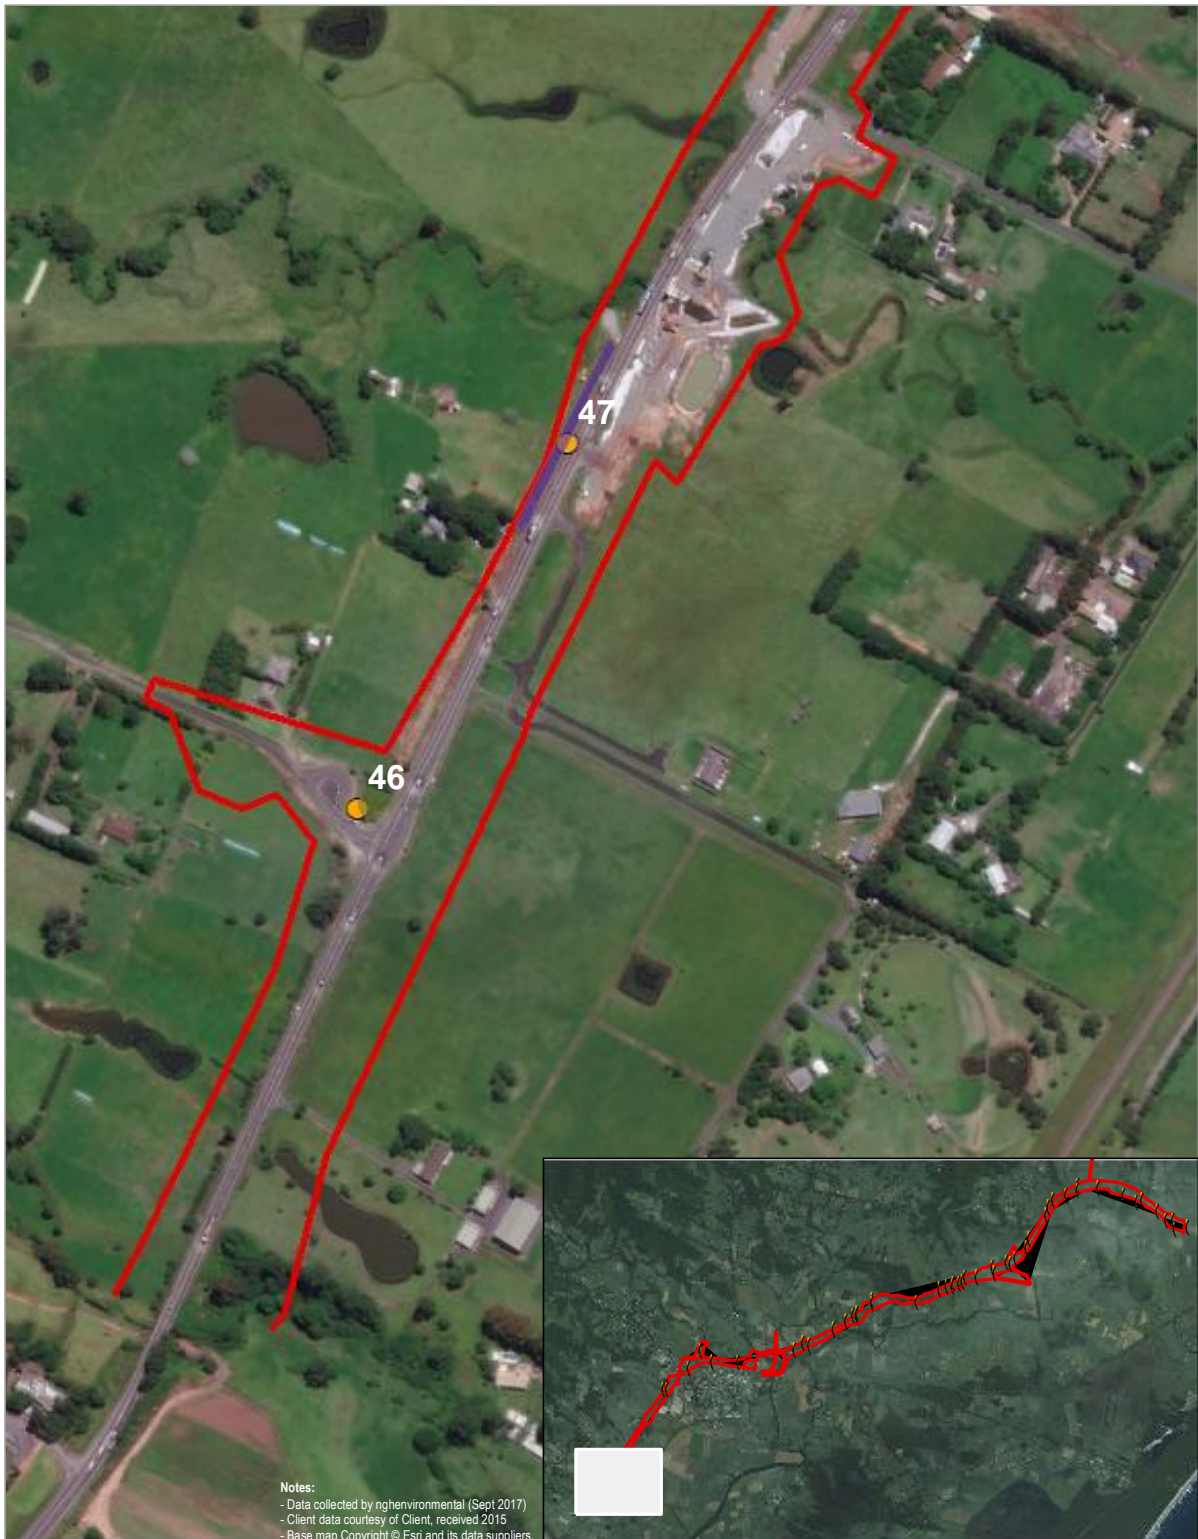
Figure 3-7 Weed distribution map 7

- Project\_boundary
- Survey locations
- Weeds**
- Fireweed, Coral Tree, Inkweed, Verbena
- Fireweed, Lantana

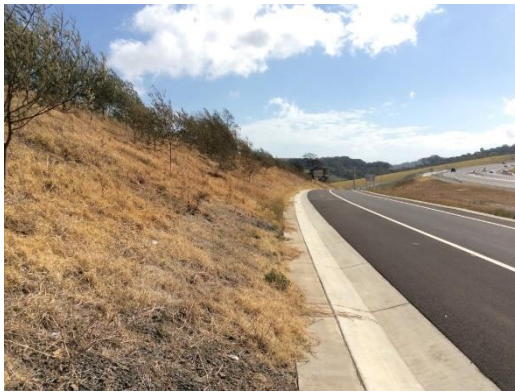
Way point	Eastings	Northings	General Location	Site Description	Weeds and abundances	Photograph
15	297055	6152294	North of Toolijooa Rd	Batter	**Fireweed <i>Senecio madagascariensis</i> – 3 Kikuyu <i>Pennisetum clandestinum</i> – 5 Verbena <i>Verbena bonariensis</i> – 1 Stinking Roger <i>Tagetes minuta</i> – 1 Sow Thistle <i>Sonchus oleraceus</i> -1 Cobbler’s Pegs <i>Bidens pilosa</i> - 2

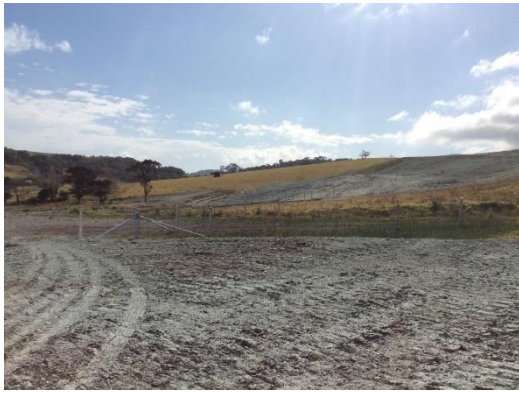
Way point	Eastings	Northings	General Location	Site Description	Weeds and abundances	Photograph
14	296835	6152244	Near turn around bay south of Toolijooa Rd	Construction area, with bare soil areas	**Fireweed <i>Senecio madagascariensis</i> – 2 Spear Thistle <i>Cirsium vulgare</i> – 1 Verbena <i>Verbena bonariensis</i> – 3 Fleabane <i>Conyza bonariensis</i> -1 Kikuyu <i>Pennisetum clandestinum</i> -5 Fennel <i>Foeniculum vulgare</i> -1 White Cover <i>Trifolium repens</i> -1 Cobbler’s Pegs <i>Bidens pilosa</i> -2

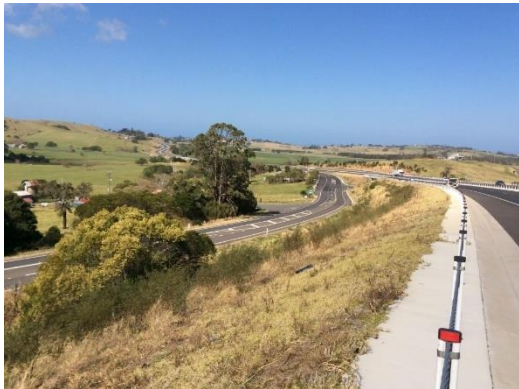
16	296799	615239	South of Toolijooa Rd	Roadside area	**Fireweed <i>Senecio madagascariensis</i> – 2 Spear Thistle <i>Cirsium vulgare</i> - 1 Verbena <i>Verbena bonariensis</i> – 1 Kikuyu <i>Pennisetum clandestinum</i> -4 Cobbler’s Pegs <i>Bidens pilosa</i> -1

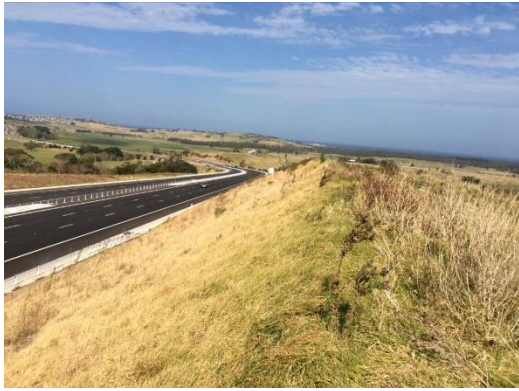
Way point	Eastings	Northings	General Location	Site Description	Weeds and abundances	Photograph
17	296675	6152401	South of Toolijooa Rd	Roadside batter	**Fireweed <i>Senecio madagascariensis</i> – 3 Spear Thistle <i>Cirsium vulgare</i> -1 Sow Thistle <i>Sonchus oleraceus</i> – 1 Kikuyu <i>Pennisetum clandestinum</i> – 5 Stinking Roger <i>Tagetes minuta</i> – 2 Inkweed <i>Phytolacca octandra</i> -2

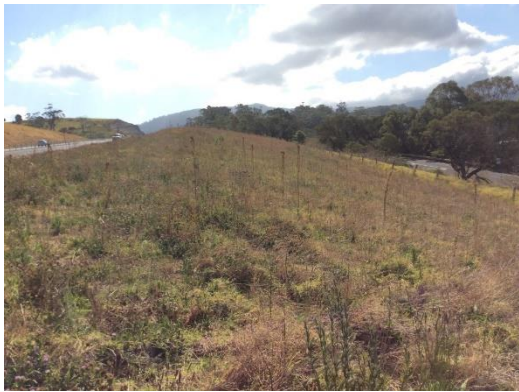
18	296523	6152549	South of Toolijooa Rd	Roadside batter	**Fireweed <i>Senecio madagascariensis</i> – 2 Stinking Roger <i>Tagetes minuta</i> – 1 White Clover <i>Trifolium repens</i> -3 Spear Thistle <i>Cirsium vulgare</i> -1 Kikuyu <i>Pennisetum clandestinum</i> – 5 Verbena <i>Verbena bonariensis</i> – 1 Inkweed <i>Phytolacca octandra</i> -1 Fleabane <i>Conyza bonariensis</i> -1

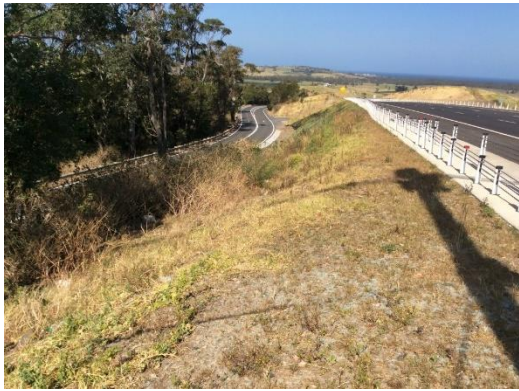
Way point	Eastings	Northings	General Location	Site Description	Weeds and abundances	Photograph
19	296251	6152744	Between BC1 and Toolijooa Rd	Roadside embankment	**Lantana <i>Lantana camara</i> – 4 **Fireweed <i>Senecio madagascariensis</i> – 3 Inkweed <i>Phytolacca octandra</i> -1 Spear Thistle <i>Cirsium vulgare</i> -1 Stinking Roger <i>Tagetes minuta</i> – 1 Cobbler’s Pegs <i>Bidens pilosa</i> -1 Kikuyu <i>Pennisetum clandestinum</i> – 3

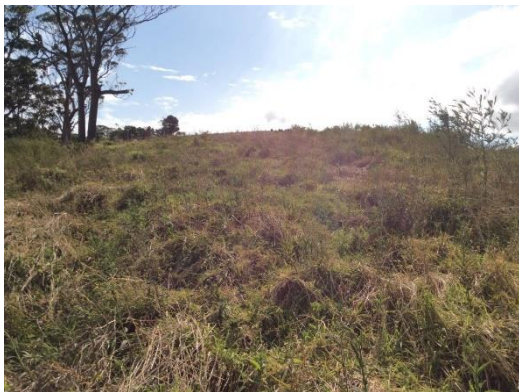
20	296157	6152704	Between BC1 and Toolijooa Rd	Access track between Toolijooa Rd and BC1	**Fireweed <i>Senecio madagascariensis</i> – 3 Inkweed <i>Phytolacca octandra</i> – 1 Verbena <i>Verbena bonariensis</i> -3 Kikuyu <i>Pennisetum clandestinum</i> – 5 Spear Thistle <i>Cirsium vulgare</i> -1 Cobbler’s Pegs <i>Bidens pilosa</i> -1

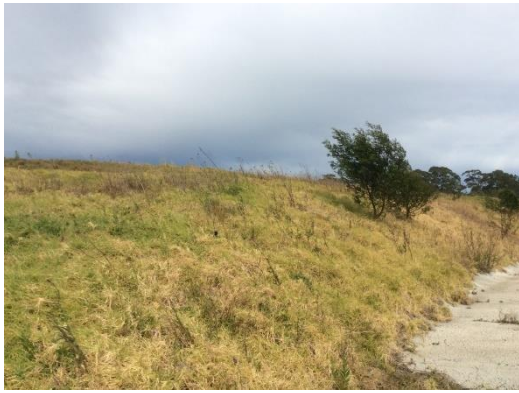
Way point	Eastings	Northings	General Location	Site Description	Weeds and abundances	Photograph
21	29593	6152819	Between BC1 and Toolijooa Rd	Top of cut	**Fireweed <i>Senecio madagascariensis</i> - 1 Kikuyu <i>Pennisetum clandestinum</i> – 5 Verbena <i>Verbena bonariensis</i> -4 Spear Thistle <i>Cirsium vulgare</i> -1 Stinking Roger <i>Tagetes minuta</i> – 1 Paddy’s Lucerne <i>Sida rhombifolia</i> -3 Fleabane <i>Conyza bonariensis</i> -1

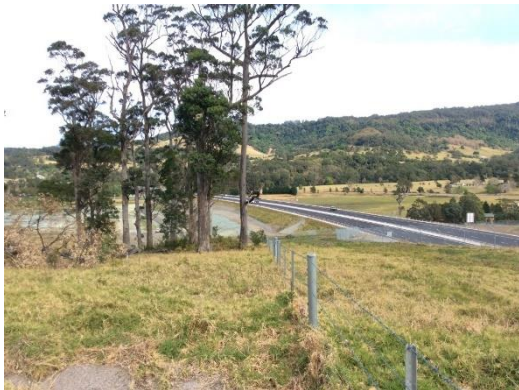
22	295486	6152939	Between BC1 and Toolijooa Rd	Light vehicle track	**Fireweed <i>Senecio madagascariensis</i> – 2 **Giant Parramatta Grass <i>Sporobolus fertilis</i> - 3 Inkweed <i>Phytolacca octandra</i> – 1 Verbena <i>Verbena bonariensis</i> – 3 Spear Thistle <i>Cirsium vulgare</i> – 3 Kikuyu <i>Pennisetum clandestinum</i> – 4 Paddy’s Lucerne <i>Sida rhombifolia</i> -2

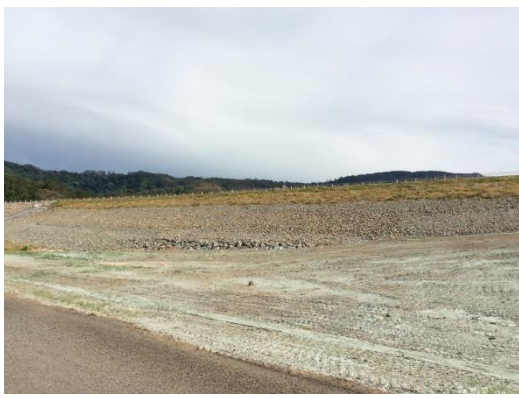
Way point	Eastings	Northings	General Location	Site Description	Weeds and abundances	Photograph
24	295121	6152887	BC1	Adjacent to compound	**Fireweed <i>Senecio madagascariensis</i> – 2 Verbena <i>Verbena bonariensis</i> -1 Stinking Roger <i>Tagetes minuta</i> – 1 Inkweed <i>Phytolacca octandra</i> – 1 Kikuyu <i>Pennisetum clandestinum</i> – 5

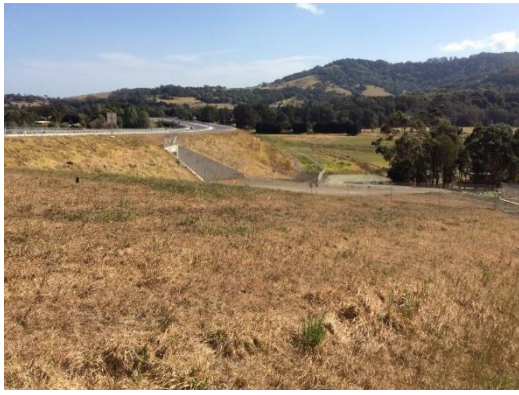
31	295126	6152978	BC1	Roadside batter	**Fireweed <i>Senecio madagascariensis</i> – 2 **Giant Parramatta Grass <i>Sporobolus fertilis</i> - 3 Kikuyu <i>Pennisetum clandestinum</i> – 5 Stinking Roger <i>Tagetes minuta</i> – 1 Inkweed <i>Phytolacca octandra</i> – 1 White Clover <i>Trifolium repens</i> - 1

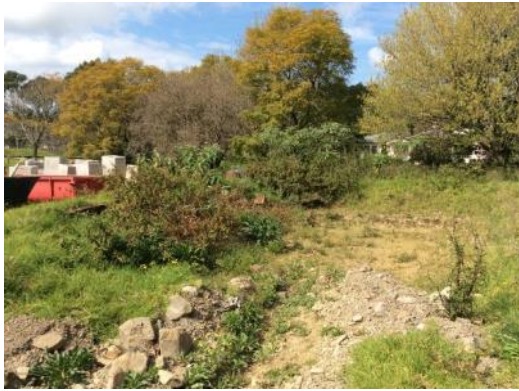
Way point	Eastings	Northings	General Location	Site Description	Weeds and abundances	Photograph
25	294923	6152794	BC1	BC1	Wild Tobacco <i>Solanum mauritianum</i> - 1 Inkweed <i>Phytolacca octandra</i> – 3 Fleabane <i>Conyza bonariensis</i> - 1 Paddy's Lucerne <i>Sida rhombifolia</i> – 2 Kikuyu <i>Pennisetum clandestinum</i> - 4

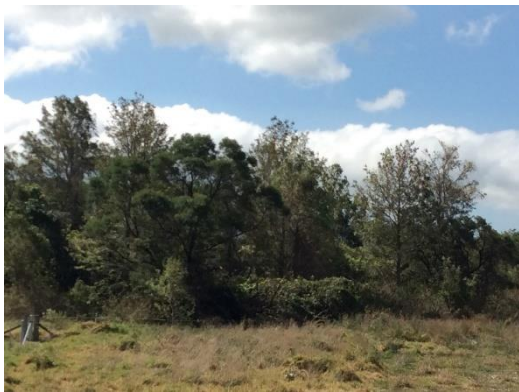
26	294695	6152708	Between BC1 and BC2	Road side	**Fireweed <i>Senecio madagascariensis</i> – 4 Verbena <i>Verbena bonariensis</i> -1 White Clover <i>Trifolium repens</i> - 2 Wild Tobacco <i>Solanum mauritianum</i> - 1 Inkweed <i>Phytolacca octandra</i> – 2 Kikuyu <i>Pennisetum clandestinum</i> - 5 Fleabane <i>Conyza bonariensis</i> - 1

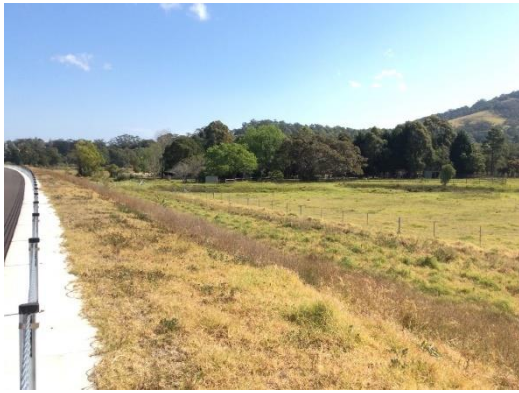
Way point	Eastings	Northings	General Location	Site Description	Weeds and abundances	Photograph
27	294623	6152587	Between BC1 and BC2	Road side	**Fireweed <i>Senecio madagascariensis</i> – 4 Verbena <i>Verbena bonariensis</i> -1 White Clover <i>Trifolium repens</i> - 2 Wild Tobacco <i>Solanum mauritianum</i> - 1 Inkweed <i>Phytolacca octandra</i> – 2 Kikuyu <i>Pennisetum clandestinum</i> - 5 Fleabane <i>Conyza bonariensis</i> - 1

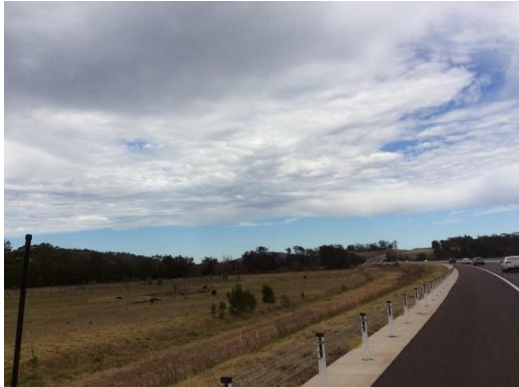
30	294583	6152452	Between BC1 and BC2	Road side	**Fireweed <i>Senecio madagascariensis</i> - 5 Spear Thistle <i>Cirsium vulgare</i> - 1 White Clover <i>Trifolium repens</i> – 1 Verbena <i>Verbena bonariensis</i> -1 Dandelion <i>Taraxacum officinale</i> 1

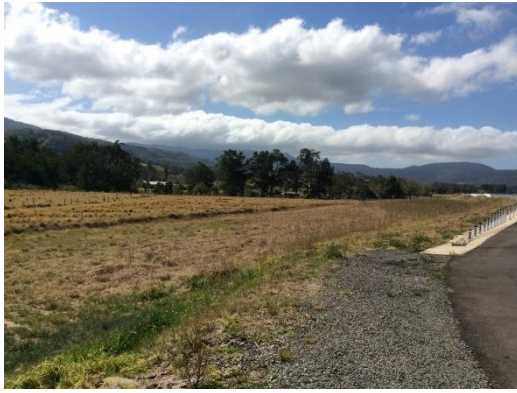
Way point	Eastings	Northings	General Location	Site Description	Weeds and abundances	Photograph
28	294296	6152021	Between BC1 and BC2	Road side	**Fireweed <i>Senecio madagascariensis</i> - 5 Whiskey Grass <i>Andropogon virginicus</i> -6 Verbena <i>Verbena bonariensis</i> -3 Kikuyu <i>Pennisetum clandestinum</i> – 1 Cobbler’s Pegs <i>Bidens pilosa</i> -1 White Clover <i>Trifolium repens</i> - 1 Wild Tobacco <i>Solanum mauritianum</i> - 1 Paddy's Lucerne <i>Sida rhombifolia</i> – 1 Curly Dock <i>Rumex crispus</i> -1

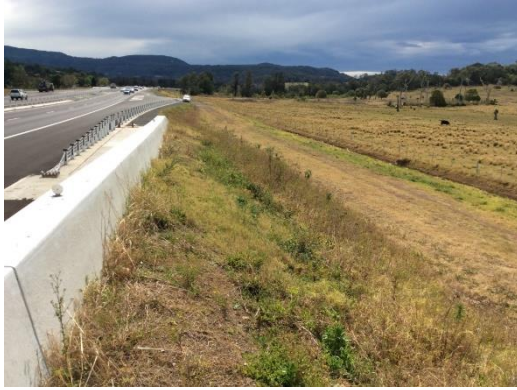
29	294250	6151865	Between BC1 and BC2	Road side	**Fireweed <i>Senecio madagascariensis</i> - 3 Inkweed <i>Phytolacca octandra</i> – 2 Spear Thistle <i>Cirsium vulgare</i> - 2 Verbena <i>Verbena bonariensis</i> - 2 Wild Tobacco <i>Solanum mauritianum</i> - 1 Deadly Nightshade <i>Solanum nigrum</i> - 2 White Clover <i>Trifolium repens</i> - 4 Paddy’s Lucerne <i>Sida rhombifolia</i> - 5

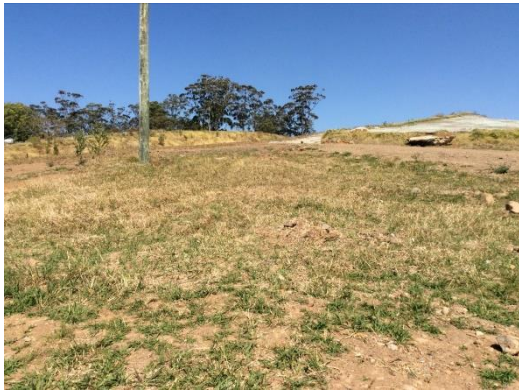
Way point	Eastings	Northings	General Location	Site Description	Weeds and abundances	Photograph
32	294059	6151679	Between Austral Park compound and BC3	Access track	**Fireweed <i>Senecio madagascariensis</i> - 3 Paspalum <i>Paspalum dilatatum</i> -3 Kikuyu <i>Pennisetum clandestinum</i> – 2 Sow Thistle <i>Sonchus oleraceus</i> -1

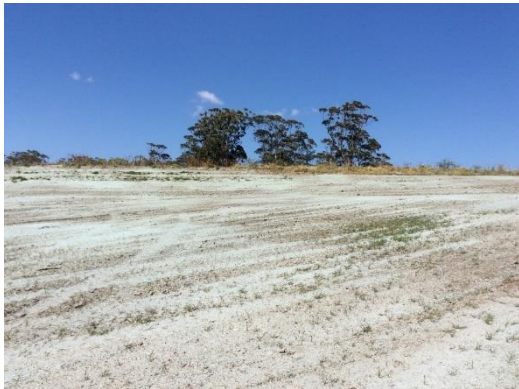
33	293916	6151611	Between Austral Park compound and BC3	Batter	**Fireweed <i>Senecio madagascariensis</i> - 2 Kikuyu <i>Pennisetum clandestinum</i> – 1 Inkweed <i>Phytolacca octandra</i> – 1 Spear Thistle <i>Cirsium vulgare</i> - 1

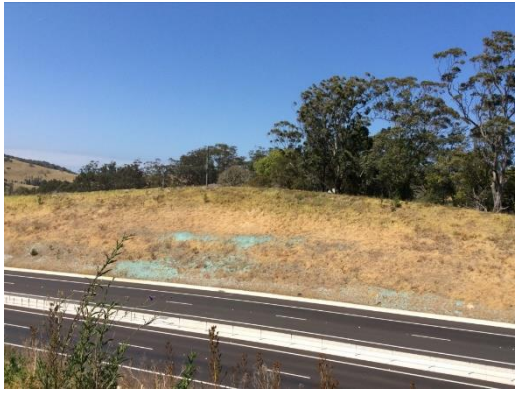
Way point	Eastings	Northings	General Location	Site Description	Weeds and abundances	Photograph
34	293975	6151579	Between Austral Park compound and BC3	Batter	**Fireweed <i>Senecio madagascariensis</i> - 2 Kikuyu <i>Pennisetum clandestinum</i> – 5 Inkweed <i>Phytolacca octandra</i> – 3 Spear Thistle <i>Cirsium vulgare</i> - 1

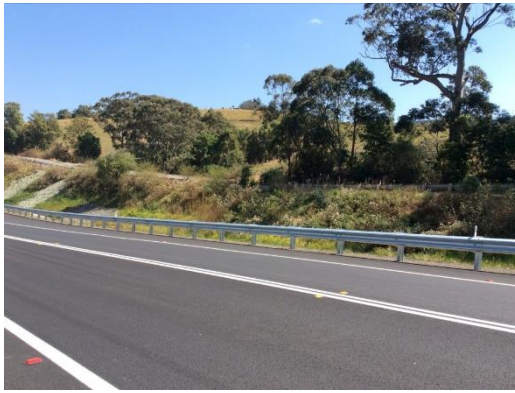
35	293661	6151517	Between Austral Park compound and BC3	Batter	**Fireweed <i>Senecio madagascariensis</i> - 2 **Lantana <i>Lantana camara</i> - 3 Crofton Weed <i>Ageratina adenophora</i> - 4 Wild Tobacco <i>Solanum mauritianum</i> – 2 Stinking Roger <i>Tagetes minuta</i> – 1 Whiskey Grass <i>Andropogon virginicus</i> -1

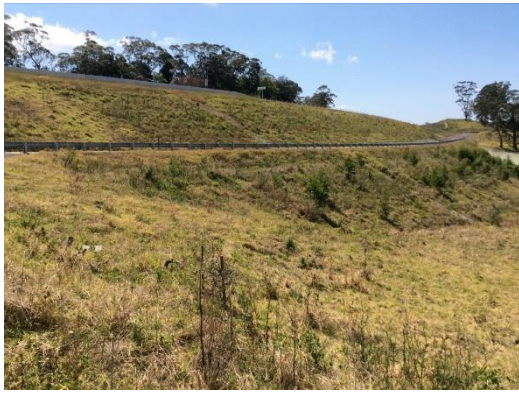
Way point	Eastings	Northings	General Location	Site Description	Weeds and abundances	Photograph
36	293699	6151420	Between Austral Park compound and BC3	Batter	**Fireweed <i>Senecio madagascariensis</i> - 4 Inkweed <i>Phytolacca octandra</i> – 2 Fleabane <i>Conyza bonariensis</i> - 2 Verbena <i>Verbena bonariensis</i> -2 White Clover <i>Trifolium repens</i> - 1 Kikuyu <i>Pennisetum clandestinum</i> – 4 Spear Thistle <i>Cirsium vulgare</i> - 1 Wild Tobacco <i>Solanum mauritianum</i> – 1 Stinking Roger <i>Tagetes minuta</i> – 1

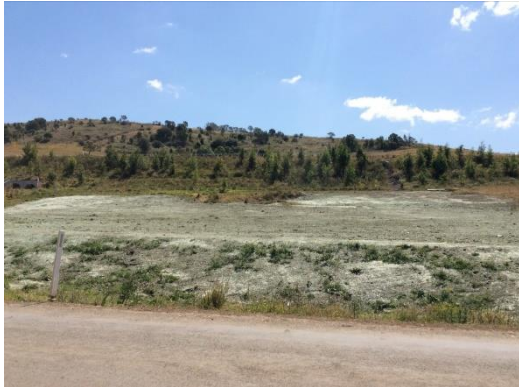
37	293391	6151342	Between Austral Park compound and BC3	Batter	**Fireweed <i>Senecio madagascariensis</i> - 3 Inkweed <i>Phytolacca octandra</i> – 2 Fleabane <i>Conyza bonariensis</i> - 1 Verbena <i>Verbena bonariensis</i> -2 White Clover <i>Trifolium repens</i> - 1 Kikuyu <i>Pennisetum clandestinum</i> – 3 Spear Thistle <i>Cirsium vulgare</i> - 1 Wild Tobacco <i>Solanum mauritianum</i> – 1 Stinking Roger <i>Tagetes minuta</i> – 1 Paddy's Lucerne <i>Sida rhombifolia</i> – 1 Wild Aster <i>Aster subulatus</i> -1

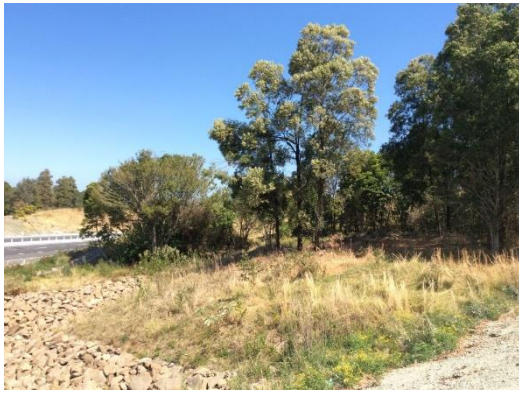
Way point	Eastings	Northings	General Location	Site Description	Weeds and abundances	Photograph
13	293197	6151331	Austral Park	Western side Princess Hwy	**Fireweed <i>Senecio madagascariensis</i> - 2 Fleabane <i>Conyza bonariensis</i> - 1 Verbena <i>Verbena bonariensis</i> -1 Kikuyu <i>Pennisetum clandestinum</i> – 1 Wild Tobacco <i>Solanum mauritianum</i> – 1 Stinking Roger <i>Tagetes minuta</i> – 1 Paddy’s Lucerne <i>Sida rhombifolia</i> – 2 Wild Aster <i>Aster subulatus</i> -1 Whiskey Grass <i>Andropogon virginicus</i> -

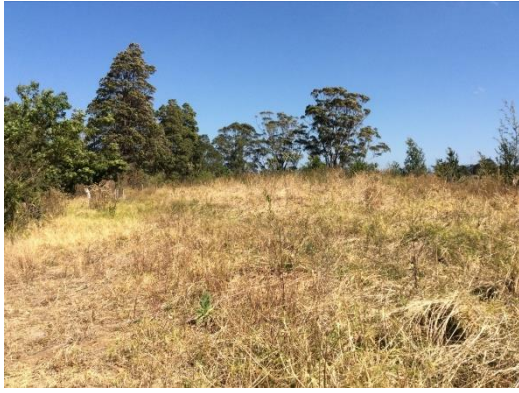
38	293143	6151252	Austral Park	Western side Princess Hwy	**Fireweed <i>Senecio madagascariensis</i> – 2 Wild Oats <i>Avena fatua</i> -1 Kikuyu <i>Pennisetum clandestinum</i> – 4 Wild Aster <i>Aster subulatus</i> -1 Verbena <i>Verbena bonariensis</i> -1 Crofton Weed <i>Ageratina adenophora</i> - 2 Wild Tobacco <i>Solanum mauritianum</i> – 1 Spear Thistle <i>Cirsium vulgare</i> - 1

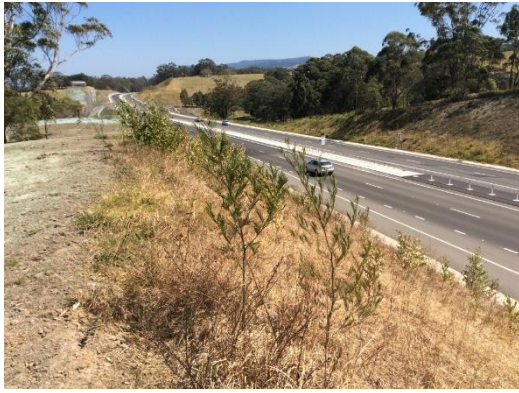
Way point	Eastings	Northings	General Location	Site Description	Weeds and abundances	Photograph
12	293089	6151221	Austral Park	Western side Princess Hwy	**Fireweed <i>Senecio madagascariensis</i> - 3 Paspalum <i>Paspalum dilatatum</i> -1 Inkweed <i>Phytolacca octandra</i> – 1 Kikuyu <i>Pennisetum clandestinum</i> – 1 Verbena <i>Verbena bonariensis</i> -1

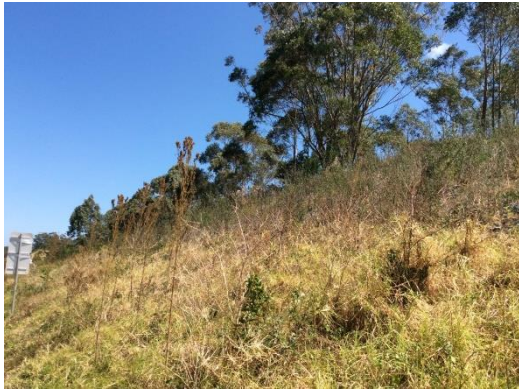
10	292987	6151220	Austral Park	Western side Princess Hwy	**Fireweed <i>Senecio madagascariensis</i> - 2 Kikuyu <i>Pennisetum clandestinum</i> – 5 Verbena <i>Verbena bonariensis</i> -1 Inkweed <i>Phytolacca octandra</i> – 1 Deadly Nightshade <i>Solanum nigrum</i> - 1 Paddy's Lucerne <i>Sida rhombifolia</i> – 1 Stinking Roger <i>Tagetes minuta</i> – 2

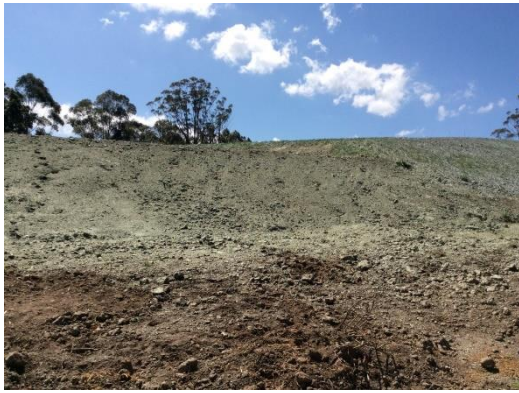
Way point	Eastings	Northings	General Location	Site Description	Weeds and abundances	Photograph
11	292977	6151168	Austral Park	Soil mound	**Fireweed <i>Senecio madagascariensis</i> - 3 Paddy's Lucerne <i>Sida rhombifolia</i> - 3 Inkweed <i>Phytolacca octandra</i> – 1 Spear Thistle <i>Cirsium vulgare</i> - 1

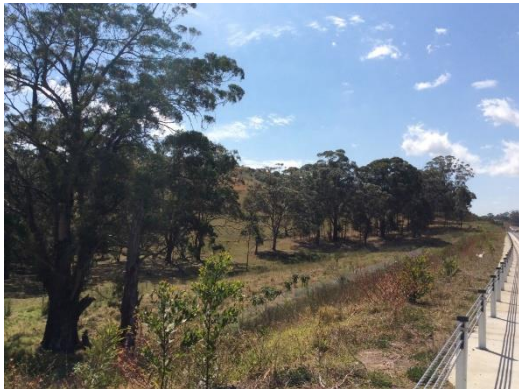
9	292873	6151166	Austral Park	Batter	**Fireweed <i>Senecio madagascariensis</i> - 3 White Clover <i>Trifolium repens</i> - 4 Wild Tobacco <i>Solanum mauritianum</i> – 1 Kikuyu <i>Pennisetum clandestinum</i> – 3 Deadly Nightshade <i>Solanum nigrum</i> - 1 Inkweed <i>Phytolacca octandra</i> – 2

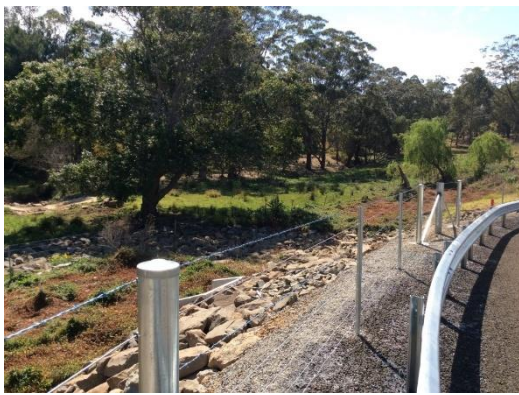
Way point	Eastings	Northings	General Location	Site Description	Weeds and abundances	Photograph
8	292746	6151115	Austral Park	Road side	**Fireweed <i>Senecio madagascariensis</i> - 2 Inkweed <i>Phytolacca octandra</i> - 2 Wild Tobacco <i>Solanum mauritianum</i> – 2 Small-leaf Privet <i>Ligustrum sinense</i> – 1 Spear Thistle <i>Cirsium vulgare</i> – 1 Verbena <i>Verbena bonariensis</i> -1

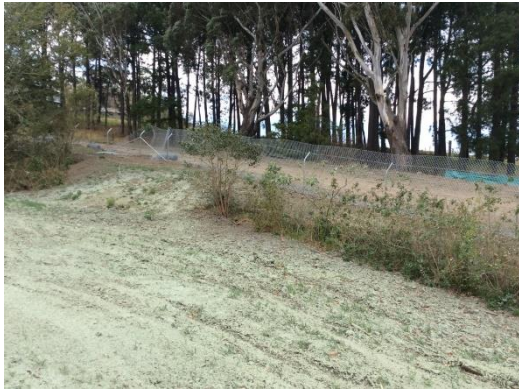
7	292355	6150882	Central zone	Road side	*Lantana <i>Lantana camara</i> – 3 Spear Thistle <i>Cirsium vulgare</i> - 2 Wild Tobacco <i>Solanum mauritianum</i> – 3

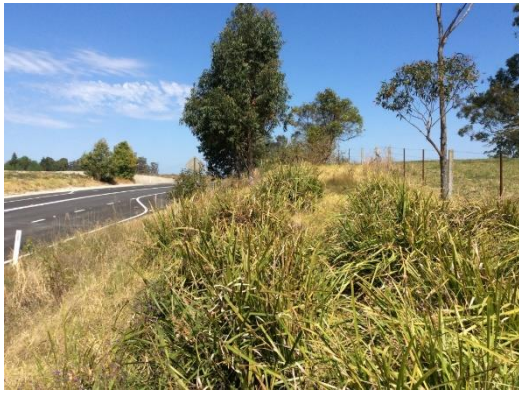
Way point	Eastings	Northings	General Location	Site Description	Weeds and abundances	Photograph
6	291579	6150900	Tindall's Lane	Road side	**Fireweed <i>Senecio madagascariensis</i> – 2 **Lantana <i>Lantana camara</i> - 1 Fleabane <i>Conyza bonariensis</i> - 1 Wild Oats <i>Avena fatua</i> -1 Kikuyu <i>Pennisetum clandestinum</i> – 4 Deadly Nightshade <i>Solanum nigrum</i> - 1 Verbena <i>Verbena bonariensis</i> -1

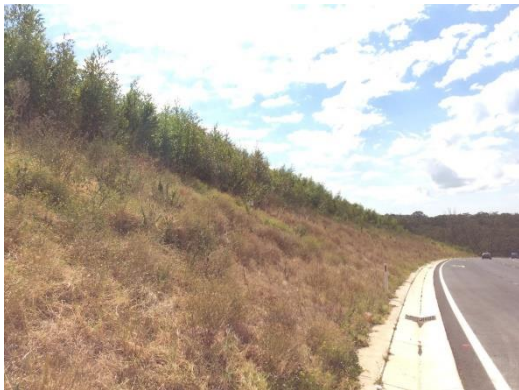
5	291578	6150845	Tindall's Lane	Batter	**Fireweed <i>Senecio madagascariensis</i> - 3 Kikuyu <i>Pennisetum clandestinum</i> – 4 Inkweed <i>Phytolacca octandra</i> - 1 Spear Thistle <i>Cirsium vulgare</i> - 1 Wild Tobacco <i>Solanum mauritianum</i> – 1 Fleabane <i>Conyza bonariensis</i> - 1 Verbena <i>Verbena bonariensis</i> -1

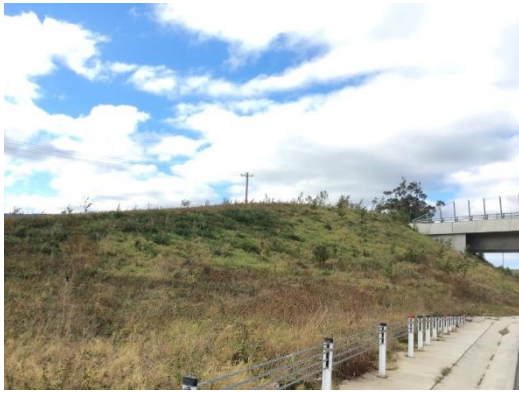
Way point	Eastings	Northings	General Location	Site Description	Weeds and abundances	Photograph
4	291320	6150671	Central zone Cut 6	Batter	**Fireweed <i>Senecio madagascariensis</i> - 2 Wild Tobacco <i>Solanum mauritianum</i> - 1

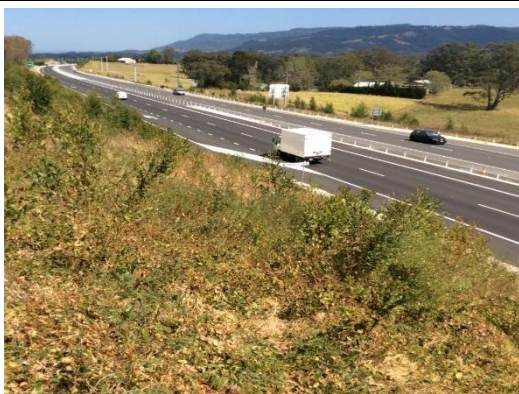
3	291317	6150605	Central zone Cut 6	Batter	**Fireweed <i>Senecio madagascariensis</i> - 2 Pink Clover <i>Trifolium pratense</i> – 4 Paddy's Lucerne <i>Sida rhombifolia</i> - 2 Kikuyu <i>Pennisetum clandestinum</i> – 4 Inkweed <i>Phytolacca octandra</i> - 1 Fleabane <i>Conyza bonariensis</i> - 1

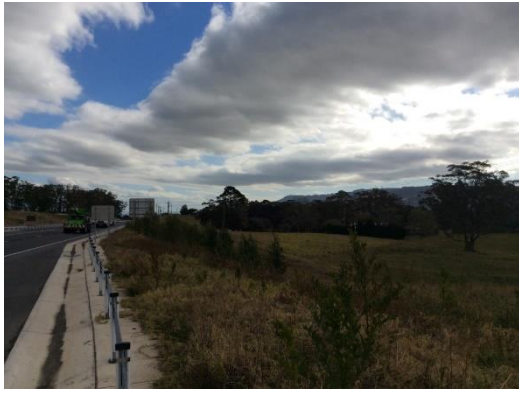
Way point	Eastings	Northings	General Location	Site Description	Weeds and abundances	Photograph
2	291251	6150619	Central zone Cut 6	Batter	**Fireweed <i>Senecio madagascariensis</i> - 1 White Clover <i>Trifolium repens</i> – 4 Kikuyu <i>Pennisetum clandestinum</i> – 4

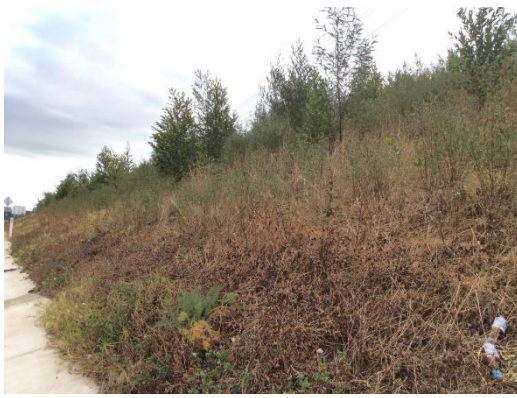
Way point	Eastings	Northings	General Location	Site Description	Weeds and abundances	Photograph
0	290920	6150386	Central zone	Batter	**Fireweed <i>Senecio madagascariensis</i> - 2 Kikuyu <i>Pennisetum clandestinum</i> - 1 Verbena <i>Verbena bonariensis</i> -1 Fleabane <i>Conyza bonariensis</i> - 1

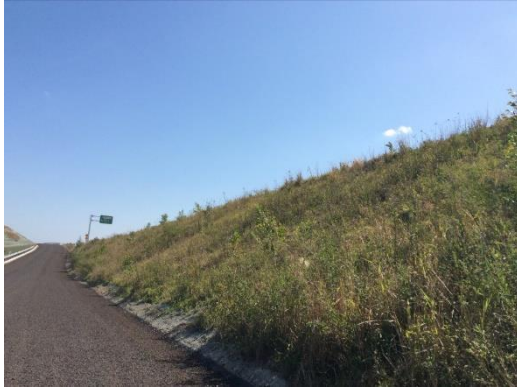
39	290499	6150097	Southern zone	Batter	**Fireweed <i>Senecio madagascariensis</i> - 3 Spear Thistle ( <i>Cirsium vulgare</i> ) - 1 Verbena ( <i>Verbena bonariensis</i> ) - 1 Inkweed ( <i>Phytolacca octandra</i> ) - 2 Dandelion <i>Taraxacum officinale</i> -2 Paspalum <i>Paspalum dilatatum</i> -1 Kikuyu <i>Pennisetum clandestinum</i> – 4 Fleabane <i>Conyza bonariensis</i> - 2

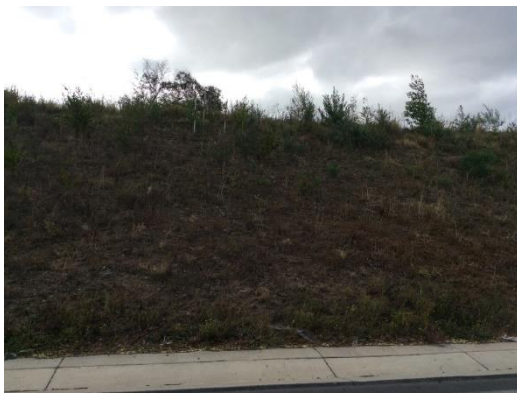
Way point	Eastings	Northings	General Location	Site Description	Weeds and abundances	Photograph
41	290384	6150131	Southern zone	Batter	**Lantana <i>Lantana camara</i> - 1 **Fireweed <i>Senecio madagascariensis</i> - 1 Fleabane <i>Conyza bonariensis</i> - 1 Cobbler's Pegs <i>Bidens pilosa</i> -1

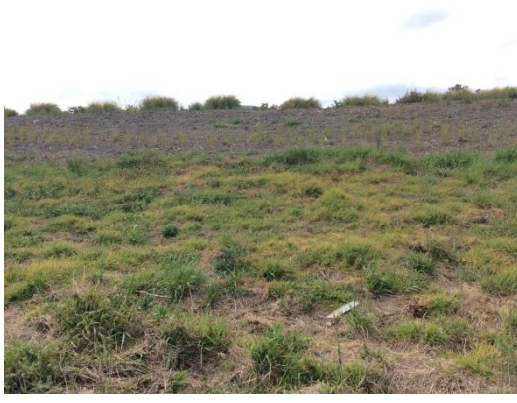
Way point	Eastings	Northings	General Location	Site Description	Weeds and abundances	Photograph
42	289262	6149761	Southern zone	Batter	**Fireweed <i>Senecio madagascariensis</i> - 4 Inkweed <i>Phytolacca octandra</i> - 1 Paddy's Lucerne <i>Sida rhombifolia</i> - 1 Sow Thistle <i>Sonchus oleraceus</i> -1 Spear Thistle <i>Cirsium vulgare</i> - 1 Wild Tobacco <i>Solanum mauritianum</i> - 1

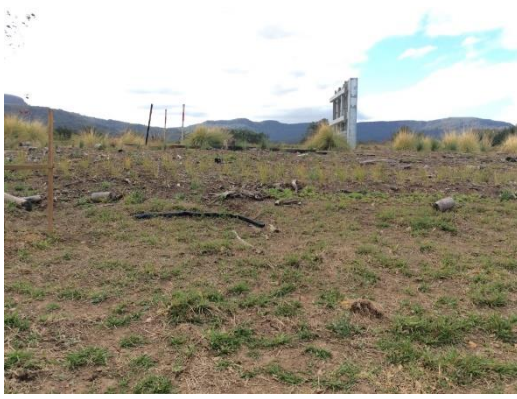
43	288808	6149755	Southern zone	Batter	**Fireweed <i>Senecio madagascariensis</i> - 1

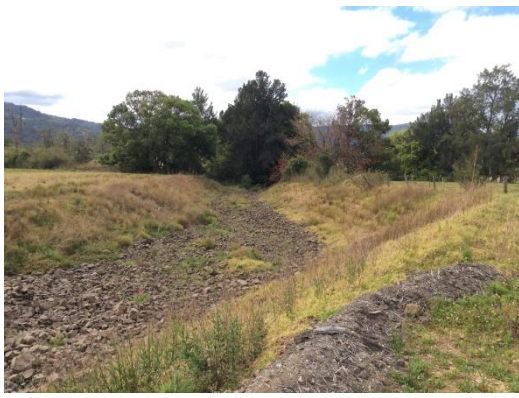
Way point	Eastings	Northings	General Location	Site Description	Weeds and abundances	Photograph
49	288598	6149960	Southern zone	Town Creek Diversion, Rawling's Lane	**Lantana <i>Lantana camara</i> – 2 Cobbler's Pegs <i>Bidens pilosa</i> – 1 Plantain <i>Plantago lanceolata</i> – 2 Kikuyu <i>Pennisetum clandestinum</i> – 2 Curly Dock <i>Rumex crispus</i> -1 Verbena <i>Verbena bonariensis</i> - 2

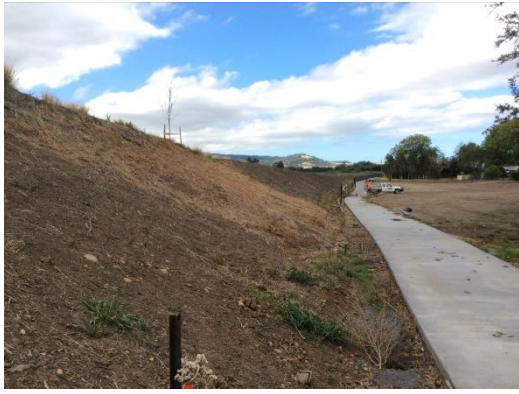
44	288407	6149644	Southern zone	Noise mound	**Fireweed <i>Senecio madagascariensis</i> - 2 Spear Thistle <i>Cirsium vulgare</i> - 1 Sow Thistle <i>Sonchus oleraceus</i> – 1 Deadly Nightshade <i>Solanum nigrum</i> – 1 Wild Tobacco <i>Solanum mauritianum</i> - 1

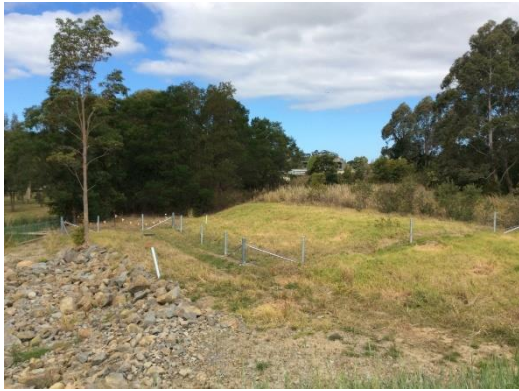
Way point	Eastings	Northings	General Location	Site Description	Weeds and abundances	Photograph
45	288031	6149263	Southern zone	Roadside	**Fireweed <i>Senecio madagascariensis</i> - 2 **Lantana <i>Lantana camara</i> – 2 **Blackberry <i>Rubus fruticosus</i> species aggregate -2 Deadly Nightshade <i>Solanum nigrum</i> – 1

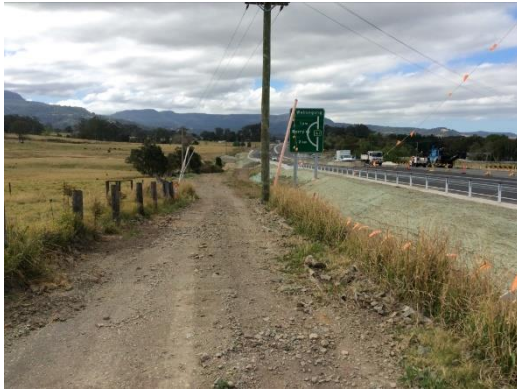
Way point	Eastings	Northings	General Location	Site Description	Weeds and abundances	Photograph
47	287054	6147773	Southern zone	Roadside	**Fireweed <i>Senecio madagascariensis</i> - 2 **Lantana <i>Lantana camara</i> - 1

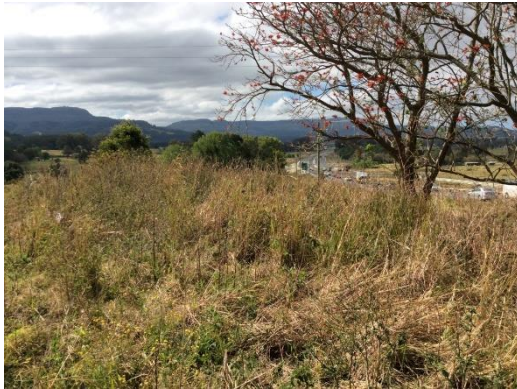
46	286918	6147524	Southern zone	Roadside	**Fireweed <i>Senecio madagascariensis</i> - 2 Coral Tree <i>Erythina x sykesii</i> - 1 Inkweed <i>Phytolacca octandra</i> - 3 Verbena <i>Verbena bonariensis</i> - 3

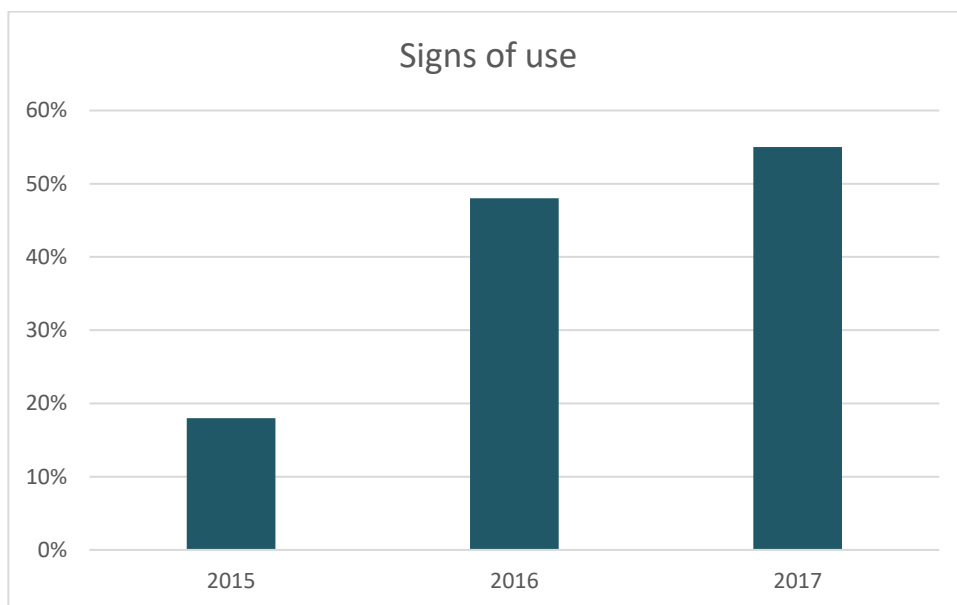
As discussed within the limitations section, it may take local fauna a longer period of time to start using nest boxes for refuge and nesting purposes, and the 2016 monitoring report predicted that a greater abundance of local fauna would be using the nest boxes in year three (2017) of the monitoring period (Lindenmeyer *et al.* 2009). As predicted within the 2016 report, the rate of fauna utilisation of nest boxes is higher than in previous studies. It is noted that a higher percentage of nest boxes were recorded as having been used during the current surveys (55% of total boxes) compared to the first year’s survey (18%), and last year’s survey (48%), as shown in the Figure 1-1Figure 2 below.

Figure 2 – Percentage of surveyed nest boxes showing signs of use

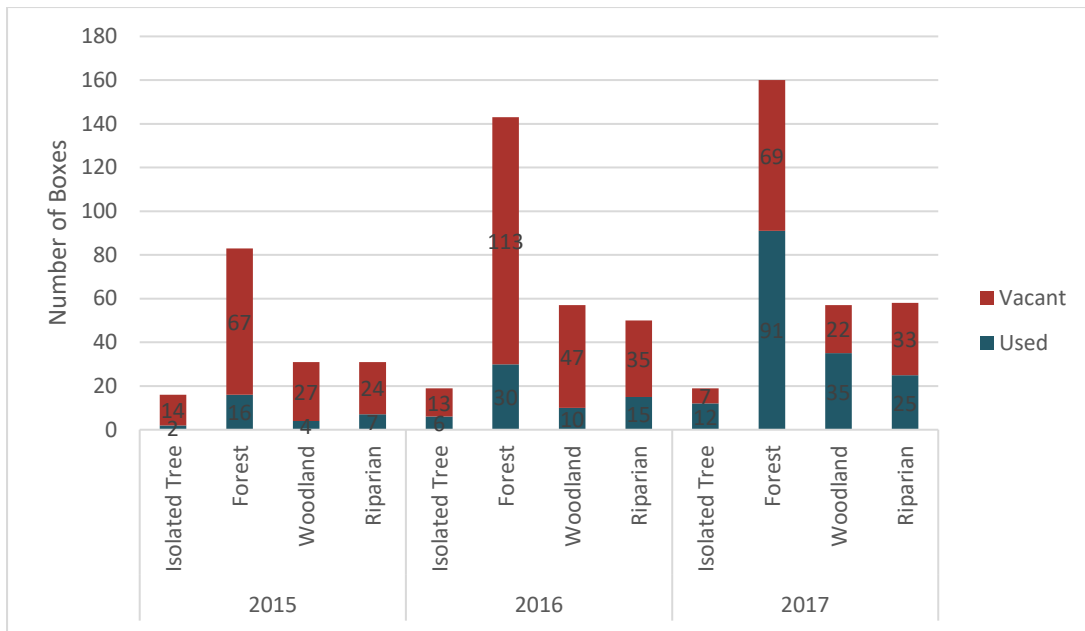
Proportionally, nest boxes installed in areas of forest and woodland habitats showed the greatest increase in occupancy or signs of use over time, with forest boxes going from 21% showing signs of use in 2016 to 57% showing signs of use in 2017, and woodland boxes going from 15.5% of boxes showing signs of use in 2016 to 61% in 2017. Isolated paddock trees showed a far higher degree of use with a change from 32% showing signs of use in 2016 to 63% showing signs of use in 2017. Riparian nest boxes rose from 30% showing signs of use in 2016 to 43% in 2017. Nest box use has increased over time in all habitat types. These results are shown in Figure 3 below.

Figure 3 – Proportion of boxes showing signs of use in habitat types over time

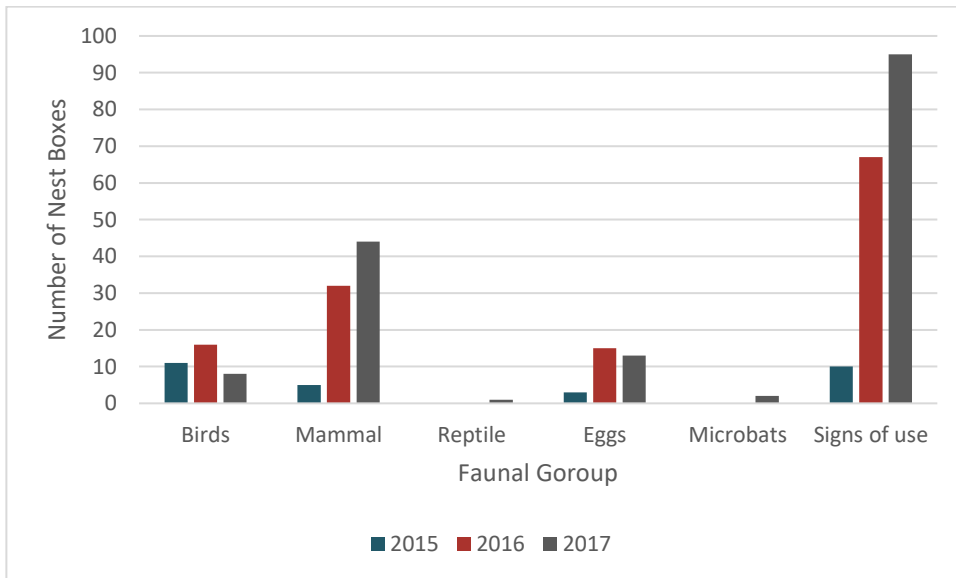
Species diversity rose slightly in 2017 to 14 species, however the additional species was not identifiable, whilst the percentage of nest boxes with fauna occupying them increased. Detections of birds utilising nest boxes declined, and the number of boxes containing mammals increased. Two new faunal groups were identified during the 2017 survey utilising boxes, with a Diamond Python found utilising a nest box, and two microbat boxes found to contain microbats. Both of these microbat boxes were located within forest habitat. The number of boxes showing signs of use also increased significantly, as would be anticipated as fauna discover and utilise the boxes over time. Figure 4 below shows this data graphically.

Figure 4 – Nest Box occupation by fauna groups over time – note that those shown as showing signs of use exclude those containing fauna

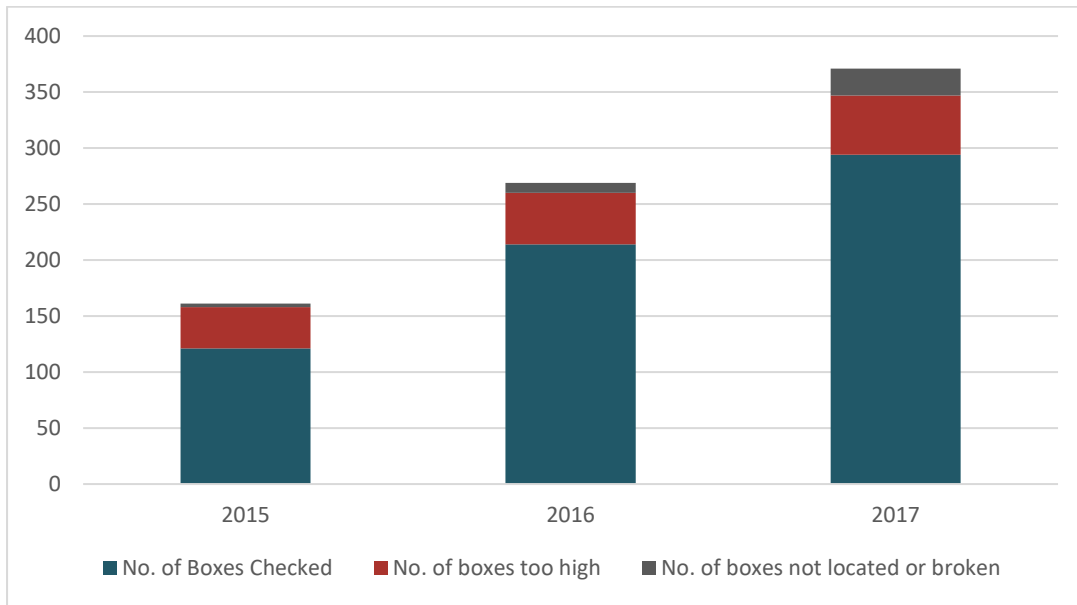
currently unsuitable for habitation. Figure 5 below illustrates the proportion of nest boxes able to be inspected.

Figure 5 - Box condition over time
