**Transport
for NSW**

FOXGROUND AND BERRY BYPASS

2020 Post Construction Ecological, Aquatic, and Weed Monitoring Report

August 2021

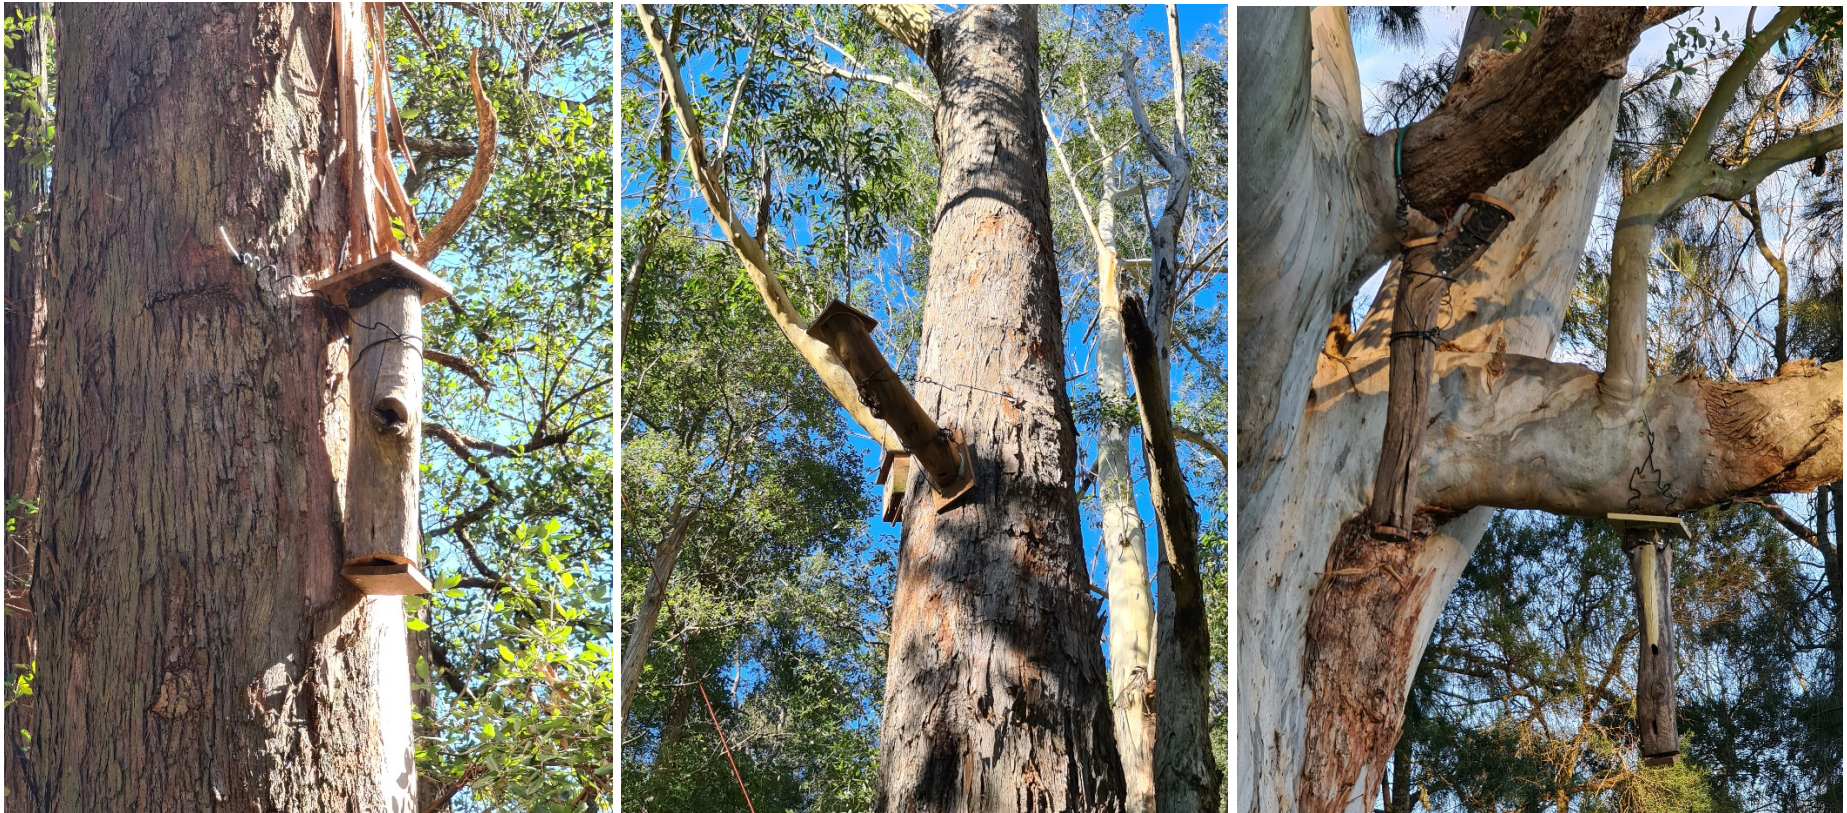
Figure 2-10 Installed recycled natural hollows for microbats

Eight (8) microbat nest boxes were constructed using recycled natural hollows, wood offcuts, and steel plates. A total of three designs were constructed, and boxes were installed at two locations on 2nd December 2019. The details of nest box style and installation are found in the table below. An example of the nest boxes can be seen in Figure 2-10.

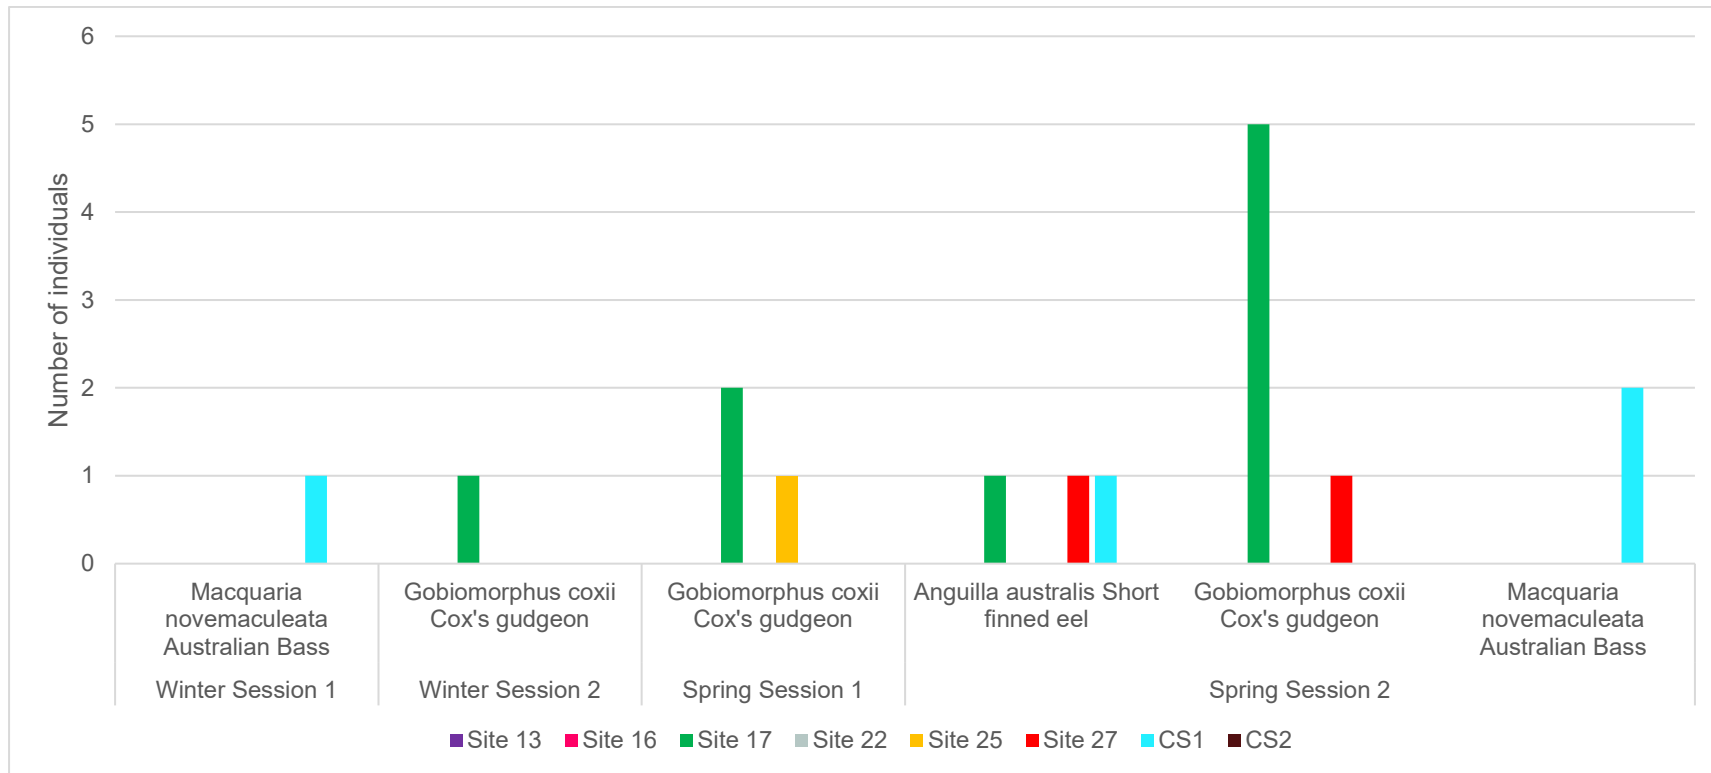
Figure 3-16 Aquatic fauna species observed across all sites and sessions in 2020

A total of 13 individuals were collected/observed across two common fish species in 2020 (see Figure 3-16). The only other aquatic species observed in 2020 were three (3) Short-finned Eels observed at Site 17, Site 27 and Control site 1 during Spring Session 2. No new aquatic species were recorded in 2020 surveys. Previous years data can be seen in Appendix C.

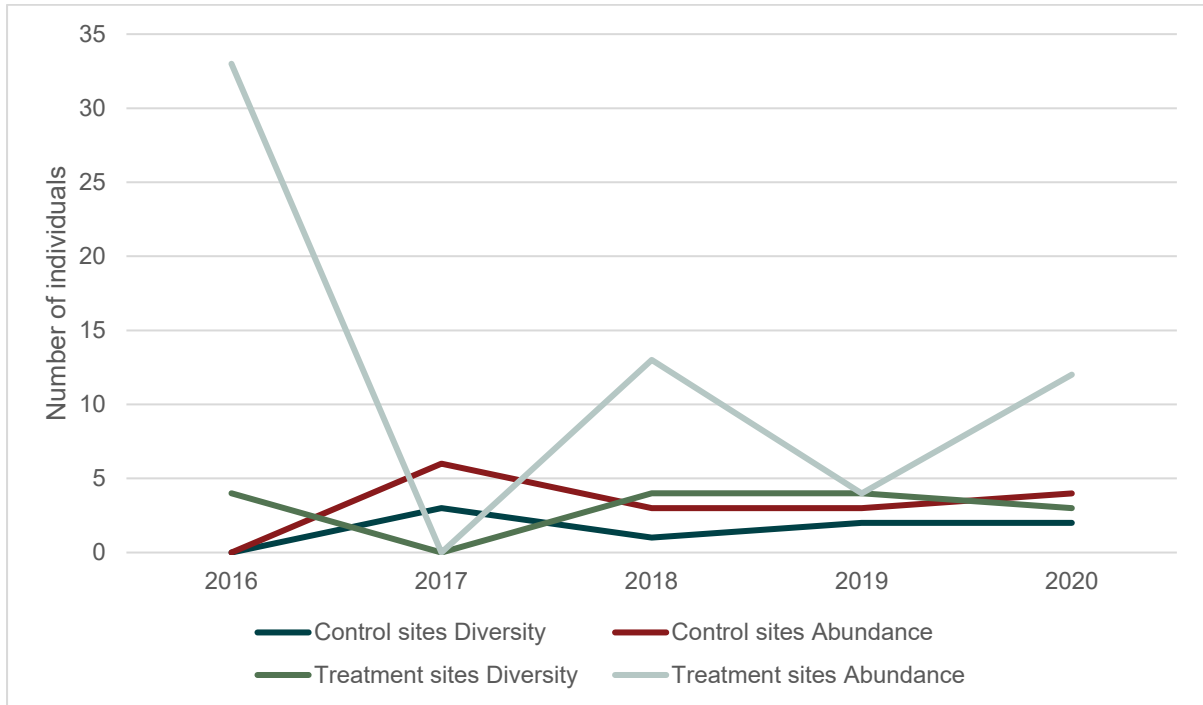
Figure 3-17 Diversity and abundance of aquatic fauna species (2016-2020)

Aquatic fauna diversity at control sites was similar to 2019 records, with diversity increasing by from 3 (2019) to 4 (2020) and abundance remaining at 2 individuals across the two periods, see figure 3-17. These figures remain lower than control site surveys in 2017 (abundance 6, diversity 3). Treatment sites in 2020 had greater abundance of aquatic fauna (12) but a lower diversity (3) was recorded than in 2019 (abundance 4, diversity 4).

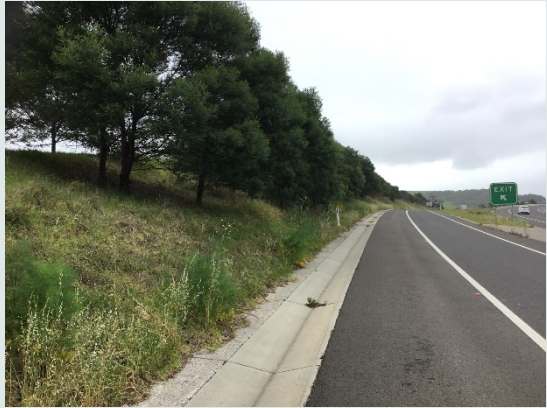
Way point	Easting	Northing	General Location	Site Description	Weeds and abundances	Photograph
15	297055	6152294	North of Toolijooa Rd	Batter	Mustard <i>Brassica oleracea</i> – 1 Kikuyu <i>Cenchrus clandestinus</i> – 5 Cobbler's Pegs <i>Bidens pilosa</i> – 3 Paddy's Lucerne <i>Sida rhombifolia</i> – 2 Lantana <i>Lantana camara</i> – 1 Paspalum <i>Paspalum dilatatum</i> – 3 Fennel <i>Foeniculum vulgare</i> – 3 Fireweed <i>Senecio madagascariensis</i> – 1 Moth vine <i>Araujia sericifera</i> – 1 Sow thistle <i>Sonchus oleraceus</i> – 1 Common Wild Oat <i>Avena fatua</i> – 2 Rhodes Grass <i>Chloris gayana</i> – 2 Mallow <i>Malva parviflora</i> – 2

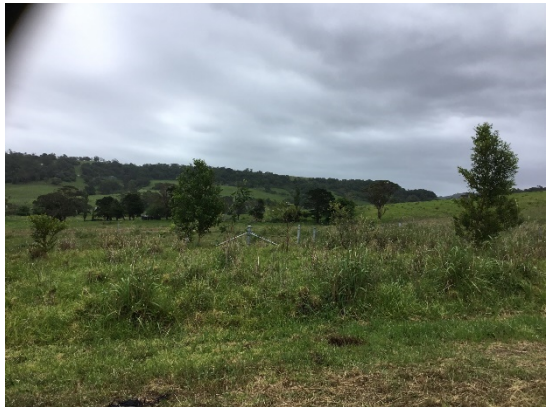
14	296835	6152244	Near turn around bay south of Toolijooa Rd	Construction area, with bare soil areas	Kikuyu <i>Cenchrus clandestinus</i> – 5 Cobbler's Pegs <i>Bidens pilosa</i> – 2 Purpletop <i>Verbena bonariensis</i> – 2 Paspalum <i>Paspalum dilatatum</i> – 4 Fennel <i>Foeniculum vulgare</i> - 3 White Clover <i>Trifolium repens</i> - 2 Cat's ear <i>Hypochaeris radicata</i> - 2 Paddy's Lucerne <i>Sida rhombifolia</i> – 2 Vasey Grass <i>Paspalum urvillei</i> – 2

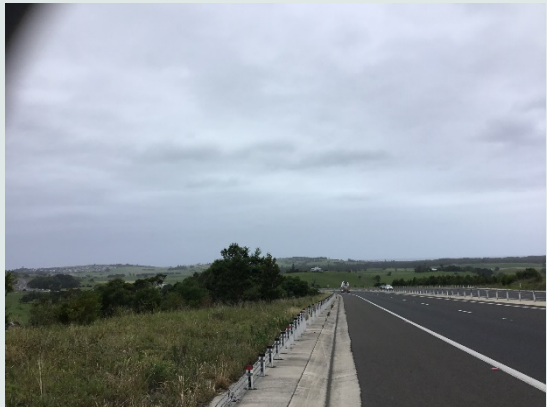
Way point	Easting	Northing	General Location	Site Description	Weeds and abundances	Photograph
16	296799	615239	South of Toolijooa Rd	Roadside area	<p>Kikuyu <i>Cenchrus clandestinus</i> – 5 Paspalum <i>Paspalum dilatatum</i> – 4 Purpletop <i>Verbena bonariensis</i> – 2 Cobbler's Pegs <i>Bidens pilosa</i> – 3 Sow thistle <i>Sonchus oleraceus</i> – 2 Fireweed <i>Senecio madagascariensis</i> – 1 Paddy's Lucerne <i>Sida rhombifolia</i> – 3 Common Wild Oat <i>Avena fatua</i> – 2 Cottonbush <i>Gomphocarpus physocarpus</i> – 1 Mallow <i>Malva parviflora</i> – 2 Cocksfoot <i>Dactylis glomerata</i> – 2 Shivery Grass <i>Briza minor</i> – 2 Fleabane <i>Conyza bonariensis</i> – 3 Ribwort Plantain <i>Plantago lanceolata</i> – 2 White Clover <i>Trifolium repens</i> – 2</p>

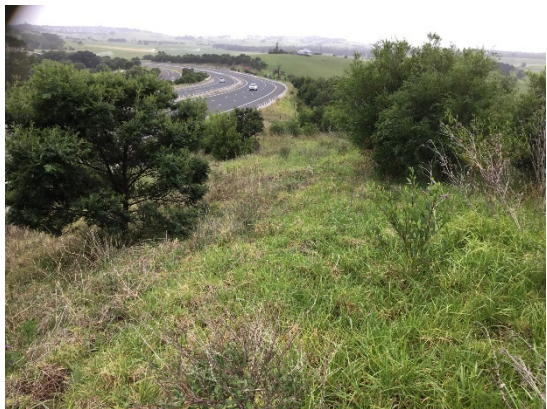
17	296675	6152401	South of Toolijooa Rd	Roadside batter	<p>Cobbler's Pegs <i>Bidens pilosa</i> – 3 Fireweed <i>Senecio madagascariensis</i> – 1 Purpletop <i>Verbena bonariensis</i> – 3 Paddy's Lucerne <i>Sida rhombifolia</i> – 3 Kikuyu <i>Cenchrus clandestinus</i> – 5 Paspalum <i>Paspalum dilatatum</i> – 4 Sow thistle <i>Sonchus oleraceus</i> – 2 Moth vine <i>Araujia sericifera</i> – 1 Curly Dock <i>Rumex obtusifolius</i> – 1</p>

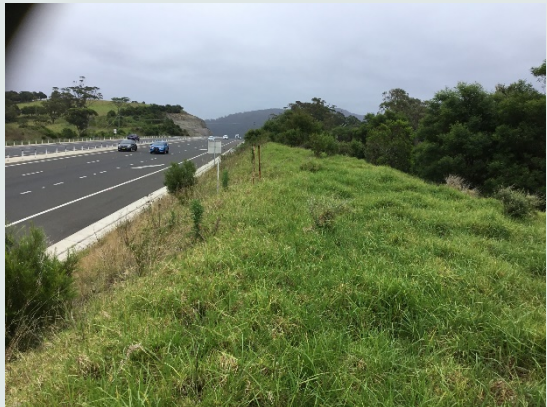
Way point	Easting	Northing	General Location	Site Description	Weeds and abundances	Photograph
18	296523	6152549	South of Toolijooa Rd	Roadside batter	<p>Kikuyu <i>Cenchrus clandestinus</i> – 6 Paspalum <i>Paspalum dilatatum</i> – 4 Cobbler's Pegs <i>Bidens pilosa</i> – 2 Paddy's Lucerne <i>Sida rhombifolia</i> – 3 Fireweed <i>Senecio madagascariensis</i> – 2 Purpletop <i>Verbena bonariensis</i> – 2 Fleabane <i>Conyza bonariensis</i> – 2 Moth vine <i>Araujia sericifera</i> – 1 Fennel <i>Foeniculum vulgare</i> – 1 Cocksfoot <i>Dactylis glomerata</i> – 2 Common Wild Oat <i>Avena fatua</i> – 2 Mustard <i>Brassica oleracea</i> – 1 Perennial Ryegrass <i>Lolium perenne</i> – 2</p>

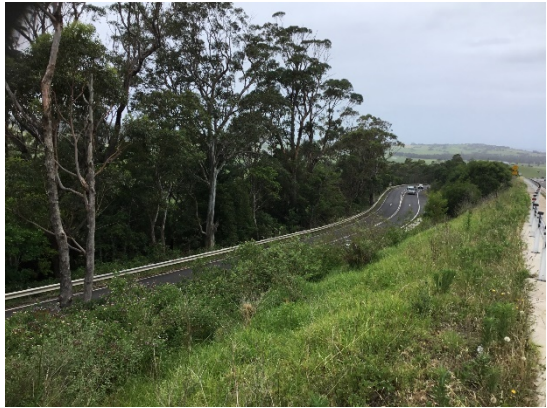
19	296251	6152744	Between BC1 and Toolijooa Rd	Roadside embankment	<p>Lantana <i>Lantana camara</i>- 5 Kikuyu <i>Cenchrus clandestinus</i> – 5 Fleabane <i>Conyza bonariensis</i> – 3 Cobbler's Pegs <i>Bidens pilosa</i> – 3 Stinking Roger <i>Tagetes minuta</i> – 2 Purpletop <i>Verbena bonariensis</i> – 2 Sow thistle <i>Sonchus oleraceus</i> 2 Spear Thistle <i>Cirsium vulgare</i> – 1 Common Wild Oat <i>Avena fatua</i> – 2 White Clover <i>Trifolium repens</i> – 2 Mallow <i>Malva parviflora</i> – 2 Paddy's Lucerne <i>Sida rhombifolia</i> – 2 Curly Dock <i>Rumex obtusifolius</i> – 1 Ribwort Plantain <i>Plantago lanceolata</i> – 2</p>

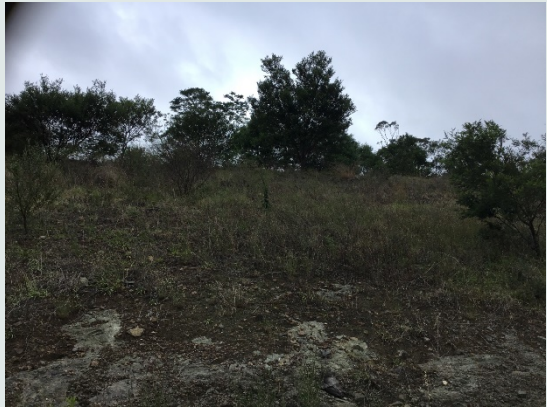
Way point	Easting	Northing	General Location	Site Description	Weeds and abundances	Photograph
					Moth vine <i>Araujia sericifera</i> – 2 Crofton Weed <i>Ageratina adenophora</i> – 2 Perennial Ryegrass <i>Lolium perenne</i> – 1	
20	296157	6152704	Between BC1 and Toolijooa Rd	Access track between Toolijooa Rd and BC1	Kikuyu <i>Cenchrus clandestinus</i> – 4 Paspalum <i>Paspalum dilatatum</i> – 3 Paddy's Lucerne <i>Sida rhombifolia</i> – 3 Fireweed <i>Senecio madagascariensis</i> – 1 Purpletop <i>Verbena bonariensis</i> – 2 Stinking Roger <i>Tagetes minuta</i> – 2 Fleabane <i>Conyza bonariensis</i> - 2 Ribwort Plantain <i>Plantago lanceolata</i> – 2 Curly Dock <i>Rumex obtusifolius</i> – 1 Common Wild Oat <i>Avena fatua</i> – 1

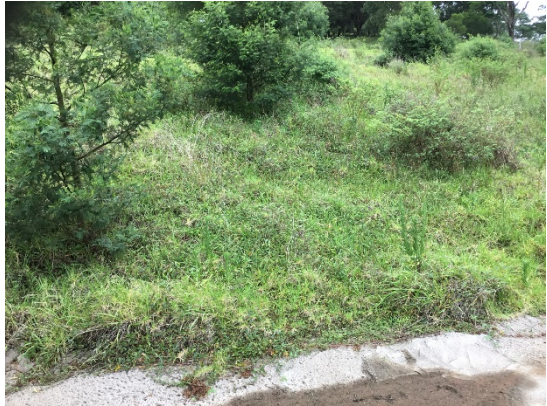
21	29593	6152819	Between BC1 and Toolijooa Rd	Top of cut	Kikuyu <i>Cenchrus clandestinus</i> – 4 Paddy's Lucerne <i>Sida rhombifolia</i> – 3 Lantana <i>Lantana camara</i> – 2 Purpletop <i>Verbena bonariensis</i> – 2 Fireweed <i>Senecio madagascariensis</i> – 2 Paspalum <i>Paspalum dilatatum</i> – 4 Cobbler's Pegs <i>Bidens pilosa</i> – 3 Cottonbush <i>Gomphocarpus physocarpus</i> – 1 Fleabane <i>Conyza bonariensis</i> – 2 White Clover <i>Trifolium repens</i> – 1 Alfalfa <i>Medicago sativa</i> – 1

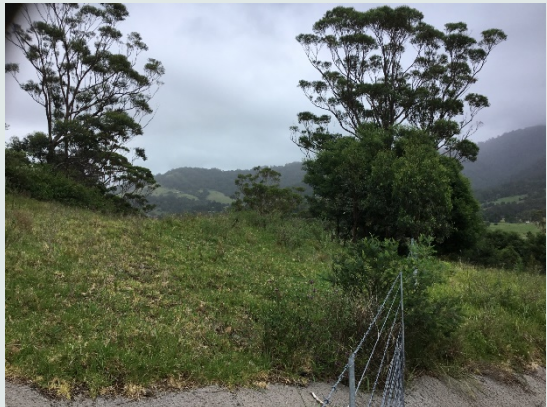
Way point	Easting	Northing	General Location	Site Description	Weeds and abundances	Photograph
22	295486	6152939	Between BC1 and Toolijooa Rd	Light vehicle track	<p>Fireweed <i>Senecio madagascariensis</i> – 2 Kikuyu <i>Cenchrus clandestinus</i> – 6 Spear Thistle <i>Cirsium vulgare</i> – 2 Purpletop <i>Verbena bonariensis</i> – 2 Blackberry <i>Rubus fruticosus</i> – 1 Paspalum <i>Paspalum dilatatum</i> – 3 Cobbler's Pegs <i>Bidens pilosa</i> – 3 Paddy's Lucerne <i>Sida rhombifolia</i> – 4 Wild tobacco <i>Solanum mauritianum</i> - 1 Inkweed <i>Phytolacca octandra</i> – 3 Lantana <i>Lantana camara</i> – 1 St Barnaby's Thistle <i>Centaurea solstitialis</i>– 2</p>

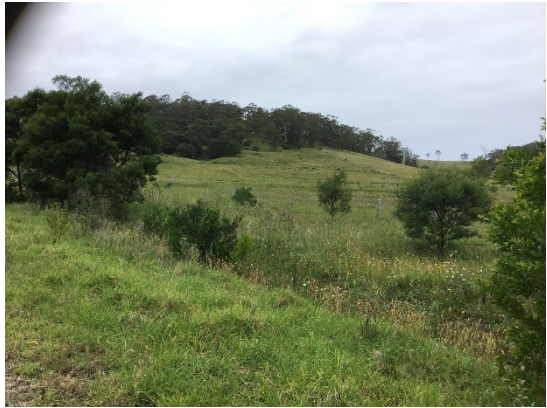
24	295121	6152887	BC1	Adjacent to compound	<p>Kikuyu <i>Cenchrus clandestinus</i> – 6 Cobbler's Pegs <i>Bidens pilosa</i> – 2 Purpletop <i>Verbena bonariensis</i> – 3 Fireweed <i>Senecio madagascariensis</i> – 2 Stinking Roger <i>Tagetes minuta</i> – 1 Crofton weed <i>Ageratina adenophora</i> – 2 Paddy's Lucerne <i>Sida rhombifolia</i> – 2 Paspalum <i>Paspalum dilatatum</i> – 3 Fleabane <i>Conyza bonariensis</i> – 2 Wild tobacco <i>Solanum mauritianum</i> - 1 Cat's Ear <i>Hypochaeris radicata</i> - 2 Sow Thistle <i>Sonchus oleraceus</i> – 2 Cocksfoot <i>Dactylis glomerata</i> – 3</p>

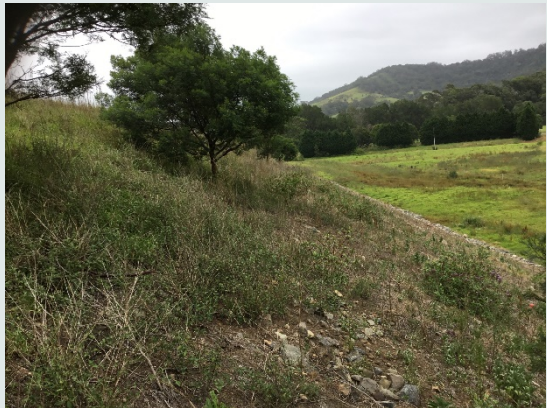
Way point	Easting	Northing	General Location	Site Description	Weeds and abundances	Photograph
31	295126	6152978	BC1	Roadside batter	<p>Fireweed <i>Senecio madagascariensis</i> – 2 Kikuyu <i>Cenchrus clandestinus</i> – 4 Paspalum <i>Paspalum dilatatum</i> – 4 Stinking Roger <i>Tagetes minuta</i> - 2 Paddy’s Lucerne <i>Sida rhombifolia</i> – 4 Purpletop <i>Verbena bonariensis</i> – 3 Fleabane <i>Conyza bonariensis</i> – 3 Sow Thistle <i>Sonchus oleraceus</i> – 2 Alfalfa <i>Medicago sativa</i> - 1 Inkweed <i>Phytolacca octandra</i> - 2 Prickly Lettuce <i>Lactuca serriola</i> – 1 Cocksfoot <i>Dactylis glomerata</i> – 1 Perennial Ryegrass <i>Lolium perrene</i> – 2 Wild Oat <i>Avena fatua</i> – 1 Ribwort Plantain <i>Plantago lanceolata</i> – 2 Giant Paramatta Grass <i>Sporobolus fertilis</i> – 1</p>

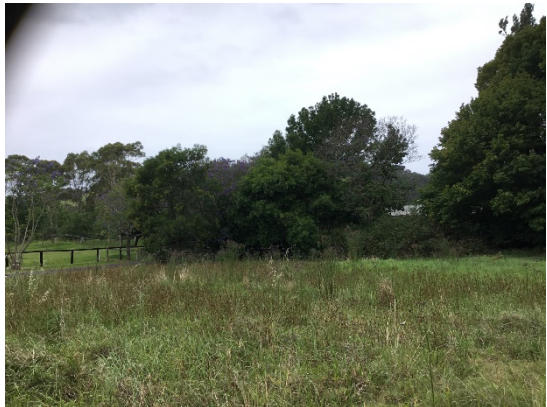
Way point	Easting	Northing	General Location	Site Description	Weeds and abundances	Photograph
25	294923	6152794	BC1	BC1	<p>Fireweed <i>Senecio madagascariensis</i> – 2 Kikuyu <i>Cenchrus clandestinus</i> – 4 Cobbler's Pegs <i>Bidens Pilosa</i> – 2 Wild tobacco <i>Solanum mauritianum</i> – 3 Lantana <i>Lantana camara</i> – 4 Fleabane <i>Conyza bonariensis</i> – 2 Spear Thistle <i>Cirsium vulgare</i> – 3 Paspalum <i>Paspalum dilatatum</i> – 4 Paddy's Lucerne <i>Sida rhombifolia</i> – 3 Purpletop <i>Verbena bonariensis</i> – 4 Moth vine <i>Araujia sericifera</i> – 3 Wild Oat <i>Avena fatua</i> – 2 Prickly Lettuce <i>Lactuca serriola</i> – 2 Ribwort Plantain <i>Plantago lanceolata</i> – 4</p>

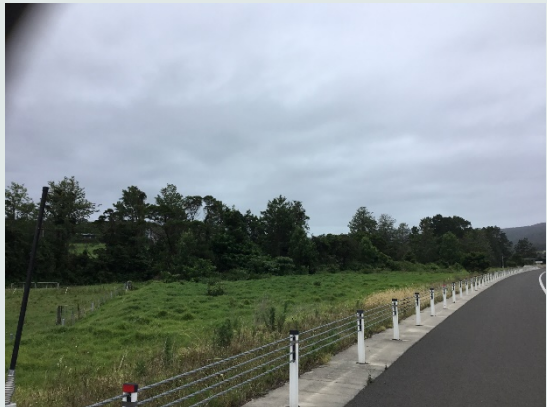
26	294695	6152708	Between BC1 and BC2	Road side	<p>Lantana <i>Lantana camara</i>- 5 Kikuyu <i>Cenchrus clandestinus</i> – 6 Sow thistle <i>Sonchus oleraceus</i> – 2 Wild tobacco <i>Solanum mauritianum</i> – 3 Fireweed <i>Senecio madagascariensis</i> – 1 Paspalum <i>Paspalum dilatatum</i> – 3 Fleabane <i>Conyza bonariensis</i> - 2 Purpletop <i>Verbena bonariensis</i> – 2 Moth vine <i>Araujia sericifera</i> – 2 Spear Thistle <i>Cirsium vulgare</i> - 1 Silky oak <i>Grevillea robusta</i> - 3 Cobbler's Pegs <i>Bidens pilosa</i> - 3 White Clover <i>Trifolium repens</i> – 3</p>

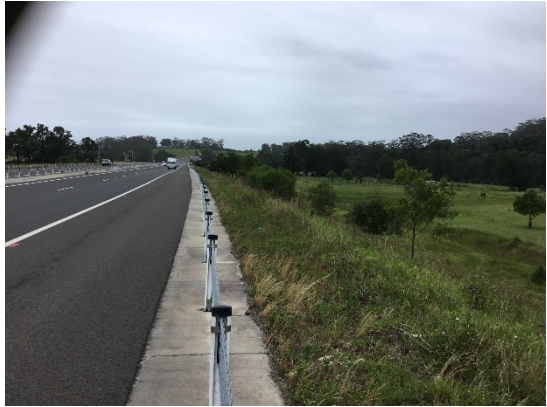
Way point	Easting	Northing	General Location	Site Description	Weeds and abundances	Photograph
					<p>Coral Tree <i>Erythrina sykesii</i> – 3 Quaking Grass <i>Briza maxima</i> – 3 Wild Oat <i>Avena fatua</i> – 2 Perennial Ryegrass <i>Lolium perrene</i> – 2</p>	
27	294623	6152587	Between BC1 and BC2	Road side	<p>Sow thistle <i>Sonchus oleraceus</i> – 2 Cobbler's Pegs <i>Bidens pilosa</i> – 3 Kikuyu <i>Cenchrus clandestinus</i> – 5 Paspalum <i>Paspalum dilatatum</i> – 4 Paddy's Lucerne <i>Sida rhombifolia</i> – 3 Fireweed <i>Senecio madagascariensis</i> – 1 Purpletop <i>Verbena bonariensis</i> – 3 Alfalfa <i>Medicago sativa</i> – 2 Fleabane <i>Conyza bonariensis</i> – 3 Quaking Grass <i>Briza maxima</i> – 2 Cocksfoot <i>Dactylis glomerata</i> – 1 Wild Oat <i>Avena fatua</i> – 1 Perennial Ryegrass <i>Lolium perrene</i> – 2 Cat's Ear <i>Hypochaeris radicata</i> - 2 Coolatai grass <i>Hyparrhenia hirta</i> - 1 Crofton Weed <i>Ageratina adenophora</i> – 1</p>

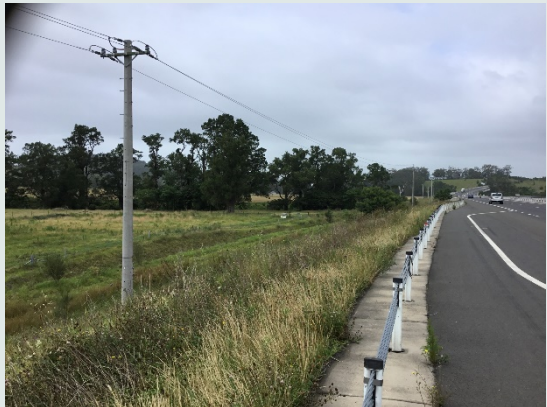
Way point	Easting	Northing	General Location	Site Description	Weeds and abundances	Photograph
30	294583	6152452	Between BC1 and BC2	Road side	<p>Kikuyu <i>Cenchrus clandestinus</i> – 4 Cobbler's Pegs <i>Bidens pilosa</i> – 3 Fireweed <i>Senecio madagascariensis</i> – 1 Purpletop <i>Verbena bonariensis</i> – 3 White Clover <i>Trifolium repens</i> – 3 Cat's Ear <i>Hypochaeris radicata</i> - 3 Fleabane <i>Conyza bonariensis</i> – 2 Crofton weed <i>Ageratina adenophora</i> - 1 Paddy's Lucerne <i>Sida rhombifolia</i> – 2 Stinking Roger <i>Tagetes minuta</i> – 1 Sow thistle <i>Sonchus oleraceus</i> – 1 Moth vine <i>Araujia sericifera</i> – 1 Paspalum <i>Paspalum dilatatum</i> – 3</p>

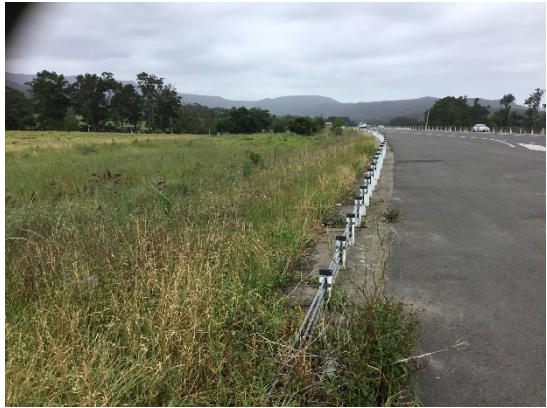
28	294296	6152021	Between BC1 and BC2	Road side	<p>White Clover <i>Trifolium repens</i> – 3 Cobbler's Pegs <i>Bidens pilosa</i> – 3 Purpletop <i>Verbena bonariensis</i> – 3 Kikuyu <i>Cenchrus clandestinus</i> – 4 Sow thistle <i>Sonchus oleraceus</i> – 3 Paspalum <i>Paspalum dilatatum</i> – 5 Fireweed <i>Senecio madagascariensis</i> – 2 Mustard <i>Brassica oleracea</i> - 2 Spear Thistle <i>Cirsium vulgare</i> – 2 Moth vine <i>Araujia sericifera</i> – 3 Paddy's Lucerne <i>Sida rhombifolia</i> - 4 Alfalfa <i>Medicago sativa</i> - 3 Cocksfoot <i>Dactylis glomerata</i> – 2 Phalaris <i>Phalaris aquatica</i> – 1</p>

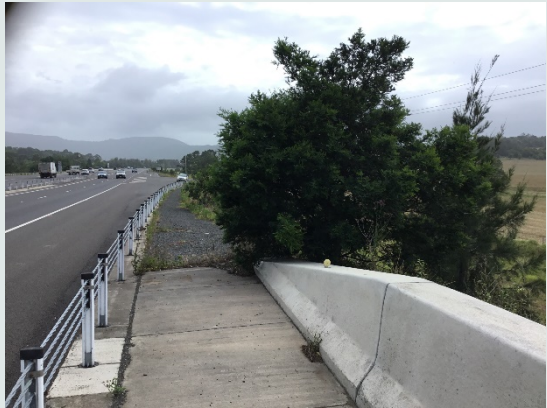
Way point	Easting	Northing	General Location	Site Description	Weeds and abundances	Photograph
					Perennial Ryegrass <i>Lolium perenne</i> – 2 Curly Dock <i>Rumex obtusifolius</i> – 2	
29	294250	6151865	Between BC1 and BC2	Road side	Kikuyu <i>Cenchrus clandestinus</i> – 5 Fireweed <i>Senecio madagascariensis</i> – 2 Blackberry <i>Rubus fruticosus</i> – 1 Lantana <i>Lantana camara</i> – 1 Paspalum <i>Paspalum dilatatum</i> – 3 Crofton weed <i>Ageratina adenophora</i> – 3 Moth vine <i>Araujia sericifera</i> – 3 Purpletop <i>Verbena bonariensis</i> – 3 Cobbler's Pegs <i>Bidens pilosa</i> - 3 Spear Thistle <i>Cirsium vulgare</i> – 3 Fleabane <i>Conyza bonariensis</i> – 3 Wild tobacco <i>Solanum mauritianum</i> -1 White Clover <i>Trifolium repens</i> – 3 Stinking Roger <i>Tagetes minuta</i> – 1 Cocksfoot <i>Dactylis glomerata</i> – 2

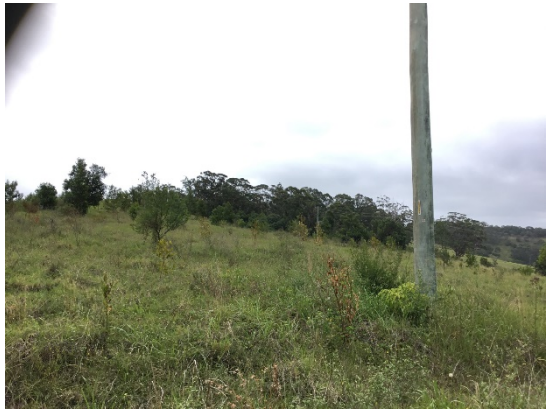
Way point	Easting	Northing	General Location	Site Description	Weeds and abundances	Photograph
32	294059	6151679	Between Austral Park compound and BC3	Access track	Fireweed <i>Senecio madagascariensis</i> – 2 Kikuyu <i>Cenchrus clandestinus</i> – 5 Paddy's Lucerne <i>Sida rhombifolia</i> – 2 Mallow <i>Malva parviflora</i> – 2 Stinking Roger <i>Tagetes minuta</i> – 1 Paspalum <i>Paspalum dilatatum</i> – 4 Whisky Grass <i>Andropogon virginicus</i> – 1 Fleabane <i>Conyza bonariensis</i> – 2 Cobbler's Pegs <i>Bidens pilosa</i> – 2 Perennial Ryegrass <i>Lolium perenne</i> – 2 Lantana <i>Lantana camara</i> – 1 Purpletop <i>Verbena bonariensis</i> – 2

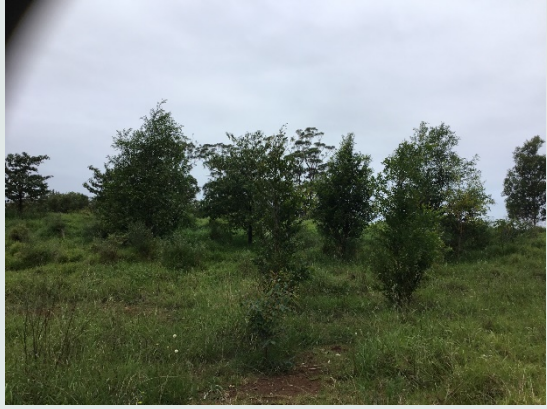
33	293916	6151611	Between Austral Park compound and BC3	Batter	Stinking Roger <i>Tagetes minuta</i> – 1 Fireweed <i>Senecio madagascariensis</i> – 2 Paspalum <i>Paspalum dilatatum</i> – 4 Paddy's Lucerne <i>Sida rhombifolia</i> – 4 Kikuyu <i>Cenchrus clandestinus</i> – 6 Purpletop <i>Verbena bonariensis</i> – 2 Cobbler's Pegs <i>Bidens pilosa</i> – 2 Moth vine <i>Araujia sericifera</i> – 1

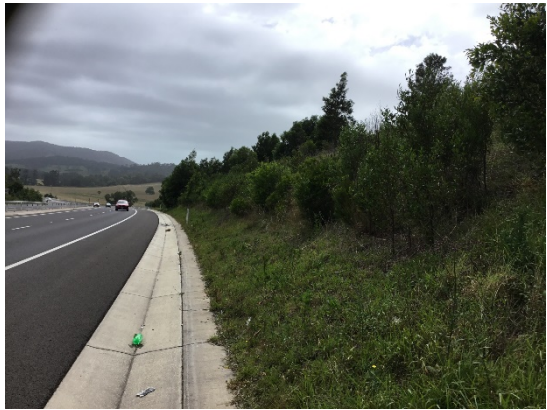
Way point	Easting	Northing	General Location	Site Description	Weeds and abundances	Photograph
34	293975	6151579	Between Austral Park compound and BC3	Batter	<p>Kikuyu <i>Cenchrus clandestinus</i> – 5 Paspalum <i>Paspalum dilatatum</i> – 5 Fleabane <i>Conyza bonariensis</i> – 3 Sow Thistle <i>Sonchus oleraceus</i> – 2 Cobbler's Pegs <i>Bidens pilosa</i> – 3 Purpletop <i>Verbena bonariensis</i> – 2 Moth vine <i>Araujia sericifera</i> – 2 Fireweed <i>Senecio madagascariensis</i> – 2 Paddy's Lucerne <i>Sida rhombifolia</i> – 3 Cat's Ear <i>Hypochaeris radicata</i> – 2 Cobbler's Pegs <i>Bidens pilosa</i> – 2</p>

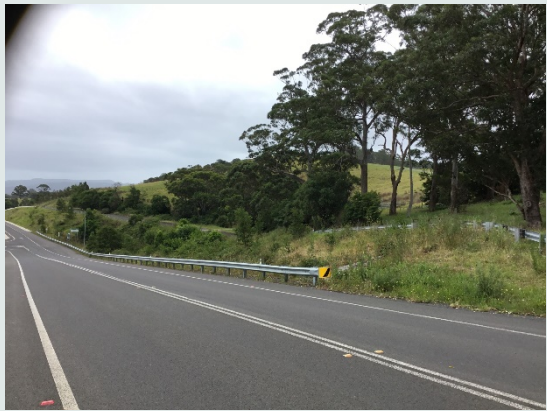
35	293661	6151517	Between Austral Park compound and BC3	Batter	<p>Stinking Roger <i>Tagetes minuta</i> – 2 Lantana <i>Lantana camara</i> – 3 Crofton weed <i>Ageratina adenophora</i> – 4 Fleabane <i>Conyza bonariensis</i> – 2 Kikuyu <i>Cenchrus clandestinus</i> – 4 Purpletop <i>Verbena bonariensis</i> – 2 Fireweed <i>Senecio madagascariensis</i> – 2 Inkweed <i>Phytolacca octandra</i> – 2 Spear thistle <i>Cirsium vulgare</i> – 2 Cobbler's Pegs <i>Bidens pilosa</i> – 3 Common Wild Oat <i>Avena fatua</i> – 3 Paspalum <i>Paspalum dilatatum</i> – 3</p>

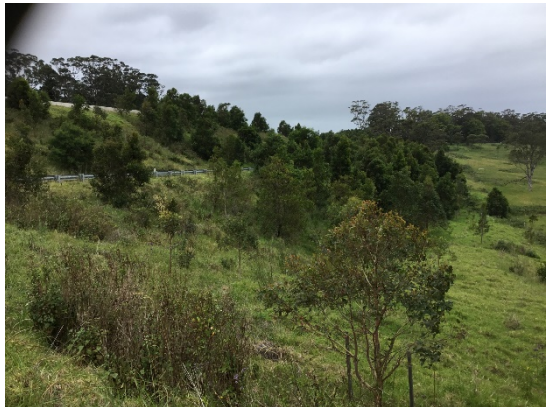
Way point	Easting	Northing	General Location	Site Description	Weeds and abundances	Photograph
36	293699	6151420	Between Austral Park compound and BC3	Batter	<p>Kikuyu <i>Cenchrus clandestinus</i> – 6 Paspalum <i>Paspalum dilatatum</i> – 6 Purpletop <i>Verbena bonariensis</i> – 3 Fireweed <i>Senecio madagascariensis</i> – 2 Crofton weed <i>Ageratina adenophora</i> – 4 Fleabane <i>Conyza bonariensis</i> – 3 Inkweed <i>Phytolacca octandra</i> – 2 Spear thistle <i>Cirsium vulgare</i> – 2 Mallow <i>Malva parviflora</i> – 2 Cobbler's Pegs <i>Bidens pilosa</i> – 3 White Clover <i>Trifolium repens</i> – 2 Moth Vine <i>Araujia sericifera</i> – 3 Wild tobacco <i>Solanum mauritianum</i> -1 Lantana <i>Lantana camara</i> - 1 Ribwort Plantain <i>Plantago lanceolata</i> – 2 Prickly Lettuce <i>Lactuca serriola</i> – 1</p>

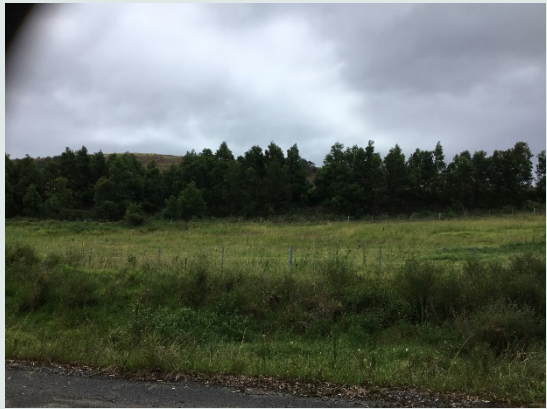
37	293391	6151342	Between Austral Park compound and BC3	Batter	<p>Fireweed <i>Senecio madagascariensis</i> – 3 Inkweed <i>Phytolacca octandra</i> – 3 Purpletop <i>Verbena bonariensis</i> – 3 Kikuyu <i>Cenchrus clandestinus</i> – 6 Paspalum <i>Paspalum dilatatum</i> – 5 Paddy's Lucerne <i>Sida rhombifolia</i> – 3 Stinking Roger <i>Tagetes minuta</i> – 1 Cobbler's Pegs <i>Bidens pilosa</i> – 2 Fleabane <i>Conyza bonariensis</i> – 2 Moth vine <i>Araujia sericifera</i> – 2 Crofton weed <i>Ageratina adenophora</i> – 1</p>

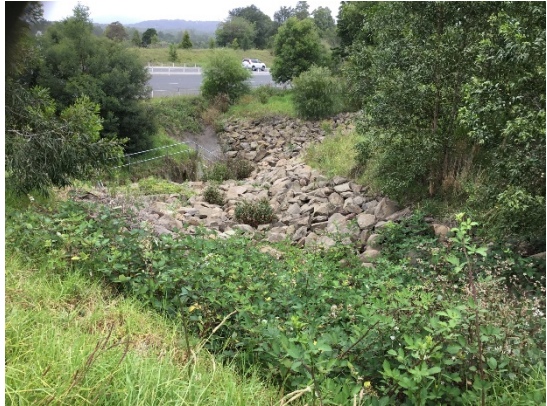
Way point	Easting	Northing	General Location	Site Description	Weeds and abundances	Photograph
					Spear thistle <i>Cirsium vulgare</i> – 1 Prickly Lettuce <i>Lactuca serriola</i> – 1 Ribwort Plantain <i>Plantago lanceolata</i> – 2	
13	293197	6151331	Austral Park	Western side Princess Hwy	Lantana <i>Lantana camara</i> – 4 Crofton weed <i>Ageratina adenophora</i> – 3 Blackberry <i>Rubus fruticosus</i> – 4 Moth vine <i>Araujia sericifera</i> – 3 Wild tobacco <i>Solanum mauritianum</i> – 1 Fireweed <i>Senecio madagascariensis</i> – 2 Inkweed <i>Phytolacca octandra</i> – 2 Purpletop <i>Verbena bonariensis</i> – 3 Kikuyu <i>Cenchrus clandestinus</i> - 6 Paspalum <i>Paspalum dilatatum</i> – 3 Paddy's Lucerne <i>Sida rhombifolia</i> – 4 Spear thistle <i>Cirsium vulgare</i> – 2 Fleabane <i>Conyza bonariensis</i> – 2 Whisky grass <i>Andropogon virginicus</i> – 1 Cobbler's Pegs <i>Bidens pilosa</i> – 2 Common Wild Oat <i>Avena fatua</i> – 2 Cat's Ear <i>Hypochaeris radicata</i> – 2

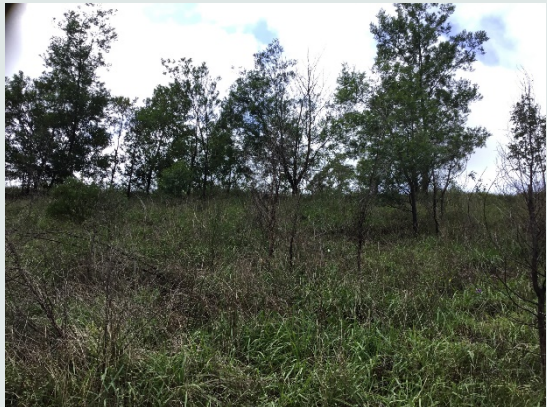
Way point	Easting	Northing	General Location	Site Description	Weeds and abundances	Photograph
38	293143	6151252	Austral Park	Western side Princess Hwy	<p>Kikuyu <i>Cenchrus clandestinus</i> – 4 Paspalum <i>Paspalum dilatatum</i> – 5 Cobbler's Pegs <i>Bidens pilosa</i> – 3 Paddy's Lucerne <i>Sida rhombifolia</i> – 3 Fireweed <i>Senecio madagascariensis</i> – 2 Lantana <i>Lantana camara</i> – 3 Blackberry <i>Rubus fruticosus</i> – 2 Crofton weed <i>Ageratina adenophora</i> – 2 Inkweed <i>Phytolacca octandra</i> – 2 Purpletop <i>Verbena bonariensis</i> – 3 Fleabane <i>Conyza bonariensis</i> – 2 Moth Vine <i>Araujia sericifera</i> – 2 Wild Tobacco <i>Solanum mauritianum</i> – 1 Spear Thistle <i>Cirsium vulgare</i> – 1 Common Wild Oat <i>Avena fatua</i> – 1 Cobbler's Pegs <i>Bidens pilosa</i> – 3</p>

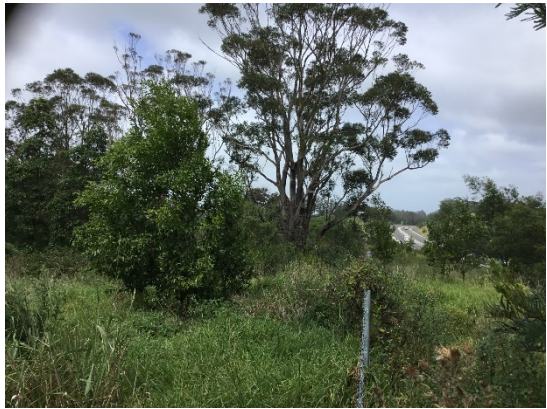
12	293089	6151221	Austral Park	Western side Princess Hwy	<p>Blackberry nightshade <i>Solanum nigrum</i> – 1 Fireweed <i>Senecio madagascariensis</i> – 1 Stinking Roger <i>Tagetes minuta</i> – 2 Paspalum <i>Paspalum dilatatum</i> – 5 Kikuyu <i>Cenchrus clandestinus</i> – 6 Paddy's Lucerne <i>Sida rhombifolia</i> – 4 Inkweed <i>Phytolacca octandra</i> – 1 Wild tobacco <i>Solanum mauritianum</i> – 2 Purpletop <i>Verbena bonariensis</i> – 3 Lantana <i>Lantana camara</i> – 2 Spear Thistle <i>Cirsium vulgare</i> – 3</p>

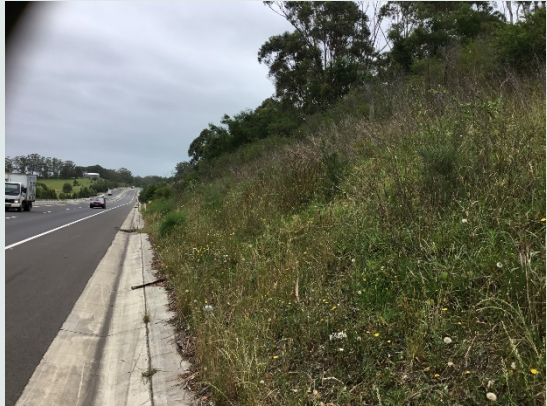
Way point	Easting	Northing	General Location	Site Description	Weeds and abundances	Photograph
					<p>Moth Vine <i>Araujia sericifera</i> – 2 Paspalum <i>Paspalum dilatatum</i> – 3 Crofton weed <i>Ageratina adenophora</i> – 1 Cobbler's Pegs <i>Bidens pilosa</i> – 2</p>	
10	292987	6151220	Austral Park	Western side Princess Hwy	<p>Fireweed <i>Senecio madagascariensis</i> – 2 Kikuyu <i>Cenchrus clandestinus</i> – 5 Purpletop <i>Verbena bonariensis</i> – 2 Paddy's Lucerne <i>Sida rhombifolia</i> – 3 Cobbler's Pegs <i>Bidens pilosa</i> – 3 Fennel <i>Foeniculum vulgare</i> – 3 Spear Thistle <i>Cirsium vulgare</i> – 2 Quaking Grass <i>Briza maxima</i> – 2 Fleabane <i>Conyza bonariensis</i> – 2 Sow Thistle <i>Sonchus oleraceus</i> – 2 Moth Vine <i>Araujia sericifera</i> – 2 Common Wild Oat <i>Avena fatua</i> – 2 Perennial Ryegrass <i>Lolium perenne</i> – 3 Cocksfoot <i>Dactylis glomerata</i> – 3</p>

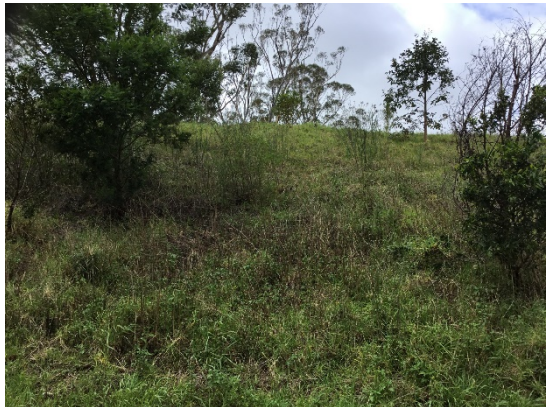
Way point	Easting	Northing	General Location	Site Description	Weeds and abundances	Photograph
11	292977	6151168	Austral Park	Soil mound	<p>Sow Thistle <i>Sonchus oleraceus</i> – 2 Cobbler's Pegs <i>Bidens Pilosa</i> – 3 Fennel <i>Foeniculum vulgare</i> – 2 Kikuyu <i>Cenchrus clandestinus</i> – 5 Purpletop <i>Verbena bonariensis</i> – 3 Fireweed <i>Senecio madagascariensis</i> – 1 Patty's lucerne <i>Sida rhombifolia</i> - 3 Moth Vine <i>Araujia sericifera</i> – 2</p>

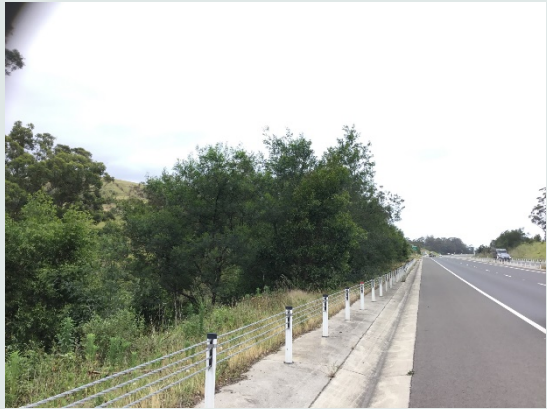
9	292873	6151166	Austral Park	Batter	<p>Sow Thistle <i>Sonchus oleraceus</i> – 1 Fireweed <i>Senecio madagascariensis</i> – 1 Lantana <i>Lantana Camara</i> – 3 Purpletop <i>Verbena bonariensis</i> – 3 Paspalum <i>Paspalum dilatatum</i> – 3 Kikuyu <i>Cenchrus clandestinus</i> – 5 Fleabane <i>Conyza bonariensis</i> – 2 Cobbler's Pegs <i>Bidens pilosa</i> – 2 Patty's lucerne <i>Sida rhombifolia</i> – 3 White Clover <i>Trifolium repens</i> – 2 Common Wild Oat <i>Avena fatua</i> – 2 Ribwort Plantain <i>Plantago lanceolata</i> – 2 Blackberry nightshade <i>Solanum nigrum</i> – 1 Spear Thistle <i>Cirsium vulgare</i> – 2 Wild tobacco <i>Solanum mauritianum</i> – 3 Moth Vine <i>Araujia sericifera</i> – 2</p>

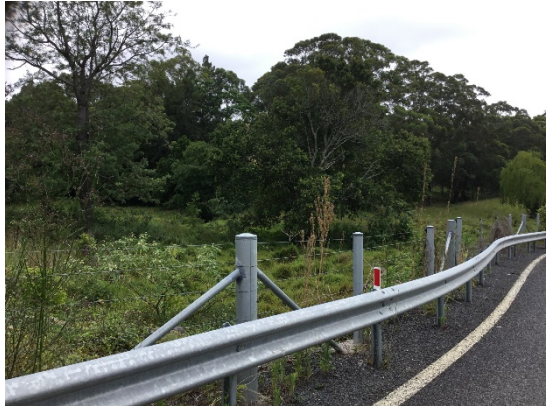
Way point	Easting	Northing	General Location	Site Description	Weeds and abundances	Photograph
					Turkey Rhubarb <i>Acetosa sagittata</i> – 3	
8	292746	6151115	Austral Park	Road side	Fireweed <i>Senecio madagascariensis</i> – 2 Wild tobacco <i>Solanum mauritianum</i> – 3 Purpletop <i>Verbena bonariensis</i> – 3 Paspalum <i>Paspalum dilatatum</i> – 3 Small-leaved privet <i>Ligustrum sinense</i> – 2 Fleabane <i>Conyza bonariensis</i> – 2 Tall flatsedge <i>Cyperus eragrostis</i> – 2 Kikuyu <i>Cenchrus clandestinus</i> – 3 Inkweed <i>Phytolacca octandra</i> – 1 Patty's Lucerne <i>Sida rhombifolia</i> – 2 Sow Thistle <i>Sonchus oleraceus</i> – 2 Cobbler's Pegs <i>Bidens pilosa</i> – 2 Blackberry <i>Rubus fruticosus</i> – 3 Curly Dock <i>Rumex obtusifolius</i> – 2 Stinking Roger <i>Tagetes minuta</i> – 2

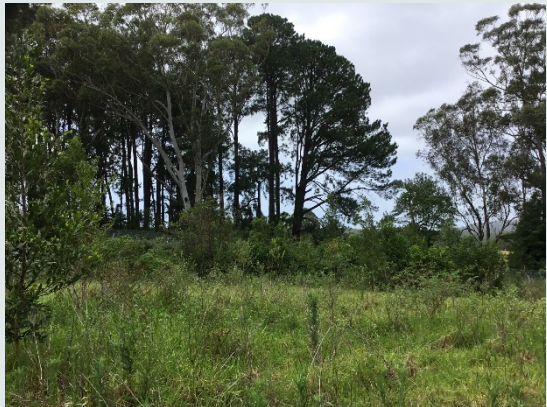
Way point	Easting	Northing	General Location	Site Description	Weeds and abundances	Photograph
7	292355	6150882	Central zone	Road side	Inkweed <i>Phytolacca octandra</i> – 1 Fireweed <i>Senecio madagascariensis</i> – 2 Kikuyu <i>Cenchrus clandestinus</i> – 6 Lantana <i>Lantana camara</i> – 3 Purpletop <i>Verbena bonariensis</i> – 2 Stinking Roger <i>Tagetes minuta</i> – 2 Paspalum <i>Paspalum dilatatum</i> – 3 Ribwort Plantain <i>Plantago lanceolata</i> – 1 Cobbler's Pegs <i>Bidens pilosa</i> – 3 Patty's lucerne <i>Sida rhombifolia</i> – 3 Fleabane <i>Conyza bonariensis</i> – 2 Spear Thistle <i>Cirsium vulgare</i> – 2

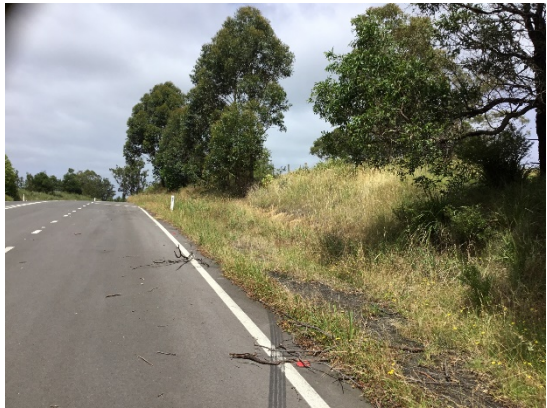
6	291579	6150900	Tindell's Lane	Road side	Kikuyu <i>Cenchrus clandestinus</i> – 3 Blackberry <i>Rubus fruticosus</i> – 2 Paspalum <i>Paspalum dilatatum</i> – 3 Lantana <i>Lantana camara</i> – 2 Purpletop <i>Verbena bonariensis</i> – 2 Common Wild Oat <i>Avena fatua</i> – 1 Moth Vine <i>Araujia sericifera</i> – 1 White Clover <i>Trifolium repens</i> – 2 Quaking Grass <i>Briza maxima</i> – 3 Ribwort Plantain <i>Plantago lanceolata</i> – 2 Small-leaved privet <i>Ligustrum sinense</i> – 1 Cat's Ear <i>Hypochaeris radicata</i> – 2

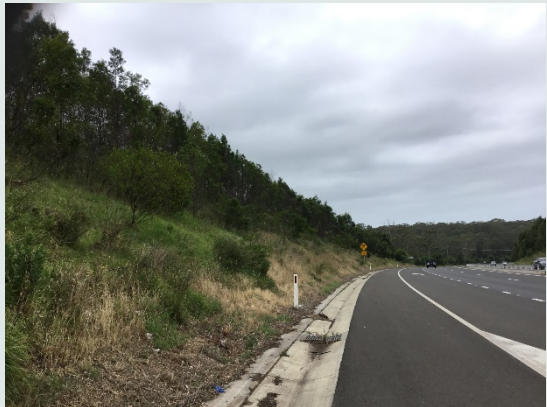
Way point	Easting	Northing	General Location	Site Description	Weeds and abundances	Photograph
5	291578	6150845	Tindell's Lane	Batter	<p>Kikuyu <i>Cenchrus clandestinus</i> – 5 Paspalum <i>Paspalum dilatatum</i> – 4 Patty's lucerne <i>Sida rhombifolia</i> – 4 Fireweed <i>Senecio madagascariensis</i> – 2 Moth vine <i>Araujia sericifera</i> – 2 Purpletop <i>Verbena bonariensis</i> – 2 Cobbler's Pegs <i>Bidens pilosa</i> – 2 Fleabane <i>Conyza bonariensis</i> – 2 Sow Thistle <i>Sonchus oleraceus</i> – 2 Spear Thistle <i>Cirsium vulgare</i> – 2 Quaking Grass <i>Briza Maxima</i> – 3 Ribwort Plantain <i>Plantago lanceolata</i> – 2 Prickly Lettuce <i>Lactuca serriola</i> – 1</p>

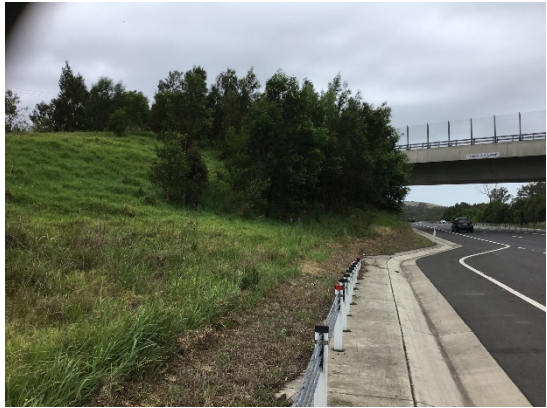
4	291320	6150671	Central zone Cut 6	Batter	<p>Kikuyu <i>Cenchrus clandestinus</i> – 6 Sow Thistle <i>Sonchus oleraceus</i> – 2 Cobbler's Pegs <i>Bidens pilosa</i> – 2 Purpletop <i>Verbena bonariensis</i> – 2 Paspalum <i>Paspalum dilatatum</i> – 3 Fleabane <i>Conyza bonariensis</i> – 2 Mallow <i>Malva parviflora</i> – 2 Patty's lucerne <i>Sida rhombifolia</i> – 2 Spear Thistle <i>Cirsium vulgare</i> – 1 Cat's Ear <i>Hypochaeris radicata</i> – 2</p>

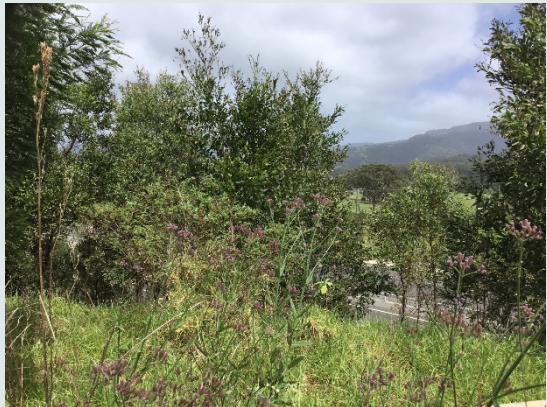
Way point	Easting	Northing	General Location	Site Description	Weeds and abundances	Photograph
3	291317	6150605	Central zone Cut 6	Batter	<p>Kikuyu <i>Cenchrus clandestinus</i> – 6 Paspalum <i>Paspalum dilatatum</i> – 3 Purpletop <i>Verbena bonariensis</i> – 2 Cobbler's Pegs <i>Bidens pilosa</i> – 2 Fireweed <i>Senecio madagascariensis</i> – 1 Patty's Lucerne <i>Sida rhombifolia</i> – 3 Fleabane <i>Conyza bonariensis</i> – 2 White Clover <i>Trifolium repens</i> – 2 Moth Vine <i>Araujia sericifera</i> – 2 Sow Thistle <i>Sonchus oleraceus</i> – 2 Prickly Lettuce <i>Lactuca serriola</i> – 1 Fennel <i>Foeniculum vulgare</i> – 1</p>

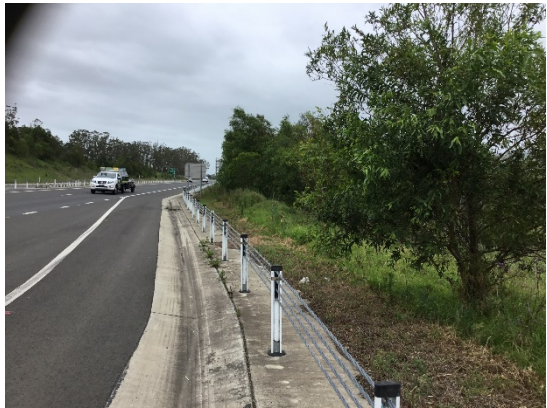
2	291251	6150619	Central zone Cut 6	Batter	<p>Kikuyu <i>Cenchrus clandestinus</i> – 6 Fireweed <i>Senecio madagascariensis</i> – 1 Cobbler's Pegs <i>Bidens pilosa</i> – 2 Fleabane <i>Conyza bonariensis</i> – 2 Purpletop <i>Verbena bonariensis</i> – 2 Patty's lucerne <i>Sida rhombifolia</i> – 2 Fennel <i>Foeniculum vulgare</i> – 1 Spear Thistle <i>Cirsium vulgare</i> – 1 Cat's Ear <i>Hypochaeris radicata</i> – 2 Paspalum <i>Paspalum dilatatum</i> – 3 Moth Vine <i>Araujia sericifera</i> – 1 Prickly Lettuce <i>Lactuca serriola</i> – 1</p>

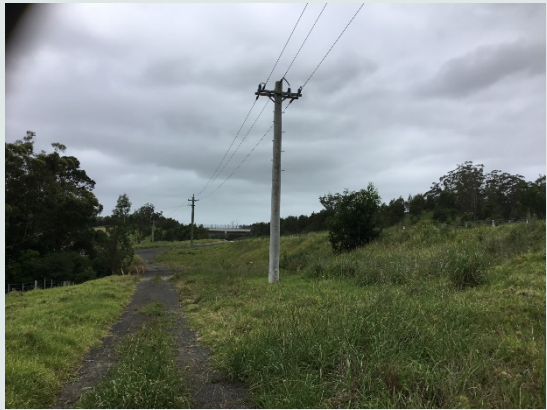
Way point	Easting	Northing	General Location	Site Description	Weeds and abundances	Photograph
1	291130	6150523	Central zone Cut 6	Batter	<p>Kikuyu <i>Cenchrus clandestinus</i> – 6 Paspalum <i>Paspalum dilatatum</i> – 4 Purpletop <i>Verbena bonariensis</i> – 2 Fireweed <i>Senecio madagascariensis</i> – 1 Crofton weed <i>Ageratina adenophora</i> – 1 Mallow <i>Malva parviflora</i> – 2 Sow Thistle <i>Sonchus oleraceus</i> – 2 Patty's Lucerne <i>Sida rhombifolia</i> – 3 Fleabane <i>Conyza bonariensis</i> - 2 Inkweed <i>Phytolacca octandra</i> – 2 White clover <i>Trifolium repens</i> – 2</p>

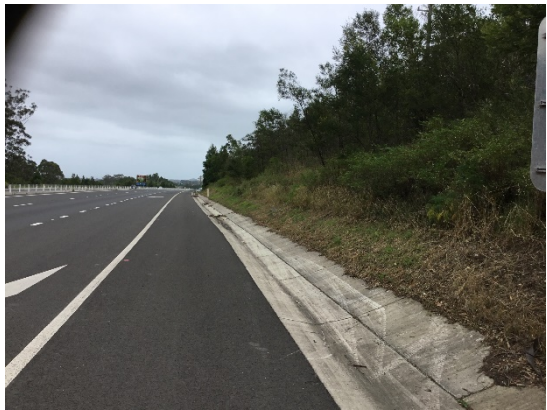
0	290920	6150386	Central zone	Batter	<p>Kikuyu <i>Cenchrus clandestinus</i> – 3 Paspalum <i>Paspalum dilatatum</i> – 3 Patty's Lucerne <i>Sida rhombifolia</i> – 3 Fennel <i>Foeniculum vulgare</i> – 2 Common Wild Oat- <i>Avena fatua</i> – 2 Spear Thistle <i>Cirsium vulgare</i> – 1 Purpletop <i>Verbena bonariensis</i> – 1 Moth Vine <i>Araujia sericifera</i> – 1 Quaking Grass <i>Briza maxima</i> – 3 Fleabane <i>Conyza bonariensis</i> - 2</p>

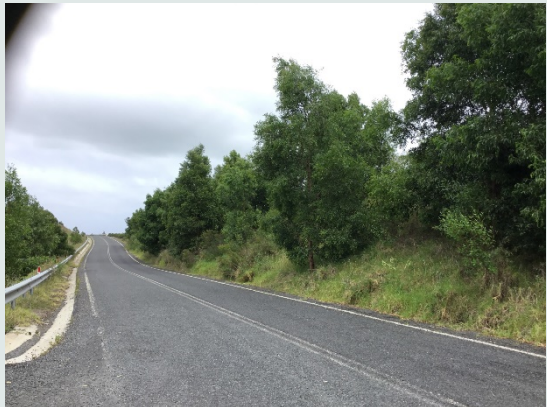
Way point	Easting	Northing	General Location	Site Description	Weeds and abundances	Photograph
39	290499	6150097	Southern zone	Batter	<p>Kikuyu <i>Cenchrus clandestinus</i> – 5 Paspalum <i>Paspalum dilatatum</i> – 4 Fireweed <i>Senecio madagascariensis</i> – 1 Patty’s Lucerne <i>Sida rhombifolia</i> – 3 Crofton weed <i>Ageratina adenophora</i> – 1 Lantana <i>Lantana camara</i> – 2 Purpletop <i>Verbena bonariensis</i> – 2 Fleabane <i>Conyza bonariensis</i> – 3 Cobbler’s Pegs <i>Bidens pilosa</i> – 2 Blackberry <i>Rubus fruticosus</i> – 2 Moth Vine <i>Araujia sericifera</i> – 2 Spear Thistle <i>Cirsium vulgare</i> – 1 Cocksfoot <i>Dactylis glomerata</i> – 1 Cat’s Ear <i>Hypochaeris radicata</i> – 2</p>

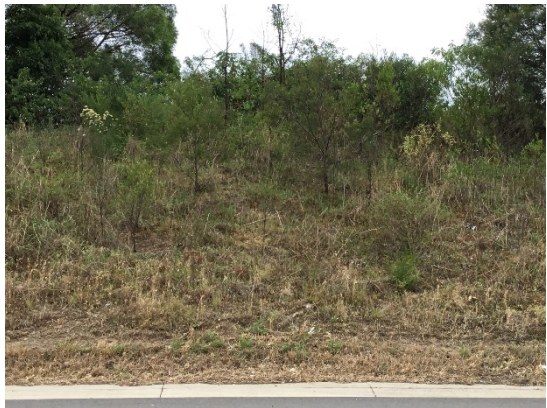
41	290384	6150131	Southern zone	Batter	<p>Mallow <i>Malva parviflora</i> – 1 Fireweed <i>Senecio madagascariensis</i> – 1 Kikuyu <i>Cenchrus clandestinus</i> – 4 Purpletop <i>Verbena bonariensis</i> – 1 Paspalum <i>Paspalum dilatatum</i> – 3 Sow Thistle <i>Sonchus oleraceus</i> – 2 Cobbler’s Pegs <i>Bidens pilosa</i> – 2 Fleabane <i>Conyza bonariensis</i> – 2 Patty’s Lucerne <i>Sida rhombifolia</i> – 2 Common Wild Oat <i>Avena fatua</i> – 2</p>

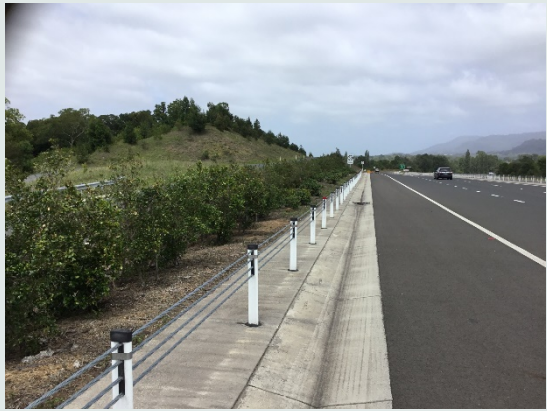
Way point	Easting	Northing	General Location	Site Description	Weeds and abundances	Photograph
40	290237	6150006	Southern zone	Embankment	<p>Kikuyu <i>Cenchrus clandestinus</i> – 3 Fireweed <i>Senecio madagascariensis</i> – 1 Sow Thistle <i>Sonchus oleraceus</i> – 2 Cobbler's Pegs <i>Bidens pilosa</i> – 2 Mallow <i>Malva parviflora</i> – 2 Fleabane <i>Conyza bonariensis</i> – 2 Paspalum <i>Paspalum dilatatum</i> – 2 Cocksfoot <i>Dactylis glomerata</i> – 2 Purpletop <i>Verbena bonariensis</i> – 1 Stinking Roger <i>Tagetes minuta</i> – 2</p>

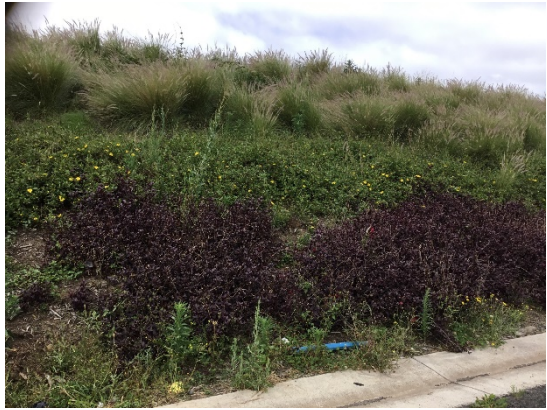
42	289262	6149761	Southern zone	Batter	<p>White Clover <i>Trifolium repens</i> – 2 Sow Thistle <i>Sonchus oleraceus</i> – 2 Mallow <i>Malva parviflora</i> – 2 Cobbler's Pegs <i>Bidens pilosa</i> – 2 Pigeon Grass <i>Setaria parviflora</i> – 2 Paspalum <i>Paspalum dilatatum</i> – 2 Prickly Lettuce <i>Lactuca serriola</i> – 1 Fleabane <i>Conyza bonariensis</i> – 2 Fireweed <i>Senecio madagascariensis</i> – 1 Knotted Barley <i>Hordeum secalinum</i> – 1</p>

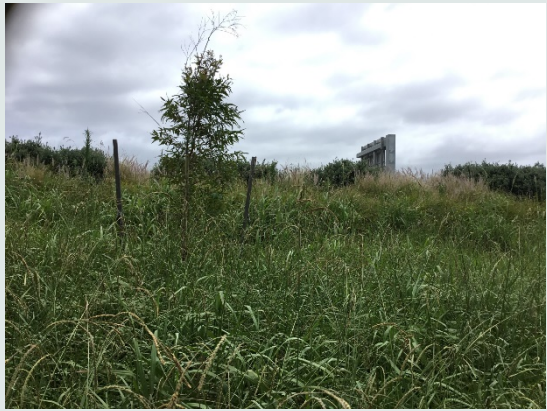
Way point	Easting	Northing	General Location	Site Description	Weeds and abundances	Photograph
43	288808	6149755	Southern zone	Batter	<p>Paspalum <i>Paspalum dilatatum</i> – 5 Fireweed <i>Senecio madagascariensis</i> – 1 Fleabane <i>Conyza bonariensis</i> – 2 White Clover <i>Trifolium repens</i> – 2 Ribwort Plantain <i>Plantago lanceolata</i> – 2 Cat's Ear <i>Hypochaeris radicata</i> – 1 Purpletop <i>Verbena bonariensis</i> – 1 Cobbler's Pegs <i>Bidens pilosa</i> – 1 Mallow <i>Malva parviflora</i> – 1</p>

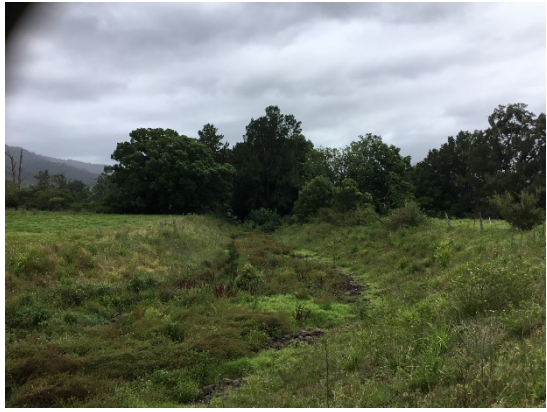
49	288598	6149960	Southern zone	Town Creek Diversion, Rawling's Lane	<p>Lantana <i>Lantana camara</i> – 3 Fireweed <i>Senecio madagascariensis</i> – 3 Patty's lucerne <i>Sida rhombifolia</i> – 3 Kikuyu <i>Cenchrus clandestinus</i> – 5 Curly Dock <i>Rumex obtusifolius</i> – 2 Paspalum <i>Paspalum dilatatum</i> – 3 Purpletop <i>Verbena bonariensis</i> – 2 White Clover <i>Trifolium repens</i> – 2 Ribwort Plantain <i>Plantago lanceolata</i> – 2</p>

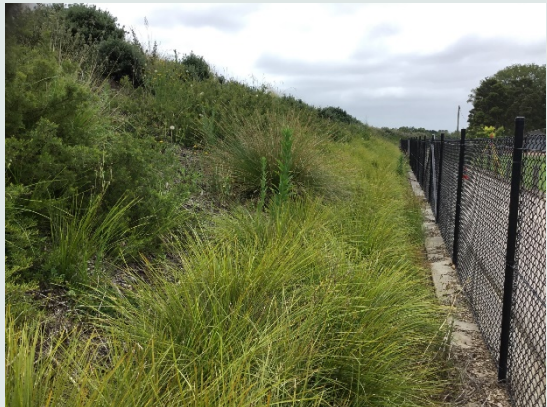
Way point	Easting	Northing	General Location	Site Description	Weeds and abundances	Photograph
44	288407	6149644	Southern zone	Noise mound	Cobbler's Pegs <i>Bidens pilosa</i> – 4 Sow Thistle <i>Sonchus oleraceus</i> – 2 Paspalum <i>Paspalum dilatatum</i> – 2 Fireweed <i>Senecio madagascariensis</i> – 1 Purpletop Verbena <i>bonariensis</i> – 1 Fleabane <i>Conyza bonariensis</i> – 3 Blackberry nightshade <i>Solanum nigrum</i> – 1 Mustard <i>Brassica oleracea</i> – 1 White Clover <i>Trifolium repens</i> – 1 Curly Dock <i>Rumex obtusifolius</i> – 1 White goosefoot <i>Chenopodium album</i> – 1 Spear Thistle <i>Cirsium vulgare</i> – 1 Patty's lucerne <i>Sida rhombifolia</i> – 2 Prickly Lettuce <i>Lactuca serriola</i> – 1
