**Transport
for NSW**

FOXGROUND AND BERRY BYPASS

2020 Post Construction Ecological, Aquatic, and Weed Monitoring Report

August 2021

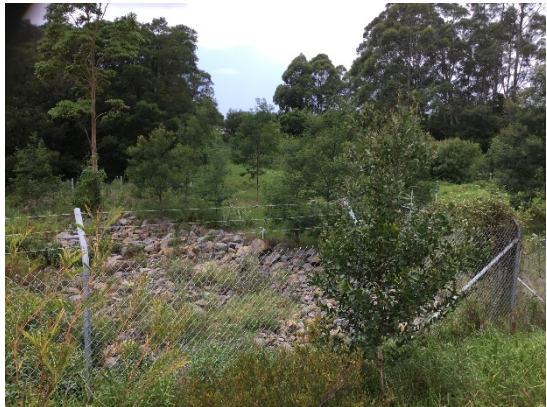
45	288031	6149263	Southern zone	Roadside	Fireweed <i>Senecio madagascariensis</i> – 1 Kikuyu <i>Cenchrus clandestinus</i> – 5 Blackberry nightshade <i>Solanum nigrum</i> – 2 Moth vine <i>Araujia sericifera</i> – 1 Patty's lucerne <i>Sida rhombifolia</i> – 2 Fleabane <i>Conyza bonariensis</i> – 2 Cobbler's Pegs <i>Bidens pilosa</i> – 3 Sow Thistle <i>Sonchus oleraceus</i> – 2 Blackberry <i>Rubus fruticosus</i> – 2 Lantana <i>Lantana camara</i> – 3 Inkweed <i>Phytolacca octandra</i> – 2 Purpletop Verbena <i>bonariensis</i> – 2 Crofton weed <i>Ageratina adenophora</i> – 3

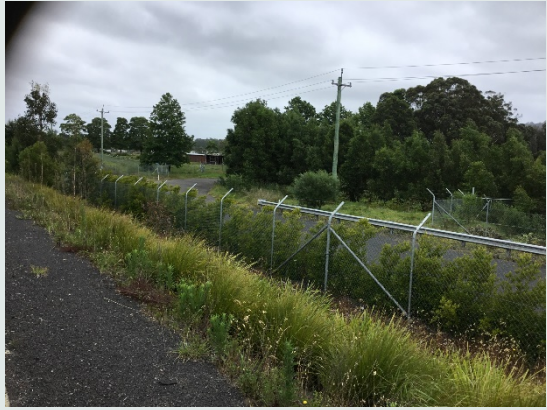
Way point	Easting	Northing	General Location	Site Description	Weeds and abundances	Photograph
					<i>Paspalum dilatatum</i> – 3	
48	287971	6149266	Southern zone	Roadside	<i>Kikuyu Cenchrus clandestinus</i> – 4 Purpletop <i>Verbena bonariensis</i> – 2 Fireweed <i>Senecio madagascariensis</i> – 1 Patty's lucerne <i>Sida rhombifolia</i> – 2 Cobbler's Pegs <i>Bidens pilosa</i> – 2 <i>Paspalum dilatatum</i> – 3 Sow Thistle <i>Sonchus oleraceus</i> – 2 White Clover <i>Trifolium repens</i> – 3 Fleabane <i>Conyza bonariensis</i> – 2 Quaking Grass <i>Briza maxima</i> – 3 Stinking Roger <i>Tagetes minuta</i> – 2

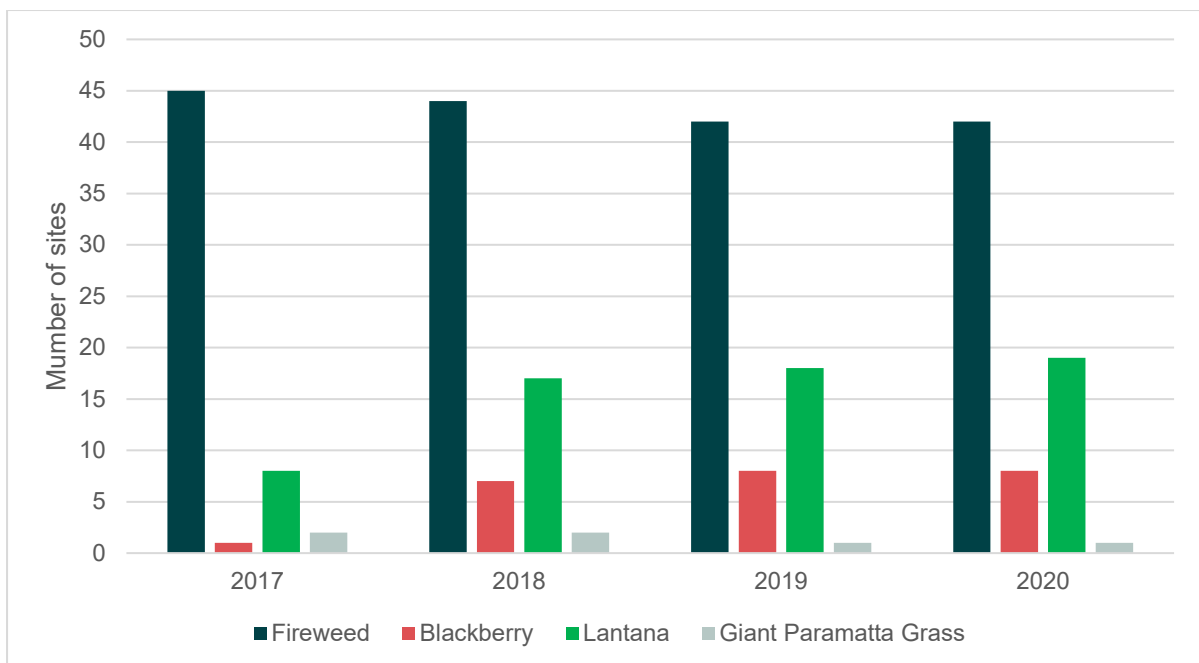
Figure 4-4 Priority weed occurrence 2017-2020

There were no new Priority Weeds detected during 2020. Fireweed is the most prevalent priority weed, detected at the same number of sites in 2020 as 2019 (42 sites). This is lower than the 44 sites observed in 2018 and 45 sites in 2017 (Figure 4-3). There has also been a decrease in average relative abundance of Fireweed across the project alignment (according to modified Braun-Blanquet) 2.17 in 2019 to 1.55 in 2020 (Figure 4-4). Blackberry was found at the same number of sites in 2020 as 2019. The average relative abundance reduced from 2.5 in 2019 to 2.13 in 2020. Lantana was observed in one additional site in 2020; 19 sites in 2020 compared to 18 in 2019. There was however an overall reduction in Lantana in the alignment, with an average of 2.58 being observed compared to 3.06 in 2019. As Blackberry and Lantana are both dense monoculture species and are highly prevalent in the project's surrounds, these species are expected to spread across the project alignment without appropriate control. Giant Parramatta Grass was observed at just one (1) site in this years' survey, similarly to 2019, with abundance staying the same between the years with an average of 1 being observed. See Figure 4-3 and Figure 4-4 below.

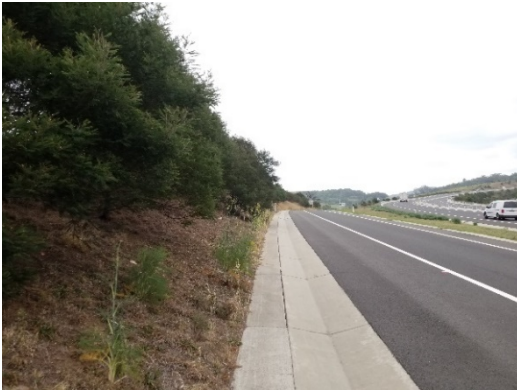
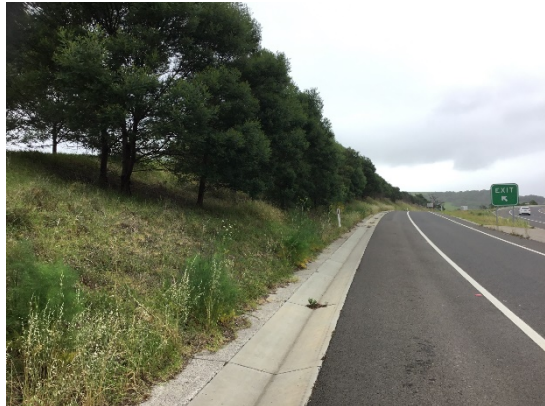
Way point	Eastings	Northings	General Location	Site Description	2019 Photograph	2020 Photograph
15	297055	6152294	North of Toolijooa Rd	Batter

Way point	Easting	Northing	General Location	Site Description	Weeds and abundances	Photograph
15	297055	6152294	North of Toolijooa Rd	Batter	Mustard <i>Brassica oleracea</i> – 1 Kikuyu <i>Cenchrus clandestinus</i> – 5 Cobbler's Pegs <i>Bidens pilosa</i> – 3 Paddy's Lucerne <i>Sida rhombifolia</i> – 2 Lantana <i>Lantana camara</i> – 1 Paspalum <i>Paspalum dilatatum</i> – 3 Fennel <i>Foeniculum vulgare</i> – 3 Fireweed <i>Senecio madagascariensis</i> – 1 Moth vine <i>Araujia sericifera</i> – 1 Sow thistle <i>Sonchus oleraceus</i> – 1 Common Wild Oat <i>Avena fatua</i> – 2 Rhodes Grass <i>Chloris gayana</i> – 2 Mallow <i>Malva parviflora</i> – 2

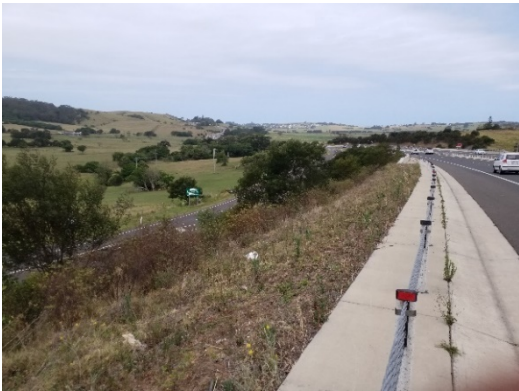
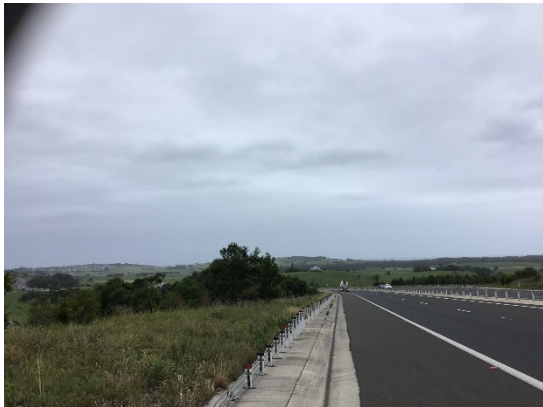
Way point	Eastings	Northings	General Location	Site Description	2019 Photograph	2020 Photograph
16	296799	615239	South of Toolijooa Rd	Roadside area

Way point	Easting	Northing	General Location	Site Description	Weeds and abundances	Photograph
16	296799	615239	South of Toolijooa Rd	Roadside area	<p>Kikuyu <i>Cenchrus clandestinus</i> – 5 Paspalum <i>Paspalum dilatatum</i> – 4 Purpletop <i>Verbena bonariensis</i> – 2 Cobbler's Pegs <i>Bidens pilosa</i> – 3 Sow thistle <i>Sonchus oleraceus</i> – 2 Fireweed <i>Senecio madagascariensis</i> – 1 Paddy's Lucerne <i>Sida rhombifolia</i> – 3 Common Wild Oat <i>Avena fatua</i> – 2 Cottonbush <i>Gomphocarpus physocarpus</i> – 1 Mallow <i>Malva parviflora</i> – 2 Cocksfoot <i>Dactylis glomerata</i> – 2 Shivery Grass <i>Briza minor</i> – 2 Fleabane <i>Conyza bonariensis</i> – 3 Ribwort Plantain <i>Plantago lanceolata</i> – 2 White Clover <i>Trifolium repens</i> – 2</p>

A photograph showing a concrete drainage ditch or culvert running alongside a road. The ditch is filled with water and has a red marker on the side. The surrounding area is grassy and hilly.

A photograph showing a similar view to the 2019 photo, but from a slightly different angle. The road and drainage ditch are visible, with a cloudy sky in the background.
17	296675	6152401	South of Toolijooa Rd	Roadside batter

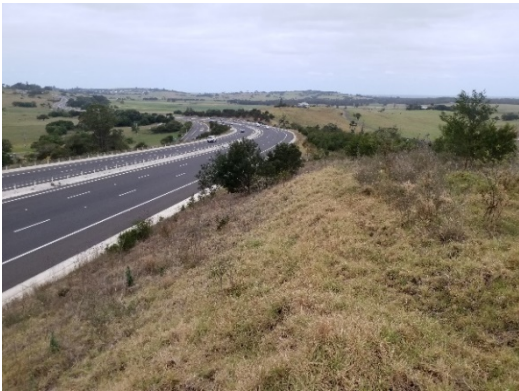
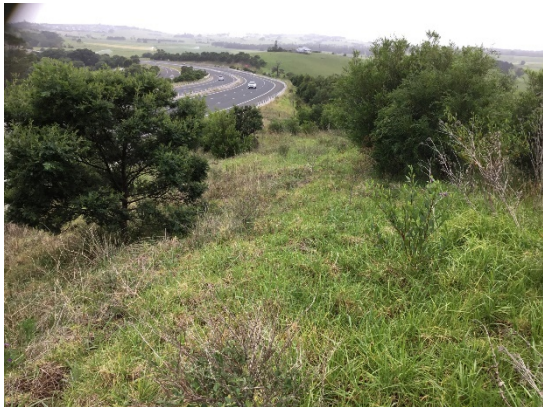
A photograph showing a wide view of a road curving through a landscape. The road is bordered by a concrete barrier. The surrounding area is grassy and hilly.

A photograph showing a similar view to the 2019 photo, but from a slightly different angle. The road and surrounding landscape are visible, with a cloudy sky in the background.

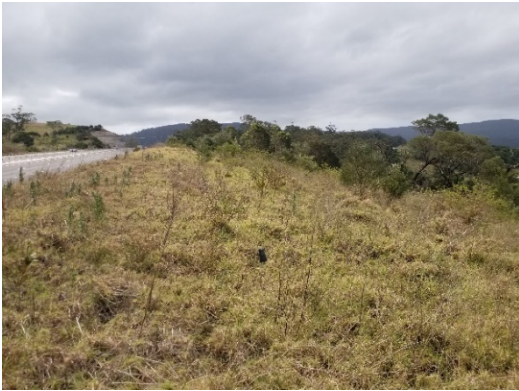
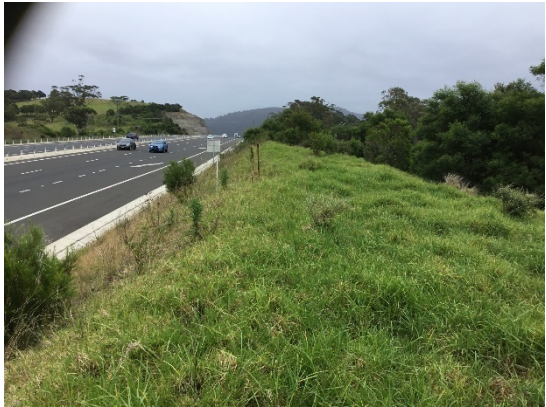
Way point	Eastings	Northings	General Location	Site Description	2019 Photograph	2020 Photograph
18	296523	6152549	South of Toolijooa Rd	Roadside batter

Way point	Easting	Northing	General Location	Site Description	Weeds and abundances	Photograph
18	296523	6152549	South of Toolijooa Rd	Roadside batter	<p>Kikuyu <i>Cenchrus clandestinus</i> – 6 Paspalum <i>Paspalum dilatatum</i> – 4 Cobbler's Pegs <i>Bidens pilosa</i> – 2 Paddy's Lucerne <i>Sida rhombifolia</i> – 3 Fireweed <i>Senecio madagascariensis</i> – 2 Purpletop <i>Verbena bonariensis</i> – 2 Fleabane <i>Conyza bonariensis</i> – 2 Moth vine <i>Araujia sericifera</i> – 1 Fennel <i>Foeniculum vulgare</i> – 1 Cocksfoot <i>Dactylis glomerata</i> – 2 Common Wild Oat <i>Avena fatua</i> – 2 Mustard <i>Brassica oleracea</i> – 1 Perennial Ryegrass <i>Lolium perenne</i> – 2</p>

A photograph showing a roadside batter area with dry, yellowish-brown grass and some scattered trees under a cloudy sky.

A photograph showing the same roadside batter area, but the grass is now lush and green, indicating regrowth.
19	296251	6152744	Between BC1 and Toolijooa Rd	Roadside embankment

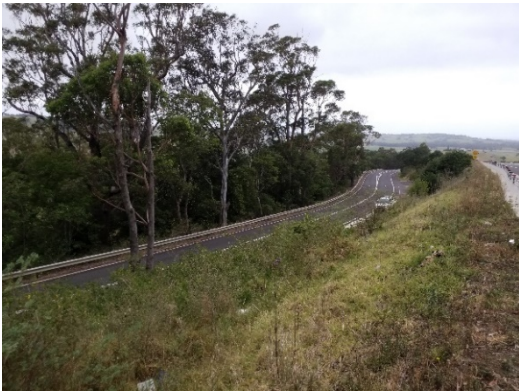
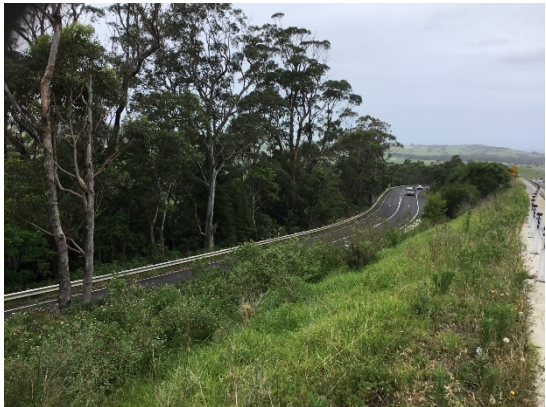
A photograph of a roadside embankment with a road curving to the right. The embankment is covered in dry grass and has several trees.

A photograph of the same roadside embankment, showing more green grass and trees, suggesting improved vegetation.

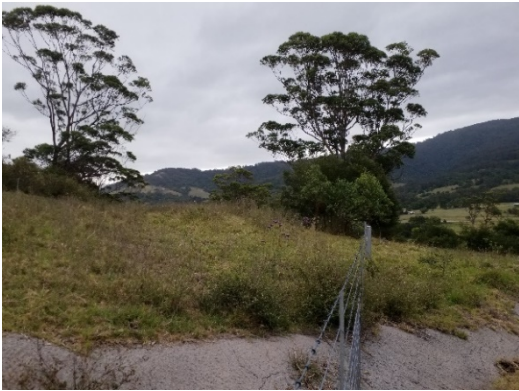
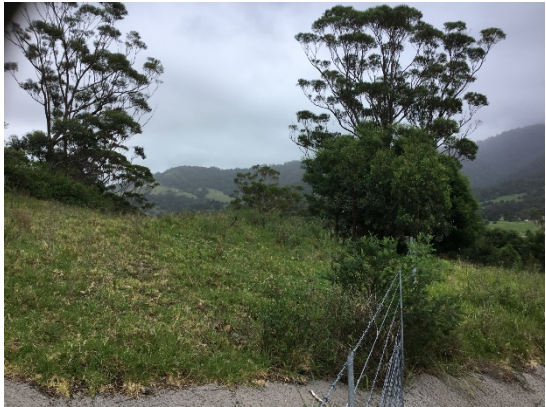
Way point	Eastings	Northings	General Location	Site Description	2019 Photograph	2020 Photograph
22	295486	6152939	Between BC1 and Toolijooa Rd	Light vehicle track

Way point	Easting	Northing	General Location	Site Description	Weeds and abundances	Photograph
22	295486	6152939	Between BC1 and Toolijooa Rd	Light vehicle track	<p>Fireweed <i>Senecio madagascariensis</i> – 2 Kikuyu <i>Cenchrus clandestinus</i> – 6 Spear Thistle <i>Cirsium vulgare</i> – 2 Purpletop <i>Verbena bonariensis</i> – 2 Blackberry <i>Rubus fruticosus</i> – 1 Paspalum <i>Paspalum dilatatum</i> – 3 Cobbler's Pegs <i>Bidens pilosa</i> – 3 Paddy's Lucerne <i>Sida rhombifolia</i> – 4 Wild tobacco <i>Solanum mauritianum</i> - 1 Inkweed <i>Phytolacca octandra</i> – 3 Lantana <i>Lantana camara</i> – 1 St Barnaby's Thistle <i>Centaurea solstitialis</i>– 2</p>

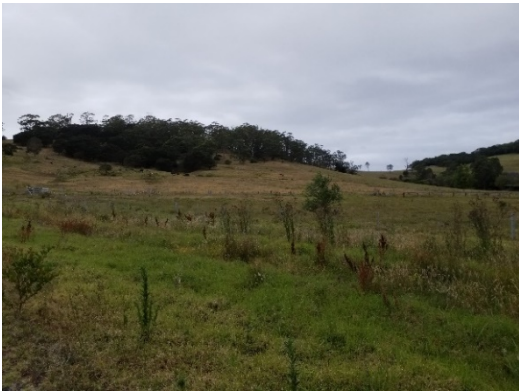
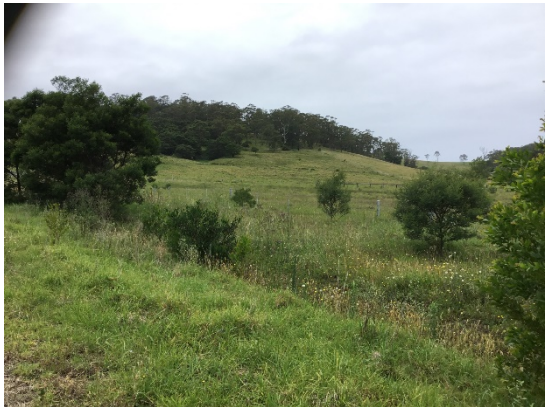
24	295121	6152887	BC1	Adjacent to compound

Way point	Easting	Northing	General Location	Site Description	Weeds and abundances	Photograph
31	295126	6152978	BC1	Roadside batter	<p>Fireweed <i>Senecio madagascariensis</i> – 2 Kikuyu <i>Cenchrus clandestinus</i> – 4 Paspalum <i>Paspalum dilatatum</i> – 4 Stinking Roger <i>Tagetes minuta</i> - 2 Paddy’s Lucerne <i>Sida rhombifolia</i> – 4 Purpletop <i>Verbena bonariensis</i> – 3 Fleabane <i>Conyza bonariensis</i> – 3 Sow Thistle <i>Sonchus oleraceus</i> – 2 Alfalfa <i>Medicago sativa</i> - 1 Inkweed <i>Phytolacca octandra</i> - 2 Prickly Lettuce <i>Lactuca serriola</i> – 1 Cocksfoot <i>Dactylis glomerata</i> – 1 Perennial Ryegrass <i>Lolium perrene</i> – 2 Wild Oat <i>Avena fatua</i> – 1 Ribwort Plantain <i>Plantago lanceolata</i> – 2 Giant Paramatta Grass <i>Sporobolus fertilis</i> – 1</p>

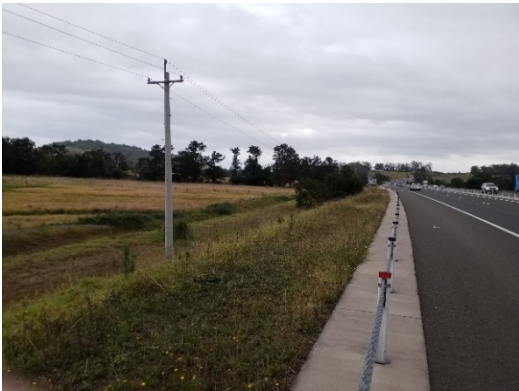
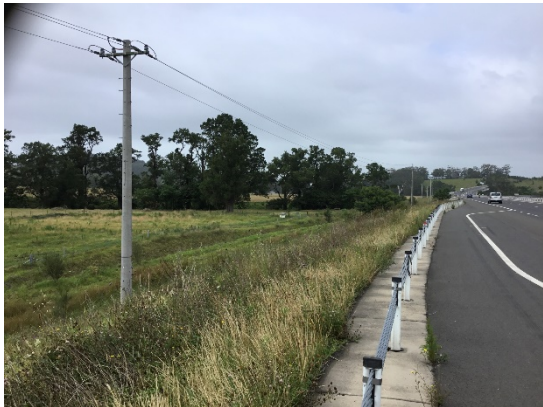
Way point	Eastings	Northings	General Location	Site Description	2019 Photograph	2020 Photograph
30	294583	6152452	Between BC1 and BC2	Road side

Way point	Easting	Northing	General Location	Site Description	Weeds and abundances	Photograph
30	294583	6152452	Between BC1 and BC2	Road side	<p>Kikuyu <i>Cenchrus clandestinus</i> – 4 Cobbler's Pegs <i>Bidens pilosa</i> – 3 Fireweed <i>Senecio madagascariensis</i> – 1 Purpletop <i>Verbena bonariensis</i> – 3 White Clover <i>Trifolium repens</i> – 3 Cat's Ear <i>Hypochaeris radicata</i> - 3 Fleabane <i>Conyza bonariensis</i> – 2 Crofton weed <i>Ageratina adenophora</i> - 1 Paddy's Lucerne <i>Sida rhombifolia</i> – 2 Stinking Roger <i>Tagetes minuta</i> – 1 Sow thistle <i>Sonchus oleraceus</i> – 1 Moth vine <i>Araujia sericifera</i> – 1 Paspalum <i>Paspalum dilatatum</i> – 3</p>

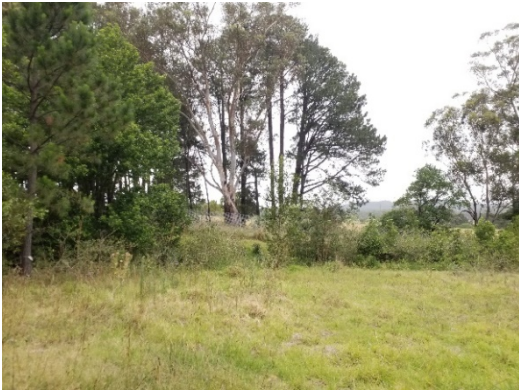
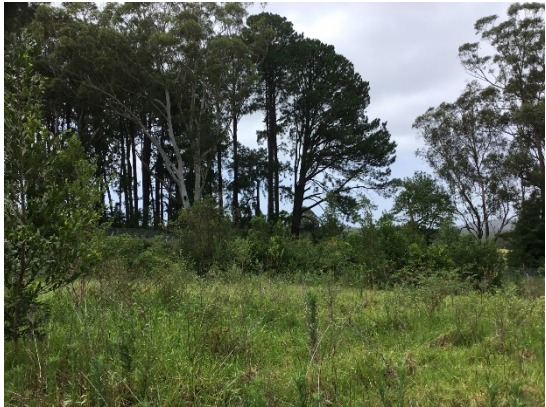
Way point	Eastings	Northings	General Location	Site Description	2019 Photograph	2020 Photograph
7	292355	6150882	Central zone	Road side

Way point	Easting	Northing	General Location	Site Description	Weeds and abundances	Photograph
7	292355	6150882	Central zone	Road side	Inkweed <i>Phytolacca octandra</i> – 1 Fireweed <i>Senecio madagascariensis</i> – 2 Kikuyu <i>Cenchrus clandestinus</i> – 6 Lantana <i>Lantana camara</i> – 3 Purpletop <i>Verbena bonariensis</i> – 2 Stinking Roger <i>Tagetes minuta</i> – 2 Paspalum <i>Paspalum dilatatum</i> – 3 Ribwort Plantain <i>Plantago lanceolata</i> – 1 Cobbler's Pegs <i>Bidens pilosa</i> – 3 Patty's lucerne <i>Sida rhombifolia</i> – 3 Fleabane <i>Conyza bonariensis</i> – 2 Spear Thistle <i>Cirsium vulgare</i> – 2

- 9 – Although mid storey revegetation attempts have been successful in this area, it is recommended that immediate weed control is conducted to reduce this risk of exotic vines suffocating native mid storey.
- 12 – Area was previously dominated by exotic grasses however and was observed with establishing thistles and emerging abundances of lantana and exotic vines. With

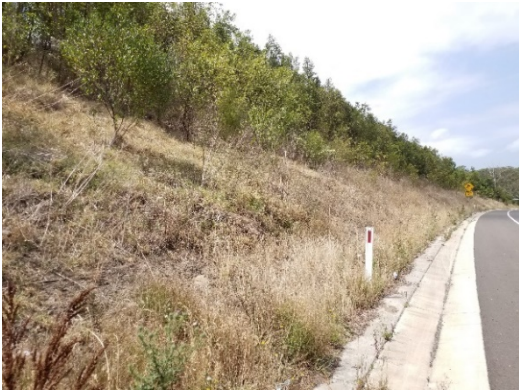
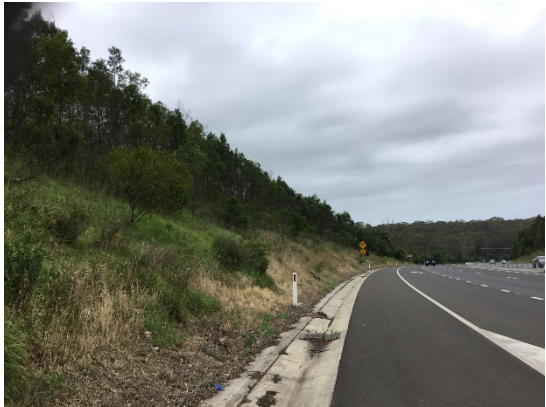
Way point	Eastings	Northings	General Location	Site Description	2019 Photograph	2020 Photograph
5	291578	6150845	Tindell's Lane	Batter

Way point	Easting	Northing	General Location	Site Description	Weeds and abundances	Photograph
5	291578	6150845	Tindell's Lane	Batter	<p>Kikuyu <i>Cenchrus clandestinus</i> – 5 Paspalum <i>Paspalum dilatatum</i> – 4 Patty's lucerne <i>Sida rhombifolia</i> – 4 Fireweed <i>Senecio madagascariensis</i> – 2 Moth vine <i>Araujia sericifera</i> – 2 Purpletop <i>Verbena bonariensis</i> – 2 Cobbler's Pegs <i>Bidens pilosa</i> – 2 Fleabane <i>Conyza bonariensis</i> – 2 Sow Thistle <i>Sonchus oleraceus</i> – 2 Spear Thistle <i>Cirsium vulgare</i> – 2 Quaking Grass <i>Briza Maxima</i> – 3 Ribwort Plantain <i>Plantago lanceolata</i> – 2 Prickly Lettuce <i>Lactuca serriola</i> – 1</p>

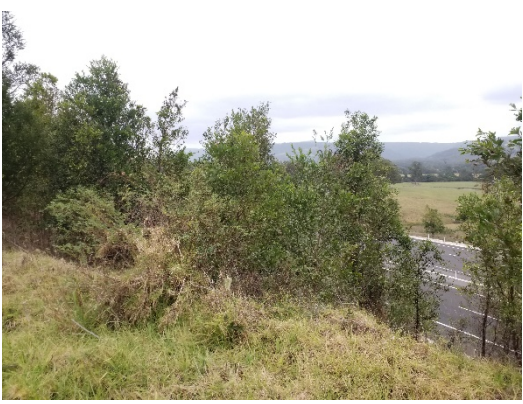
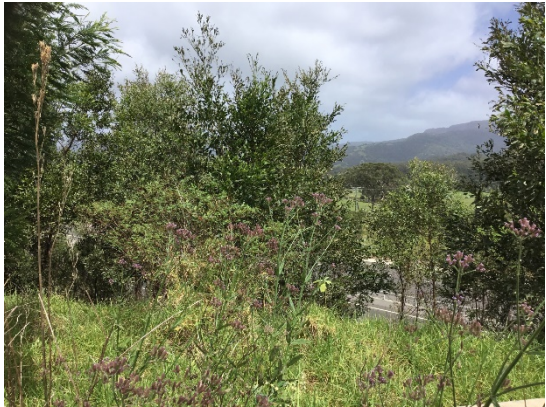
Way point	Eastings	Northings	General Location	Site Description	2019 Photograph	2020 Photograph
3	291317	6150605	Central zone Cut 6	Batter

Way point	Easting	Northing	General Location	Site Description	Weeds and abundances	Photograph
3	291317	6150605	Central zone Cut 6	Batter	<p>Kikuyu <i>Cenchrus clandestinus</i> – 6 Paspalum <i>Paspalum dilatatum</i> – 3 Purpletop <i>Verbena bonariensis</i> – 2 Cobbler's Pegs <i>Bidens pilosa</i> – 2 Fireweed <i>Senecio madagascariensis</i> – 1 Patty's Lucerne <i>Sida rhombifolia</i> – 3 Fleabane <i>Conyza bonariensis</i> – 2 White Clover <i>Trifolium repens</i> – 2 Moth Vine <i>Araujia sericifera</i> – 2 Sow Thistle <i>Sonchus oleraceus</i> – 2 Prickly Lettuce <i>Lactuca serriola</i> – 1 Fennel <i>Foeniculum vulgare</i> – 1</p>
