Foxground and Berry Bypass: Archaeological Investigation Report

Prepared for Roads and Maritime Services

2 September 2014

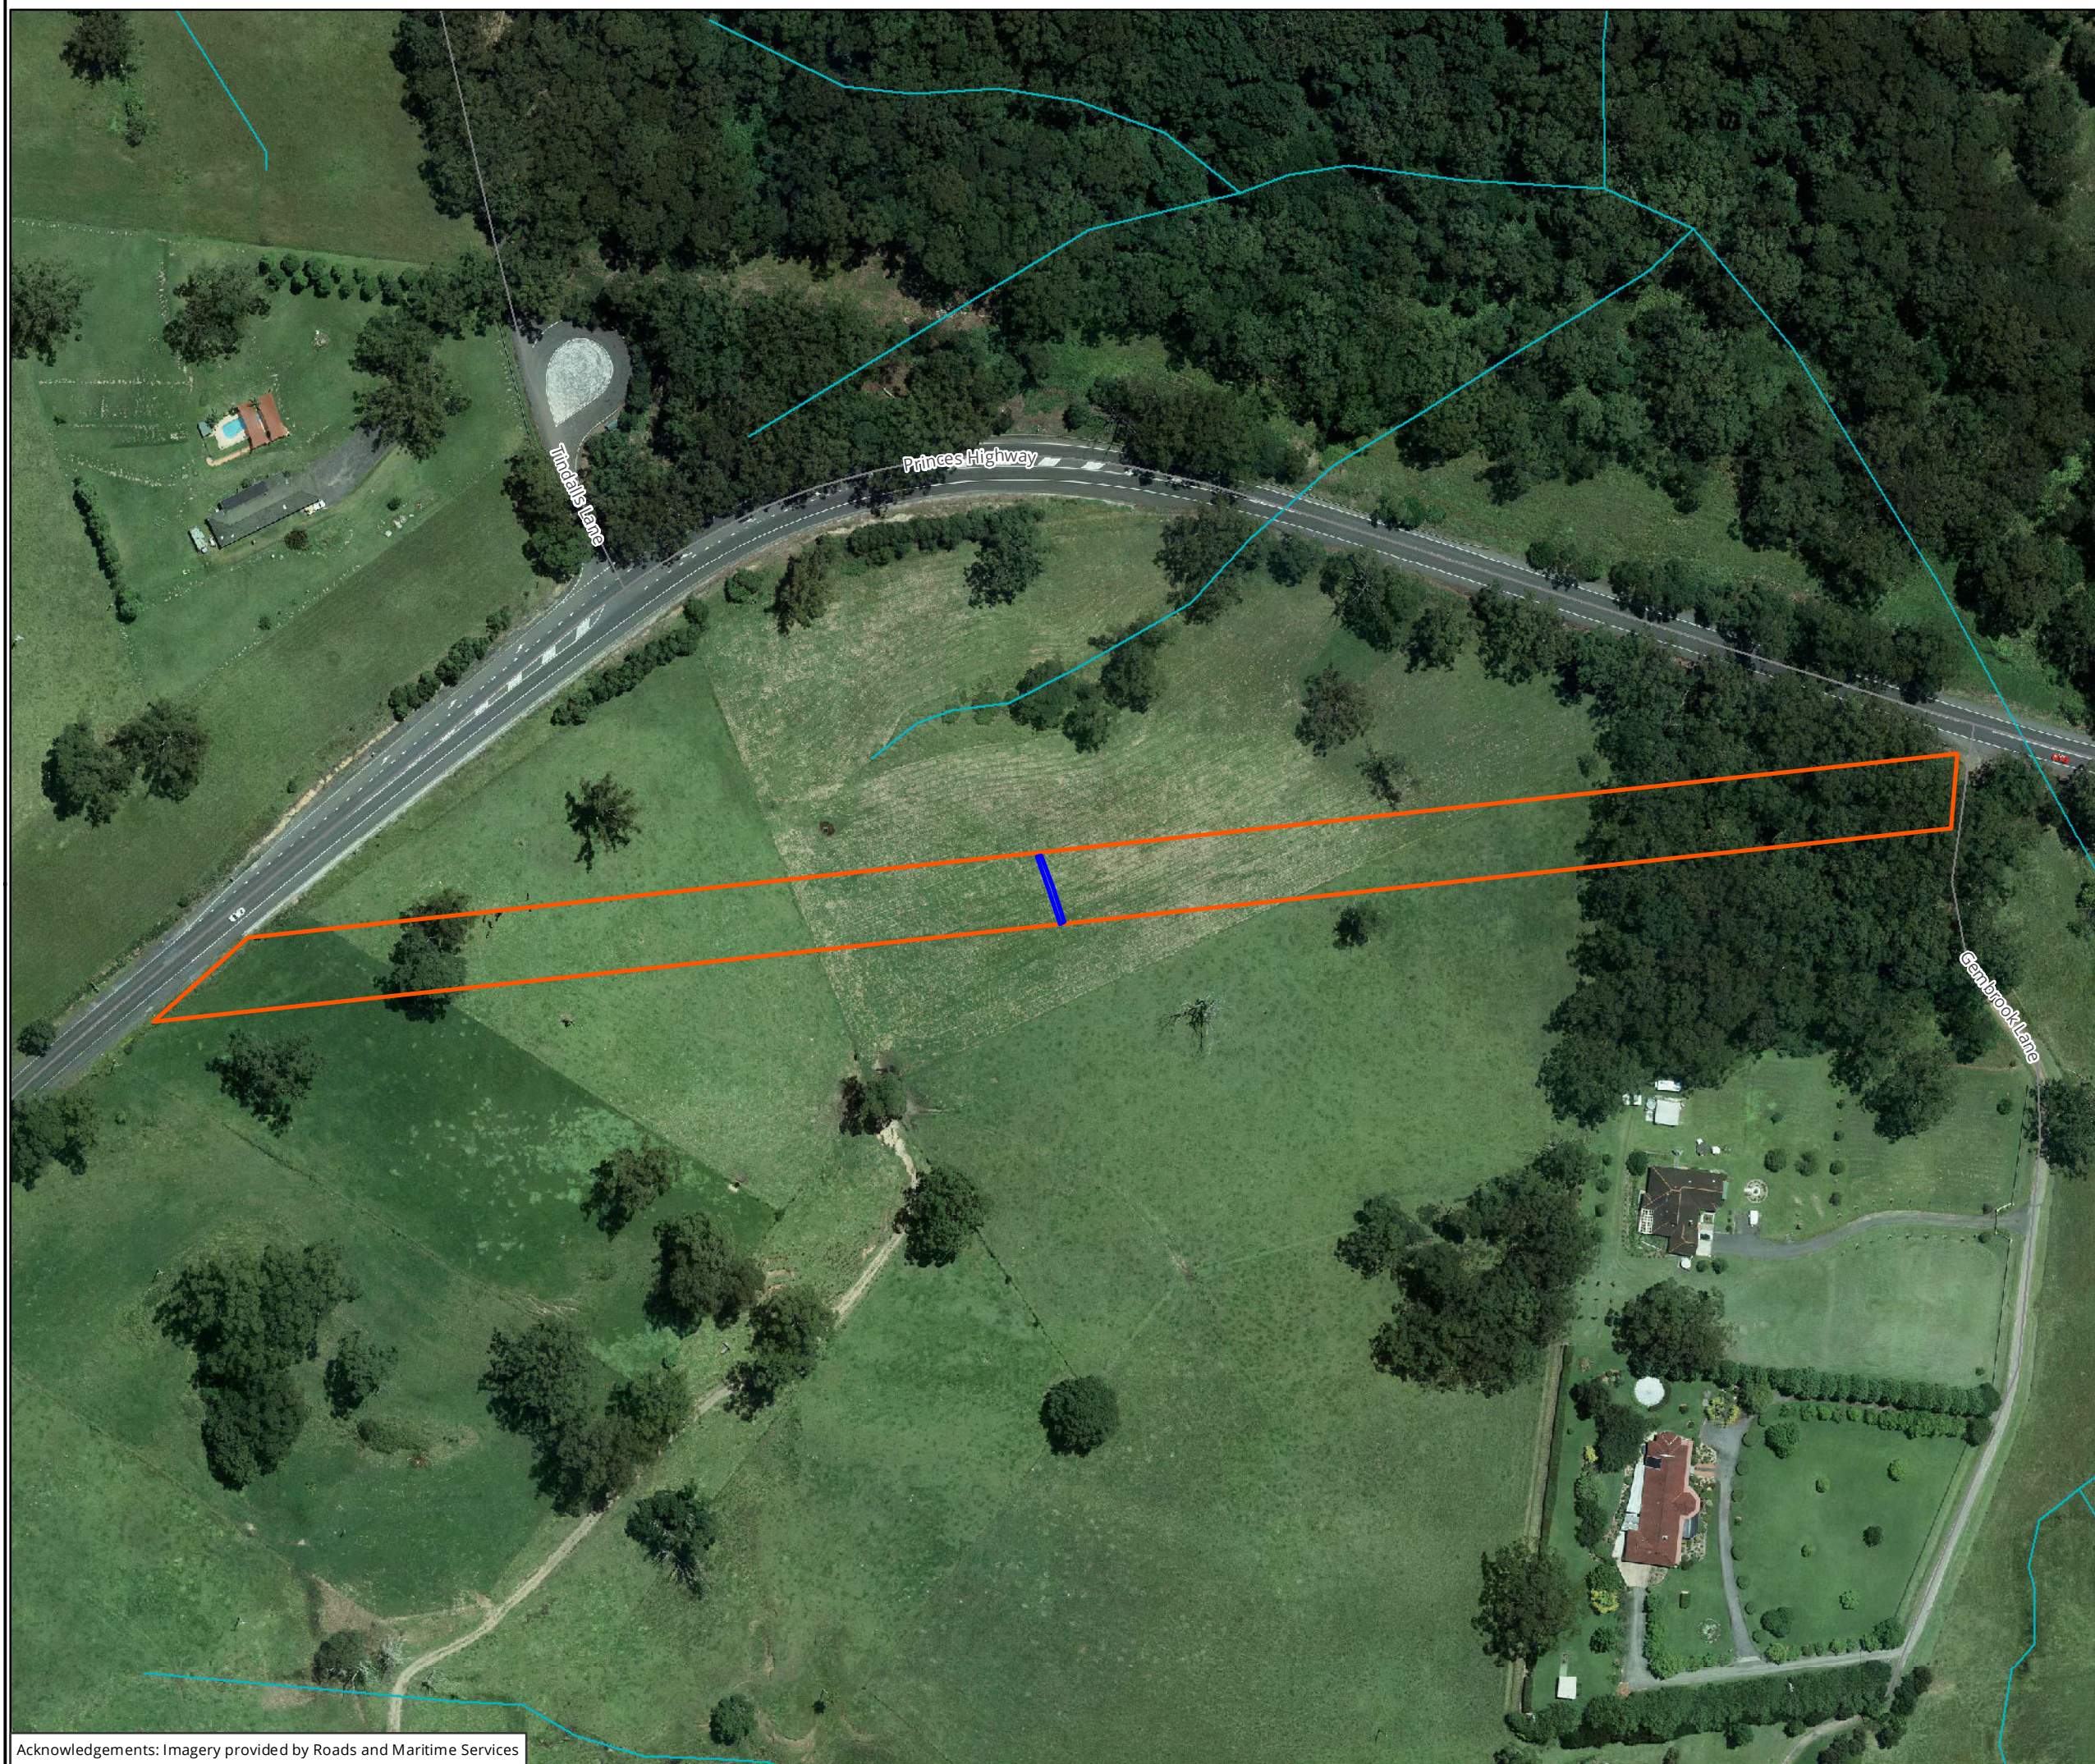
Figure 3: Location of archaeological excavations within G2B H19

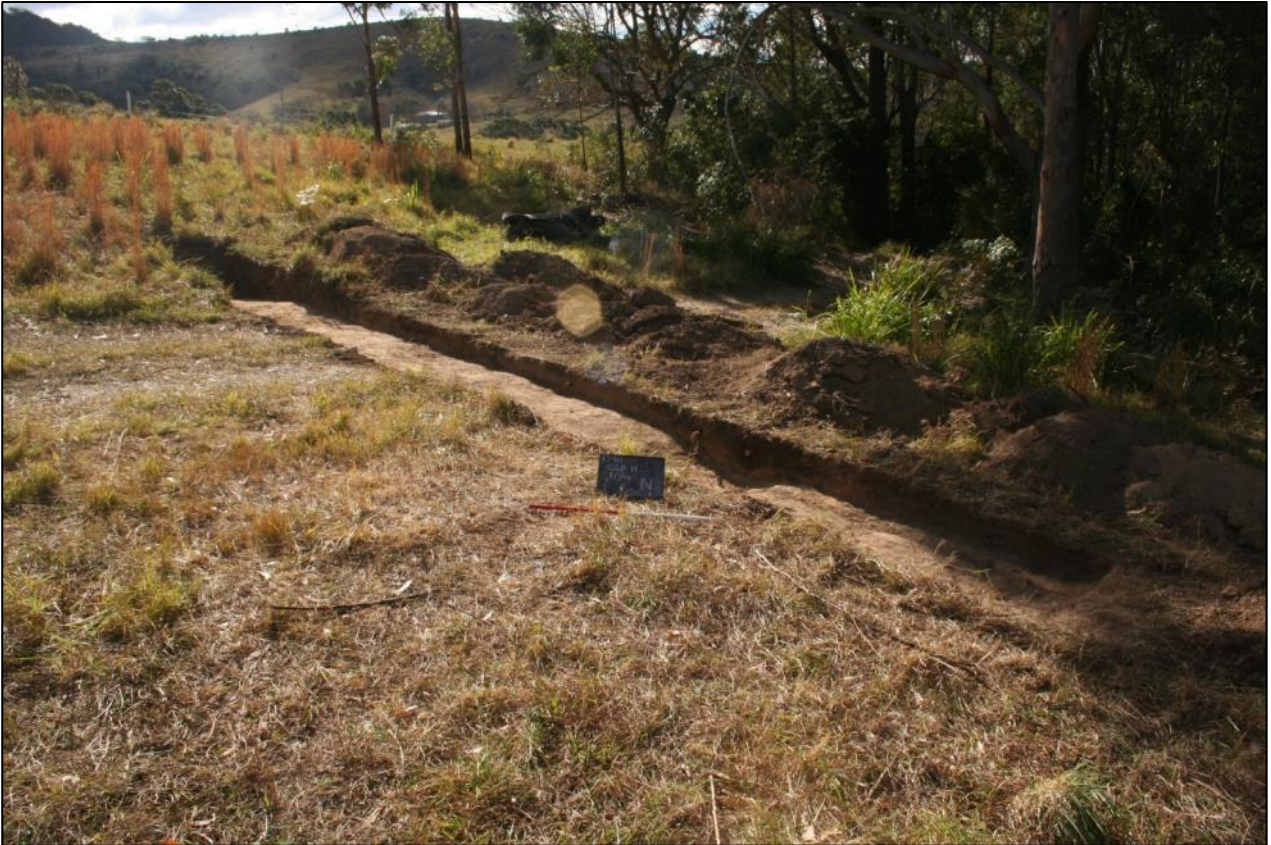
Plate 3: East facing oblique photograph of G2B H22, 1 m scale (Source: Biosis, 2014)

See an oblique excavation photograph for Plate 3 and Plate 4 for an excavated section of the road profile showing cut 002.

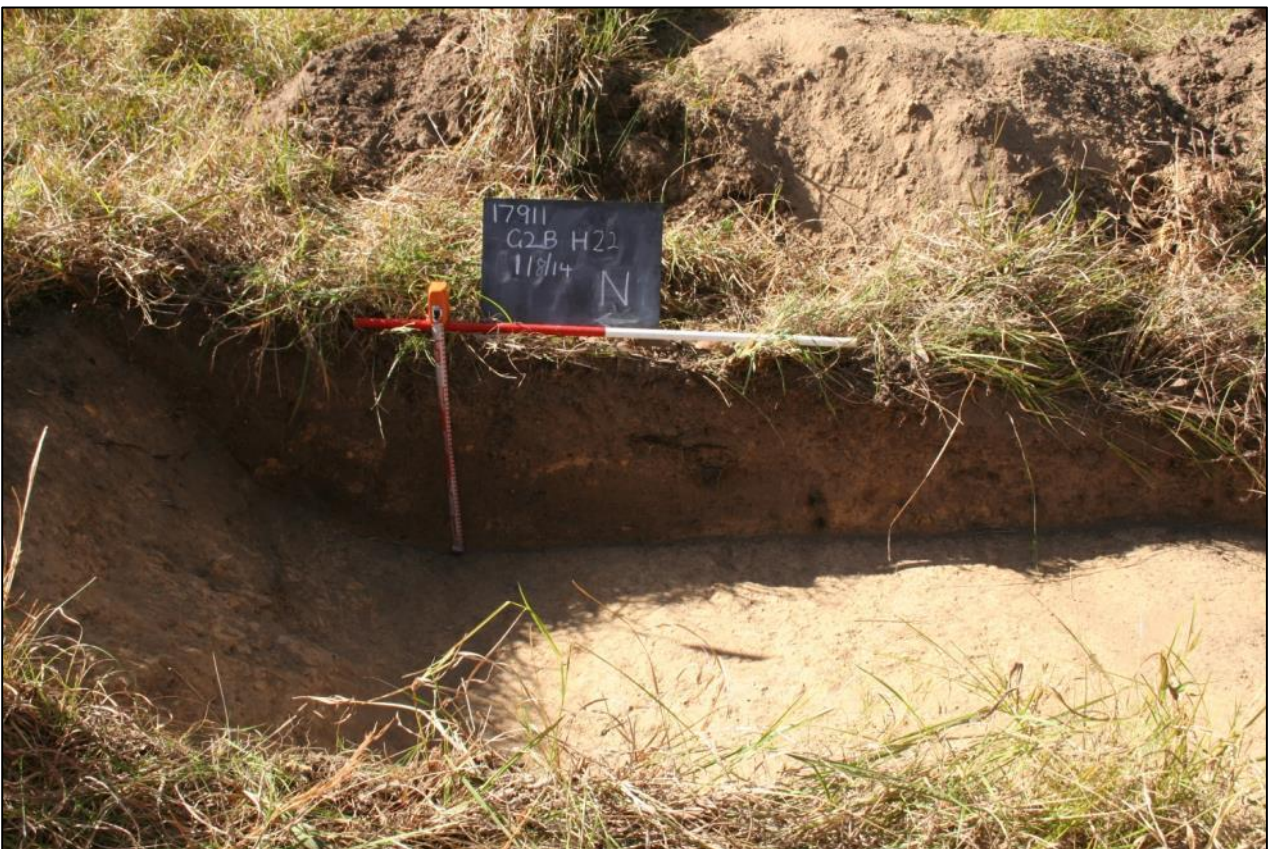
Plate 4: Section archaeological feature 003 of G2B H22, 1 m scale (Source: Biosis, 2014)

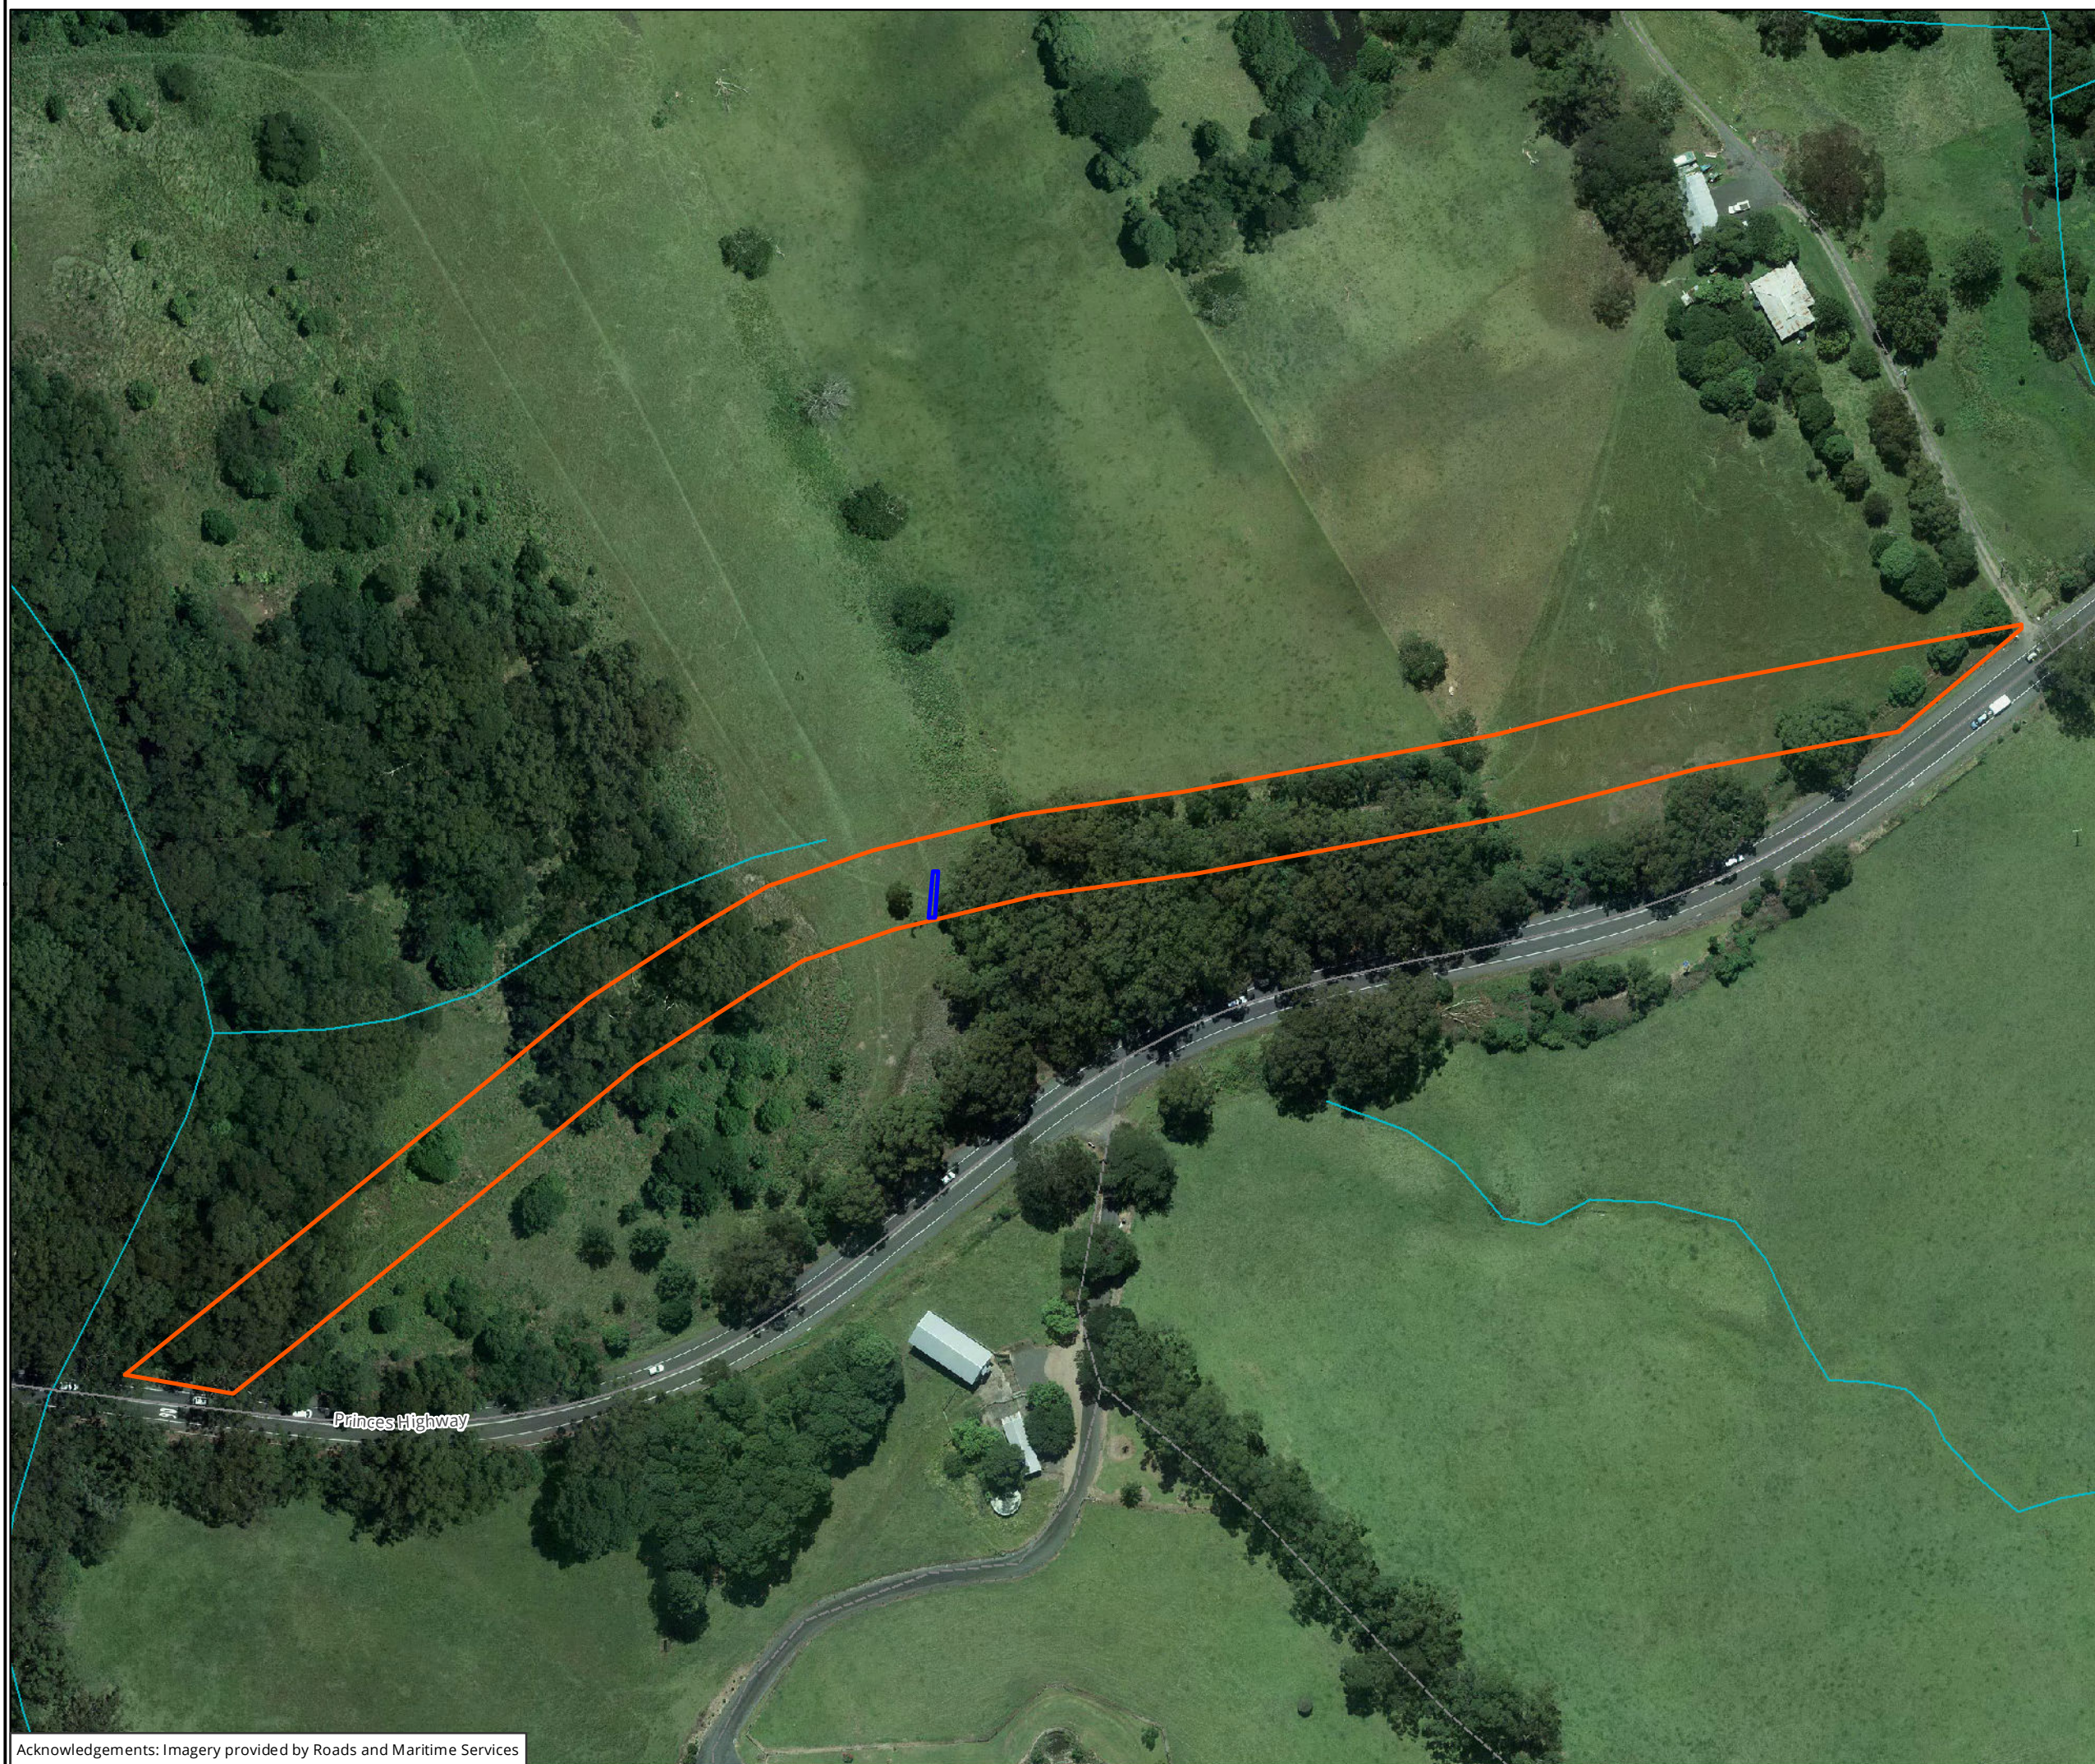
Figure 4: Location of archaeological excavations within G2B H22

The excavation at this site consisted of a 1.2 by 10 m trench excavated across the road alignment identified in the NOHC report. The trench contained two deposits and one feature, consisting of a ditch [003] and associated fill (004). Detailed descriptions of these deposits are detailed in Table 4. The excavation of G2B H22 did not recover any artefacts. The excavation of G2B H22 failed to recover any artefacts, the location of the trench in relation to the site listing detailed in Figure 4.

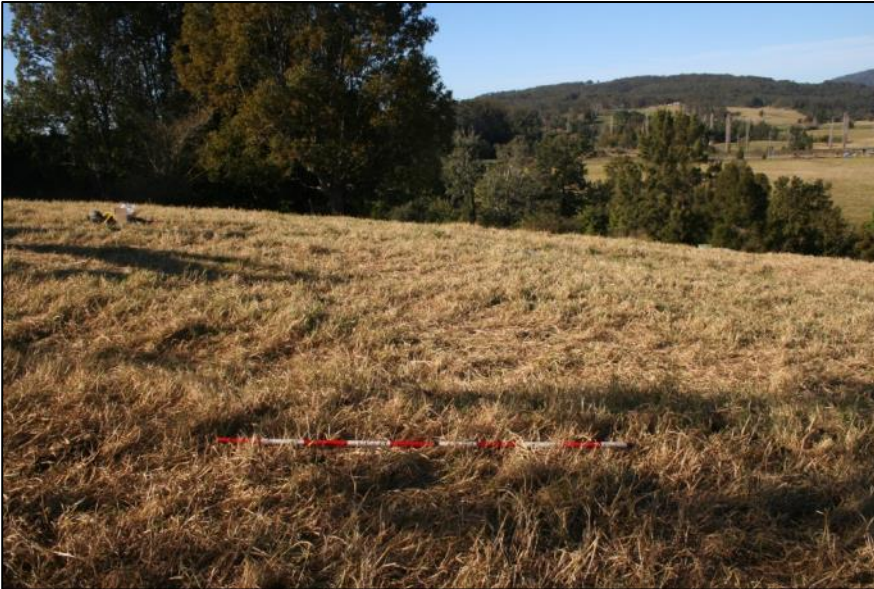
Plate 10: West facing pre-excitation photograph of trench, 2 m scale (Source: Biosis, 2014).

The road alignment and landform prior to excavation can be seen in Plate 10, along with a post-excavation photograph and section in Plate 11 and Plate 12 respectively.

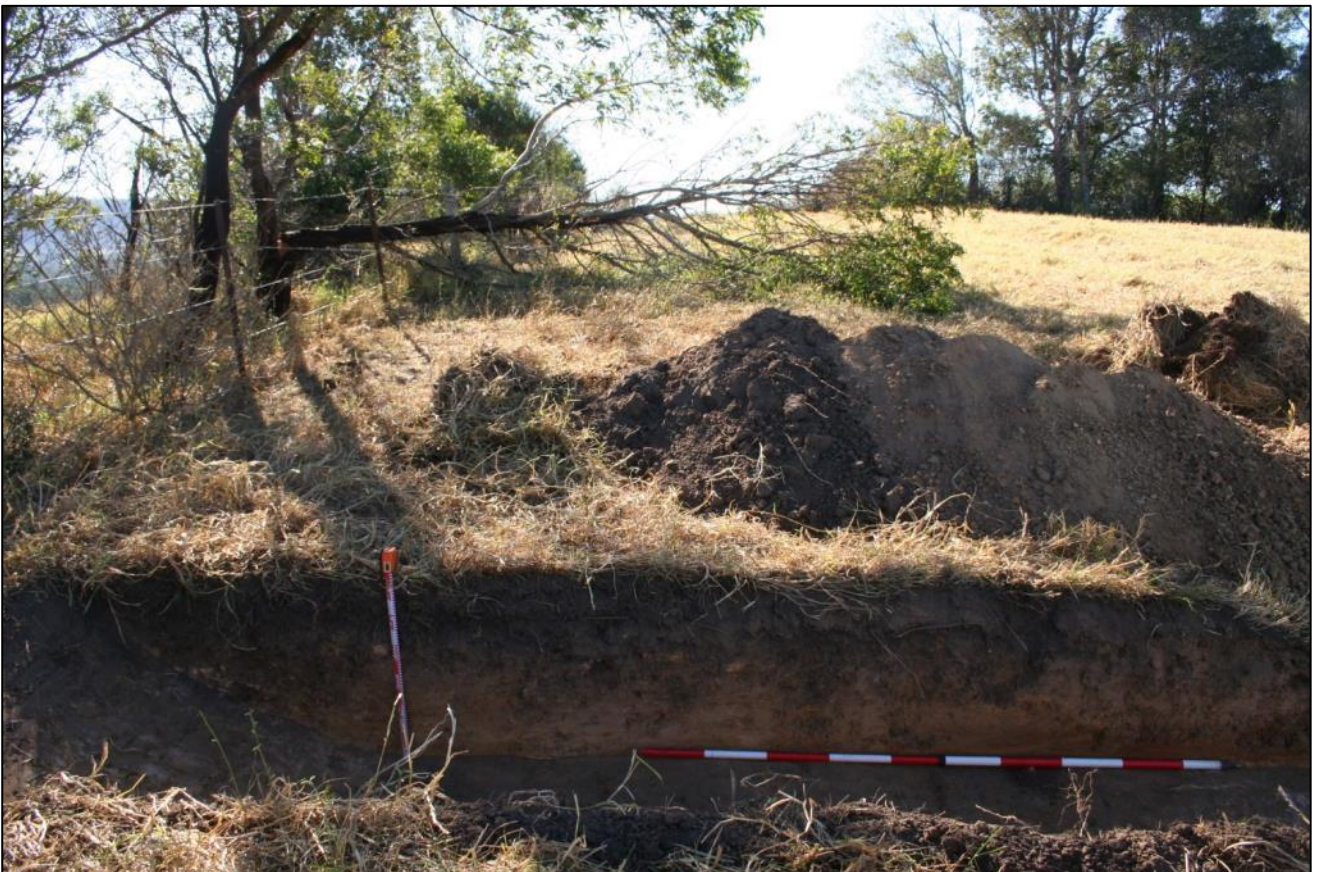
Plate 12: West facing section of trench, 2 m scale (Biosis, 2014).

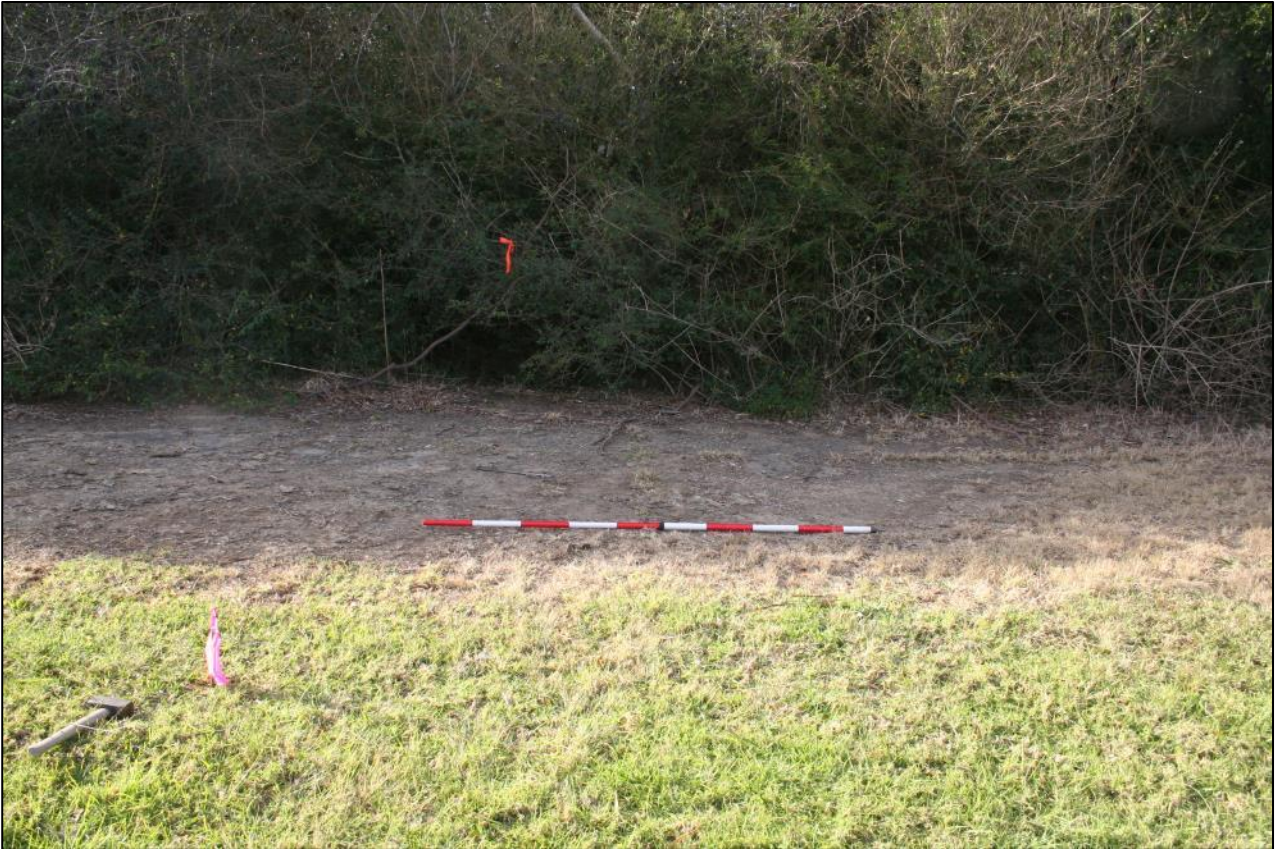
Plate 13: East facing pre-excavation photograph of G2B H15 with 2 m scale (Source: Biosis, 2014)

A pre-excavation photograph showing the metalling associated with G2B H15 is in Plate 13 and section of the road layers is in Plate 14.

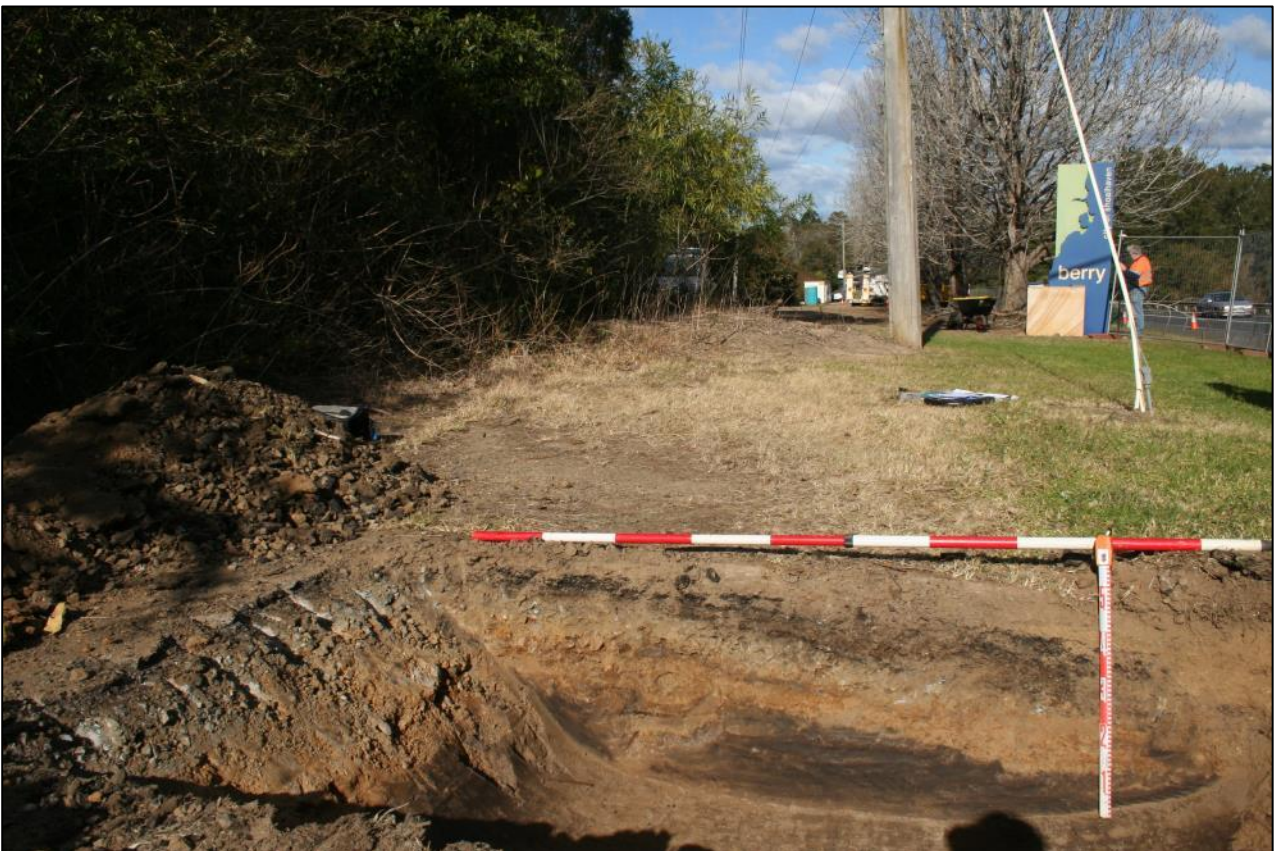
Plate 14: South facing section of G2B H15 with 2 m scale (Source: Biosis, 2014).

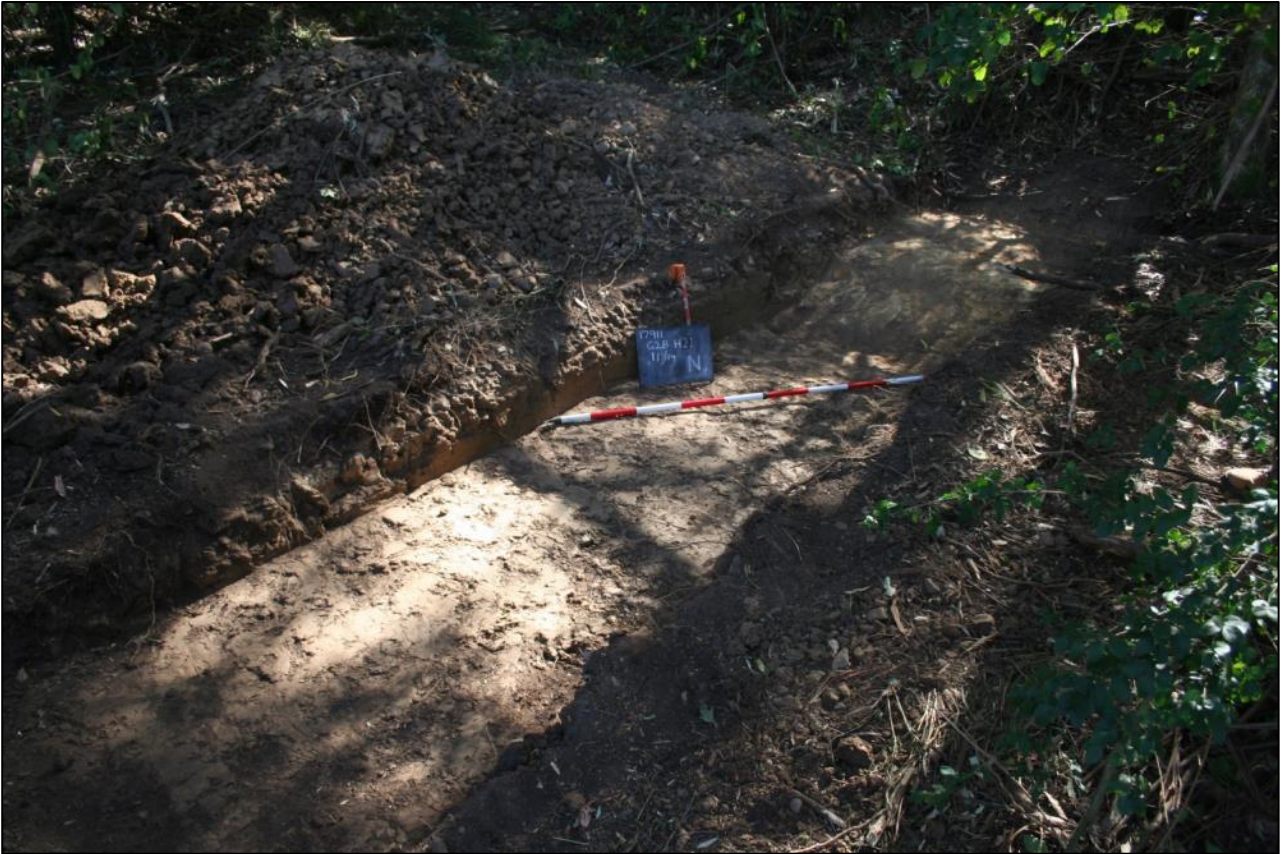
Plate 15: North facing oblique photograph of G2B H21 with 2 m scale (Source: Biosis, 2014).

See Plate 15 for a post excavation photograph of G2B H21 and Plate 16 for an excavated section of the road profile.

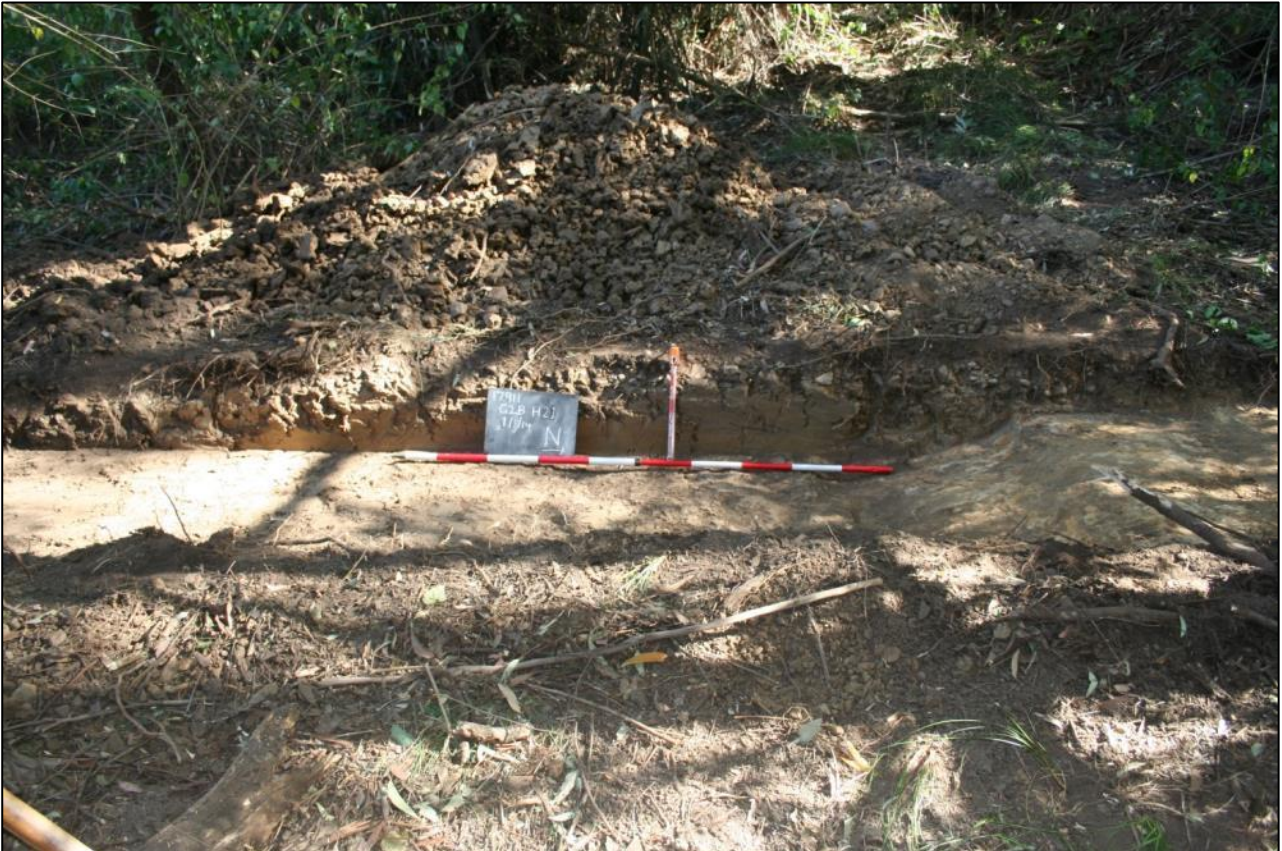
Plate 16: West facing section of G2B H21 with 2 m scale (Source: Biosis, 2014).

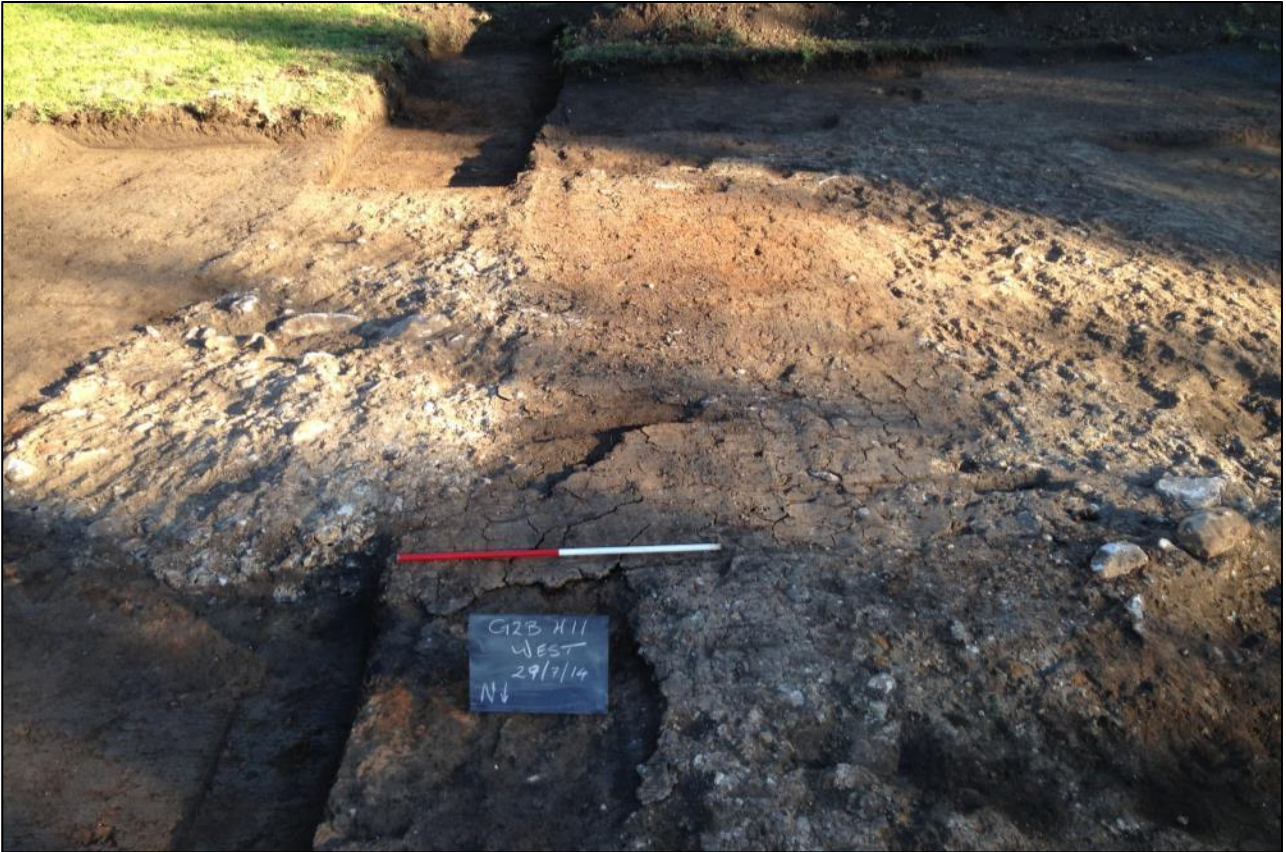
Plate 20: South facing post excavation photograph of G2B H11 - West with 1 m scale (Source: Biosis, 2014).

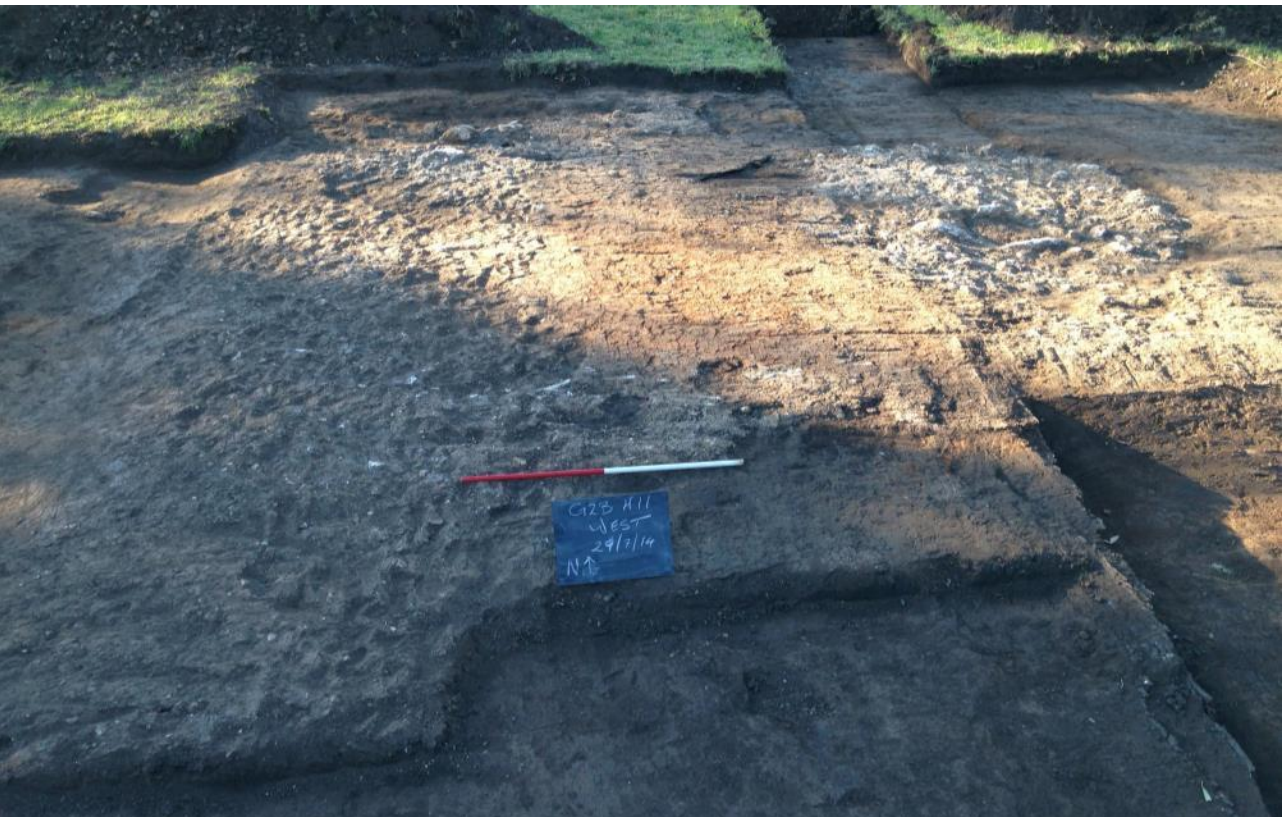
Plate 21: North facing post excavation photograph of G2B H11 - West 1 m scale (Source: Biosis, 2014).

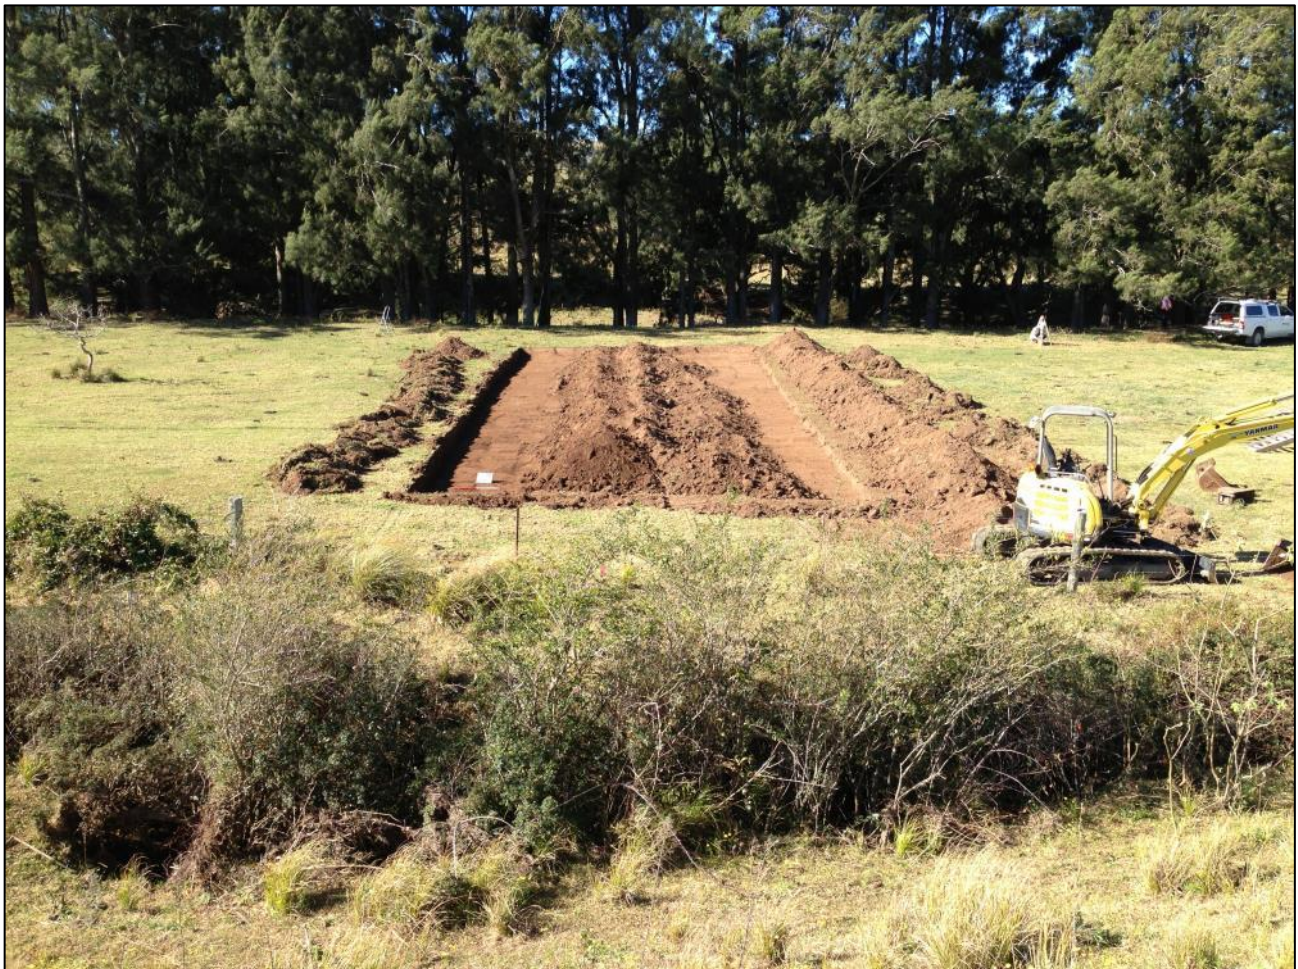
Plate 22: East facing photograph of G2B H28 showing entire stripped area (Source: Biosis, 2014)

The excavations at G2B H28 consisted of a 1.3 m by 6.7 m trench which contained a single deposit and no archaeological features. No artefacts were recovered as part of the excavation of G2B H28. The location of the trench can be seen in Figure 16. Detailed descriptions of these deposits are detailed in Table 13.

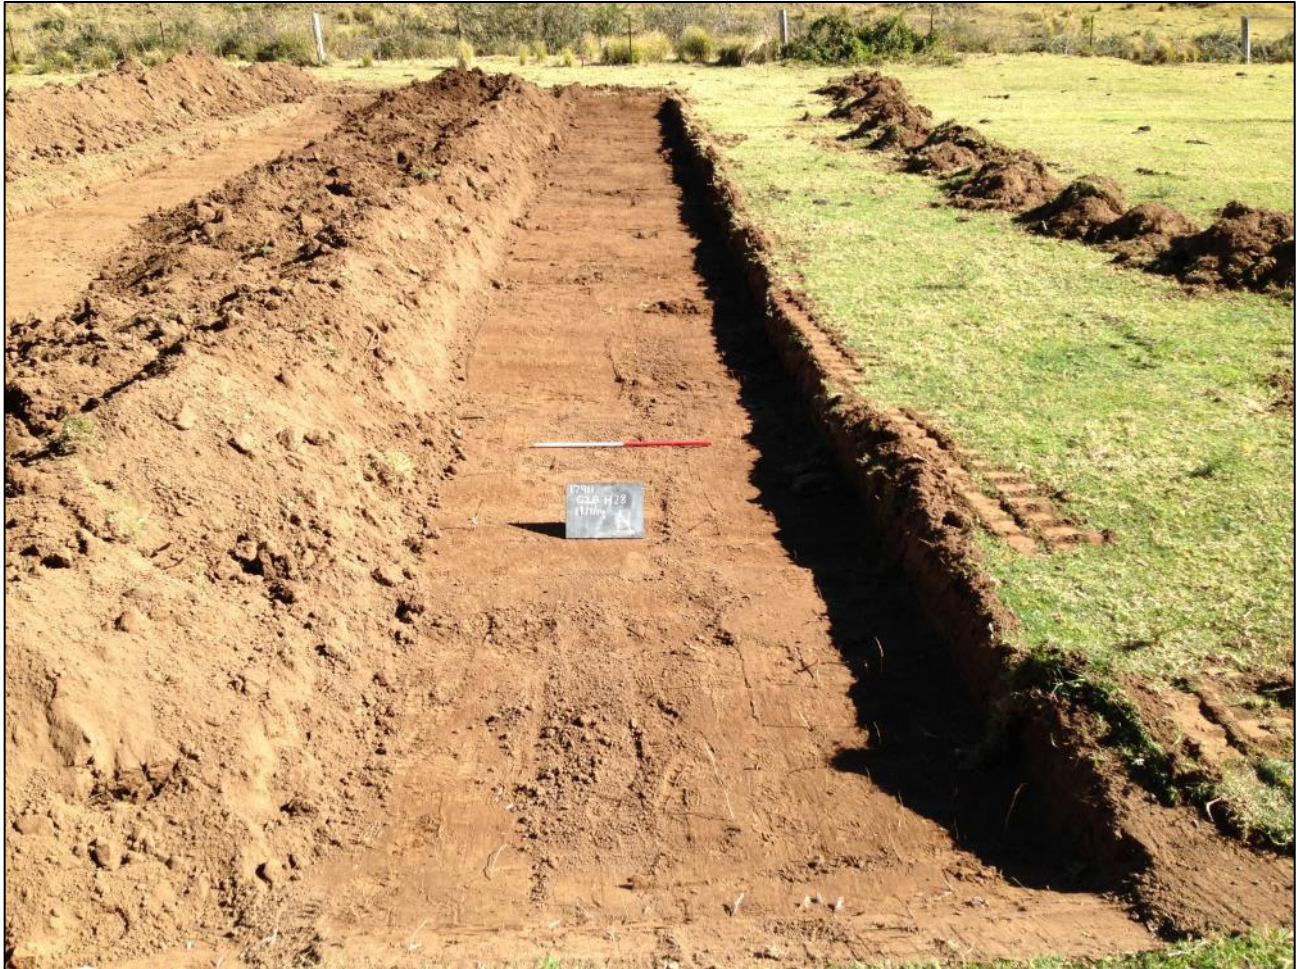
Plate 23: West facing photograph of G2B H28 showing excavated deposits with 1 m scale (Source: Biosis, 2014)

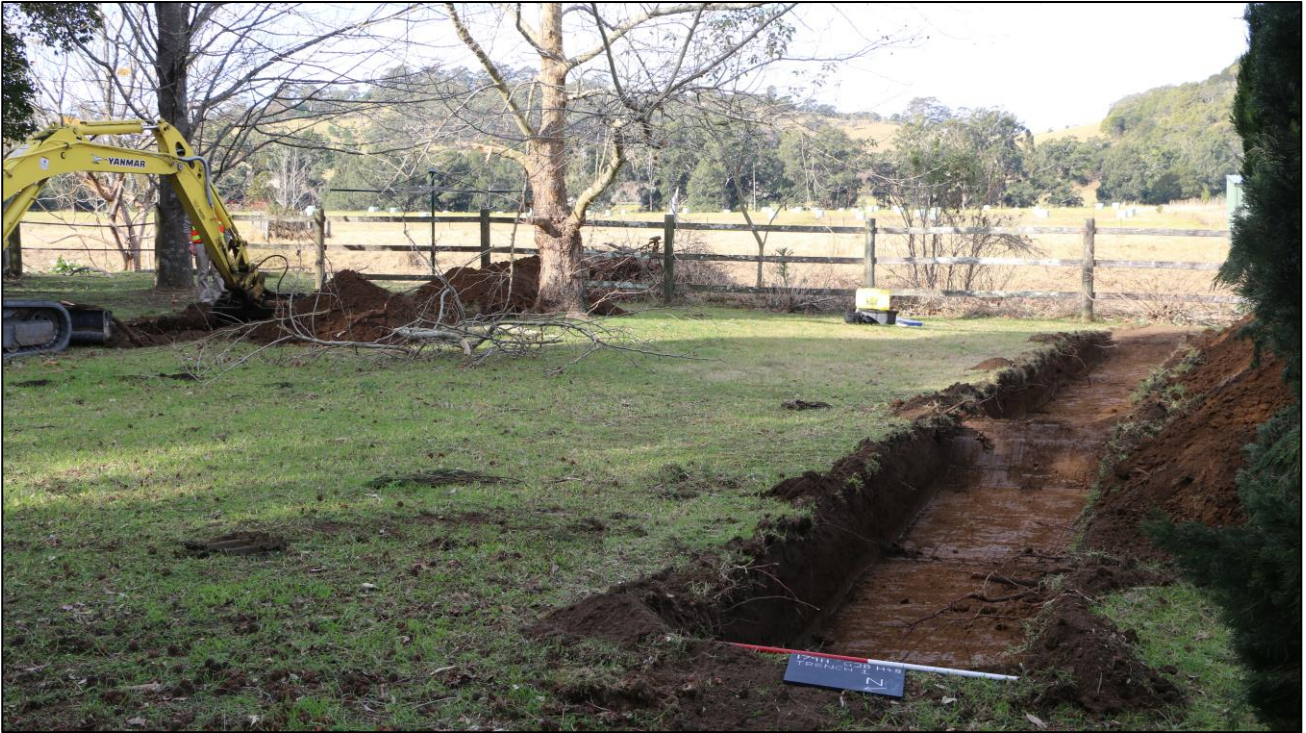
Plate 24: Post-excitation photograph of Trenches 2 and 3 at G2B H48, 1 m scale (Source: Biosis, 2014).

Sample photographs for G2B H48 include Plate 24 and a post-excavation photograph and Plate 25 for an excavated section showing deposits.

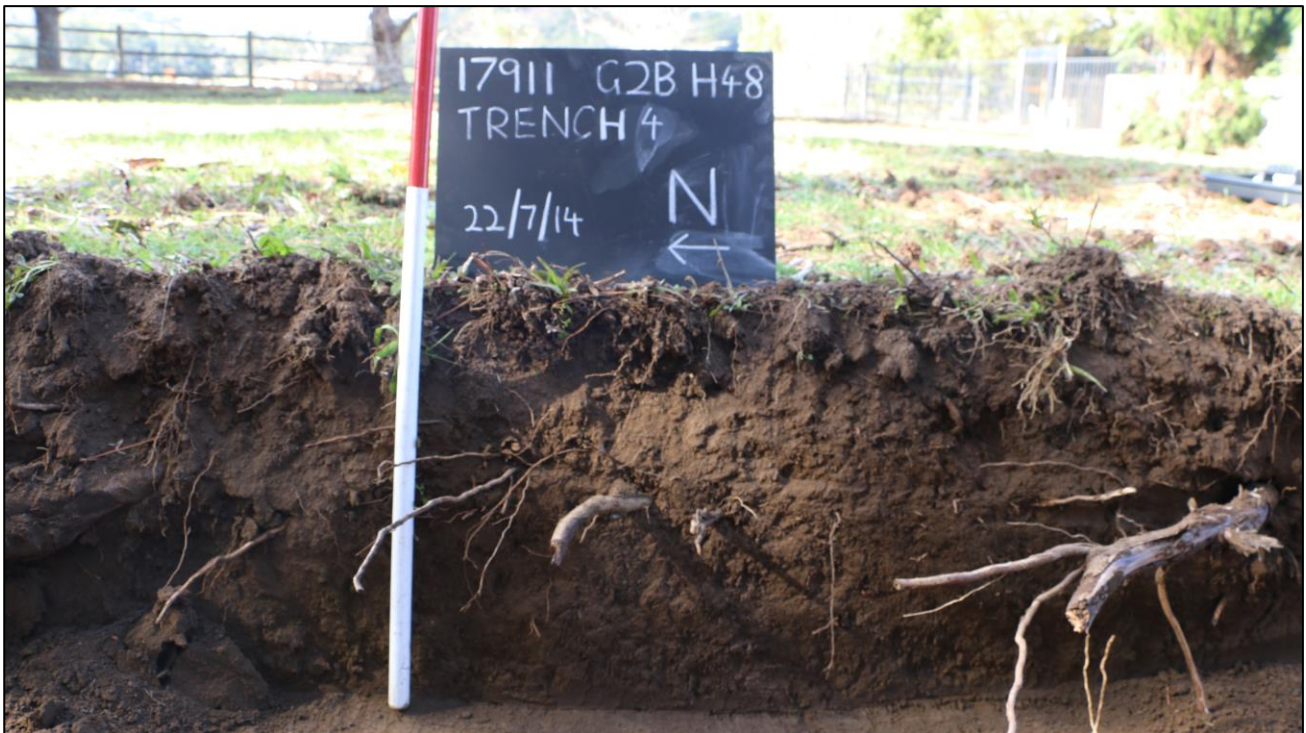
Plate 25: Section photograph showing deposits within G2B H48 from Trench 4, 1 m scale (Source: Biosis, 2014)
