Foxground and Berry Bypass: Archaeological Investigation Report

Prepared for Roads and Maritime Services

2 September 2014

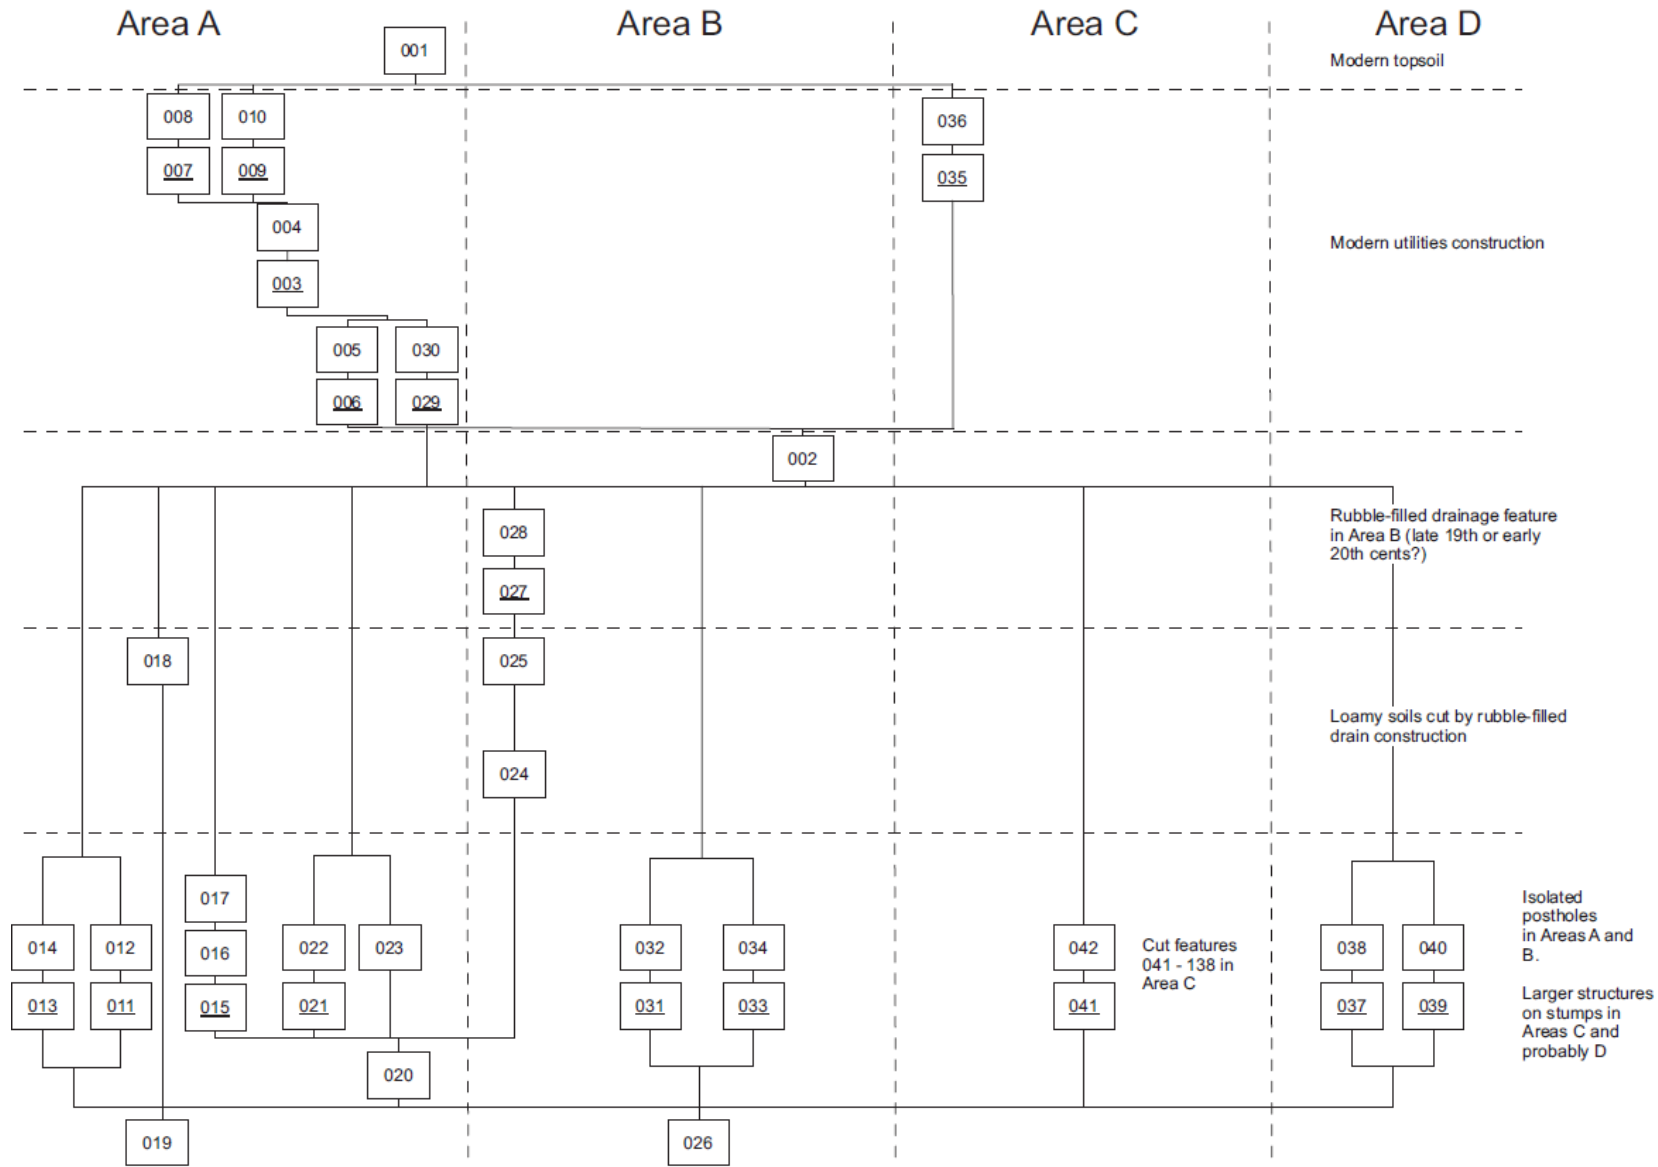
Figure 18:
Stratigraphic matrix for archaeological features within G2B H49 (Source: Biosis, 2014).

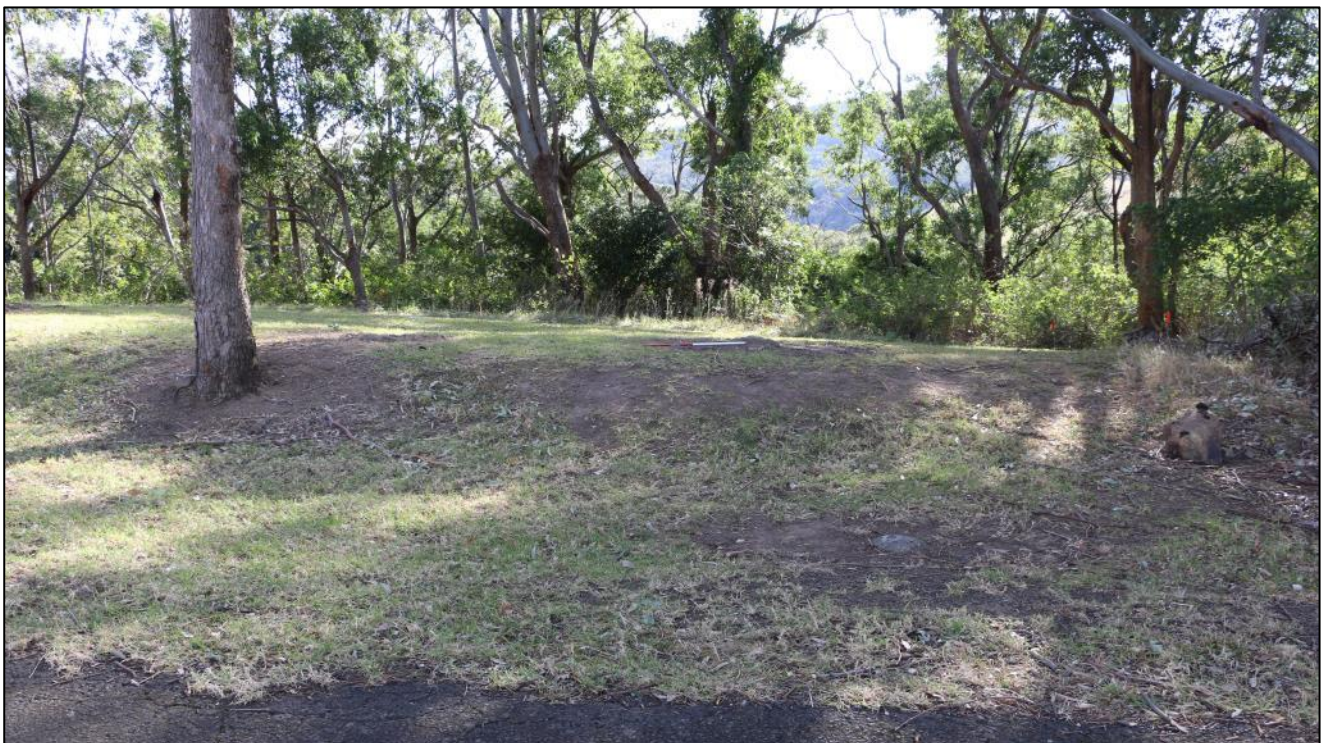
Plate 30: West facing pre excavation photograph of G2B H53, 1 m scale (Source: Biosis, 2014).

A pre-excavation photograph and selection of photographs detailing the extent of excavations can be seen in Plate 30, Plate 31 and Plate 32.

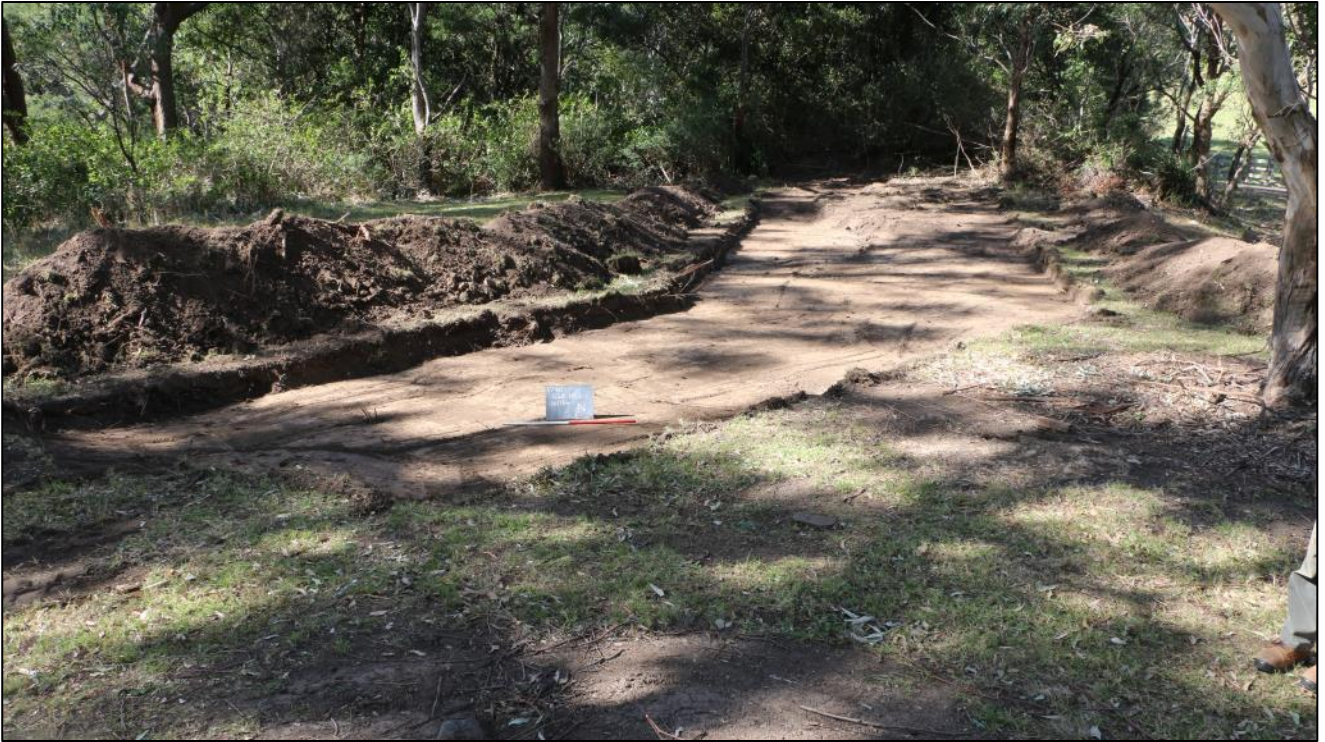
Plate 31: North-west facing post excavation photograph of G2B H53, 1 m scale (Source: Biosis, 2014).

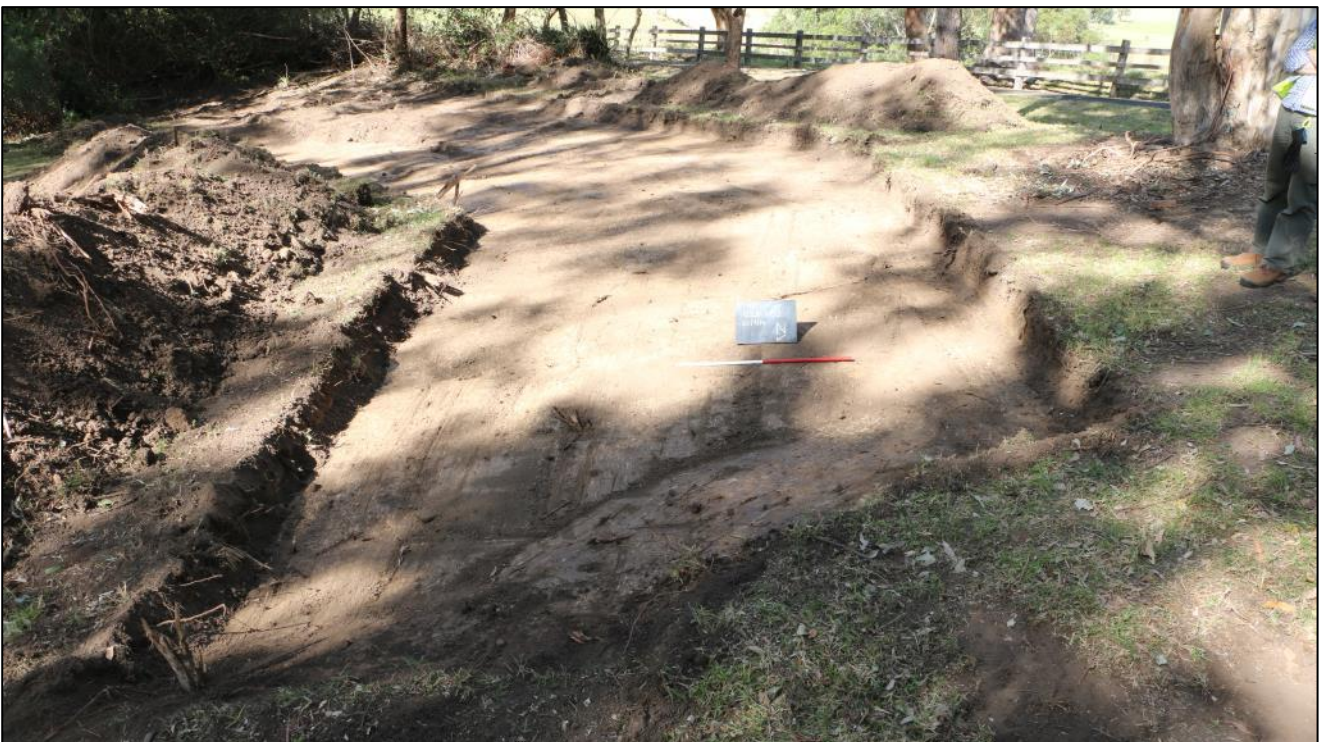
Plate 32: North facing post excavation photograph of G2B H53, 1 m scale (Source: Biosis, 2014).

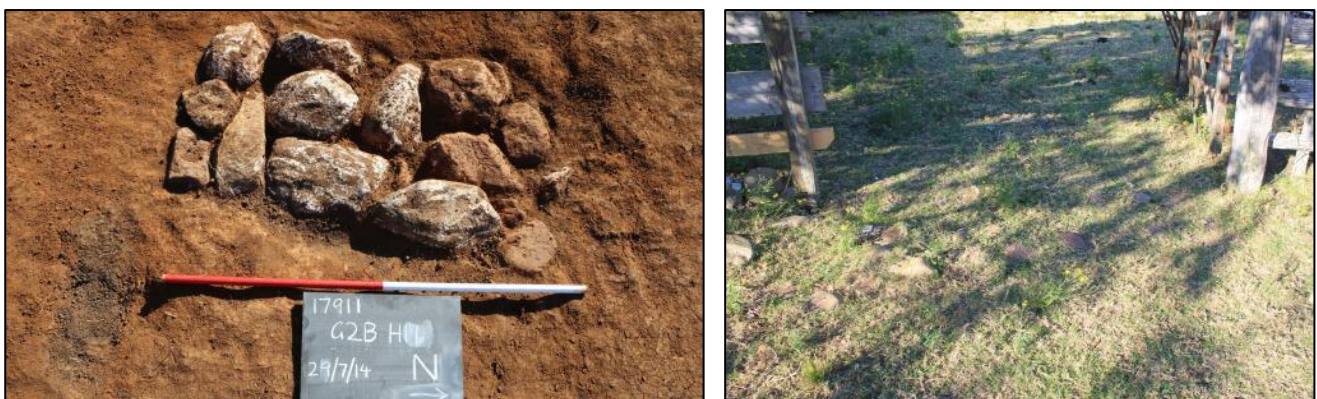
Plate 33: Comparison between feature 006 at G2B H11 – East and example of stone surface within cattle run observed locally during excavations (Source: Biosis 2014).

Excavations at G2B H11 (East and West) and G2B H49 did identify substantial archaeological remains; however whether these are associated with tenant farms is debatable. None of the excavations identified any underfloor deposits or structural evidence of hearths. The excavations at G2B H49 identified a large number of diffuse post holes and features which have been heavily truncated through modern land use activities. Although limited evidence of wall cuts were present the size of the post holes indicates that the trench identified the site was most likely the location of several permutations of small agricultural structures. The excavations at G2B H11 – East identified post holes and stone feature, however the post holes had been disturbed through rabbit burrowing. The stone feature (006) at G2B H11 – East, whilst substantial may represent a small surface used to reinforce the ground surface against cattle movement. Examples seen at local properties display similar characteristics in terms of the size, shape and composition of the stone used (see Plate 33). If correct, this may indicate that the post holes and features within G2B H11- East represent a cattle run rather than a structure.

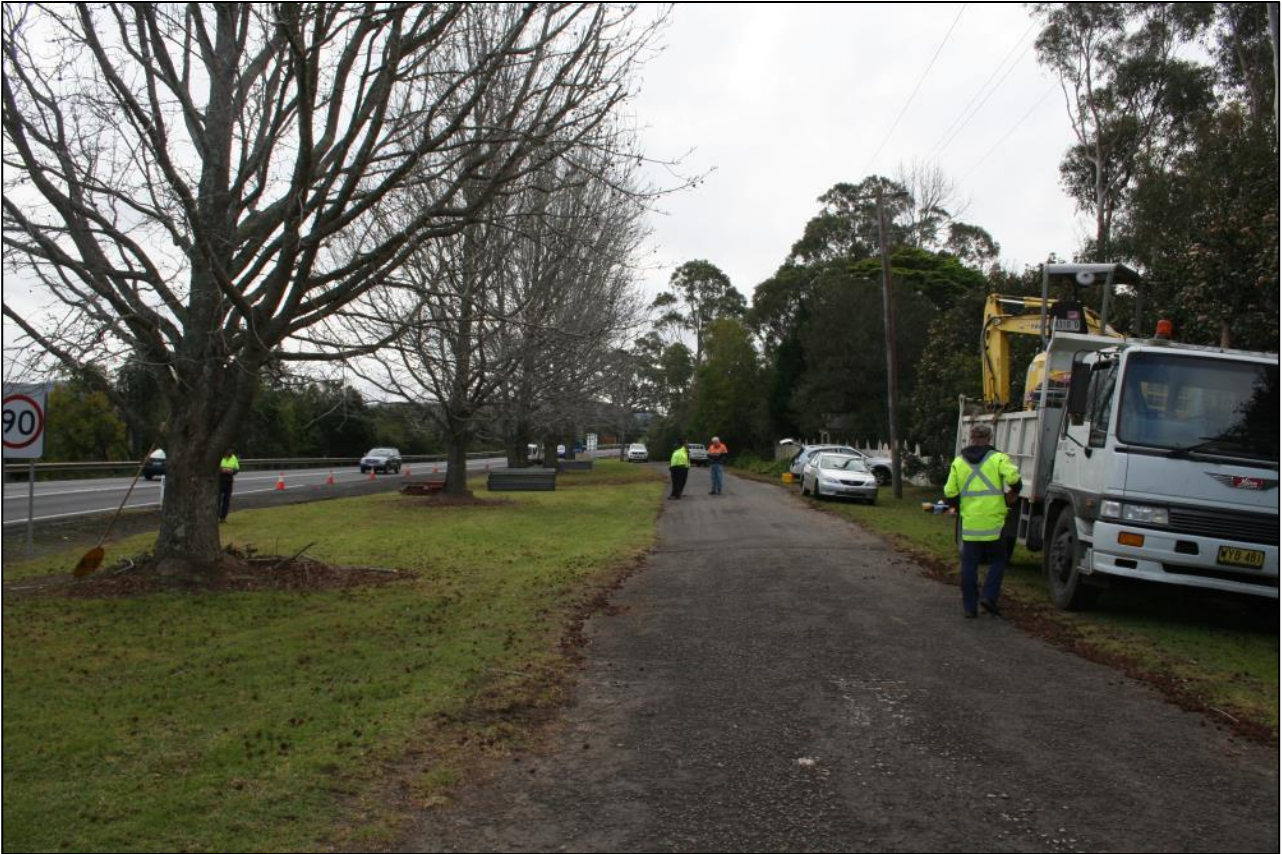
Plate 34: Pre-excitation photograph of G2B H14 (Source: Biosis, 2014).

Pre and Post excavation photographs of G2B H14 are displayed in Plate 34 and Plate 35.

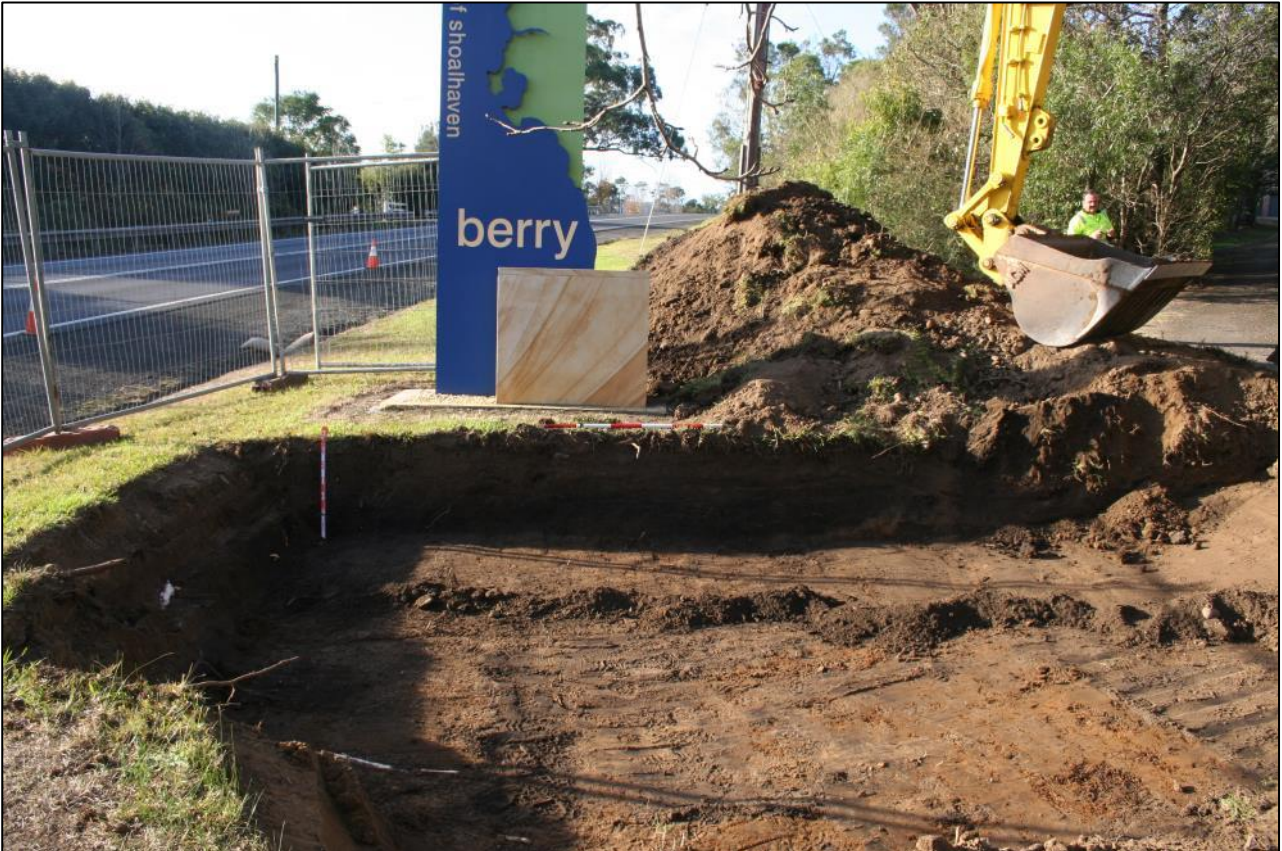
Plate 35: North facing section photograph of Trench 1 (Source: Biosis, 2014).

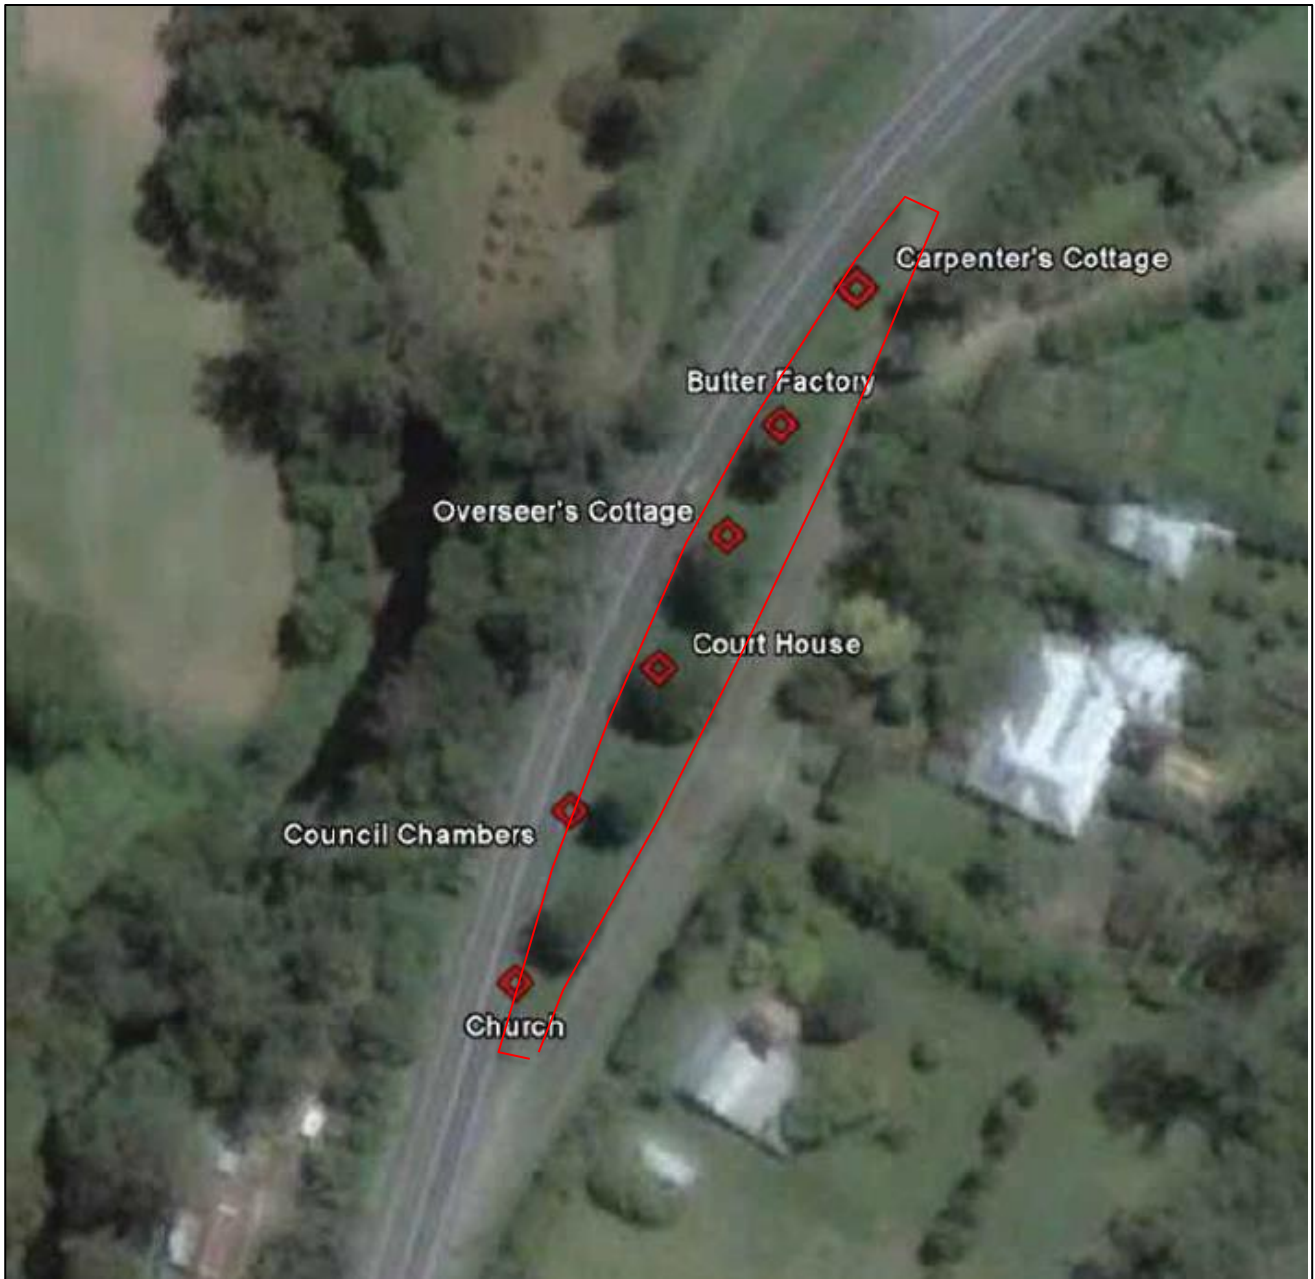
Plate 5: Configuration of Broughton Creek Village according to NOHC 2012: Figure 6.1, page 81. The Red annotation denotes the approximate area of open area excavation.

Archaeological salvage was recommended within the construction footprint associated with G2B H14 for the area to be lowered and under the road platform. The site visit conducted by Biosis has indicated that archaeological remains are unlikely to occur underneath the road platform given the extent of disturbance which has taken place within this area. As a result, Biosis is proposing to undertake an open area excavation between the current Princes Highway and old alignment which has the highest potential to contain intact archaeological structural and depositional remains.
