Foxground and Berry bypass

Princes Highway upgrade

Volume 2 – Appendix J

**Technical paper:
Aboriginal heritage**

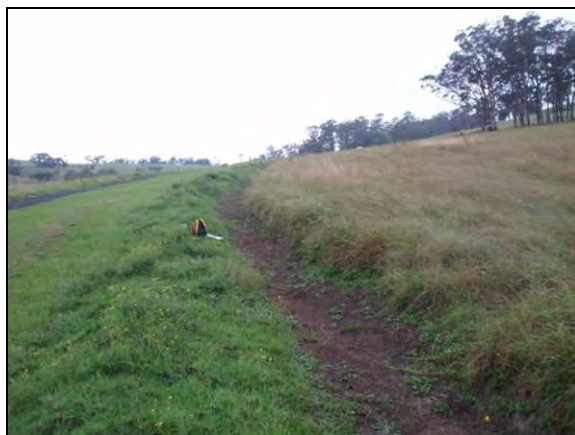
Figure 6-1: G2B A3 - Looking upslope along drainage ditch in which artefacts are exposed

The artefacts occur within an interval of 160 metres and have been exposed as a result of mechanical ground disturbance (**Figure 6-1** and **Figure 6-2**). No artefacts were noted outside of mechanical exposures. All artefacts appear to be associated with the upper 10 to 20 centimetres of the exposed soil profile.

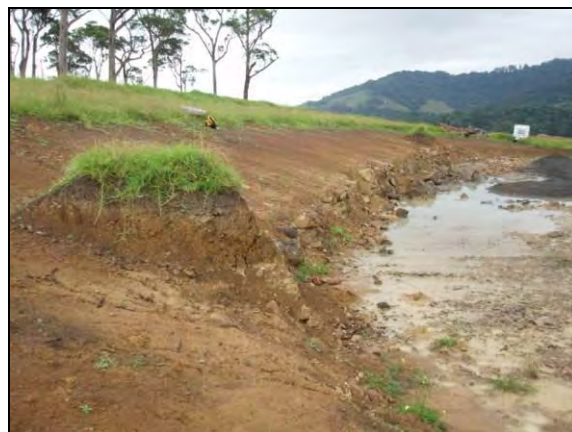
Figure 6-2: G2B A3 – Looking across excavated platform, artefacts are exposed along upslope edge of embankment

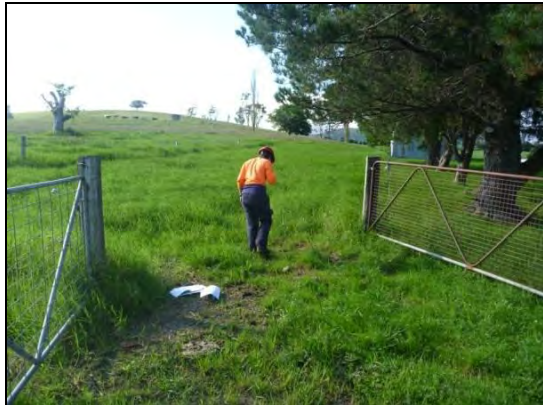
Figure 6-3: Looking across the location of isolated surface find (G2B A38)

This site consists of a single surface stone artefact and an associated area of assessed archaeological potential. It is located within a property being considered for use as an ancillary area (NOHC 2012). The artefact was located on the crest of a south facing, descending minor spur, in a basal slope valley context. The site overlooks an unnamed tributary of the Crooked River (**Figure 6-3**, **Figure 6-4** and **Figure 6-5**).

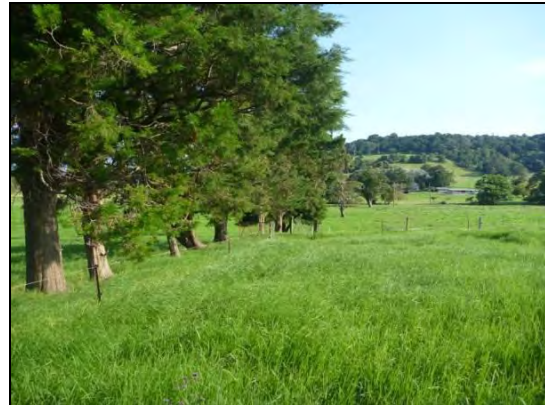
Figure 6-4: Looking towards site G2B A 38 (at gate in middle of picture)

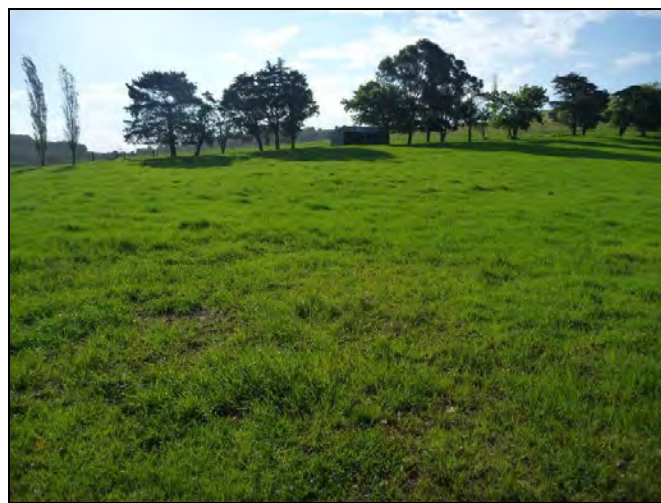
Figure 6-5: Looking from the valley floor towards G2B A38 and the associated basal slopes which constitute a surrounding area of archaeological potential

Given the poor visibility and high archaeological potential of the ground surrounding the find (indicated by its locally elevated, low gradient nature, adjacent to the valley floor and a tributary streamline), an area of archaeological potential has been identified in association with the surface find. This area has approximate dimensions of 100 x 80 metres in area and has a moderate potential to contain Aboriginal objects.

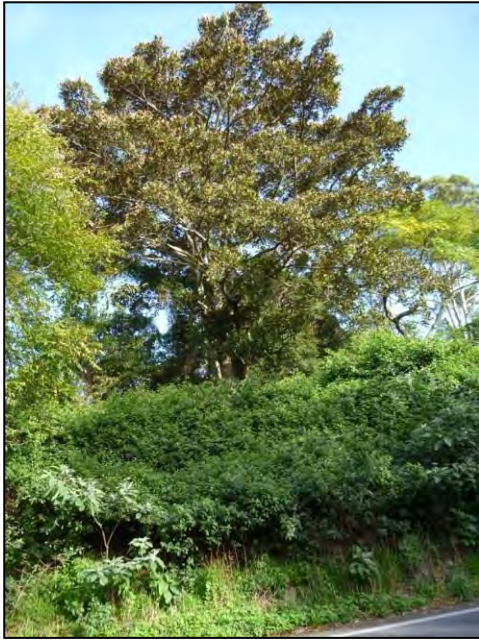
Figure 6-9: A low and spreading fig tree (MFT12) on the crest of Toolijooa Ridge. This is the only fig tree within the construction zone.

Only one of these trees, MFT12, located on the crest of Toolijooa Ridge, is situated within an area of anticipated direct construction impact. A review of aerial photography reveals that this tree has grown substantially since 1958, where it is evident as a relatively small tree (**Figure 6-9**).

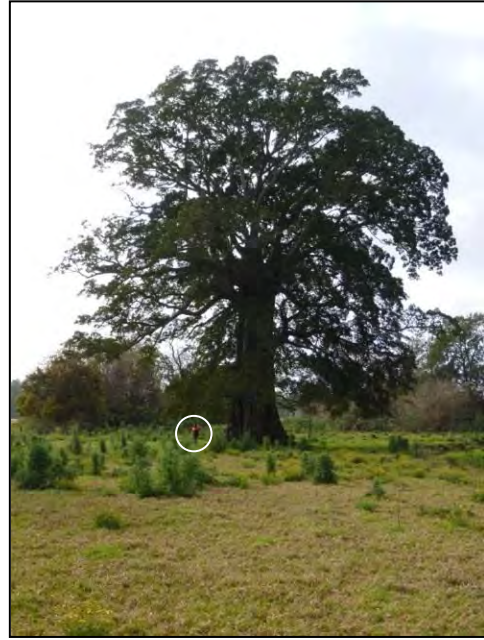
Figure 6-10: A tall and formerly epiphytic fig tree (MFT22) which is clearly a pre-European, tall canopy forest remnant. Note human figure for scale.

The exception is MFT22, which, by its growth pattern and height, is clearly an old-growth remnant of a high canopy forest and certainly predates the arrival of Europeans (**Figure 6-10 and Figure 6-12**).

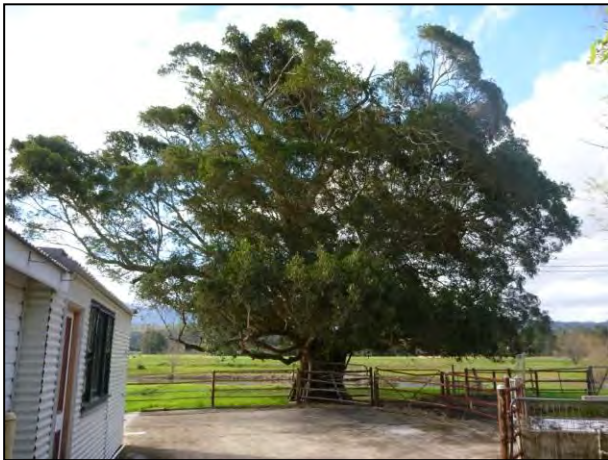
Figure 6-11: A low and spreading fig tree which was probably planted as part of farmhouse development (MFT23)

To date, twelve large or old growth fig trees (MFT12 – MFT23) have been noted within or near the project area (**Figure 6-9 – Figure 6-12**). With one exception, all of these are interpreted as trees which have grown and matured within an open grassland environment, after the clearance of the original high canopy forest. This assessment is based on the low and spreading nature of the trees and the absence of any evidence for an early epiphytic phase (i.e. early growth in the canopy branch of another tree and later strangulation of that tree). Based on the location of many of these trees at the sites of extant or former European homesteads, many of these examples are likely to have been planted (**Figure 6-11**).

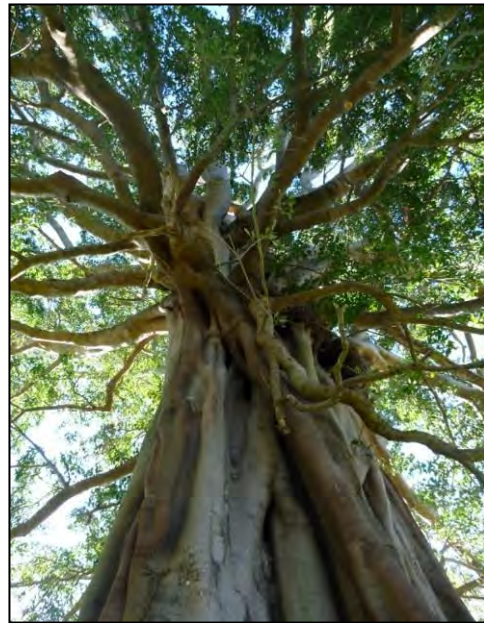
Figure 6-12: View looking up MFT22, showing characteristic 'strangler fig' nature of the tall trunk.

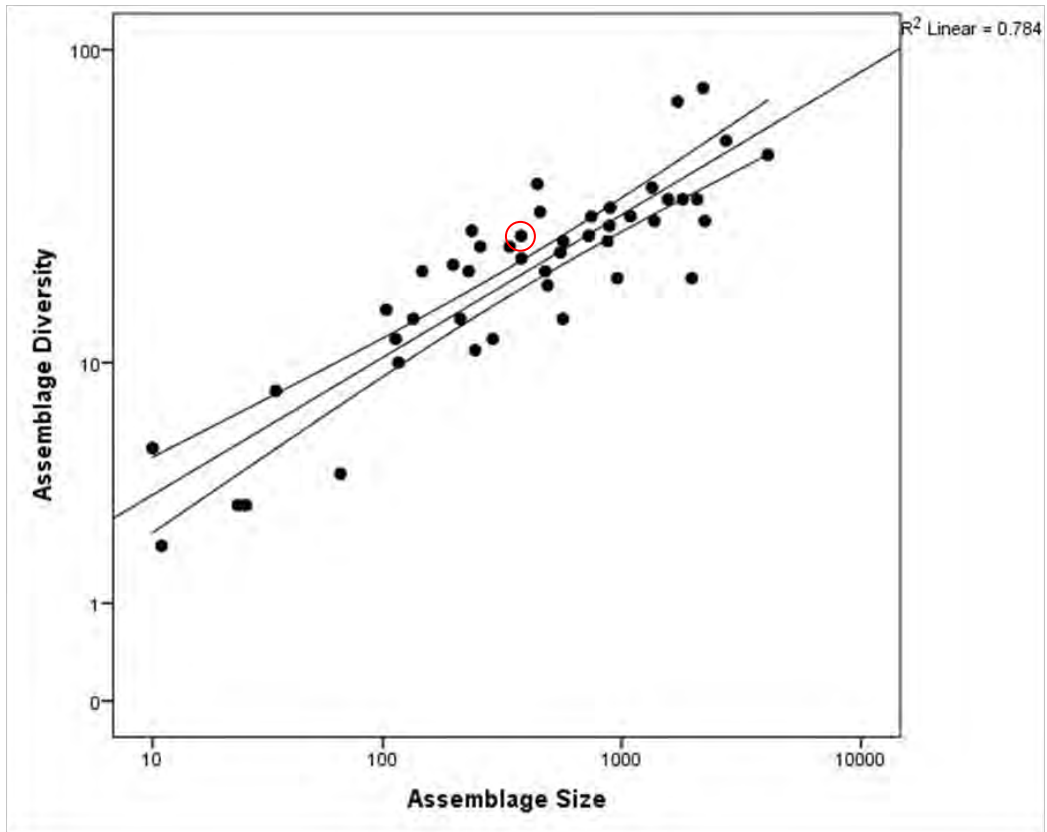
Figure 7-9: Assemblage richness for the project study (red circle) in comparison to 39 assemblages from southeastern Australia.

However, an issue that arises that is further discussed below is that several assemblage types relate to heat damage, and are not representative of cultural factors creating assemblage diversity. Even with heat damage components removed from the assemblage diversity count, the project assemblage remains above the 95 per cent confidence interval.

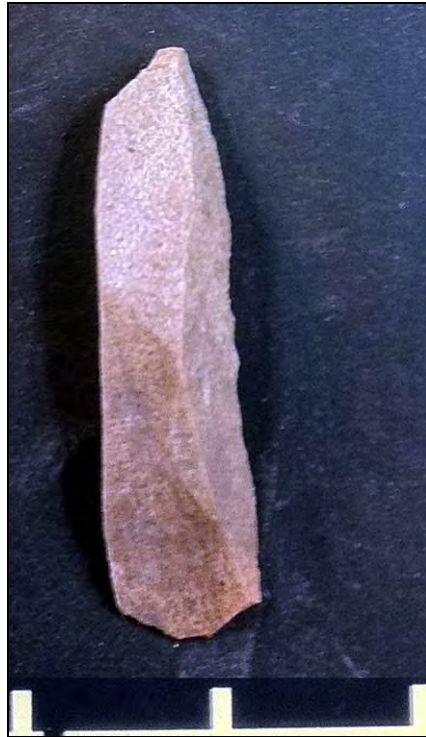
Figure 7-11: Silcrete microblade (No.27)

Flakes are all of widely varying shape and size however, with most being squat and somewhat parallel sided. Silcrete flakes stand out as having higher than average elongation, and indeed one microblade of silcrete was found in the assemblage (**Figure 7-11**).

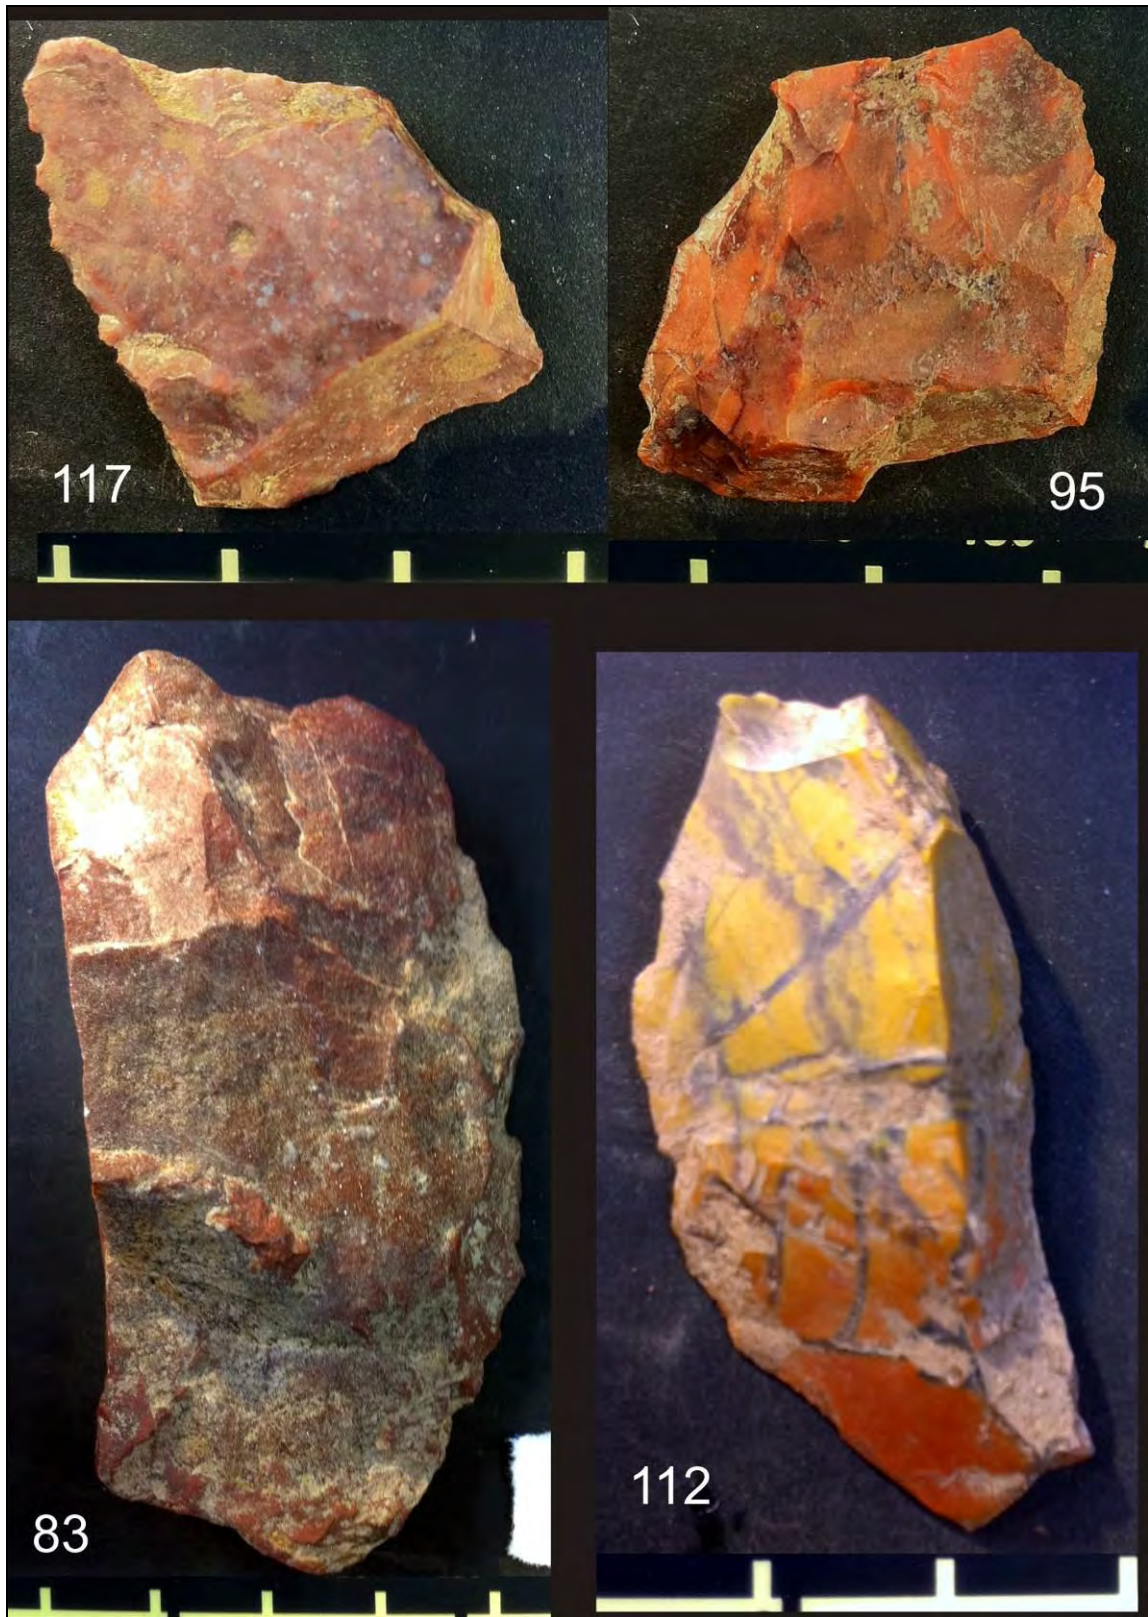
Figure 7-12: Some examples of complete chert flakes

Table 7-11 provides summary statistics for complete flakes (N=66) from the project assemblages (**Figure 7-11** and **Figure 7-12**). It can be observed from this table that flakes made from most raw materials excepting quartzite and mudstone are small, with chalcedony being the smallest.

Figure 7-12 provides examples of complete flakes found in the project assemblage.

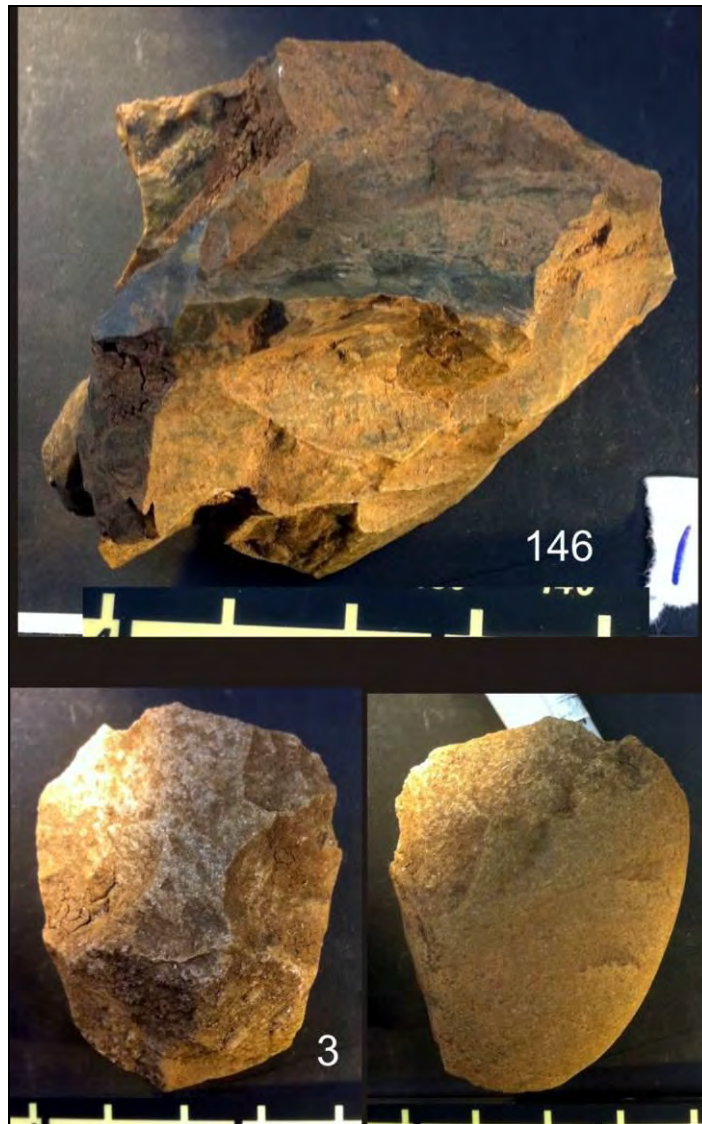
Figure 7-13: Examples of cores from the project assemblage. No.146 is an extensively rotated chert core. Number 3 is a quartzite core with a conchoidal platform

Figure 7-13 provides examples of cores from the assemblage.

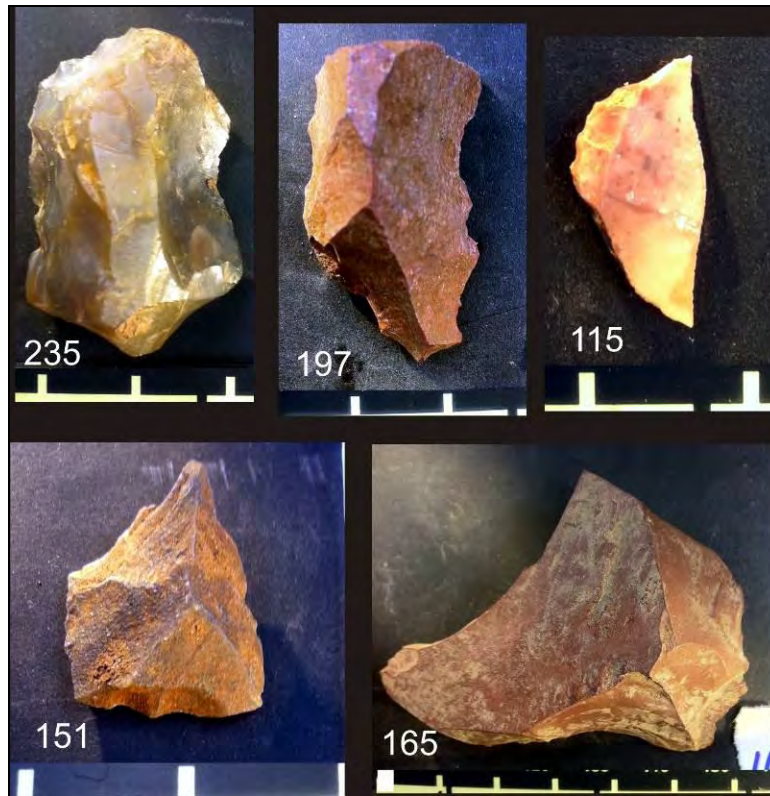
Figure 7-14: Retouched flakes from the project assemblages. 235: Notched double side and end scraper, 197: extensively retouched broken scraper, 115: asymmetric backed artefact, 151: end scraper, 165: notched broken scraper.

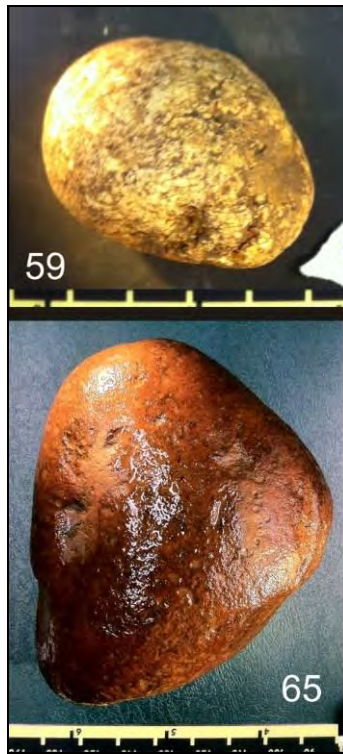
Figure 7-15: Hammerstones and anvils. No. 59: Hammerstone and No.65: hammerstone with anvil pitting.

Two are small hammerstones made from unidentified dense rock (probably plutonic or metamorphic) weighing around 70 grams (**Figure 7-15**). Both have broken areas that are suggestive of impact damage. The other hammerstone also shows impact pitting and was likely also used as an anvil. It is much larger and is made from softer stone, most likely mudstone.

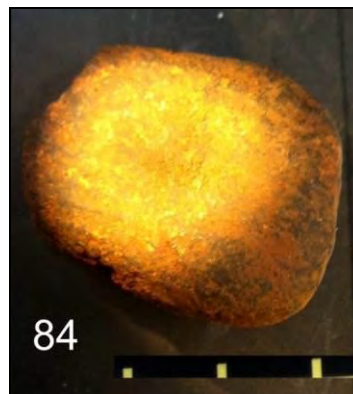
Figure 7-16: Yellow ochre crayon

A single large piece of yellow ochre, now stained black on the external surface, was found in Pit 2, Spit 4 at PASA 20 (**Figure 7-16**). Although no striations were visible under a hand lens, faint lineations do appear to be present; it seems likely that this piece is a crayon that smoothed and shaped by rubbing against a hard surface to apply colourant.

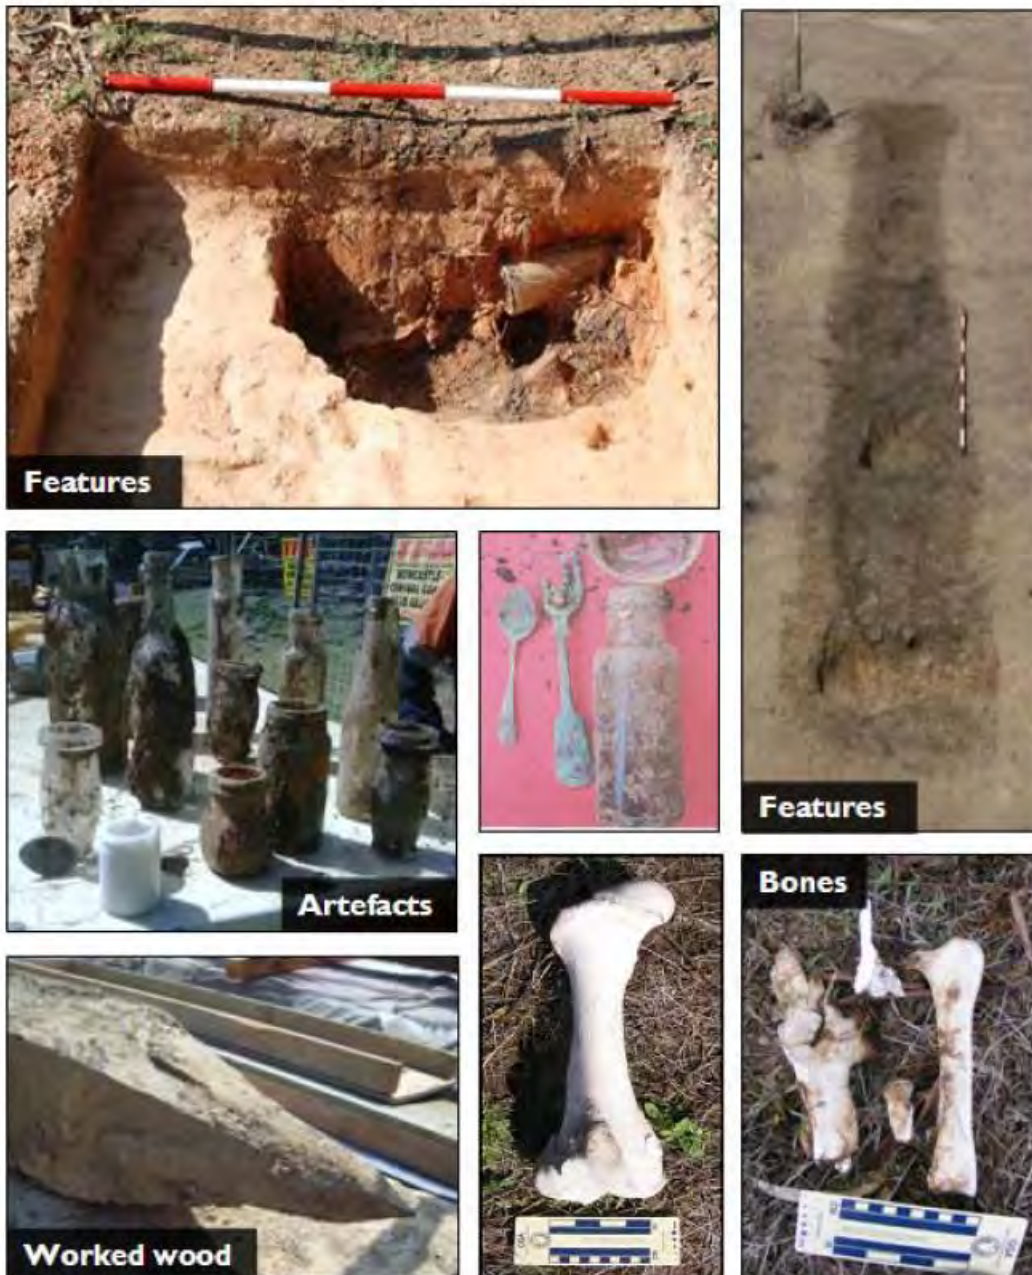
Top left hand picture continuing clockwise: Stock camp remnants (Hume Highway Bypass at Tarcutta); Linear archaeological feature with post holes (Hume Highway Duplication), Animal bones (Hume Highway Bypass at Woomargama); Cut wooden stake; Glass jars, bottles, spoon and fork recovered from refuse pit associated with a Newcastle Hotel (Pacific Highway, Adamstown Heights, Newcastle area).

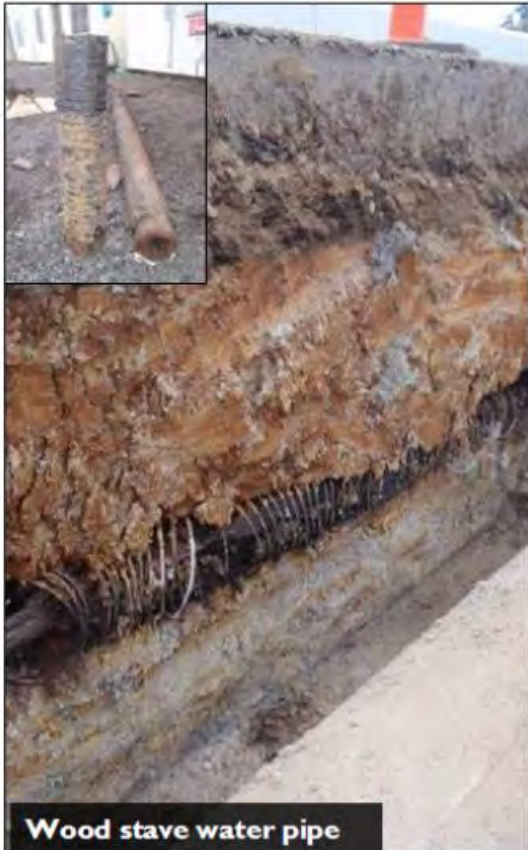
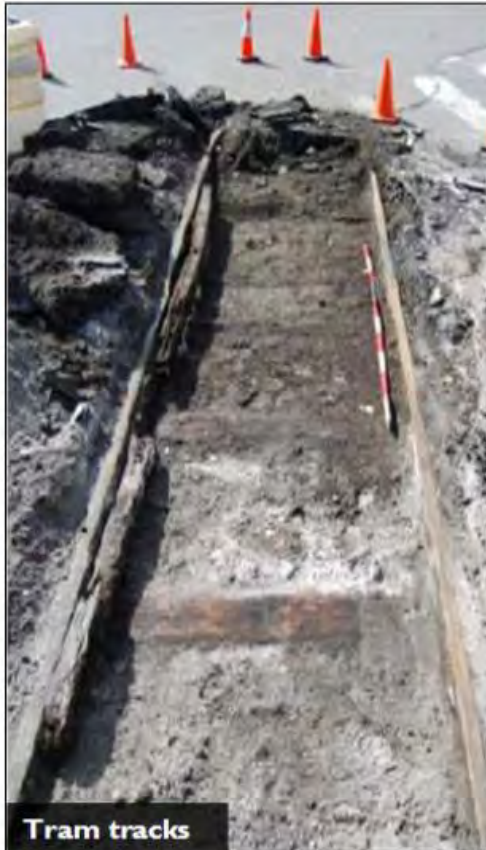
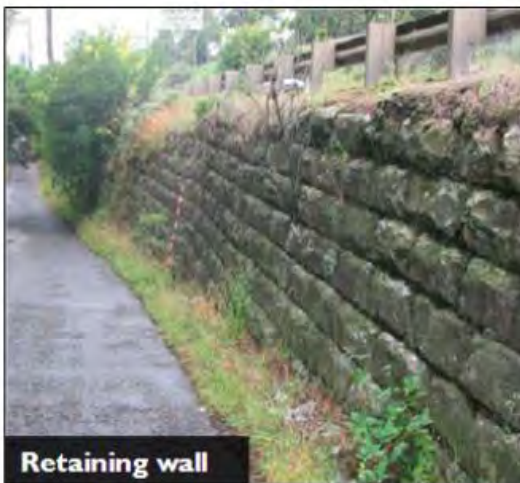
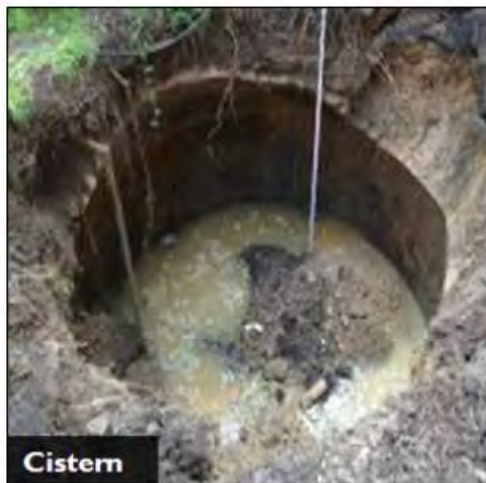
Top left hand picture continuing clockwise: Woodstave water pipe with tar and wire sealing (Horsley Drive); Tram tracks (Sydney); Brick lined cistern (Clyde); Retaining wall (Great Western Highway, Leura).

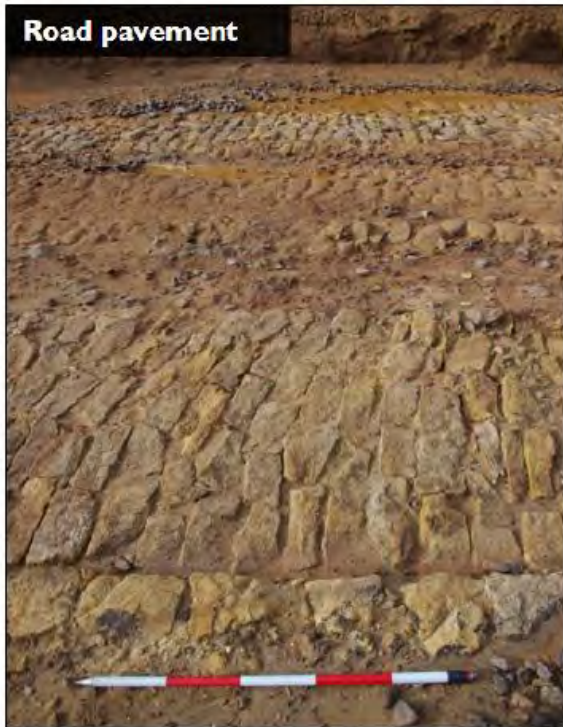
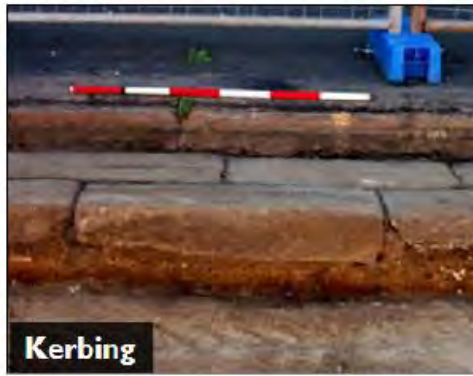
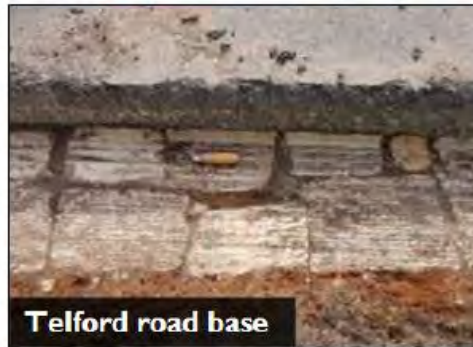
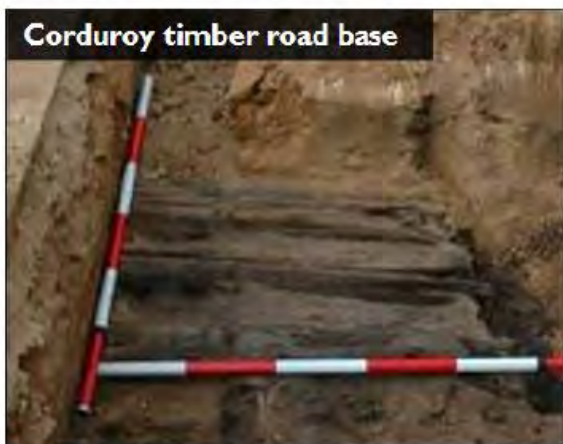
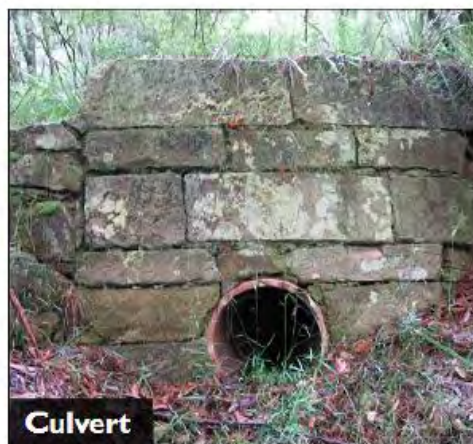
Top left hand picture continuing clockwise: Road pavement (Great Western Highway, Lawson); Sandstone kerbing and guttering (Parramatta Road, Mays Hill); Telford road (sandstone road base, Great Western Highway, Leura); Ceramic conduit and sandstone culvert headwall (Blue Mountains, NSW); Corduroy road (timber road base, Entrance Road, Wamberai).

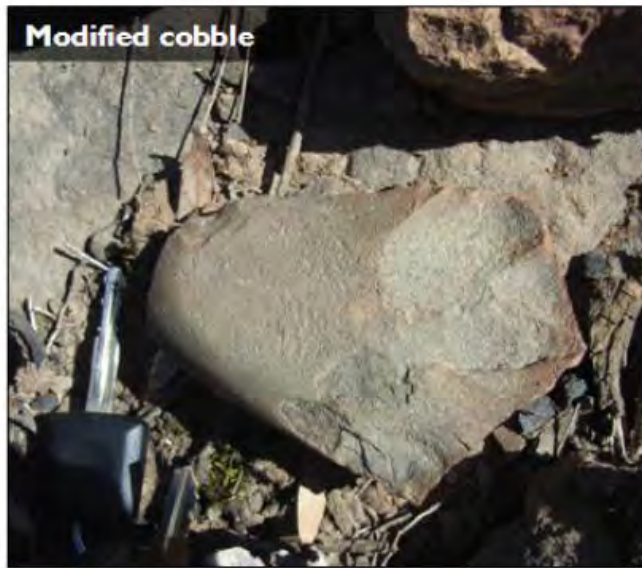
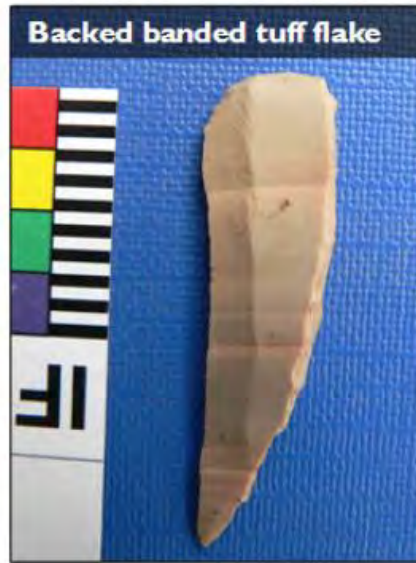
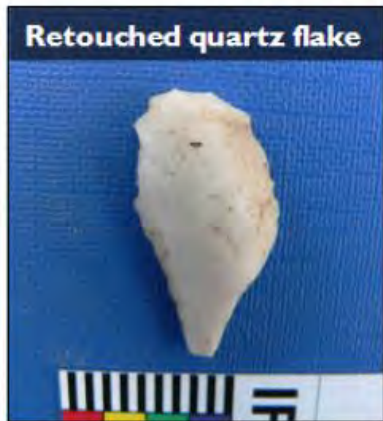
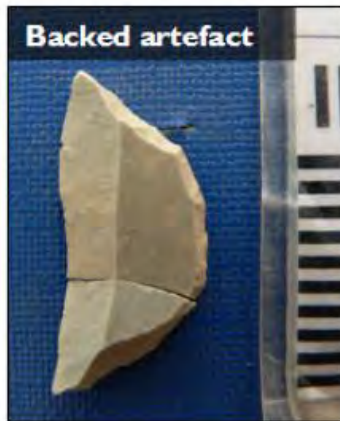
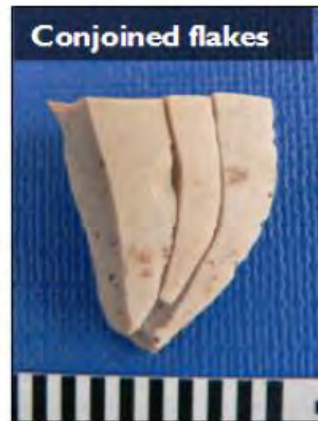
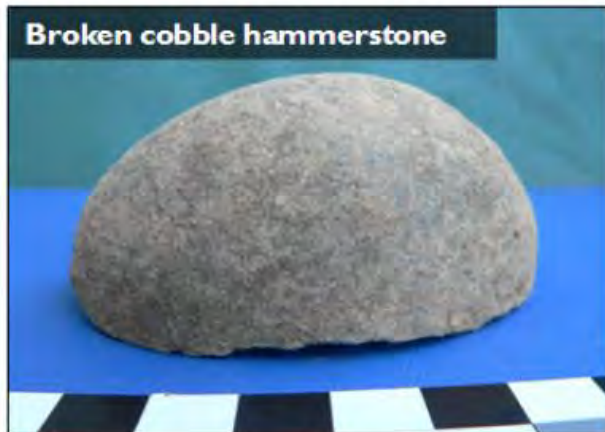
Top left hand corner: Culturally modified stone discovered on Main Road 92, about two kilometres west of Sassafras. The rest of the images show a selection of stone artefacts retrieved from test and salvage archaeological excavations during the Hume Highway Duplication and Bypass projects from 2006-2010.

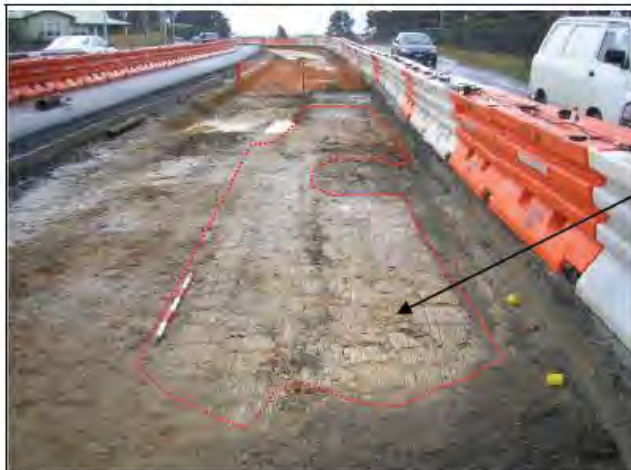
Figure 1: Telford road uncovered on the Great Western Highway (Leura) in 2008.

It is important to take a general photograph (Figure 1) to convey the location and setting of the find. This will add much value to the subsequent detailed photographs also required (Figure 2).

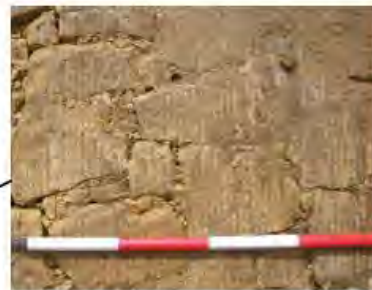
Figure 2: Close up detail of the sandstone surface showing material type, formation and construction detail. This is essential for establishing date of the feature.

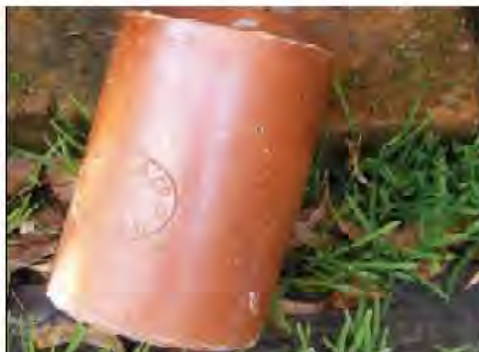
Figure 3: Ceramic bottle artefact with stamp.

Where unexpected finds (eg artefacts) have a distinguishing feature, close up detailed photographs must be taken of this, where practicable. See Figures 3 and 4 for examples.

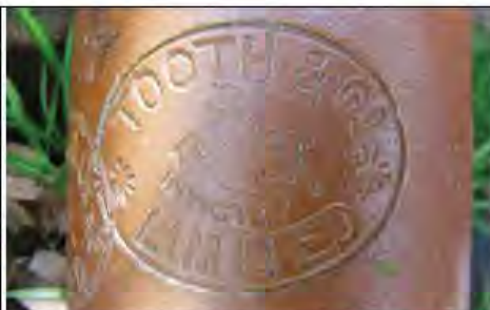
Figure 4: Detail of the stamp allows 'Tooth & Co Limited' to be made out. This is helpful to a specialist in gauging the artefact's origin, manufacturing date and likely significance.

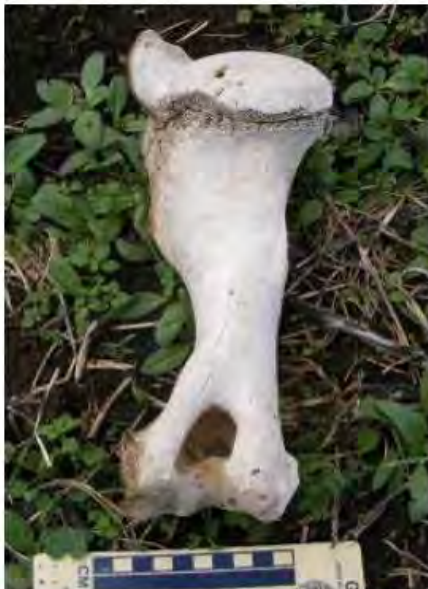
Figure 7: Photograph showing complete bone.

Ensure that all close up photographs include the whole bone and then specific details of the bone (especially the ends of long bones, the *epiphysis*, which is critical for species identification). Figures 7 and 8 are examples of good photographs of bones that can easily be identified from the photograph alone. They show sufficient detail of the complete bone and the epiphysis.

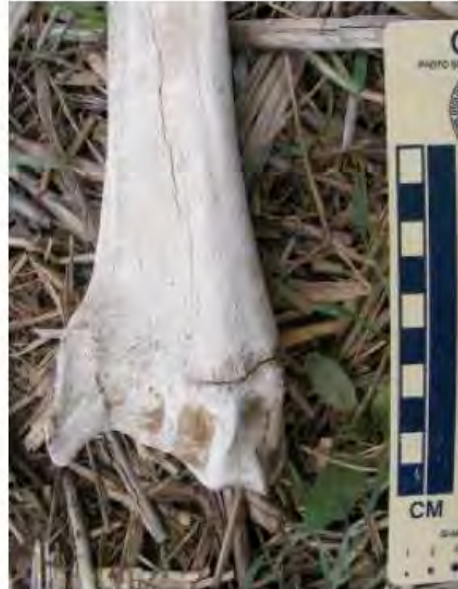
Figure 8: Close up of a long bone's epiphysis.

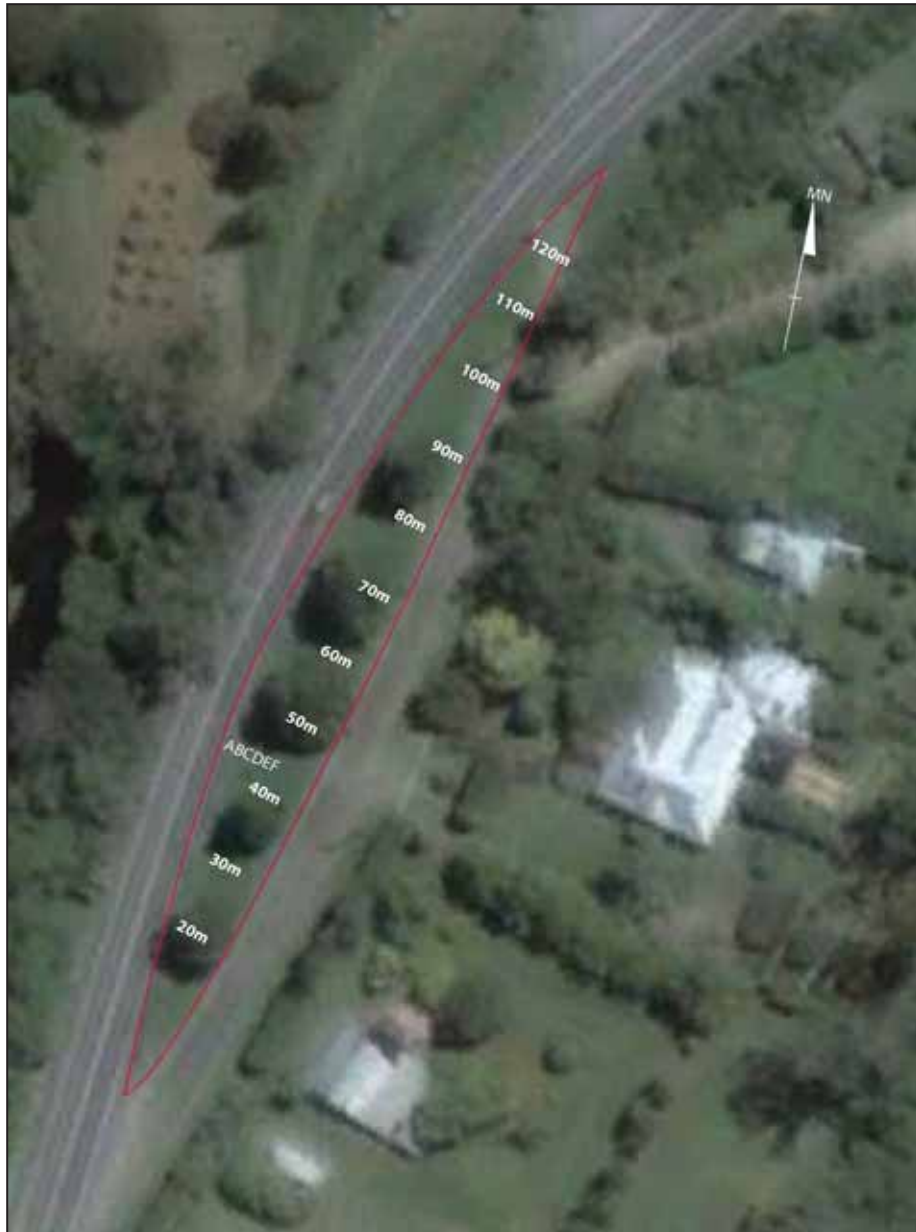
Figure 2.1: Layout of excavation grid at G2B H14 (Base image - Google Earth 2011)

A 120 metre x six metre section of the site was pegged out along the western margin of G2B H14. An alphanumeric grid of one metre x one metre squares was established across this area (aligned to a bearing of 16 degrees) with each grid square allocated a number between '1' and '120' from south to north, and 'A' to 'F' from west to east (**Figure 2.1** and **Figure 5.1**). Each of these one x one metre grid squares was further divided into 50 centimetre x 50 centimetre quadrats identified by roman numerals (northwest: I, northeast: II, southwest: III and southeast: IV).

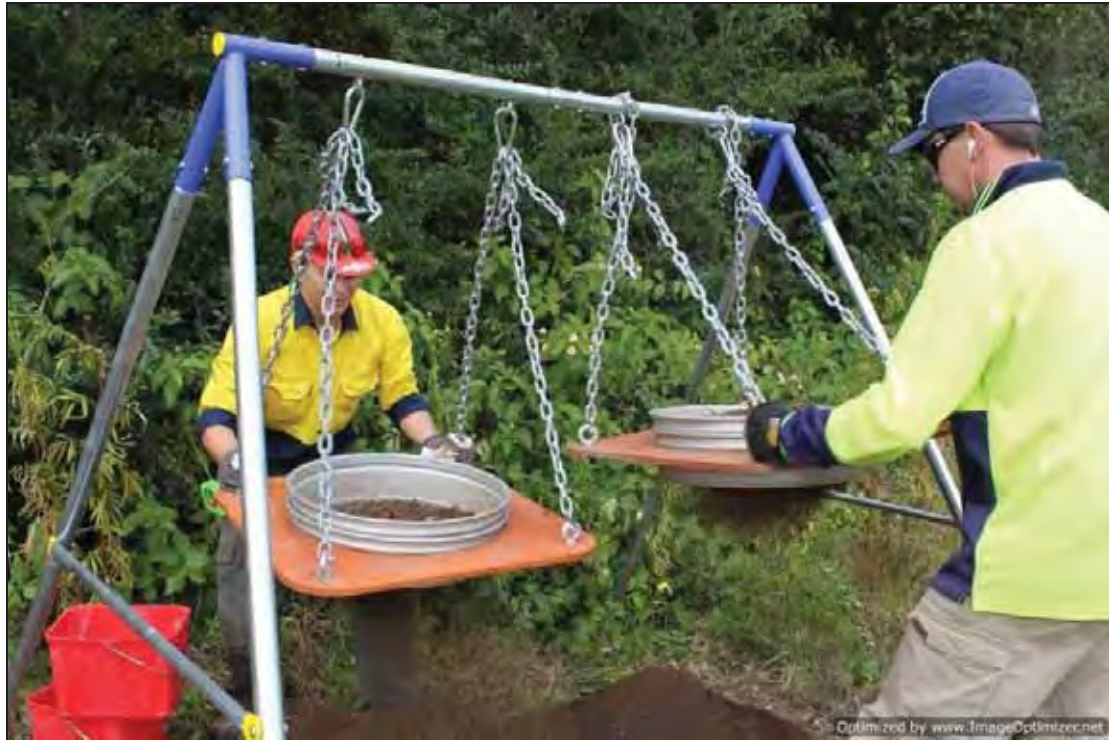
Figure 2.2 Sieve station at G2B H14

The test excavation was undertaken using shovels (including a lightweight pneumatic jack hammer fitted with a shovel-head), trowels and handpicks. Soil recovered from the excavation was 'dry-sieved' through metal sieves with four millimetre meshed apertures (**Figure 2.2**). The excavated area was backfilled with soil recovered from the excavations, and the whole area was re-covered with grass, soil and stones removed from the surface of the site before excavation.

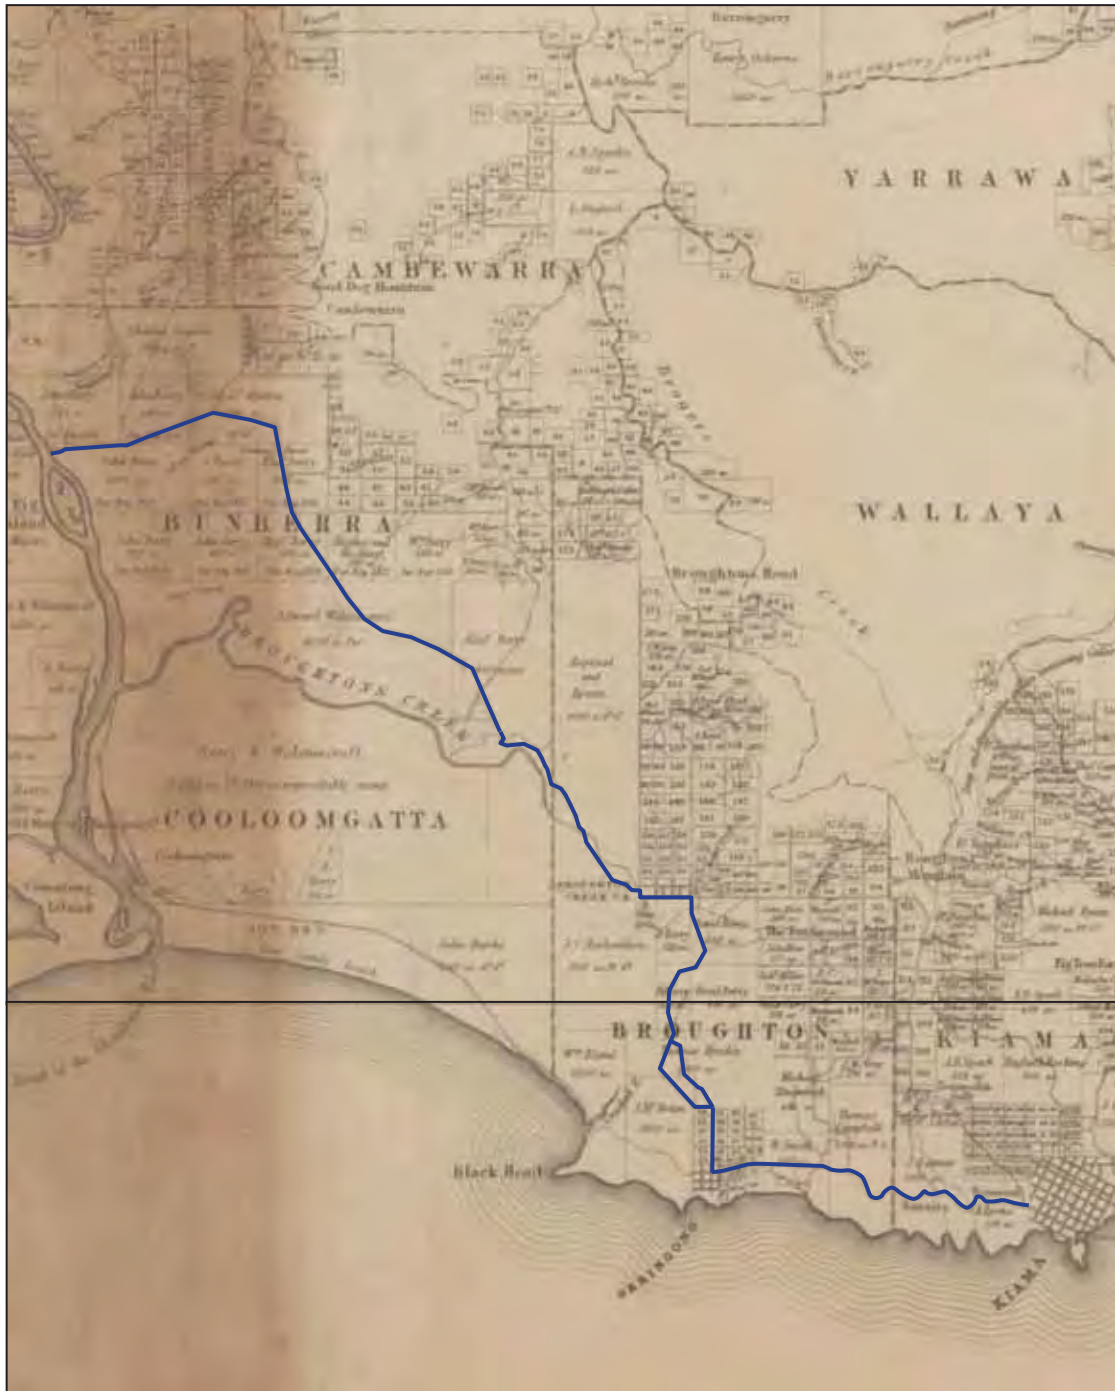
Figure 4.16: Extract from an 1866 map of the County of Camden, showing the location of roads between Kiama, Gerringong, Broughton Creek (Berry) and Bomaderry, highlighted in blue. Note the alignment of the Berry Estate Road between Gerringong and Bomaderry which comprises many straight sections with minimal bends and deviations (County of Camden, New South Wales, 1866 compiled by Messrs Braddock & Baly, & engraved by John L. Ross. National Library of Australia 1866. MAP RM 1798. Part 2; <http://nla.gov.au/nla.map-rm1798-s1-sd-cd>)

The first European established roads were most probably sawyers' tracks, which allowed the hauling of felled red cedar logs from the hinterland forests to points of maritime access such as coastal ports and navigable streams. This activity would have commenced with the first cedar harvesting in 1812. Trails are likely to have followed terrain and gradients of least resistance, such as ridge and spur crests, as well as the level ground of the valley floors and associated meadows. Some examples of the informal trails which developed prior to the construction of formal roads are shown on the 1866 County map for Camden (**Figure 4.16** and **Figure 4.17**).

It is this private road that is shown on an 1866 map of the County of Camden (**Figure 4.16** and **Figure 4.17**). The alignment of this road established a transport corridor which has been retained to the present day, with many sections of the Princes Highway retaining the original alignment. The Berry Estate road was distinctive in its use of long straight sections, which often traversed steep spurs and ridges without apparent regard for the consequentially steep gradients. The straight and sometimes steep nature of the road may be explained by:

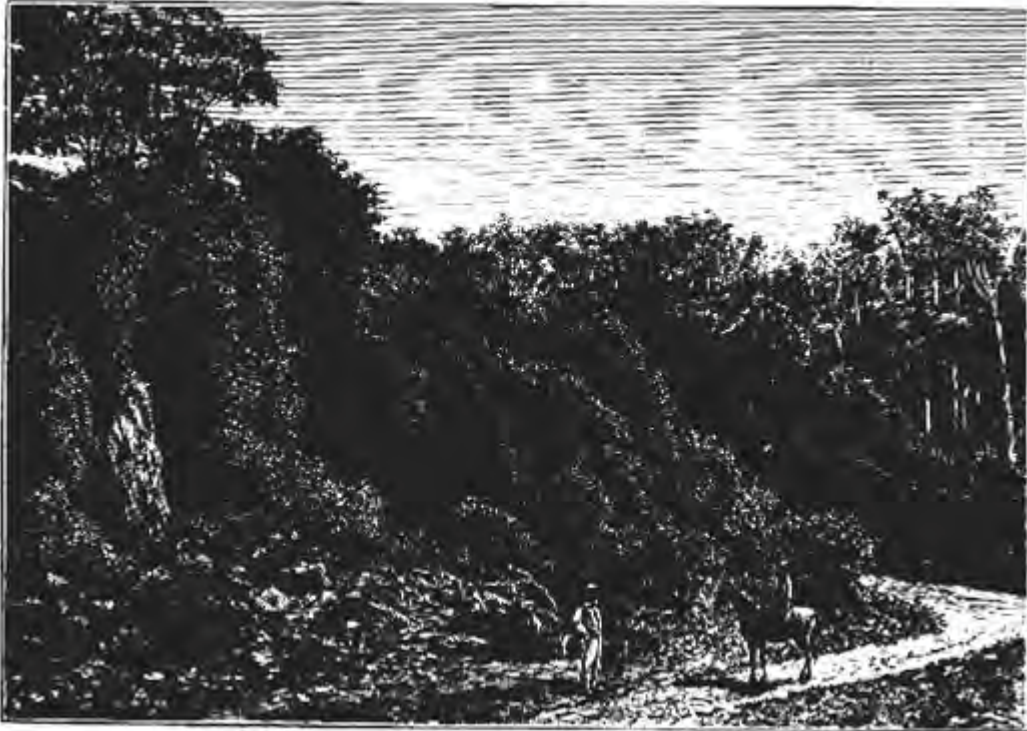
Figure 4.18: “A Sketch of the Broughton Creek Road” (Illustrated Sydney News 21 November 1885:p14 & 16), “ not far distant from Broughton Creek [Berry]”

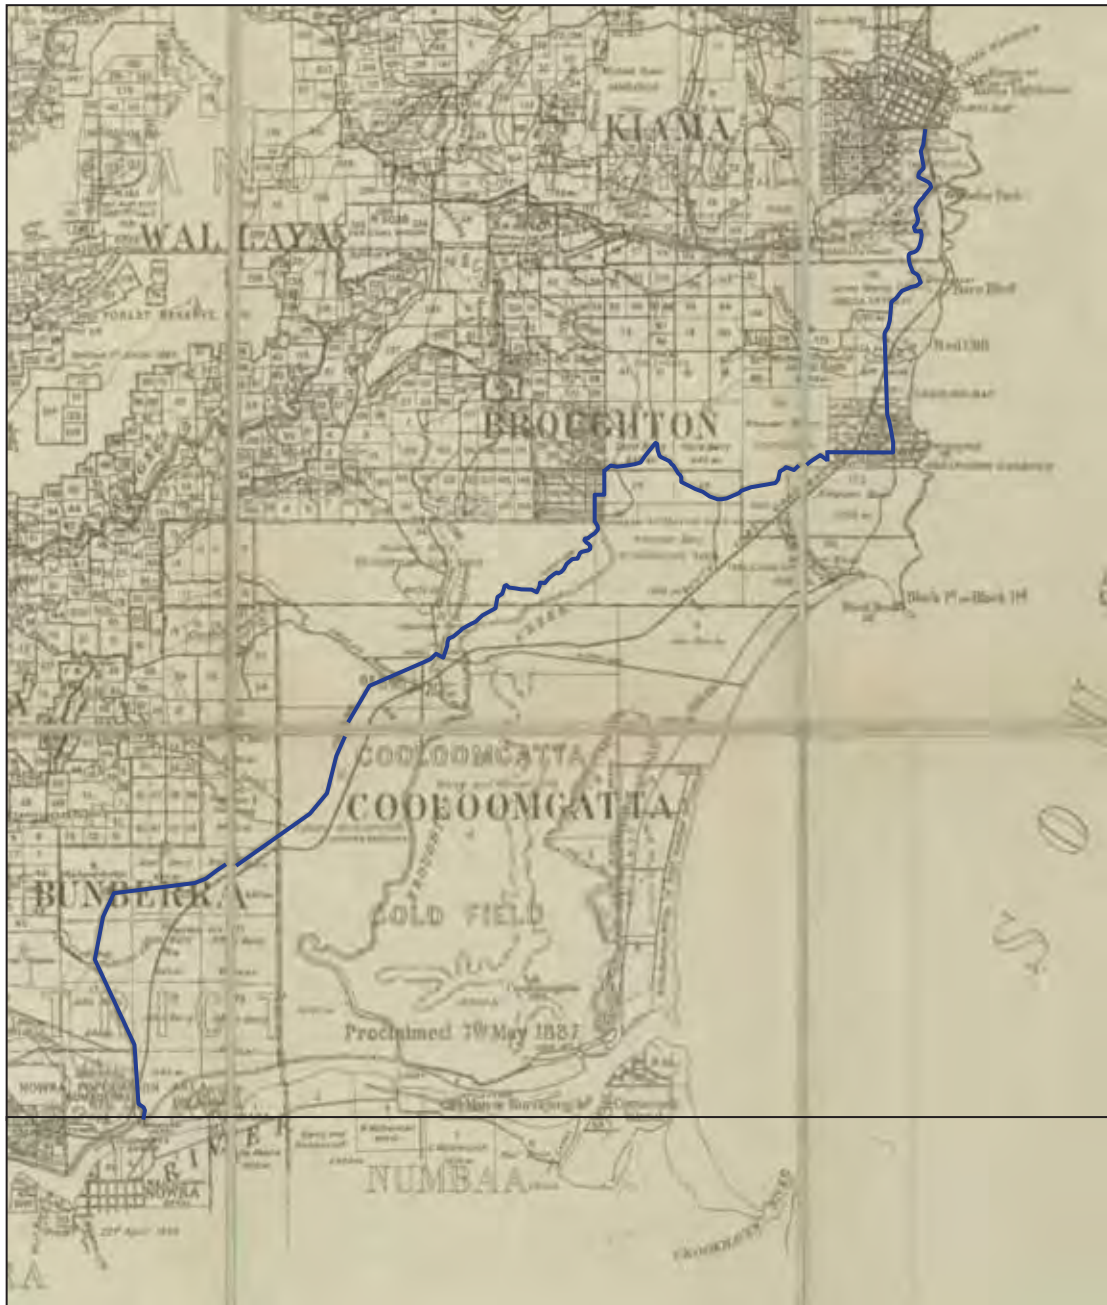
Figure 4.19 Extract of an 1895 map of the County of Camden, showing the road between Gerringong and Bomaderry. Note how the development of the road by local councils, and following the break-up of the Berry Estates has introduced numerous bends and irregularities from Berry's original alignment (Map of the County of Camden, Eastern Division, NSW 1895 / compiled, drawn and printed at the Department of Lands, Sydney NSW. 24th June 1895. National Library of Australia <http://nla.gov.au/nla.map-f262>)

In the period between Berry's original construction of the estate road from Gerringong to Bomaderry in the late 1850s, and the 1890s, the further development of the road by the local Councils resulted in a longer and more angular alignment, involving switch-backs and deviations around spurs. This is evident in a comparison of the 1866 and 1895 County Maps (**Figure 4.19** to **Figure 4.22**). The elaboration and revision of Berry's originally straight alignments appears to have been a consequence of establishing more gradual grades, suitable for horse drawn vehicles, and complying with various farm boundaries and related cadastre. By this time, most of the latter were now freehold title following the break up and sale of the Berry Estate.
