Foxground and Berry bypass

Princes Highway upgrade

Volume 2 – Appendix J

**Technical paper:
Aboriginal heritage**

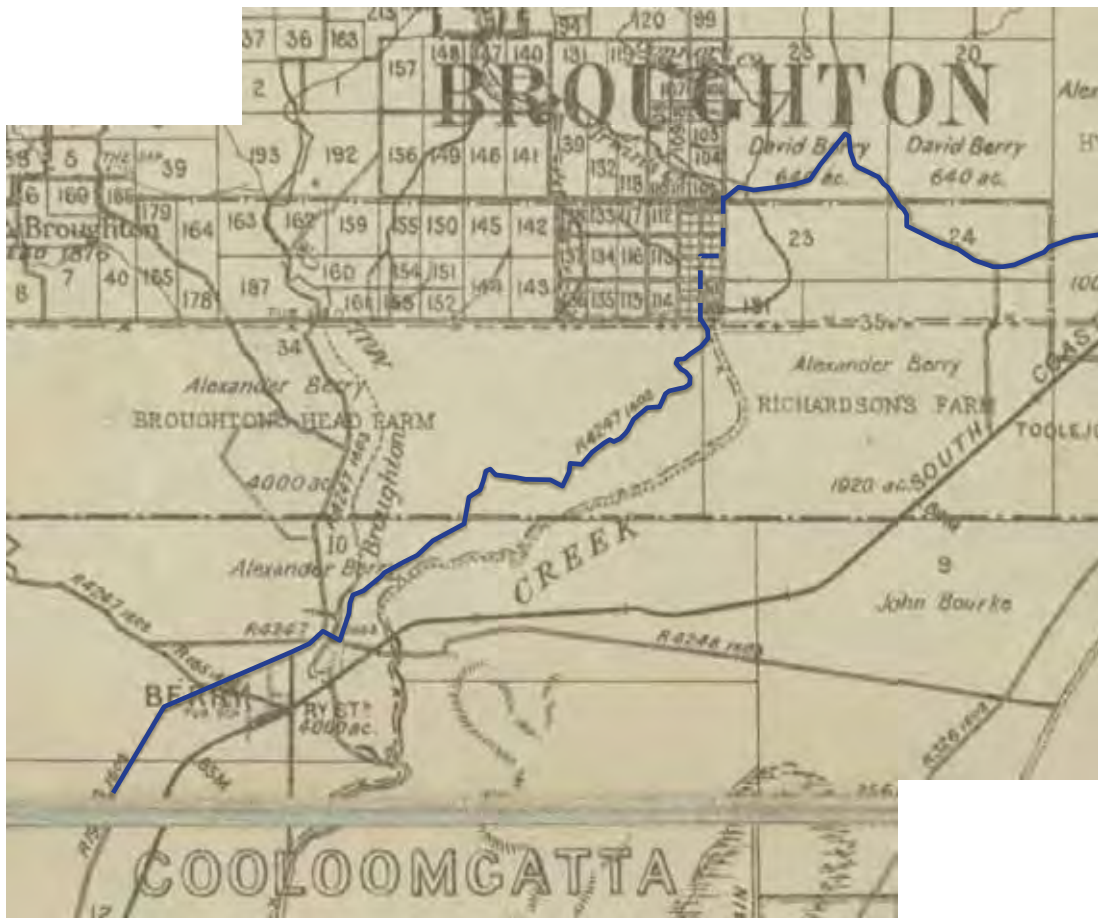
Figure 4.20: Enlarged detail from extract of 1895 map of the County of Camden, showing the location of the roads between Kiama, Gerringong and Broughton Village, the vicinity of the project

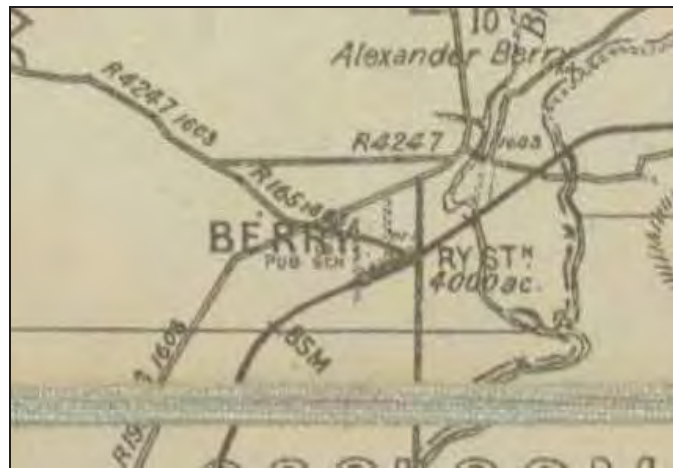
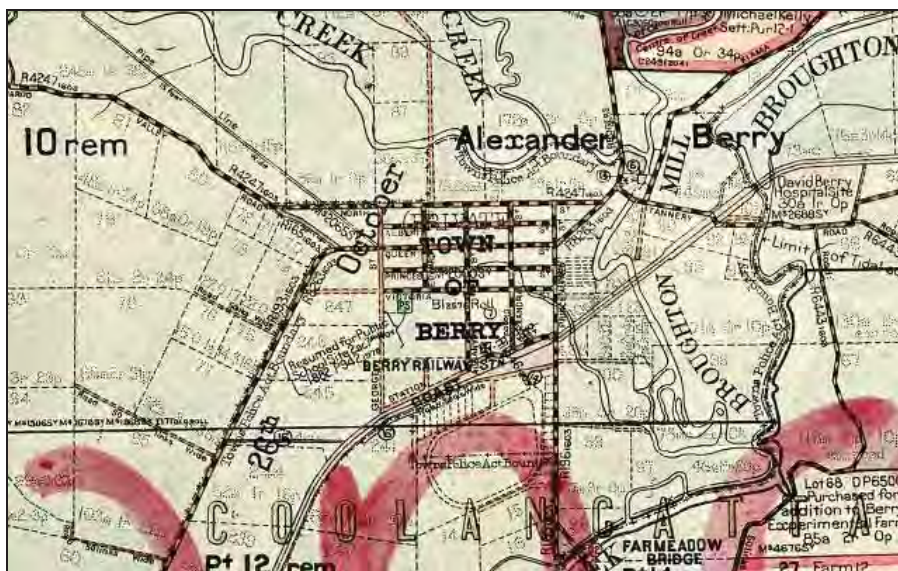
Figure 4.23: Extract from County and Parish maps showing the change in the orientation of the main south road through Broughton Creek (Berry), from a southwest to an east-west alignment occasioned by the establishment of a street grid in the 1880s.

Following the death of David Berry in 1889, the estate passed to his cousin John Hay. Hay developed a formal street grid for the town of Broughton Creek in the 1880s, on the western side of Broughton Mill Creek. This was surveyed in 1879 and well established by 1890 (Cousins 1948:262; RMS s170 register, Broughton Creek bridge citation). This provided for the future growth of the town beyond the limited area on the east of the creek where the original town had developed around the Pulman Street ridgeline (refer **Figure 4.10** and **Figure 4.11**). The new grid was orientated slightly differently to the existing emergent streetscape, and this resulted in many buildings being misaligned, necessitating their movement or realignment to the new pavements (Lidbetter 1993:19). Another consequence was that the existing road to Bomaderry which lead away from the town in a straight south westerly trajectory would be truncated by the new grid, and a new approach road would have to be developed at the north western corner of the grid. The current highway alignment follows this late nineteenth century revision (**Figure 4.23**).

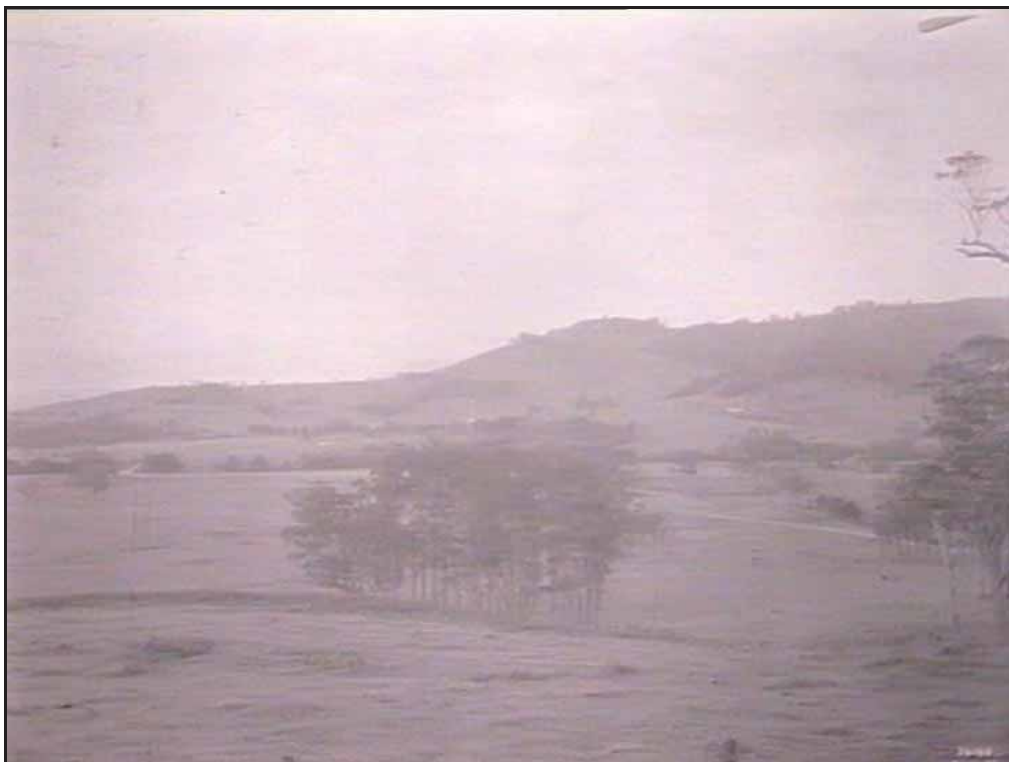
Figure 4.24: 1937 Photo, looking south, across the Broughton Village bypass, showing the original road alignment on the right (middle portion of photo), and new alignment and Broughton Creek bridge on the left (middle portion of photo) State Library of New South Wales.

Unemployment relief work was undertaken along the highway during the 1930s. The lookout at Mount Pleasant was constructed in 1935. In 1935-6 a new concrete bridge was constructed over Broughton Creek, on a short deviation, 650 metres downstream of the original timber structure (**Figure 4.24**). The cadastral street grid of Broughton Village was largely bypassed by the new alignment (**Figure 4.25**).

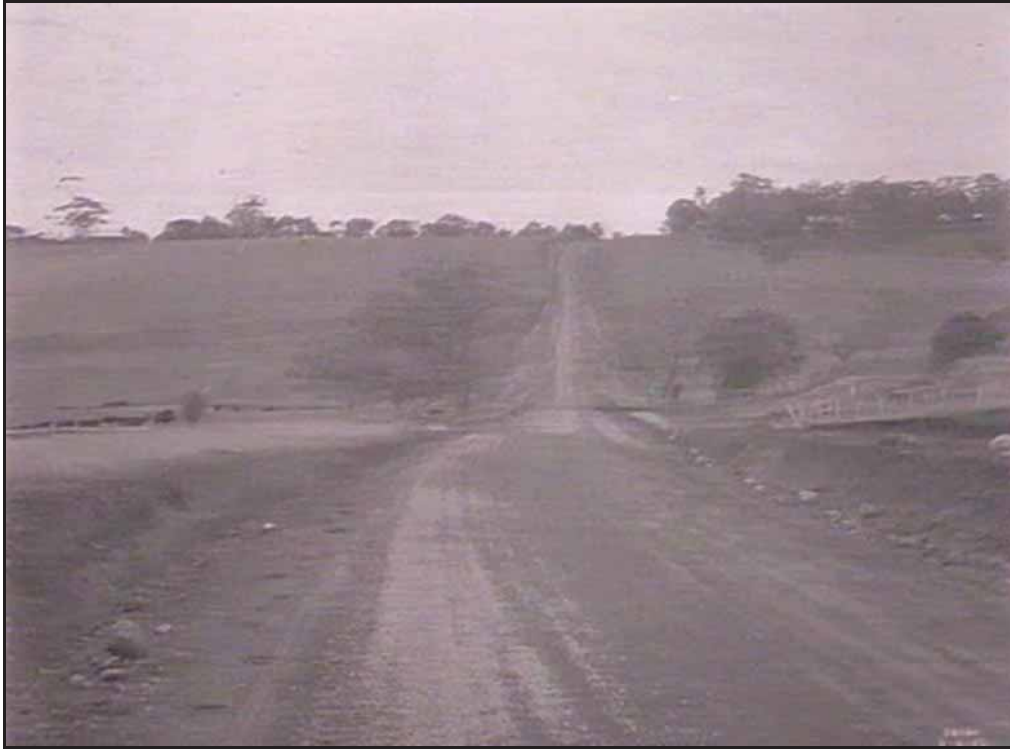
Figure 4.26: View looking south across a straightened alignment of the Princes Highway, south of Broughton Village, completed in 1936. This road section is known locally as the 'Big Dipper' (State Library of NSW d1_27129r)

1936 also saw the completion of a 1.7 kilometre deviation through steep country to the south of the creek (Figure 4.26, Figure 4.27 and Figure 4.28). This section included what is now known as 'The Big Dipper', and cut off a tight bend known at the time as 'Binks' Corner' (OzRoads website; Parish map of Broughton 6th edition 1916-1938).

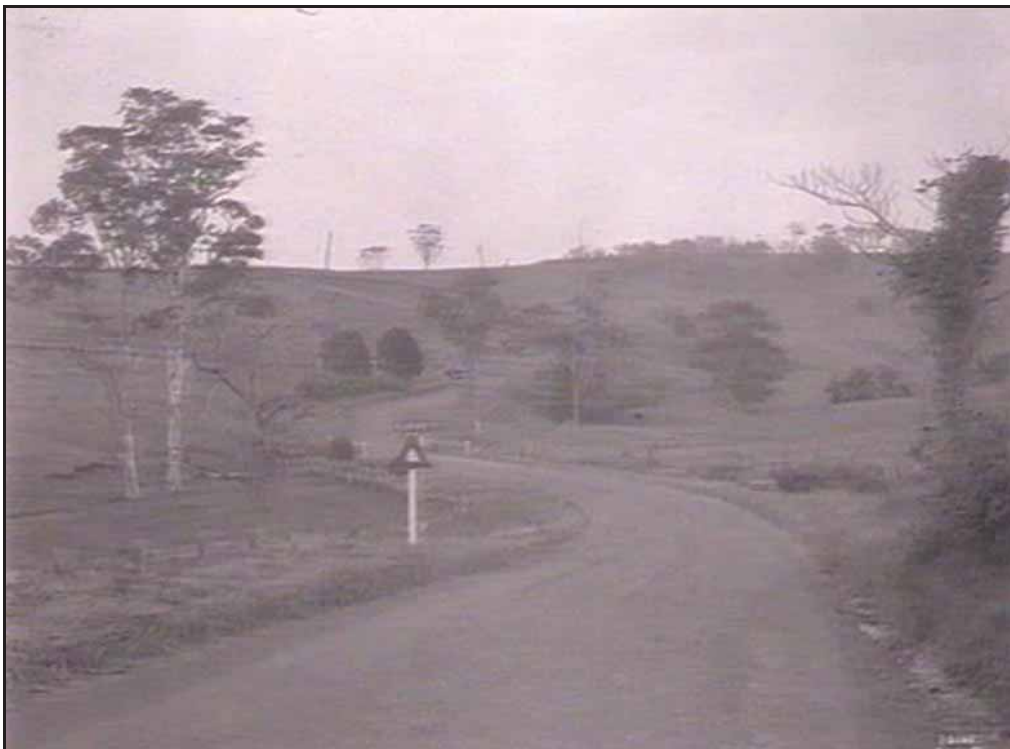
Figure 4.27: 'Binks Corner - old abandoned roadway 1937'. The section of former highway was bypassed by the new alignment pictured above in 1936. (State Library of NSW d1_27130r)

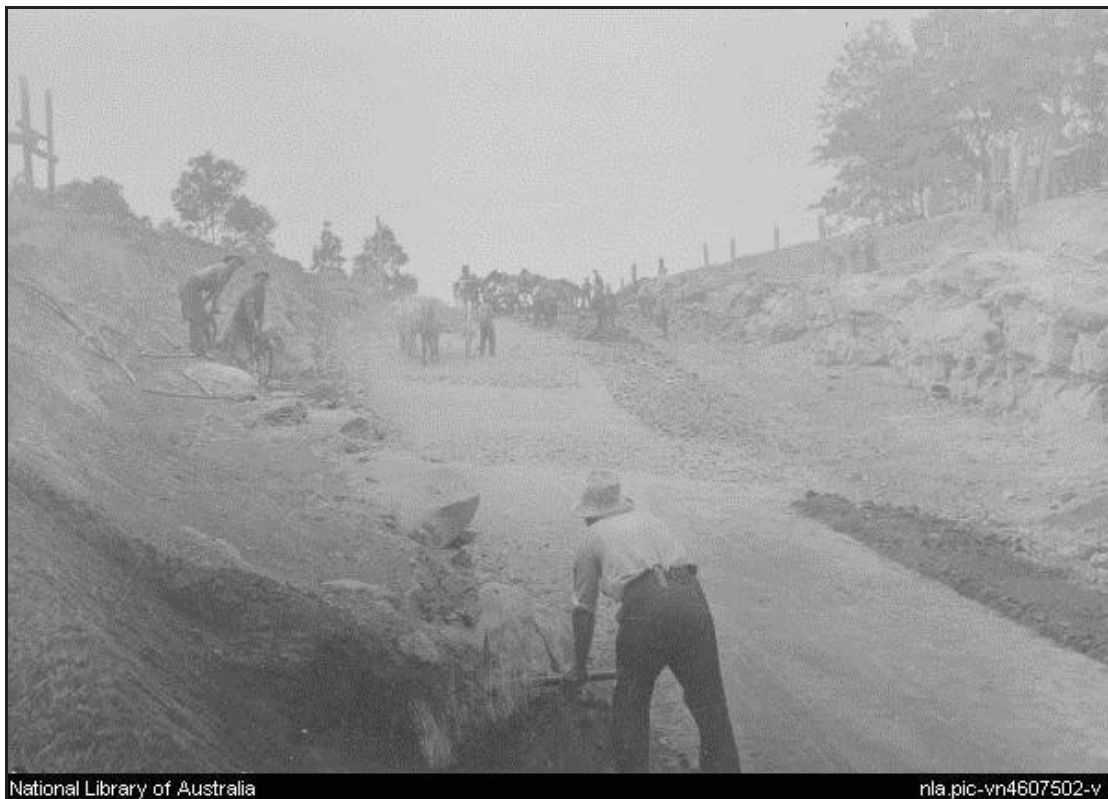
Figure 4.29: Road construction ca. 1918, stated to be in the area of the 'Big Dipper'. Note the apparent depiction of pneumatic drills by the two figures on the left embankment (National Library of Australia nla.pic-vn4607502-v)

Photos in the collection of the Berry and District Historical Society are referenced as depicting road construction at the big dipper around 1918 (refer Figure 4.29 and Figure 4.30). This date is contrary to the documentary record of highway works, but appears consistent with the technology depicted - horse drawn carts and possibly also pneumatic drills (c.f. Lees n.d.). Potential explanations are that: the recorded location or date is wrong; or these excavations occurred prior to the 1936 deviation; perhaps as part of the 1870s construction of the Berry to Broughton Village road. The latter option would depend on the identification of pneumatic drills in the photos being incorrect.

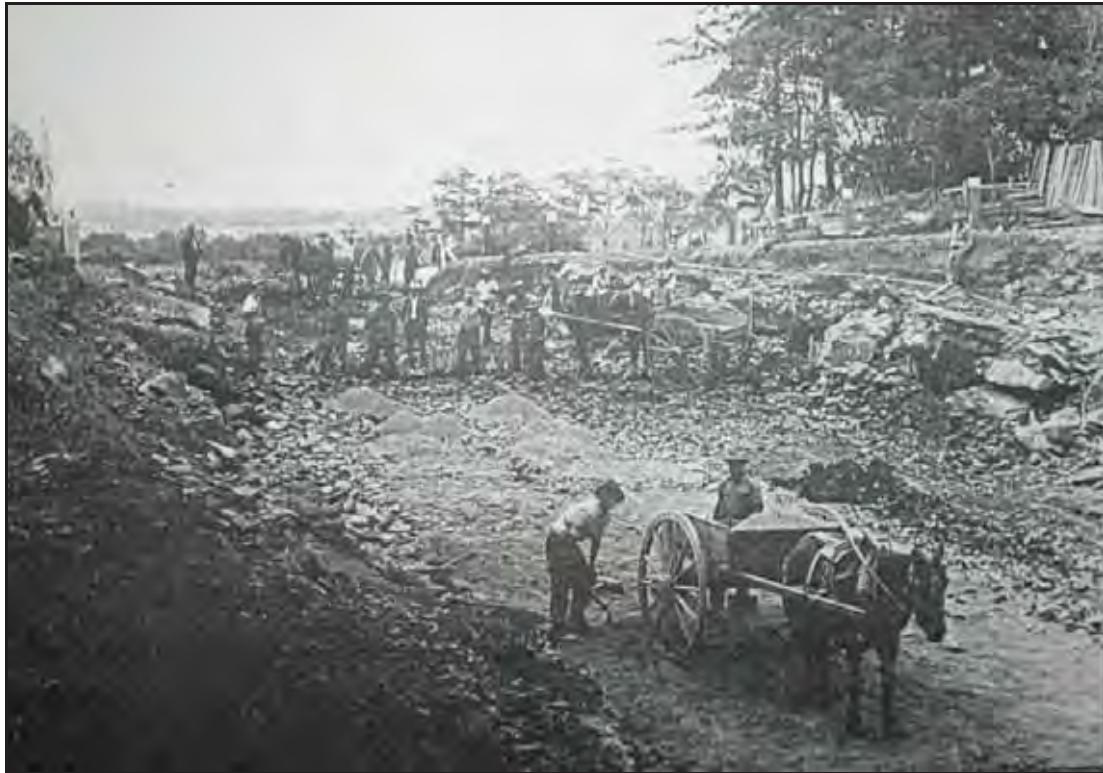
Figure 4.30: Road construction at the 'Big Dipper'. This view has been taken of the same cutting, slightly higher and upslope of the picture above. (From collection of Berry and District Historical Society)

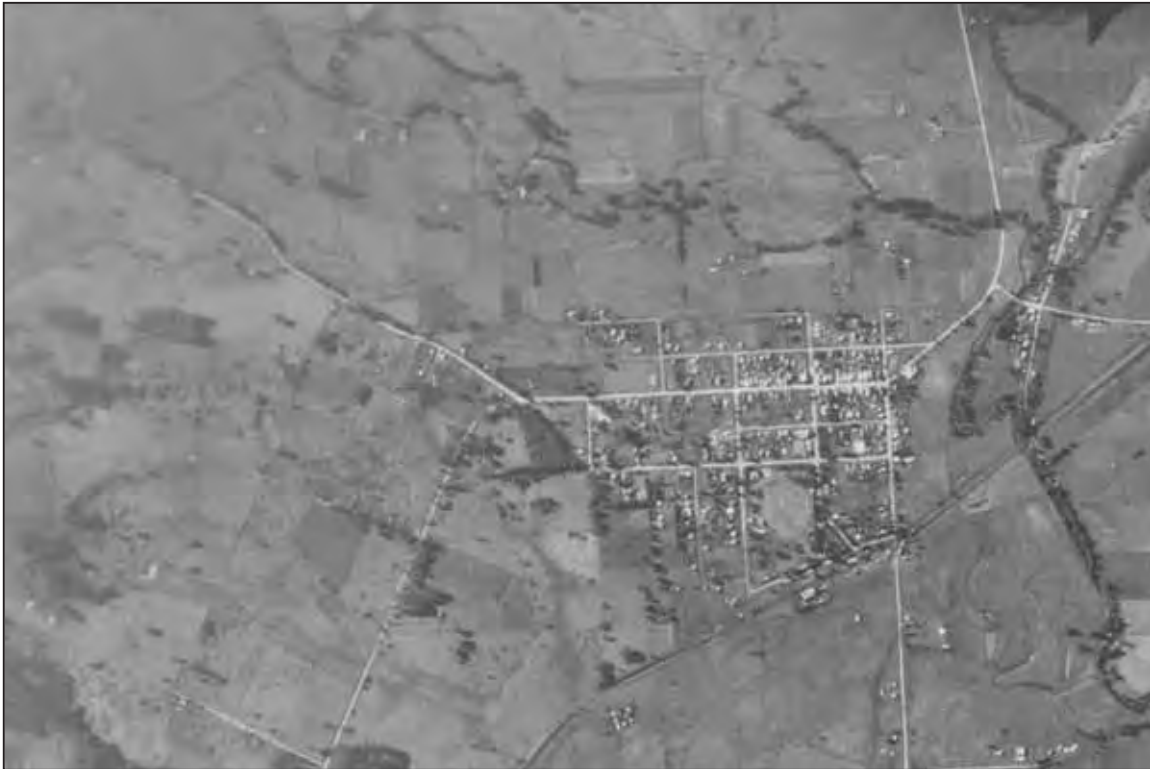
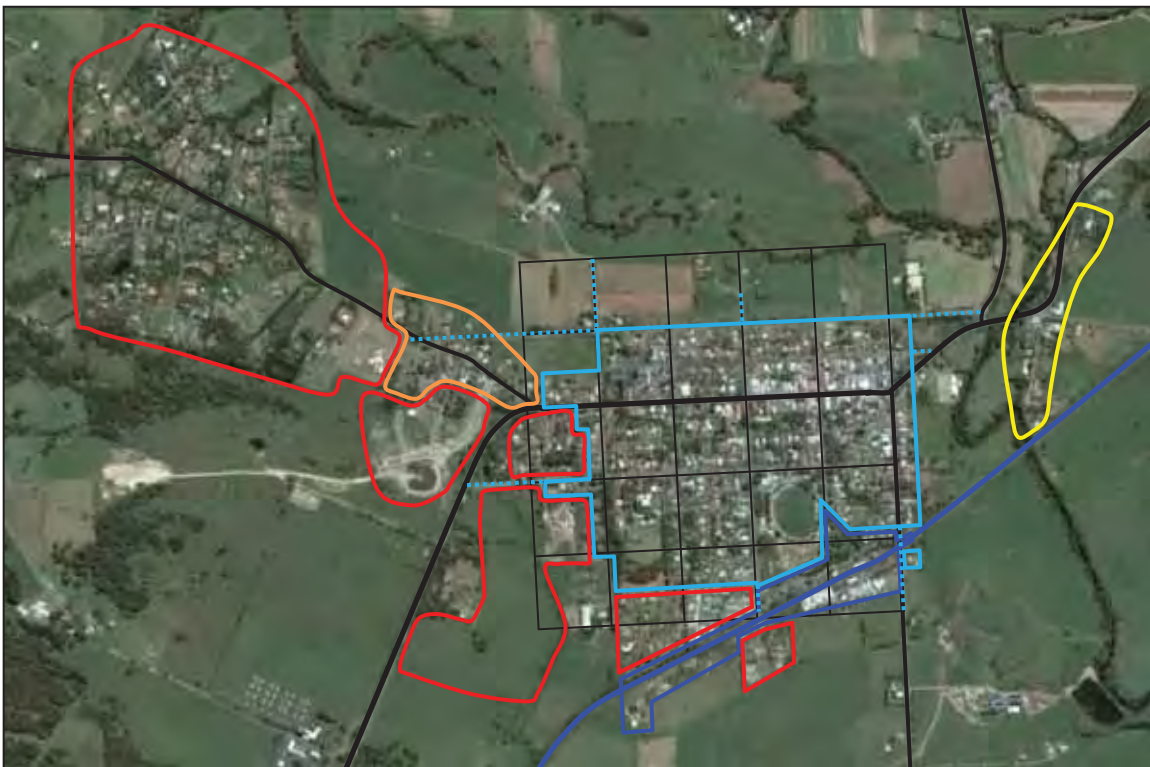
Comparison of 1949 and 2006 aerial images of Berry township, showing the progressive evolution of three main built environment precincts (SVY 552/Nowra 5164 Run2 (155-166) 4/04/1949; and Google Earth Pro. 2006)

A visual analysis of the chronological development of the Berry township and its urban structure is provided in **Figure 5.8**. A number of key points can be made from the analysis:

- The sharp boundary between urban and pastoral landscape along the north and southern sides of the town grid, noted in both the National Trust and Conybeare Morrison & Partners descriptions, has only become well defined in the second half of the last century (Figure 5.9). This is due to the confinement of urban development in these areas to within the established town grid. Prior to this, the edge of town was far less distinct, with pastures and farmhouses occurring within the grid. The 1949 aerial photograph demonstrates this. It shows a ‘porous’ edge to the town with much of the current urban grid consisting of pasture (Figure 5.8).

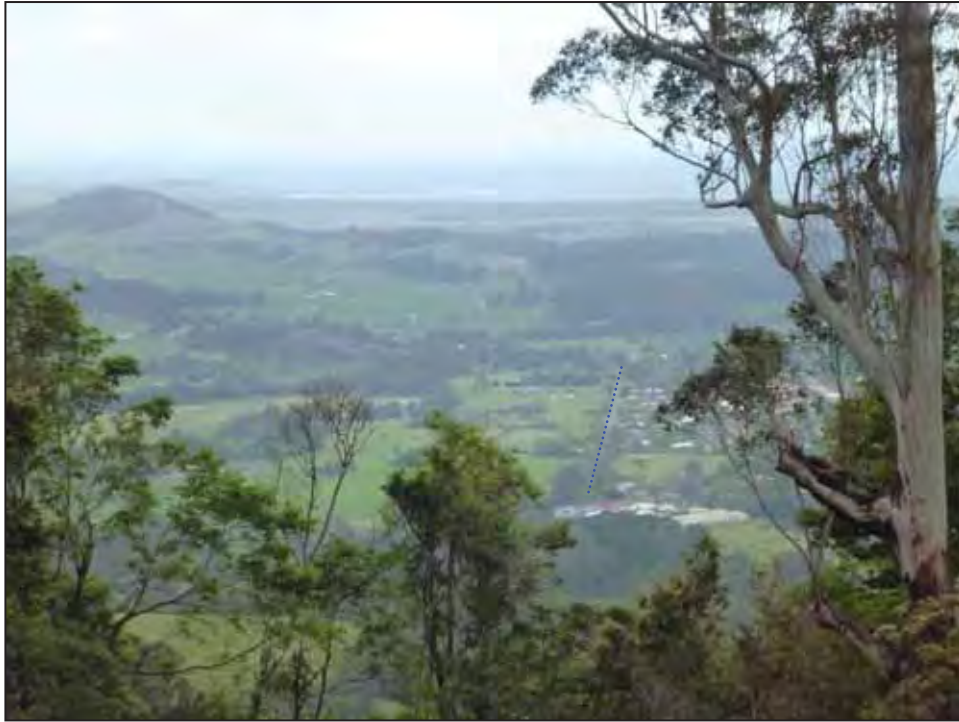
Figure 5.9: Distant view of the northern edge of Berry, looking east from Ben Dooley Rd, Berry Mountain. Note the distinct boundary along North Street (indicated by dotted blue line) between the urban and pastoral landscape.

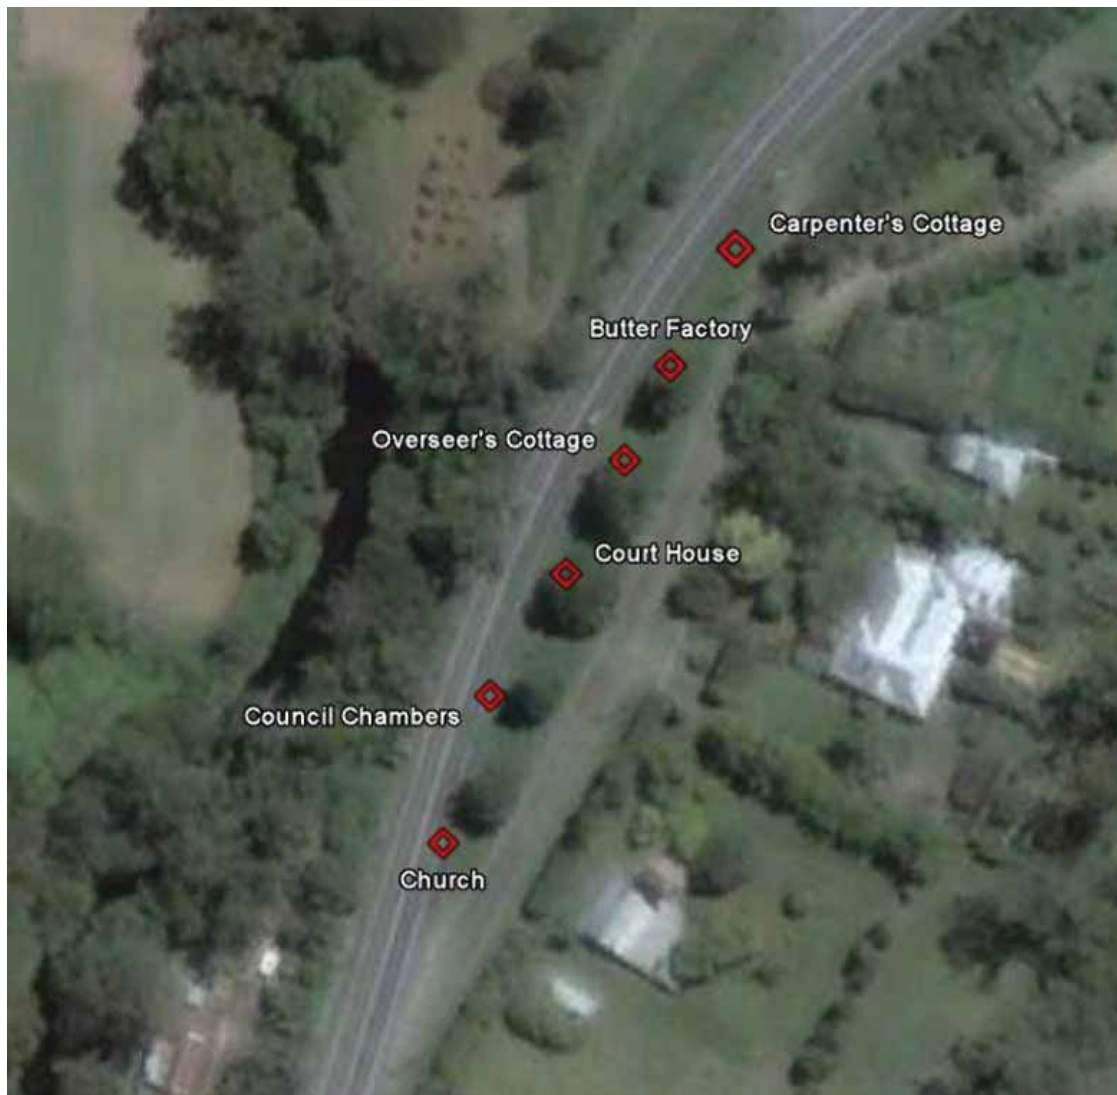
Figure 6.1: Approximate and indicative location of structures that may have once occupied the area at G2B H14 (Base image - Google Earth 2011)

An approximation of the possible relative locations of these structures is provided in **Figure 6.1**, which is based on information gathered by the Berry Historic Museum.

The site currently comprises a relatively level grassed area with a row of five plane trees planted at 20 metre intervals along a north-south alignment (**Figure 6.1**, also refer Appendix G Figures G.189-G.191). A “Welcome to Berry” sign is located at the northern end of the site (**Figure 6.2** and **Figure 6.3**), approximately 10 metres north of the northernmost plane tree.

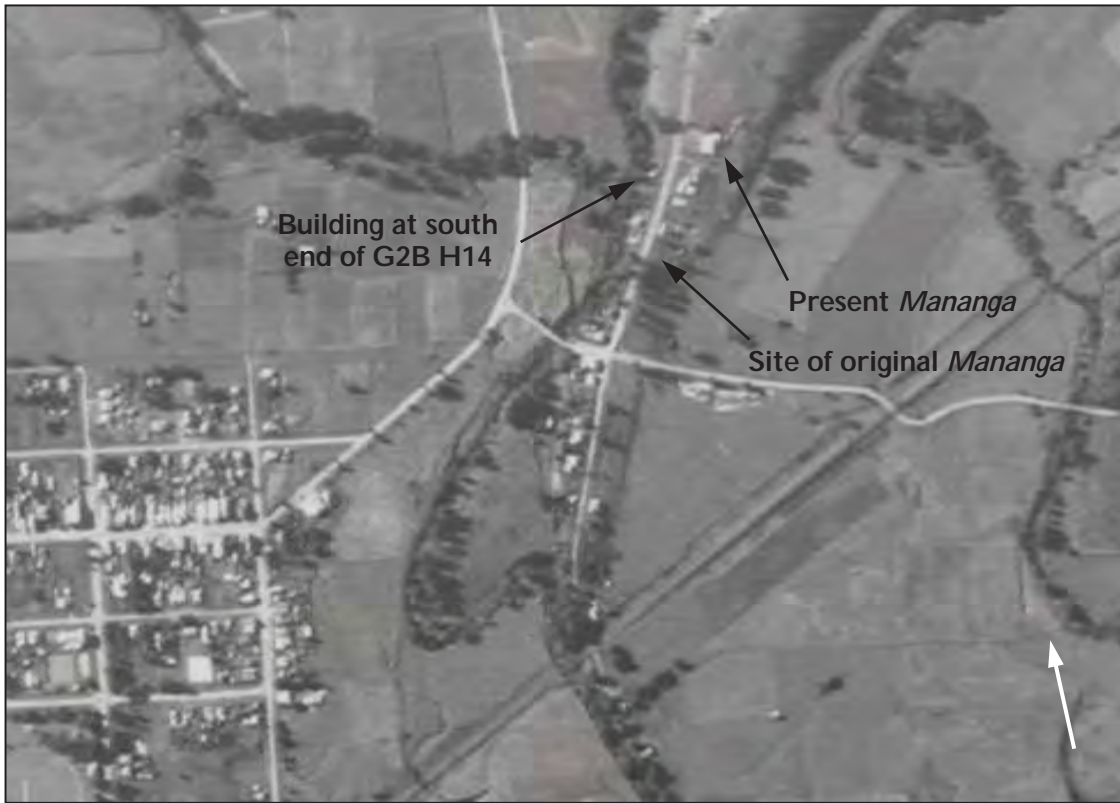
Figure 6.4: 1944 aerial photograph showing the relative locations of the old Princes Highway, *Mananga* homestead and a building at G2B H14.

Aerial photography for this location shows that, in the 1940s (**Figure 6.4**), there was at least one structure opposite *old Mananga*, immediately to the southwest of the potential archaeological deposits identified at G2B H14. This building had disappeared by the 1950s (**Figure 6.5**), when the new highway alignment was shifted to the west. Overlays of the various highway alignments and the location of the structure from the 1940s are provided in **Figure 6.6**. It can be seen from these overlays that the structure present in the 1940s was set back approximately 10 metres from the edge of the highway. This translates to about 30 feet, which was a relatively common width for frontages in NSW towns in the nineteenth and early twentieth-century; indeed, the buildings along the main street in Berry were all situated a similar distance from the road.

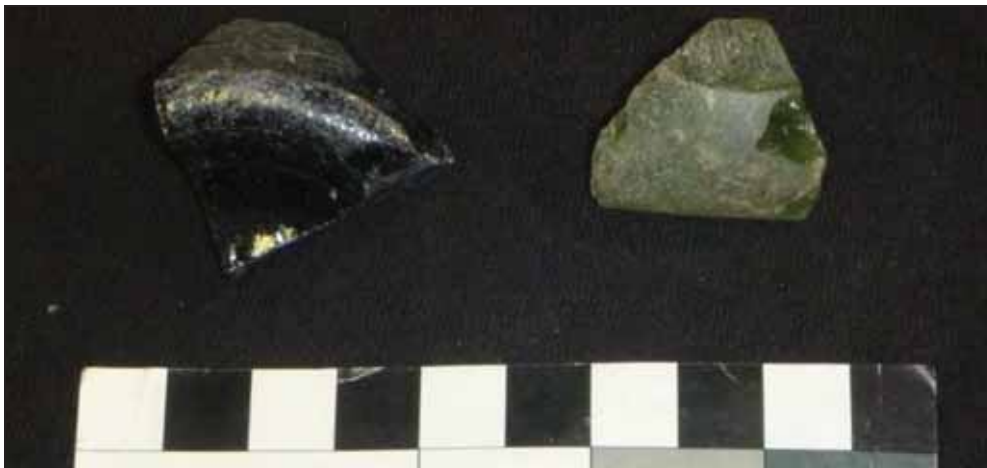
Figure 6.8: Scuffed green glass bottle bases (2058 and 2013). Scale shows 10mm intervals.

The southern section of the site extends for approximately 20 metres from F20 through to F39-40. This portion of the site is characterised by the presence of *in situ* cobbling (F30 and F31), disturbed cobbling (F20 and to a lesser extent F39-F40) and highly fragmented, worn or scuffed artefacts (**Figure 6.8**). Excavations in F39 revealed an early twentieth-century telecommunications trench, which was also evidenced along the western margin of F30-F31. This feature clearly post-dated the cobbled surface.

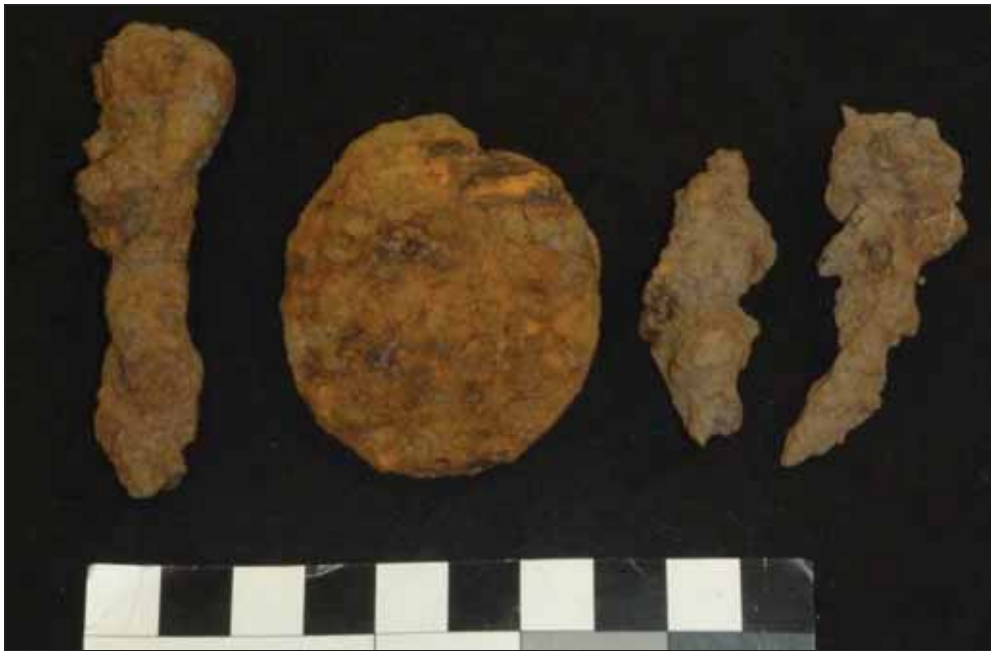
Figure 6.9: Corroded iron structural items: bolt (4013), washer (4015), and suspected wire nails (4004). Scale shows 10 millimetre intervals.

Metal items from the southern portion of the site were dominated by fasteners such as nails, bolts and washers from F20 (Contexts 2 and 9). These items were all heavily corroded (**Figure 6.9**), although the nails did appear to potentially be wire nails, which were produced from the 1860s to the 1880s (Varman, 1986:260).

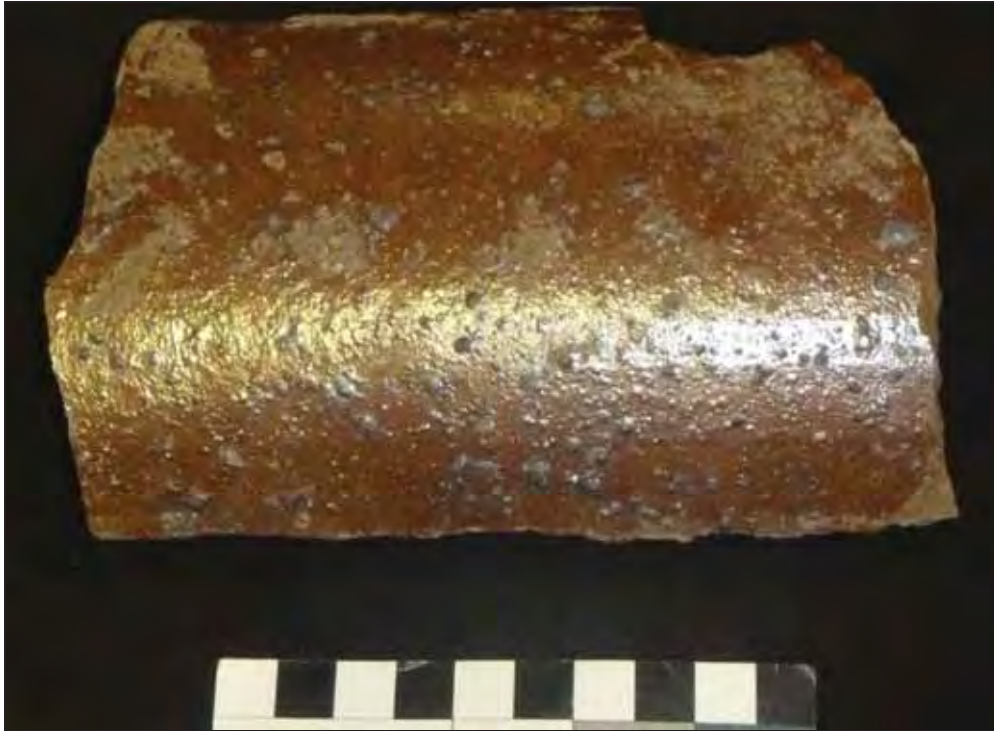
Figure 6.10: Stoneware pipe fragment (1003). Scale shows 10 millimetre intervals.

Ceramic artefacts from this area include fragments of glazed stoneware pipe (**Figure 6.10**) from F39 (Contexts 8 and 14), which may have been from a drainage pipe that was subsequently disturbed by installation of the telecommunications trench, and two small fragments of domestic items from F20 (Context 9) and F39 (Context 14). Neither of the domestic fragments is chronologically diagnostic.

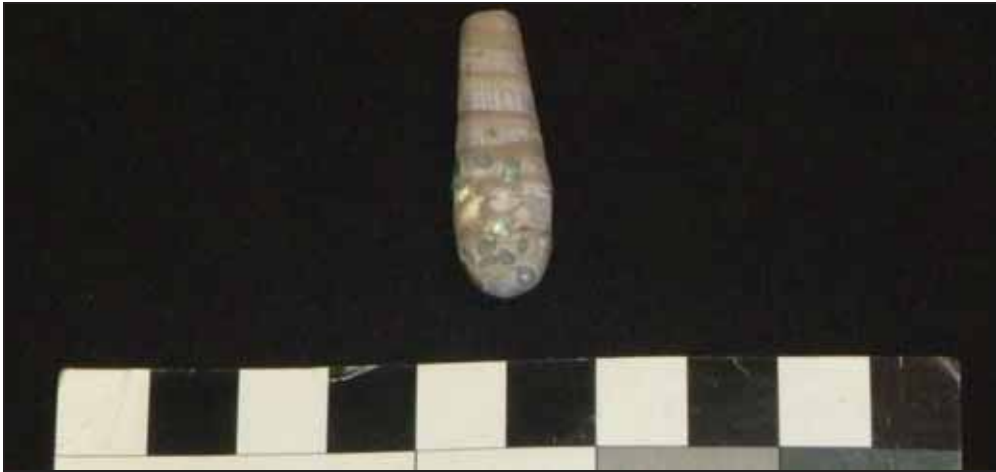
Figure 6.12: Shell pendant (3018). Scale shows 10 millimetre intervals.

A ground shell pendant with inlaid decoration (**Figure 6.12**), presumably from an earring or necklace, was recovered from the lower levels of D80 (Context 32). This is the only personal item recovered from test excavations at G2B H14; it is difficult to ascertain an accurate date for this item, however its handmade nature and state of preservation is potentially indicative of the turn of the nineteenth to twentieth-century.

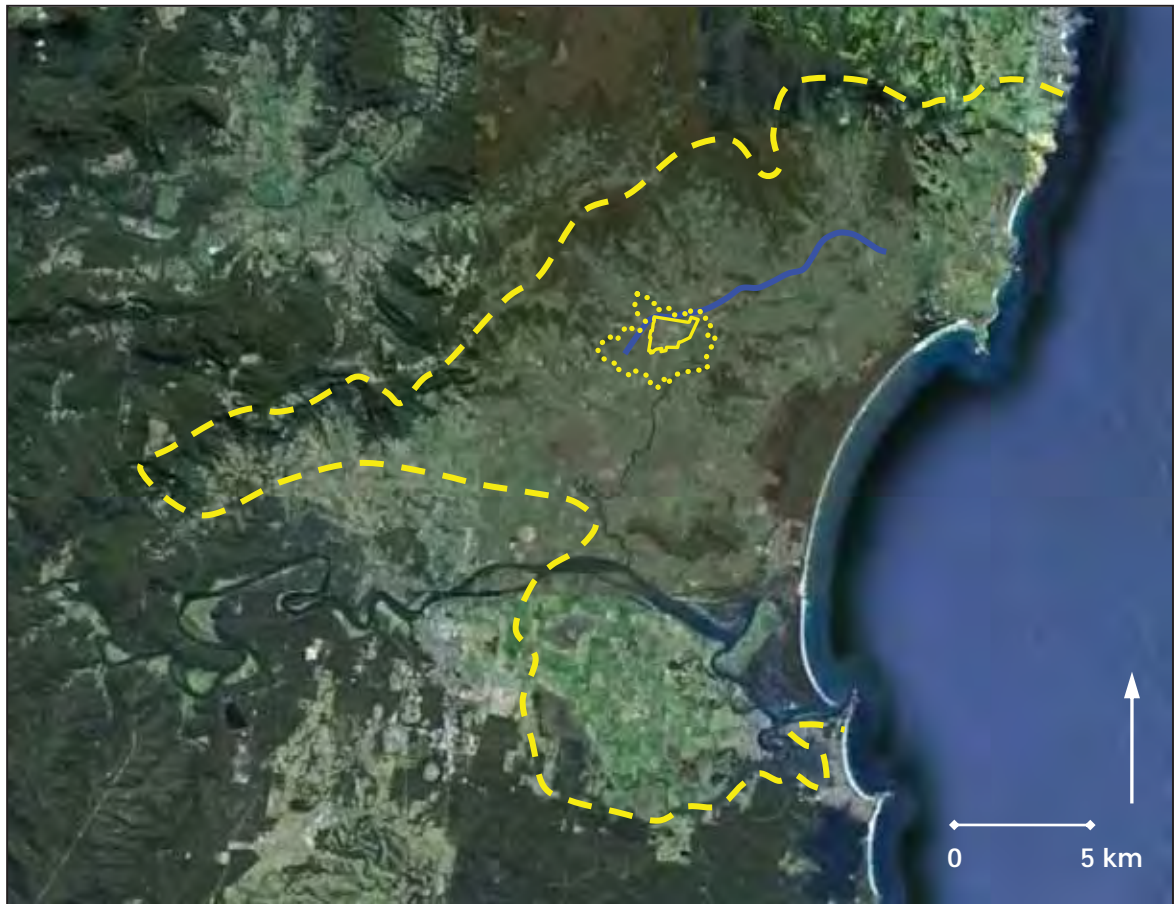
Figure 9.1: Location of proposed project relative to the SICPH CL. (After Figure 13 in Clarke and Duyker 2010; and The boundary of the Berry – Bolong Pastoral Landscapes (Shoalhaven Heritage Inventory) (base image: Google Earth Pro 2009)

The following section provides an overview of the development impact to cultural landscape values. A detailed statement of heritage impact is provided in Appendix I under the Southern Illawarra Coastal Plain and Hinterland recording, item SICPH CL. **Figure 9.1** and **Figure 9.2** illustrate the location of the project relative to the zones and boundaries of the SICPH CL and previous landscape recordings.

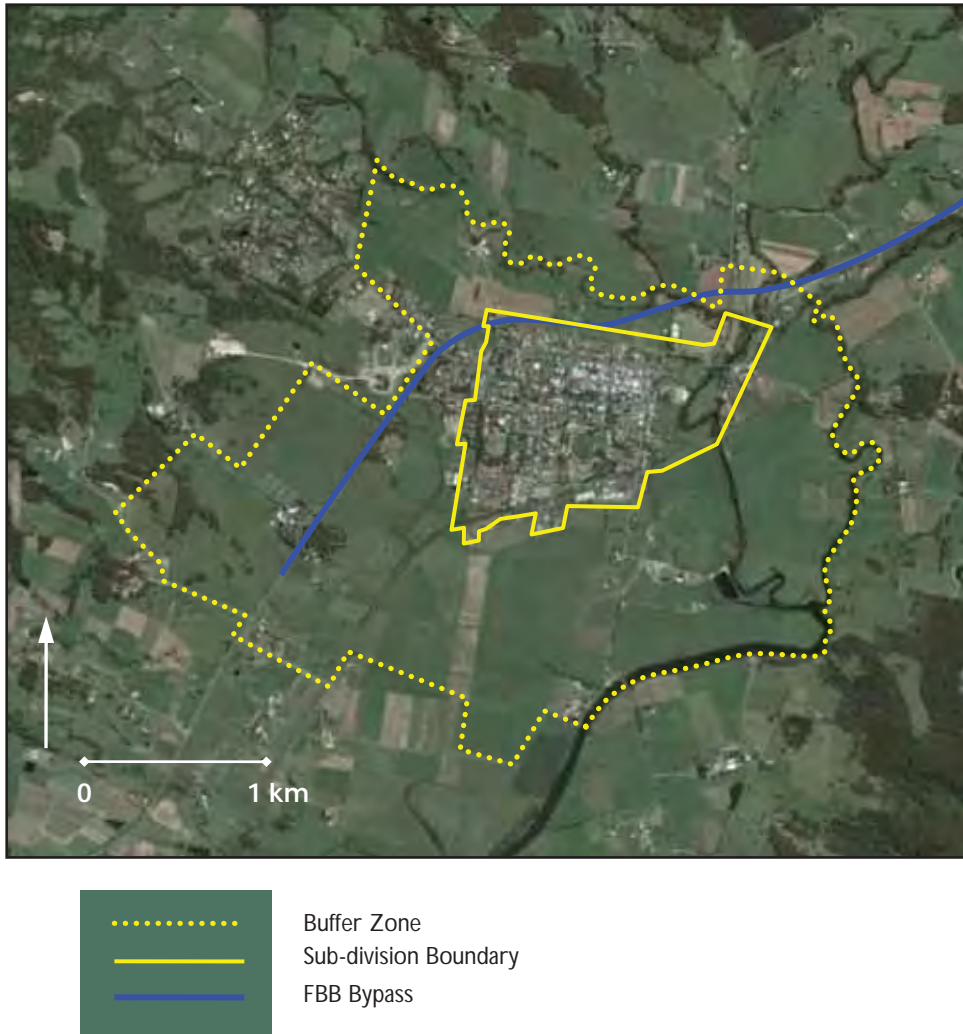
Figure 9.2: Location of proposed project relative to the Buffer Zone and Subdivision Boundary of the National Trust defined Berry Township Urban Conservation Area (After Figure 13 in Clarke and Duyker 2010) (Google Earth Pro 2006).

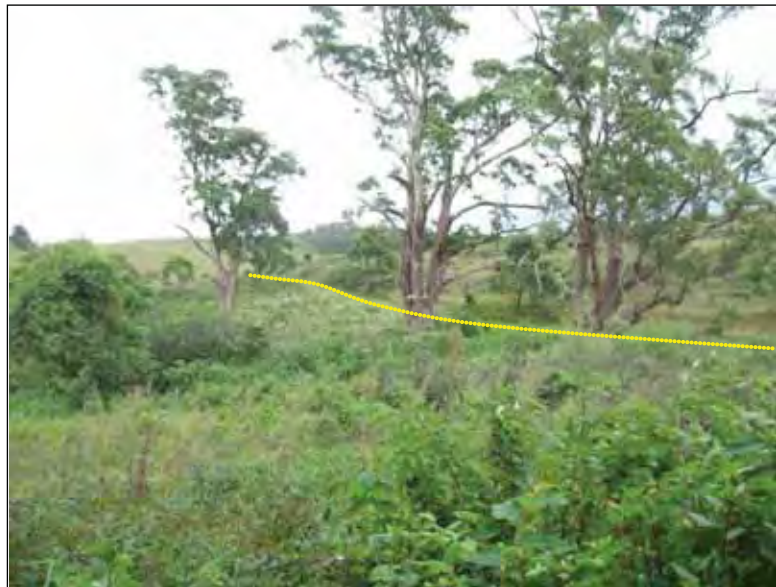
Figure G.14 Closer view of best preserved, cut and benched, middle section of the remnant road (alignment indicated by yellow dotted line), looking W.

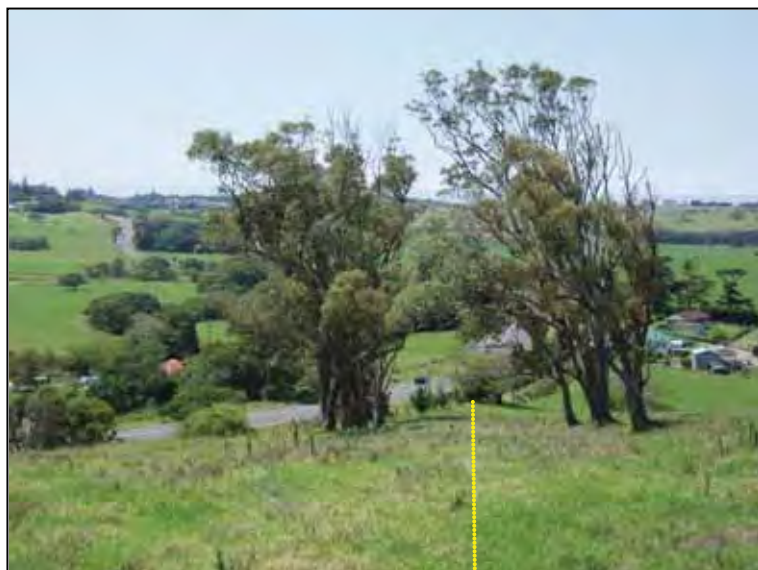
Figure G.20 View, looking E towards Toolijooa Rd intersection, along remnant road platform at eastern end of site, Note tree avenues and ditches on either side (approximate alignment marked in yellow)

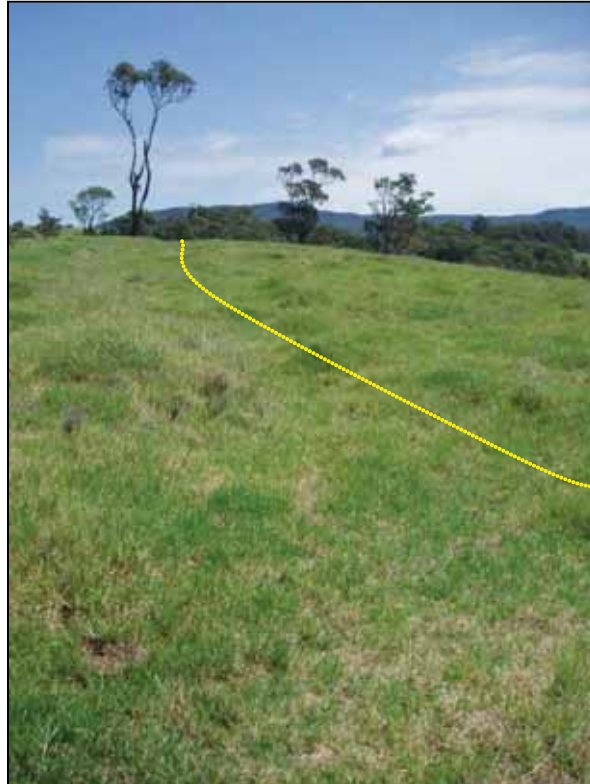
Figure G.21 View of remnant road section where side ditches are evident , looking NW

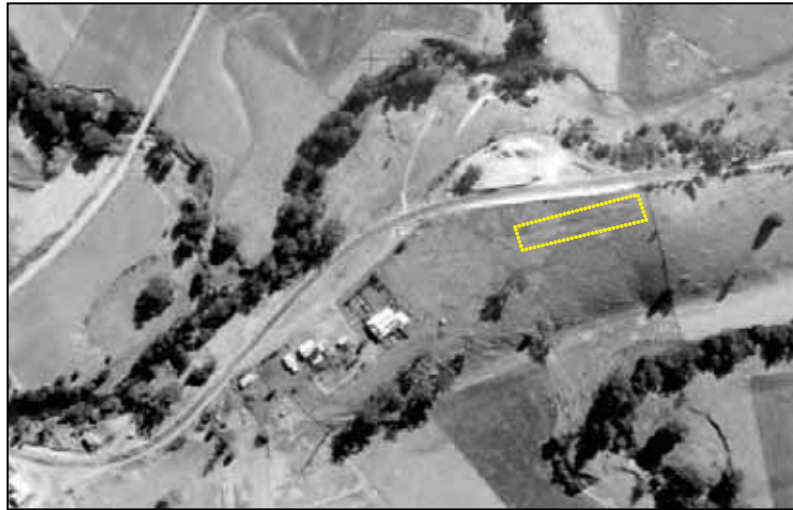
Figure G.27 Road remnant visible on 1958 aerial photo (outlined in yellow), (NSW 699-5036, SH.I Dapto-Ulladulla Run GK11 23/07/58)

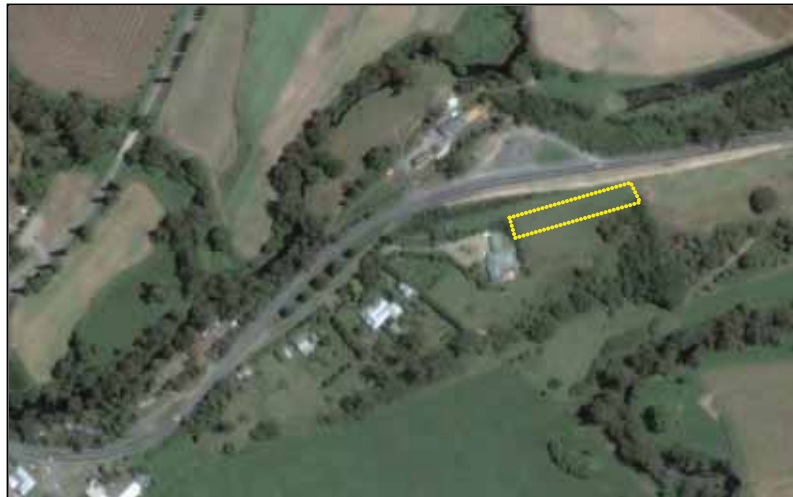
Figure G.28 Aerial image (2006) of area of road remnant (outlined in yellow), (Google Earth Pro 2011)

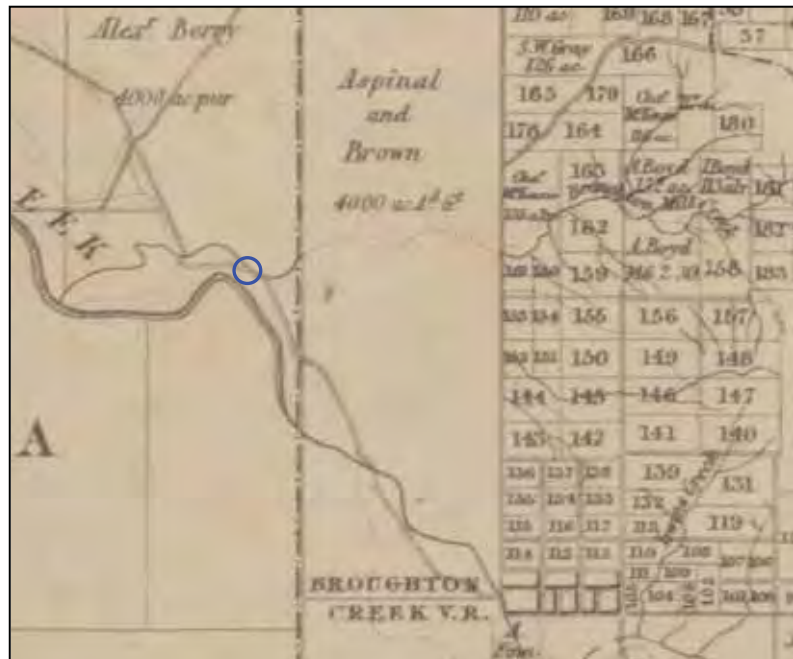
Figure G.29 Approximate location of road remnant relative to road alignment as shown on 1866 County map (County of Camden, National Library of Australia (Braddock and Baly 1866))

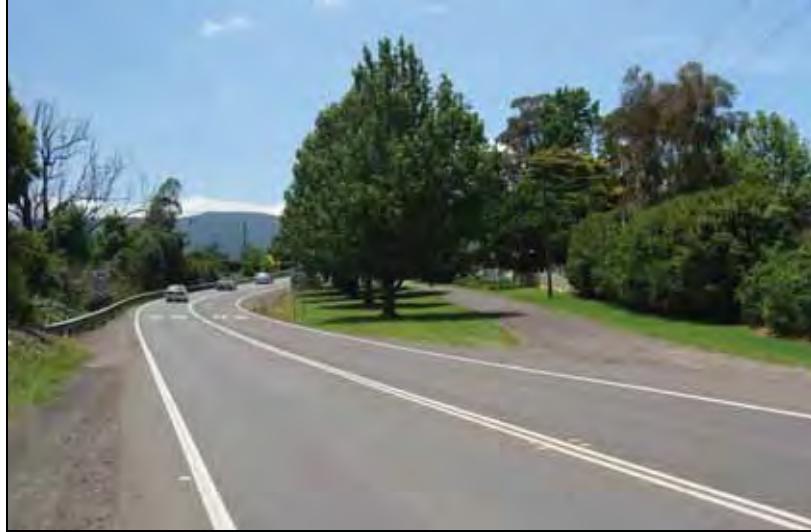
Figure G.35 General view of remnant (to right of current highway) looking N

Physical condition: The remnant is in good condition. For the majority of its length, the sealed road surface appears complete and in good repair and has probably been maintained and renewed post 1950s. At its northern and southern ends the roadway has been impacted by has construction of the current highway alignment. A spoil pile blocks use of the northern extent of the remnant, just after the northernmost driveway. At the southern end, access onto the current highway is maintained and possibly the original bitumen surface remain visible and has been eroded and patched due to side drainage and potholing. An avenue of five deciduous trees have been planted along the western side of the remnant (sometime between 1972 and 1986), between the remnant and the current highway.

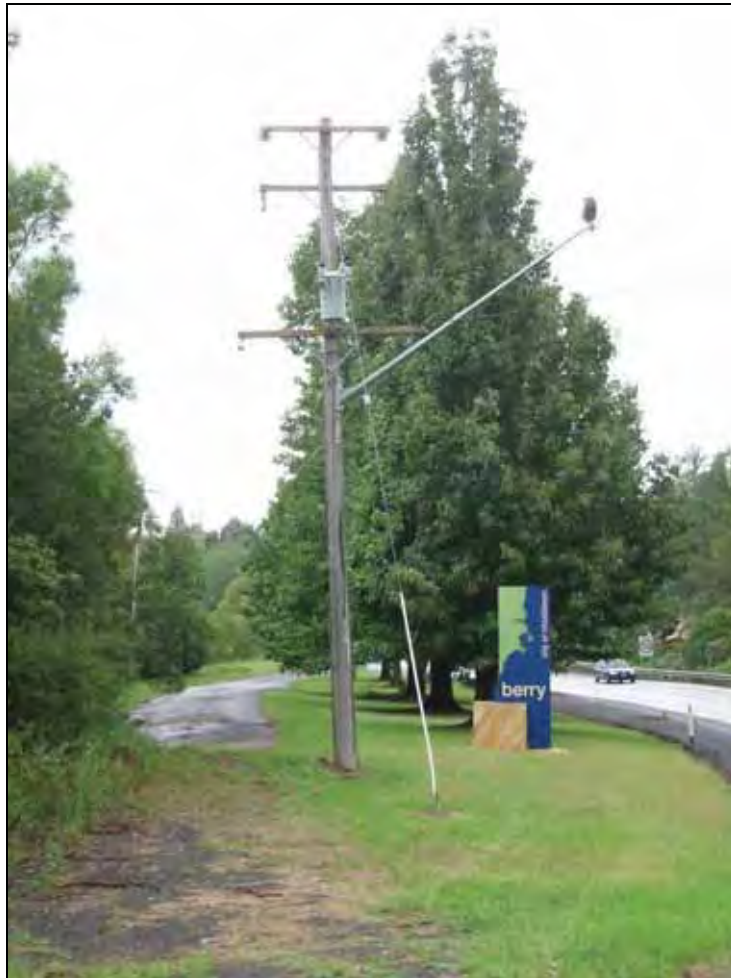
Figure G.36 General view of remnant (on left) looking S

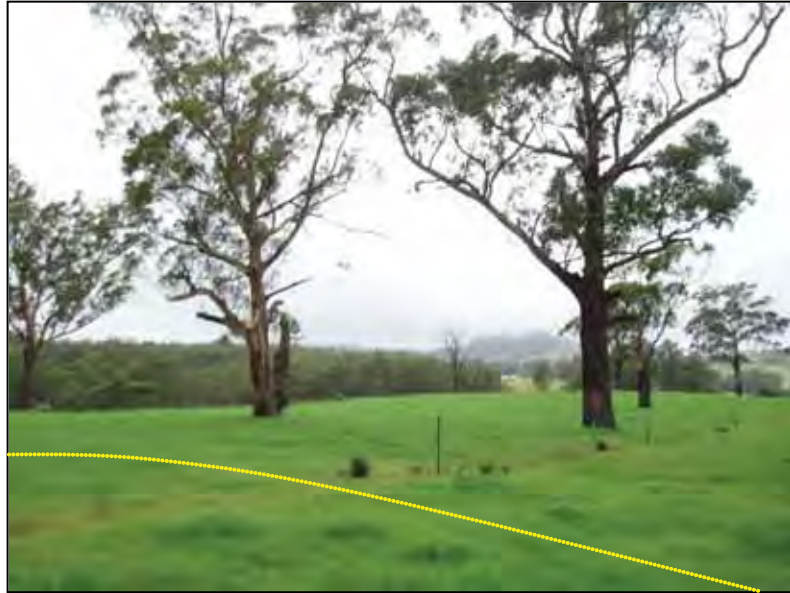
Figure G.40 General view, looking E, across the southern portion of the road remnant (foreground), (approximate alignment marked in yellow), .

Physical condition: The remnant is in poor condition. The remnant is indicated only by low relief and indistinct ground relief. The establishment of pasture grasses and probable ploughing/tilling, has apparently reduced surface relief and removed other potential surface features.
