Foxground and Berry bypass

Princes Highway upgrade

Volume 2 – Appendix J

**Technical paper:
Aboriginal heritage**

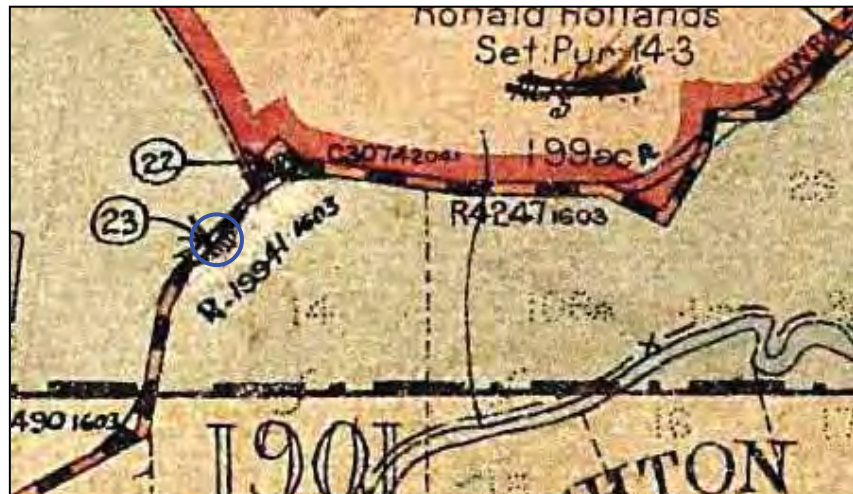
Figure G.41 Extract from Sixth edition of parish map of Broughton (1916, cancelled 1938, Parish Map Preservation Project ID no. 10353901), showing resumption of severed land at G2B H18 (blue circle) in Aug 1936 (map reference note 23)

This highway section was bypassed by the current highway alignment when it was upgraded and straightened in the mid 1930s. The sixth edition of the parish map for Broughton (1916, cancelled 1938) notes that this road remnant was resumed as severed land in August 1936 (Figure G.41).

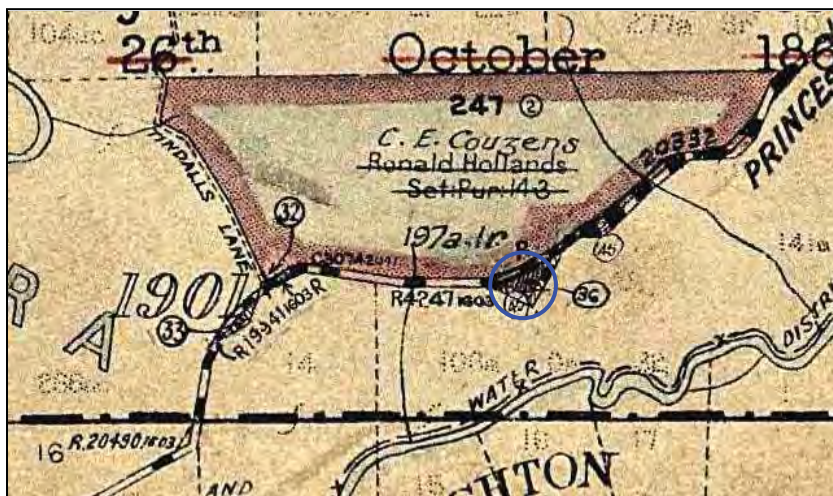
Figure G.45 Extract from Seventh edition of parish map of Broughton (1938, cancelled 1959, Parish Map Preservation Project ID no. 10354001), showing resumption of severed land at G2B H20 (blue circle) in Aug 1938 (map reference note 36)

This highway section was bypassed by the current highway alignment when it was upgraded and straightened in the mid 1930s. The seventh edition of the parish map for Broughton (1938 cancelled 1959) notes that this road remnant was resumed as severed land in August 1938 (Figure G.45).

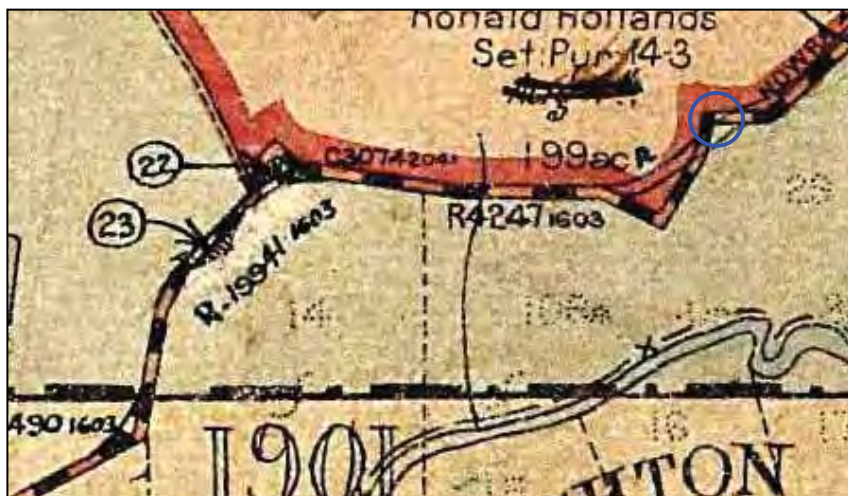
Figure G.48 Extract from Sixth edition of parish map of Broughton showing the G2B H21 portion of highway (blue circle) and an adjacent upgraded alignment (reference note 24, resumed and gazetted public road Dec 1936 (1916, cancelled 1938, Parish Map Preservation Project ID no. 10353901)

This highway section was presumably bypassed by the current highway alignment when it was upgraded and straightened in the mid 1930s, at the same time as the bypass of G2B H20 (c1936). The seventh edition of the parish map for Broughton (1938, cancelled 1959) does not show this remnant or indicate its severance (Figure G.45). The earlier carriageway is however shown on the previous edition along with an indicative upgraded alignment (Figure G.48).

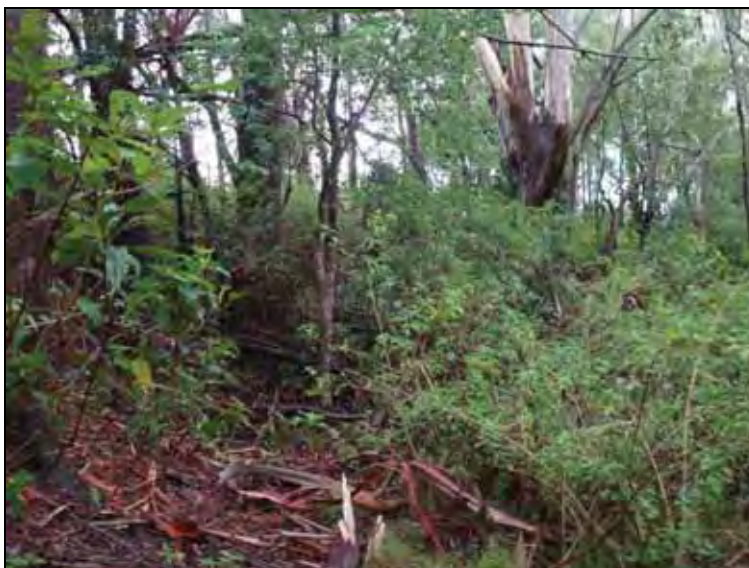
Figure G.49 View of the G2B H21 platform and cutting looking N from the western end of the remnant. Note thick understory growth and sapling regrowth.

Physical condition: The ground relief of the remnant remains distinct, though the embankment has been impacted by collapse and erosion in some places. The platform is obscured by sapling regrowth and woody weeds.

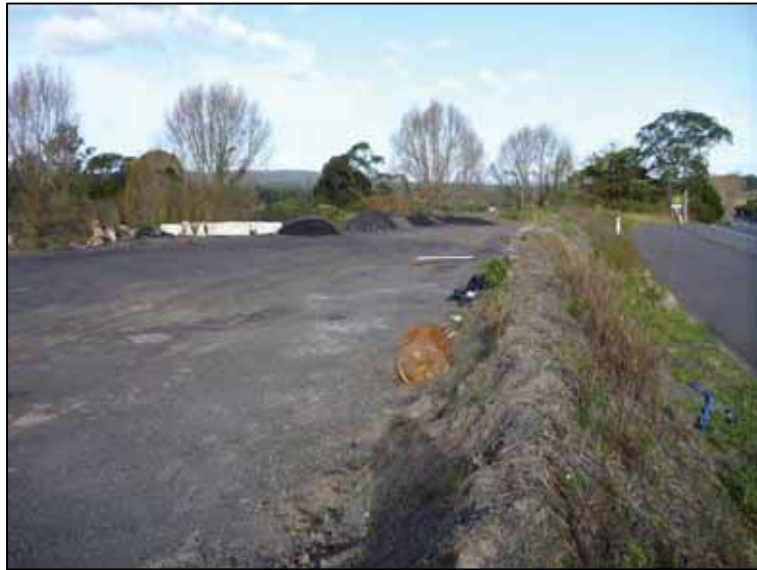
**Figure G.53 View of the
G2B H24 area, looking
SW, note filling and
levelling across site**

Physical condition: There is little evidence of the original road platform or associated earth works. The majority of the alignment and the adjacent upslope area has been filled and levelled for use as a materials storage area.

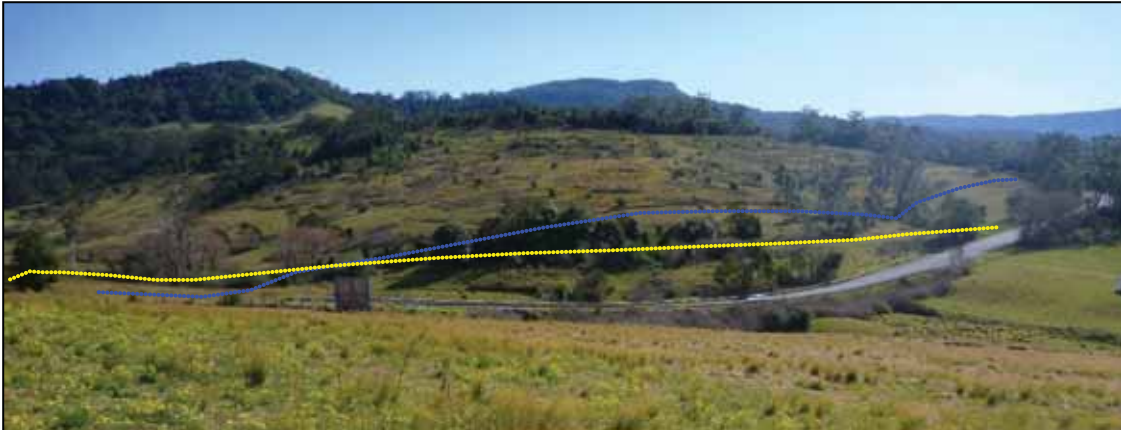
Figure G.54 View, looking
NW from the upgrade
alignment towards G2B
H26 road remnant (
yellow dotted line), Berry
Estate road (G2B H27)
in blue)

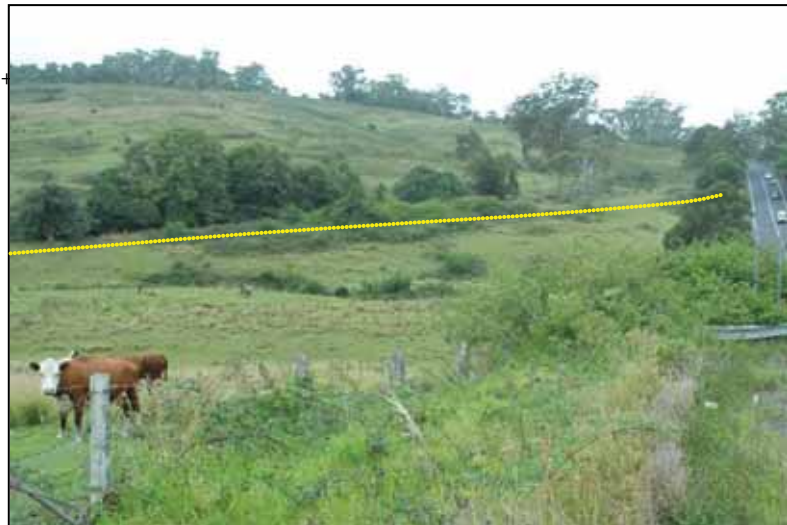
Figure G.55 View of
northern portion of road
remnant (approx.
alignment marked in
yellow), looking N

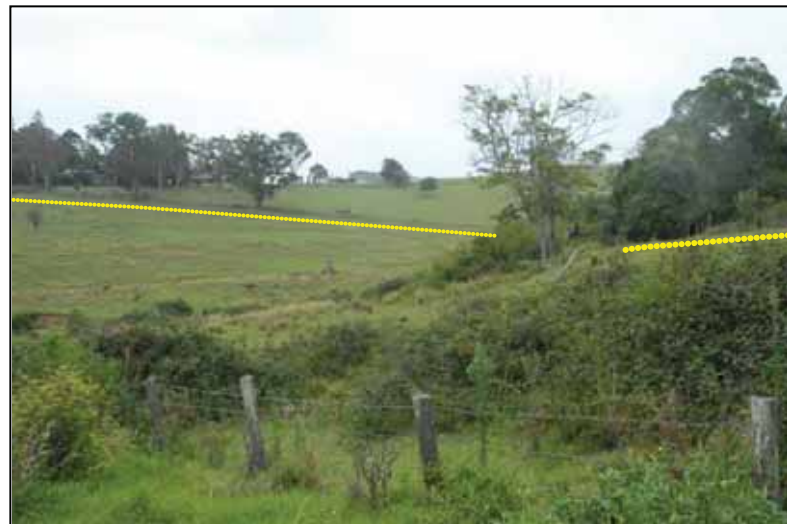
Figure G.56 View looking
SW, showing well
benched platform in right
foreground and more
distant alignment on
southern side of valley
(mid distance) (approx.
alignment marked in
yellow)

Physical condition: This remnant is in relatively good condition, with the ground relief of the platform, and associated cuttings, ditches and embankments still clearly evident. There is some sapling regrowth across the platform in the northern section, and there may have been erosion of the platform in the area of the creek crossings. A number of current or former fence lines cross the platform.

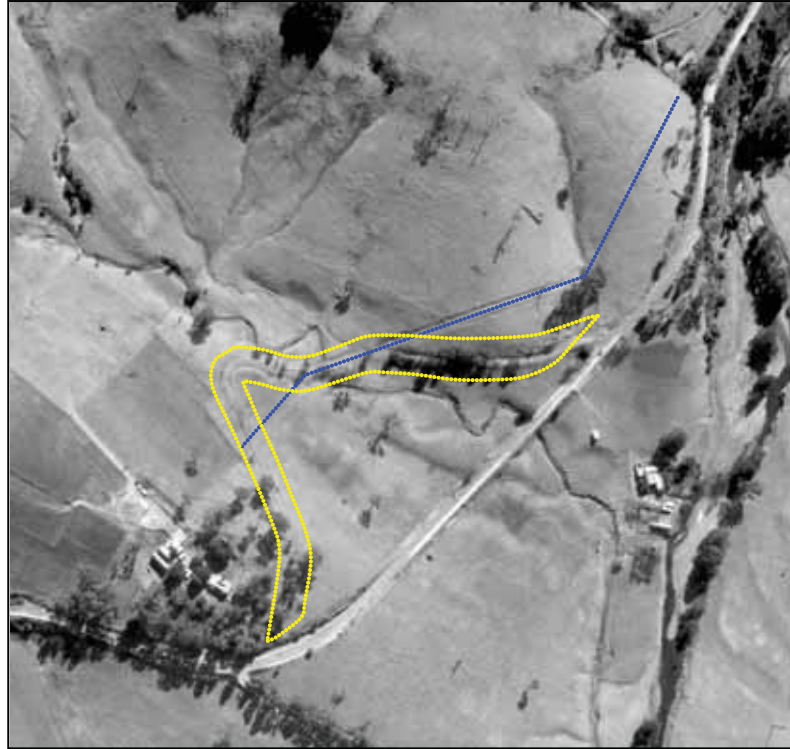
Figure G.57 Road remnant visible on 1958 aerial photo (outlined in yellow), The alignment of the earlier Berry Estate road is shown in blue (NSW 699-5028, SH.I Dapto-Ulladulla Run GK11 23/07/58)

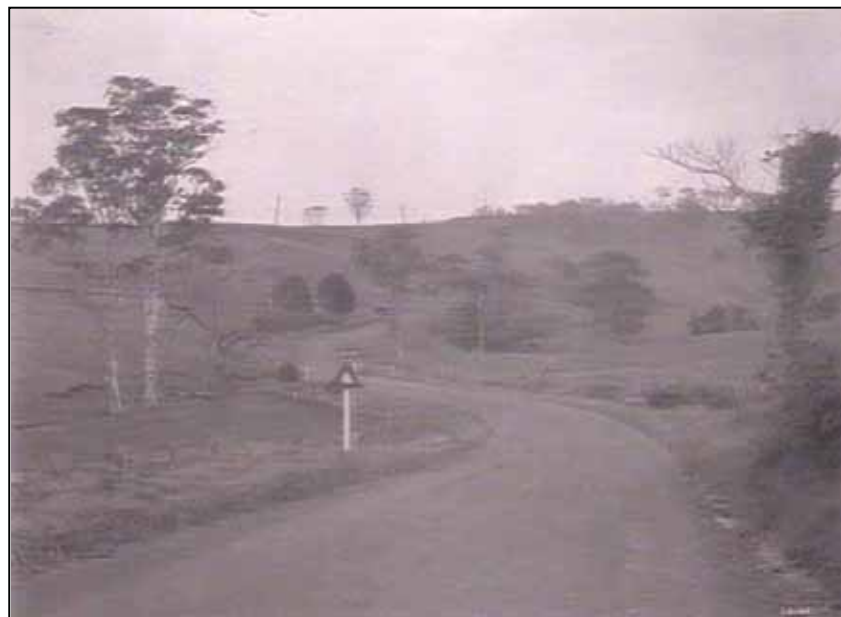
Figure G.61 "Binks Corner - old abandoned roadway 1937". This photo was taken looking SW and downslope towards the main creek crossing. (State Library of NSW d1_27130r)

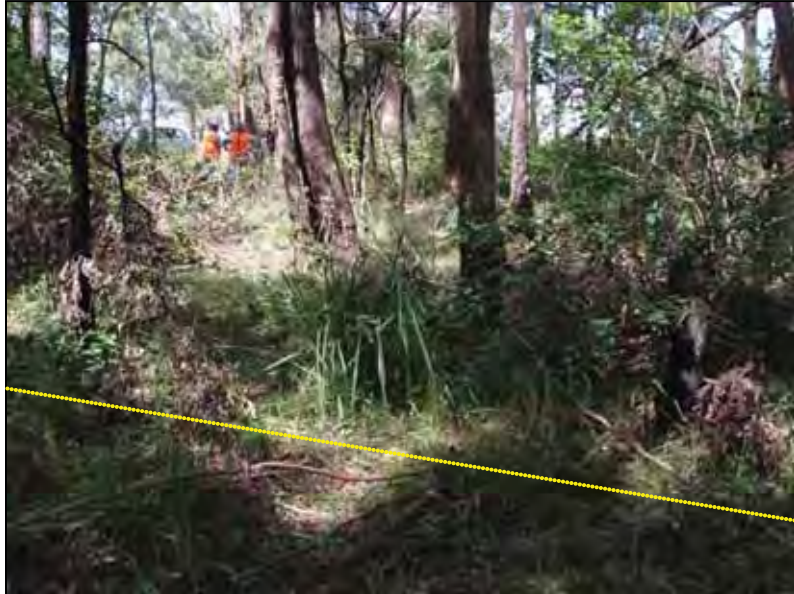
Figure G.62 General view, looking SW, showing edge of recessed remnant road platform (foreground), (approximate alignment marked in yellow) (photo: Dec 2005)

Physical condition: The remnant is in poor condition. The section closest to Tindalls Lane has been encroached upon by the recent construction of a turning bay. Clearance of the eastern gas pipeline easement has also impacted upon another section. Forest regrowth is now obscuring the platform and its edges.

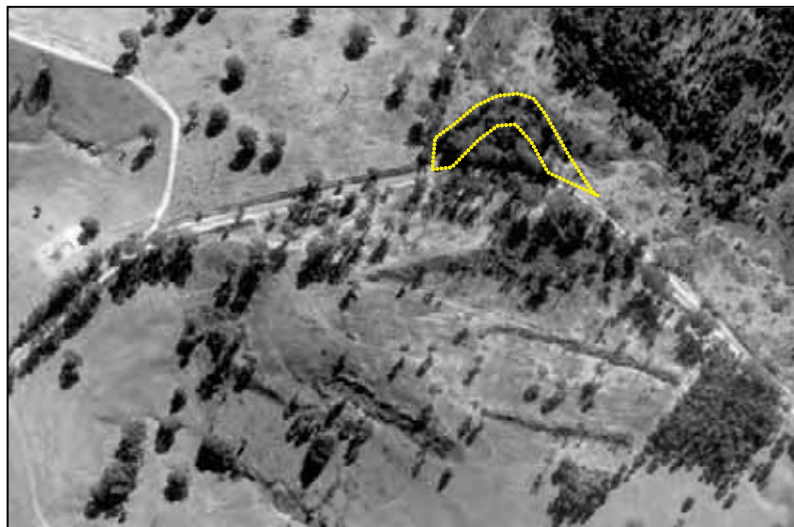
Figure G.64 1958 aerial image of area of road remnant G2B H57 (outlined in yellow – note that outline shows full extent of remnant as of 1958, current remnant has been reduced in size by eastern gas pipeline and turning bay on Tindalls lane) (SHI Dapto-Ulladulla Run GK11 699-5032, 23/07/1958)

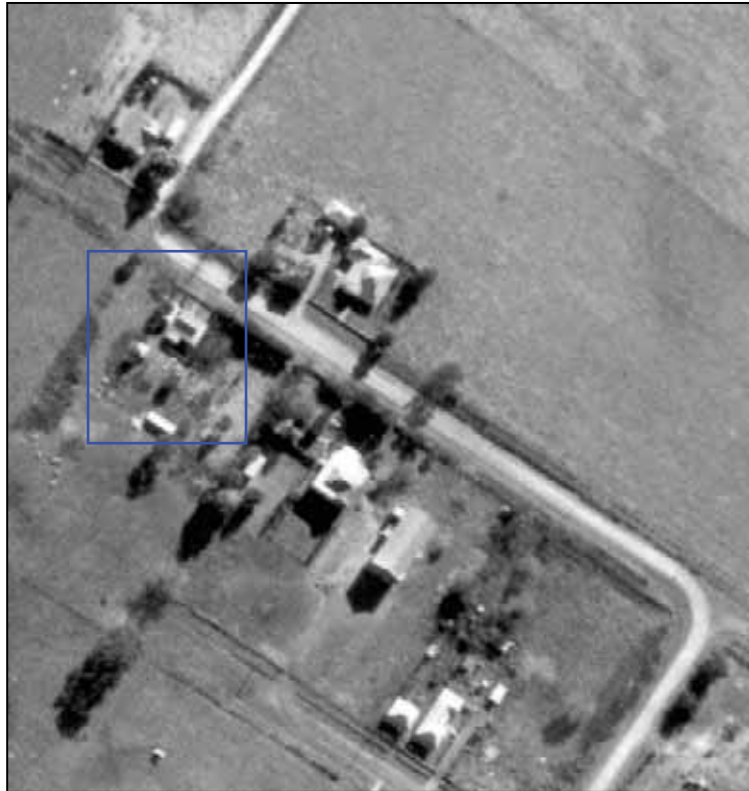
Figure G.68 1958 aerial image showing context of G2B H10 (SH.I Dapto-Ulladulla Run GK11 699-503 23/07/1958)

The 1958 aerial image suggests that at this time, there was a garage abutting its western side, and verandas were present along its southern and eastern sides, but absent along the front (Figure G.68).

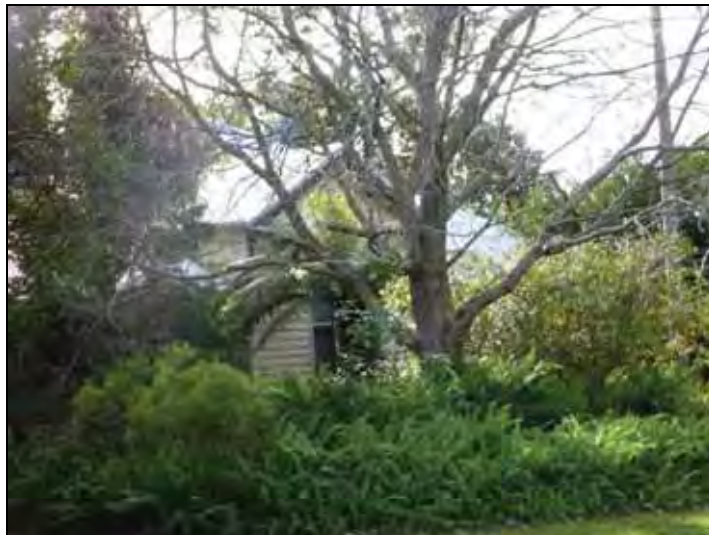
Figure G.72 Front view of *GlenDevan Cottage*, looking NE

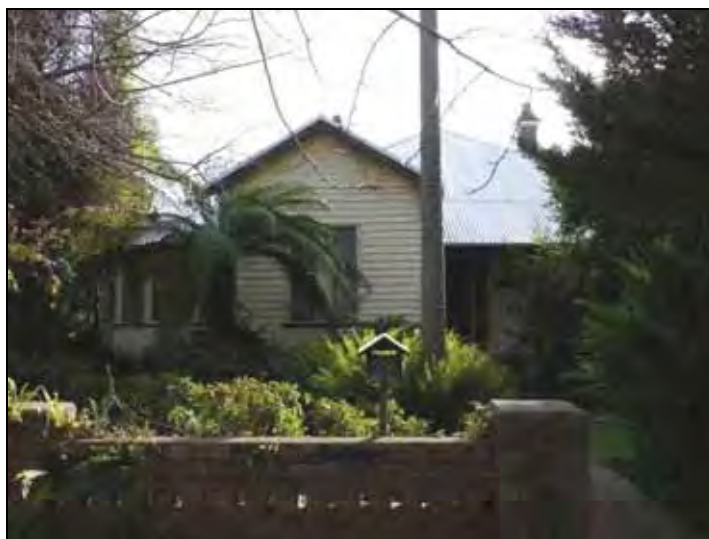
Figure G.73 Detail of front of building, looking N

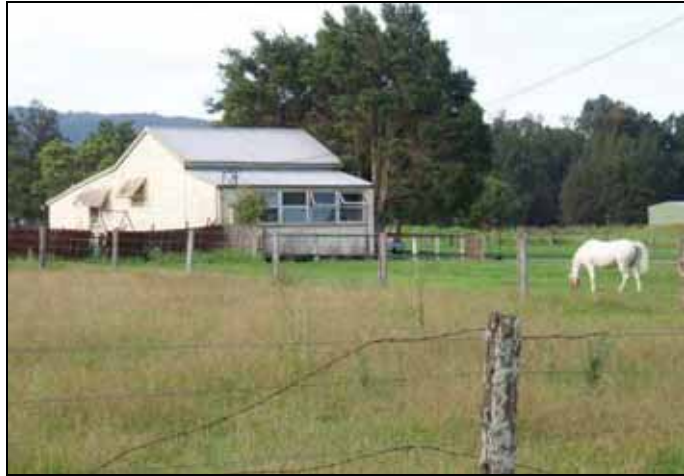
Figure G.77 General view of cottage looking NE

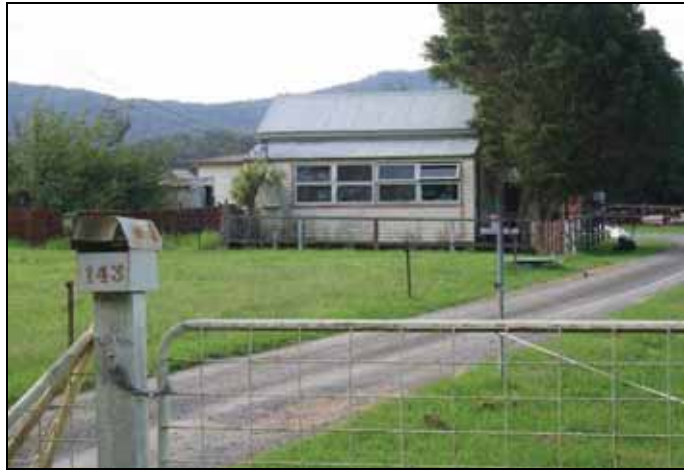
Figure G.78 Cottage looking N

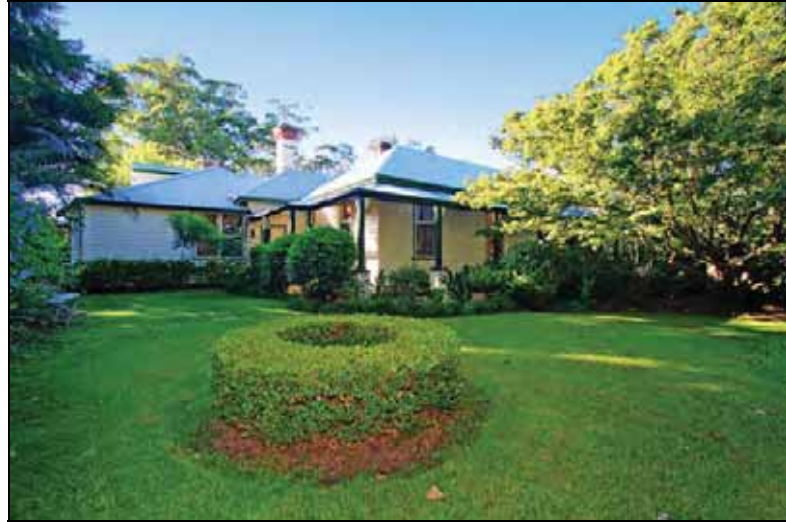
Figure G.84 View looking SE showing extension to NE corner of original building (Photo: <http://www.stayz.com.au/31300>)

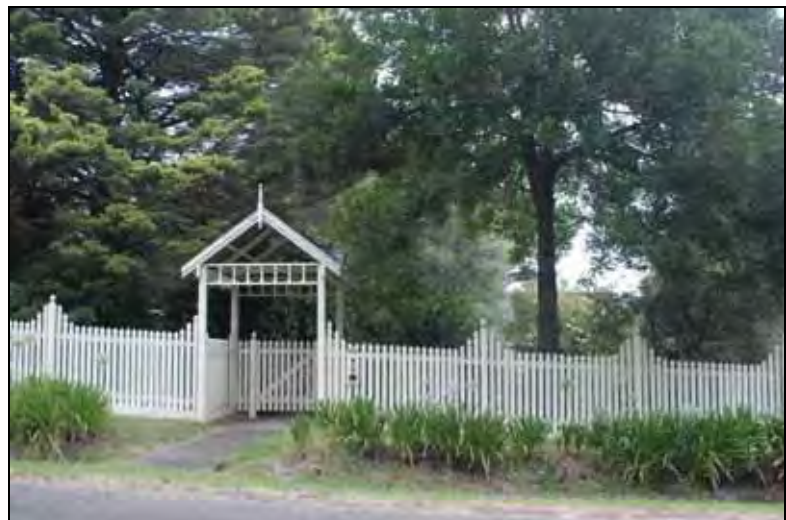
Figure G.86 Detail of roadside boundary fence and entrance, looking E

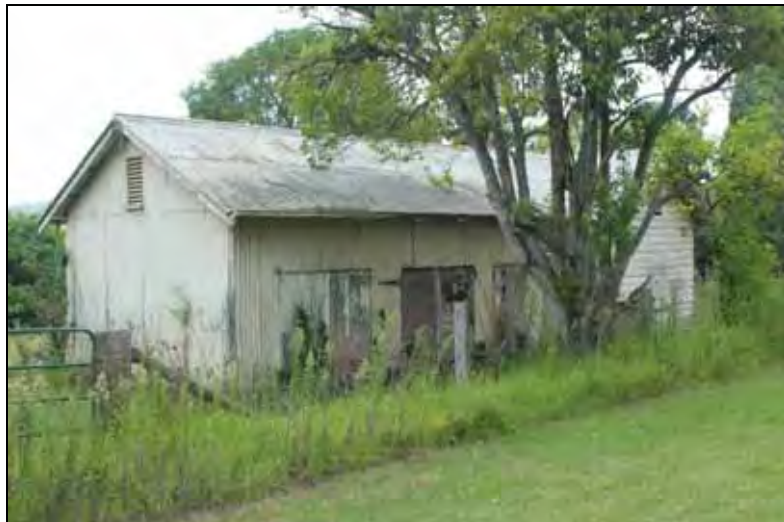
Figure G.89 View of the 'old bails', the southernmost remaining outbuilding in the *Mananga* homestead complex, looking SE

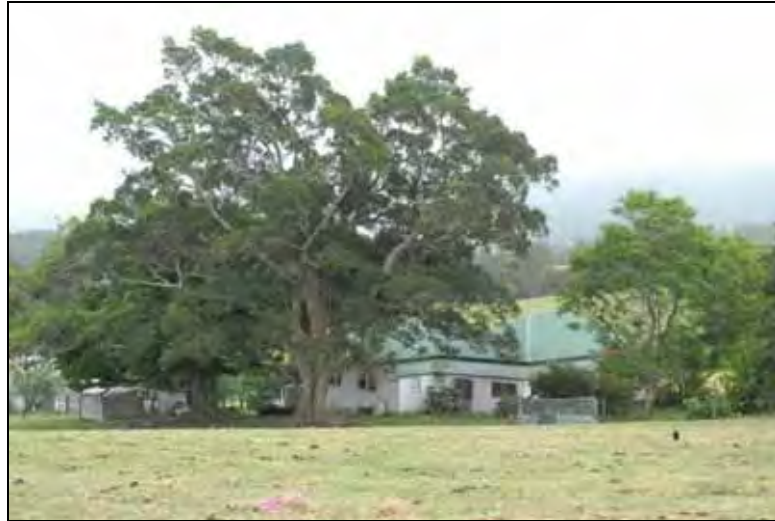
Figure G.99 View of western side of the *Hillview* homestead, looking NE

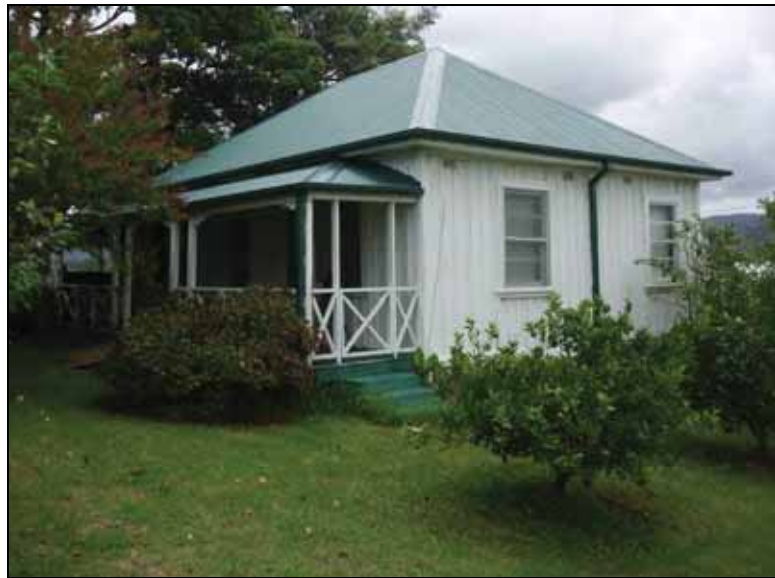
Figure G.100 View of eastern front corner and verandah of original homestead building

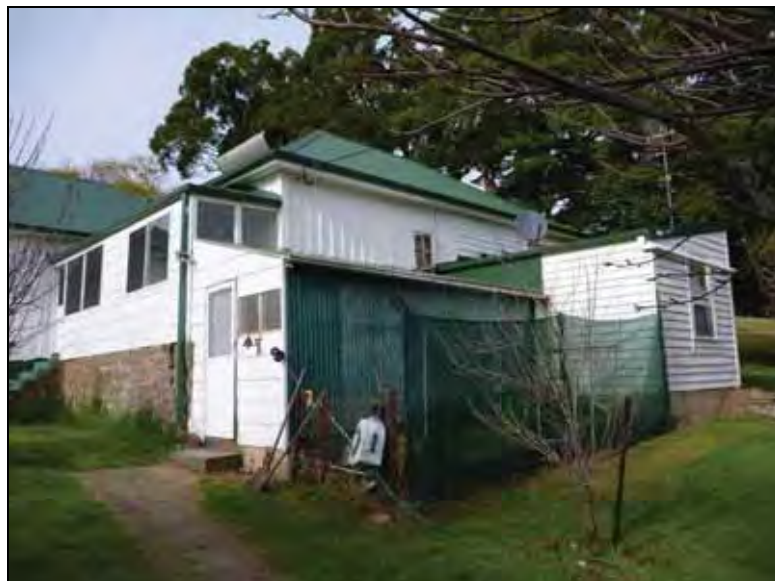
- Original verandas on SE and SW side of house, and eastern side of kitchen wing. West and east facing verandas have been infilled using (synthetic?) wide horizontal cladding, with aluminium framed windows. This treatment replaced an earlier partial infilling on the western veranda (refer Figure G.98).

Figure G.101 View of back (northwest facing) portion of homestead, showing veranda infill and skillion additions, looking S

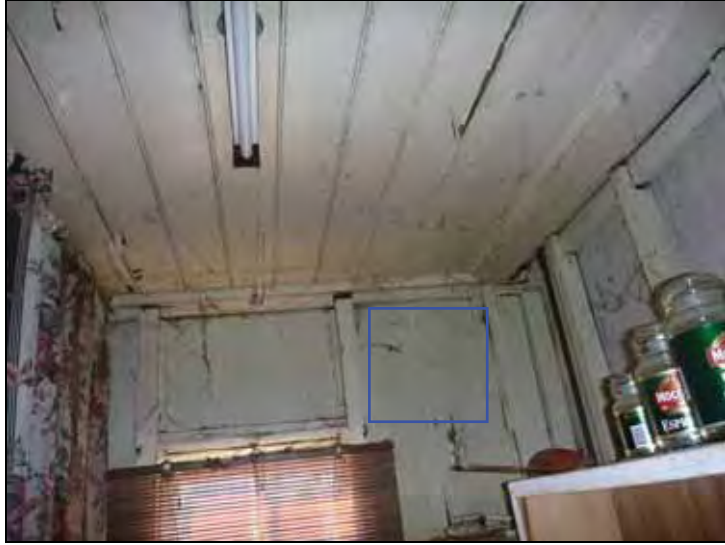
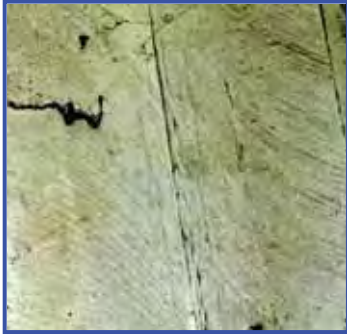
Figure G.102 Ceiling boards and exposed timber frame joinery and vertical slabs on wall and around four pane window (room over back stairway)

Enhanced detail showing circular saw marks on wall slabs

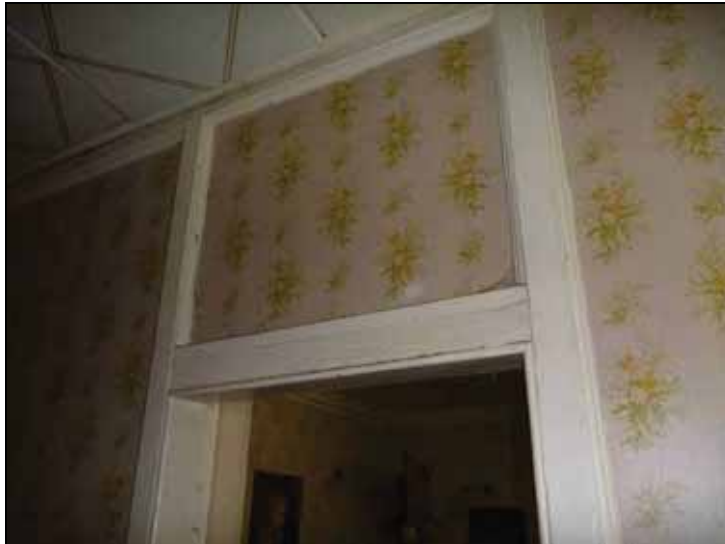
Figure G.103 Typical internal detail of exposed wall framing above door in central hall

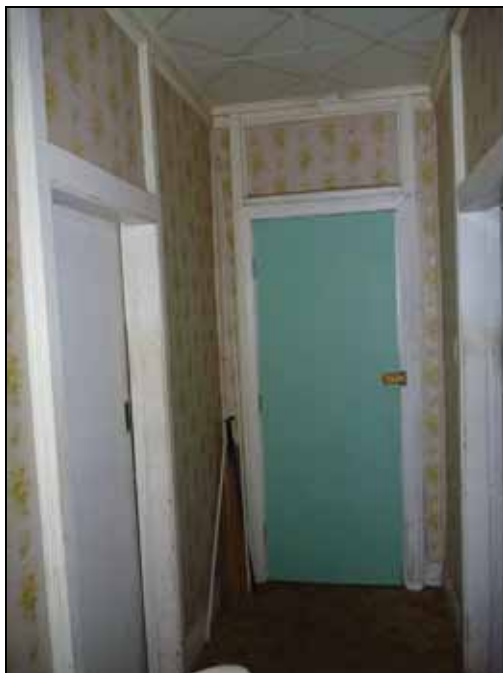
Figure G.104 View along central hall toward front door, showing exposed framing around doors

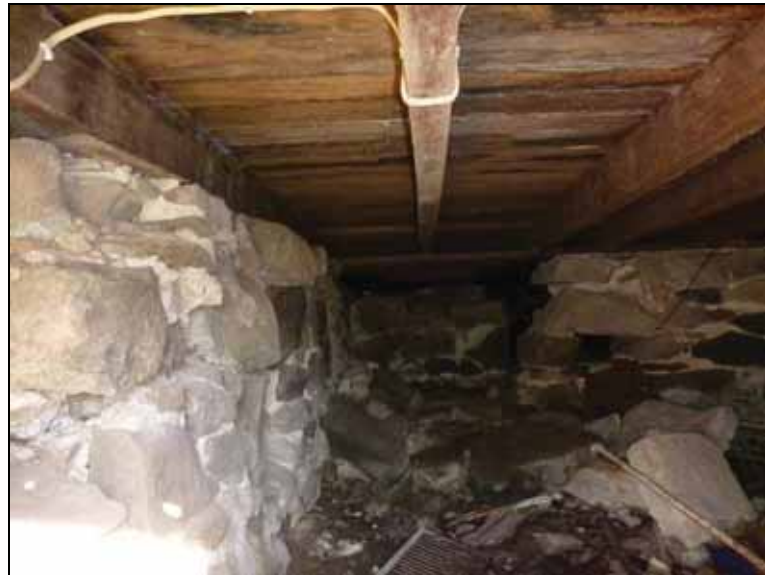
Figure G.107 Sandstone pillars supporting later northwestern addition to homestead

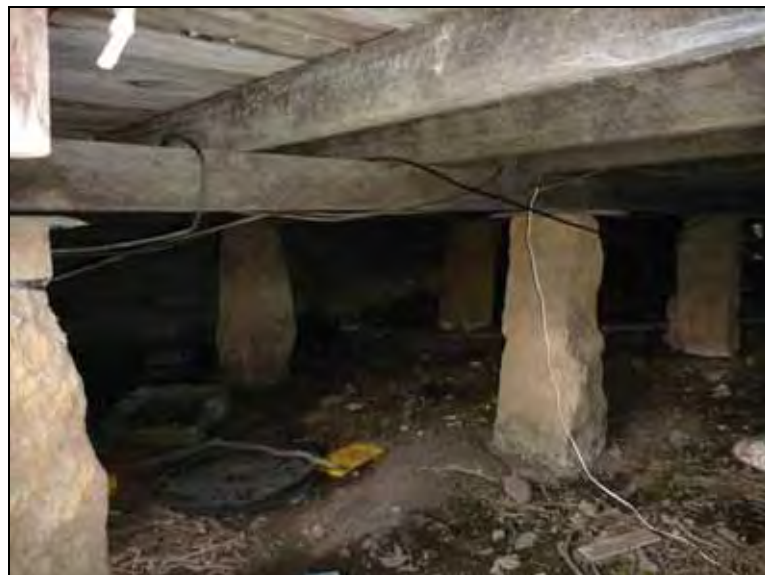
- Rough sandstone wall foundations under original building, and stone pillars used under the lounge room addition (Figures 6.106 and 6.107).
- Two fig trees have been planted on the western side of the homestead and are now large and mature. They may date to the nineteenth century (Figures G.108 & G.116).

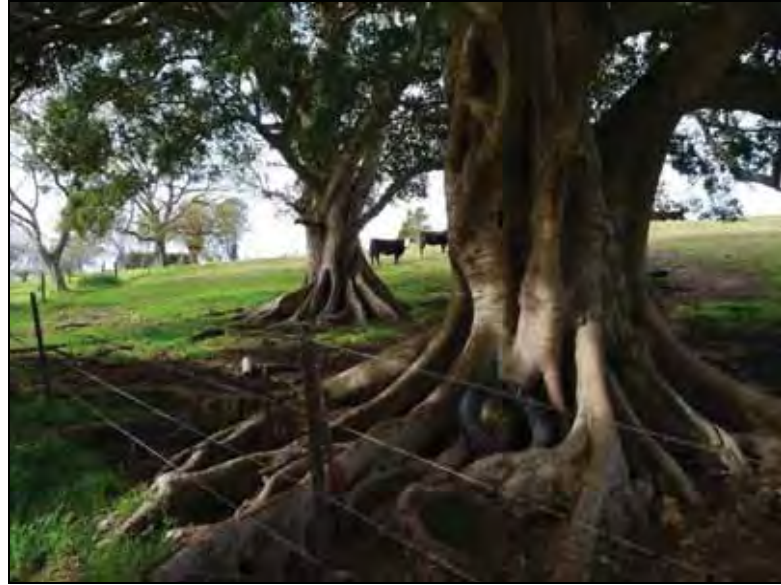
Figure G.108 Detail of large fig trees planted along western side of homestead

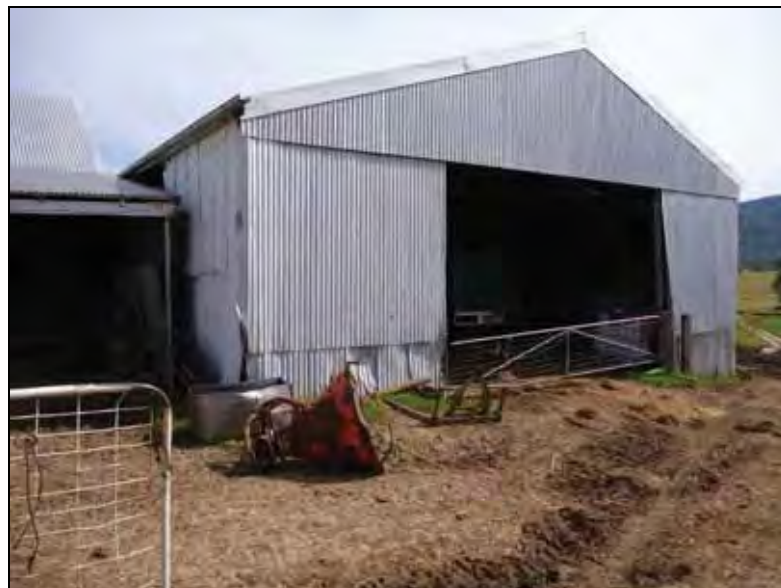
Figure G.110 Front of downslope shed, built using components from a Port Kembla shed used for processing immigrant workers

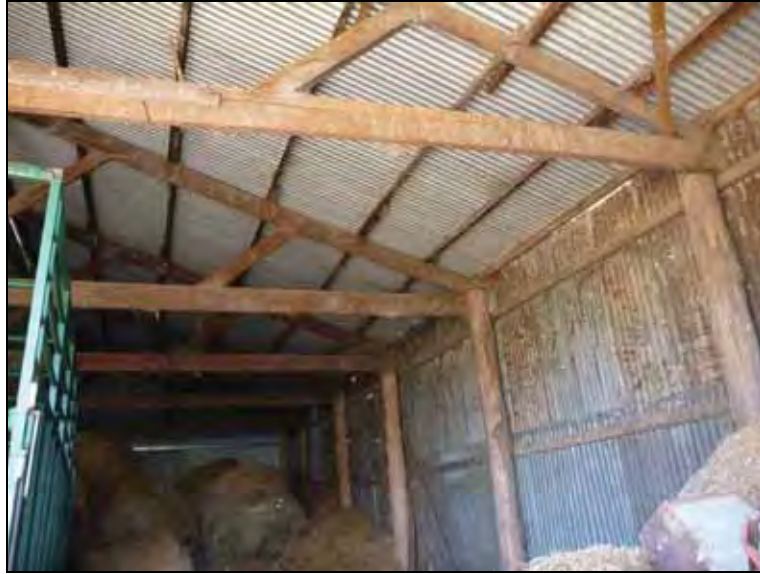
Figure G.111 Detail of internal wooden frame in downslope shed

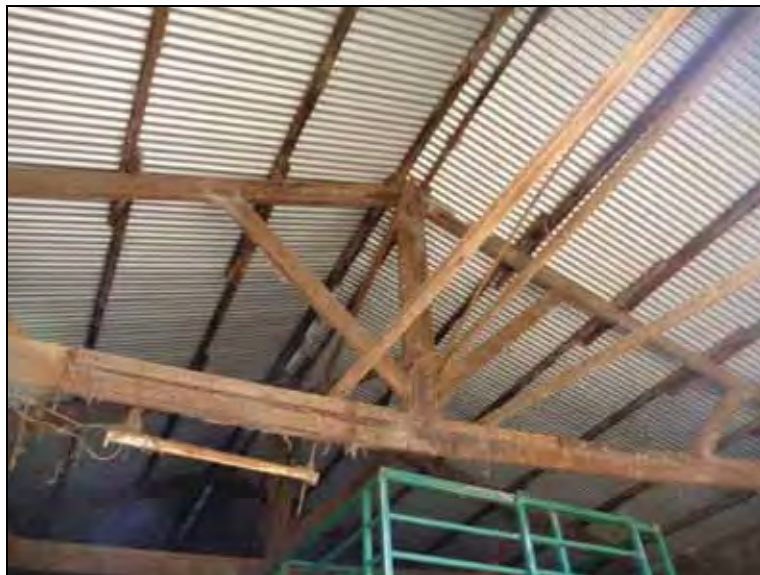
Figure G.112 View of king truss used to support roof in downslope shed

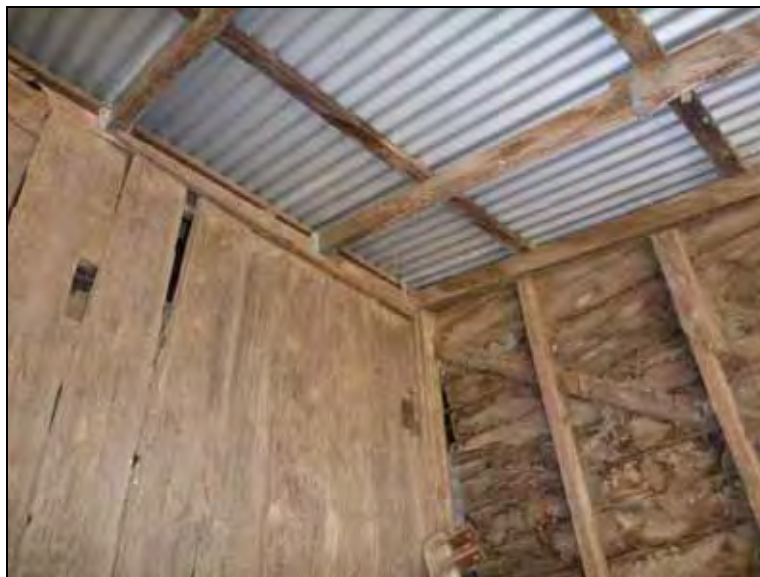
Figure G.113 View of reused vertical wooden slabs and sawn horizontal boards within a smaller shed adjacent to the large downslope shed

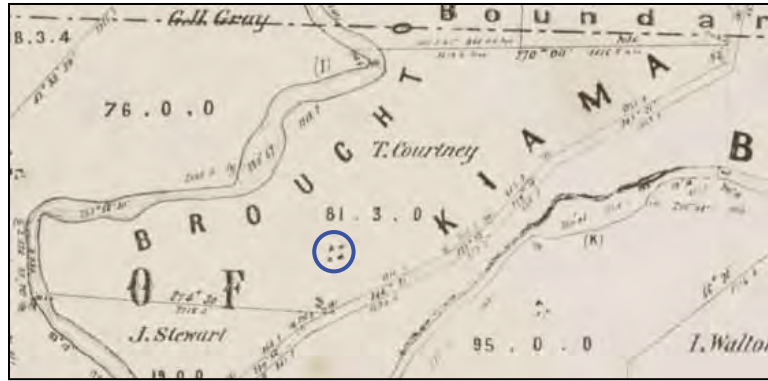
Figure G.114 Extract from 1890s map of the northern Berry Estate, showing four buildings at the location of Hillview (blue circle) ('Part of the Berry Estates, Parishes of Broughton and Coolangatta, County of Camden' original at State Library of NSW, M_Ser4_000_1_MLMSS315_Map 17)

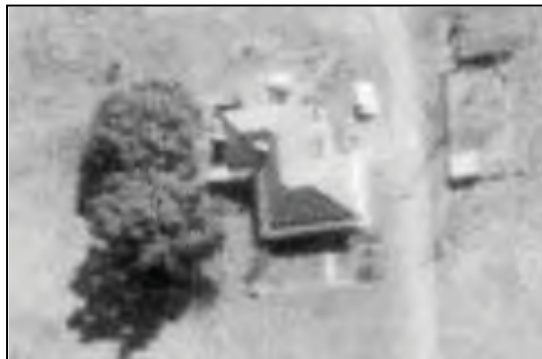
Figure G.115 Detail of 1958 aerial photo showing original 'L' configuration of homestead with addition of lounge room on northwestern corner

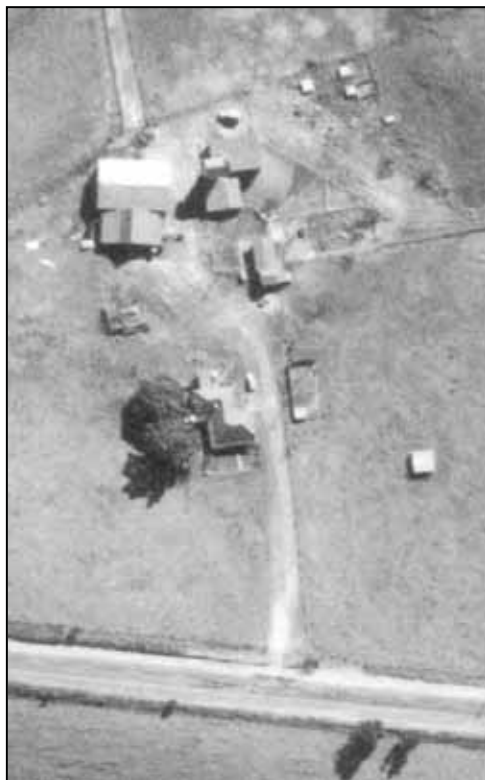
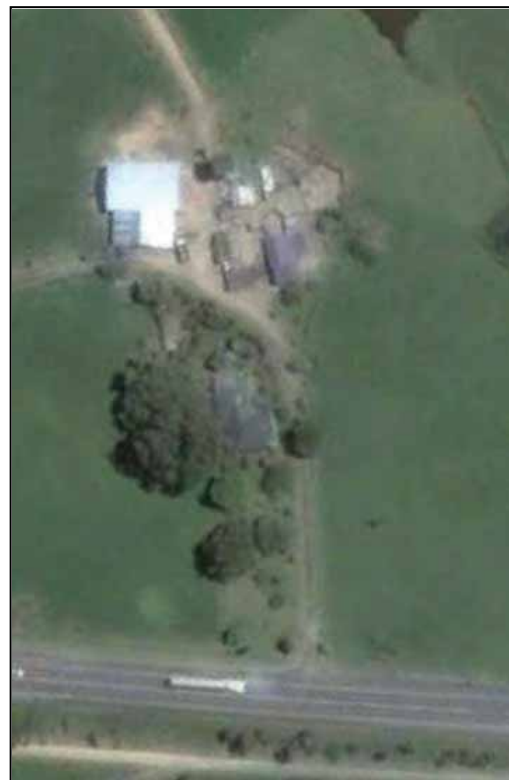
Figure 6.116 Extracts from 1958 and 2006 aerial photography showing little change in the number and configuration of buildings. Apart from the two fig trees, the garden development largely post dates 1960 (SH.I Dapto-Ulladulla Run GK11 699-5035 23/07/1958; Google Earth Pro 2006)

Figure 6.116 Extracts from 1958 and 2006 aerial photography showing little change in the number and configuration of buildings. Apart from the two fig trees, the garden development largely post dates 1960 (SH.I Dapto-Ulladulla Run GK11 699-5035 23/07/1958; Google Earth Pro 2006)

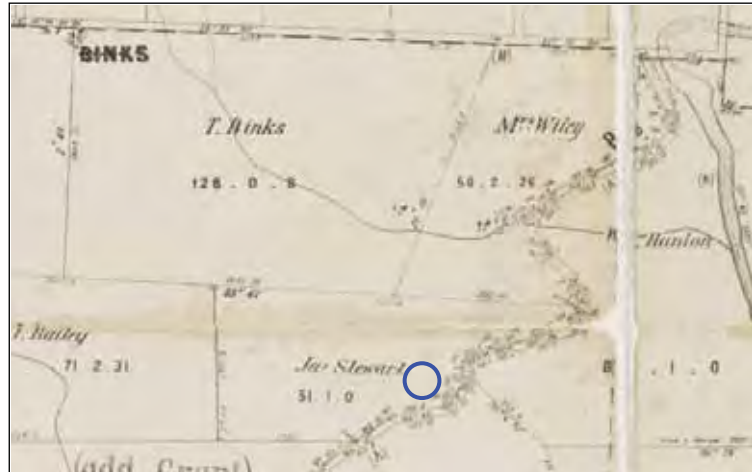
Figure G.120 Extract from 1890s map of the northern Berry Estate, showing the original Binks leasehold farm (top left) and location of 1902 (blue circle) ('Part of the Berry Estates, Parishes of Broughton and Coolangatta, County of Camden' original at State Library of NSW, M_Ser4_000_1_MLMSS315_Map 17)

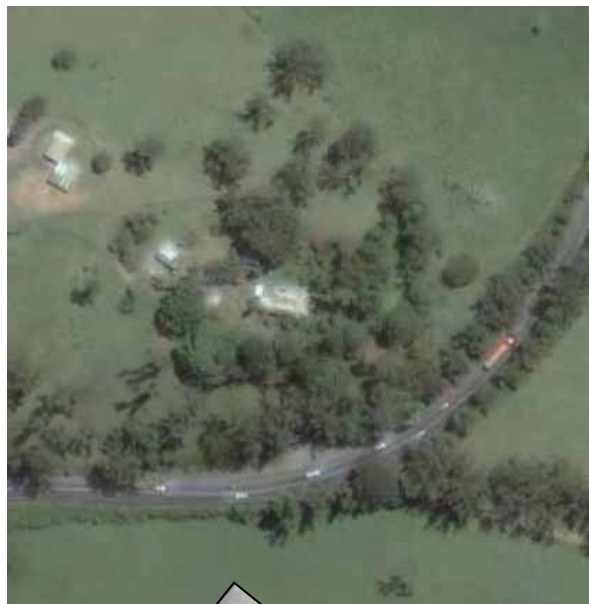
Figure G.121 Aerial image (2007) of Sedgeford and associated plantings and grounds. Note changes in out-buildings (Google Earth Pro 2011)

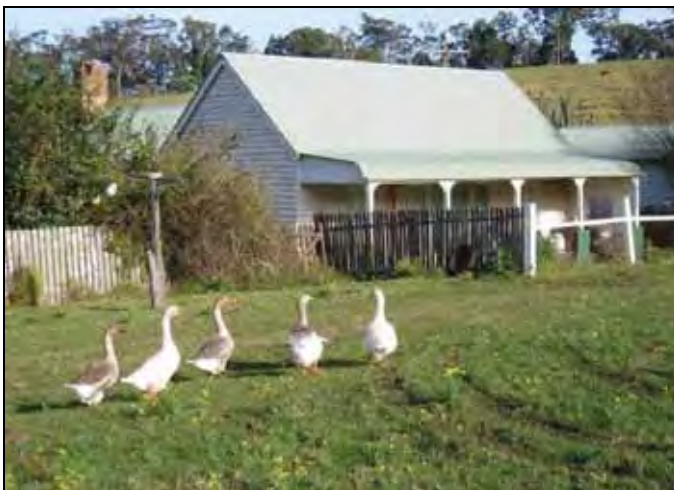
Figure G.125 Detail of front of *Brookside* homestead, looking SW. The front section of the homestead was originally located at G2B H59 and re-constructed at the present site to form *Brookside*.

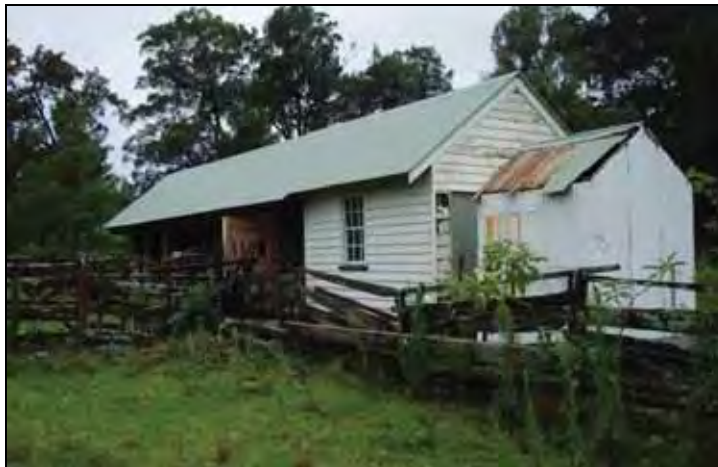
Figure G.129 Storage Shed incorporating elements of a former dairy, looking SE

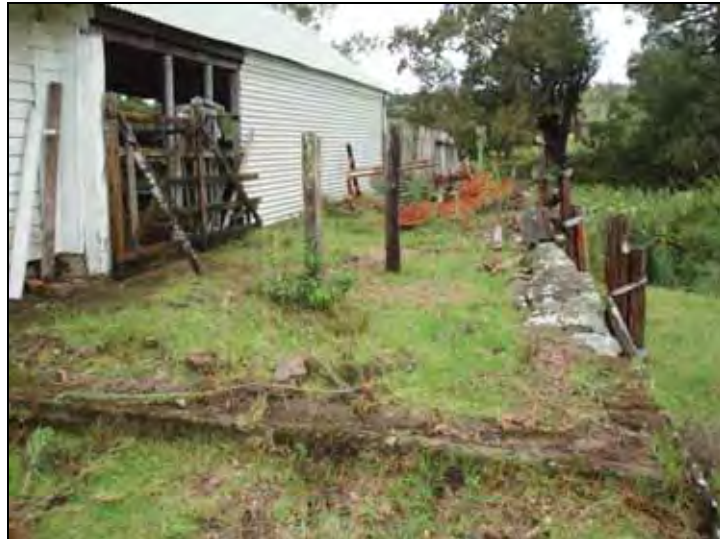
Figure G.130 earth platform behind (south of) storage shed, with cement footings, drains, *in situ* poles and sandstone retaining wall, probably indicative of a former dairy complex, looking E

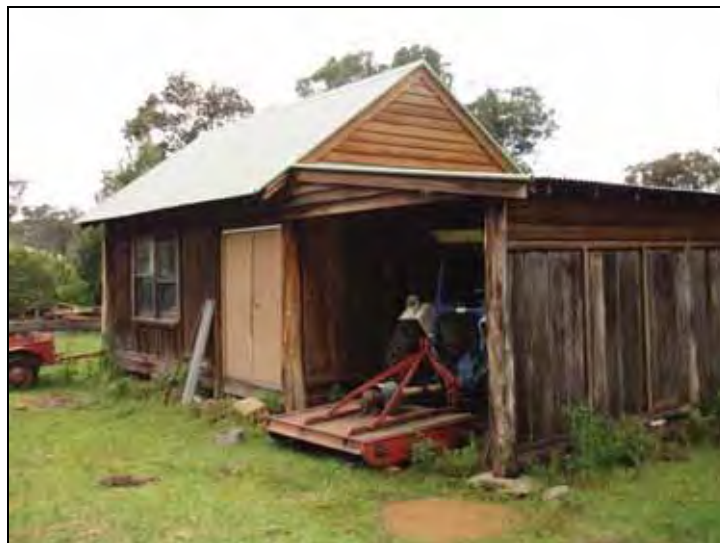
Figure G.132 New timber cottage, with re-used vertical timber slabs, looking SE

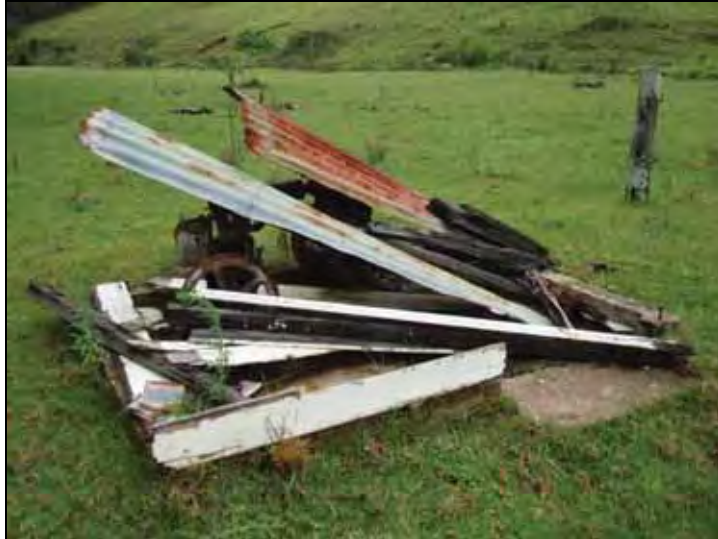
Figure G.133 Remains of a water pump and shed at the edge of a former orchard area (behind pump), looking SW

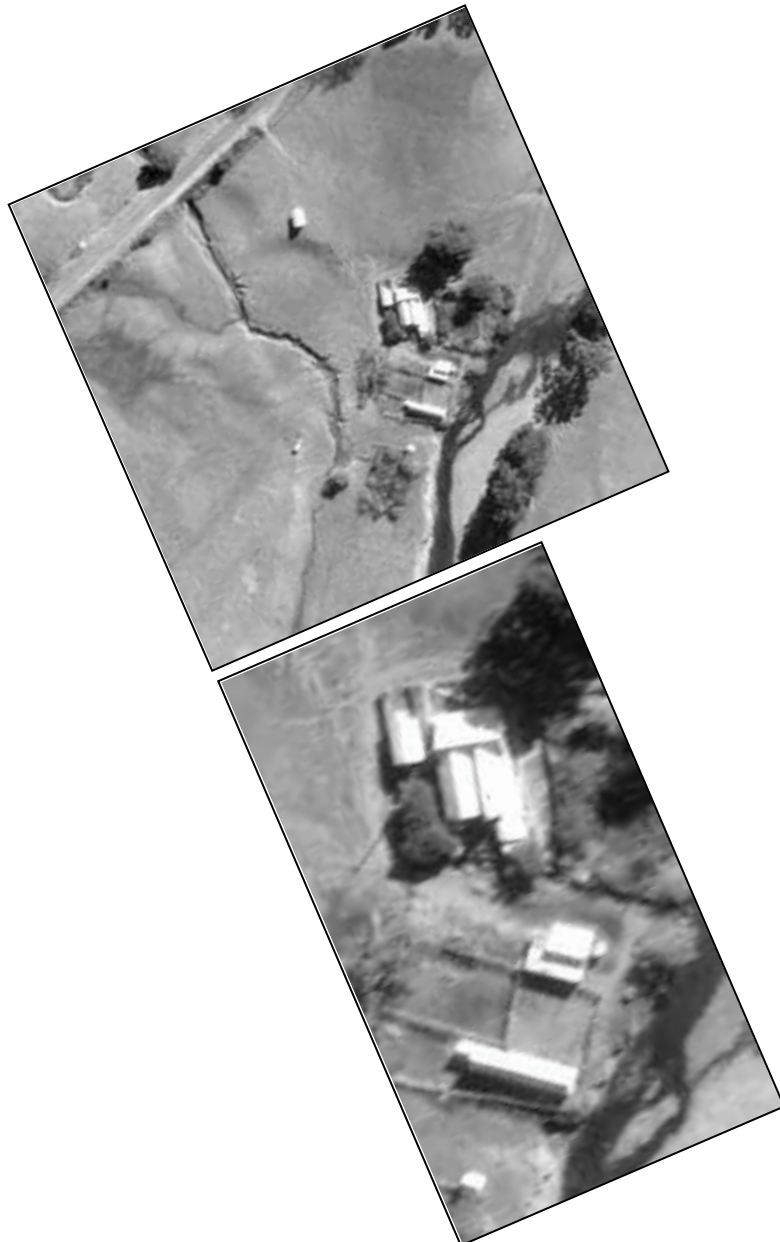
**Figure G.136 Aerial image(and enlargement)
of Brookside and
associated features in
1958, note former orchard
and pump house south of
homestead, out
building/cottage(?)
behind homestead, and
small structure on
opposite side of tributary
west of the orchard (SHI
Dapto-Ulladulla 697-5103,
Run GK10 10/07/58)**

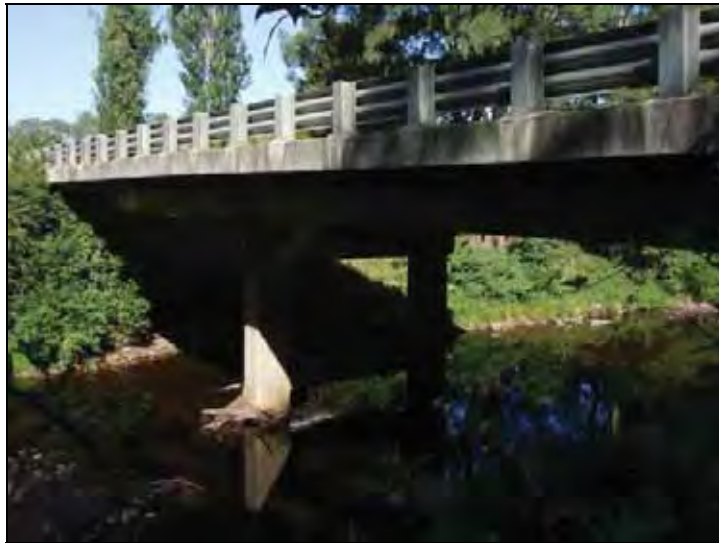
Figure G.137 General view of bridge from upstream west bank

The concrete bridge was constructed in 1935 as part of a bypass of Broughton Village. It replaced a timber truss bridge on the old highway alignment (650 metres upstream), which was probably constructed in the 1890s. In the 1950s the old timber truss bridge was still in use by landowners, as part of the private access routes to their properties. Its demolition occurred subsequent to this time.

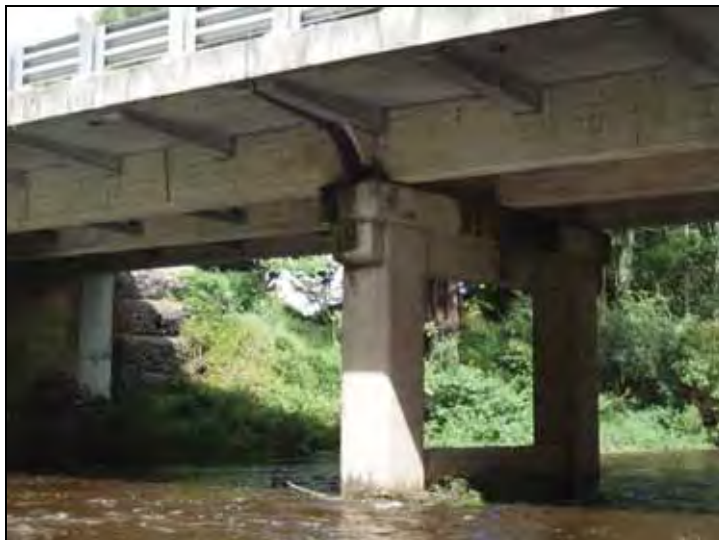
Figure G.138 General view of central pier, longitudinal beams and cantilever supports for widened deck

- This item has an assessed local level of significance under criteria a, c, f & g.
- The existing bridge structure would not be directly impacted by the development.
- The construction of the bypass bridge immediately adjacent to the existing bridge would provide an interpretive opportunity to contrast and compare differences and developments in concrete bridge construction. The continued use of this crossing point continues a practise first established by perhaps the first European pathway along the valley floor, indicated on the 1860s county map (refer Figure 6.216 & 217).
- The reduction in vehicle traffic on the existing highway provides an opportunity to make it easier for visitors to stop and inspect the heritage bridge.
