Foxground and Berry bypass

Princes Highway upgrade

Volume 2 – Appendix J

**Technical paper:
Aboriginal heritage**

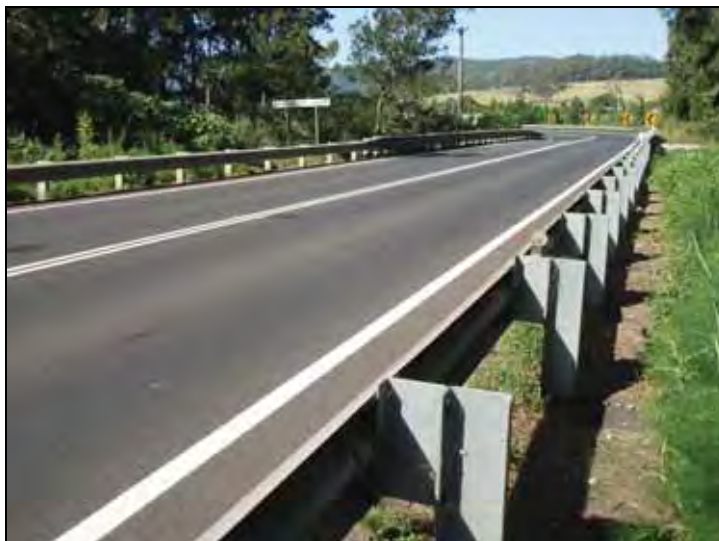
Figure G.139 General view of road top and approaches to bridge, looking NE

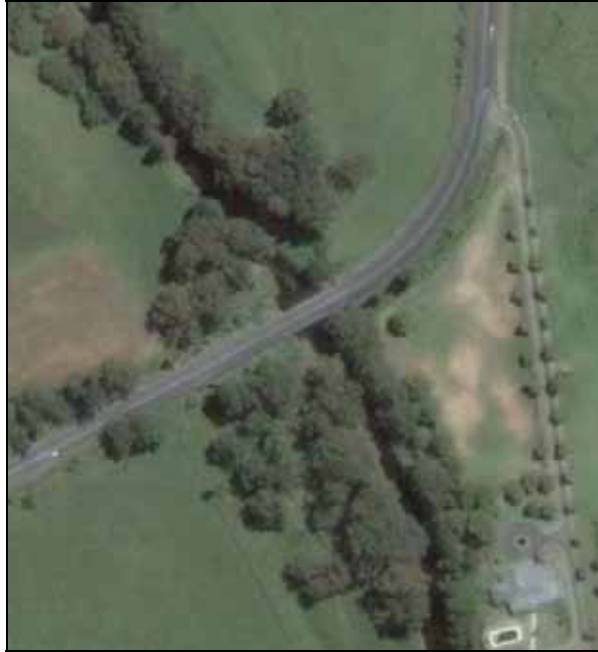
Figure G.140 Aerial image (2007) of bridge (Google Earth Pro 2011)

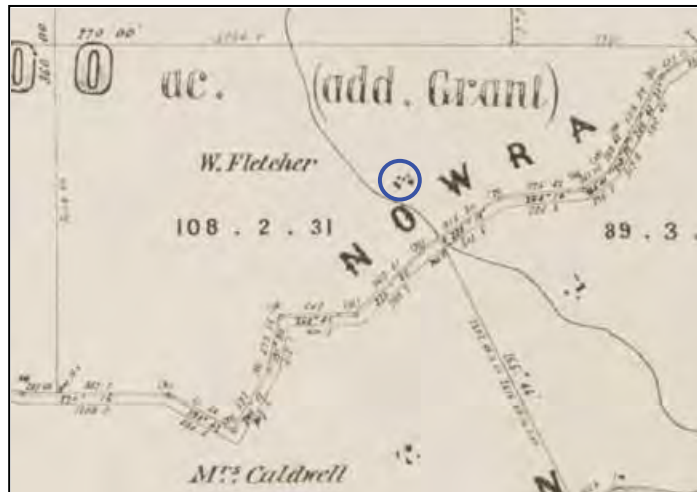
Figure G.145 Extract from 1890s map of the northern Berry Estate, showing four buildings at the location of *Glenvale* (blue circle) ('Part of the Berry Estates, Parishes of Broughton and Coolangatta, County of Camden' original at State Library of NSW, M_Ser4_000_1_MLMSS315_Map 17)

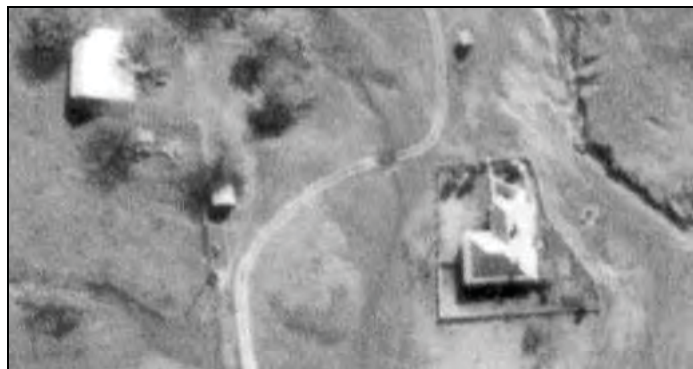
Figure G.146 Detail of 1958 aerial photo showing reverse 'L' configuration of homestead

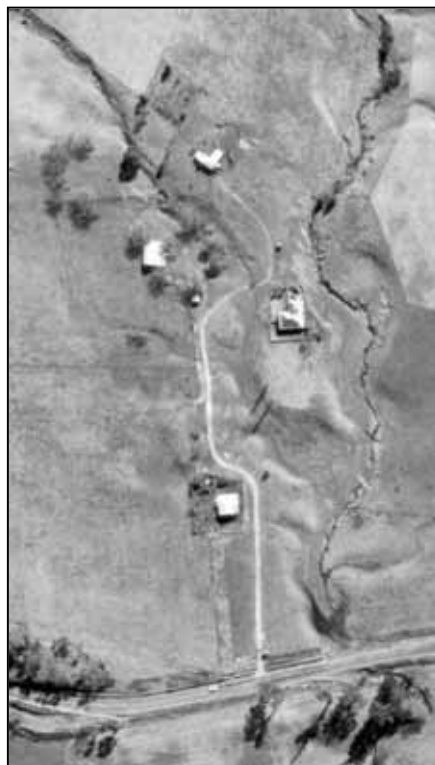
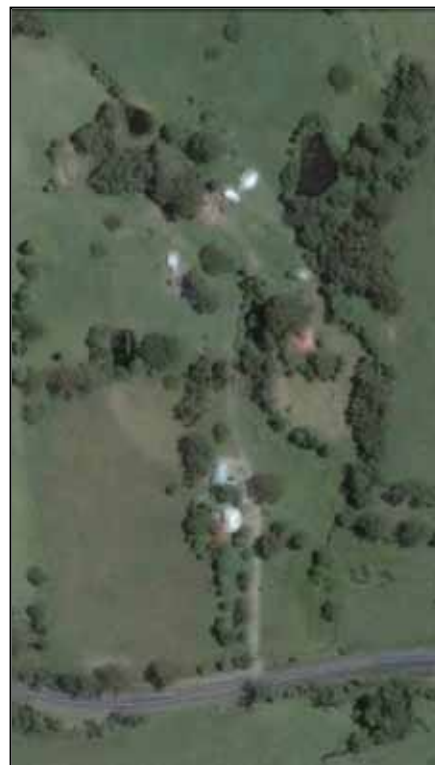
Figure G.147 Extracts from 1958 and 2006 aerial photography showing *Glenvale* homestead complex and replacement of out-buildings in same arrangement (SH.I Dapto-Ulladulla Run GK11 699-5030 23/07/1958; Google Earth Pro 2011)

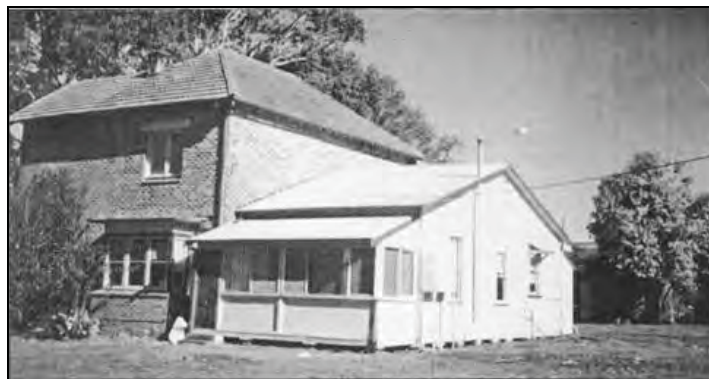
Figure G.150 Rear view of the convent building (date unknown) showing the adjacent priest's quarters (now demolished) (Faherty accessed 2011)

A convent was constructed adjoining the church in 1921. This replaced the older cottage which was then sold and transported to Queen Street, Berry. A priest's apartment was attached to the new building at the rear (Figure G.150).

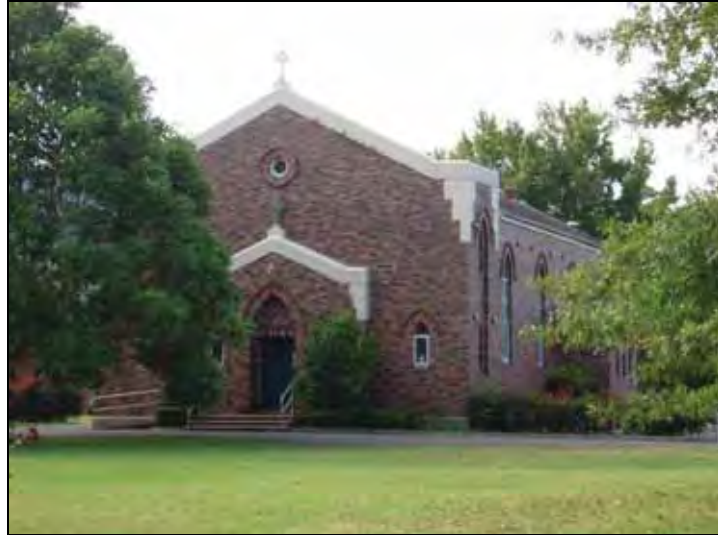
Figure G.152 Front view of St Patrick's Church, looking N

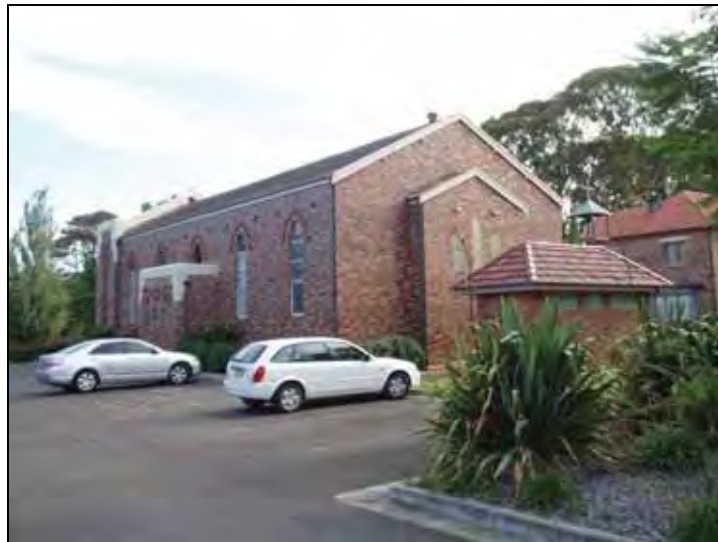
Figure G.153 Rear view of St Patrick's Church, looking S

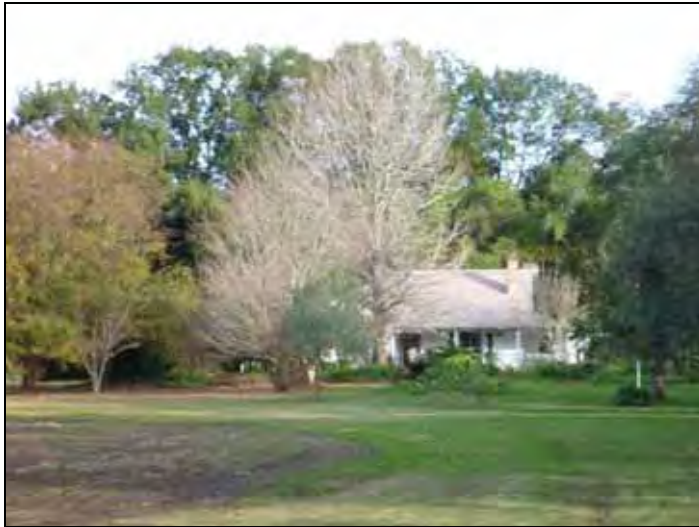
Figure G.155 General view of front of farmhouse, looking W

Physical condition: Farmhouse in excellent condition. Roof and chute cladding on silos now dilapidated. No clear surface indication of original tenant farm structures remains, however archaeological deposits may exist.

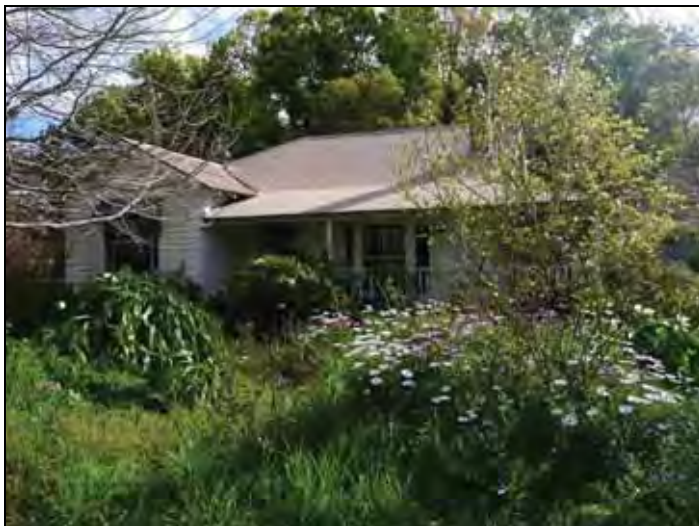
Figure G.156 View of front of farmhouse, looking W

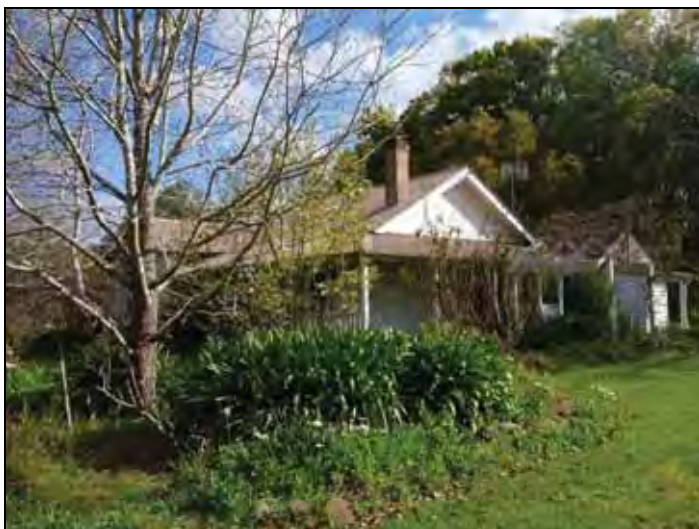
Figure G.157 View of farmhouse looking SW

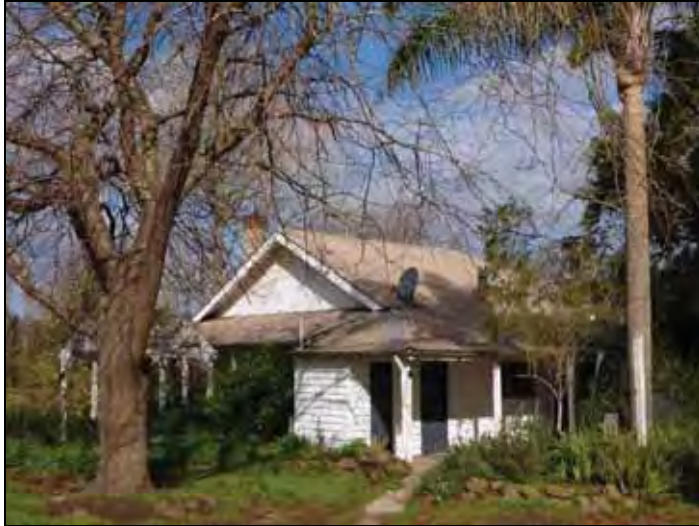
**Figure G.158 View of
farmhouse looking SE**

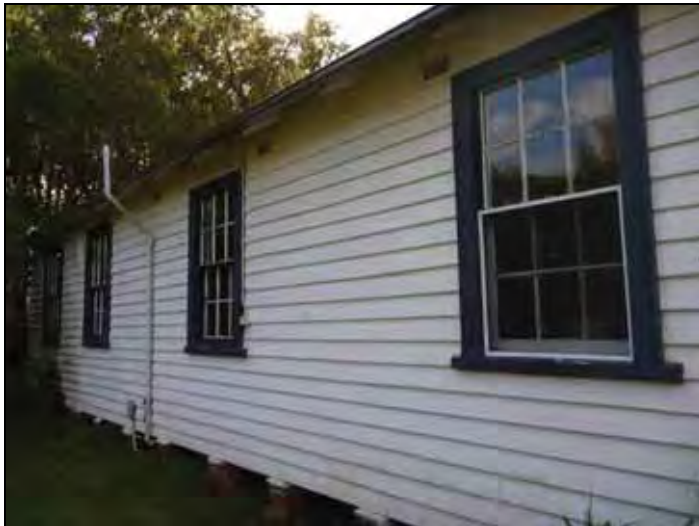
**Figure G.159 Detail of
southern side of farmhouse
looking NW**

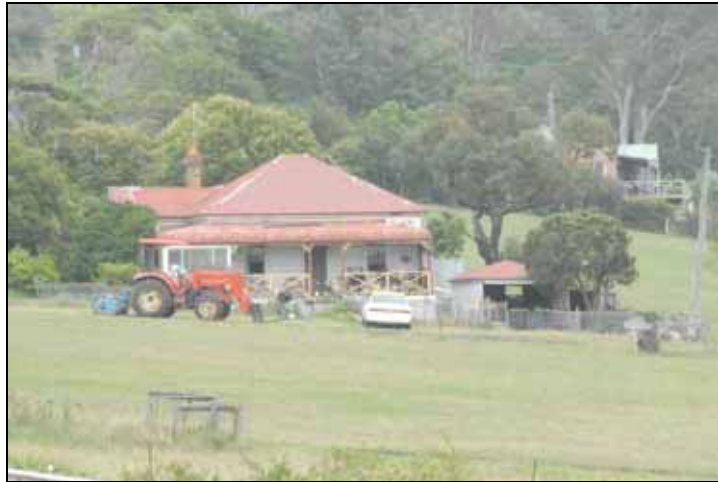
**Figure G.162 General view
looking W**

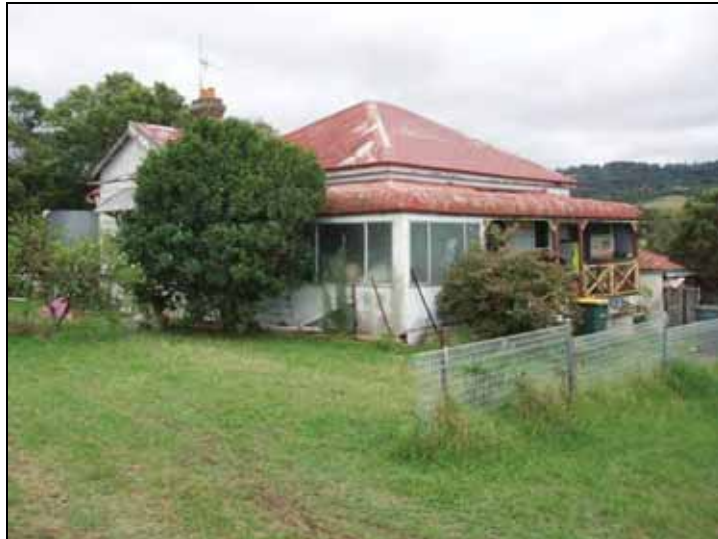
**Figure G.163 General view
looking NW**

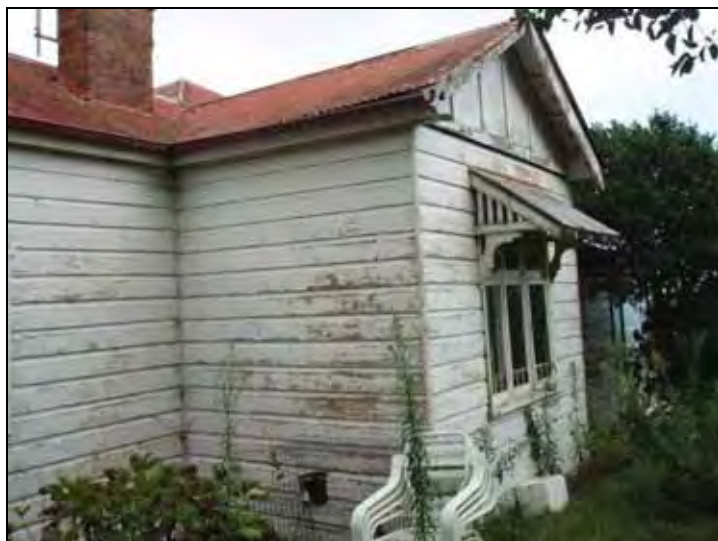
**Figure G.164 View of
Federation style extension
at SW corner of building**

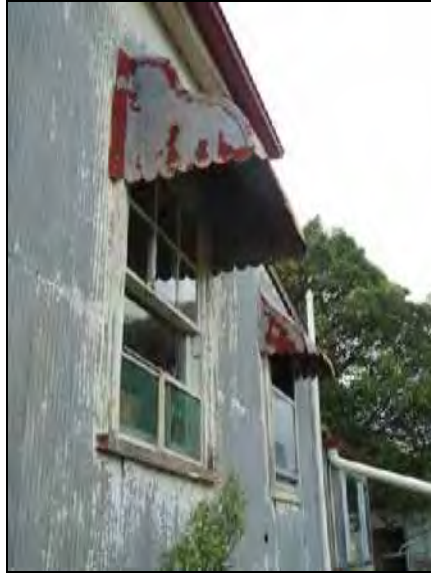
Figure G.165 Detail of awnings and corrugated iron cladding on N side of building

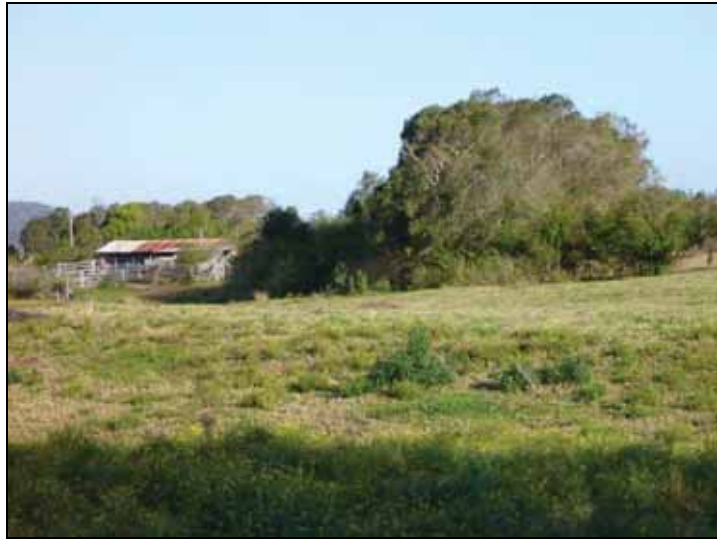
Physical condition: Homestead in poor and uninhabitable condition – wooden frame still standing, however roof, ceiling, wall cladding and floor now unstable and structurally compromised. Building is no longer weather proof. Most of verandah has collapsed except for western side. Whole building now obscured by vegetation and vine growth. Outbuildings adjacent to homestead, except for Dairy group in similar condition. Broken asbestos sheeting poses a health risk.

Figure G.175 General view of complex looking south from creek flats, Dairy on left, homestead behind vegetation on right

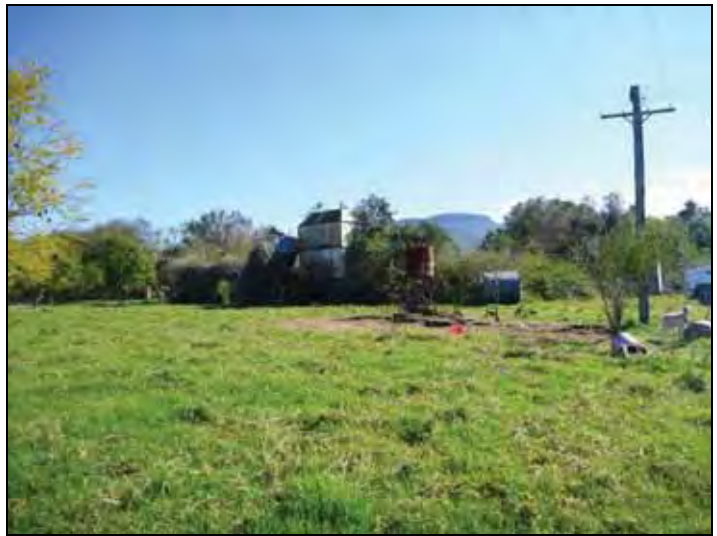
Figure G.176 General view of homestead site looking north, note disused silos

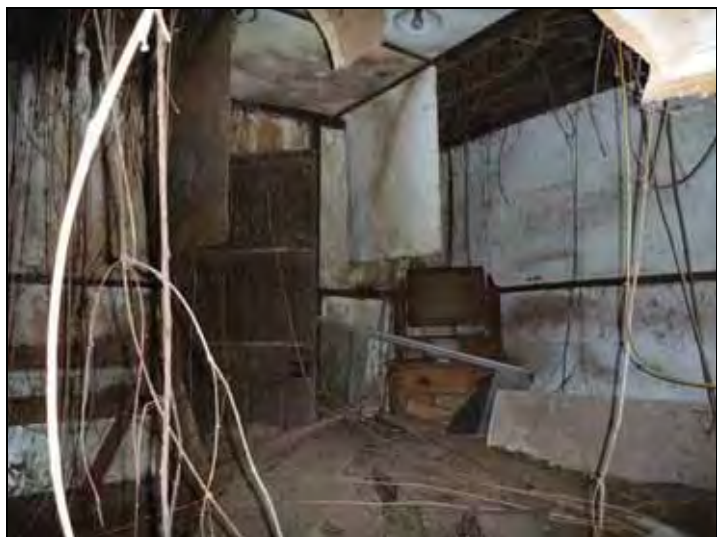
Figure G.177 Interior view of north eastern room

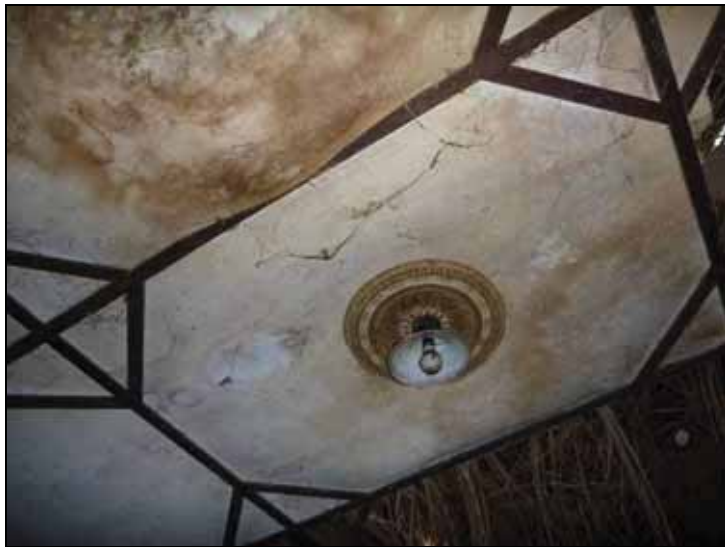
Figure G.178 Detail of ceiling and light fitting

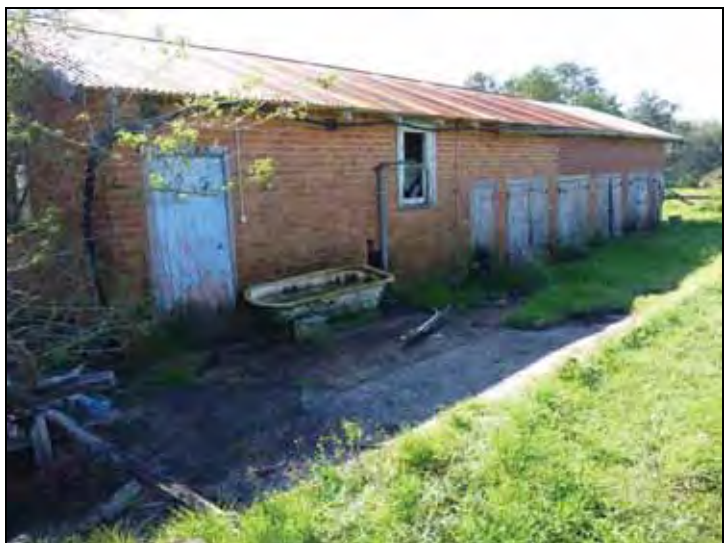
Figure G.180 Southern side of disused dairy, looking NE

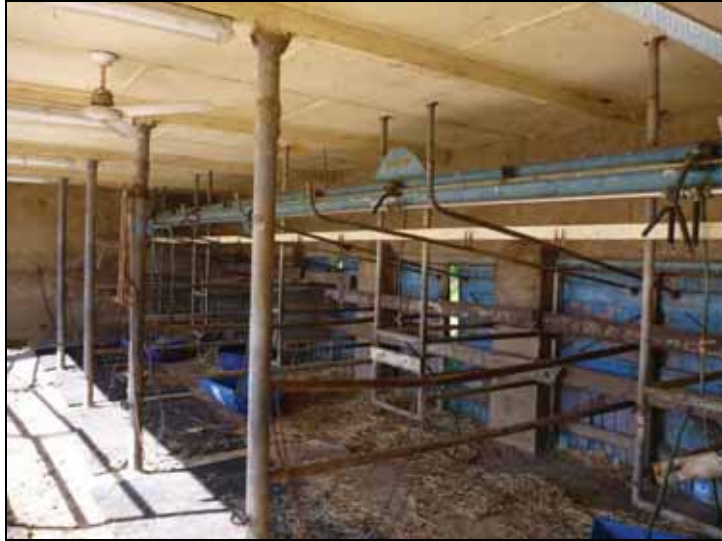
Figure G.181 Interior view of Dairy and “Dangar-G” Milker apparatus, looking SE

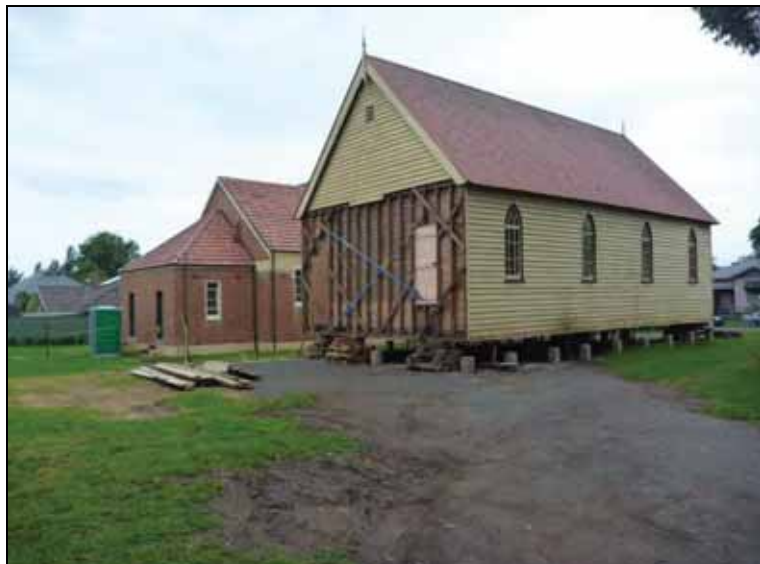
Physical condition: Good. Deterioration issues noted in 2002 (paint condition, weatherboard rot, roof leaks) appear to have been addressed. Following the recent re-positioning of the building, the consequential installation of new piles and higher ground clearance will address previously noted issues of dampness from soil contact.

Figure G.188 The new location of the former chapel, on the west side of the 1932 church building looking SE

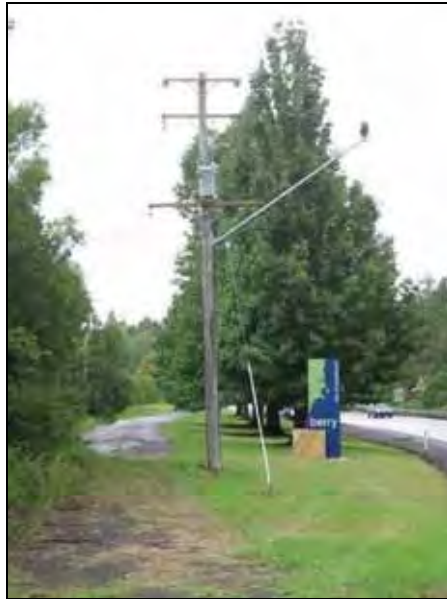
- Physical condition:* Results from an archaeological subsurface testing program confirm that archaeological deposits occur under a variable layer of construction related overburden in the grassed area situated between the pre and post 1955 highway alignments. The deposit has probably been totally or substantially removed along the upslope (eastern) half of the current highway platform. However, due to the probable use of fill to create an elevated and benched platform on the downslope margin of the highway, there remains good potential for archaeological deposits to remain under the western half of the highway platform.

Figure G.189 General view of the portion of archaeological deposit G2B H14 situated between the former (left) and current (right) highway platforms, looking S

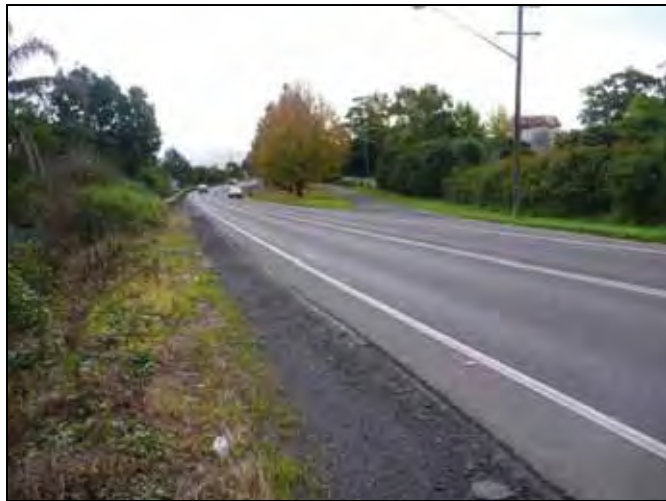
Figure G.190 General view of archaeological deposit G2B H14, looking N from its southern end. Note 1870s to 1955 highway alignment diverging from current highway on right hand side (middle of picture). The potential for archaeological deposits under the road platform remains untested

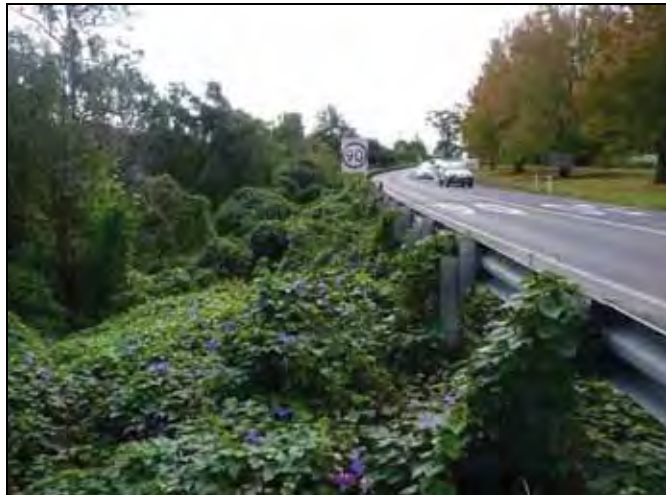
Figure G.191 General view of archaeological deposit G2B H14, looking N W, along the downslope side of the current highway platform. There is an untested potential for archaeological deposits to survive under the fill which supports this 1955 roadway

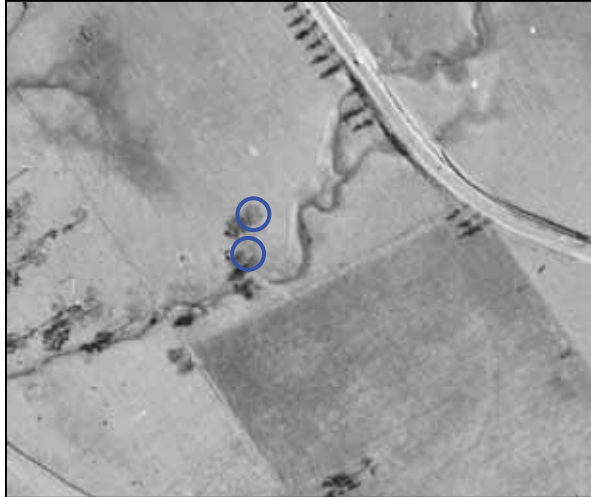
Figure G.198 Aerial image of location of former homestead in 1958. Note remnant trees (blue circled) (SHI Dapto-Ulladulla NSW Run GK10 697-5101 10/07/58)

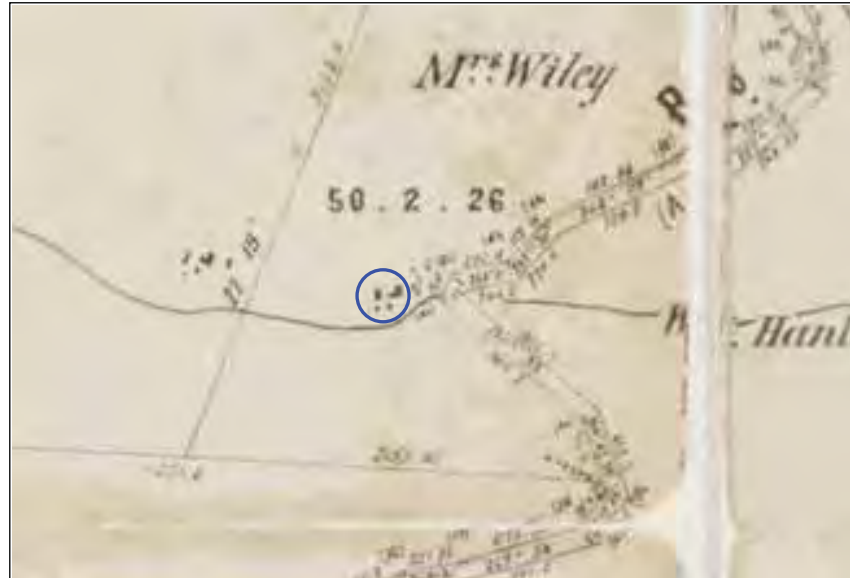
Figure G.203
 Extract from 1890s
 map of the
 northern Berry
 Estate, showing a
 group of former
 tenant estate farm
 buildings at
 "Bink's Corner"
 (blue circle) ('Part
 of the Berry
 Estates, Parishes
 of Broughton and
 Coolangatta,
 County of
 Camden' original
 at State Library of
 NSW,
 M_Ser4_000_1_MLM
 SS315_Map 17

An 1890s map of tenant farms across the northern portion of the Berry Estate (probably dating from 1892, refer Graham 1998), shows a homestead complex at this location leased by a Mrs. Wiley. The farm consisted of approximately 50 acres (Figure G.203).

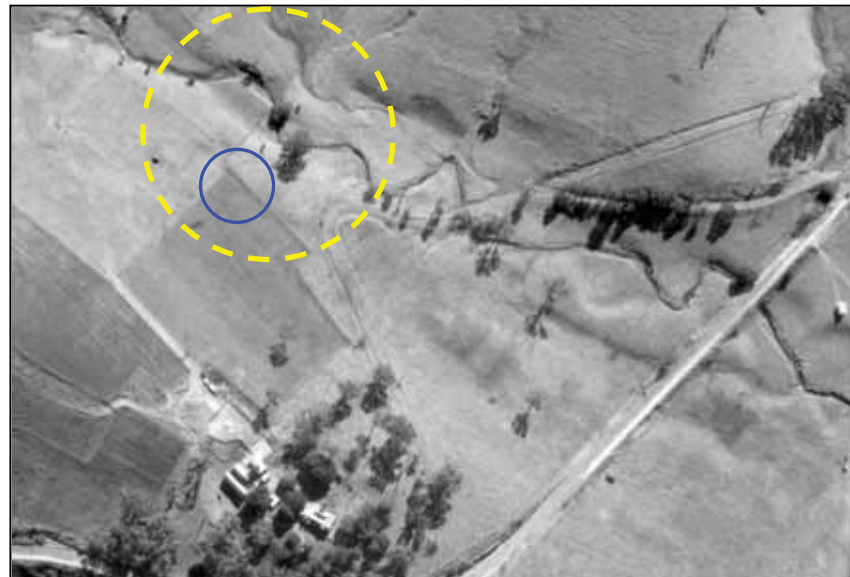
Figure G.204 1958
 aerial image of
 location of former
 homestead based
 on 1892 map (blue
 circle) and
 potential actual
 location based on
 topography and
 map interpretation
 options (yellow
 dashed circle) (SHI
 Dapto-Ulladulla
 NSW Run GK10
 697-5103 10/07/58)

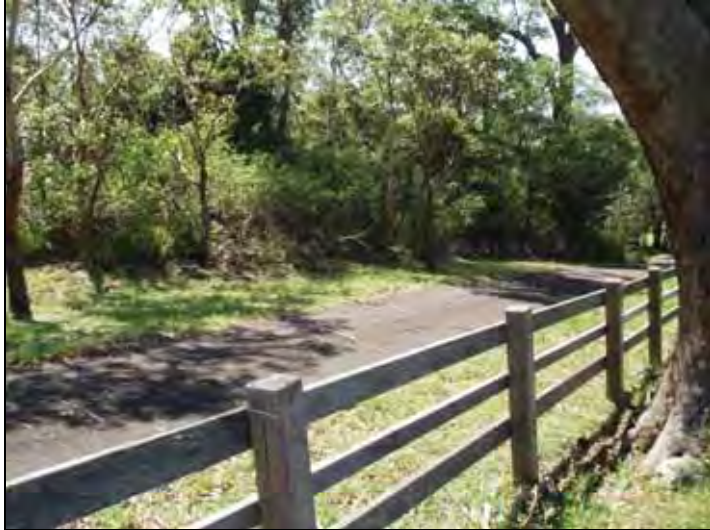
Figure G.205 General view of
piled alignment of rock
rubble, looking NE

1. It is the graded remains of a former agricultural dry stone wall (a surviving wall is located 80 metres to the northwest).
2. It is the graded/disturbed remains of stone walls or foundations from the former tenant farm structure.
3. It is a spoil dump from the construction of the 1856 Berry Estate Road.
4. It is the spoil dump from the construction of a more recent road, either the 1870s highway (35 metres downslope), or a farm access track and/or the most recent residential driveway.

Of these, option 3 seems least likely given the form of the Berry Estate roadway elsewhere across the study area, and especially the general disregard for gradient (and thus the need for excavation) evident in its design. Based on the present evidence, option 4 seems the most likely, however the close spatial association of the alignment with the former tenant farm structure cannot yet be discounted.

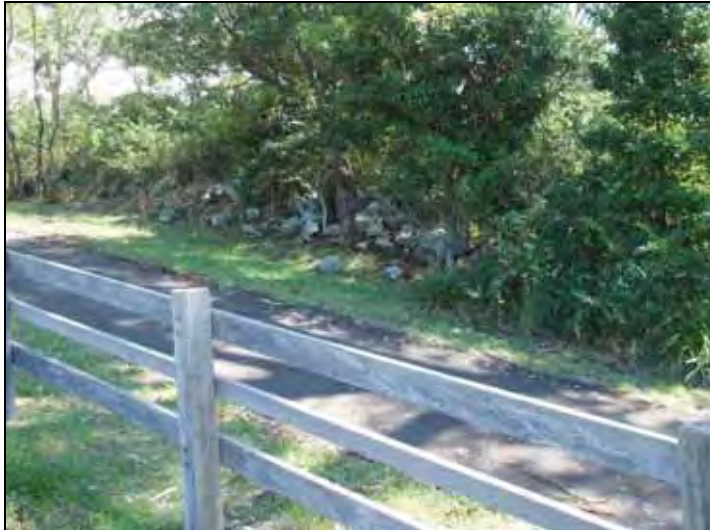
Figure G.206 View of piled
alignment of rock rubble,
looking NW

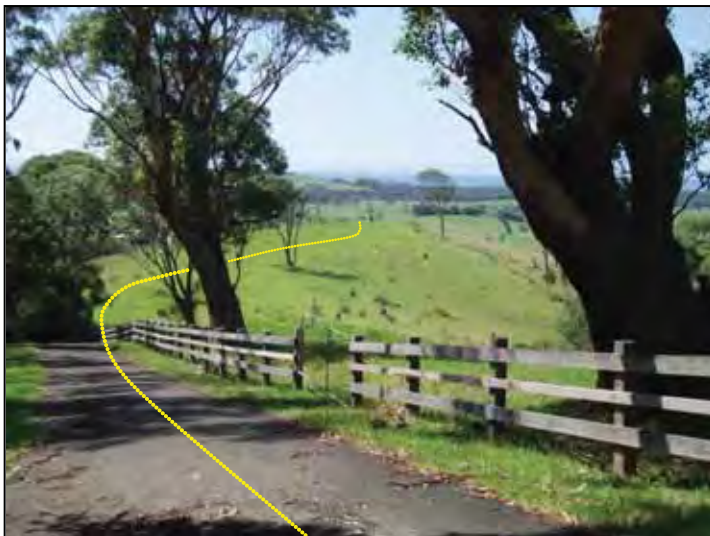
Figure G.207 View looking SE
along modern driveway
(which parallels the rubble
alignment, just left of the
picture) and which follows the
alignment of the 1856 Berry
Estate Road (yellow dotted
line), G2B H30 along spurline
shoulder in middle distance

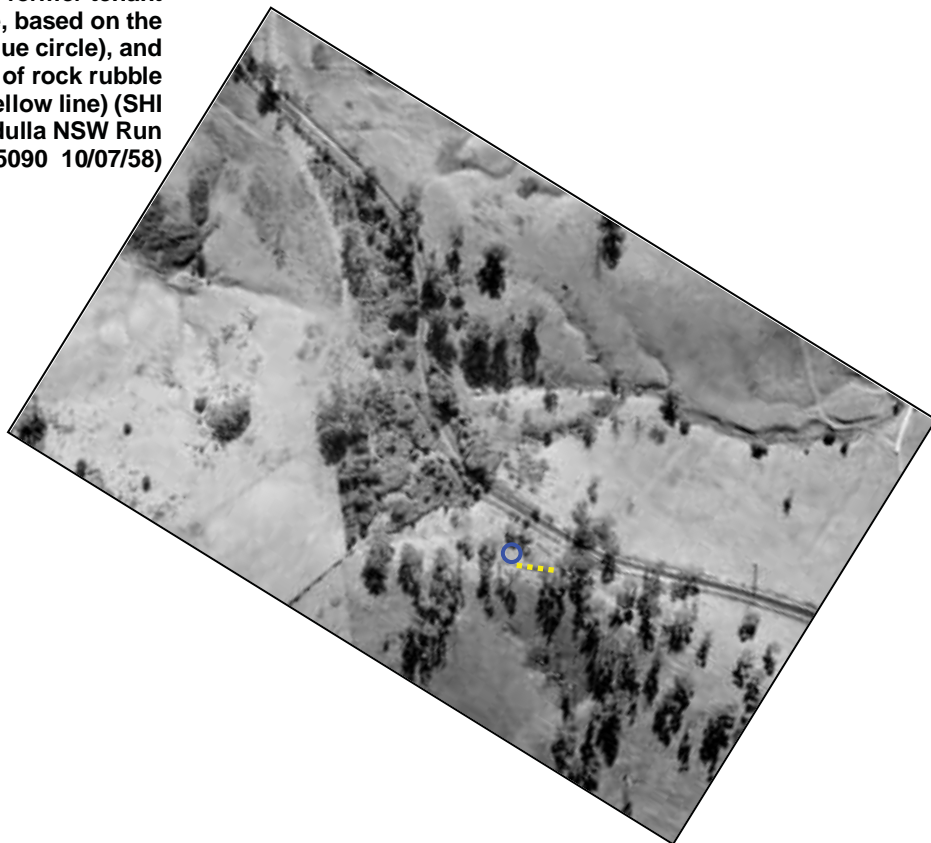
Figure G.209 Location of the site of the former tenant farm structure, based on the 1890s map (blue circle), and the alignment of rock rubble (dotted yellow line) (SHI Dapto-Ulladulla NSW Run GK9 697-5090 10/07/58)

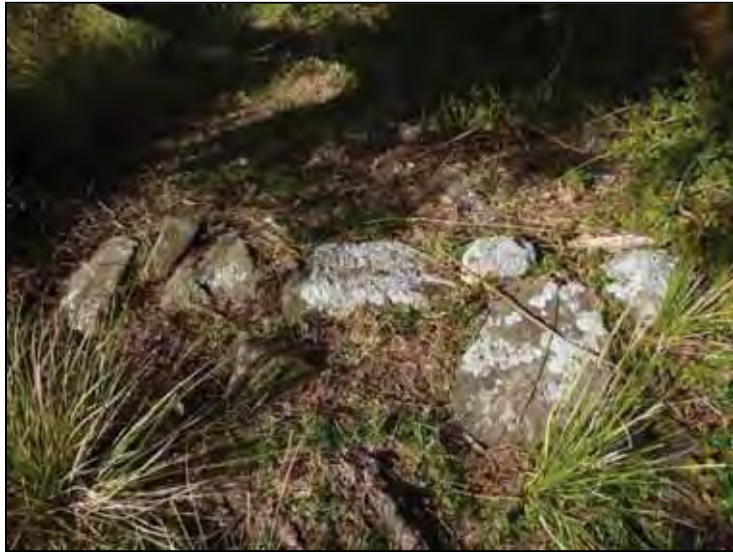
Figure G.213 Detail of aligned cobbles, probably indicative of relatively undisturbed foundations and associated archaeological deposits

Description/fabric: The site consists of a range of remnant garden plants, including a mature live pine tree, two standing pine tree stumps, and ground storey succulents. The pine trees are aligned approximately north south. An extensive area (at least 10 x 10 metres) of low mounded and aligned rock cobbles (most being alluvial in origin) are evident at the northern end of the grouping of pine trees. These appear to relate to former hearth and wall foundations.

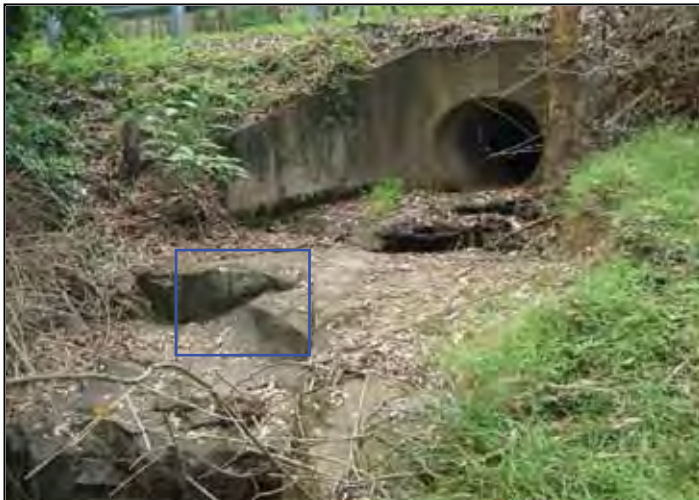
Figure G.219 View of upper rock ledge with area of drill or jumper mark indicated, looking N

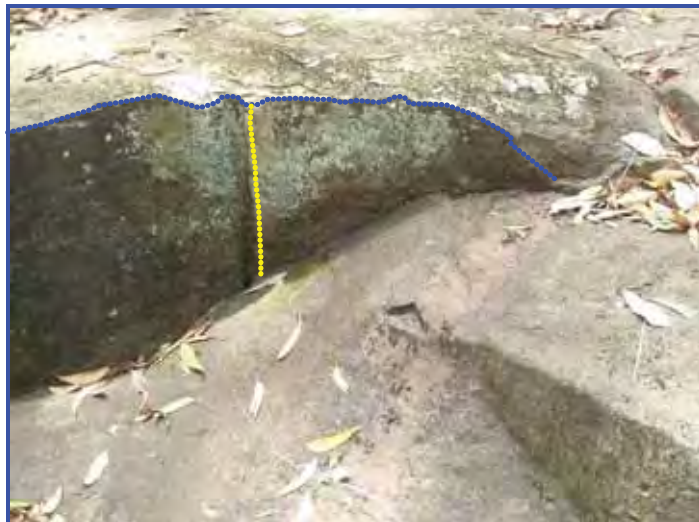
Figure G.220 Detail of drill or jumper mark (yellow dotted line) and quarried edge (blue dotted line) evident on upper ledge, looking NW

1. Early quarrying related to the construction of the 1856 Berry Estate Road (which followed the current highway alignment at this location. Procured stone may have been used for the construction of a culvert or gutter.
2. Quarrying related to the construction of the later 1870s highway alignment, or for later upgrading or maintenance of this road.
3. Quarrying unrelated to the adjacent road, and most probably associated with construction of piers and foundations for local homesteads.

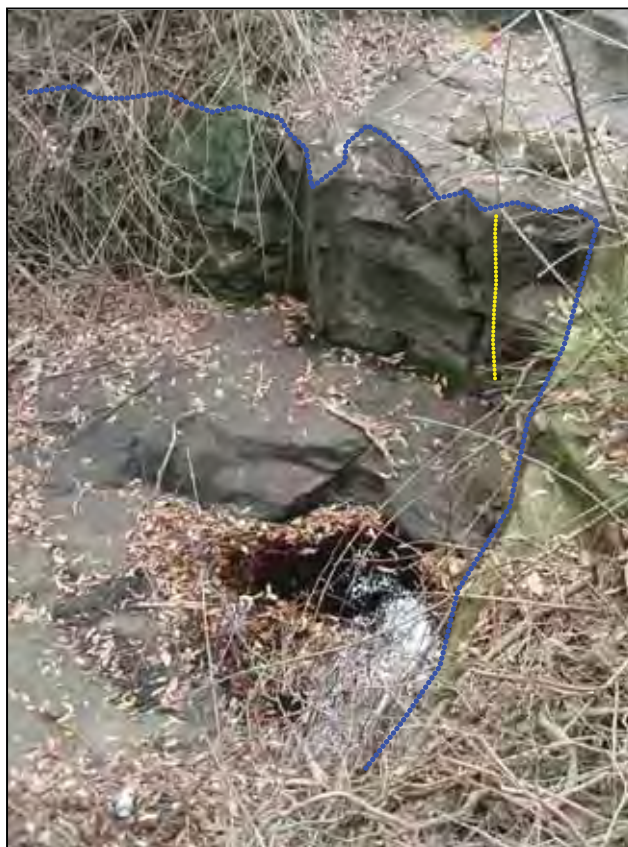
Figure G.221 drill or jumper mark (yellow dotted line) and quarried edge (blue dotted line) evident across the second ledge

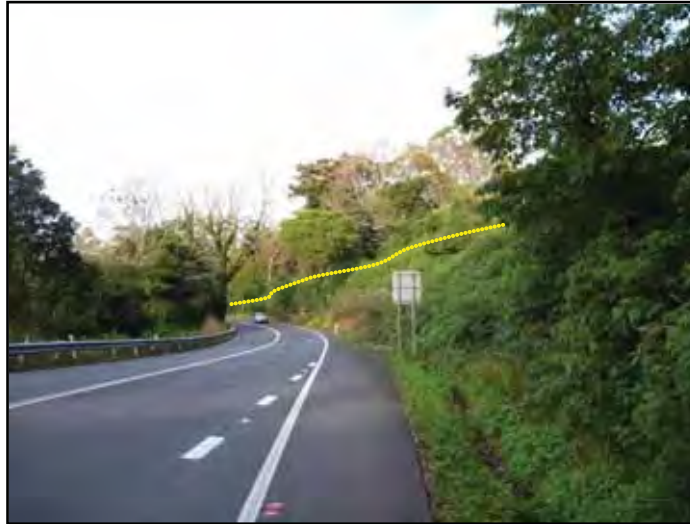
Figure G.230 General view of the Princes Highway corridor, just east of the Toolijooa Ridge crest, looking S. A dry stone wall, obscured by vegetation, is located approximately along the western road easement boundary (yellow dotted line)

The alignment of the G2B H54 wall along the upslope boundary of the highway easement suggests that it served as a roadway boundary. An alternative, or additional function, would be as a retaining wall on this steep slope. The close association with the current highway corridor provides a maximum age of approximately the 1870s - the period when the current highway alignment, replaced the Berry Estate Road, which is situated on the spur crest some 80 metres to the south. The construction of this wall may have been a component of the 1870s highway alignment, or subsequently sponsored by the Berry Estate for a leasehold farm, or by a freehold farmer following the sale of the farm around the turn of the twentieth century.

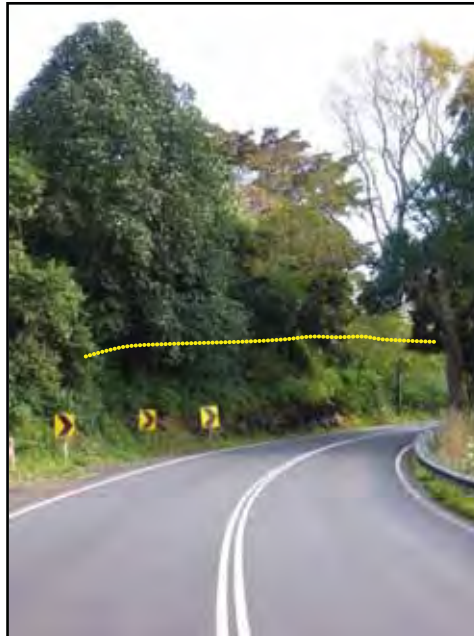
Figure G.231 General view of the Princes Highway corridor, east of the Toolijooa Ridge crest, looking NW. A dry stone wall, obscured by vegetation, is located approximately along the western road easement boundary (yellow dotted line)

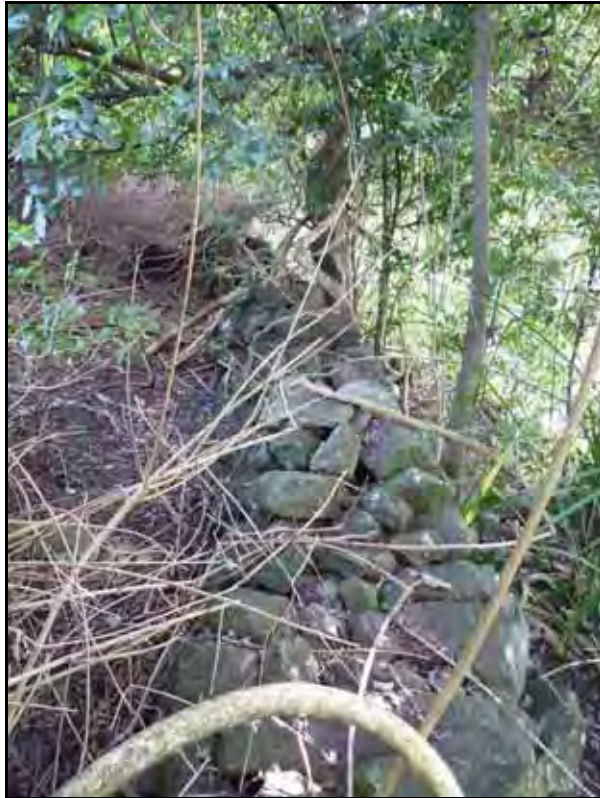
Figure G.234 Detail of dry stone wall , looking NW from near the southern known extent of the wall. . Note clear double-dyke technique and higher ground level on upslope side of fence

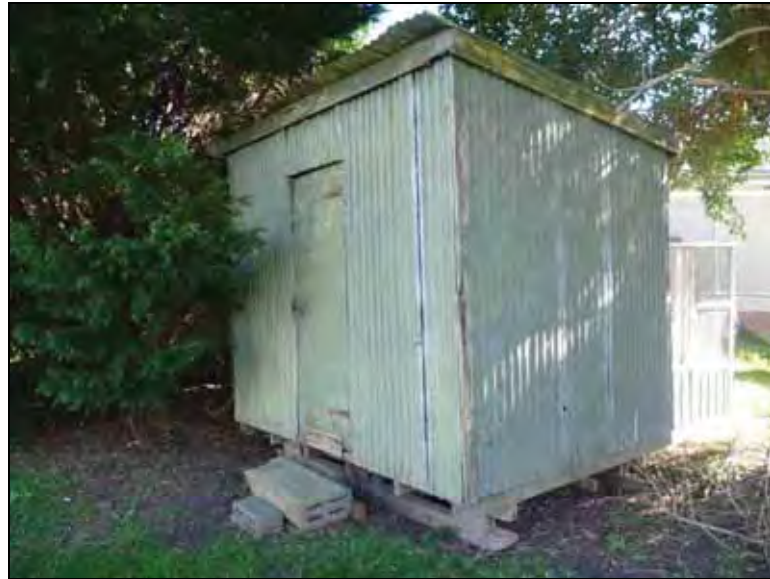
Figure G.235 Exterior of shed and door side, viewed from a corner

Description/fabric: The shed consists of a rectangular sawn hardwood stud frame clad with corrugated iron on the exterior walls and roof (painted green), and masonite panelling on the interior (painted cream). The floor is hardwood boards. The roof has a single slope, elevated on the door side. A single window is set on one side, opposite a ply and cross-boarded single door. The window is protected by a metal grid mounted over the exterior of the window. Two cupboards (now missing doors and shelves) have been installed into the two corners on the right side of the door, and a bench top spans the two cupboards.

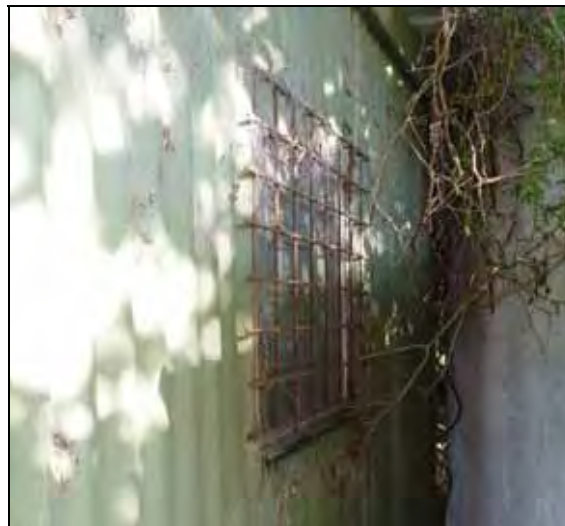
Figure G.236 Detail of metal grid over window

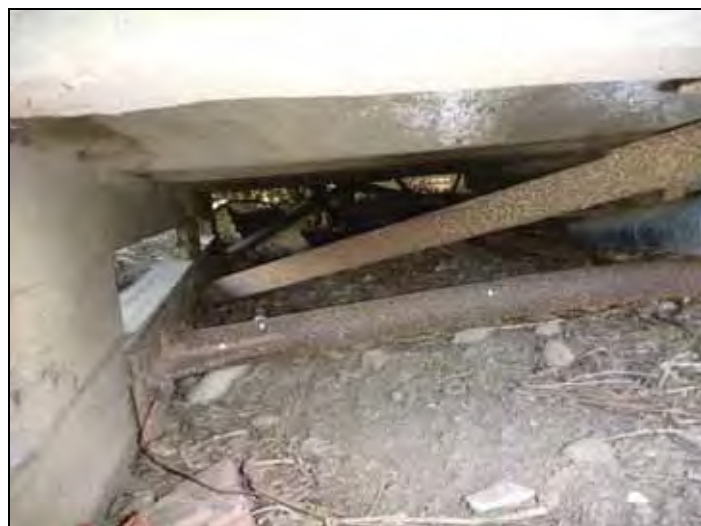
Figure G.237 Detail of the metal cross bracing between the wooden skids and floor

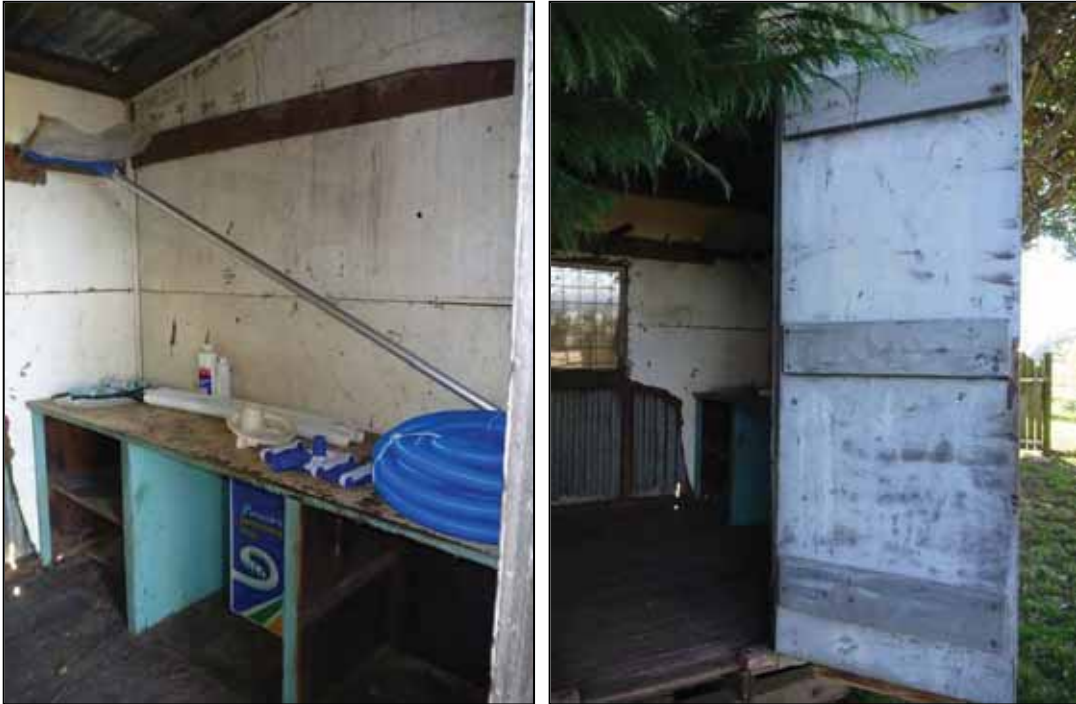
Figure G.239 Interior view showing damage to interior wall cladding and addition of wall boards for hanging items

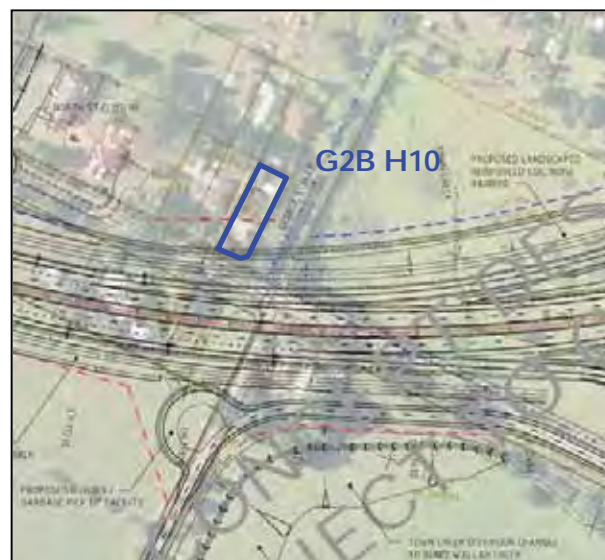
Figure I.11 Location of G2B H10 relative to proposed bypass works.

The footprint of a reinforced soil noise barrier and an adjacent footpath on the south side of the southbound off-ramp for the south Berry interchange, will encroach to within two metres of the existing cottage building. Associated property acquisition would include the whole cottage.

Construction of the bypass would result in direct impact to the whole cottage and the front (northern) half of the urban lot. Removal of the house is required either through demolition or the full or partial salvage of the structure.

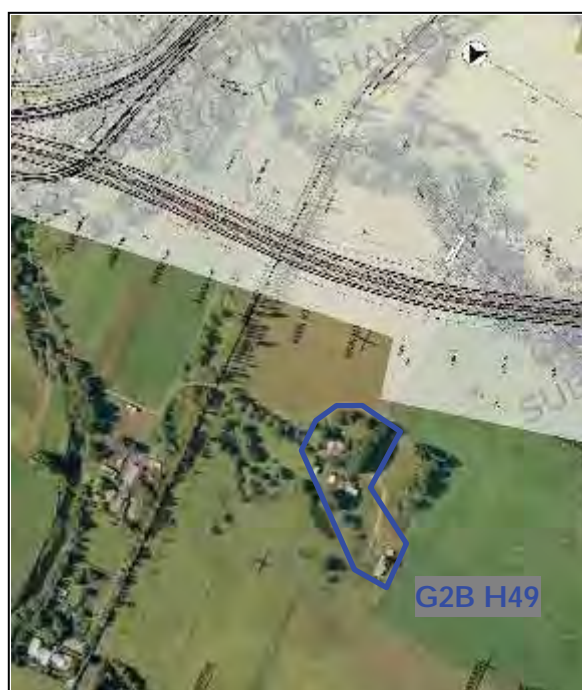
Neither the farmhouse nor its grounds would be directly impacted. The closest section of the bypass carriageway is 100 metres to the south. Existing tree plantings provide a visual buffer and barrier between the homestead, its grounds, and the bypass easement. An open field is situated between the farmhouse grounds and the bypass. There would not be an appreciable impact to the landscape context values of the farmhouse.

Figure I.21 Location of G2B H49 relative to proposed bypass works.

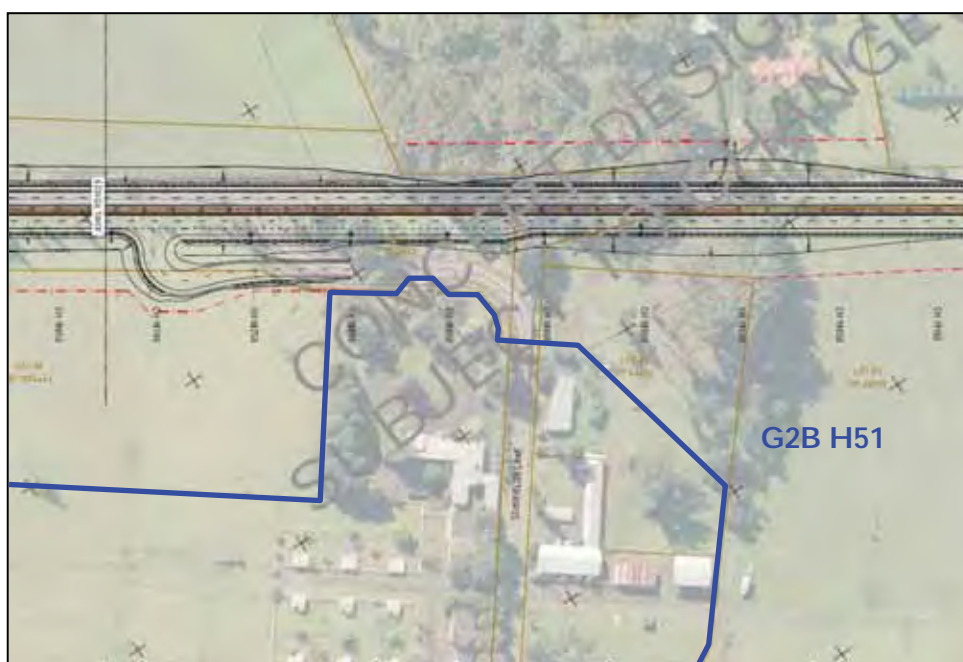
The edge of construction works for the bypass carriageway would extend to approximately 20 metres of the eastern boundary of Graham Park. This would not pose an appreciable impact to the visual and contextual values of the site.

Figure I.23 Location of G2B H51 relative to proposed bypass works.

- It is recommended that the design of any access roadworks in the vicinity of the *Graham Park* entrance should not exclude the capacity for visitors to pull over and safely inspect the entrance feature. If necessary, allowance should be made in the design for the potential future installation of interpretive signage.
- Where there is no anticipated direct construction impact to heritage items, it is recommended that measures be instigated, where and as considered warranted, to protect these structures from accidental or incidental impact during construction, or other form of RMS use.
- During the period of bypass construction, temporary fencing would be erected around the feature to identify a 'no-go' area.
