Foxground and Berry bypass

Princes Highway upgrade

Volume 2 – Appendix J

**Technical paper:
Aboriginal heritage**

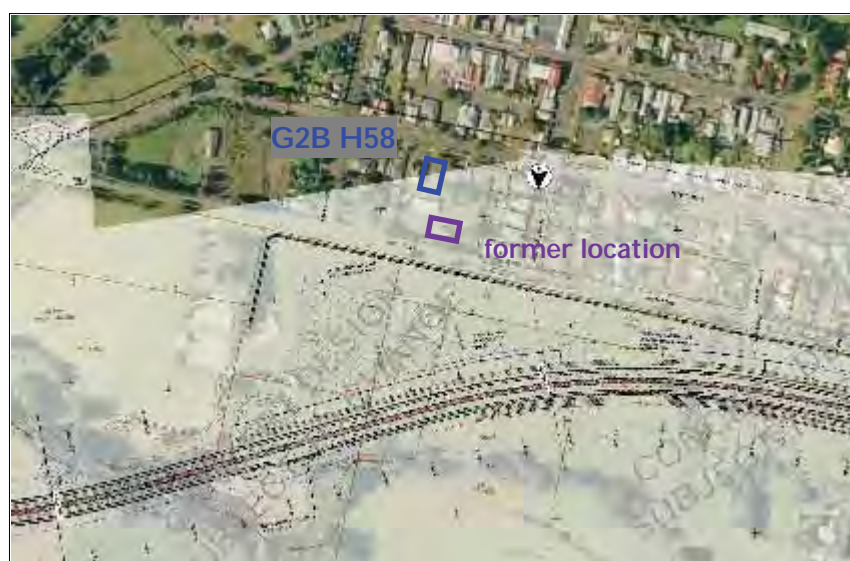
This former church building, until recently situated on the south side of North Street, and now re-positioned 50 metres to the south and, facing Albert Street, would not be directly or indirectly impacted. The building entrance now faces south, away from the bypass, and vistas from the building no longer include the pastoral view on the north side of North Street. The bypass would be situated 200 metres away to the northwest. Existing buildings occur between the former chapel and the bypass.

Figure I.25 Location of G2B H58 relative to proposed bypass works.

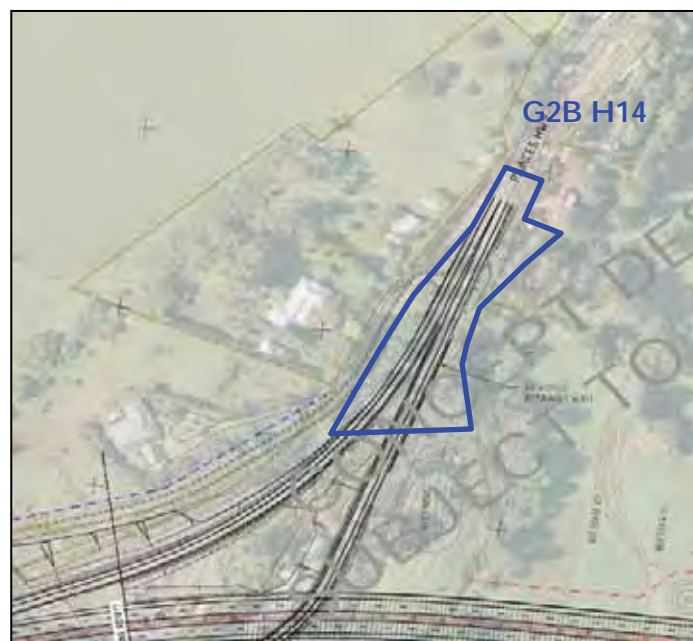
The intersection of the new off-ramp with the former 1955 highway remnant (G2B H15), would be moved 100 metres further north, allowing the construction of a safer 90 degree angle of approach. This would involve direct impact to a roughly 190 m² (12.5 x 15 metres) portion of the G2B H14 archaeological deposit

Figure I.26 Location of G2B H14 relative to proposed bypass works.

- It is proposed that prior to development impact, a program of archaeological salvage be conducted within those portions of the deposit subject to direct impact.
- For those sections of the deposit not subject to direct impact, it is recommended that measures be instigated, where and as considered warranted, to protect them from accidental or incidental impact during construction, or other form of RMS use.

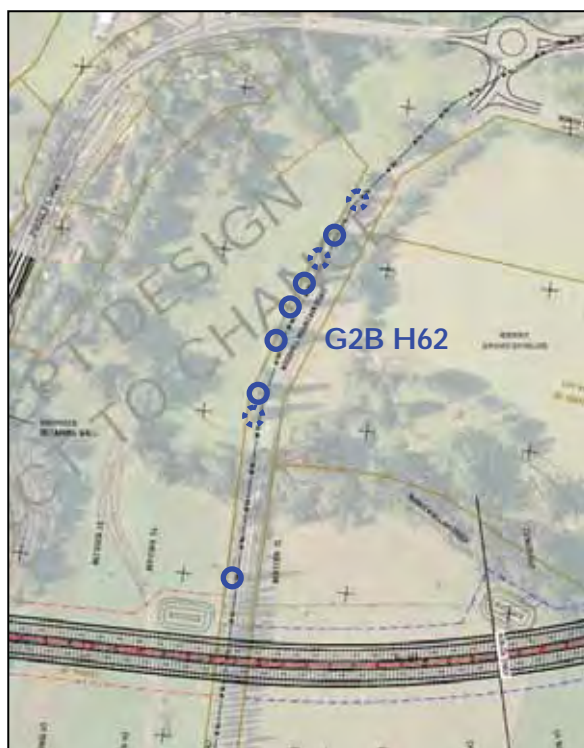
Construction of the bypass would not involve direct impact to the remaining six poplar trees in this avenue, (which originally included nine trees). The bypass would be constructed in close proximity to the northern most tree, at right angles to the alignment.

A younger and more densely planted avenue of poplar trees, extends to the north of the northern most recorded tree in the G2B H62 avenue. Some of these trees would be directly impacted by the project. This younger avenue does not form part of the G2B H62 recording.

Figure I.31 Location of G2B H62 relative to proposed bypass works (dead or removed trees are shown by a dashed circle).

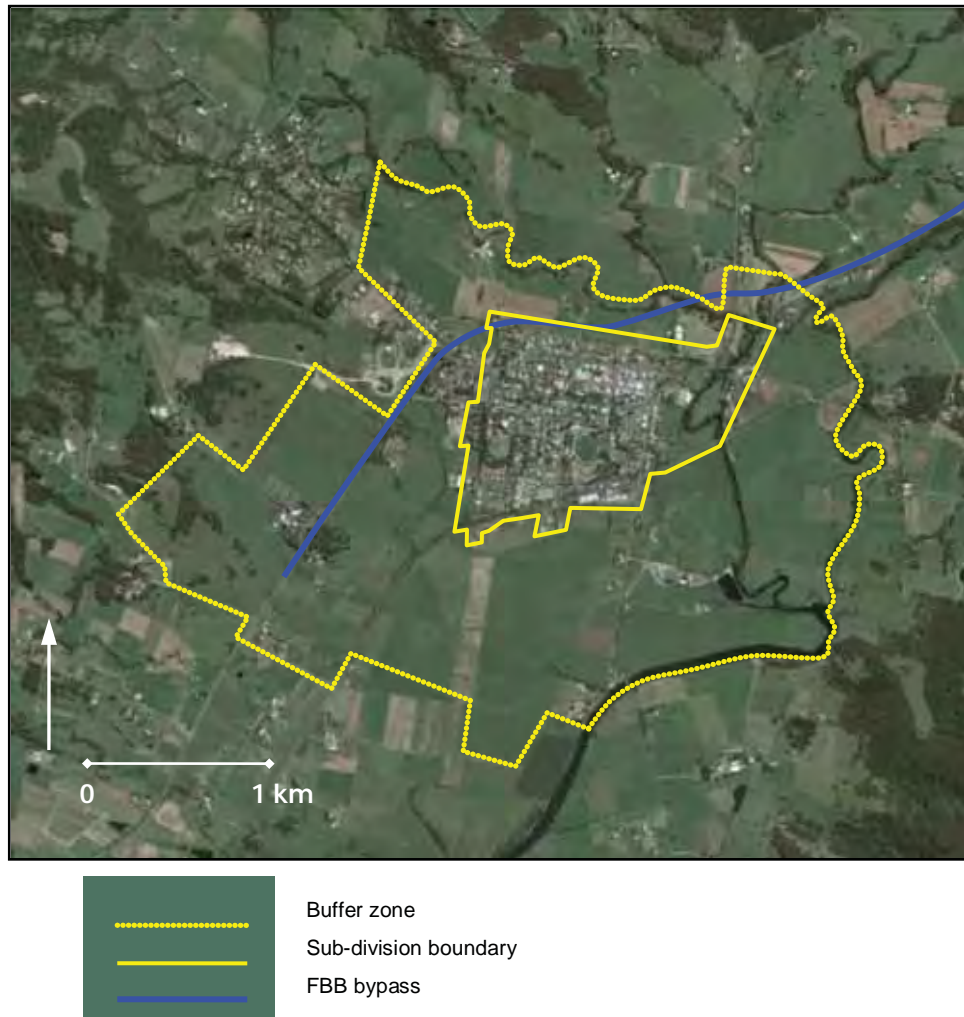
Figure I.35 Location of proposed bypass works relative to the Buffer Zone and Subdivision Boundary of the National Trust defined Berry Township Urban Conservation Area (After Figure 13 in Clarke and Duyker 2010) (Google Earth Pro 2006).

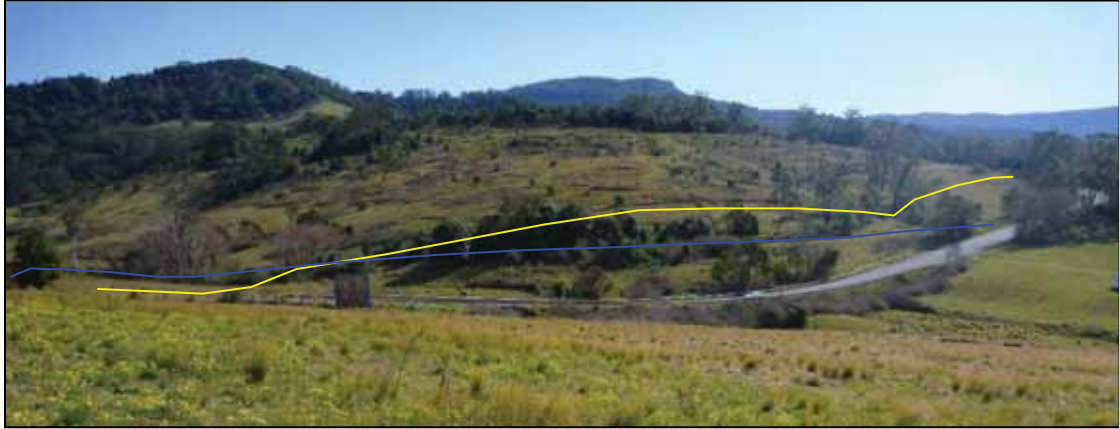
Figure G.14 Closer view of best preserved, cut and benched, middle section of the remnant road (alignment indicated by yellow dotted line), looking W.

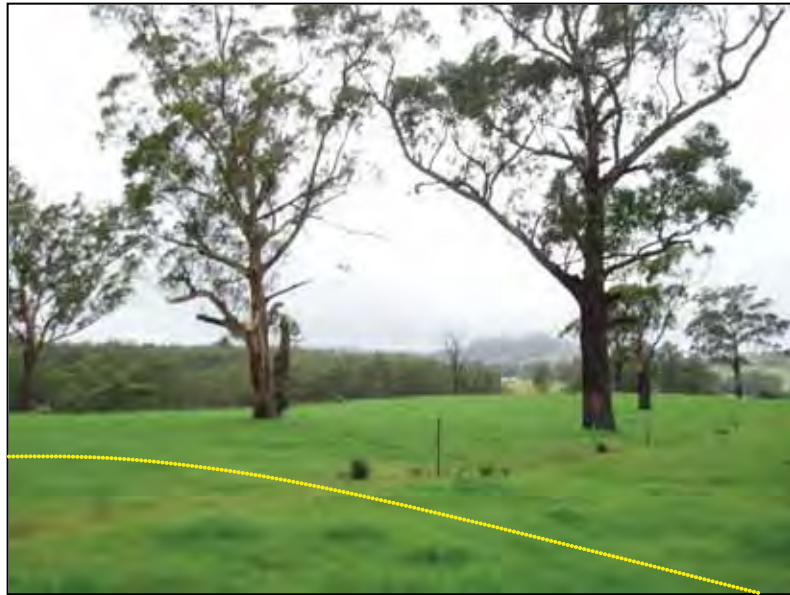
Figure G.40 General view, looking E, across the southern portion of the road remnant (foreground), (approximate alignment marked in yellow), .

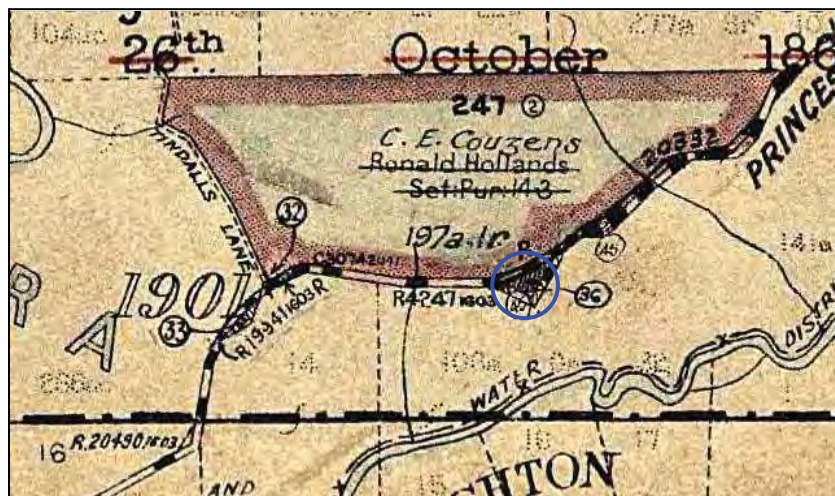
Figure G.45 Extract from Seventh edition of parish map of Broughton (1938, cancelled 1959, Parish Map Preservation Project ID no. 10354001), showing resumption of severed land at G2B H20 (blue circle) in Aug 1938 (map reference note 36)

This highway section was bypassed by the current highway alignment when it was upgraded and straightened in the mid 1930s. The seventh edition of the parish map for Broughton (1938 cancelled 1959) notes that this road remnant was resumed as severed land in August 1938 (Figure G.45).

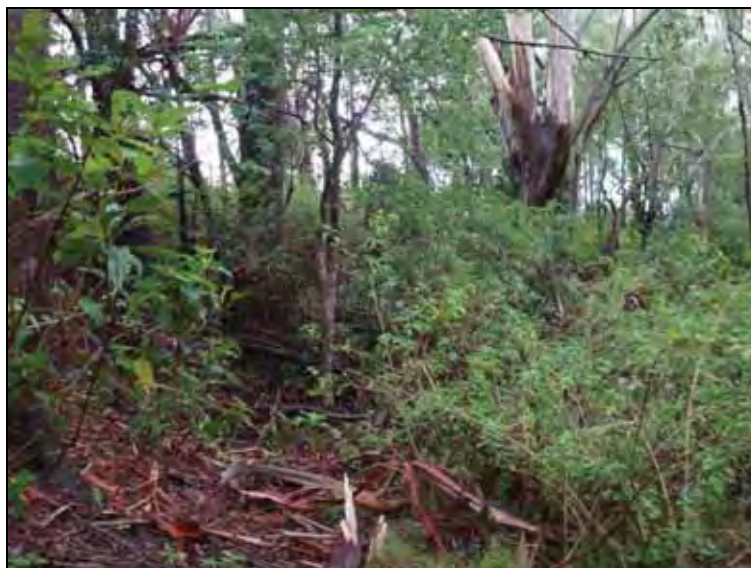
Figure G.49 View of the G2B H21 platform and cutting looking N from the western end of the remnant. Note thick understory growth and sapling regrowth.

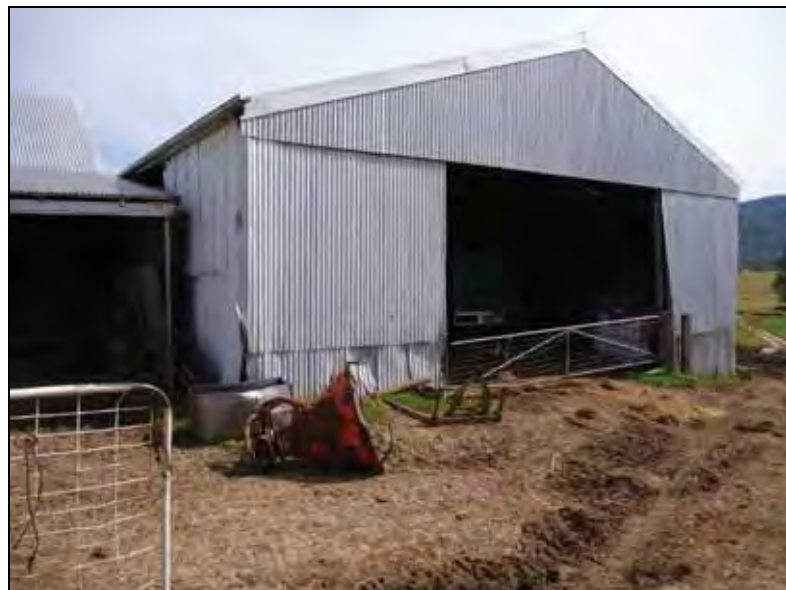
Figure G.110 Front of downslope shed, built using components from a Port Kembla shed used for processing immigrant workers

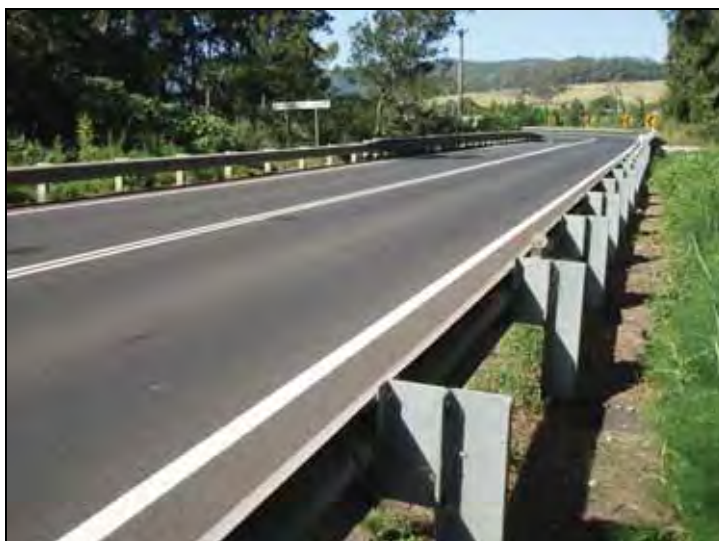
Figure G.139 General view of road top and approaches to bridge, looking NE

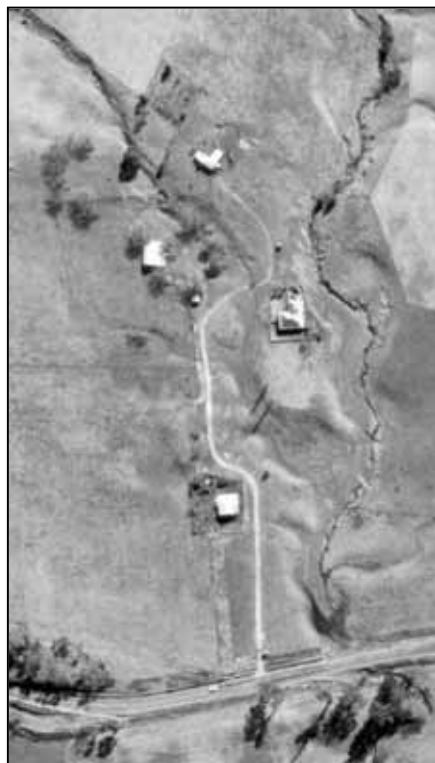
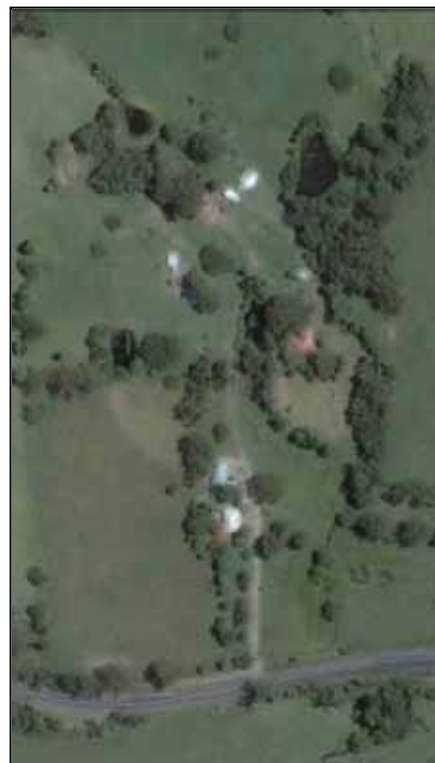
Figure G.147 Extracts from 1958 and 2006 aerial photography showing *Glenvale* homestead complex and replacement of out-buildings in same arrangement (SH.I Dapto-Ulladulla Run GK11 699-5030 23/07/1958; Google Earth Pro 2011)

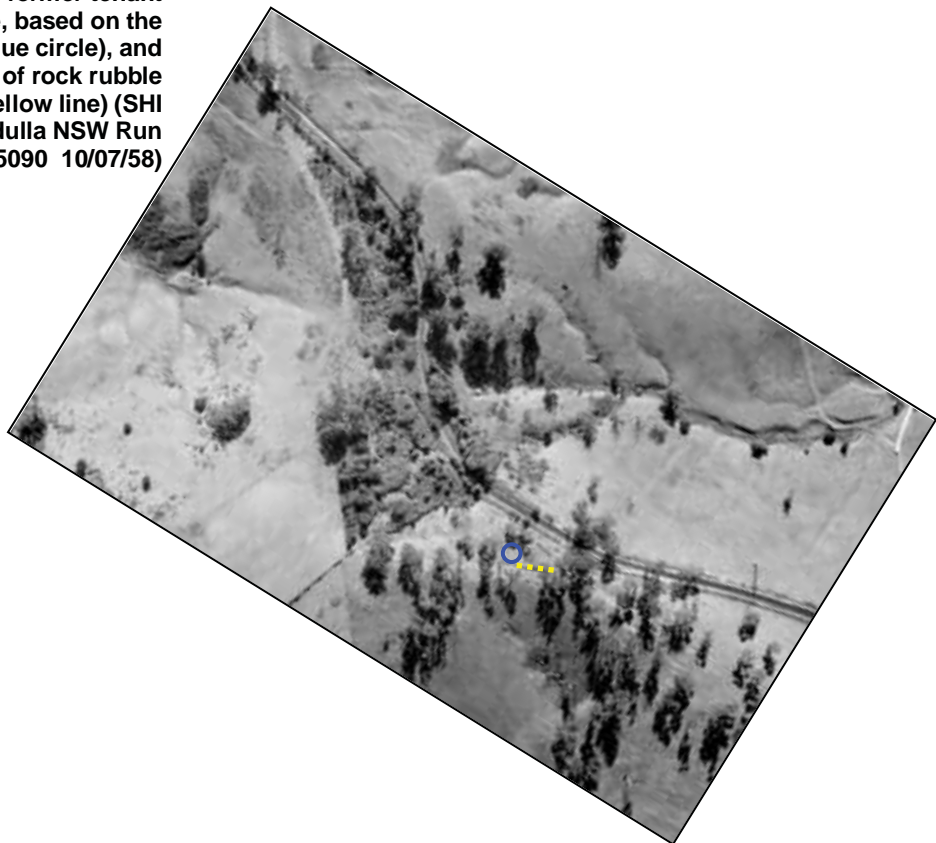
Figure G.209 Location of the site of the former tenant farm structure, based on the 1890s map (blue circle), and the alignment of rock rubble (dotted yellow line) (SHI Dapto-Ulladulla NSW Run GK9 697-5090 10/07/58)

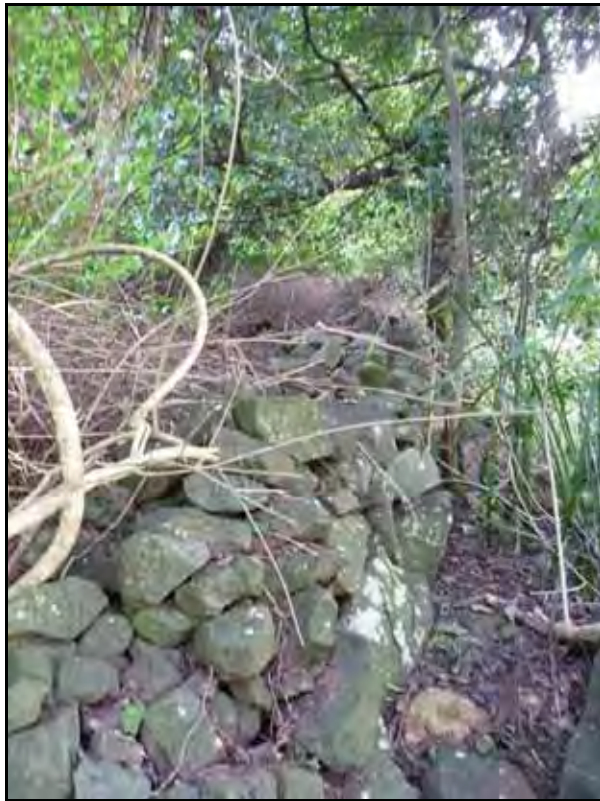
Figure G.233 Detail of dry stone wall , looking NW from near the southern known extent of the wall. Note partial collapse in foreground and large foot stones

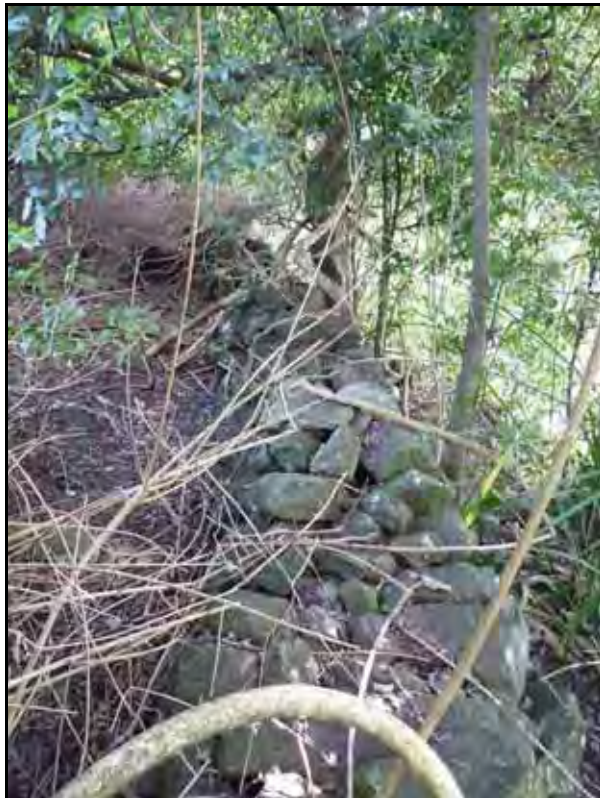
Figure G.234 Detail of dry stone wall , looking NW from near the southern known extent of the wall. . Note clear double-dyke technique and higher ground level on upslope side of fence
