RMS Factual Geotechnical Investigation Report

Foxground and Berry Bypass Project

Proposed South Berry Option, Princes Hwy (HW1), Berry NSW

Factual Geotechnical Investigation Report

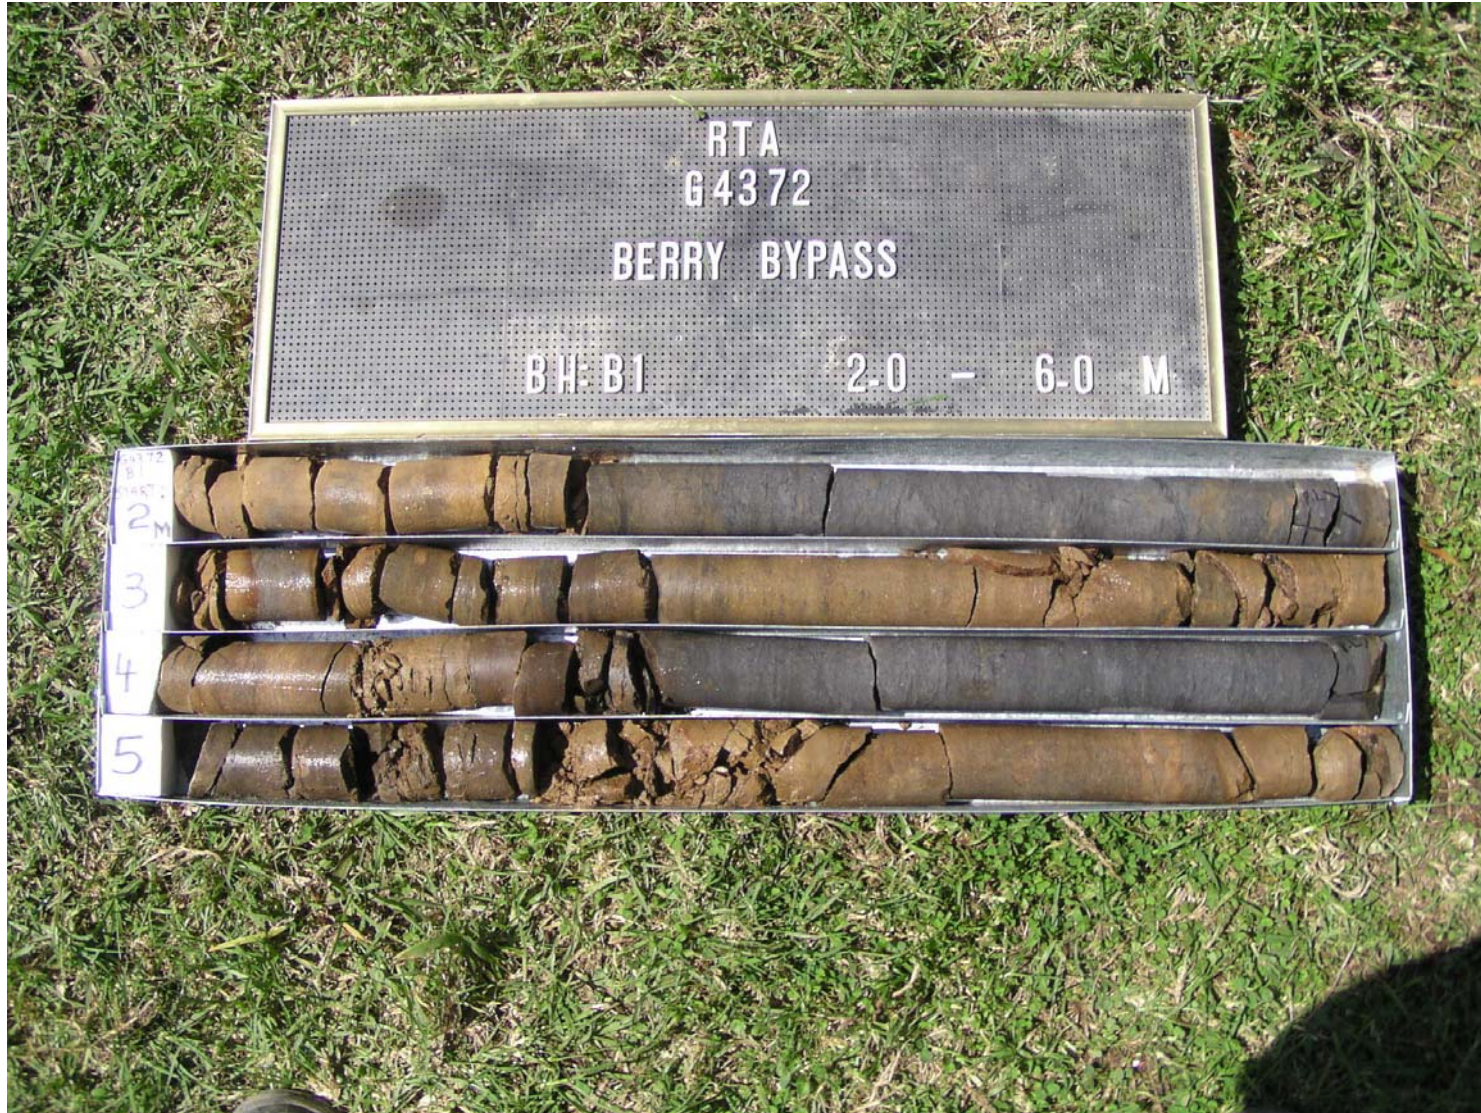
Photo 1 of 6

Geotechnical Investigation
Bore Hole: B1

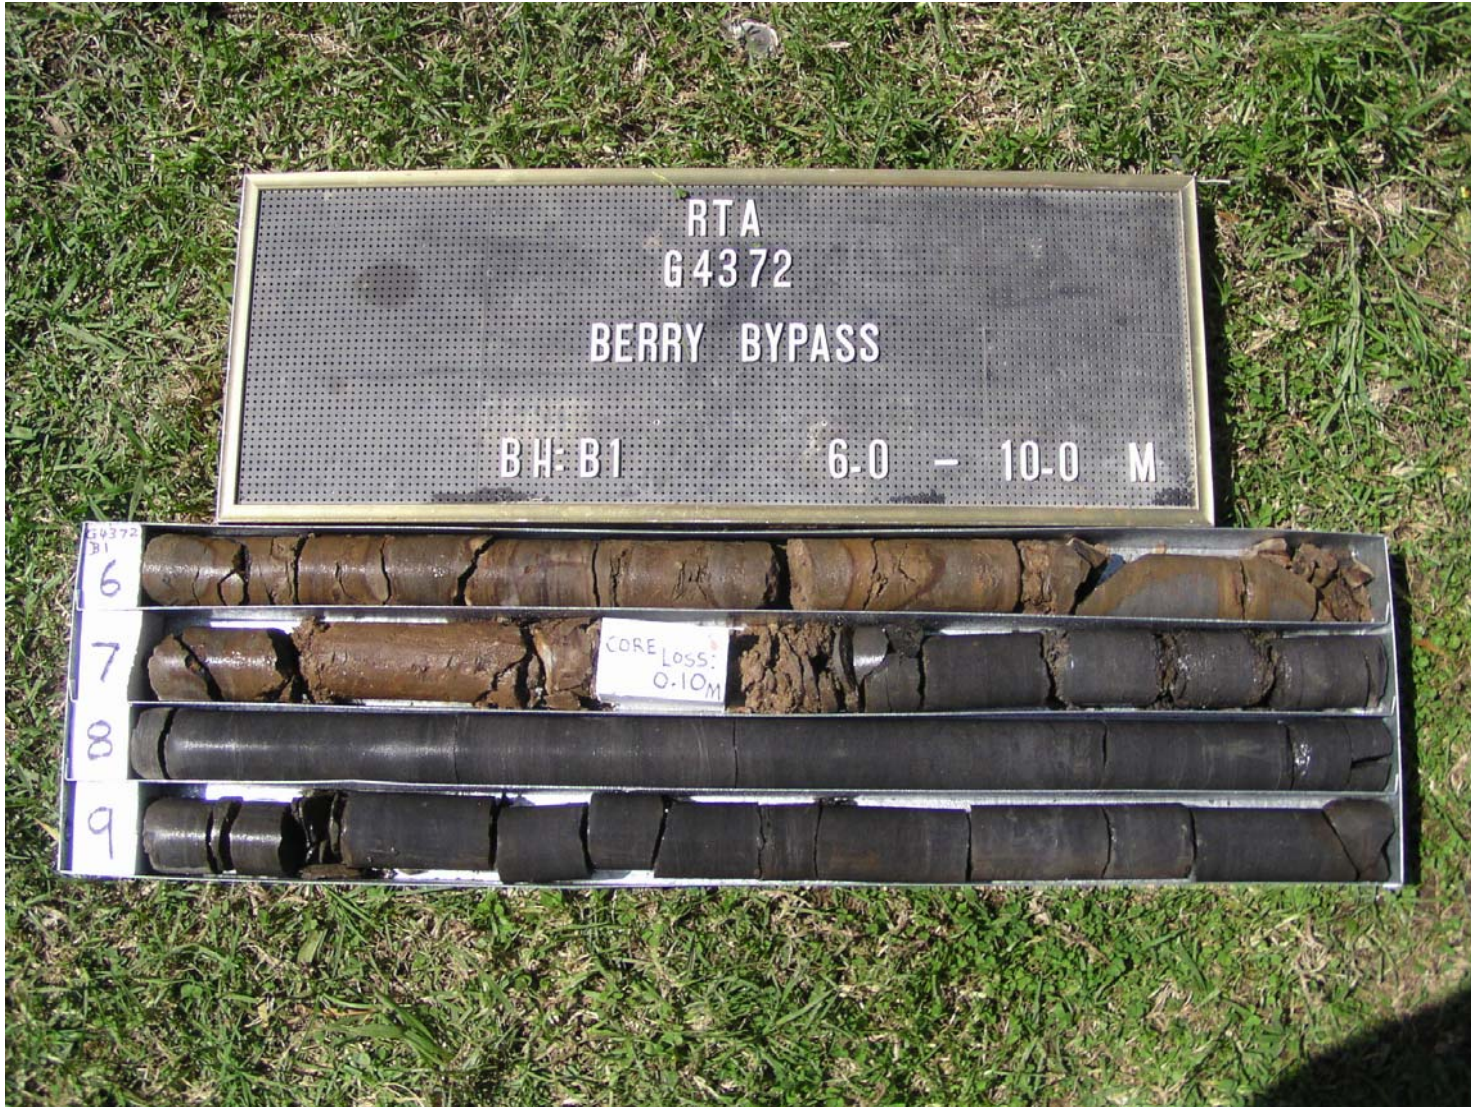
Photo 2 of 6

Geotechnical Investigation
Bore Hole: B1

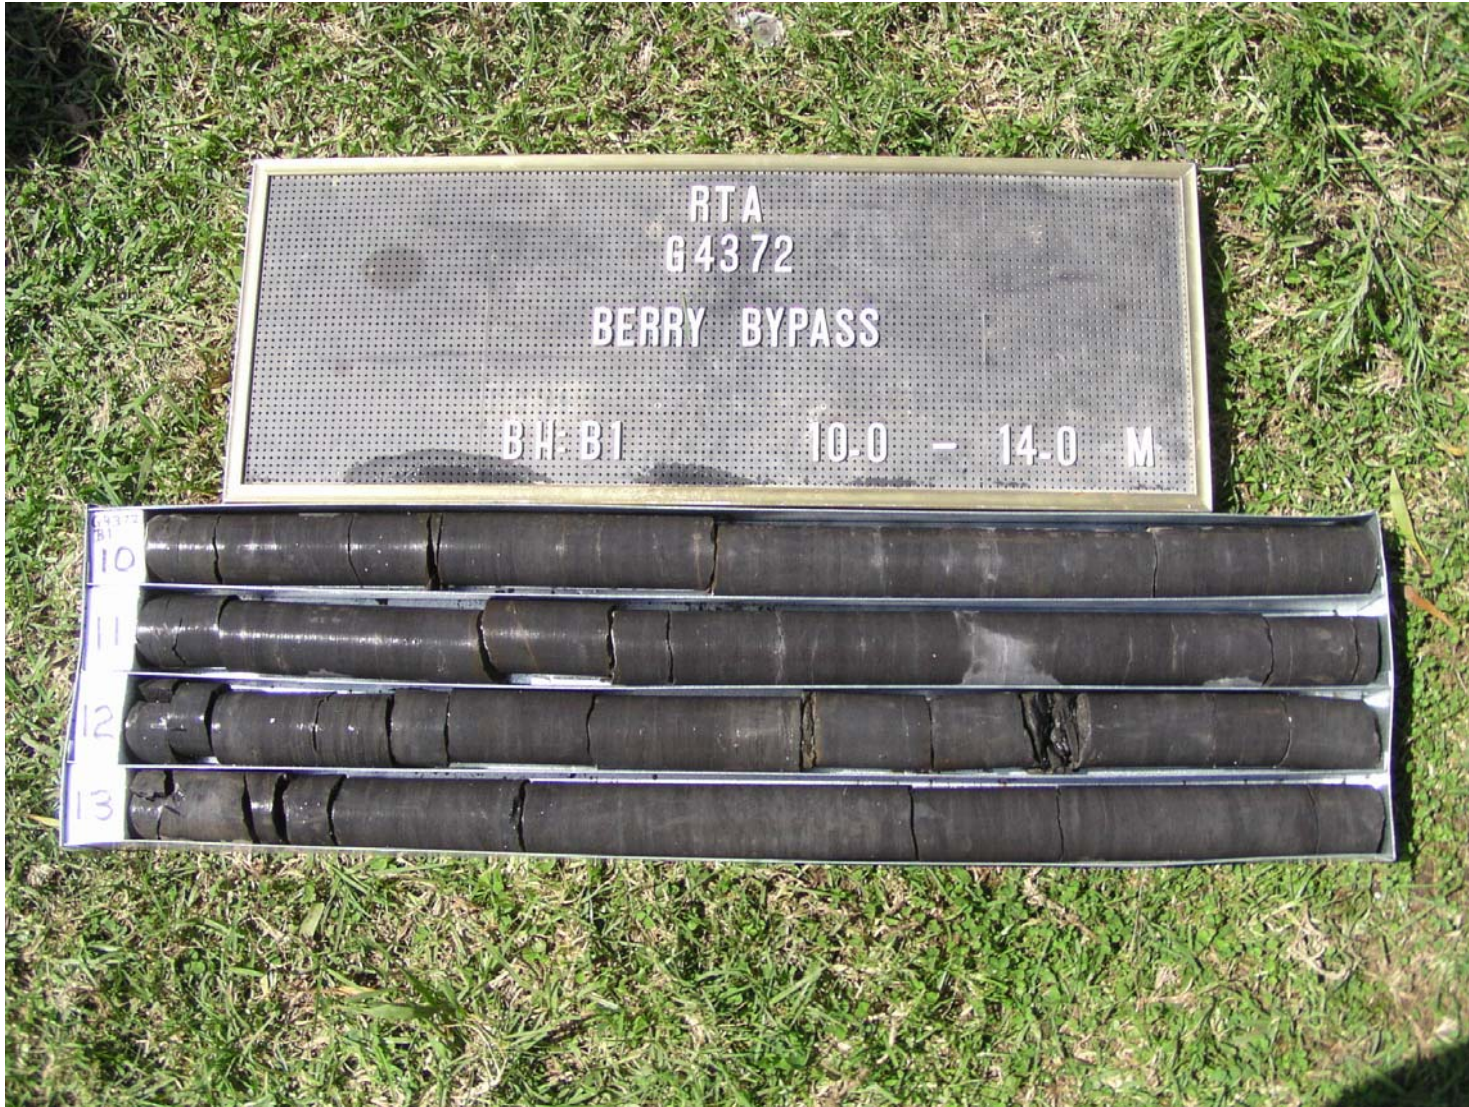
Photo 3 of 6

Geotechnical Investigation
Bore Hole: B1

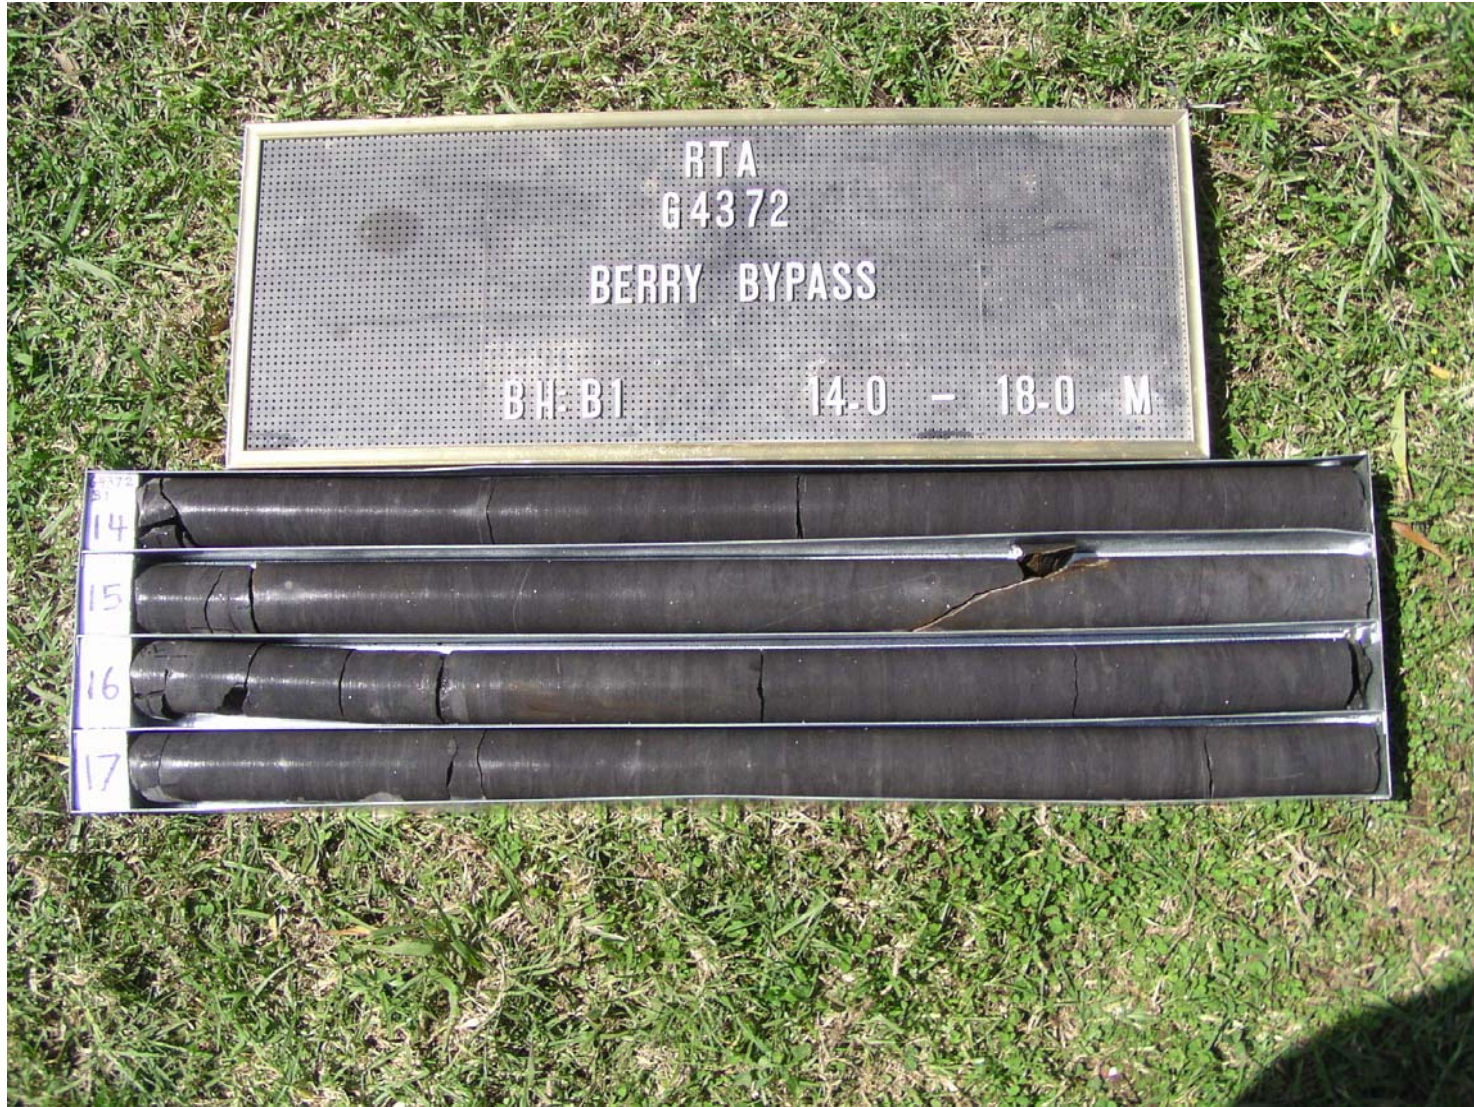
Photo 4 of 6

Geotechnical Investigation
Bore Hole: B1

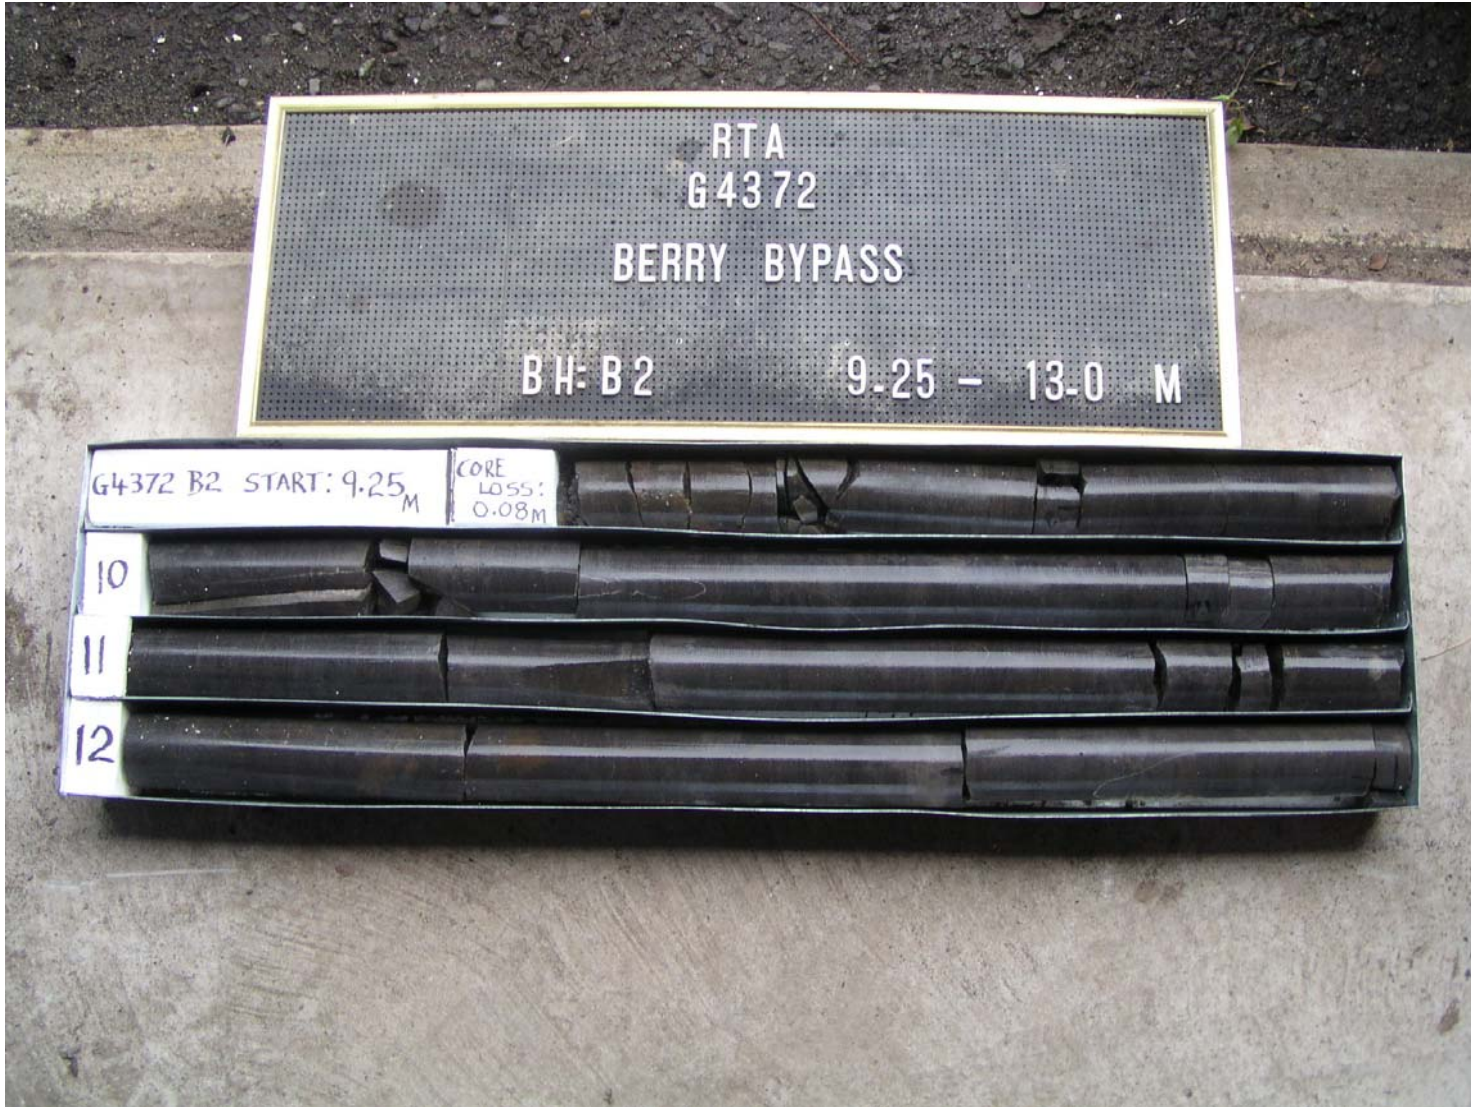
Photo 1 of 2

Geotechnical Investigation
Bore Hole: B2

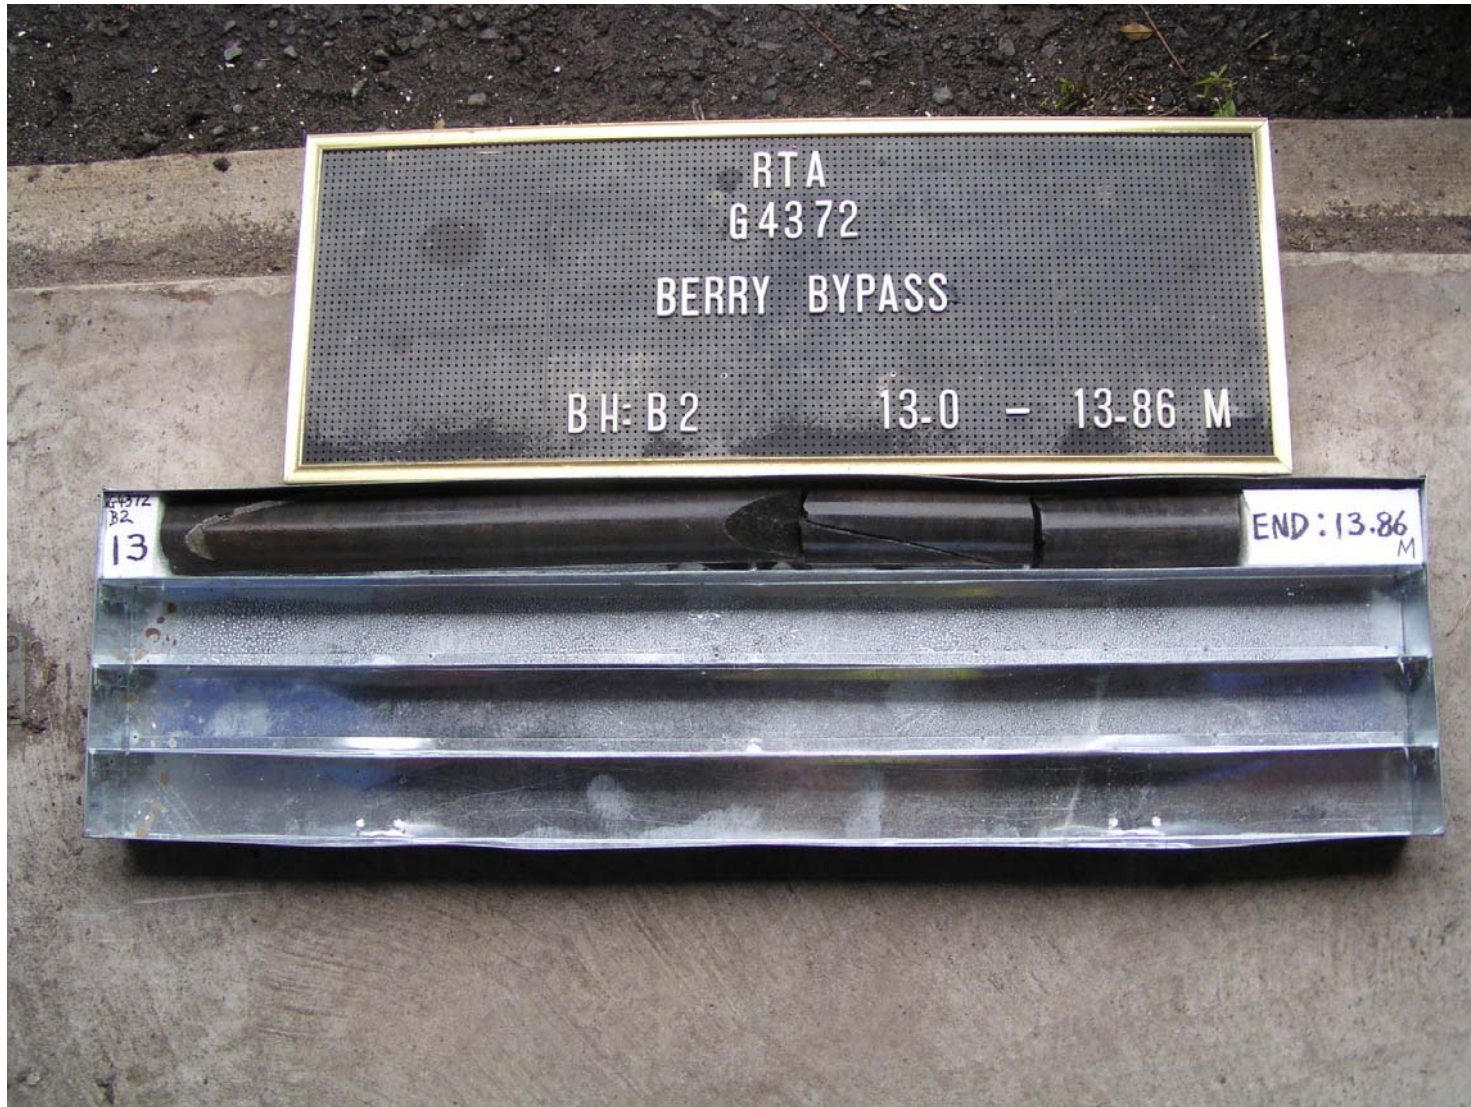
Photo 2 of 2

Geotechnical Investigation
Bore Hole: B2

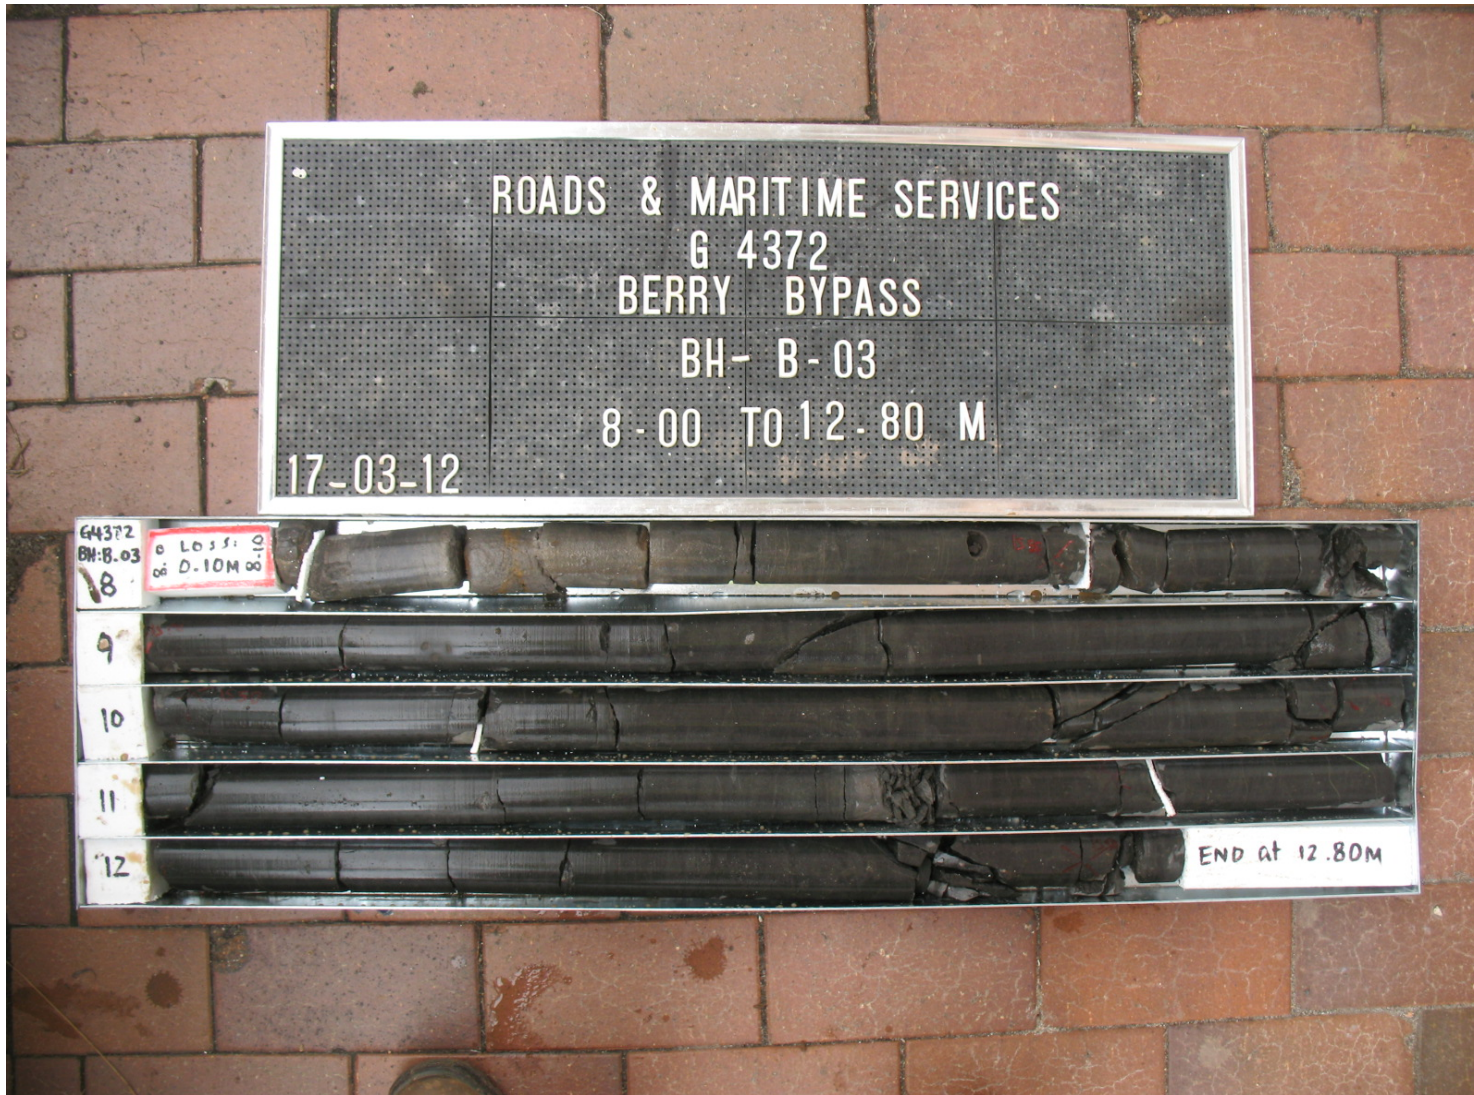
Photo 1 of 1

Geotechnical Investigation
Bore Hole: B3

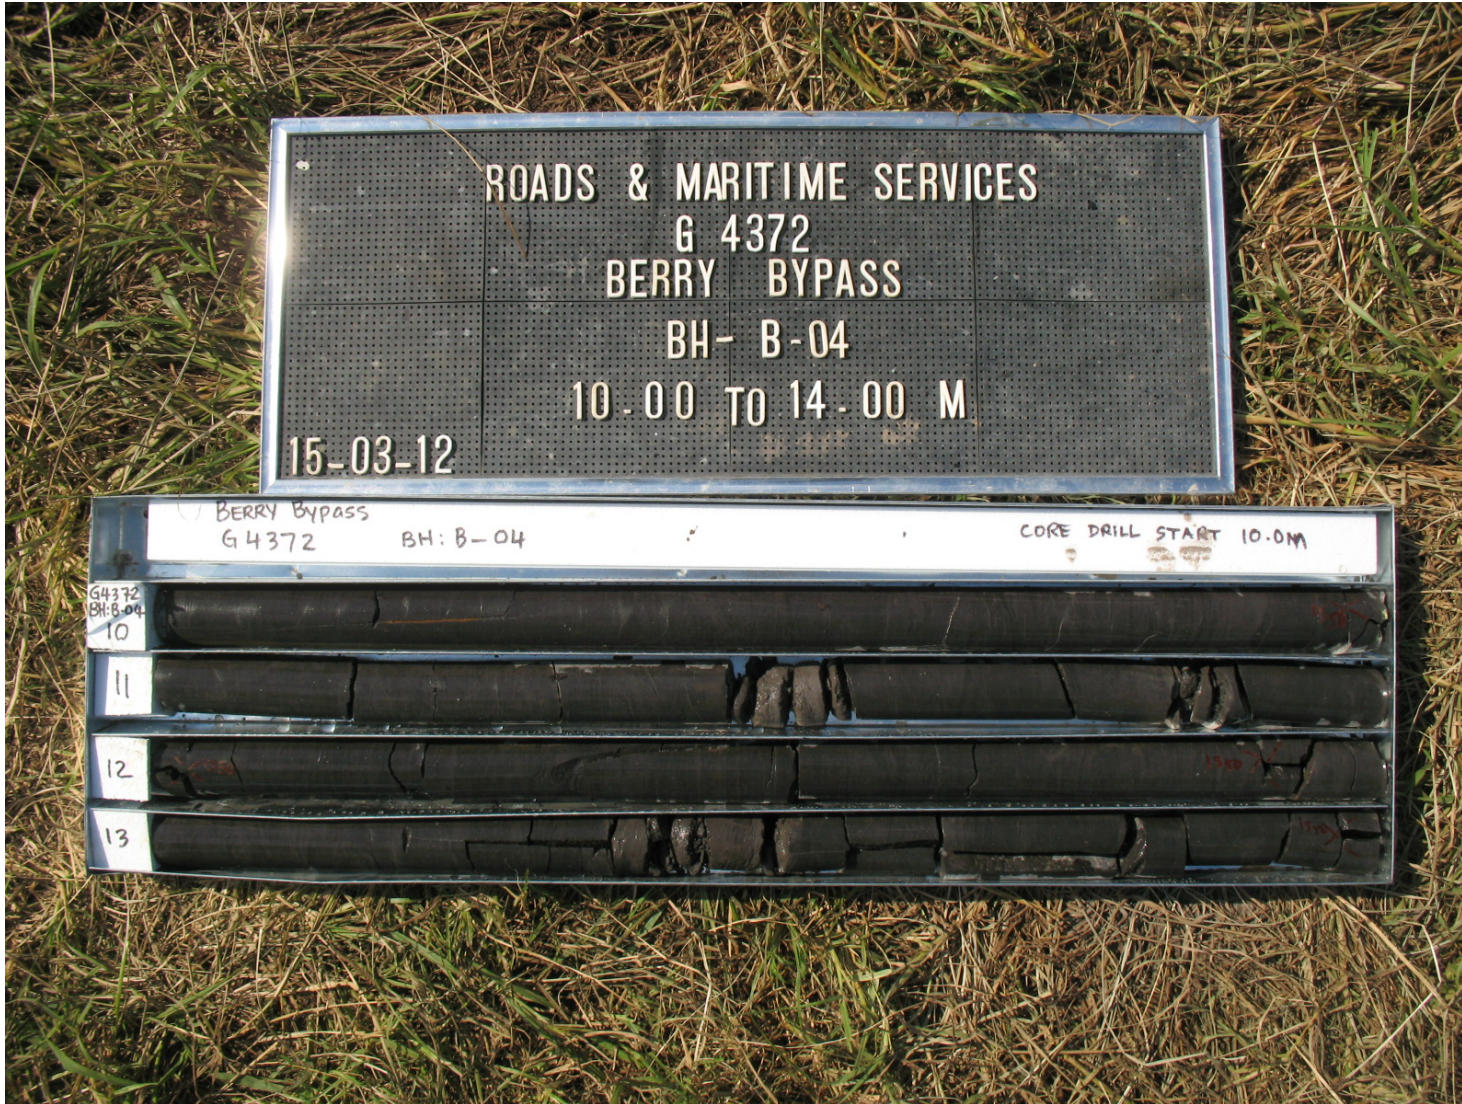
Photo 1 of 2

Geotechnical Investigation
Bore Hole: B4

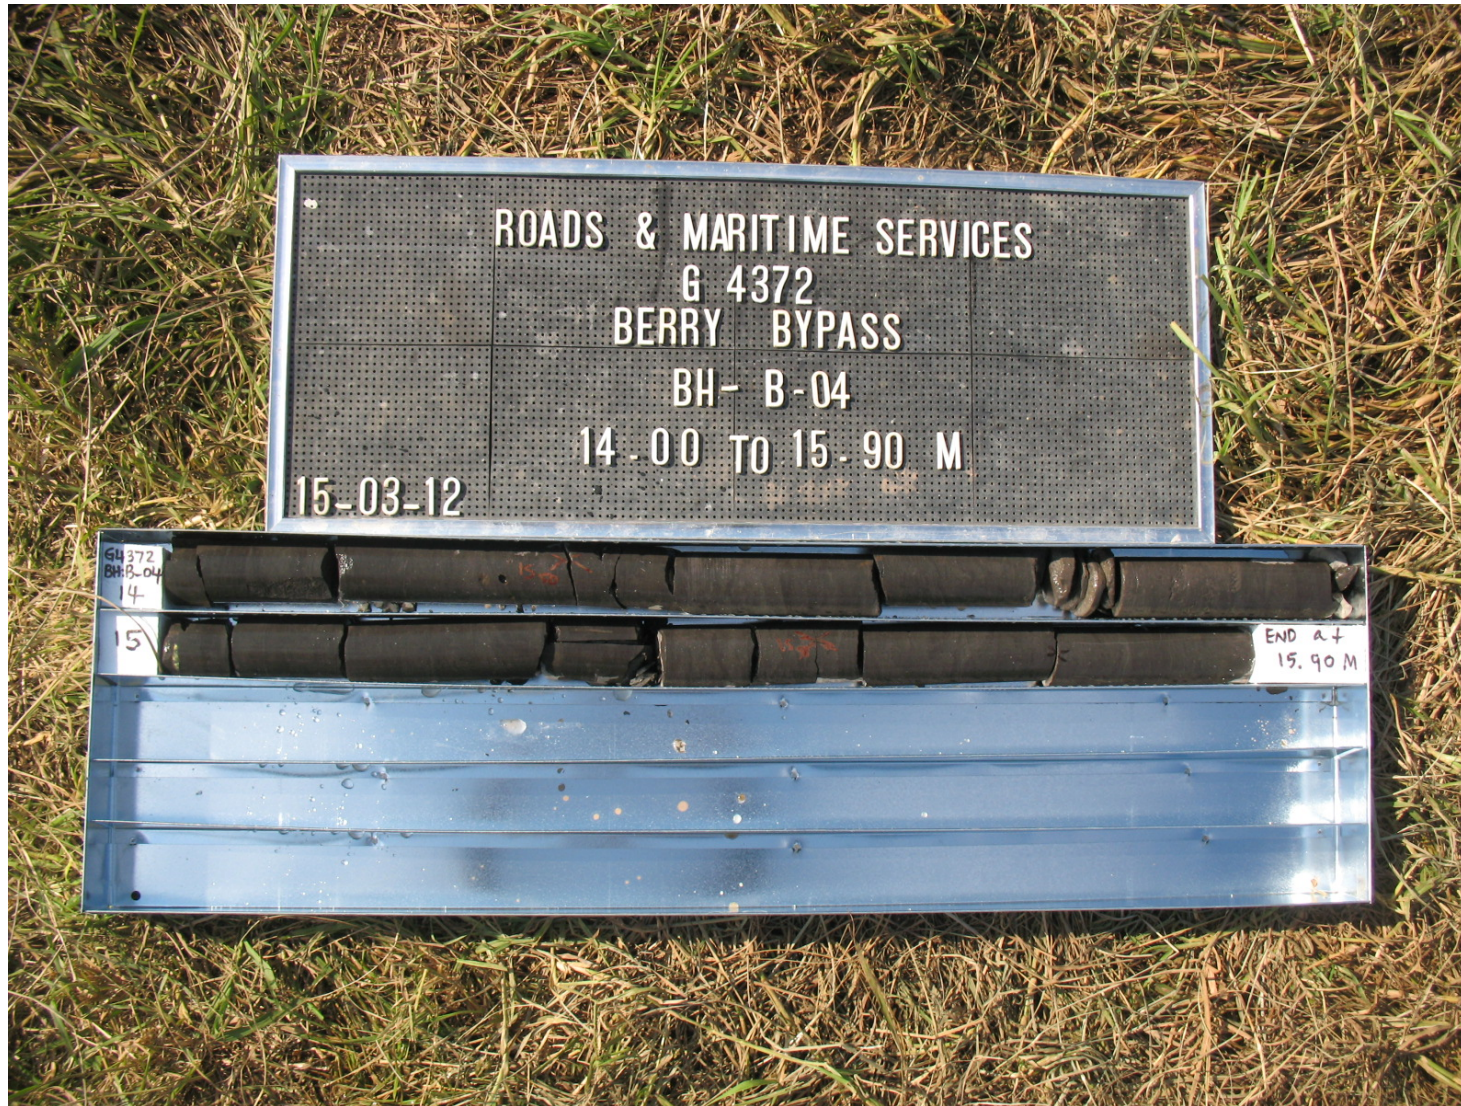
Photo 2 of 2

Geotechnical Investigation
Bore Hole: B4
