'Glen Devon'

Cultural Heritage Assessment Documentary and Physical Investigation

Supplementary Investigation Environmental Assessment Princes Highway Foxground and Berry bypass

June 2013

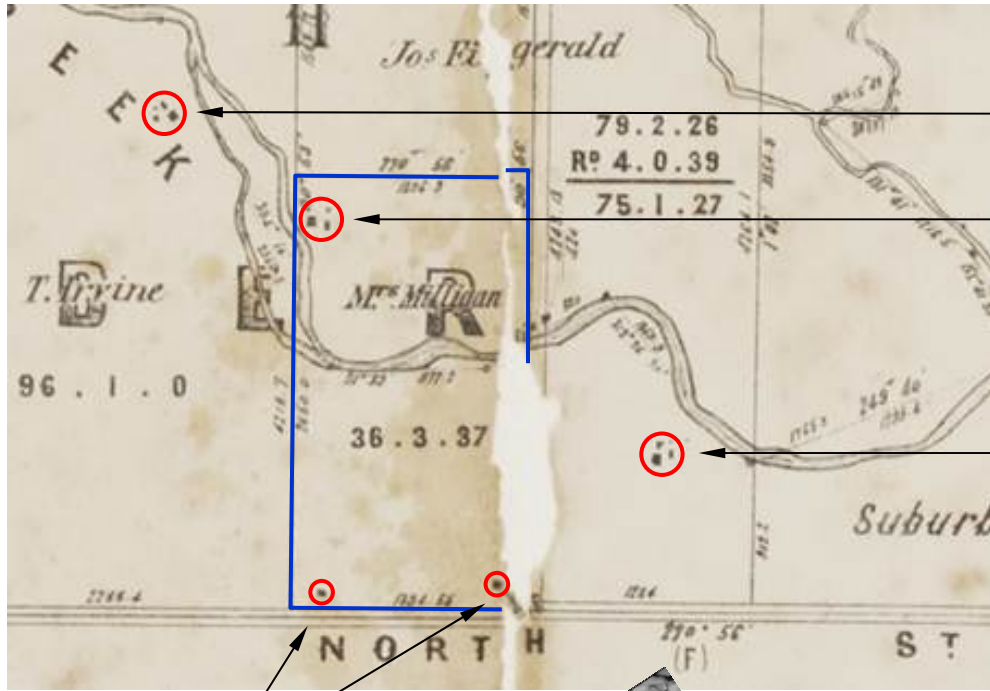
Prior to the 1880s, North Street did not exist, and the closest public road was probably a southern extension of the current Kangaroo Valley Road, 300 metres to the south (Figure 3.4). The current town grid was proposed in 1883 and its subsequent adoption necessitated the reorientation or modification of many existing town buildings to comply with the new consistent east-west alignment (Lidbetter 1993 *Historic Sites of Berry*, BDHS Inc. p.18-19). The North Street easement was one of the first of the new grid alignments to appear as a road on maps. This rapid adoption may have been due to its amenity as an access track for the bordering tenant farms. Based on this evidence it is argued that Glen Devon cannot predate the establishment of North Street, which could not be earlier than the mid to late 1880s.

Main tenant farm buildings (note creek-side locations and presence of outbuildings)

Other buildings (note absence of outbuildings and close association with North Street)

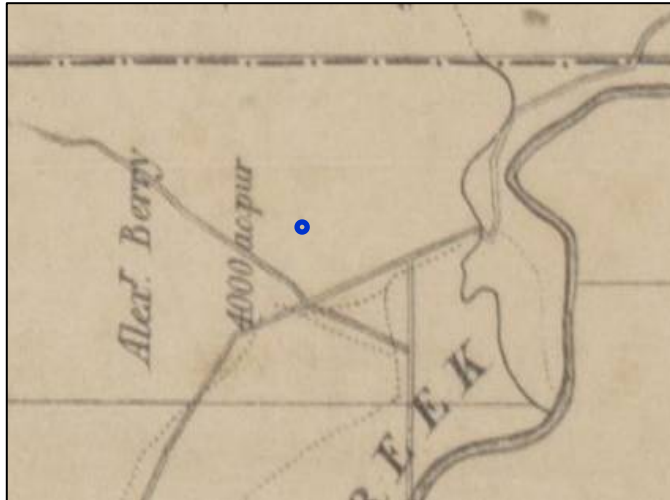
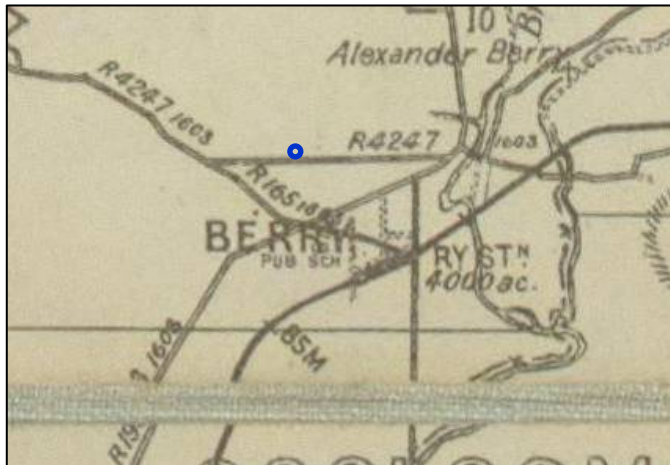
Figure 3.4 Extracts from County and Parish maps showing the position of the 'Glen Devon' cottage (blue circle) relative to surrounding roads, prior to, and after the establishment of the town grid after 1883. Refer also figure 4.23 of Appendix K of the EA, p. 46).

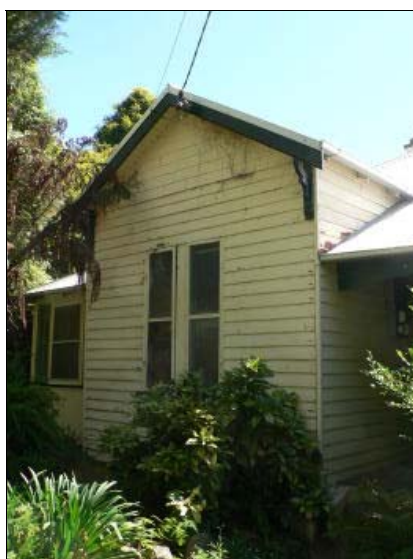
Figure 2: Southern gable

The cottage is a single-storey weatherboard Edwardian/Federation building with a verandah encircling most of the house with the exception of where two rooms of the house project to the north and south and a bathroom addition on the north-east corner. The verandahs are enclosed on the south-east corner and west side of the house with weatherboards to around 1200mm above floor and casement windows above. Weatherboards throughout the cottage are splayed with a chamfered leading edge. The windows in the main house are timber framed double hung sash. Generally there are 4 panes per sash however the front bedroom windows are single pane.

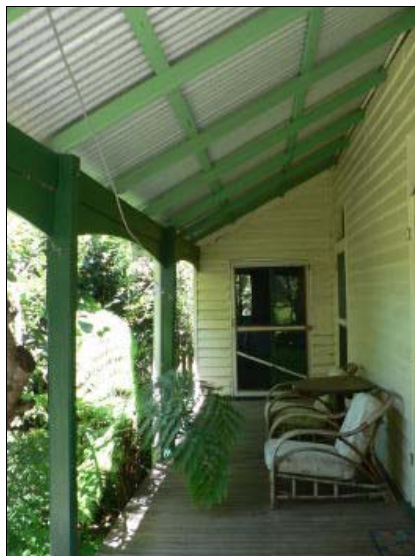
Figure 6: Eastern verandah

The verandah floor is timber and appears to have been replaced in places. Verandah posts are timber with a splayed aris on each face. A scalloped timber valance spans between the posts directly below the fascia beam. There is evidence on the verandah

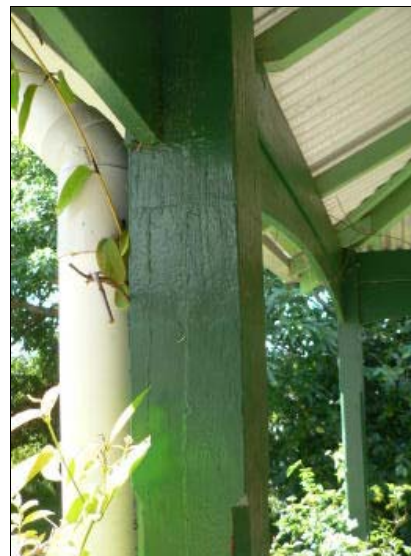
Figure 7: Detail at top of verandah post

posts that originally the verandah detail was more decorative. There appears to have been two rows of moulding near the top of the post. The upper moulding was at the level of the underside of the present valance and may have formed the base for timber or lace filigree originally.

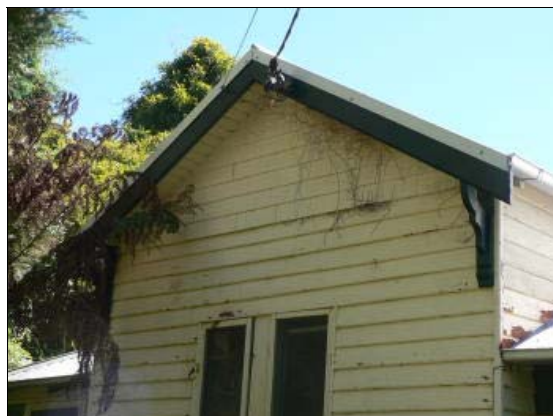
Figure 8: Gable detail south wall

The house is presently constructed on face brick piers. There is a gable projection from the roof above the bedroom adjacent to the front door and on the north elevation of the kitchen. The gable face of the southern gable is lined in painted timber shingles with scrolled timber brackets at the lower edge of the barge each side of the gable. The gable over the kitchen is lined with Asbestos cement sheet and battens. (This lining material is of a mid-20th century origin so either is a replacement material or the gable is of later construction.) This may indicate a later date of construction or simply using a cheaper material on a less visible façade. There is a timber framed canopy over the northern window of the kitchen.

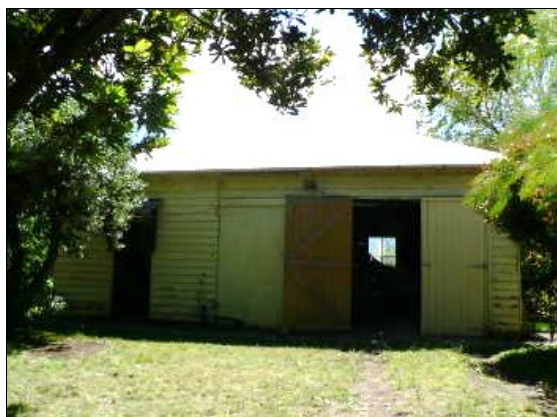
Figure 10: Shed from driveway

The garage has two pairs of large ledged and braced doors on the southern elevation, reflecting its use as a vehicle storage building. There is a single leaf ledged and braced door to the former laundry room on the southern wall. All doors are vertical timber boarded. A former vehicle doorway on the west has been converted to a window. There is evidence in the weatherboard cladding that at least one of the sets of doors (on the south wall) has been altered in height. The door leaves are not original but may have been reconstructed to original detail. The doorway to the laundry has a timber framed canopy over with scrolled support brackets. Condition would imply this is a later addition.

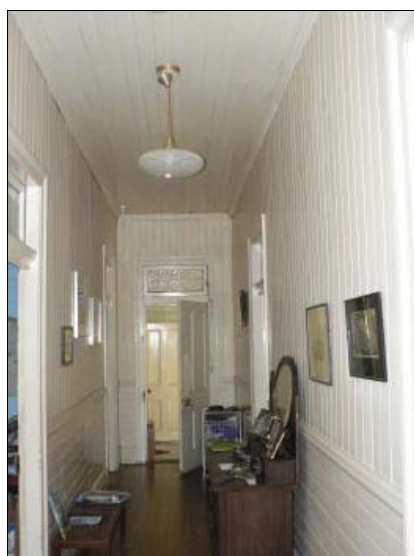
Figure 14: Main corridor showing typical detailing

- Walls and ceilings are lined with v-jointed timber boarding. Wall lining is horizontal to dado level then vertical above with the exception of the dining room which has vertical lining to picture rail level and horizontal above. Cornice is profiled timber.
- All timberwork except floors is presently paint finished but some areas may have been stained (evidence from chips in paint).
- Two designs of profiled timber skirting are used throughout the house.
- Door and window architraves are profiled timber.
- Floors are wide timber boards, with evidence of former Black Japan finish previously.

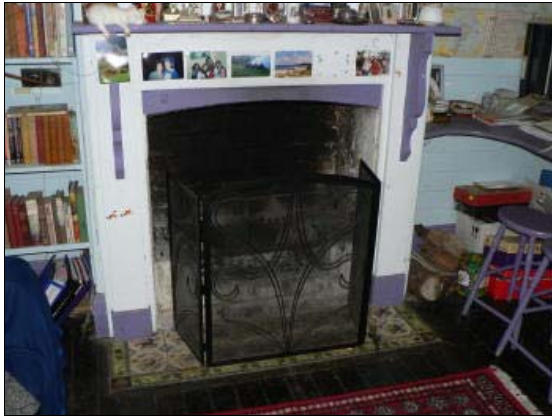
Figure 17: Fireplace Bedroom 2

- Internal doors are all profiled four panel timber which are paint finished. The doors to the verandah are half glazed timber framed French doors with similar profiled moulding to the solid panels in the base of the leaf matching the four panel doors. All doors have a bottom hinged awning glazed highlight over.
- Door locks are typically the original rimlock style. The locks to the verandah doors have a more ornate casing than the main room doors.
- Several of the rooms have a pressed metal ceiling rose at the light fitting
- The outer walls of the verandahs are unlined.
- Three of the rooms have fireplaces. The bedroom has an open fireplace with a tiled hearth. The Dining Room and Family Rooms have cast iron fire place inserts of a Federation/Edwardian design. The tile slides to the side of the

inserts are a floral design as are the tiles in the hearth of these two fireplaces. The interior of the cottage is in good condition particularly considering its age.

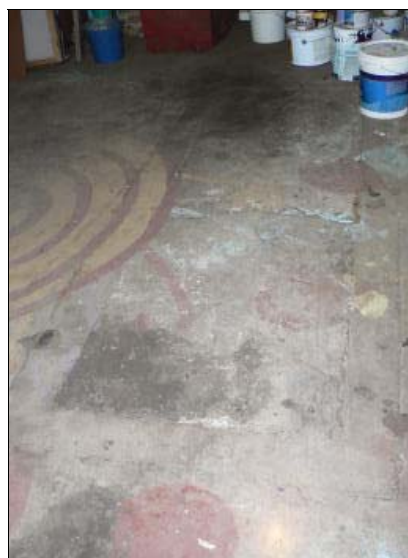
Figure 21: Location of former Service Pit

The floor of the garage and laundry areas is a concrete slab on ground. There is evidence that the former service pit in the garage has been filled in and a slab poured over. The interior areas that were visible appear to be in good condition.

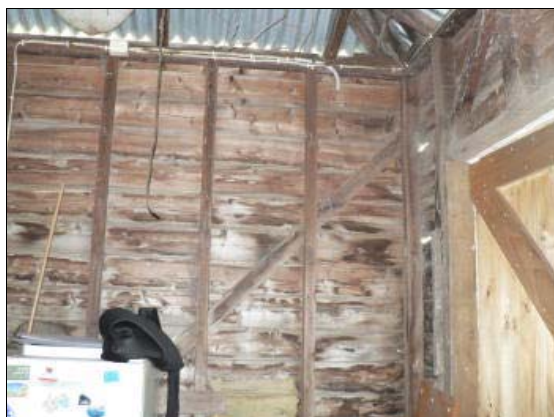
Figure 22: Wall and door construction

Walls and ceilings in the garage area are unlined and the exposed stud framing reveals a butt jointed stud frame with timber bracing boards let into the outer face of wall studs. The walls and ceiling to the Laundry are lined in horizontal weatherboards.

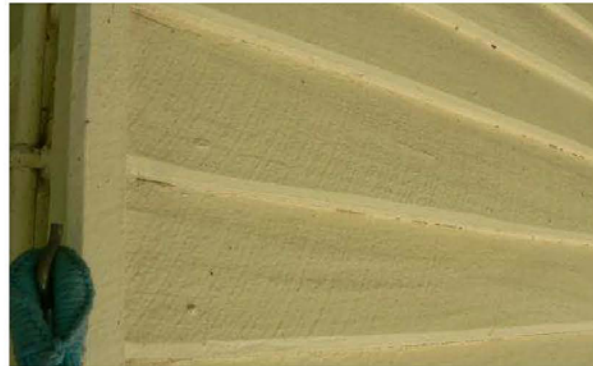
P1230596 Representative weatherboards showing profile & saw marks

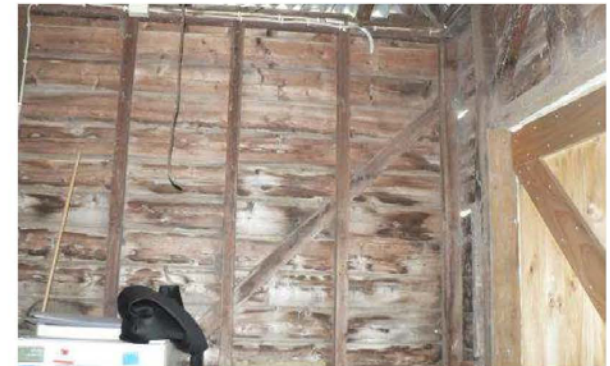
P1230648 Wall & door construction detail
