Foxground and Berry bypass Princes Highway upgrade

Microbat Management Plan

14 April 2015

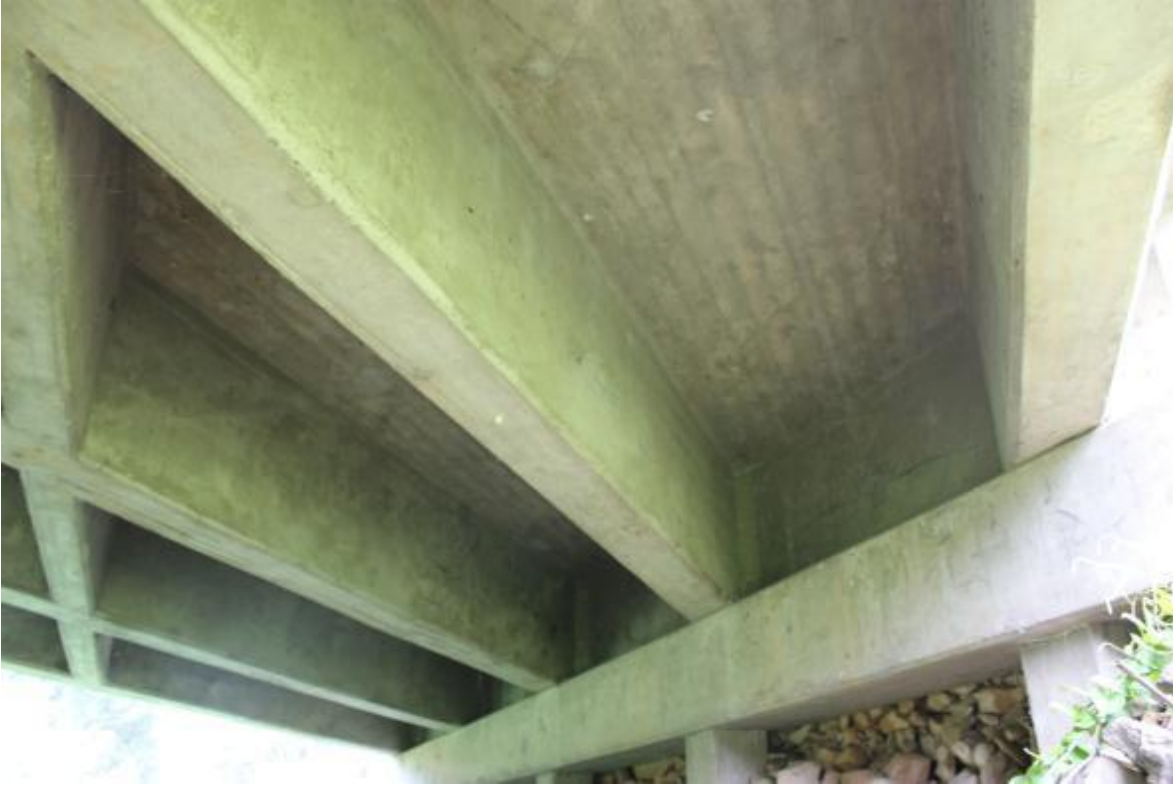
Photo 1 Broughton Mill Creek Bridge with Southern Myotis

- Under a bridge over Broughton Mill Creek near Berry (Photos 1 and 2), which occurs within the project area and has the potential to be impacted by the project.
- In a culvert positioned along Flying Fox Creek, immediately adjacent to the southern extremity of the project just past Berry (Photos 3 and 4). This site is technically outside of the project area and would not be impacted by the project.

Structure	Roost type	Location	Requirements
Bridge	Structural crevice (Photo 1 and Photo 2)	Broughton Mill Creek (near Tannery Road). Refer to Figure 1.1 for location.	Routine inspection and pre-clearance surveys Where practicable, preference remains for avoiding roost exclusion as this structure itself will not be directly impacted. However, if during construction more than one microbat was observed utilising the structure, then temporary roost exclusion could be warranted (i.e. using plywood to board off roost sites, which can be easily removed following construction related disturbance).

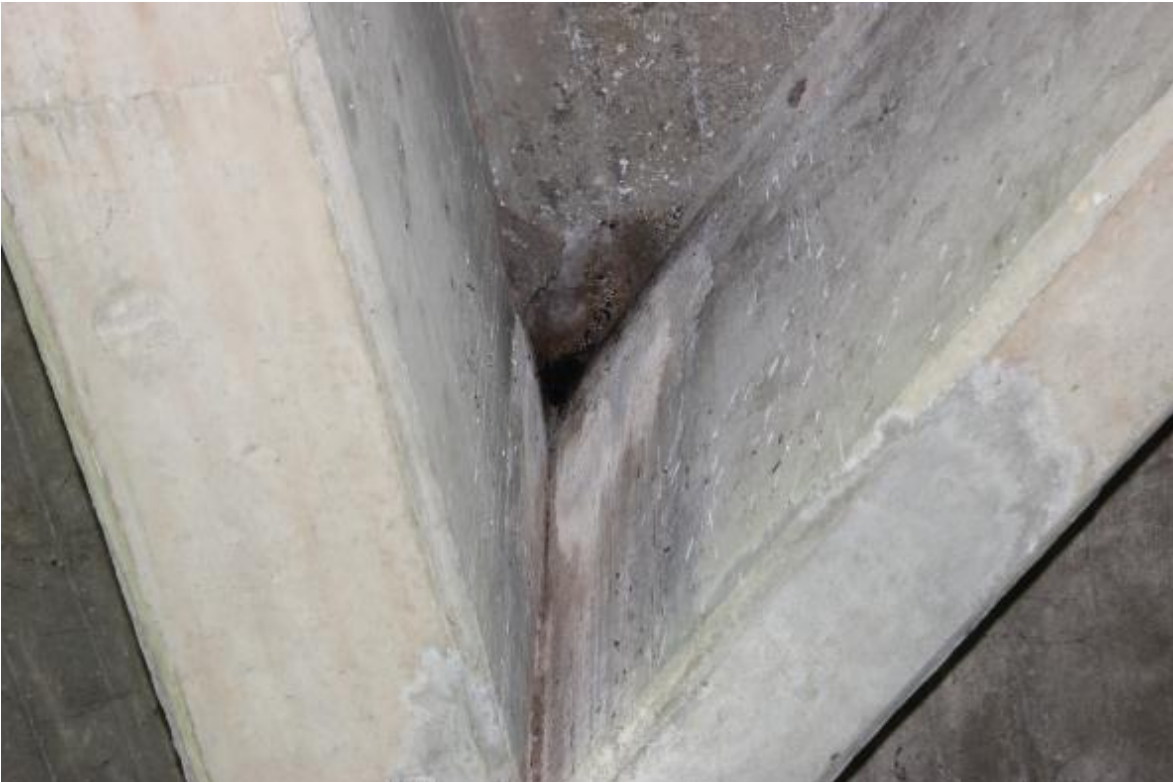
Photo 2 Southern Myotis roost location Broughton Mill Creek Bridge

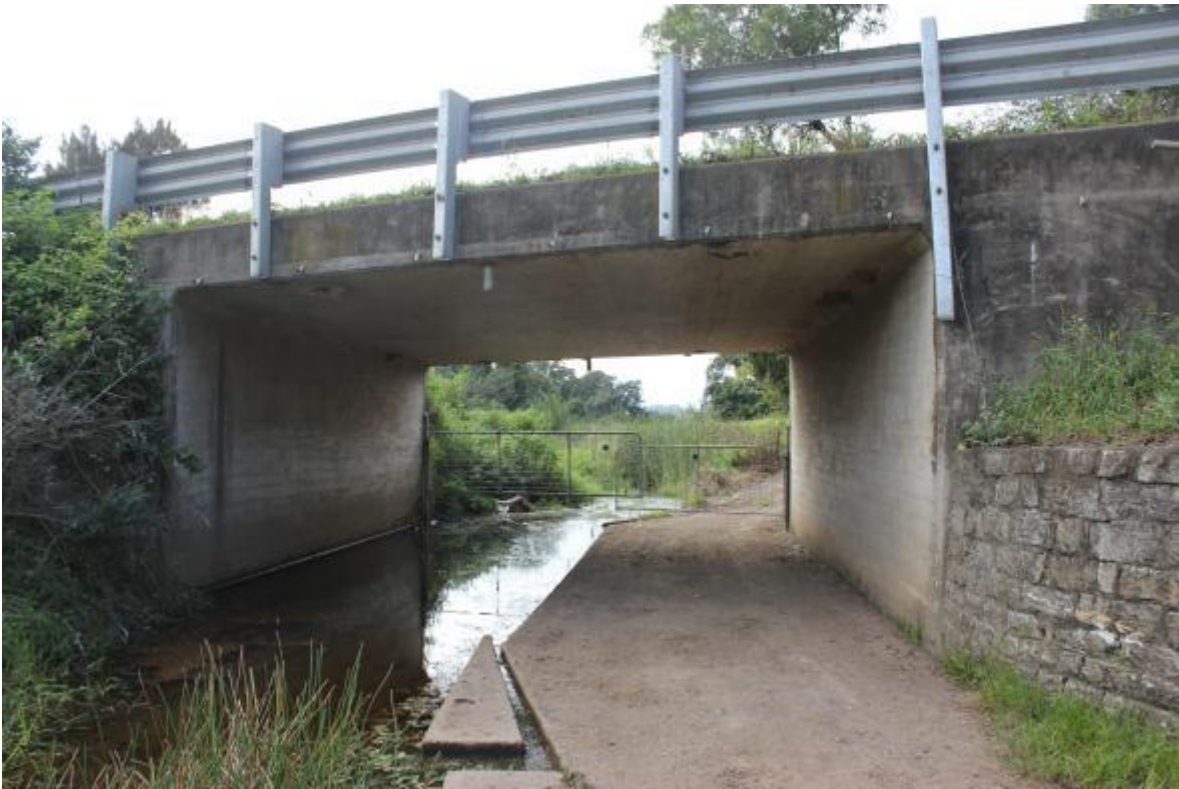
Photo 3 Flying Fox Creek culvert with Southern Myotis

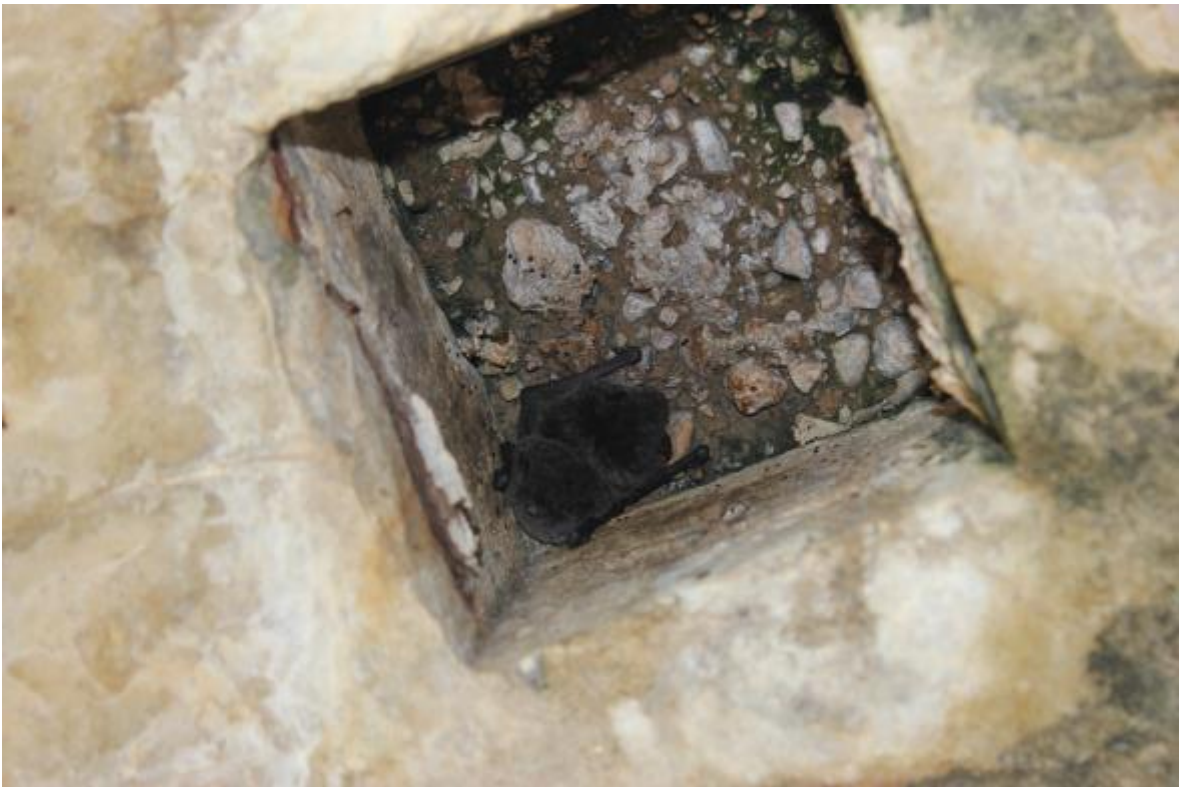
Photo 4 Southern Myotis roost location in Flying Fox Creek culvert
