WAKOOL SHIRE COUNCIL

**PROPOSED REPLACEMENT GEE GEE
BRIDGE OVER THE WAKOOL RIVER**

GEOTECHNICAL INVESTIGATION

REPORT NO N1662R1 APRIL 2015

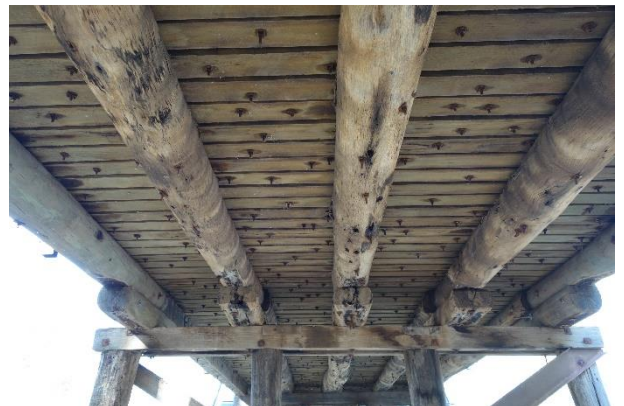
Image 8 - Underside of bridge from north east bank

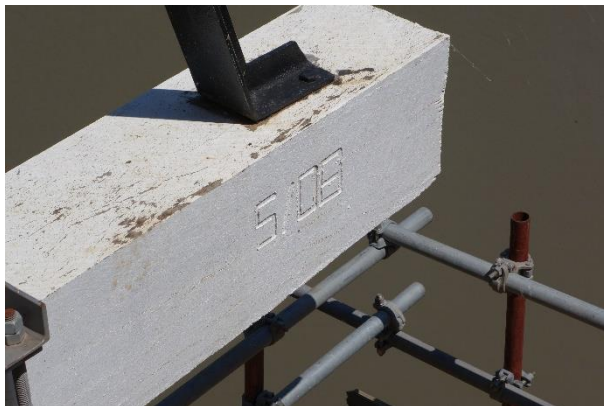
Image 9 - Truss span repair works dated May 2008

Various steel and timber repair work / reinforcing has been conducted, with the timber beams within and adjacent to the truss span. These are dated from the 1990s to the 2000s.

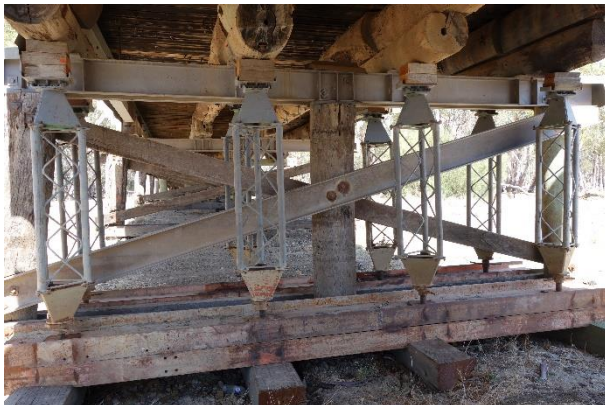
Image 15 – Steel truss props

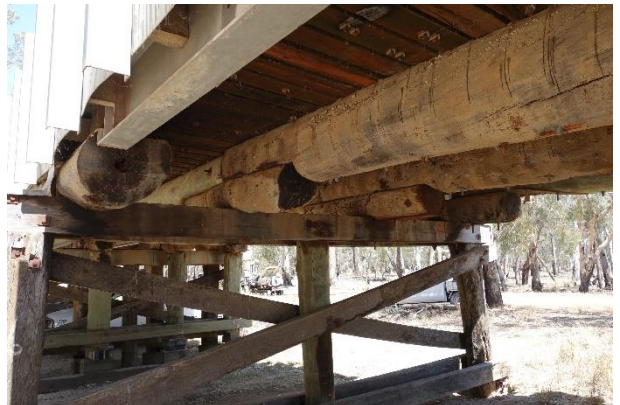
Image 16 – Steel beam replacing timber log

The superstructure and substructure appear to have been repaired many times, with extensive alterations including additional steel beams within the superstructure, and additional driven steel and driven timber piles in the substructure. Most of the piers have been propped with timber logs supported on timber beams on the subgrade. Some of the piers have been propped with adjustable steel trusses supported on large steel beams which rest on timber beams which rest on the subgrade. Dates carved on the timber repairs range from the 1980s to the 2000s.

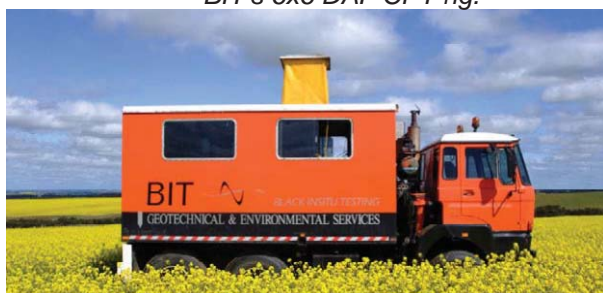
BIT's 6x6 DAF CPT rig.

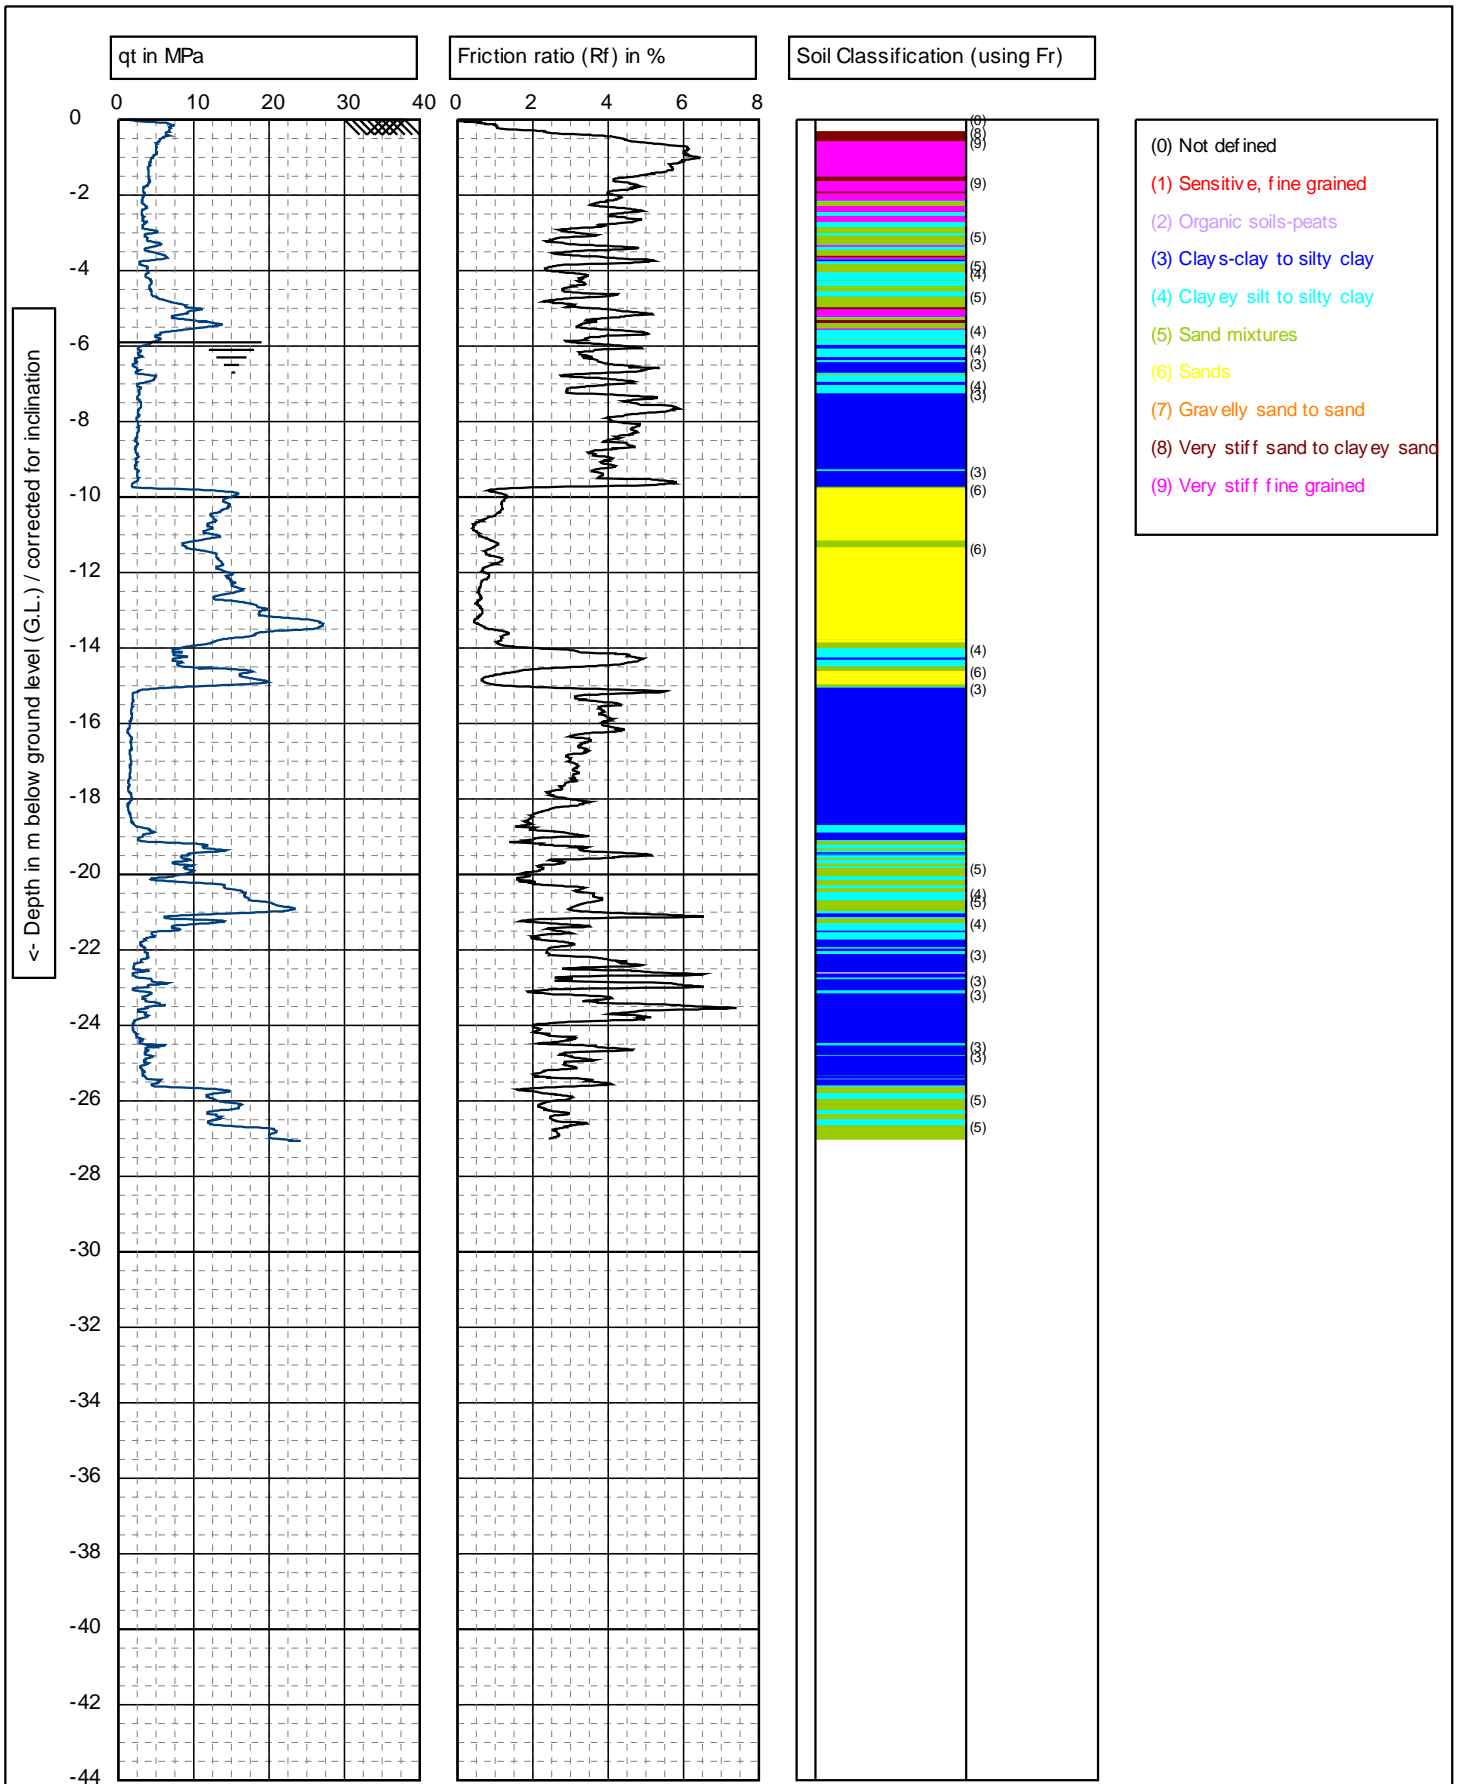
Predrill : **0 m Predrilled**
 Date: **6/02/2015**
 Cone no.: **S15CFIP.S12299**
 Project no.: **D145**
 CPT no.: **Abut A** | 1/2

Refusal at 27.27m qc>25MPa

Hole closed at 8.9m

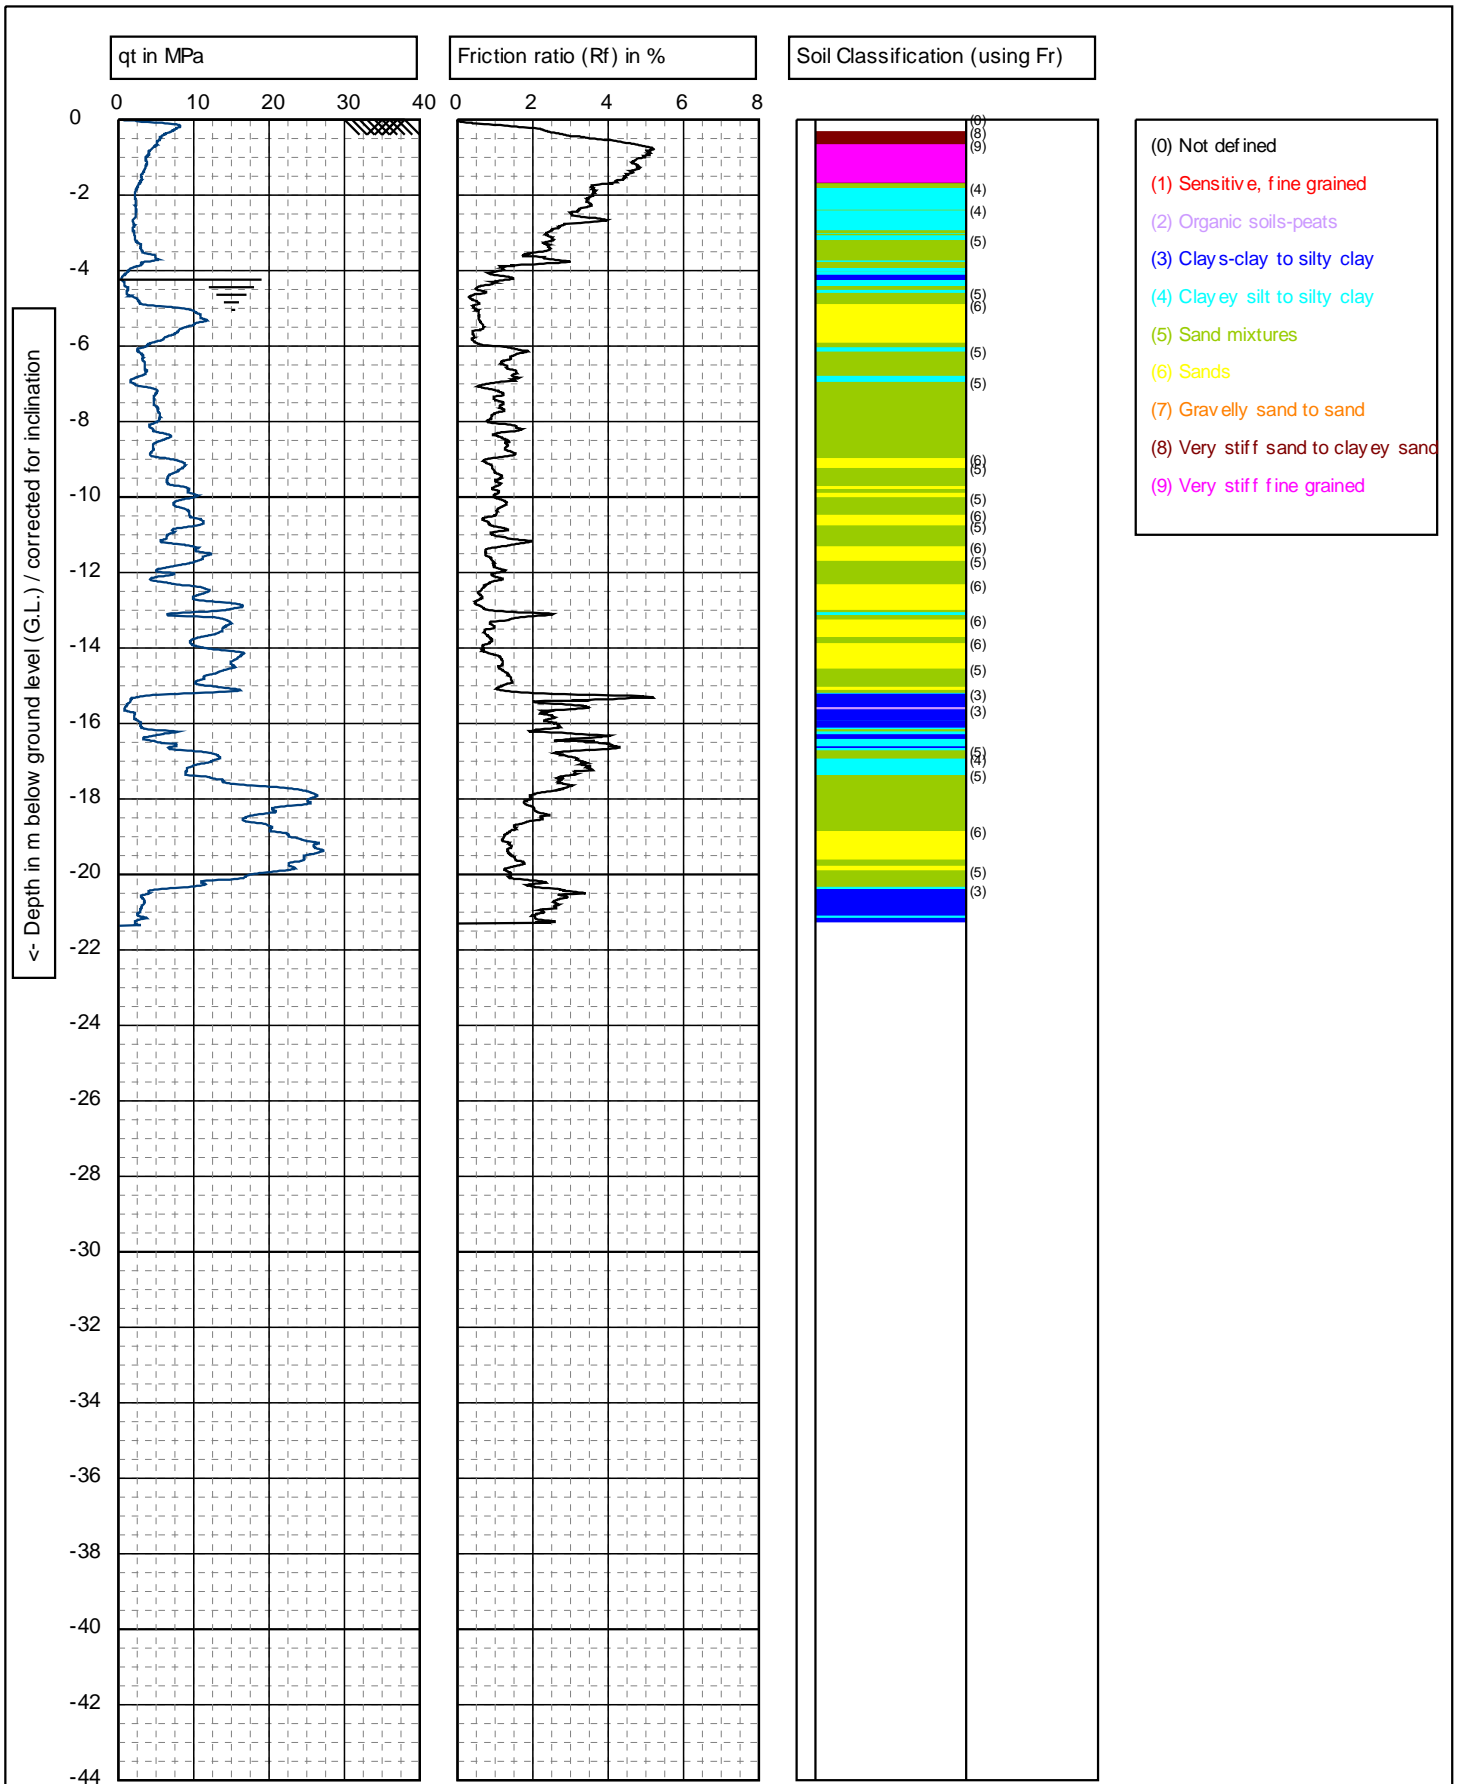
Client : Black Geotechnical		Predrill : 0 m Predrilled	
G.L. 68 AHD	W.L.: -4.24	Date:	7/02/2015
Project: Gee Gee Bridges		Cone no.: S15CFIP.S12299	
Location: Wakool Shire		Project no.: D145	
Position:		CPT no.: P 5	1/2

Test complete at 21.51m

hole open to 4.39m
