# Heathcote Road Bridge

Addendum Review of  
Environmental Factors

April 2022

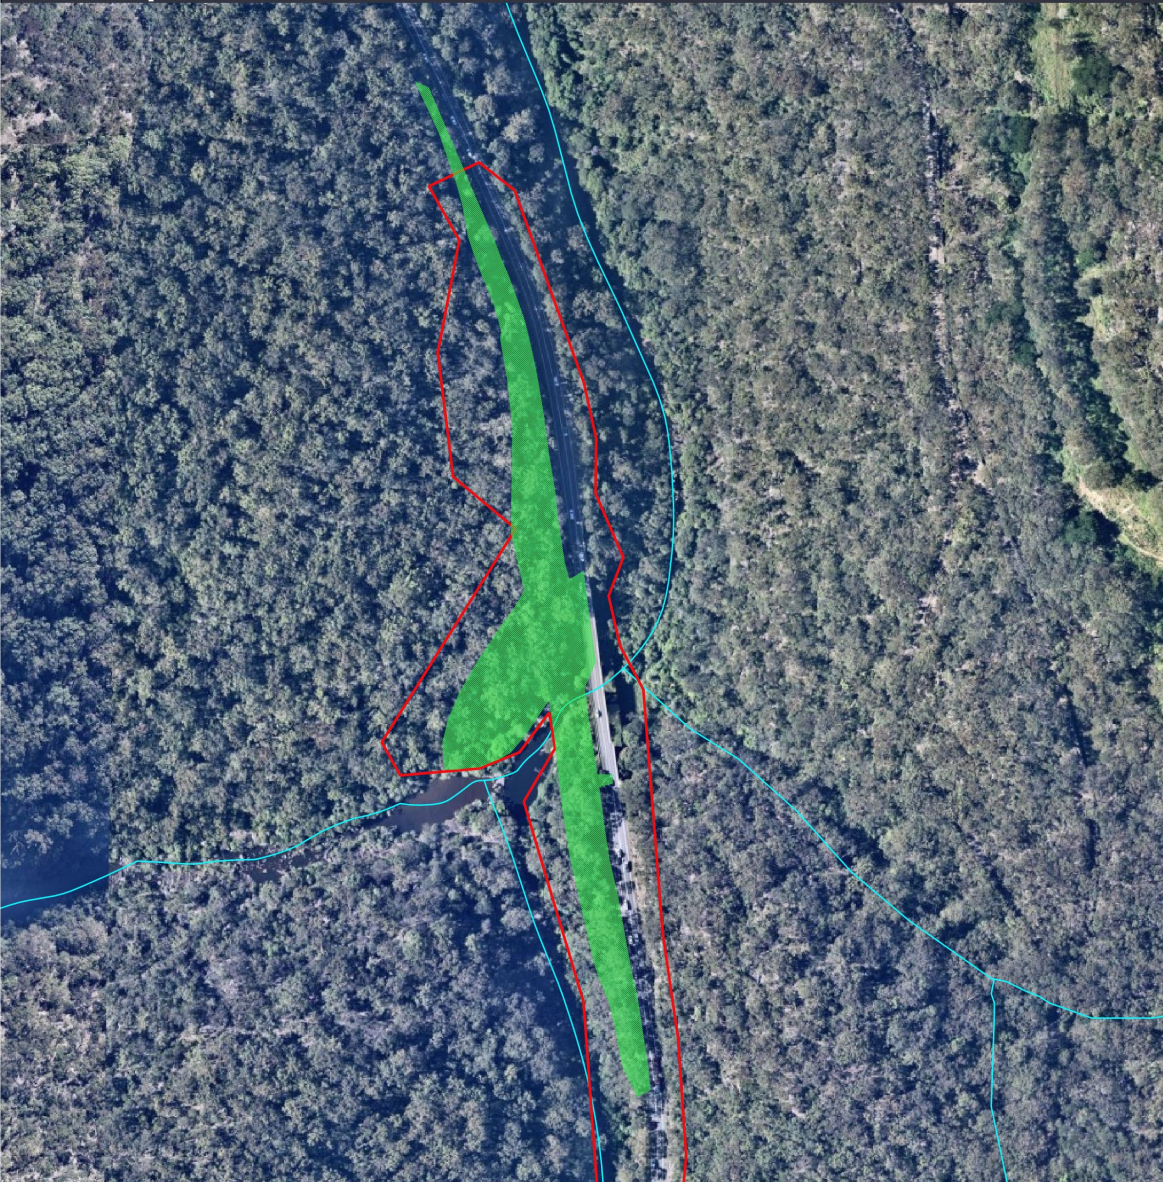
**Figure 1: Heathcote Road Bridge Upgrade impact area**

- Original Proposal Area
- Final impact area (approximately 1.2ha)
- Hydrolines

Vegetation clearance is lower under the final design alignment than was originally considered in the REF. No more than 1.2ha of native vegetation is to be impacted. Vegetation above the southeast cut is no longer impacted, however an extended area of clearance is required above the northwest cut. Both areas of vegetation are in a similar condition and are characteristic of PCT 1250, which is not associated with a Threatened Ecological Community. The final design alignment avoids downstream clearance of PCT 781 which can be associated with an Endangered Ecological Community.

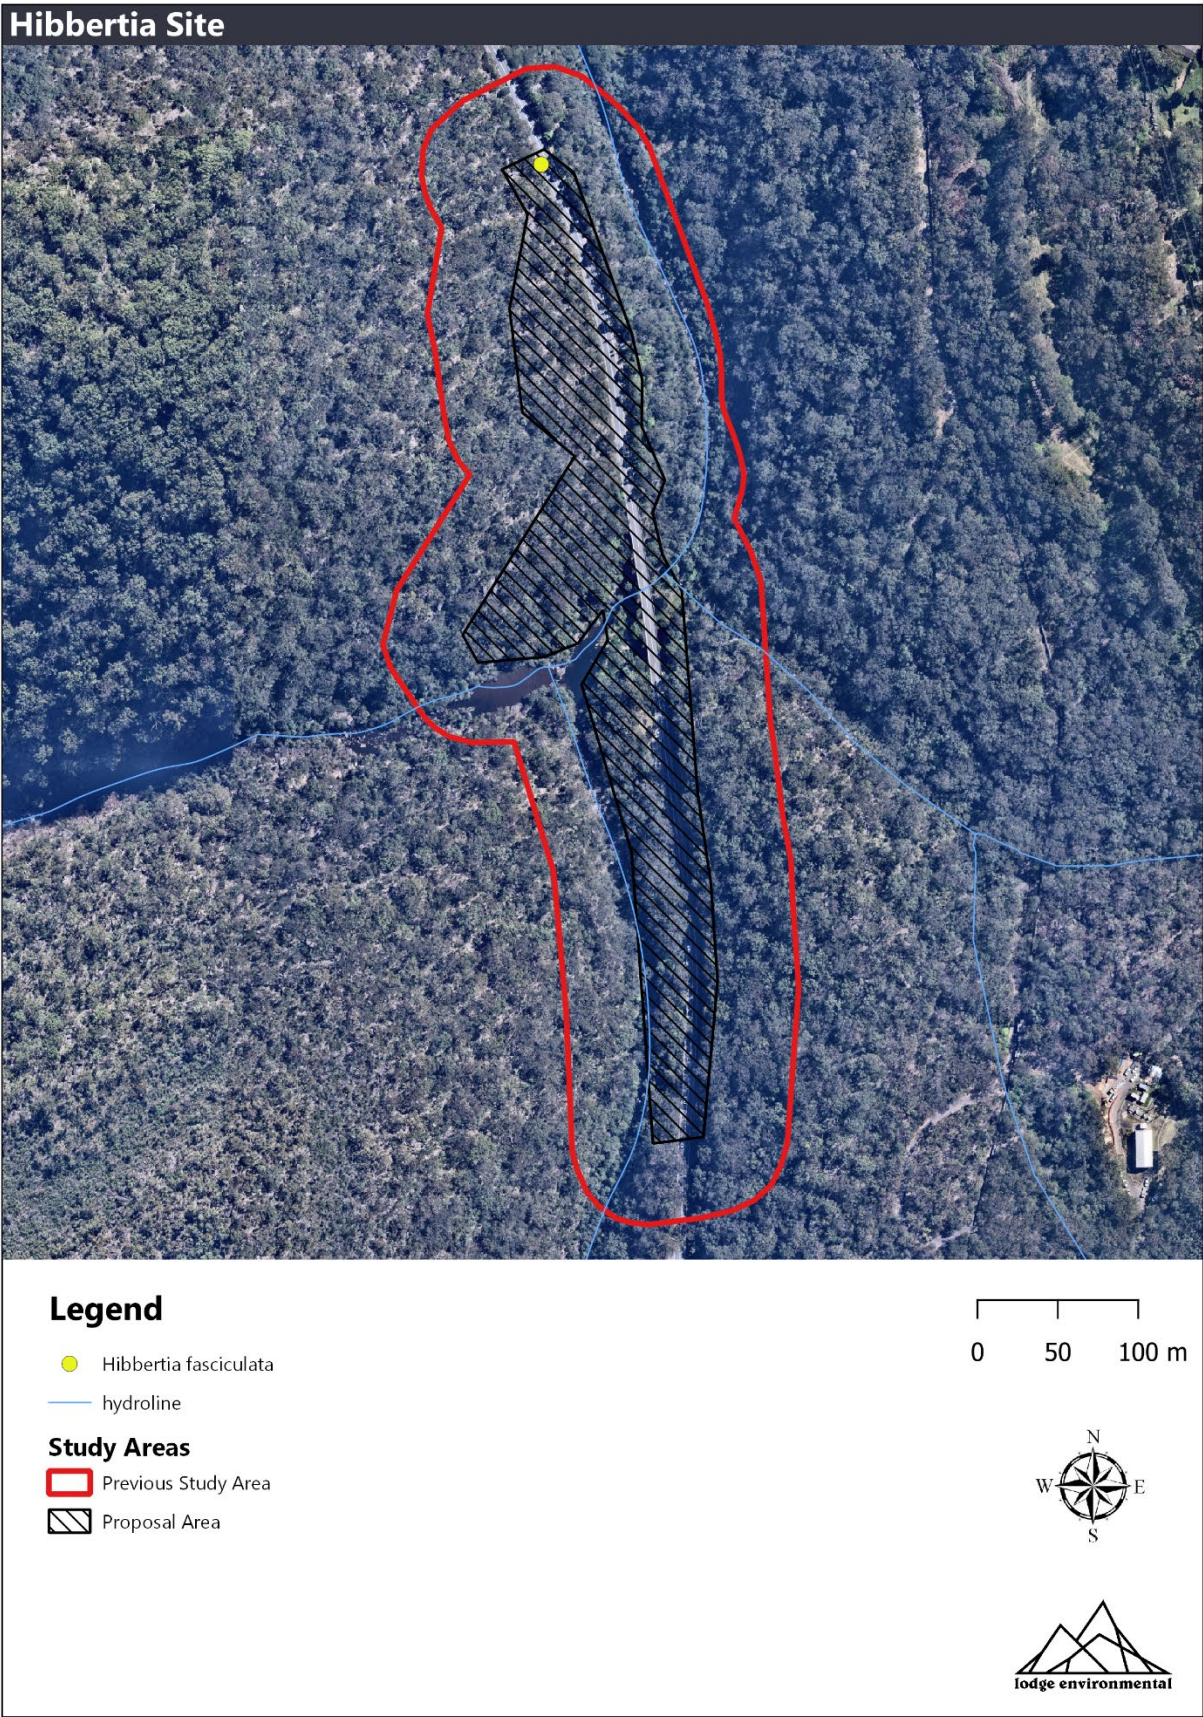
**Figure 2: *Hibbertia fasciculata* location in relation to initial design layout**

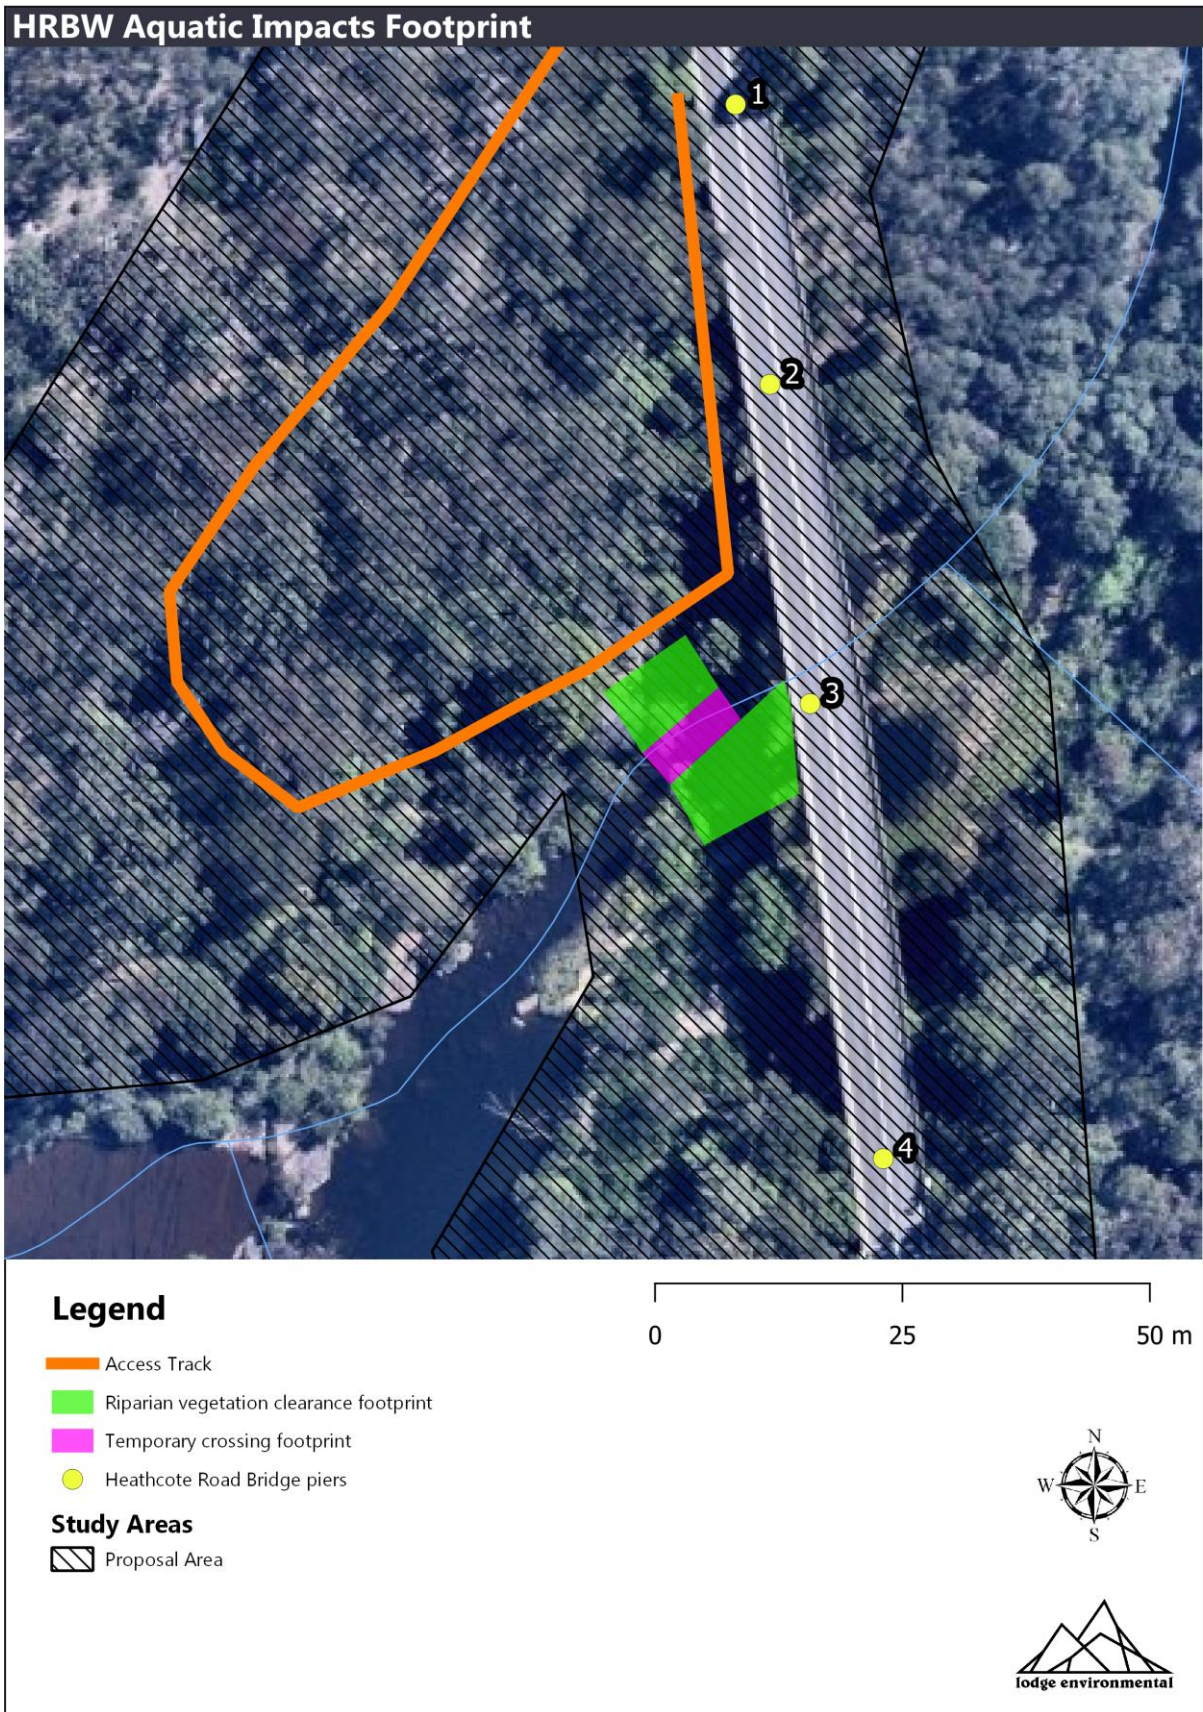
**Figure 1: Aquatic impact areas**

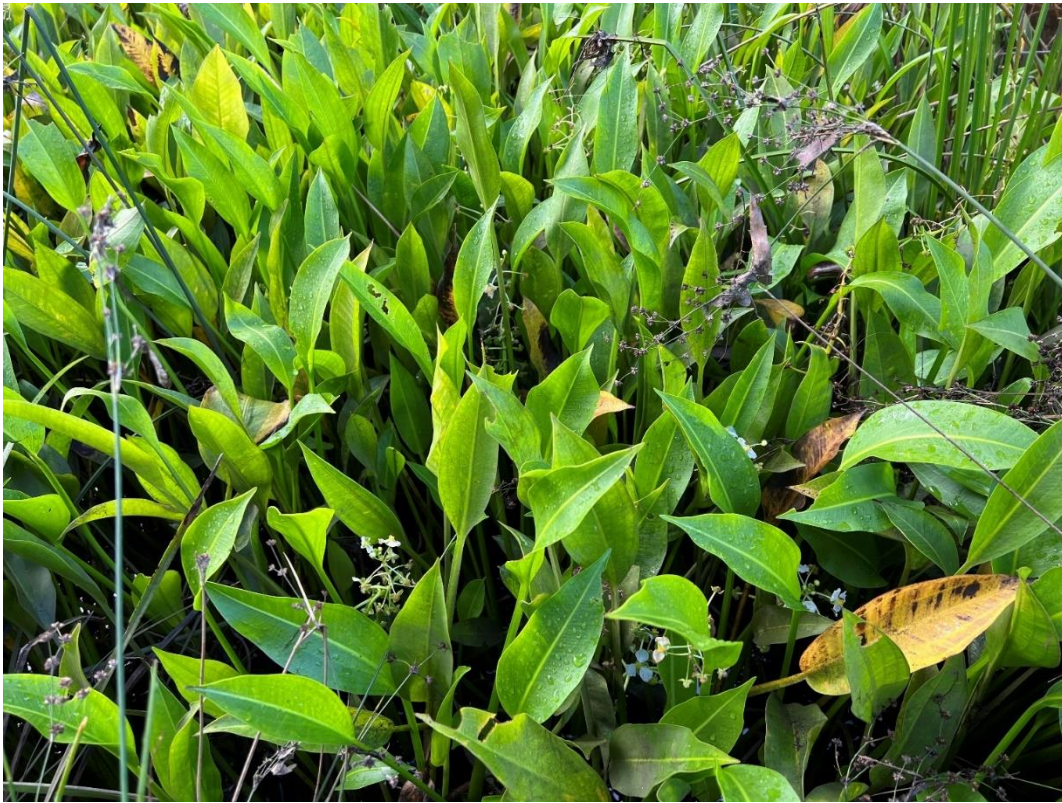
**Figure 2: *Sagittaria platyphylla* growing adjacent to the southern bank**

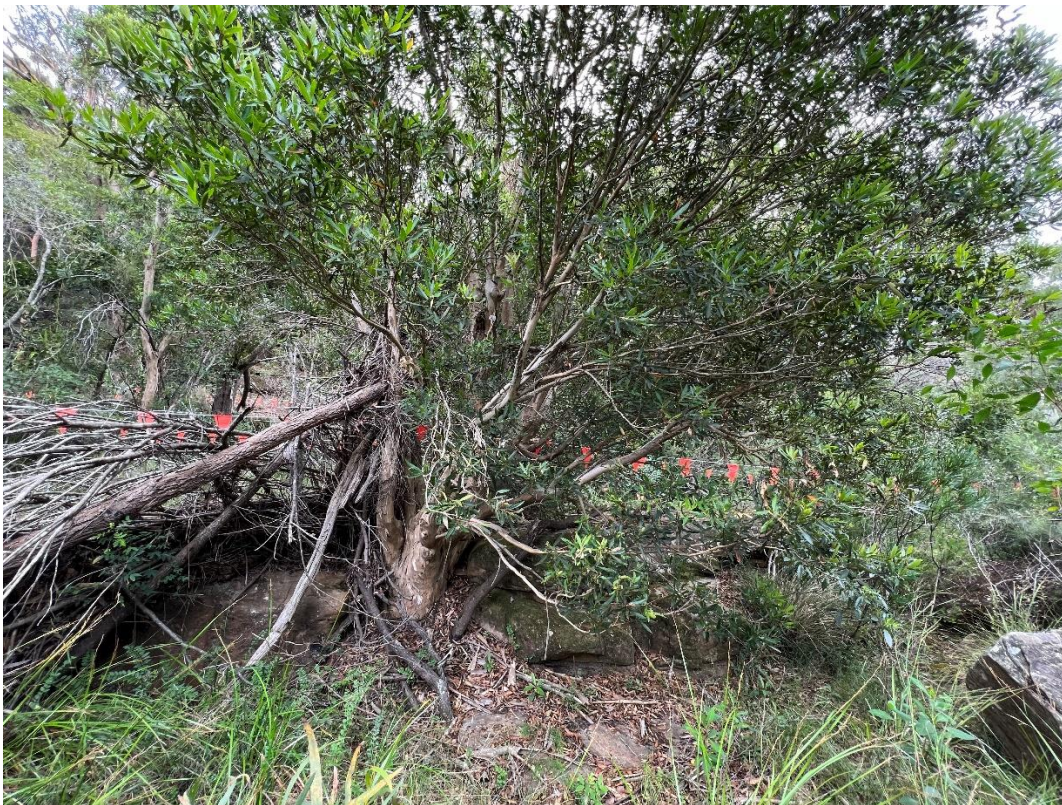
**Figure 3: Native vegetation growing along the northern bank**

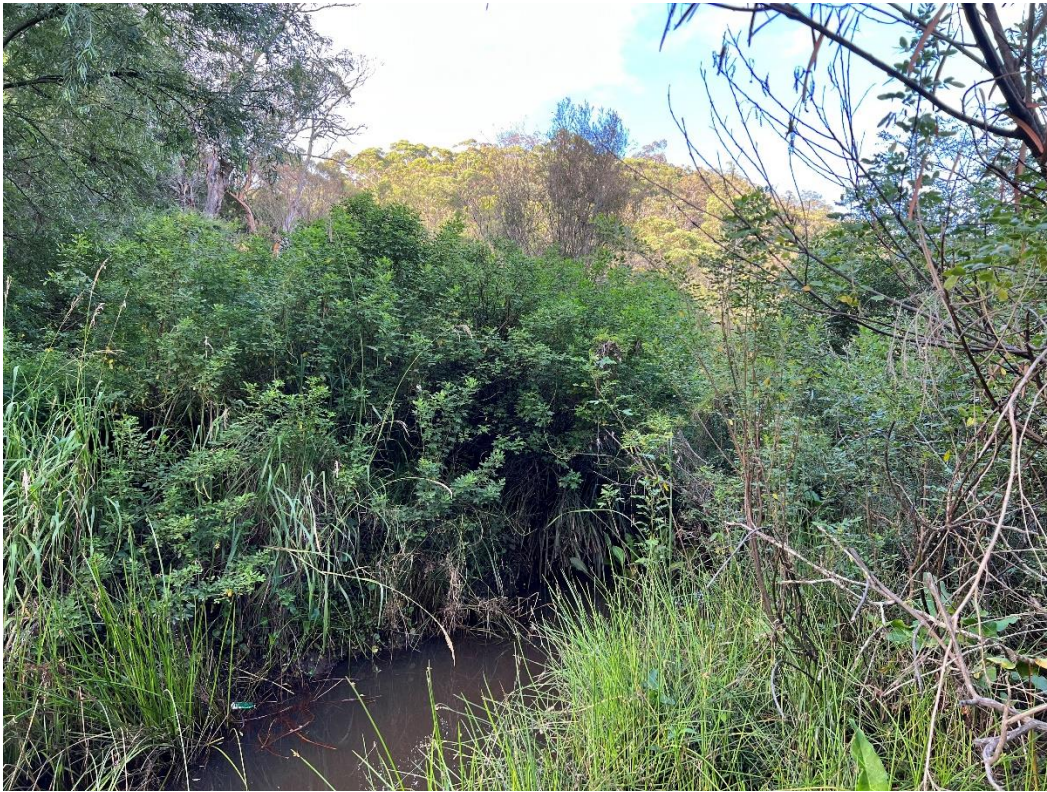
**Figure 4: High density exotic vegetation and minimal native vegetation was recorded along the southern bank**

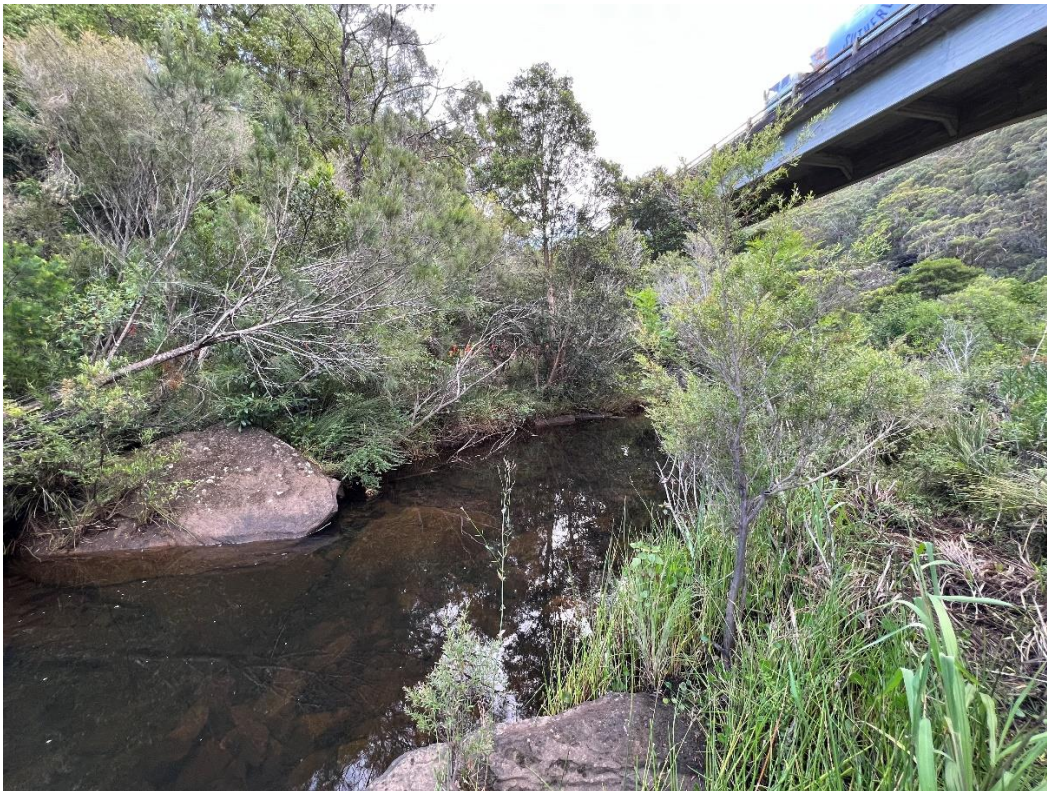
**Figure 5: Approximate location of temporary river crossing**

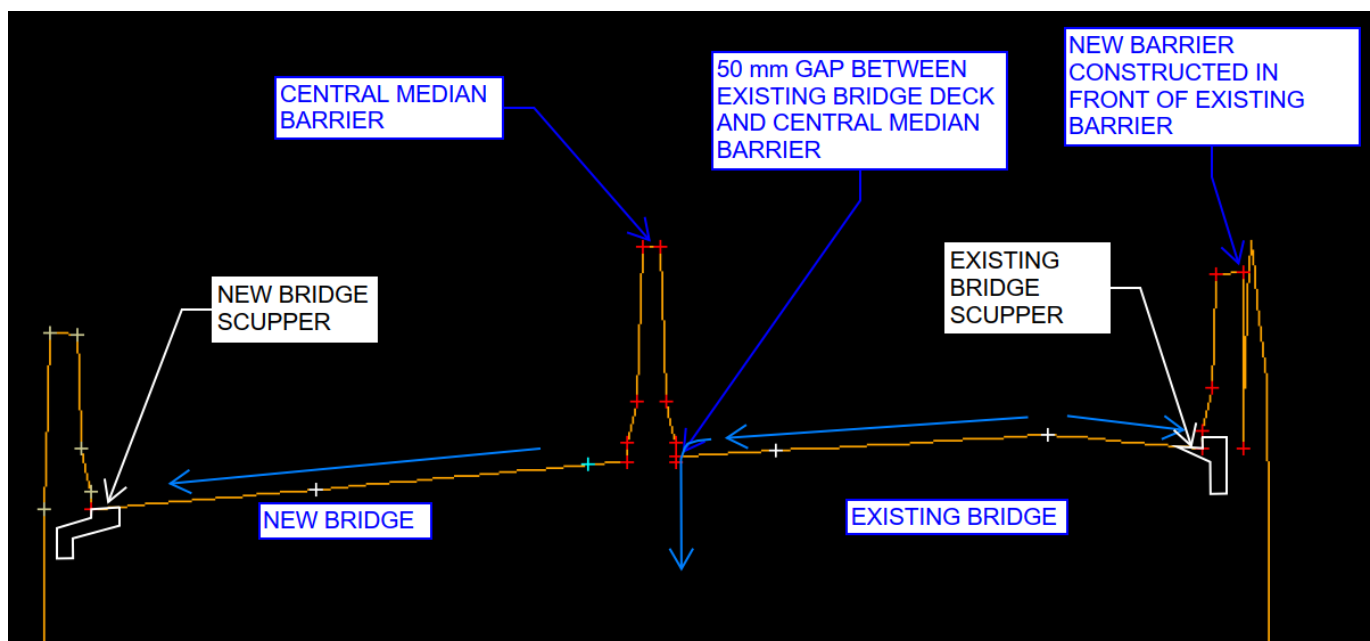
● Figure 3: Existing and new bridge deck drainage strategy.

Free-draining scuppers have been proposed to collect bridge deck runoff, consistent with the existing bridge drainage strategy (refer Figure 3).

Since the longitudinal grade of the bridge is 0% on both the existing and new bridge, the edge of the outer bridge barrier where bridge deck runoff accumulates will also have a flat longitudinal grade. A scupper spacing of 4 m shall be proposed on both bridges to improve drainage outcomes for the bridge. Due to the wide shoulder on the new bridge, this bridge drainage strategy would allow water to pond up to a high enough depth within the shoulder to still get pushed through the scuppers. However, the flat grade along the base the barrier would lead to the water ponding against the barrier having a very low velocity. Sediments suspended in the bridge deck runoff would likely build up against the barrier over time, requiring regular pressure cleaning.

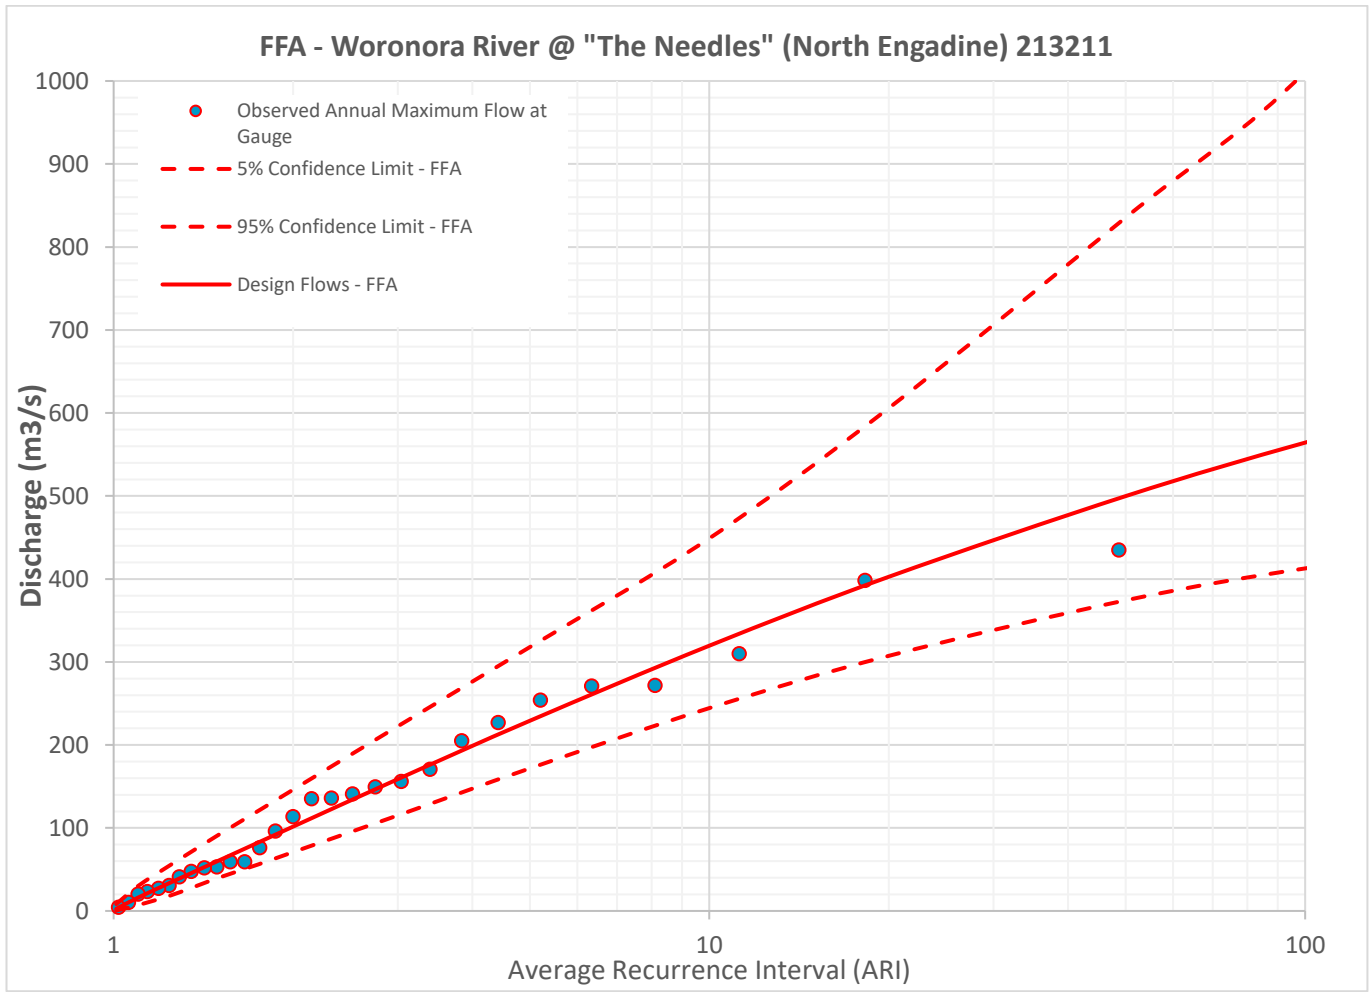
● Figure 5: Flood Frequency Analysis for Woronora River @ “The Needles” (North Engadine) 213211.

Figure 5 shows the FFA flow estimates, 5% and 95% confidence intervals.

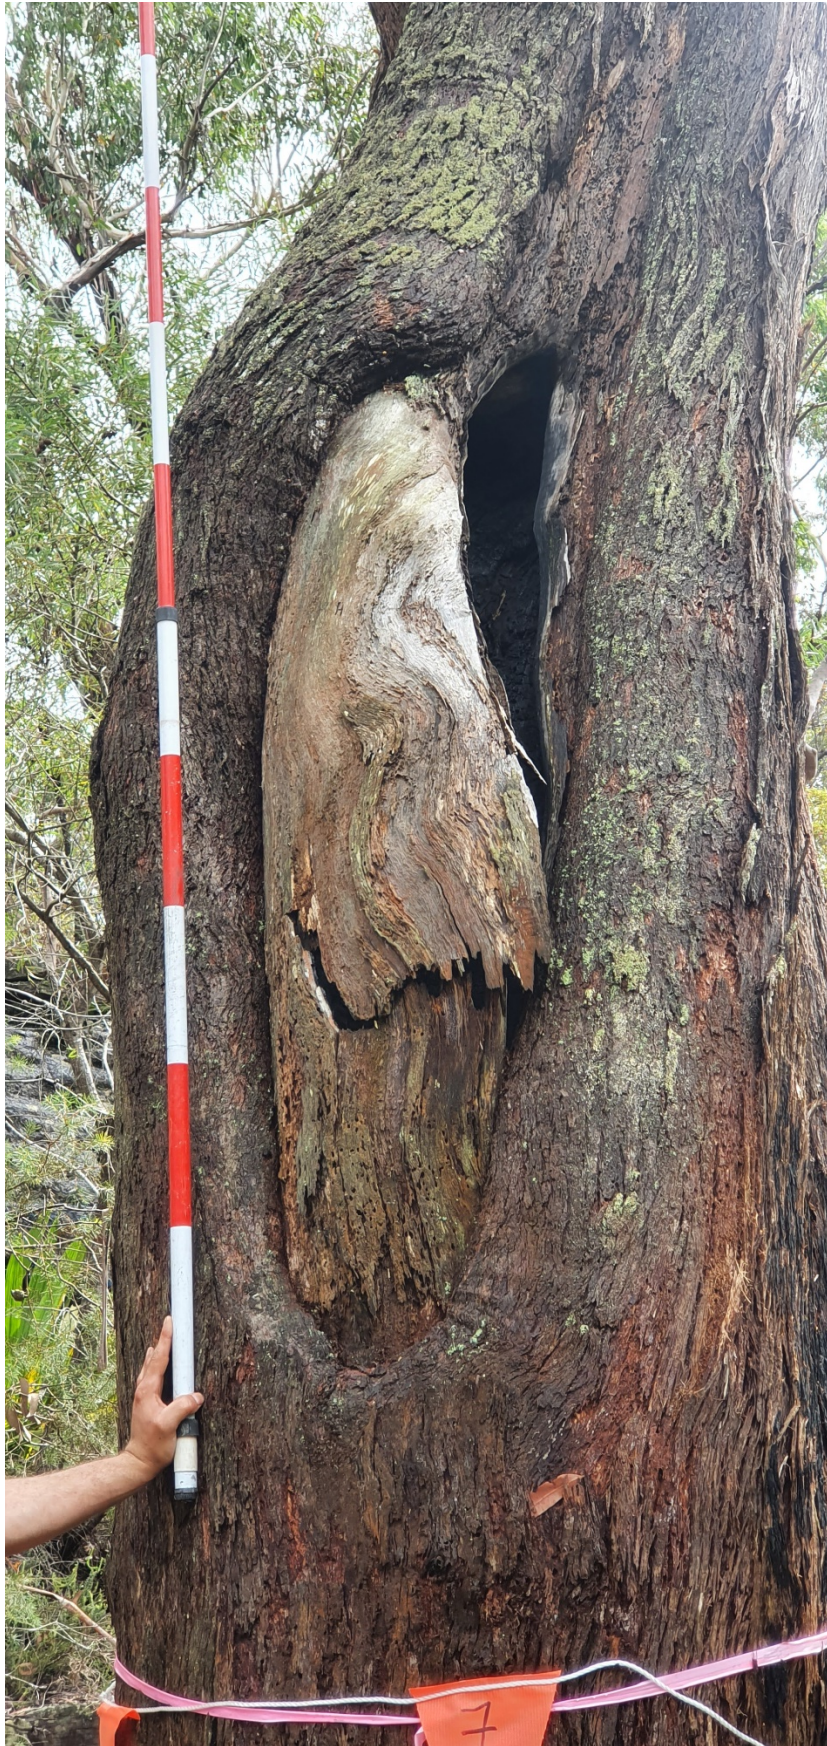
Site photo: Heathcote Road bridge, vegetation above north-west cutting

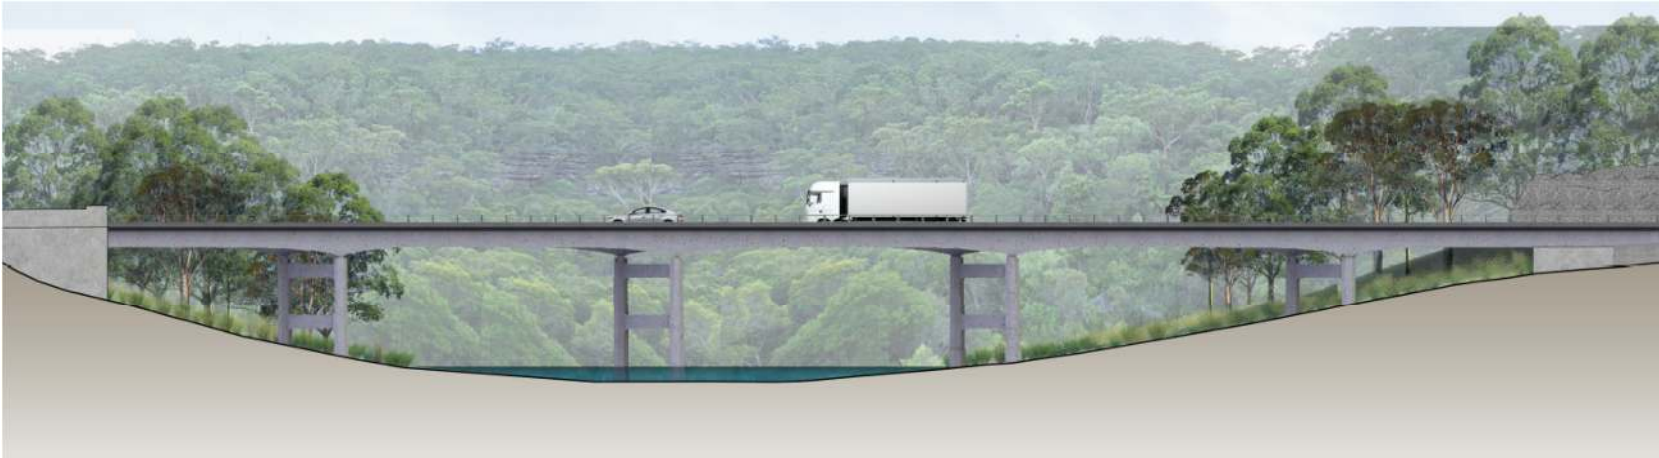
Elevation view of the existing bridge.

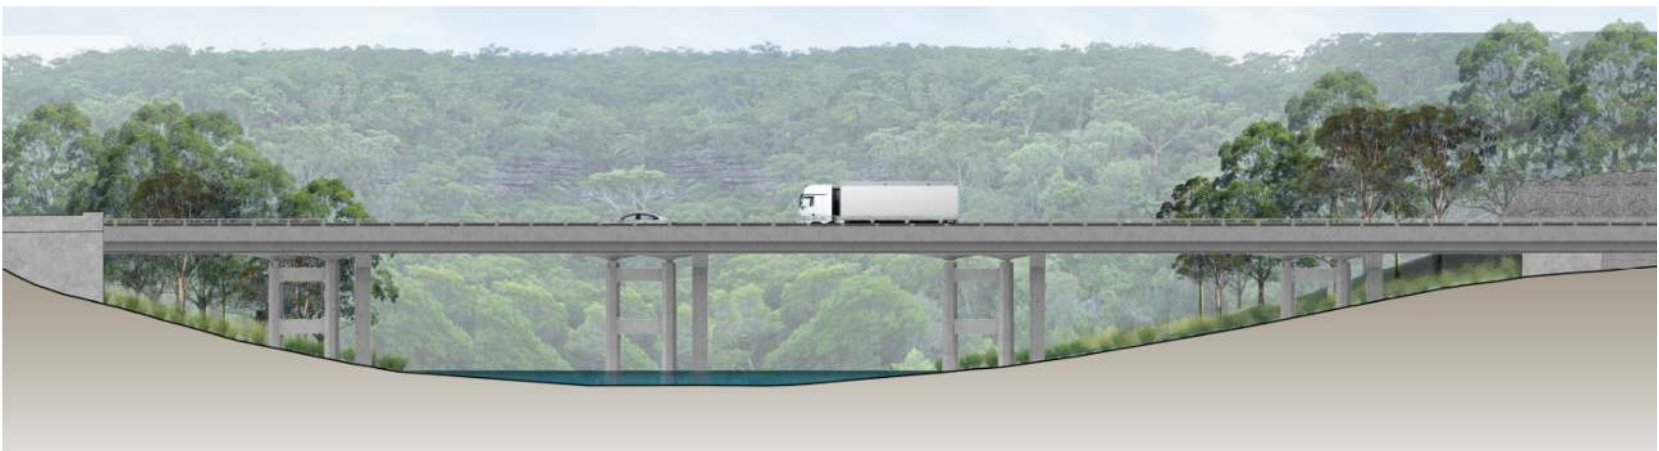
Elevation view with the additional upstream bridge.

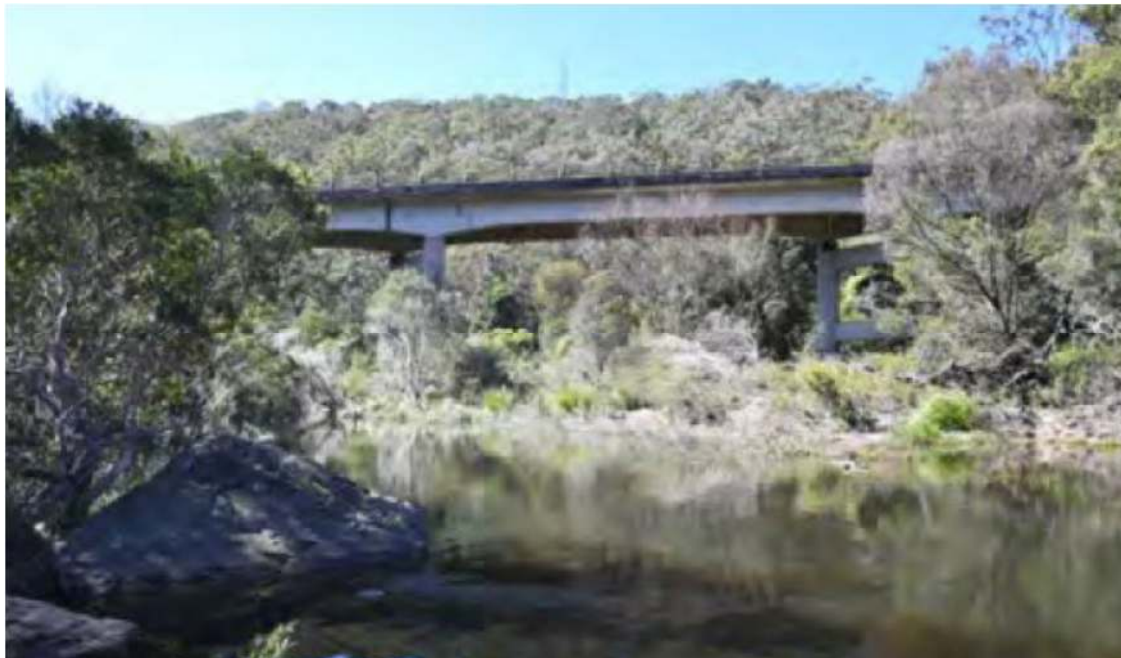
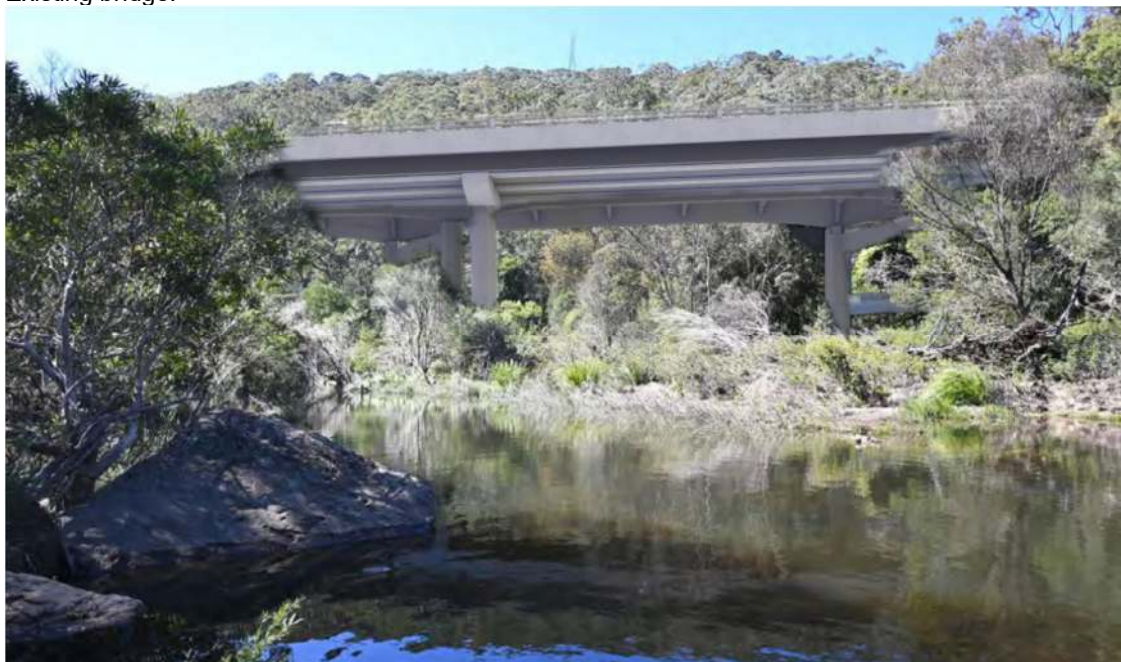
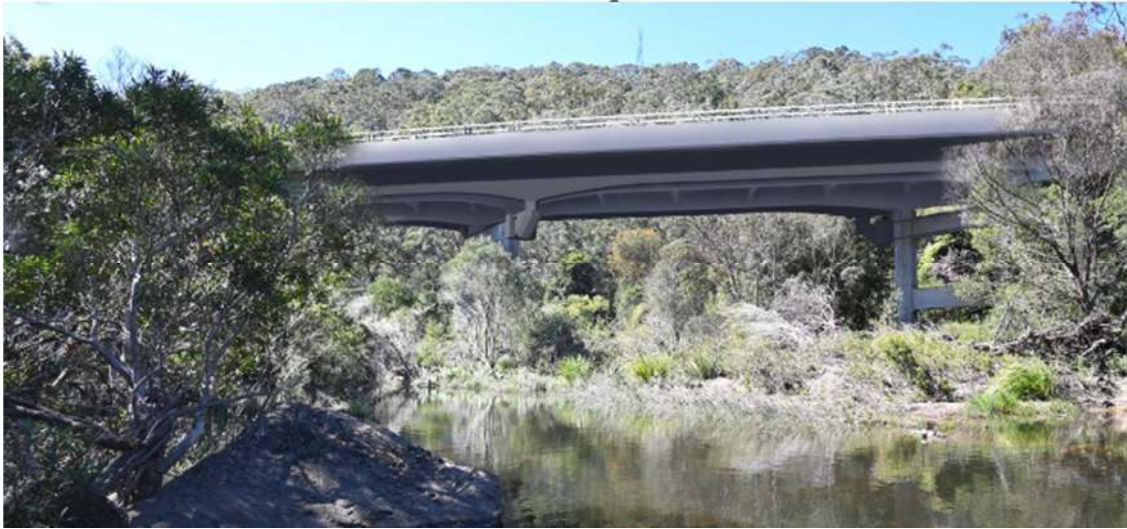
Figure 8: Photo montage comparison of the current and previous proposals compared to existing structure (Source – Urban Design Report, Tract 2022).

Existing bridge.

Proposed design.

Previous design.

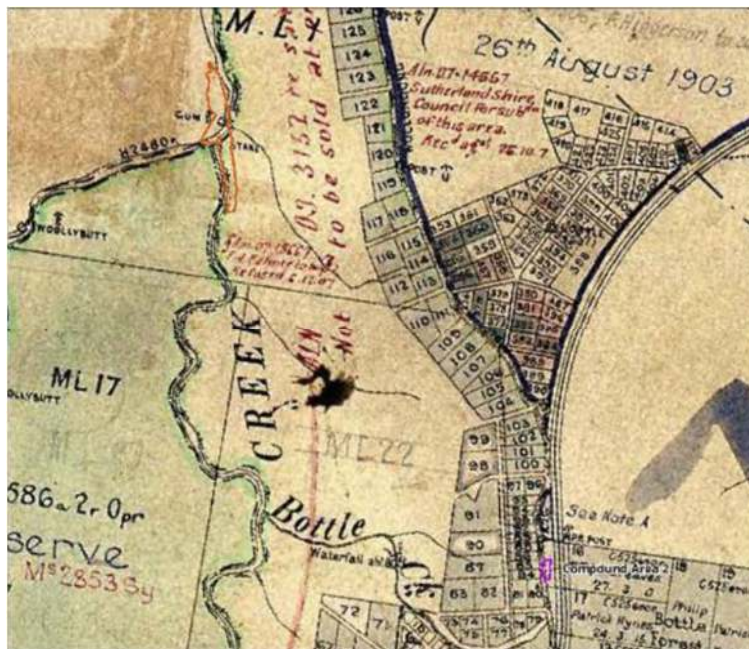
**Figure 15: 1903 parish map, construction footprint in orange (Source: NSW HLRV).**

The southern Woronora River region was first mapped in 1843 as the original southern route of the Illawarra route was plotted<sup>10</sup>. The first village in the region was initially called Bottle Forest, although it was later renamed Heathcote for the Parish it was situated in<sup>11</sup>. Though the early town was small and featured small allotments, they housed large, wealthy manors like the now heritage listed Heathcote Hall<sup>12</sup>. A newspaper article from 1886 described the considerations surrounding building a railway station at Bottle Forest as ‘extensive...not to be entered upon without due consideration’, which further emphasise the small nature of the early town<sup>13</sup>. By 1879, approximately 7,000 hectares of Crown land was set aside as National Park under the Crown Land Alienation Act of 1861<sup>14</sup>. This action would lead to the subsequent establishment of the Heathcote and Royal National Parks, which border the modern suburb of Heathcote. The abundance of trees within the National Park area meant that the Heathcote area acted as an important source for timber supplies to support the developing region around it<sup>15</sup>. Parish maps from 1903 show that the Heathcote National Park area had been reserved from development for this purpose, and the tree used as the survey marker for the map is recorded at the bend in the Woronora River; the tree is noted as a gum tree with a broad arrow and a ‘D’ as the survey mark (Figure 15 and Figure 16).

land to the west of the current Woronora River Bridge, within the construction footprint of the proposed works. On the southwest side of the bridge, the landscape was densely vegetated, with trees and shrubbery taking up the majority of this portion of the study area. Northwest of the bridge was featured similarly dense vegetation (Figure 30 and Figure 31). However, much of this area is significantly elevated above Heathcote Road, located on a sandstone outcropping that was partially cut through in order to construct the road ( Figure 32 and Figure 33). This section of the study area was unable to be accessed during Biosis' initial site inspection, however no previously unknown items of heritage significance were identified during Artefact's inspection. Neither the Biosis or Artefact inspections located the survey marker tree used in the 1903 parish map (Figure 15 and Figure 16).

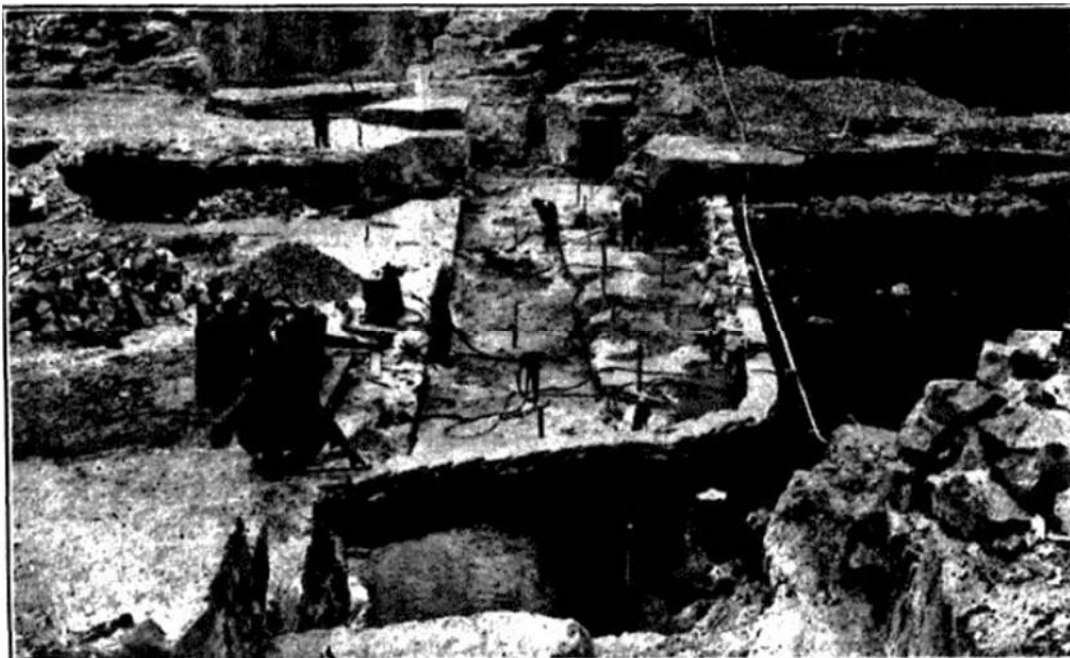
**Figure 17: Kolara Weir's construction, 1931 (Source: 'Site of Weir on Woronora River', Construction and Real Estate Journal, 11 March 1931).**

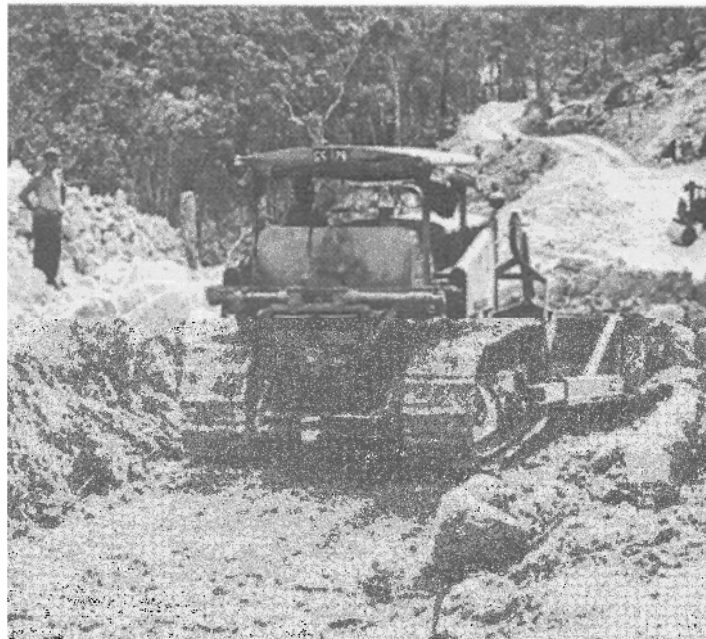
**Figure 18: Construction of Heathcote Road, 1941 (Source: Department of Main Roads, NSW, 2000).**

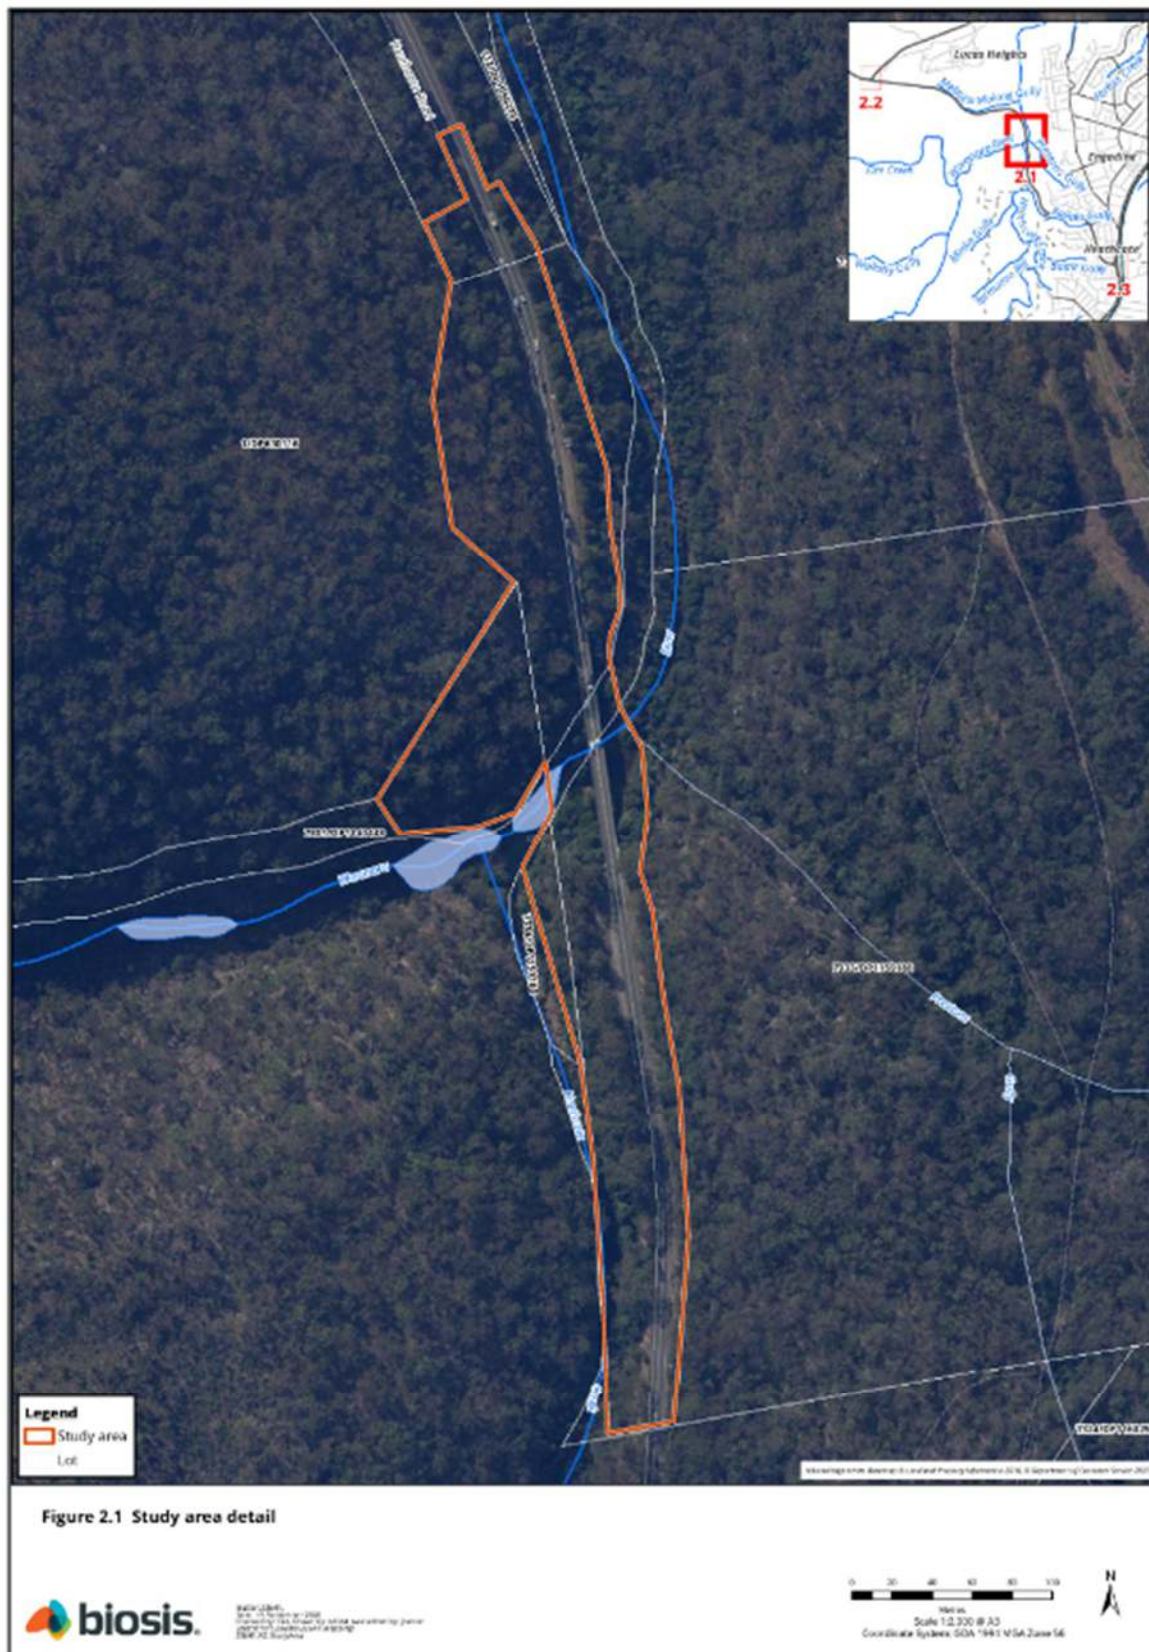
Figure 21: Study area in Biosis report (Source: Biosis, 2020).

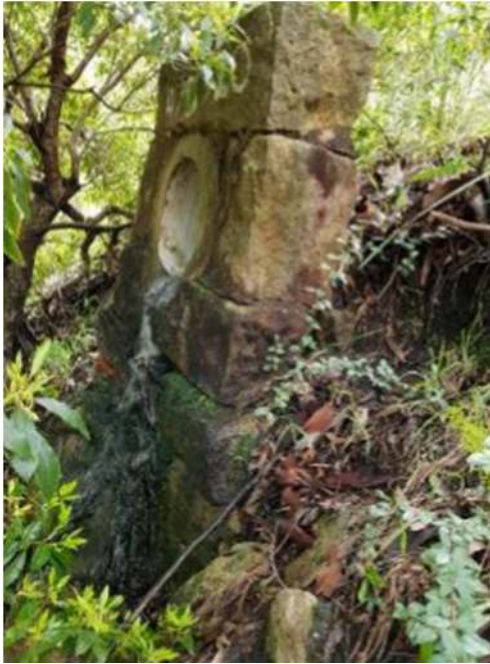
**Figure 22: Example of sandstone culvert headwall with reinforced concrete pipe (culvert no. 475320) along south-western road alignment, facing north (Source: Biosis, 2020).**

- Road surfaces, rock cuttings and guardrails throughout the central portion of the study area
- Culvert headwalls and inlets along the north-eastern and south-western portions of the study area, within the Heathcote Road corridor (Figure 22)

Unlisted heritage features have been considered as they contribute to the local features of a Conservation Management Plan for the bridge and ultimately a potential future curtilage for formal nomination for State Heritage Listing. The reduced length of roadworks on the approaches has avoided impact to some of the cross culverts which required extension in the original design. This avoids impact to some of the heritage stone features observed at the culvert outlets (Figure 22).

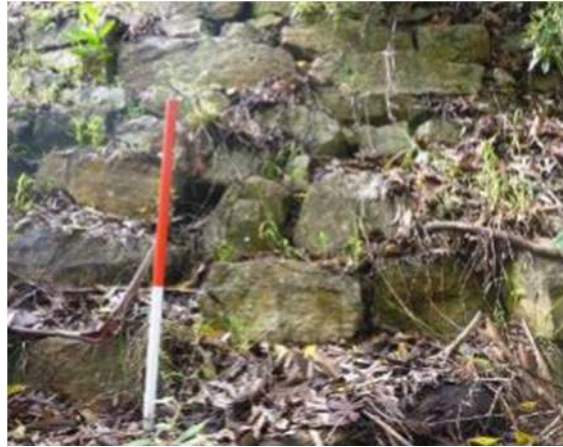
**Figure 23: Sandstone retaining wall section within the south-western portion of the study area, adjacent to road corridor, facing east (Source: Biosis, 2020).**

Construction works on the southern approach in the original scope had the potential to directly (through earthworks) or indirectly (i.e. through vibration) impact the unlisted retaining wall features at the existing bridge edges both east and west of the existing north and south abutments (Figure 23). In the revised project, the southwest sandstone wall will potentially be impacted. The impacted wall would be captured in the scope of pre-works archival recording and encapsulation under geo-technical fabric, consistent with original safeguards outlined in the original SoHI and REF. Relocation of the sandstone blocks would destabilise the adjacent ground and not be feasible.

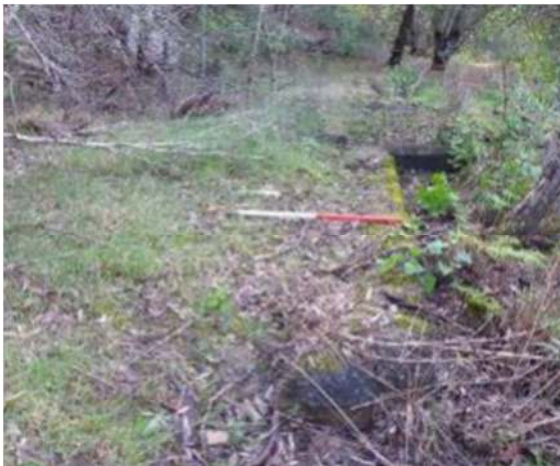
**Figure 24: Concrete foundations located in the north-western portion of the study area, most likely associated with the Kolora Weir and the amenities block (Source: Biosis, 2020).**

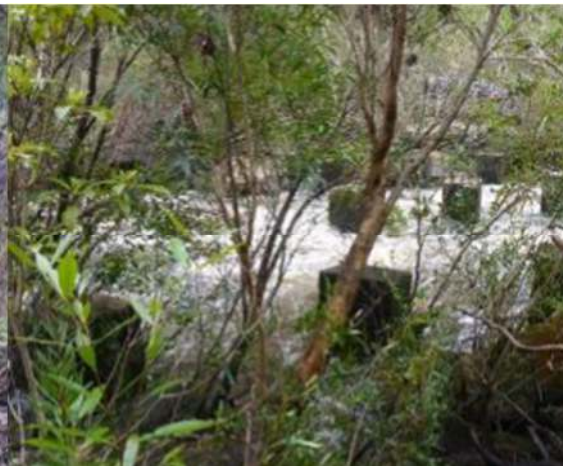
**Figure 25: Concrete piers across the extent of Heathcote Creek, associated with the access track and former bridge (Source: Biosis, 2020).**

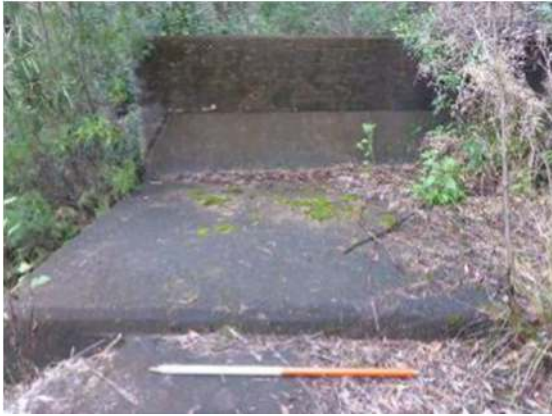
**Figure 26: Large concrete material associated with the Weir in the north-western portion of the study area (Source: Biosis, 2020).**
