# Heathcote Road Bridge

Addendum Review of  
Environmental Factors

April 2022

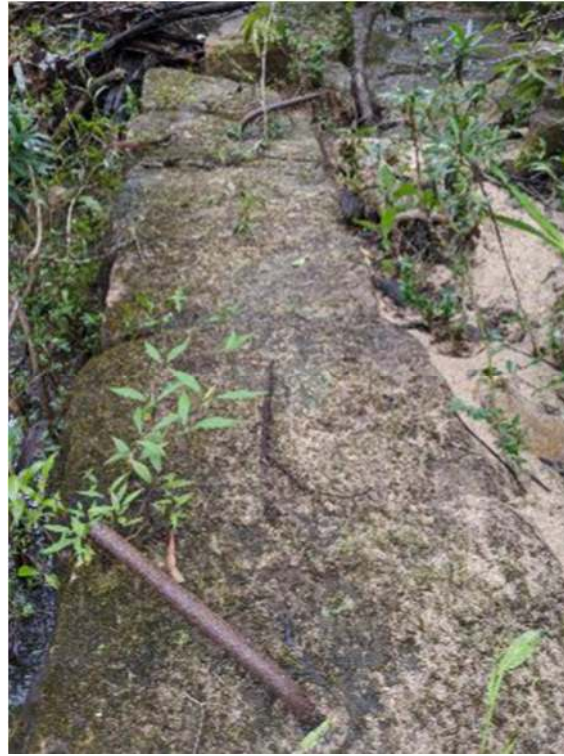
**Figure 27: Sandstone abutment possibly associated with the former crossing over Heathcote Creek and the Kolora Weir (Source: Biosis, 2020).**

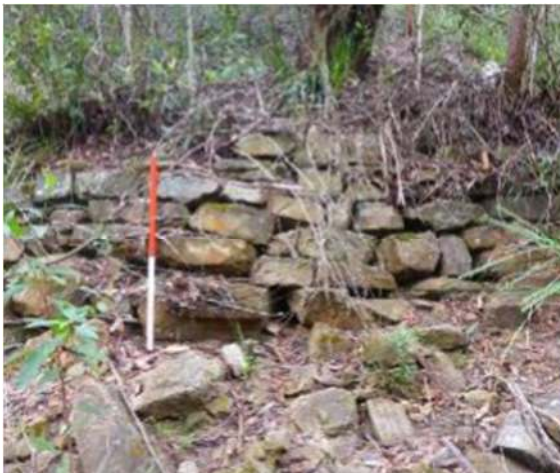
**Figure 28: Small sandstone wall located adjacent to Heathcote Creek, most likely associated with the Weir (Biosis, 2020).**

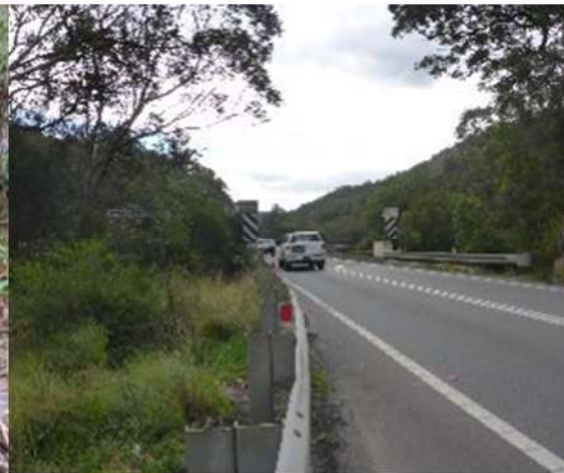
**Figure 29: View of 1990 additions to Woronora River Bridge comprising jersey kerb and rectangular steel rails on the southern approach (Biosis, 2020).**

- Woronora River Bridge (RTA Bridge no. 152) located through the centre of the study area, extending across Woronora River and forming part of Heathcote Road, including 1990 additions comprising jersey kerb and rectangular steel rails (Figure 29)

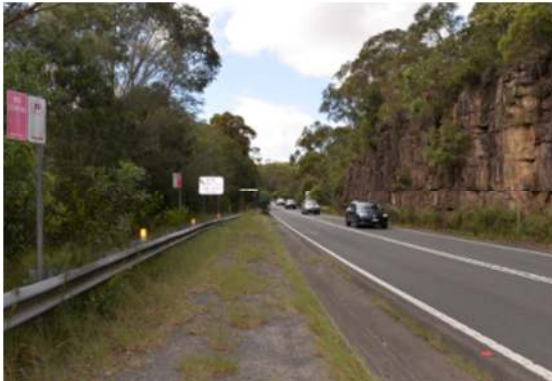
**Figure 30: Northern approach of Woronora River Bridge.**

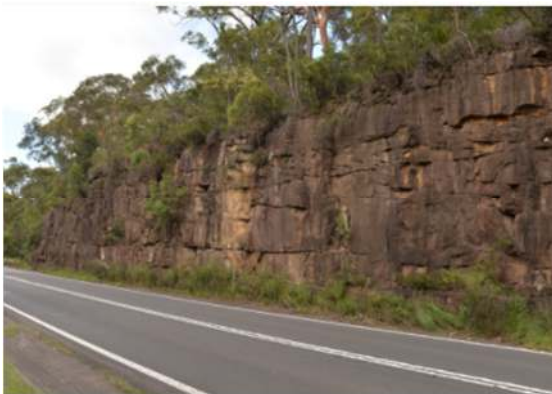
**Figure 32: Sandstone outcrop northwest of bridge, located within Cubbitch Barta National Estate Area.**

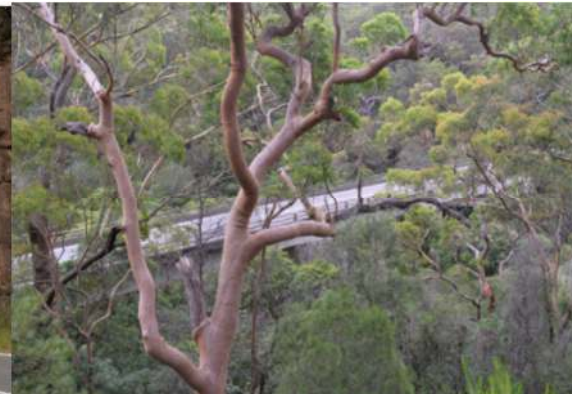
**Figure 33: Current bridge viewed from top of sandstone outcrop. Proposed bridge to be constructed parallel to current structure.**

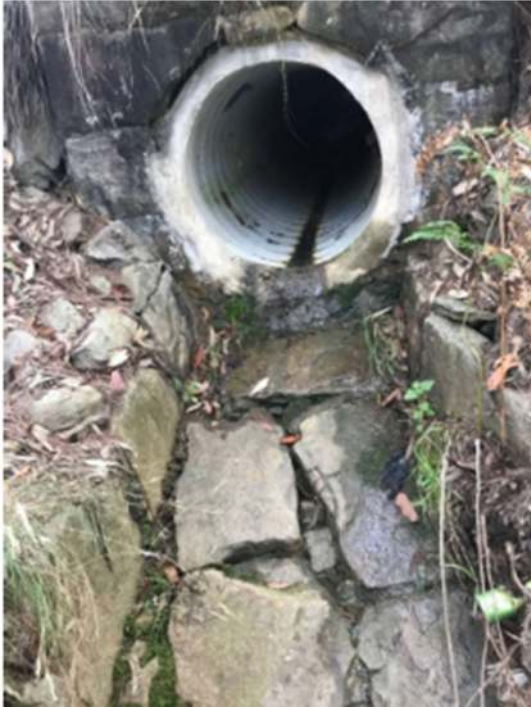
**Figure 34: Outlet for Cross Drain Exist-01, provided by Fulton Hogan.**

The issues surrounding flow width in proximity to the study area were identified after the site inspection was conducted, and, as such, Cross Drain Exist-01 and its immediate surrounds were not inspected. While images of the outlet of the culvert and the sandstone drainage chute were provided by Fulton Hogan (Figure 34 AND Figure 35), no images of the inlet were provided.

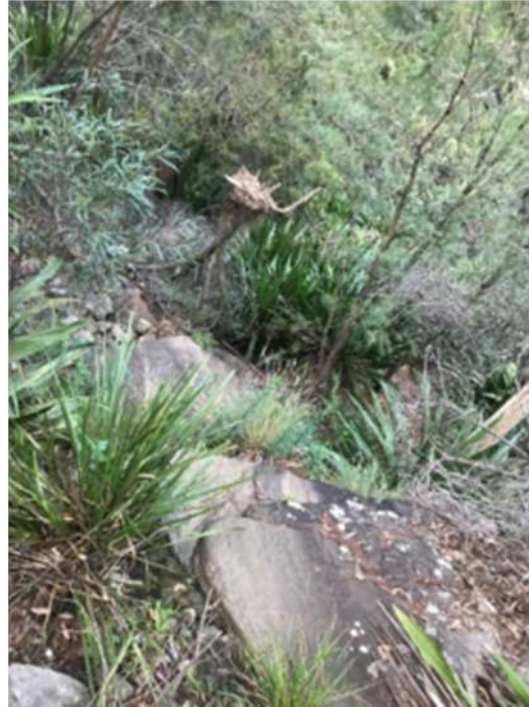
**Figure 35: Sandstone chute which drains flow from outlet, provided by Fulton Hogan.**

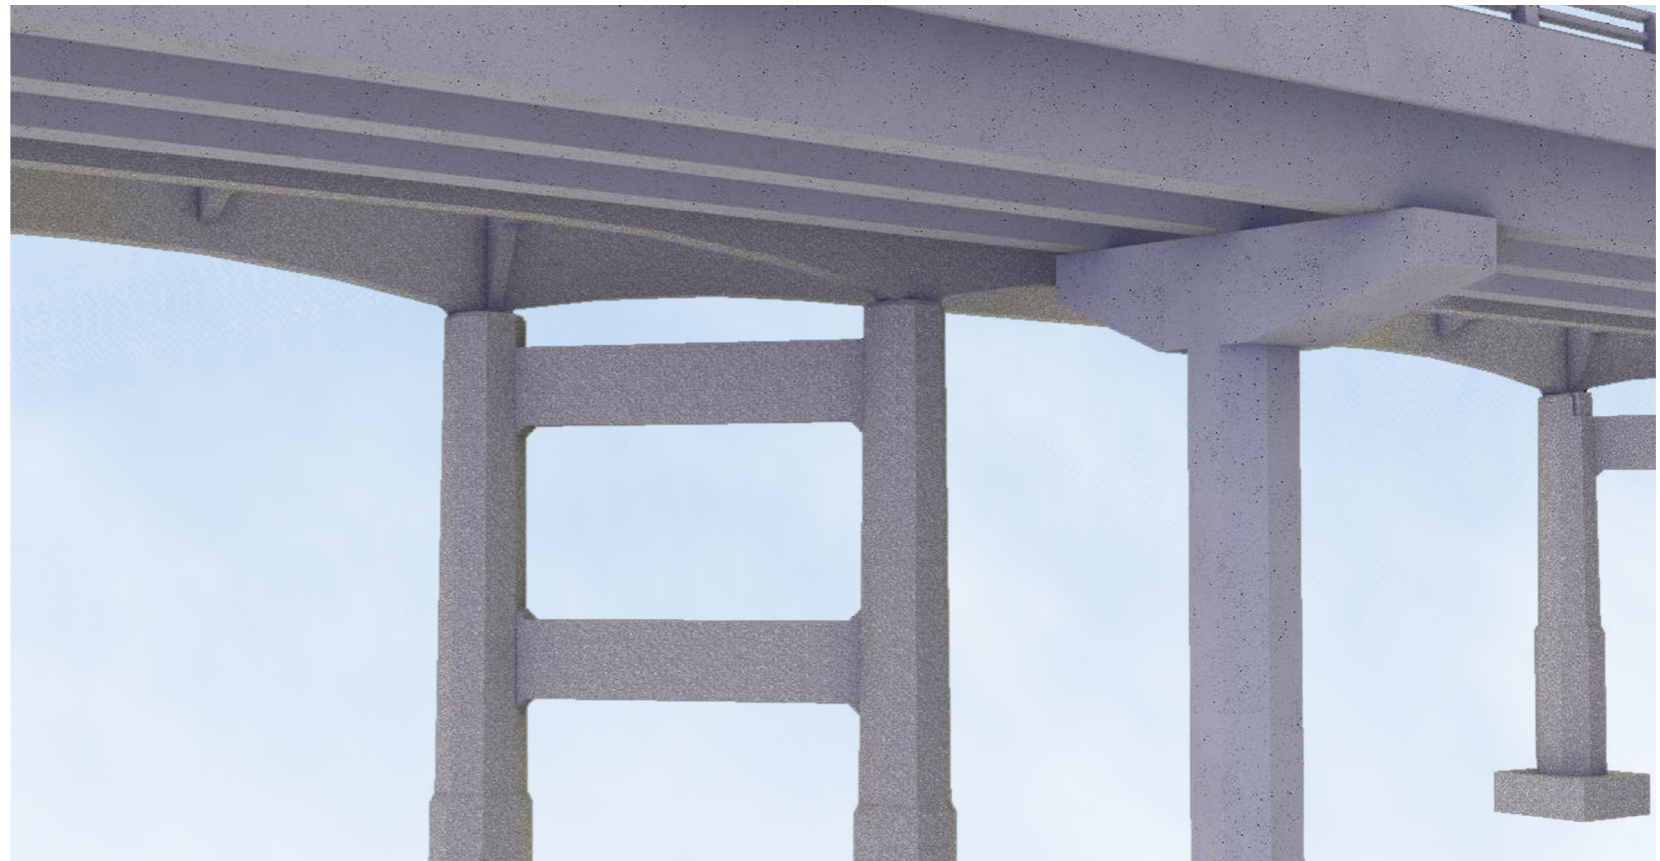
Figure 7. Indicative 3D study of underside of proposed and existing bridges

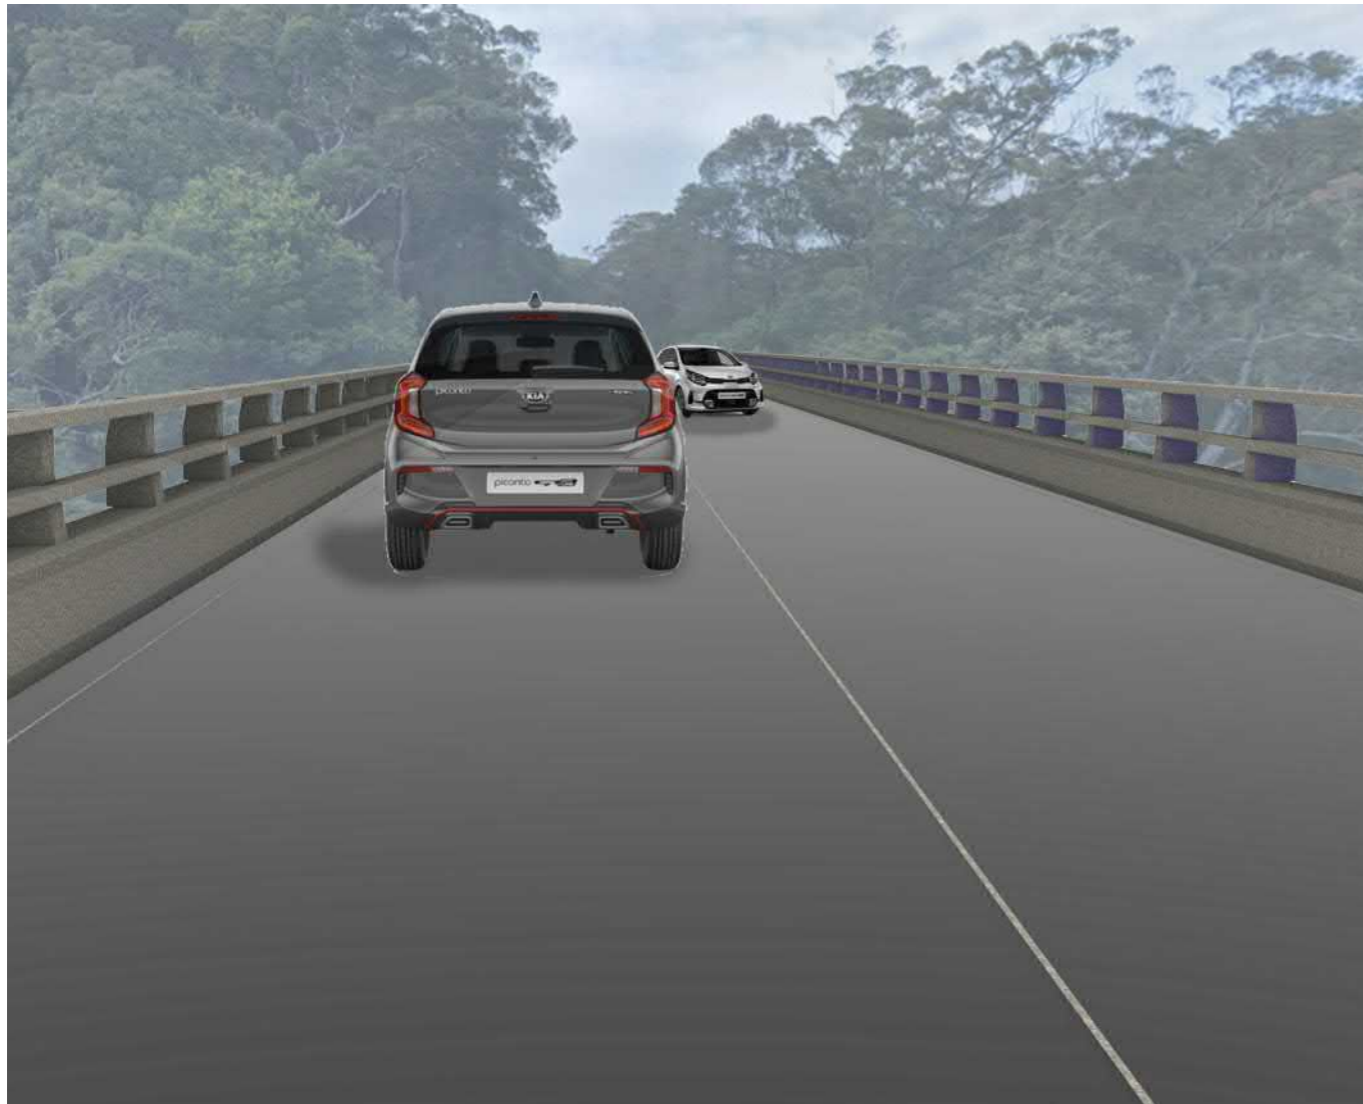
Figure 9. Visualisation of existing bridge view, looking south

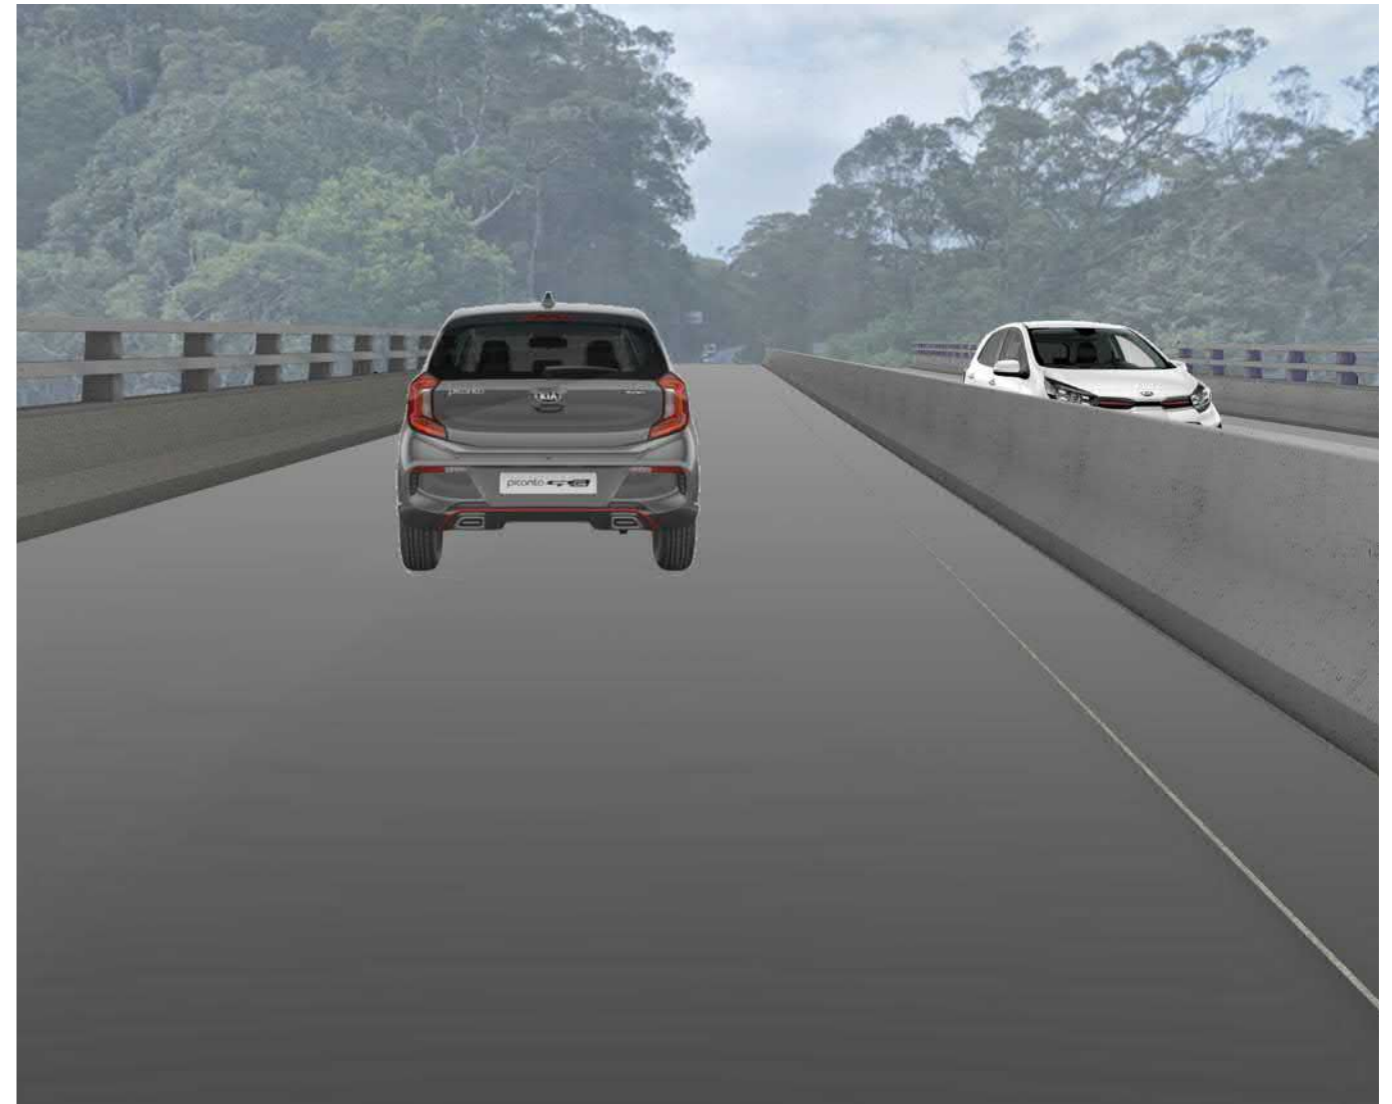
Figure 10. Visualisation of proposed bridge view showing central barrier under consideration

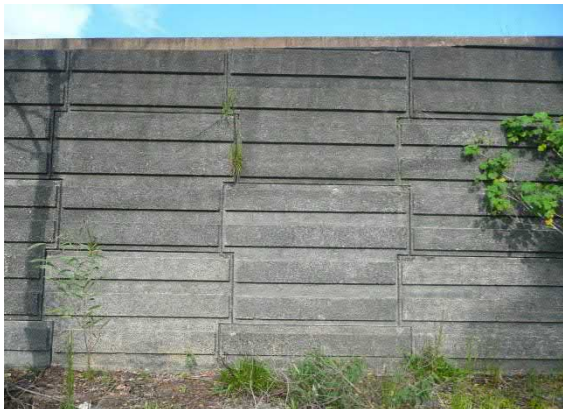
The material of the abutment is suggested to be a dark recessive colour utilising either the addition of pigments or pigments and aggregates, with simple rebates to break-up the mass of the wall and reduce its susceptibility to vandalism.

Figure 11. Abutment treatment example

Maintenance access to the abutment will be provided in the form of stairs with handrails.

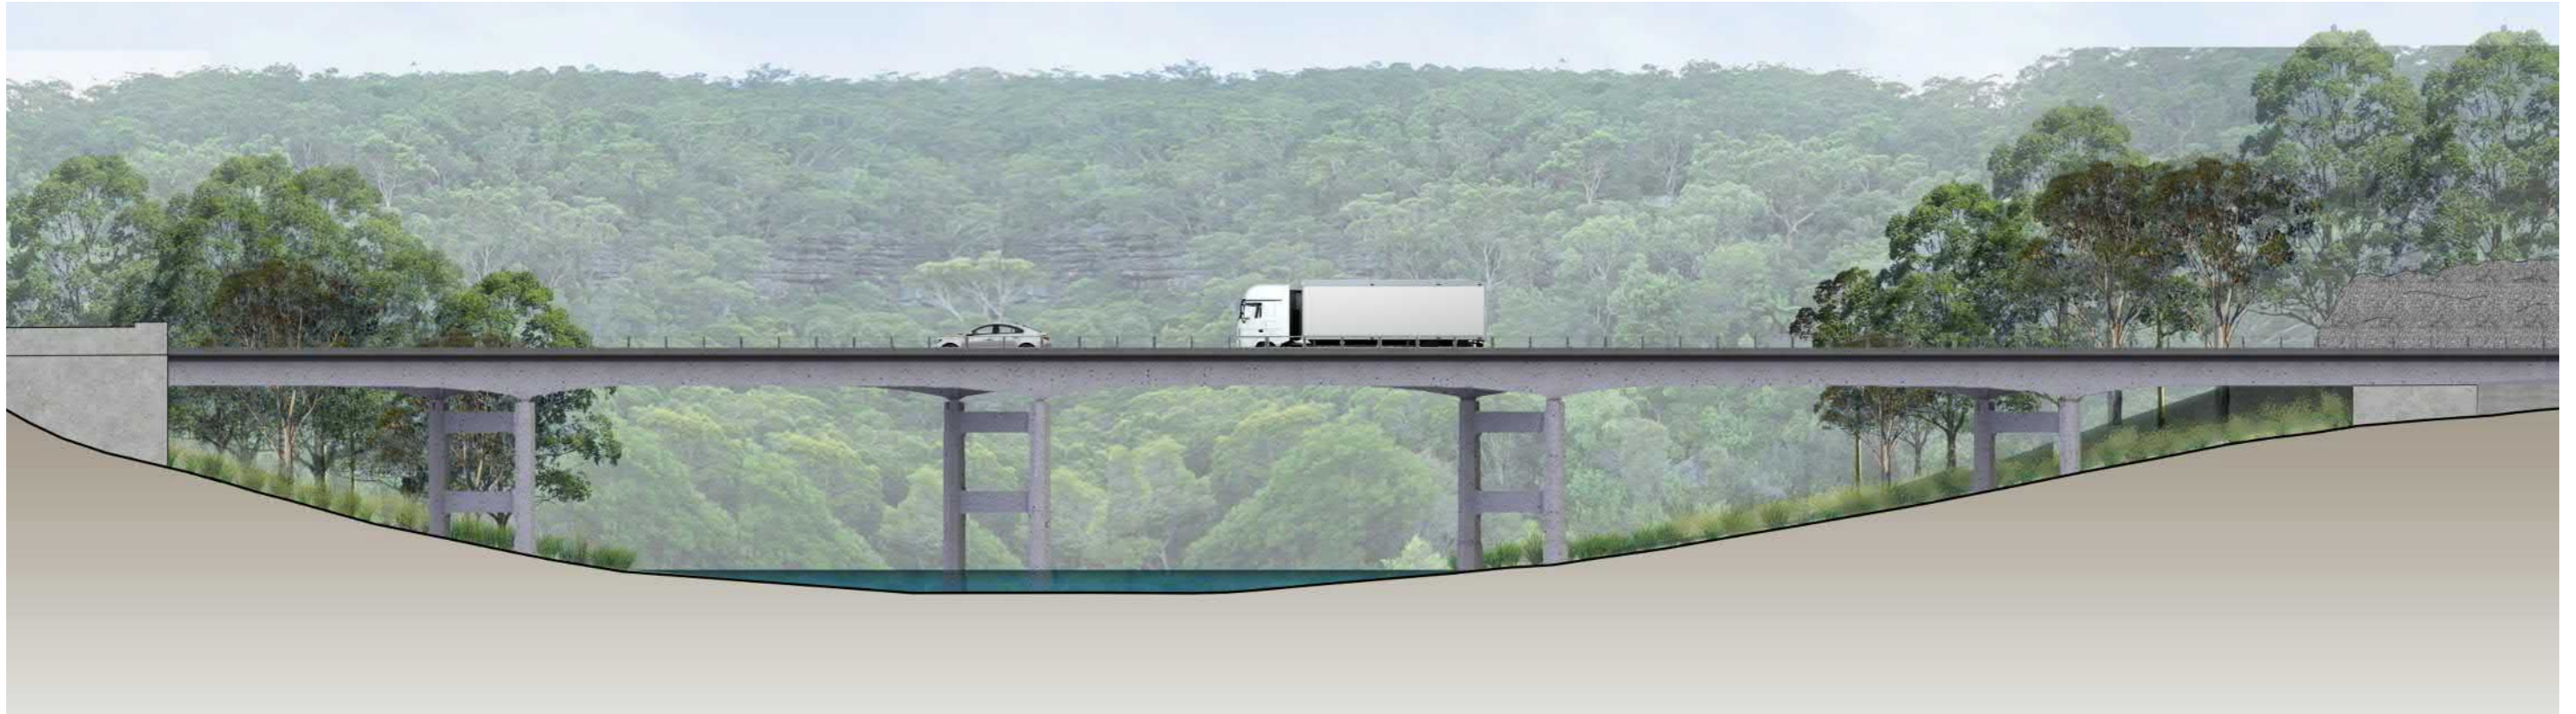
Figure 13. Elevation of existing bridge

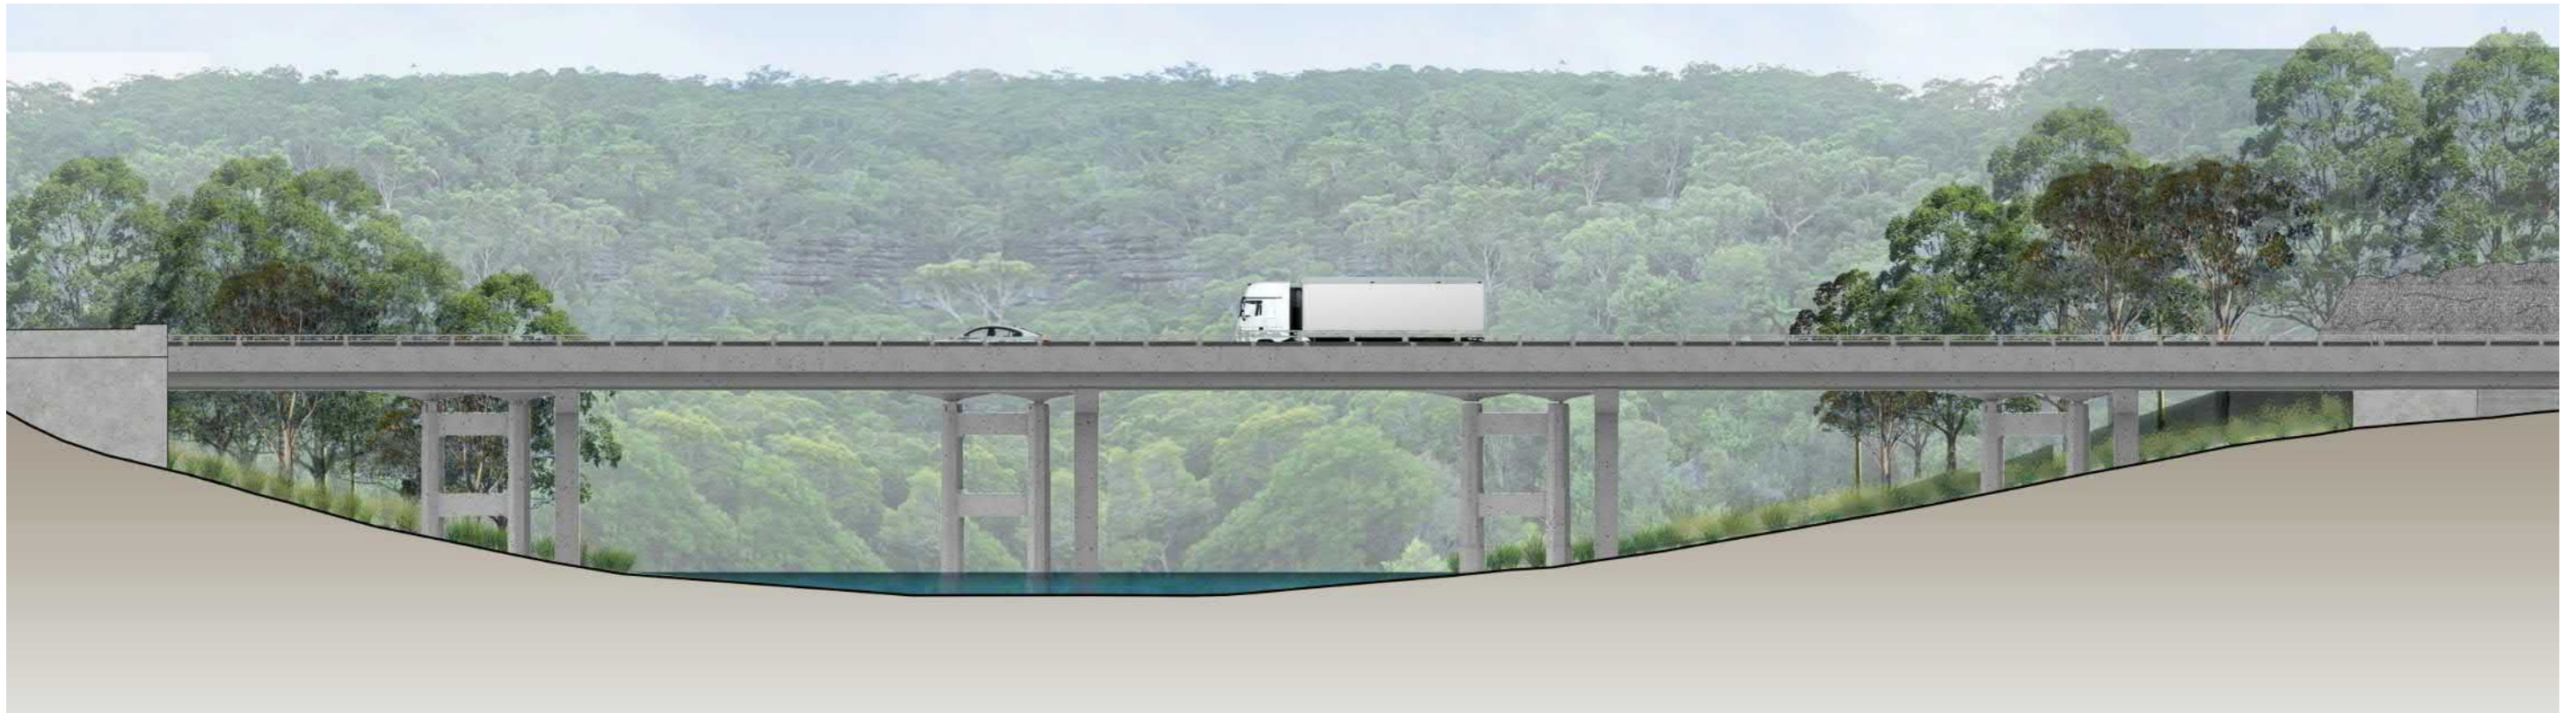
Figure 14. Elevation of new bridge in relation to existing bridge

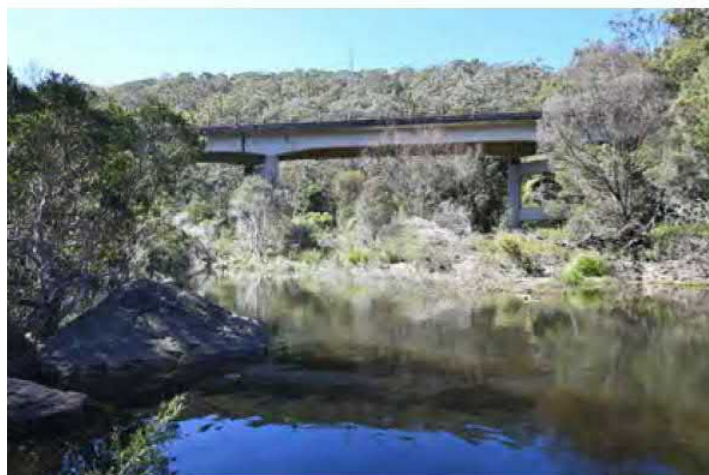
Figure 15. View of existing bridge looking east

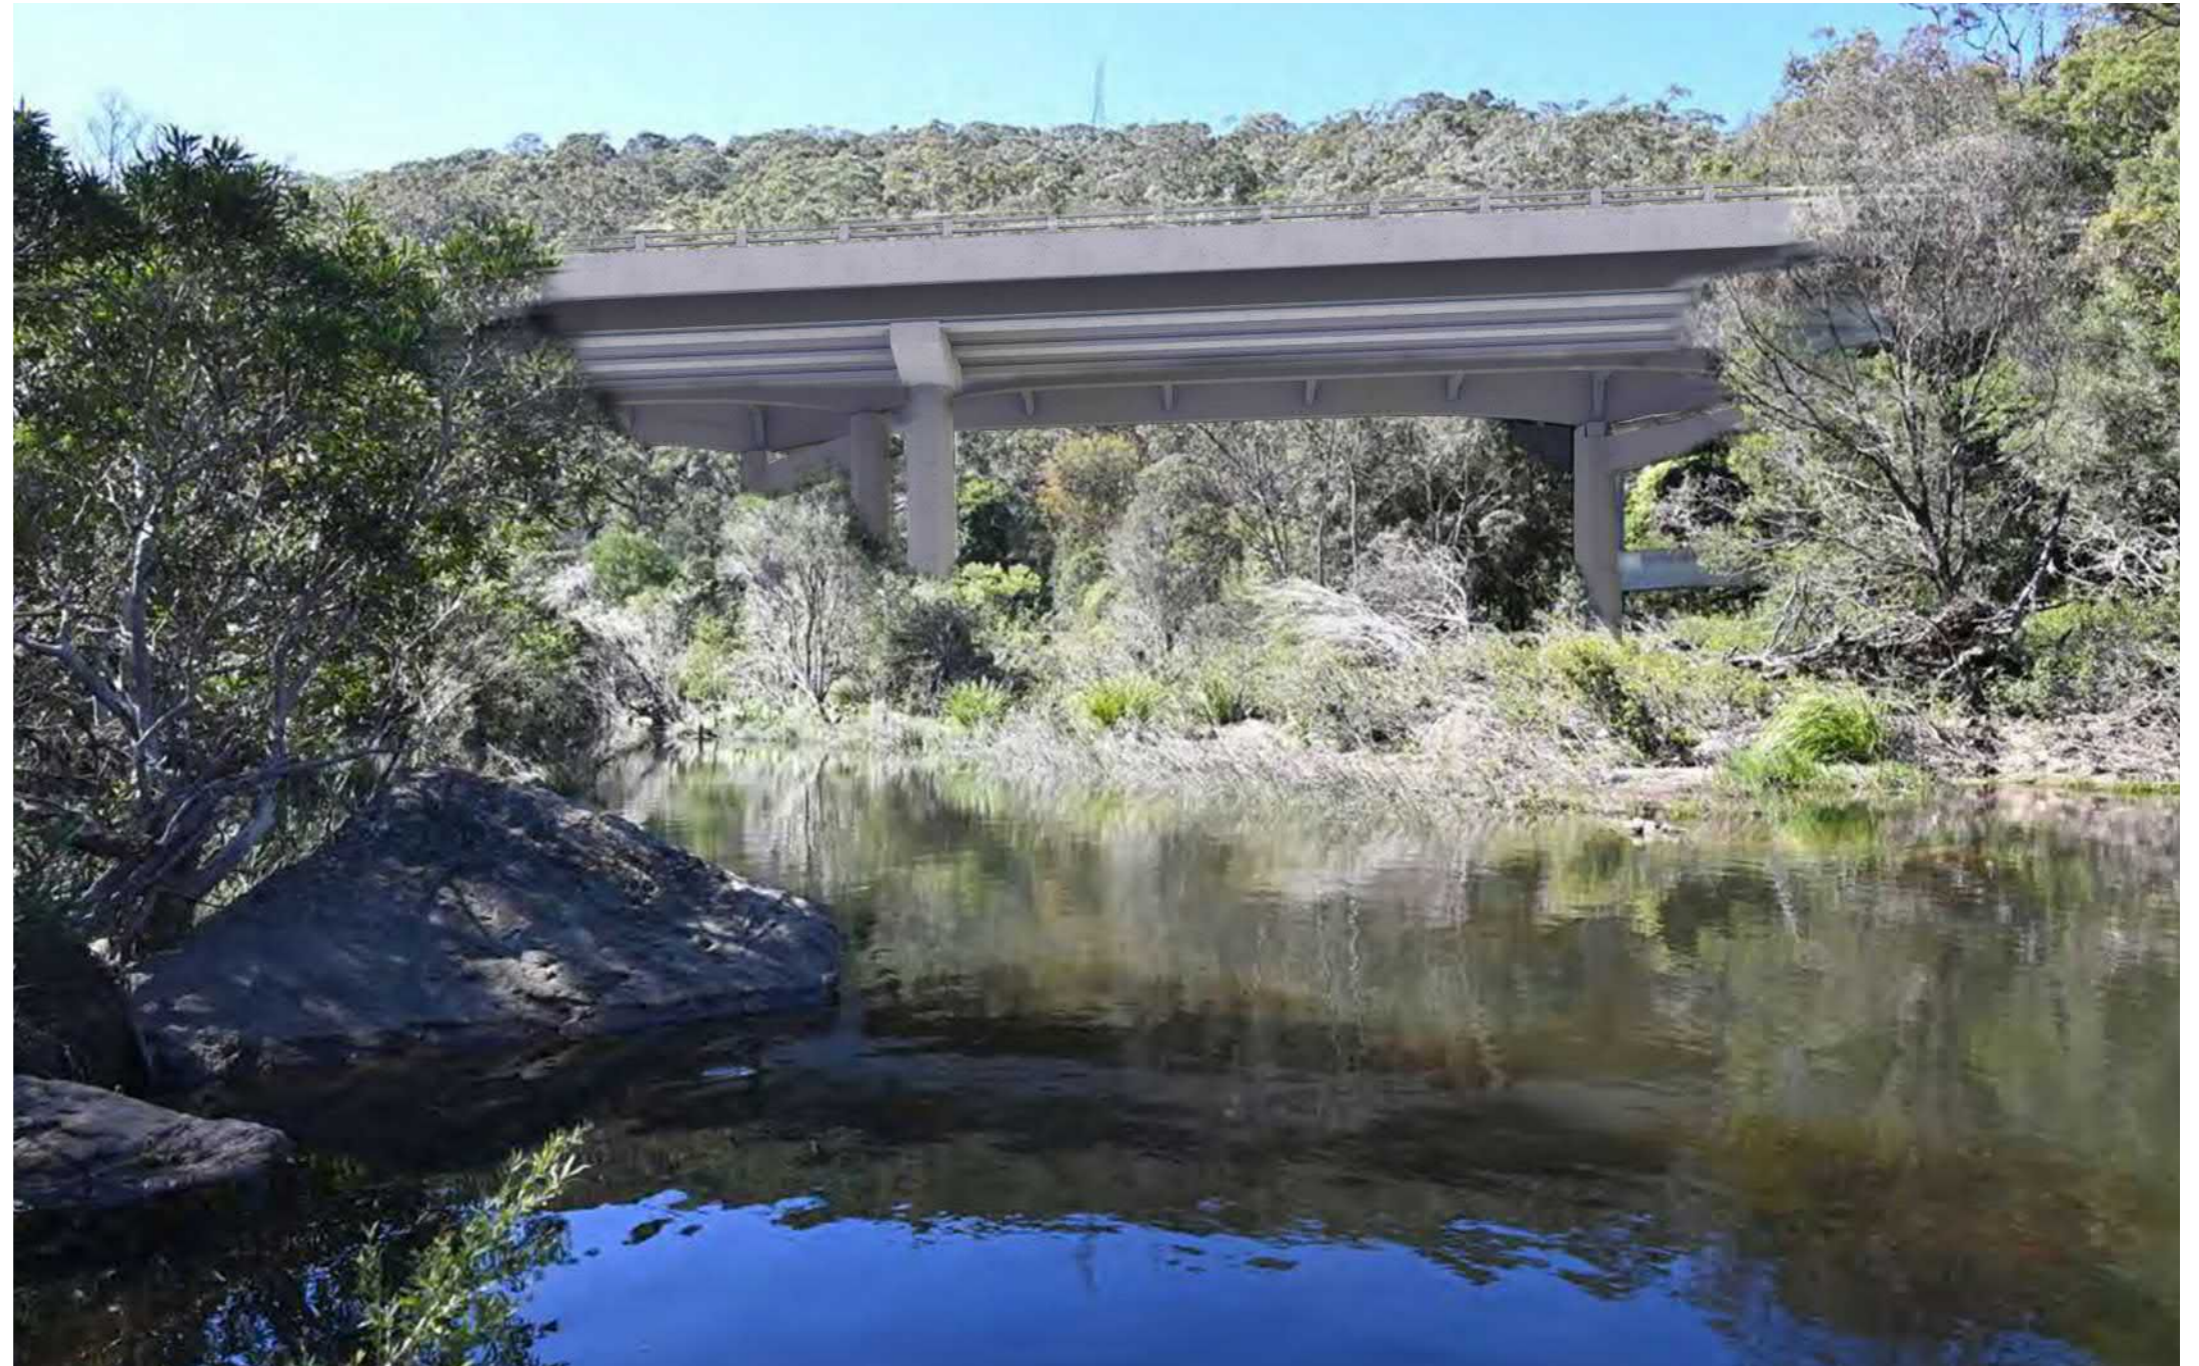
Figure 16. Indicative photomontage of the new bridge with the existing bridge

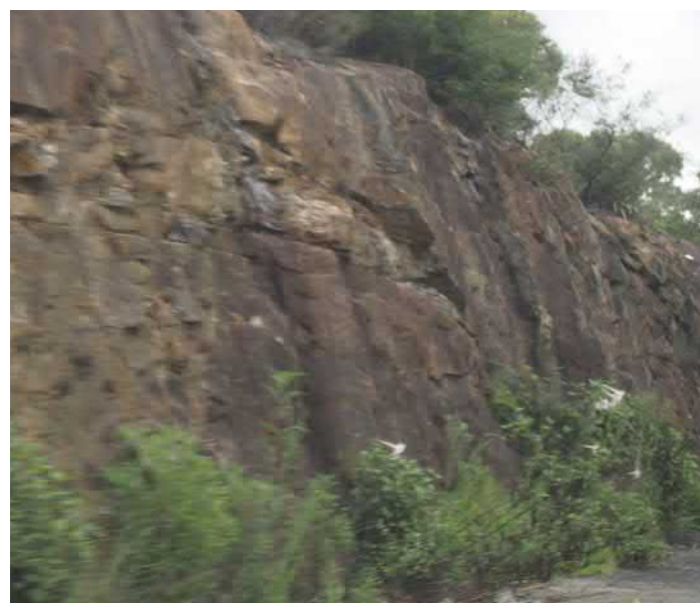
The treatment of the top of the cut plays an important role in the overall appearance of the cut, particularly where the cutting has been cut near vertical. This edge is influenced by its interface with residual soil profiles and whether it is stable without treatment. The design of this edge needs to consider the stability of this element and how this is handled.

Figure 20. Example of Linedrilling rock face

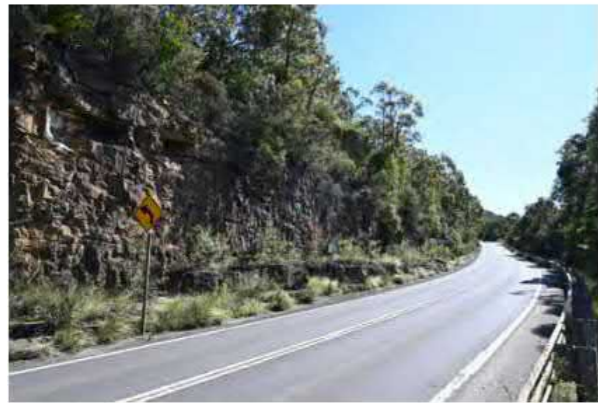
View 01 *View looking north near the northern approach to the bridge.*

View	Description of setting	Sensitivity of view		Addendum commentary
V01	Existing sandstone cutting along the northern approach to the bridge, travelling north. The cutting exposes the geology of the area and contributes to the identity of the roadway.	M	Moderate, although the road is of a high scenic quality, the transient nature of the viewer limits the sensitivity compared to other viewpoints assessed.	assessment remains
V02	Northern approach to the bridge travelling south. Highly scenic setting with dense bushland within a rugged terrain.	M	Moderate, although the road is of a high scenic quality, the transient nature of the viewer limits the sensitivity.	assessment remains
V03	Bridge over the Woronora River, travelling south. Open panoramic vistas towards the adjacent bushland with vistas towards a deep gully, exposing sandstone cliffs.	H	High, the bridge crossing visually accentuates the scenic character of the area, providing elevated panoramic views to the adjacent landscape. The crossing is a key visual marker along the journey experience and the scenic setting contributes to the higher rating to an otherwise transient viewpoint.	assessment remains

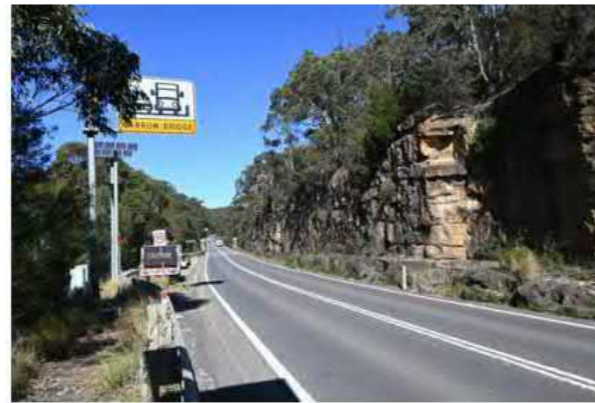
View 02 *View looking south from the northern approach to the bridge. To the right side of the picture, sandstone cuttings expose the geology of the area.*

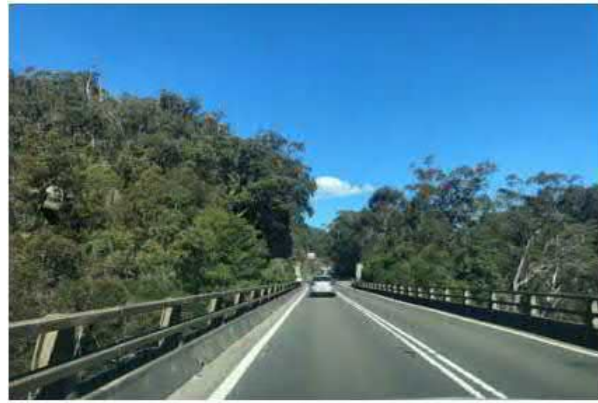
View 03 *Crossing over the Woronora River with panoramic vistas of the pristine bushland.*

V03	High	Moderate	Although the visual impact is moderate to high, the rating is a result of both a higher visual presence of the bridge but also an improved visual experience.	The enhanced perception of safety through the wider bridge also improves the opportunity to visually absorb the scenery.	Addendum NO CHANGE visual impact
V04	Moderate	Moderate	A moderate visual impact is assessed based on the relative minor interventions to the existing rock cutting and widened road formation.	It is important to ensure any shotcrete works are minimised. If larger areas are required, a set of aesthetic guidelines needs to be considered in the next phases of the design.  The use of rock mesh and bolts should be minimised to retain the existing natural character.  The overall driving experience would be slightly enhanced by introducing better sight lines.	Addendum NO CHANGE visual impact  Design has changed however, Magnitude and Visual Impact assessment remains

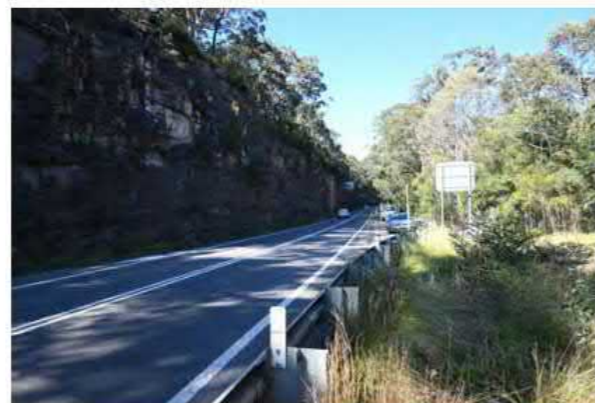
View 04 *Sandstone cutting at the southern approach creates a visually dramatic setting and displays the rugged topography.*

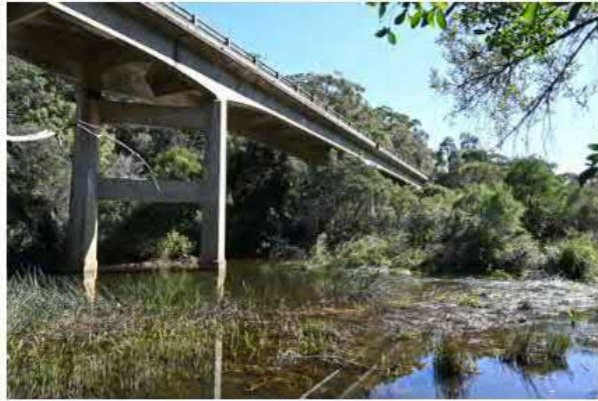
View 05 *View looking north from the river foreshore with the structure clearly visible.*

View	Description of setting	Sensitivity of view		Addendum commentary
V05	River foreshore in a pristine bushland setting with wetland grasses, rock shelves and sand banks. Road bridge clearly visible that is a dominant feature.	M	Moderate, the viewpoint's scenic quality is detracted by the bridge in close proximity, resulting in a moderate rating.	assessment remains
V06	View from under the bridge looking towards the northern abutment. Bushland setting with riverscape in the foreground	L	Low, the dominance of the structure deters the quality of the viewscape, limiting its sensitivity. This viewpoint is considered of a transient nature, contributing to the low rating.	assessment remains
V07	River foreshore looking towards road bridge overhead.	M	Moderate, although the bridge crossing is a dominant feature, the scenic quality of the setting makes this viewpoint more sensitive compared to Viewpoint 06.	assessment remains

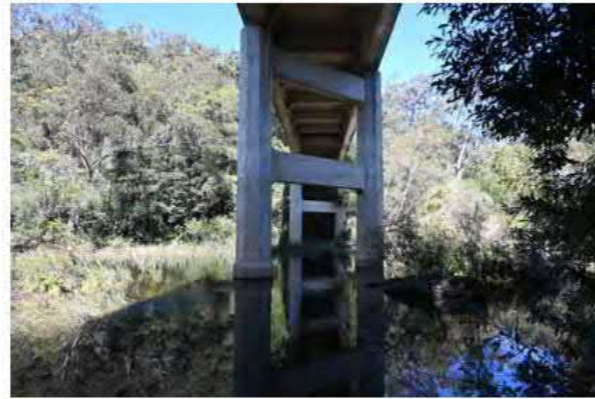
View 06 *View looking north from beneath the structure.*

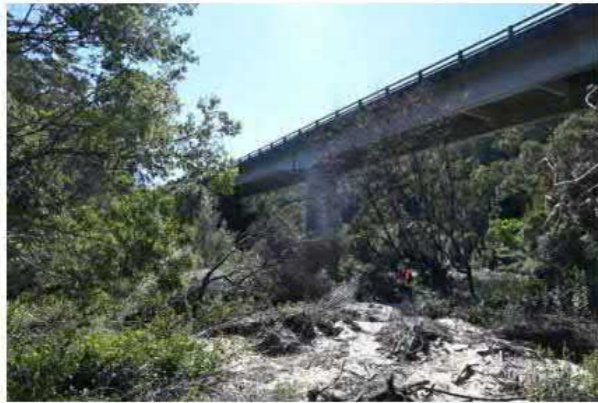
View 07 *Close up view of the structure looking from the southern foreshore to the northeast. Note the structure being in the shade (dark grey) helping it to visually blend with the backdrop.*

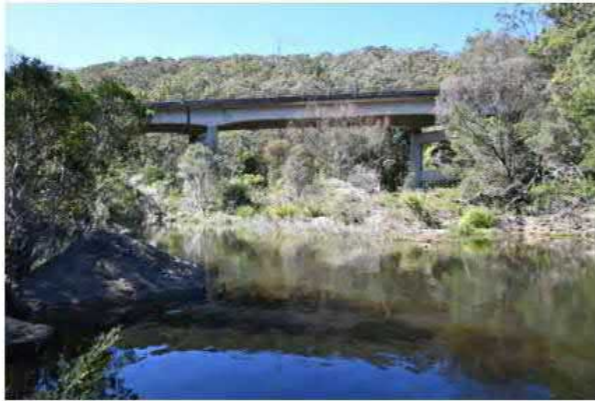
View 08 *Distant view from the northern foreshore looking east. The bushland backdrop helps settle the structure in its setting.*
